**Town of Fairfield**  
Town Planning and Zoning Commission  
725 Old Post Road  
Fairfield, Connecticut 06824

**To: Members of the RTM**  
**From: Jim Wendt, Planning Director**  
**Date: April 19, 2022**  
**Re: Opt-Out of State Mandated Zoning Regulation Language**

FAIRFIELD TOWN PLAN AND ZONING COMMISSION PROPOSED OPT-OUT OF  
STATE MANDATED REGULATION LANGUAGE REGARDING OFF-STREET PARKING.

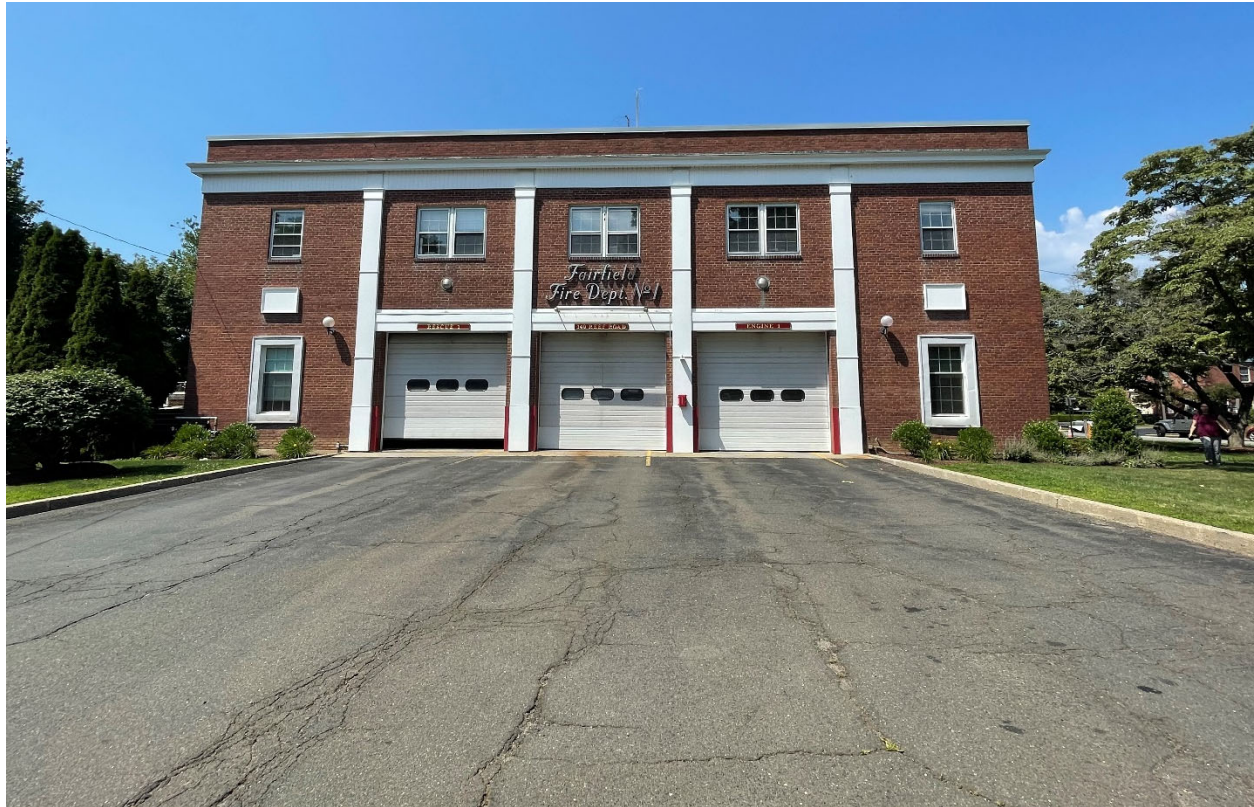
### **Exterior Building Envelope**

This two-story facade is in good condition. The exterior brick walls of the fire station are generally in good condition, with a limited areas of settling and spalling. The building is constructed with brick "veneer" with no air space evident. The energy efficiency of this construction is very low, and typical in the 1950s ("pre-energy crisis"), and not one that is easily or readily corrected. There are limited areas which will eventually require repointing or repairing, most notably on the lower portions of the wall near grade. Overall, the building's envelope is in good condition, considering its age.

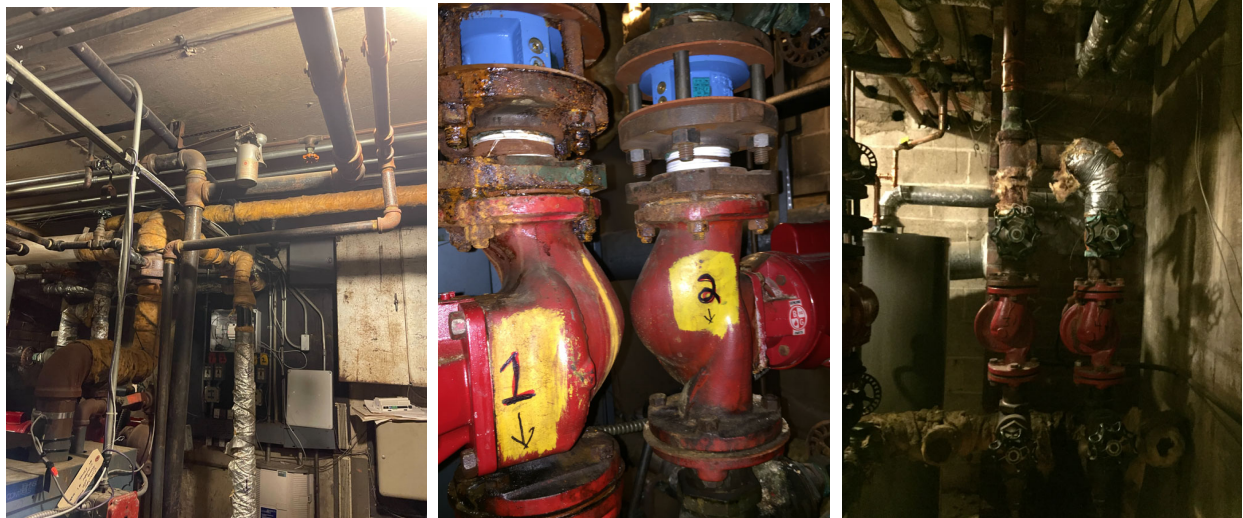
The existing steel piping distribution system and associated components are showing signs of wear, they are likely original to the building and should be considered for replacement. There are newer hot water copper pipes with press fittings routed in the basement. Date of installation is unknown; it is likely that copper pipes are less than 20 years old since the pro-press technology were only introduced to the US market in 1999.

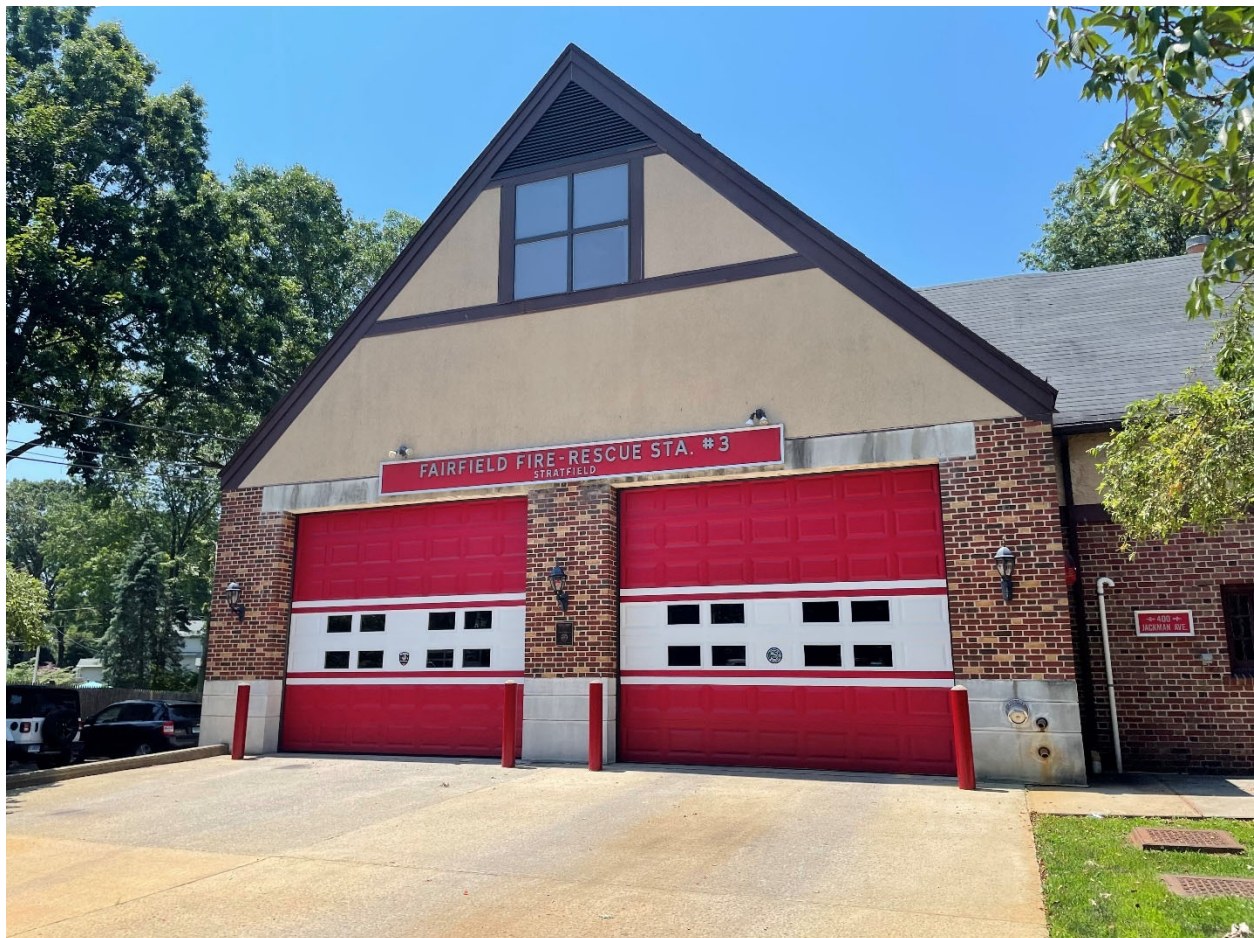
### Exterior Building Envelope

Considering the age of this building the exterior walls are in great condition. The concrete foundation looks dated with the rear portion consisting of staining and a little deterioration. The exterior brick walls of the fire station are generally in good condition, with a limited areas of settling and spalling. The building is constructed with brick "veneer" with no air space evident, predictable for its age. The energy efficiency of this construction is very low, and typical in the 1920s ("pre-energy crisis"), and not one that is easily or readily corrected. It is evident that repointing in some areas have been previously performed. There are still some limited areas which will eventually require

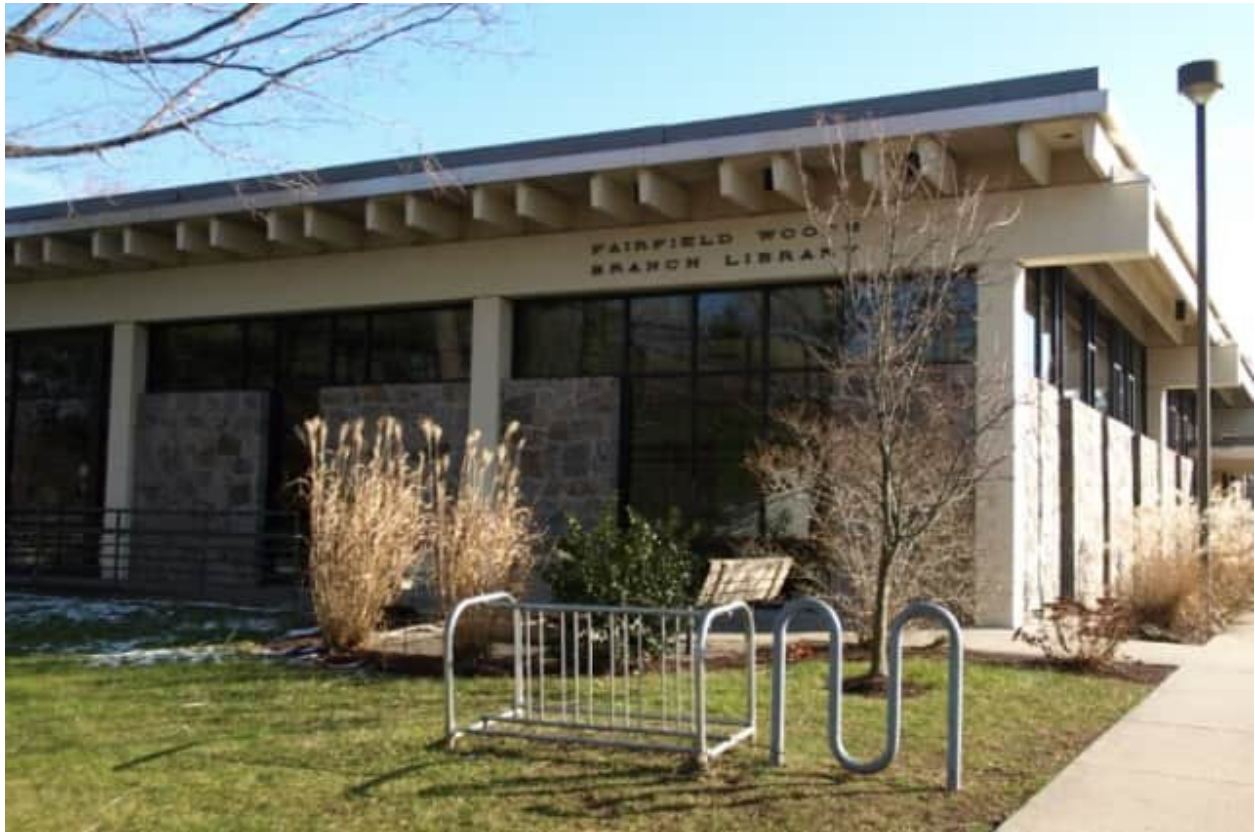
### Exterior Building Envelope

The single-story facade is composed of stone cavity walls within a concrete structure. The exterior of the building is in good condition, with some areas of wear and tear. The mortar is in good condition with limited areas in need of repointing. There are some minor cracks throughout the concrete portion. Many areas of the concrete structure have peeling paint and should be scraped, primed and painted.

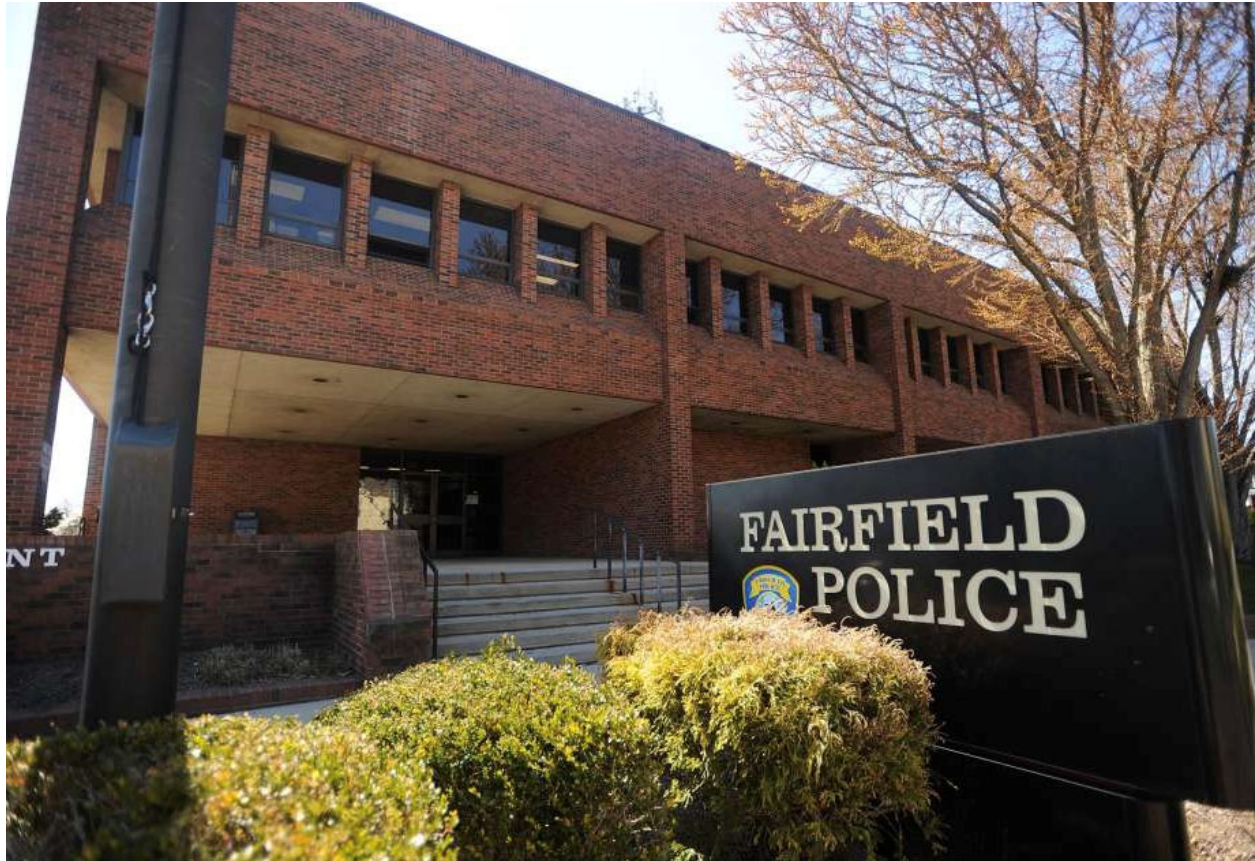
### Exterior Building Envelope

The exterior of the building is in good condition. The building is constructed with brick "veneer", rigid insulation, air space and painted concrete masonry unit or brick interior. Overall, the mortar is in reasonably good condition although the age of the building suggests that in the future a detail review should evaluate if repointing is required. Additionally, some vegetation and mildew have been growing at the base of the building in some areas. These should be cleaned and sealed to ensure the longevity of this construction.

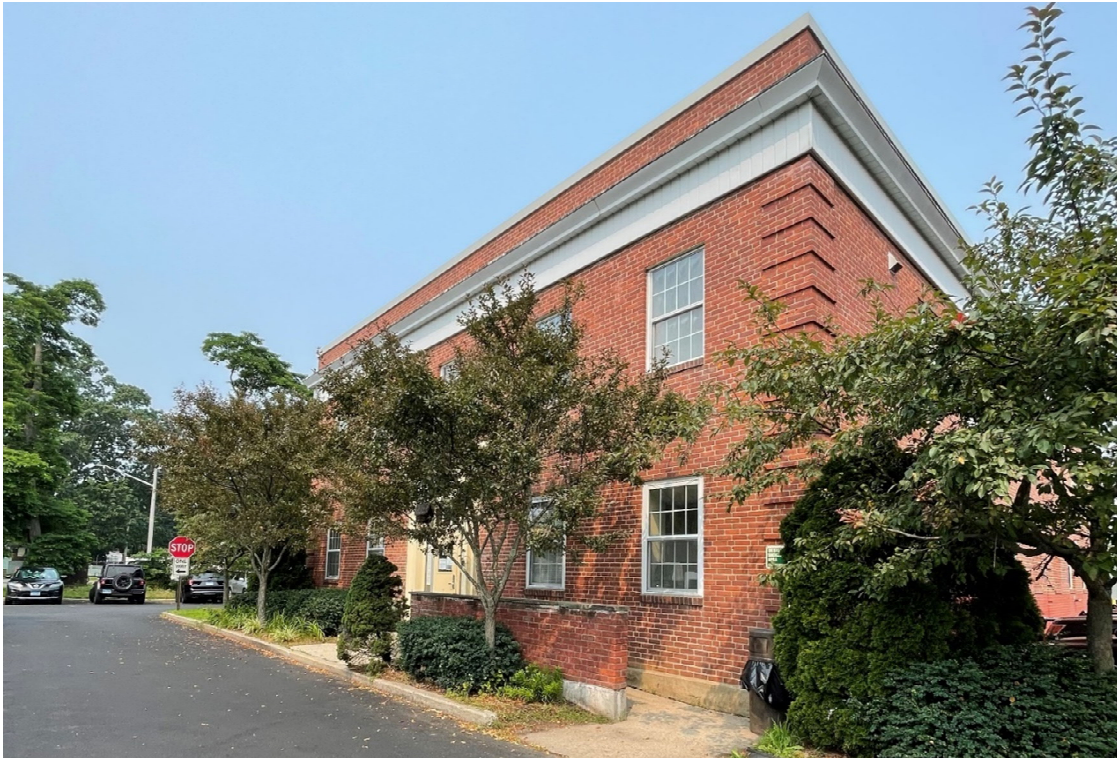
### Exterior Building Envelope

This two-story facade has many areas of disrepair. The building is constructed with brick “veneer” with no air space evident. The energy efficiency of this construction is very low, and typical in the 1950s (“pre-energy crisis”), and not one that is easily or readily corrected. The exterior brick walls have a considerable amount of settling and spalling. The north and west elevations have a large amount of spalling bricks throughout that should be replaced. In addition the building should be cleaned and remove the unwanted vegetation on the side of the building.
