H. SMITH RICHARDSON GOLF COURSE CLUBHOUSE
FEASIBILITY STUDY

Re: Report of Findings

H. Smith Richardson Golf Course
Clubhouse Renovation/ Expansion/ Replacement Feasibility Study
Fairfield, CT

Re: **Building Evaluation of the
Mechanical, Electrical, Plumbing and Life Safety Systems
Smith Richardson Golf Course Clubhouse
2425 Morehouse Highway
Fairfield, CT**

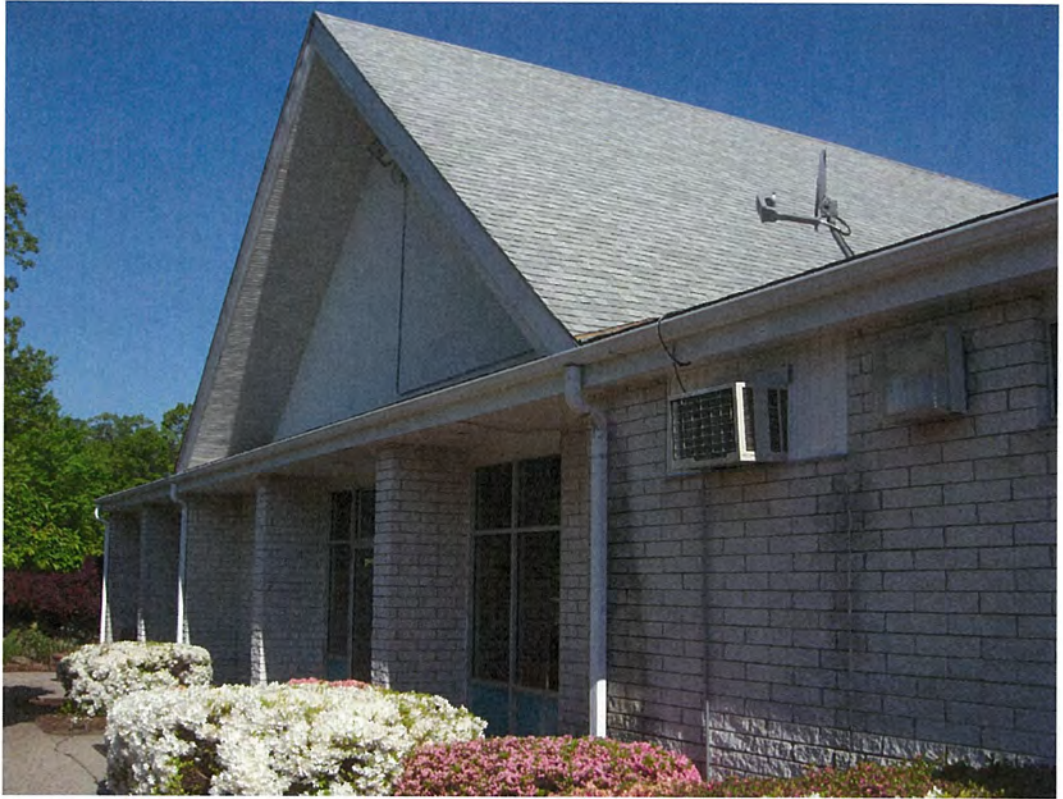
Photo 1: Southside Entrance

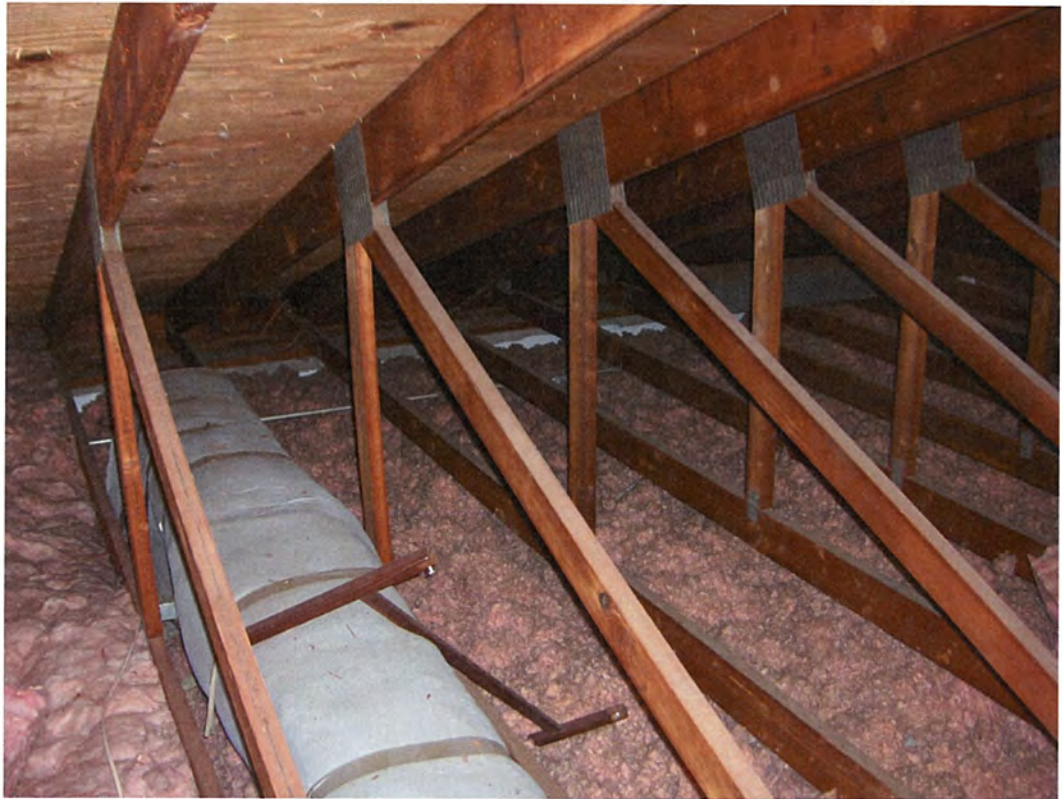
- Wood trusses composed of construction grade 2x4, 2x6, and 2x8 lumber and galvanized gusset joint reinforcement installed in two segments: north side and south side of primary east-west ridge providing support to a gable roof. (See Photo 2). These trusses are supported by the exterior and the main interior bearing walls. No obvious buckling or deterioration was apparent. There is no attic floor besides a narrow path and the trusses and ductwork do not permit the use of this large space – even for storage. Loose blown-in insulation was installed between the bottom cords of the trusses but not likely to conform to current energy code requirements;

Photo 2: Roof Trusses, Ductwork, and Blown-in Insulation.

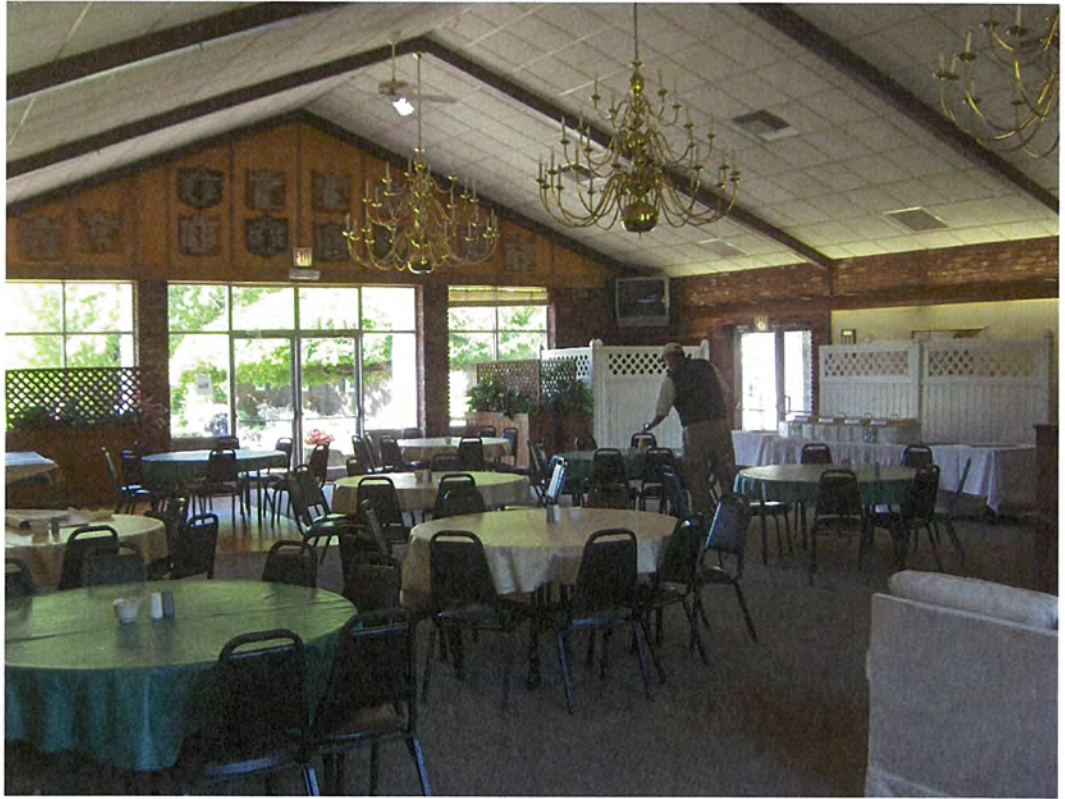
- The Dining Room ceiling is also suspended acoustic ceiling tile in a standard tee grid and is pitched to the slope of the underside of the scissor trusses above. (See Photo 3.) This ceiling is segmented by three lines of decorative (non-supporting) wood beams – condition fair;
- Lighting is provided by ample natural light from the north and south ends of the room and by (3) large chandeliers suspended at the peaks of the three decorative beams and by linear wall-mounted fluorescent lights with valances running the length of the room on both sides except where interrupted by the

Photo 3: Dining Room

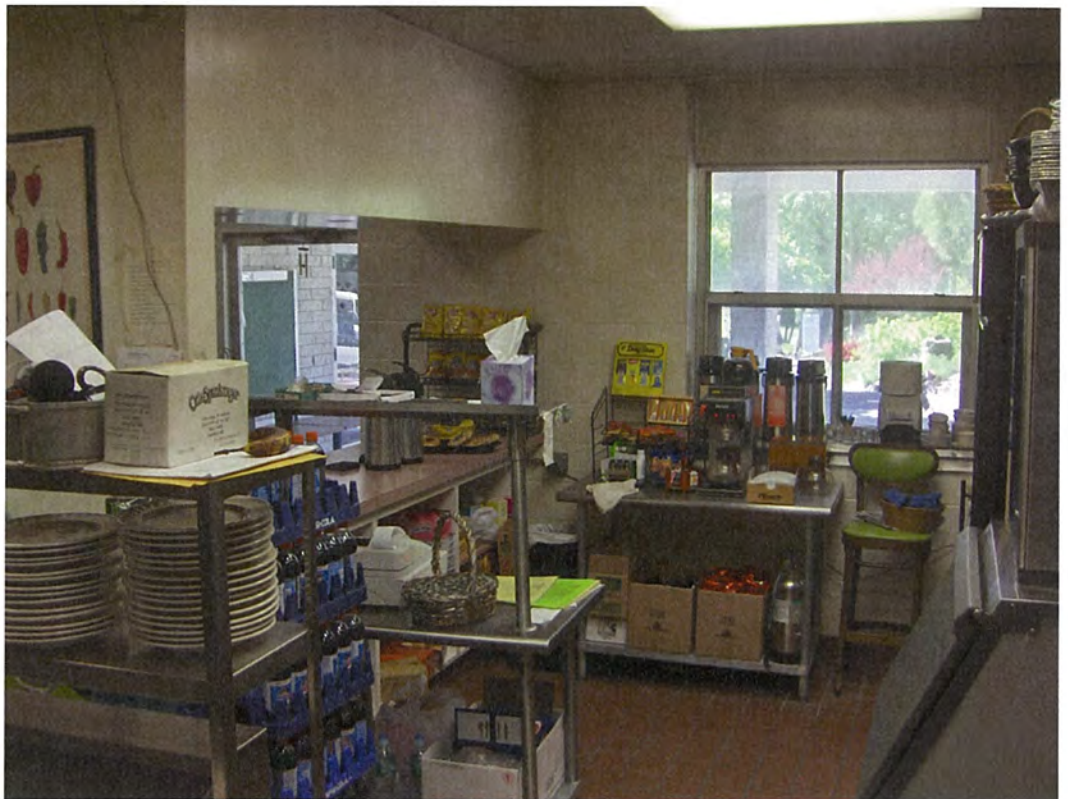
- The Kitchen was substantially renovated in 2003 and is in good condition. It appears cramped with inadequate storage as evidenced by the boxes of supplies and stock in many views;
- Walls are painted cmu – condition good;
- Ceilings are suspended washable ceiling tiles in a 2' x 2' grid - condition fair; Drawing indicate that the ceiling is fire rated;
- The floor is quarry tile – condition good.

Photo 4: Kitchen/ Snack Bar

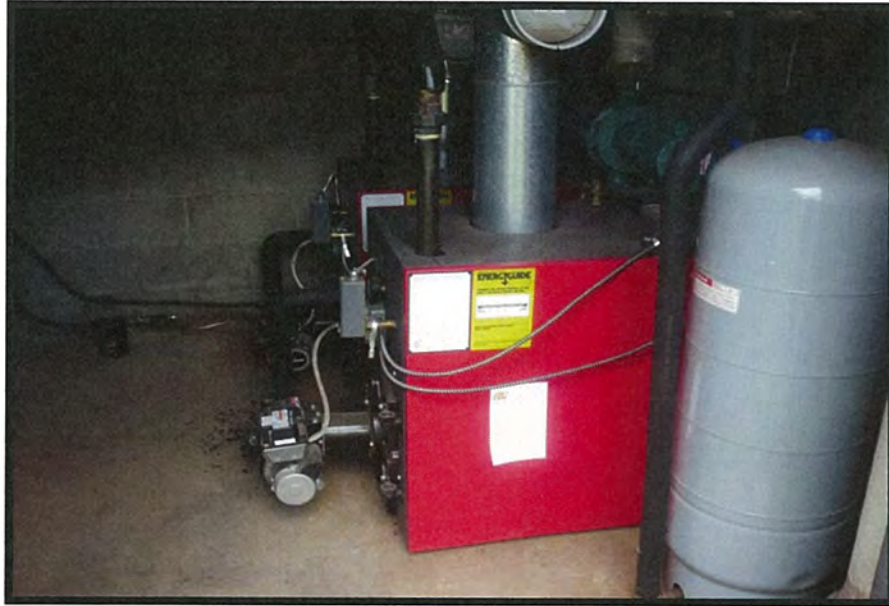
There are two oil fired boilers that provide heating hot water to the air handling units located throughout the building (Photo #1). This equipment is located in a stand-alone building to the east of main building. The boilers are manufactured by Crown, model TWZ200B0W11PSU with an individual capacity of 238,000 BTU/HR at 2.0 gallons per hour of fuel. These boilers are 5 section, residential type boilers with an efficiency of 83.3%. The oil fired burners are manufactured by Carlin, model EZ-1HP with a firing range of 0.5-1.6 gallons per hour. This equipment appears to be newly installed and based on our conversation with Crown, manufactured within the past 3 years.

The heating hot water is circulated by two in-line circulating pumps located above the boilers and distributed to the building through 2" copper supply and return pipes. These pipes are routed below grade and up to the attic of the main building where they distribute heating hot water to the mechanical equipment. A Honeywell 32 gallon expansion tank, model XPS60, also appears to have been installed at the time the boilers were replaced.

Photo #1: Oil Fired Boilers

Depending upon the extent of the anticipated renovations, these boilers and pumping systems may have to be upgraded to support the new heating loads. Options for upgrade would include adding a third boiler to supplement the load or upgrading to commercial grade boilers with higher efficiencies.

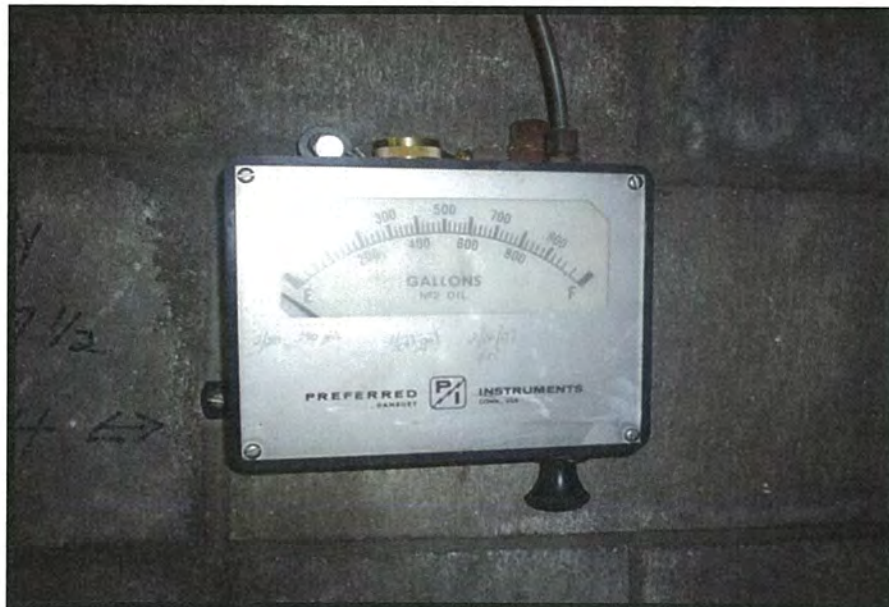
Fuel is stored in an underground fuel tank and based on the gauge within the boiler building, the estimated capacity is approximately 1,000 gallons (Photo #2). At the time of survey, no additional information on the fuel tank was available. If installation and testing documentation of the existing tank is not available, we would recommend that the tank be tested to confirm compliance with all local codes.

Photo #2: Fuel Oil Gauge

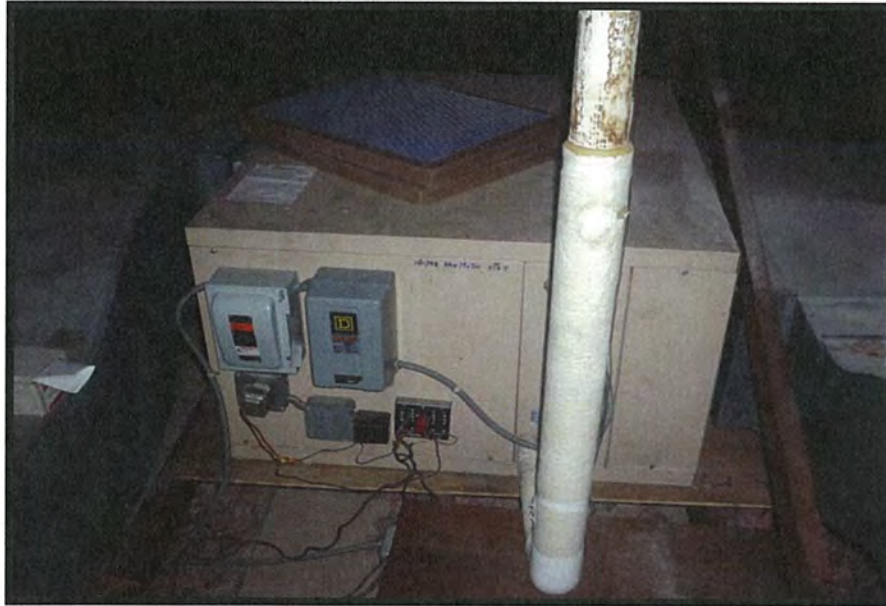
The unit which supports the locker rooms, bathrooms, pro shop, offices and core areas is located in the main attic. This air handler is utilized for heating and ventilation only (no cooling) and is manufactured by Bohn Heating/Wickes Manufacturing, model DA-090A and appears to be original construction (Photo #3). It is supported by 1" copper supply and return copper piping from the hot water heating system and all ductwork is routed within the attic space. It should be noted that about half of the insulation on the supply air ductwork was missing (Photo #4). The unit has surpassed its anticipated useful life expectancy and we would recommend replacement during any proposed renovation work.

Photo #3: Air Handling Unit

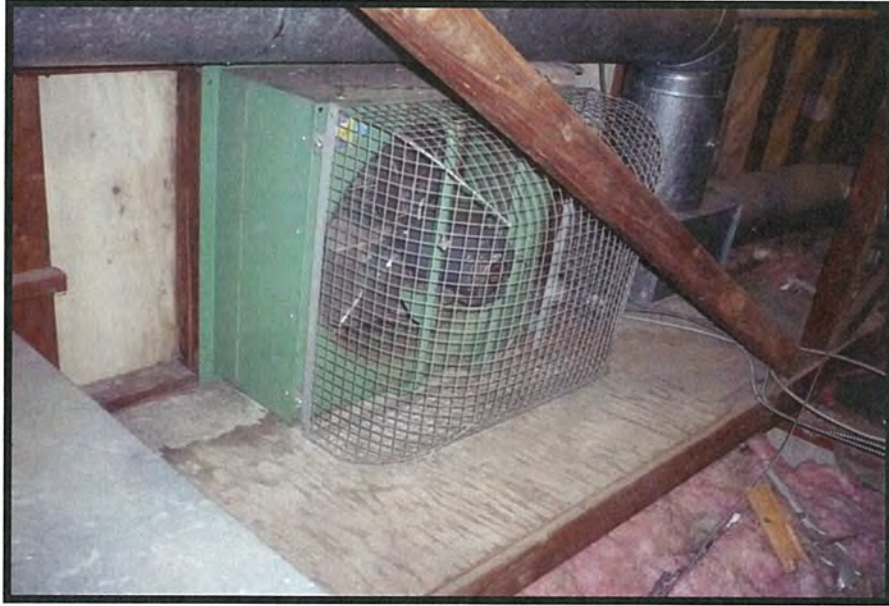
An attic exhaust fan, 1/4 HP, is located at the gable end of the attic (Photo #5) and a bathroom exhaust system, 1/3 HP is also located in the attic (Photo #6). The nameplate on the attic exhaust fan was not attainable but the bathroom exhaust fan was manufactured by Peerless Electric, Model D9C. As mentioned in the latter part of this report, we would recommend that these devices be connected to a new energy management system so that they can be properly monitored and controlled throughout the year.

Photo #5: Attic Exhaust Fan

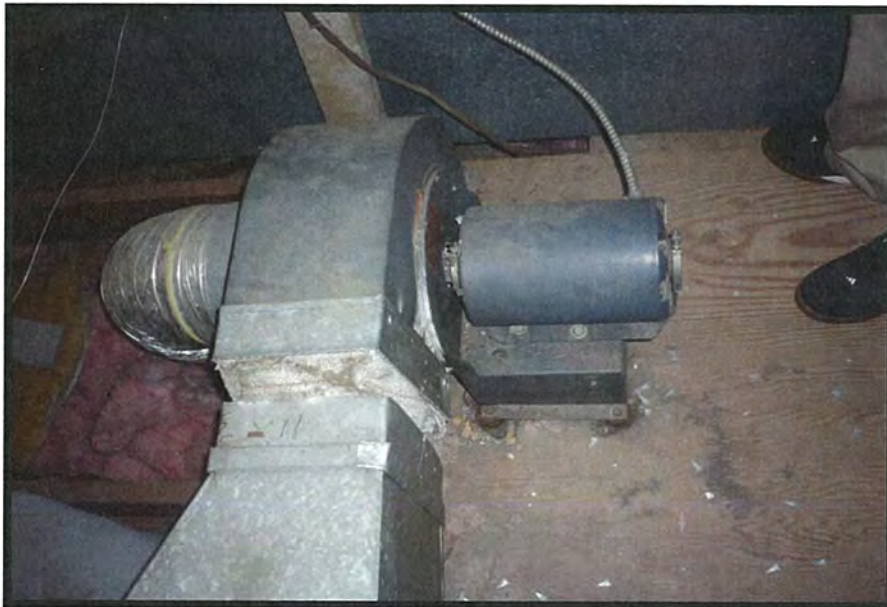
Photo #6: Bathroom Exhaust Fan

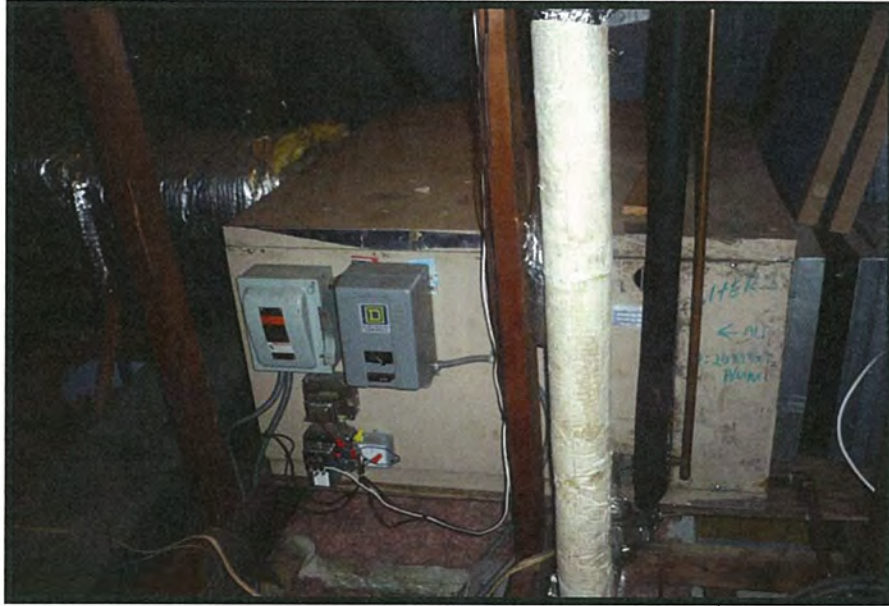
The lounge/dining area is supported by three separate air handling systems. Air handler AHU-1 is a heating and DX cooling type unit and located in the main attic area (Photo #7). This unit was manufactured by Bohn Heating/Wickes Manufacturing, model DA-090A and appears to be original construction. The condenser for this system is a York model H4CE090A25C and appears to have been replaced within the last 10 years. This condenser is located on the front side of the building in the area that is adjacent to the mens locker rooms. The ductwork is distributed above the ceiling along the east side of the lounge/dining area. This unit has also surpassed its anticipated useful life expectancy and we would recommend replacement during any proposed renovation work to support the lounge/dining area.

Photo #7: Lounge/Dining Area AHU-1

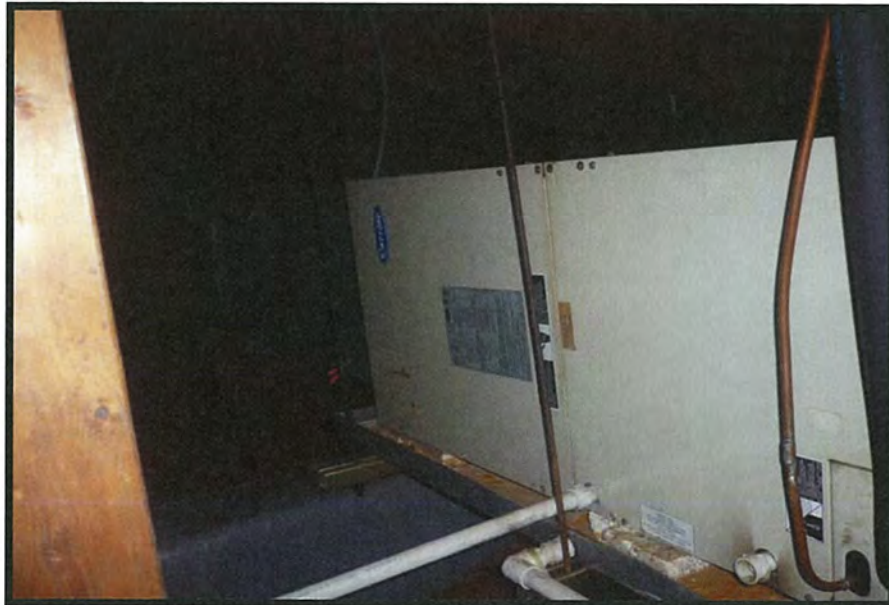
Air handler AHU-2 and AHU-3 are also heating and DX cooling type units and are located in the attic area above the kitchen (Photo #8). These units were manufactured by Carrier, model 40YRM060300, were manufactured in 1998 and are in the 5 ton capacity range. The condensers for these units are Carrier 38TH060500DL and also appear to have been manufactured in 1998. The condensers are located on the north side of the building in the area adjacent to the kitchen. The ductwork is distributed above the ceiling along the west side of the lounge/dining area. These units are in fair condition, are approximately 10 years old and have an anticipated life expectancy of 5-10 additional years. Depending upon the anticipated renovation, we would most likely reuse these units with the option to change them out in the future. If the renovation is limited to finishes, we would anticipate that most of the ductwork could be reutilized.

Photo #8: Lounge/Dining Area AHU-2

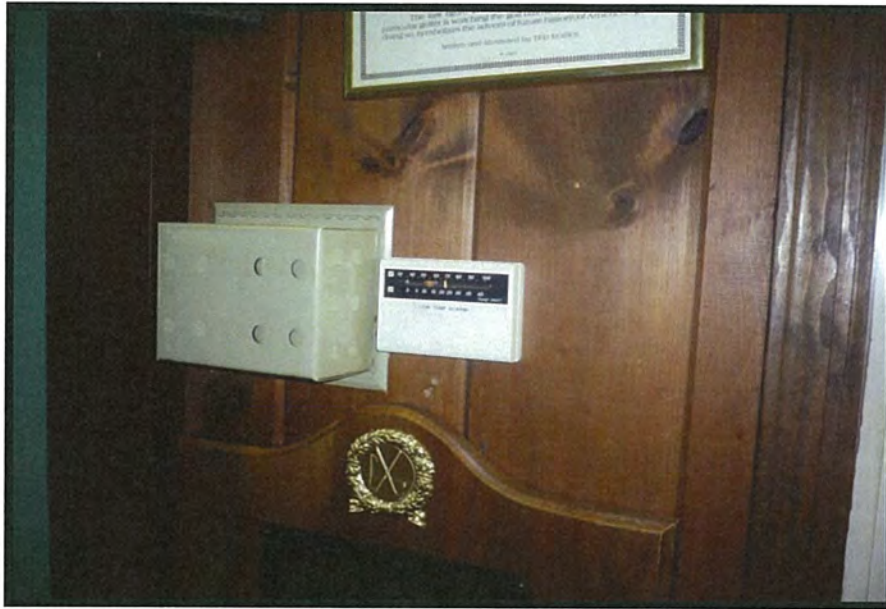
Control of all of the HVAC systems are local; there is no central energy management system (Photo #9). Depending upon the extent of the proposed renovations, the installation of a new building management system is recommended to monitor and control the buildings HVAC system. These systems can assist in managing and controlling energy costs of the equipment.

Photo #9: Local Control Systems

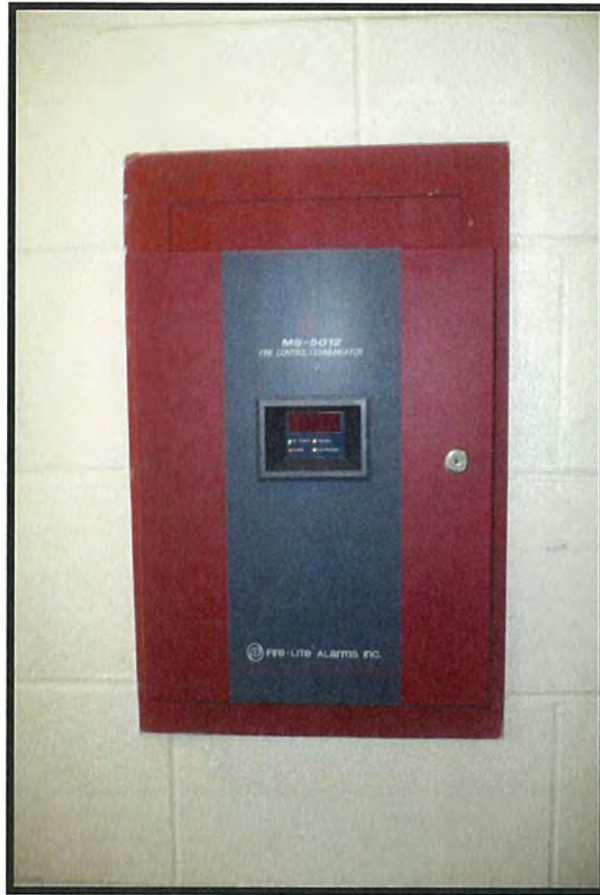
The fire alarm system consists of a Firelite Alarms MS-5012 panel that is located in the main corridor (Photo #11). There was also a Notifier panel located in the main electrical room which appeared to be abandoned in place. Ancillary devices include pull stations that did not appear to be installed to ADA requirements and annunciator bells that were installed in limited areas of the building. This system will most likely have to be upgraded with a new code compliant fire alarm system for any type of renovation that takes place. We would recommend a fully addressable type system for the building to include new pull stations, horn strobes along with smoke detectors and heat detectors in specific areas.

Photo #11: Fire Alarm Panel
