### Site Photographs

Site Photographs were taken October 20, 2022

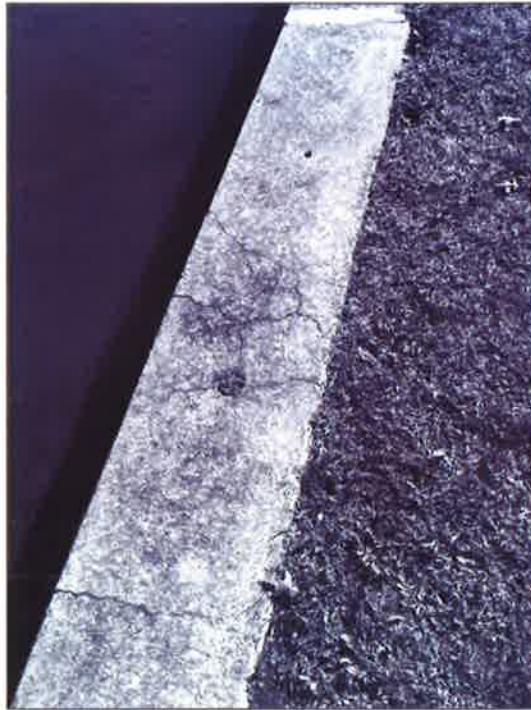
Photograph 4 - Typical cracking in concrete cap

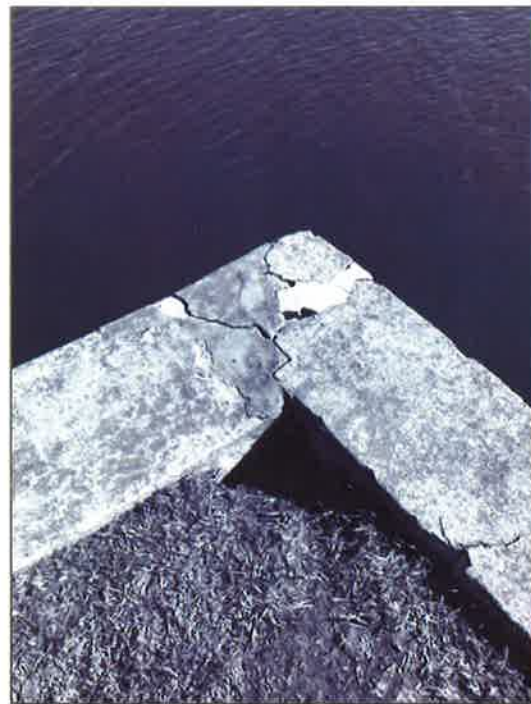
Photograph 5 - Cracking and sinkhole at corner STA 0+96

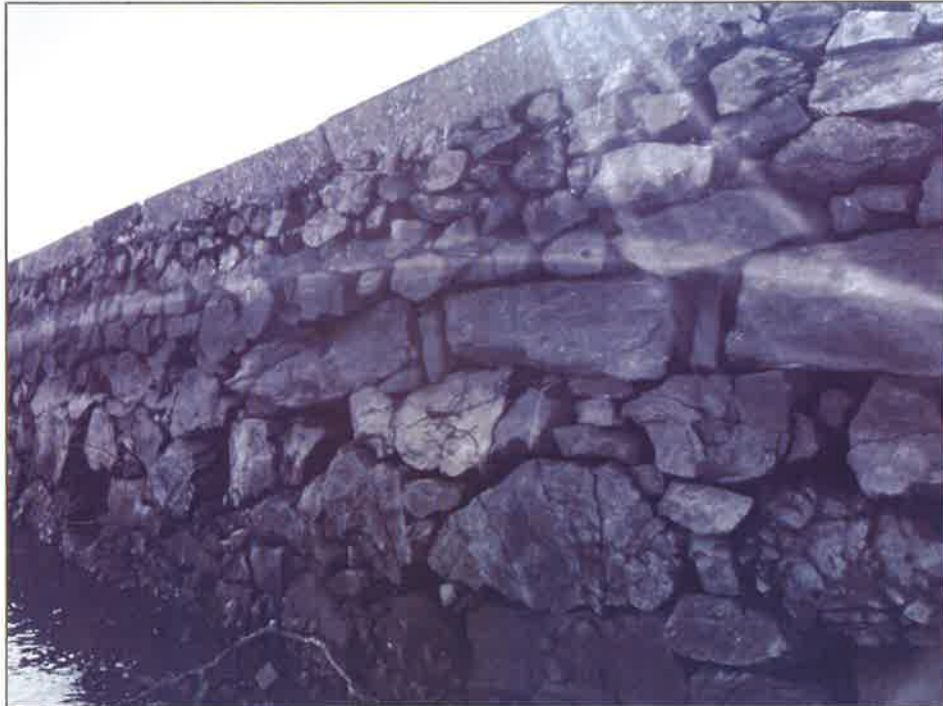
Photograph 6 – Areas of missing stone and outfall location circled in red

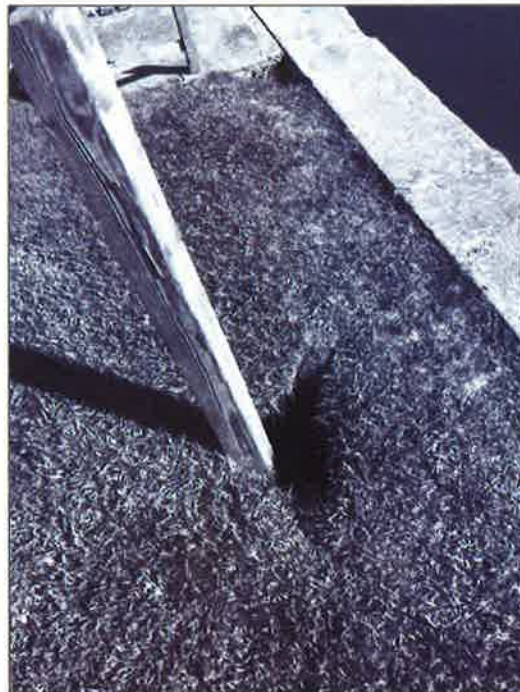
Photograph 7 – Sinkhole at STA 1+02 and shown rotation of concrete pad for bench.

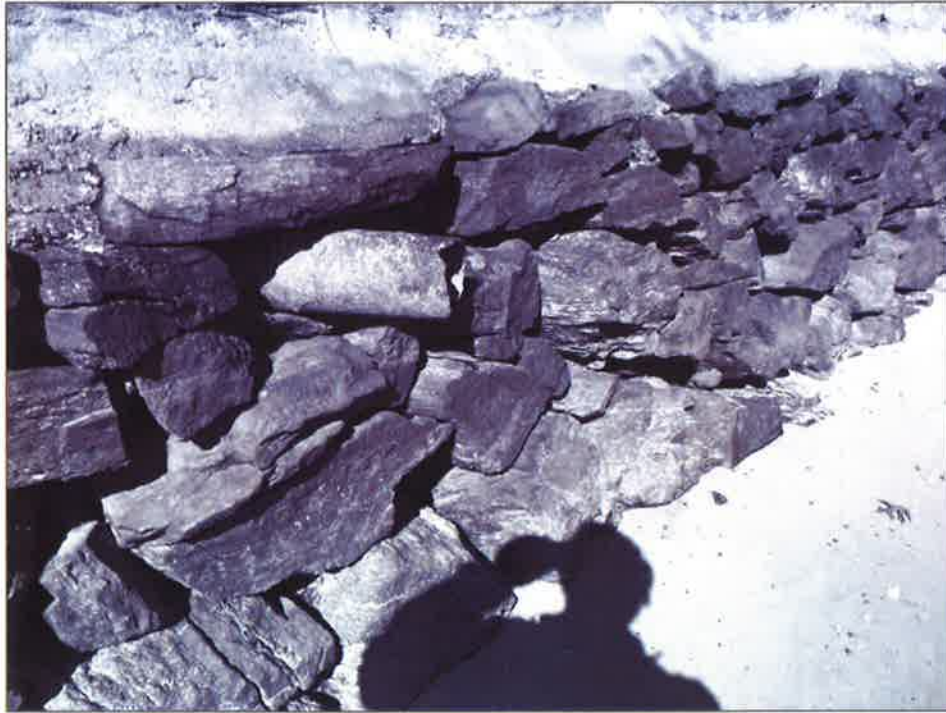
Photograph 10 - STA 1+40 Outfall

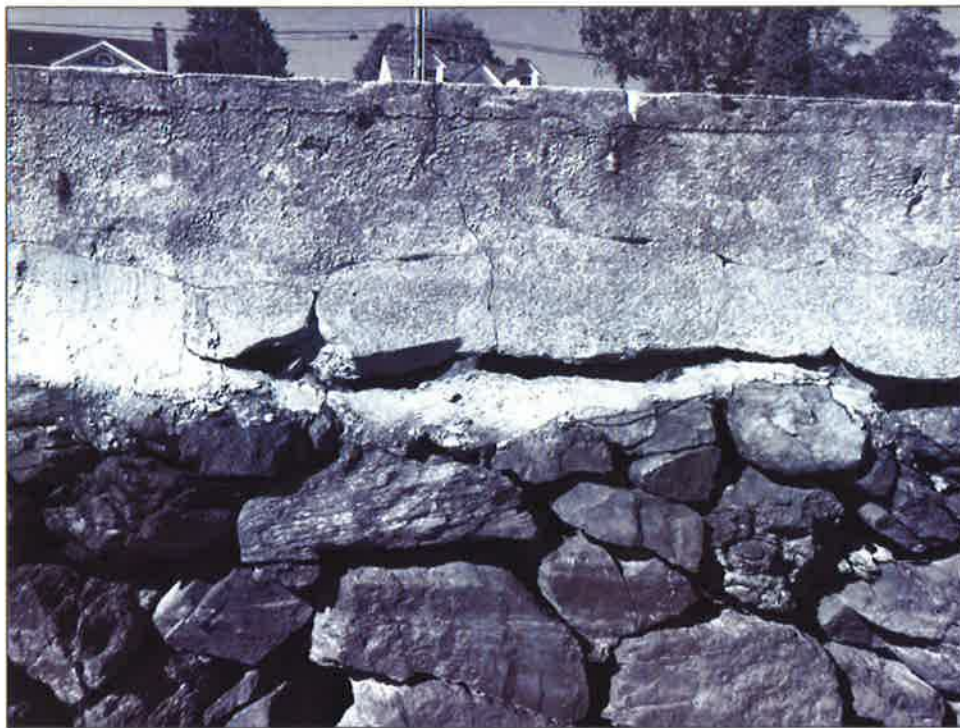
Photograph 11 - Deterioated concrete cap

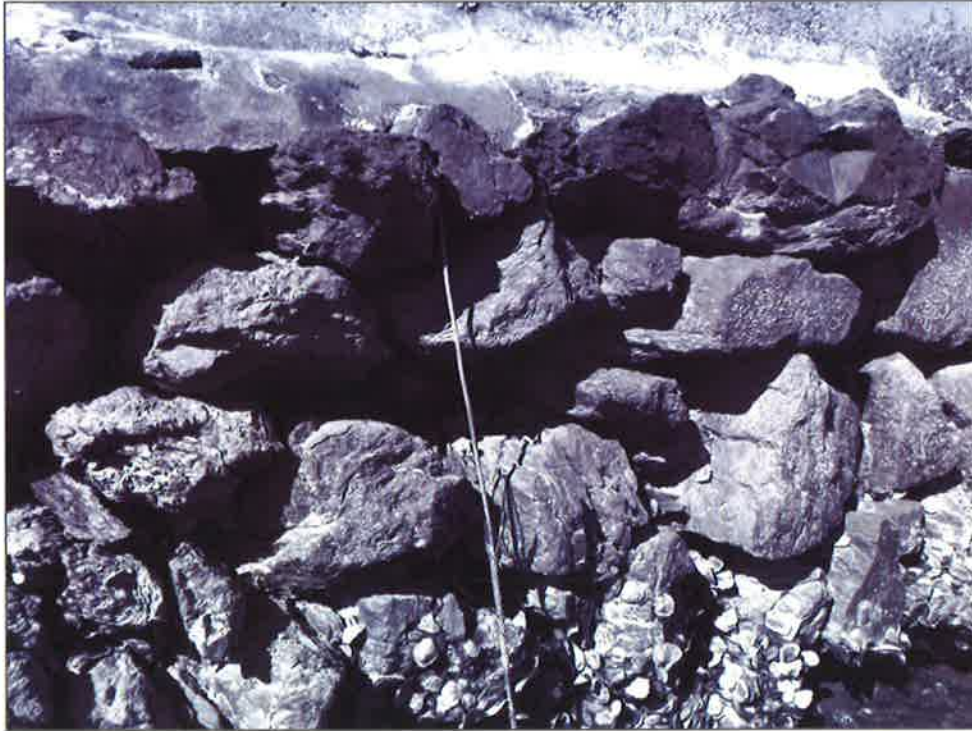
Photograph 18 – Seawall voids at STA 2+27

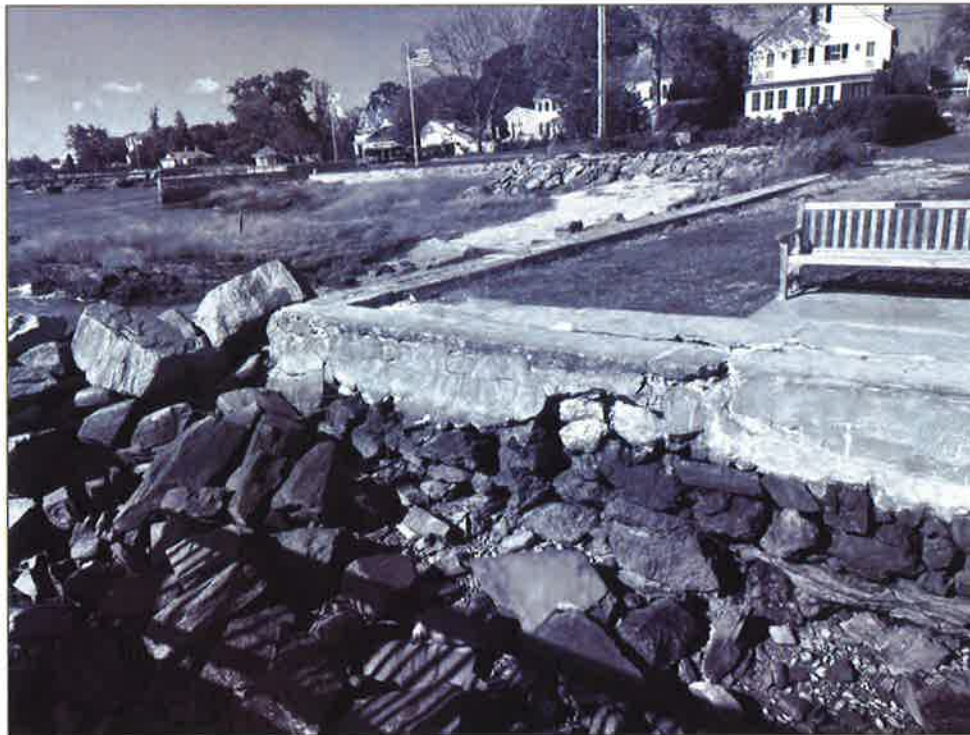
Photograph 19 – Poor condition of the concrete cap and dislodged stones STA 2+73-2+95

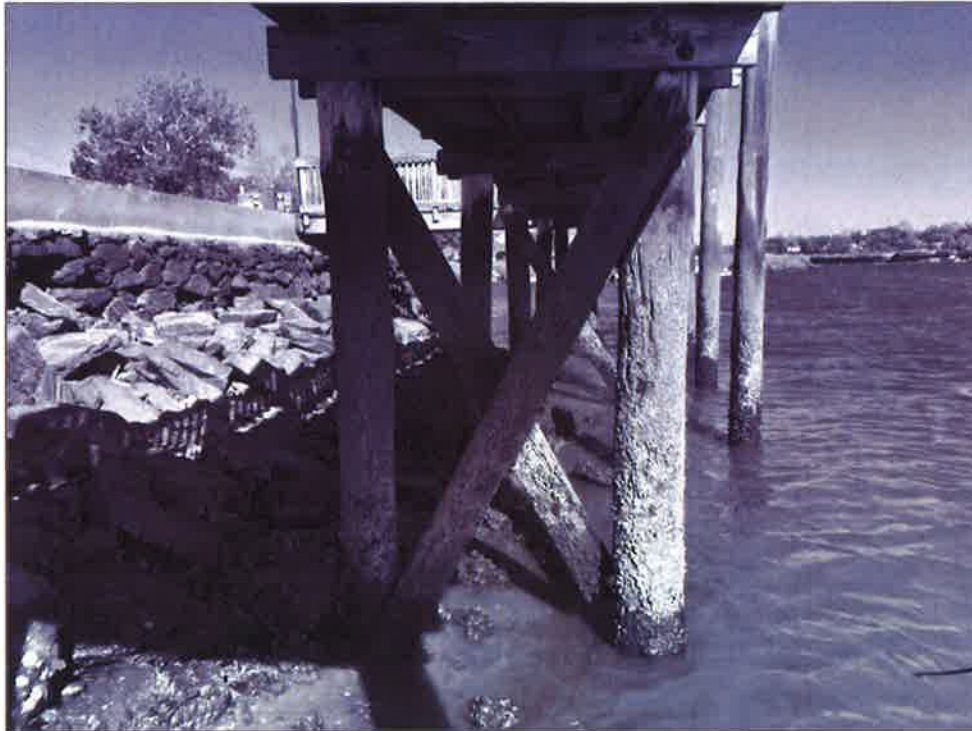
Photograph 24 - Typical damage of the cross bracing

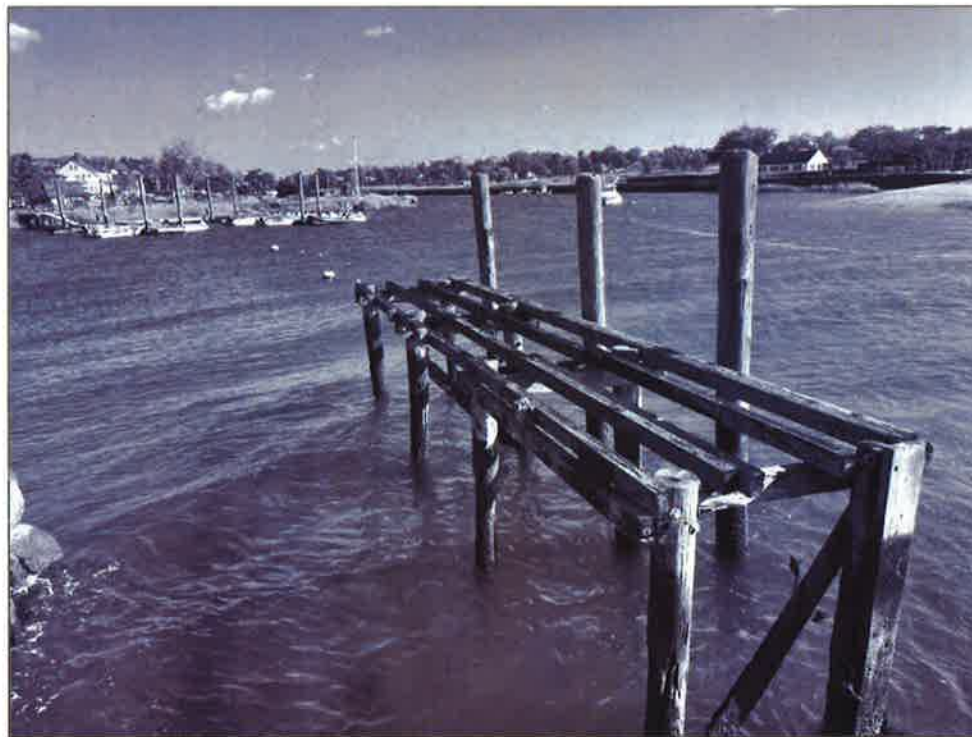
Photograph 23 - Remaining timber wharf T-head
