RE: Hazardous Materials Survey Report
Asbestos and Lead-Based Paint
Furgary Boat Club
Hudson, NY
Ambient Project Number: 150602AB

HAZARDOUS MATERIALS SURVEY

Asbestos and Lead-Based Paint

*Furgary Boat Club
Hudson, NY*

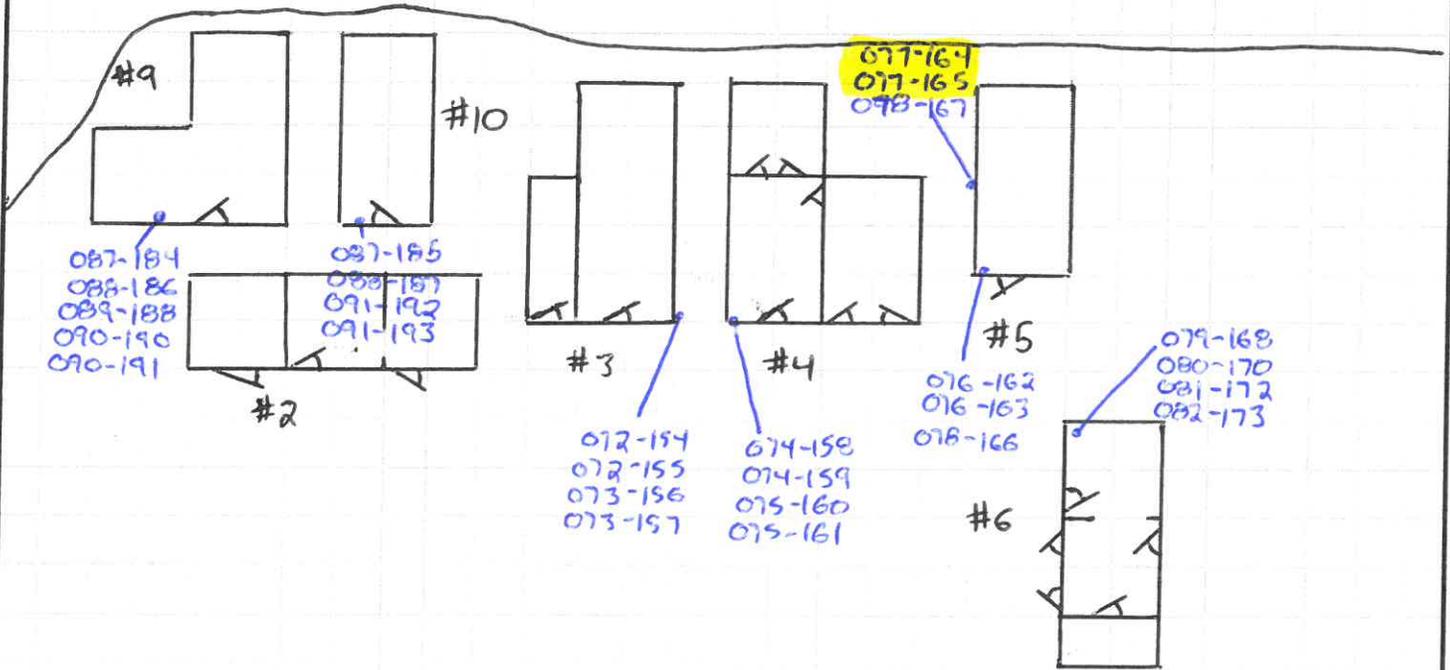
Asbestos Sample Locations (Roofs)

###-### = Positive Asbestos Containing Sample

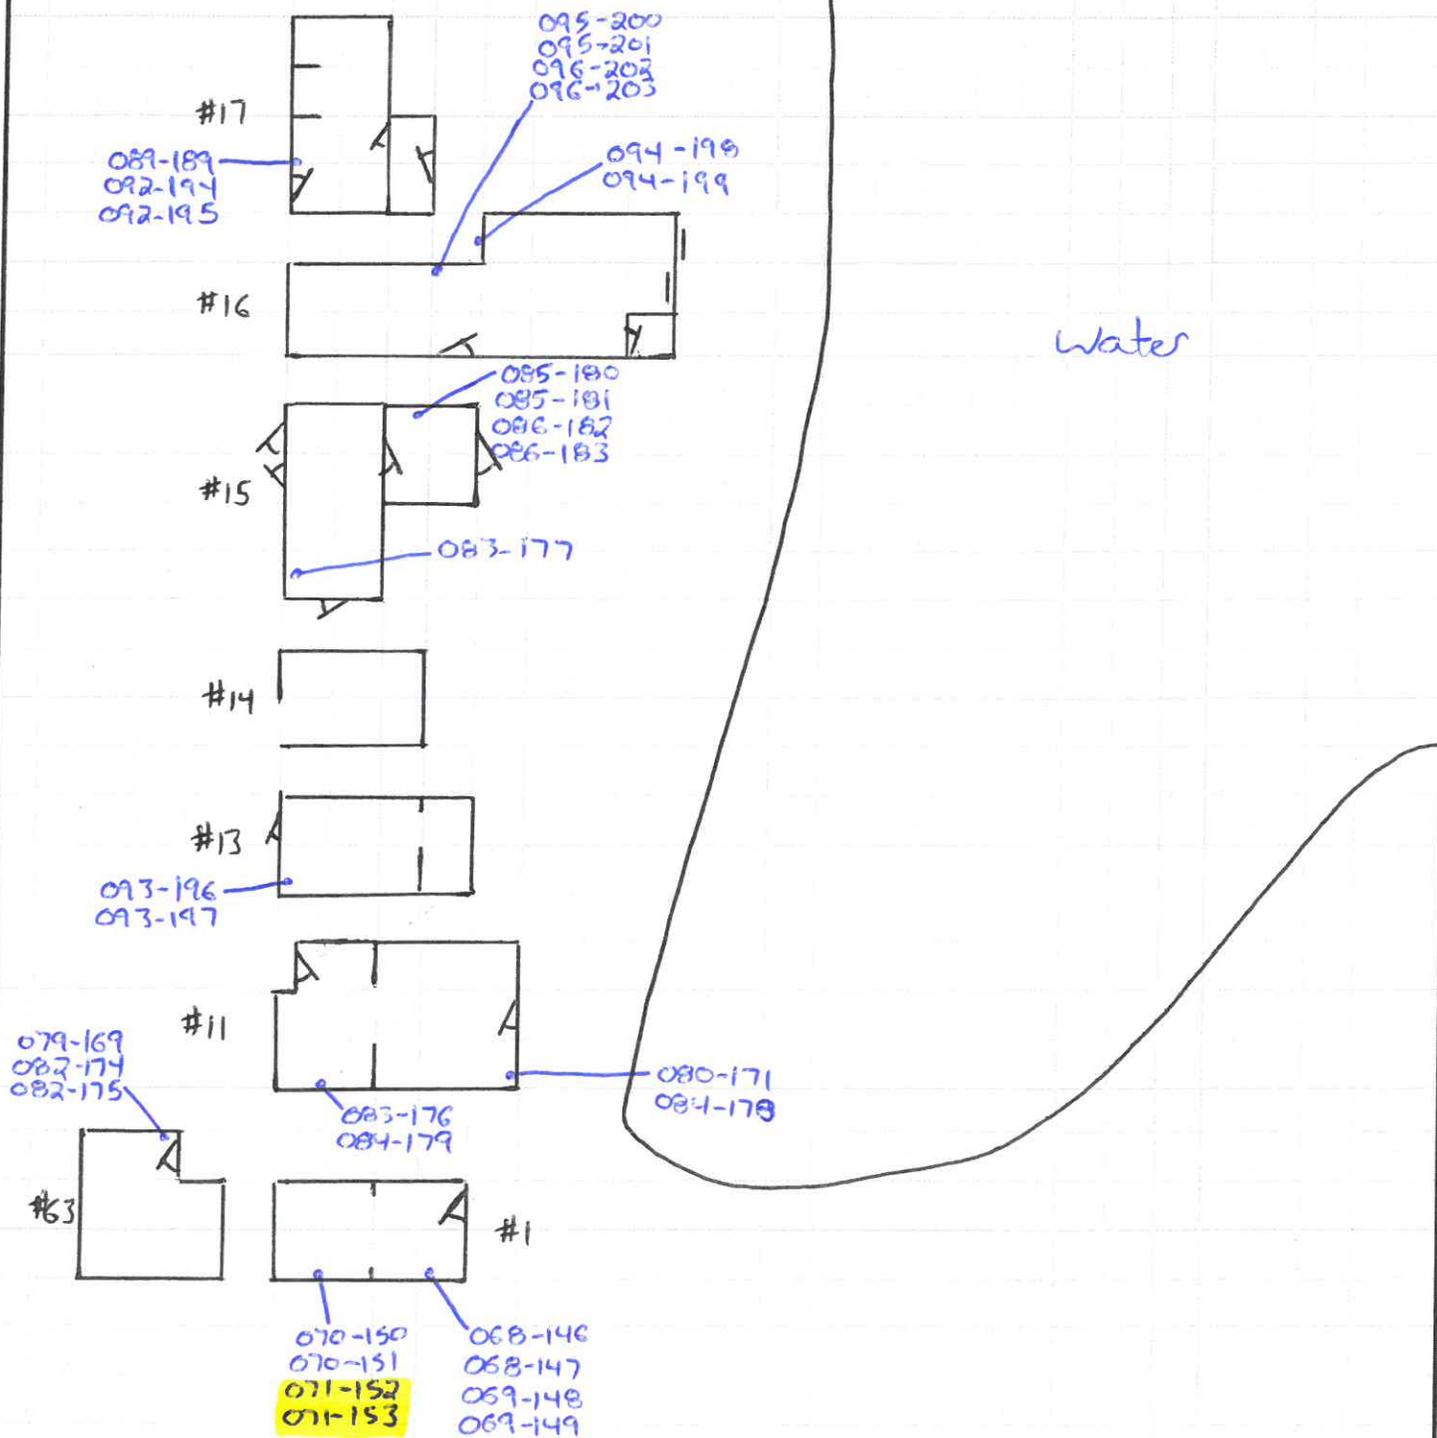
Asbestos Sample Locations (Roofs)

- ### = Positive Asbestos Containing Sample

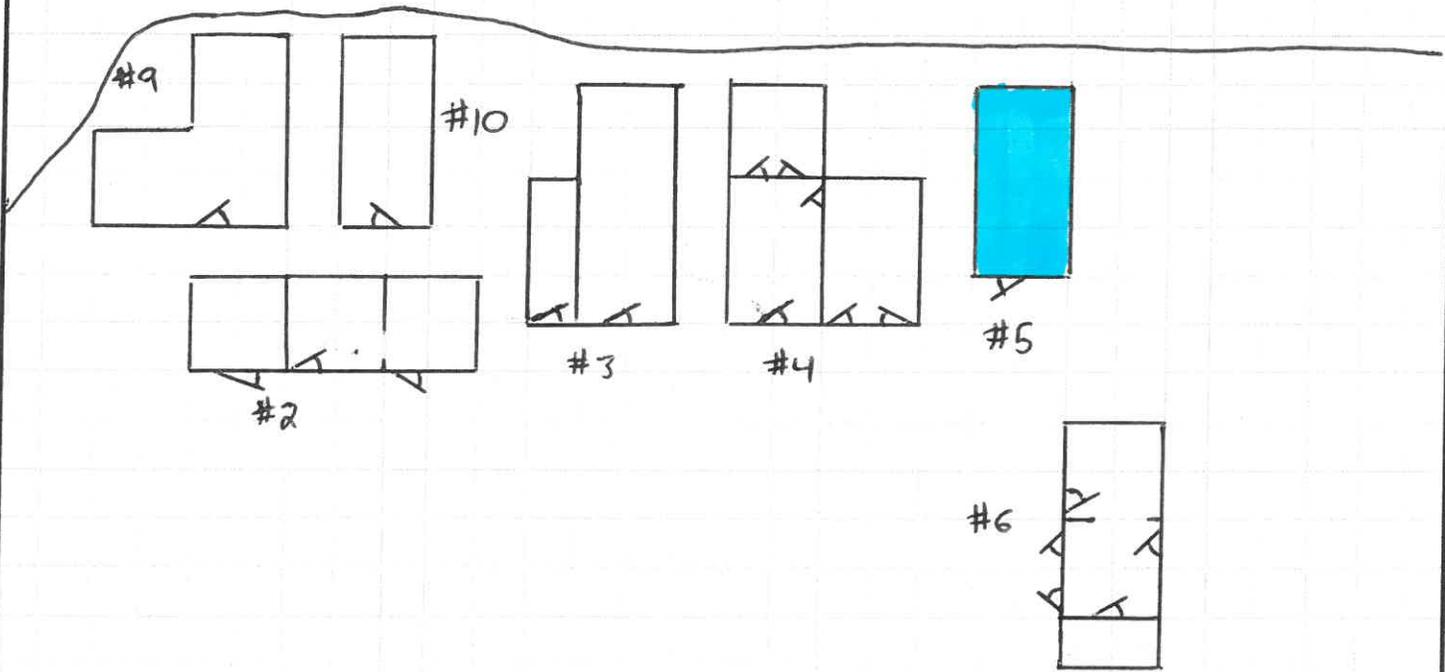
Asbestos Containing Material Locations (Roofs)

= White Rolled Roofing
