**Arborist's Report**  
**June 18, 2022**

# **Tree Preservation Plan**

**For Edison Park, City of Huntington Beach**

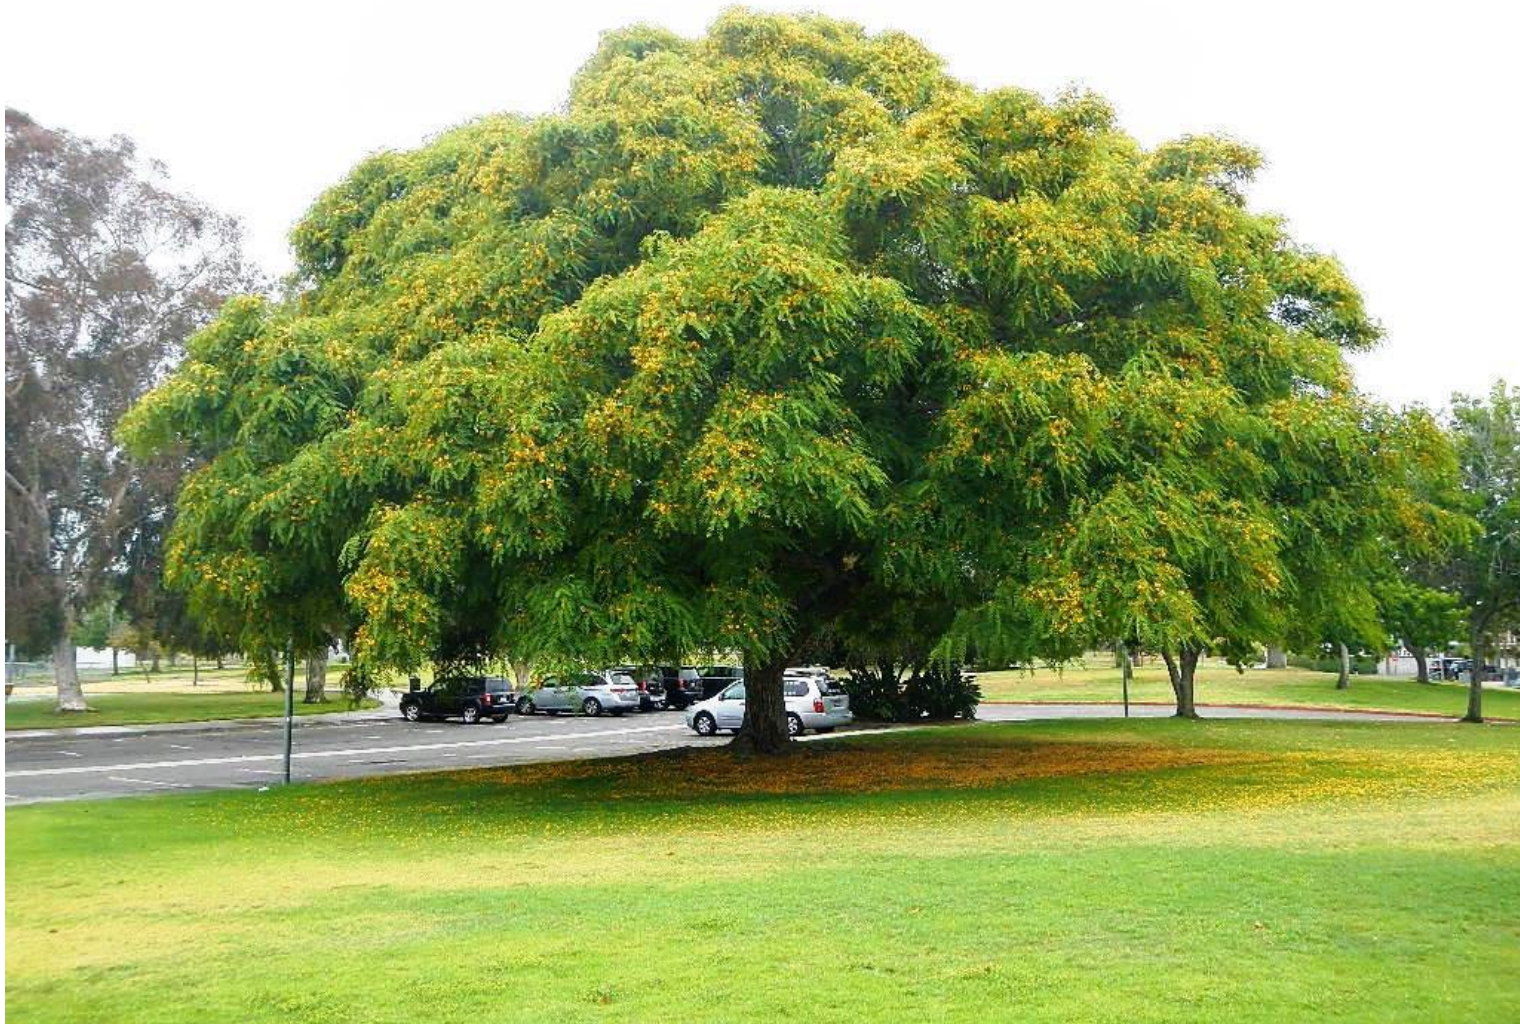
Note the golden carpet below tipu tree # 1

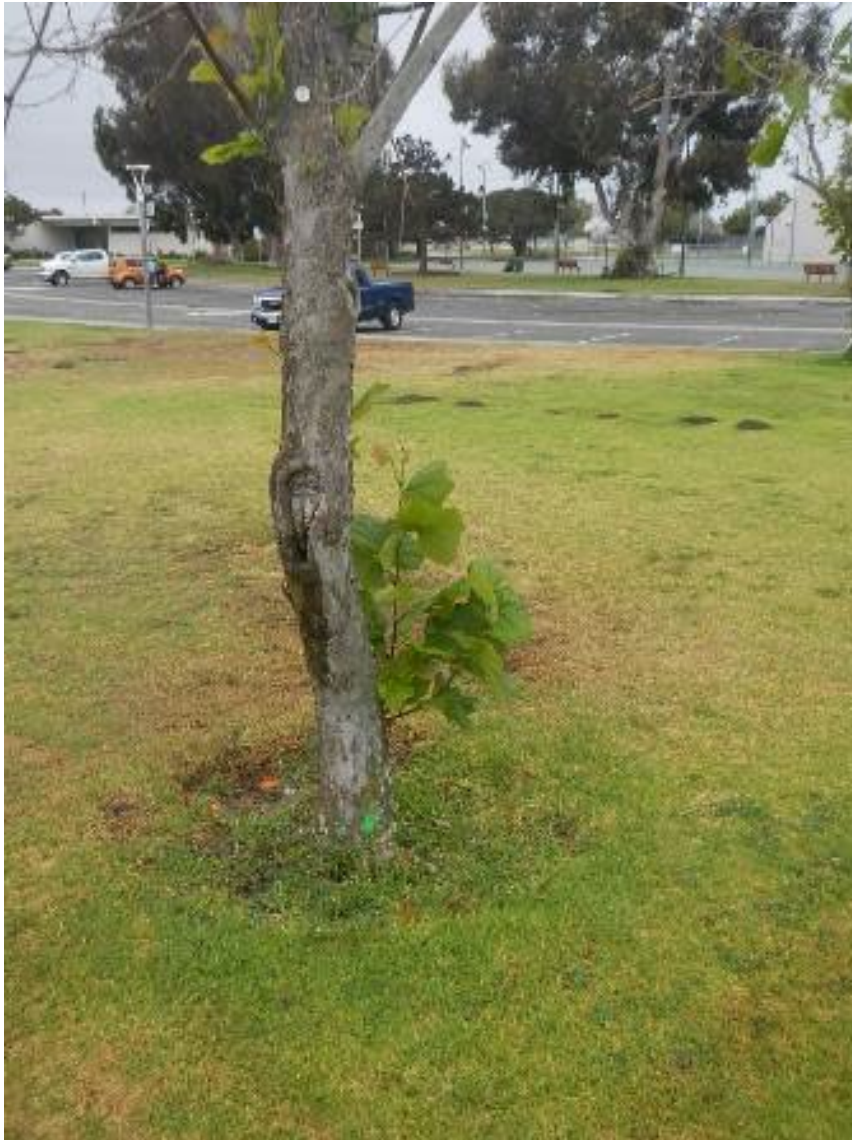
#19 London plane – note limb torn out

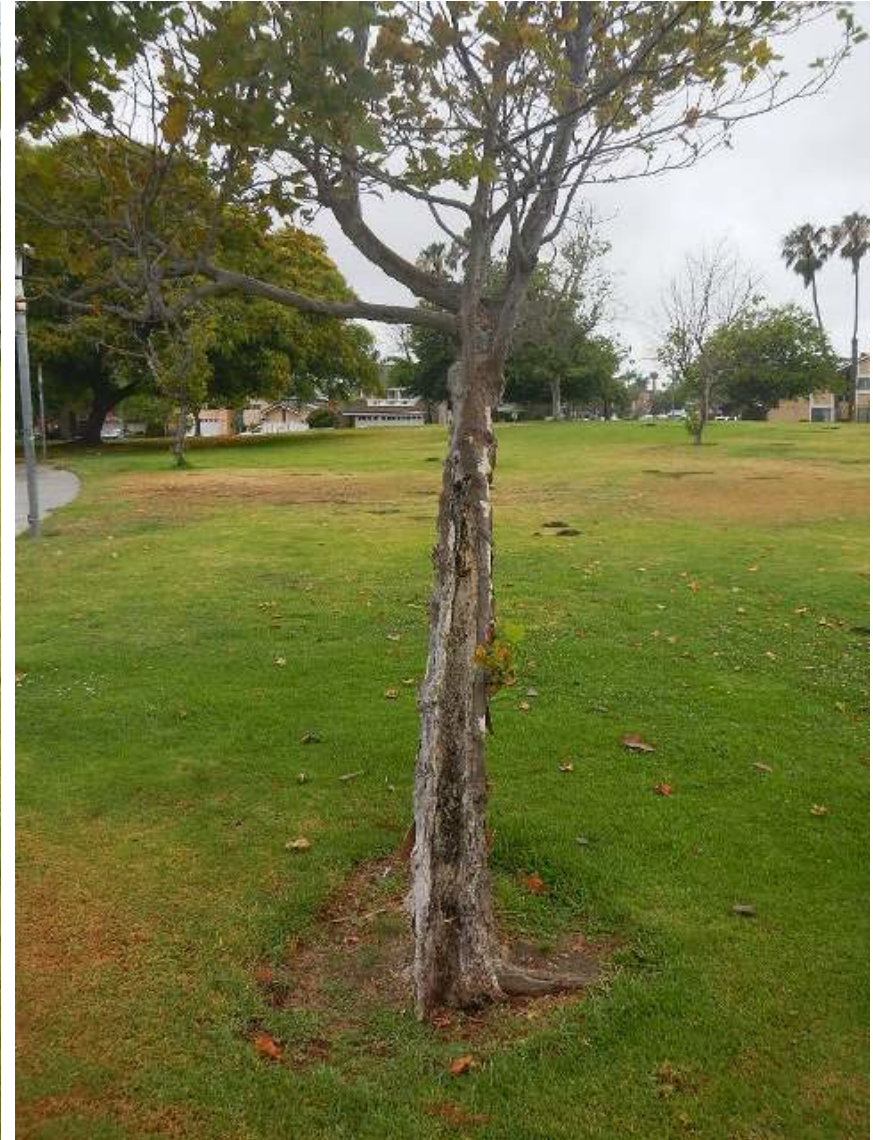
Decay probably started with a basal injury by a lawn mower.

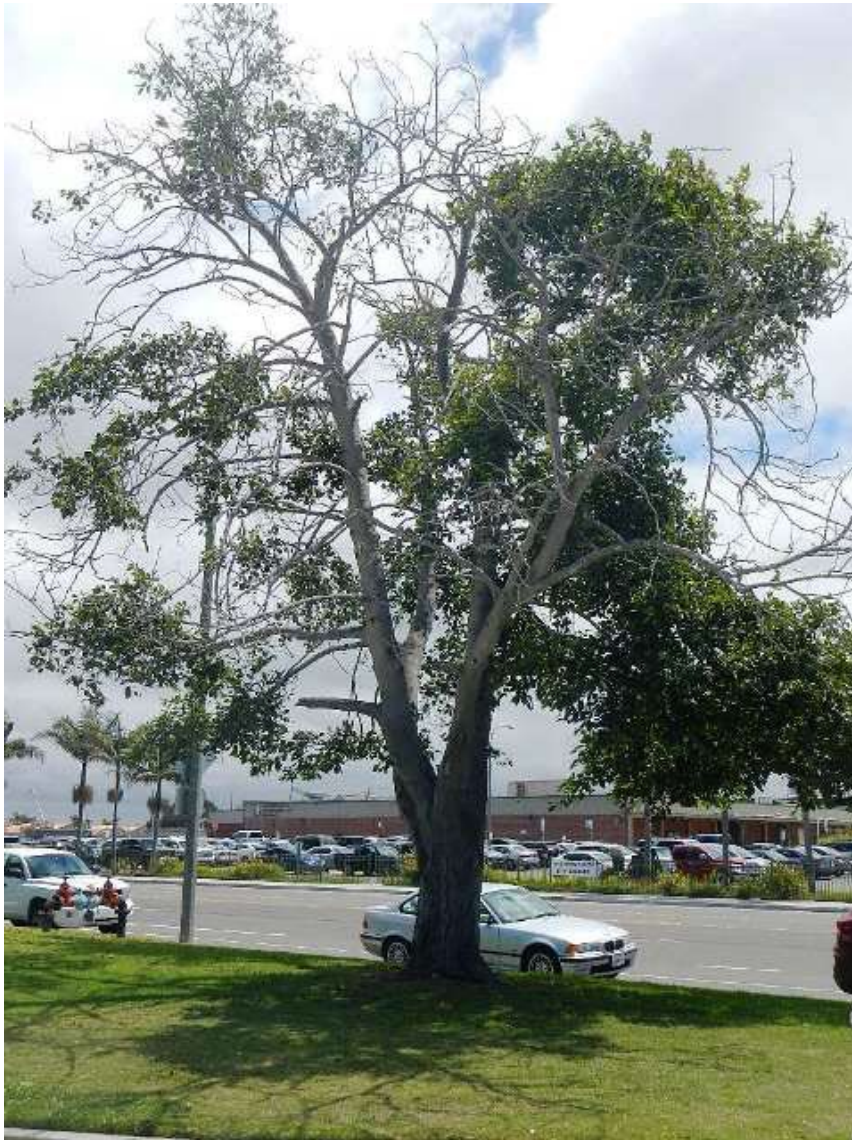
Alders in decline

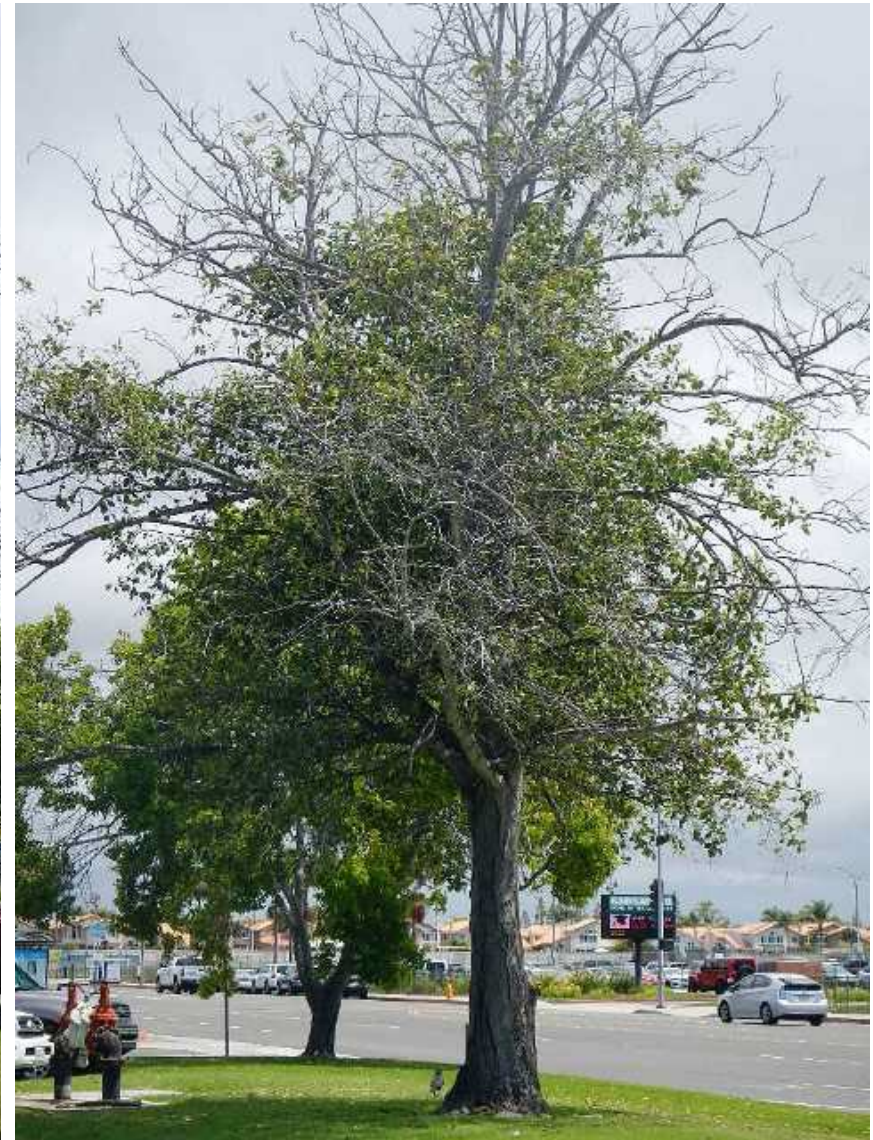
The Liquidambar behind make the alder look fuller.

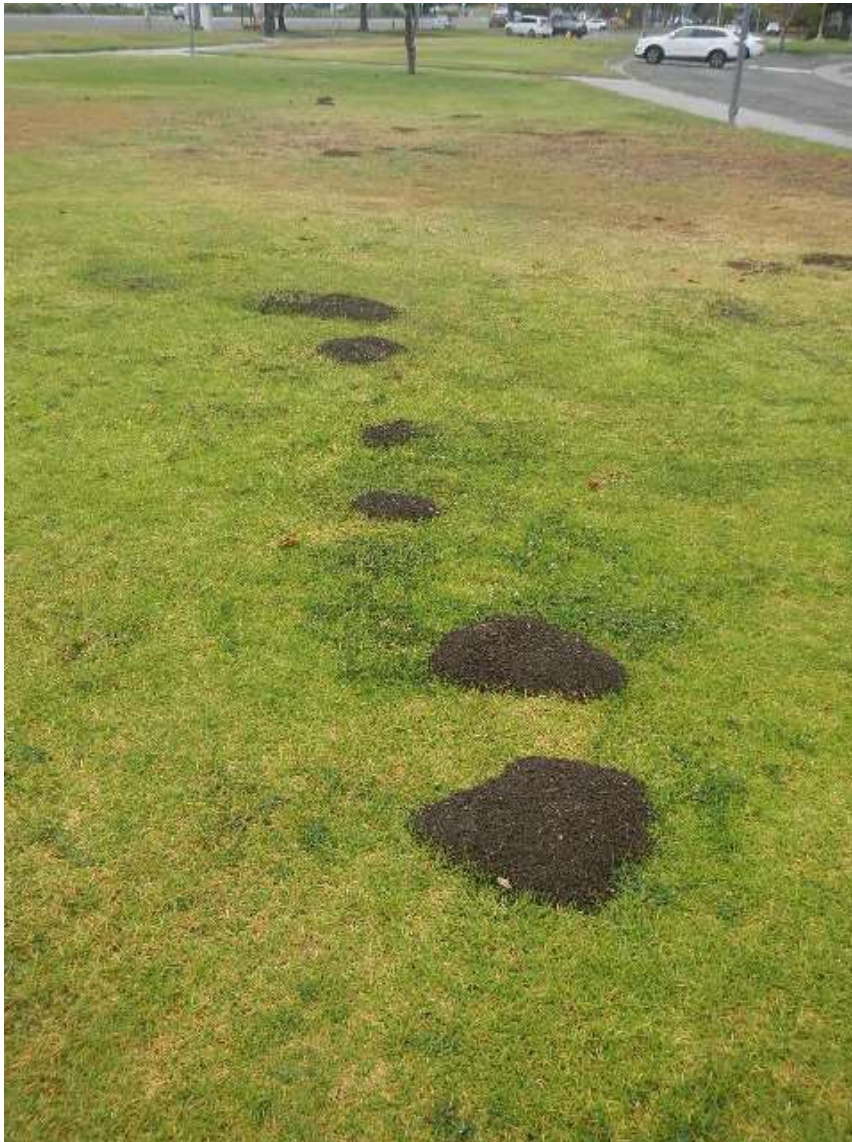
Gophers or ground squirrels abound.

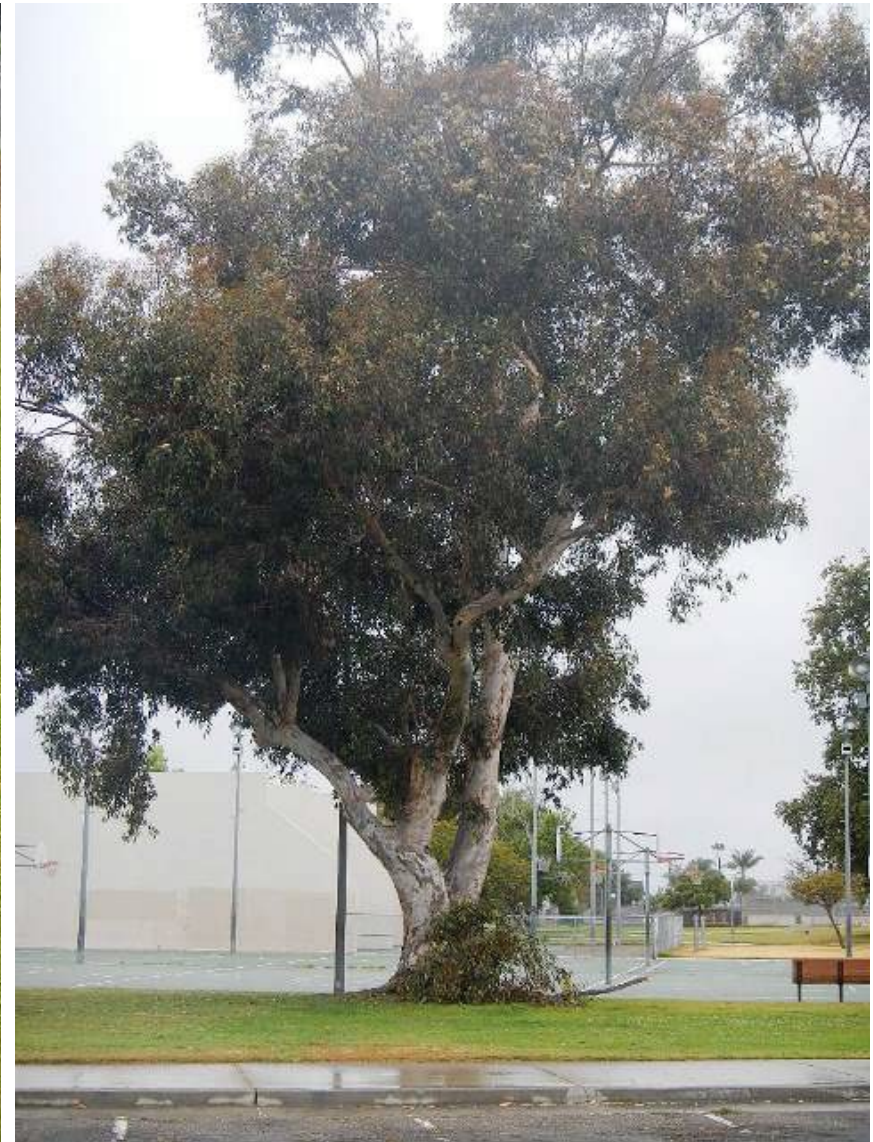
Note a recently fallen branch.

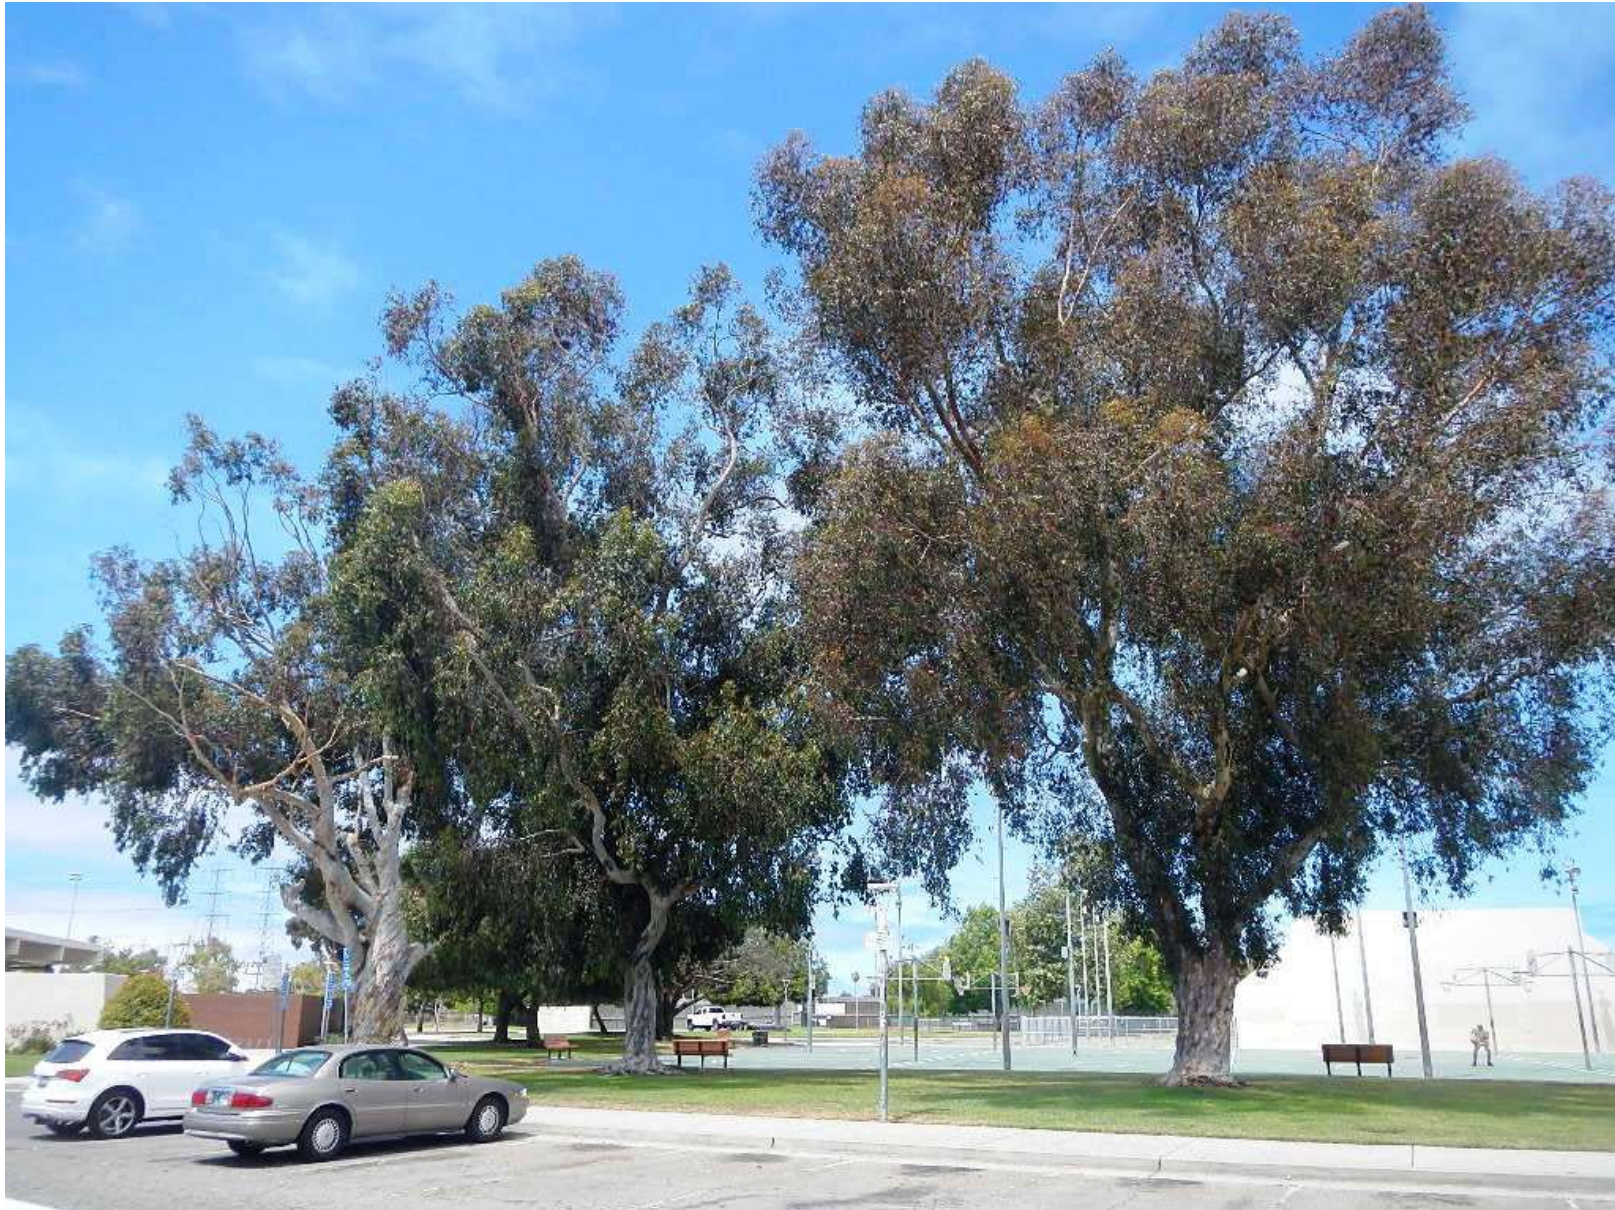
Most of the larger eucalypts need corrective pruning to reduce risk.

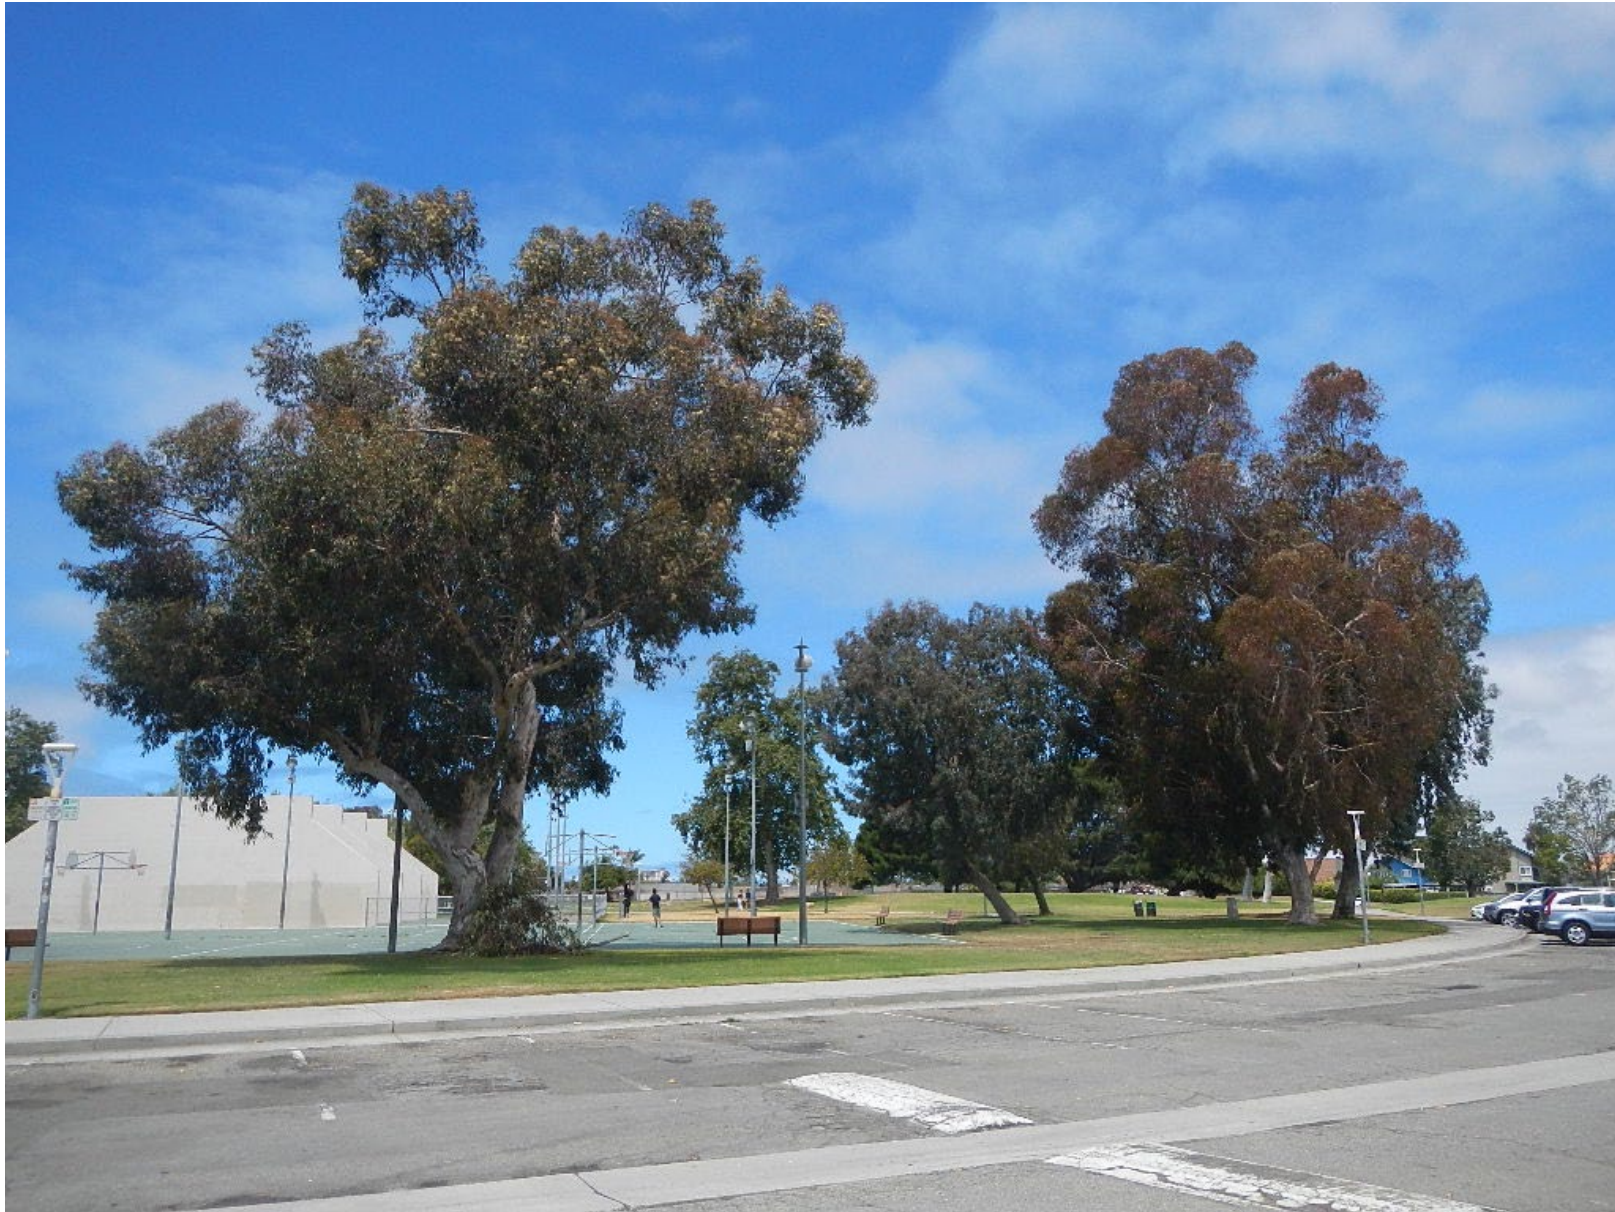
Locals know these trees have dropped limbs, but everyone wanted to make sure they were not removed.

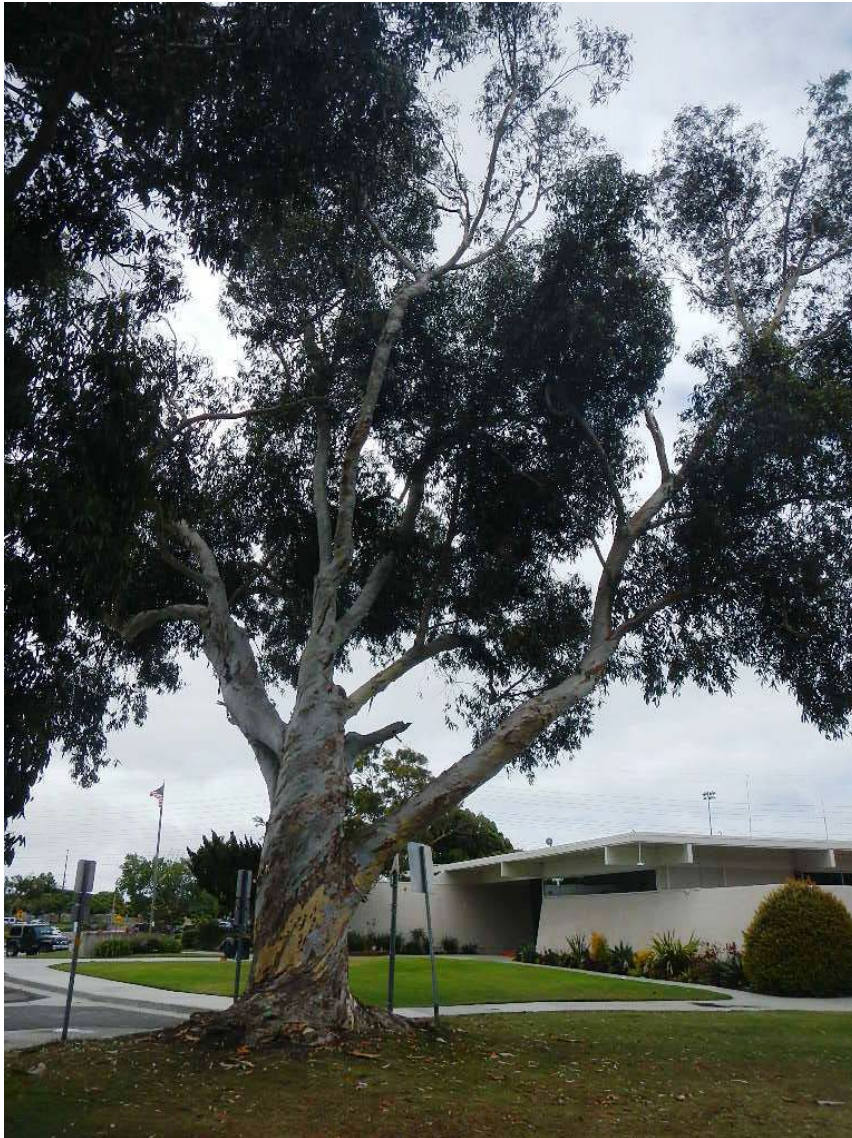
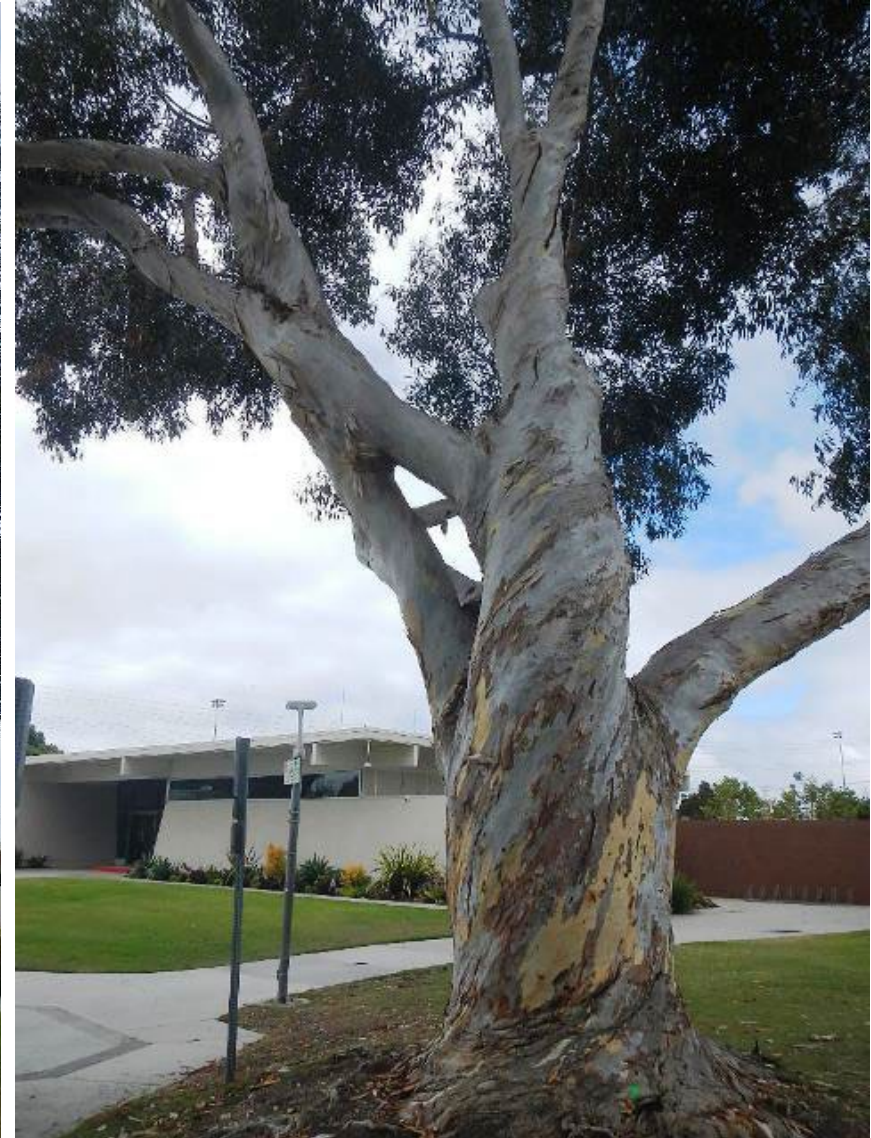
#206 Sugar gum is one-sided and has crossing limbs that fused.

See above ↑

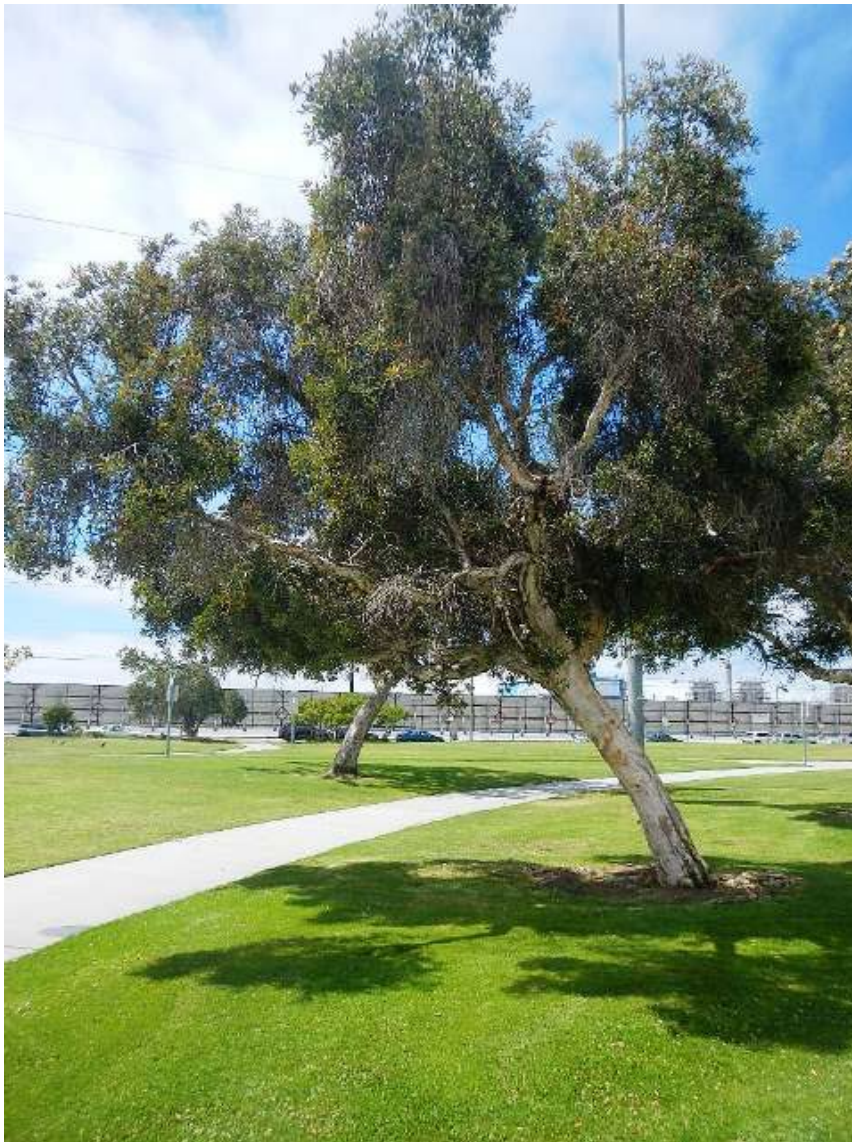
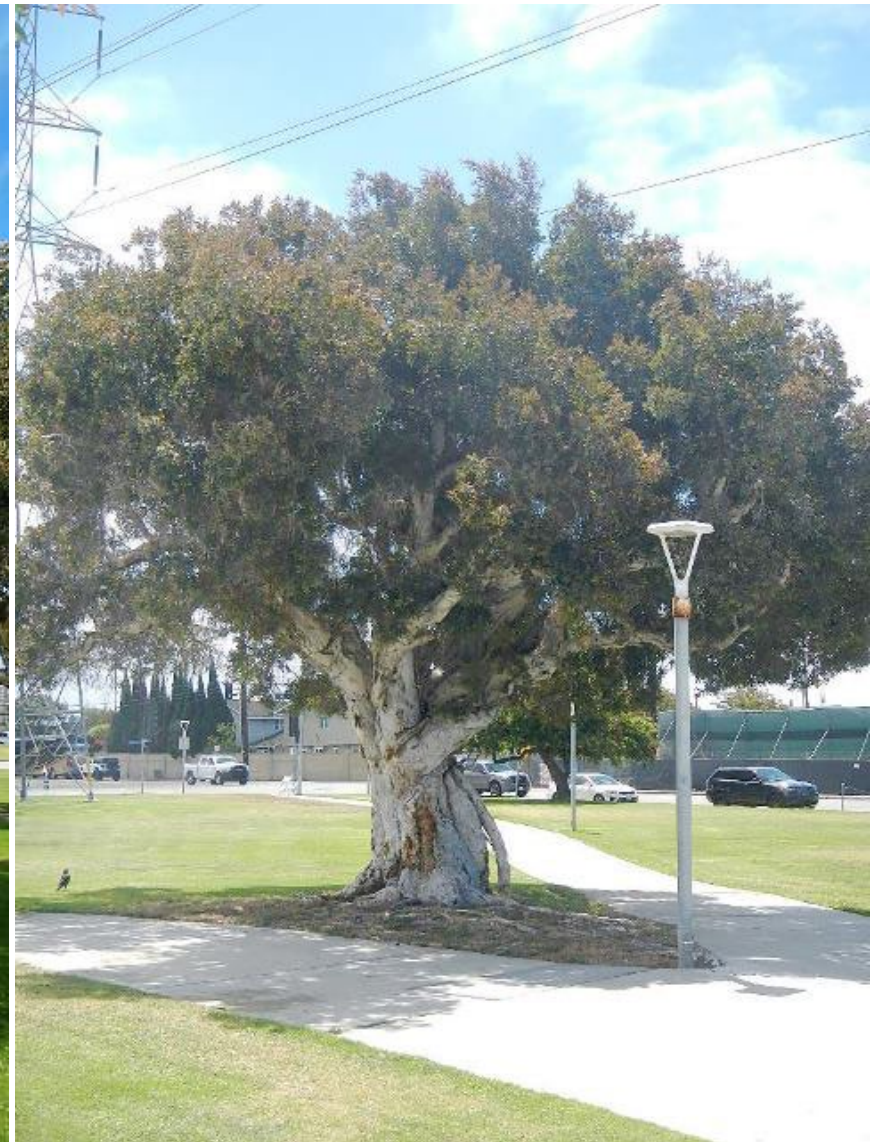
Cajeput or paperbark trees should be a good species for this soil and climate. Some are declining though.

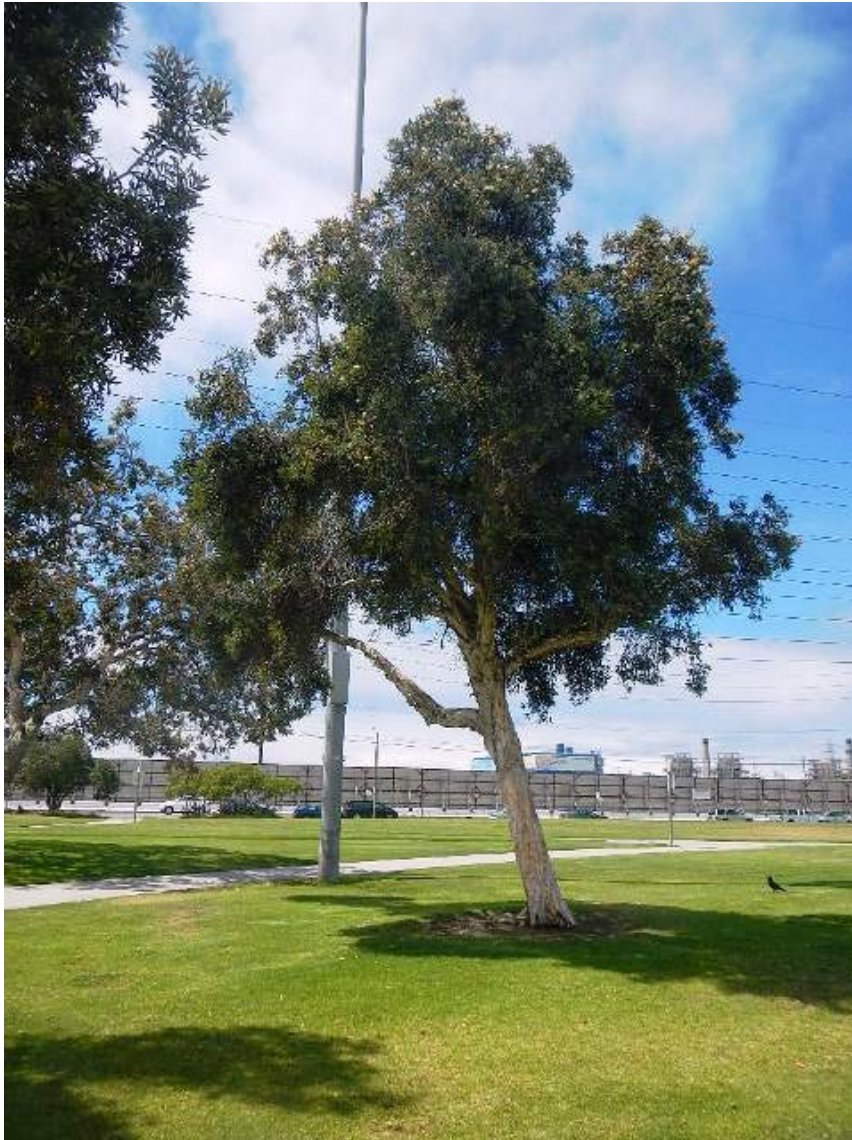
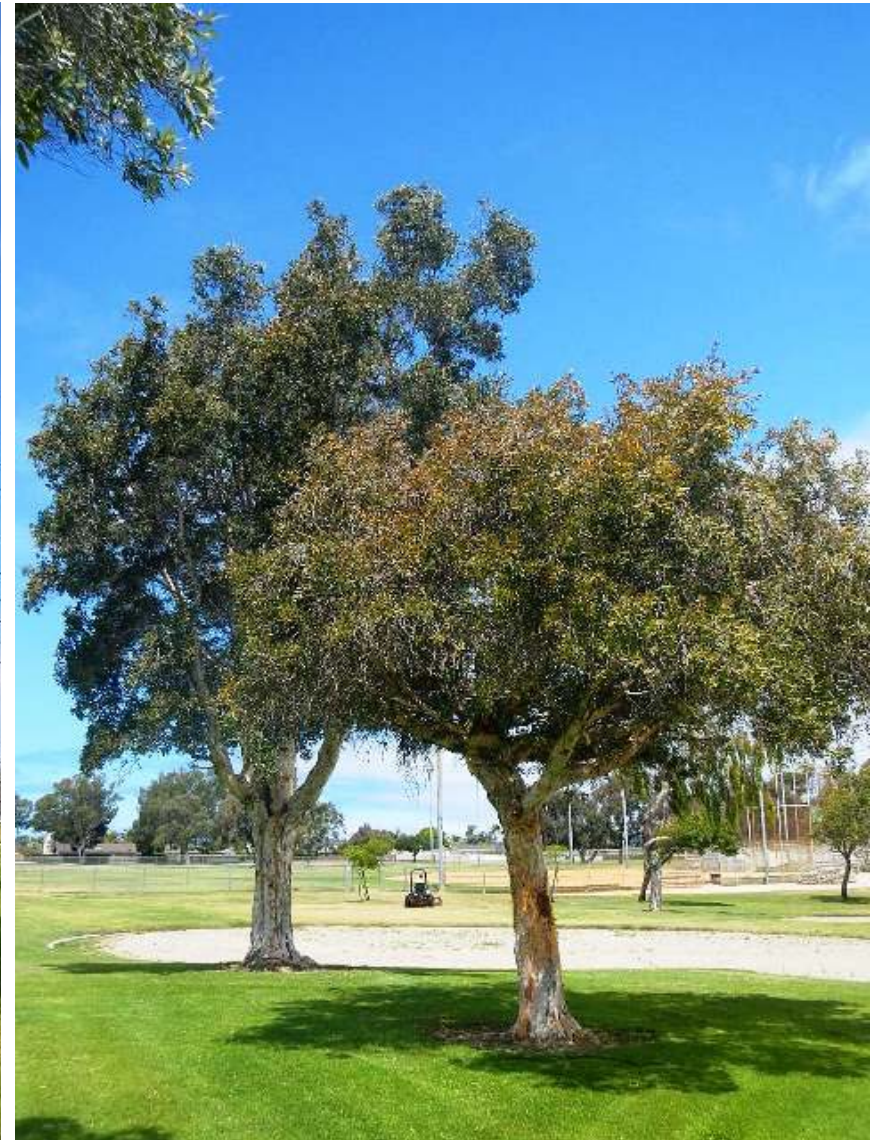
Cajeput or paperbark trees should be a good species for this soil and climate. The most common deterrent to good health are root injuries.

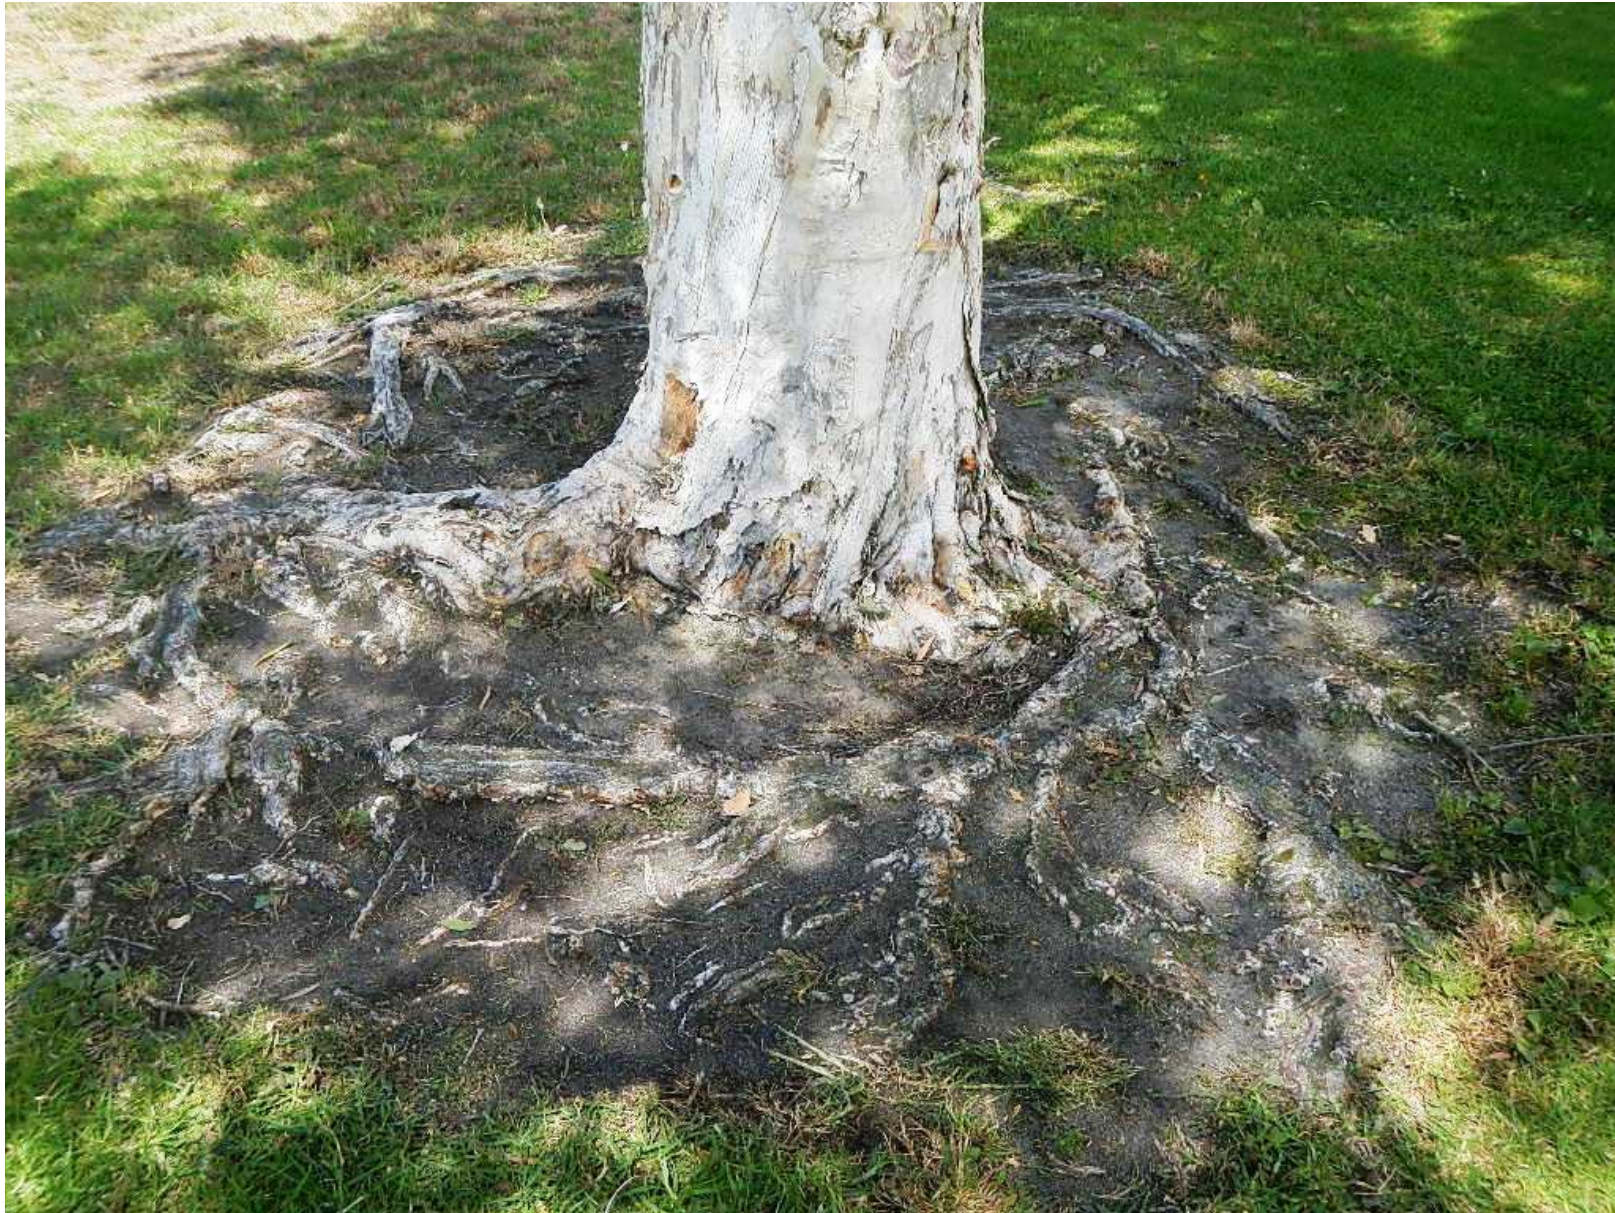
Note the planed down surface roots common around their basess.

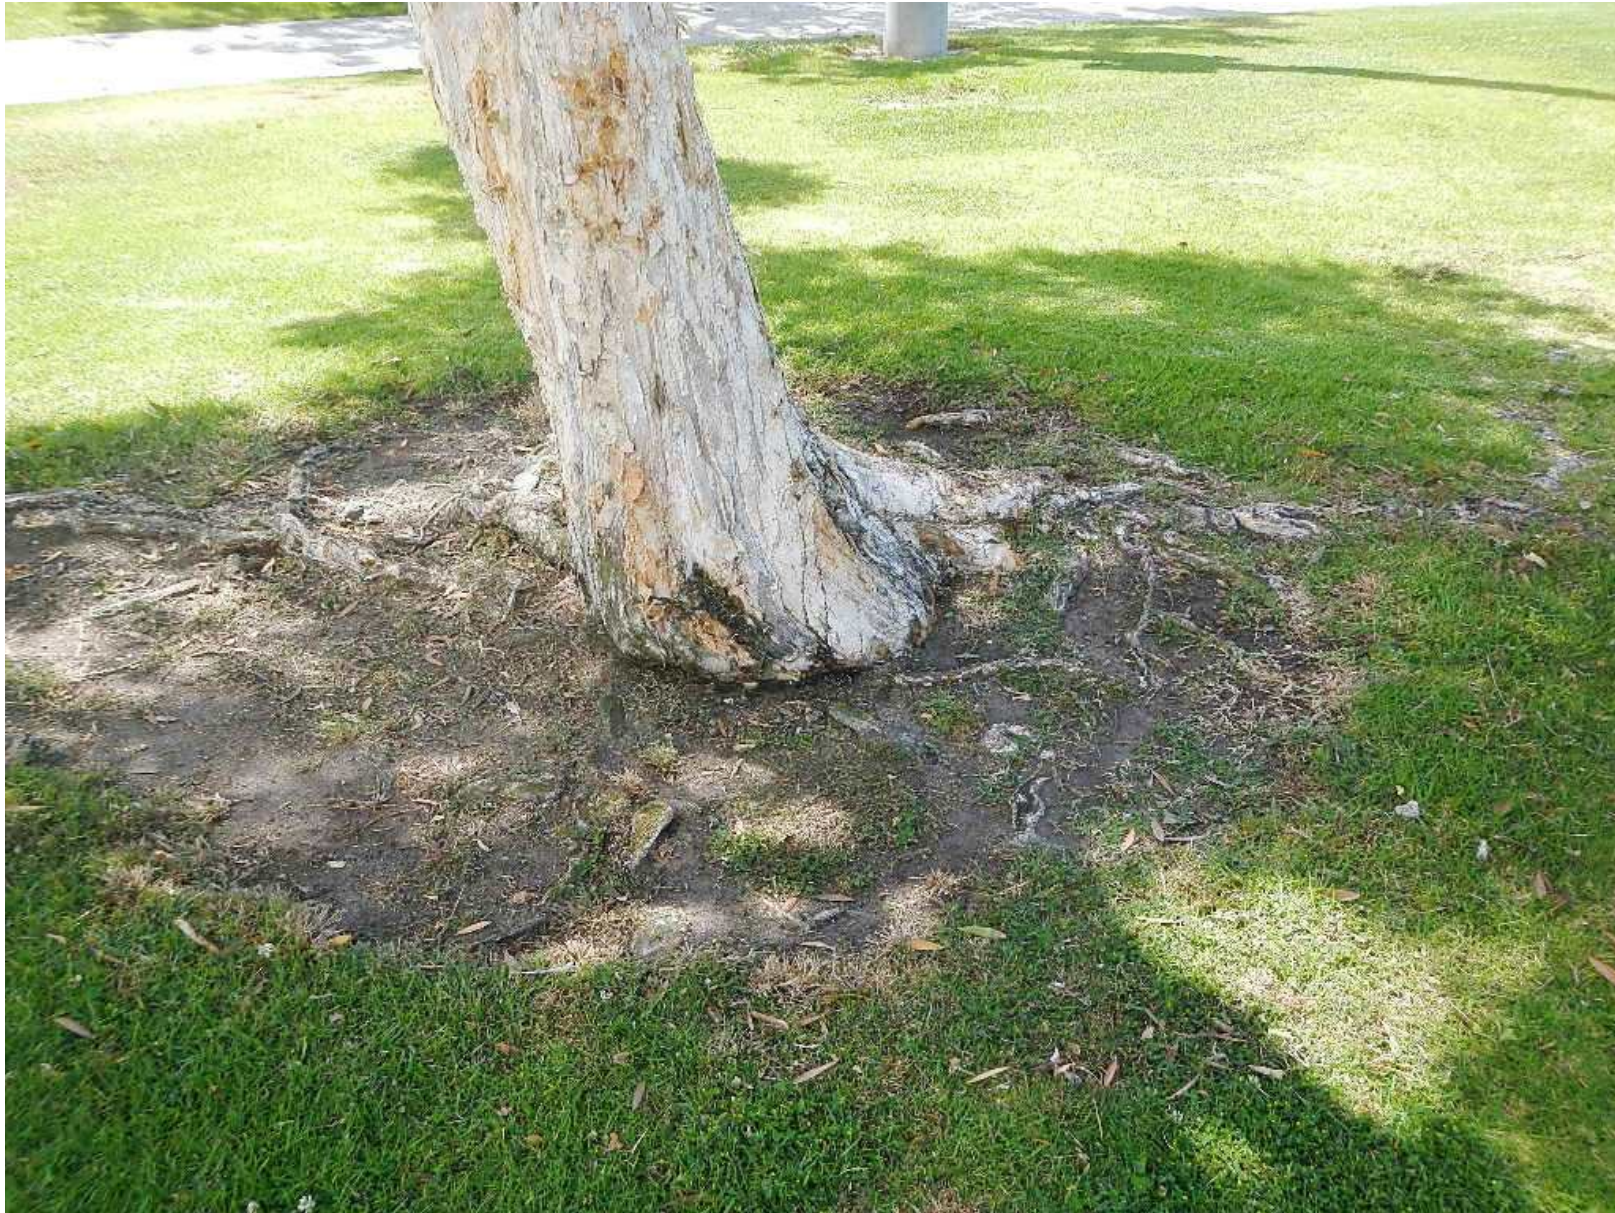
Note the planed down surface roots common around their bases. This one is also girdled

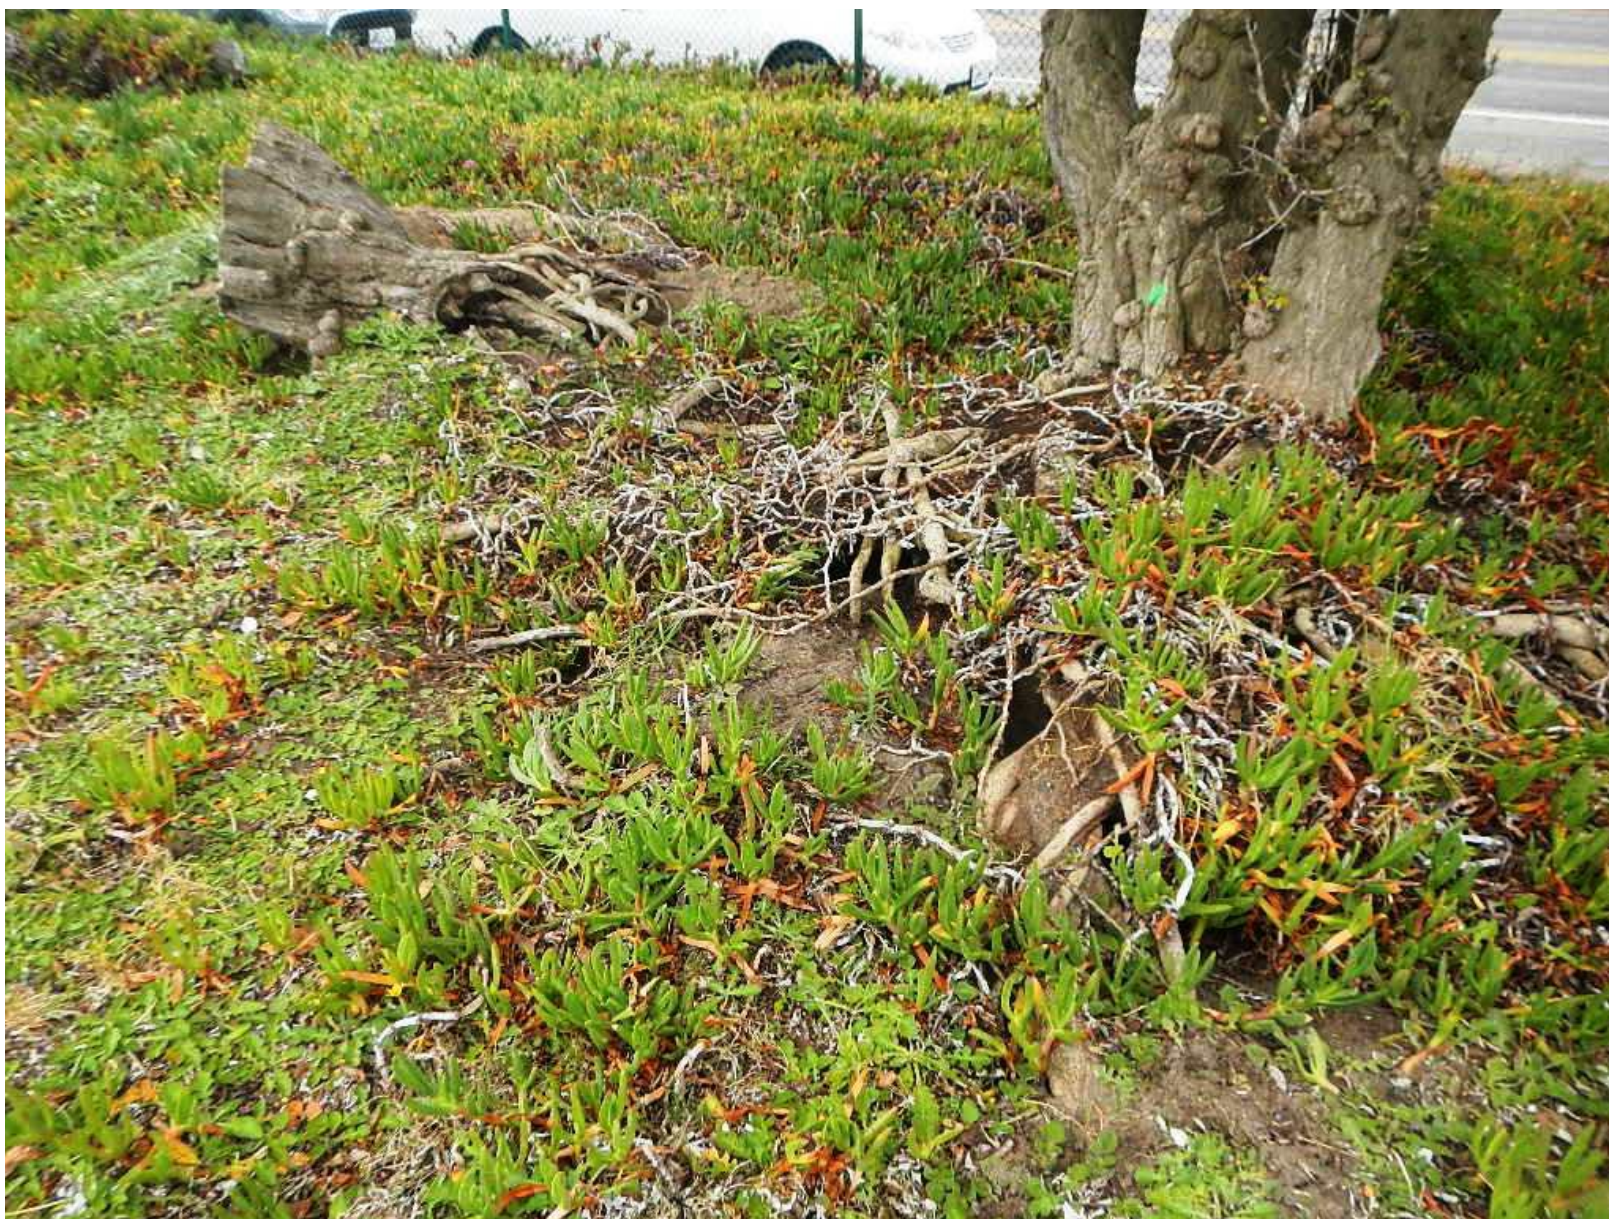
Many myoporums are root sprung.
