**Arborist's Report**  
**June 18, 2022**

# **Tree Preservation Plan**

**For Edison Park, City of Huntington Beach**

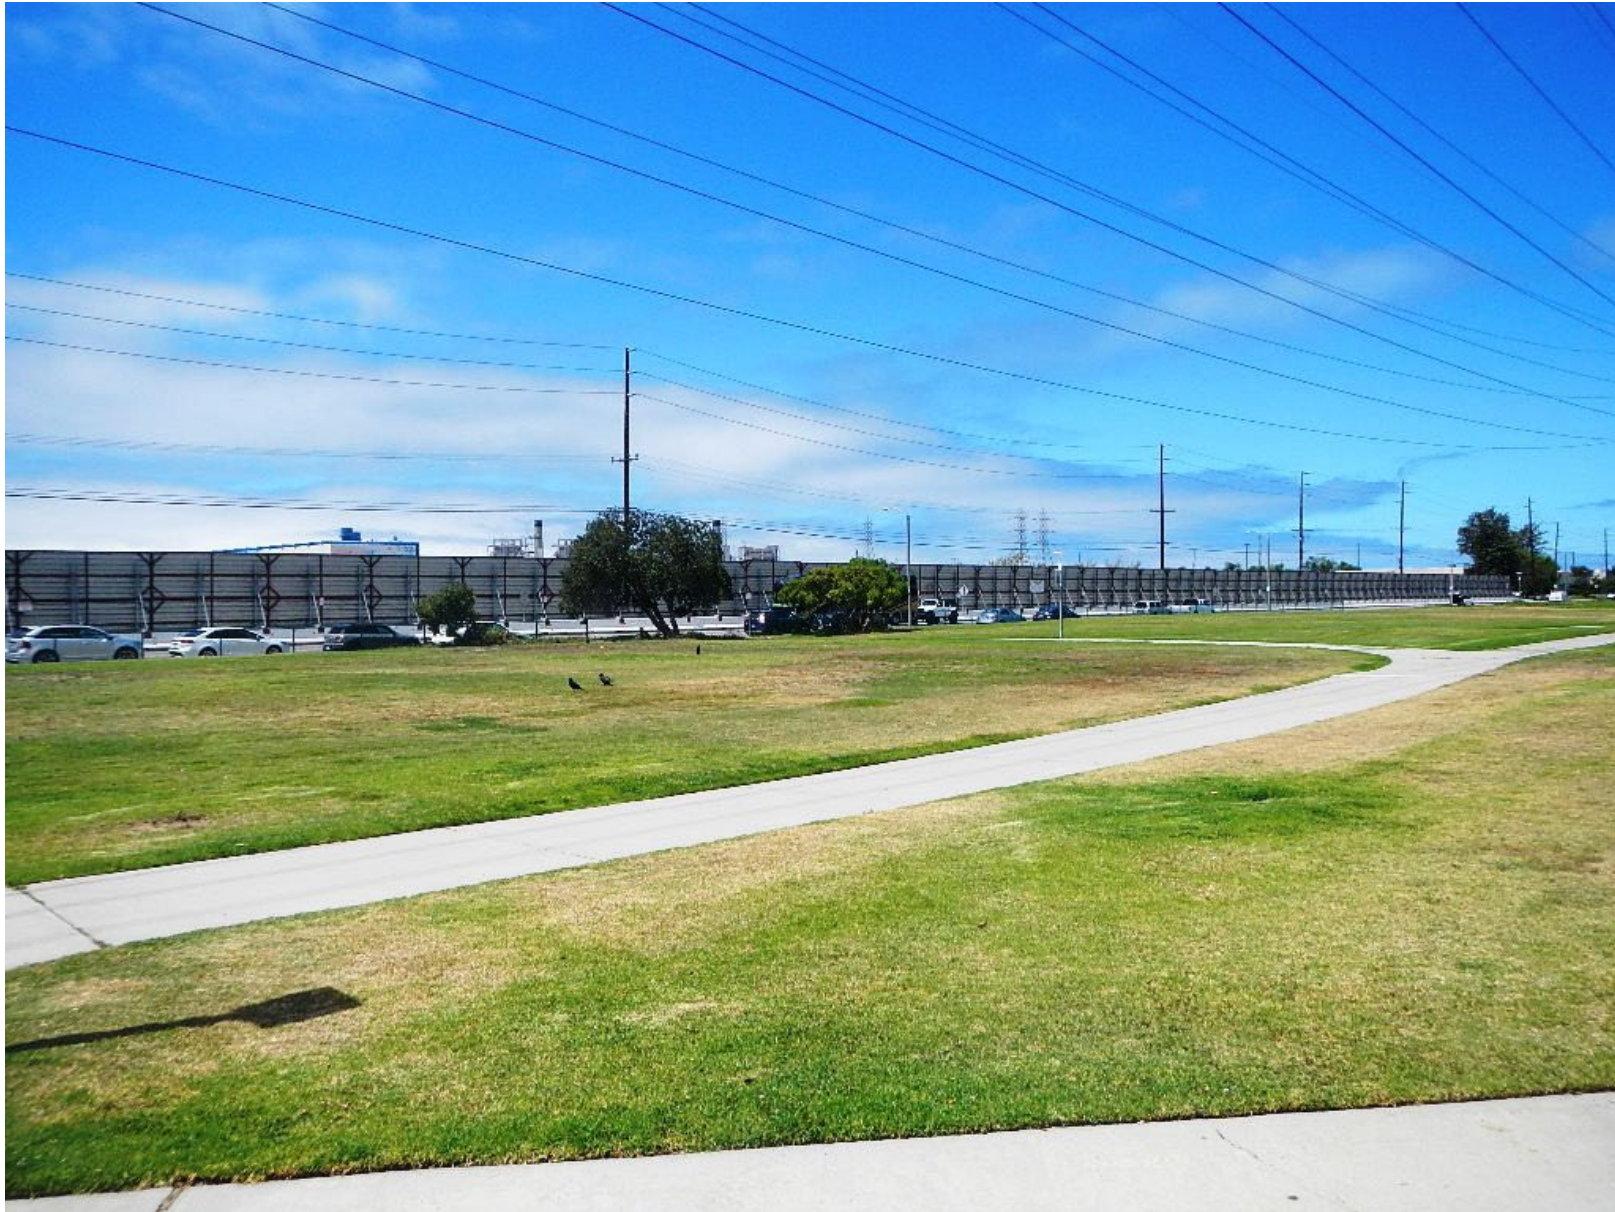
The south edge used to have many more myoporum.

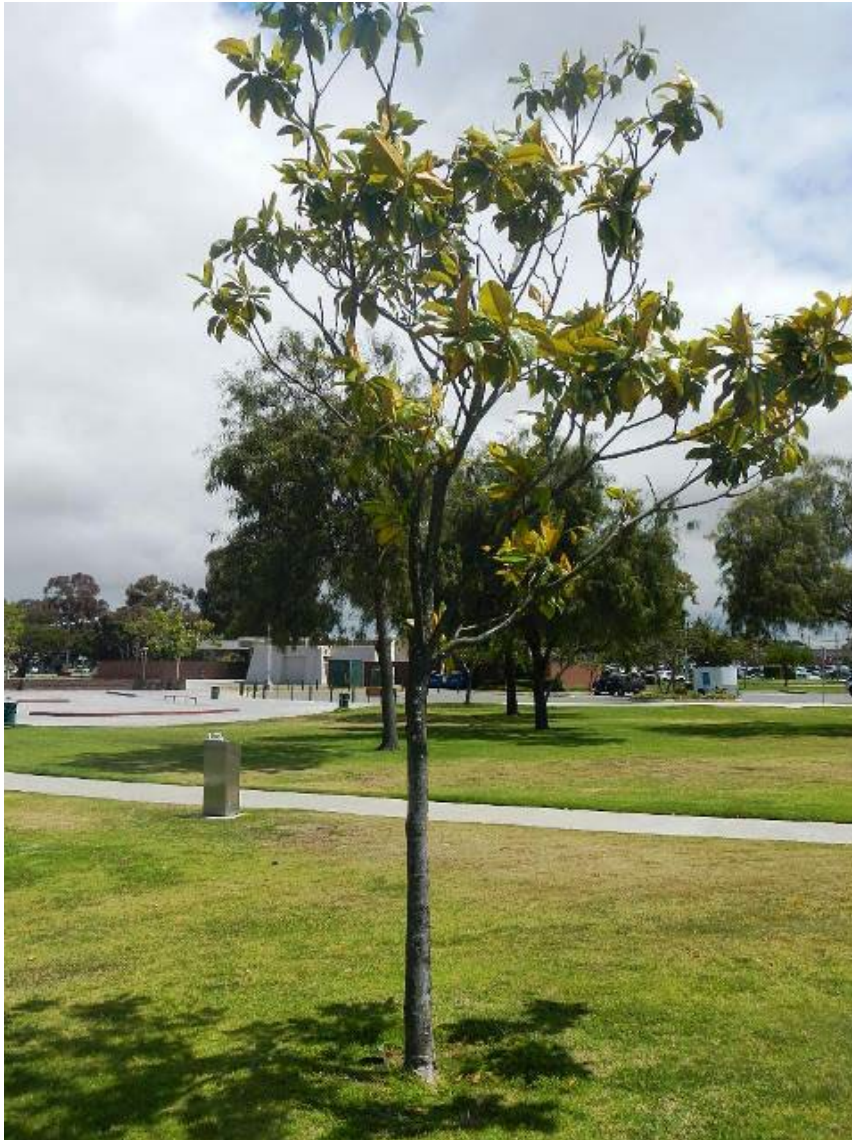
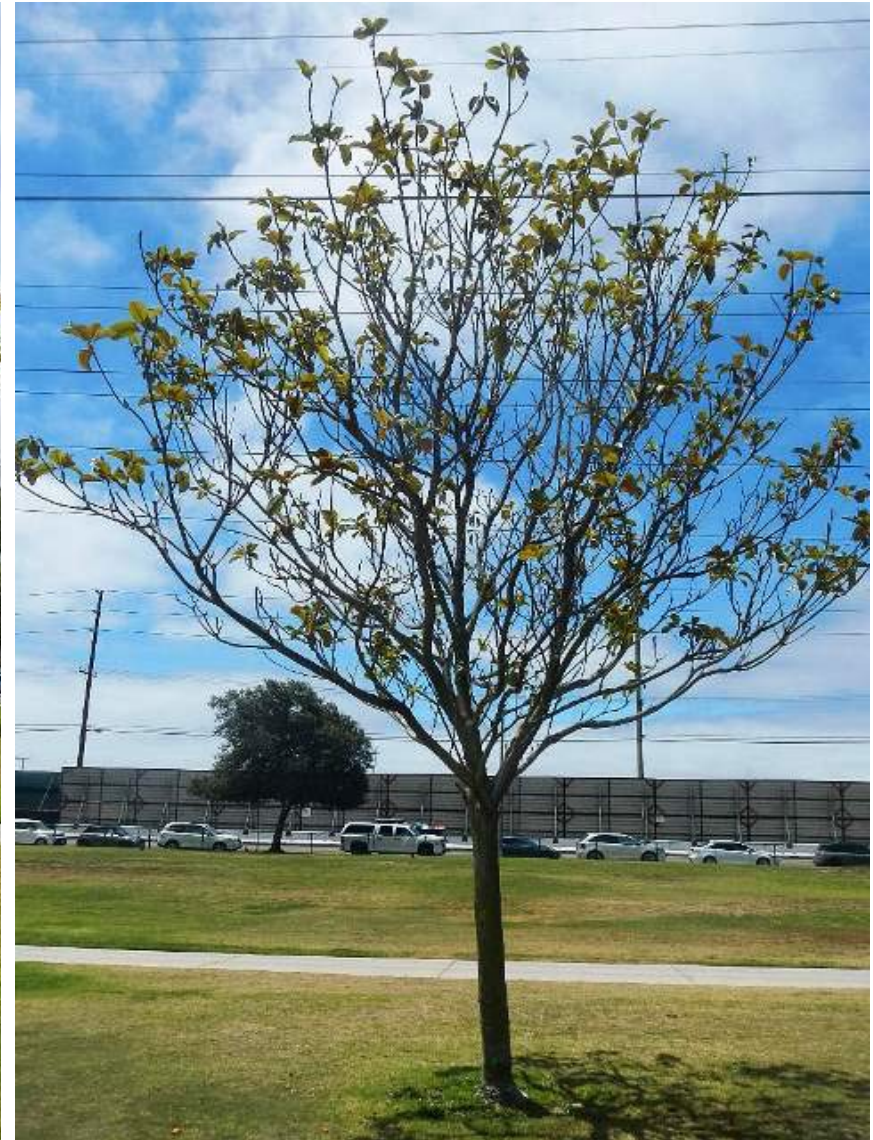
Magnolias are usually a good lawn tree, but need better soil. Note the unhealthy turf surrounding these trees.

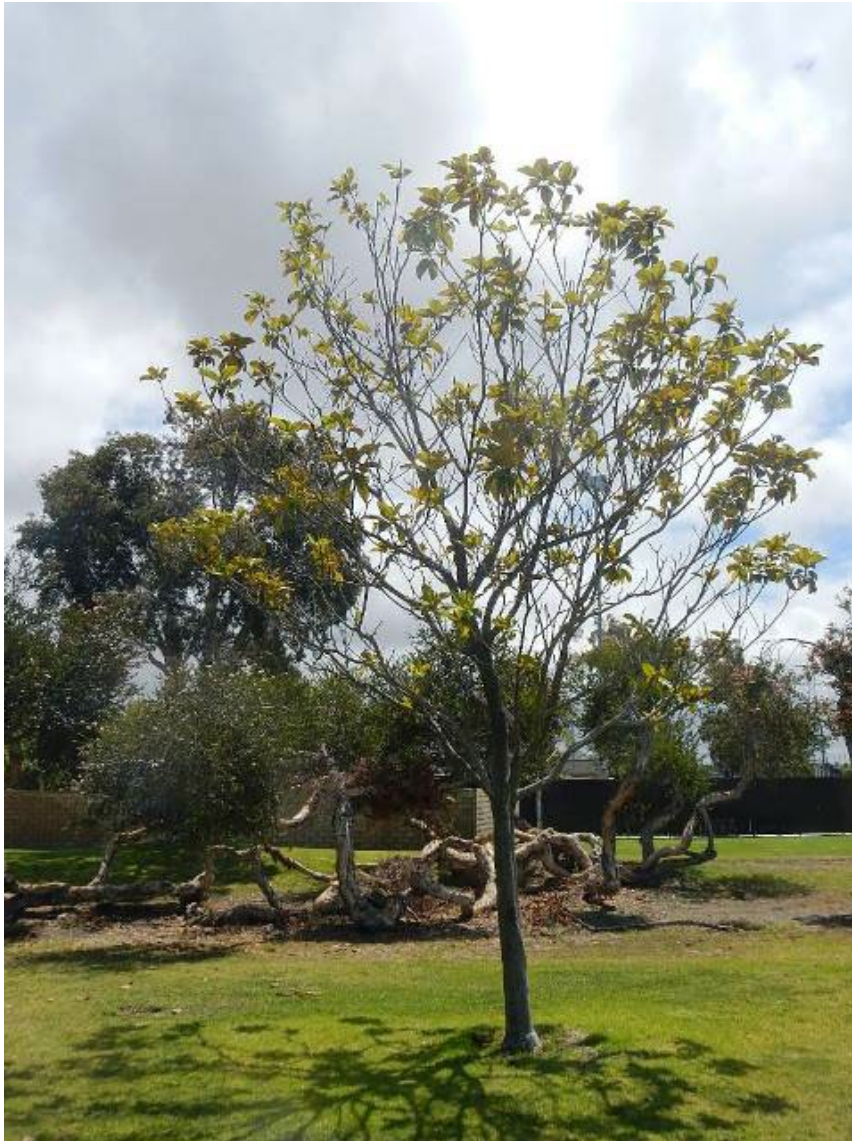
Note the unhealthy turf surrounding these trees.

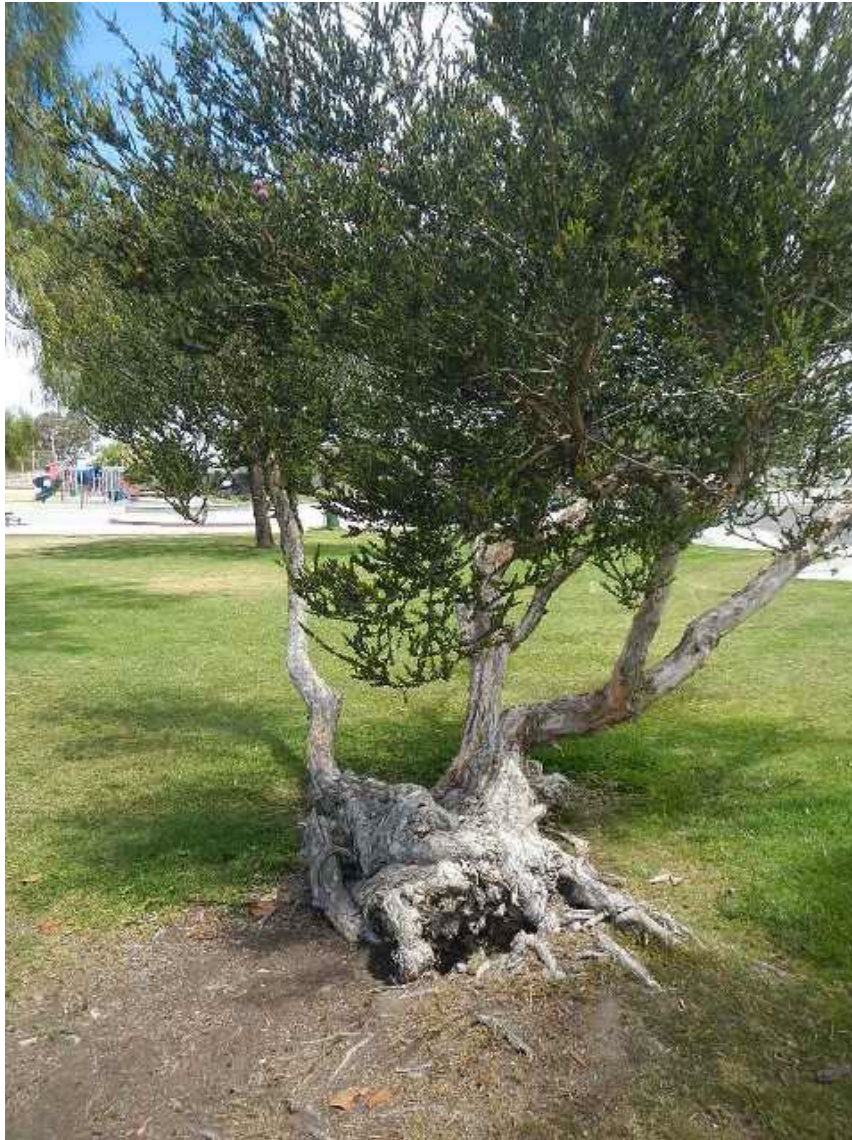
A root sprung pink melaleuca.

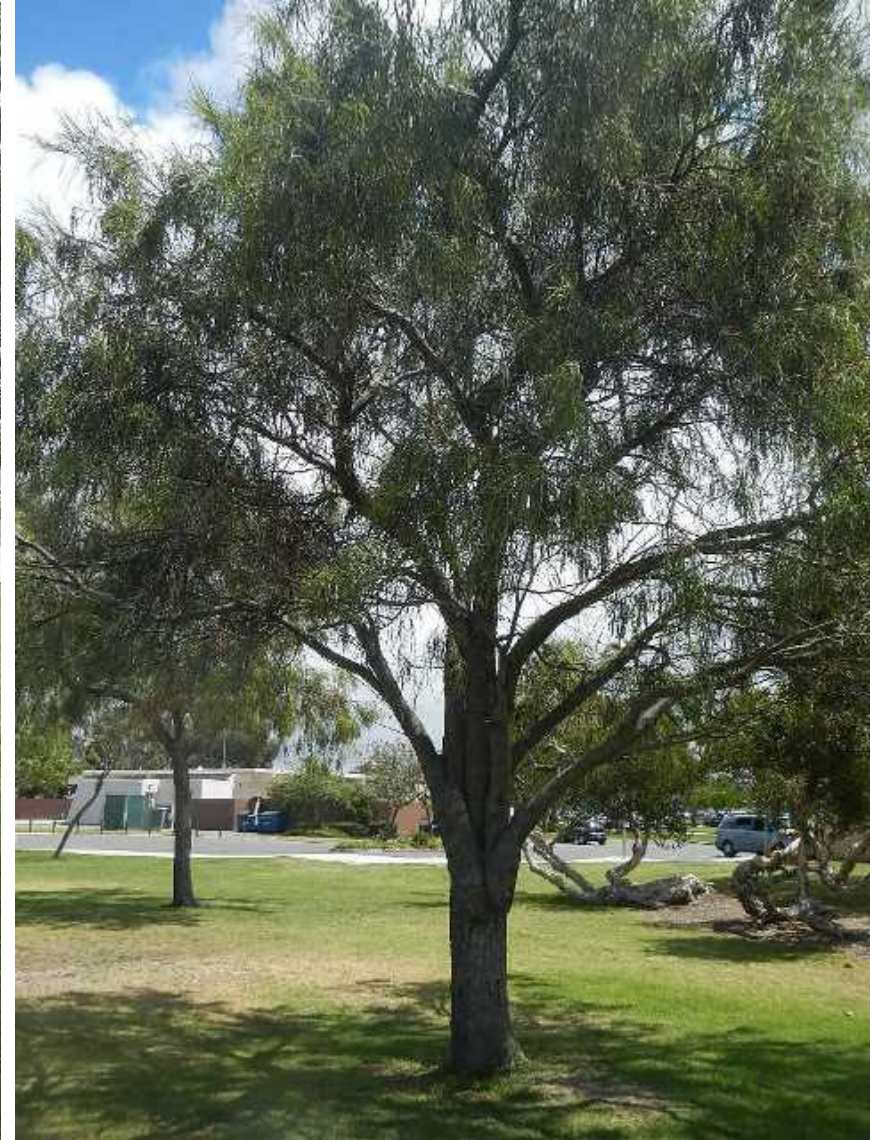
#67 Willow pittosporum with a braided trunk.

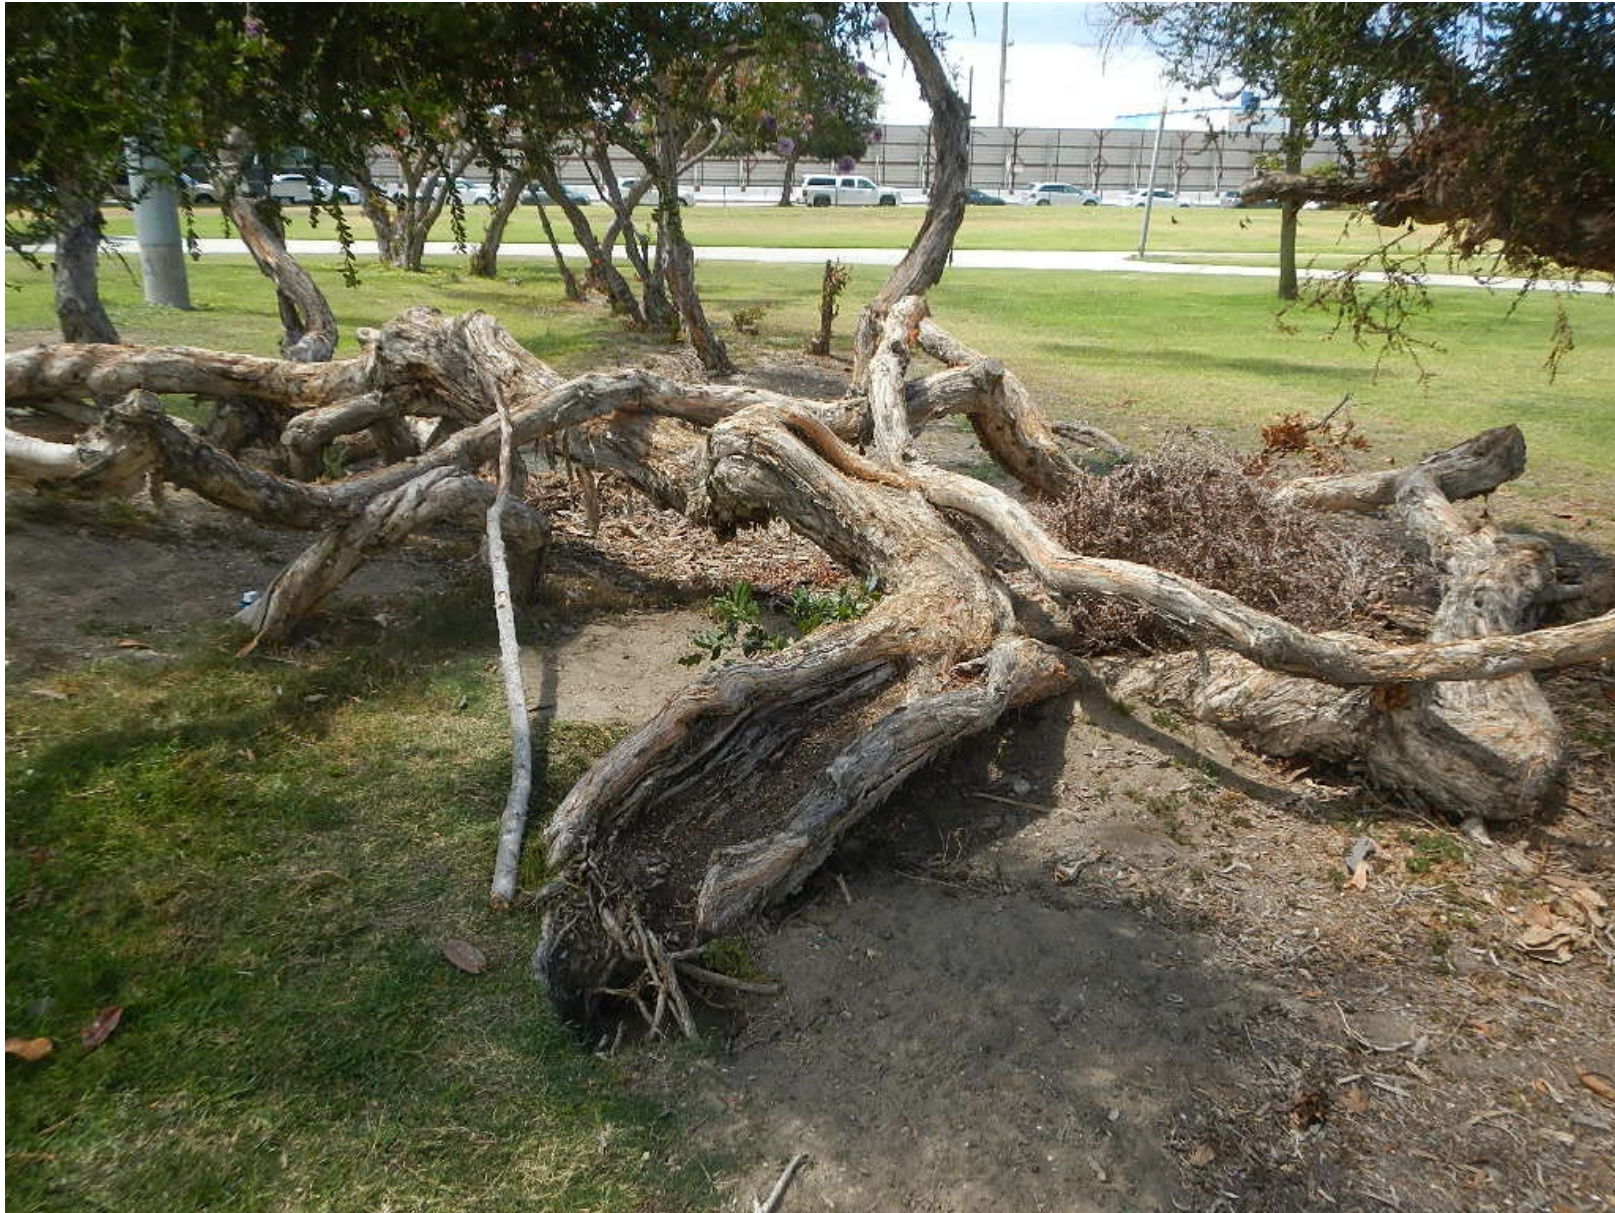
A root-sprung, decayed and headed pink melaleuca, but not dead.

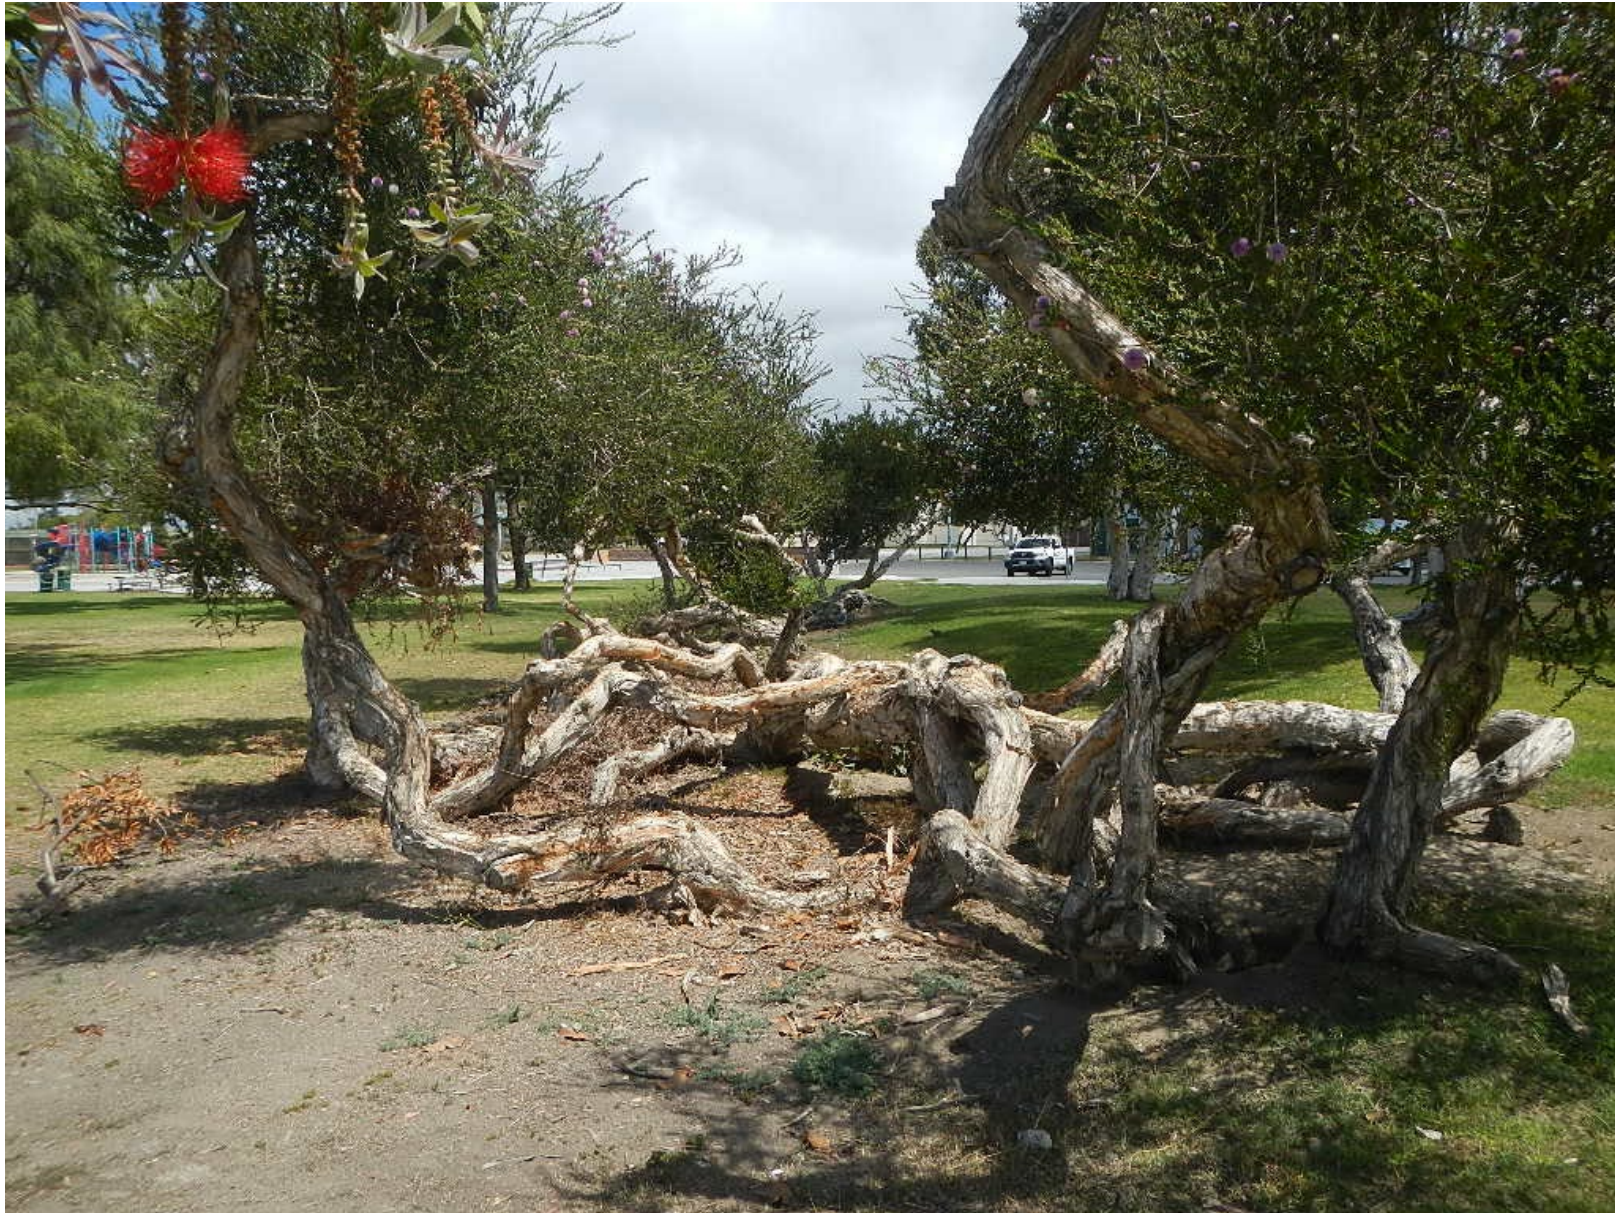
A root-sprung, decayed and headed pink melaleuca, but interesting.

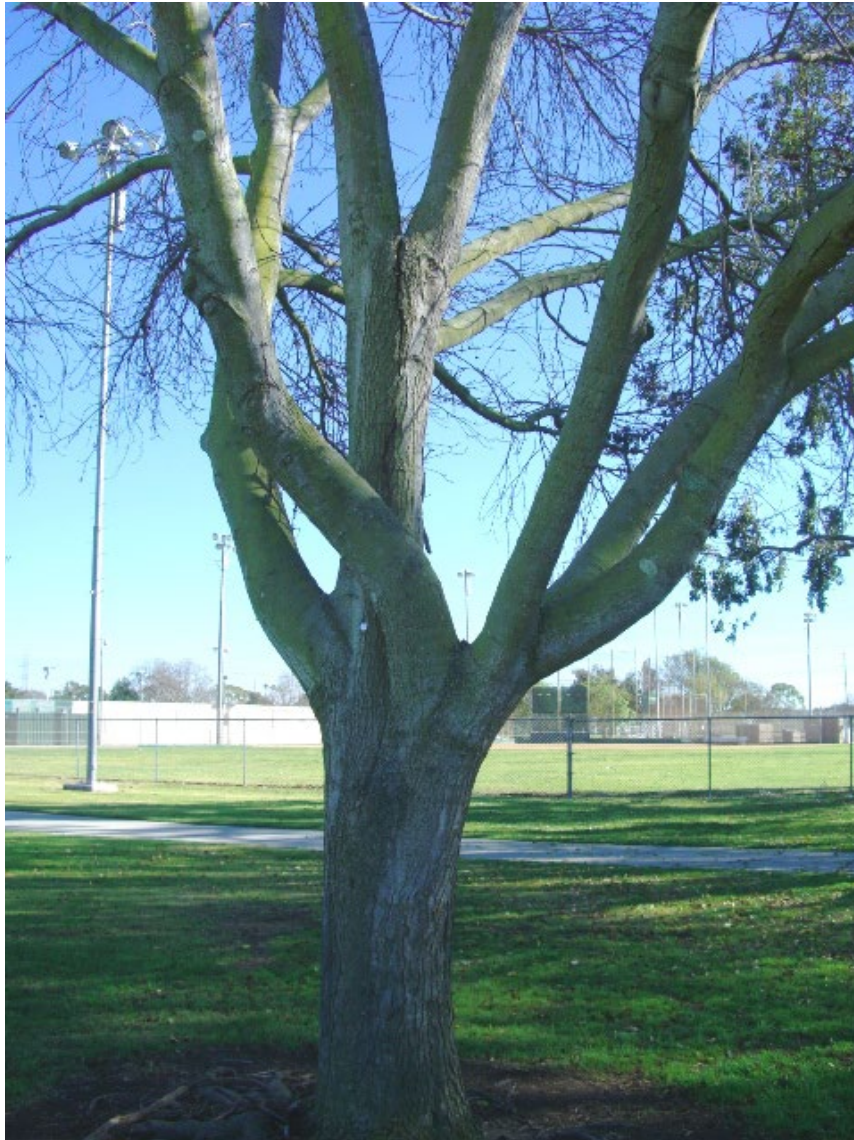
Tag #145, Liquidambar styraciflua with crowded codominant limbs

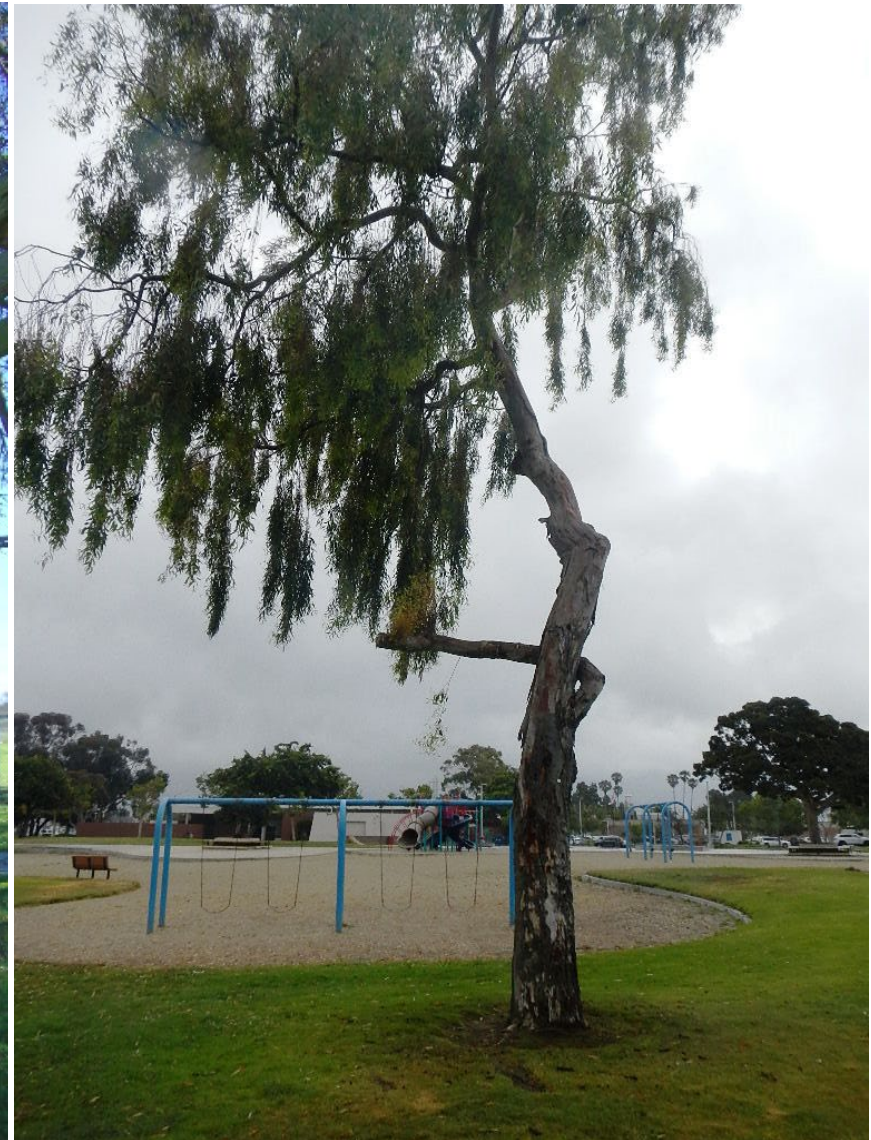
#71 Eucalyptus camaldulensis – note headed lower limb wraps around

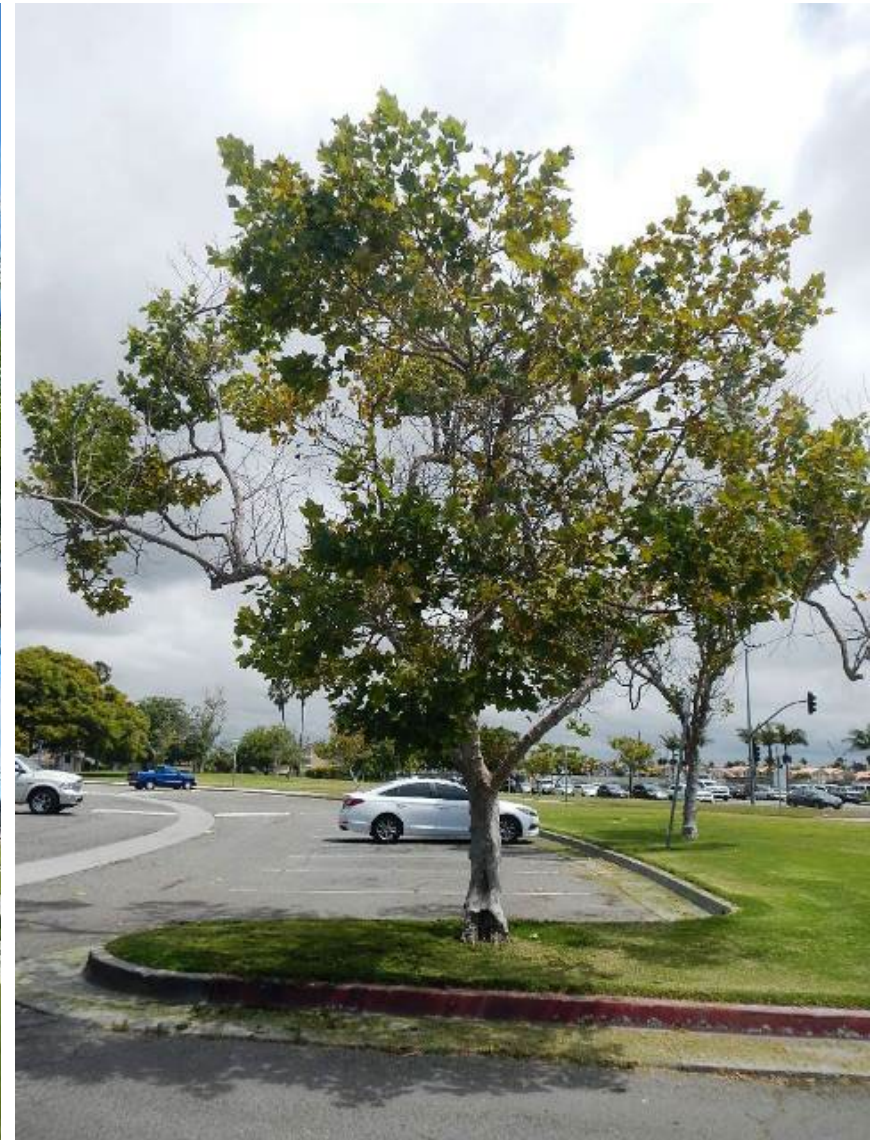
London planes just to the north are in poor health. Soil or water?

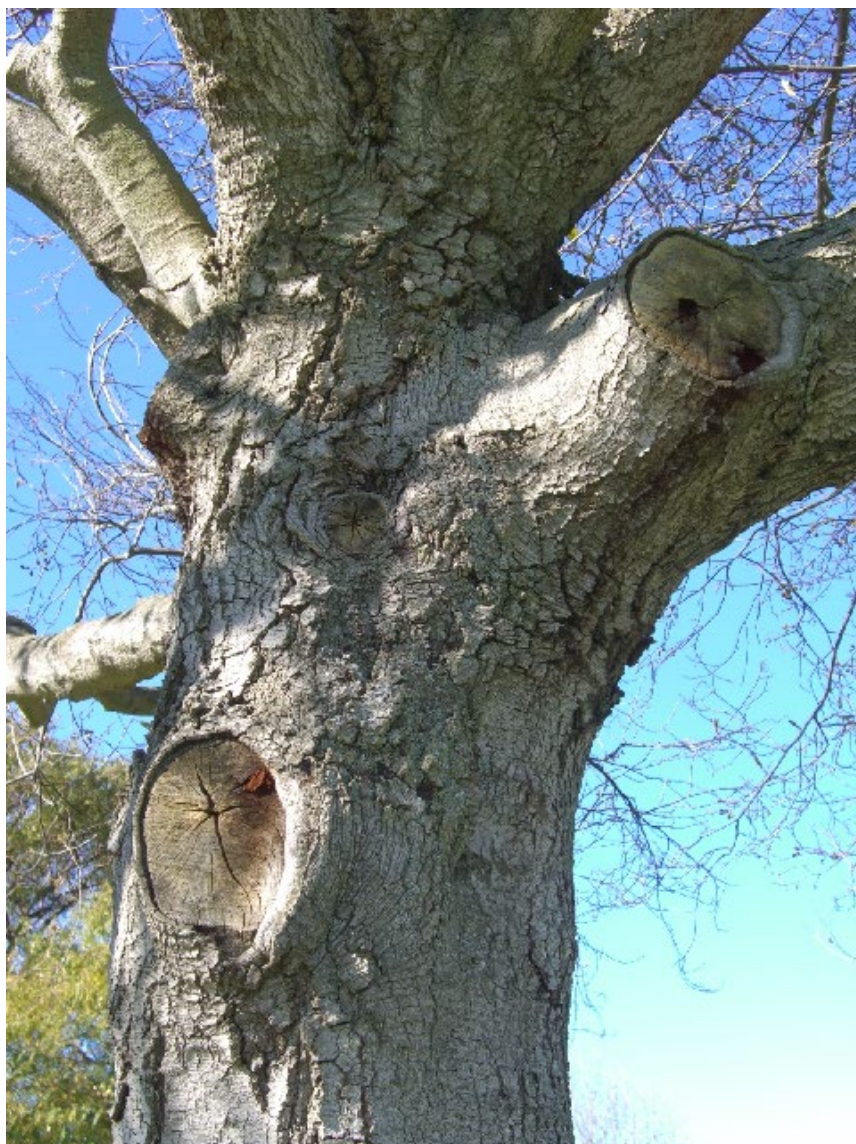
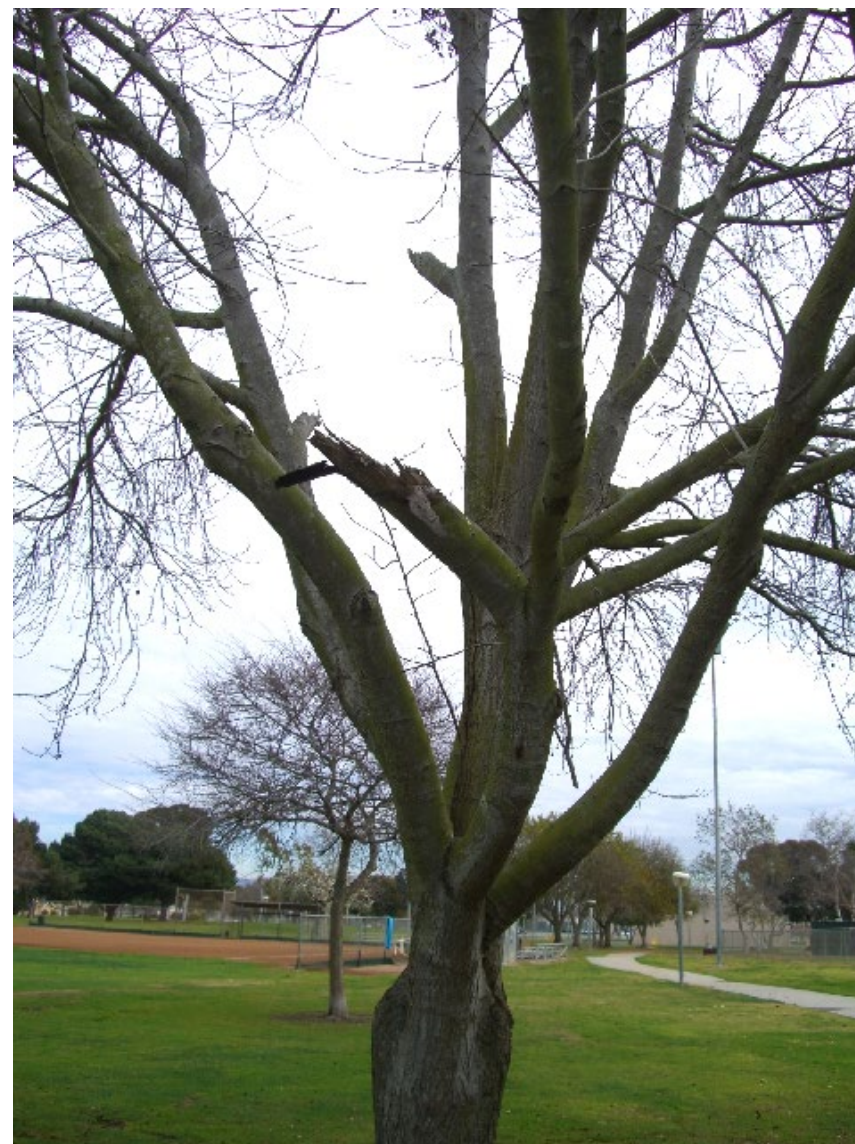
Flush cuts on trunk resulted in velvet stem (*Flammulina velutipes*) decay. #145, Liquidambar with included bark, codominant, broken limbs

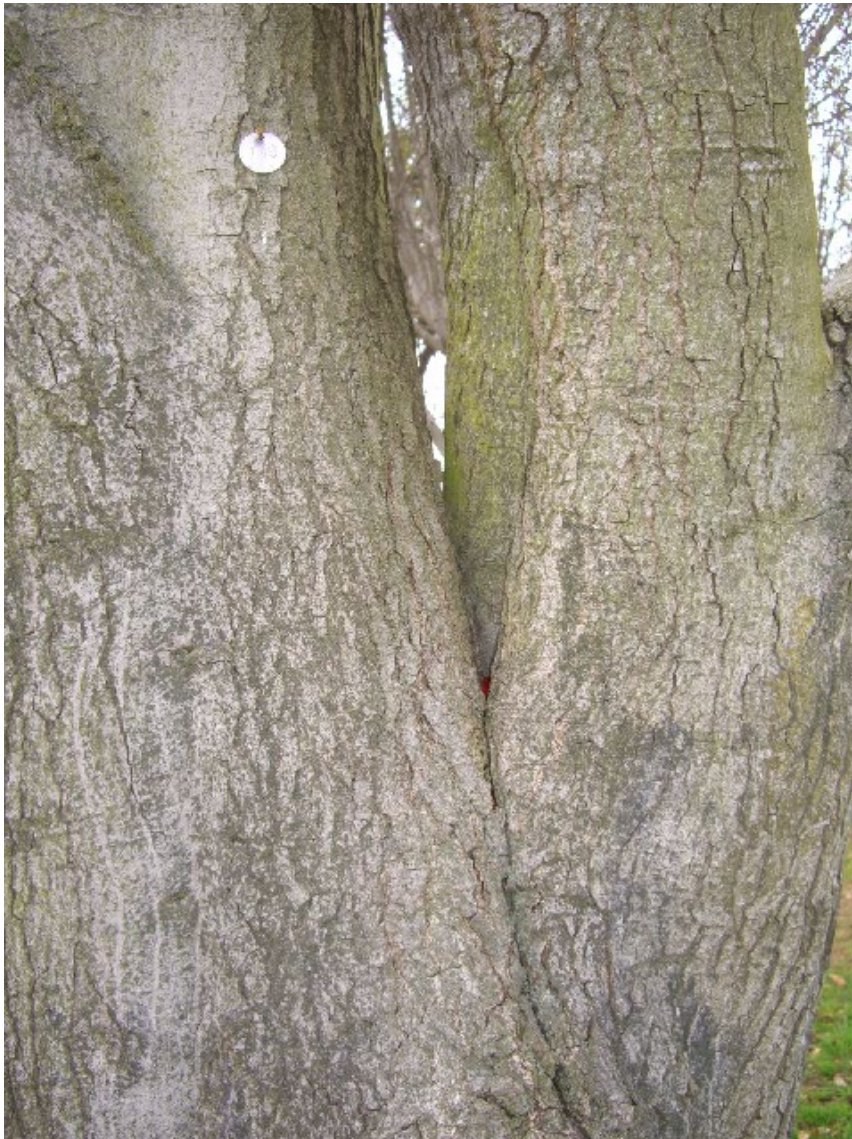
Tag #145, Liquidambar with codominant limbs and included bark.

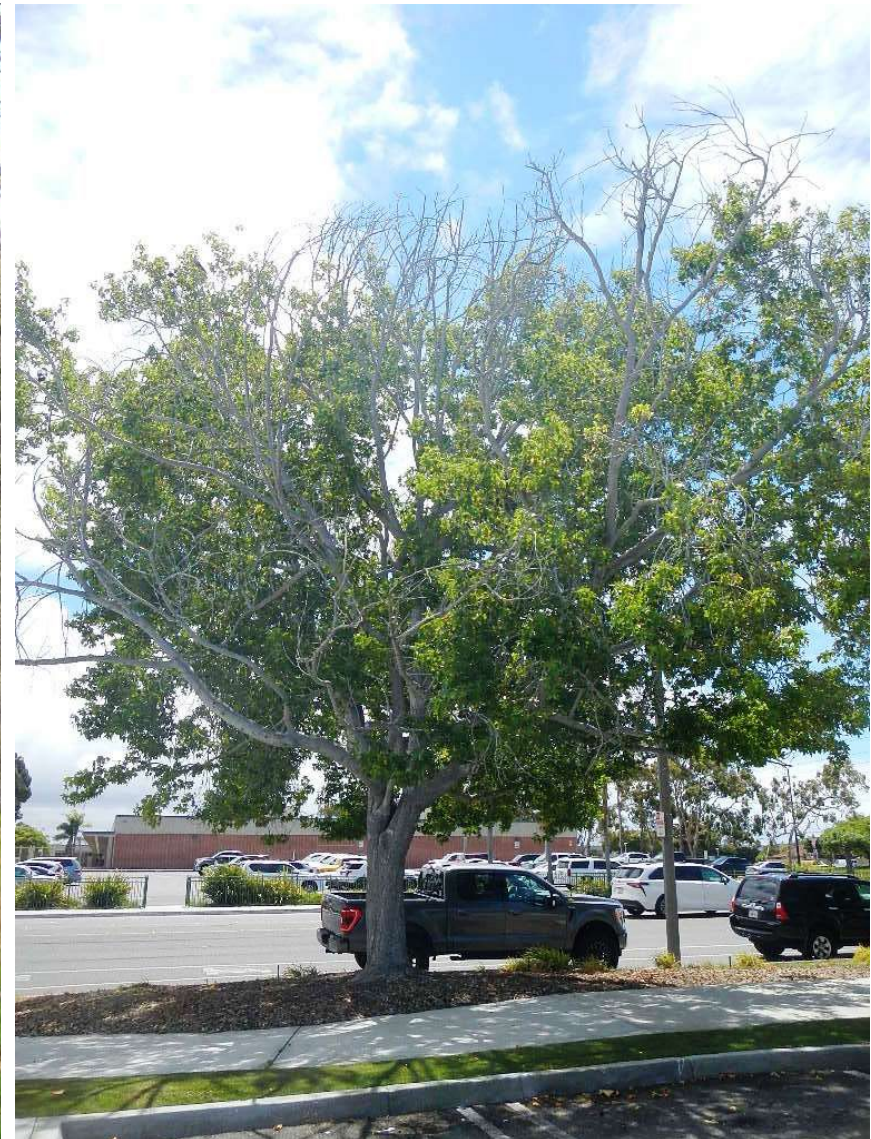
#50 Liquidambar with much dieback; Xylella?

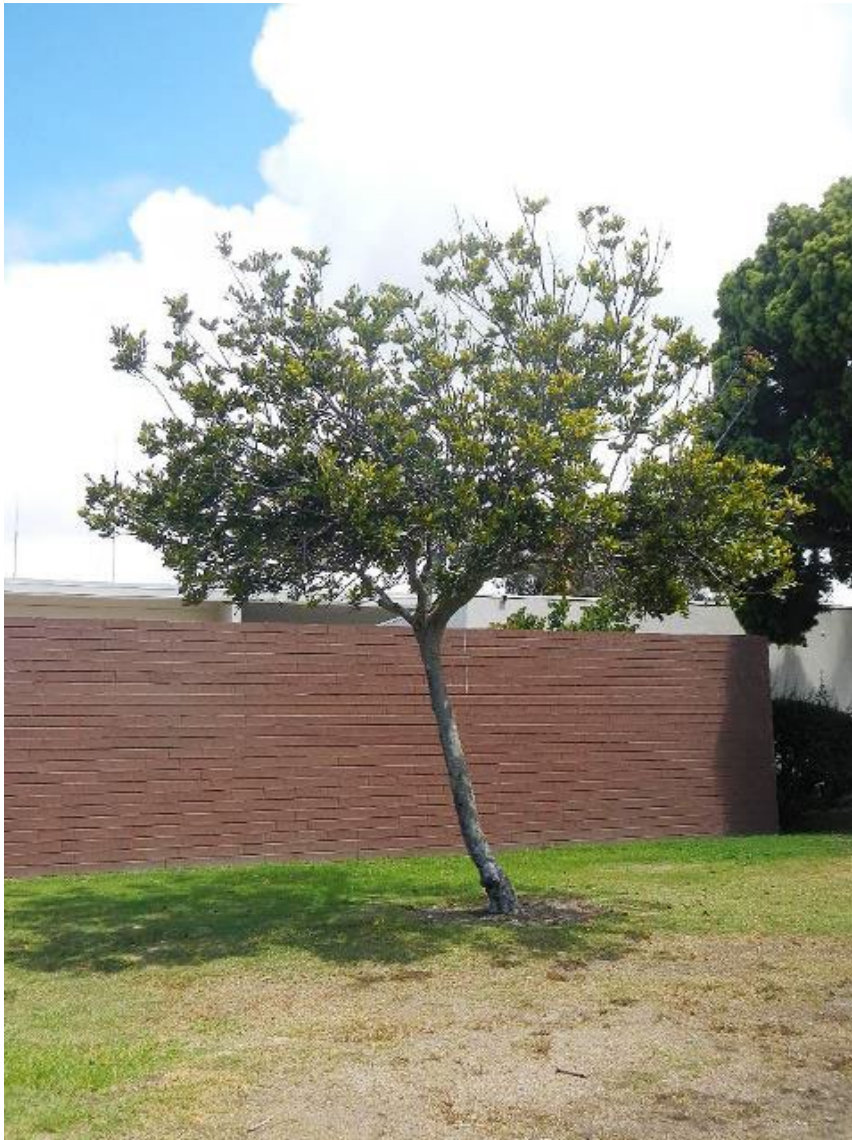
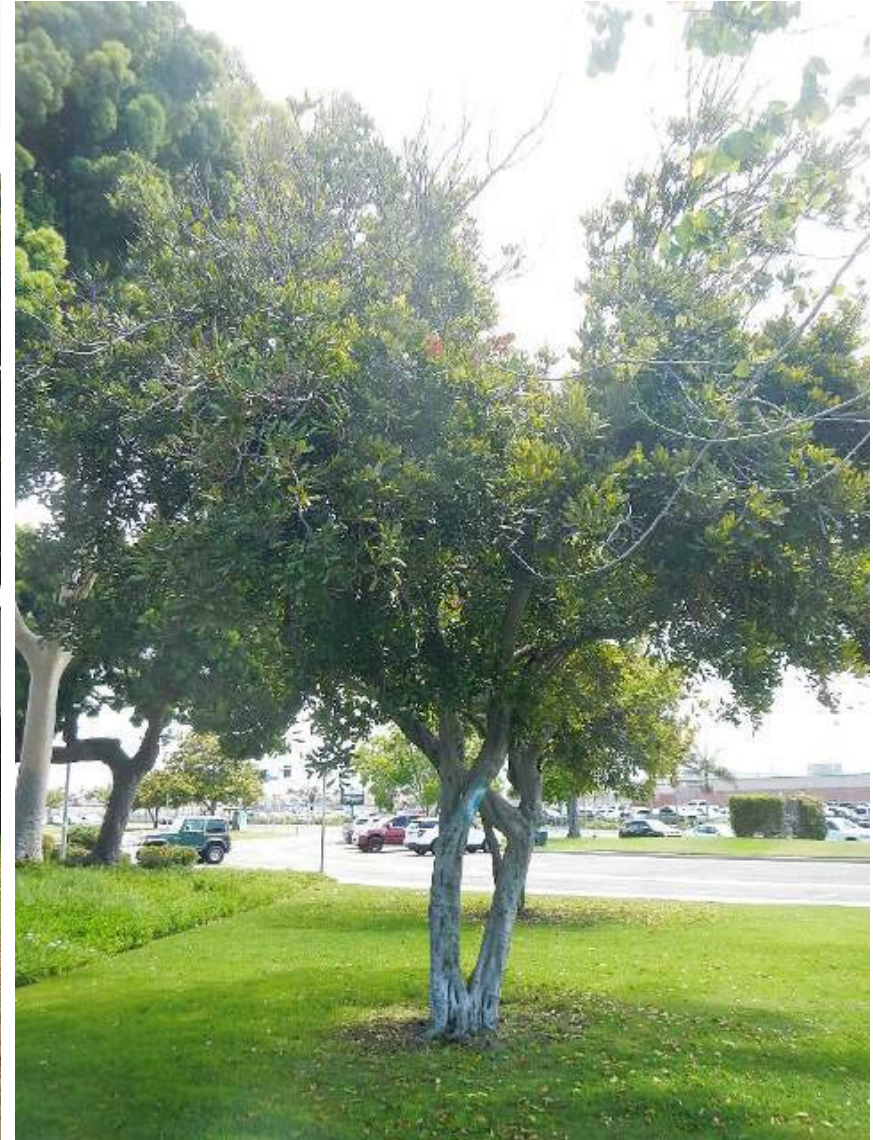
This carrotwood has barely grown at all since 2009. Note the root crown. This carrotwood is also stunted. Note the root crown.

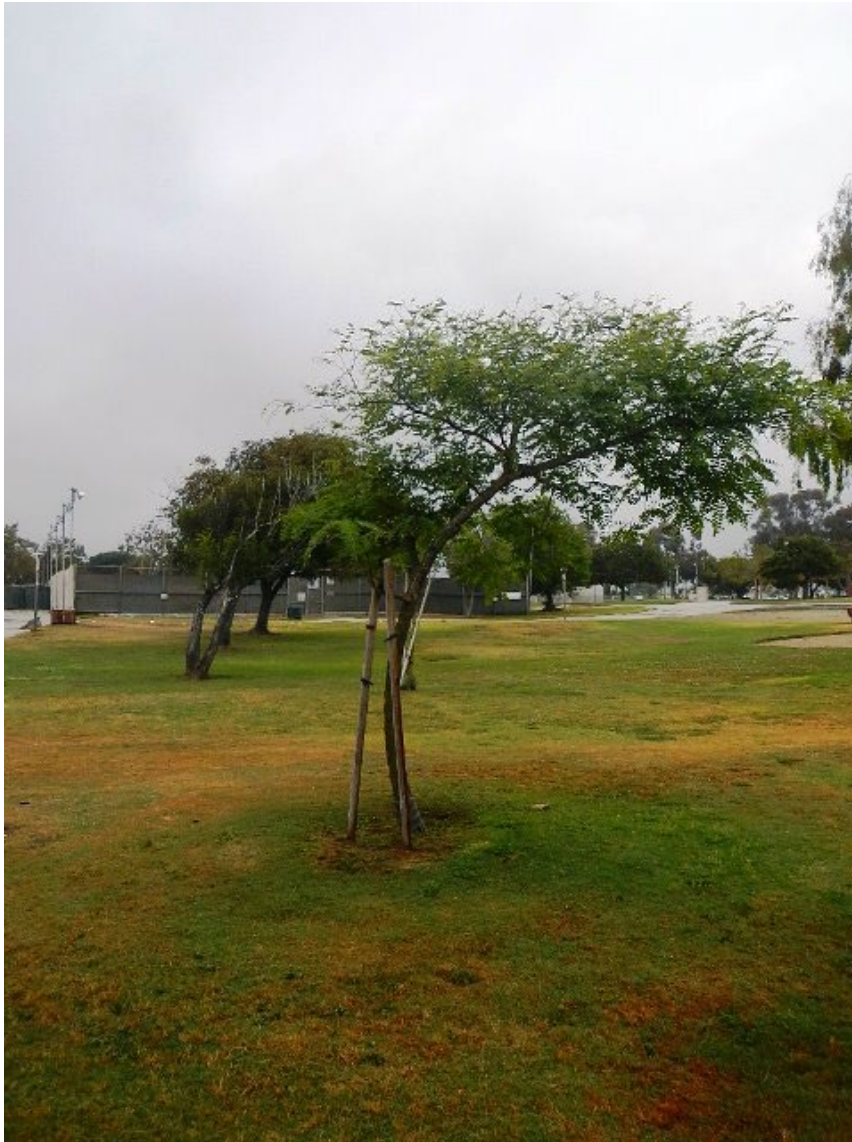
#269 Fraxinus uhdei – wind swept?

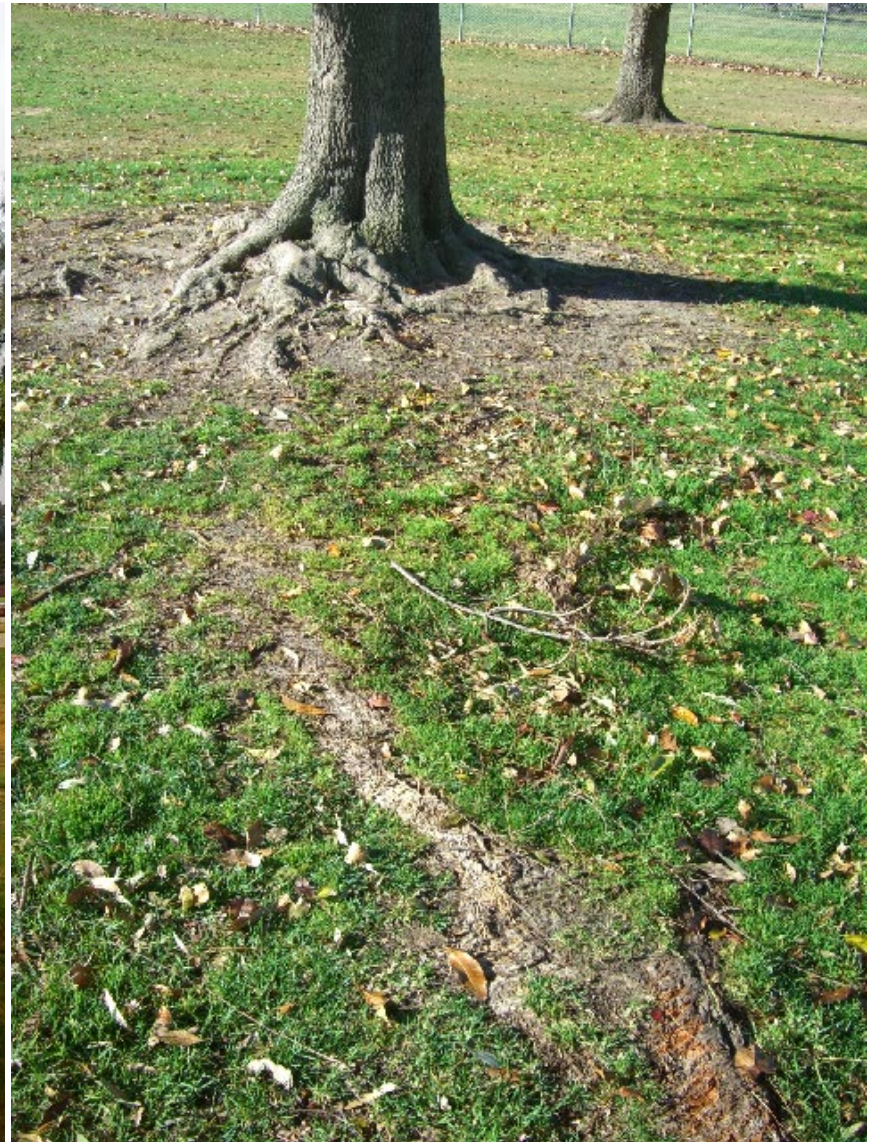
Fraxinus uhdei – note roots shaved by mowers.

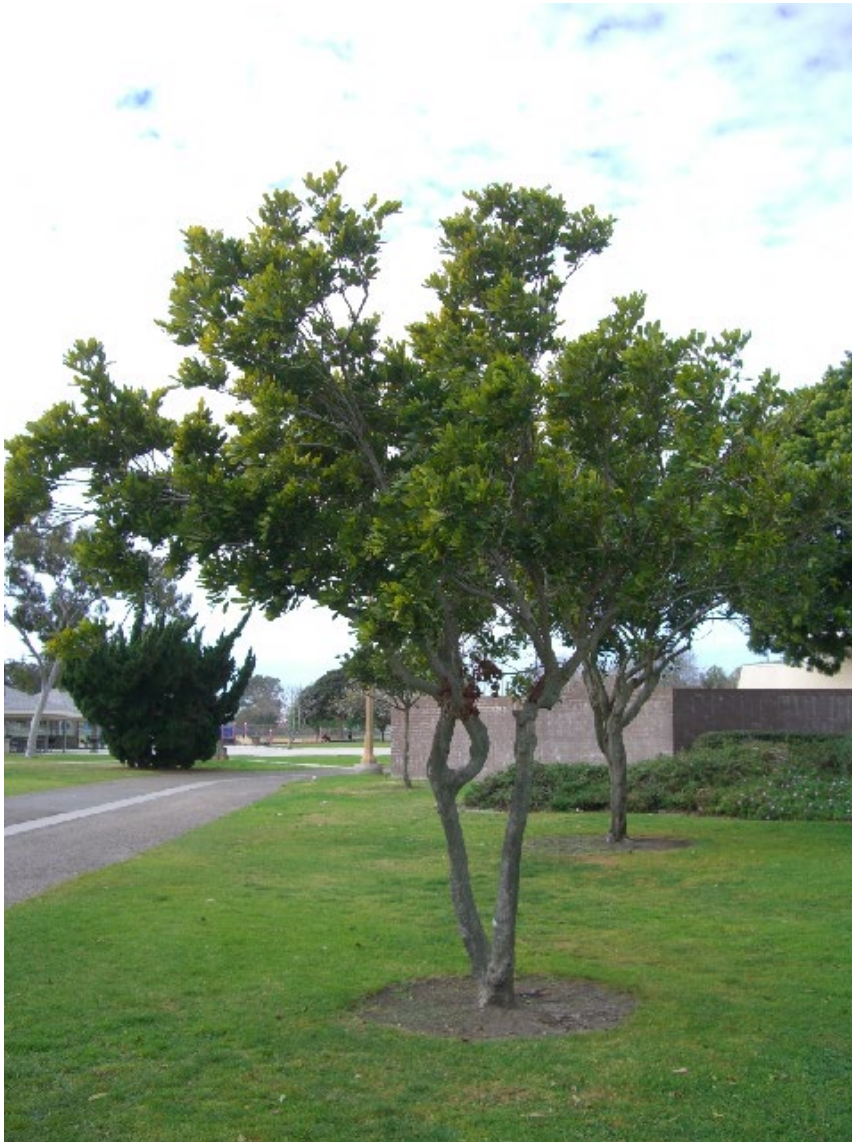
More stunted carrotwoods surround the community building.
