APPENDIX D: FACILITY CONDITIONS AND PROGRAM FEASIBILITY ANALYSIS - FROMER CONGREGATION ADATH ISRAEL

Facility Condition and Program Feasibility Assessment

FORMER CONGREGATION ADATH ISRAEL

East Third and East Oneida Streets
Oswego, New York

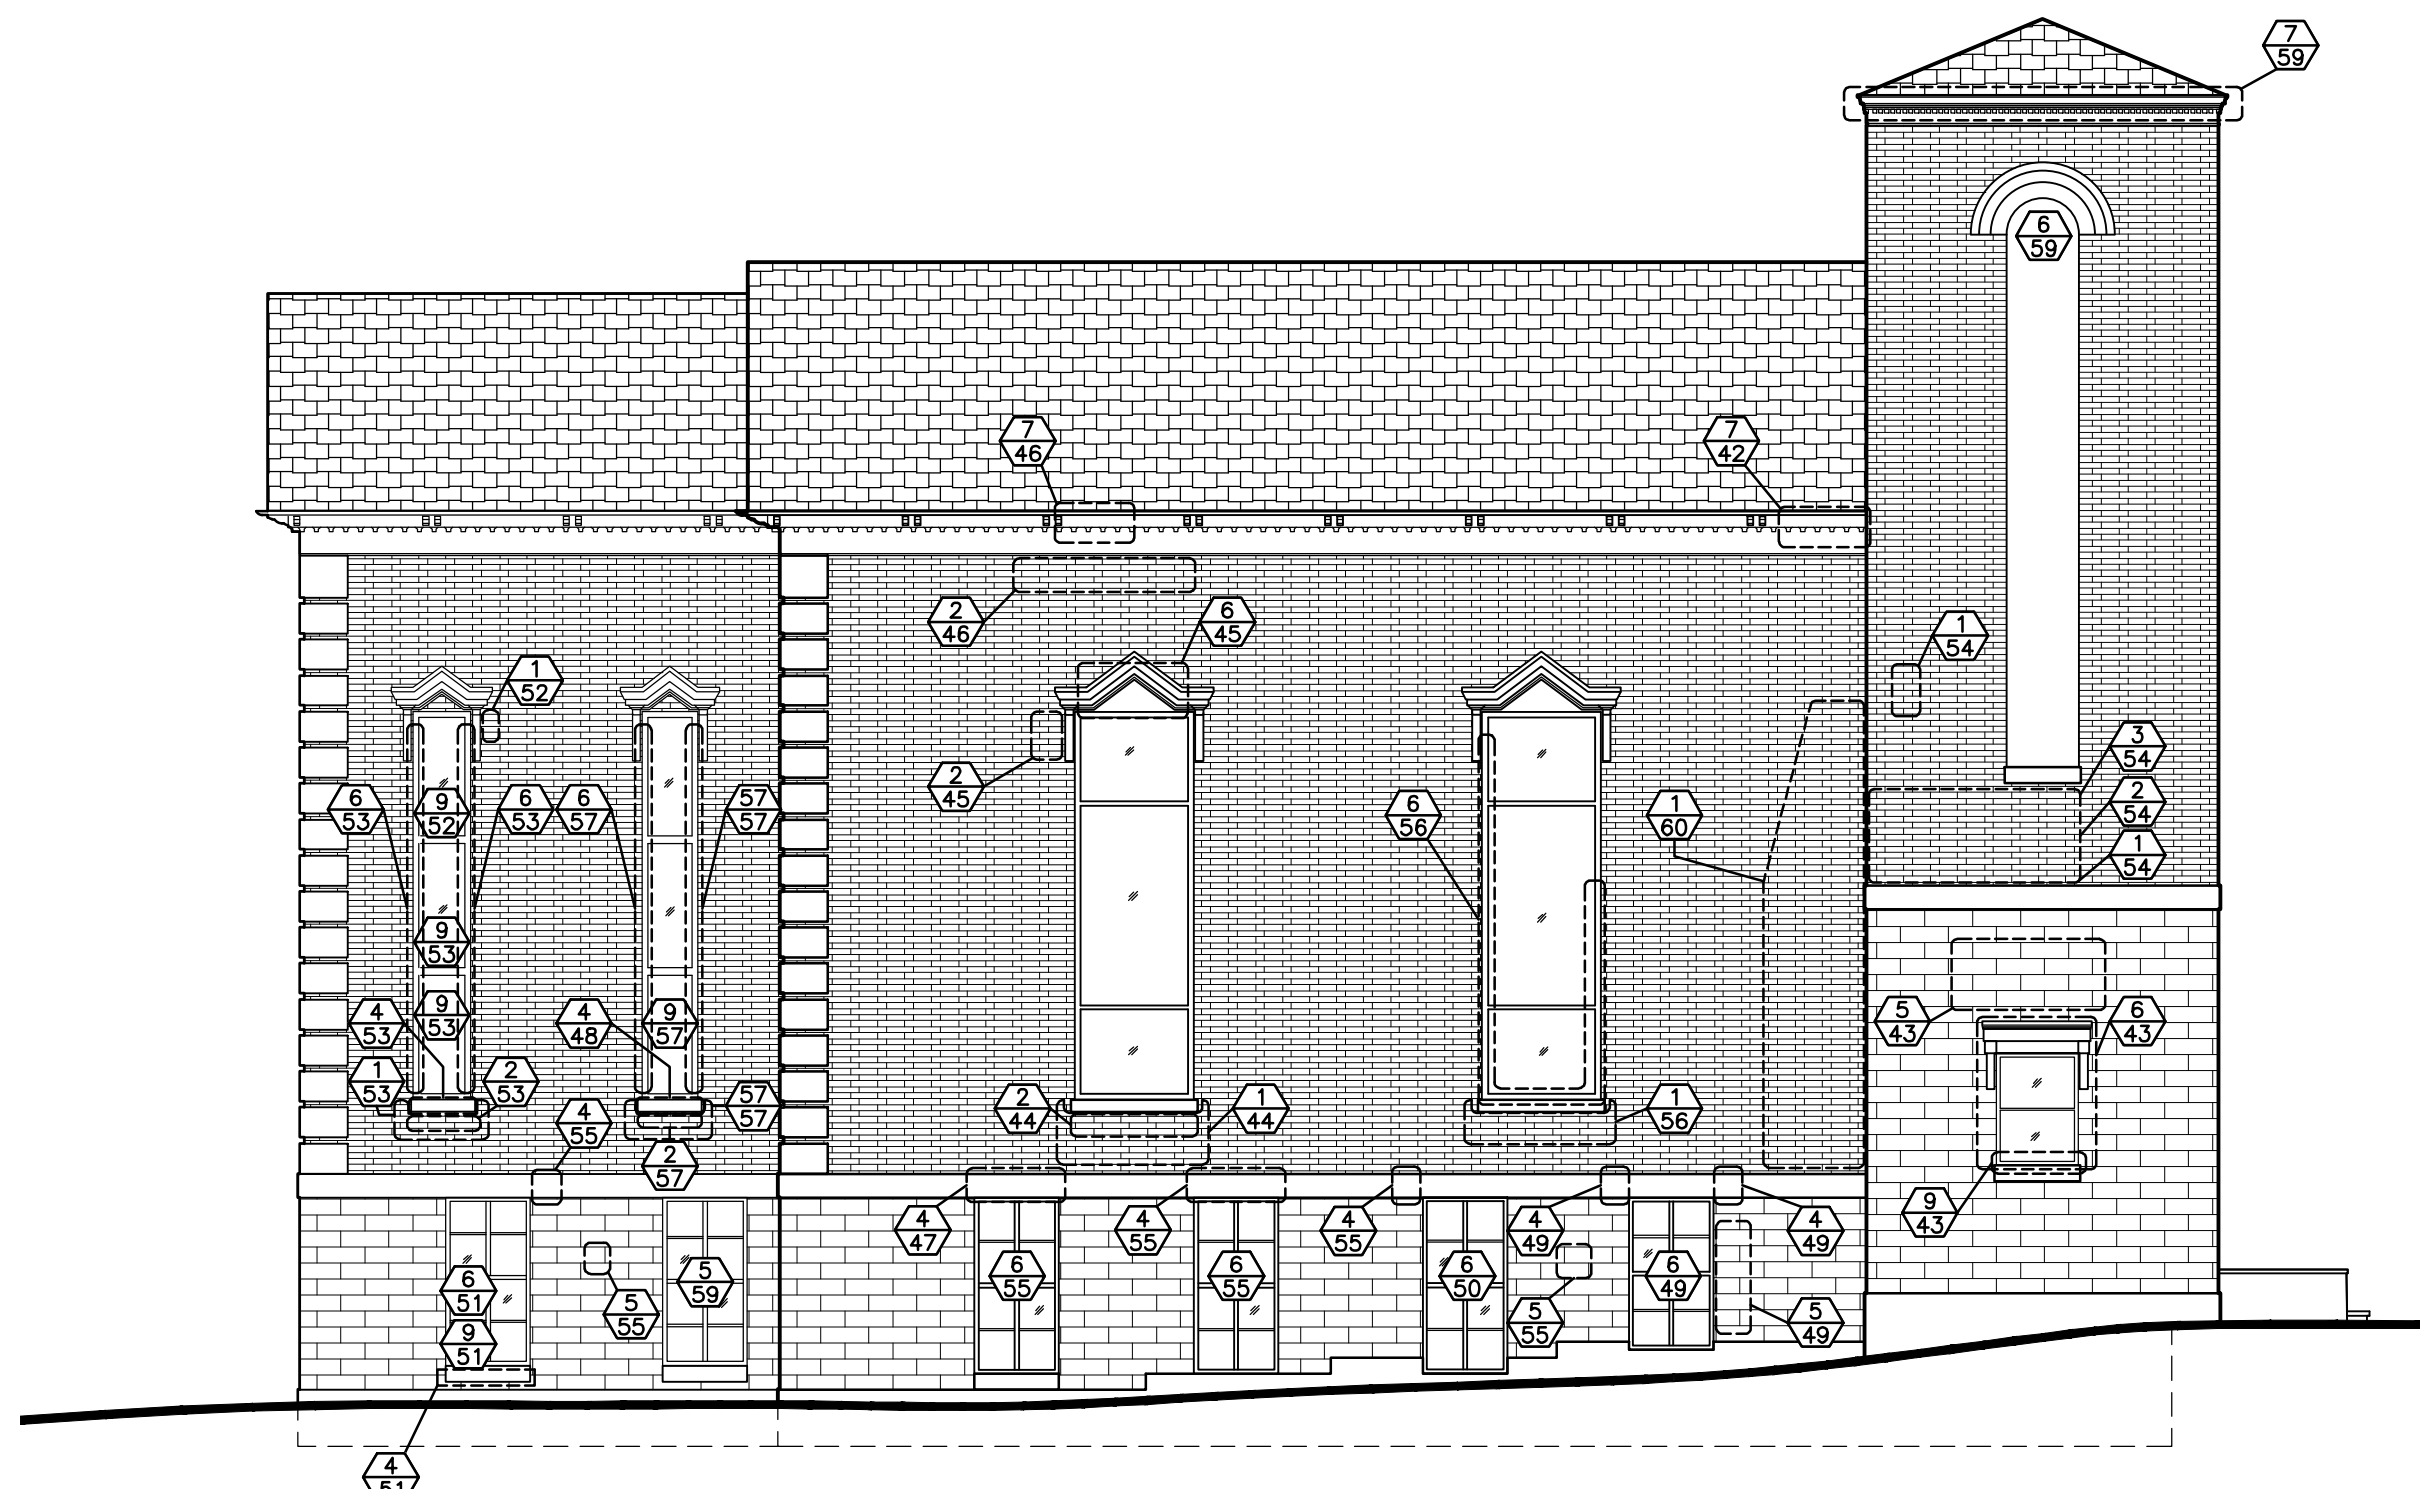
- 1 MASONRY WATER DAMAGE / DISCOLORATION
- 2 MASONRY IN NEED OF REPOINTING
- 3 SEVERELY DETERIORATED MASONRY IN NEED OF REPLACEMENT
- 4 DAMAGED / CRACKED CONCRETE IN NEED OF PATCH / REPAIR
- 5 STONEWORK IN NEED OF REPOINTING
- 6 WOOD / TRIM IN NEED OF REPAIR / REPAINTING
- 7 FASCIA IN NEED OF PATCH / REPAIR / REPAINTING
- 8 DOOR IN NEED OF REPAINTING / REFINISHING
- 9 DAMAGED GLASS IN NEED OR REPLACEMENT

- Remove vegetative growth on façade and clean existing masonry;
- Repoint / replace brick masonry, and repair concrete head and sill units at windows;
- Repair, and refinish exterior wood doors and replace hardware as required;
- Re-glaze existing stained glass window units and provide new exterior storm units with screen units for ventilation;
- Replace security screens at ground level window units;
- Repair masonry belt-course at transition between existing brick and embossed masonry;
- Replace / replace window units in tower and lower level at front elevation;
- Clean and repoint concrete and brick masonry at main entry stoop;
