OSWEGO CANAL CORRIDOR BOA

APPENDIX L: FORMER CYCLOTHERM SITE STRUCTURAL ASSESSMENT

**Former Cyclotherm Site
Retaining Structures/Wall
Condition Inspection and Structural Assessment**

**Prepared for:
Bergmann Associates
March 23, 2017**

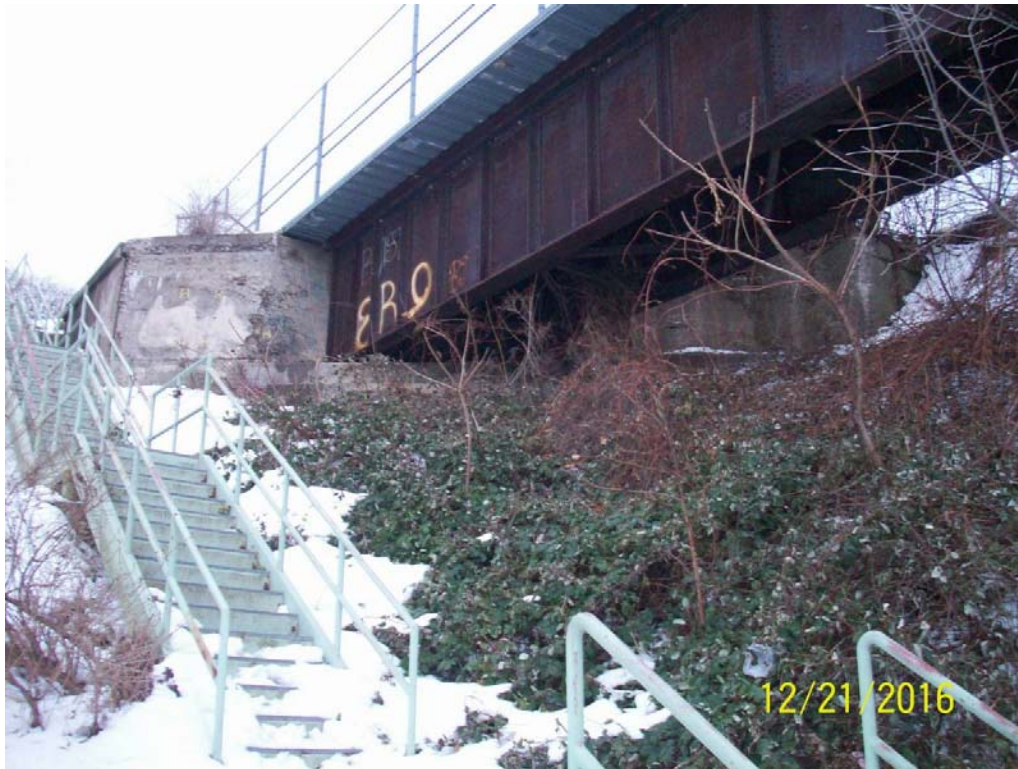
The concrete is in fair structural condition, especially considering its age. There is widespread minor cracking, surface spalling, and hollow-sounding areas affecting approximately 50% of

the exposed surfaces. These are mainly cosmetic defects and do not appear to affect the performance of the structure in a negative way at this time.

Photo 1 – Abutment, looking east

3. It is recommended that the concrete surfaces be cleaned and concrete spalls be properly repaired. Following the concrete repair the application of a penetrating concrete sealer to reduce absorption is recommended as a preventative maintenance measure.

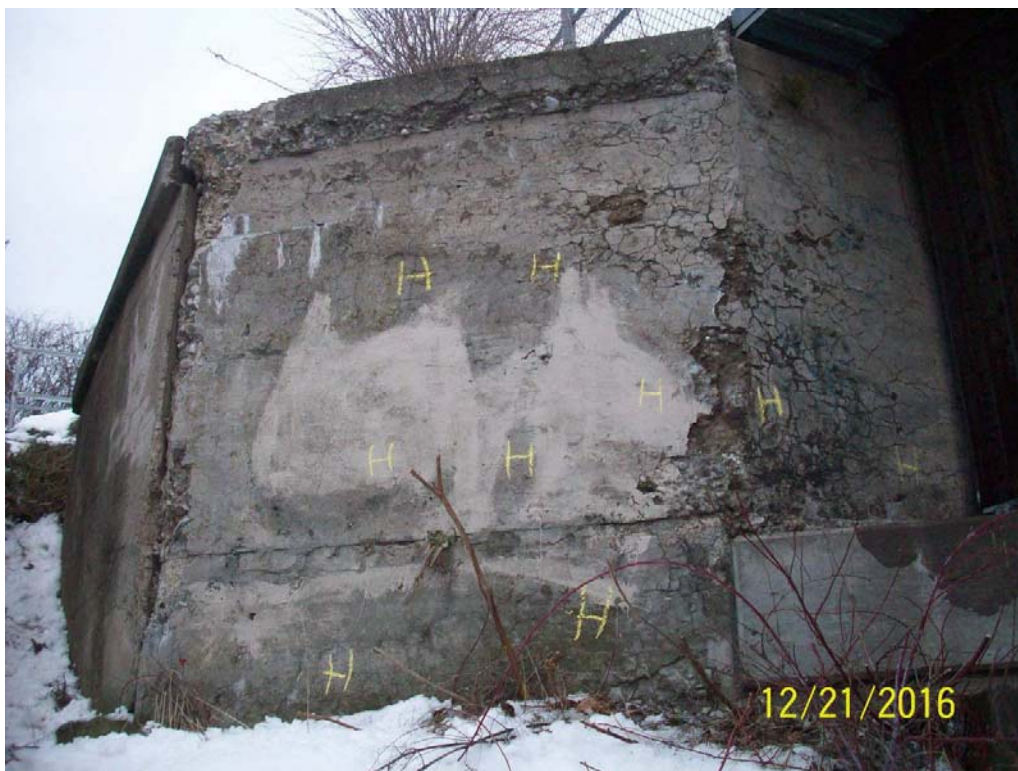
Photo 2 – North side of Abutment

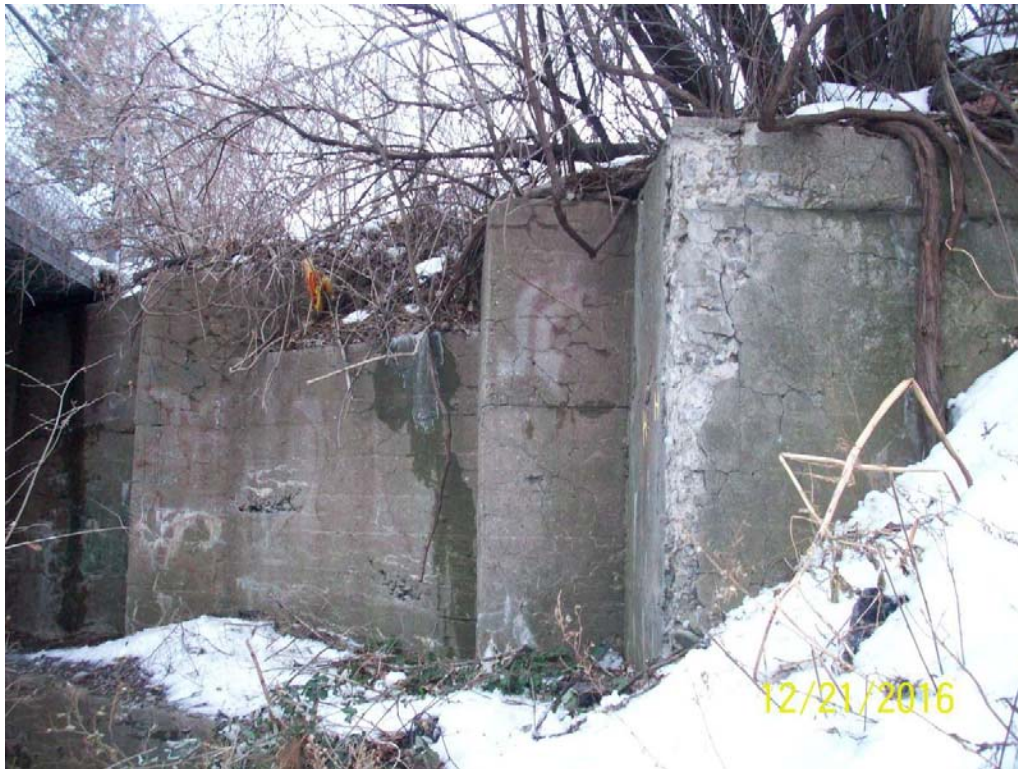
The concrete abutment seat and bearings were reconstructed during the trail conversion project in 2001, and these components remain in good condition. The unused portion of the abutment seat on the south side was not reconstructed, and the original concrete is covered with dirt and debris.

Photo 3 – South side of abutment

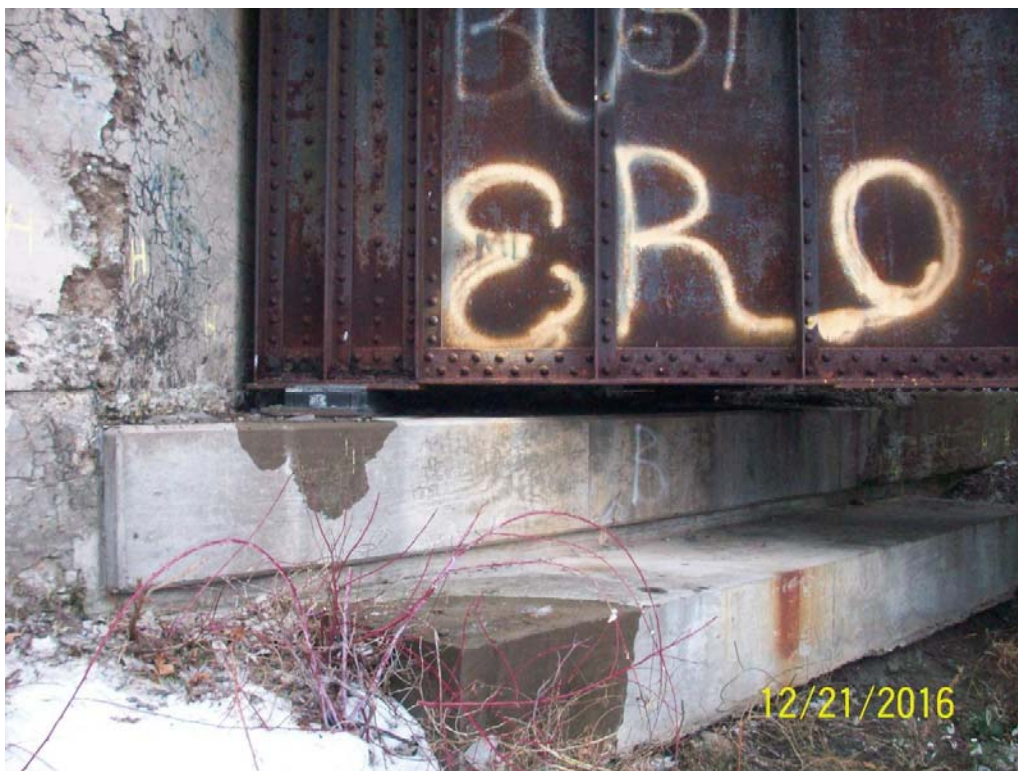
There is a 3.25' wide x 17' long x 1.5' thick concrete pad immediately in front of the abutment stem. This appears to have been placed as a jacking pad for temporary shoring of the girders during the trail conversion project in 2001. An insignificant amount of subgrade erosion has undermined the front edge of the pad; however this has no effect on the abutment.

Undermining of the concrete jacking slab in front of the abutment has no effect on the structure and does not require mitigation at this time.

Photo 4 – Abutment seat and jacking pad, looking south

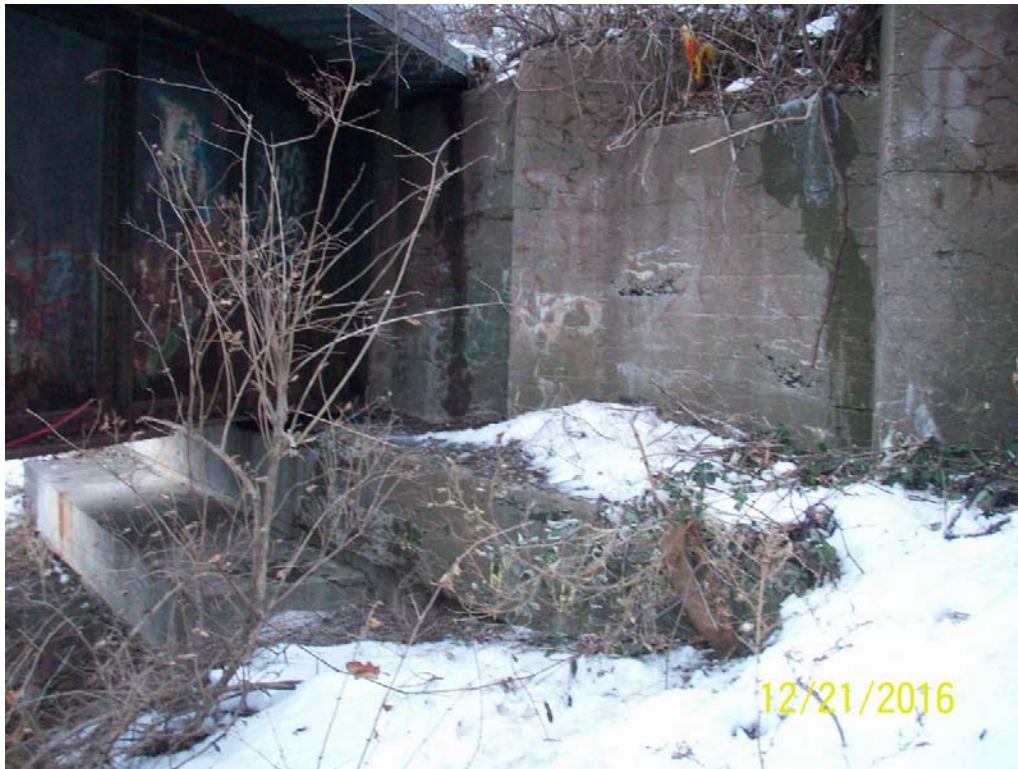
Photo 5 – Abutment, looking north

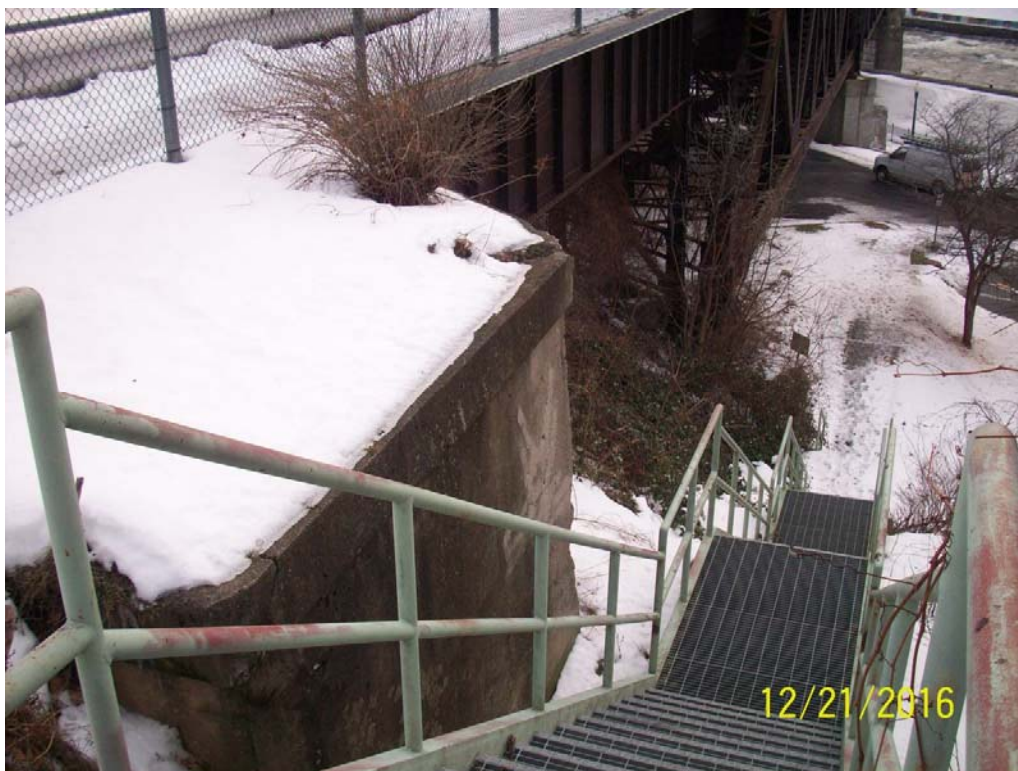
Photo 6 – Wingwall and stairs at north side of abutment

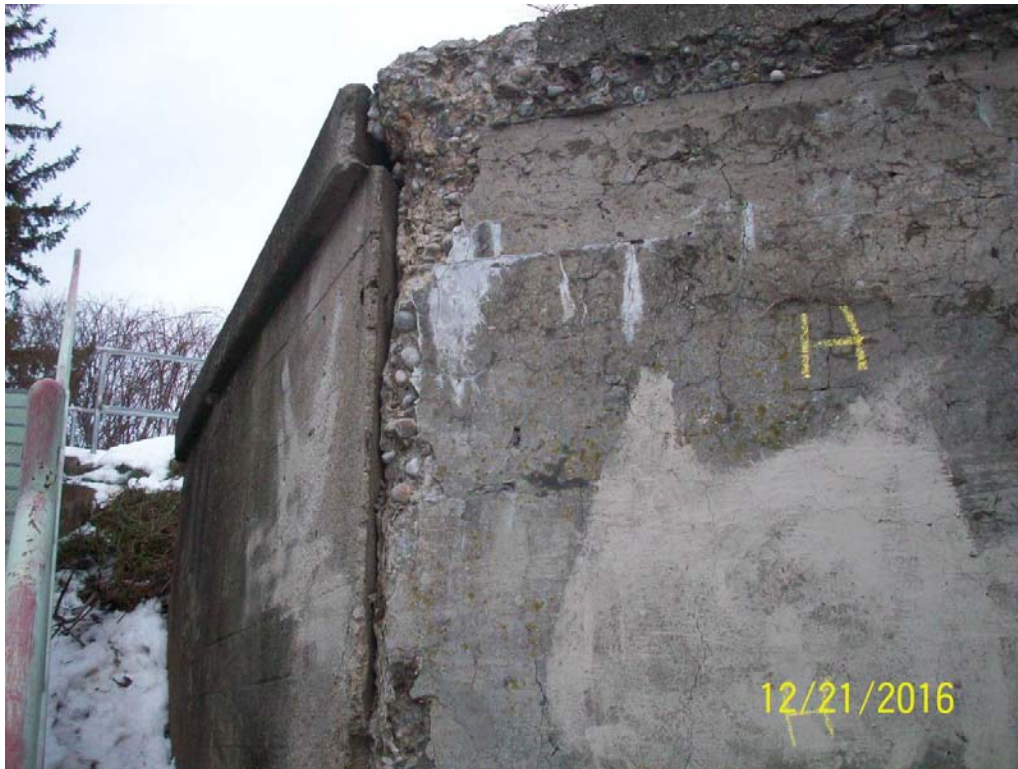
At the north side of the abutment, the wing wall construction joint is separated up to 1" at the top of the wall. This appears to be indicative of minor settlement of the wing wall foundation, which may have occurred due to normal settlement shortly after construction. The wall appears stable.

Photo 7 – Separation at north wingwall construction joint

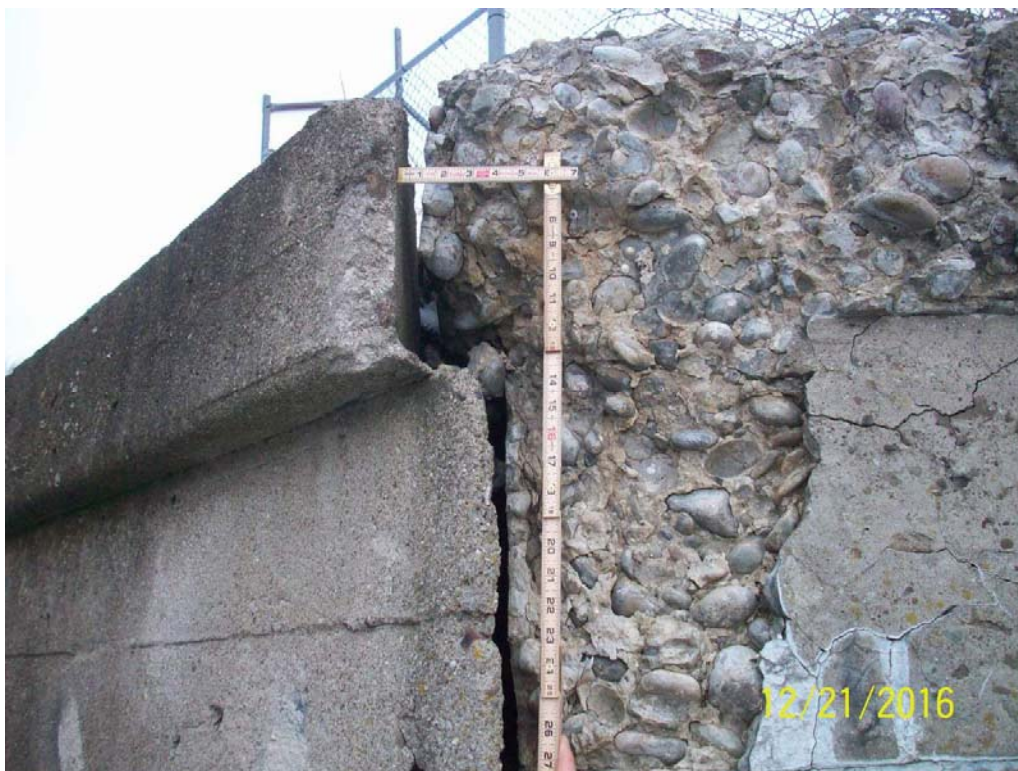
Photo 8 – Close-up of separation at north wingwall construction joint

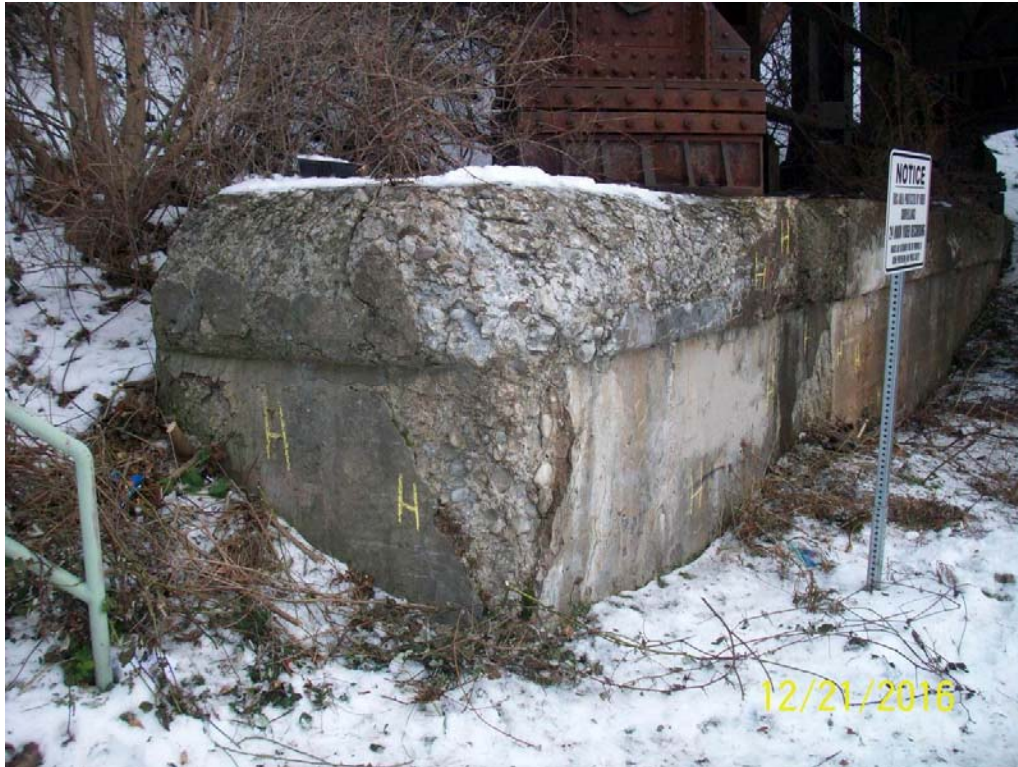
The concrete is in fair to poor condition. There is widespread cracking, spalling, and hollow-sounding areas affecting approximately 70% of the exposed surfaces. The top corner of the seat is spalled 2" to 6" deep along the north end and most of the west side. The concrete remains solid beneath the superstructure bearings, and there is no structural cracking or distress.

Photo 9 – North and west face of pier, looking south

4. Concrete spalling is attributed mainly to freeze-thaw action, and is expected to progressively worsen over time. Even surface concrete repairs discussed in item 3 above may have a relatively short-term durability. Gradual freeze-thaw damage in the original concrete substrate may begin to loosen patches within 10 to 20 years. A more permanent repair could be achieved by re-facing exposed surfaces with a 6" thickness of new reinforced concrete anchored to sound substrate.

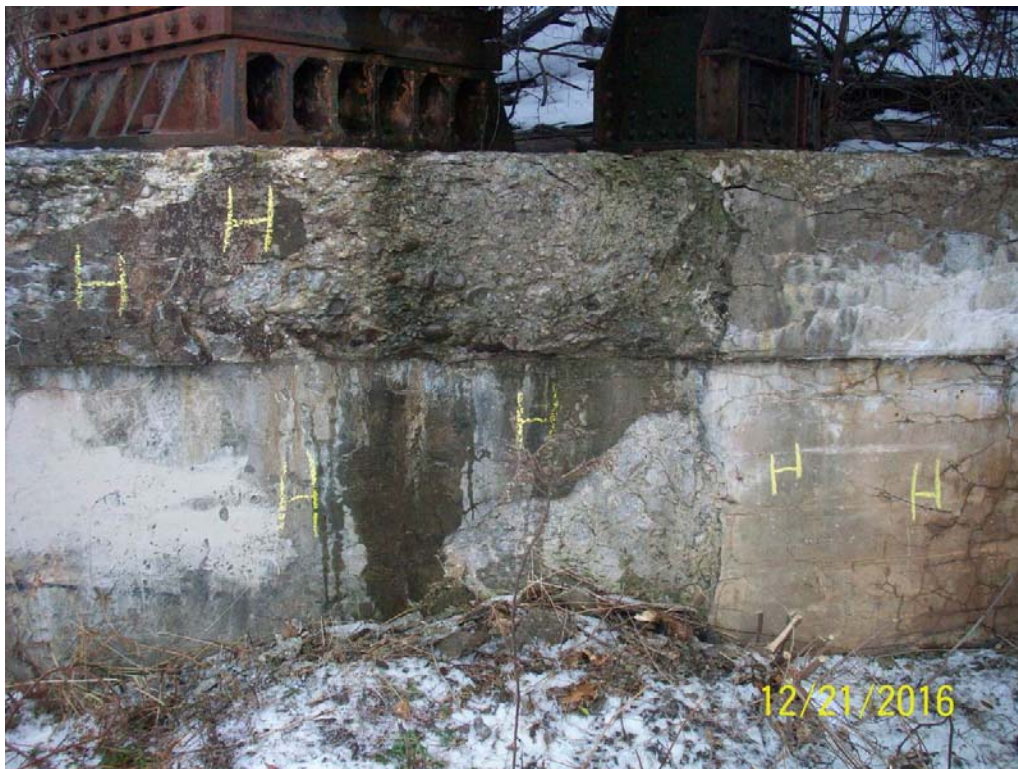
Photo 10 - West face of pier, below north truss bearing

5. To prevent additional deterioration in the long-term, the concrete structures are recommended to be routinely monitored and regularly maintained. This is critical to avoid the potential spalling along the edge of the bridge pier seat and undermining of the bridge bearings. These concrete repair recommendations also provide an aesthetically pleasing appearance to the concrete structures which enhances the attractiveness the area.

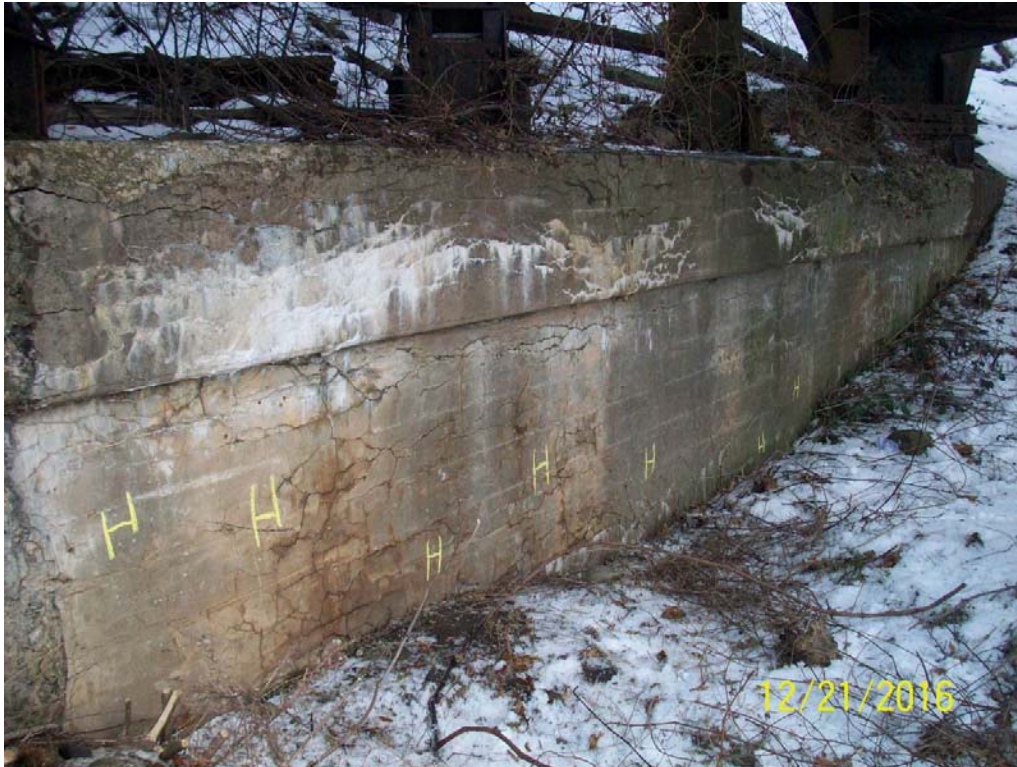
Photo 11 - West face of pier, near middle

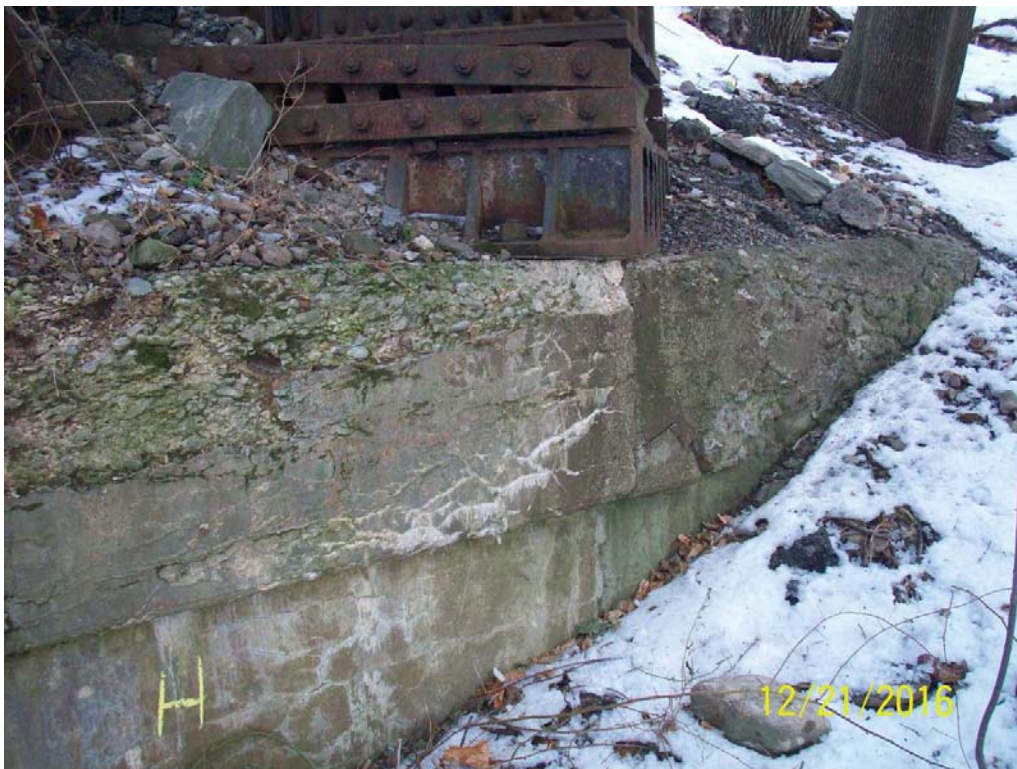
Photo 12 - West face of pier, near south end

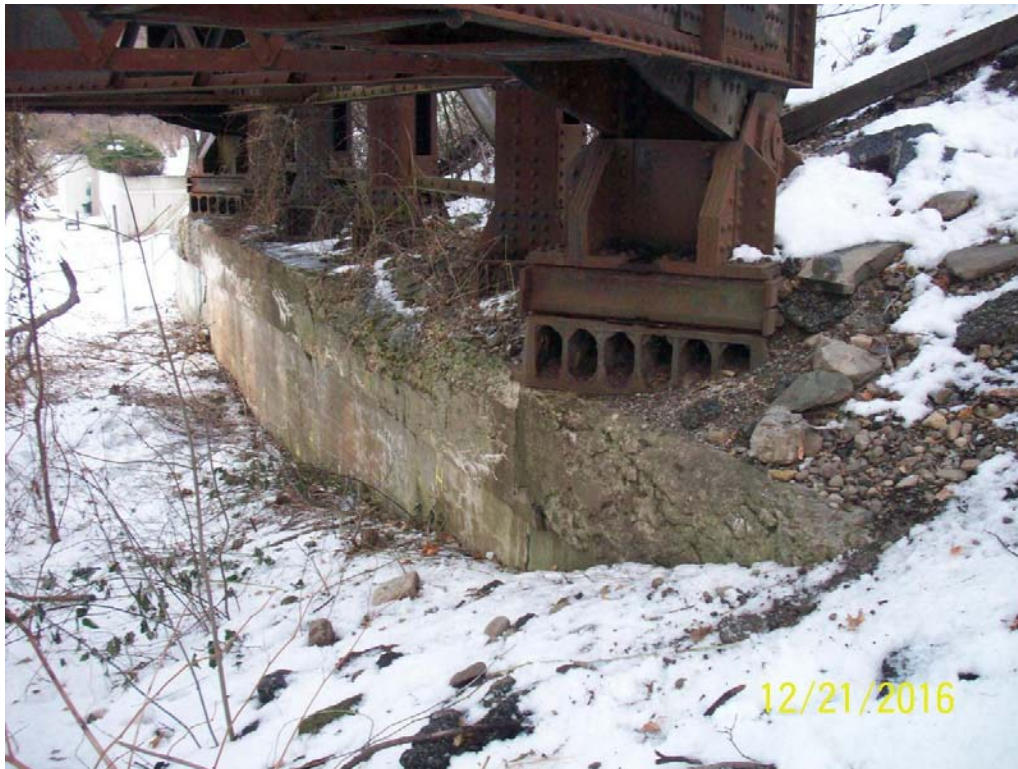
Photo 13 – West face of pier, looking north
