OSWEGO CANAL CORRIDOR BOA

APPENDIX N: WESTSIDE COAL PIER STRUCTURAL ASSESSMENT

**Westside Coal Pier
Condition Inspection and Structural Assessment**

**Prepared for:
Bergmann Associates
March 23, 2017
(Revised May 26, 2017)**

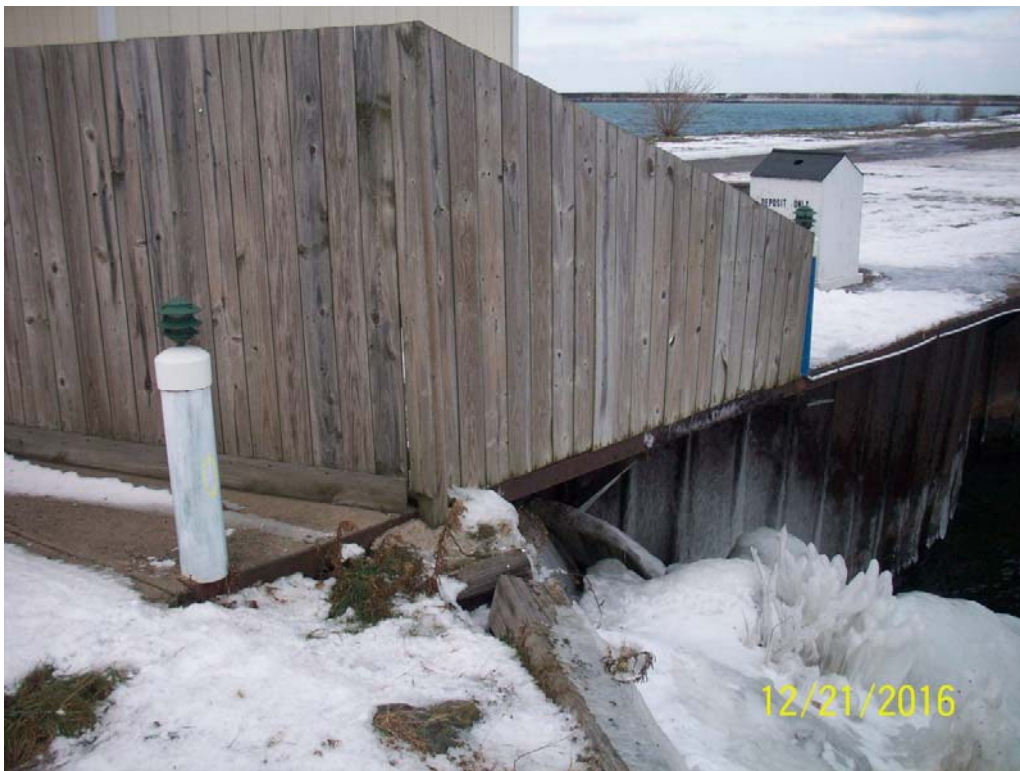
top of the piles are in good condition, and the cells remain well aligned. The concrete walkway and a small crane founded above this portion of the wall are in good condition with no indications of settlement. Refer to Photos 2 through 7.

Photo 2 - East side of pier at shore, showing STA 0 location at first bollard

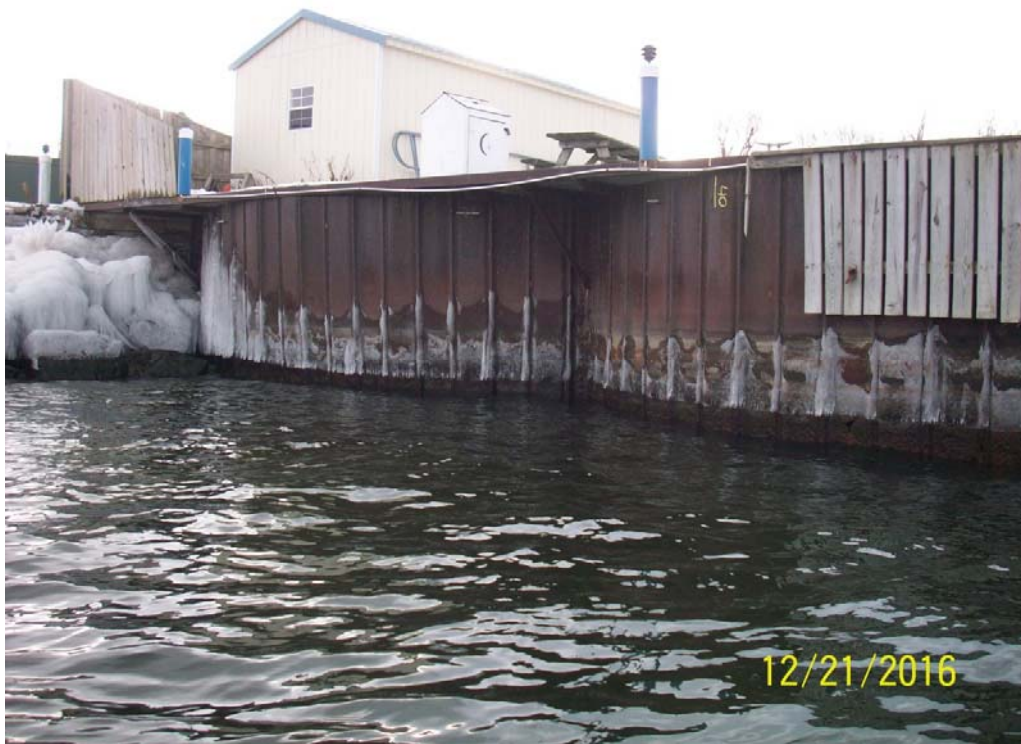
Photo 3 – Cellular sheet pile wall near STA 40

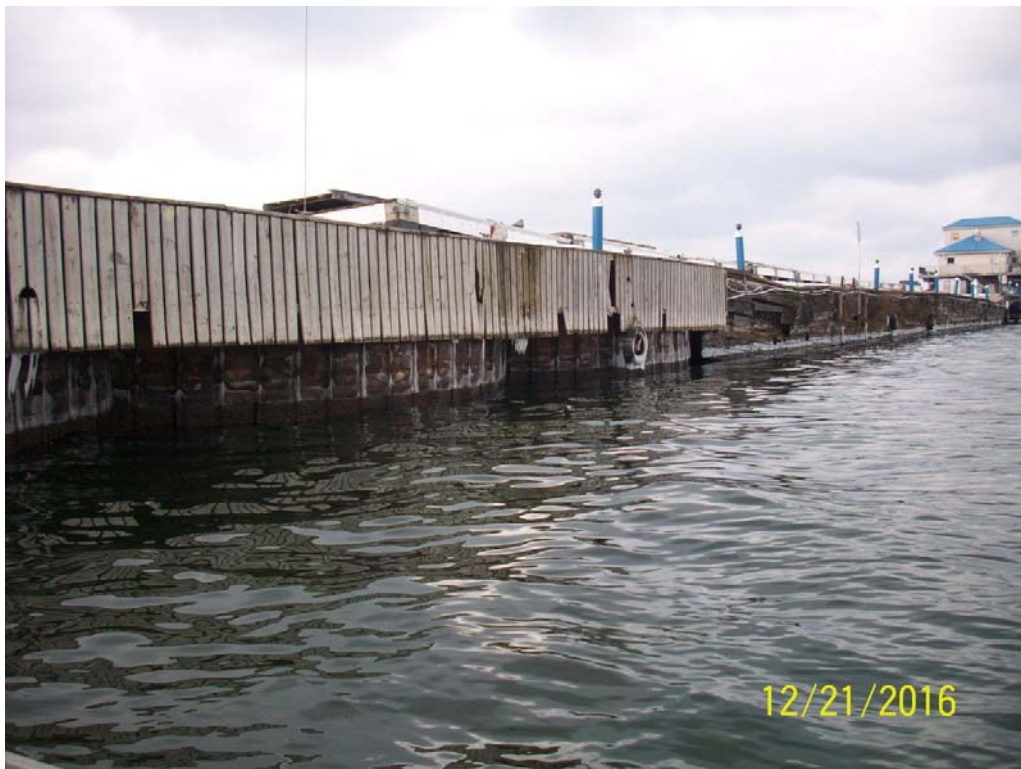
Photo 4 - Cellular sheet pile wall near STA 80

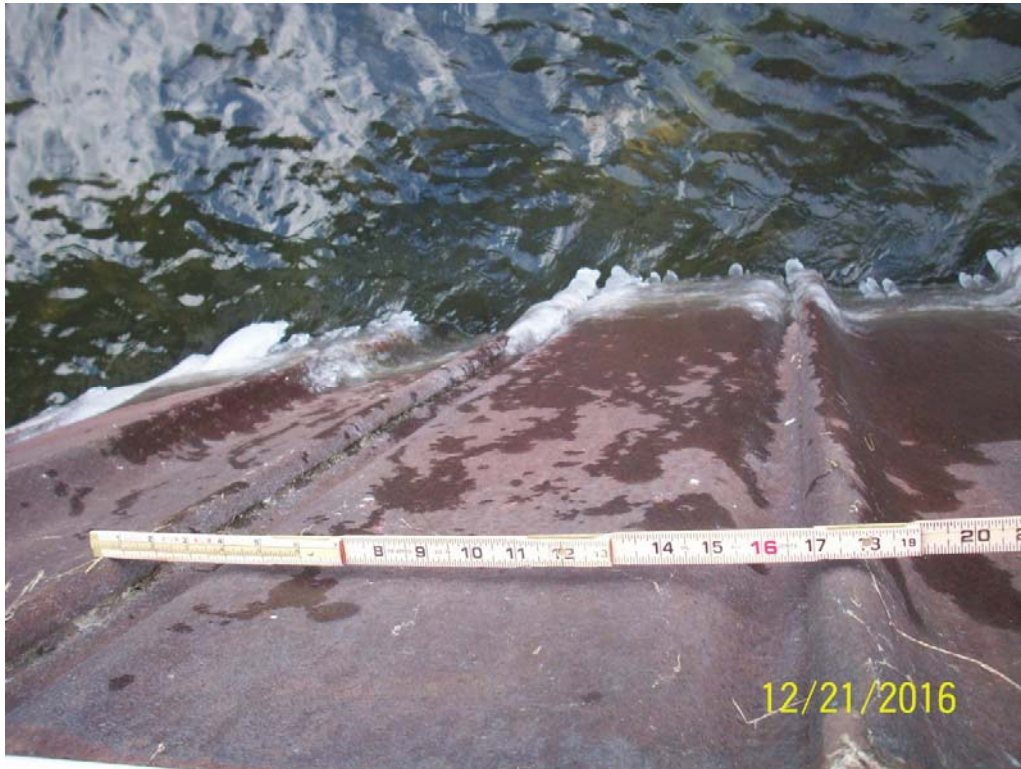
Photo 5 – Top of typical cellular wall pile, 1st cell near STA 20 shown.

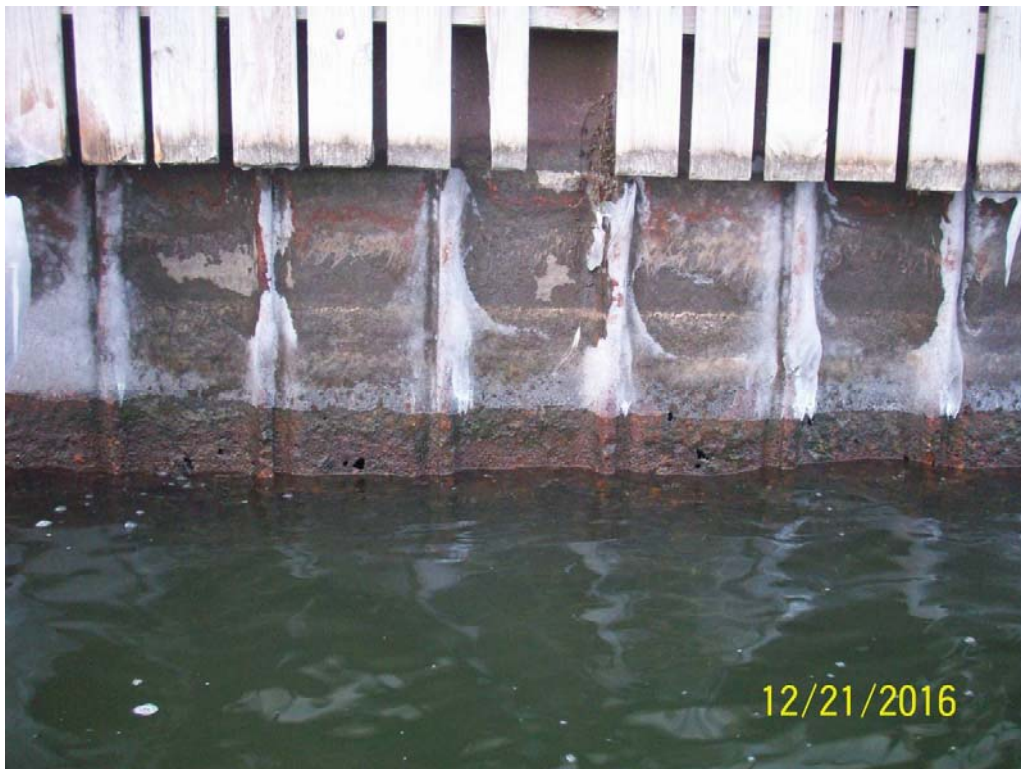
Beginning near the shoreline, a cellular steel sheet pile wall extends approximately 120' from STA 9 to 129. This section of the wall consists of five 24' lengths of cellular sheet pile wall systems having a circular appearance constructed of 16" wide x 3/8" thick flat sheet piles (PSA23 or similar), and most likely dates from the 1930s or 1940s. The wall height varies, with a maximum expose height of 23.9' above the harbor bottom, and water depth up to 17.7'. The exposed piles are heavily corroded near the water level with numerous small rust holes. The

The cellular steel sheet pile wall systems near the shoreline (STA 9 to 129) remain stable and functional. This type of wall relies on lateral tension and interlock between the piles in the cellular ring to retain the mass of backfill, which functions as a gravity structure. The localized section loss near the water level is not perceived to be a serious structural concern at this time. However, there is potential for long-term erosion and settlement behind the wall, especially as the size of rust holes gradually increase.

Photo 6 – Cellular wall near STA 120, showing typical corrosion near water level

4. The 120’ long portion of the cellular steel sheet pile wall systems near the shoreline (STA 9 to 129) could conceivably be rehabilitated, but replacement/replacement may be more practical and cost-effective, since the rest of the wall needs replacement.

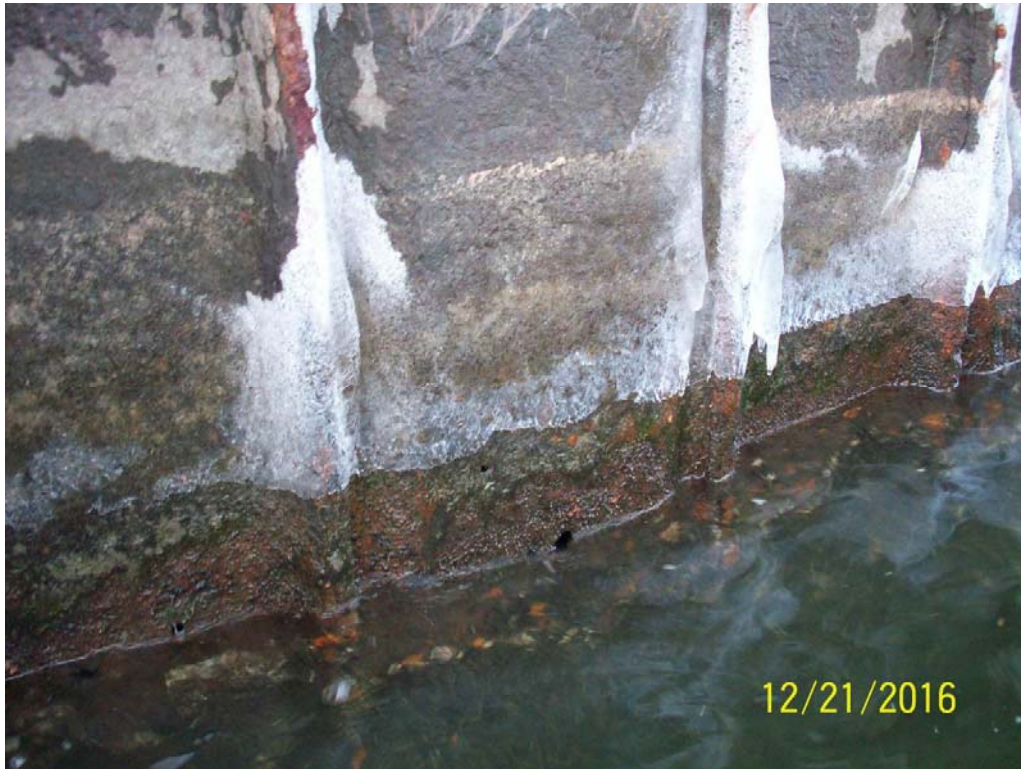
Photo 7 - Cellular wall near STA 120, close-up of typical pile corrosion

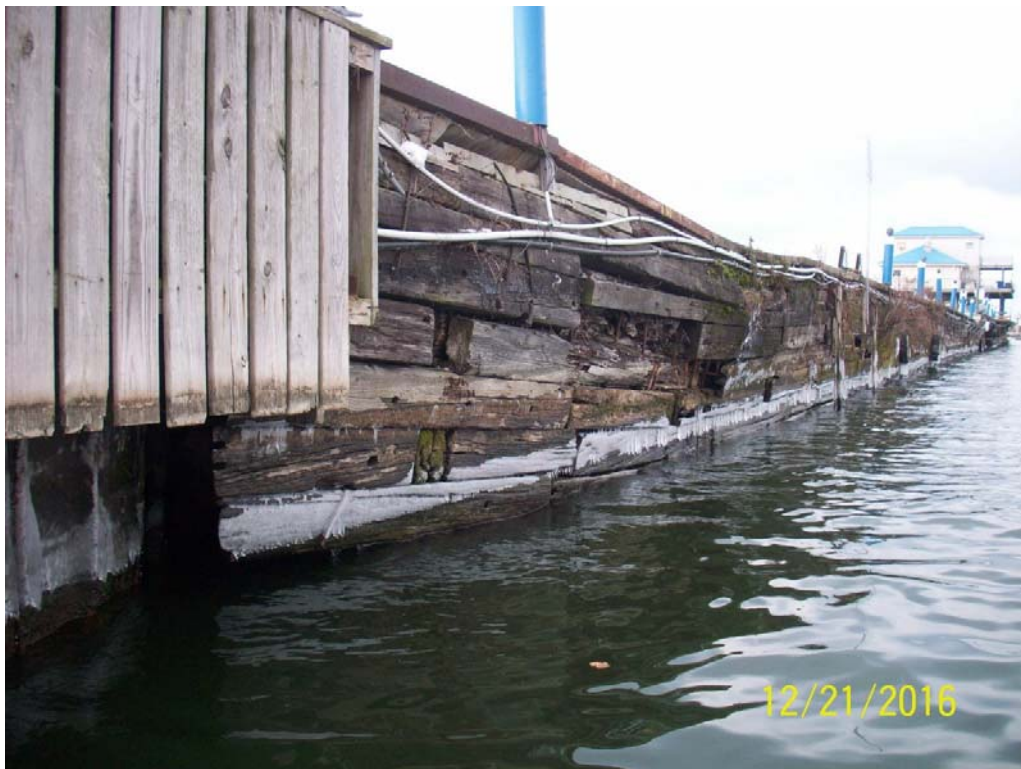
An old timber cribbing wall extends approximately 215' from STA 129 to 344. This portion of the wall is in very poor condition. The wall height is approximately 20' to 22' above the harbor bottom, and the water depth is approximately 14' to 16'. The timbers have widespread severe decay above the water level. Portions of the wall are severely displaced and settled from STA 135 to 160 and from STA 300 to 344. Shallower water depth measurements in these areas suggest that substantial amounts of backfill may have spilled from behind the wall. In areas where the timber cribbing is displaced, settlement of the concrete walkway is also evident, which indicates that movement has occurred fairly recently. Refer to Photos 8 through 15.

Photo 8 – Timber cribbing wall, beginning at STA 129

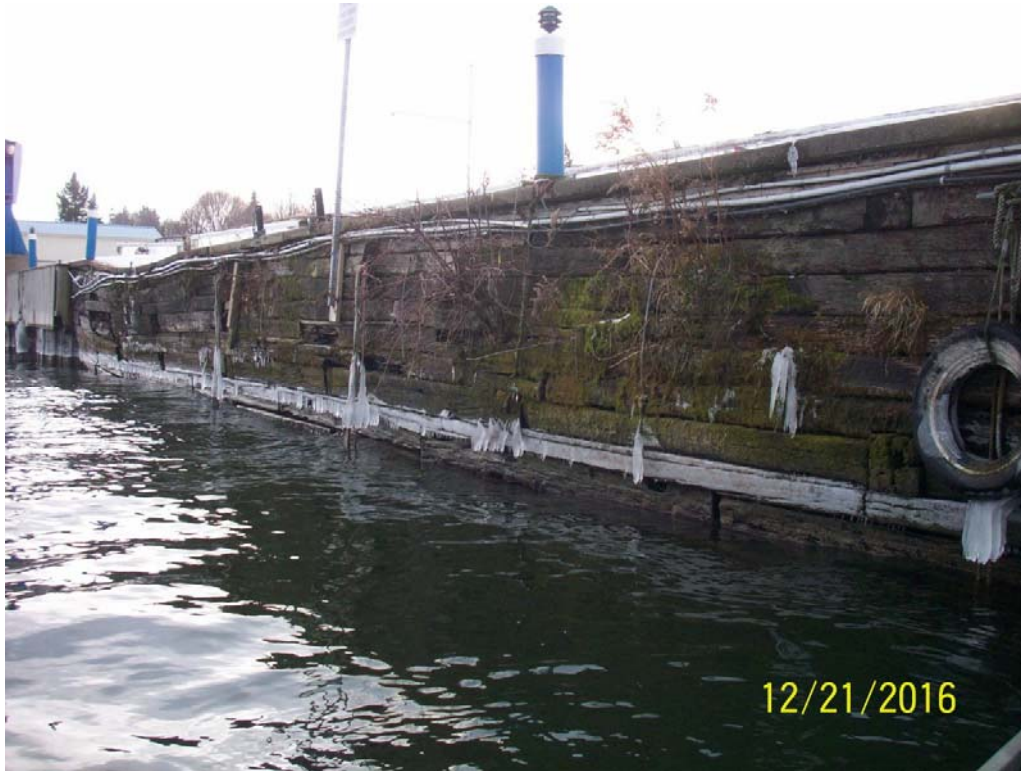
Photo 9 – Timber cribbing wall, looking south near STA 200

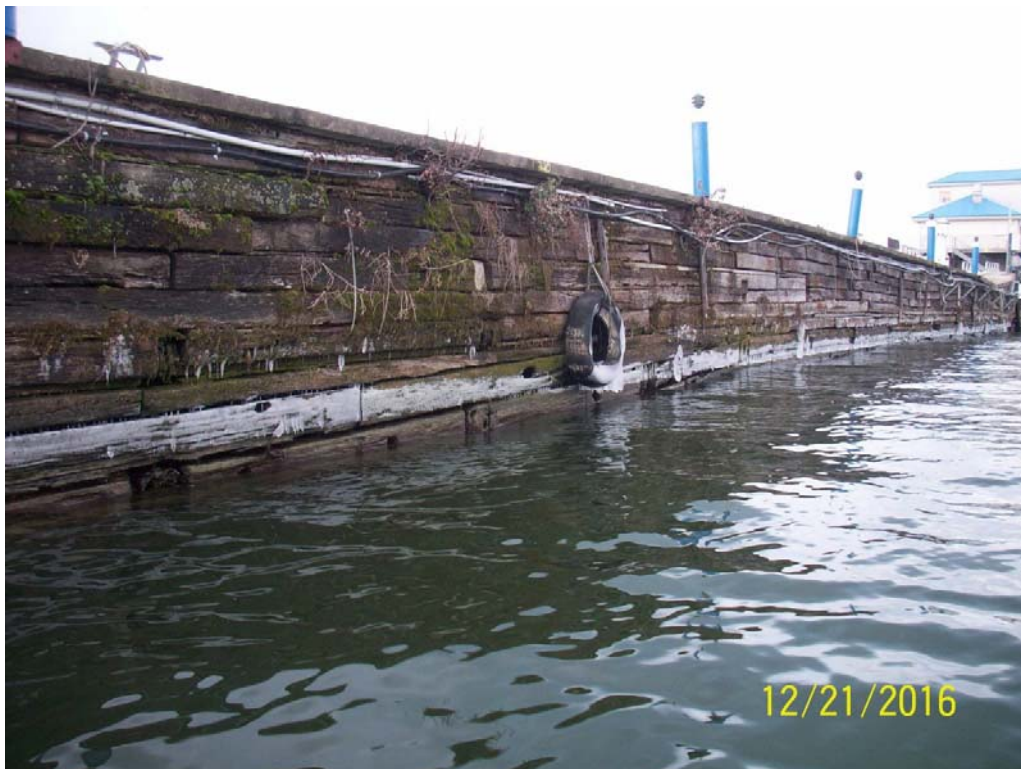
Photo 10 - Timber cribbing wall, looking north near STA 200

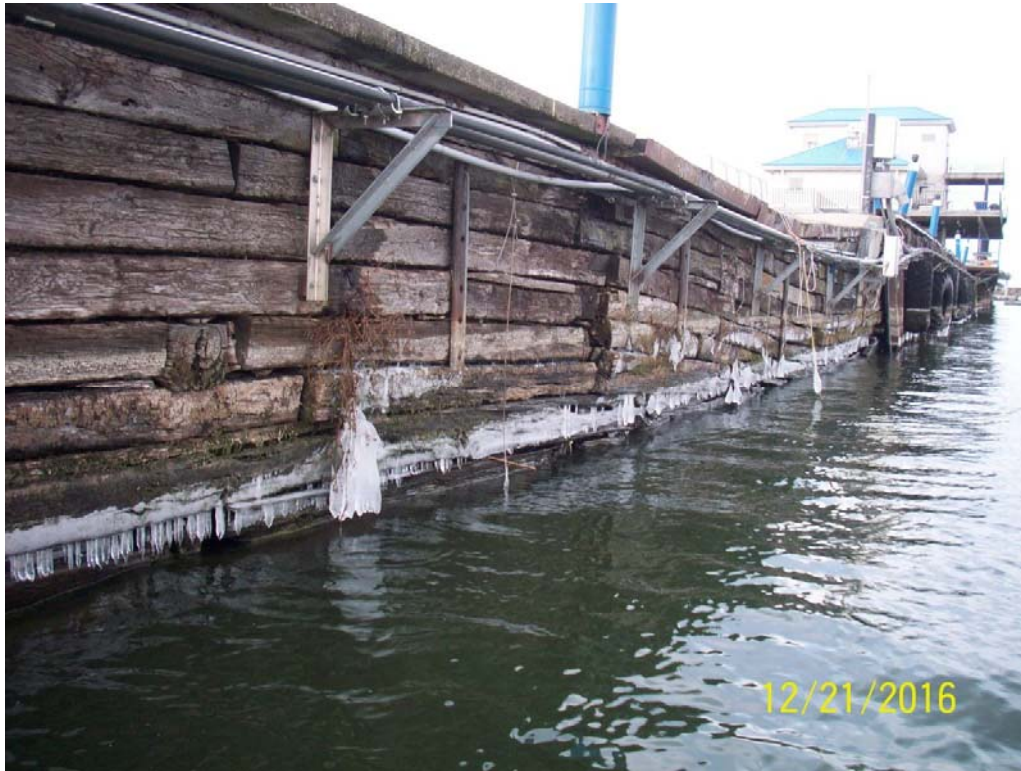
Photo 11 - Timber cribbing wall, looking north near STA 300

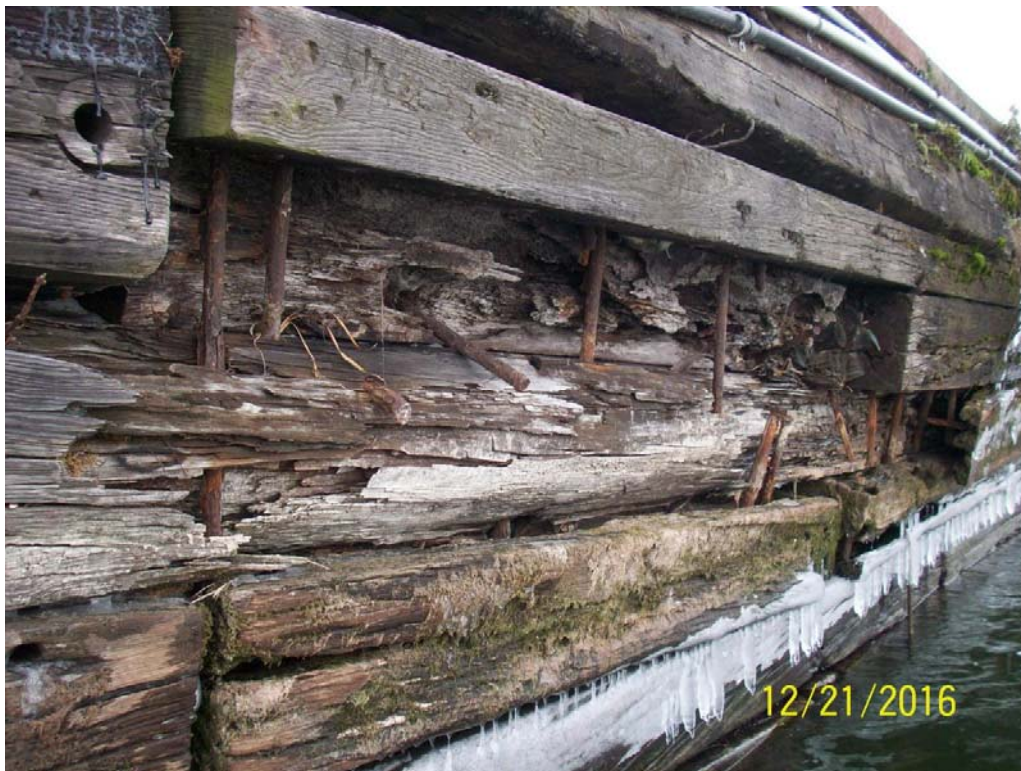
Photo 12 - Timber cribbing wall, close-up of decay near STA 140

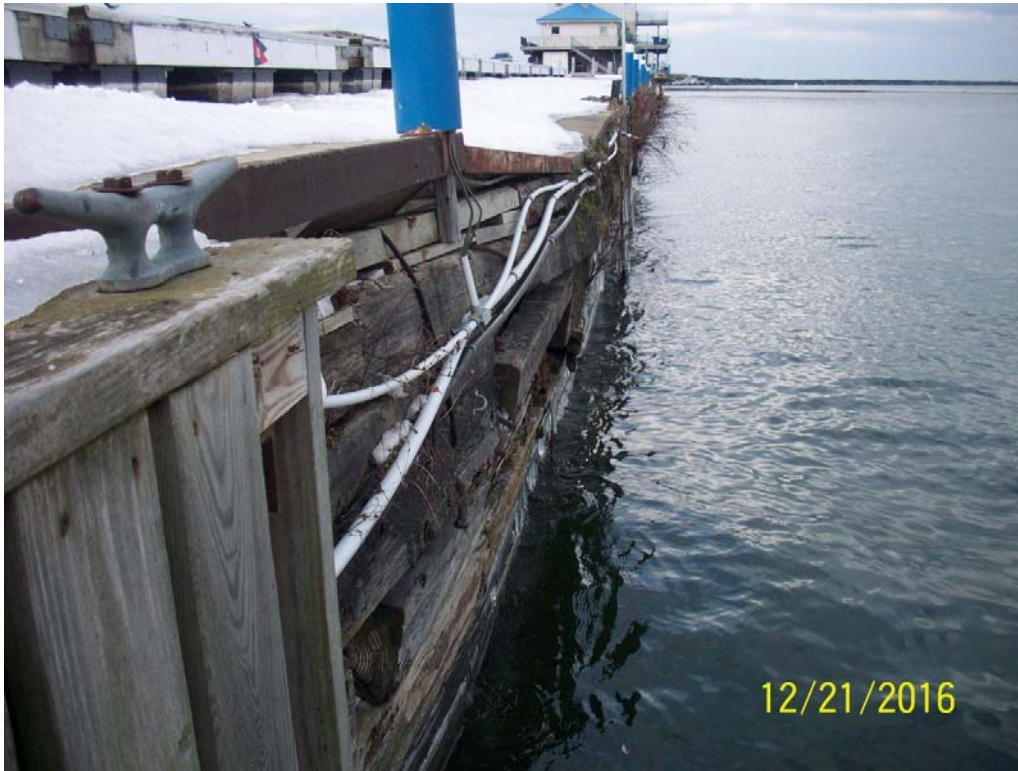
Based on observations above the water level, the current safety and stability of portions of the pier wall is questionable. The old timber wall from STA 129 to 344 has large areas of severe misalignment and settlement which suggest that failures may have already occurred below water.

Photo 13 – Top of timber cribbing wall, showing settlement between STA 135 and 160

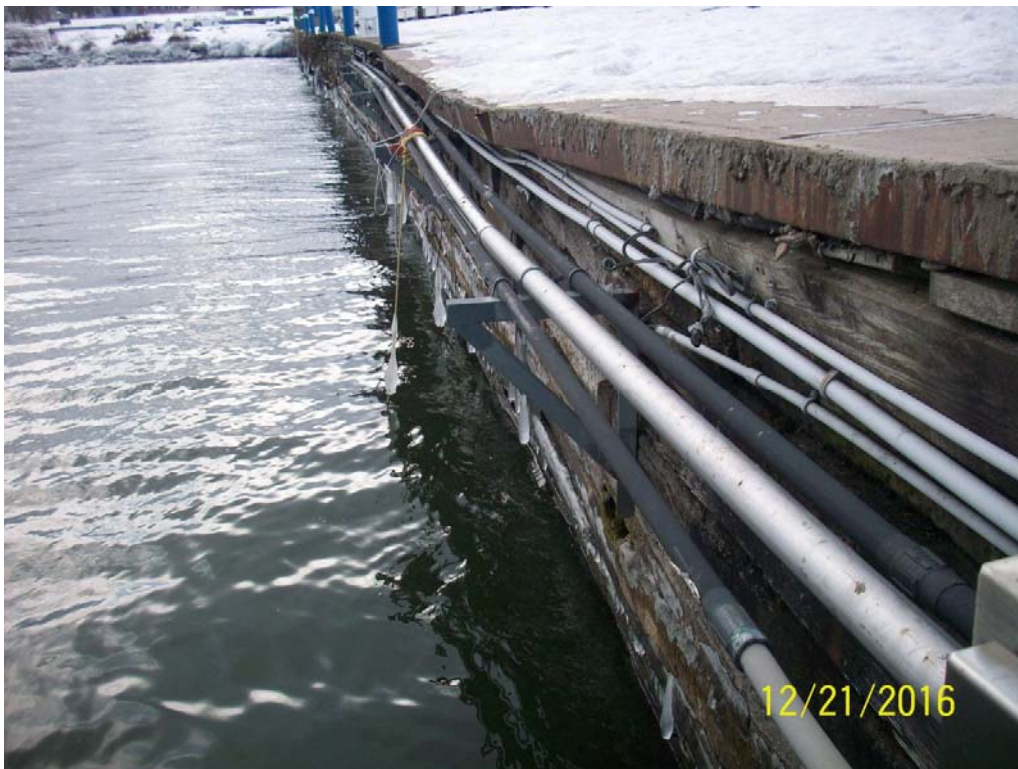
Photo 14 - Top of timber cribbing wall, showing settlement between STA 300 and 344

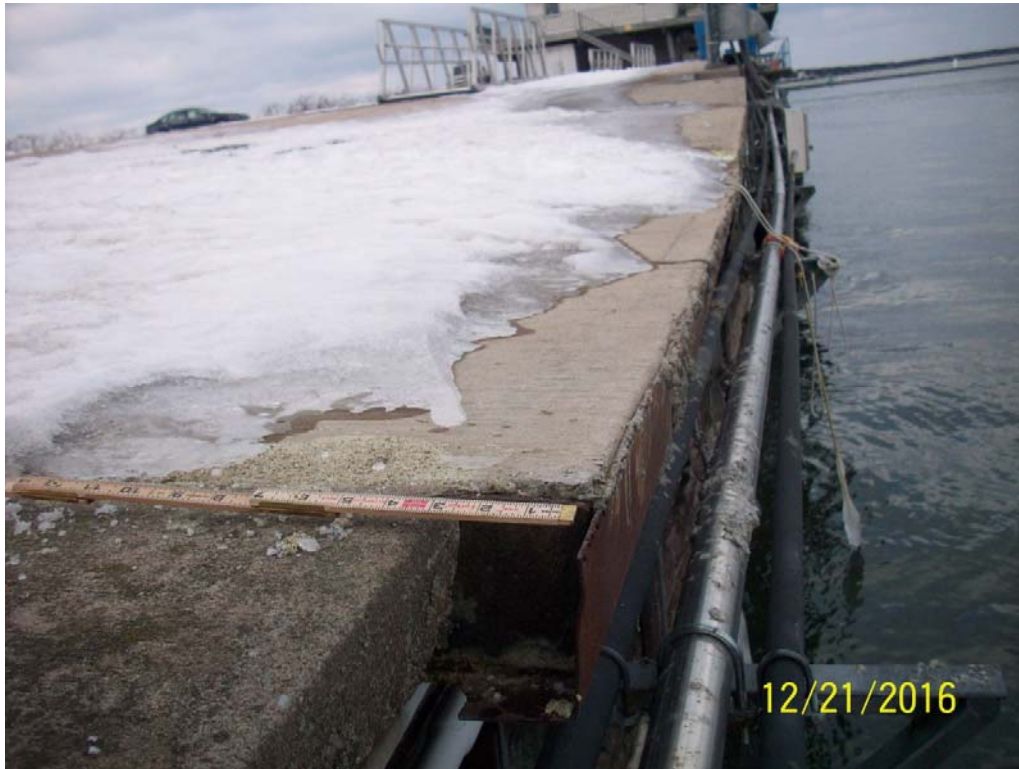
Photo 15 - Top of timber cribbing wall, showing concrete slab displacement at STA 304

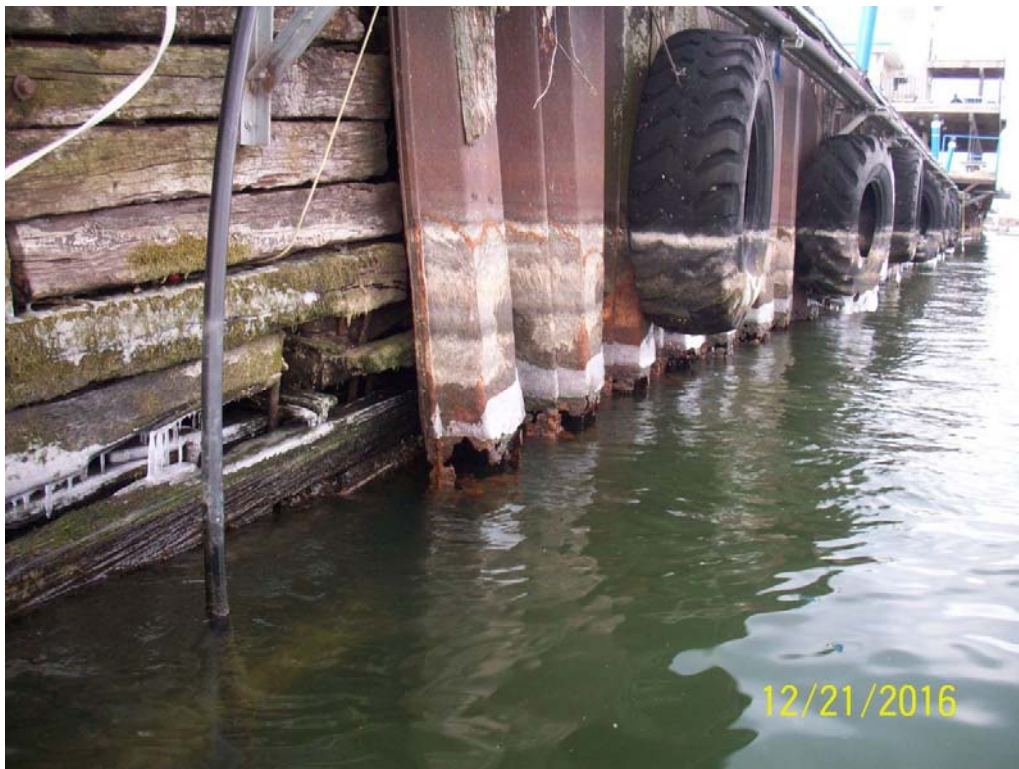
A steel sheet pile wall extends from STA 344 to 857, and the sheeting continues approximately 110' across the north end of the pier (Photos 16 through 20). The wall height is approximately 21' to 25' above the harbor bottom, the water depth is approximately 14' to 17', and the pile embedment depth is unknown. This portion of the wall consists of 16" wide x 5" deep x 3/8" thick U-shaped sheet piles (PDA27 or similar), and most likely dates from the 1930s (Photo 33). The top of the sheets are anchored to a horizontal waler and tie-backs behind the sheeting. The piles are severely corroded with large rust holes near the water level. Overall pile section loss varies and is estimated in the range of 60% to 90% (Photos 21 and 23). Probing through several holes with a survey rod, timber could be felt about 1' to 2' behind the sheeting. The sheeting appears to have been placed immediately in front of an older timber wall. The timber wall remnants appear to be limiting the loss of backfill through the holes in the steel sheeting, but settlement of sidewalk slabs behind the wall suggests that active erosion is occurring as wave action constantly flushes water in and out of the holes (Photo 38).

Photo 16 – Beginning of sheet pile wall at STA 344

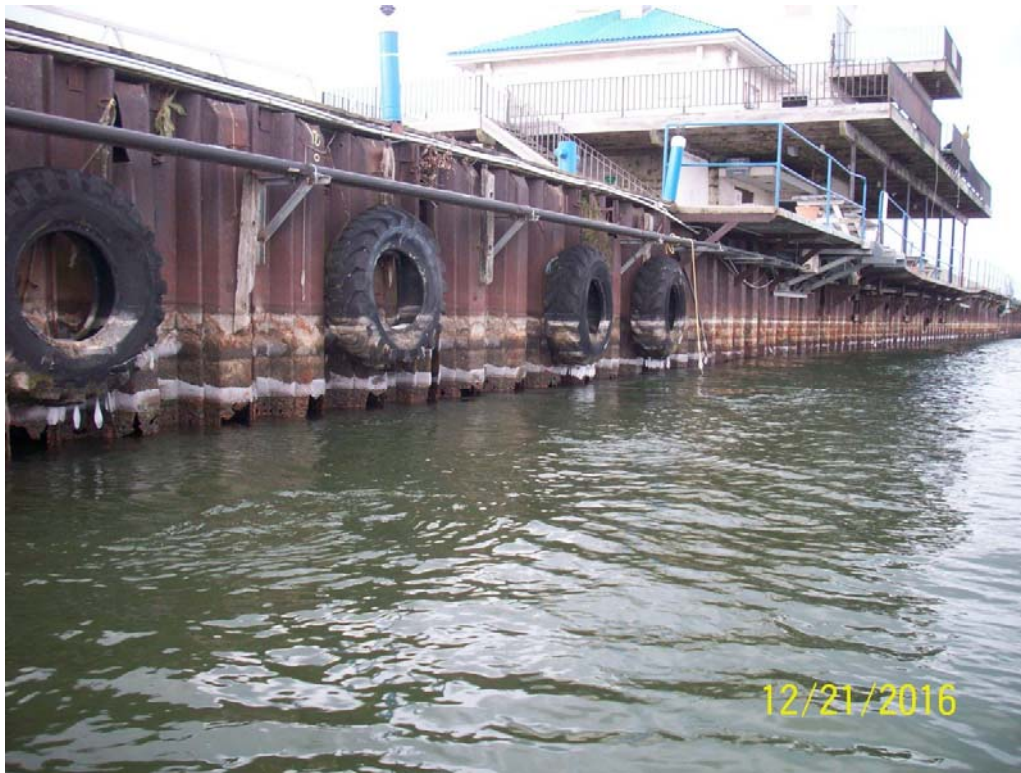
side of the Yacht Club Building (Photos 17, 18, and 34 through 36). The support brackets for the cantilevered walkway and the wood deck are in good structural condition, but these supports are dependent on the stability of the severely deteriorated sheet piles beneath it (Photos 18 and 37). There is no visible settlement or distress in the sheet piles at this time.

The yacht club building appears to be in good structural condition (Photos 17, and 34 through 36). The building is set back approximately 5' to 10' behind the sheet pile retaining wall, which is approximately 23' to 24' high in this area. Based on discussion with a contractor that was involved during construction of the building (Jim Tabor of J. D. Taber Masonry Inc.), the foundation is believed to be a spread concrete footing on the pier fill material. The footing is located approximately 4' below finished grade. A concrete walkway slab located between the building and the retaining wall is settled up to 2" (Photo 38), which may indicate loss of backfill in this area. There is no significant cracking or distress in the concrete block building itself.

Photo 17 - Sheet pile wall, looking north near STA 400

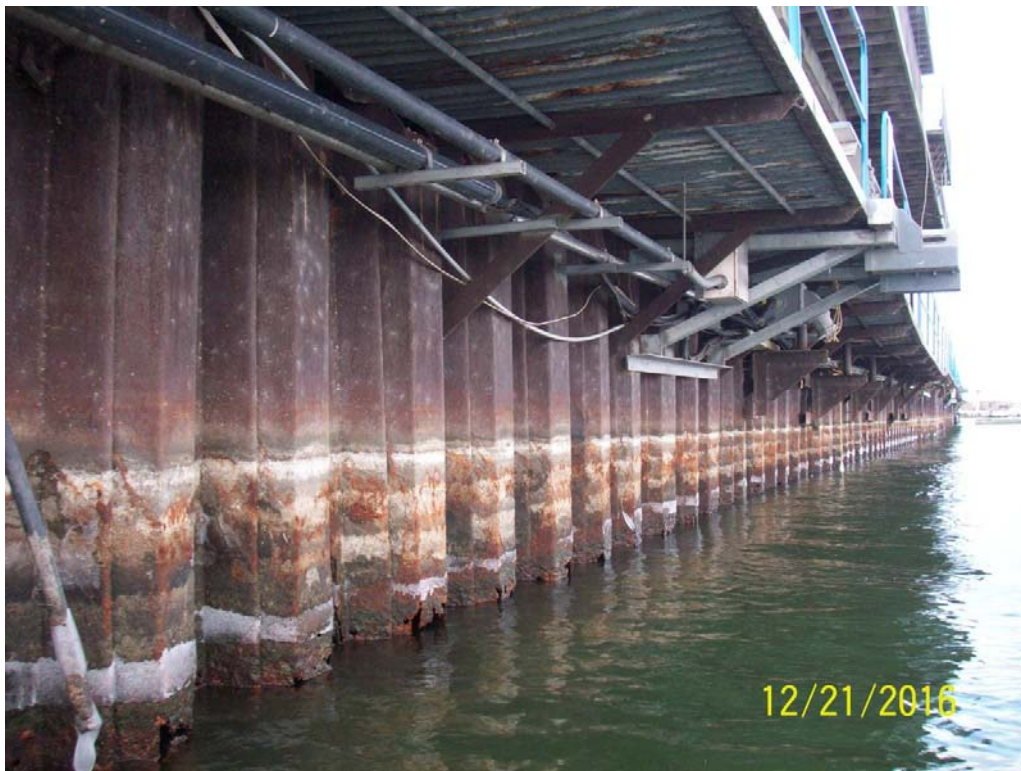
Photo 18 - Sheet pile wall, looking north near STA 450

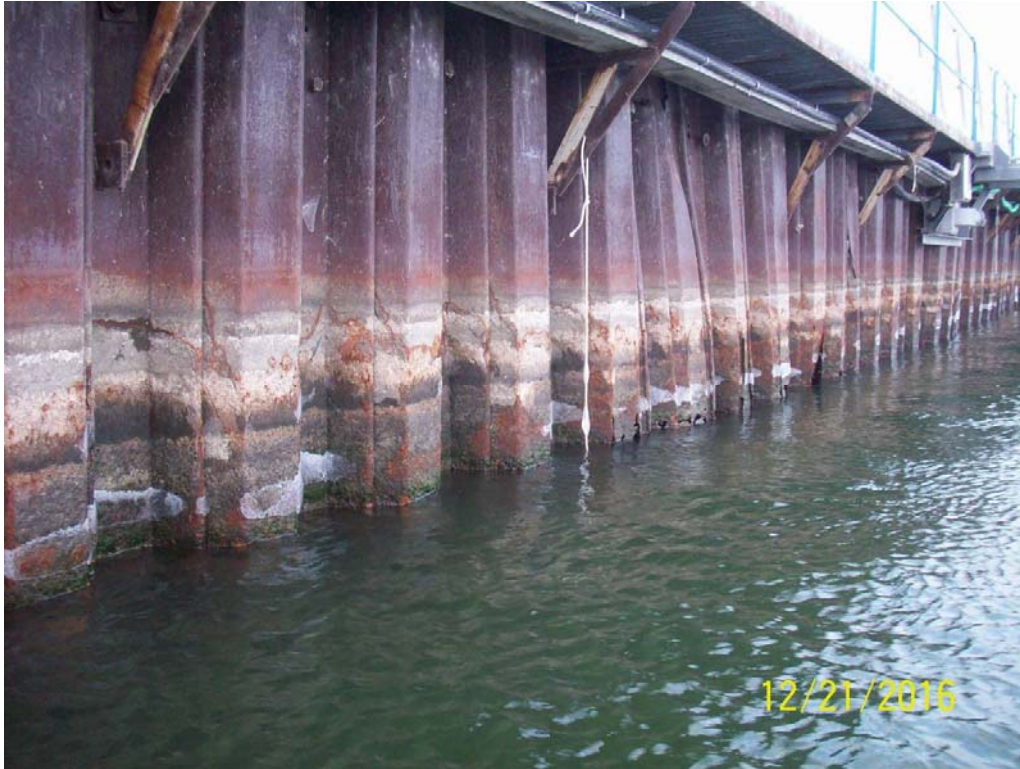
- A portion of 1 pile is missing above the water level at STA 425 (Photo 22).
- Three piles are badly torn and deformed near STA 560 (Photo 24).
- There is moderate misalignment and deformation of piles from STA 580 to 600 (Photo 19).
- From STA 730 to 830, the top 3.5' of the sheeting was cut off and new piles were welded on. The splices are very irregular and poorly aligned. From STA 790 to 830, different size piles and some flat plates were set on top of the cut off piles without proper connections (Photos 25 through 29).
- At the northwest corner of the pier, the piles are leaning up to 20 degrees and the bottom of the wall appears to be displaced toward the lake (Photos 31 and 32).

Photo 19 - Sheet pile wall, looking north near STA 580

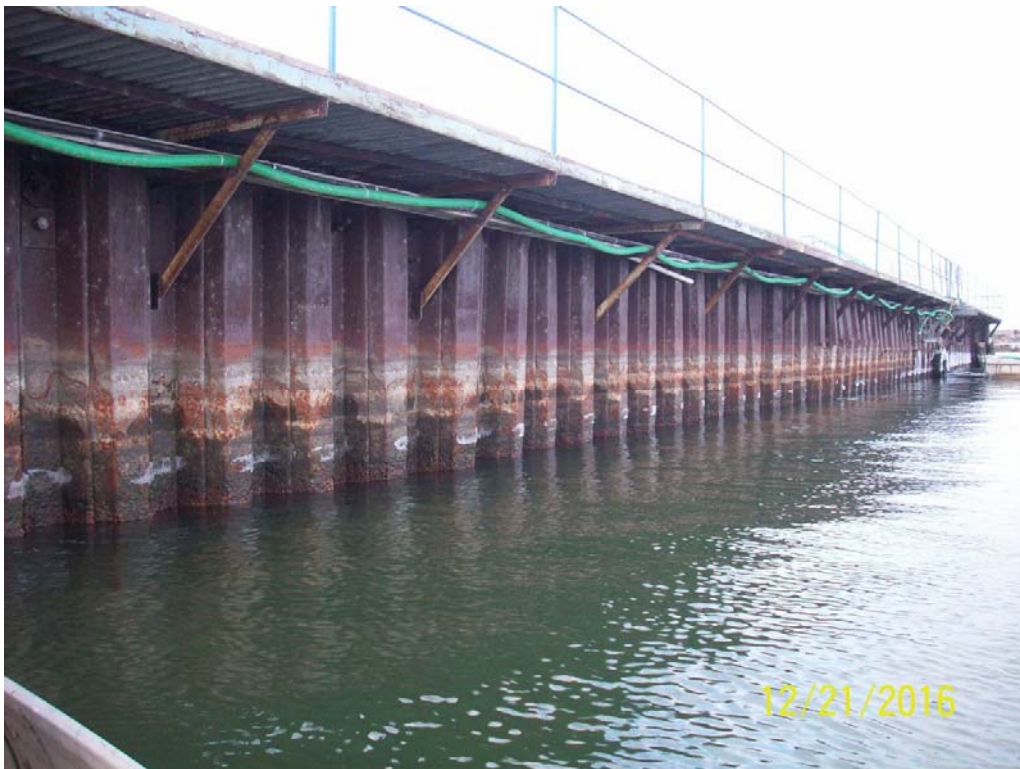
Photo 20 - Sheet pile wall, looking north near STA 660

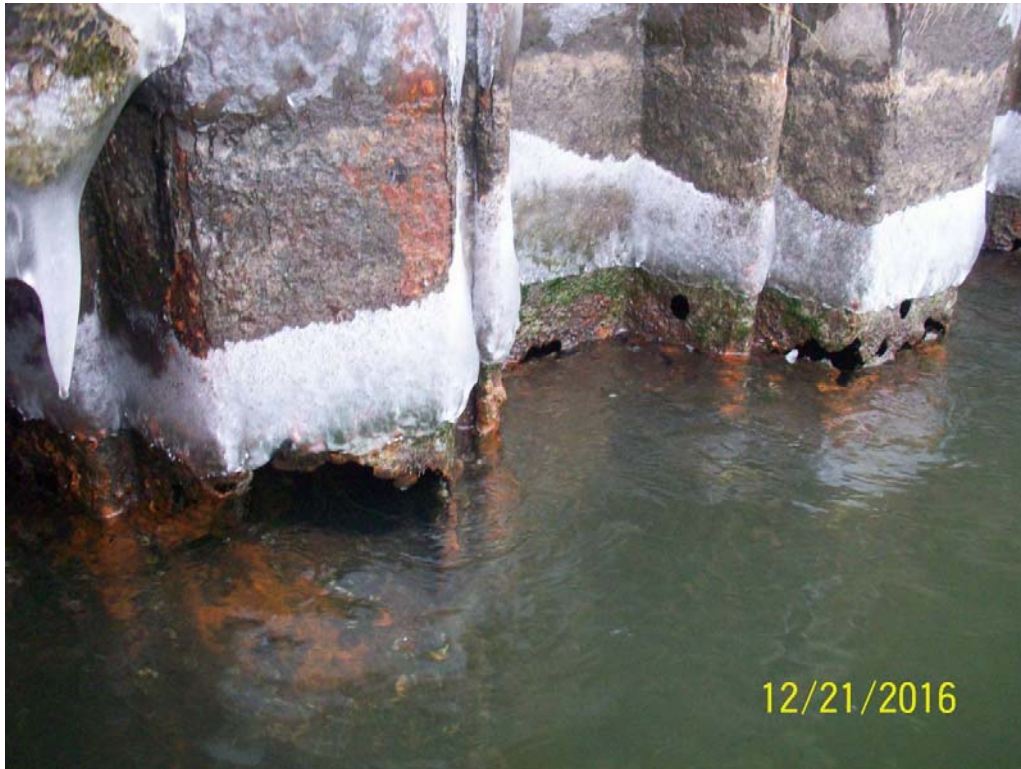
The steel sheet pile retaining walls are approximately 70 to 80 years old. From STA 344 to 857 and continuing along the north end, the sheeting is severely corroded with large holes near the water level. The tied-back wall configuration relies on the flexural strength of the sheet piles, which have been compromised by section loss in the high stress region near the water level. The weight of the concrete walkway and the wood deck at the yacht club building also induce axial stress on the sheet piles. Considering the severity of section loss without serious deformation of the sheet pile wall, it is suspected that remnants of the original timber cribbing behind the wall may be resisting a substantial portion of the lateral earth pressure on the wall.

Photo 21 – Sheet pile wall, close-up of typical holes near low water level at STA 350

6. The tied-back sheet pile wall appears to be at the end of its service life and should be programmed for replacement.

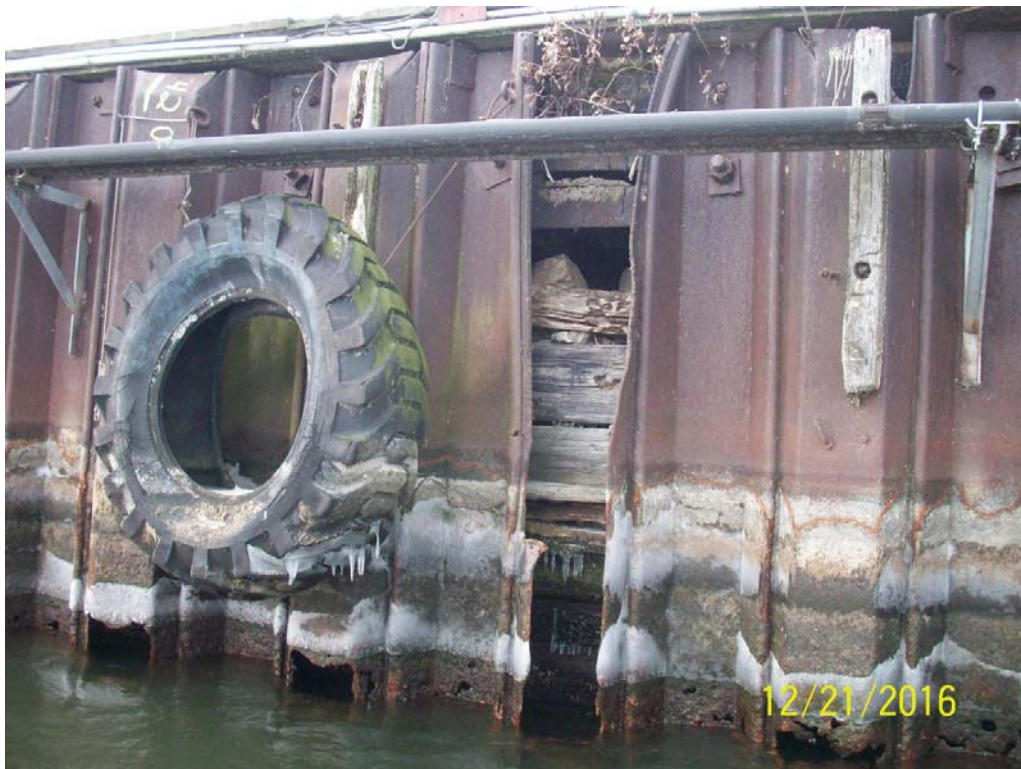
Photo 22 - Sheet pile wall, missing section of pile exposed timber cribbing at STA 425

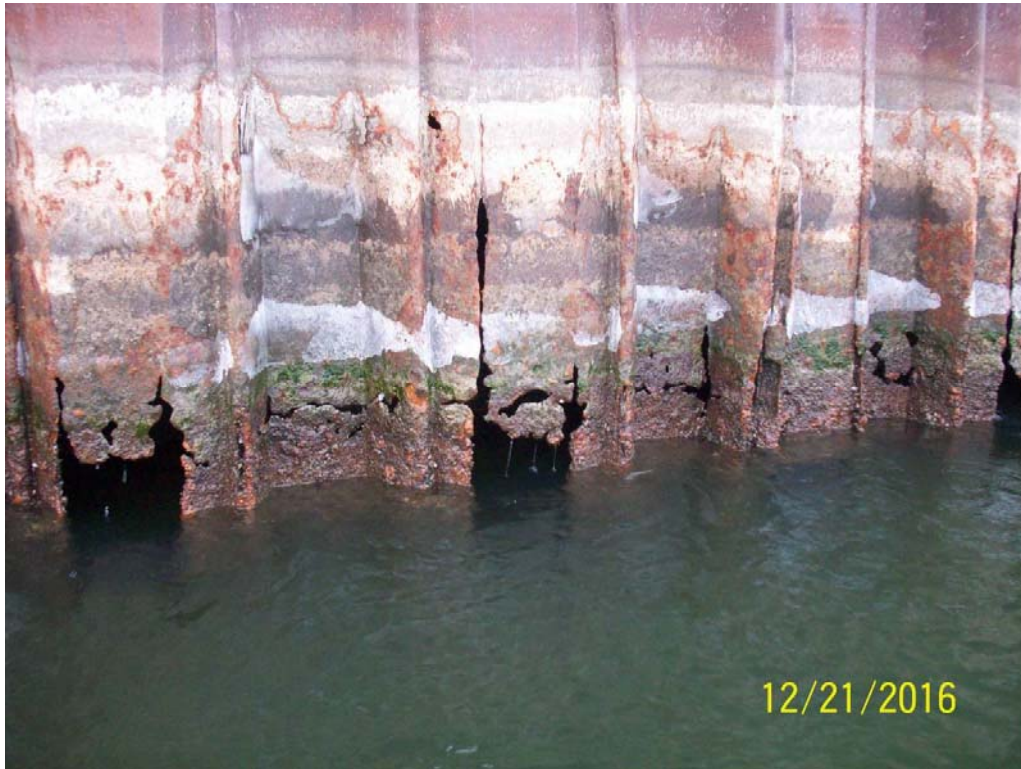
Photo 23 - Sheet pile wall, close-up of typical holes near low water level at STA 600

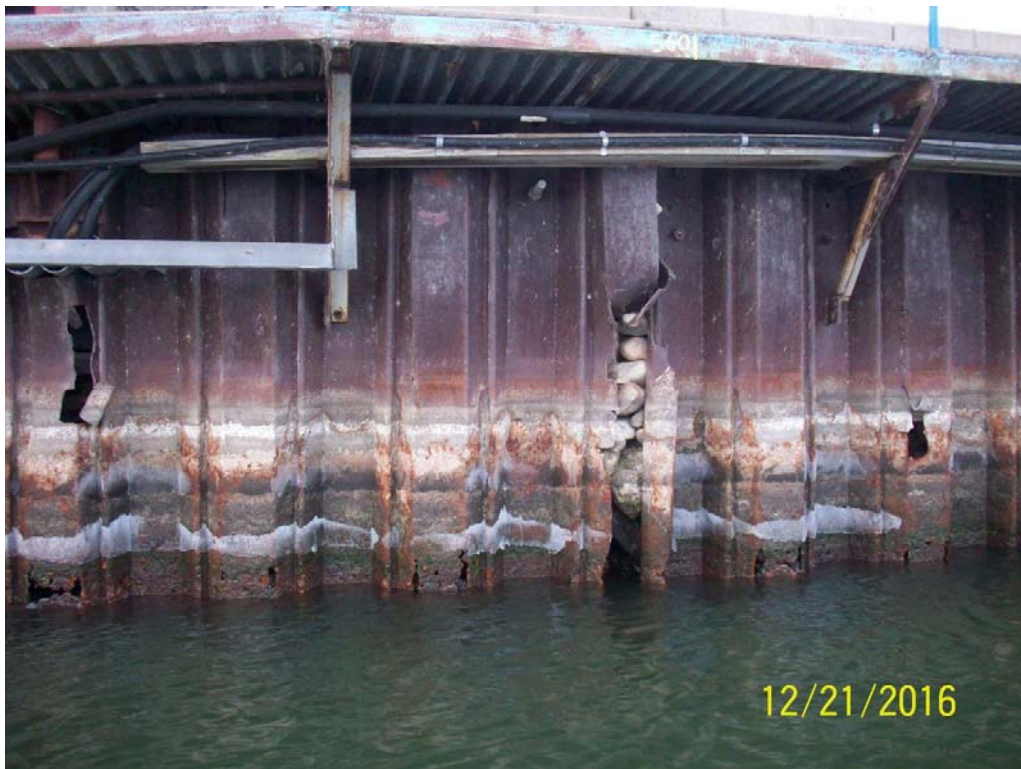
Photo 24 - Sheet pile wall, torn piles near at STA 560

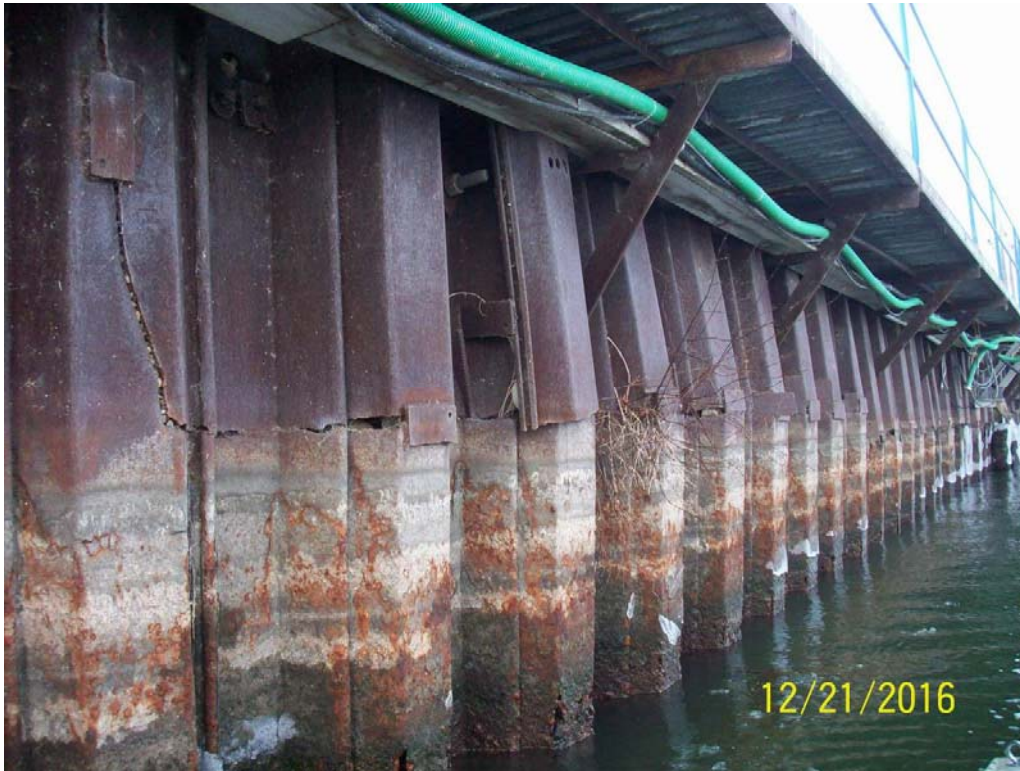
Photo 25 - Sheet pile wall, irregular welded splices beginning at STA 730

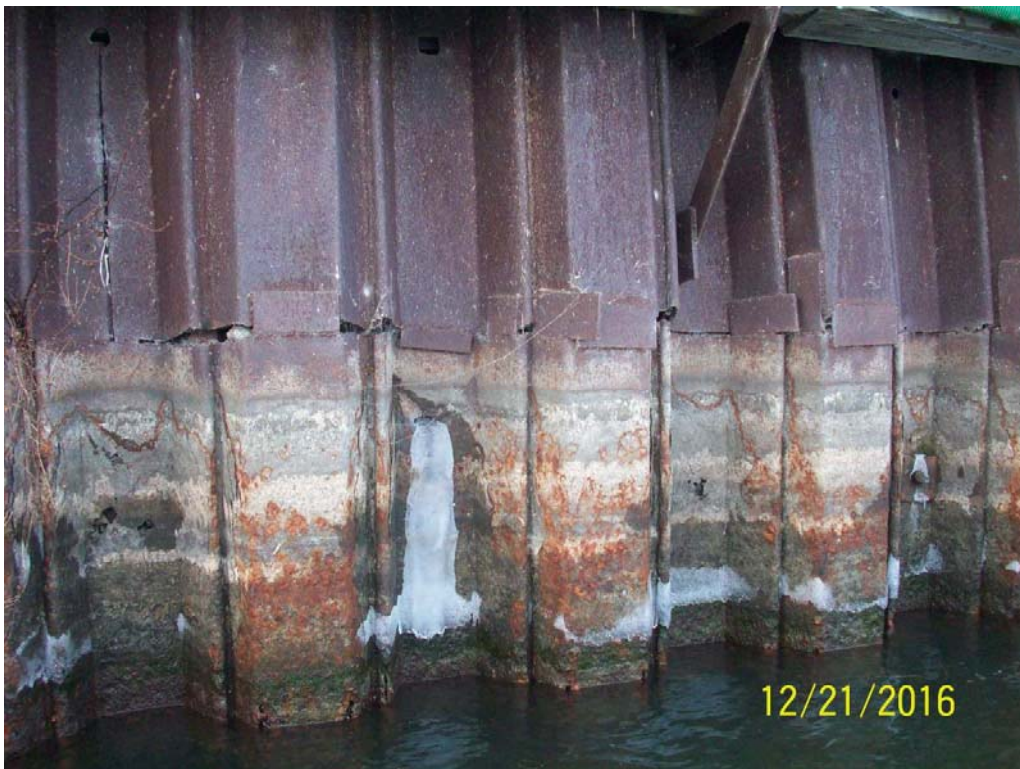
Photo 26 - Sheet pile wall, irregular welded splices at STA 750

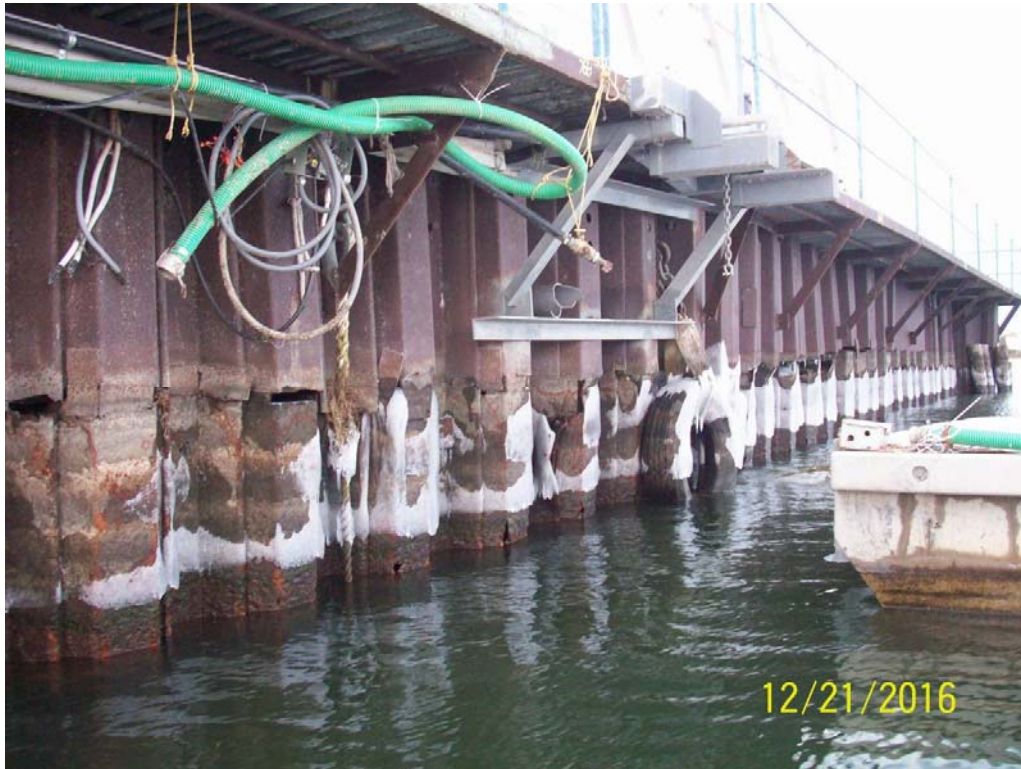
Photo 27 – Sheet pile wall, irregular welded splices near STA 780
