OSWEGO CANAL CORRIDOR BOA

APPENDIX N: WESTSIDE COAL PIER STRUCTURAL ASSESSMENT

**Westside Coal Pier
Condition Inspection and Structural Assessment**

**Prepared for:
Bergmann Associates
March 23, 2017
(Revised May 26, 2017)**

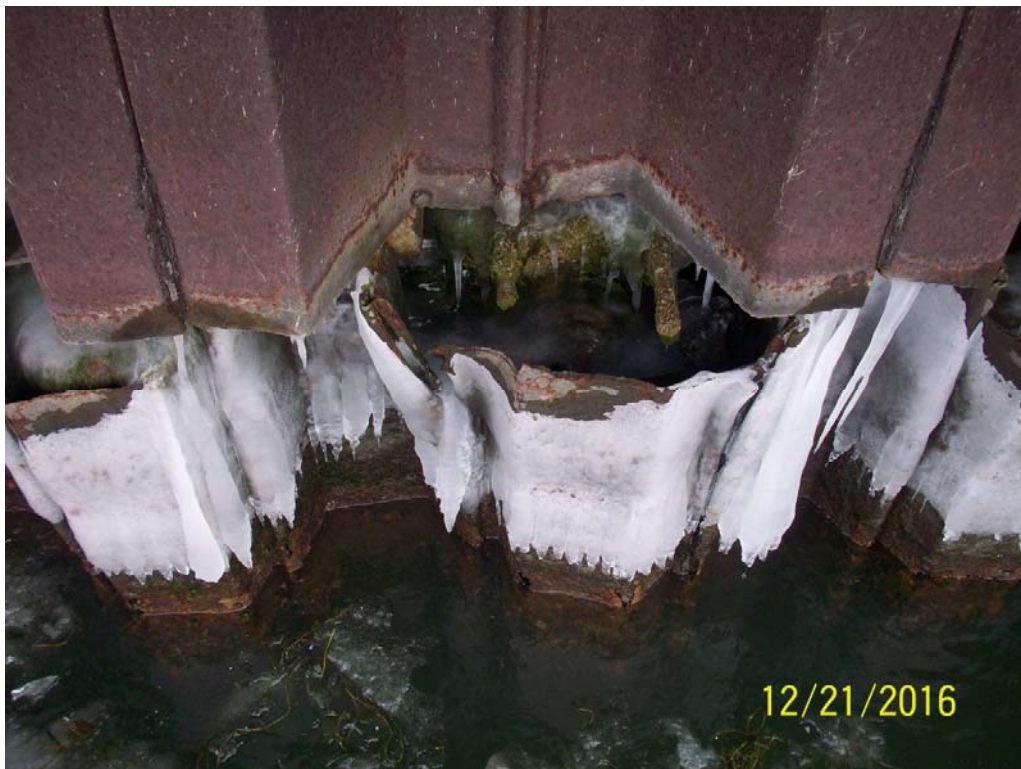
- A portion of 1 pile is missing above the water level at STA 425 (Photo 22).
- Three piles are badly torn and deformed near STA 560 (Photo 24).
- There is moderate misalignment and deformation of piles from STA 580 to 600 (Photo 19).
- From STA 730 to 830, the top 3.5' of the sheeting was cut off and new piles were welded on. The splices are very irregular and poorly aligned. From STA 790 to 830, different size piles and some flat plates were set on top of the cut off piles without proper connections (Photos 25 through 29).
- At the northwest corner of the pier, the piles are leaning up to 20 degrees and the bottom of the wall appears to be displaced toward the lake (Photos 31 and 32).

Photo 28 - Sheet pile wall, mis-matched pile "splice" near STA 800

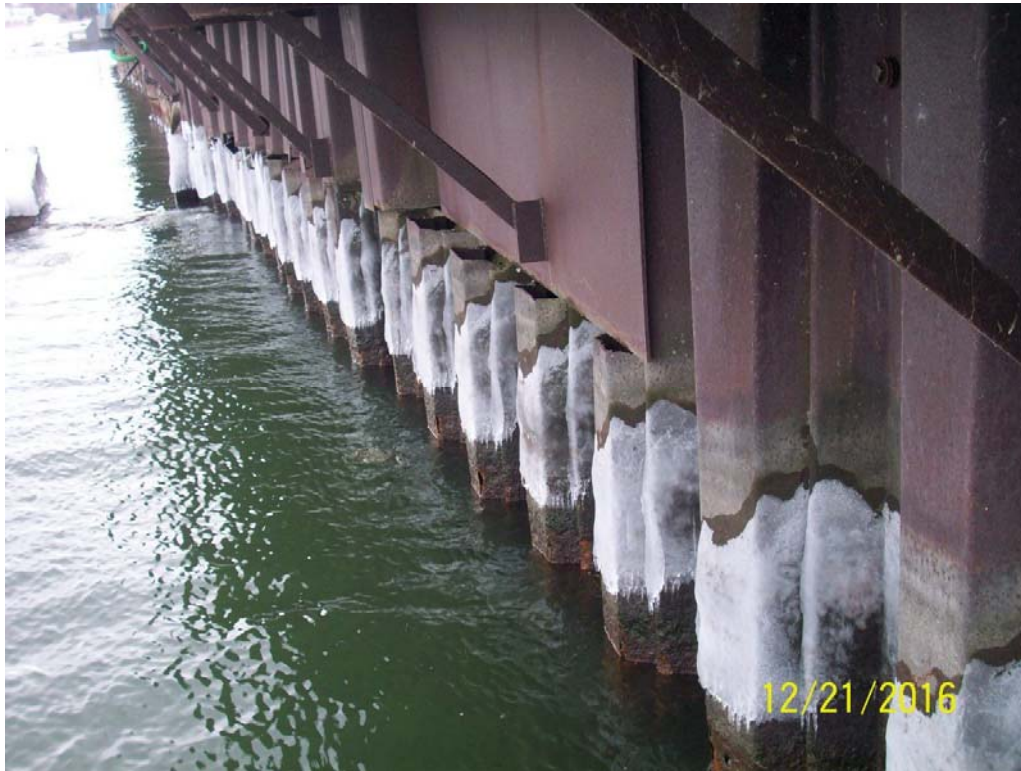
Photo 29 – Sheet pile wall, plate repair near STA 830

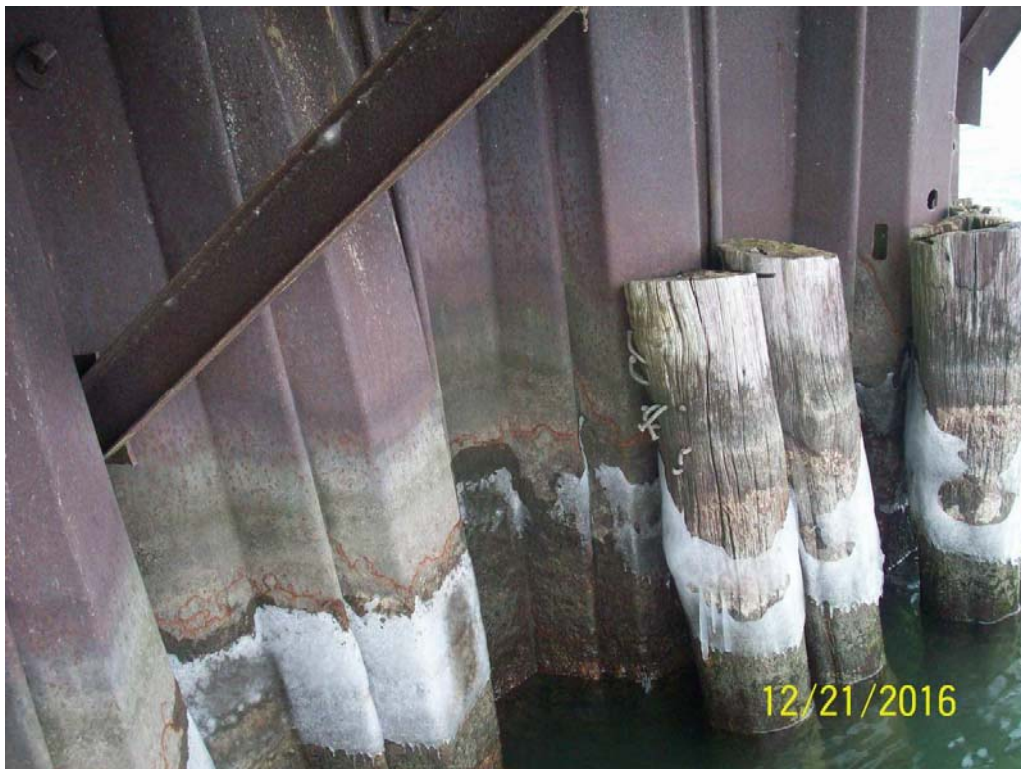
Photo 30 – Sheet pile wall and timber piles at STA 850

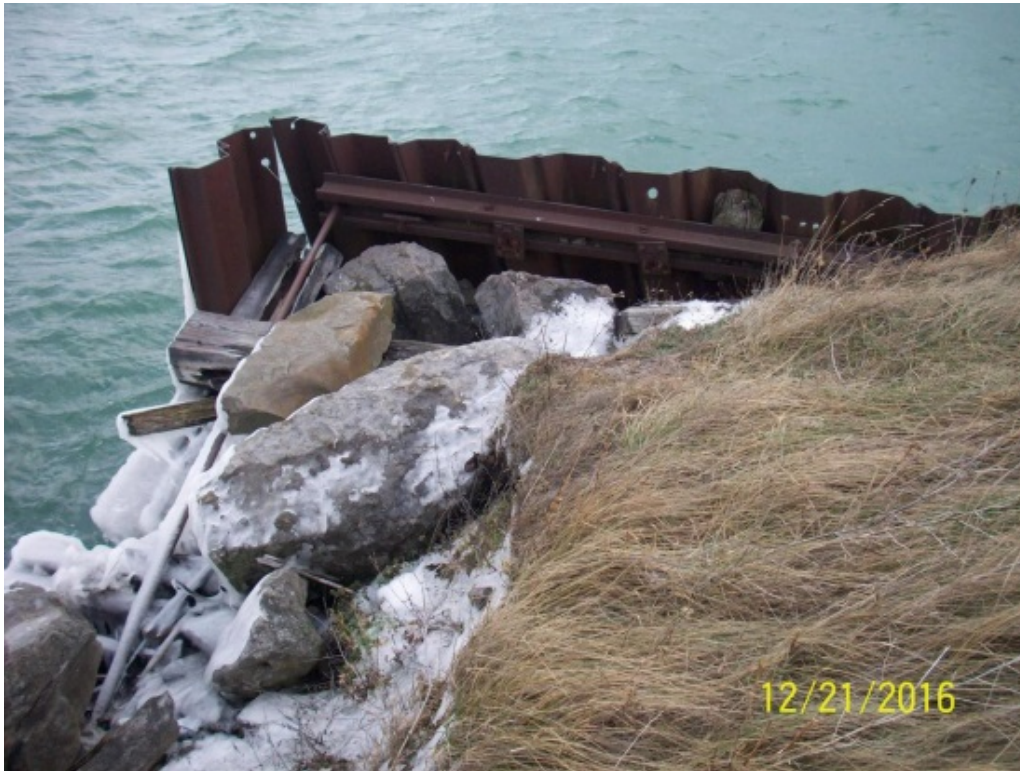
Photo 31 – End of sheet pile wall at northwest corner of pier,

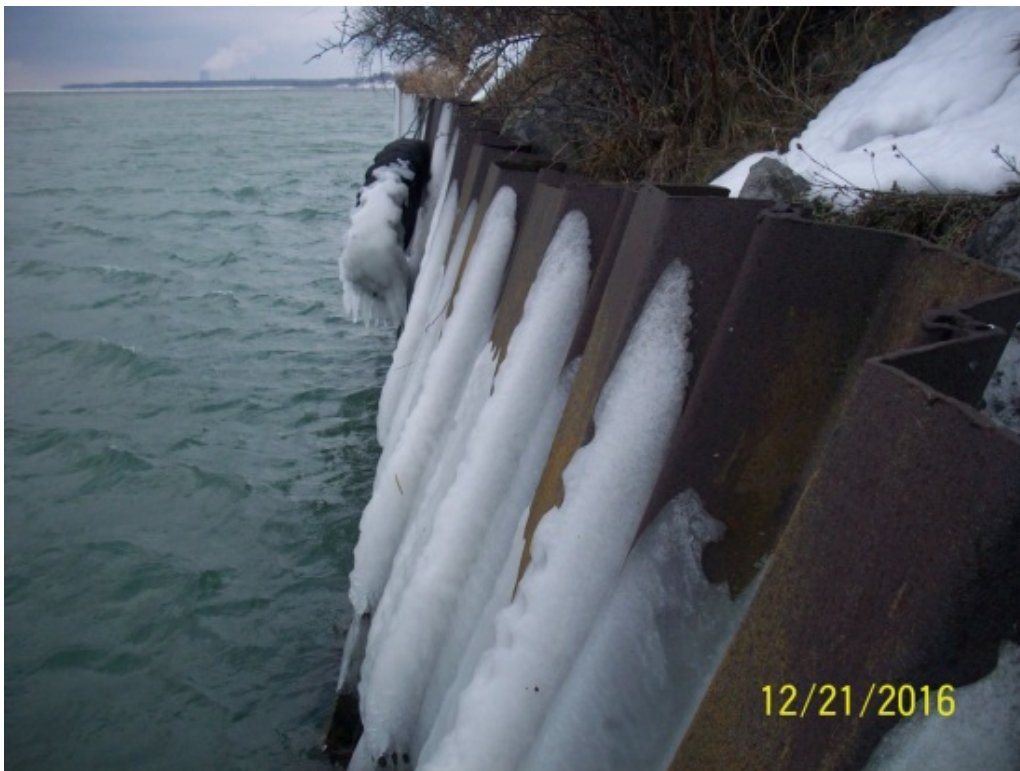
Photo 32 – Leaning sheet piles at northwest corner of pier

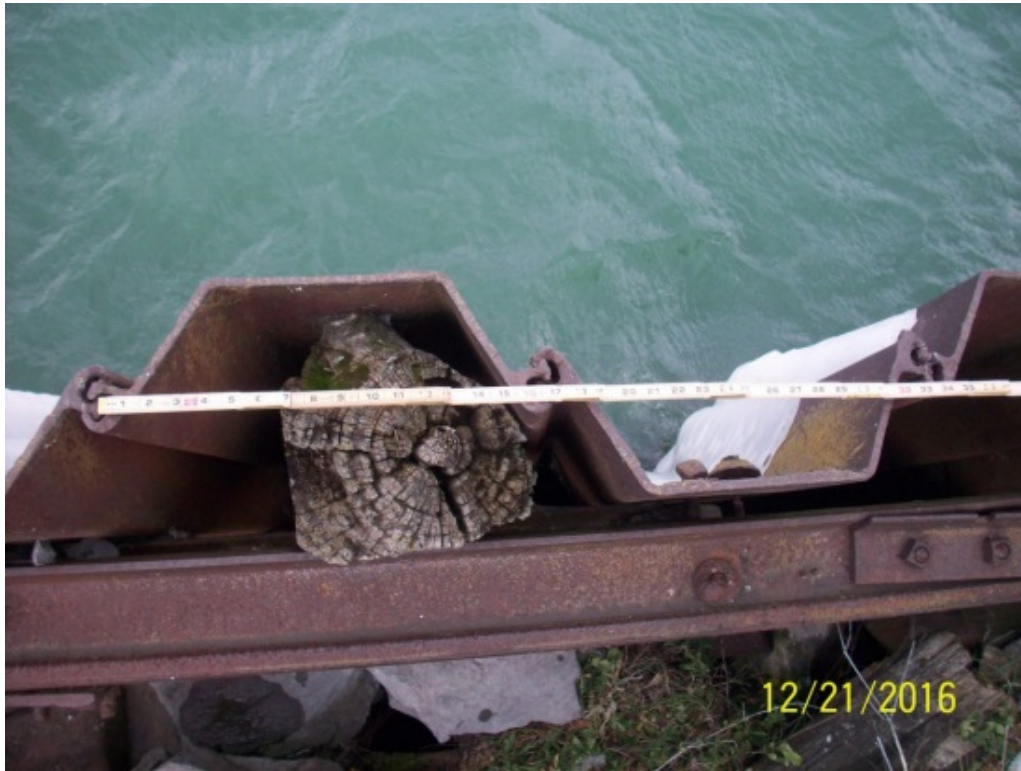
Photo 33 – Top of typical sheet pile, at northwest corner of pier

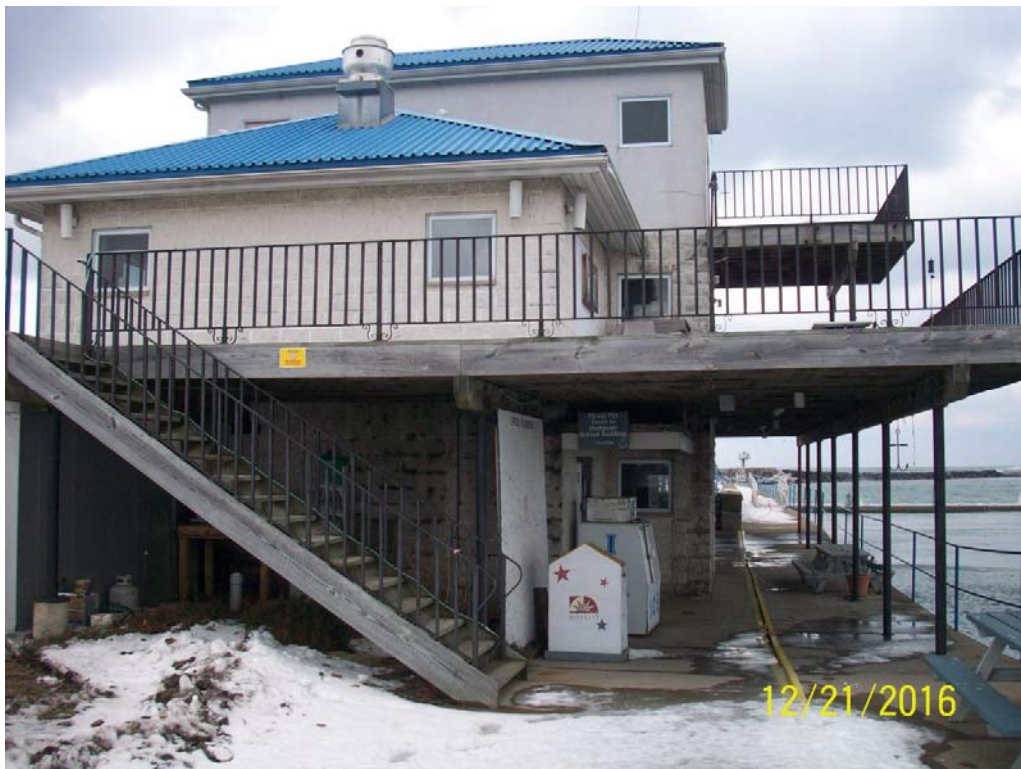
side of the Yacht Club Building (Photos 17, 18, and 34 through 36). The support brackets for the cantilevered walkway and the wood deck are in good structural condition, but these supports are dependent on the stability of the severely deteriorated sheet piles beneath it (Photos 18 and 37). There is no visible settlement or distress in the sheet piles at this time.

The yacht club building appears to be in good structural condition (Photos 17, and 34 through 36). The building is set back approximately 5' to 10' behind the sheet pile retaining wall, which is approximately 23' to 24' high in this area. Based on discussion with a contractor that was involved during construction of the building (Jim Tabor of J. D. Taber Masonry Inc.), the foundation is believed to be a spread concrete footing on the pier fill material. The footing is located approximately 4' below finished grade. A concrete walkway slab located between the building and the retaining wall is settled up to 2" (Photo 38), which may indicate loss of backfill in this area. There is no significant cracking or distress in the concrete block building itself.

Photo 34 – Yacht Club building, looking north

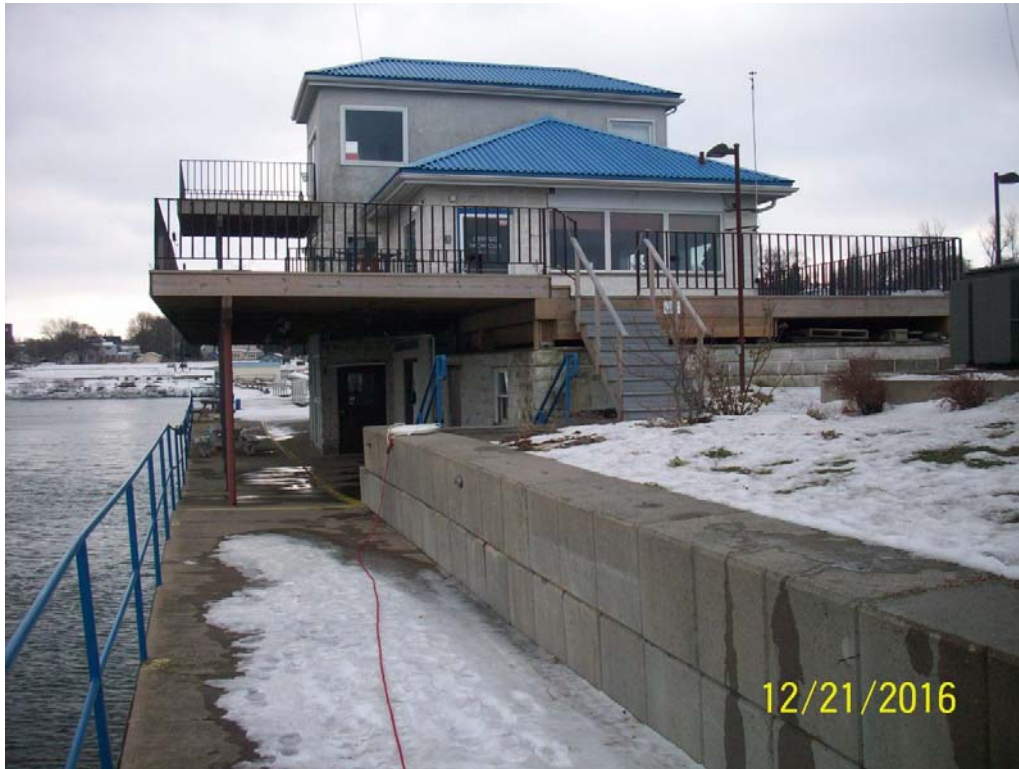
Photo 35 – Yacht Club building, looking south

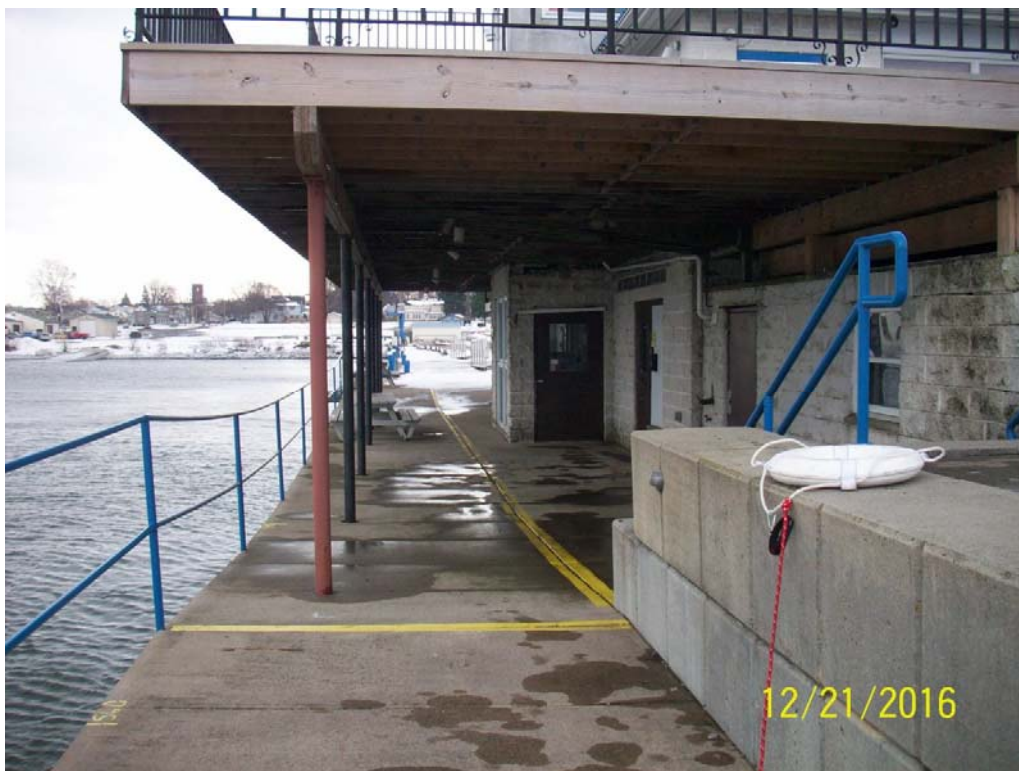
Photo 36 – Yacht Club building deck supports, looking south

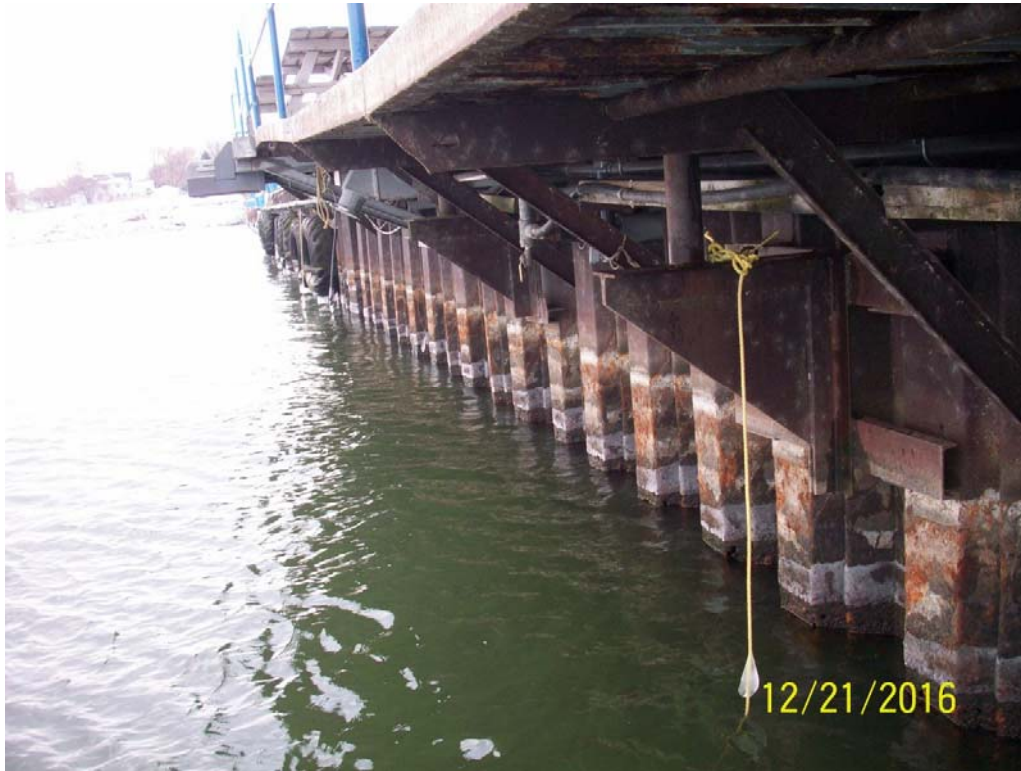
Photo 37 – Deck column support brackets near STA 500

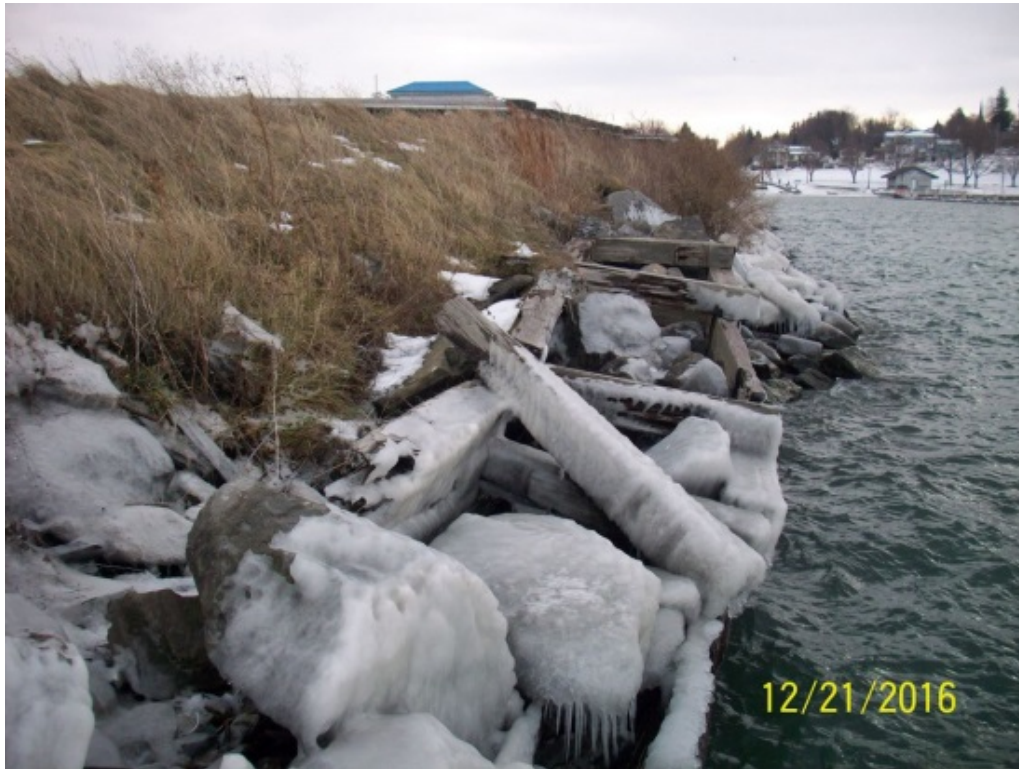
The sheet pile wall terminates at the northwest corner of the pier, and a steeply sloped bank lined with heavy stone bank protection extends along the west side of the pier. Remnants of the original timber cribbing are still visible in the stone slope near the northwest corner. The stone bank protection is in good condition and appears stable (Photos 39 and 40).

Photo 39 – Remnants of timber cribbing at near northwest corner of pier

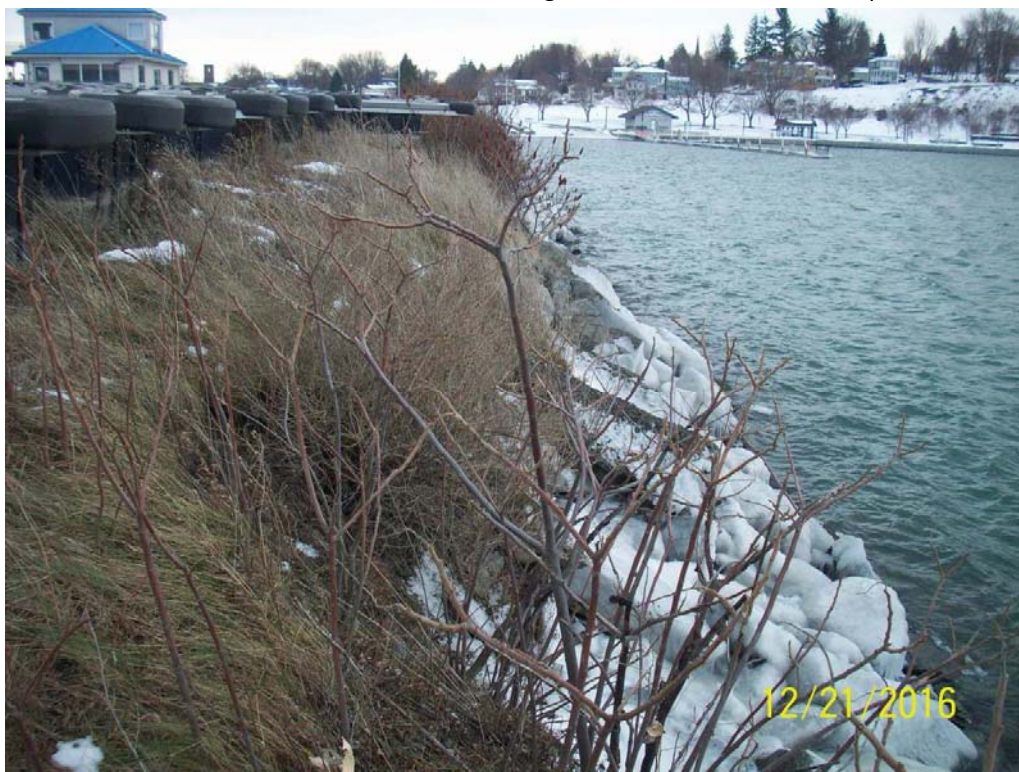
Photo 40 – Stone bank protection at west side of pier
