# OSWEGO CANAL CORRIDOR BOA

## APPENDIX E: SYNAGOGUE STRUCTURAL REUSE AND ASSESSMENT

# Facility Condition and Program Feasibility Assessment

## FORMER CONGREGATION ADATH ISRAEL

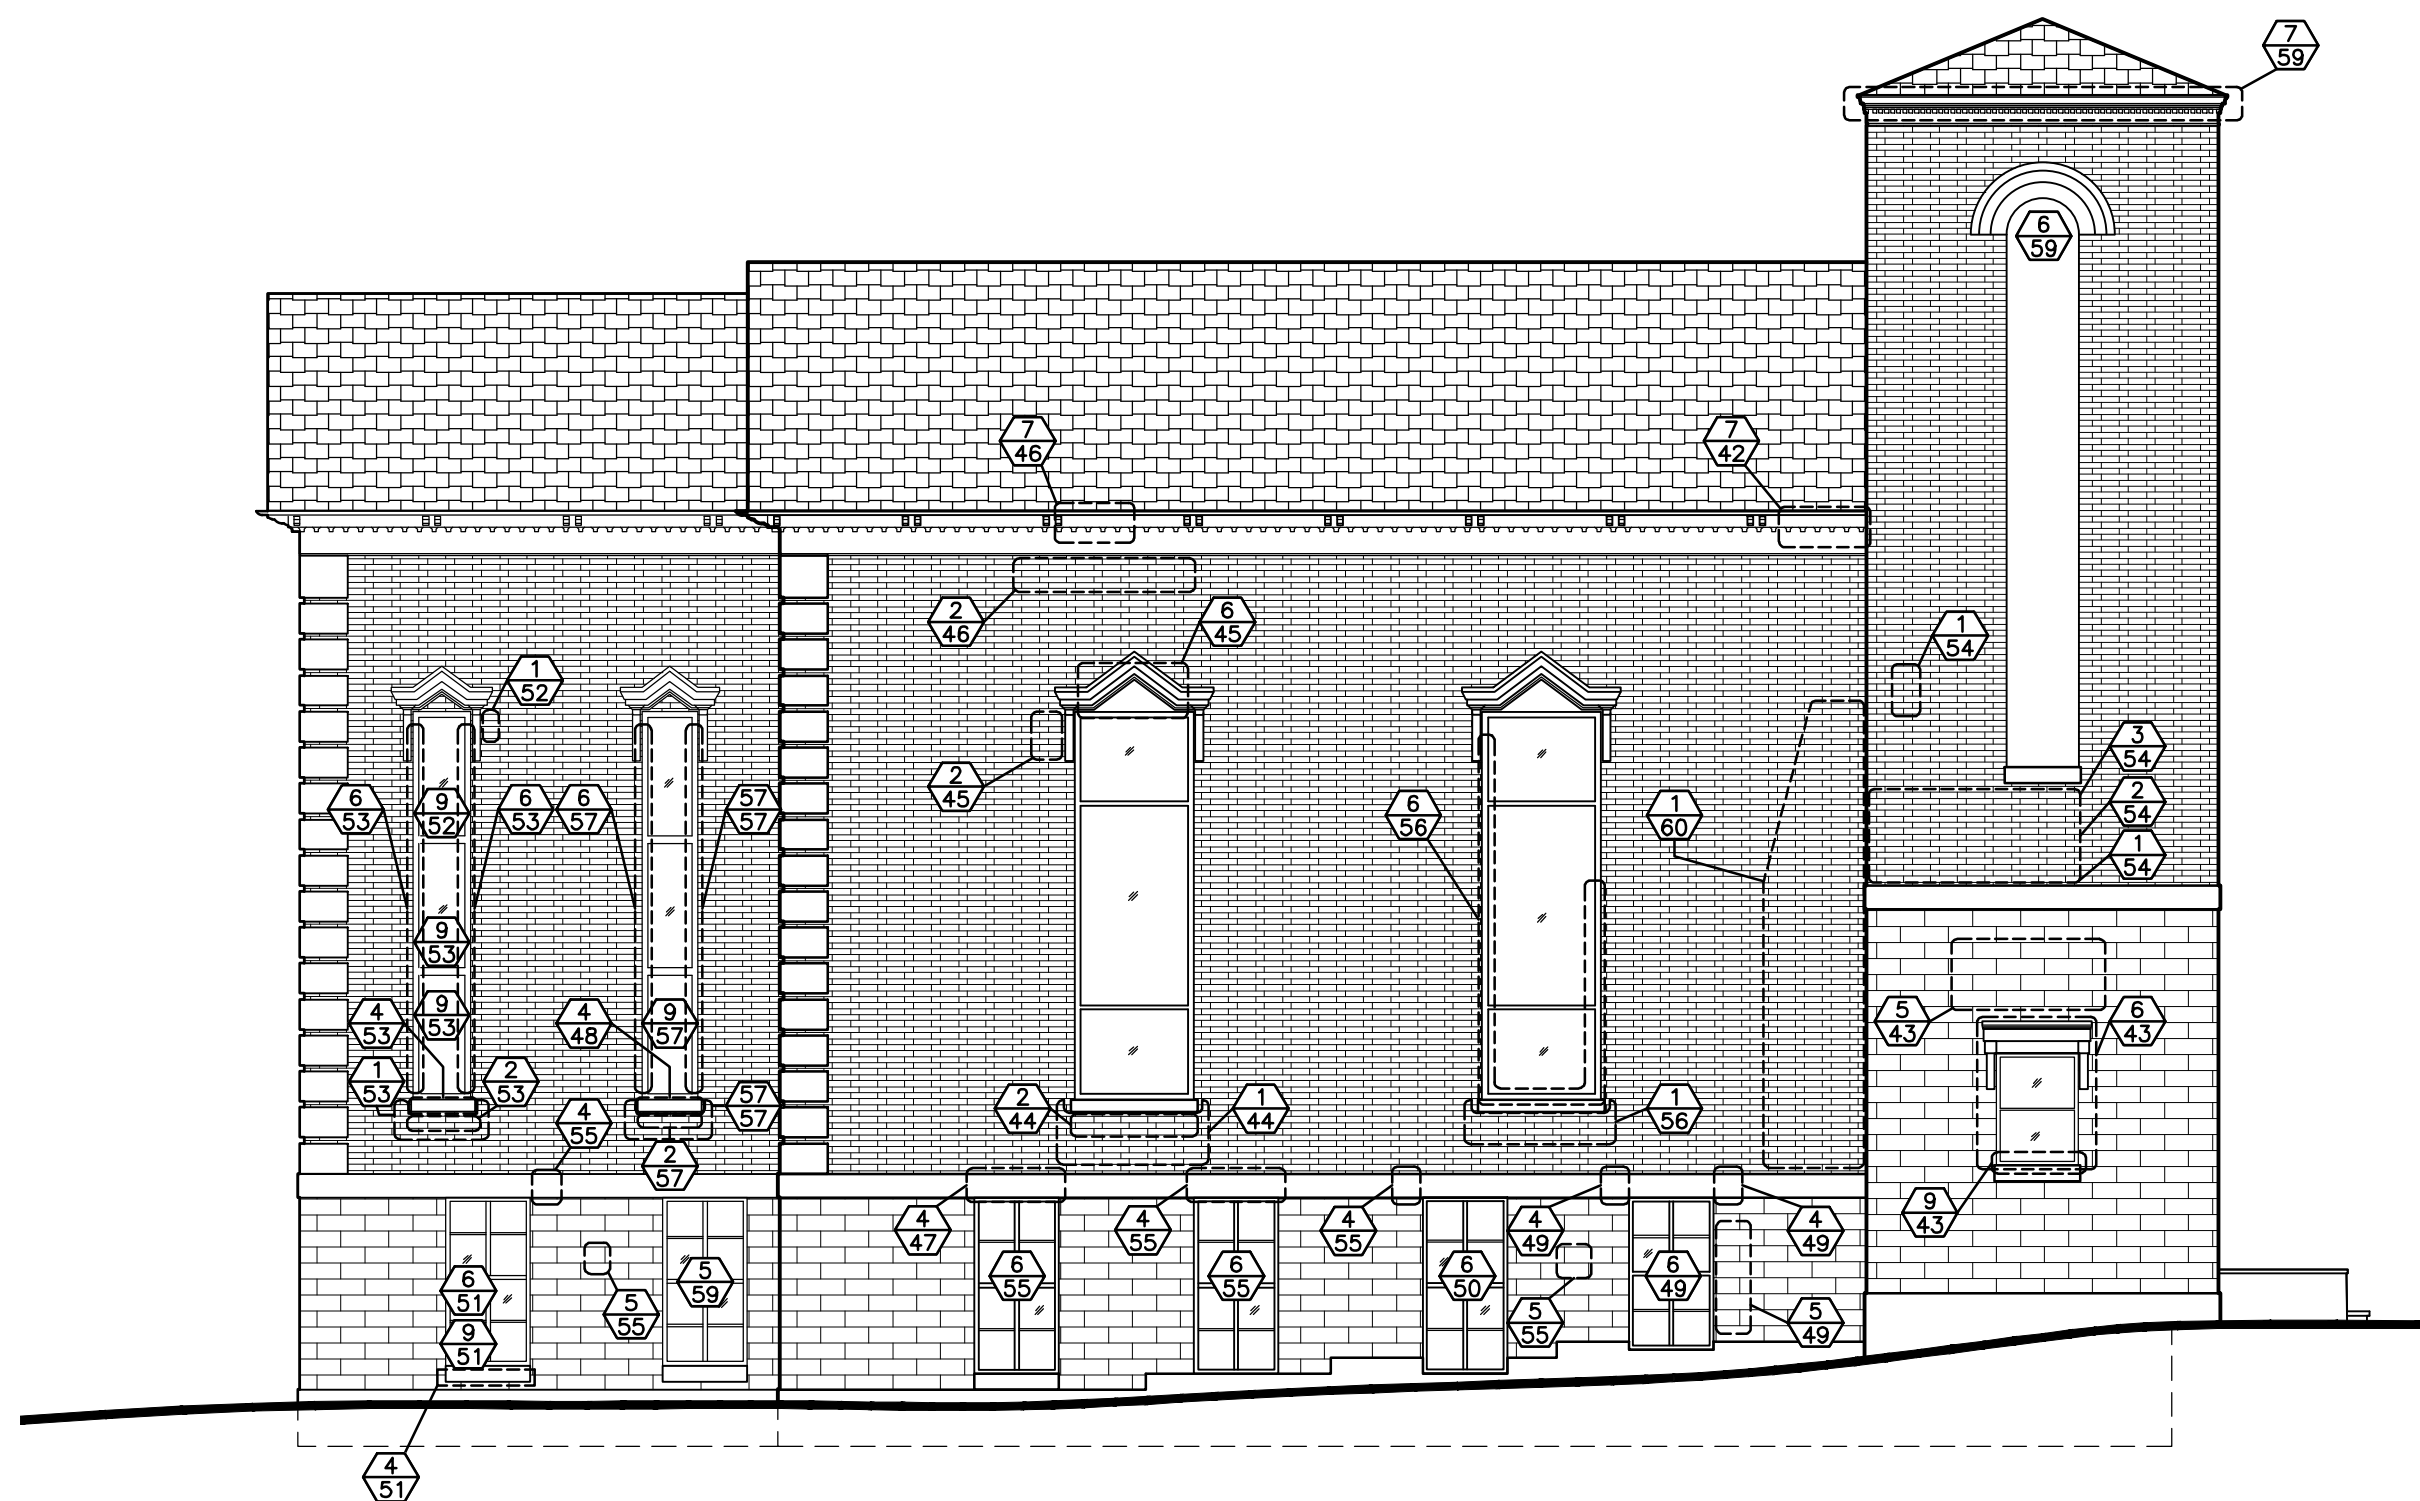
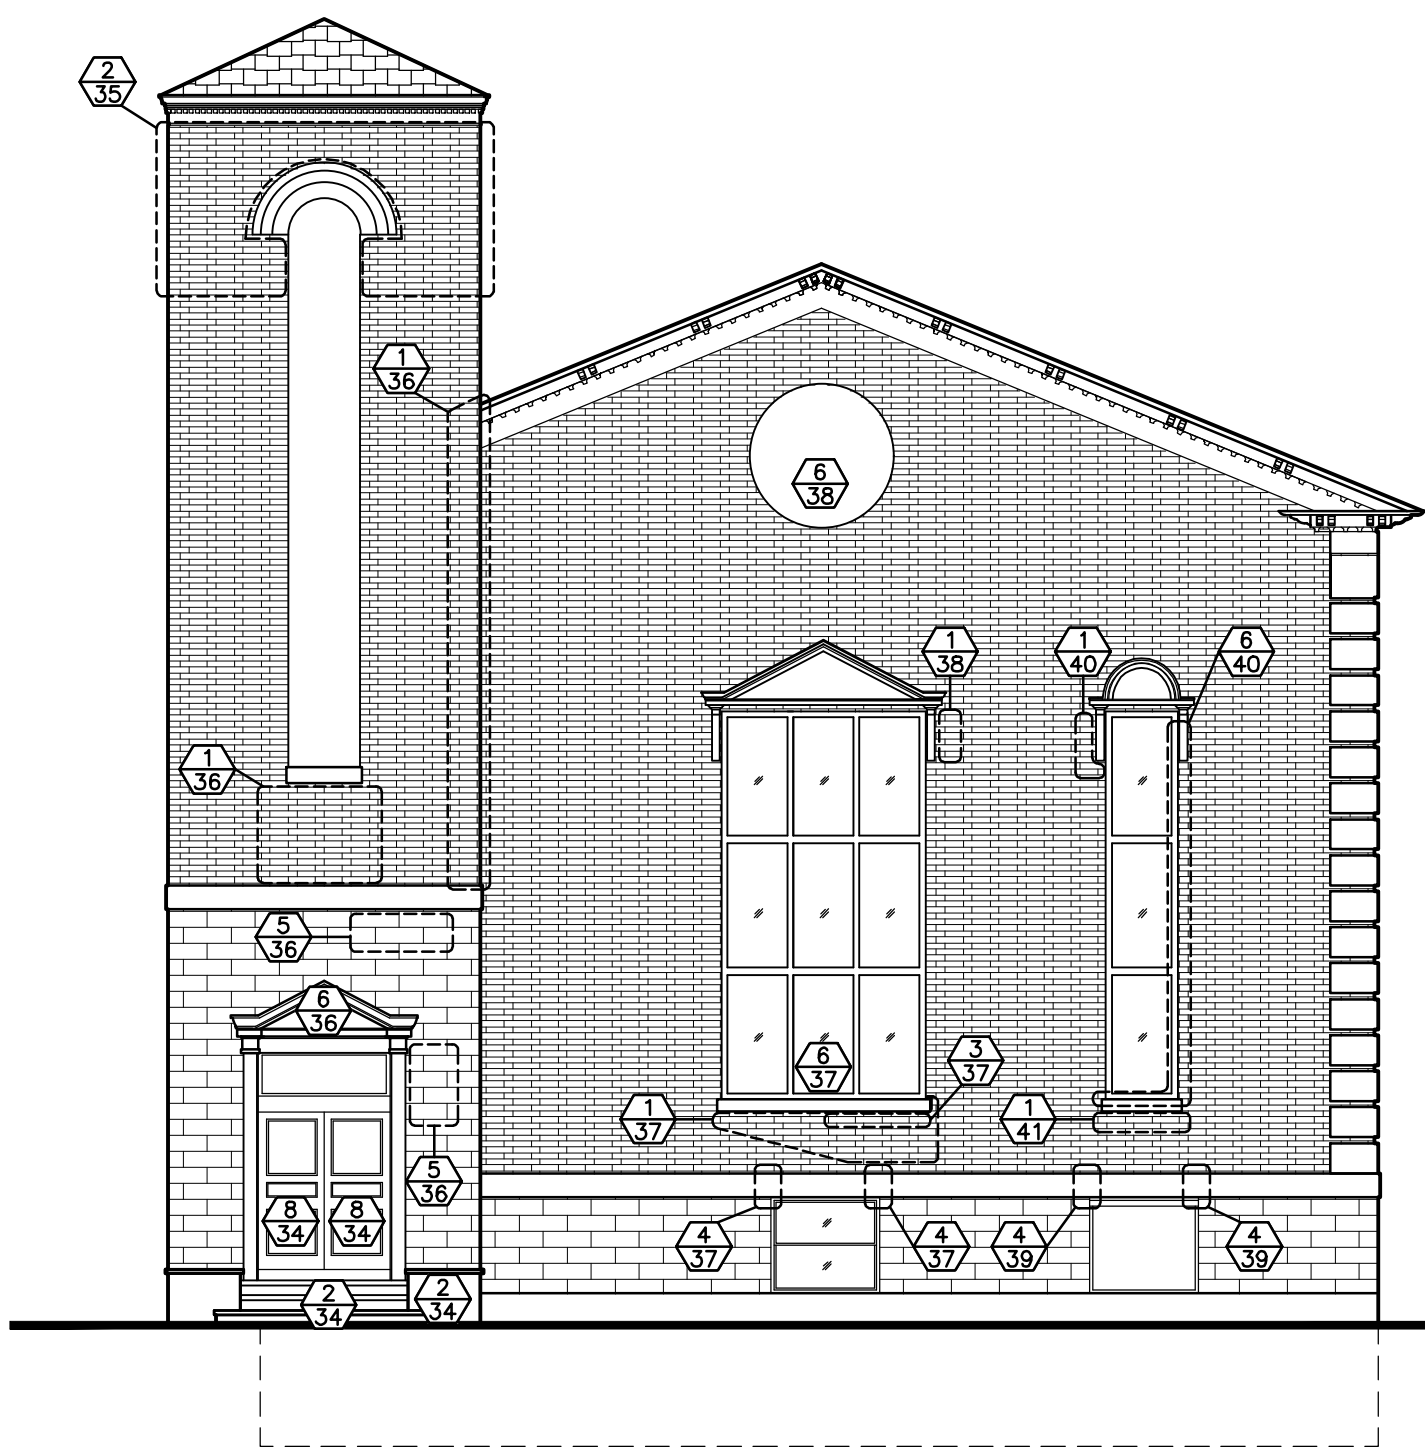
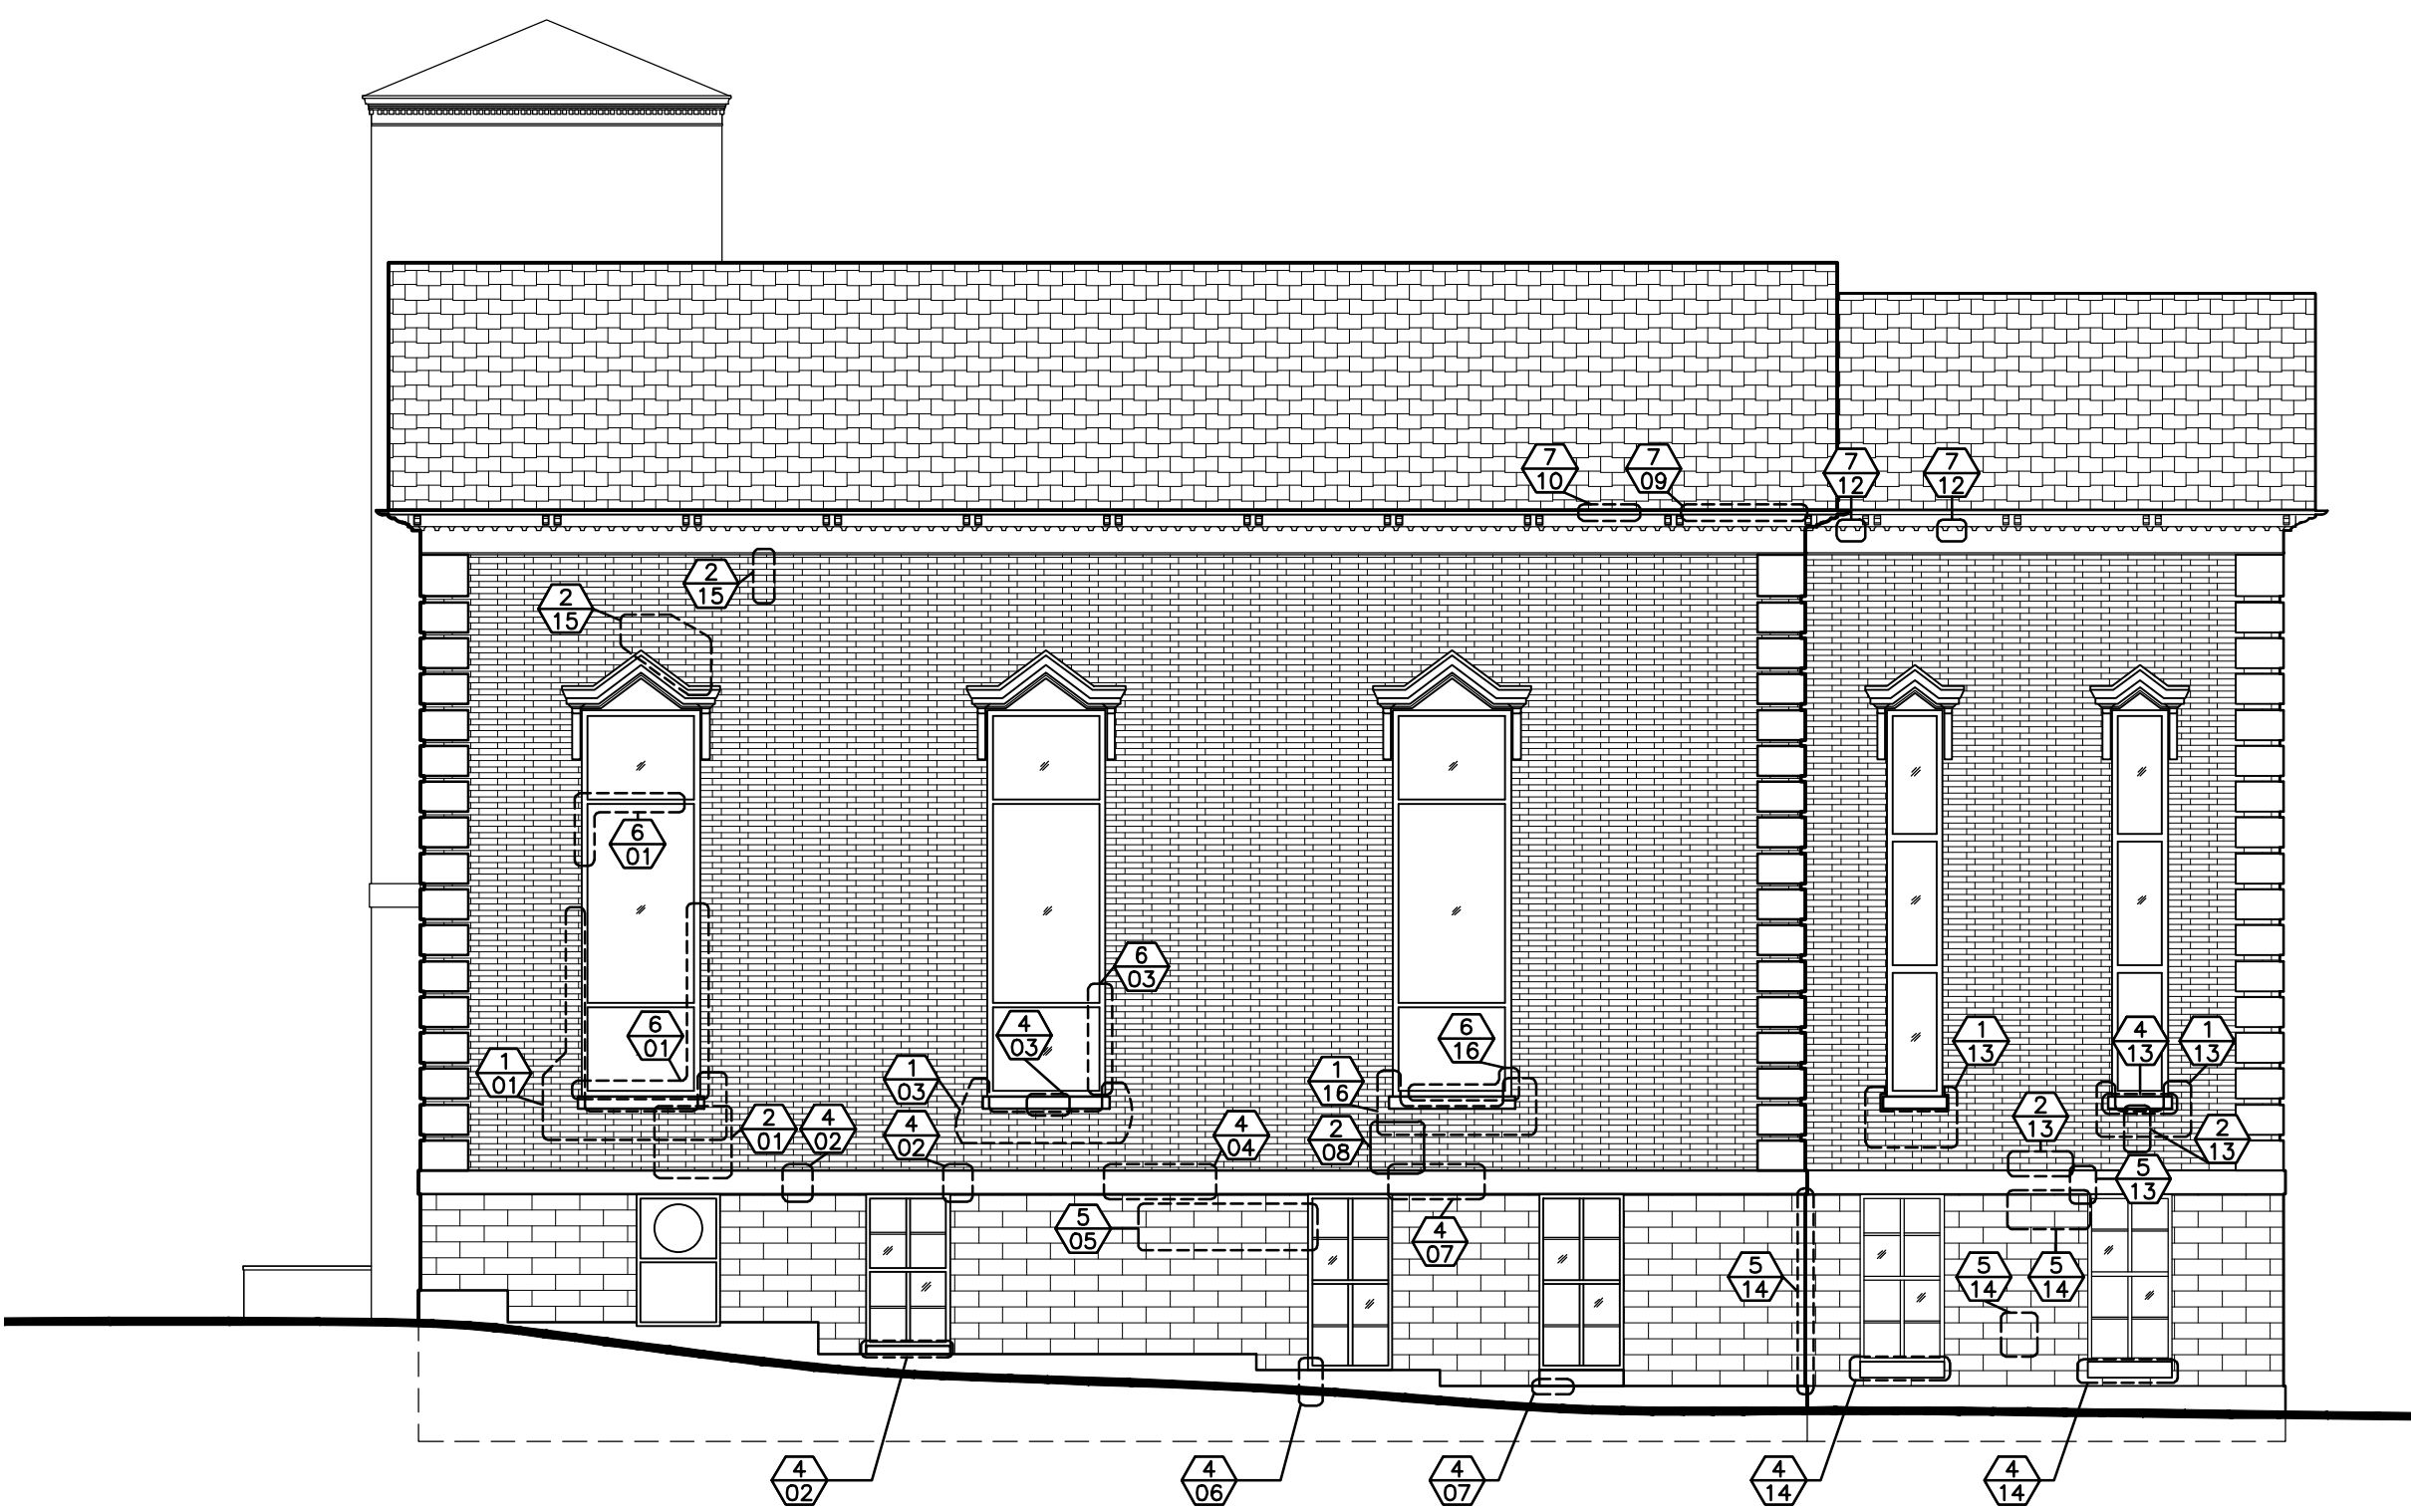
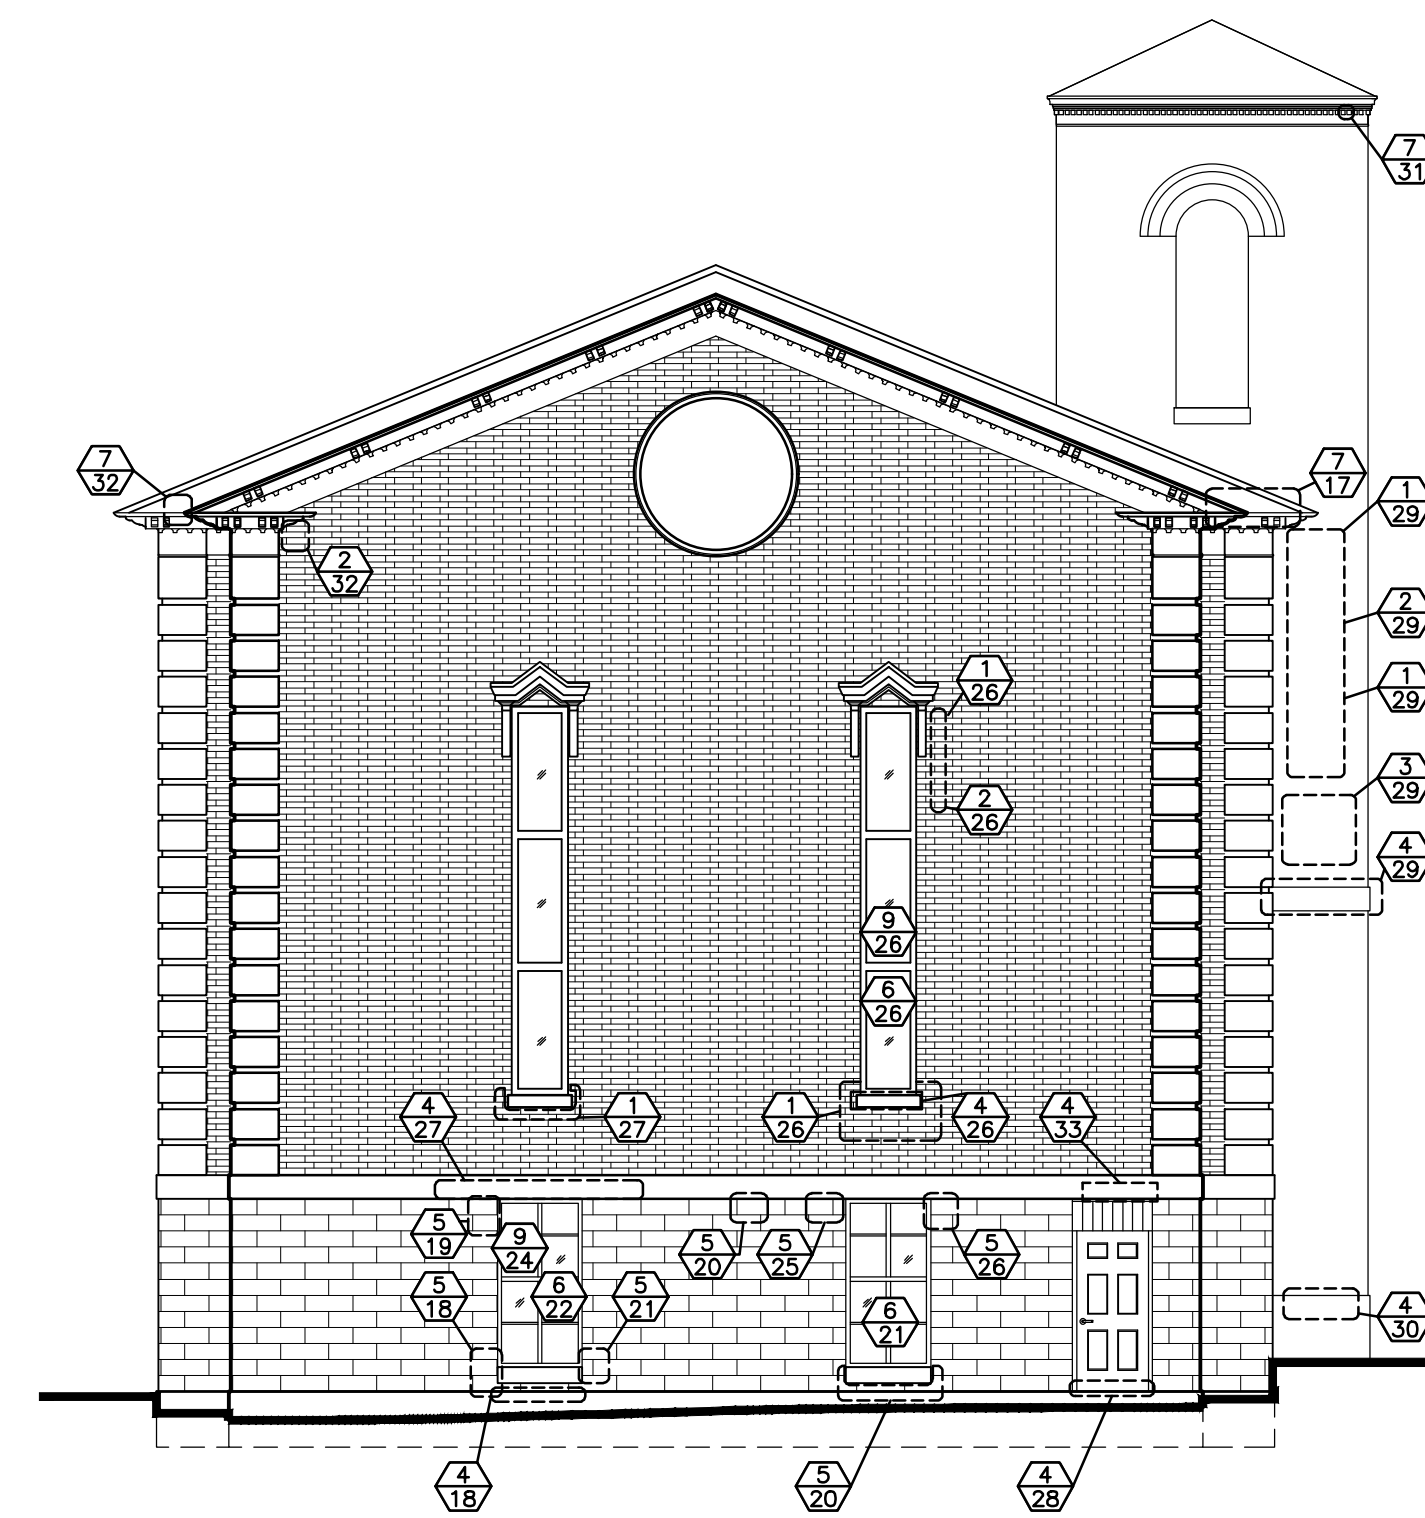
- 1 MASONRY WATER DAMAGE / DISCOLORATION
- 2 MASONRY IN NEED OF REPOINTING
- 3 SEVERELY DETERIORATED MASONRY IN NEED OF REPLACEMENT
- 4 DAMAGED / CRACKED CONCRETE IN NEED OF PATCH / REPAIR
- 5 STONEWORK IN NEED OF REPOINTING
- 6 WOOD / TRIM IN NEED OF REPAIR / REPAINTING
- 7 FASCIA IN NEED OF PATCH / REPAIR / REPAINTING
- 8 DOOR IN NEED OF REPAINTING / REFINISHING
- 9 DAMAGED GLASS IN NEED OR REPLACEMENT
