OSWEGO CANAL CORRIDOR BOA

APPENDIX Q: WESTSIDE COAL PIER STRUCTURAL ASSESSMENT

**Westside Coal Pier
Condition Inspection and Structural Assessment**

**Prepared for:
Bergmann Associates
March 23, 2017
(Revised May 26, 2017)**

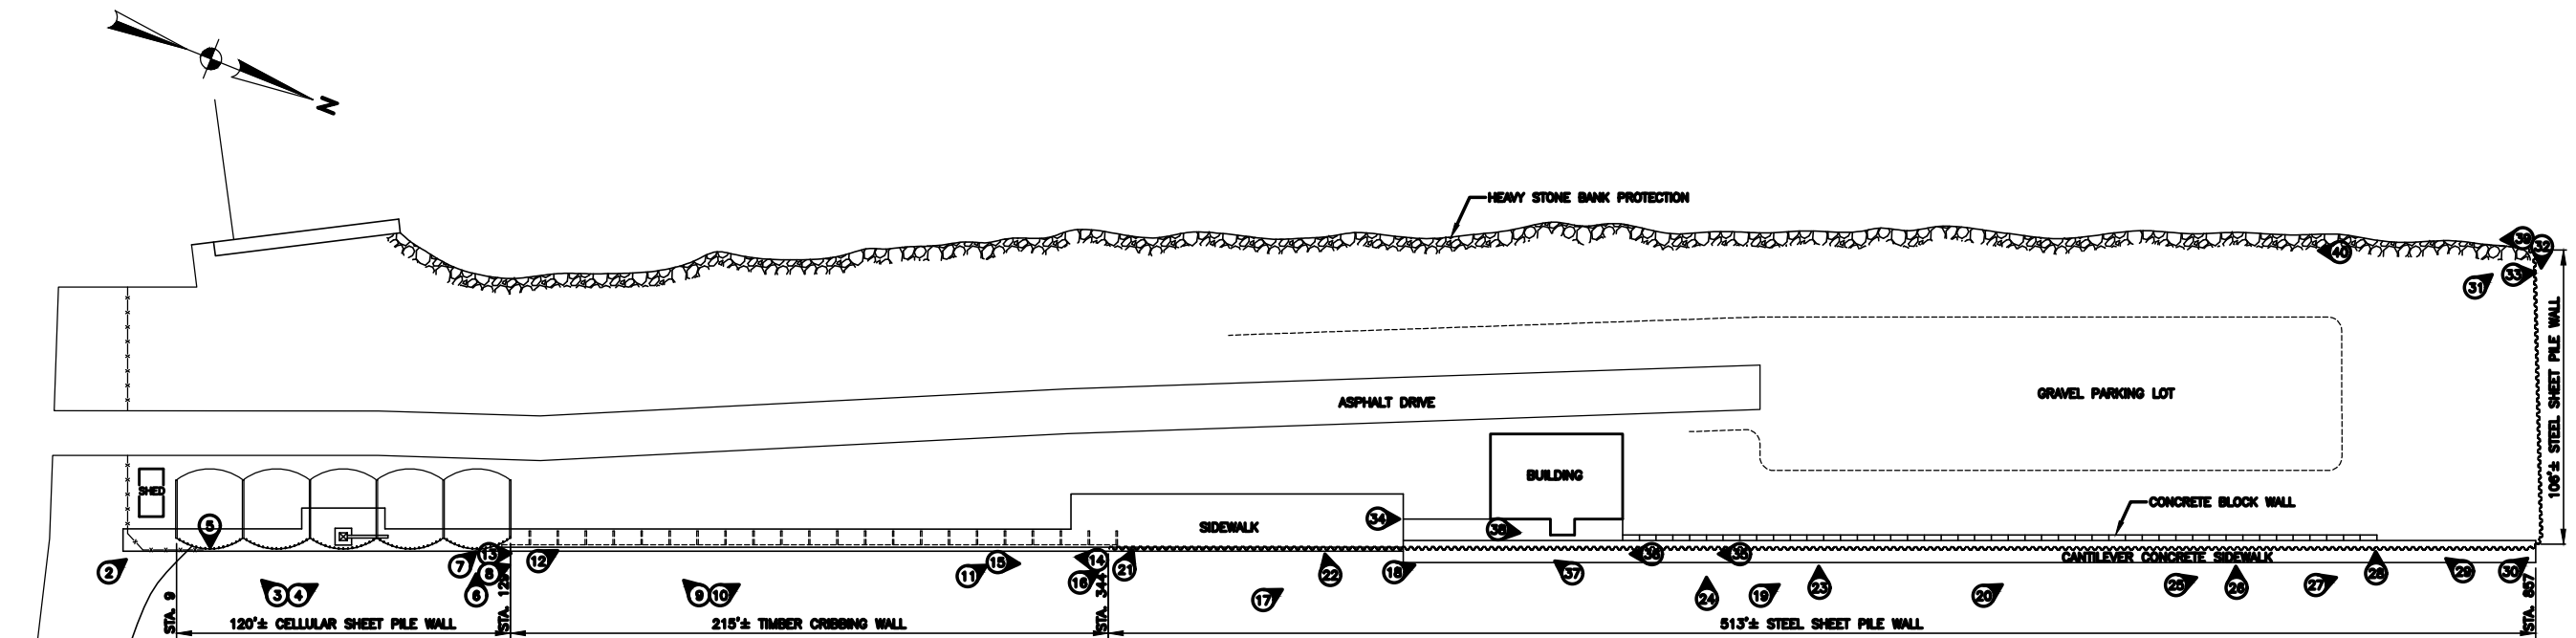
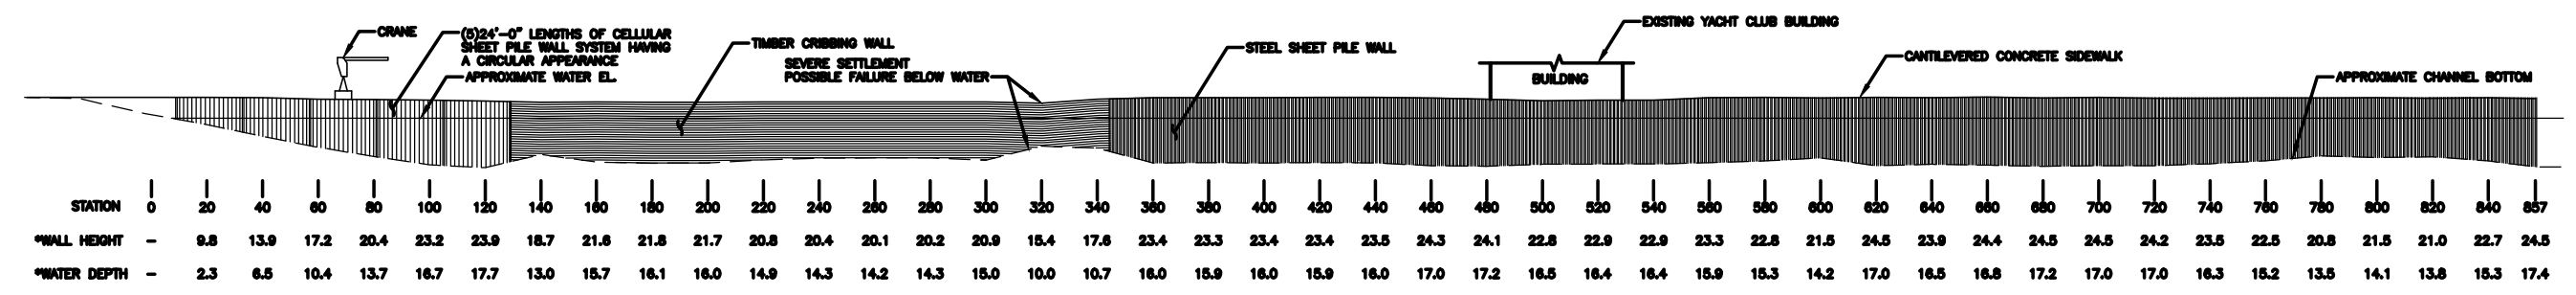
WESTSIDE COAL PIER EXISTING PLAN AND ELEVATION

The coal pier is approximately 850' long. For inspection purposes, stationing along the east wall was established beginning at the corner of the concrete walkway slab at the shore. Site photos are included in Appendix A, and the existing Plan and Elevation Sketch SK-1 is included at the end of the Inspection Findings section.

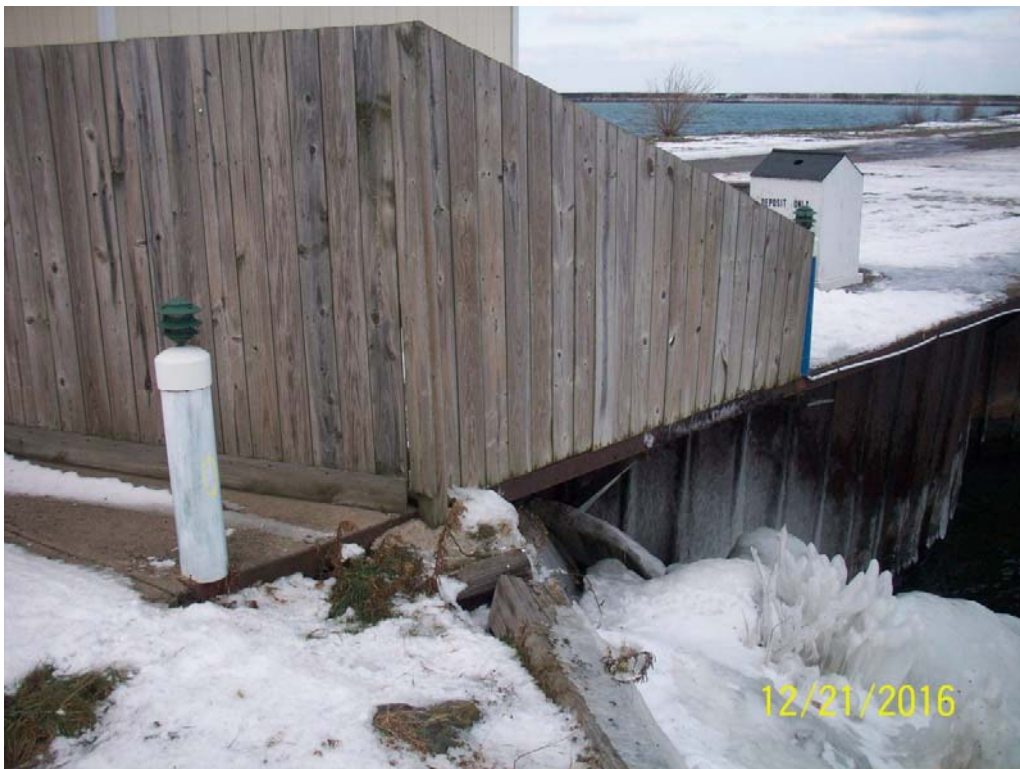
Beginning near the shoreline, a cellular steel sheet pile wall extends approximately 120' from STA 9 to 129. This section of the wall consists of five 24' lengths of cellular sheet pile wall systems having a circular appearance constructed of 16" wide x 3/8" thick flat sheet piles (PSA23 or similar), and most likely dates from the 1930s or 1940s. The wall height varies, with a maximum expose height of 23.9' above the harbor bottom, and water depth up to 17.7'. The exposed piles are heavily corroded near the water level with numerous small rust holes. The

top of the piles are in good condition, and the cells remain well aligned. The concrete walkway and a small crane founded above this portion of the wall are in good condition with no indications of settlement. Refer to Photos 2 through 7.

Photo 2 - East side of pier at shore, showing STA 0 location at first bollard

4. The 120’ long portion of the cellular steel sheet pile wall systems near the shoreline (STA 9 to 129) could conceivably be rehabilitated, but replacement/replacement may be more practical and cost-effective, since the rest of the wall needs replacement.

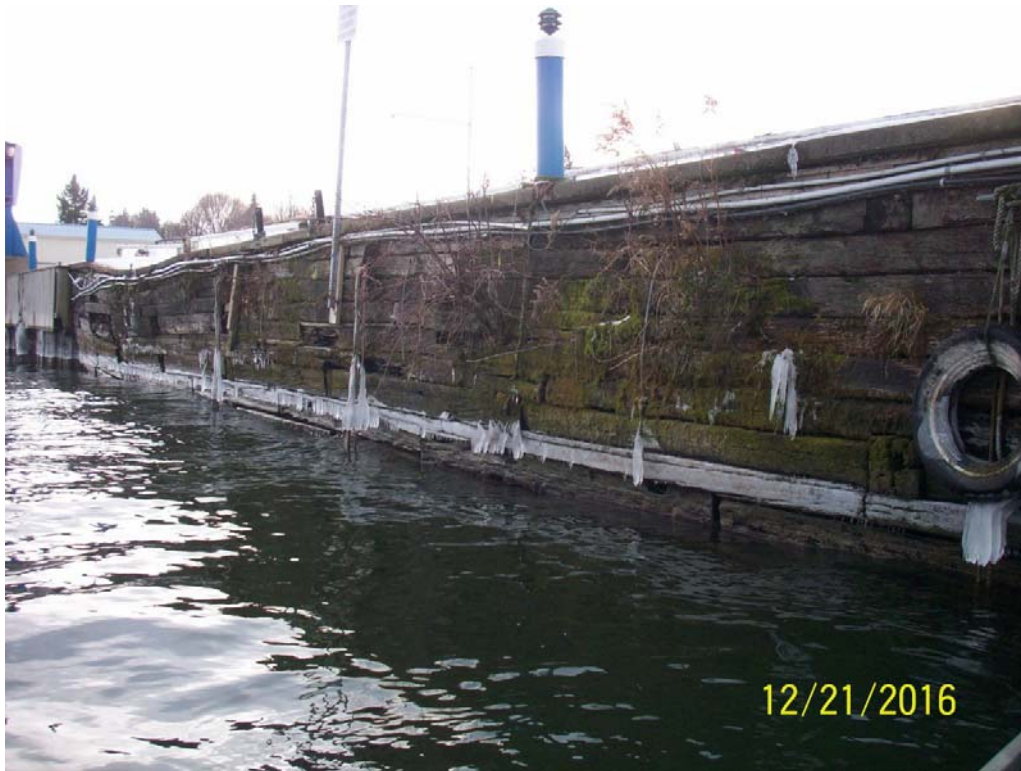
An old timber cribbing wall extends approximately 215' from STA 129 to 344. This portion of the wall is in very poor condition. The wall height is approximately 20' to 22' above the harbor bottom, and the water depth is approximately 14' to 16'. The timbers have widespread severe decay above the water level. Portions of the wall are severely displaced and settled from STA 135 to 160 and from STA 300 to 344. Shallower water depth measurements in these areas suggest that substantial amounts of backfill may have spilled from behind the wall. In areas where the timber cribbing is displaced, settlement of the concrete walkway is also evident, which indicates that movement has occurred fairly recently. Refer to Photos 8 through 15.

Photo 9 – Timber cribbing wall, looking south near STA 200

5. A diving inspection is recommended to assess below-water conditions for full length of wall, given widespread poor condition. In the meantime, the owner should prevent vessels from docking along this portion of the wall, and temporary fencing should be erected behind the wall to restrict pedestrian access. The timber wall appears to be at the end of its service life and should be programmed for replacement. Based upon information gathered from the diving inspection the removal of the existing wall’s timber may be required, however this should not be done prior to the placement of added steel sheet piling reinforcement wall and concrete fill.

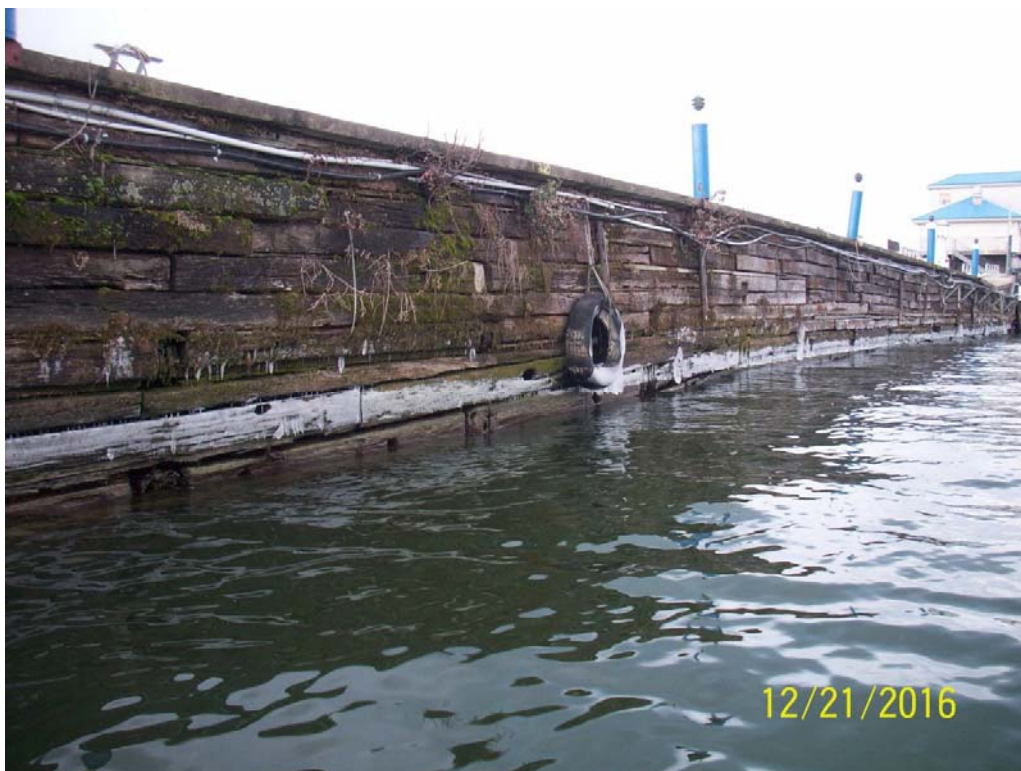
Photo 10 - Timber cribbing wall, looking north near STA 200

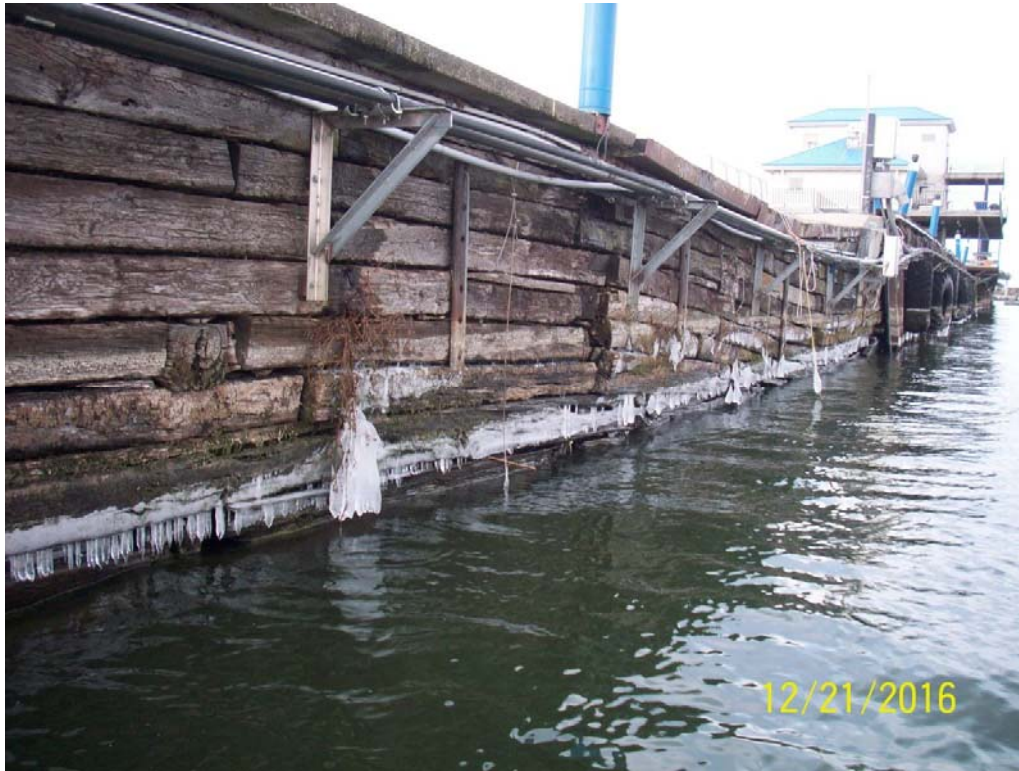
Photo 11 - Timber cribbing wall, looking north near STA 300

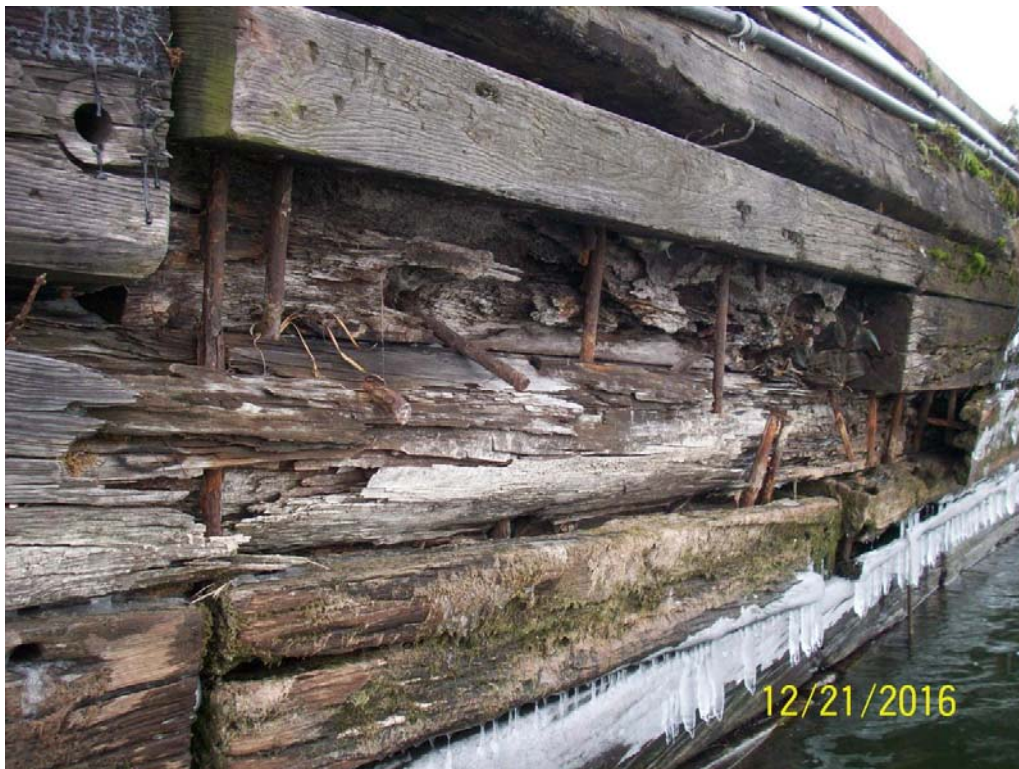
Photo 12 - Timber cribbing wall, close-up of decay near STA 140

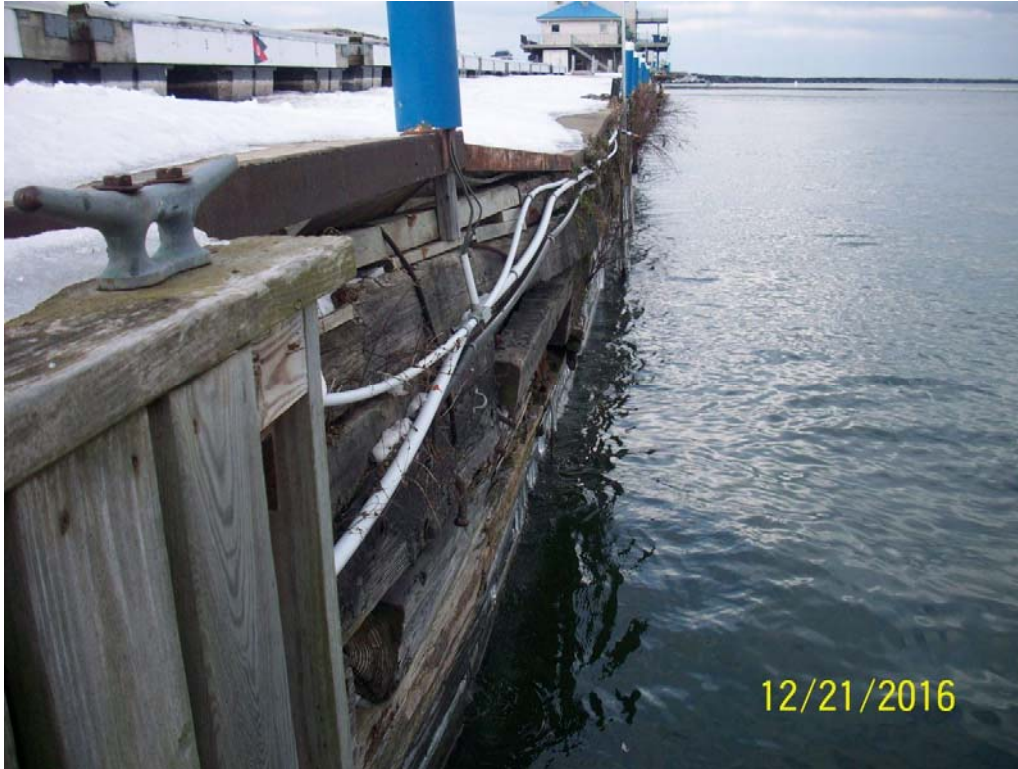
Based on observations above the water level, the current safety and stability of portions of the pier wall is questionable. The old timber wall from STA 129 to 344 has large areas of severe misalignment and settlement which suggest that failures may have already occurred below water.

Photo 13 – Top of timber cribbing wall, showing settlement between STA 135 and 160

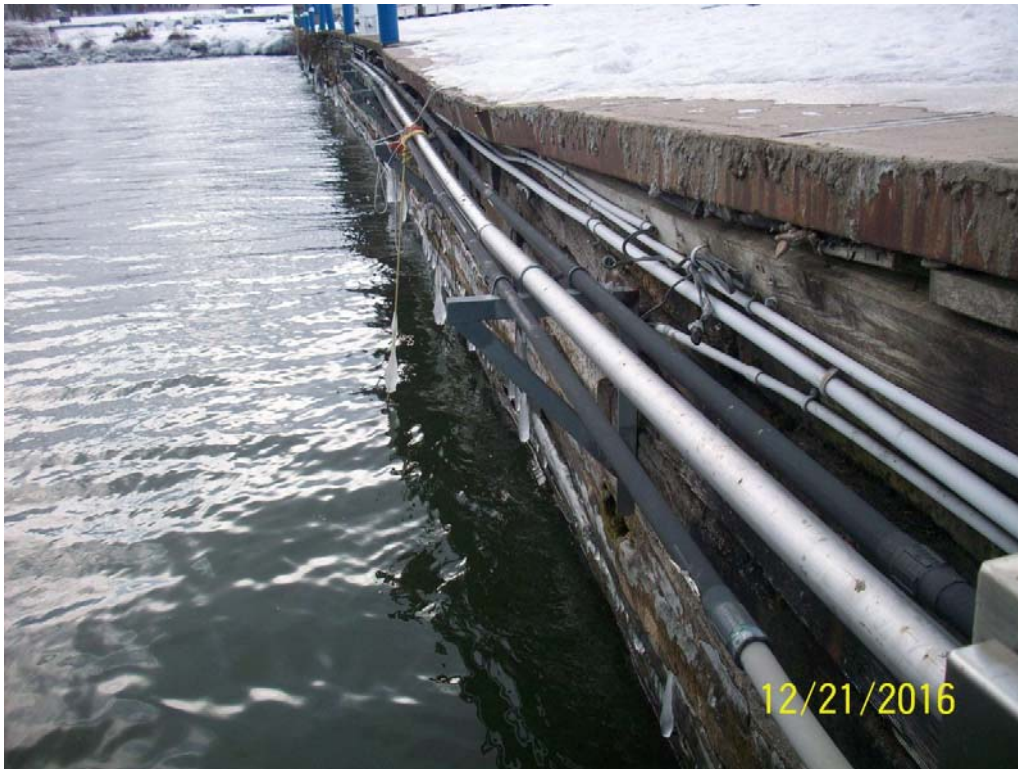
Photo 14 - Top of timber cribbing wall, showing settlement between STA 300 and 344

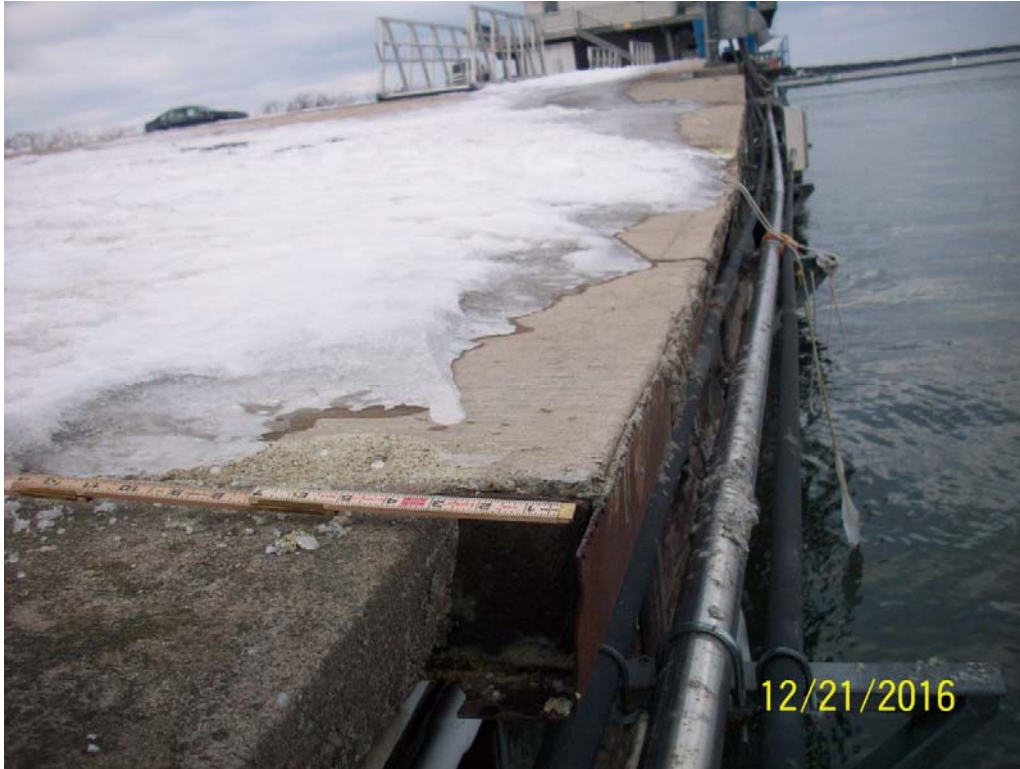
Photo 15 - Top of timber cribbing wall, showing concrete slab displacement at STA 304

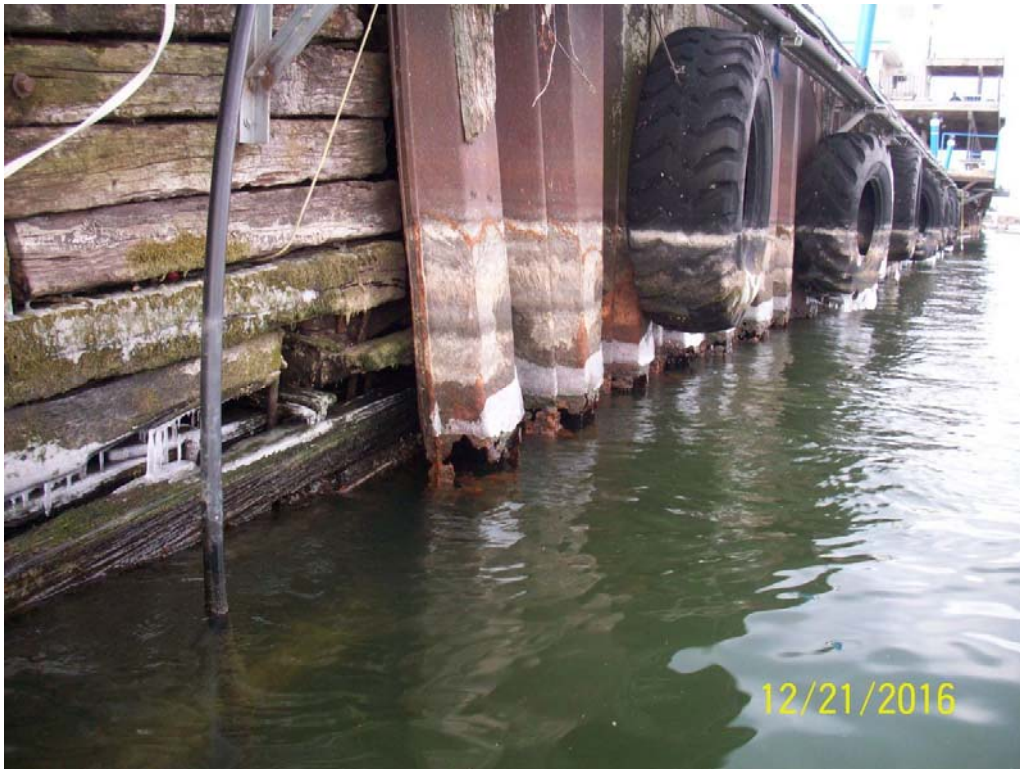
A steel sheet pile wall extends from STA 344 to 857, and the sheeting continues approximately 110' across the north end of the pier (Photos 16 through 20). The wall height is approximately 21' to 25' above the harbor bottom, the water depth is approximately 14' to 17', and the pile embedment depth is unknown. This portion of the wall consists of 16" wide x 5" deep x 3/8" thick U-shaped sheet piles (PDA27 or similar), and most likely dates from the 1930s (Photo 33). The top of the sheets are anchored to a horizontal waler and tie-backs behind the sheeting. The piles are severely corroded with large rust holes near the water level. Overall pile section loss varies and is estimated in the range of 60% to 90% (Photos 21 and 23). Probing through several holes with a survey rod, timber could be felt about 1' to 2' behind the sheeting. The sheeting appears to have been placed immediately in front of an older timber wall. The timber wall remnants appear to be limiting the loss of backfill through the holes in the steel sheeting, but settlement of sidewalk slabs behind the wall suggests that active erosion is occurring as wave action constantly flushes water in and out of the holes (Photo 38).

Photo 16 – Beginning of sheet pile wall at STA 344

6. The tied-back sheet pile wall appears to be at the end of its service life and should be programmed for replacement.

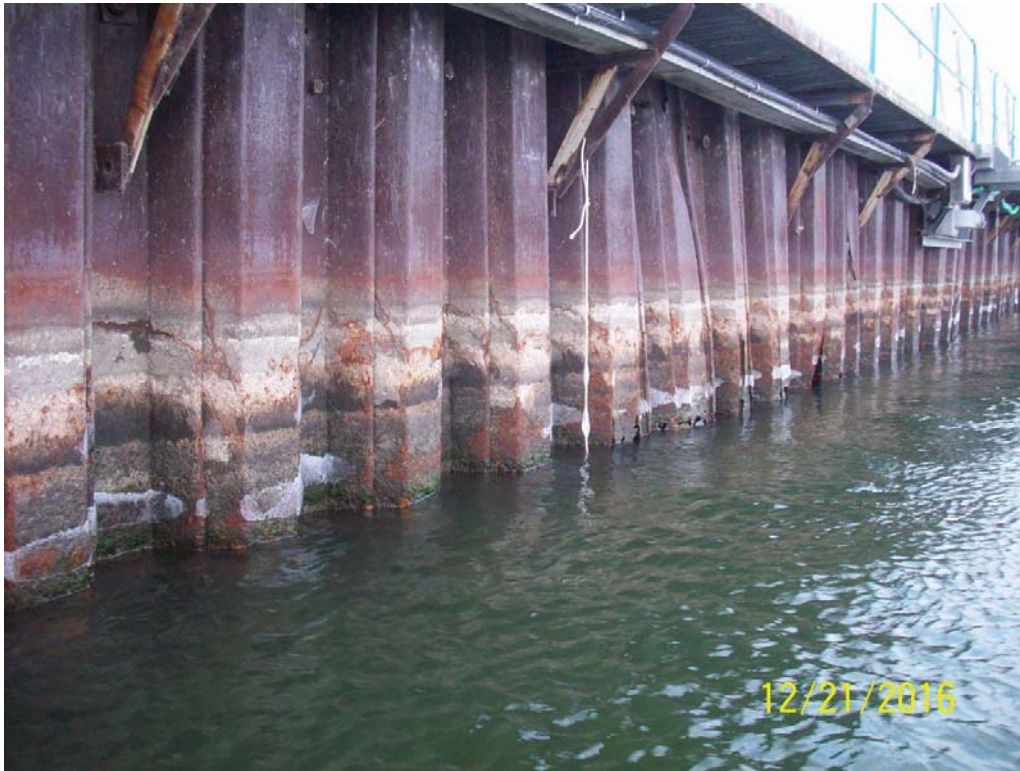
- A portion of 1 pile is missing above the water level at STA 425 (Photo 22).
- Three piles are badly torn and deformed near STA 560 (Photo 24).
- There is moderate misalignment and deformation of piles from STA 580 to 600 (Photo 19).
- From STA 730 to 830, the top 3.5' of the sheeting was cut off and new piles were welded on. The splices are very irregular and poorly aligned. From STA 790 to 830, different size piles and some flat plates were set on top of the cut off piles without proper connections (Photos 25 through 29).
- At the northwest corner of the pier, the piles are leaning up to 20 degrees and the bottom of the wall appears to be displaced toward the lake (Photos 31 and 32).

Photo 19 - Sheet pile wall, looking north near STA 580

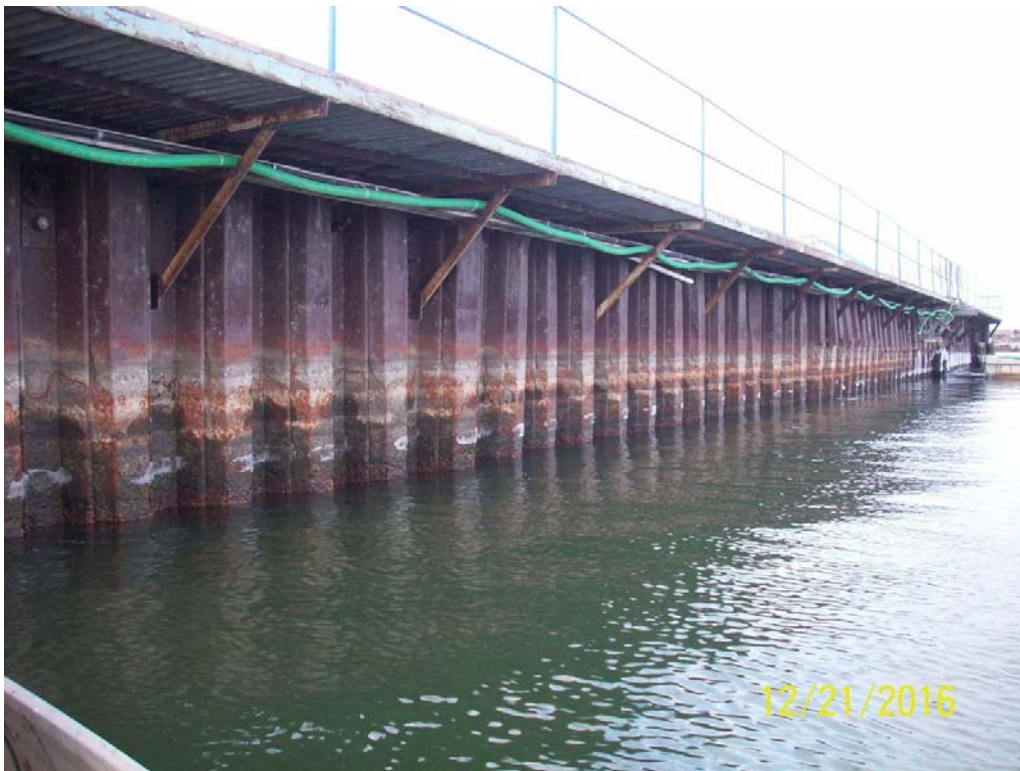
Photo 20 - Sheet pile wall, looking north near STA 660

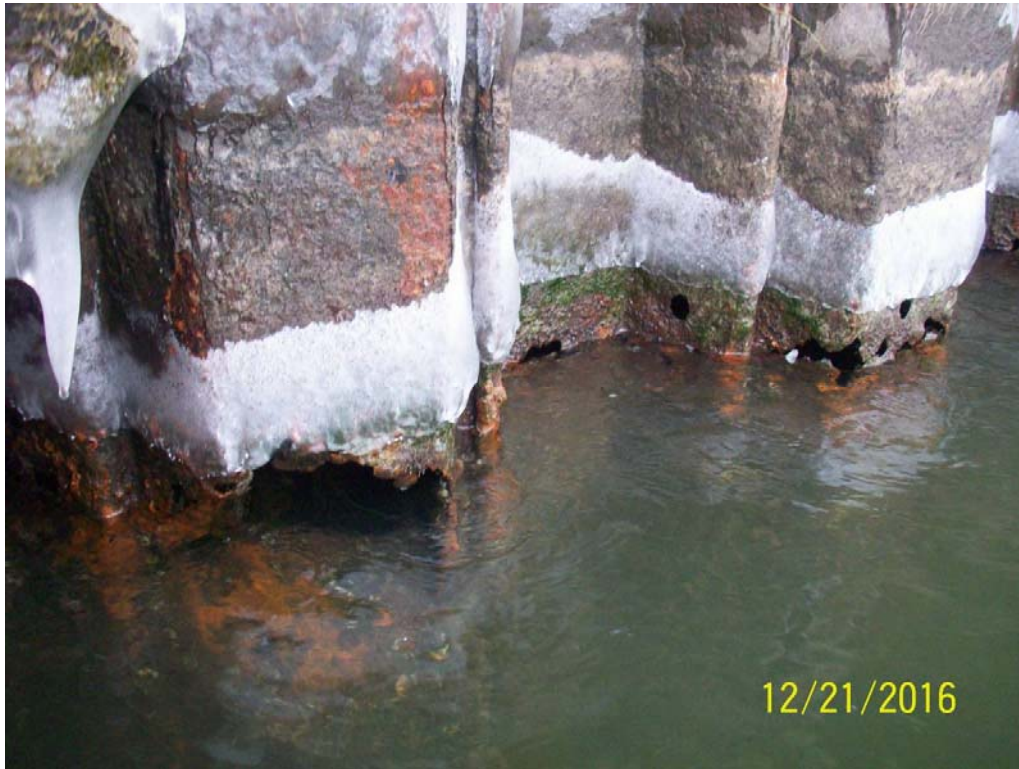
The steel sheet pile retaining walls are approximately 70 to 80 years old. From STA 344 to 857 and continuing along the north end, the sheeting is severely corroded with large holes near the water level. The tied-back wall configuration relies on the flexural strength of the sheet piles, which have been compromised by section loss in the high stress region near the water level. The weight of the concrete walkway and the wood deck at the yacht club building also induce axial stress on the sheet piles. Considering the severity of section loss without serious deformation of the sheet pile wall, it is suspected that remnants of the original timber cribbing behind the wall may be resisting a substantial portion of the lateral earth pressure on the wall.

Photo 21 – Sheet pile wall, close-up of typical holes near low water level at STA 350

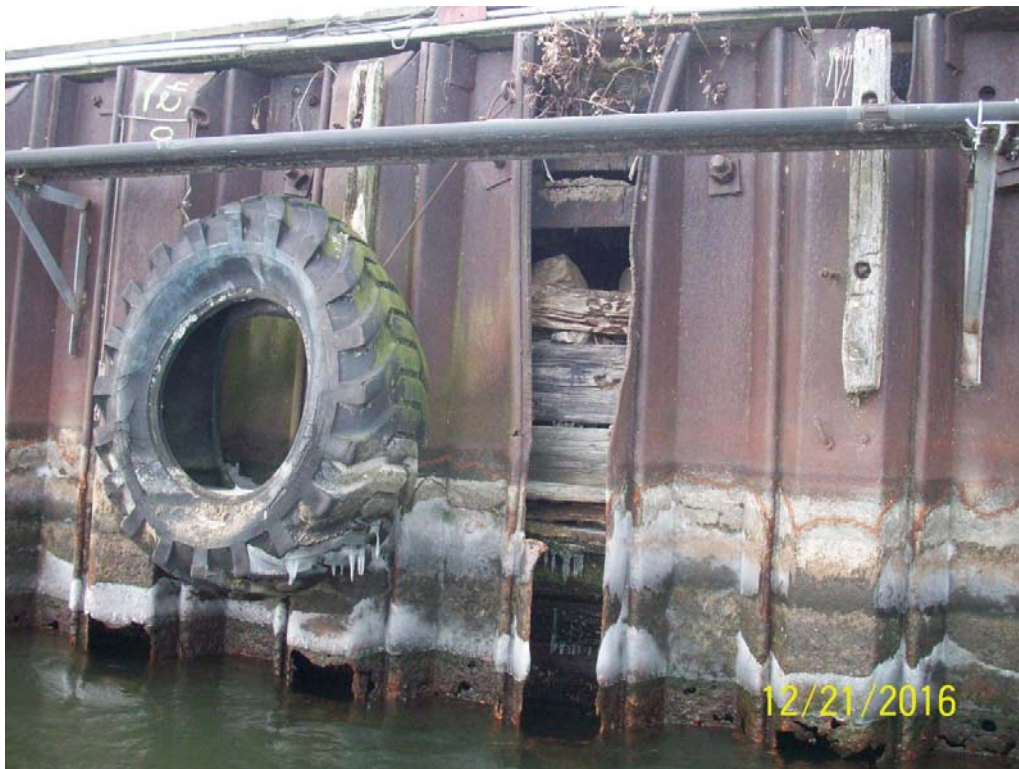
Photo 22 - Sheet pile wall, missing section of pile exposed timber cribbing at STA 425

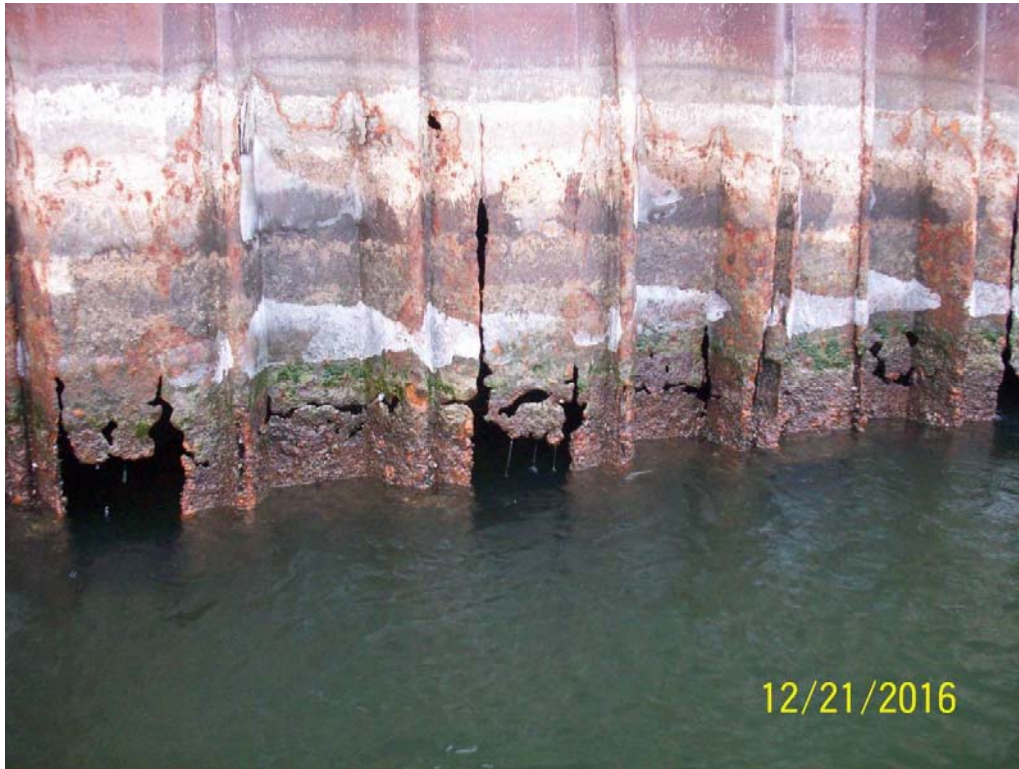
Photo 23 - Sheet pile wall, close-up of typical holes near low water level at STA 600

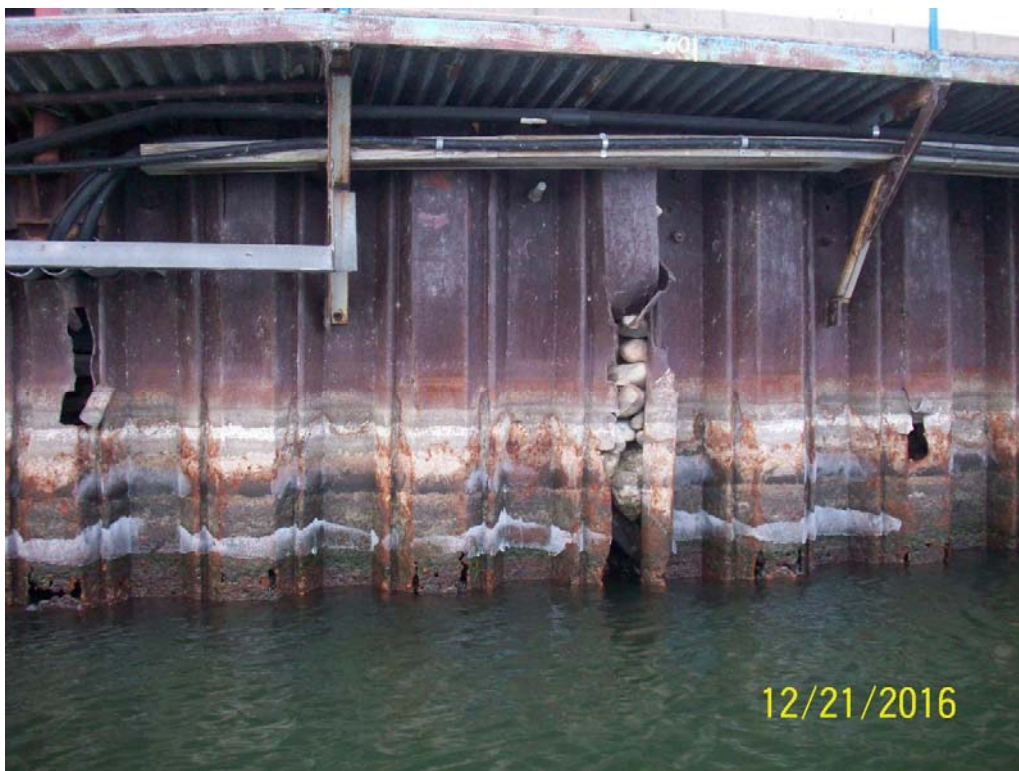
Photo 24 - Sheet pile wall, torn piles near at STA 560

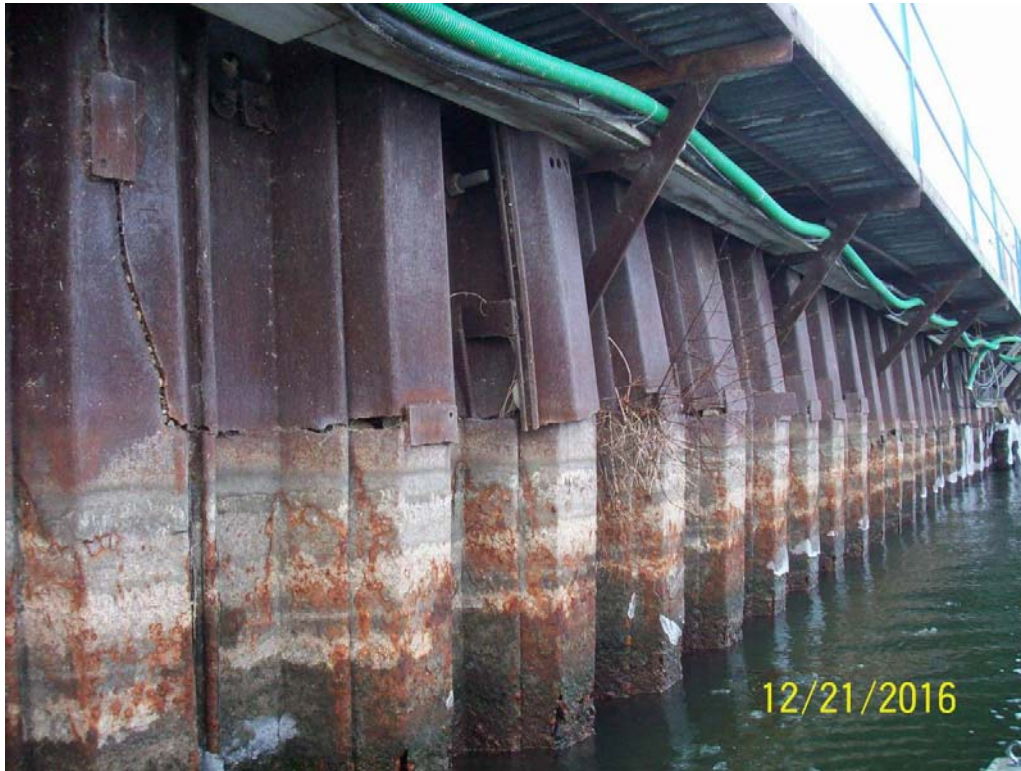
Photo 25 - Sheet pile wall, irregular welded splices beginning at STA 730

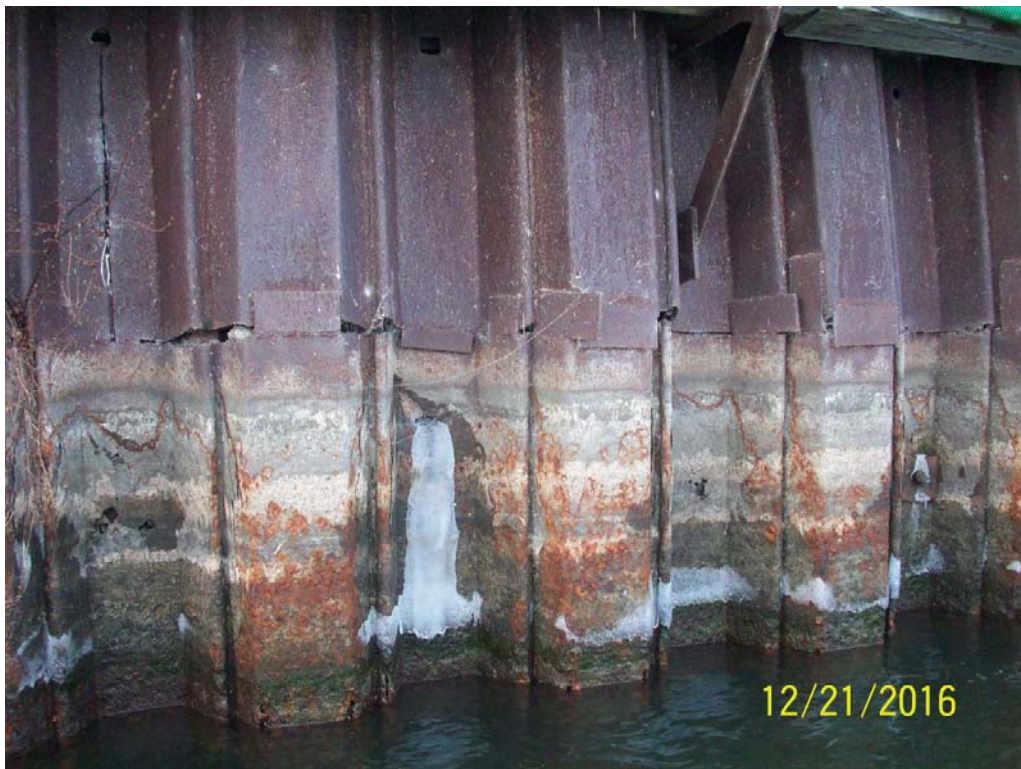
Photo 26 - Sheet pile wall, irregular welded splices at STA 750

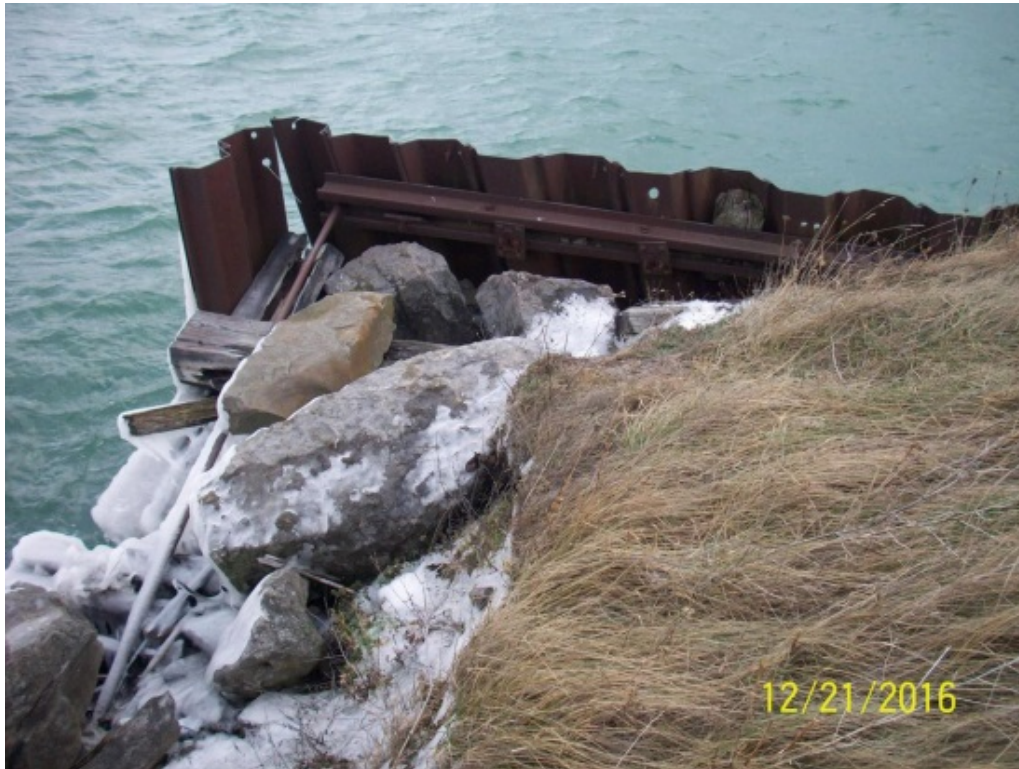
Photo 31 – End of sheet pile wall at northwest corner of pier,

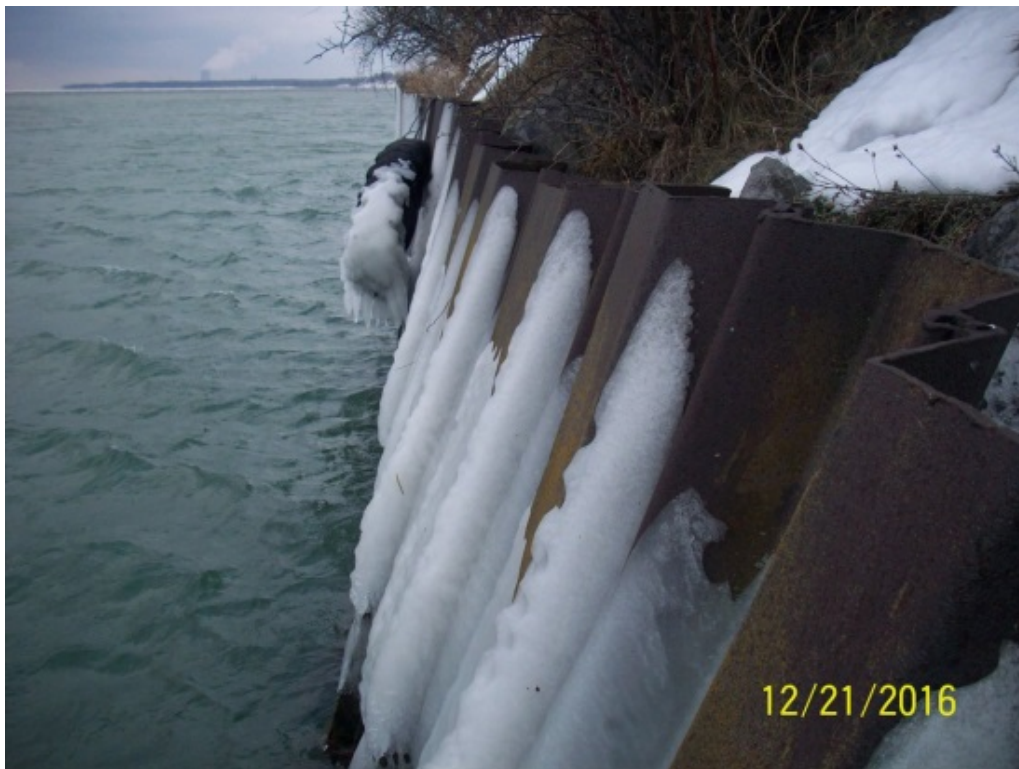
Photo 32 – Leaning sheet piles at northwest corner of pier

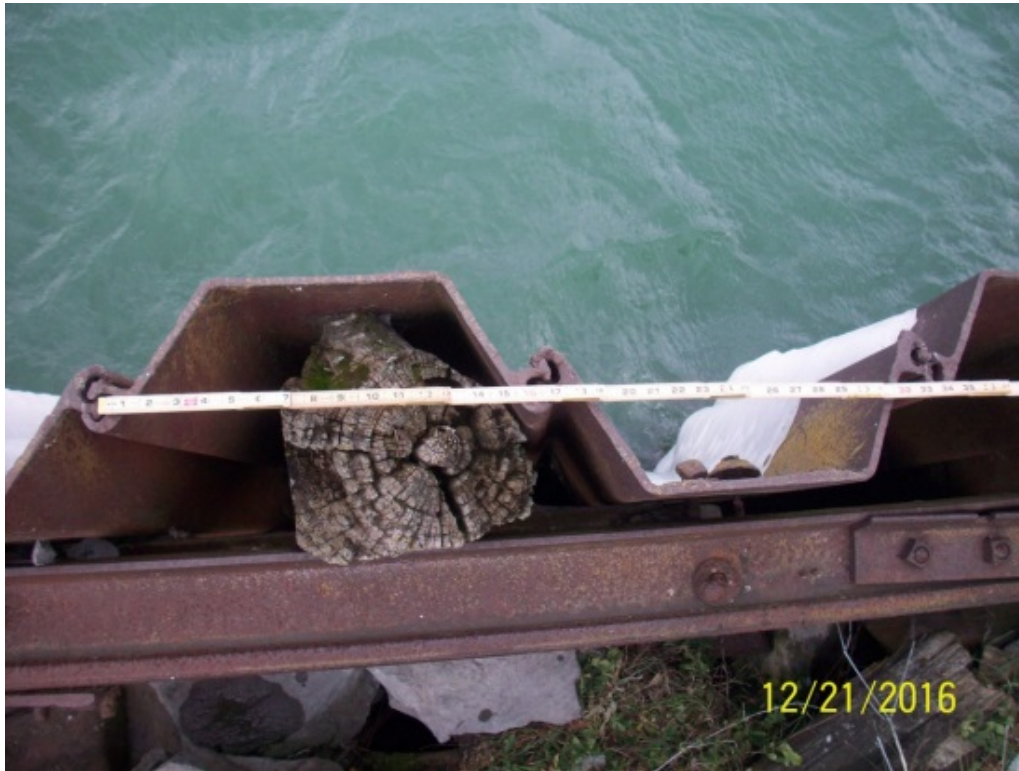
Photo 33 – Top of typical sheet pile, at northwest corner of pier

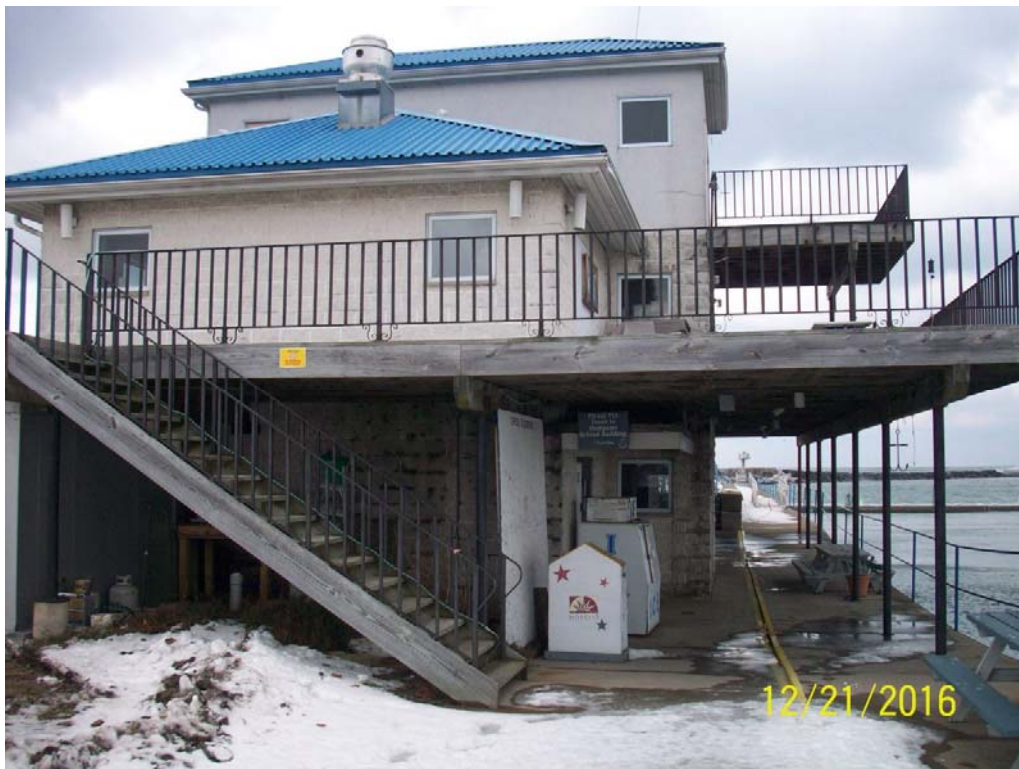
side of the Yacht Club Building (Photos 17, 18, and 34 through 36). The support brackets for the cantilevered walkway and the wood deck are in good structural condition, but these supports are dependent on the stability of the severely deteriorated sheet piles beneath it (Photos 18 and 37). There is no visible settlement or distress in the sheet piles at this time.

The yacht club building appears to be in good structural condition (Photos 17, and 34 through 36). The building is set back approximately 5' to 10' behind the sheet pile retaining wall, which is approximately 23' to 24' high in this area. Based on discussion with a contractor that was involved during construction of the building (Jim Tabor of J. D. Taber Masonry Inc.), the foundation is believed to be a spread concrete footing on the pier fill material. The footing is located approximately 4' below finished grade. A concrete walkway slab located between the building and the retaining wall is settled up to 2" (Photo 38), which may indicate loss of backfill in this area. There is no significant cracking or distress in the concrete block building itself.

Photo 34 – Yacht Club building, looking north
