**Belmont Creek Watershed Study, Creek Assessment, and Recommendations
for Sustainable Improvements
San Mateo County, California**

Technical Study

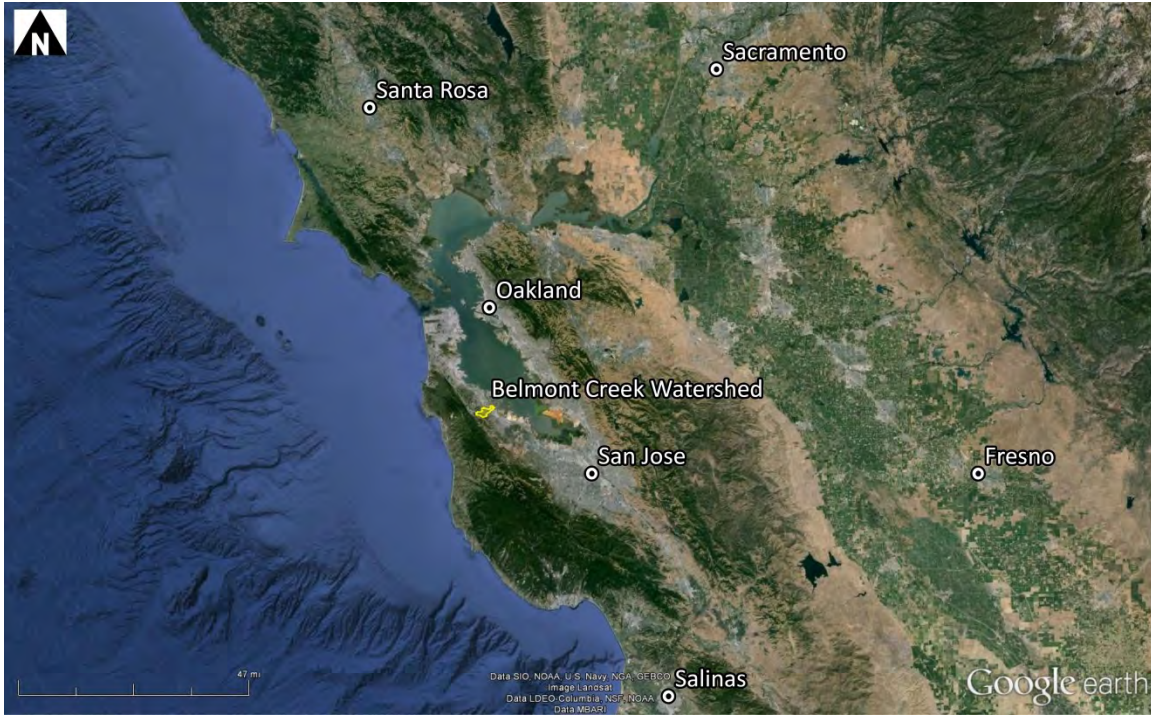
Figure 1. Project Location Map

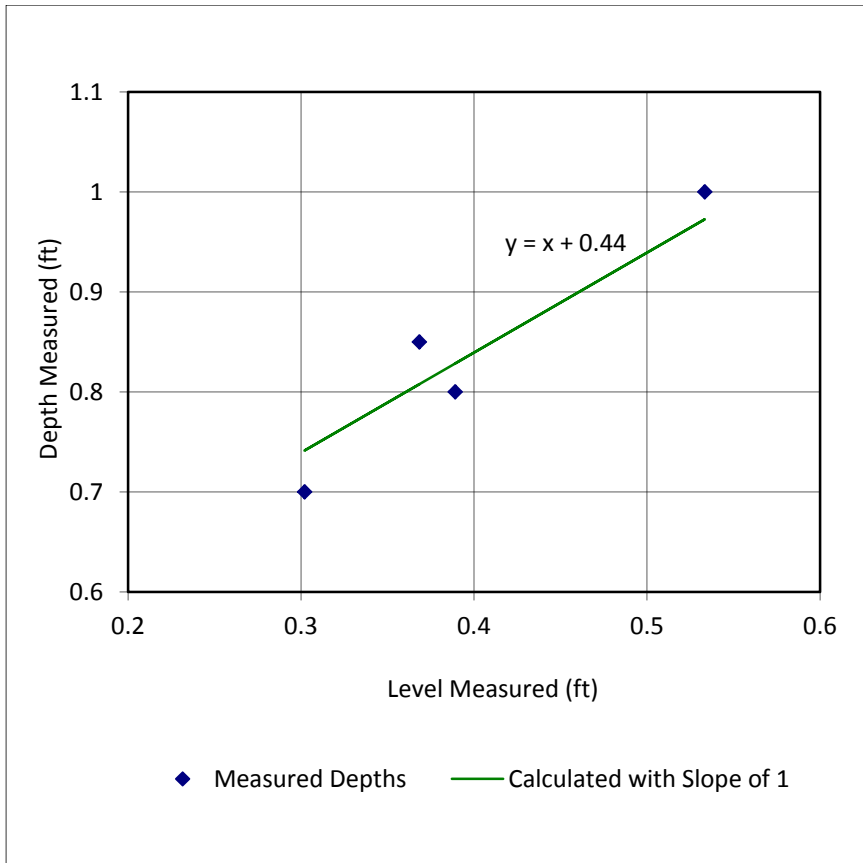
Figure 3. Relationship between Levellogger and Observed Depths

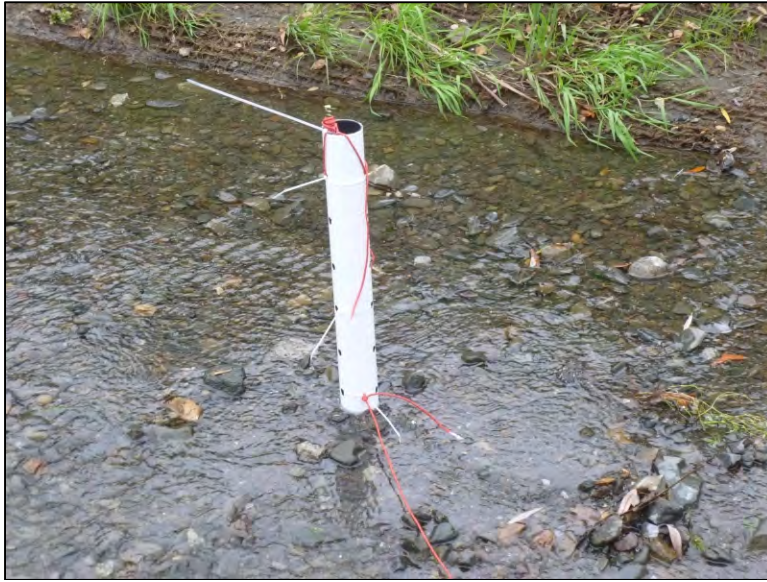
Figure 4. Perforated Pipe with Levellogger Inside

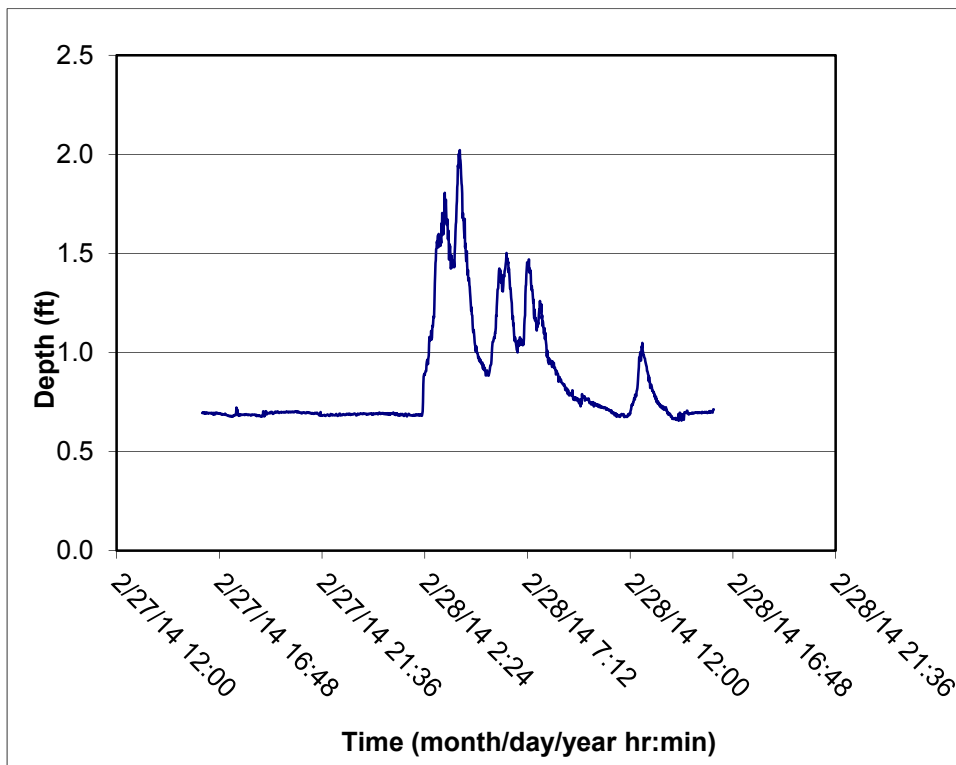
Figure 5. Depths Observed During Monitoring Period

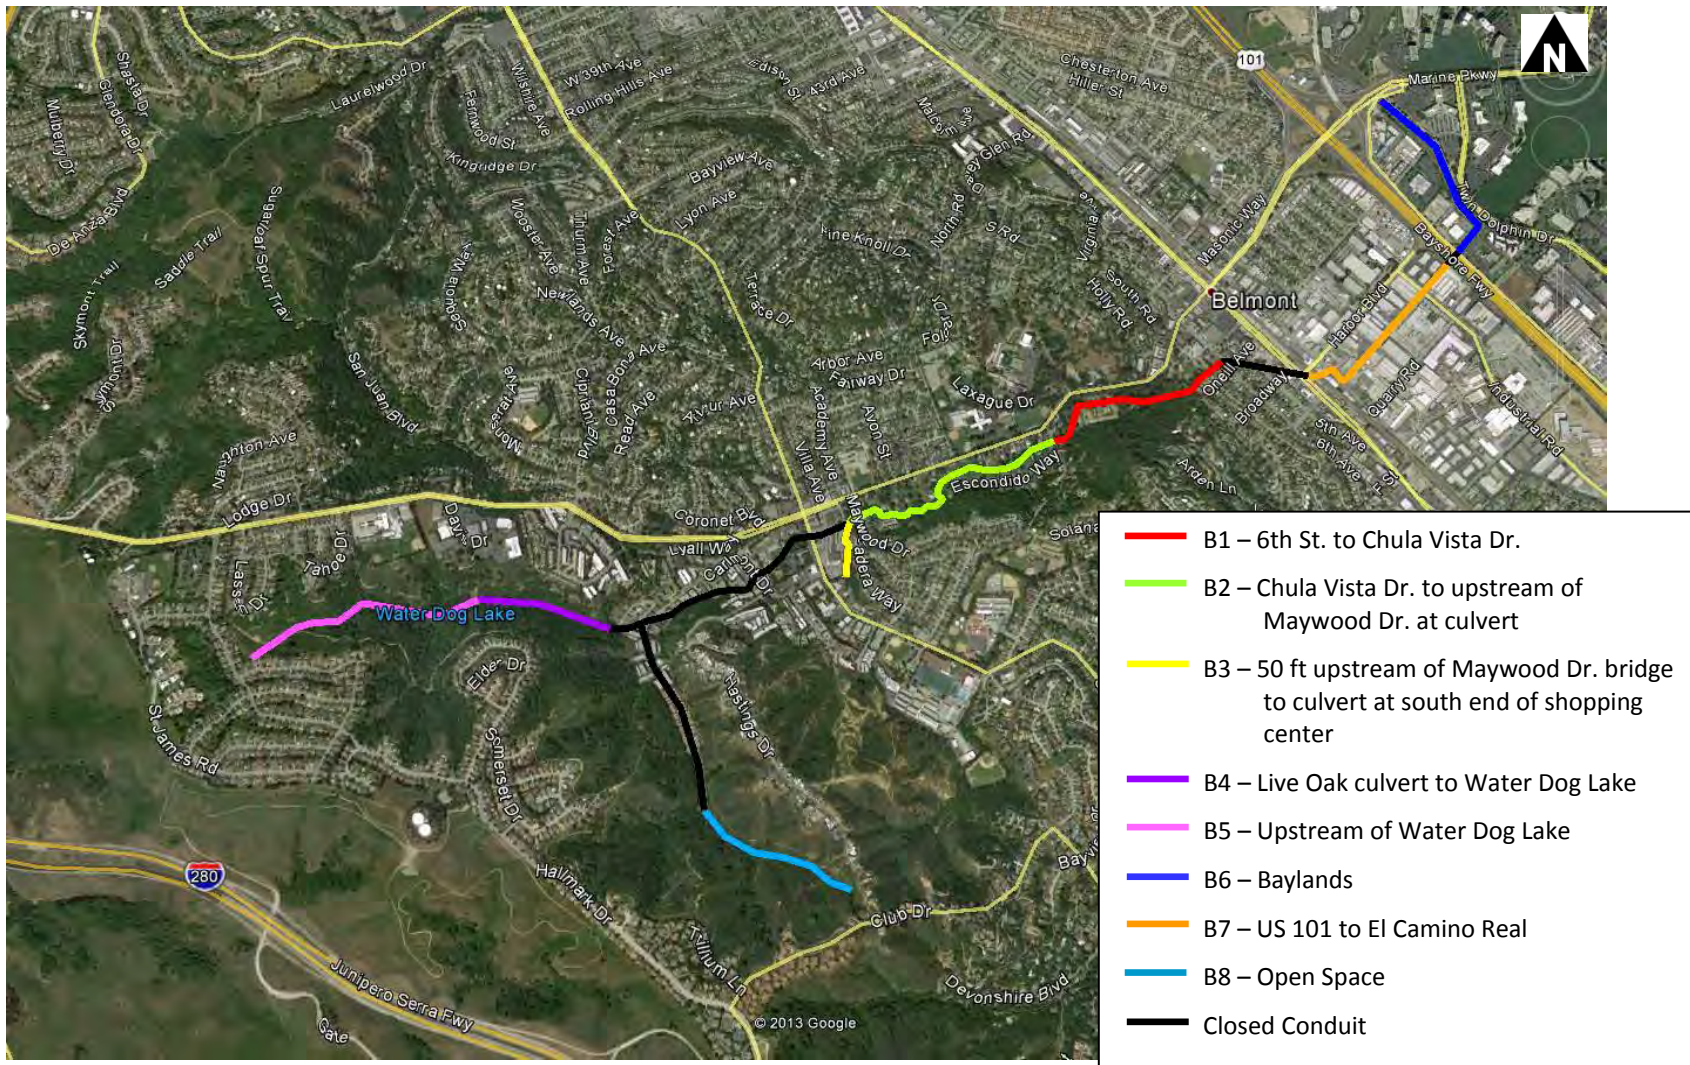
Figure 8. Belmont Creek Reaches

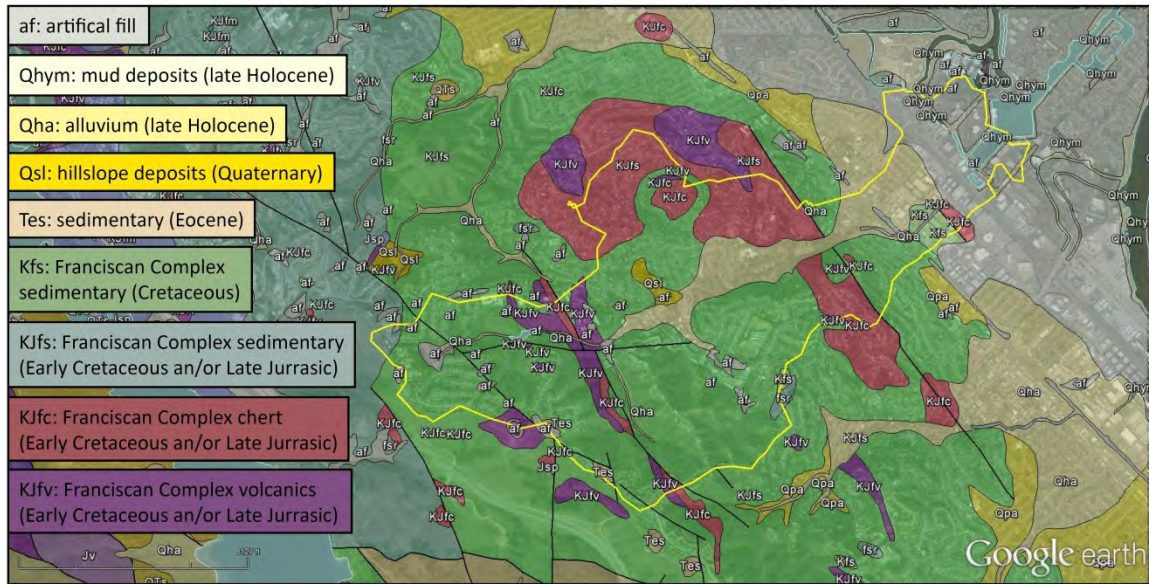
Figure 9. Geologic Map with Watershed Boundary

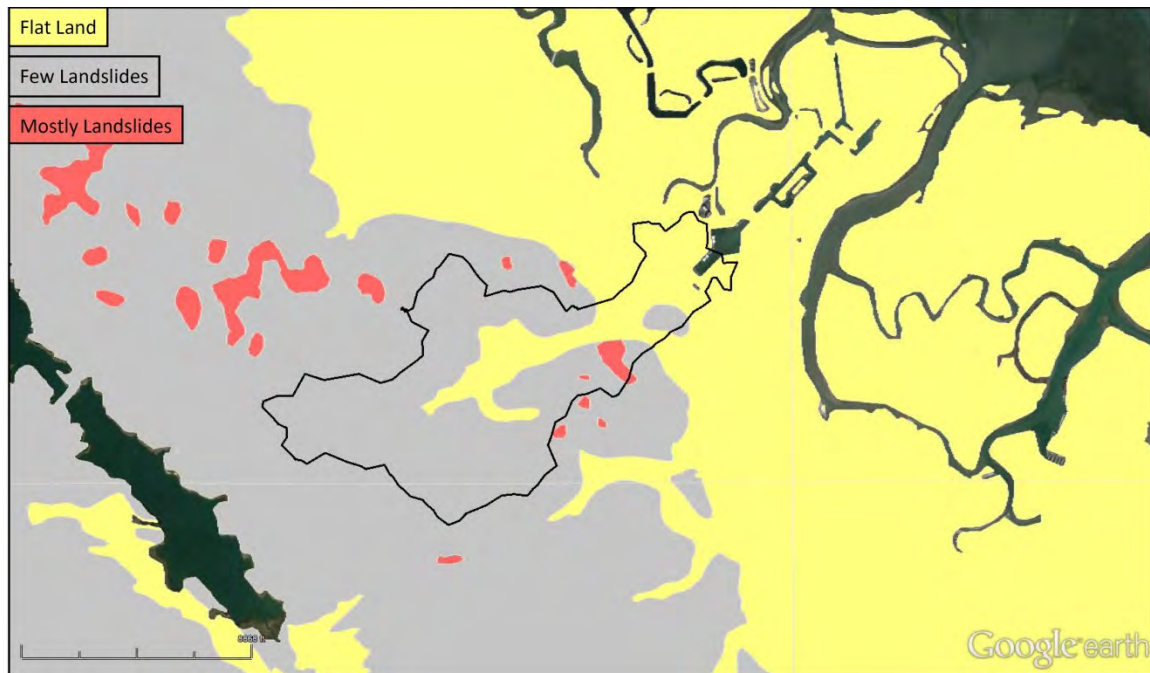
Figure 10. Landslide Potential in the Belmont Creek Watershed

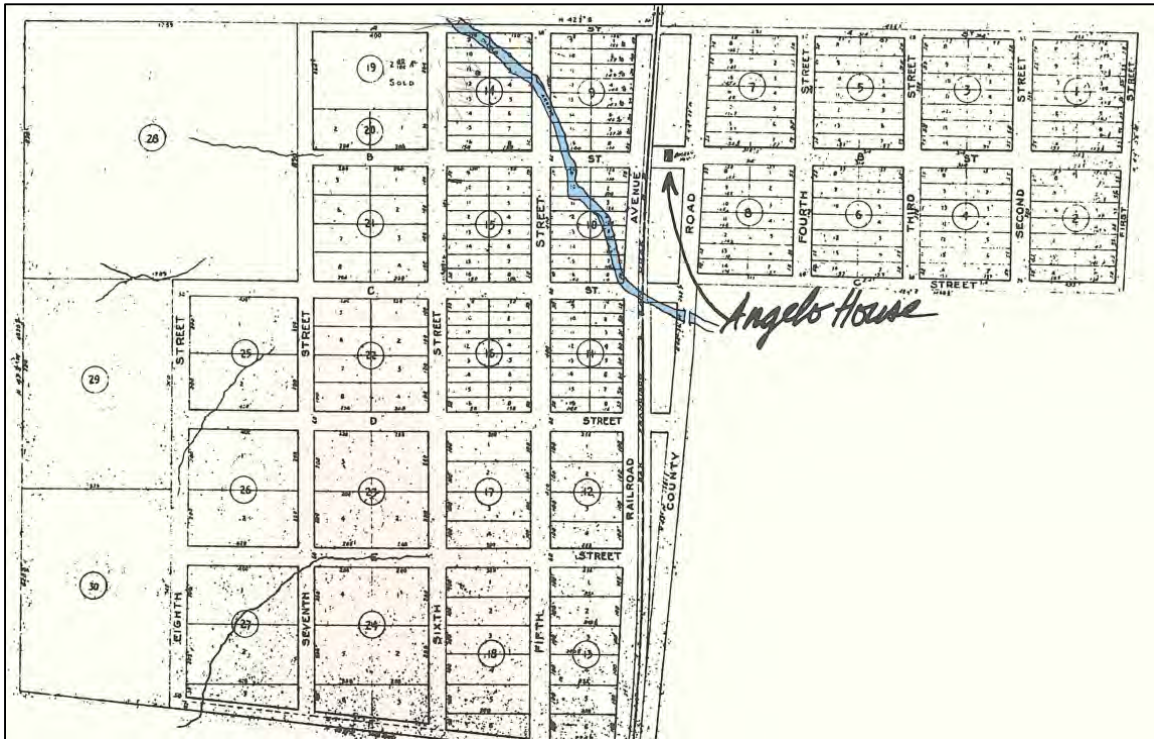
Figure 11. Molitor Subdivision Map, Color Added to Belmont Creek, 1856

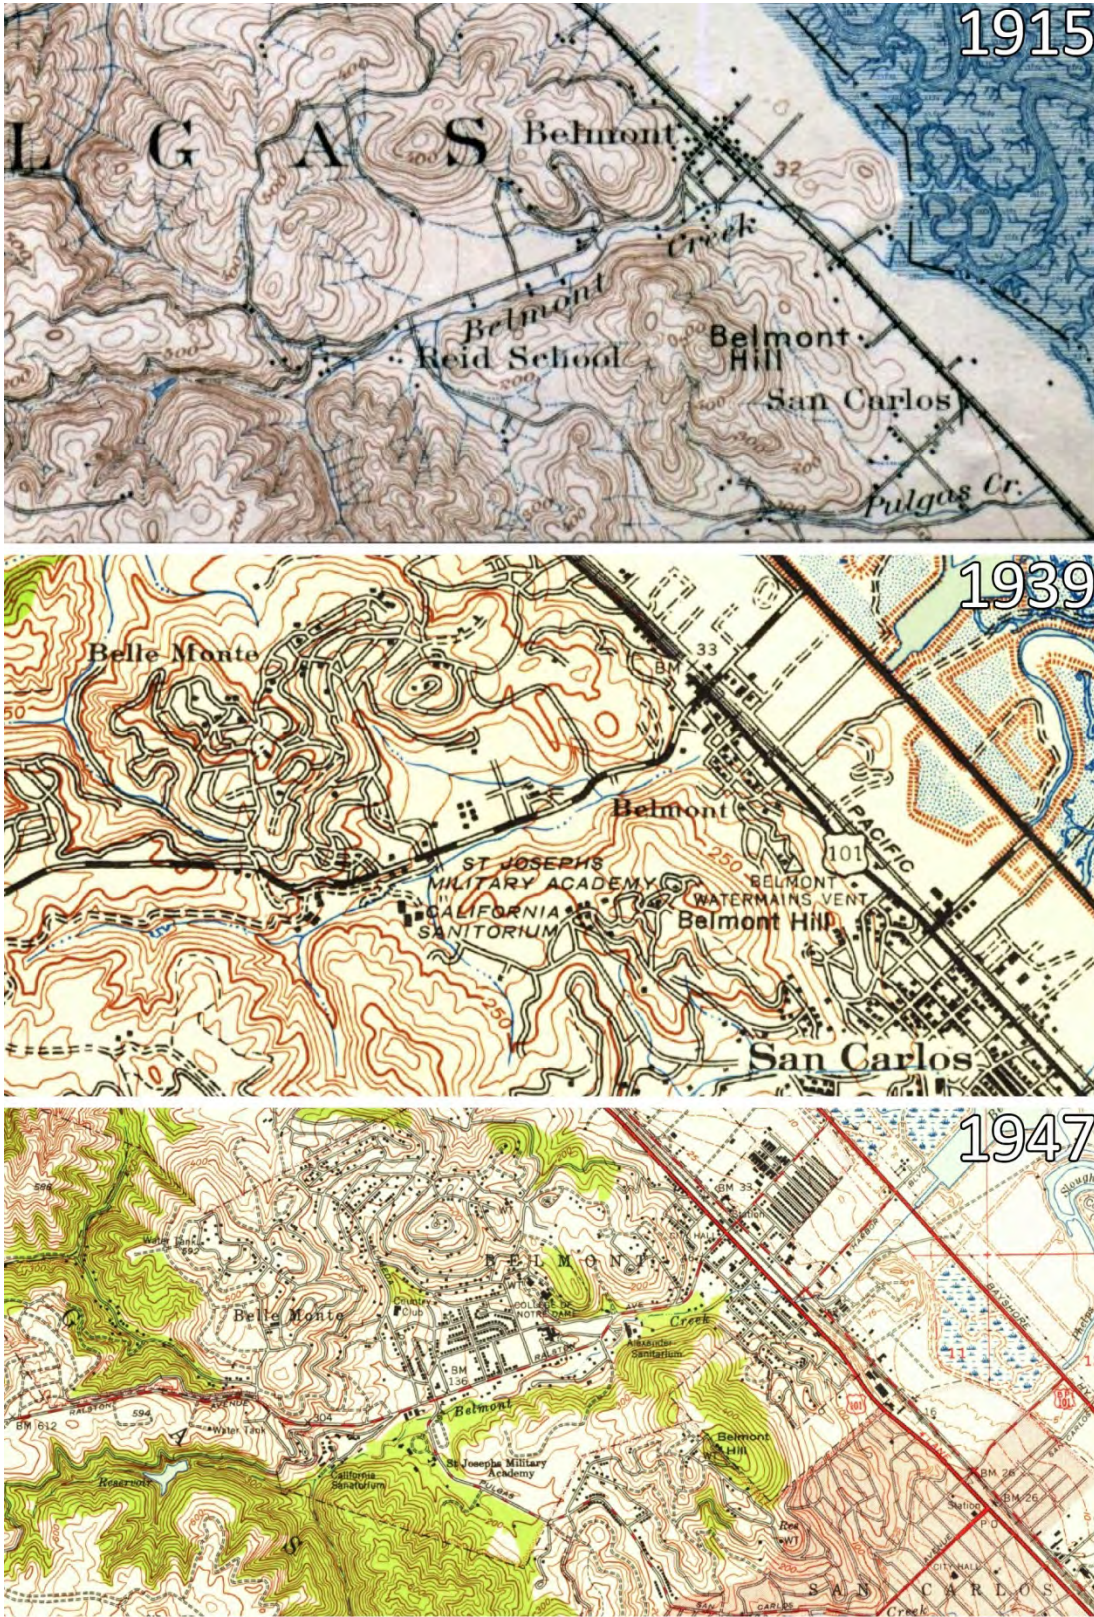
Figure 15. Comparison of Historical USGS Topographic Maps

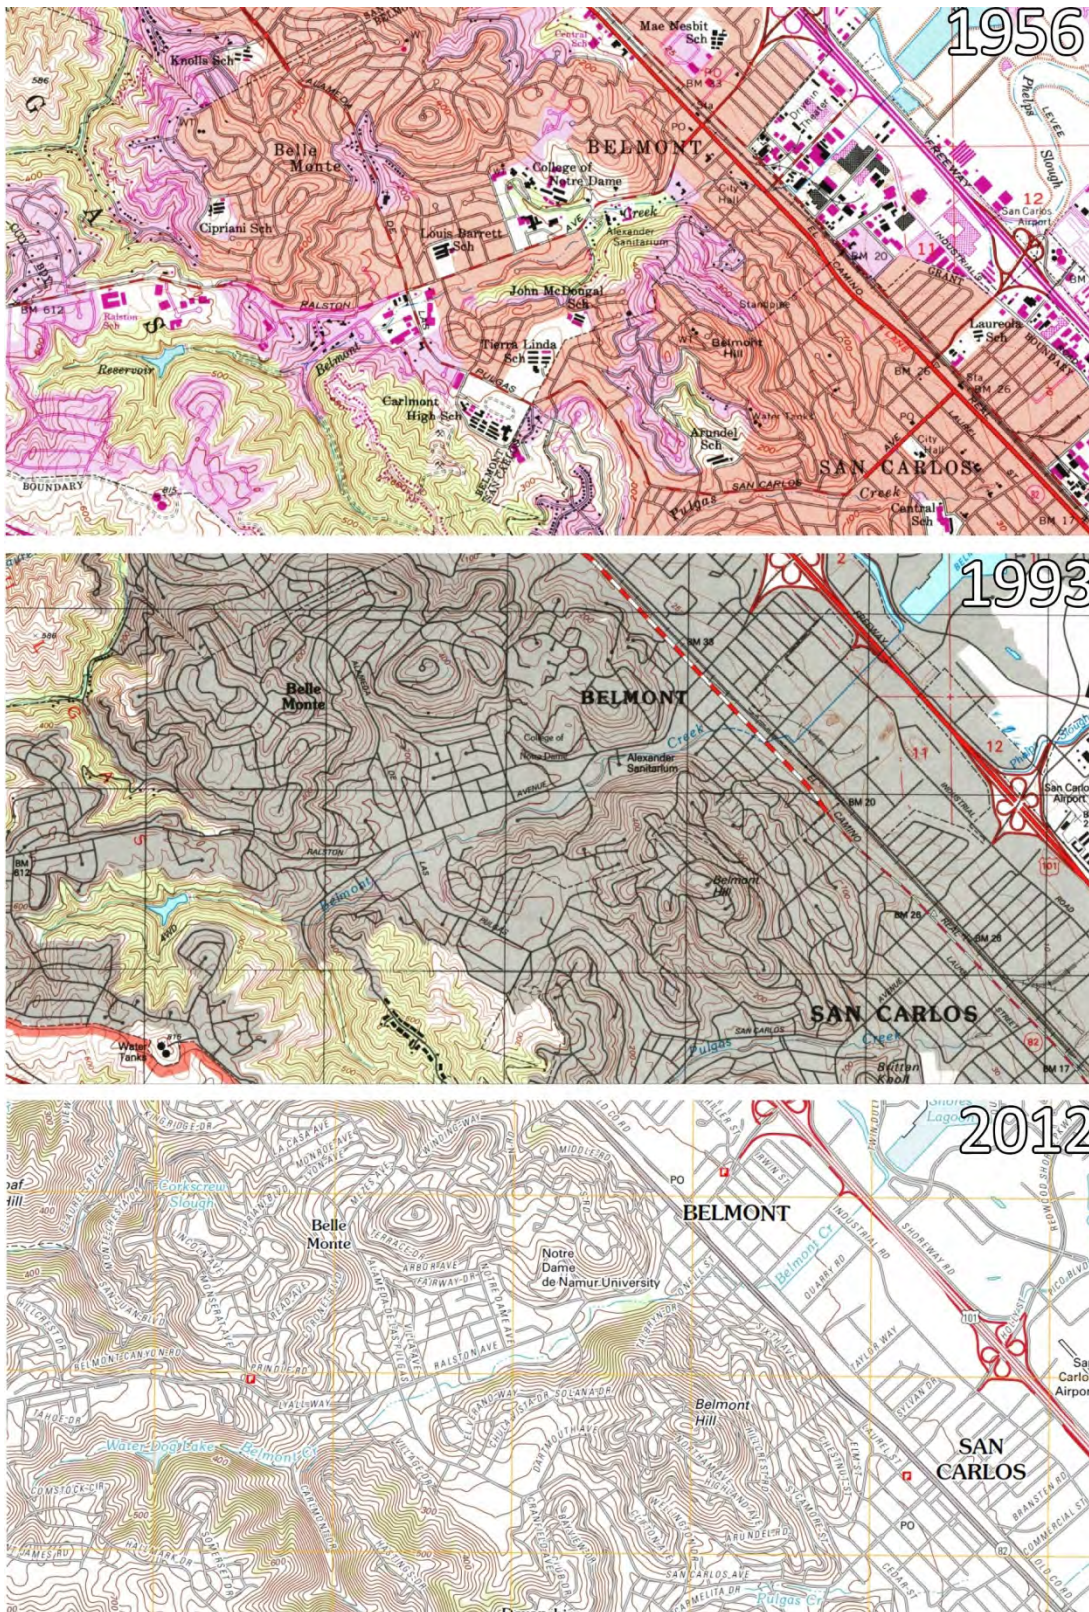
Figure 16. Comparison of Historical USGS Topographic Maps (continued)

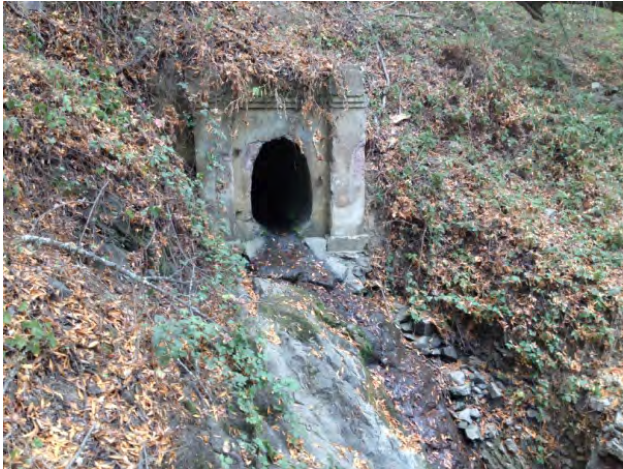
Photo 1. Water Dog Lake Outfall

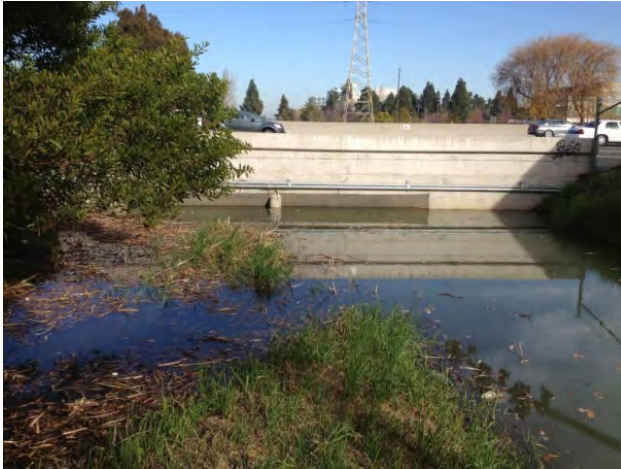
Photo 4. Old County Road Culvert

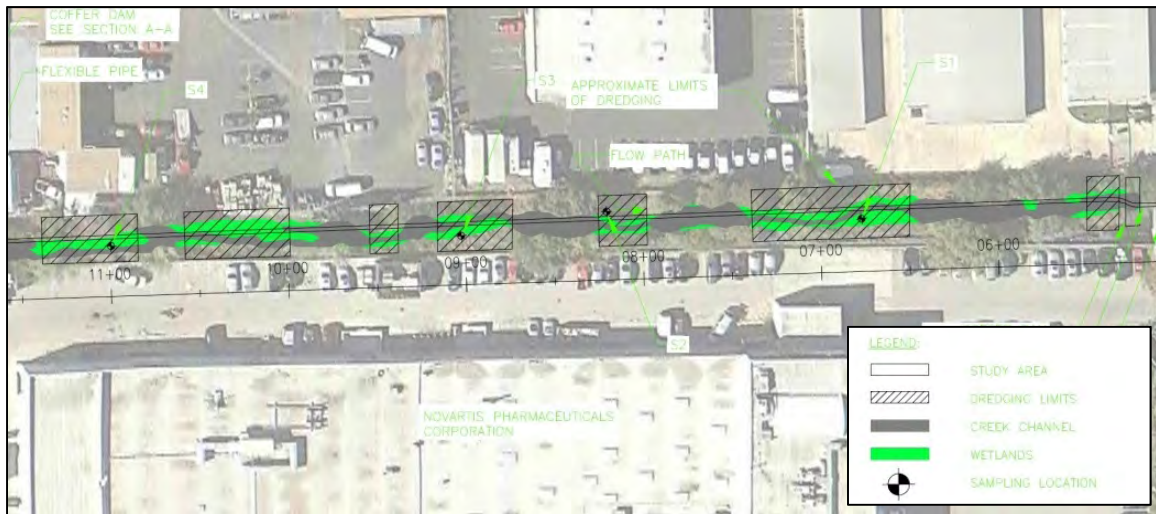
Figure 18. Sample Location Map, July 22, 2013

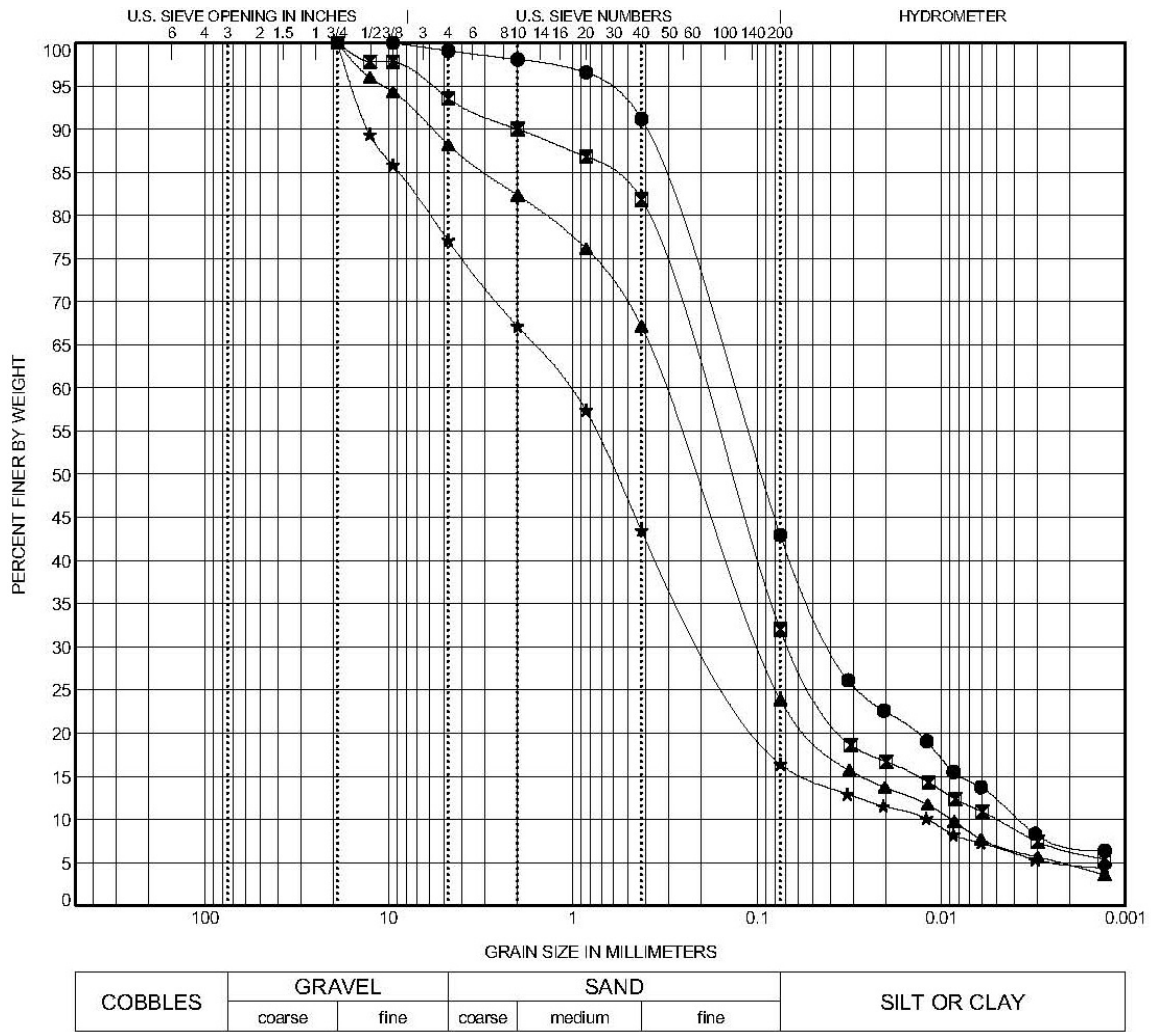
Figure 19. Grain Size Analysis of Channel Substrate in Reach B7

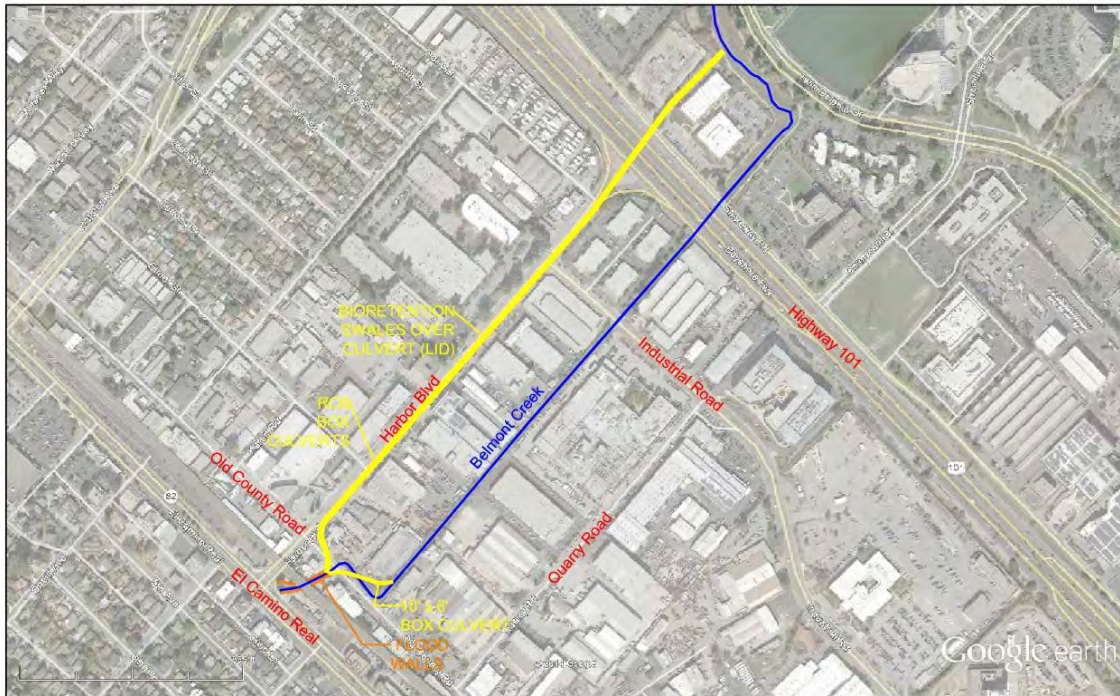
Figure 30. Modified Alternative 6 Layout

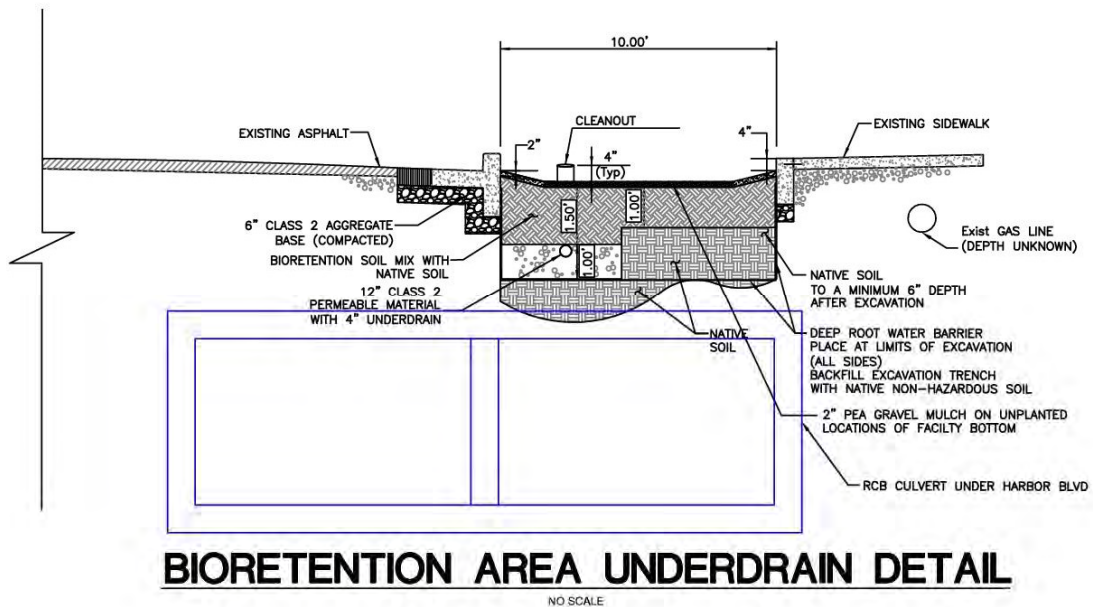
Figure 32. Typical Section of Green Street Improvements on Harbor Blvd

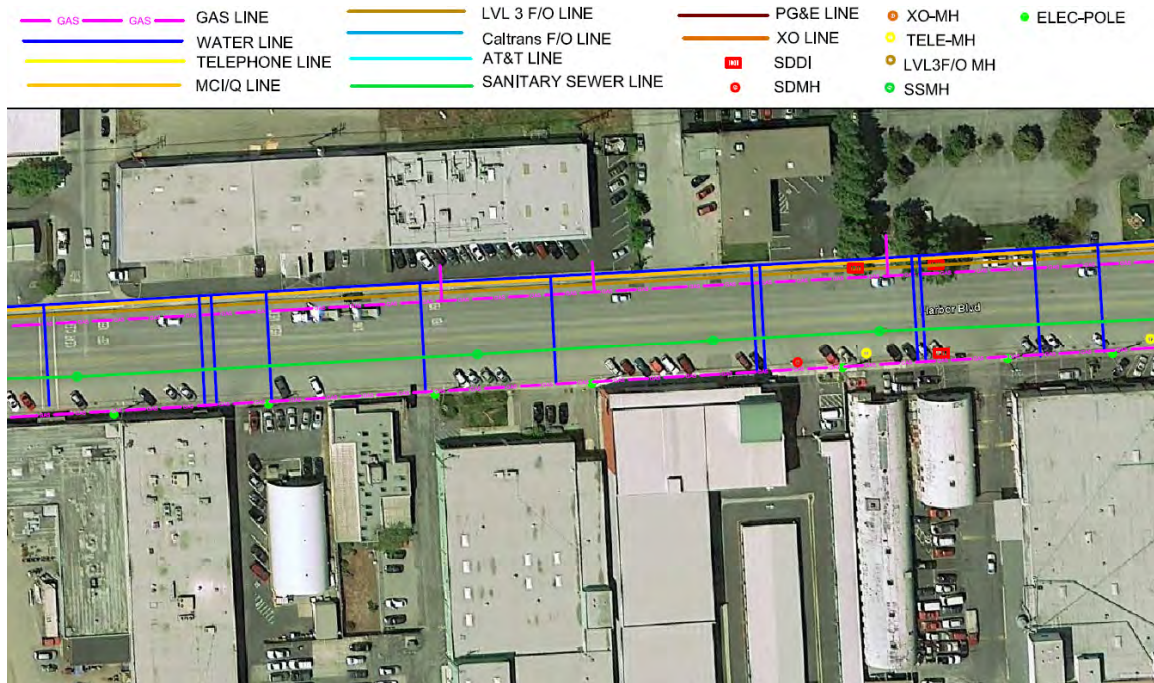
Figure 33. Approximate Utility Locations Based on Field Reconnaissance

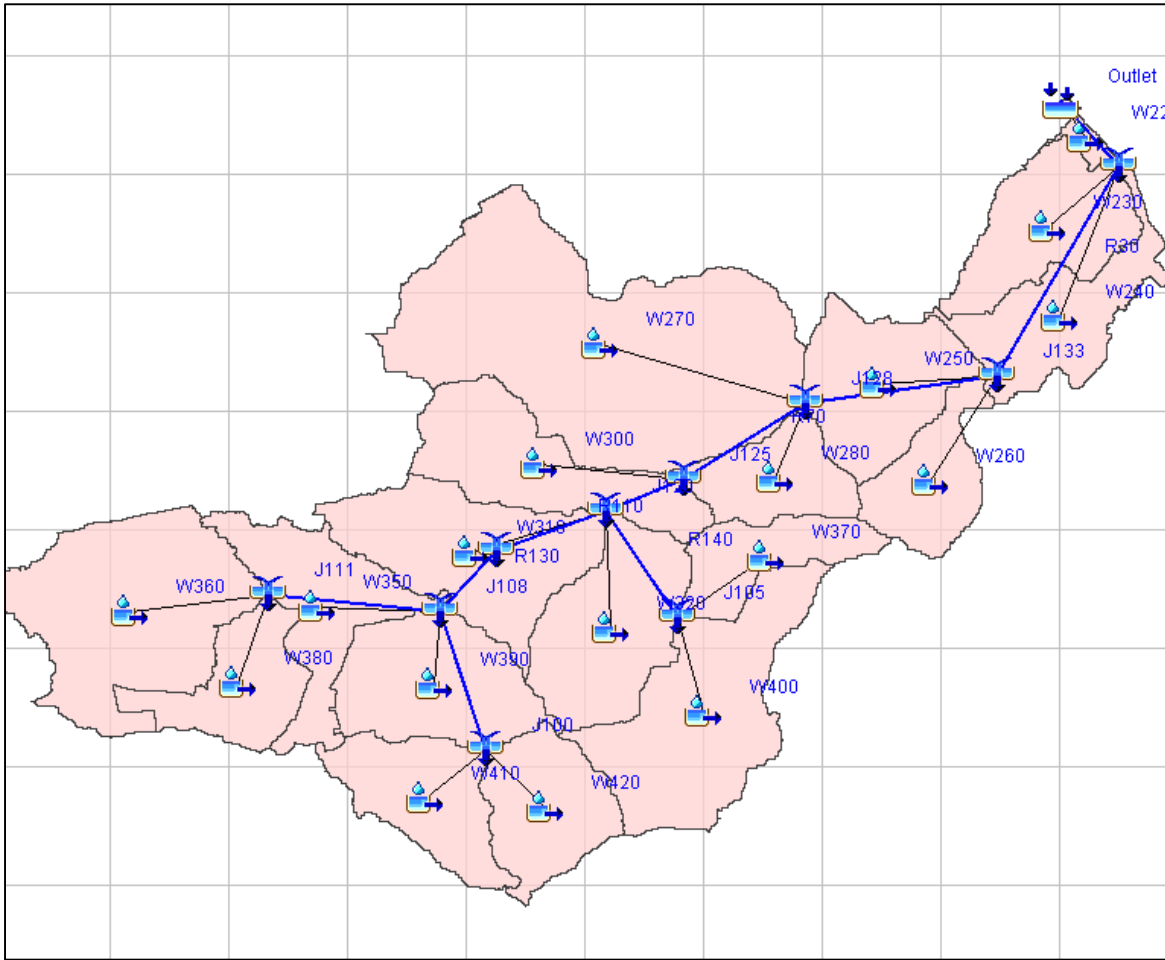
Figure 34. HEC-HMS Link Node Network for the Belmont Creek Watershed

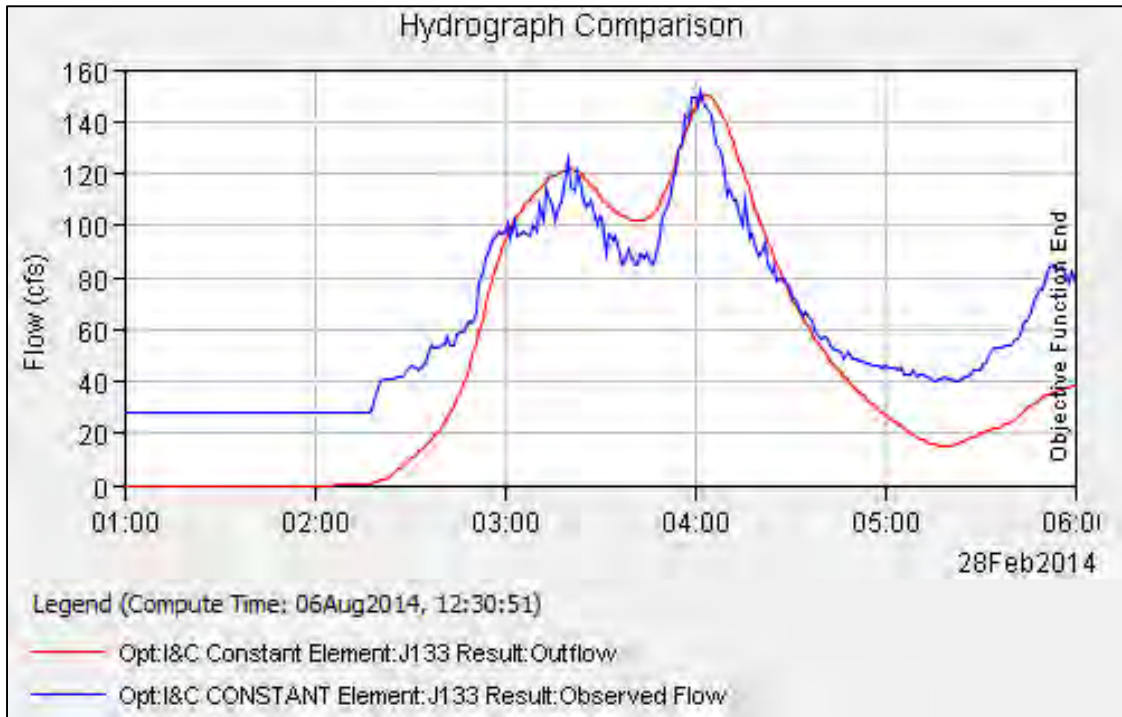
Figure 35. HEC-HMS Calculated Hydrograph versus Field-Measured (Observed Flow) Hydrograph for February 28, 2014, Storm Event

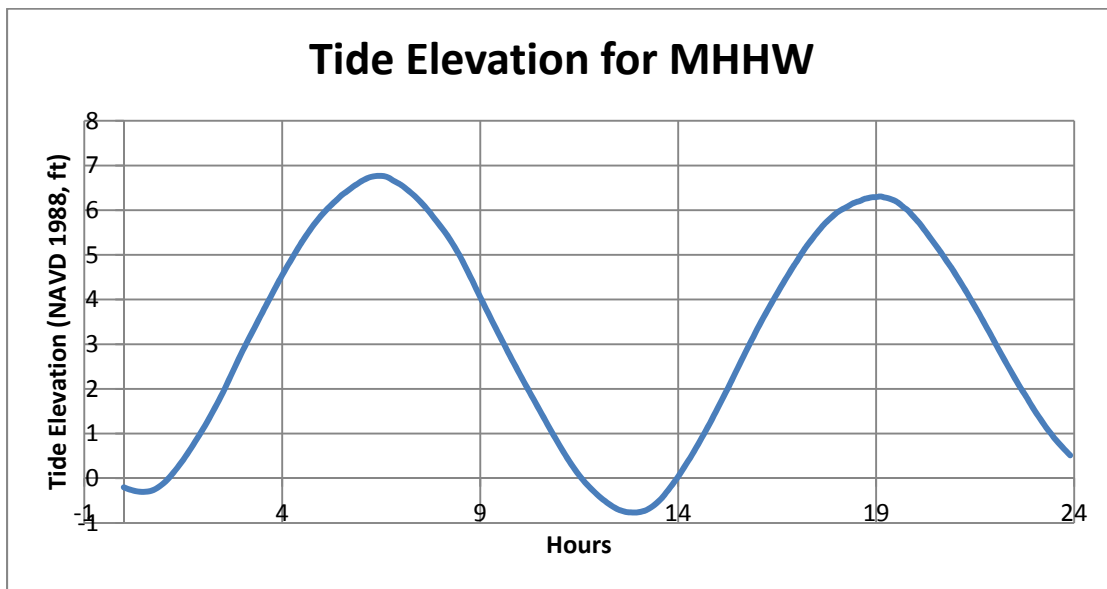
Figure 38. Tidal Curve for MHHW at the Downstream End

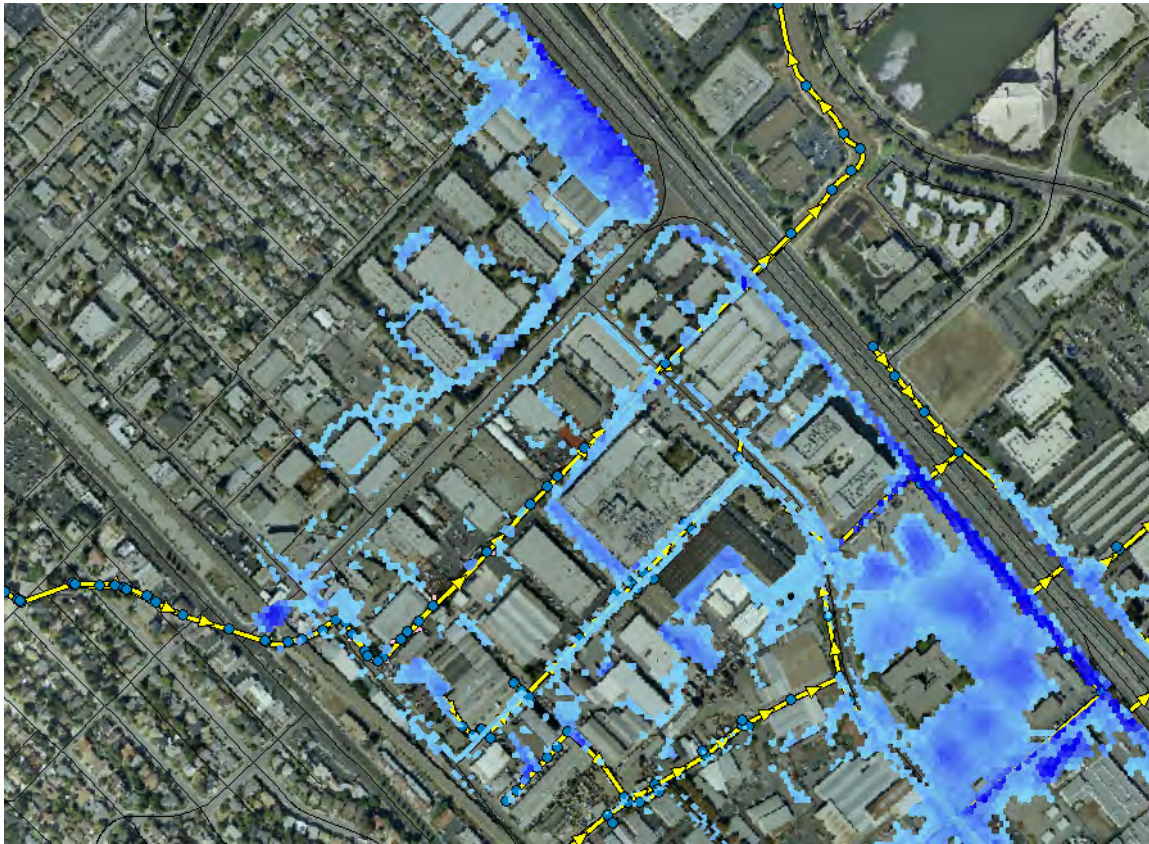
Figure 39. Existing Condition: 10-year Maximum Floodplain, Flooding at 9:00 in Model

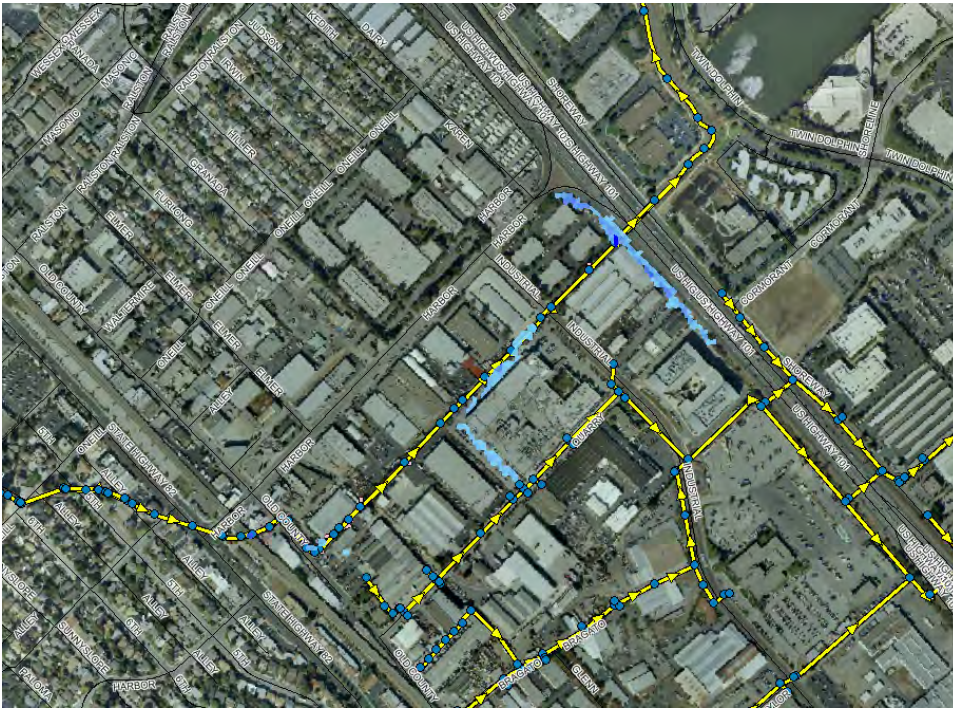
Figure 40. Flooding at 6:10 in the Model

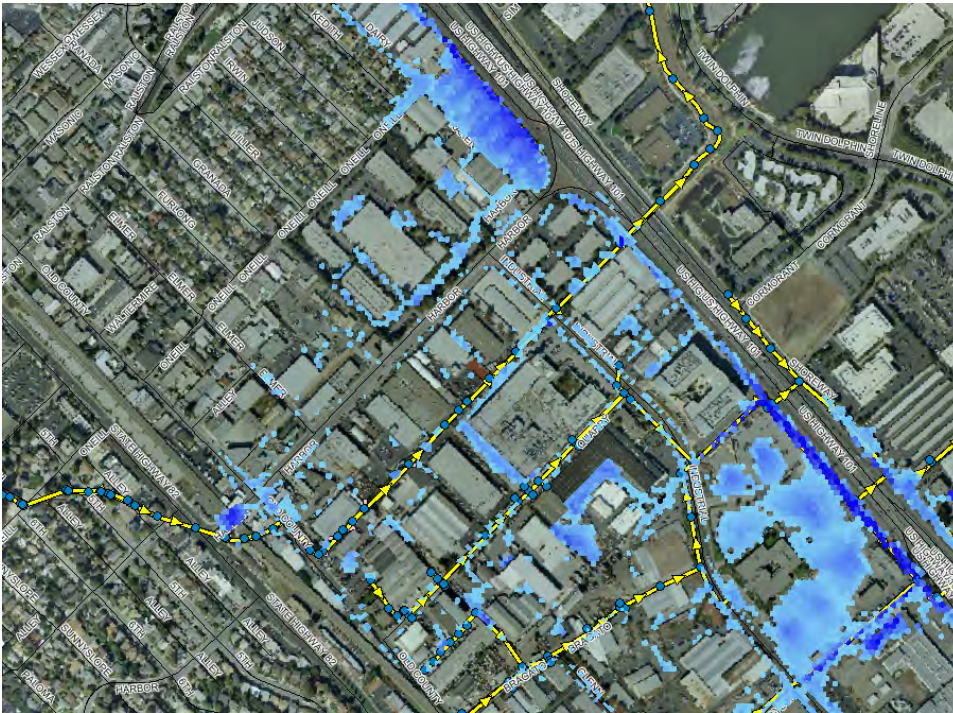
Figure 43. Flooding at 10:00 in the Model

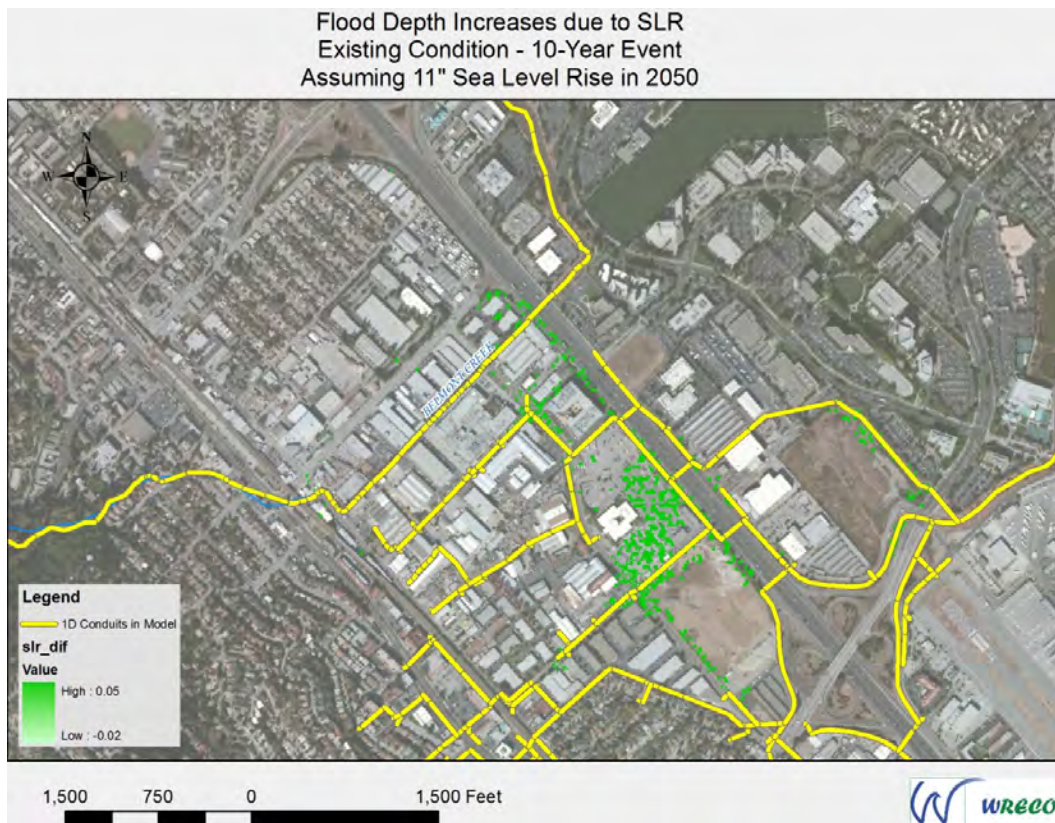
Figure 45. Sea Level Rise Impacts to the Existing Condition

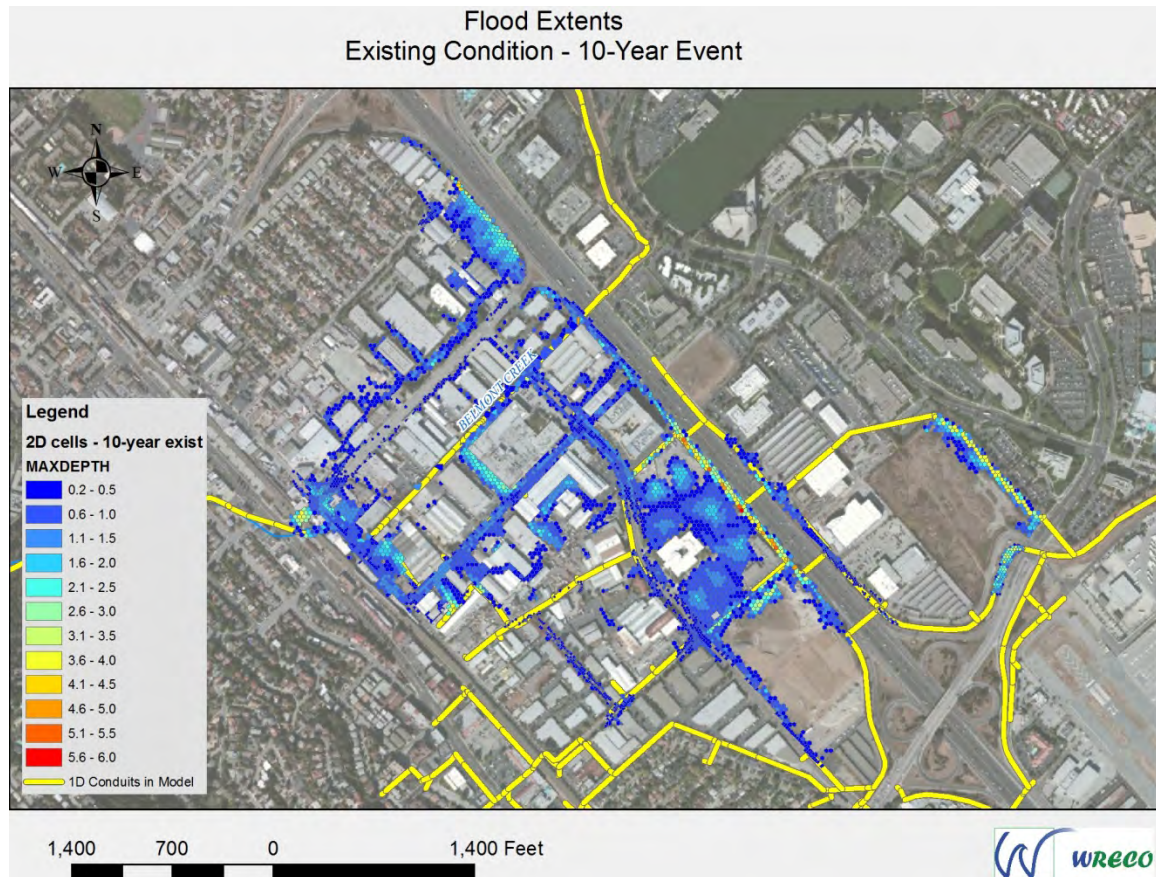
Figure 46. Peak 10-year Flooding Extents in the Existing Condition

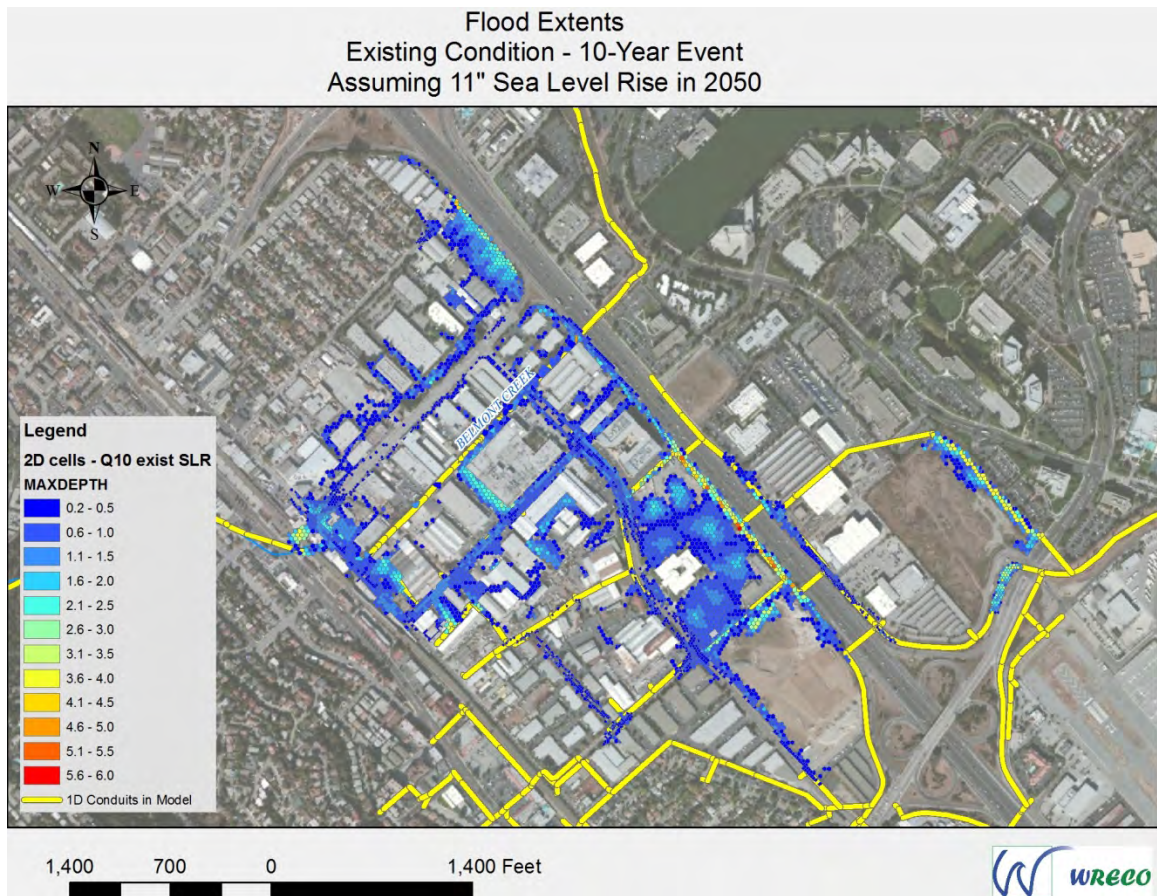
Figure 47. Peak 10-year Flooding Extents in the Existing Condition with Sea Level Rise
