**Belmont Creek Watershed Study, Creek Assessment, and Recommendations
for Sustainable Improvements
San Mateo County, California**

Technical Study

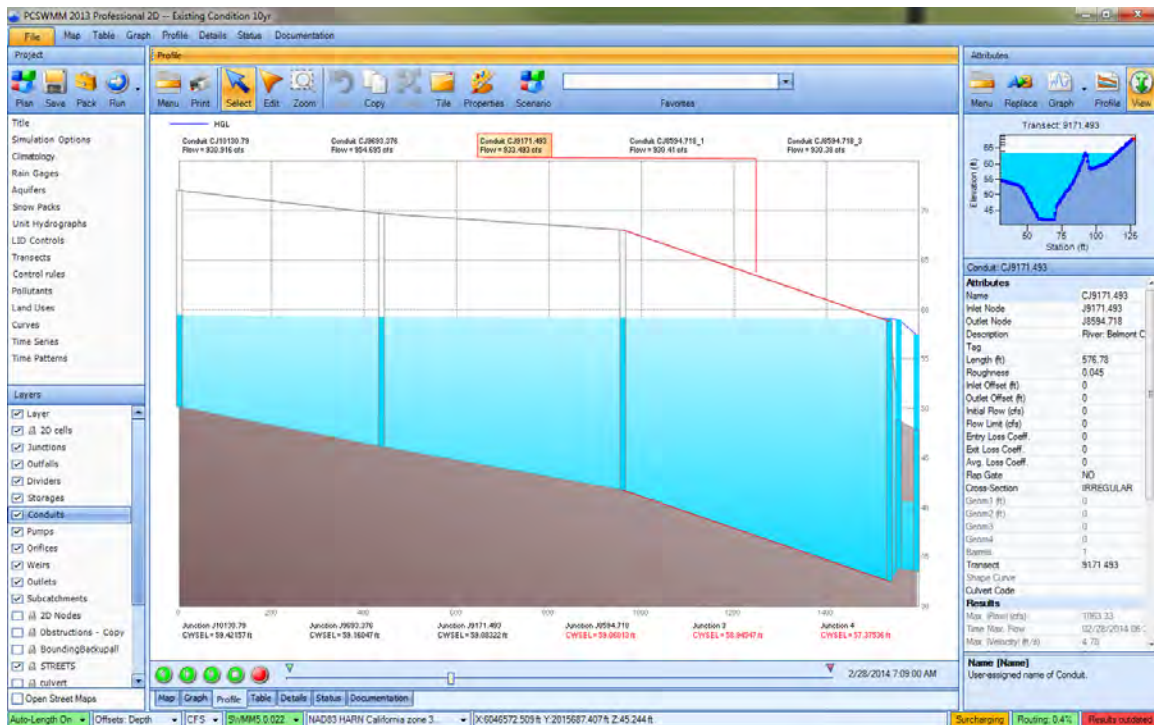
Figure 48. Culvert Backing Up within the Channel Profile

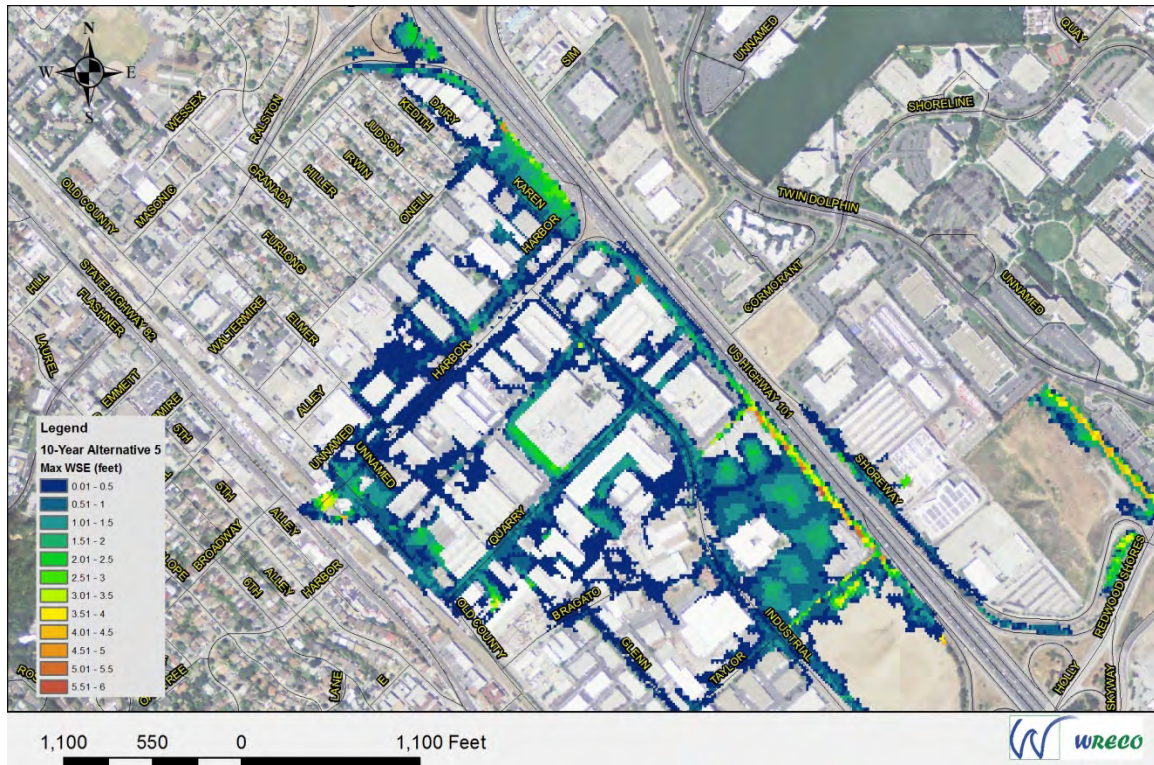
Figure 49. 10-Year Storm Flooding with Alternative 5

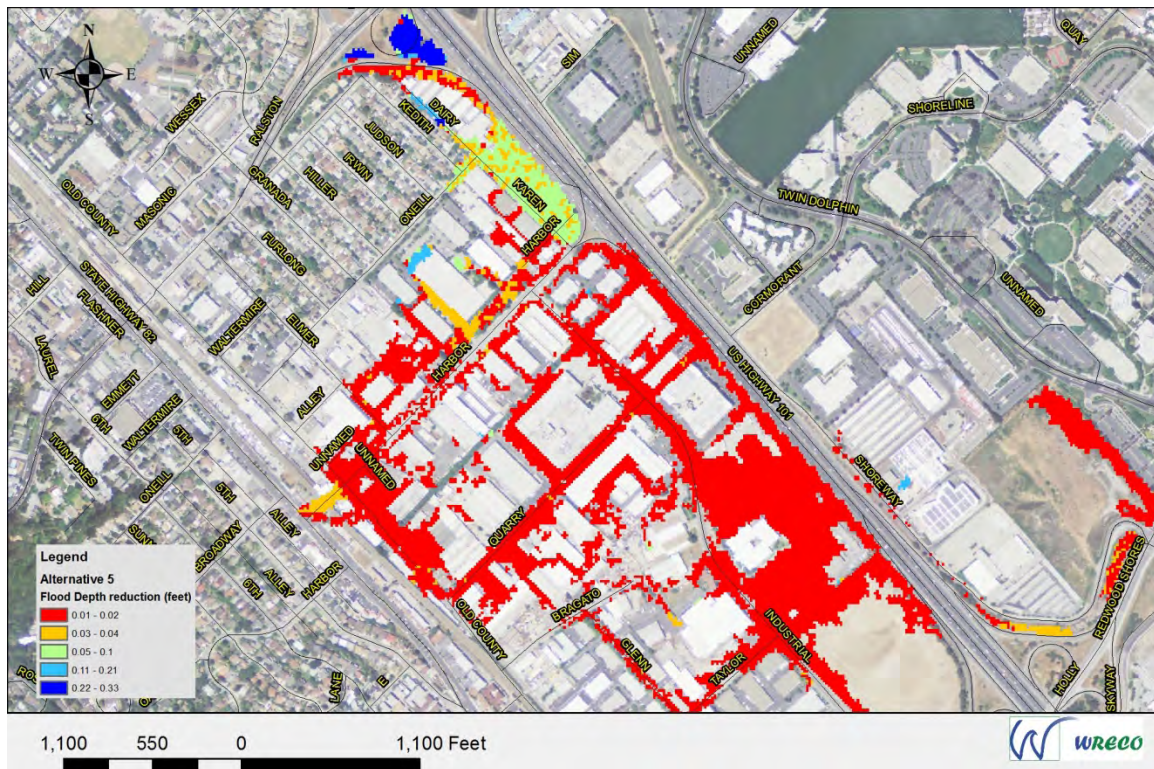
Figure 50. 10-Year Storm Flooding Reduction from Existing Condition with Alternative 5

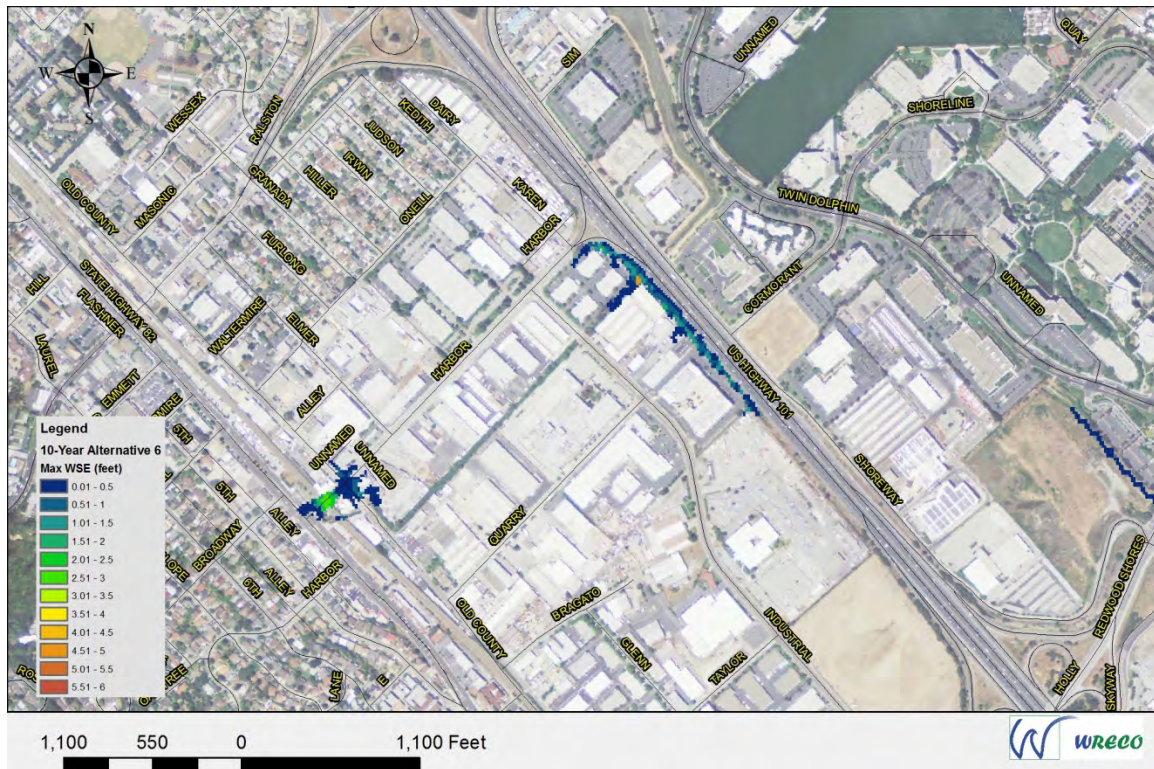
Figure 51. 10-Year Flooding with Alternative 6

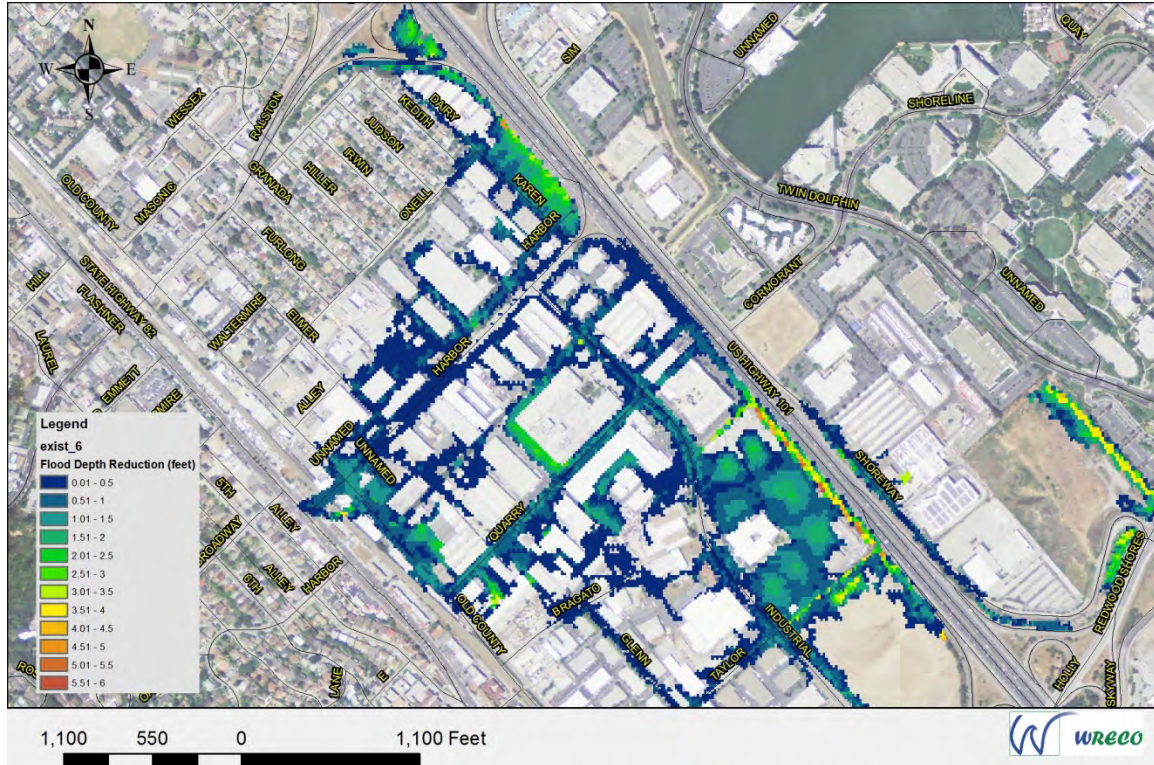
Figure 52. 10-Year Storm Flood Reduction from Existing Condition with Alternative 6

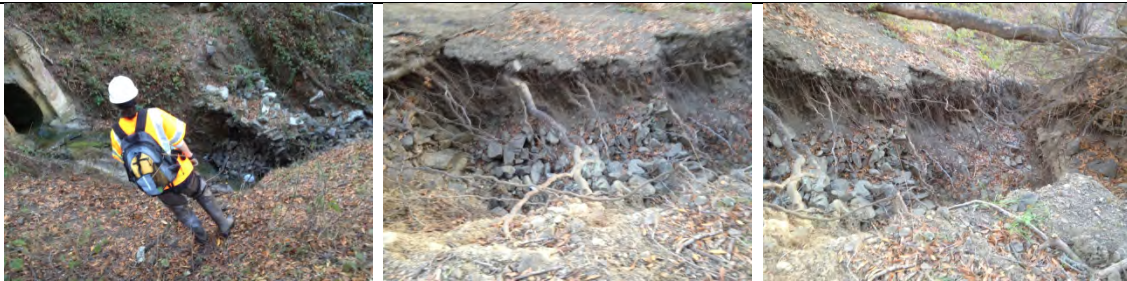
Photo 6. Taken approximately 2,000 ft upstream of the Live Oak culvert at the low flow outfall of Water Dog Lake facing upstream, left bank, and downstream, respectively

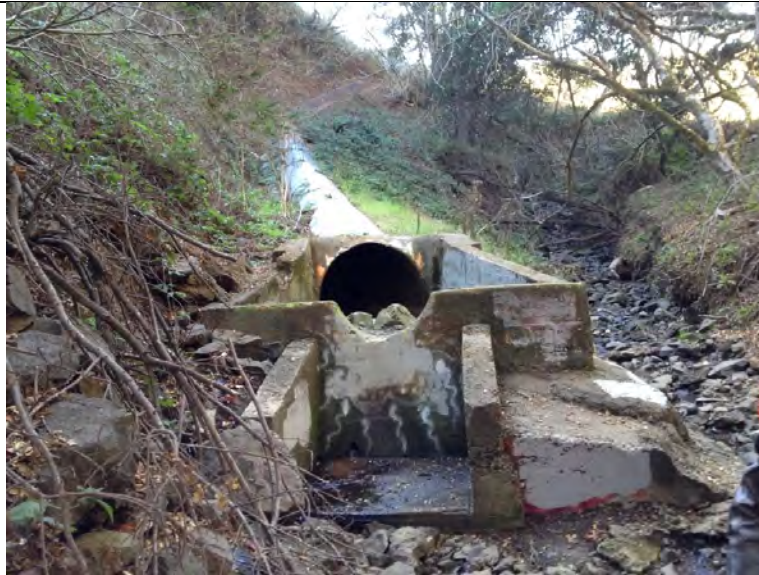
Photo 7. Taken approximately 1,760 ft upstream of the Live Oak culvert facing upstream and the right bank

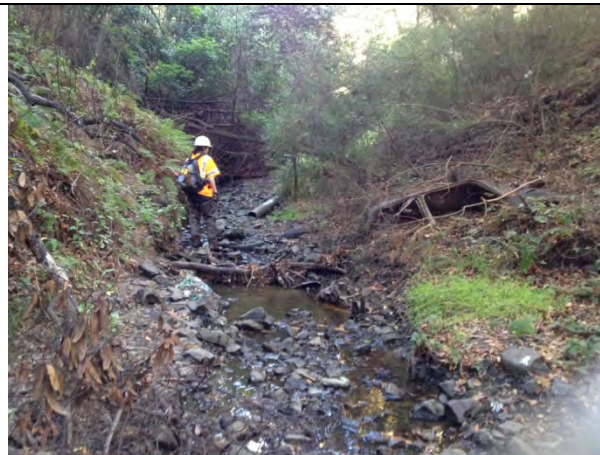
Photo 8. Taken approximately 1,500 ft upstream of the Live Oak culvert facing upstream

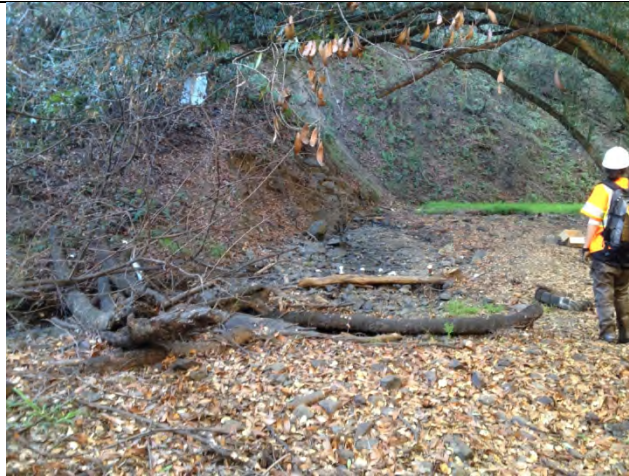
Photo 9. Taken approximately 1,320 ft upstream of the Live Oak culvert facing upstream and the right bank

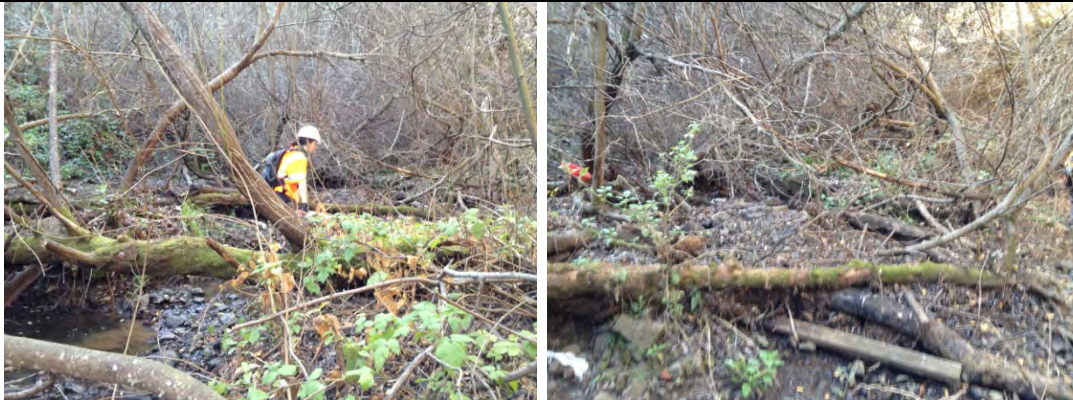
Photo 10. Taken approximately 1,250 ft upstream of the Live Oak culvert facing upstream

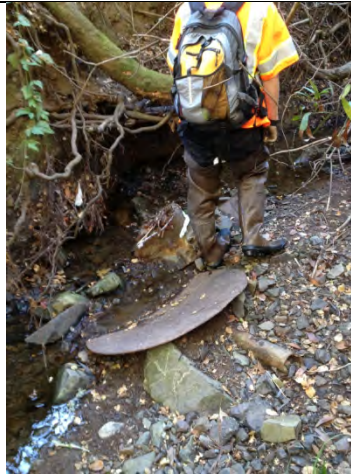
Photo 11. Taken approximately 1,200 ft upstream of the Live Oak culvert facing upstream

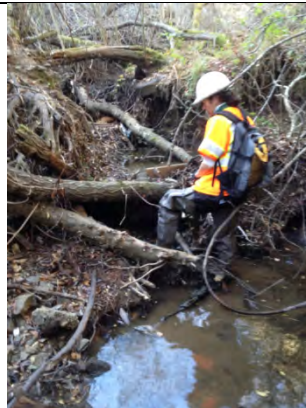
Photo 12. Taken approximately 900 ft upstream of the Live Oak culvert facing upstream

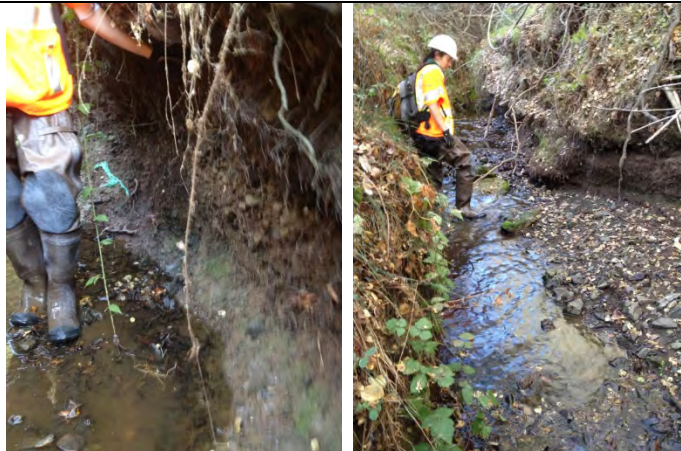
Photo 14. Taken approximately 840 ft upstream of the Live Oak culvert facing the left bank and upstream, respectively

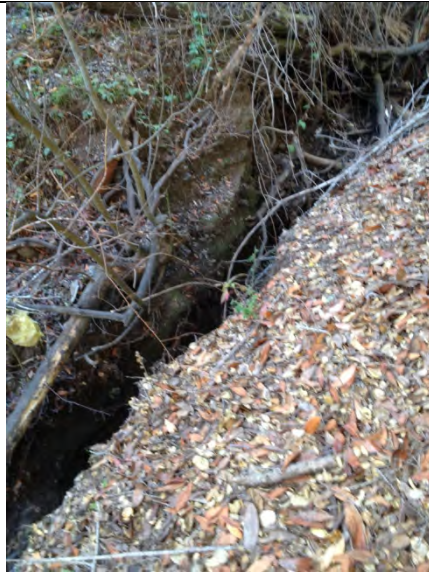
Photo 15. Taken approximately 520 ft upstream of the Live Oak culvert facing upstream

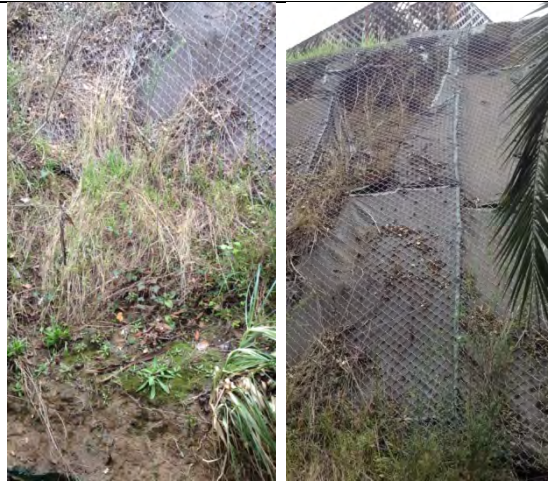
Photo 32. Taken approximately 870 ft upstream of the culvert crossing at Chula Vista Drive facing the left bank at the toe and top of bank, respectively

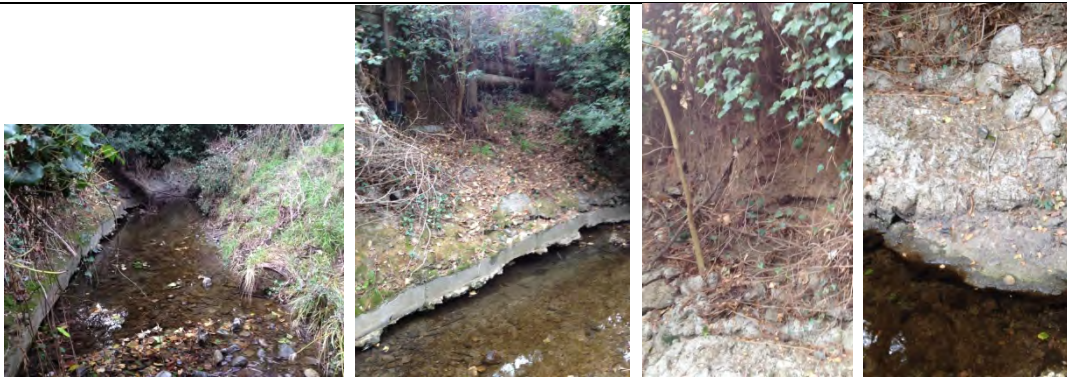
Photo 33. Taken approximately 700 ft upstream of the culvert crossing at Chula Vista Drive facing the upstream and the, respectively

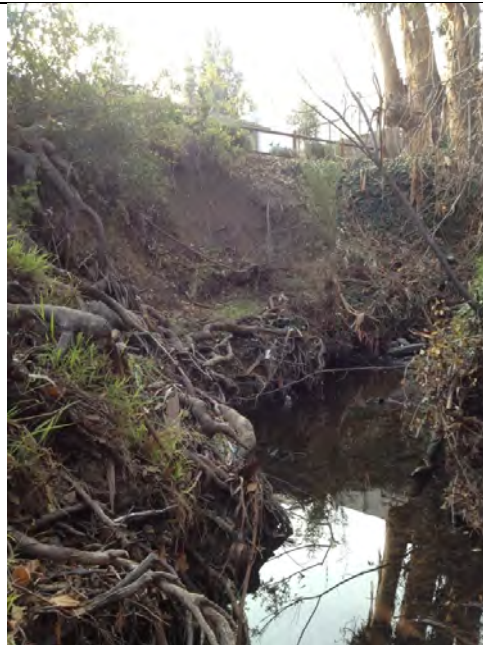
Photo 43. Taken upstream of 6th Avenue adjacent to 1000 O'Neill Avenue, facing upstream
The channel is incised. There are signs of bank scour and failure along the right bank (facing downstream) shown on the left in the picture above. The channel is undermining the right bank below existing root ball systems.

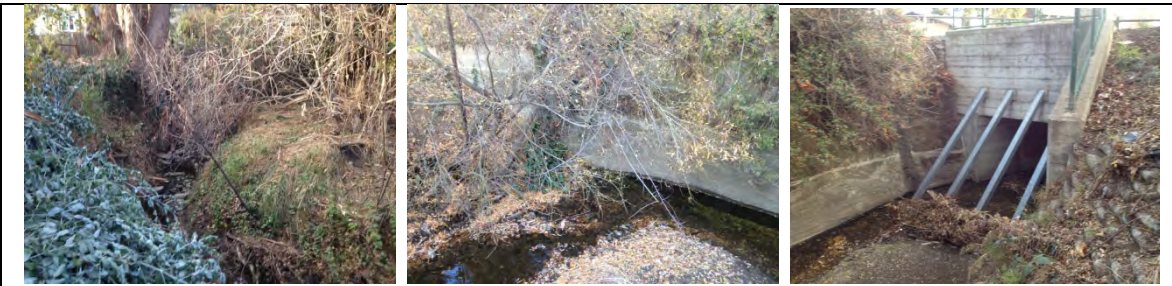
Photo 44. Taken between immediately southwest of 6th Avenue facing upstream, at a bend in the channel, and downstream at the reinforced concrete structure under 6th Avenue, respectively

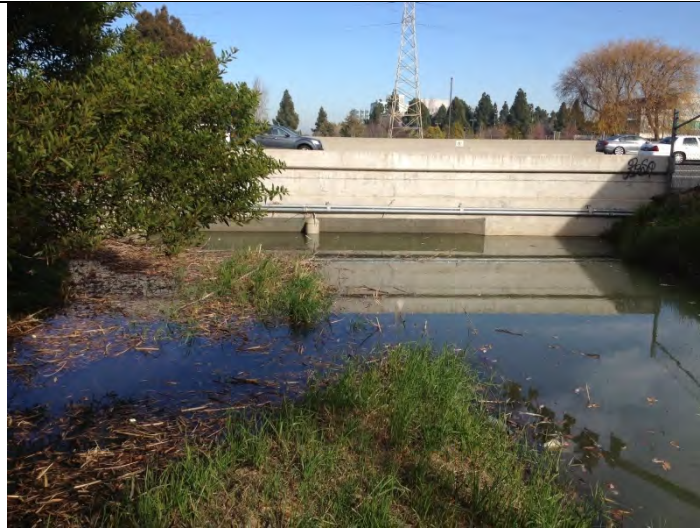
Photo 52. Taken southwest of US 101 facing US 101: Inundated Cross Culvert under US 101

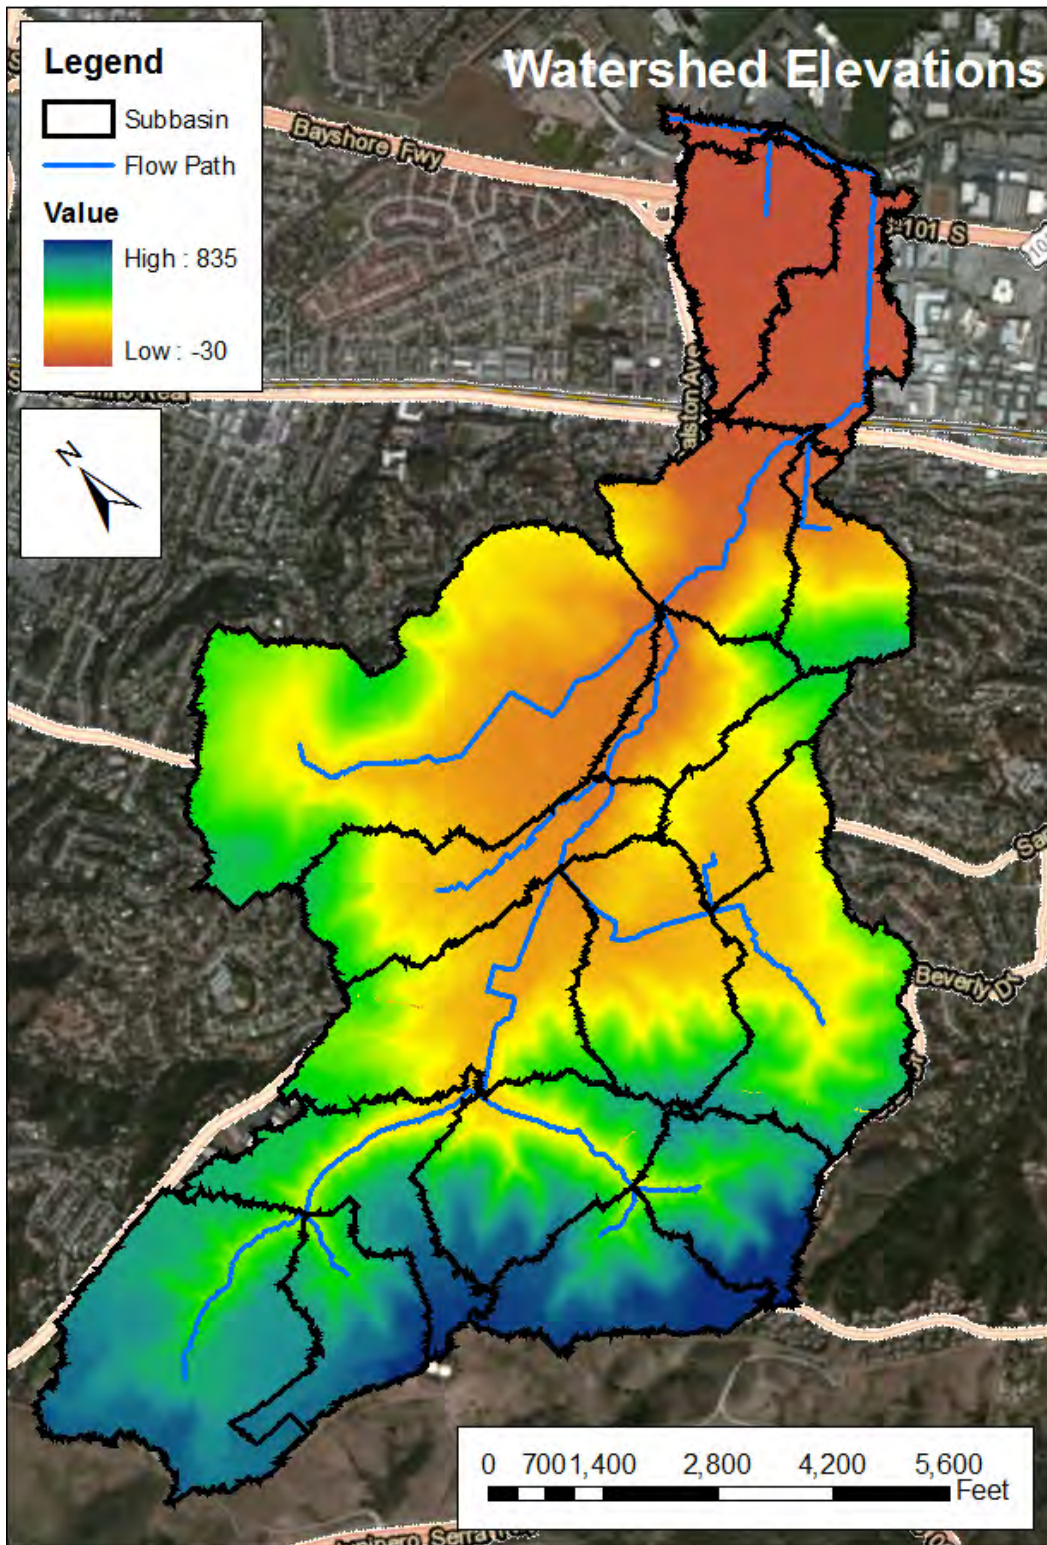
Figure 56. Elevations within the Belmont Creek Watershed

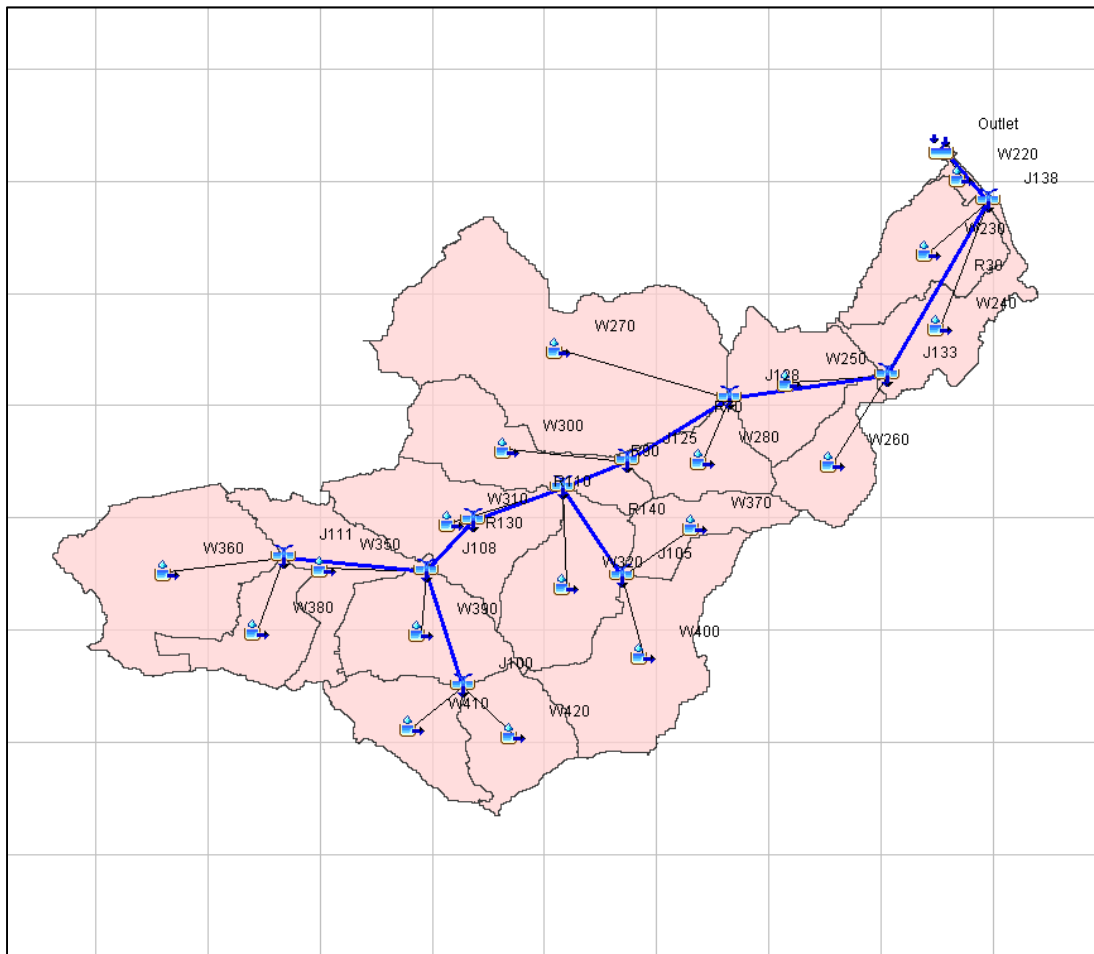
Figure 62. Basin Model

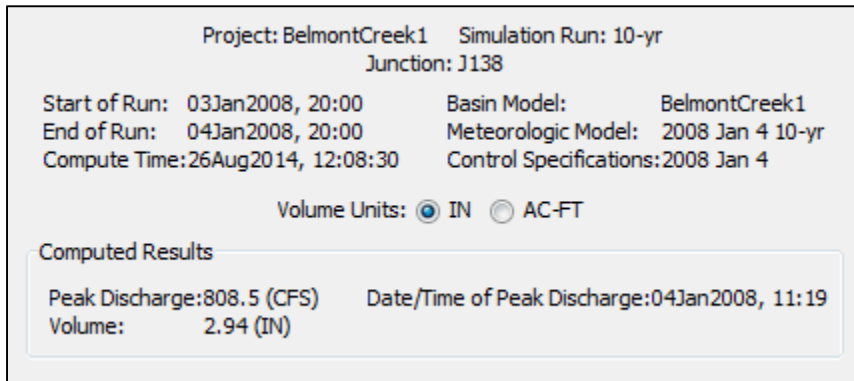
Figure 64. Result Summary J138, 10-Year Storm Event

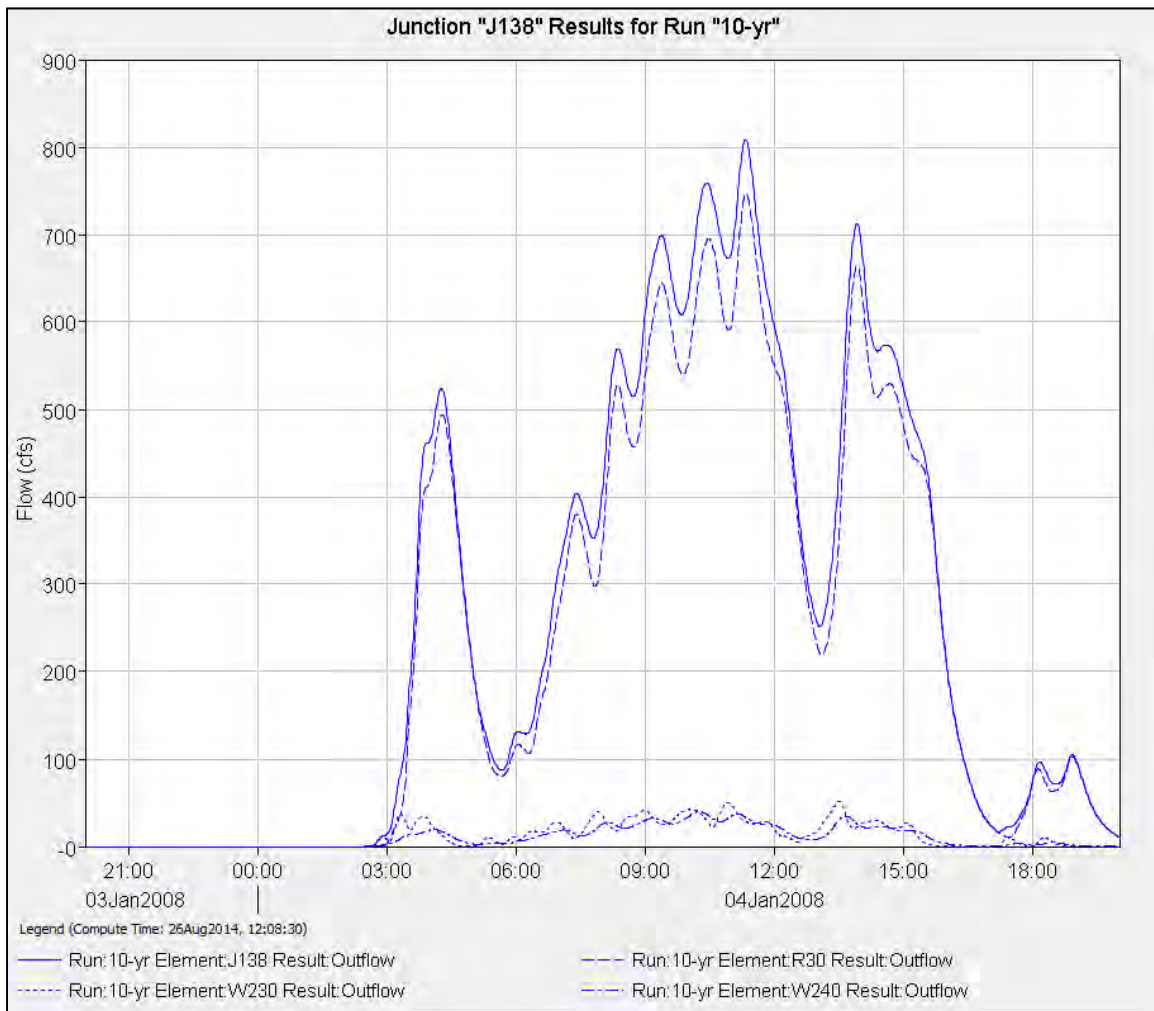
Figure 65. Outflow Hydrograph J138, 10-Year Storm Event

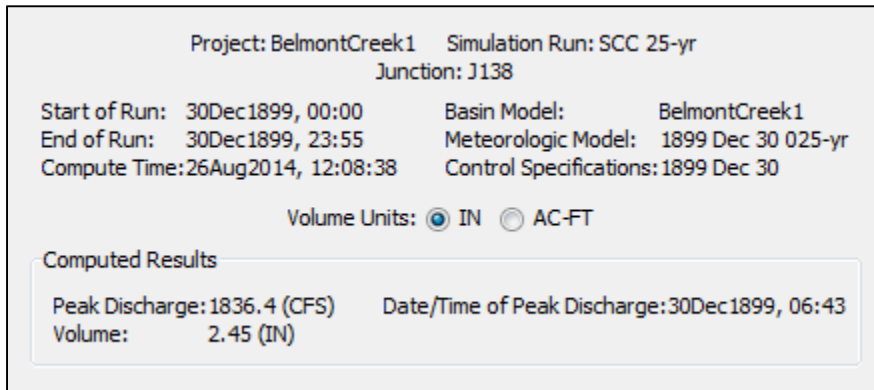
Figure 67. Result Summary J138, 25-Year Storm Event

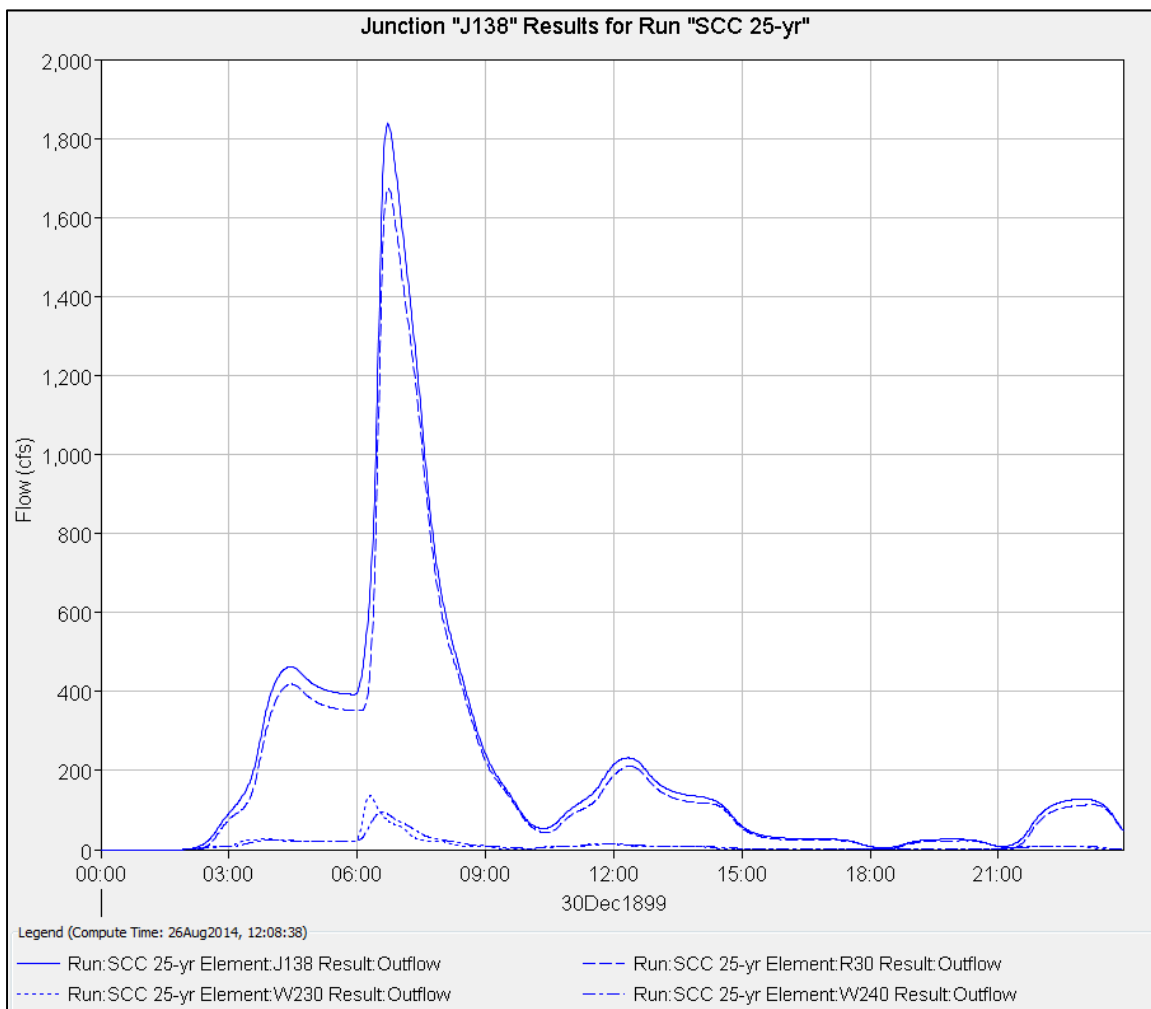
Figure 68. Outflow Hydrograph J138, 25-Year Storm Event

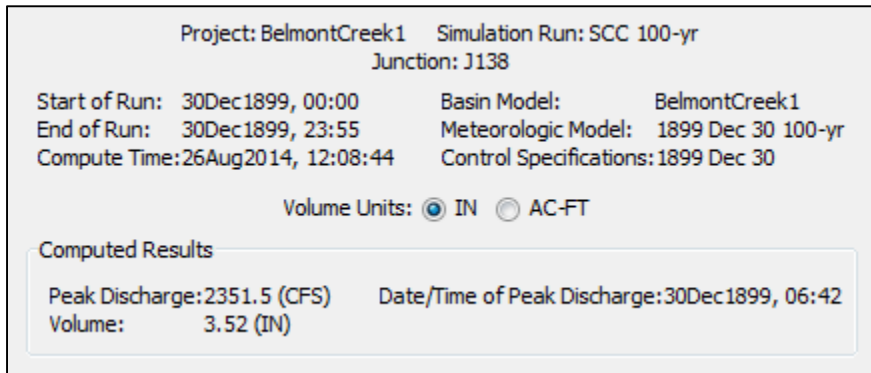
Figure 70. Result Summary J138, 100-Year Storm Event
