prepared for Orange Hall Foundation, Inc. St. Marys, Georgia

prepared by Lord, Aeck & Sargent Architecture, Inc. April, 2006

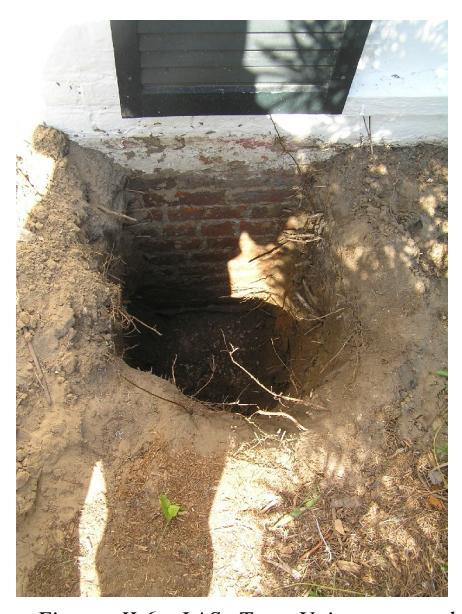
Figure II-6. LAS Test Unit excavated below column bearing point. Investigation revealed continuous foundation wall below grade. Coursing matched adjacent walls precisely. No evidence of masonry footing was present.

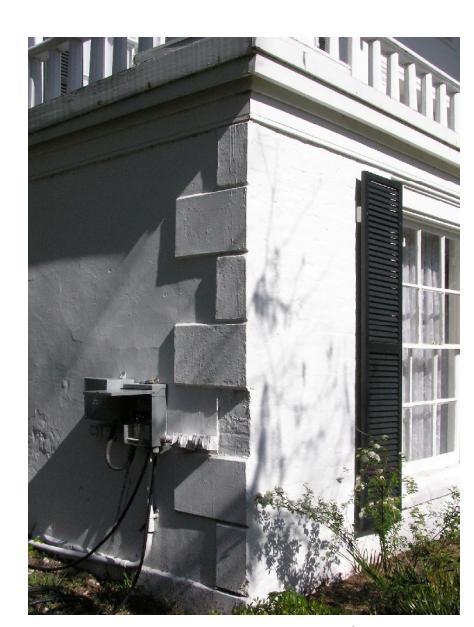
Figure II-7. Remnants of stucco quoining at the southeast corner of Orange Hall.

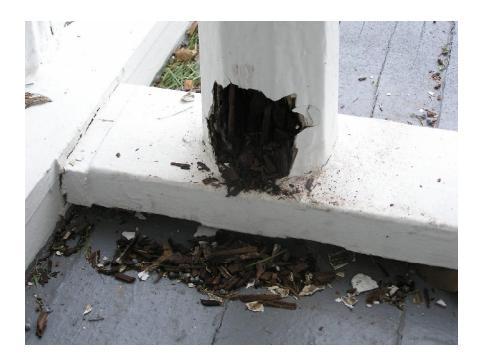
Figure II-12. Image showing deterioration of baluster at porch railing.

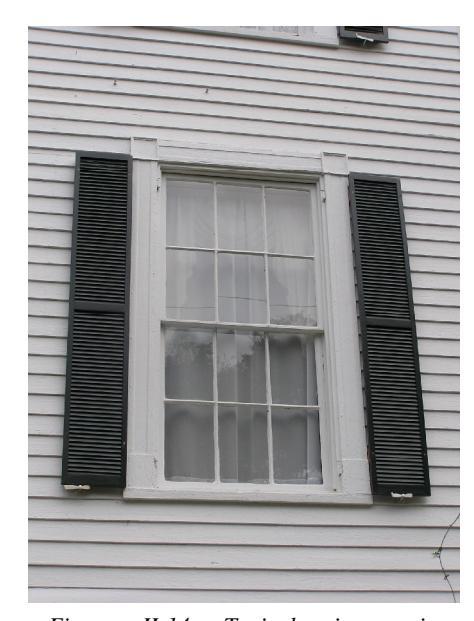
Figure II-14. Typical six-over-six, window located on First Floor, north elevation. Note replacement shutters are non-operational and narrower than original units.

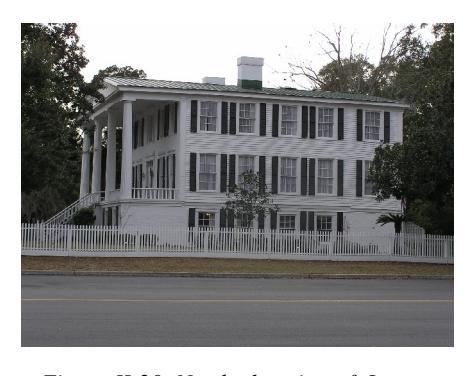
Figure II-20. North elevation of Orange Hall. Note roofing material is barely evident due to low slope.

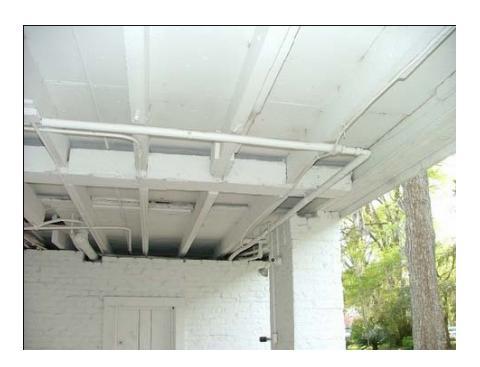
Figure II-29. Rear Porch Structure. Note 10" x 8" Girder is not connected to perimeter beam.

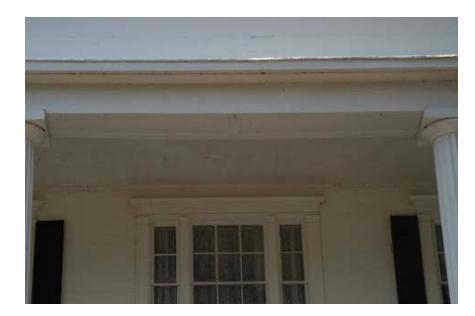
*Figure II-32. Deflection of Lintel above Porch Columns.*

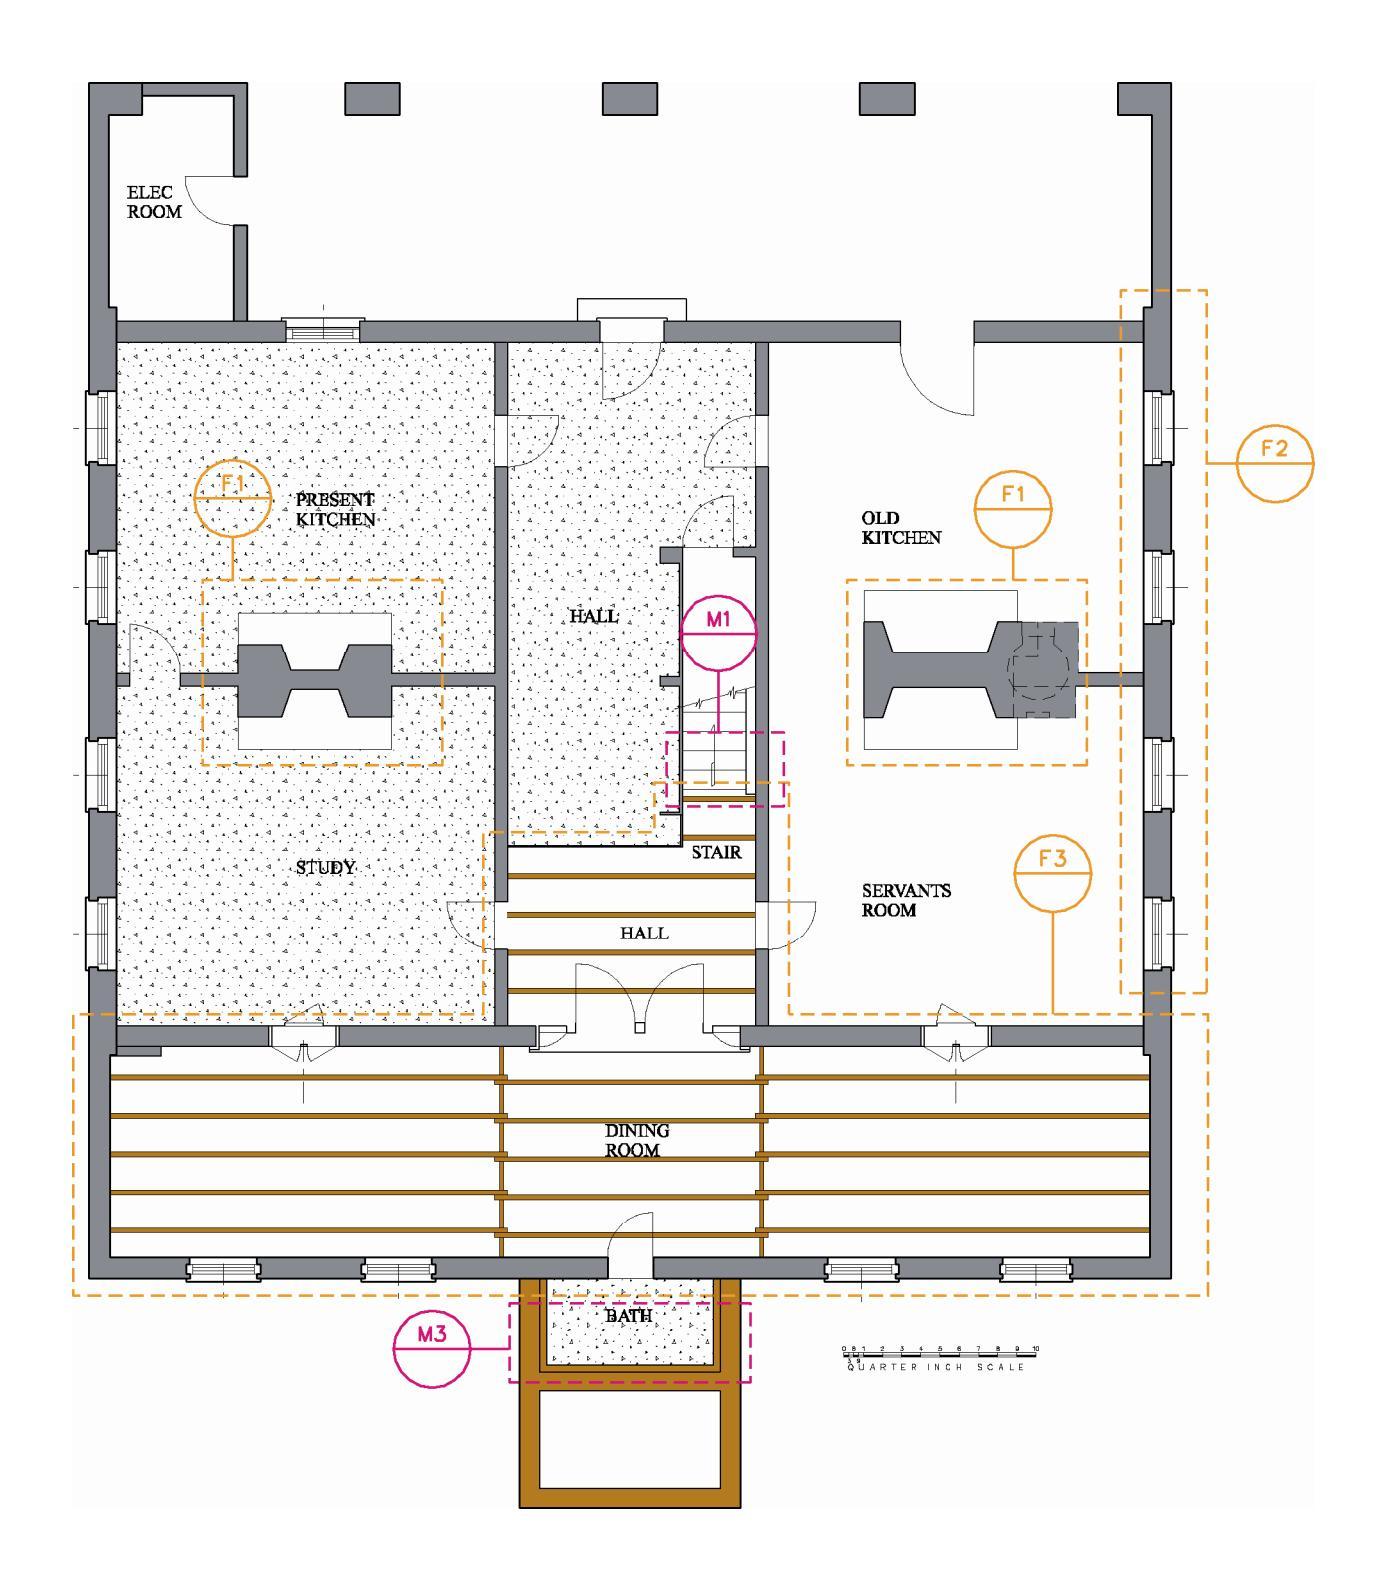
Figure II-33. Basement Level framing plan showing general location of structural deficiencies identified above.

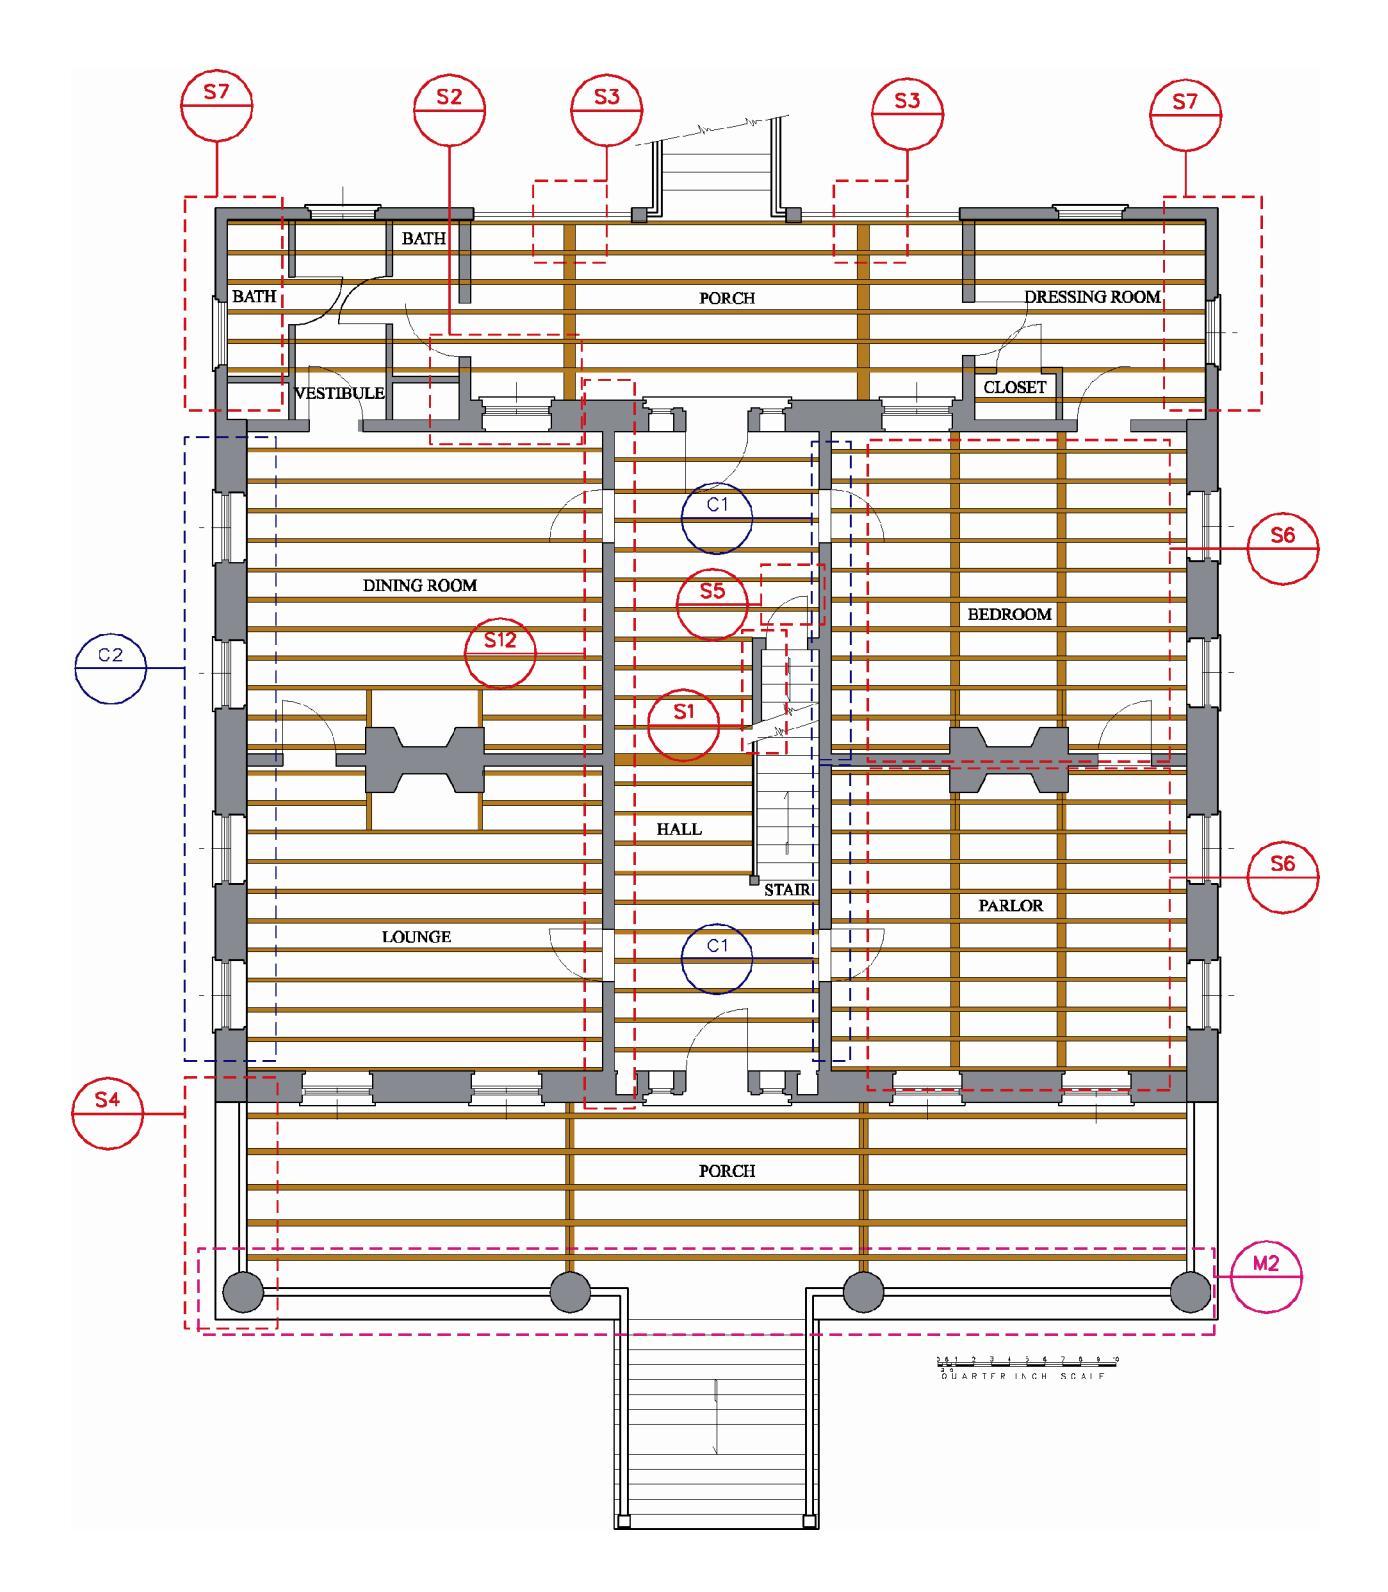
Figure II-34. First Floor Level framing plan showing general location of structural deficiencies identified above.

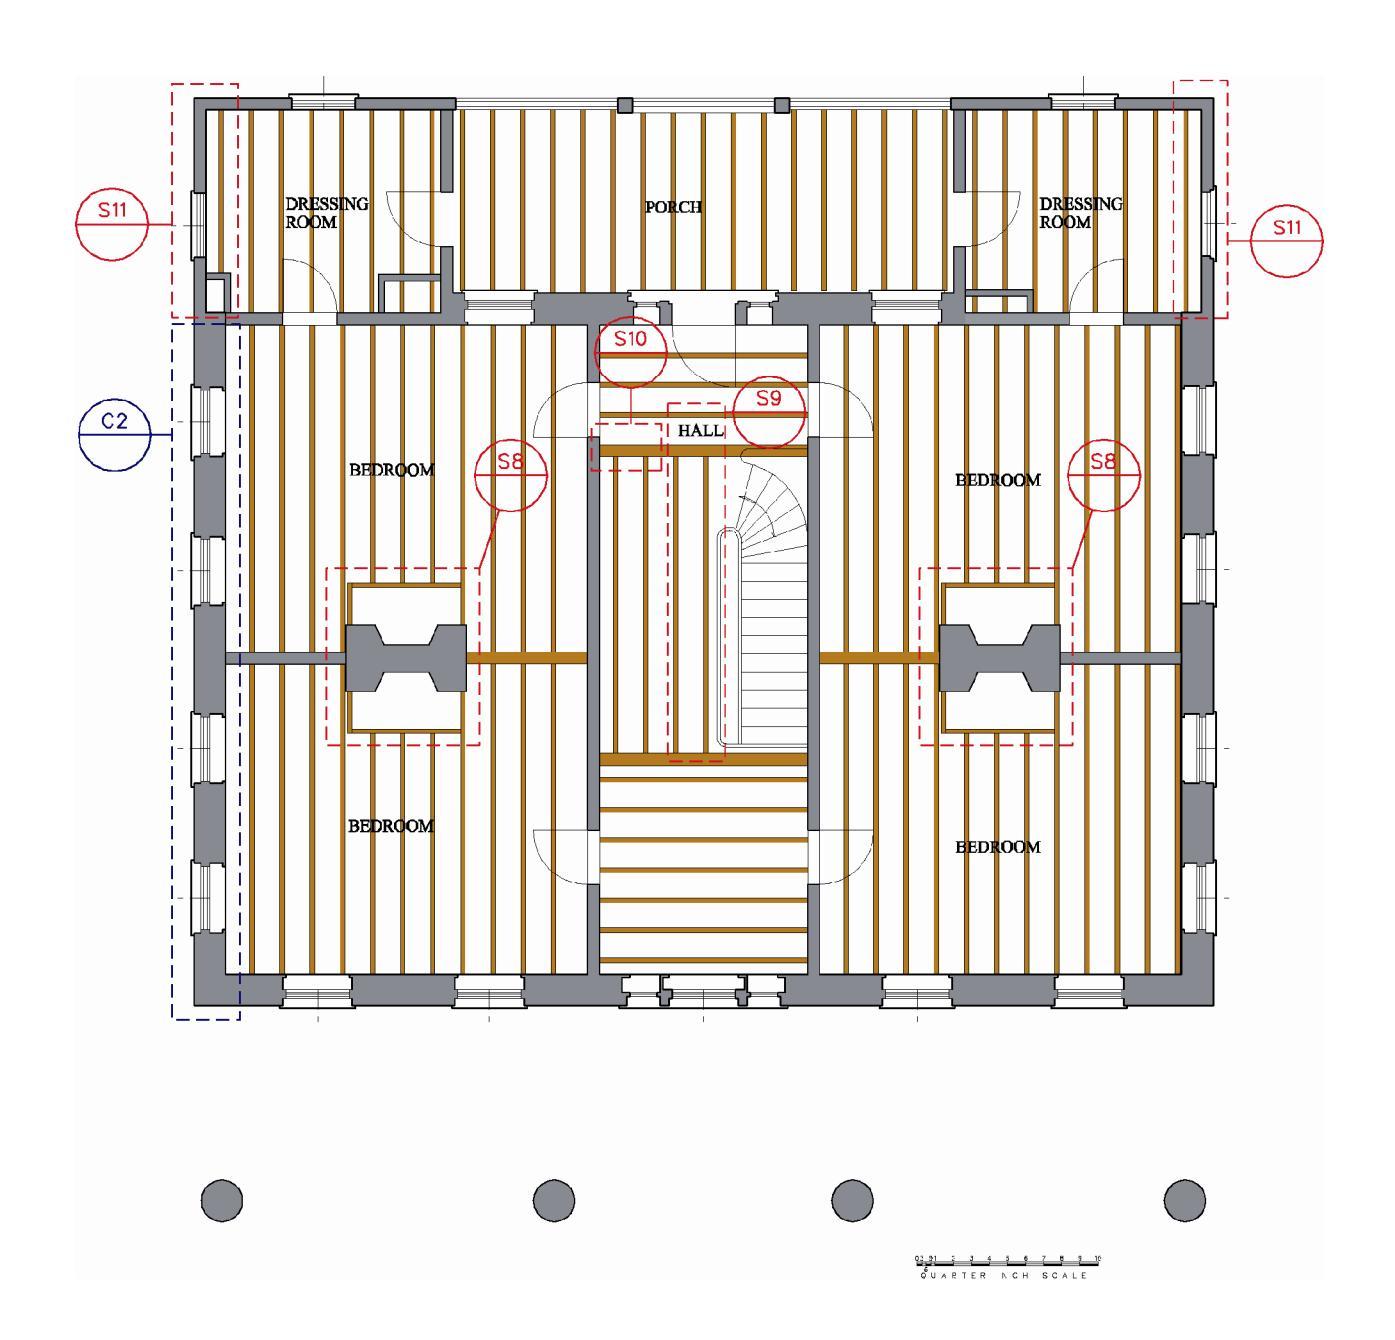
Figure II-35. Second Floor Level framing plan showing general location of structural deficiencies identified above.

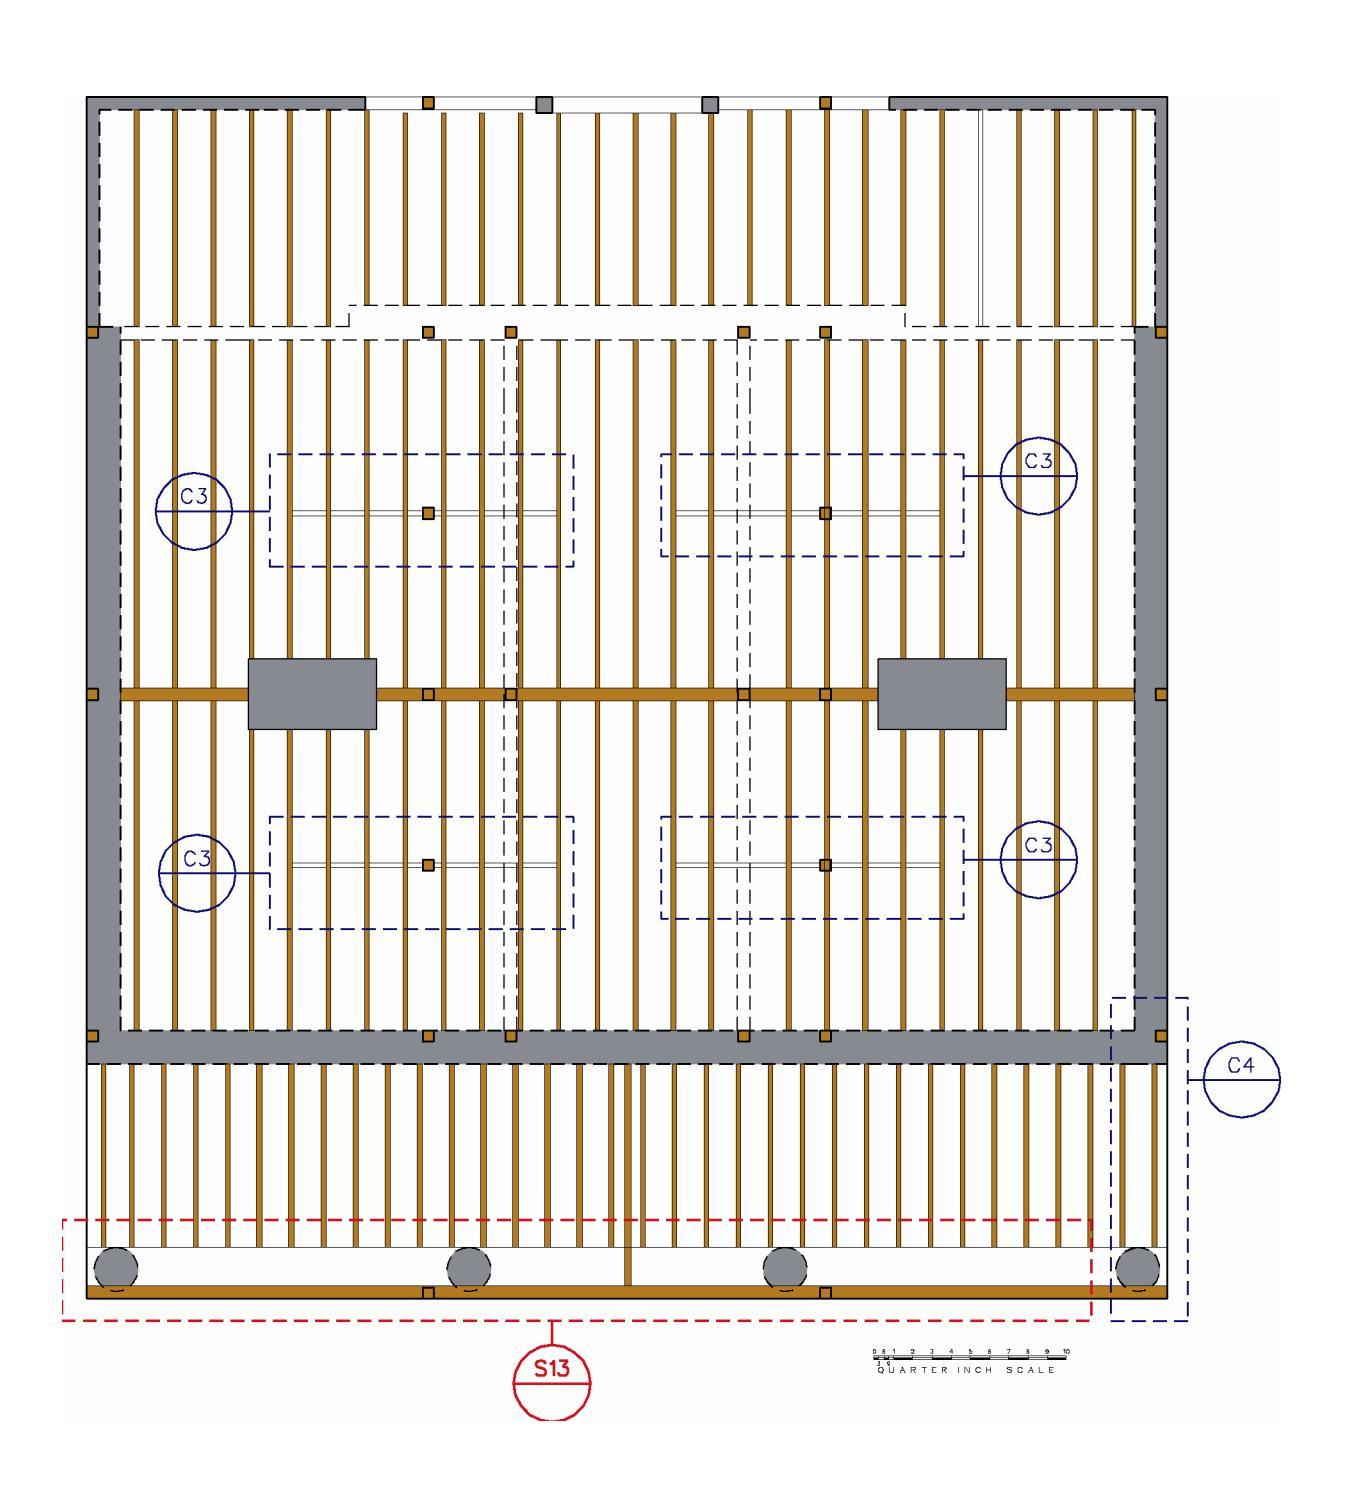
Figure II-36. Attic Level framing plan showing general location of structural deficiencies identified above.

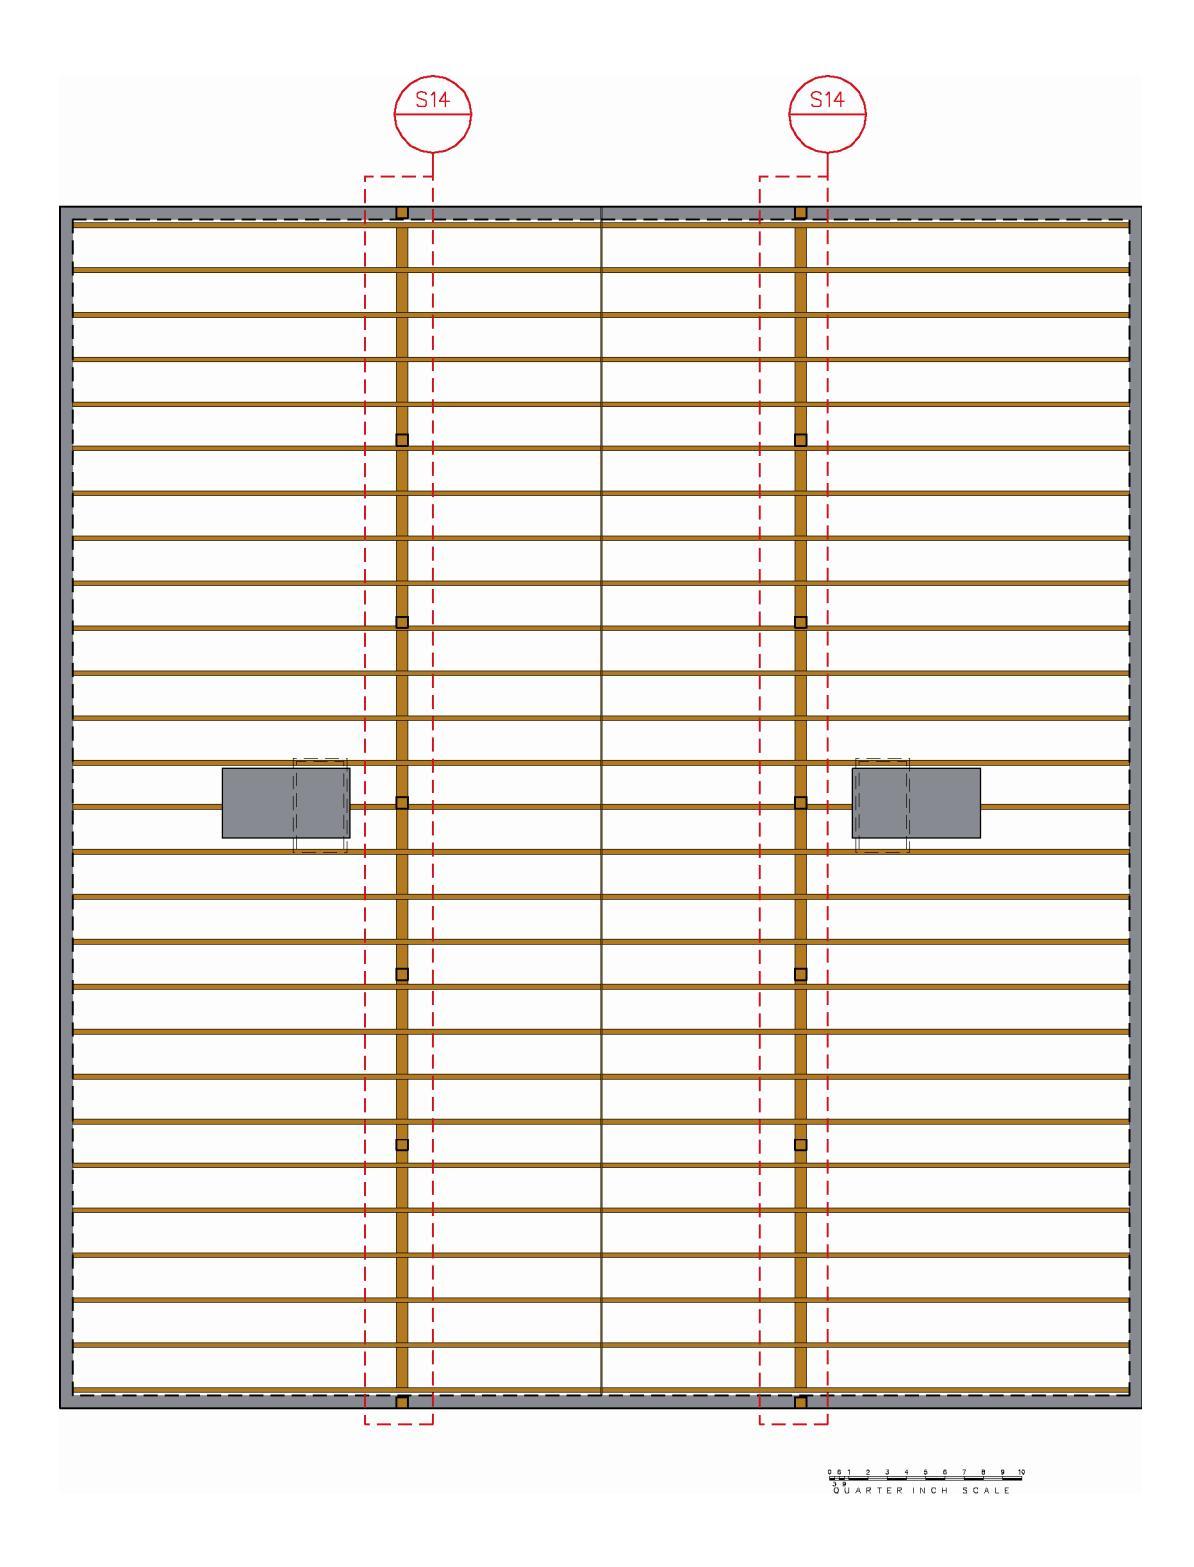
Figure II-37. Roof Level framing plan showing general location of structural deficiencies identified above.

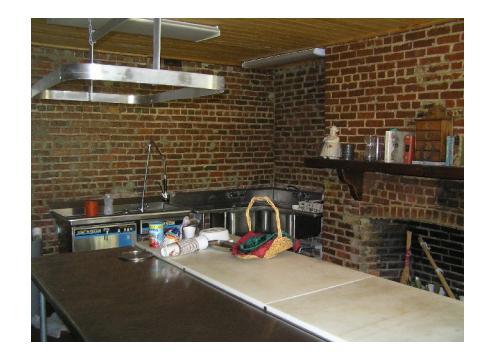
The floor of Kitchen B05 is square 5" x 5" quarry tiles over a concrete slab. The tiles were found to be in poor condition with loose and cracked tiles observed in many locations. The walls of the space are exposed brick that have been covered with a clear sealer type finish. The presence of this sealer was noted as a deficiency. Sealers applied to masonry can often accelerate or exacerbate material deterioration by trapping moisture within the wall.

Figure II-42. View of Kitchen B05.

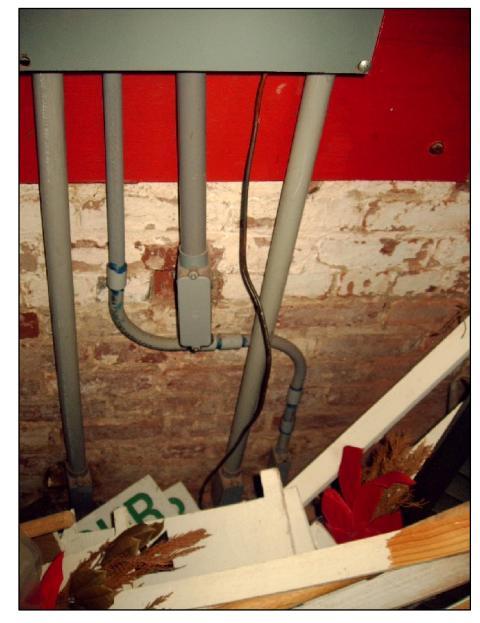
Figure II-92. Storage debris near electrical panel.

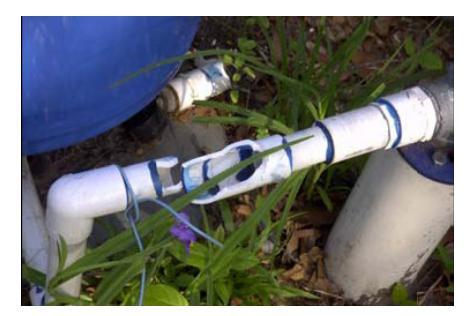
*Figure II-101. Damaged irrigation water piping at pump.*

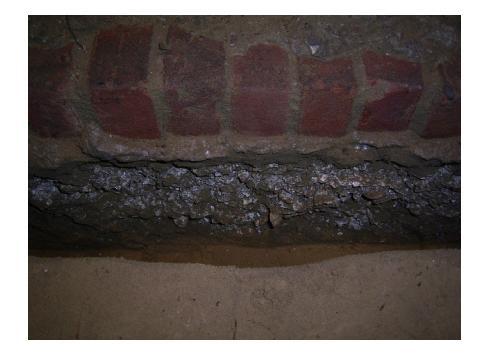
Figure II-113. Close-up of north foundation wall and oyster shell layer in builder's trench.
