# Petoskey Slope Failure Study

Petoskey, Michigan

September 16, 2020 | 13269.601.R1.Rev0

## 13269.601.R1.Rev0

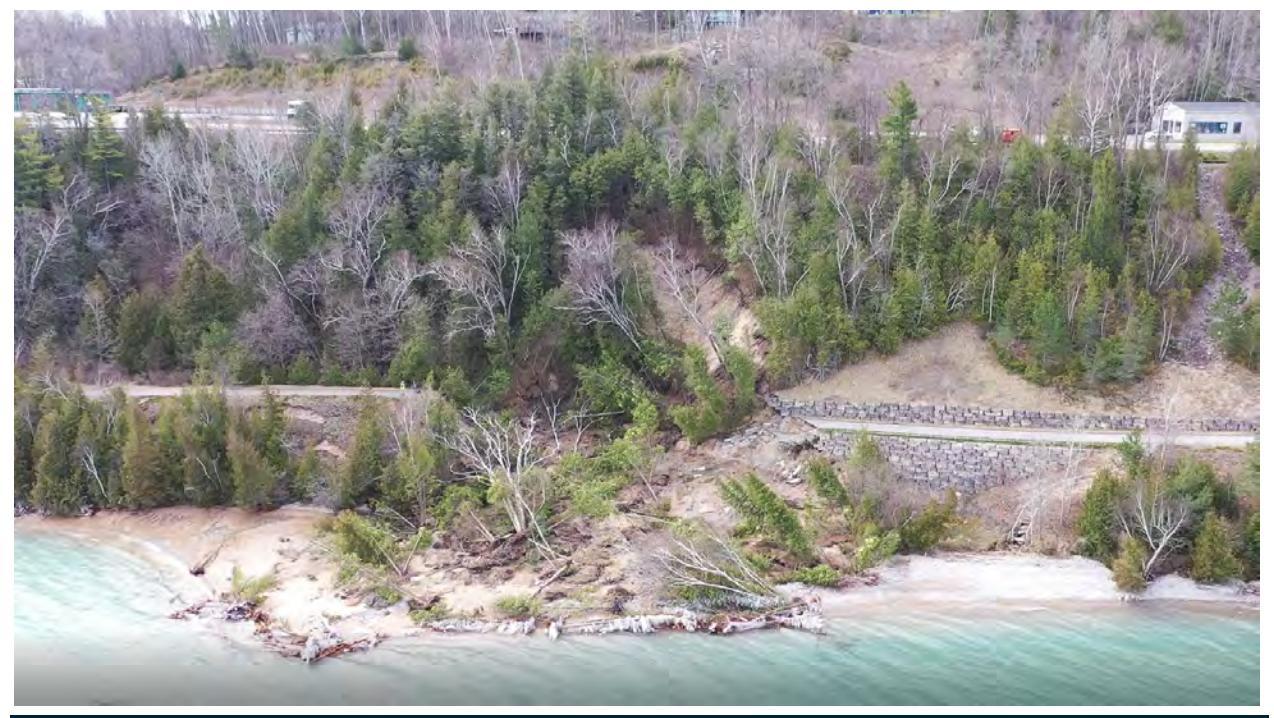
Unfortunately, near the onset of this study (on April 13, 2020) a large section of coastal bluff slope collapsed during a Lake Michigan storm event; destroying approximately 150 lineal feet (LF) of trailway. Fortunately, there were no injuries and although the extent of the failure nearly reached the U.S. Highway 31, it did not cause damage to or require closure of this roadway, which is a main arterial route between Petoskey and neighboring municipalities.

Figure 1.2: Photo 1 - UAV Image of April 13, 2020 Coastal Bluff Slope Collapse (Baird, 2020)

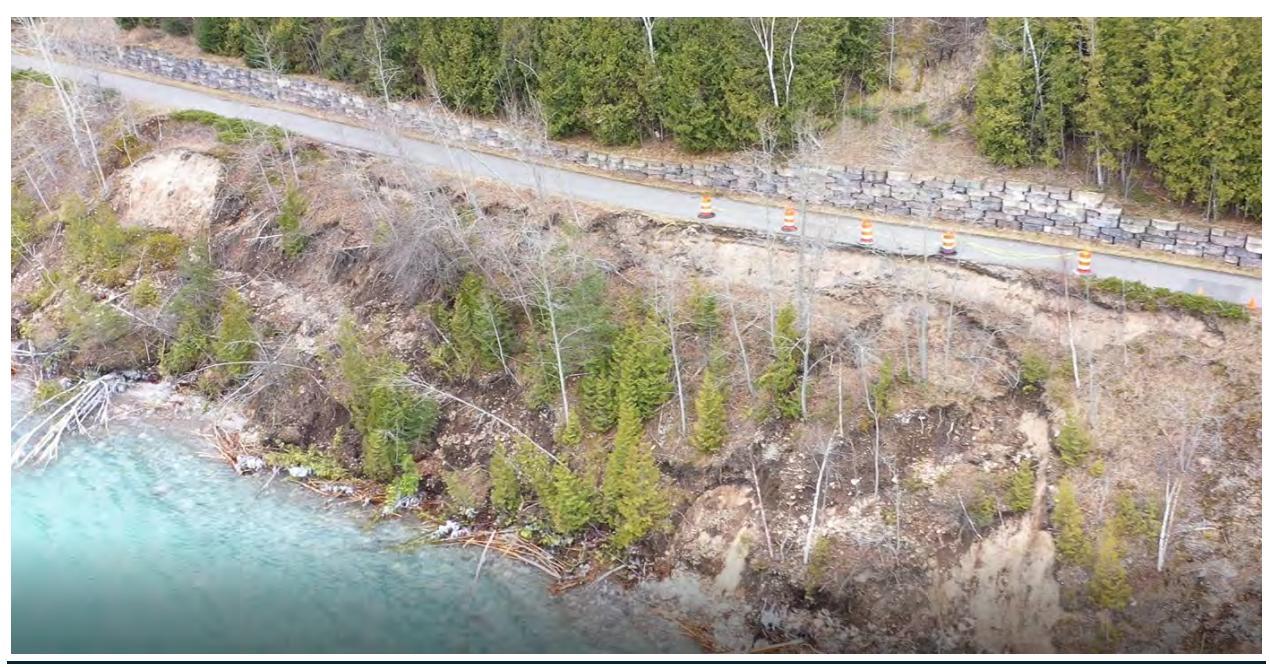
Figure 1.3: Photo 2 – UAV Image of Minor Sloughing Failures (Baird, 2020)

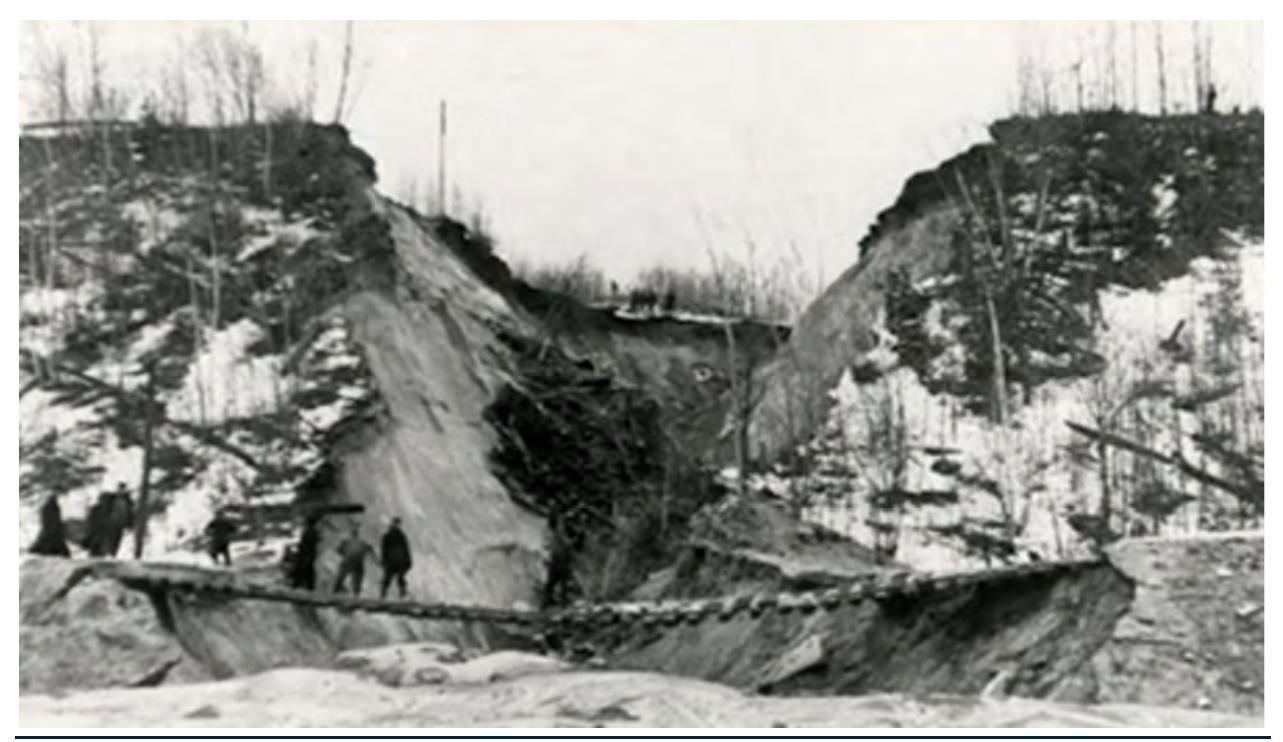
Some evidence of shallow surface slides (not occurring in the recent past) are evident. We know of one past significant failure circa 1913 (as shown Figure 2.2); however, the location and exact date of this event could not be confirmed and this appears to be related to a landside "washout" as opposed to failure of the slope. More recently, several relatively shallow surface slides have occurred (first reported to the project team in late 2019). Finally, as noted, one other more significant slide occurred on April 13, 2020. This slide, as opposed to the recent shallow slides—was a rather deep-seated coastal bluff collapse. This particular slide was utilized to "tune" the soil parameters for the slope stability analyses aspects of this study (described in Section 4.2).

Figure 2.2: Historic Coastal Bluff Washout (1913)

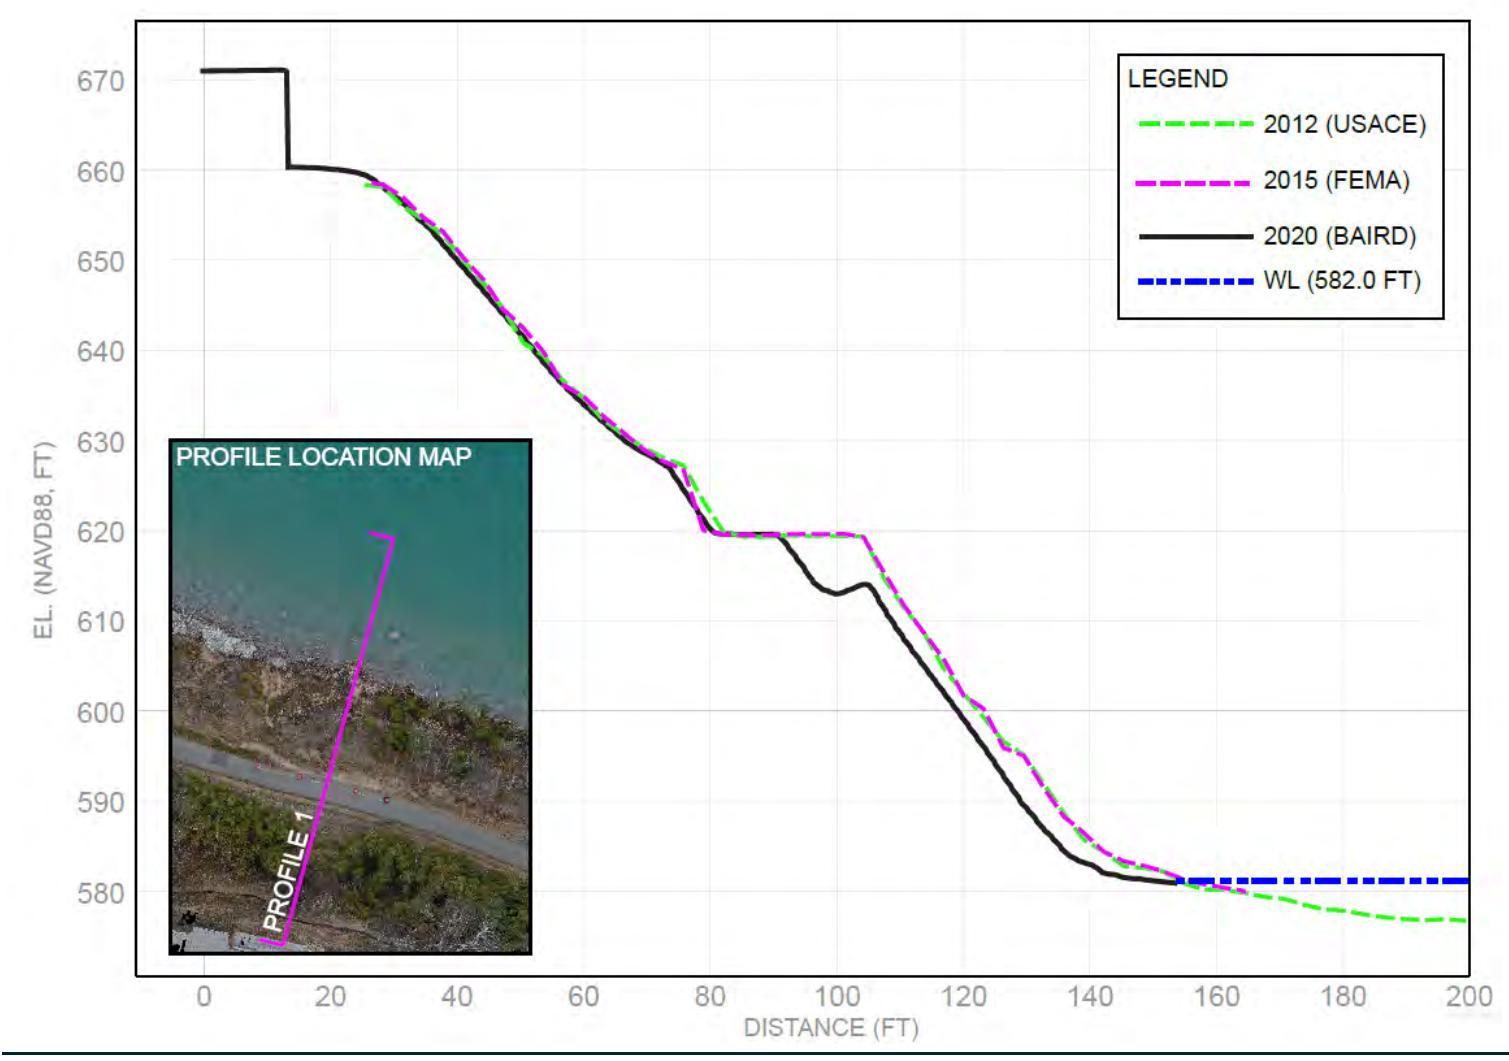
Figure 2.4: Bluff Profile Comparison (2012 to 2020) – Slough Failure

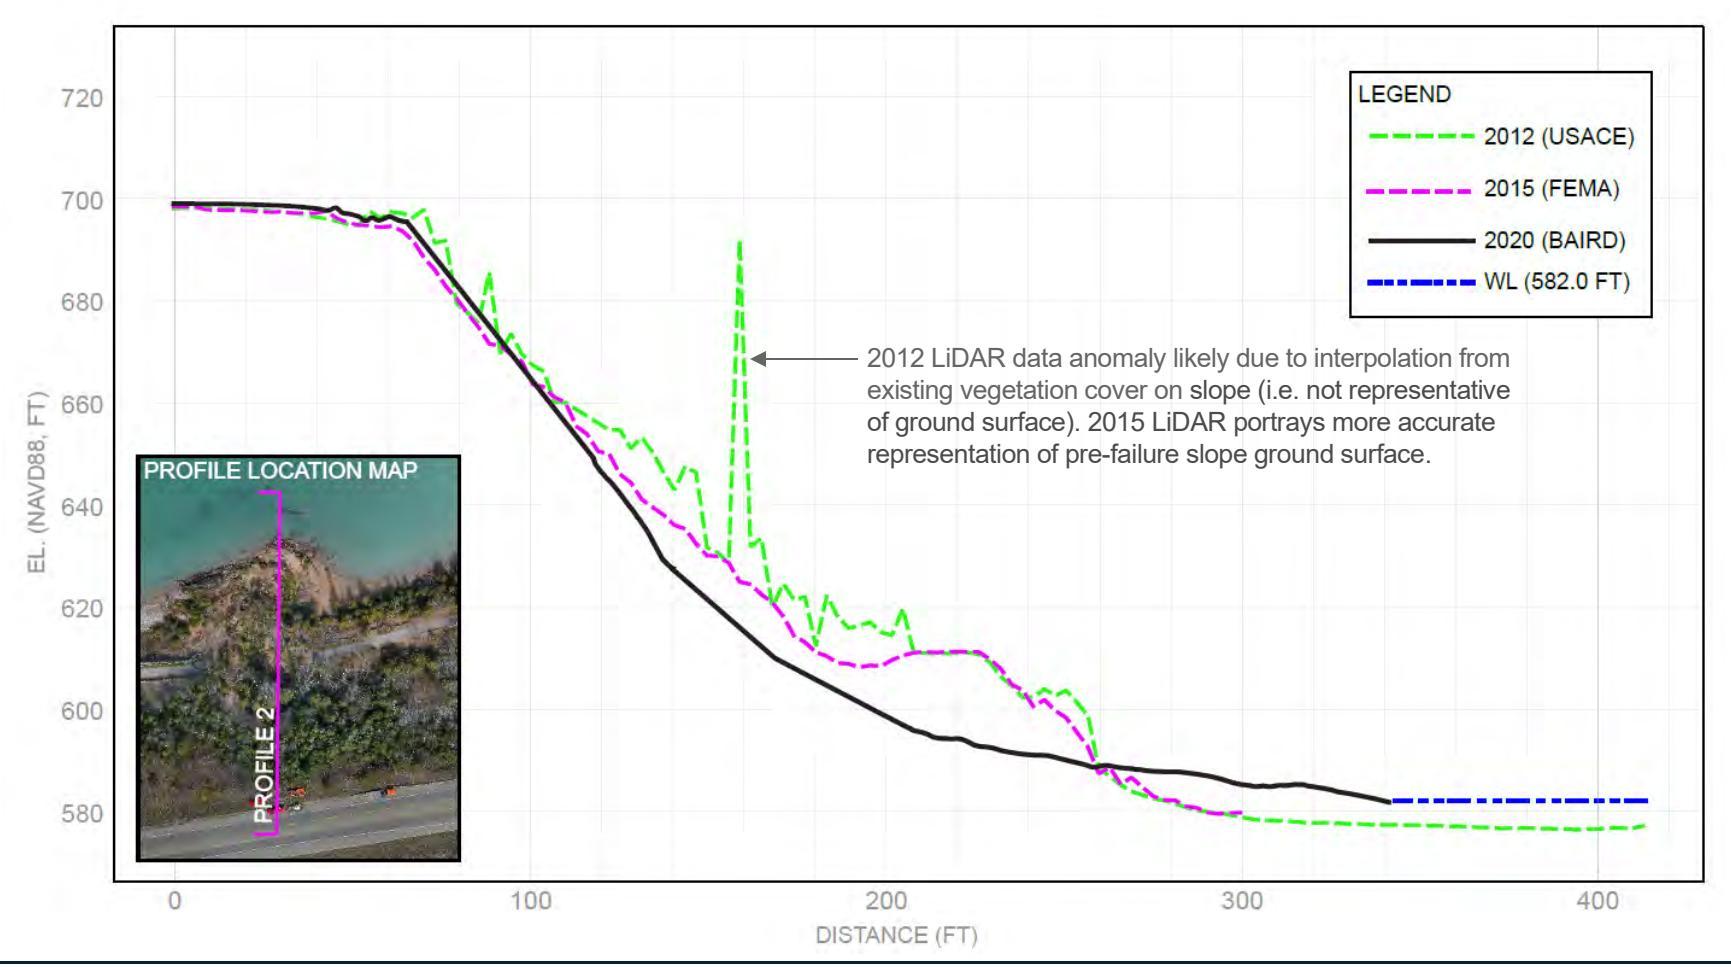
Figure 2.5: Bluff Profile Comparison (2012 to 2020) – Deep-seated Failure

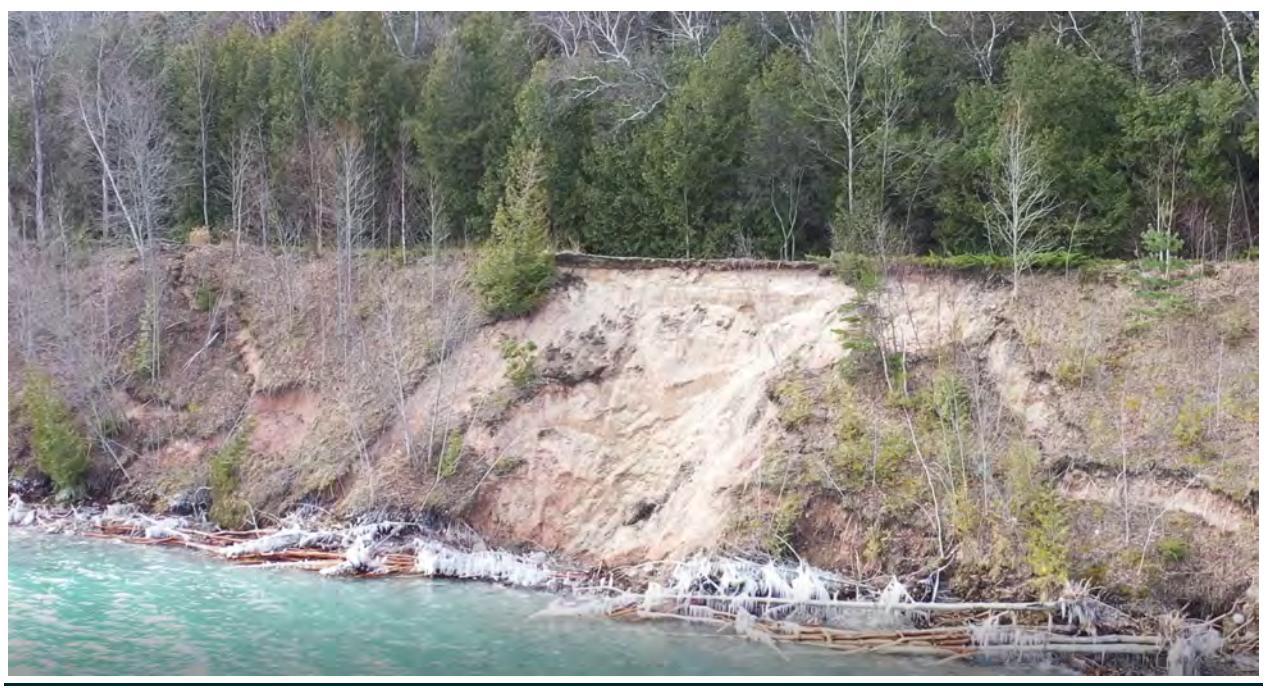
Figure 2.11: Existing Slope Failure and Nearshore Bluff Recession

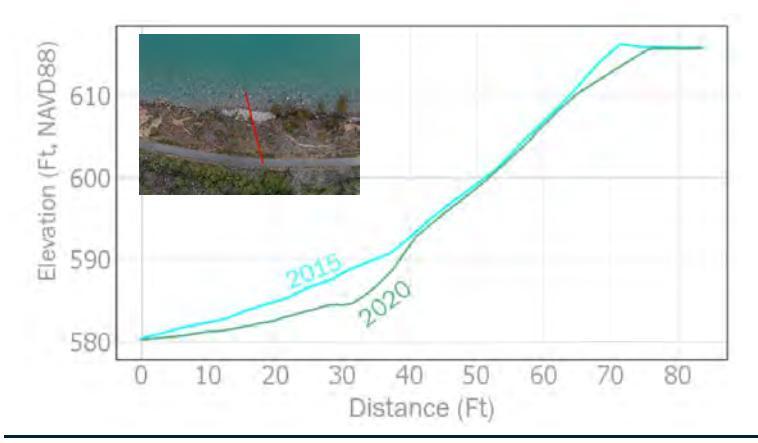
A profile through the same location that was modeled (comparing the 2015 FEMA LiDAR with the 2020 Baird UAV survey data) shows approximately 12 m (~40 ft) of recession at the toe of the bluff, with patterns similar to that portrayed in the COSMOS results (i.e. minimal erosion/ change in lakebed elevation/ recession of the nearshore bluff toe), as shown in Figure 4.4.

Figure 4.4: Survey Profile Comparison (2015 FEMA LiDAR and 2020 Baird UAV)
