CONDITION SURVEY REPORT & REPAIR RECOMMENDATIONS

PHOENIX PLAZA & PARKING GARAGE Pontiac, MI

Submitted by: DESMAN Associates May 2012

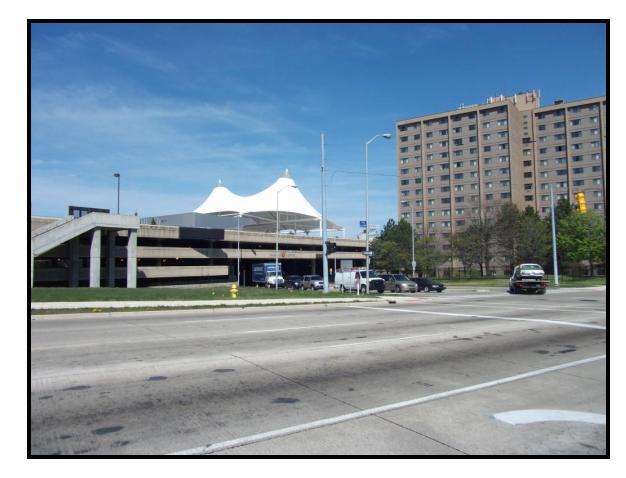
Photo #3.01

bound) and Orchard Lake Road/Auburn Avenue and is considered a west elevation. A finished plaza is situated on the roof level and consumes the entire footprint of the garage.

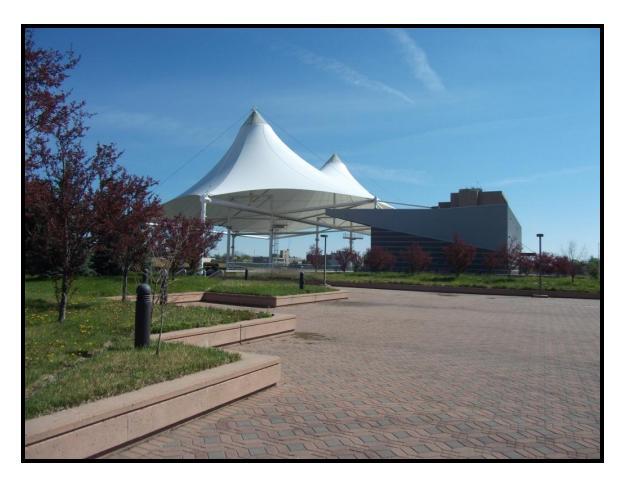
Photo #3.02

fabric canopy supported by a structural steel frame and cable system – see **Photo #3.02**. The Plaza is accessed by six sets of stairs located around the perimeter of the structure. Access to the Plaza is also provided from the three multi-story buildings adjacent to the structure. Access within the footprint of the Plaza is provided by stair & elevator towers, which

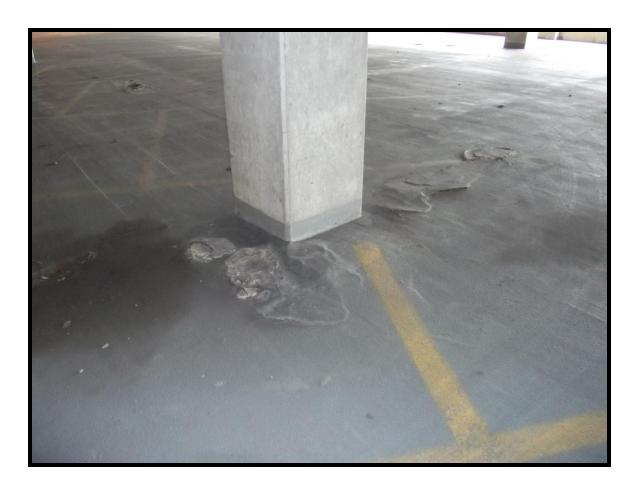
Photo #4.01

The floor slab deterioration primarily consisted of delaminations and spalling, which is believed to be due corrosion of the mild reinforcing steel as a result of chloride exposure. **Photo #4.01** displays typical top surface floor slab deterioration in the form of concrete delaminations – note the heaving in the top surface of the concrete slab near the column. **Photo #4.02** displays typical

The concrete deterioration in the form of delamination and spalling on the top surface of the floor slabs needs to be repaired. The repairs would involve removing the deteriorated concrete, cleaning the steel reinforcement, and patching the areas with a ready-mix concrete material. The concrete spalls located on the soffit of the floor slabs should be repaired in the same manner, except that a pre-packaged engineered repair material would be utilized. During this time all broken post-tensioning tendons would need to be spliced or replaced and re-stressed. This would involve removing concrete from around the PT strands and/or anchors, splicing new strand to the old strands, installing new hardware as required, re-stressing the strands, and patching the areas with a ready-mix concrete material.

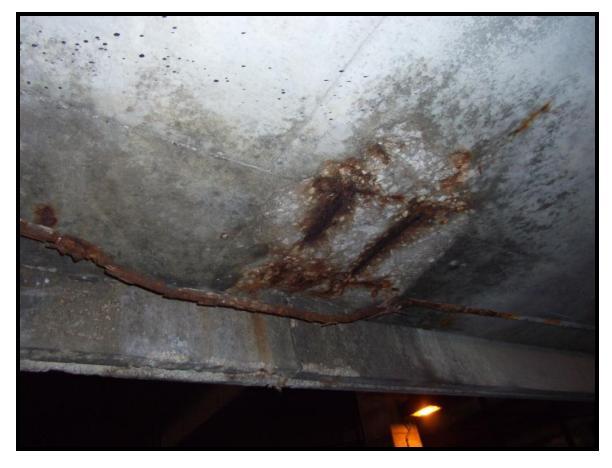
Photo #4.02

soffit floor slab deterioration in the form of concrete spalling – note the corroded reinforcing steel at the location of the spall. In order for corrosion of the reinforcing to

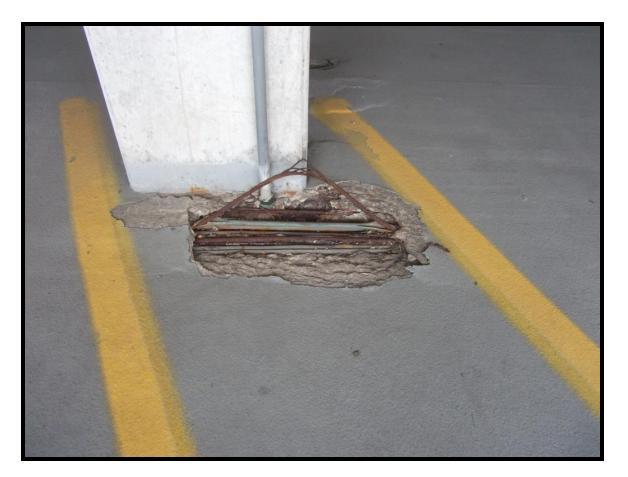
Photo #4.03

system is the main reinforcing system in the slabs and any loss would result in diminished structural integrity of the slab. During the survey a number of broken and/or de-tensioned post-tensioned cables were observed – see **Photo #4.03**.

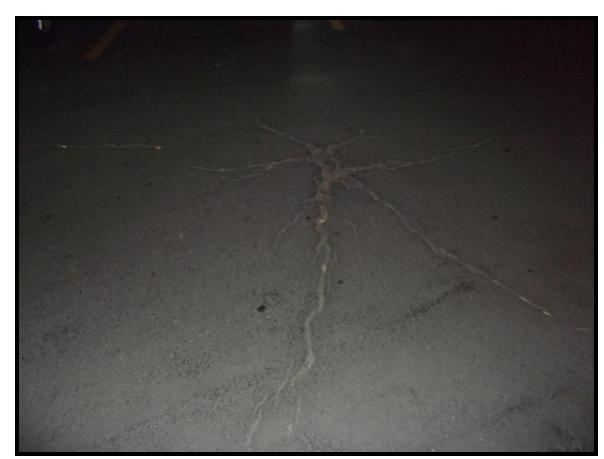
Photo #4.04

parking garage. As mentioned, the slab-on-grade consists of a bituminous asphalt pavement. The most significant observed deterioration was a large heaved area on the south half of the garage. **Photo #4.04** displays cracks in the asphalt due to heaving. This is most likely due to the use of an unstable fill material or a contaminated fill material at this location.

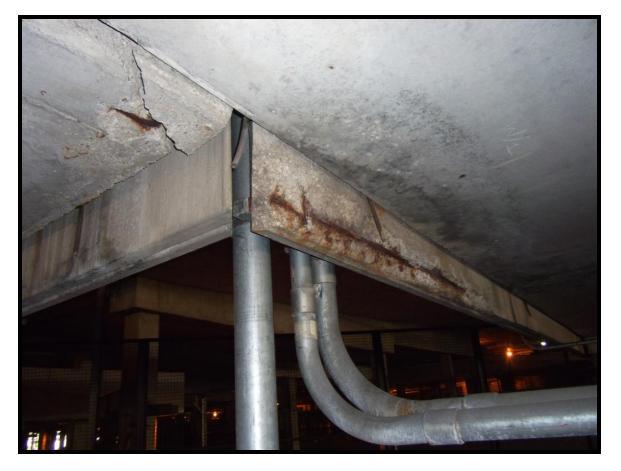
Photo #4.06

deterioration at these locations typically occurred at the bottom of the wall section and was in the form on concrete cracking, delaminations, and spalling – See **Photo #4.06**. The deterioration is believed to be due to corrosion of the mild reinforcing steel due to exposure to chloride-laden moisture. The exposure, particularly for the spandrel wall sections, is most likely due to a failed

flexible cove joint sealant, which permitted chloride-laden water to leak through the joint and expose the underlying concrete.

The concrete deterioration in the form of delamination and spalling of the concrete columns and walls needs to be repaired. The repairs would involve removing the deteriorated concrete, cleaning the steel reinforcement, and patching the areas with a pre-packaged engineered repair material.

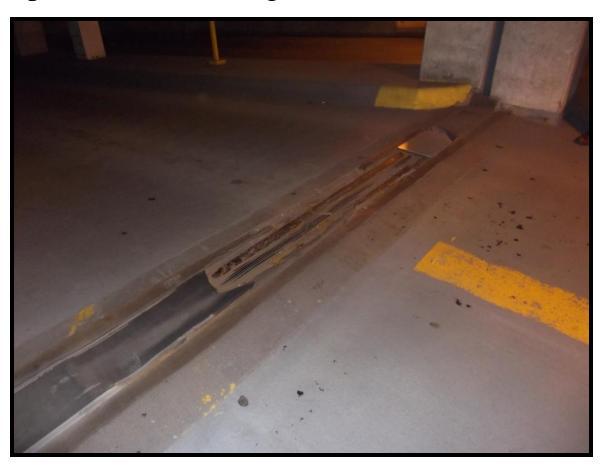
Photo #4.07

Premolded expansion systems consist of a premolded urethane seal adhered in place with a urethane nosing compound. There is usually a steel or aluminum plate below the premolded seal to allow it to span the joint opening. At numerous locations throughout the garage the joint seal is in a deteriorated state, which consists of missing sections, splits, and tears in the seal – see **Photo #4.07**. The deterioration is most likely to due to normal wear.

As mentioned, the expansion joint seals are considered to be in a deteriorated state. Therefore, we are recommending that the existing joint seals be removed at all locations and replaced with a new thermoplastic prefabricated, elastomeric winged seal that is secured with an elastomeric concrete header material.

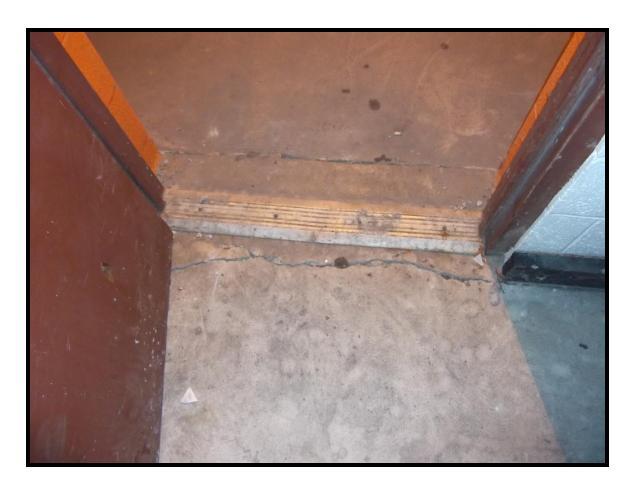
Photo #4.08

The interior stairs of the parking garage are comprised of metal pan risers with concrete in-filled treads that is supported by a structural steel frame. A majority of the stair tower deterioration observed consisted of cracking, delaminations, and spalling of the concrete in the landings, which can be seen in **Photo #4.08**. Cracked CMU block, which is utilized in the construction of the walls for these

The deterioration in the stair towers will require repair. The concrete deterioration in the landing and treads will need to be removed and replaced with either a ready mix concrete or a pre-packaged repair material. The cracks in the landings would be repaired by routing the existing cracks and then installing a polyurethane sealant. The cracked/broken CMU units should be removed and replaced in-kind.

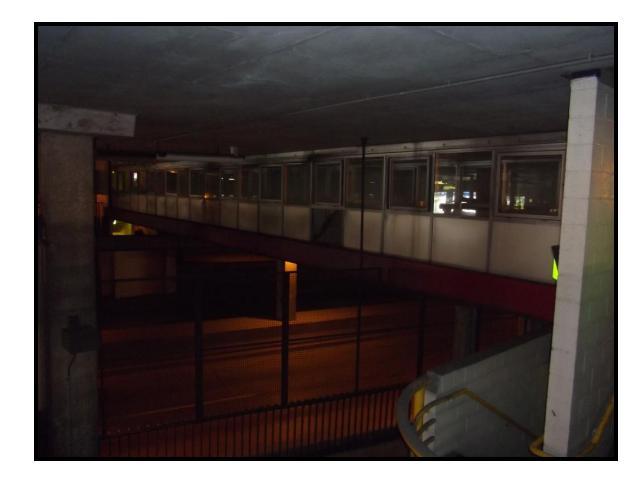
Photo #4.09

bridge, from street level, and from strategic locations within the garage – see **Photo #4.09.** At several locations the wall panels were missing/damaged and the lighting was very poor.

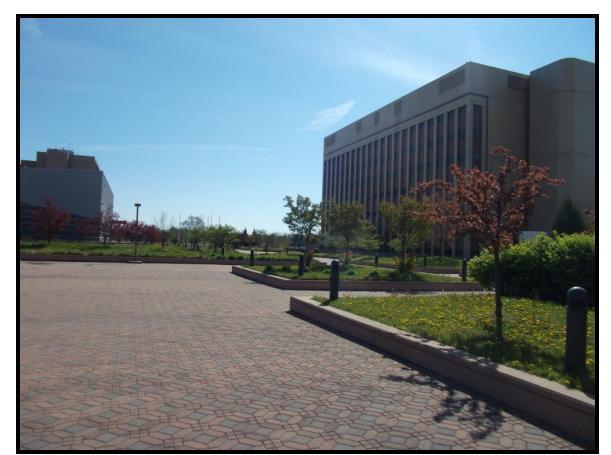
Photo #4.10

steel frame and canopy assembly – see **Photo #4.10**. The pavers, which appear to consist of concrete, displayed little to no deterioration. The walls/curbs that comprise the landscaped areas all appeared to be in "Very Good" condition. Two sections of the plaza are covered by what appears to be an elastomeric traffic bearing waterproofing membrane – similar to

the garage. The membrane is displaying some wear. The top surface of the structural slab was not observed due to the overburden. The flower beds and landscaped areas were overgrown and not in a maintained state.

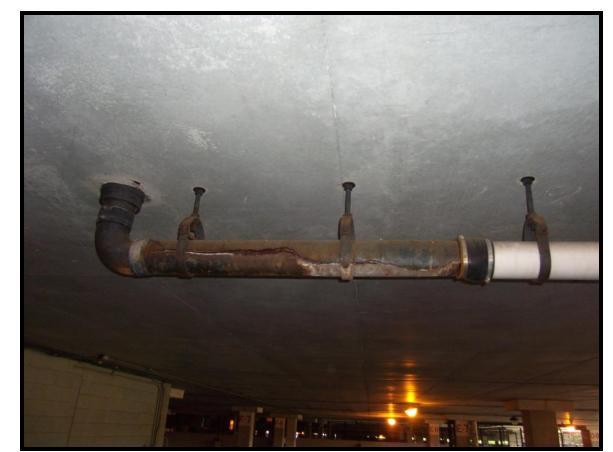
Photo #4.11

At numerous locations the drains appeared to be clogged, the grating missing/broken or it was highly corroded, and/or the drain body corroded. The branch piping, which

primarily consisted of cast iron pipe, was cracked at numerous locations throughout the garage. Cracked pipes usually occur when the pipe becomes clogged, water then fills the pipe, freezes and expands, which causes the pipe to crack – see **Photo #4.11**. Portions of the branch piping appear to be heat traced but it is not certain whether or not this system is currently operational.

The deterioration associated with the drains and branch piping will be addressed. Repairs would consist of installation of new drains, drain grating, and removal and replacement of cracked branch piping in-kind.

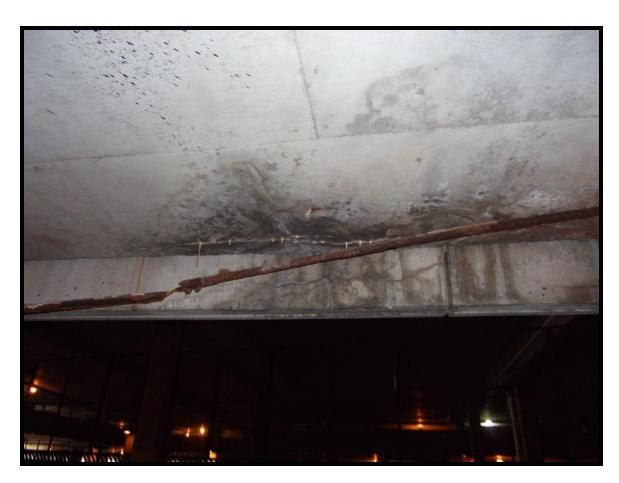
Photo #4.12

fixtures. At numerous locations the light fixture is either missing completely, not functioning, and/or missing a lens. Also, at several locations the conduit is corroded due to exposure to chloride-laden moisture that migrated from above through a crack, failed joint seal, etc. **Photo #4.12** displays a section of highly corroded conduit.

The deterioration associated with the lighting and electrical conduit should be addressed. All broken and non-functioning light fixtures would be removed and replaced in-kind and sections of corroded conduit would be replaced in-kind. The intent upon completion of this program would be to have all light fixtures operational.
