#### **GENESEE COUNTY INVITATION FOR BIDS #17-121**

6063 Natchez Dr, Mt. Morris Twp. 48458

#### IFB #17-121 - REHABILITATION OF A SINGLE-FAMILY HOME

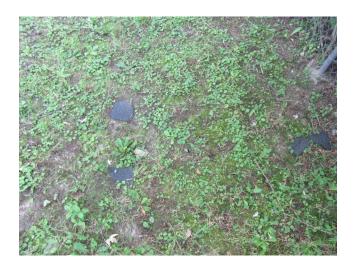
12-Grounds Roof Shingles On Ground
