Dunn Warehouse Adaptive Reuse

Redevelopment Analysis and Master Plan

SARATOGA
ASSOCIATES

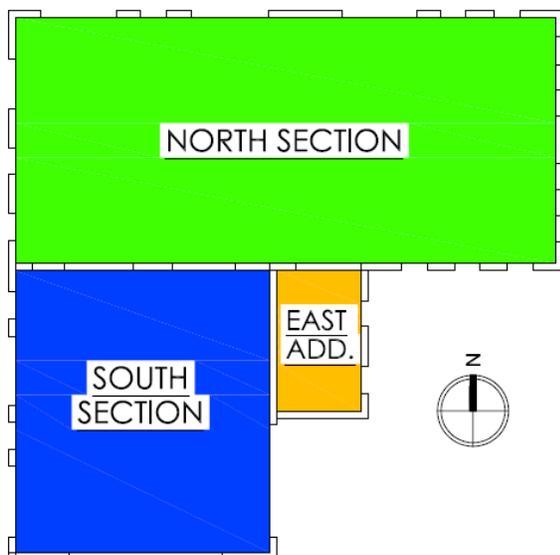
The Dunn Warehouse was constructed in three distinct components as illustrated below. The North section is a relatively low structure of brick and heavy timber construction. Wood trusses span north to south and support a gabled roof and monitor. There are no intermediate supports in the structure allowing for an open and flexible floor plan. The open truss work gives it a very interesting and human-scaled appearance. A small mezzanine located in the easternmost bays is dangerously deteriorated and should be removed.

The North section has a footprint of approximately 3,200 square feet of flexible space and can readily be developed as one leasable area or subdivided into several. The demising walls in a subdivision could follow the regularly spaced wood trusses.

The South section is one story with approximately 1,750 square feet. The floor to ceiling height is much greater than the north section and could accommodate the insertion of a second floor.

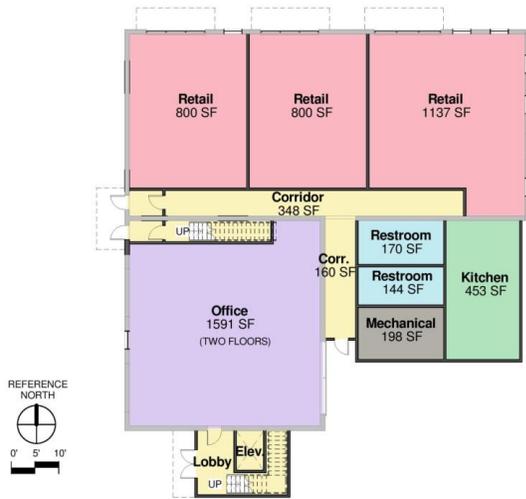
Option 1 proposes the removal of the 325 square foot east section to accommodate the men's and women's restrooms, a 450 square foot common kitchen and a mechanical room. The addition will allow for greater usable space within the existing building. **Option 2** leaves the original section and proposes converting it to a common kitchen. The common restrooms and mechanical space would be located in the southeast portion of the North Section. All would be accessible by a common corridor.

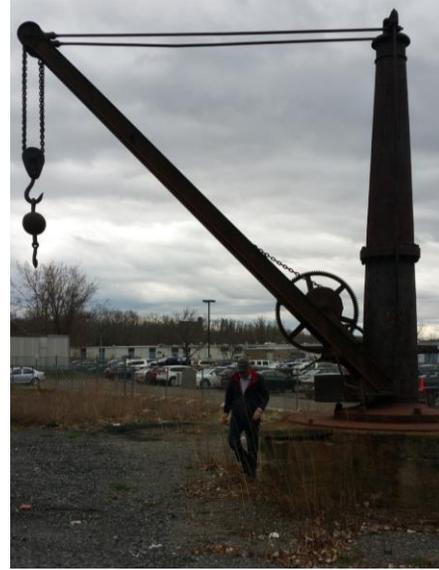
- Relocate the historic cast iron jib crane from east of the tracks to the center of the 180 degree turn of the pedestrian paving just west of Water Street. See *Illustration at right*.
- The close proximity of Dunn to the railroad station presents an opportunity to attract the large influx of weekenders travelling to Hudson from New York City. Train users are now able to walk to the Dunn from the station; however, there is no clearly identified path and the pedestrian must walk through the station parking lot to the at grade track crossing and proceed on Broad Street. A wide paved path is proposed heading south on South Front Street to Broad Street and west on Broad Street.
- The renovation and repairs to the Ferry Street Bridge, north of the Dunn should also accommodate pedestrians who wish to visit the newly revitalized waterfront.

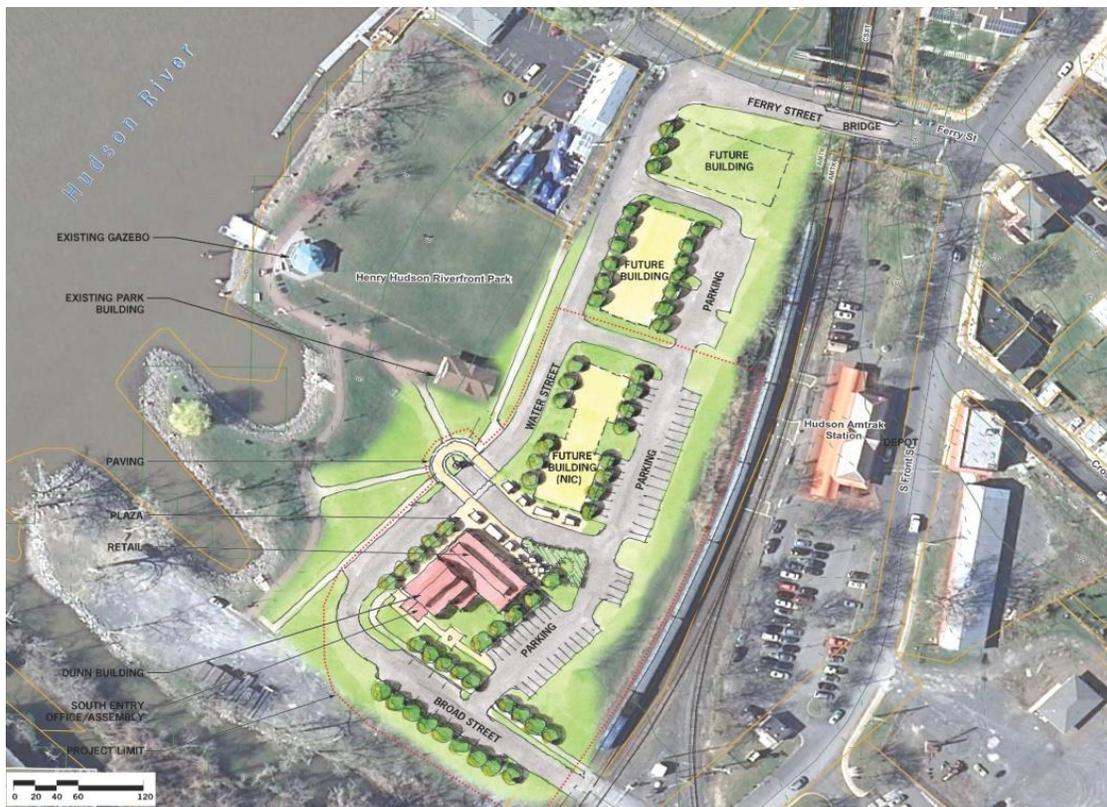
Future development is proposed north of the Dunn and generally adheres to the 1996 Vision Plan. All additional parking is proposed for the location immediately west of the rail right-of-way.

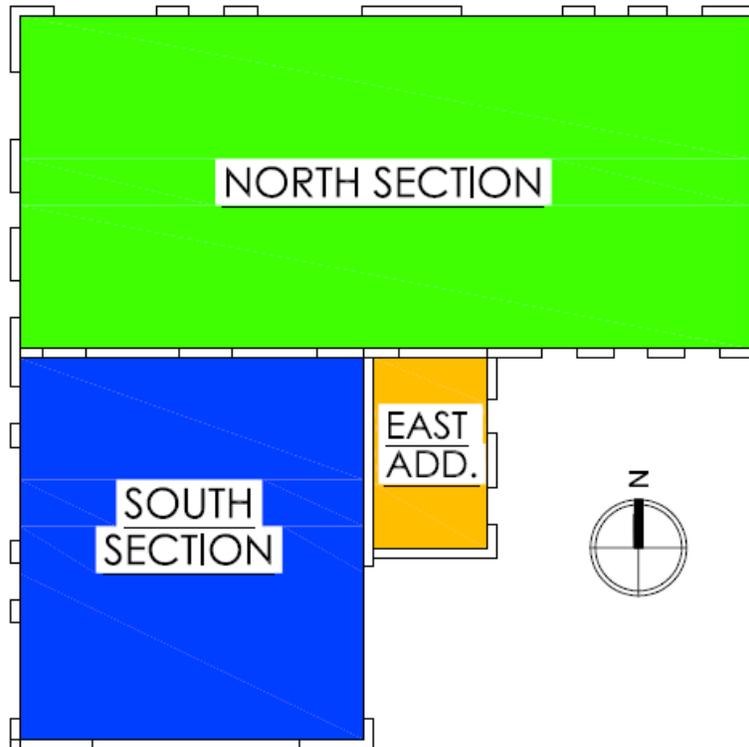
BUILDING LAYOUT PLAN

The Dunn Warehouse is composed of three sections and has an overall footprint of approximately 5,500 sf. The northern section of the building is composed of timber roof framing and masonry exterior walls, and has a small mezzanine space located along the east side. The southern section is composed of steel trusses and masonry exterior walls. The east addition, which is assumed not to be part of the original building, has a steel framed concrete roof with masonry exterior walls.

Based on historic data, the building was originally constructed around mid-nineteenth century, which matches the materials that were utilized for its construction. Over the years major modifications of the building have been conducted and were evident during the site inspection. The most notable modification was the full replacement of the north wall of the northern section, which was replaced around 2004, during the site remediation project. The second modification pertains to the roof of the southern section, which was altered from a gable to a monitor roof style. This is evident by the change in masonry unit types along the original gable roof line and the use of built-up steel trusses for the roof, which places this modification around the early twentieth century. It is also anticipated that the eastern addition was added during this same time period due to its similar built up steel roof construction.

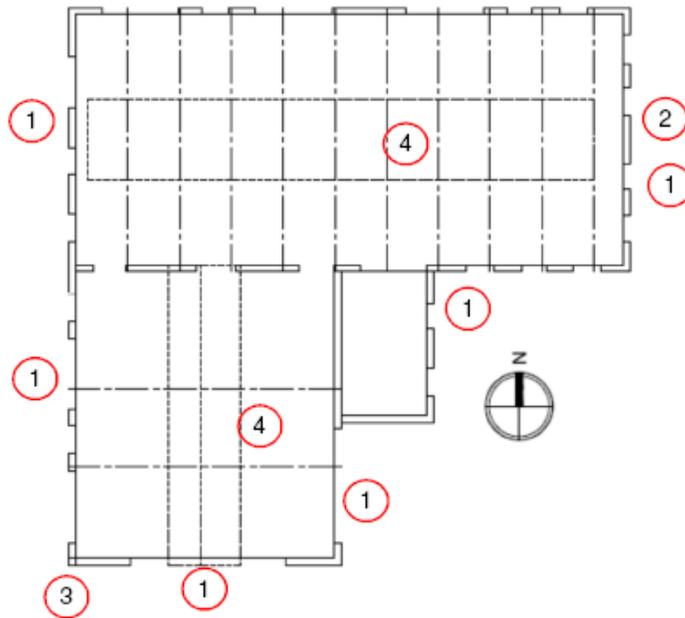
A. FOUNDATION

1. Due to the flat nature of the site, grades along the building are not adequately pitched, which allows ponding of surface water near the building edge. It is recommended that the grades be revised along the building edge to promote positive drainage. Due to site constraints, this may require the installation of new stormwater drains along the perimeter that connect into the municipal system.

2. Juvenile trees and shrubs have grown up along the east side of the north section and are directly affecting the masonry walls and foundation in this area. It is recommended that the vegetation be removed and foundation adequately assessed below grade so that corrective action can be conducted. The exact scope is unknown, but will most likely consist of replacement of deteriorated units and repointing of mortar joints.

3. A large tree is located along the southwest corner of the building and its roots extend adjacent to the west side foundation wall. The roots have most likely affected the foundation in this area in that a significant number of cracks were observed in the masonry wall above. These cracks are most likely due to a number of factors, one of them being the root penetration of the foundation masonry joints.

4. The floors of the building, excluding the west addition, were dirt. It is not known if this was always the case, or if they were removed during the site remediation project. It is recommended, at a minimum, that a 10 mil polyethylene vapor barrier be installed on the floors and covered with gravel material to prevent ground moisture from entering the interior space. It is most likely that the floors will have a concrete slab on grade, but it is not recommended that the slabs be installed until after the intended use has been determined.

The most direct solution to resolve this issue would be removal of the tree. However, this action would need to be weighed against the tree's landscaping presence and how its removal will affect the site as a whole. It is recommended that a certified arborist assess the tree's condition to determine if the roots could be removed and/or altered from around the foundation so that in general, the structural composition of the building was found to be in fair condition. Major items of concern were observed and are indicated below in **bold text**. These items pertain to load bearing elements and may lead to life safety issues should corrective action not be taken.

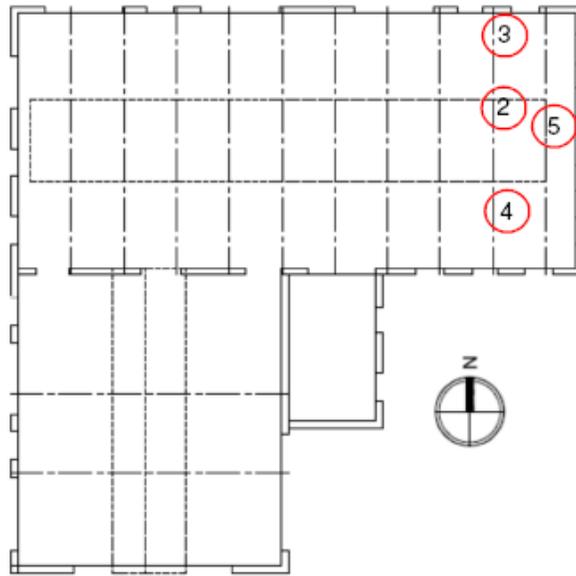
B. MEZZANINE FRAMING

1. In general, the overall framing condition of the mezzanine was poor. A summary of the specific issues observed is provided below along with corrective steps that should be taken should the historic integrity of the space need to be maintained. If this is not the case, and the historical attributes that the mezzanine provides is determined not to be significant, it is recommended that the space either be eliminate, or demolished and reframed.

2. The floor of the mezzanine consist of 2x8 t&g planking. Due to roof leaks, the floor was deteriorated in this area. It is recommended that the flooring and associated affected floor joists be removed and fully replaced.

3. A portion of the floor was missing along the side walls. It is recommended that new flooring be added.

4. Fully deteriorated flooring was located in this area, again due to roof leaks. It is recommended that the flooring and associates affected joists be fully replaced.

5. The trim joists of the stairwell have begun to sag and are most likely inadequate in size. In addition, the mortise and tenon connection of the trim joists is a potential failure point. It is recommended that the trim joists either be sistered with new 2x members, or replaced with larger single members that match the age of the original construction.

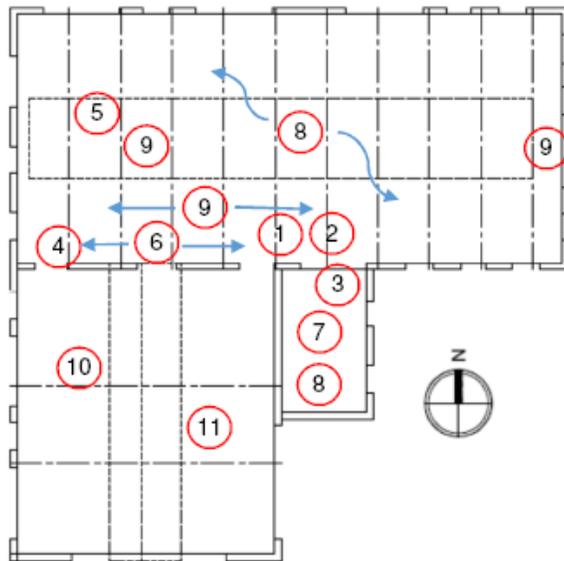
C. ROOF FRAMING

1. The most significant issue with the roof pertains to the NS timber truss #6 in from the east wall. Significant deterioration was observed at its bearing point with the south masonry wall, which has been brought about due to roof leaks in the area. The extent of the decay is to the point where it is highly recommended that temporary shoring be placed below the bearing point prior, to the next winter season.

2. Similar to the above issue, the NS timber truss # 5, from the east wall, has a similar deterioration issue at the bearing point with the south wall. The amount of decay did not appear to be as severe at that of truss #6, but should be fully assessed and corrective action taken, similar to that described above, if necessary.

3. A retrofit steel header was installed to allow access from the NS to the EA. The header consists of the two steel channels placed on either side of the wall that have been thru bolted, which allowed removal of the masonry below. It is located in the same area as truss #5 mentioned above and has significant amount of corrosion. It is recommended that the extent of the deterioration be fully assessed and corrective action taken, if necessary. Such action could involve installation of new steel members below, infilling the opening if it

4. Previous repair of the NS timber trusses was noted in these area. This was most likely conducted during the soil remediation project, during which the entire north wall of the NS was replaced.

5. Rotted top plate member of the upper roof was noted in this area along the roof hatch. It is recommended that the member be replaced along with the affected roof planking.

6. Another critical issue with the NS roof was the poor flashing condition at the roof junction with the SS and EA north walls. The slope of the gutter line is insufficient to promote proper drainage and the built-up asphalt flashing was observed to have numerous leaks. It is recommended that the trough gutter be reframed to create a constant pitch from the west wall to the east daylight point at a minimum slope of 1 on 12. The gutter should be constructed of a continuous roofing membrane, such as epdm or equal, and extend an adequate distance up the adjoining wall and gable roof to allow for snow build up. Due to the complexity of the gutter line at the transition with EA and the potential aesthetic effect of the reframed gutter trough, another option could be the installation of an internal drain.

7. The roof of the EA consists of a 4" concrete slab supported by built-up steel rafters. Cracks in the concrete slab were observed in numerous locations along with exposed and corroded steel reinforcement. With that said, no sign of weakness in the slab was observed when walking above. It is recommended that the location of the main cracks be documented and monitored for future movement.

8. The entire roofing material for the NS and EA was observed to be in poor condition and has active leaks that are affecting the structure below. It is recommended that the roofing material be fully replaced. Due to the age of the roofing, asbestos fibers may exist and should be determined and accounted for in the reconstruction costs.

9. Various sections of the NS roof decking were observed to be soft and had active leaks below. It is anticipated that these sections of decking will need to be fully replaced during the reroofing process. The majority of the soft areas were located along the south side of the NS. For budgeting purposes, it is anticipated that 50% of roof deck will need to be replaced.

10. The condition of the SS roof trusses could not be fully conducted due to the restrictive height of the space. From what could be observed, no signs of material failure, such as warping or misalignment of truss members, were identified. However, surface rust did cover the majority of the roof's steel members and the possibility of cross-sectional loss due to corrosion cannot be ruled out. It is recommended that lift equipment be utilized to allow full assessment of the roof trusses to determine the basic member sizes, connection detailing, member cross-sectional lose, and the exposure of any heavily corroded area. Of particular concern would be the bearing points along the

11. The roofing material of the SS consists of corrugated metal and was observed to be significantly rusted. It is recommended that the roofing be covered over or fully replaced with new metal roofing. The use of alternate roofing types may also be utilized, but an assessment of the roof framing should first be conducted to ensure that it will not induce an overstress condition.

The initial part of the repair step will involve conducting a full engineering assessment of the affected truss in order to determine the extent of the decay. Once fully determined, a reinforcement plan can be developed to adequately address this issue. Based on past experience, this will most likely consist of replacing and/or reinforcing the bottom and top chord with steel members. The repair will also need to incorporate the replacement of the affected roof planking above, along with the roofing material to prevent further water infiltration.

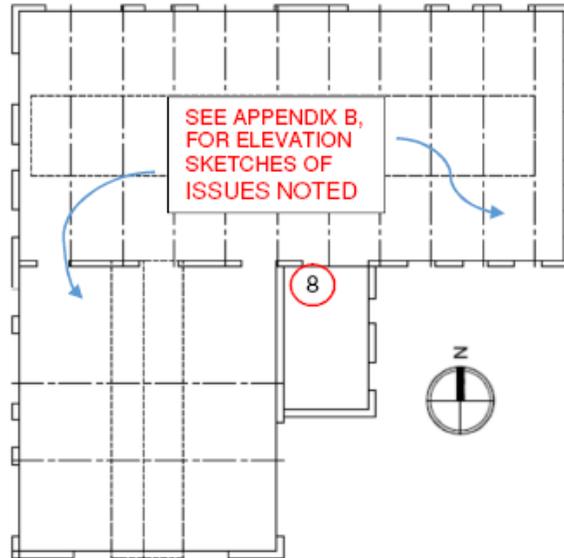
D. EXTERIOR WALLS

1. The most significant issues with the building pertains to the condition of the masonry exterior and interior walls. Numerous factors have affected the condition of the masonry namely poor grading around the building, placement of masonry below grade, vegetative growth, water infiltration thru the roof, modification of the walls with varying strength materials, alteration of the walls with large steel headers, poor repointing methods, and inadequate lateral support. A summary of the specific issues observed with the walls is provided below. To further aid in the assessment process, cursory elevation sketches are included in Appendix B that have been marked up to show the problem areas, and the areas have been numbered to match that discussed below.

2. A common problem with a masonry building of this age is called dampness rising. In simple terms, dampness rising involves the transfer/rise of water through the masonry via capillary action when in contact with the ground or other water source. The water degrades the masonry assemblage over an extended period of time via the freeze thaw cycle. Signs of rising dampness were observed on all walls of the building.

3. Eroded mortar joints were observed on all four sides of the building. The eroded joints are most likely caused by the natural deterioration of the soft lime mortar overtime. It is recommended that the joints be raked and repointed. The repointing mortar should be a soft cement / lime base mix to match the original physical properties of the original mortar. Analysis of the existing mortar is recommended to ensure compatibility.

11. Vine growth was observed on two location of the exterior wall. It is recommended that all vines be removed and masonry repaired as necessary.

Due to the heavy growth on the east wall of NS, full review of masonry could not be conducted.

The most expensive method utilized to correct this condition involves the injection of a liquid membrane at the foundation line to prevent the water from rising into the brick. A less expensive option, but not as full proof, would be to redirect the grade away from the building, along with installation of surface gutters at the building edge. The surface gutters would consist of gravel trenches lined with waterproof membranes that would extend a minimum of 3 ft from the building edge. A perforated drainage pipe would be placed within the gravel and directed towards the municipal system. Once a remedy has been determined to address the rising dampness, the affected / deteriorated masonry units should be removed and replace with like-kind units and all eroded mortar joints repointed.

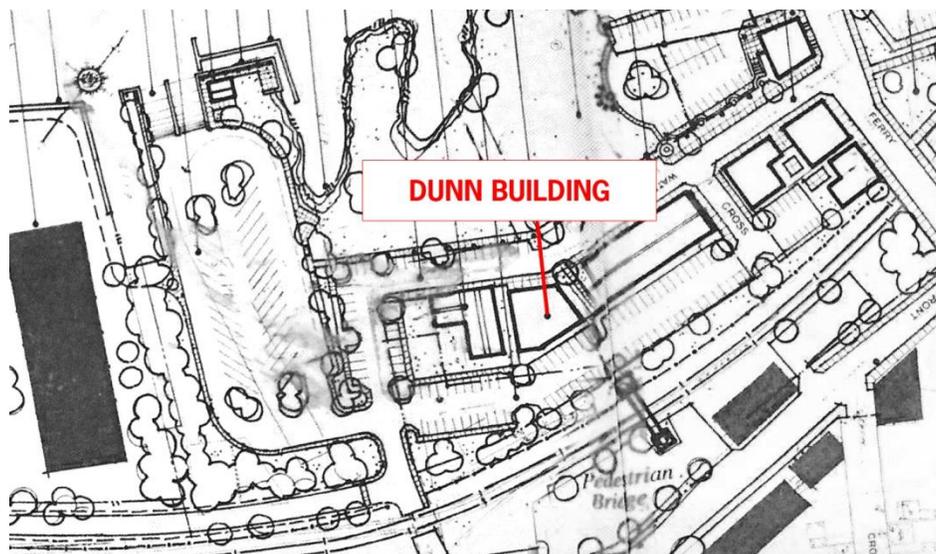
Figure A. Detail of 1996 Vision Plan

Returning the Dunn Warehouse to an active and vibrant role in the community is a natural next-step in reconnecting the Hudson River to community life albeit as a recreational and commercial district. The City has developed a wonderful Park directly across Water Street from the Dunn Warehouse which serves as both passive and active recreational activities. Directly to the north is an active marina. To the north east, immediately across the railroad tracks is the Amtrak Station, both an historic and 24/7 facility.

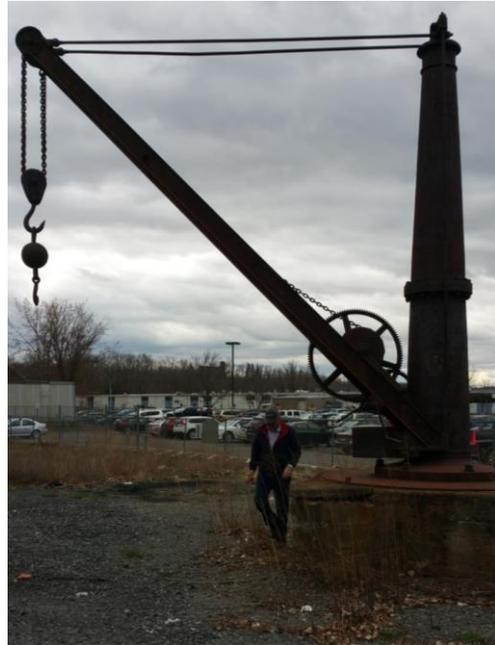
- Relocate the historic cast iron jib crane from east of the tracks to the center of the 180 degree turn of the pedestrian paving just west of Water Street. See *Illustration*.
- The close proximity of Dunn to the railroad station presents an opportunity to attract the large influx of weekenders travelling to Hudson from New York City. Train users are now able to walk to the Dunn from the station. However there is no clearly identified path and the pedestrian must walk through the station parking lot to the at grade track crossing and proceed on Broad Street. A wide paved path is proposed heading south on South Front Street to Broad Street and west on Broad Street.

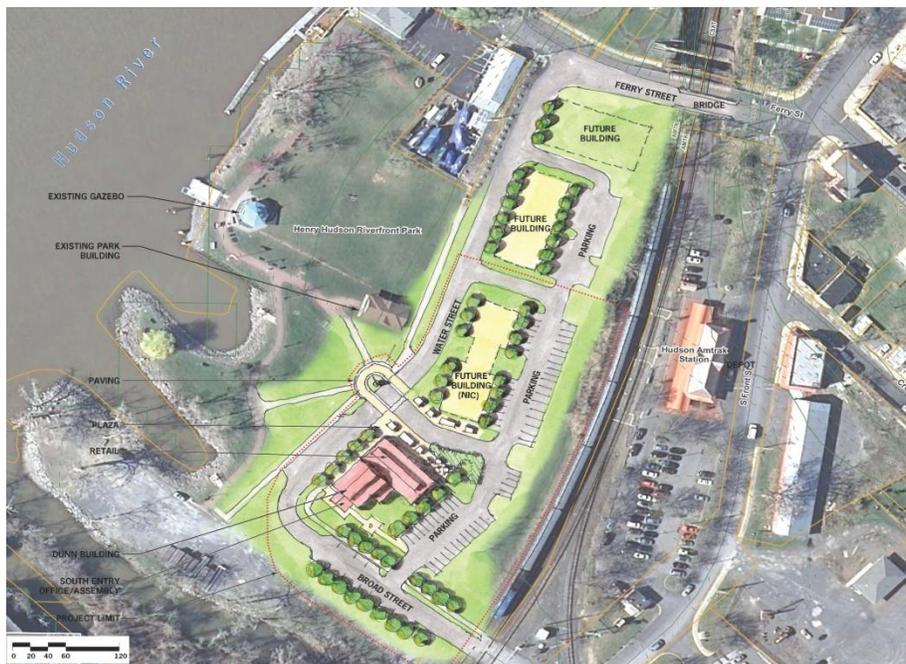
- The renovation and repairs to the Ferry Street Bridge, north of the Dunn should also accommodate pedestrians who wish to visit the newly revitalized waterfront.
- Future development is proposed north of the Dunn and generally adhere to the 1996 Vision Plan. All additional parking is proposed for the location immediately west of the rail right-of-way.

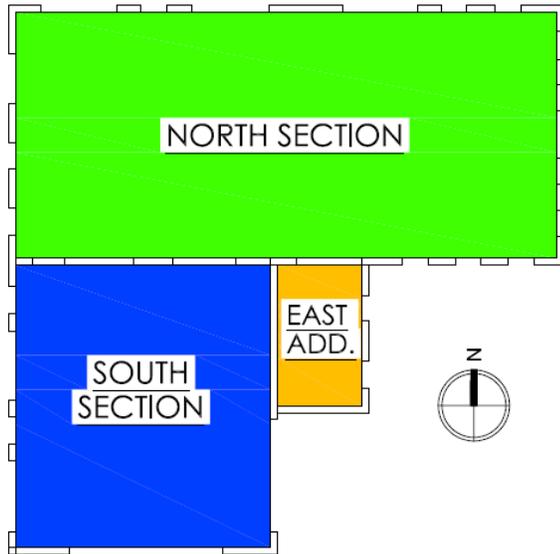
The Dunn Warehouse was constructed in three distinct components as illustrated below. The North section is a relatively low structure of brick and heavy timber construction. Wood trusses span north to south and support a gabled roof and monitor. There are no intermediate supports in the structure allowing for an open and flexible floor plan. The open truss work gives it a very interesting and human-scaled appearance. A small mezzanine located in the easternmost bays is dangerously deteriorated. And should be removed.

The North section has a footprint of approximately 3,200 square feet of flexible space and can readily be developed as one leasable area or subdivided into several. The demising walls in a subdivision could follow the regularly spaced wood trusses.

The South section is one story with approximately 1,750 square feet. The floor to ceiling height is much greater than the north section and could accommodate the insertion of a second floor.

The East section is a single one-story space of approximately 325 square feet.

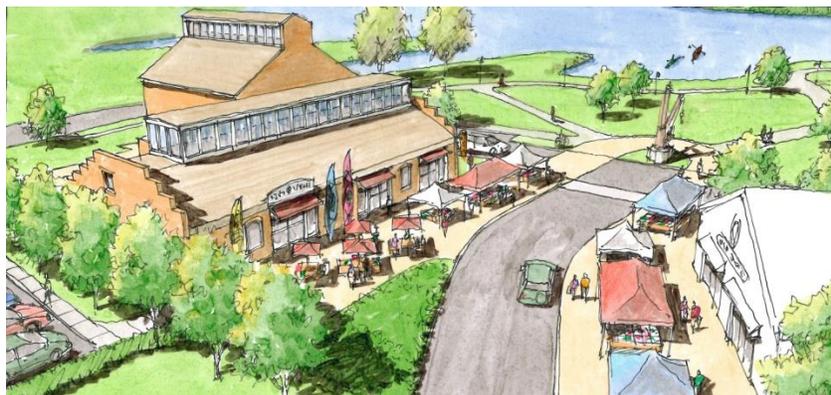
Two Design Options are presented in order to give the City flexibility in seeking a lessee or developer. It is the intent that the building be secured by the City or the building is renovated to a level where only a fit-up is required by a lessee. Fit-up ready means the entire envelope (walls, windows and roof) be put into a pristine condition; new interior concrete floors installed and new power distributed to circuit panels, exterior wall insulation and finishes, and HVAC unit(s). Basic interior accommodations such as the common corridor, kitchen and restrooms would also be built at this time.

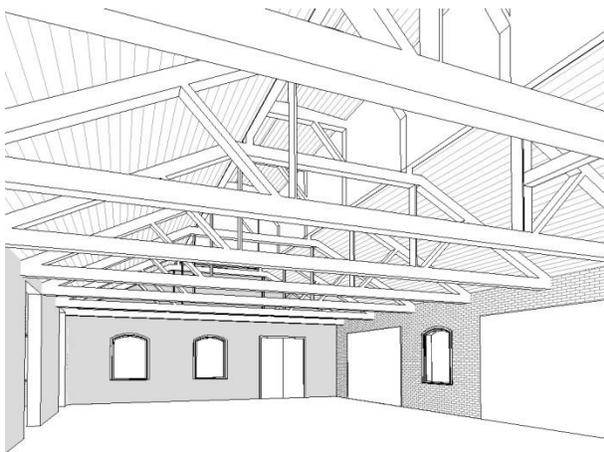
Interior Perspective – North Area Monitor A

- Exposed heavy timber wood trusses dating from the mid-nineteenth century.
- A high monitor running along the peak of the building that will let generous amounts of daylight to flood the retail floor. Multiple studies have shown the natural light from skylights in retail settings increase purchasing.
- Ample visual access through the large available openings for storefronts.
- Large, well-proportioned window openings for additional natural or window treatments.

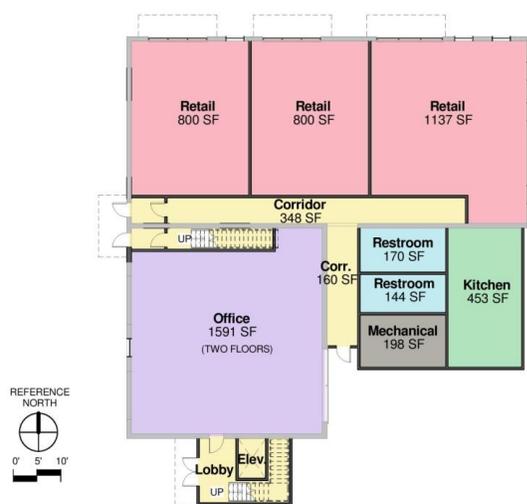
Option 1 proposes the removal of the 325 square foot east section to accommodate the men's and women's restrooms, a 450 square foot common kitchen and a mechanical room. The addition will allow for greater usable space within the existing building. **Option 2** leaves the original section and proposes converting it to a common kitchen. The common restrooms and mechanical space would be located in the southeast portion of the North Section. All would be accessible by a common corridor.

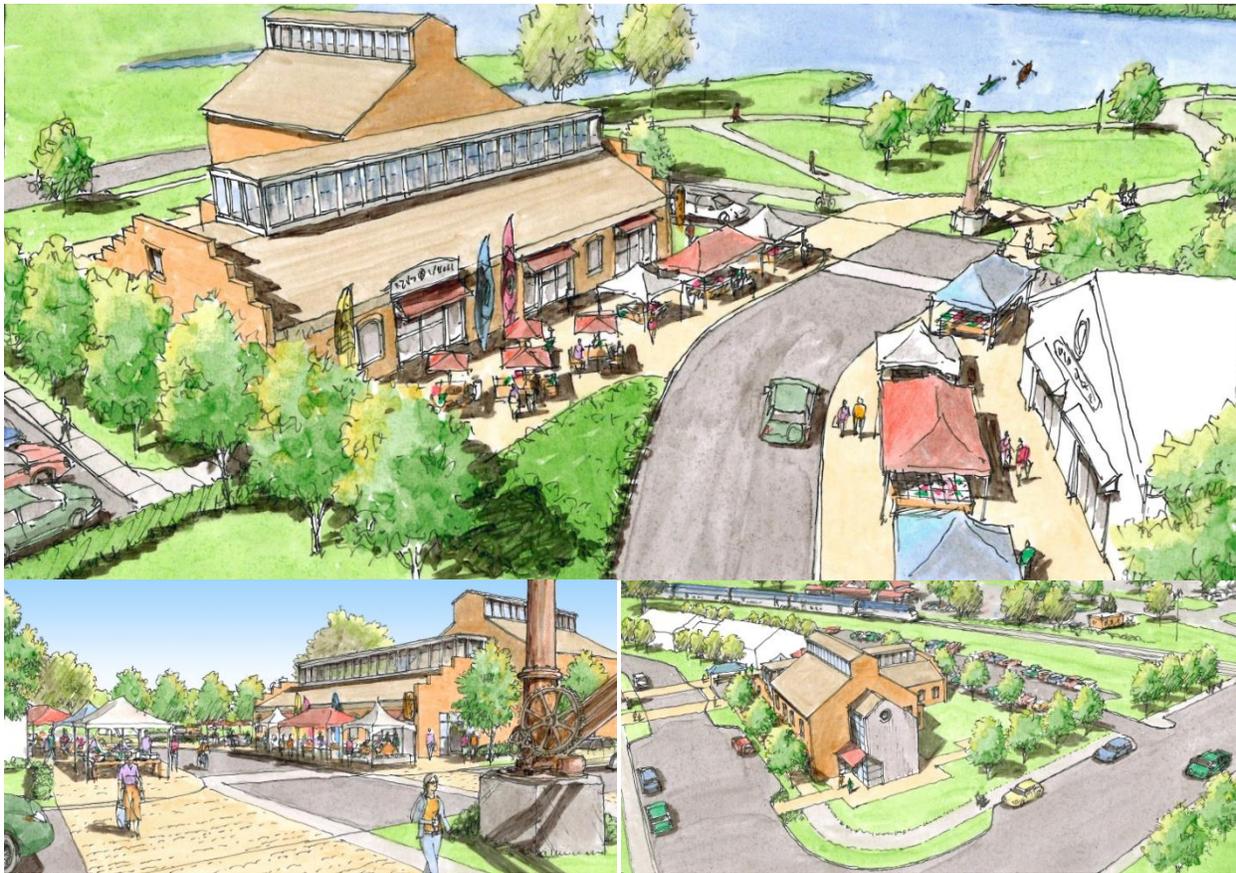
Final Schematic Design

These final schematic design options for the Dunn Warehouse and surrounding site have taken into account site history, context, and market and community conditions. In the analysis of market, site, and building, cost, and management issues, the team found that the northern section would be most conducive to a mix of retail and food activities and the southern section would be optimal as a flexible office or public use space. Having once been the location of a coal gasification plant the site has been remediated; however, there are restrictions on construction. The goal of the site design concept is to enhance the pedestrian environment and create an enjoyable place to visit, shop, and enjoy the waterfront park.
