# Conditions Study for Craig, Colorado

City of Craig  
300 W 4th Street  
Craig, CO 81625

**DGC** Community Planning and Design

January 2021

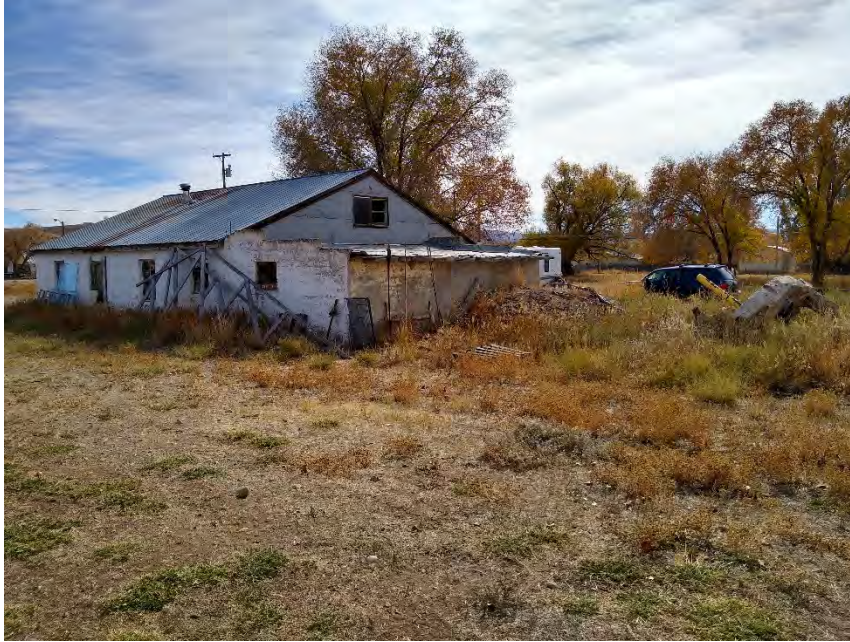
**Figure 2-1 Subarea A, Example 1**

Deteriorated external walls/roof; incomplete demolition; deteriorated fascia/soffits/eaves; lack of gutters/downspouts; deteriorated exterior finishes; deteriorated windows; presence of trash and debris; inoperable vehicles; potentially hazardous conditions; lack of outdoor lighting; inadequate site maintenance; structure in the floodplain; building code violations, public health concerns (Photo A7)

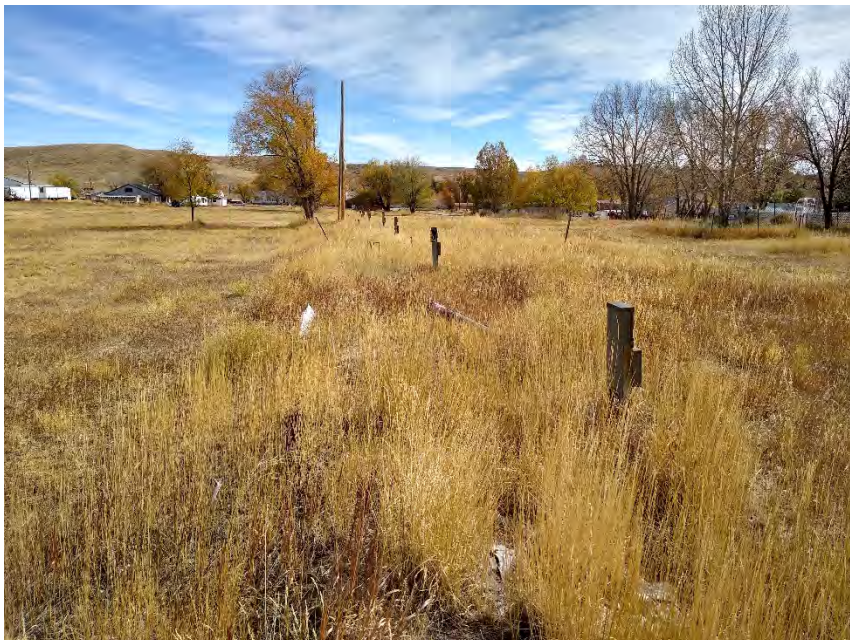
**Figure 2-2 Subarea A, Example 2**

Poor vehicle access; poorly lit/unlit area; presence of trash and debris; lack of site pavement; lack of site curb and gutter; lack of outdoor lighting; deteriorated/substandard site utilities; inadequate site maintenance; deteriorated fencing; high levels of vacancy (Photo A11)

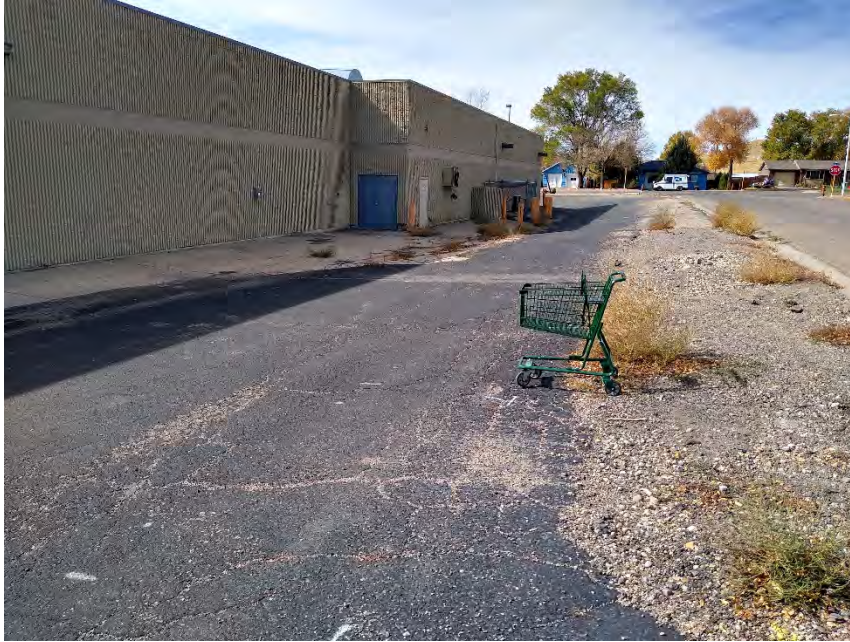
**Figure 2-3 Subarea B, Example 1**

Deteriorated exterior finishes; deteriorated doors; deteriorated barriers/walls; deteriorated wall lighting; deteriorated HVAC; poorly lit area; cracked/uneven surfaces for pedestrians; poor drainage; presence of trash and debris; potentially hazardous conditions; deteriorated site pavement; lack of site curb and gutter; lack of surface drainage facilities; inadequate site maintenance; lack of sidewalks in the right-of-way; high levels of vacancy (Photo B2)

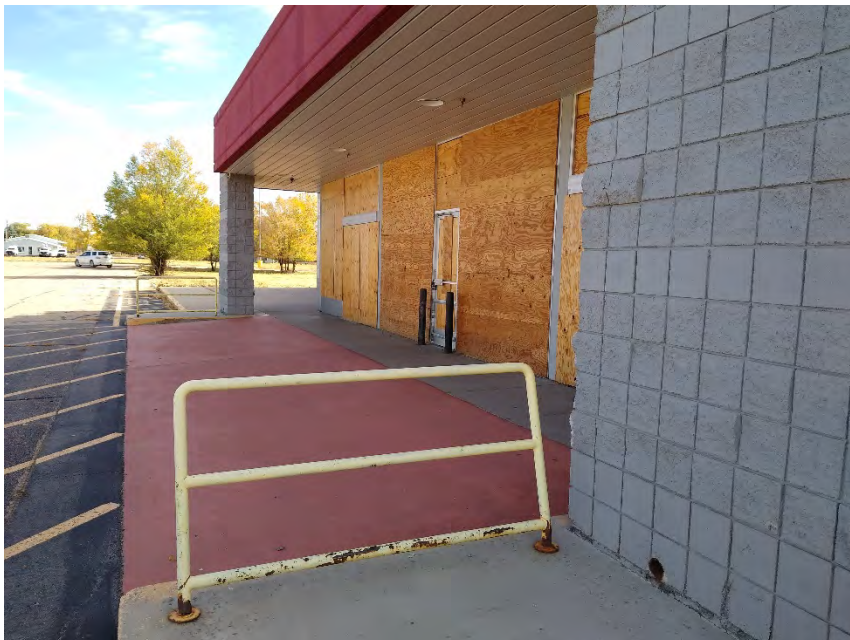
**Figure 2-4 Subarea B, Example 2**

Deteriorated windows and doors; deteriorated barriers/railings; deteriorated parking lot/site pavement; inadequate site maintenance; high levels of vacancy (Photo B12)

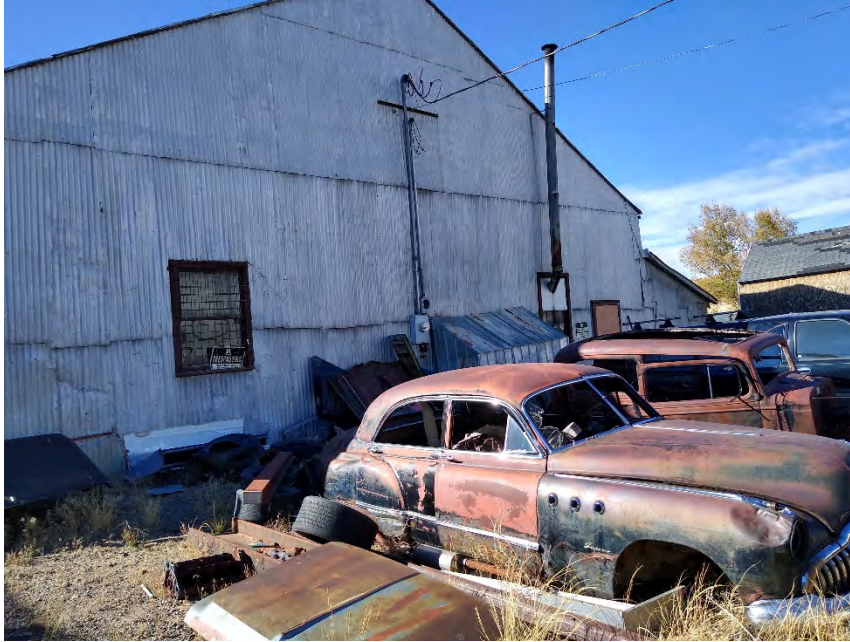
**Figure 2-5 Subarea C, Example 1**

Deteriorated external walls/roof; lack of gutters/downspouts; deteriorated exterior finishes; deteriorated windows and doors; deteriorated ancillary structures; exposed electrical; presence of trash and debris; abandoned/inoperable vehicles and equipment; potentially hazardous conditions; unfenced storage of equipment/materials; lack of site pavement; lack of site curb and gutter; inadequate site maintenance; structures in the floodplain (Photo C8)

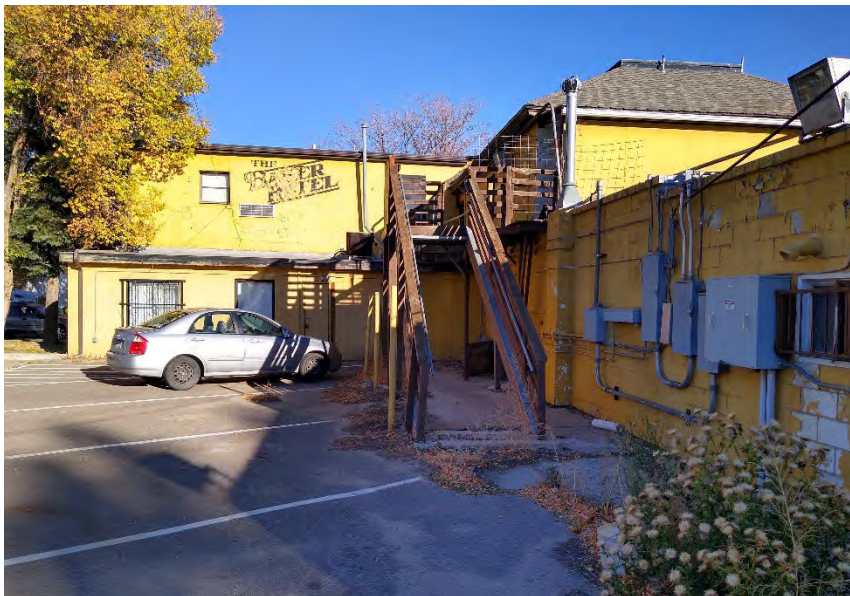
**Figure 2-6 Subarea C, Example 2**

Deteriorated fascia/soffits/eaves; deteriorated exterior finishes; deteriorated windows and doors; deteriorated stairway/fire escape; deteriorated barriers/railings; deteriorated signage; cracked/uneven surfaces for pedestrians; presence of trash and debris; unsafe drop-off; inadequate site maintenance; structure in the floodplain (Photo C24)

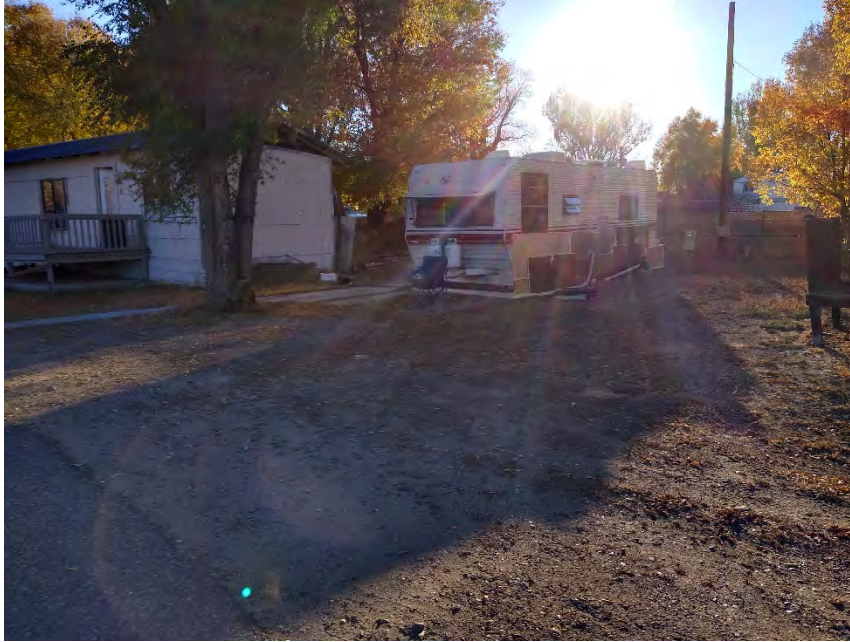
**Figure 2-7 Subarea D, Example 1**

Deteriorated external walls; deteriorated exterior finishes; inoperable vehicle; substandard site utilities; non-conformance to side development regulations; lack of curb and gutter in right-of-way; lack of sidewalks in the right-of-way; structures in floodplain; public health concerns; recreation vehicle used for permanent housing (Photo D10)

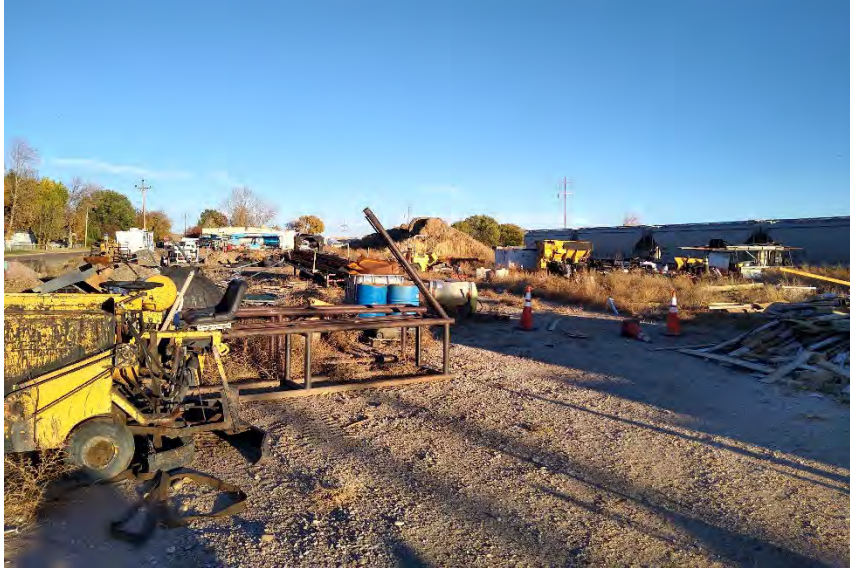
**Figure 2-8 Subarea D, Example 2**

Poor internal circulation; substandard driveway definition/curbcuts; poor parking lot layout; poorly lit/unlit area; cracked or uneven surface for pedestrians; presence of trash and debris; abandoned/inoperable vehicles and equipment; potentially hazardous materials or conditions; unfenced storage; lack of site pavement; lack of site curb and gutter; lack of outdoor lighting; lack of surface drainage facilities; inadequate site maintenance; poor grading; insufficient street lighting in right-of-way; lack of sidewalks in the right-of-way; structures in the floodplain (Photo D31)

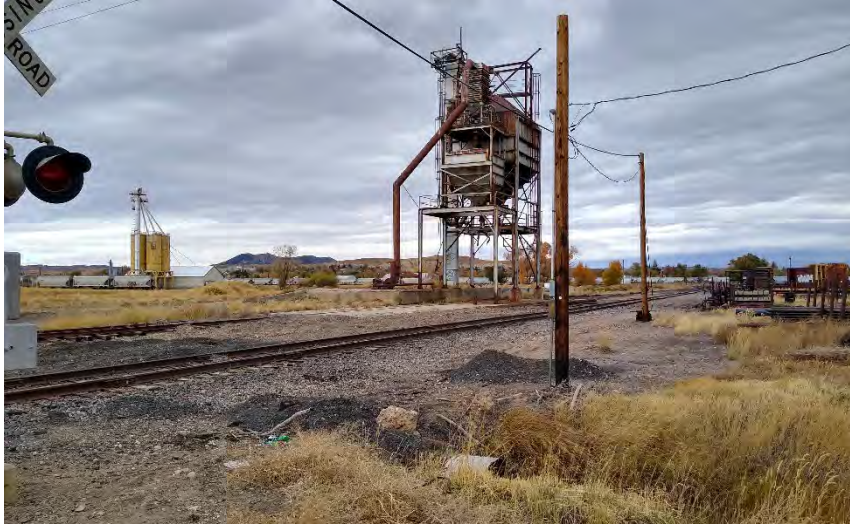
**Figure 2-9 Subarea E, Example 1**

Deteriorated visible foundation; deteriorated exterior finishes; deteriorated loading dock areas/ramps; lack of barriers/railings; deteriorated equipment; poor vehicle access; poor street layout; poorly lit/unlit area; cracked/uneven surfaces for pedestrians; presence of trash and debris; abandoned/inoperable equipment; potentially hazardous conditions; graffiti; unprotected electrical; lack of site pavement; lack of outdoor lighting; inadequate site maintenance; poor grading; unsafe level changes; high levels of vacancy (Photo E12)

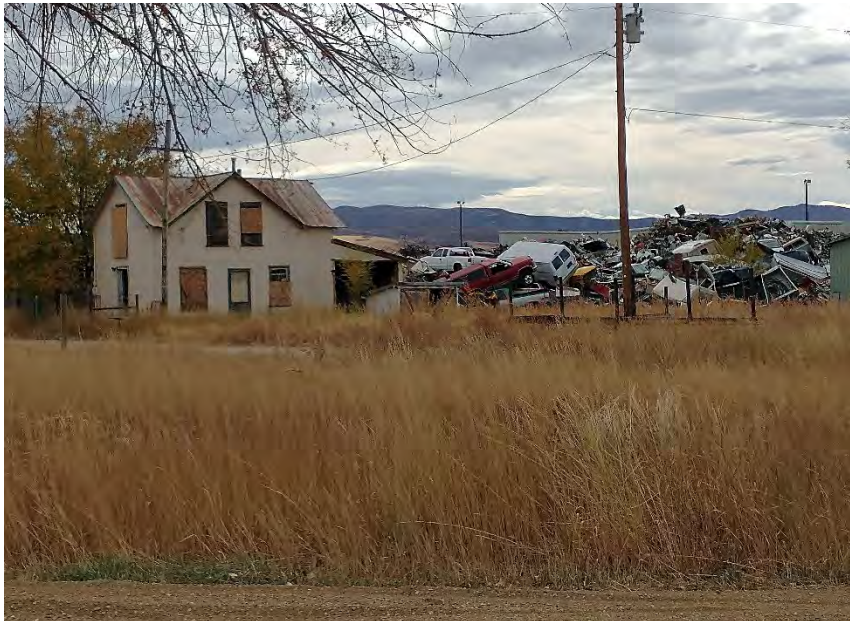
**Figure 2-10 Subarea E, Example 2**

Deteriorated external walls/roof; deteriorated fascia/soffits/eaves; lack of gutters/downspouts; deteriorated exterior finishes; deteriorated windows and doors; deteriorated ancillary structures; presence of trash and debris; abandoned/inoperable vehicles; lack of site pavement; deteriorated site utilities; inadequate site maintenance; deteriorated fencing; lack of street pavement in the right-of-way; lack of curb and gutter in the right-of-way; insufficient street lighting in the right-of-way; lack of sidewalks in the right-of-way; high levels of vacancy (Photo E22)
