Fairfield Public Schools Facilities Condition Assessment

**Fairfield Ludlowe High School
785 Unquowa Road
Fairfield, CT 06824**

The goal of the Fairfield Public Schools is to provide a mechanical means for providing fresh air, air conditioning, and fire protection for all its school buildings in accordance with current codes and standards. DTC has been retained by the Town of Fairfield to conduct a Facility Condition Assessment for nine buildings. The following is the assessment for the Fairfield Ludlowe High School.

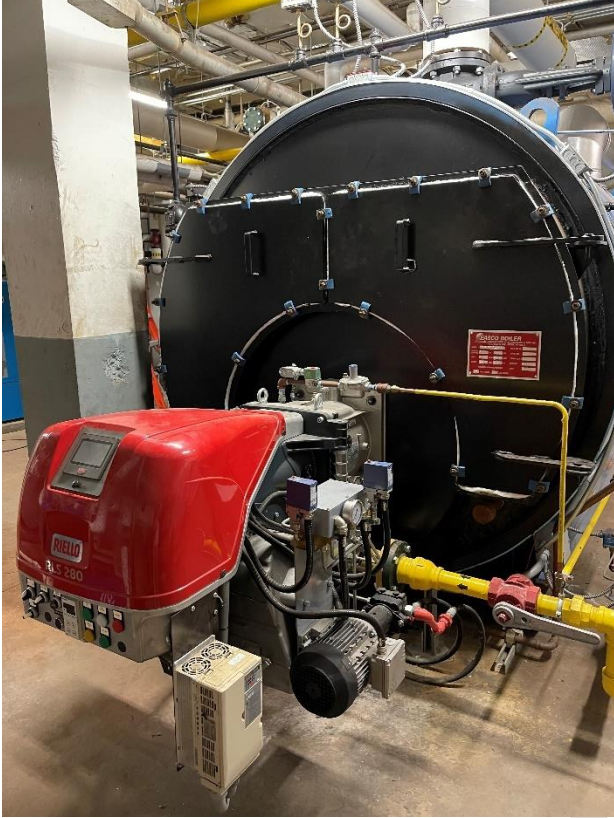
The school has a central hot water heating plant located in the first-floor mechanical/boiler room. The heating plant consists of two Easco and one Cleaver-brooks cast iron boilers that are approximately 6.7 million BTUH each. The Easco boilers were installed in 2005 and are in pristine condition, the median service life of typical cast-iron boiler is 30 years. The boilers have dual fuel Power Flame burners that can use either natural gas or diesel oil for combustion but have been converted to natural gas only. The third boiler is stand-by.

Easco Boiler #1

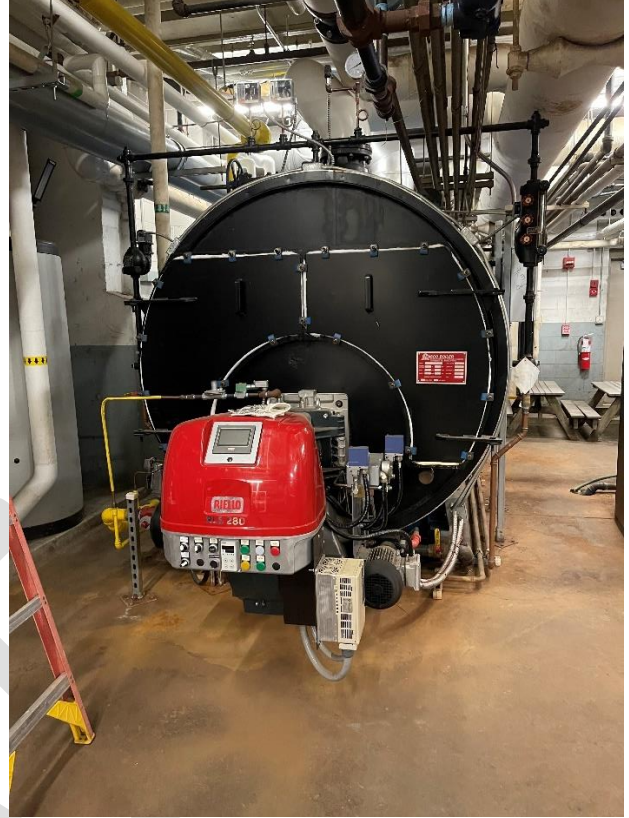
Easco Boiler #2

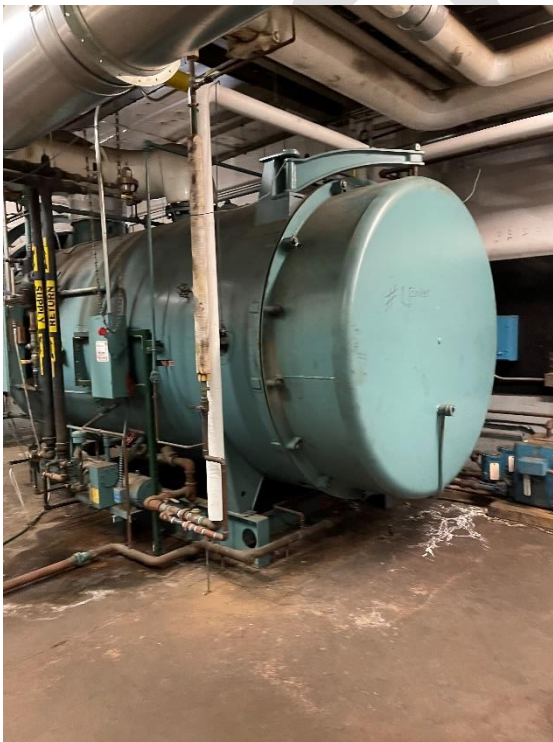
Cleaver Brooks Boiler #3

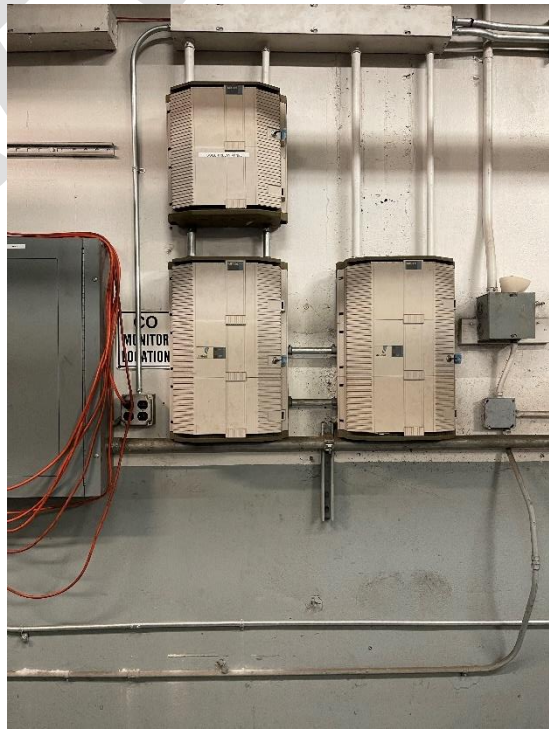
Existing Boiler BAS Controls

The BAS system consists of a Metasys Johnson Controls system. The Metasys Johnson Controls system is difficult to access due to older software versions loaded in the system and the processing speed of the networks headend. It was noted that there is limited information available for the RTU's and there is limited ability to adjust system operation. The Town currently has an ongoing BAS project that will ultimately address standardization of the building BAS and provide the required functionality for system operation. We believe that this ongoing controls project is required and will provide the Town the ability to see how the systems are operating in real time and provide the functionality to adjust operations and setpoints.

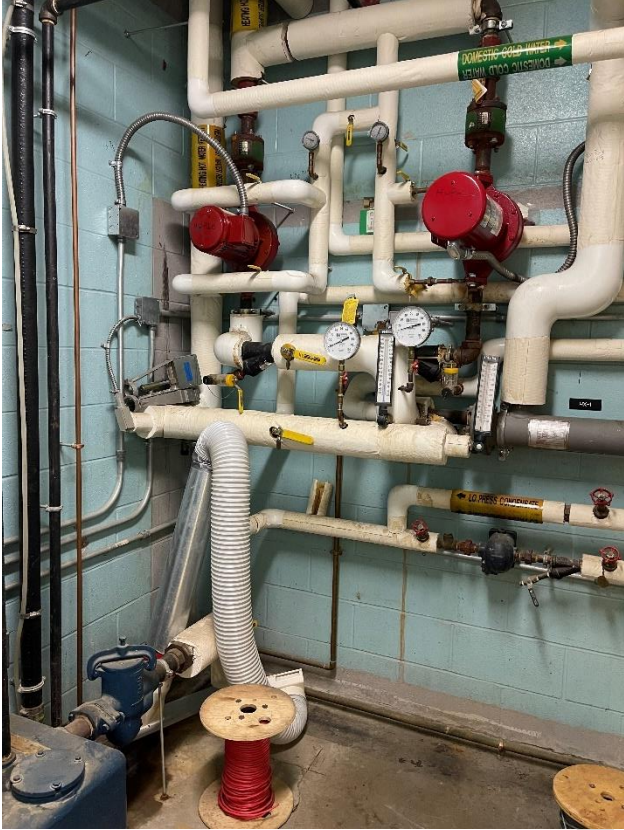
Hot water is circulated through the building by two sets of two hot water pumps, one set located on the north end and one set located on the south end of the building, each pump has a variable speed drive to control flow and pressure based on the heating demand of the building. We assume that the pumps are configured as primary, stand-by arrangement and that each is sized for 100% of the flow. The median service life for centrifugal inline pumps is 20 years. There are several hot water piping loops that go out and serve the various areas of the building to offset the envelope heating load. There are pressure sensors located out in the piping loops that measure the system pressure and modulate the pump speeds to match the system demand. Terminal hot water heating equipment located at the building includes finned tube radiators, radiant panels, cabinet unit heaters and hot water convectors.

Perimeter Shell & Tube and Pumps (HX-1)

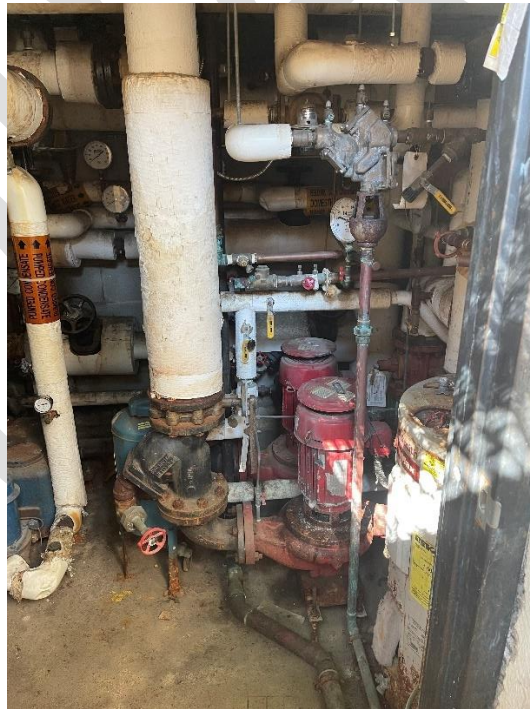
Perimeter Heating Pumps

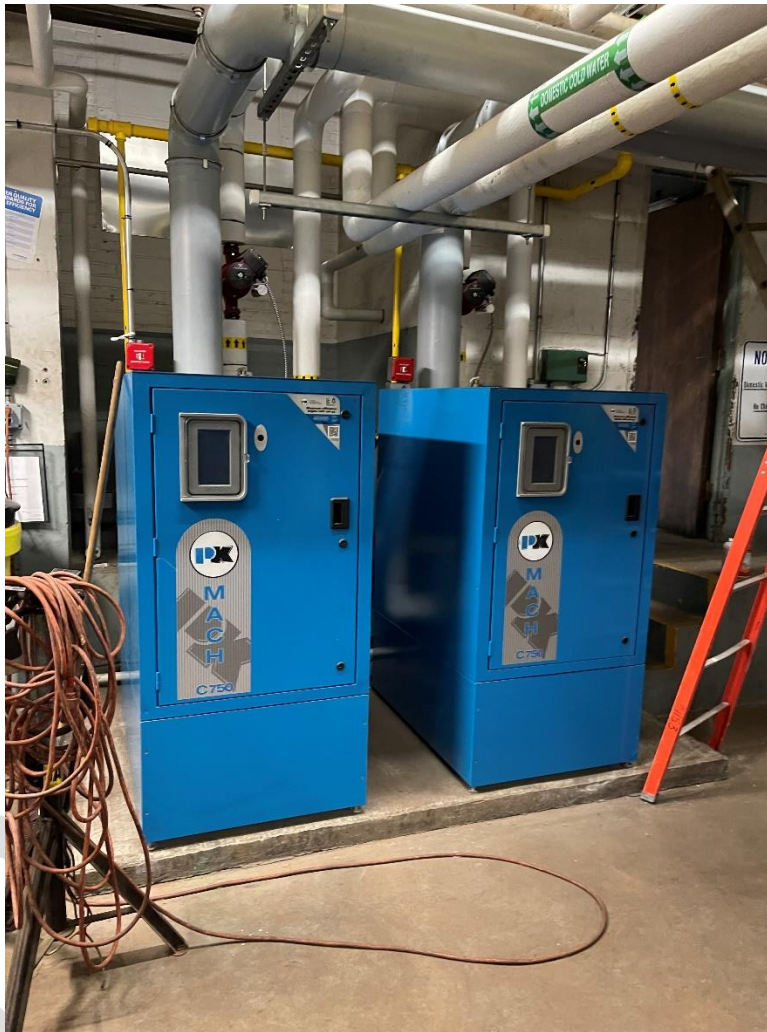
Domestic hot water is produced by two Paterson-Kelly Mach gas fired water heaters with multiple hot water loops with fractional horsepower recirculation pumps. The condition and operation of these systems appears to be good. The median service life for this type of heater is 25 years

(2) Domestic Hot Water Heaters

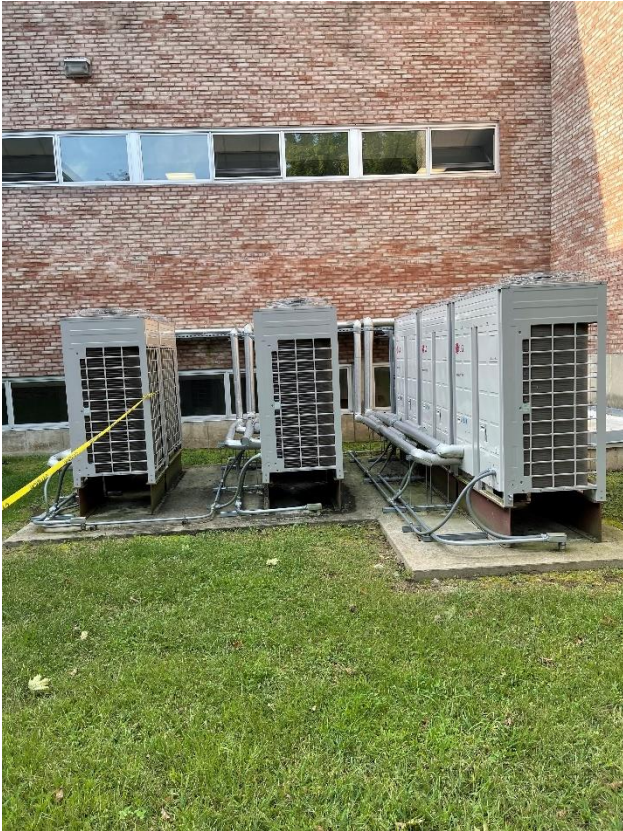
The roof is currently populated with most of the equipment serving the school with approximately a dozen condensing units located on the ground floor are within various court yards. There are approximately thirty rooftop air conditioning units (RTU's), condensing units (CU's) and heating & ventilation units (HV's) of various sizes and capacities located on the roof of the school. There are also multiple make up air units (MUA's) located on the roof and a dedicated outdoor air system (DOAS) serving areas with high ventilation rates such as the cafeteria. The ages of the equipment vary, but most are in the 10-year range. The median service life of this type of equipment is 15 years.

Courtyard Condensing Units

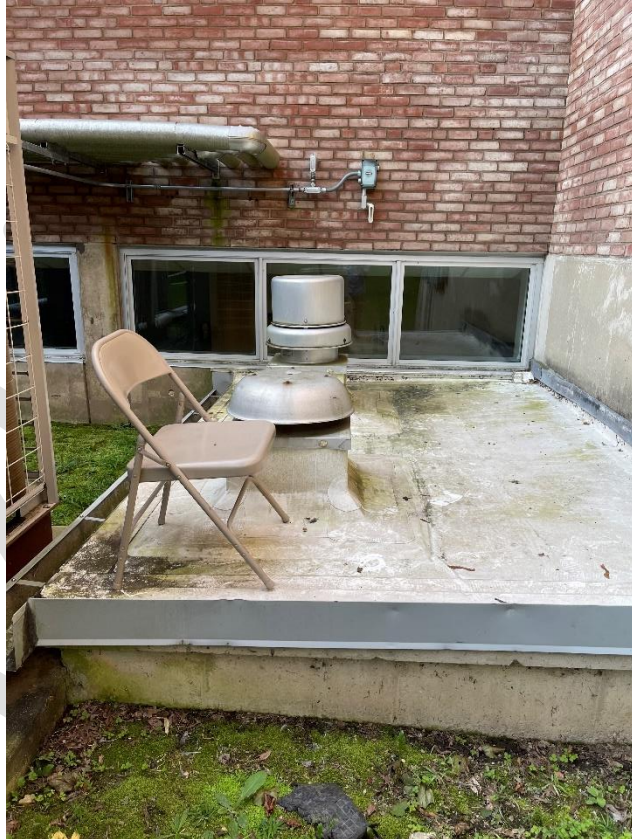
Courtyard (lower level) Exhaust Fans

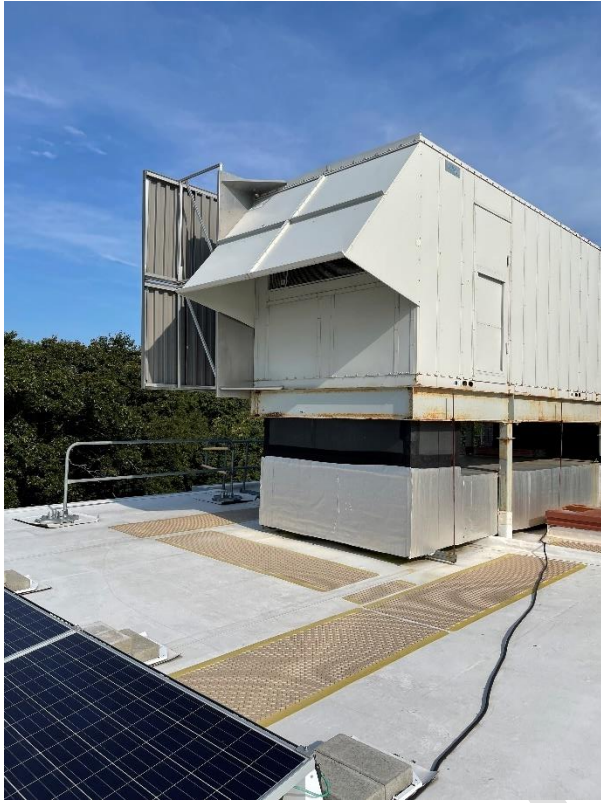
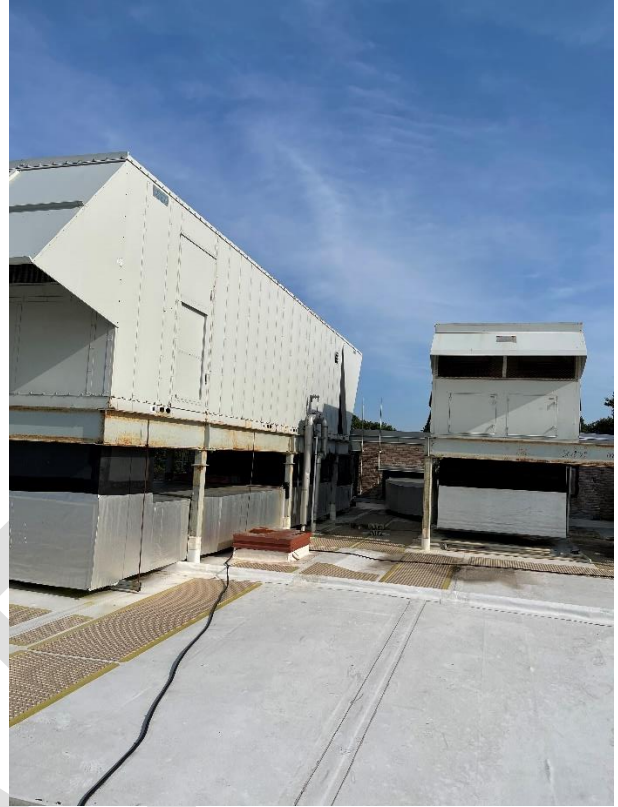
Rooftop Packaged Air-cooled Electric Heat Unit Serving the north wing.

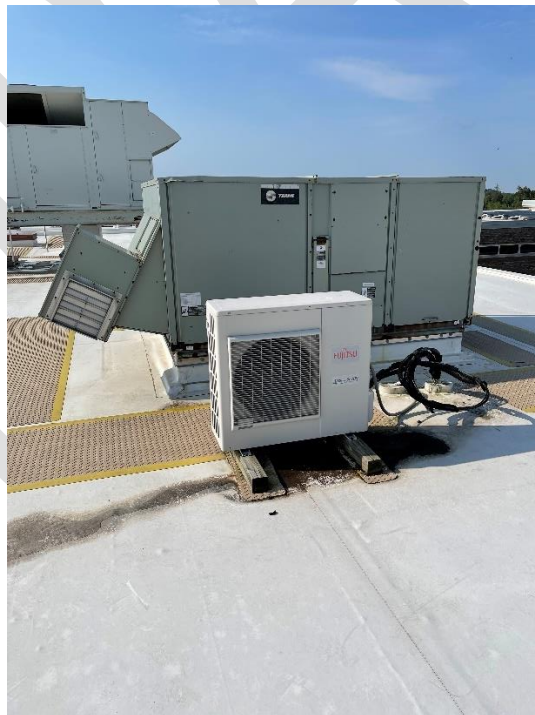
Rooftop Package Unit (Smaller Capacity) & Rooftop Condensing Unit

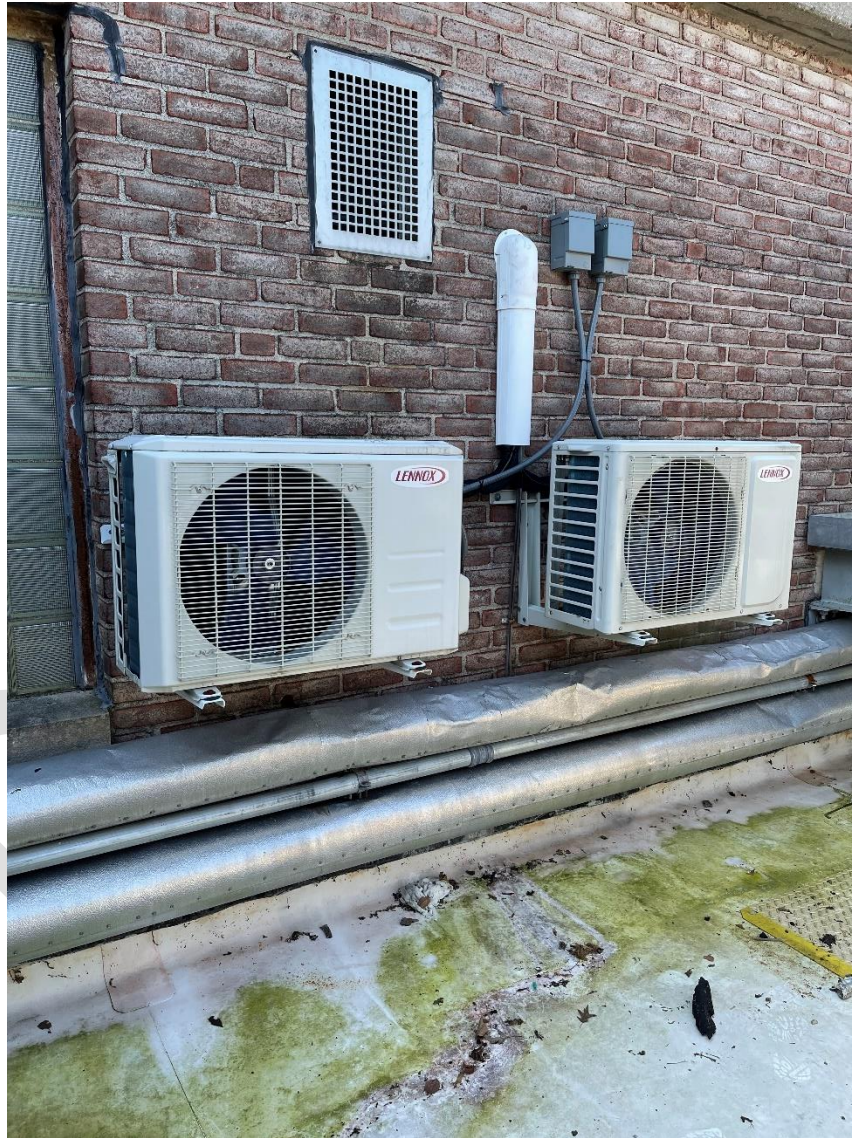
There are many mini split single room air conditioning systems scattered throughout the school. The mini split systems consist of an indoor evaporator located in the space to be cooled and a condensing unit located on the roof. These systems provide flexible room by room cooling capability. We observed equipment by a few different manufacturers and a few types of evaporators with some being wall mounted and some being ceiling cassettes. These systems do not provide ventilation air, and will generally be replaced as part of the recommended systems.

Rooftop Air-Cooled Condensing Units

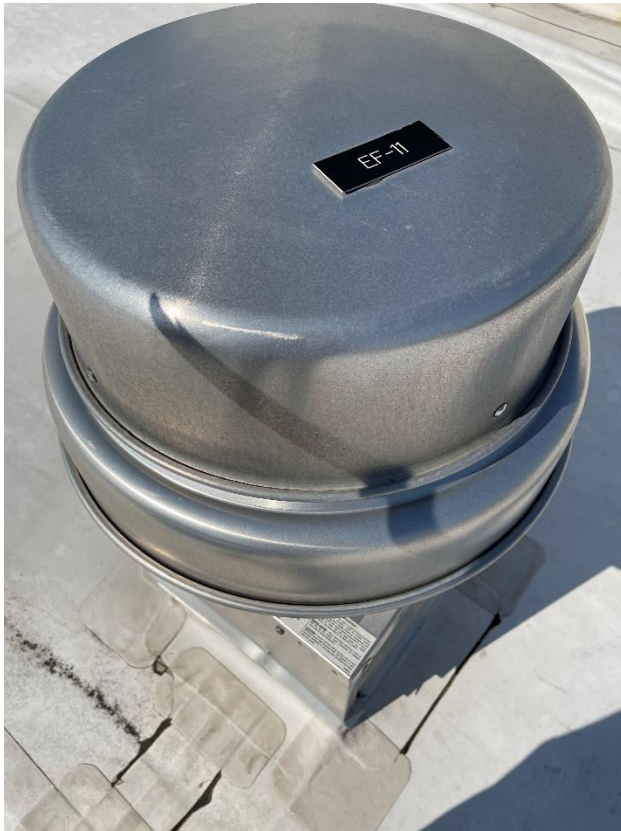
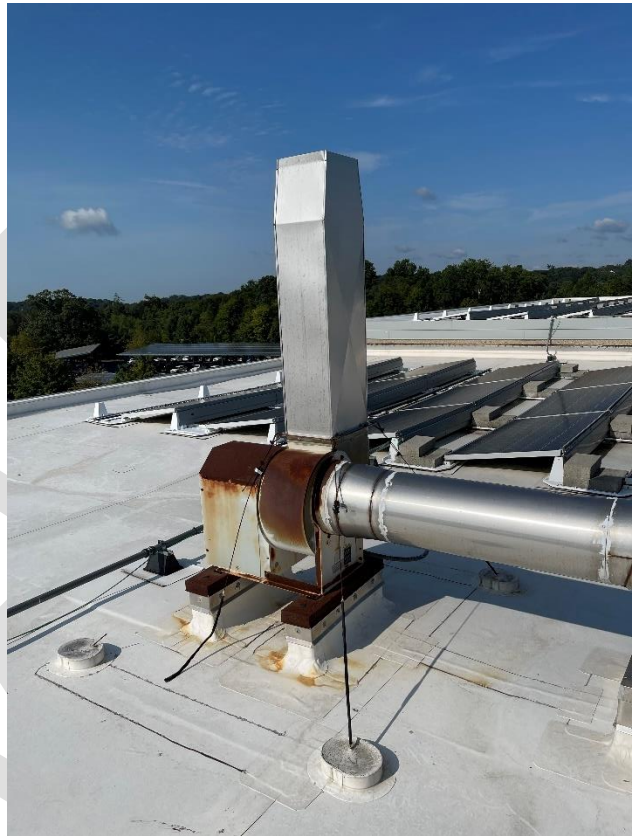
There are many exhaust fans scattered throughout the building that serve toilets, MER's, science rooms, storage rooms, kitchens and other spaces that require ventilation. Most are small mushroom style down blast type and are typical for a school application.

Miscellaneous Exhaust Fans

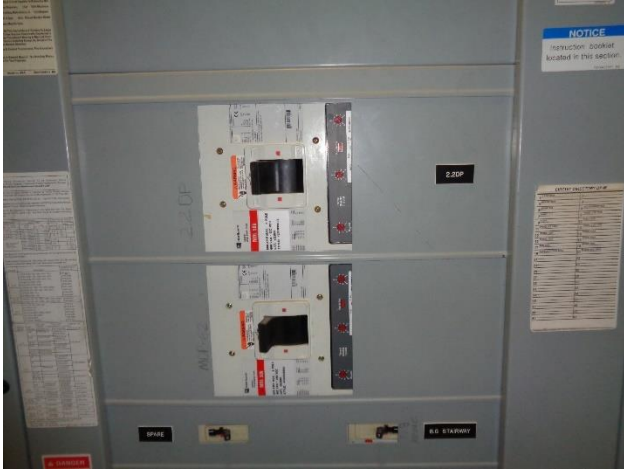
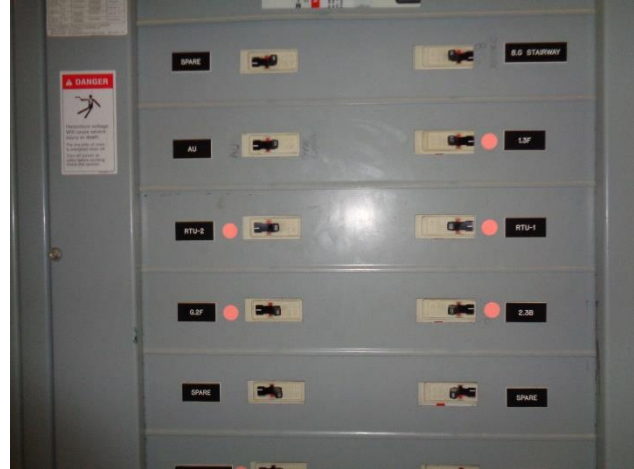
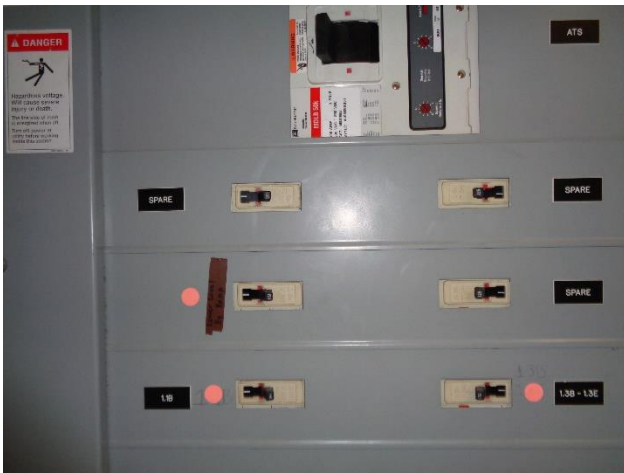
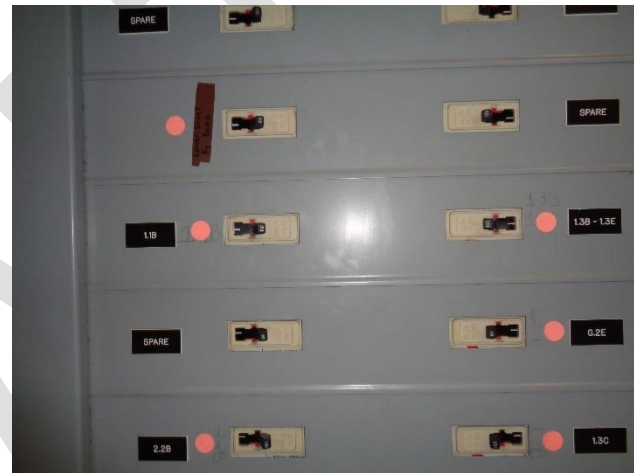
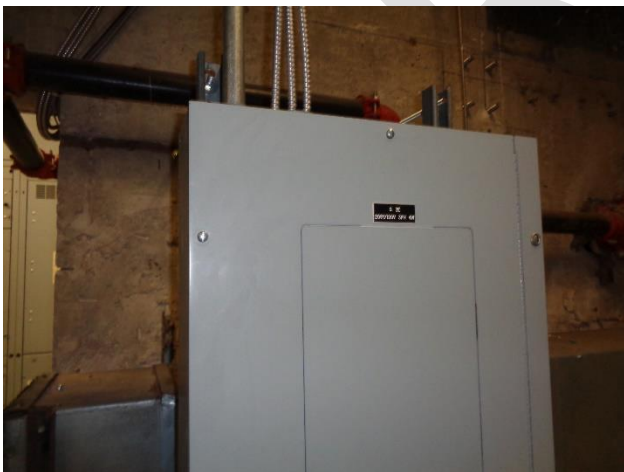
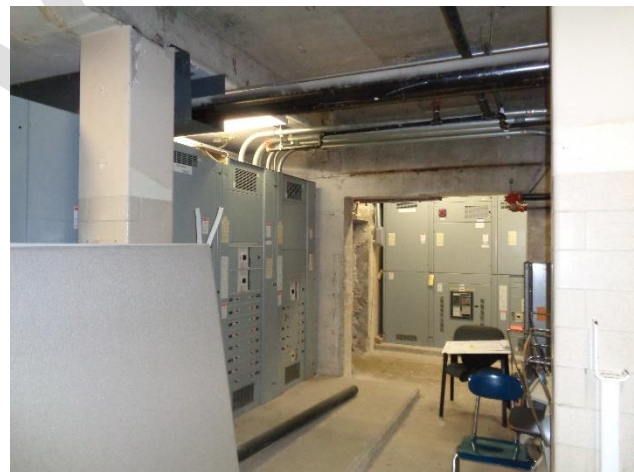
It was observed that some original vintage electrical equipment was nearing the end of its useful life and while beyond the scope of this study, we recommend beginning a plan for a phased replacement. Depending on the power requirements for the new mechanical equipment, the existing panels and switchgear may need to be replaced with new. The layout of the new power distribution panels, switchgear and step-down transformers will allow easier servicing and energy efficiency in the building. The new step-down transformers will have increased efficiency of operation and reduce operating costs.

Existing Panels
