## **Fairfield Public Schools Facilities Condition Assessment**

**Timothy Dwight Elementary School  
1600 Redding Road  
Fairfield, CT 06824**

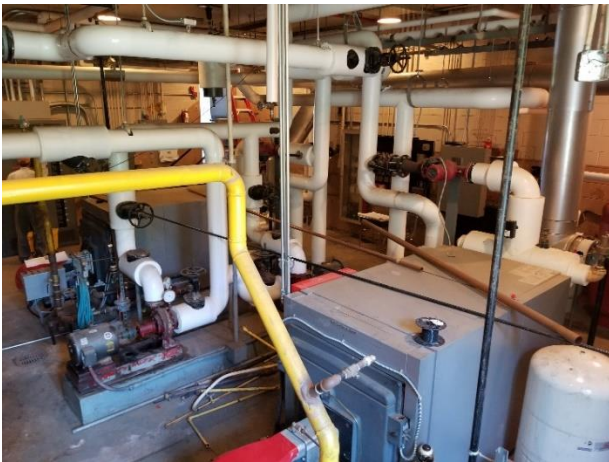
The school has an existing central hot water heating plant that consists of two high efficiency Viessmann Vitorond 200 cast iron boilers. The boilers were installed in 2012 the boilers have an input rating of 2.5 million btu/hr. The boilers have dual fuel Riello burners that can use either natural gas or diesel oil for combustion. Each boiler has a fractional horsepower circulator pump for thermal control. Hot water is circulated through the building by two 7.5 horsepower base mounted pumps, these two pumps are configured so that either can serve the two hot water loops out to the building. The pumps are configured as primary stand-by arrangement and that each is sized for 100% of the flow, no variable speed drive were noted, and we assume that the pumps operate at constant volume. The median service life for base mounted pumps is 20 years and the median service life for the cast iron boilers is 30 years. Terminal hot water heating equipment located at the building perimeter includes finned tube radiators and cabinet unit heaters.

Existing Boilers in Boiler Room

To address the boiler piping and pump concerns we recommend the town should engage a mechanical contractor, a testing company, and an engineer, to test the associated boiler equipment to confirm the current operational capacities and compare that against the equipment IO and M manuals. The information should be reviewed, and any system modifications and equipment repair and adjustments should be performed.

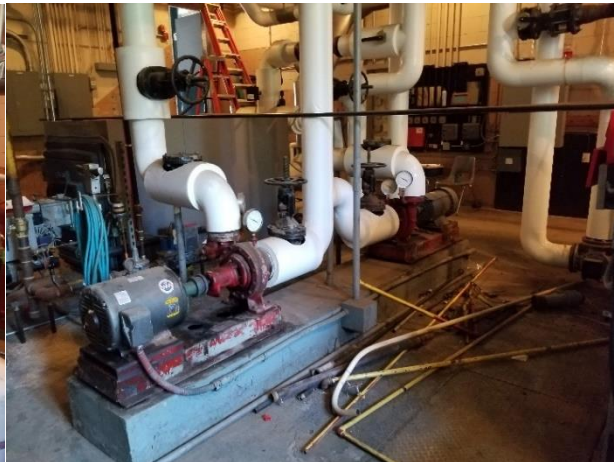
Existing Hot Water Pumps

Operational deficiencies identified for the school are accessibility, the BAS system, The boiler piping configuration and the age of the hot water pumps.

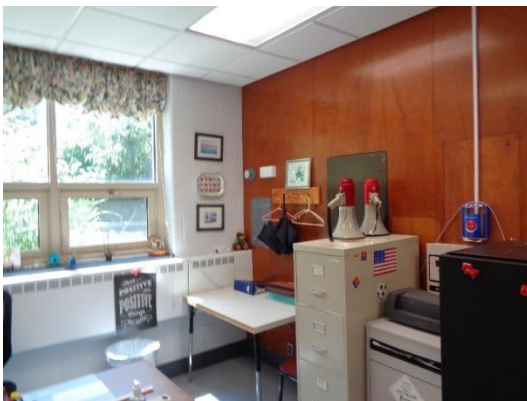
Existing Perimeter Heat

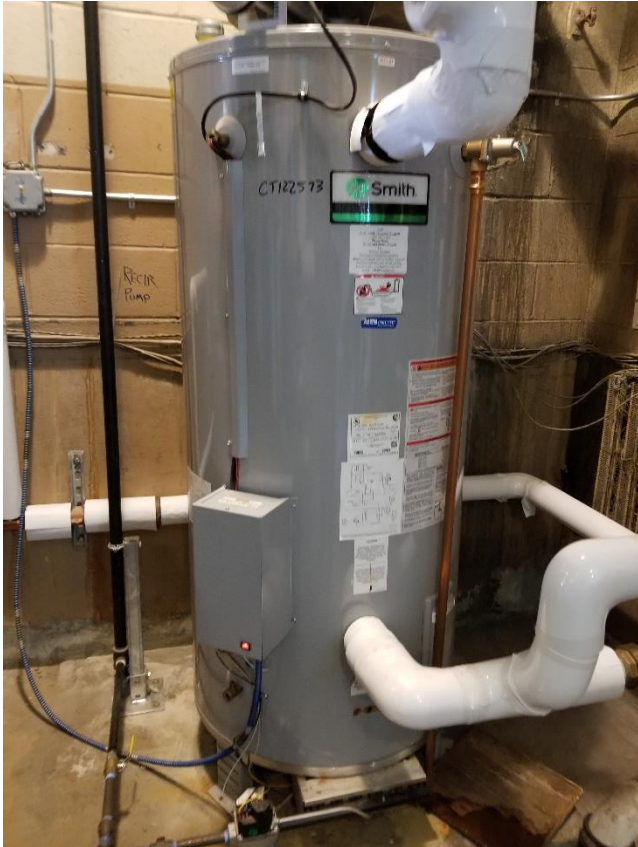
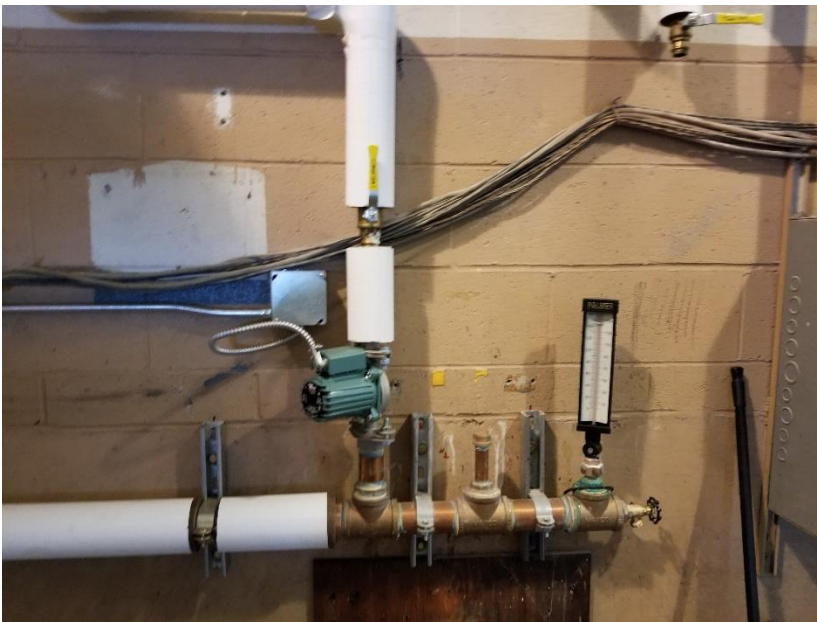
The domestic hot water for the school is provided by a 100-gallon AO Smith gas fired water heater with an input rating of 199,000 btu/hr, the water heater was manufactured in 2018 and is 3 years old. The typical service life for commercial water heaters is 10 yrs. There is one 110-degree hot water loop with fractional horsepower circulation pumps that serve the various areas of the school

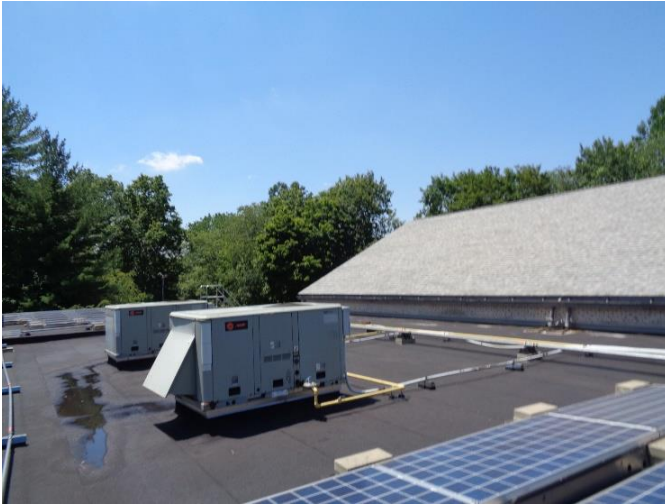
There are six rooftop air conditioning units (RTU's) of various sizes and capacities located on the roof of the school. All of the RTU's have DX cooling and gas heat. The ages of the equipment vary but most are in the 10-year range. RTU-3 is 17 years old. The median service life of this type of equipment is 15 years.

Existing RTU's 4 and 5 to be replaced in 2021

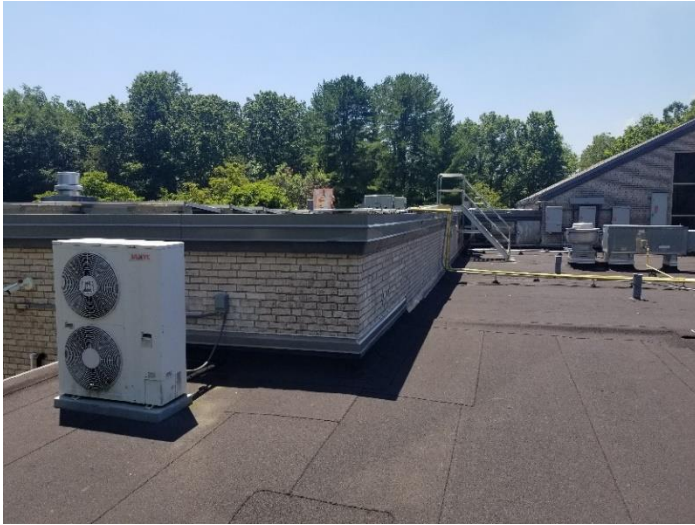
There are six mini split single room air conditioning systems scattered throughout the school. The mini split systems consist of an indoor evaporator located in the space to be cooled and a condensing unit located on grade or on the roof. These systems provide flexible room by room cooling capability. We observed equipment by a few different manufacturers and all evaporators are wall mounted and

Existing Rooftop Mini Split Condenser

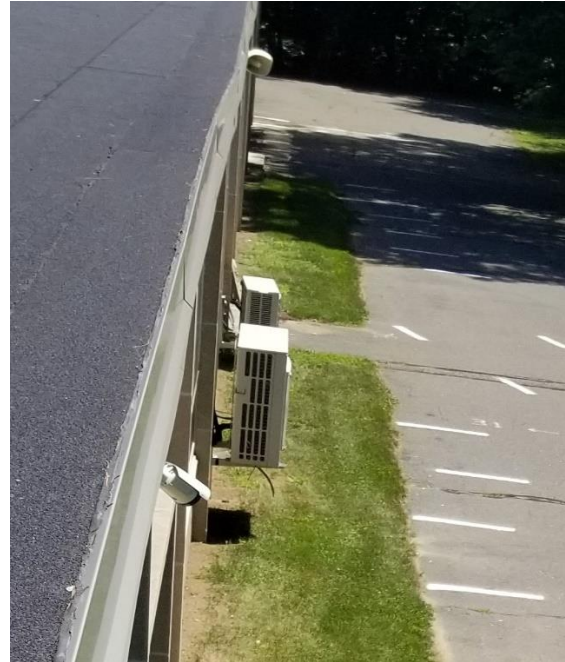
Existing Wall Mounted Mini Split Condenser

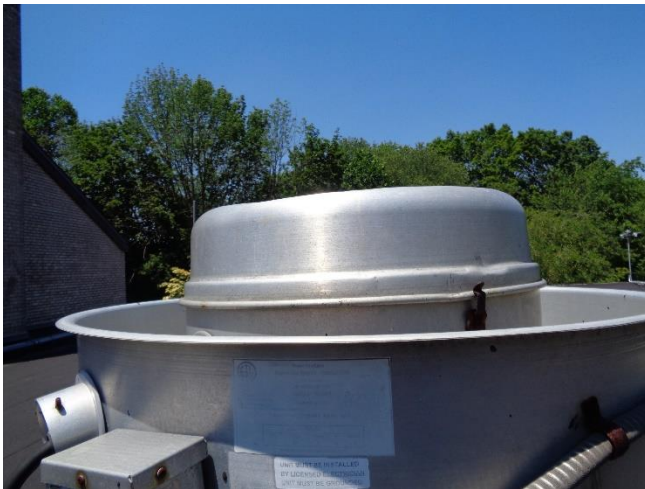
There are exhaust fans scattered throughout the building that serve toilets, MER's, science rms, storage rms, kitchen and other spaces. Most are small mushroom style down blast type and some are the louvered penthouse type but all are typical for a school application.

Existing Rooftop Exhaust Fan.

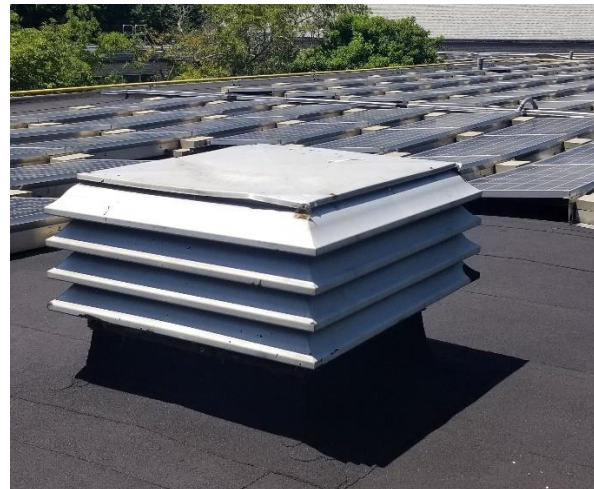
Existing Rooftop Equipment

The majority of mechanical equipment that serves the school is mounted on the roof and includes RTU's, exhaust fans and mini-split condensing units. The rooftop equipment viewed during the site visit appeared to be in average condition for their age and we did not note any obvious issues during the visit.

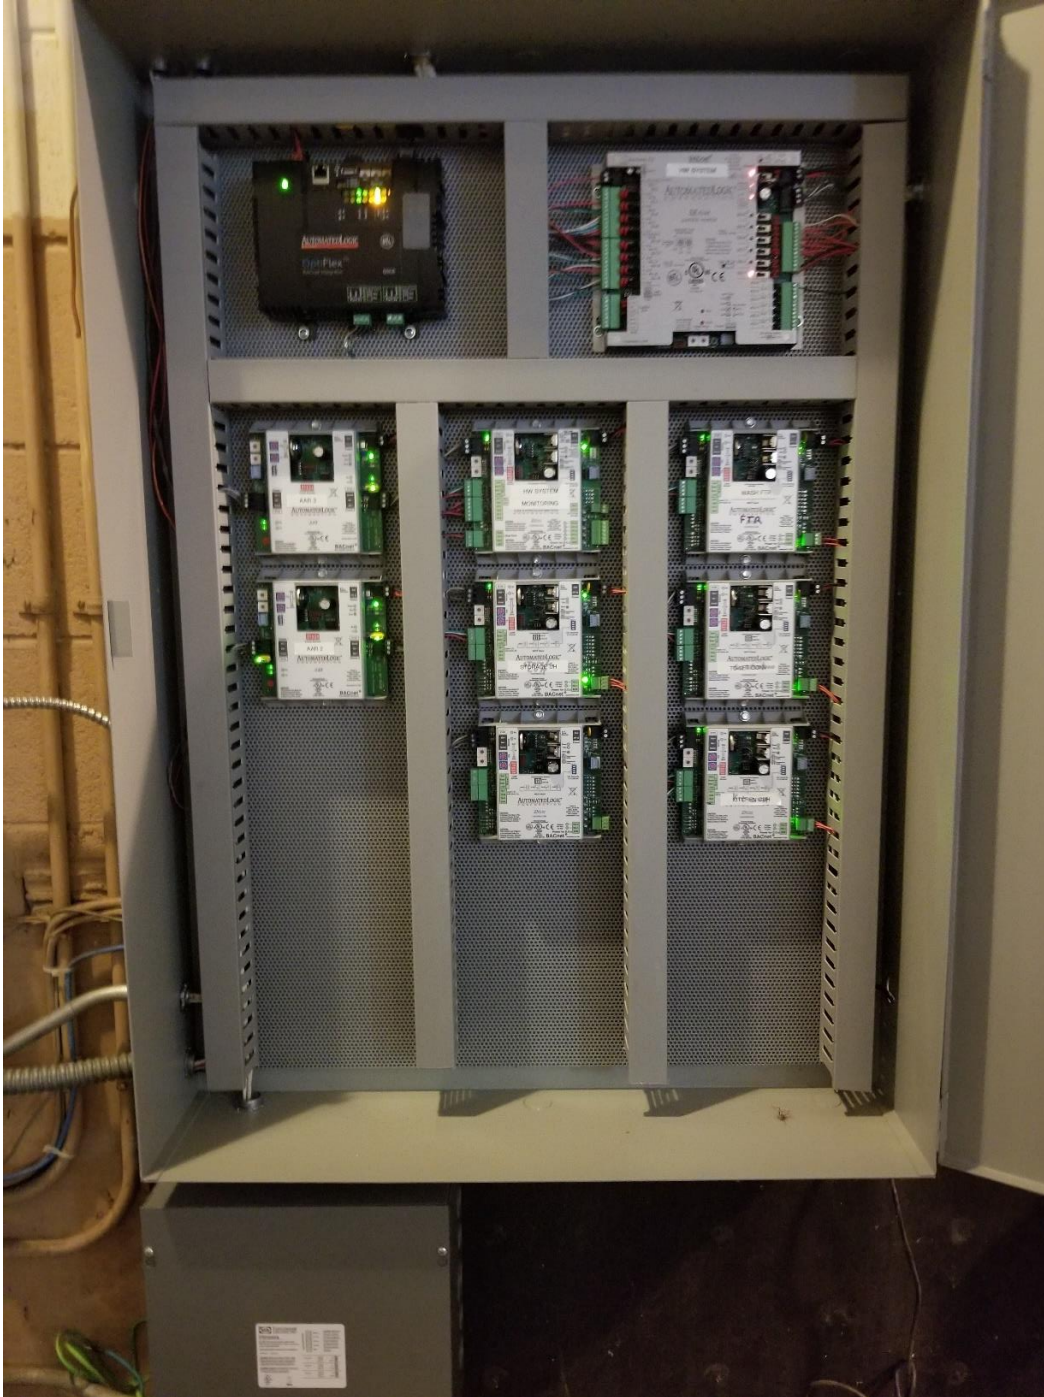
There is an existing Automated Logic Building Automation/Johnson Controls system in the building. It was noted with the building custodian that access is available in the general storage room.

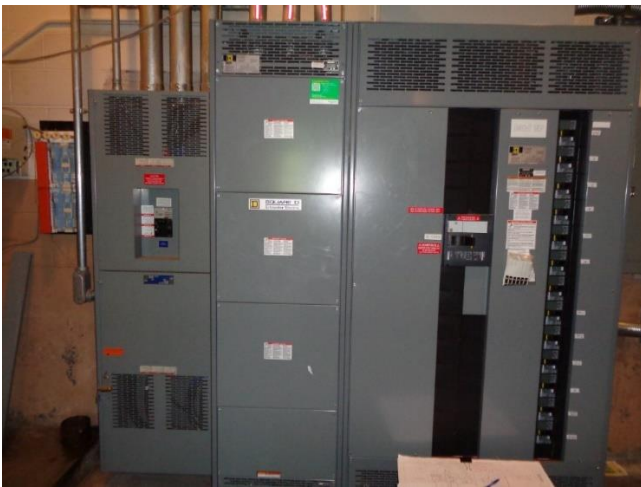
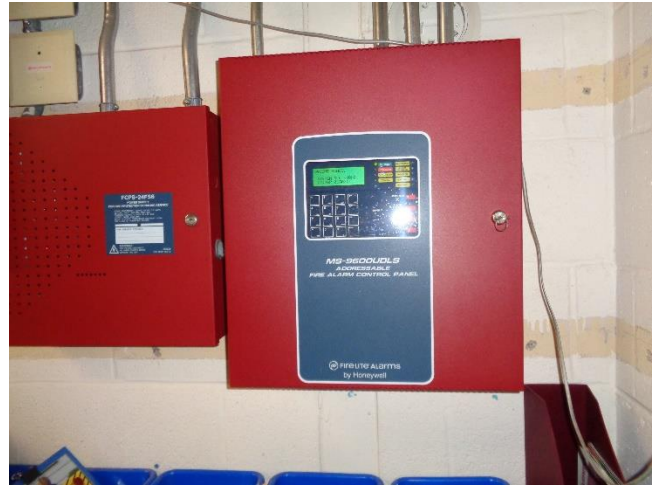
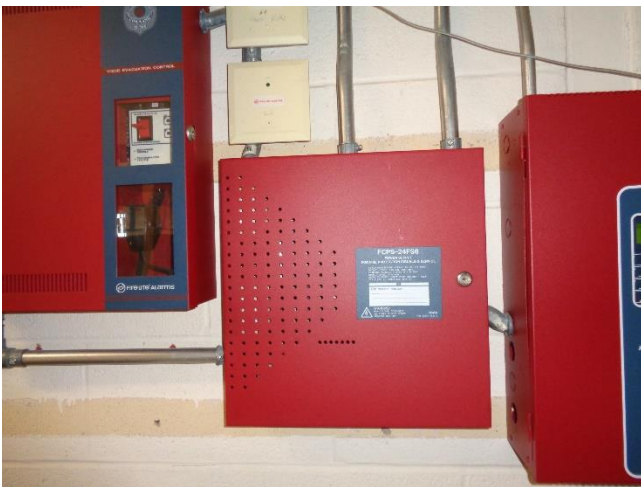
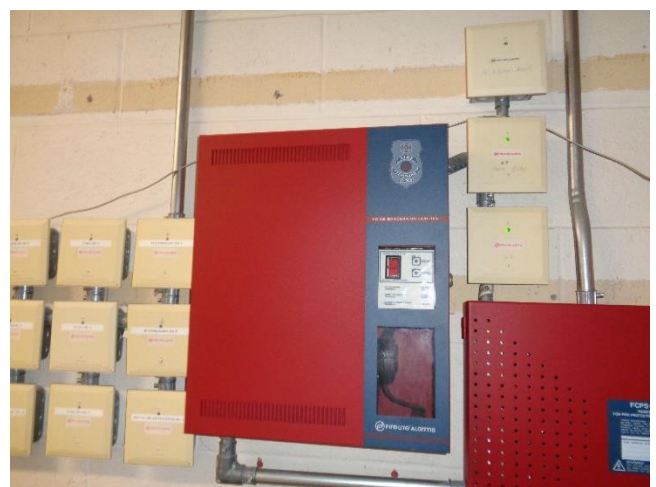
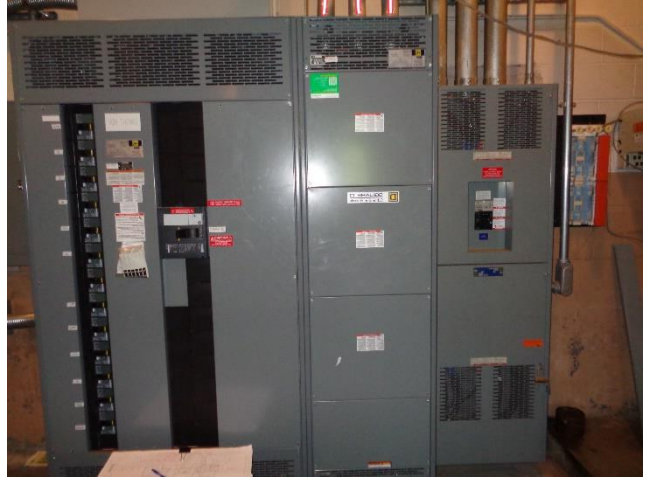
The purpose of this site visit was to perform an on-site inspection, meet with knowledgeable school staff and gain an understanding of the current condition, operation and maintenance of the entire school facility. The main electrical service is located in the boiler room with HVAC equipment. The main electrical service entrance consists of one 120Y/208 V 1200A switchgear and MDP that distributes power to the entire building. There were also branch circuit panels in corridors scattered around the building. A two section 225A panel "Y" in boiler room supports heating and other systems. Two panels are on the roof which supply the roof top units and exterior outlets with power. There is no permanent emergency generator, the emergency egress lighting is powered by a battery backup fixtures. There is an outside receptacle and 200A manual transfer switch to panel "Y" for a portable roll up generator connection to feed panel "Y" during an extended utility outage such as wire out after an ice storm. Depending on the power requirements for the new mechanical equipment, the existing panels and switchgear may need to be replaced. New panel schedules should be typed and fitted reflecting correct updated circuiting on all panels.
