# Penfield Pavilion FEMA & DEEP Remediation

# “Julian Fill” – Penfield Pavilion

# Notice of Violations (NOV)

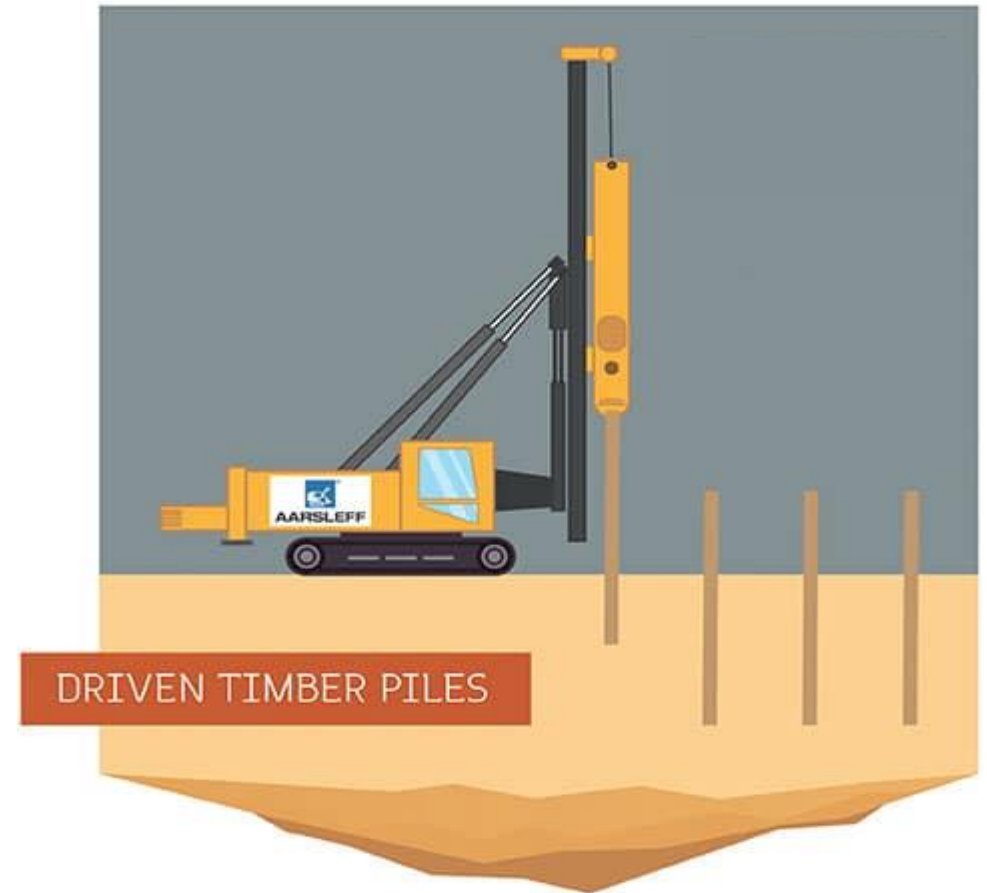
# What is a Pile Foundation?

- A pile foundation is a series of columns inserted into the ground to transmit loads to a lower level of subsoil.
- A pile is a long cylinder made up of a strong material, such as Timber.
- Piles are driven into the ground up to 30 feet to act as a steady support for structures built on top of them.

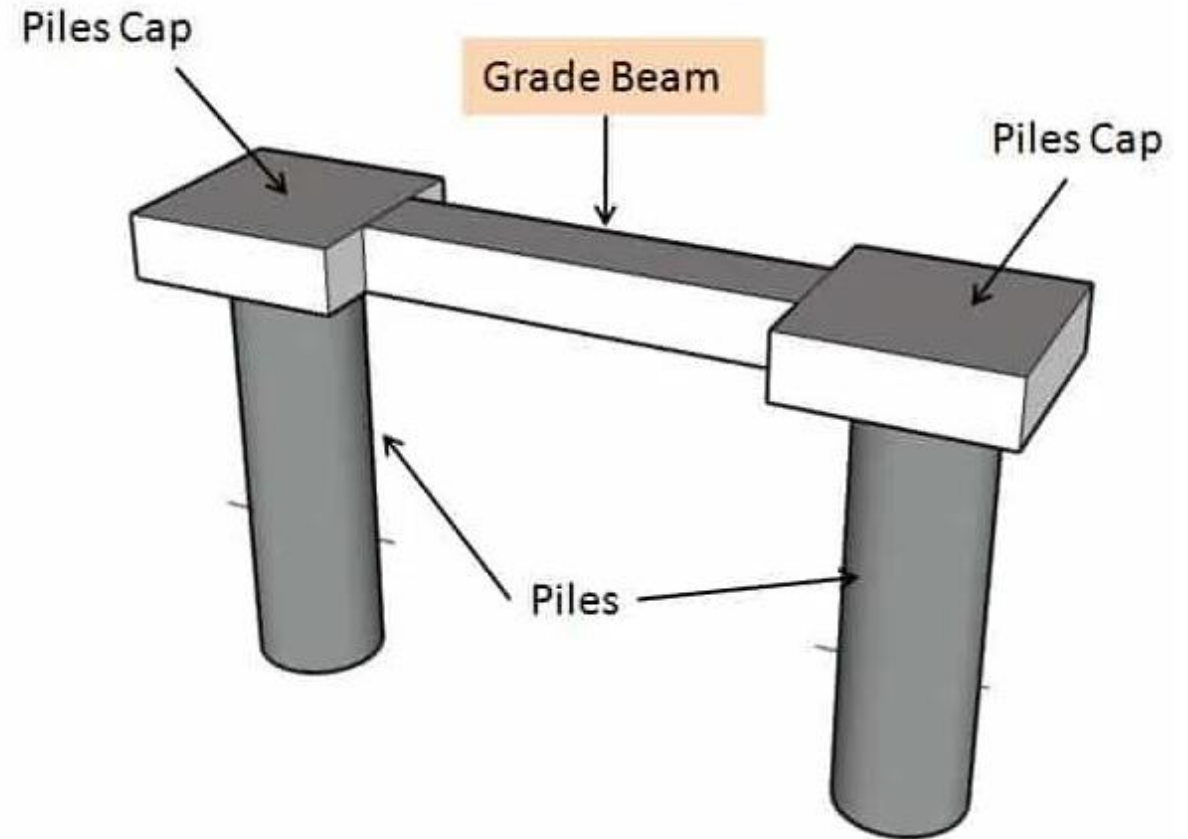
# What is a Grade Beam?

- A grade beam is a beam that is built at grade level (earth level) mostly used for buildings with piles to connect pile caps to each other.
- Grade beams are made of reinforced concrete which acts as horizontal ties between pile caps.

Issued an NOV saying the main building structure (**excluding the locker room portion**) was non-compliant. Specifically, because “the town placed horizontal grade beams above the natural grade..”
