APPENDIX A

Study Facilities

APPENDIX A
STUDY FACILITIES
Town of Fairfield Masterplan

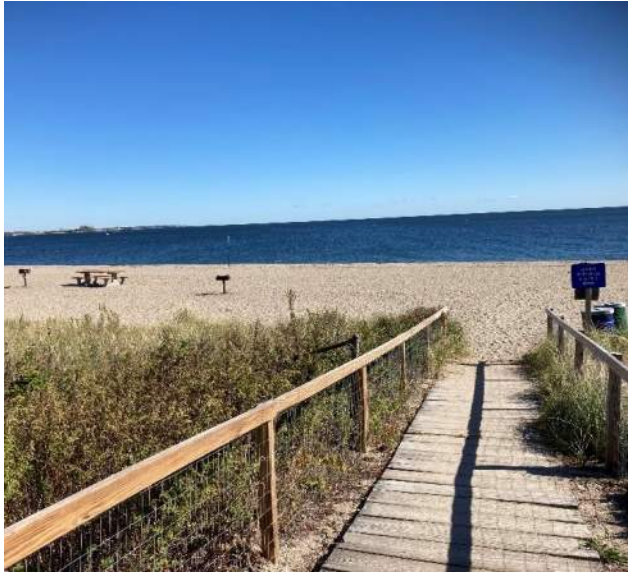
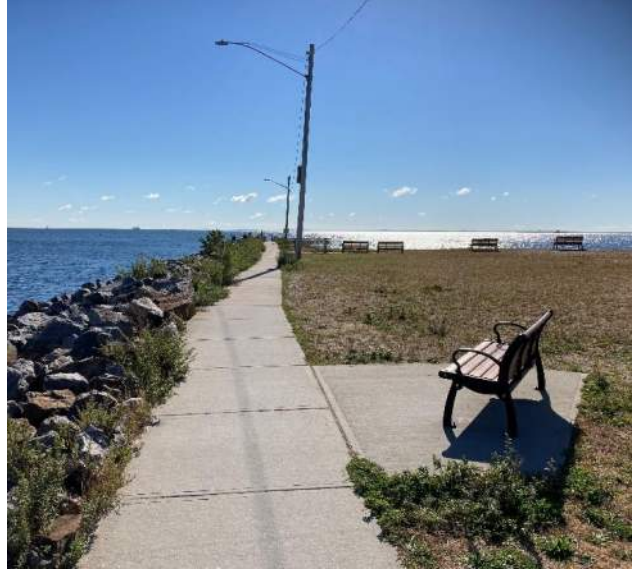
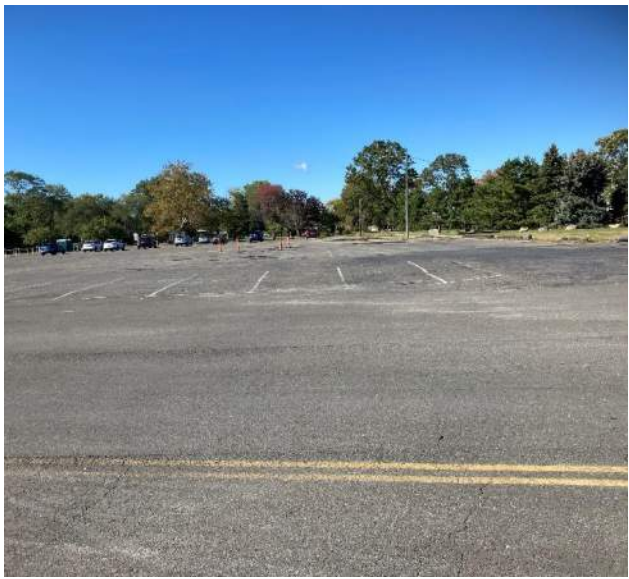
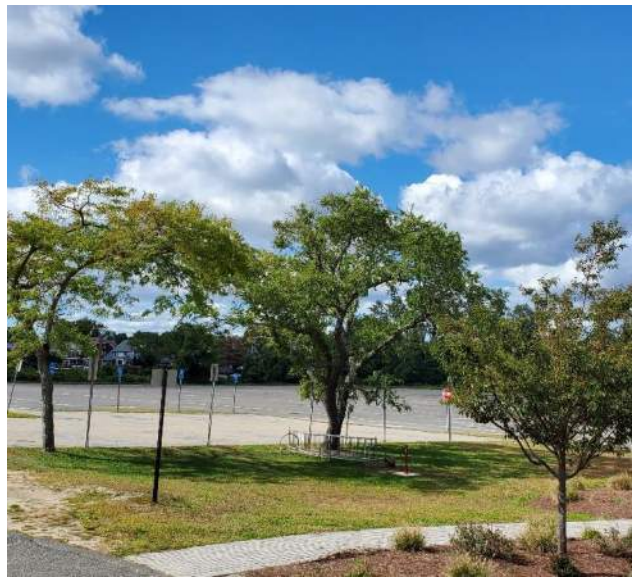
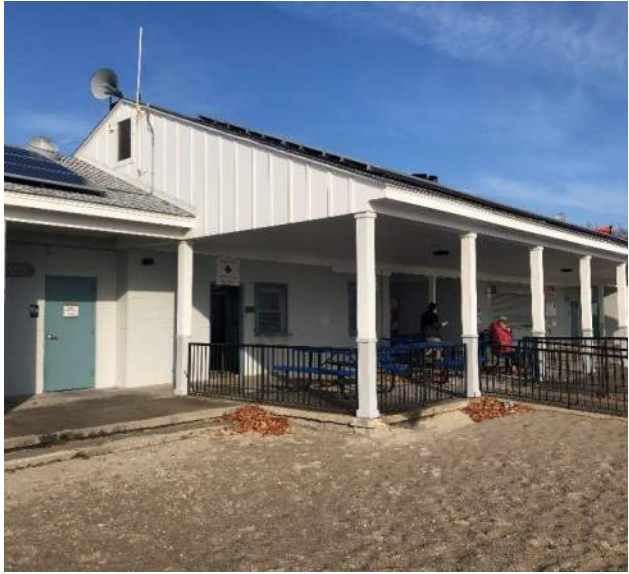
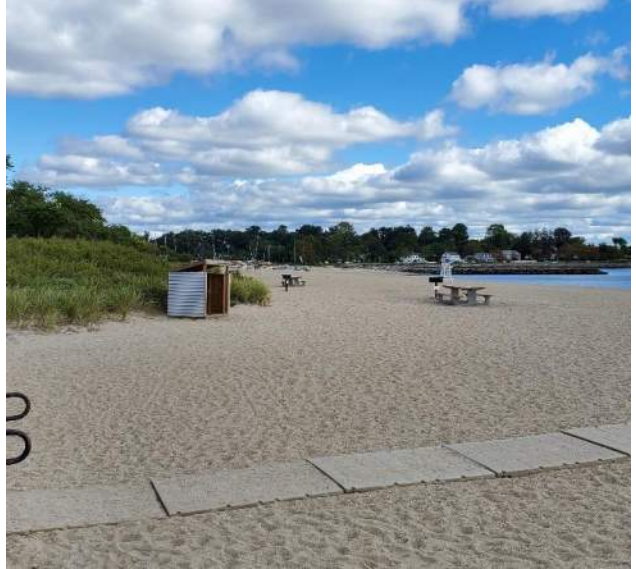
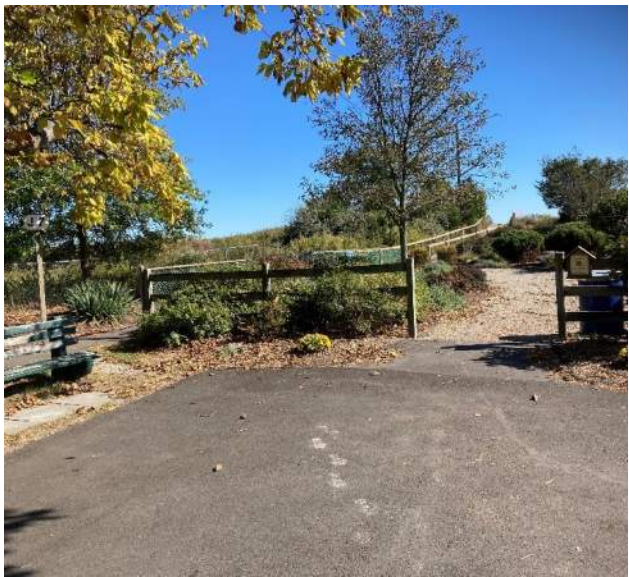
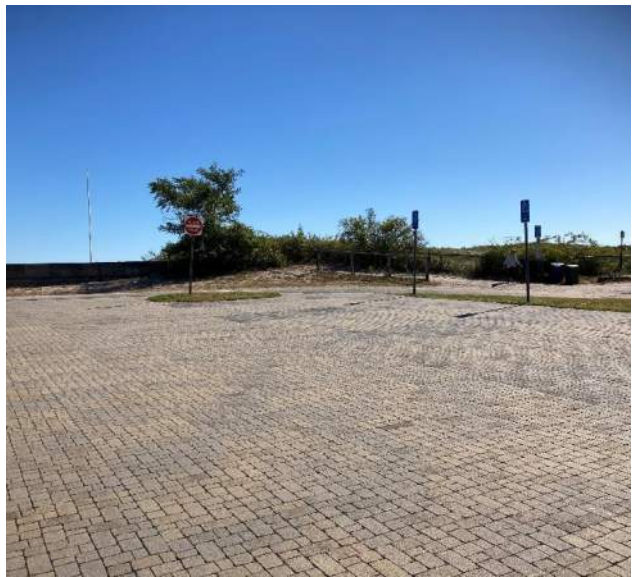
Jennings Beach is a beautiful stretch of beach adjacent to the mouth of Ash Creek with several amenities (skate park, fishing pier, kayak launch and concession building) and a nearby playground. The amenities for Jennings Beach have two different accessways (one through the S. Benson Marina area and one along S. Benson Rd) and two separate parking lots that are not connected with a through road, though pedestrian access is possible. The separate accessways and separate parking lots makes it feel like two different beaches. Both parking lots are in poor condition.

Concession building looks fine from the beach side, though nothing impressive. The concrete flooring is a bit worn and stained. However, the concession building looks terrible from the parking lot side with utility boxes, vents and unattractive screened windows and doors.

Pathway at Ash Creek/Jennings beach is weedy where it is brick and closest to S. Benson Marina, but becomes less weedy towards the beach, and highly accessible once it transitions to concrete at the beach. However, access up to the path is as described in previous note.

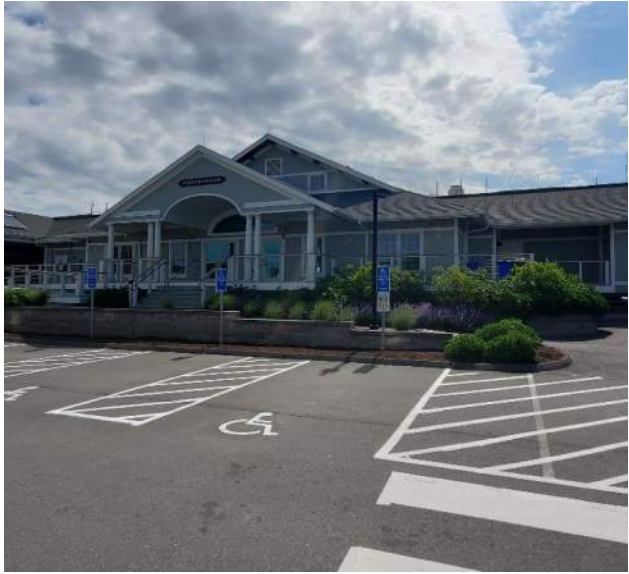
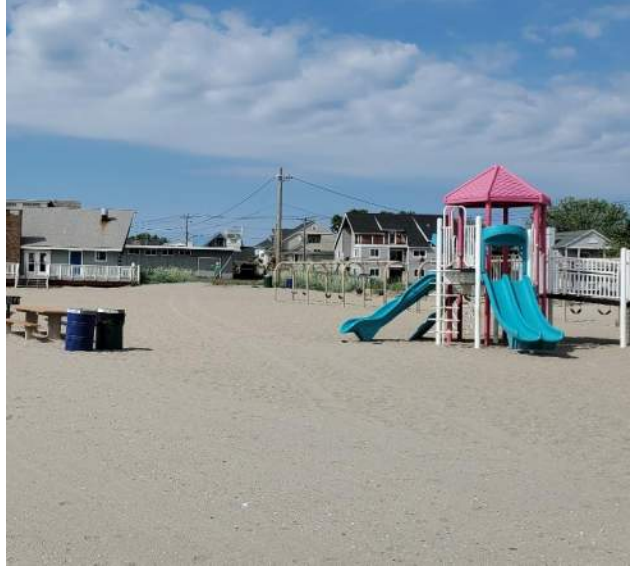
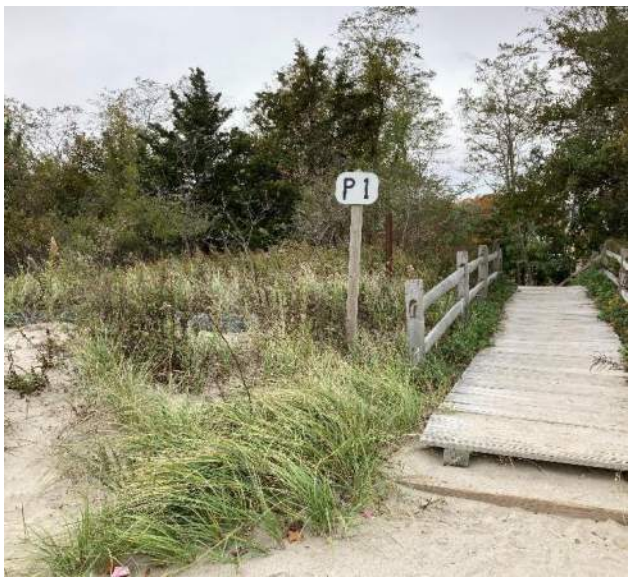
PARK: Penfield Complex
ADDRESS: 323 Fairfield Beach Rd
MAP/PARCEL: 1380230000
ACRES: 3.54 acres

A well-striped parking lot is in front of a large building with accessible ramps and decks with seating overlooking a medium-sized beach. The north side of the beach is also called Rickards Beach. A playground is located on the south side of the building and is accessibly from the parking lot by a walkway. There is a rock wall located between the playground and parking lot with a 6' drop from the beach to the parking lot which should have a safety fence installed. Additional gravel/dirt parking lots are located across Fairfield Beach Rd. Sidewalk along Fairfield Beach Rd is bituminous with frequent cracks and patches.

Rickards beach access is a wood boardwalk at a steep slope. A large 2"-3' drop occurs at the start and end of the walkway. A plastic boardwalk panel has been placed at the beach side of the walkway, but it is covered in sand and its own tripping hazard, at least in off-season conditions.

Playground appears to be part of series dedicated to Sandy Hook shooting victims. Metal play structure is showing wear and tear from frequent use and harsh beach conditions.

Plastic walkways on beach are intended to be ADA accessible but as observed in the off-season they had gaps in them that can create tripping hazards and where they start is often a 1" rise or more from the ground level.

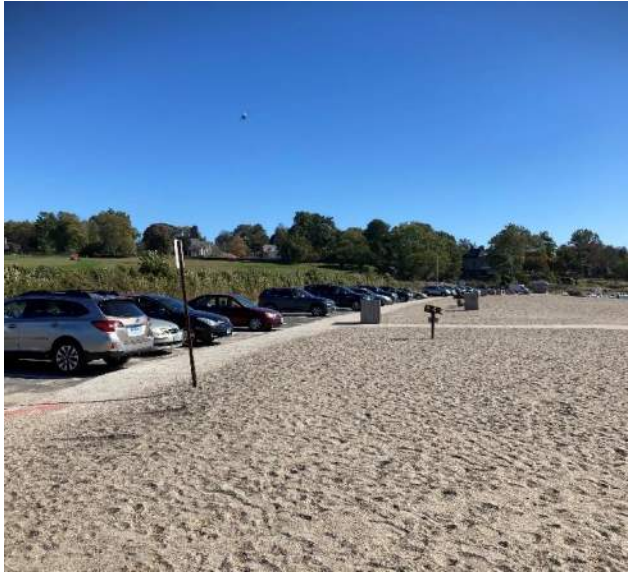
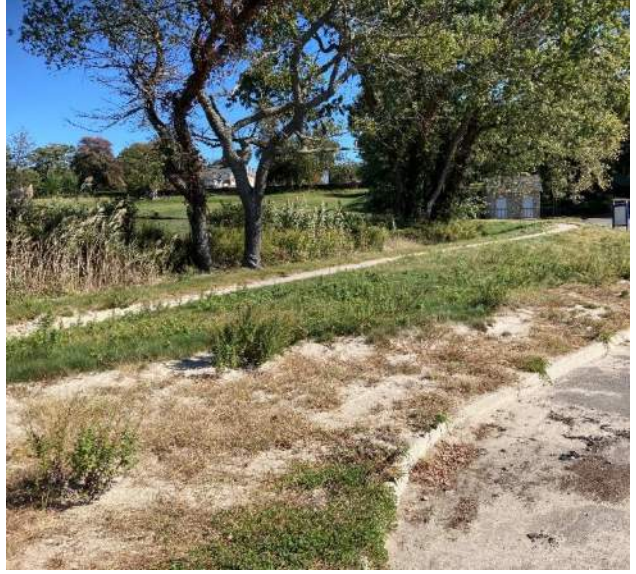
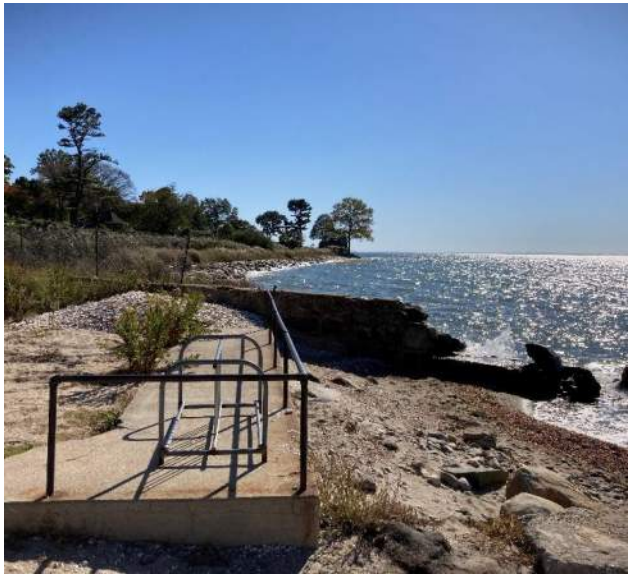
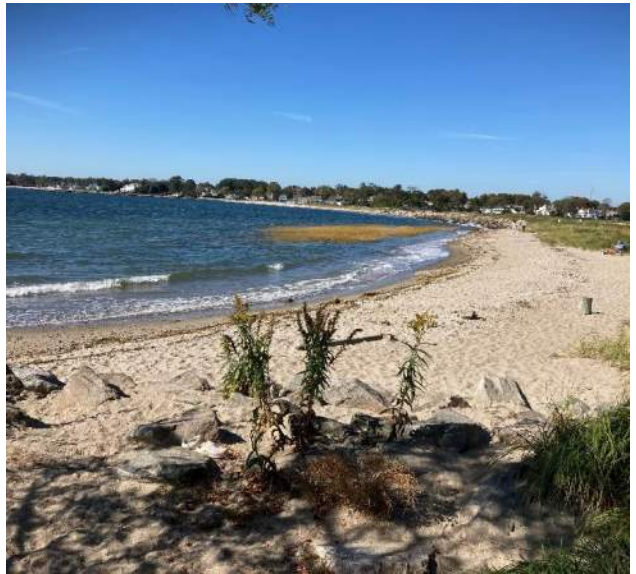
PARK: Sasco Beach
ADDRESS: 1401 Sasco Hill Rd
MAP/PARCEL: 2390160000
ACRES: 9.9

Beautiful beach setting with hillside behind and long, flat and narrow beach providing lots of water views. Accessible sidewalk between beach and parking, as well as concrete walkways leading out into the beach towards the water, makes for a highly HC-friendly beach. In the off-season many people were using the parking lot to sit in their cars and watch the water, as well as many people using the beach itself. Off season visit makes it hard to know if parking lot fills up quickly in summer even with seasonal permit parking, but most likely it does?

Two people, one limited to a wheelchair, were using the beach immediately in front of the east HC parking area demonstrating that a well-built HC accessible area, which Sasco beach large is, will have users who benefit from it.

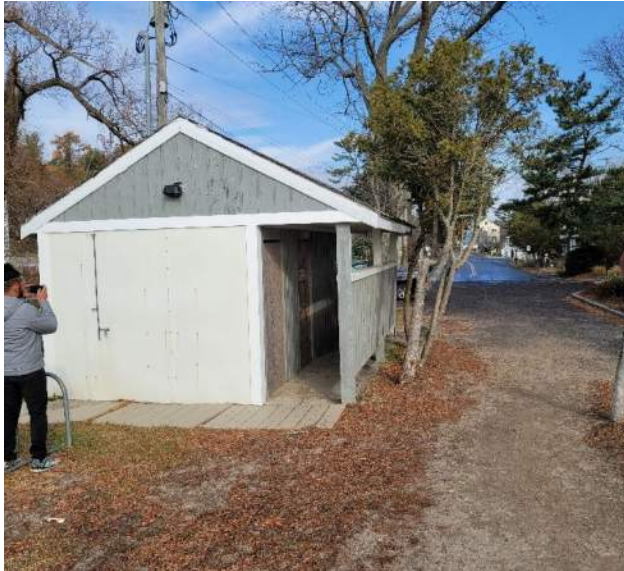
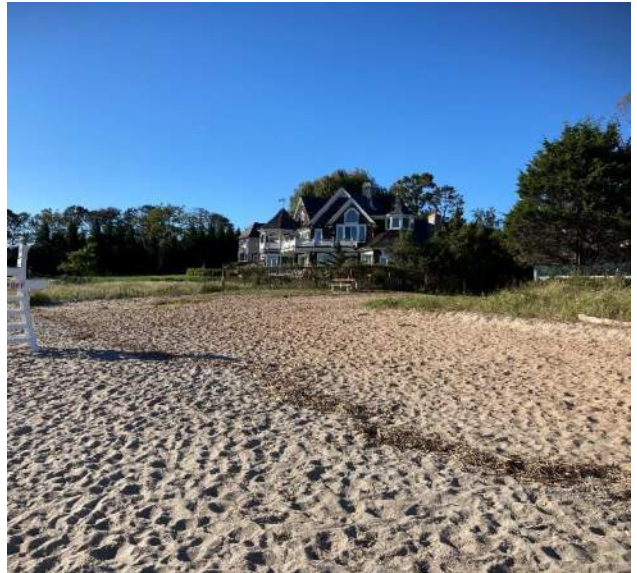
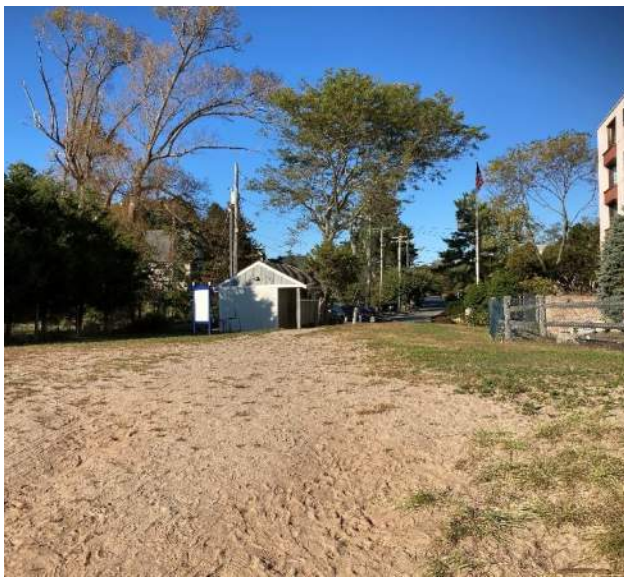
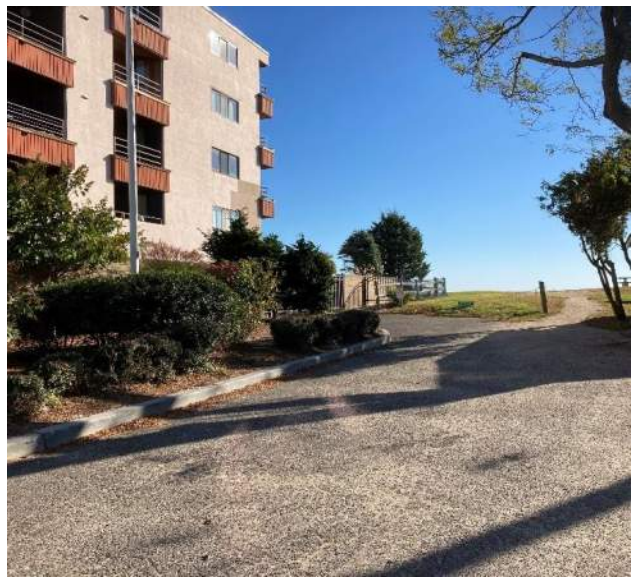
PARK: South Pine Creek Beach

This is a very small beach with only one lifeguard chair. Beach likely serves the very local neighborhood. Parking area appears very narrow and barely wide enough for cars to park and have a drive aisle behind. Restroom was boarded up at time of visit so not clear if it is open during summer months.

Unclear if fencing to west is owned by town or neighbor but it in poor condition

Overall, the restroom building is in poor condition from what can be seen on the outside.

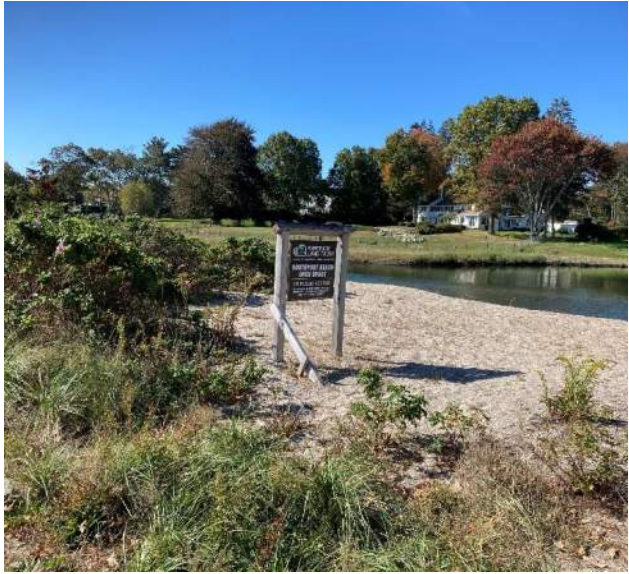
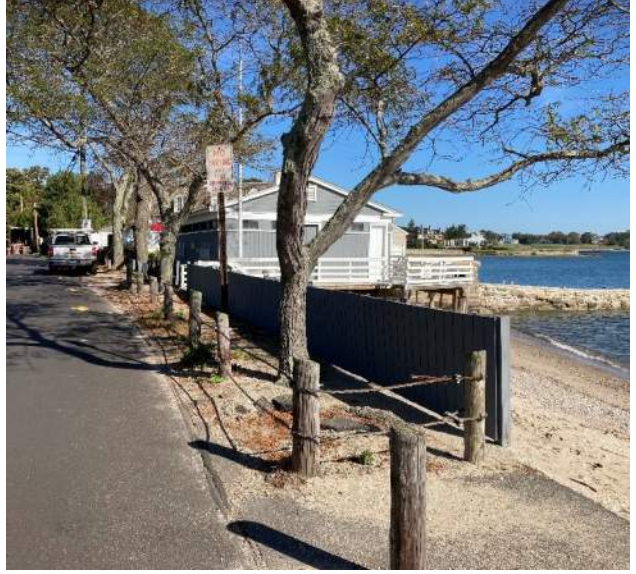
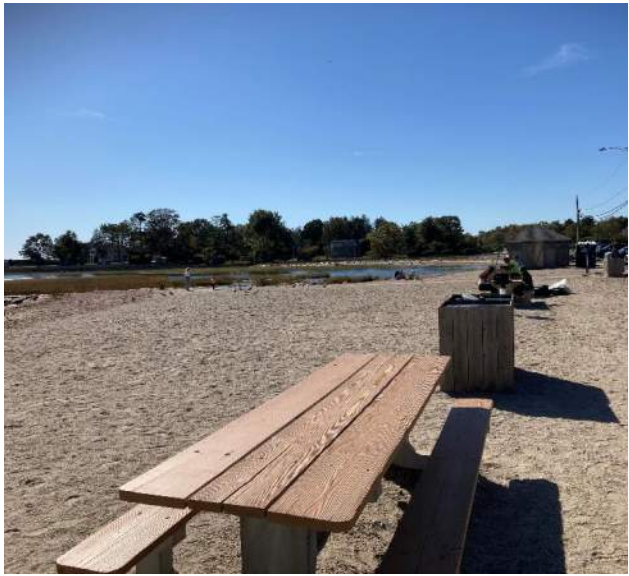
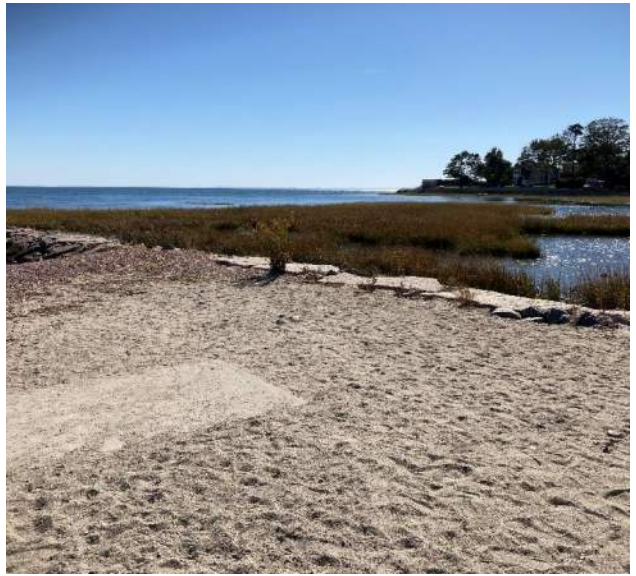
PARK: Southport Beach
ADDRESS: 1505 Pequot Ave
MAP/PARCEL: 2810210000
ACRES: 2.6

Beautiful long, flat and narrow beach is adjacent to a moderately trafficked roadway making for a busy site. Parking has no striping and all cars park 90 degree from roadway making it look like a parking lot, but also has the problems of street parking with cars frequently pulling into and out of the roadway.

Qty.	Cond.	ADA?
<i>Bike pump</i>	<i>1</i>	<i>3</i>	
<i>Storage Shed?</i>	<i>1</i>	<i>4</i>	
Notes:			
Unclear what is located in separate small building adjacent to restrooms but building itself is quite attractive.

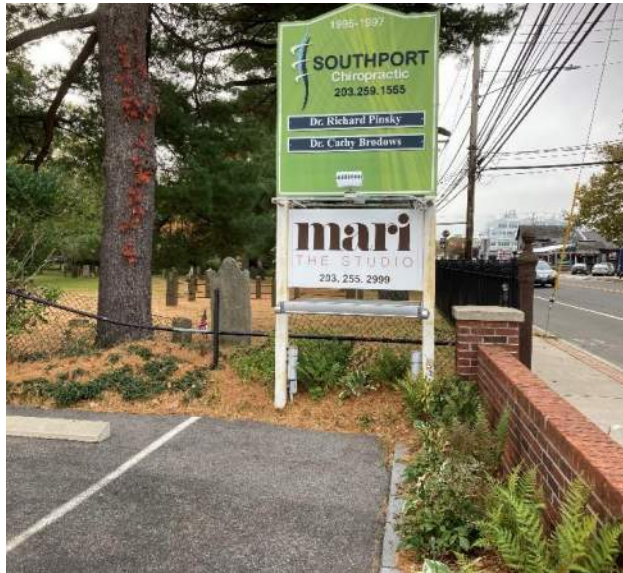
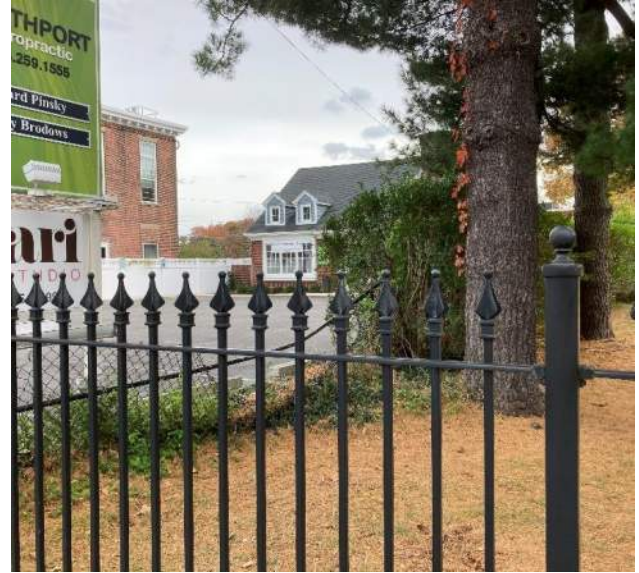
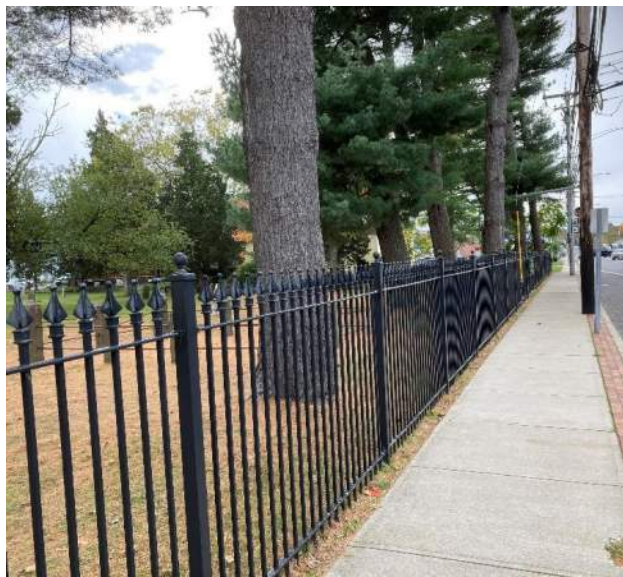
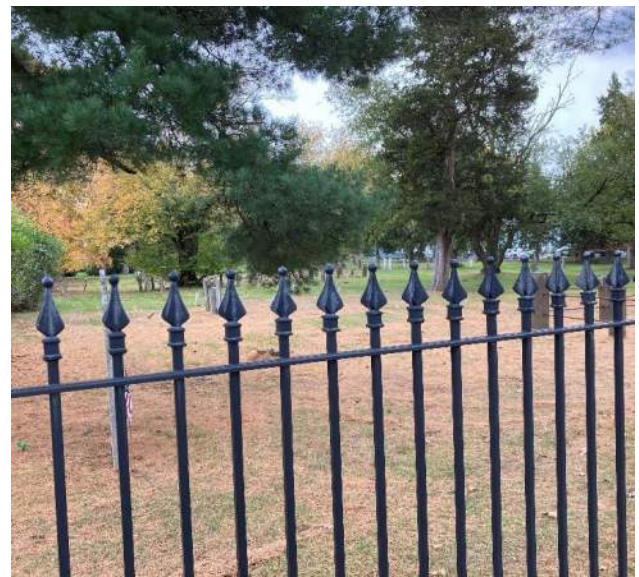
PARK: Fairfield West Cemetery

Cemetery is in a central location on a main road, on a bus line. It has no apparent parking other than nearby retail parking lots and not pathways. The 6' black metal fence along Post Road is in good condition and has a gate that has a latch and can be opened (was closed but not locked at time of visit). The chain link fence along the east side is bent and broken, and fence is possibly in similar poor condition on the south and west sides as well.

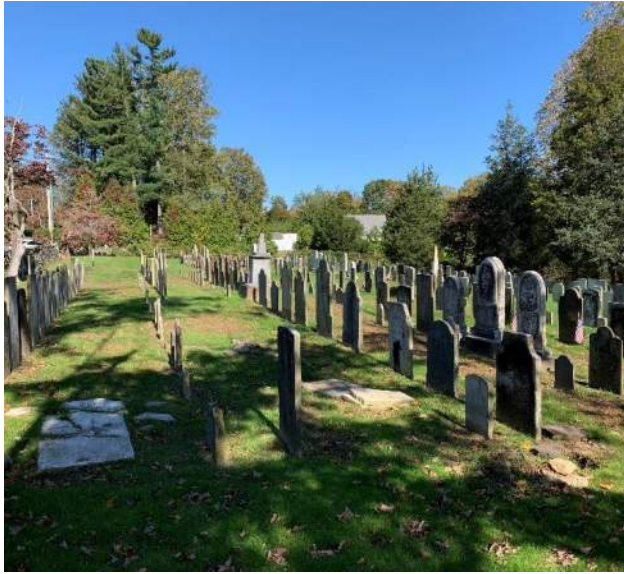
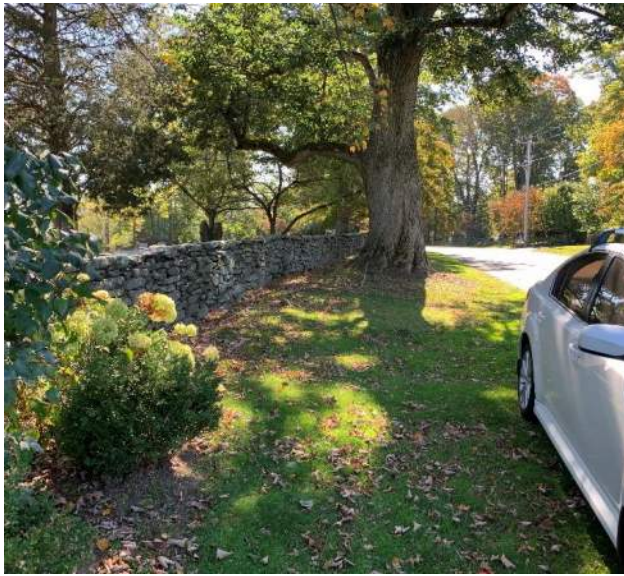
PARK: Greenfield Hill Cemetery

Too much miscellaneous objects/materials along stone wall (inside the cemetery). Steep slopes towards the back of the site. Grass condition gets worse towards the steep sloped areas.

Qty.	Cond.	ADA?
<i>Tombstones</i>		<i>2</i>	
Notes:			
Many of these tombstones are very old (from late 1700s to 1800s), and many of them are wearing out. Hard to see names on the tombstones.

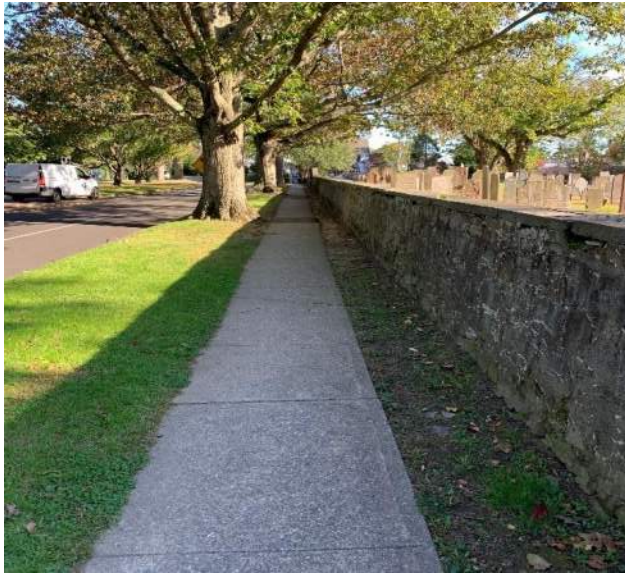
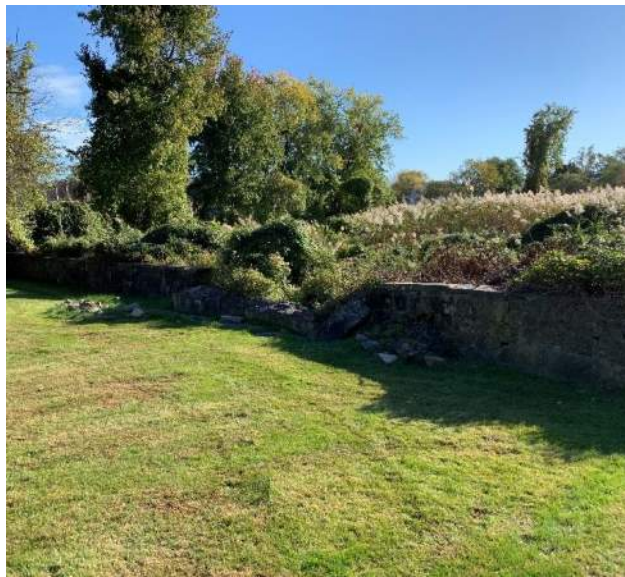
PARK: Old Burying Ground

Stone wall at the back of site and along the Fairfield Museum drive needs repair.

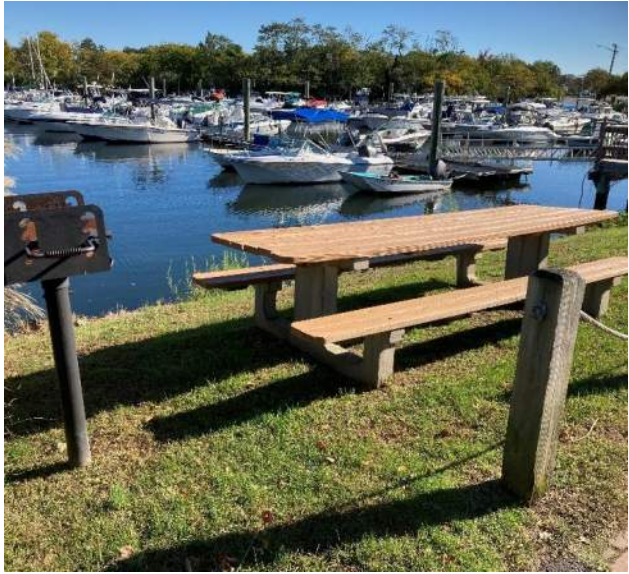
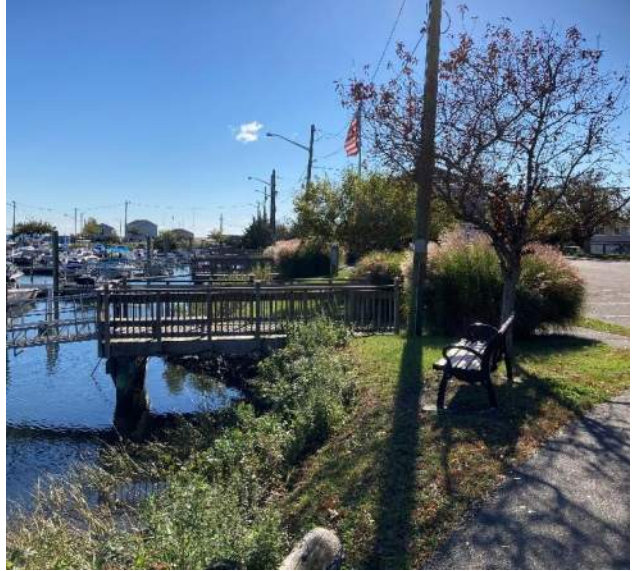
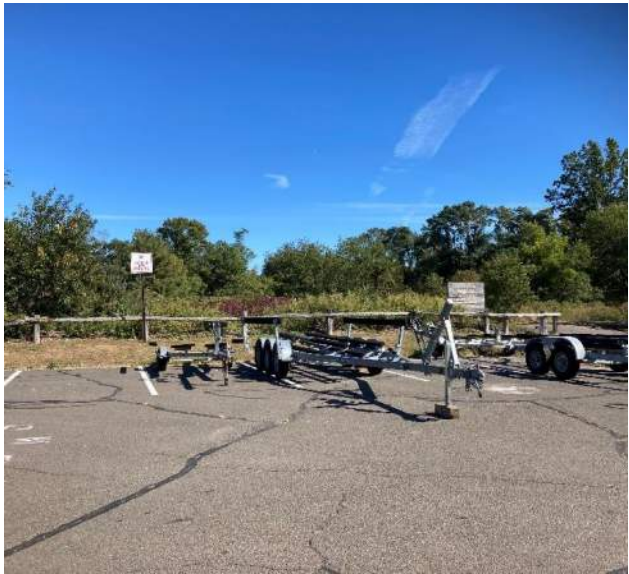
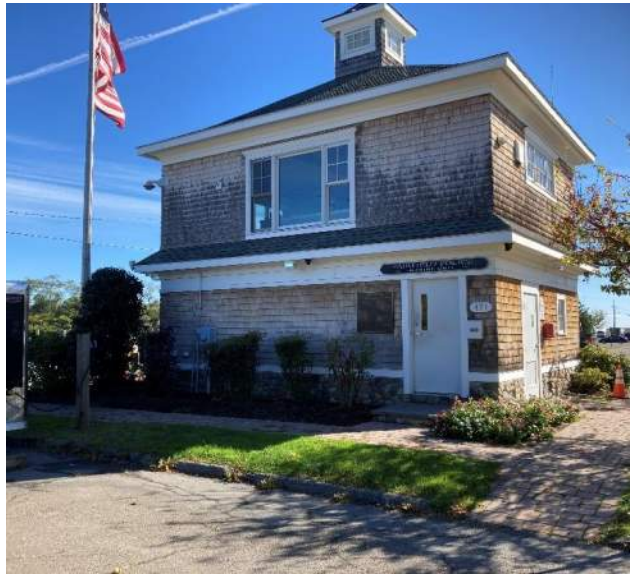
Path is in poor condition everywhere. Access to HC parking spaces is not consistent. If there is a drop off area it is not clear where that is.

Qty.	Cond.	ADA?
<i>Police building and restrooms</i>	1	3	Yes
<i>Marina Managers Office</i>	1	3	Yes
<i>Docks</i>	10	3	Yes
Notes:			
Restrooms at police building are accessible and open.			
6 of the 10 docks are accessible, though HC parking is not located near those docks			
<i>One driver was looking around for the Sandcastle park and had to back track quite a bit to go around by road, rather than being able to access the main Jennings beach parking lot which one could see from the S. Benson Parking lot.</i>			
<i>Parking for the far side of the marina and Ash Creek open space is very confusing with boat trailers parked near the main Ash Creek entrance and the HC spot for Ash Creek located far from the main entrance. The overall condition of the parking lot is very poor, as is the fencing separating the parking from the open space.</i>

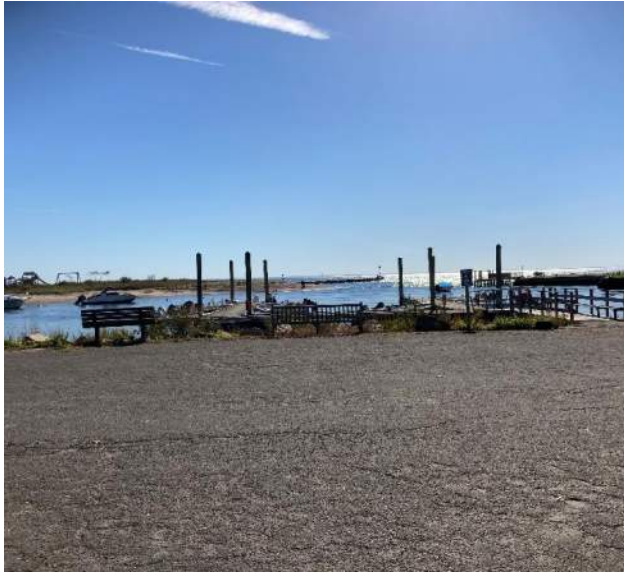
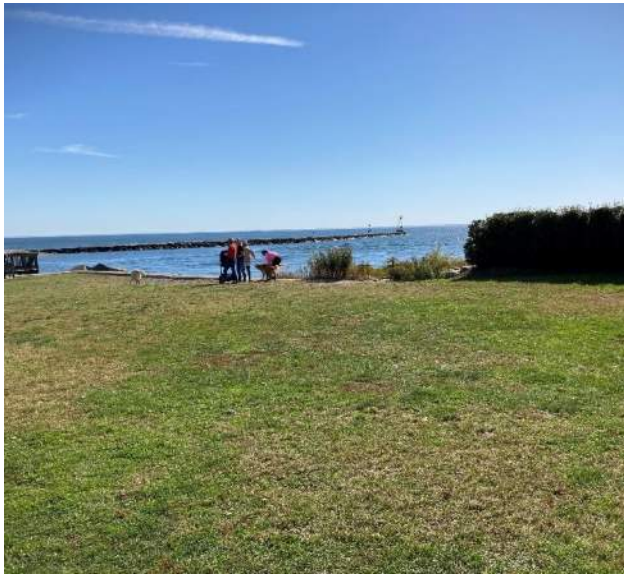
PARK: Ye Yacht Yard

Bituminous parking lot is cracked and patched, and has standing water and plant debris

Qty.	Cond.	ADA?
<i>Guard Shack</i>	1	3	
<i>Restroom/storage shed</i>	1	3	Yes
<i>Storage Building</i>	1	3	No
<i>Phone Booth</i>	1	3	
<i>South Dock – wood to metal ramp</i>	1	3	?
<i>Northeast Dock – Concrete Pad to metal ramp</i>	1	2	?
Notes:			
Restroom/storage and phone booth are attractive and rustic looking with wood paneling and wood shingles.			
Northeast dock at top of ramp is in poor condition with aging concrete and rusting, damaged fence.

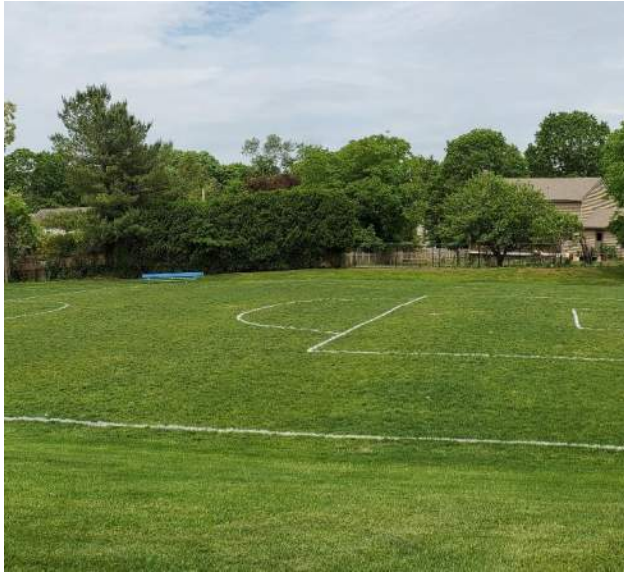
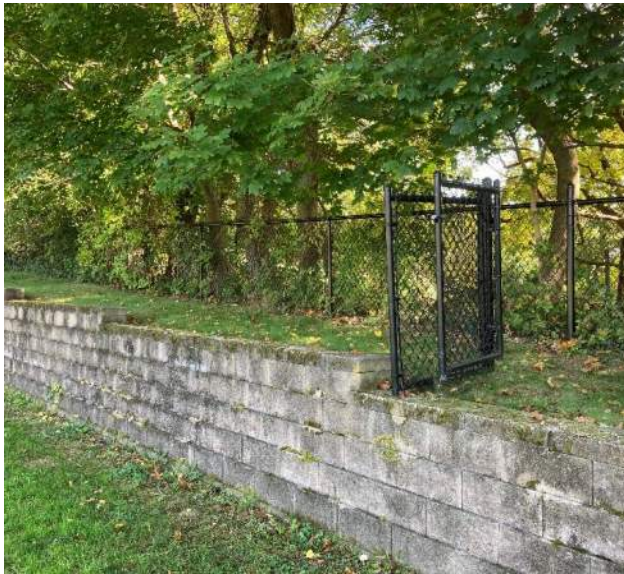
PARK: Burroughs Park
ADDRESS: 940 Burroughs Rd
MAP/PARCEL: 046138A0000
ACRES: 5.13

Parking area has no striping and therefore is just a large square of somewhat cracked bituminous paving.

Large cracks and some root disturbance to pathway

Natural turf field – grade of turf is relatively smooth, with minor ruts or small bumps where turf is worn.

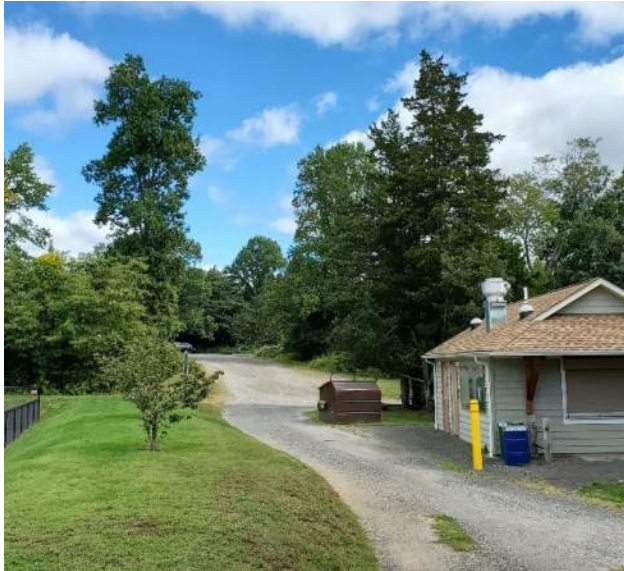
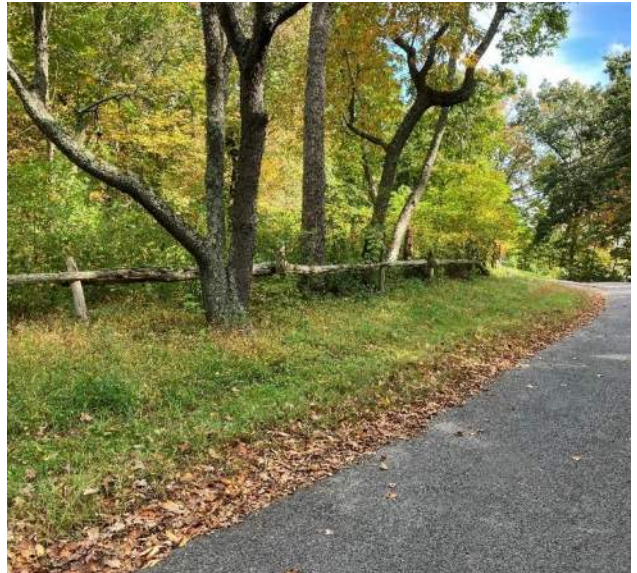
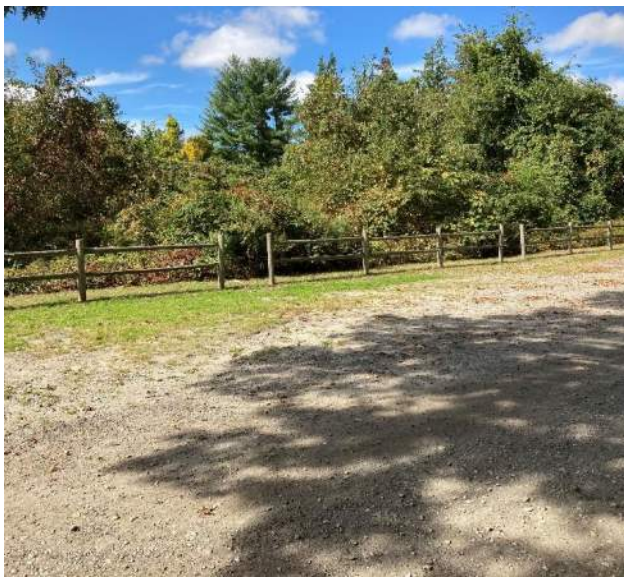
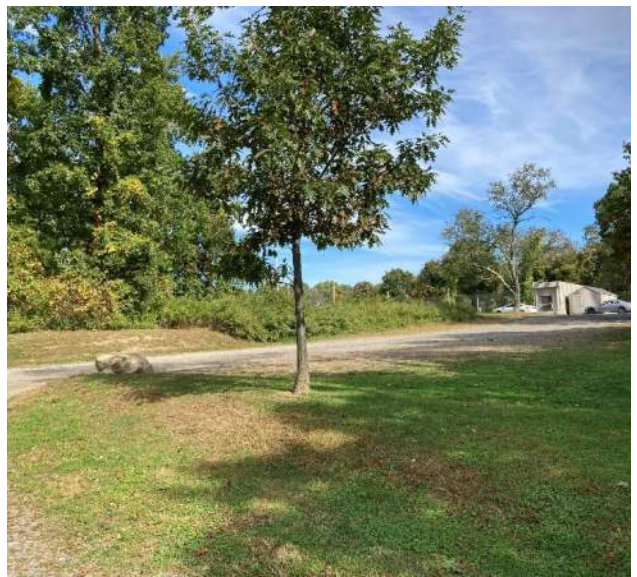
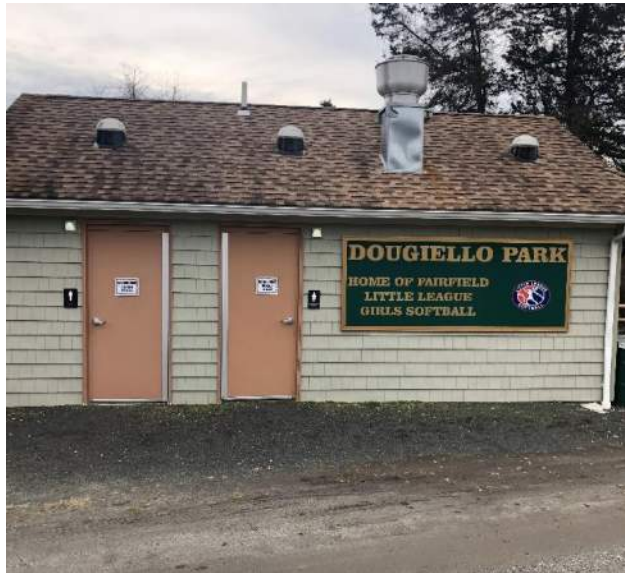
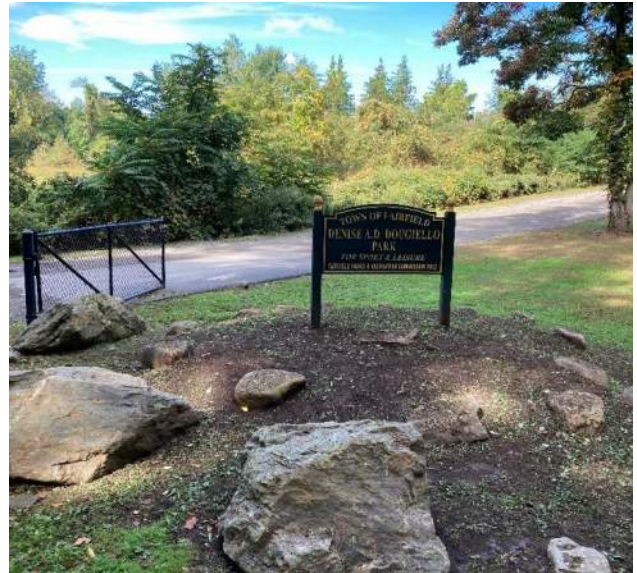
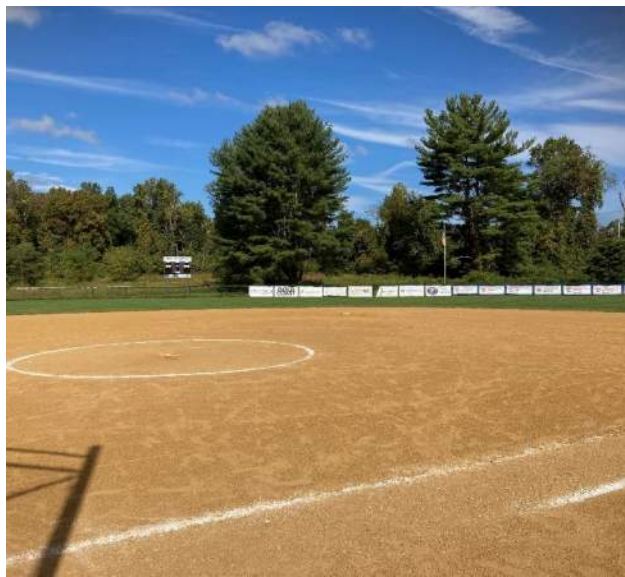
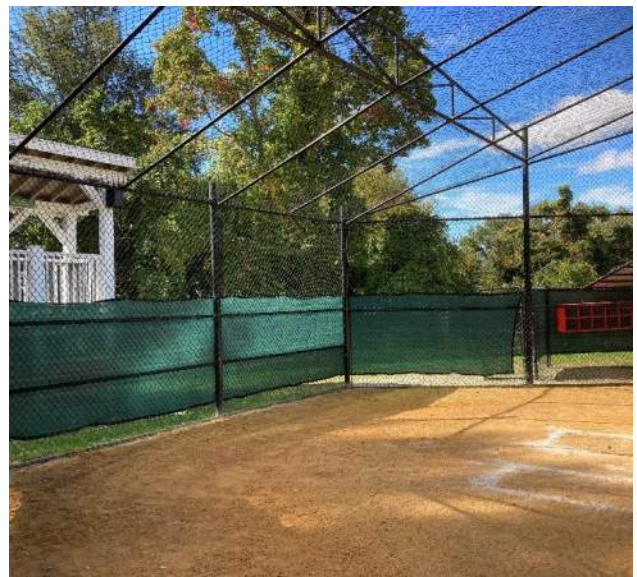
PARK: Dougiello Park
ADDRESS: 520 Hoyden's Lane
MAP/PARCEL: 0670110000
ACRES: 9.42

Facilities and field are in good condition and the location is very attractive. Access road, parking and paths are gravel surface and are eroding to the point of creating ruts in the road and an unstable walking surface. Accessibility on gravel and dirt roads is main concern with this site.

Restrooms are built to be ADA accessible but a greater than 2" gap exists at the doorway. Restrooms are clean but some rusting of metal in restrooms observed.

Gravel has been added around backstop and dugouts indicating wet conditions.

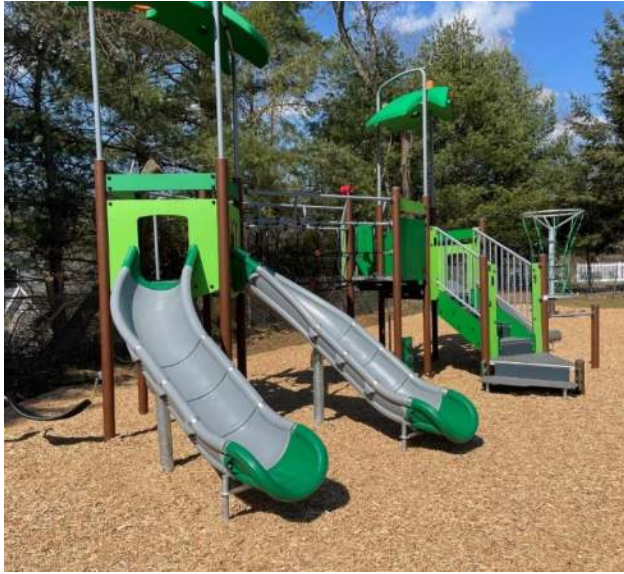
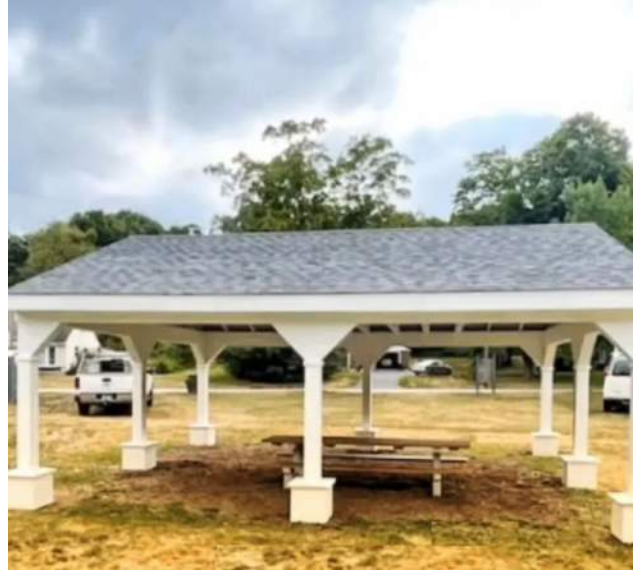
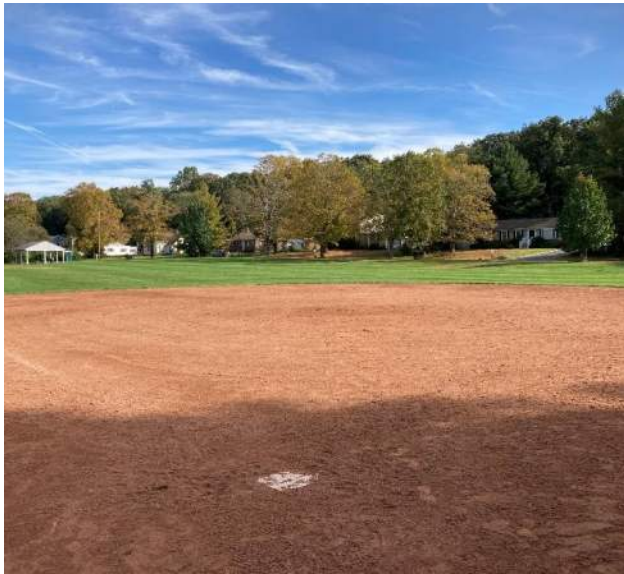
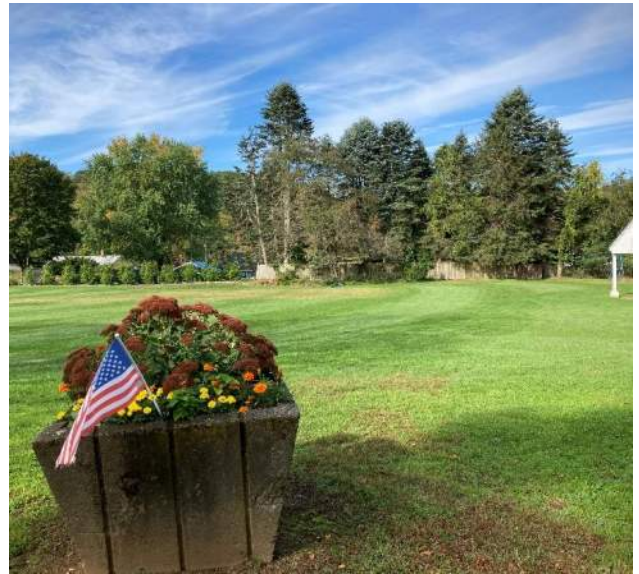
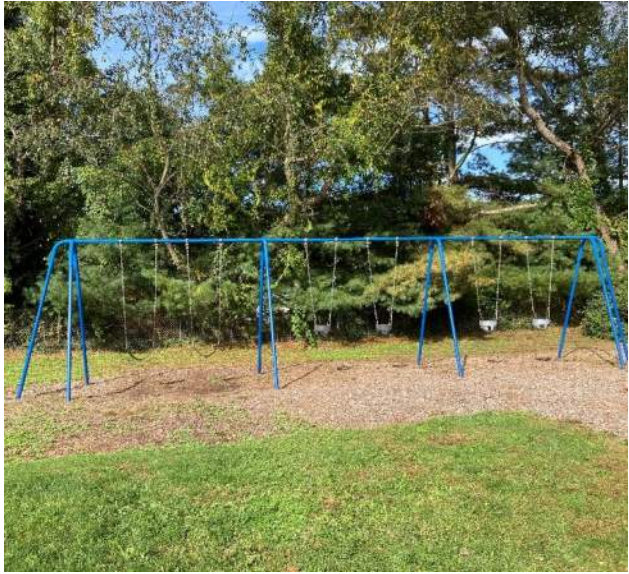
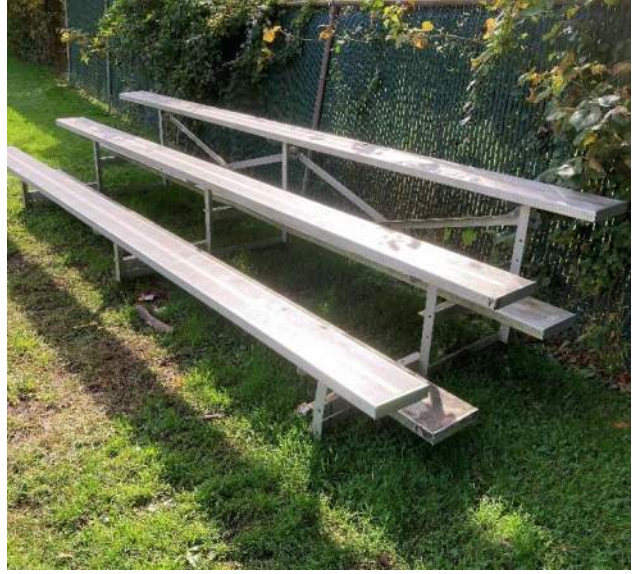
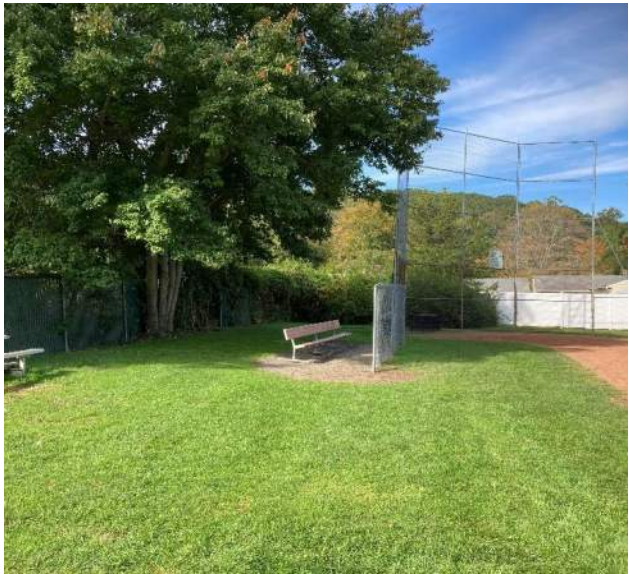
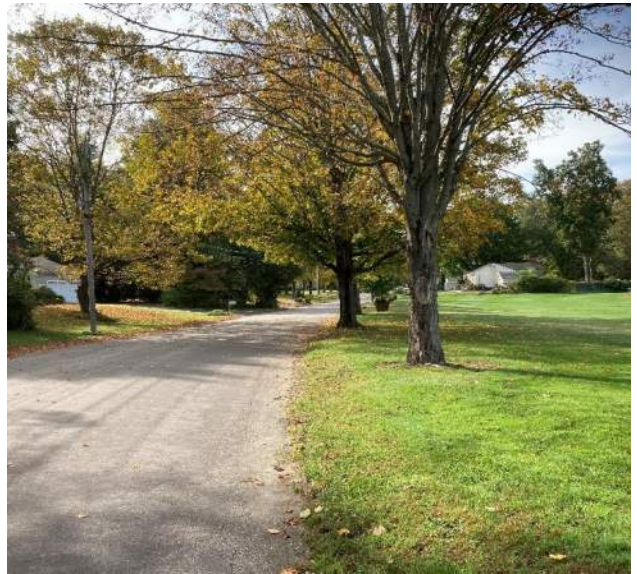
PARK: Dover Park
ADDRESS: 140 Stevenson
MAP/PARCEL: 0140620000
ACRES: 2.40

When viewed from the street, Dover Park appears to be in overall good condition with beautifully mowed lawn, a well-cared for infield and large planters of flowers along the street. Upon closer inspection the baseball benches and chain link fence are aging and just in fair condition. Playground equipment also looks good from afar, but upon closer inspection has a good amount of wear and tear and has some unsafe conditions with peeling plastic covering exposing rusting metal in places where kids are likely to be in close contract. (Note: this playground is slated for replacement in 2022)

Qty.	Cond.	ADA?
Swings	(2 kid swings/4 baby swings)	6	3	No
Play Equipment		1	2	No
Surface	wood chips			
Notes:				
Playground looks good from afar and has no obvious broken parts but when viewed up close the plastic is peeling and rusted metal is exposed on steps in a way that is potentially unsafe for children to be in close contact with it.				
There is no fencing between the playground and the street.

Qty.	Cond.	ADA?
Basic overhead pavilion at picnic area, no floor	1	2	No
Notes:			
Pavilion is wood on concrete blocks and bolts appear to be rusting, paint is peeling, and overall pavilion is functional but not attractive.

Infield and grass/lawn are in good condition. Benches are functional but aging. There is no fence in the outfield, which backs up to a street and street parking.

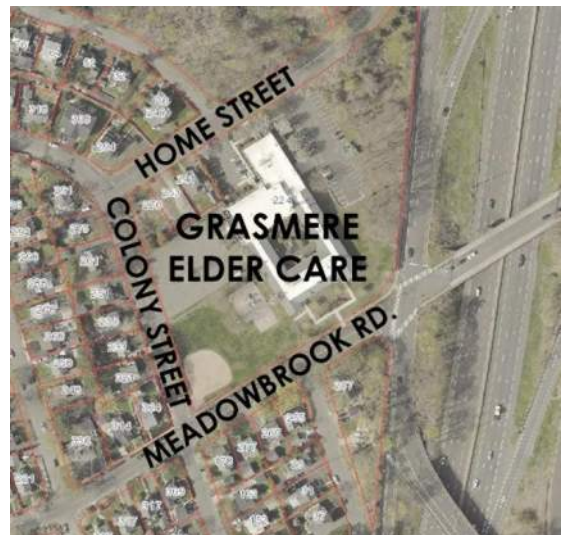
PARK: Grasmere Eldercare
ADDRESS: 224 Meadowbrook Road
MAP/PARCEL: 1282570000
ACRES: 5.05

It looks like the parking lot is used for the building on site. The sign said, "Pilot House Special Needs Center", but there wasn't anyone on site. I am not too sure what the use of the building is. I recommend restriping parking lot and if possible, add ADA accessible spaces closer to parking area.
