APPENDIX A

Study Facilities

APPENDIX A
STUDY FACILITIES
Town of Fairfield Masterplan

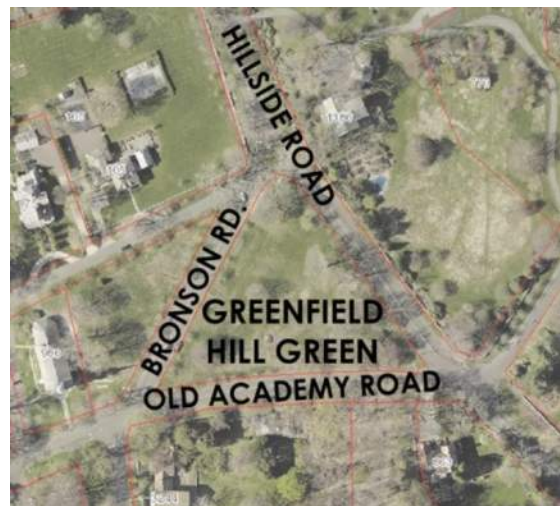
PARK: Greenfield Hill Village Green

Small open green space with roads on all sides. No sidewalks or crosswalks for access. One bench on site. Parking is unofficial street side parking. No signage for parking. Consideration for dedicated parking.

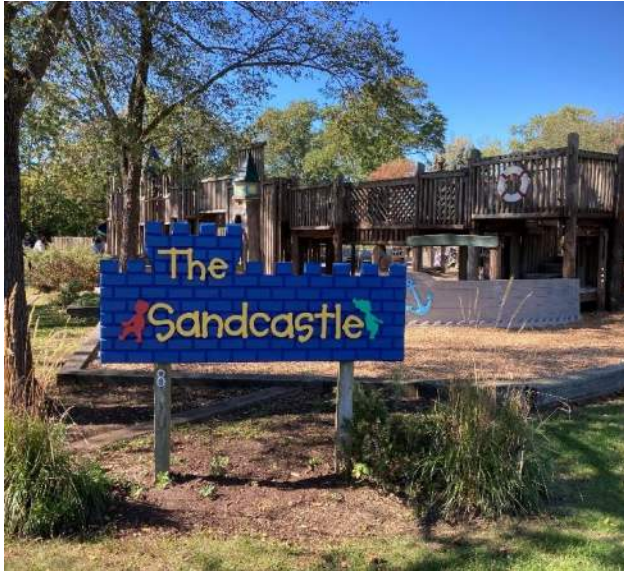
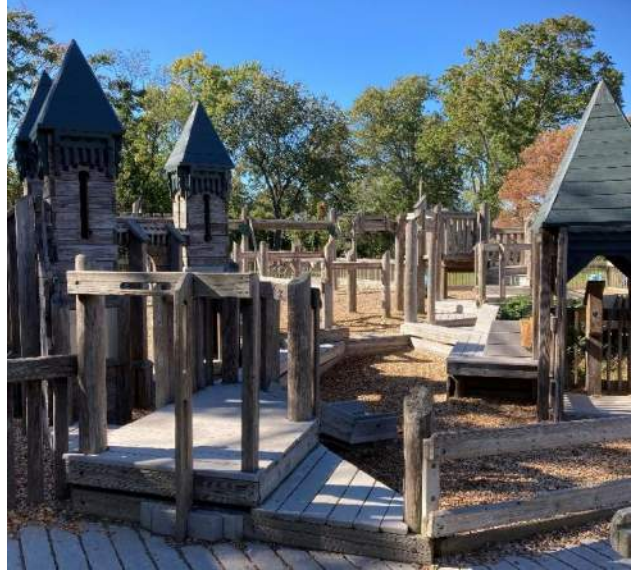
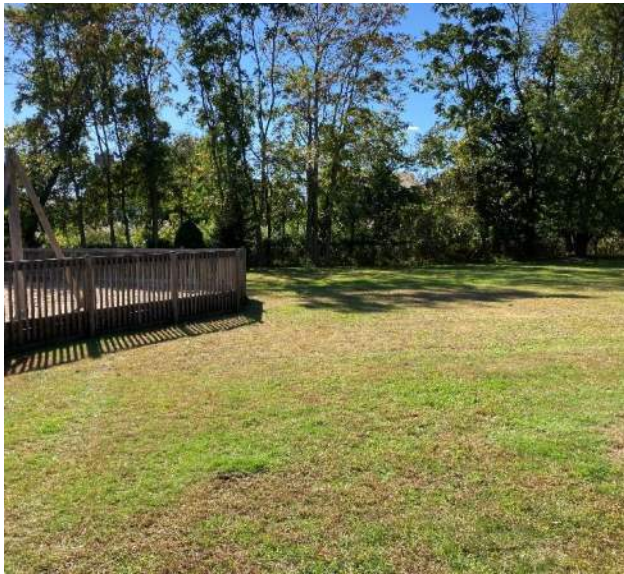
Qty.	Cond.	ADA?
Swings	2 regular, 4 baby, 2 HC, 1 tire swing	9	3	Yes
Play Equipment		1	3	Yes
Surface	Wood Chips			
Notes:				
Wood playground parts are holding up well though metal parts are rusting.				
Playground may not meet current playground safety standards or meet current ADA requirements for inclusive play. We recommend that the playground be inspected by a Certified Playground Safety Inspector (CPSI).

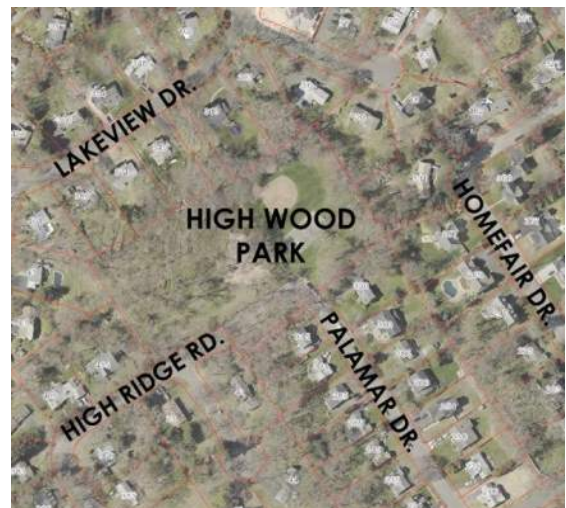
PARK: Highwood Park

Very wooded site with heavy foot traffic from children walking to and from school. Not many users of the playground observed but a group of middle-school-aged boys seemed to stay at the basketball court for several hours after school. Playground might be more actively used in summer but on a cloudy day the heavily wooded playground with aging equipment was not looking very appealing. Baseball field appears in good condition but with fewer of the features of other baseball fields such as dugout fencing and spectator seating. Most, if not all, of the site elements are not accessible.

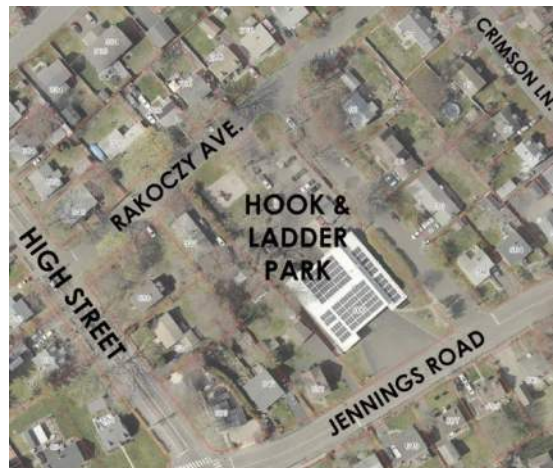
PARK: Hook & Ladder Park

Playground in fair condition. Minor repairs needed for the chain-link fence.

On site park sign needs some repair.

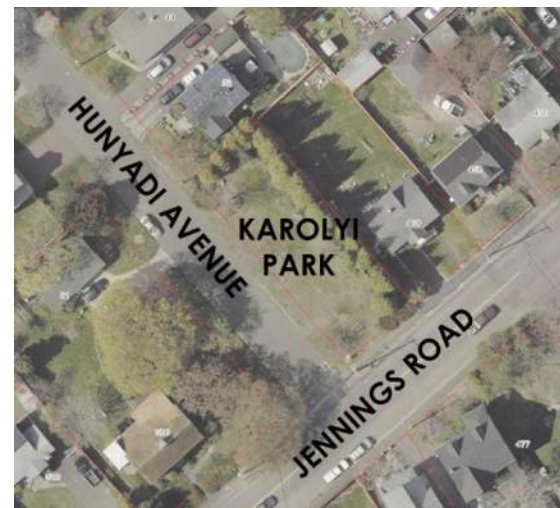
PARK: Karolyi Park
ADDRESS: 20 Hunyadi Ave
MAP/PARCEL: 0796810000
ACRES: 0.15

Park is a conventional corner pocket park with mature, attractive plantings, signage and two benches. Park plantings are maintained by at least two neighbors, one of whom mentioned he has been trimming some of the plants for safer viewing into/out of the park as there is presently a hidden 'nook' behind some plants, where a placard is located. While plantings look very nice, the lawn is patchy and weedy and could use refurbishment.

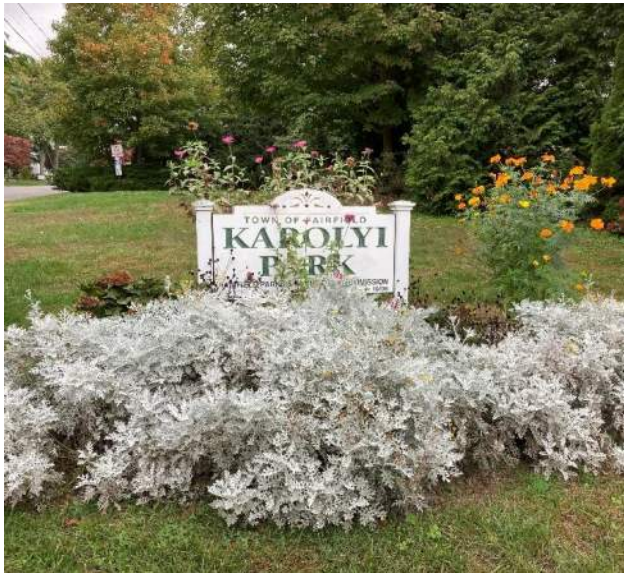
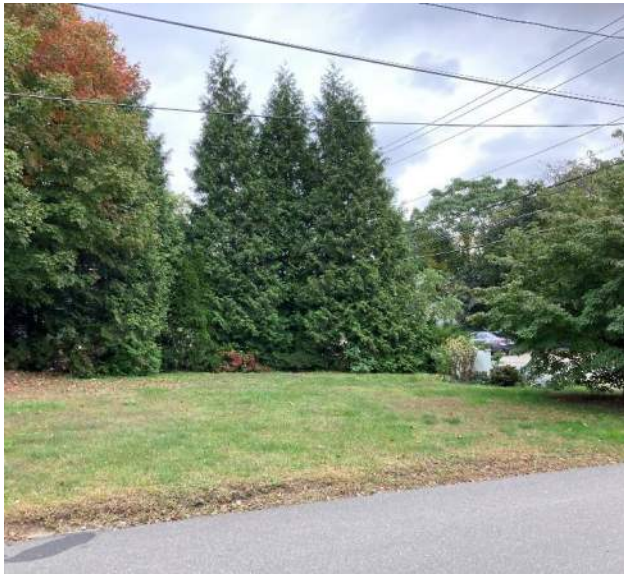
Description	Qty.	Cond.	ADA?
Restrooms		0		
Trash		0		
Storage		0		
Benches		2	3	No
ADA Seating		0		
ADA Companion Seating		0		
Perimeter Fencing		0		
Sufficient Shade on Site	Yes			
Notes:				
Benches are high quality Maglin benches, but wood seat is aging and faded grey.

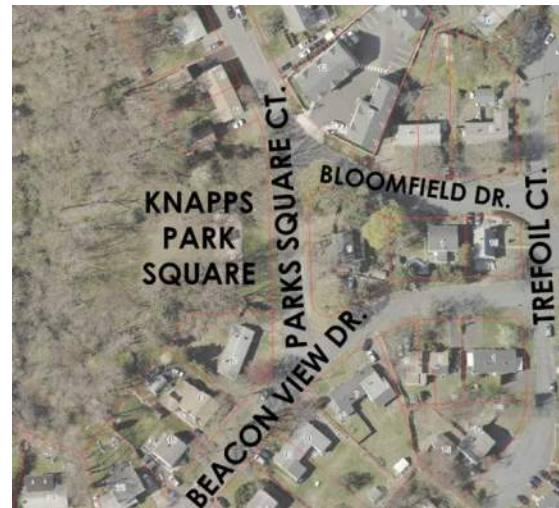
PARK: Knapps Park Square

Small playground for 3–5-year-old age group plus small swing set in a small but attractive field/wooded open space. Some children observed using the swings on their way home from school and local dogwalker using the open space. Could be a good setting for a larger playground or at least more swings, if local community is interested.

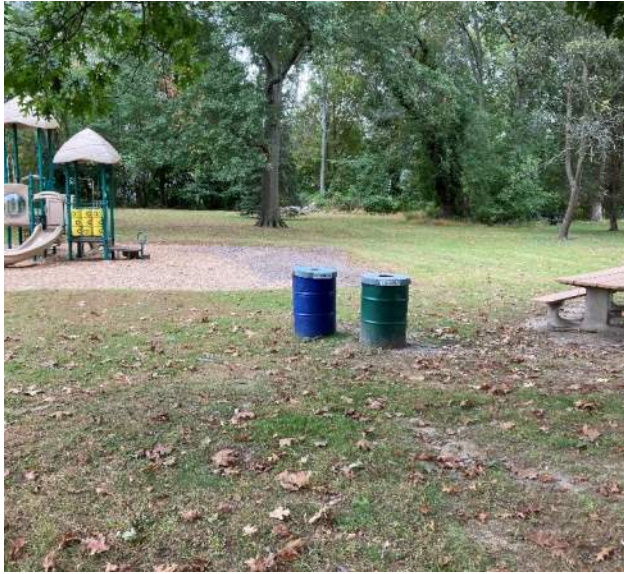
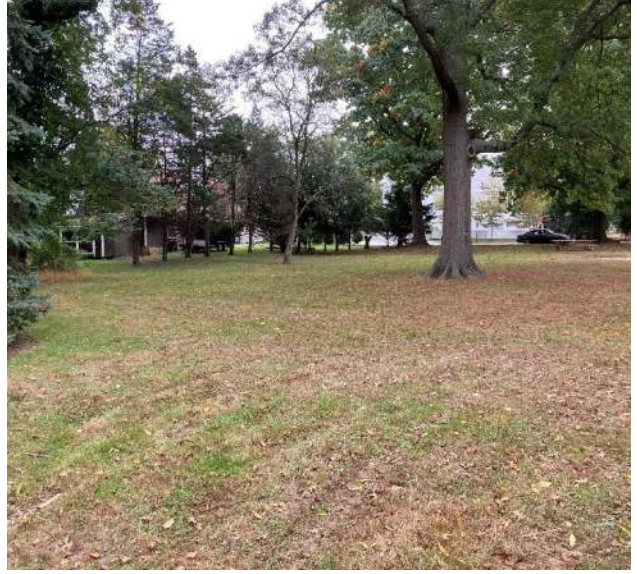
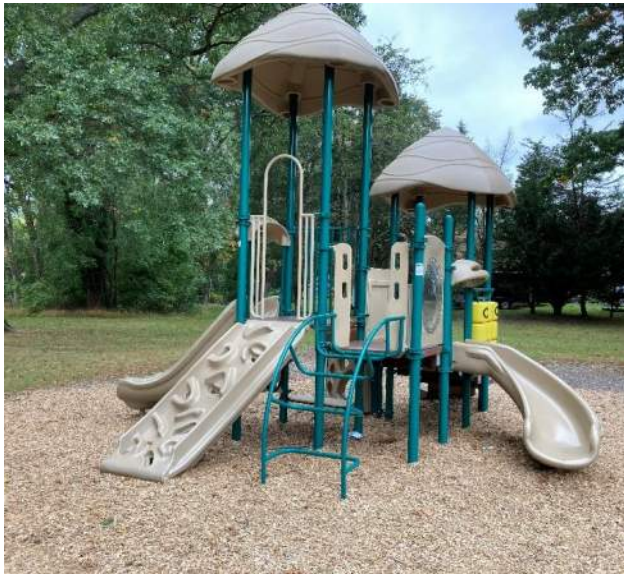
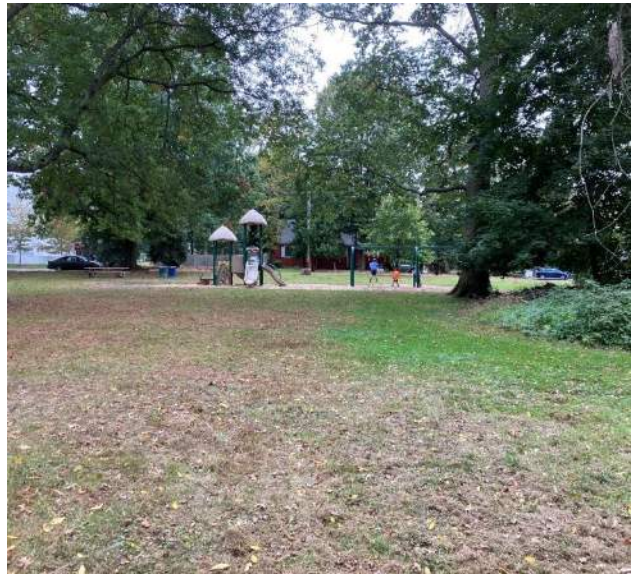
Playground is small, but in fair condition.

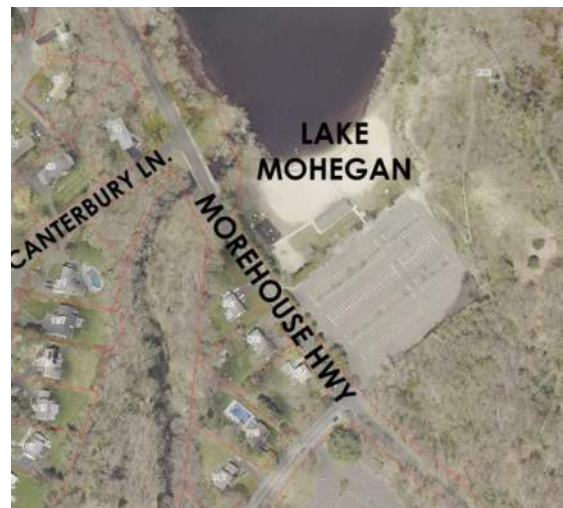
PARK: Lake Mohegan
ADDRESS: 880-960 Morehouse Hwy
MAP/PARCEL: 0491570000
ACRES: 118.6

Beach, playground, concession building, and picnic areas were all closed (behind a locked gate) at time of visit during the off season. Parking lot was still in relatively high use by trail users, including hikers, runners, and dog walkers.

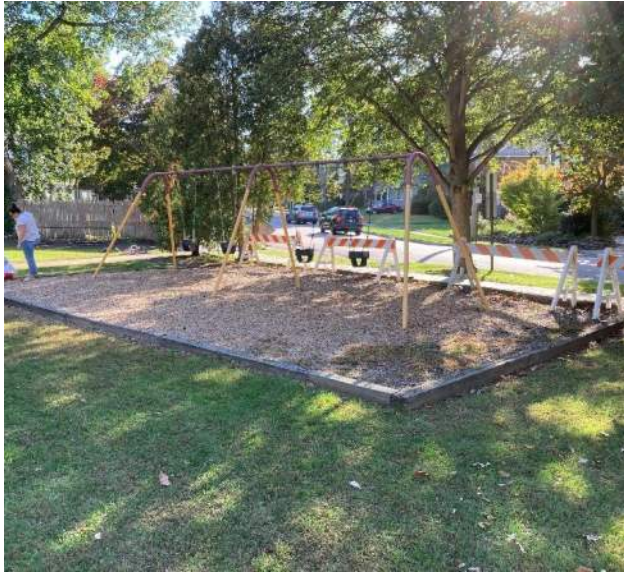
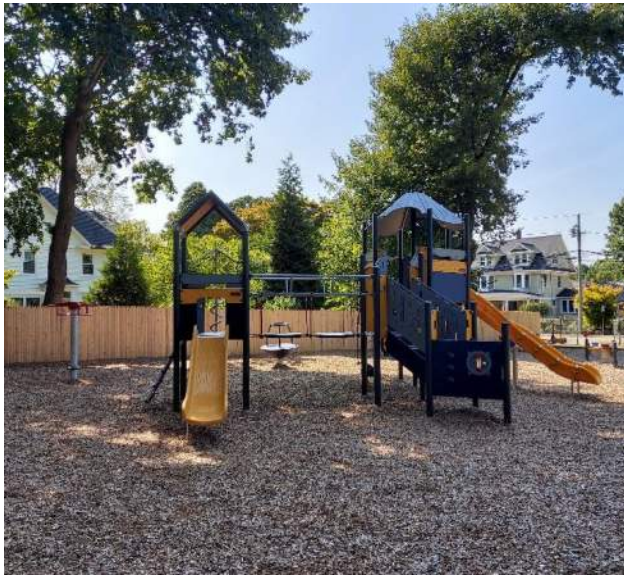
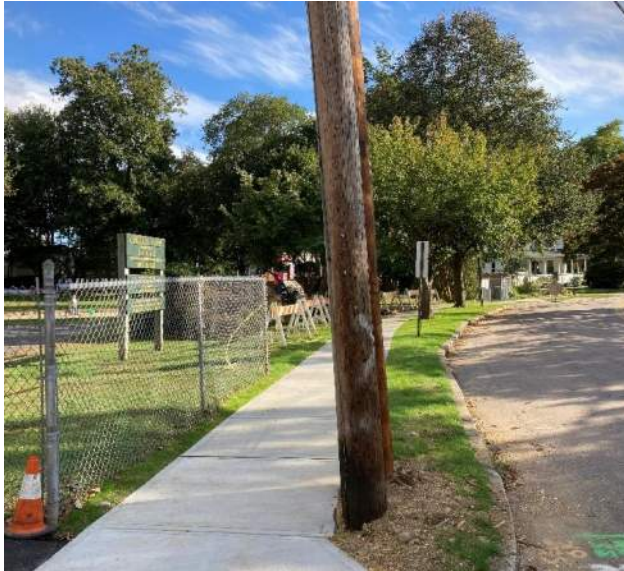
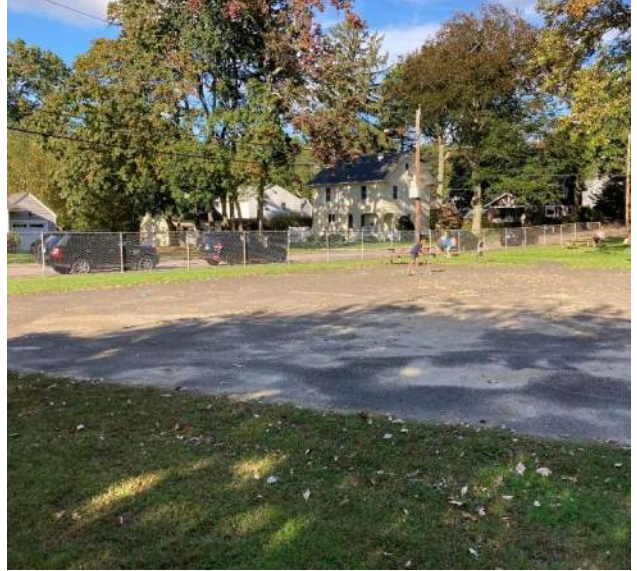
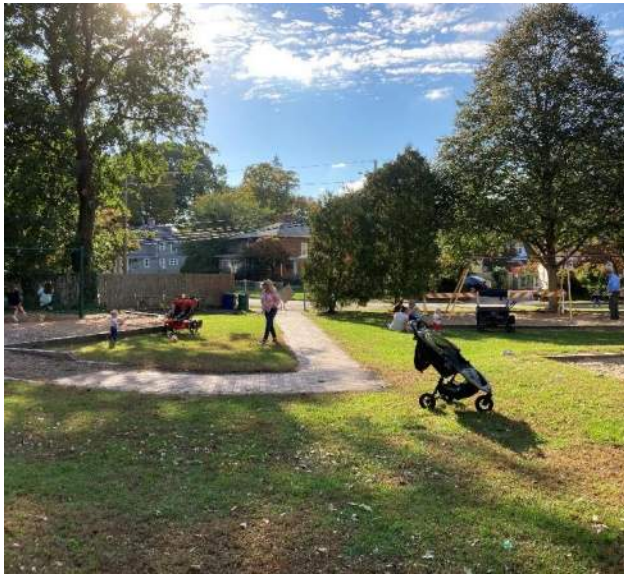
PARK: Lincoln Park
ADDRESS: 455 Jackman Ave
MAP/PARCEL: 0300350000
ACRES: 1.26

Fencing and bench along south side neighbor are in very poor condition. Wood fence is possibly owned by neighbor.

The site contains the cracked remains of a basketball court (no nets or poles), which is now used by kids with scooters. Some parents expressed a wish for the basketball court to be repaired for use as a basketball court again.

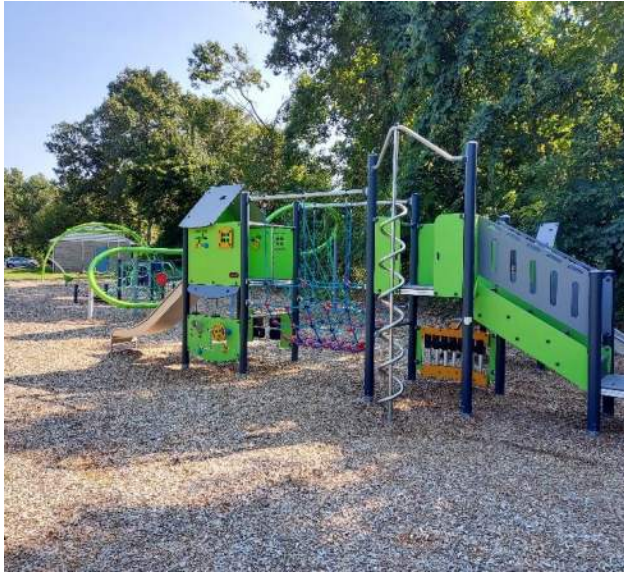
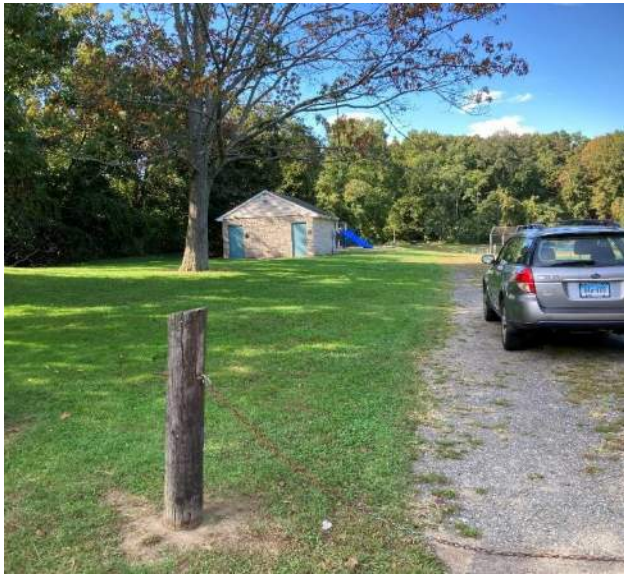
PARK: Melville Park
ADDRESS: 180 Melville Drive
MAP/PARCEL: 0460860000
ACRES: 4.51

Chain link perimeter fence to northeast is in particularly bad shape, rusting and broken.

Playground equipment has peeling plastic and exposed rusting metal. Equipment is also sun-faded in places and has a fair amount of graffiti.

Field looks good overall, some rusting on the chain link backstop and lawn is patchy further away from the field.

Chain link fencing is more minimal than field closer to Melville, but in better condition with less or no rusting.

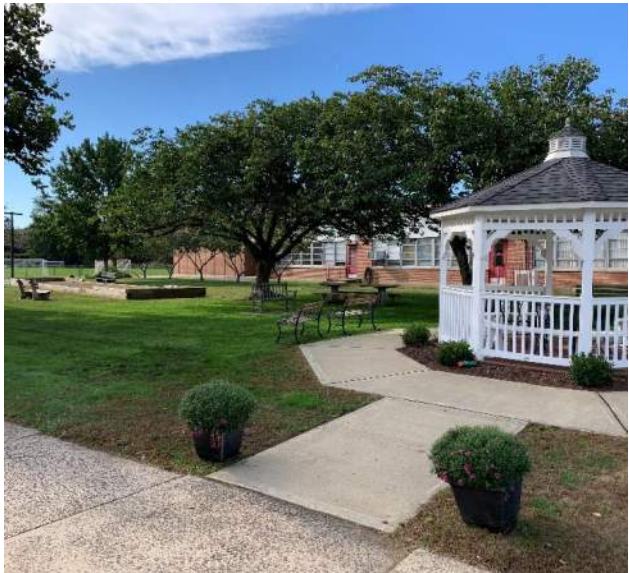
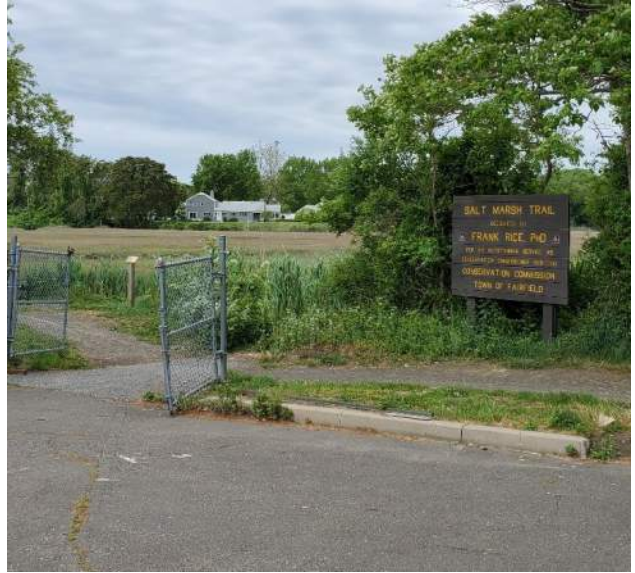
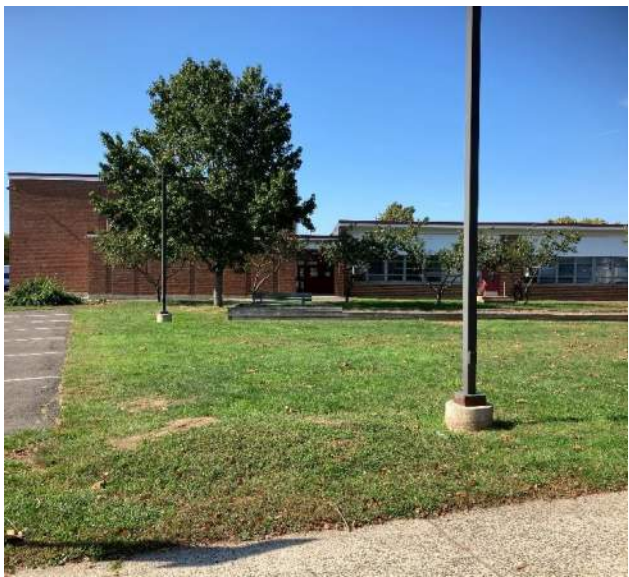
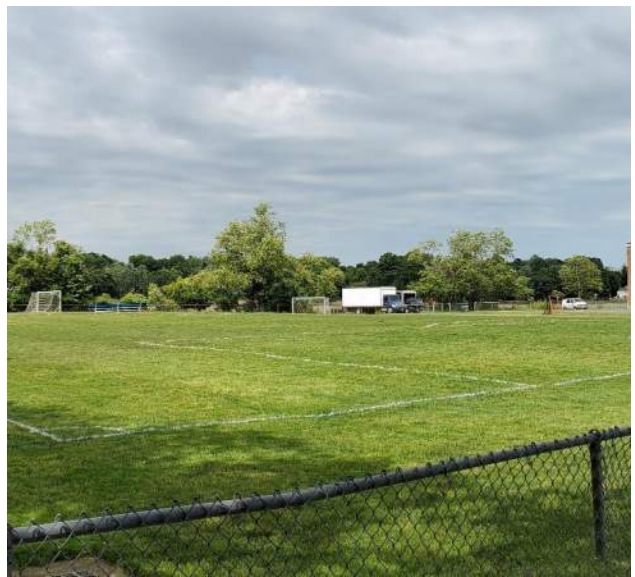
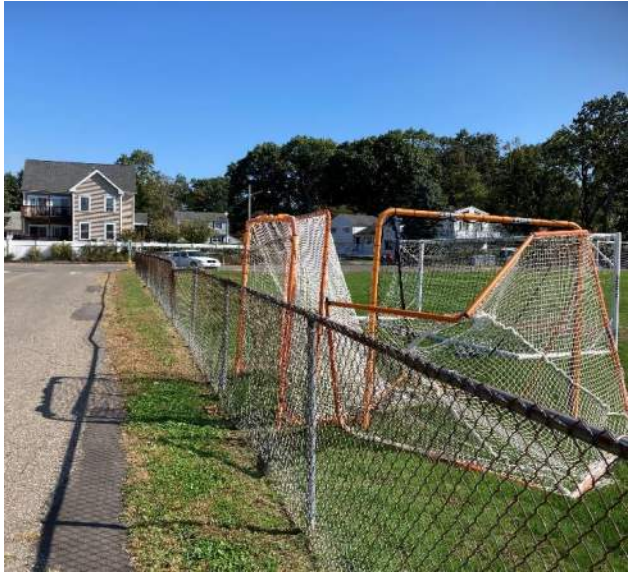
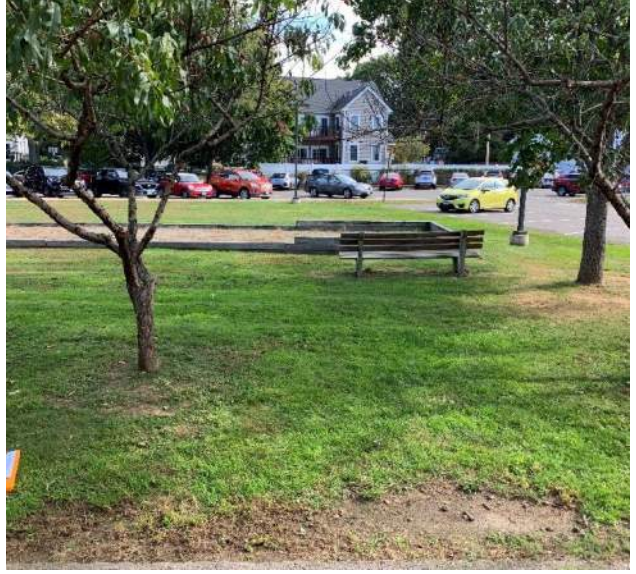
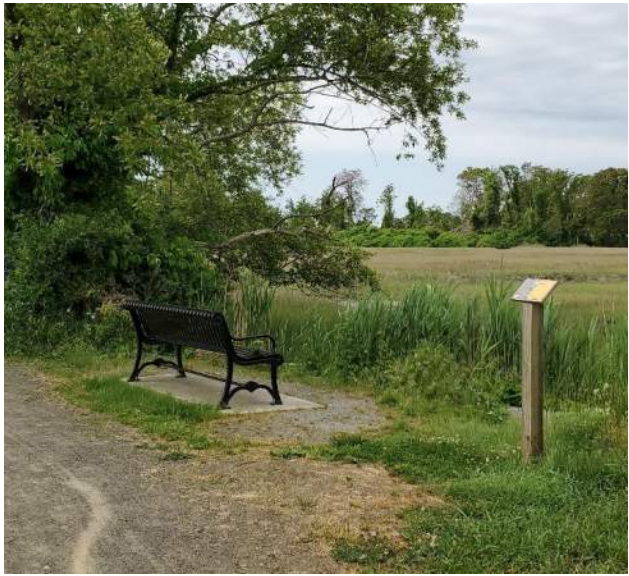
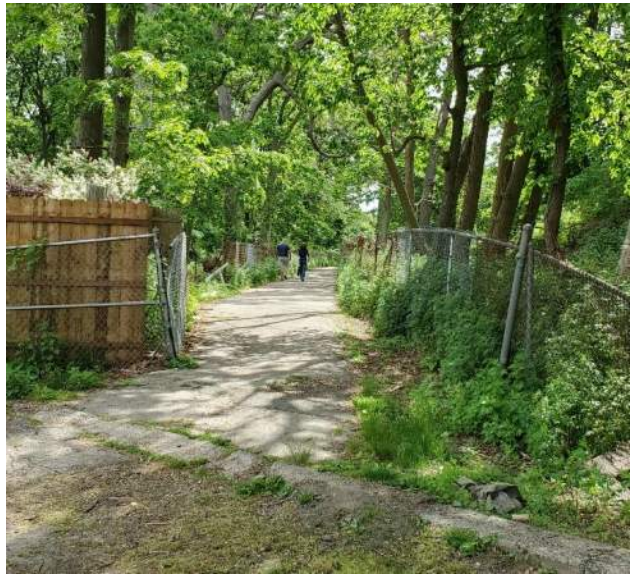
PARK: Oldfield Senior Center

There is a bituminous/gravel parking lot area to the east of the soccer field which is in very poor condition.

Bit. walk along front of building is in poor condition. Concrete walk and ramp are in fair condition with some cracks at sidewalk near road. Preschool has no protected walkway.

Qty.	Cond.	ADA?
<i>Gazebo</i>	<i>1</i>	<i>4</i>	<i>Yes</i>
<i>Bocce ball</i>	<i>1</i>	<i>2</i>	<i>No</i>
Notes:			
<i>New concrete walkway and brick patio include gazebo and 4 of 5 picnic benches.</i>			
<i>Bocce court is full of weeds and does not appear in useable condition</i>

Soccer field is heavily mounded in centerField lines for the different size fields might be confusing to players.

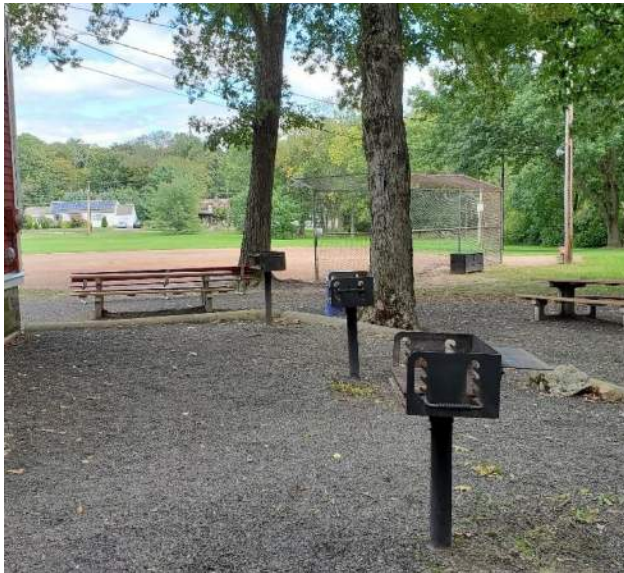
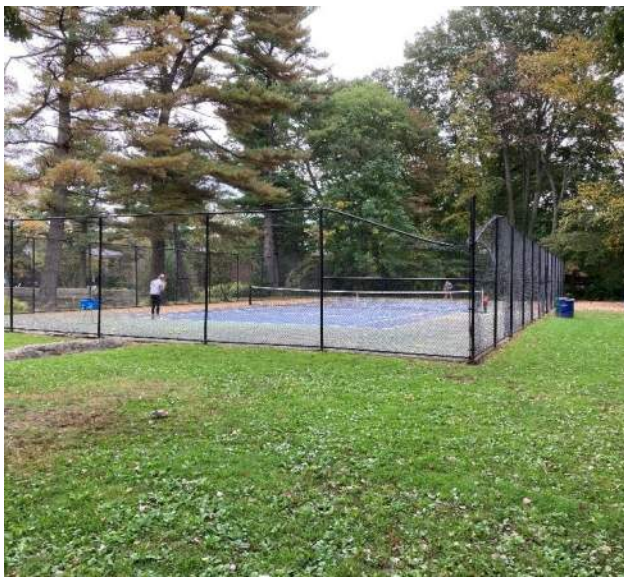
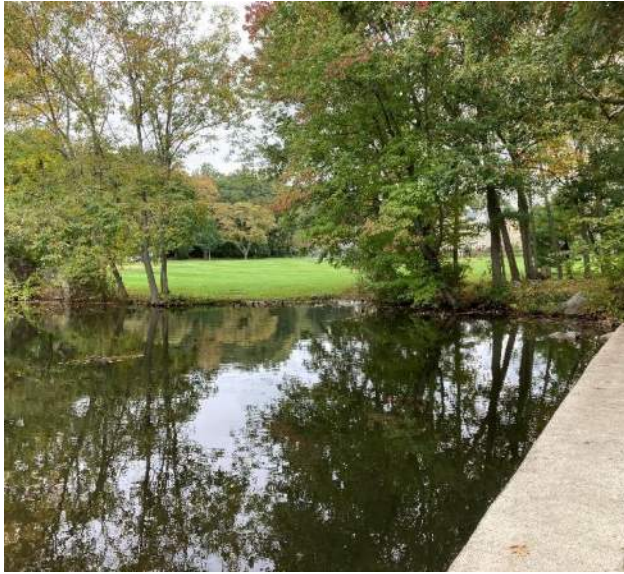
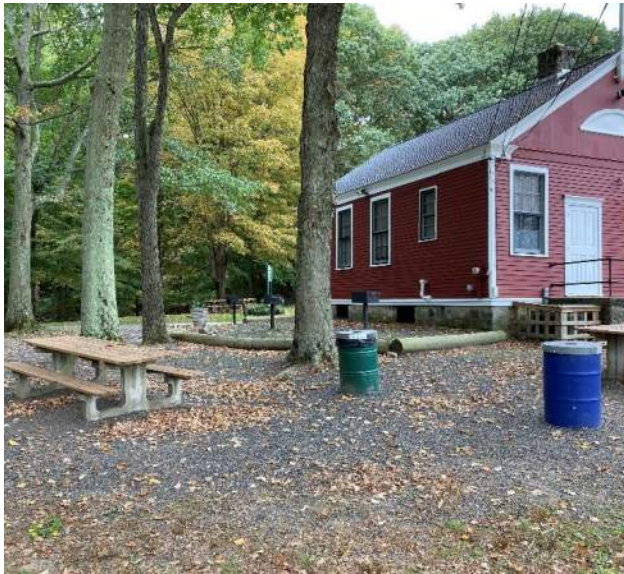
PARK: Owen Fish Park
ADDRESS: 1443 Stratfield Rd
MAP/PARCEL: 0470010000
ACRES: 11.10

Pavement in fair condition but there is no striping in parking lot.

Pine and oak leaves on court, players say they bring their own broom

Large branch appears to have fallen and damaged fence.

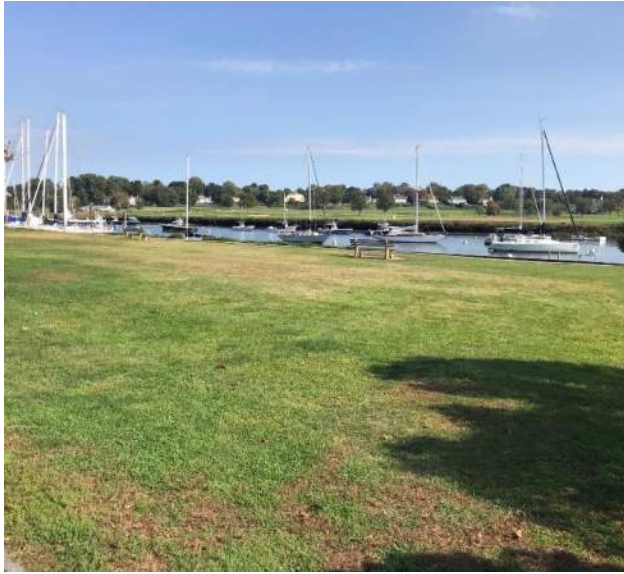
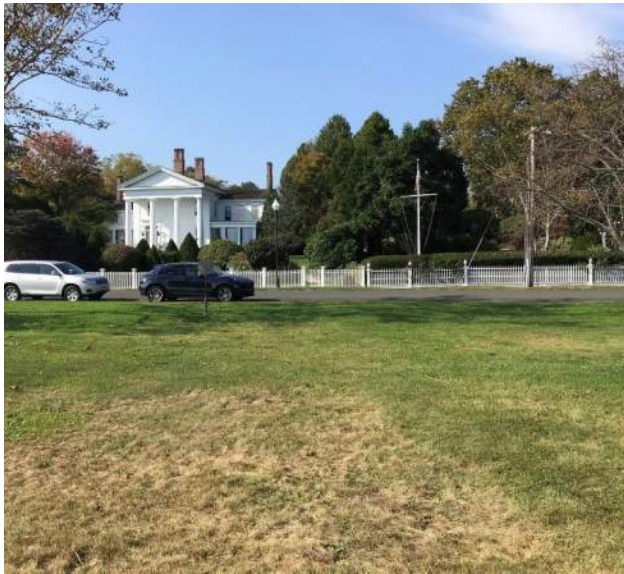
PARK: Perry's Green
ADDRESS: 701 Harbor Road
MAP/PARCEL: 2410120000
ACRES: 0.65

Open grass area with views of Southport Harbor and the Country Club of Fairfield.
Three wooden benches are in the park facility that have some splitting in the wood.
Poor ADA access from sidewalks to Perry's Green.
On-street parking is available adjacent to Perry's Green with a curb separating the parking and the green, and without marked ADA spaces.
Grass is in average/fair condition with some clover, burnt areas, weeds, and crab grass.
Wooden benches have 4 horizontal slats and 3 vertical slats. There is some splitting in the wood.

Chain link fence located on the eastern side of property. Unable to determine if fence belongs to the Town of Fairfield or adjacent property. Some rust on fence.

Grass is in average/fair condition with some clover, burnt areas, weeds, and crab grass.

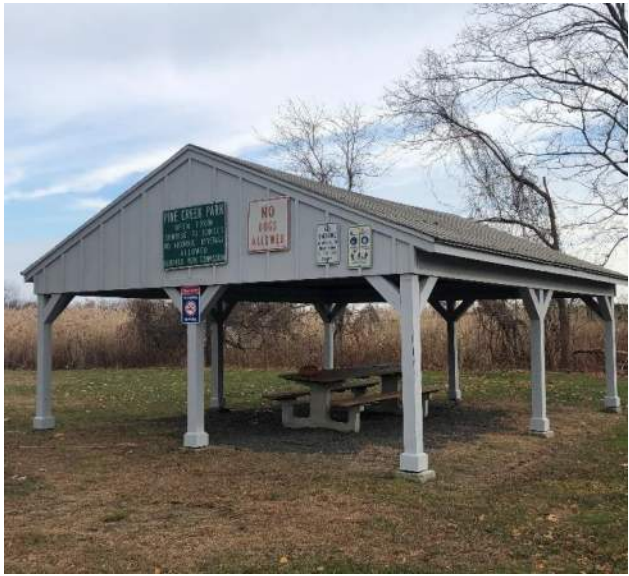
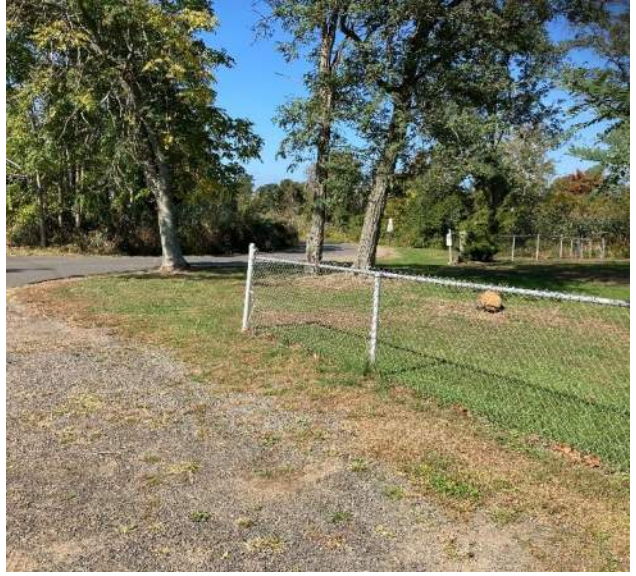
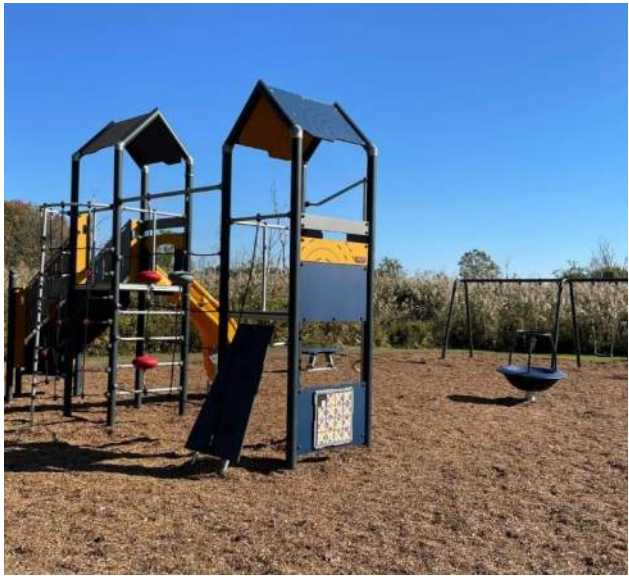
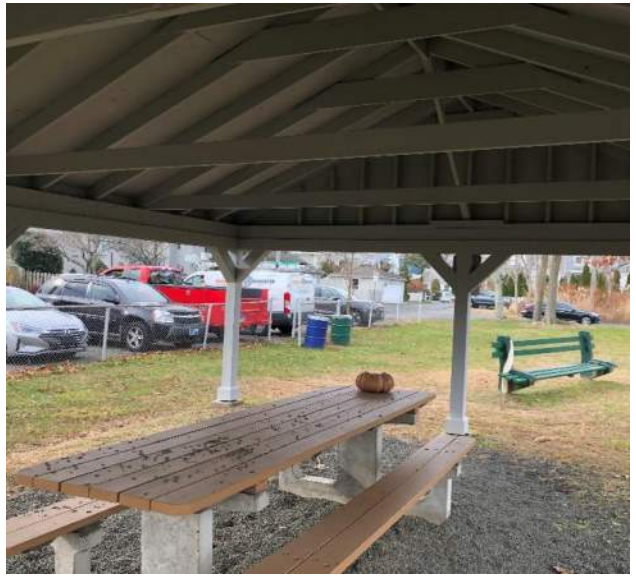
New playground was under construction at this small pocket park. Playground equipment looks promising in terms of quality and play opportunities. Remaining facilities including a picnic table, pavilion and bench all in fairly poor condition.

Chain link fence is in average condition and serves to separate cars from park. Possibly there is another fencing or option for this purpose?

Bench is in poor condition and should be replaced with benches closer to playground or around perimeter of site looking in.

Pavilion over table is helpful in beach bright conditions, though table is in poor condition with graffiti and other stains since it doesn't get cleaned by the rain.

Access to pavilion is not on accessible path

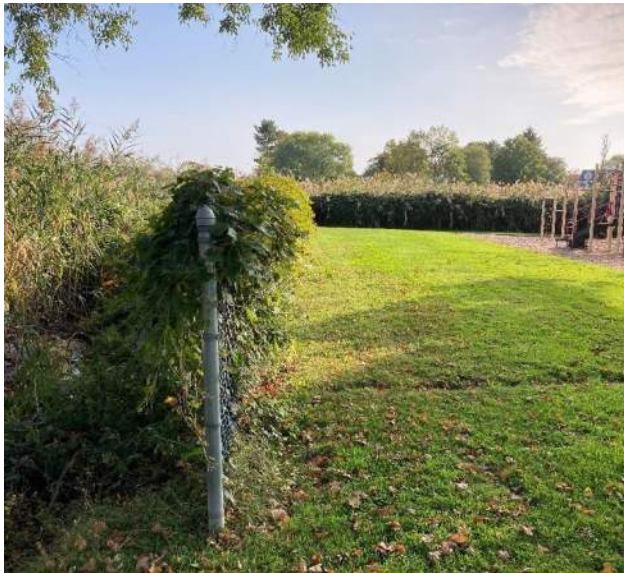
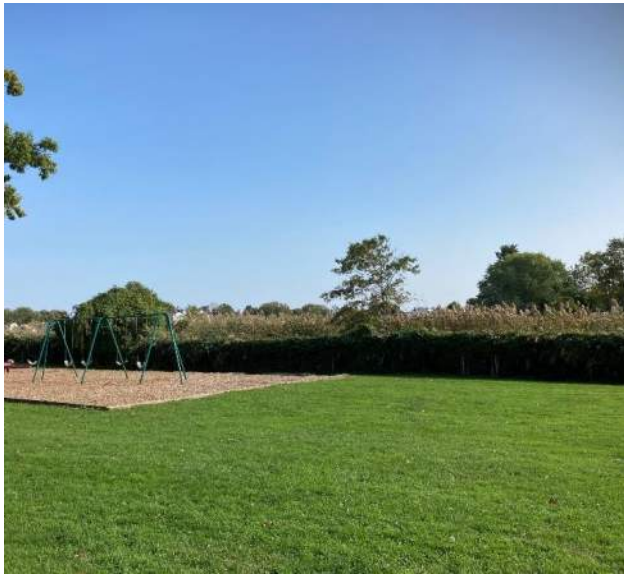
Rugby Park appears to be a small pocket park playground and lawn space, set at the end of two small roads. The usable park space is nowhere near 11.28 acres, probably closer to one acre. It is possible there used to be trails extending into the marsh from this park, but the marsh now seems to be all overgrown with invasive plants making this park appear to be tucked away from both the community and from nature.

Play equipment does not get shade so is faded and aged from the sun, in addition to excessive peeling of plastic, exposed rusted metal and broken parts.

If playground replacement is desired by the community, having sails that shade the park could be a helpful feature.

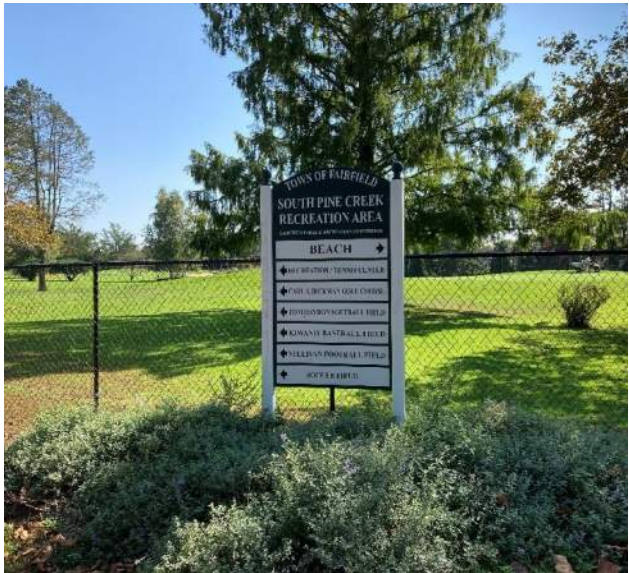
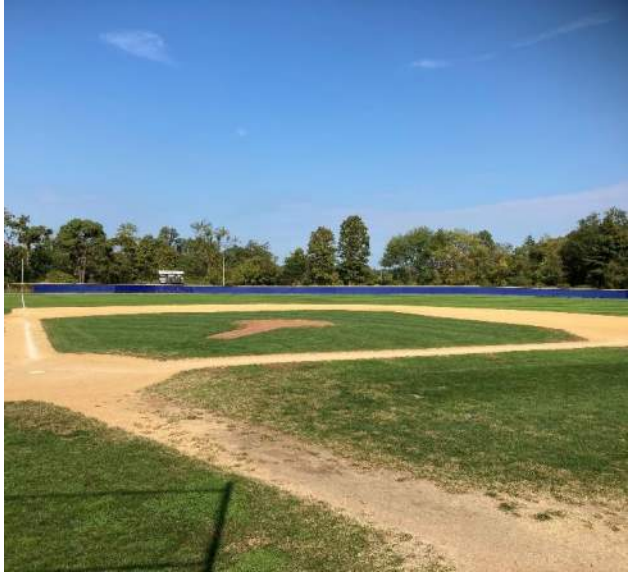
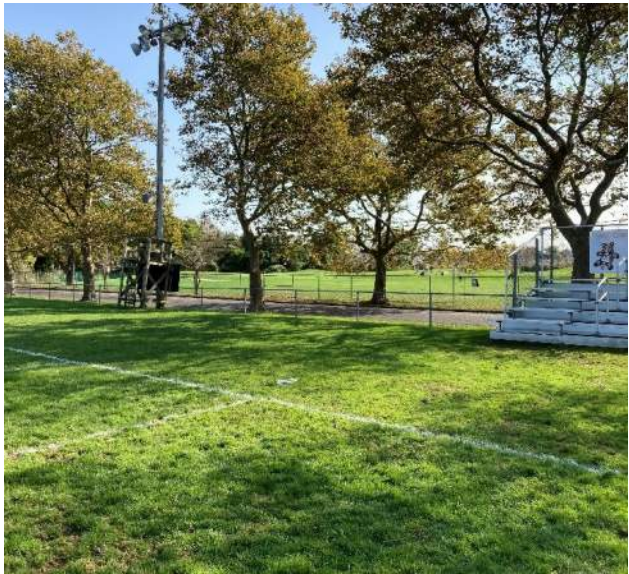
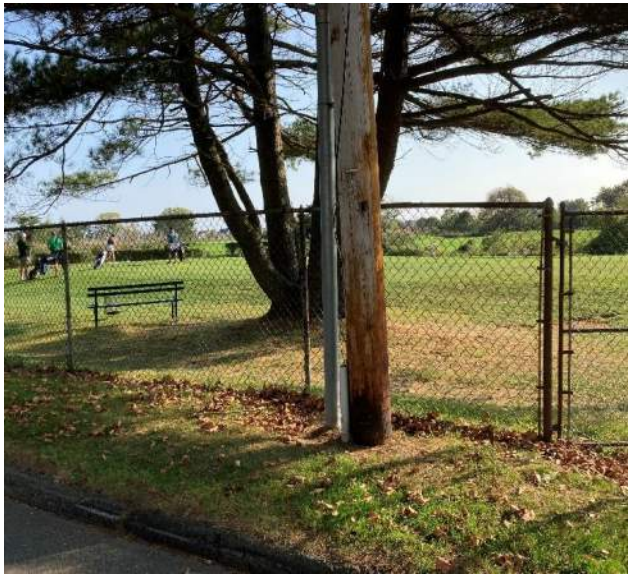
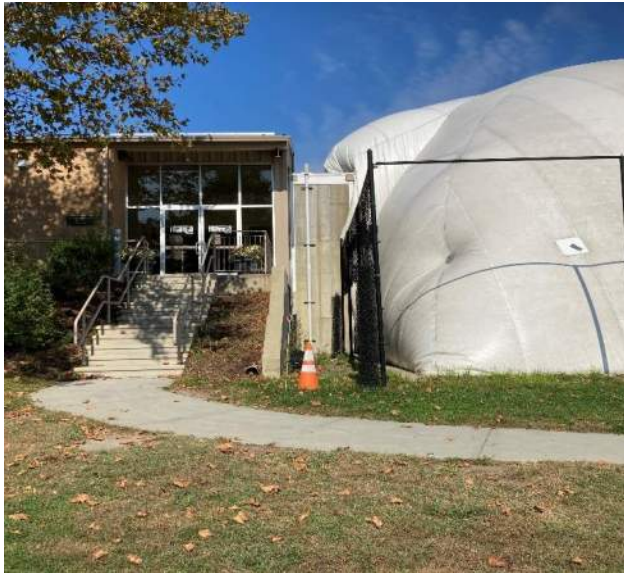
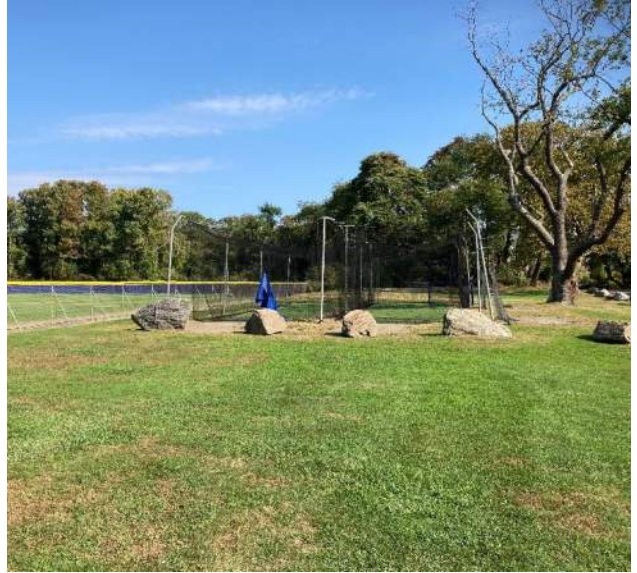
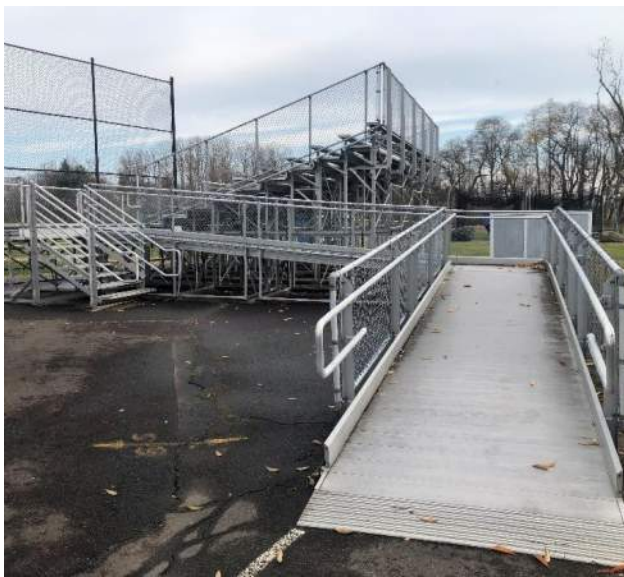
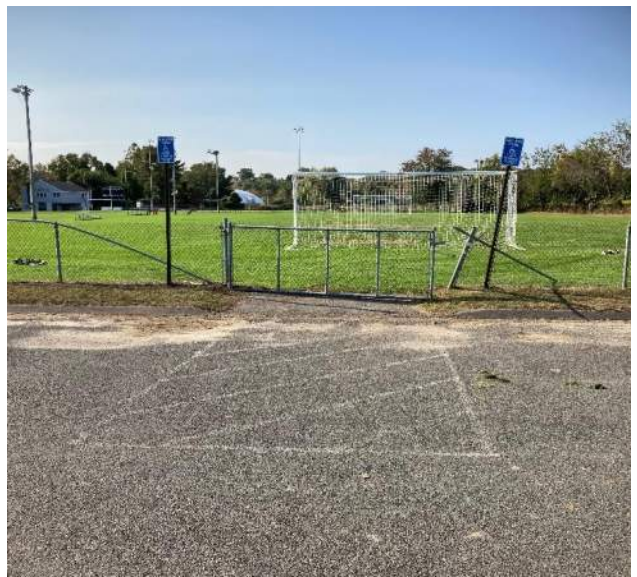
South Pine Creek Recreation Area is a large, multi-sport facility adjacent to open space and trails. Facilities are in mixed condition, with new front parking area and concrete sidewalk, but back parking lot is bituminous, cracking and poorly striped. HC parking spots, while present, do not appear to be to up to code.

Restrooms in main rec building are in good shape but not clear they are fully ADA accessible from outside. Restrooms at Kiwanis Field and Tom Hayden Field are in adequate but aging condition. Bathrooms at Kiwanis Field have 2" gap at door.

Not clear if lighting extends to soccer fieldFencing around soccer field in very poor condition, as is parts of the grass on the fieldField lacks accessibility and accessible spectator viewing areas.

Field is used by an adult baseball league, two participants of which were practicing at time of site visit. They mentioned that the infield was overwhelmingly 'dusty', and it did look to be very fine dust powder. They also mentioned the outfield was quite uneven, making it hard to run and catch at times. And they mentioned lighting can be blinding while playing.

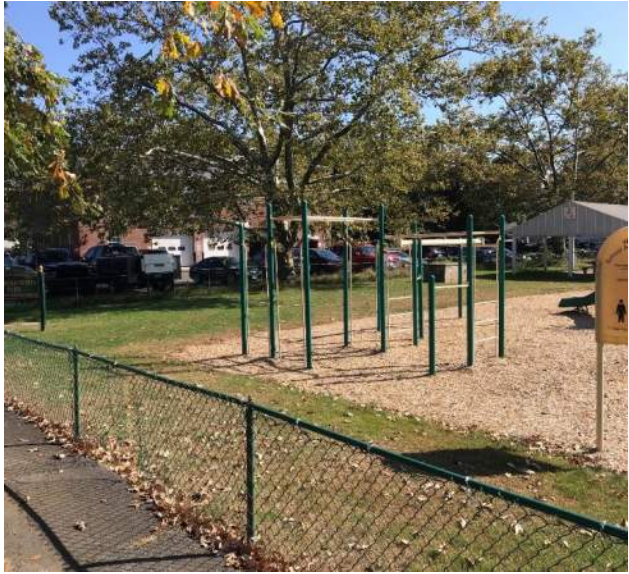
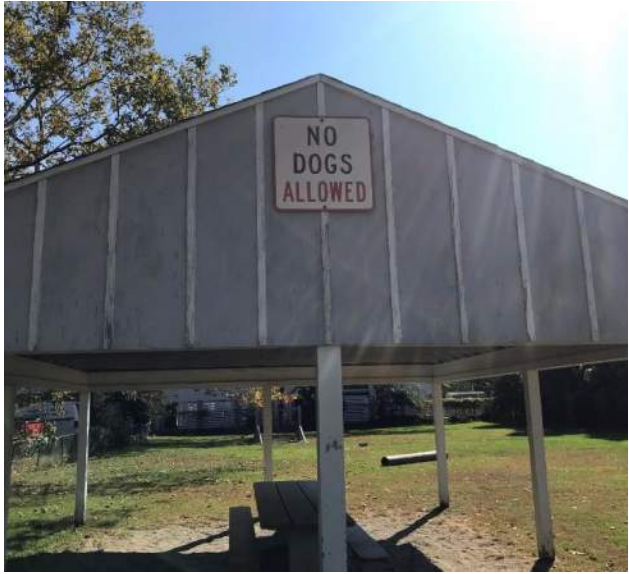
Overall, playground structures, pavilion and perimeter fencing are in poor condition.

The ADA accessible ramp at the park entrance leading into the park is in poor/fair condition and slope exceeds 5%.

Description	Qty.	Cond.	ADA?
Restrooms		0	-	-
Trash	1 trash and 1 recycle	2	3	N/A
Storage		0	-	-
Benches		0	-	-
ADA Seating		0	-	-
ADA Companion Seating		0	-	-
Perimeter Fencing	Chain link	1	1	N/A
Sufficient Shade on Site	No	-	-	-
Notes:				
Fencing is damaged on the northern and eastern side				
Minimal shade on site

Qty.	Cond.	ADA?
Swings	2 baby swings/2 kid swings	4	2	No
Play Equipment		5	2/3	No
Surface		-	2/3	N/A
Notes:				
Per site signage, playground is intended for 5–12-year-olds.				
Surface is wood chips. Play equipment includes overhead bar structure, slide structure, ladder structure, and two sitting bike play structures. Rust present on overhead bar structure.

Qty.	Cond.	ADA?
Pavilion	1	1	Yes
Fireplace structure	1	2	No
Notes:			
The pavilion supports are in poor condition with cracking in the wood and additional reinforcement provided. Gravel and stone base under pavilion.			
Fireplace structure has vegetation growing out of the center opening.

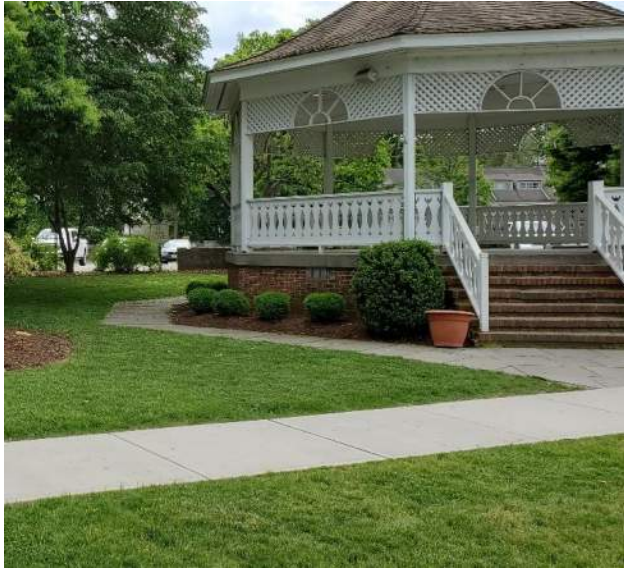
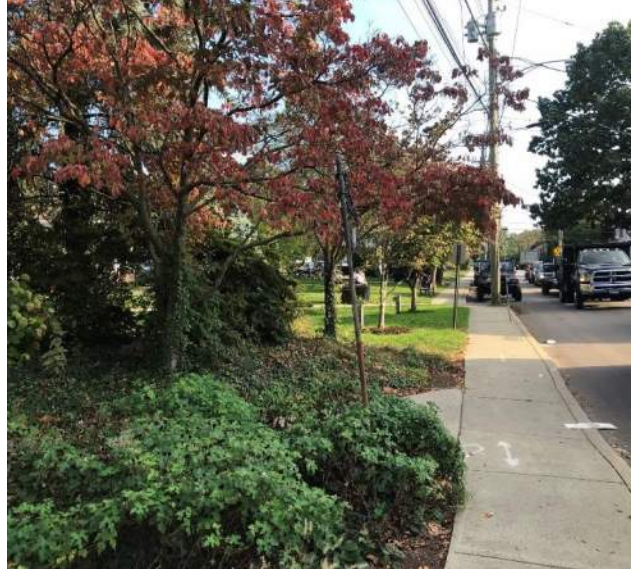
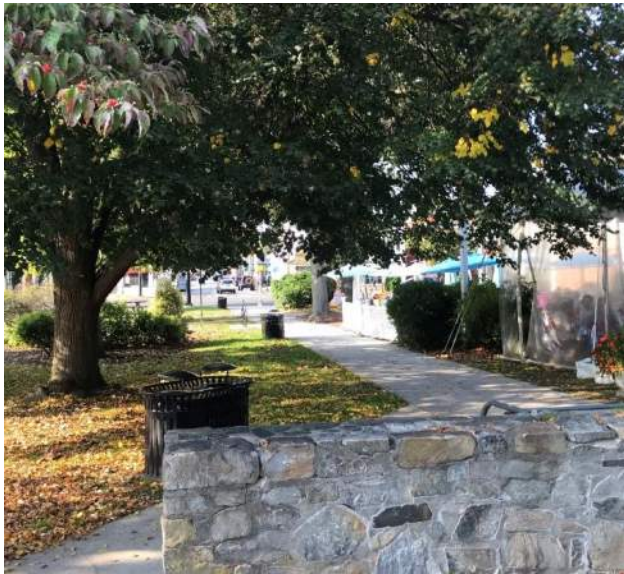
Sherman's Green has a gazebo structure and tables throughout the green space. The parking lot in the southern portion of the parcel is in fair condition with cracking in the bituminous asphalt pavement. There are concrete and stone paver paths from the ADA accessible parking spaces into green; however, one path is only 2 feet wide. Concrete sidewalks are present throughout the green space. Low to moderate intensity of use during inspection.

The bus shelter is a brick structure with glass panes, wooden bench, light fixture, and concrete surface. The glass panes are intact but weathered. ADA ramp is available to cross the street. One brick is missing from the exterior façade.

One ADA space is missing a sign.
Cracked pavement in one ADA space.
Parking lot has 103 spaces with approximately 8 on street parking spaces.

The grass in Sherman's Green is in fair to good condition with some areas of clover and dead grass. The grass surrounding the northernmost picnic tables is worn and is mostly dirt.

The gazebo has under storage and has a white wooden fence surrounding the concrete surface. The concrete surface has minor hairline cracking. Some shingles on the edge of the roof are broken or cracked. Electrical outlets are mounted on the interior wooden fence. 10 lights are mounted to the ceiling of the structure. Stairs are the only method to access the gazebo.
