APPENDIX A

Study Facilities

APPENDIX A
STUDY FACILITIES
Town of Fairfield Masterplan

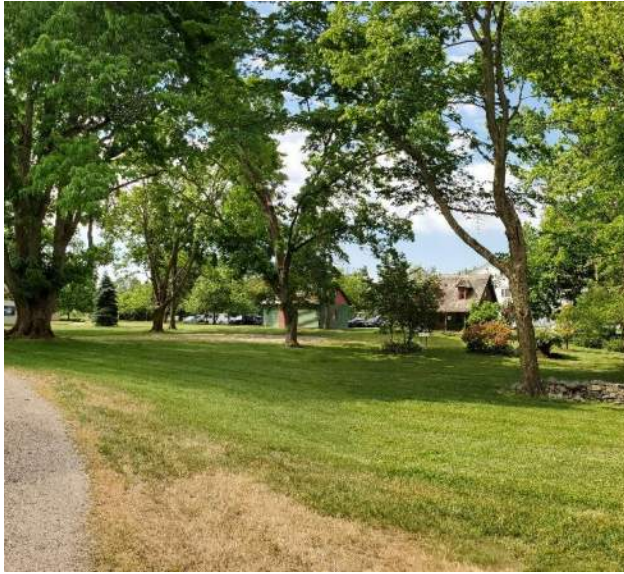
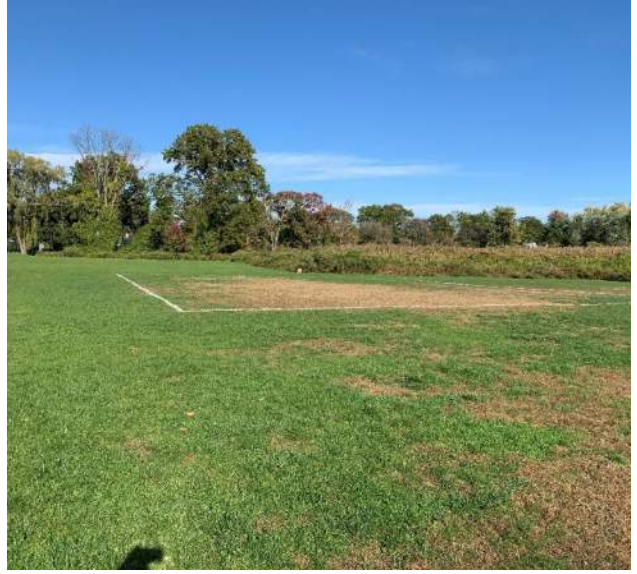
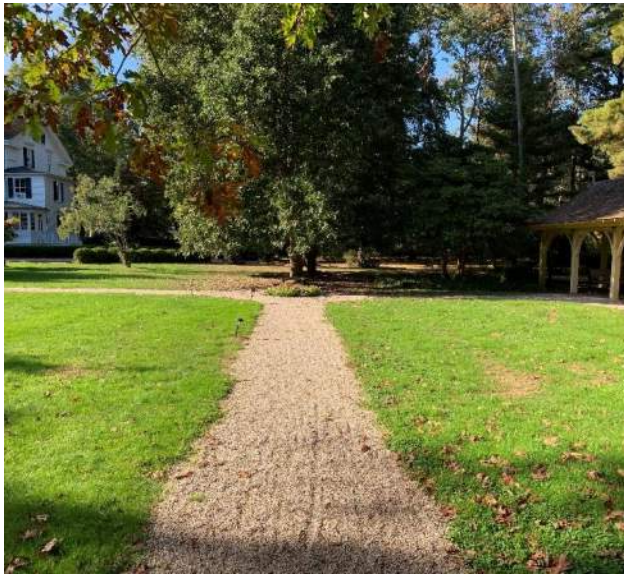
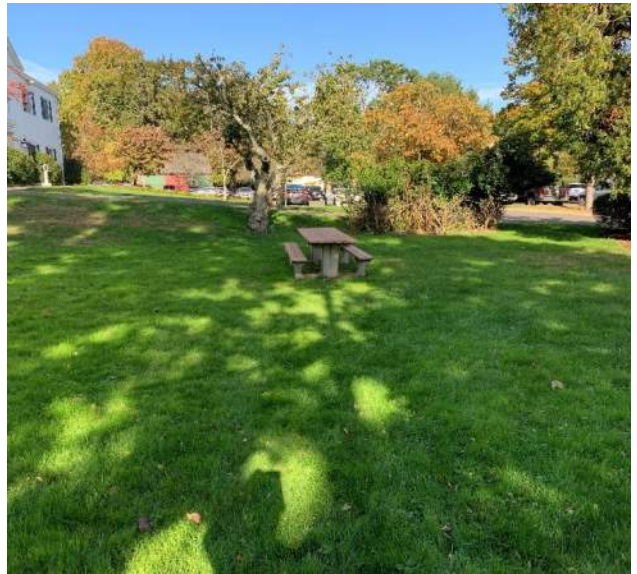
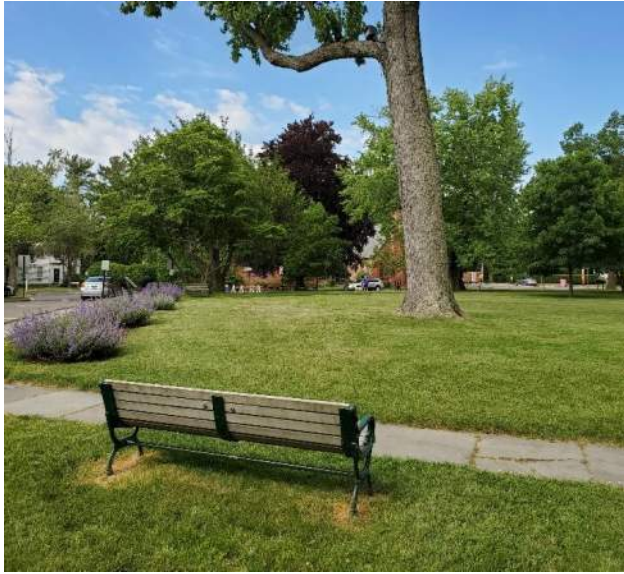
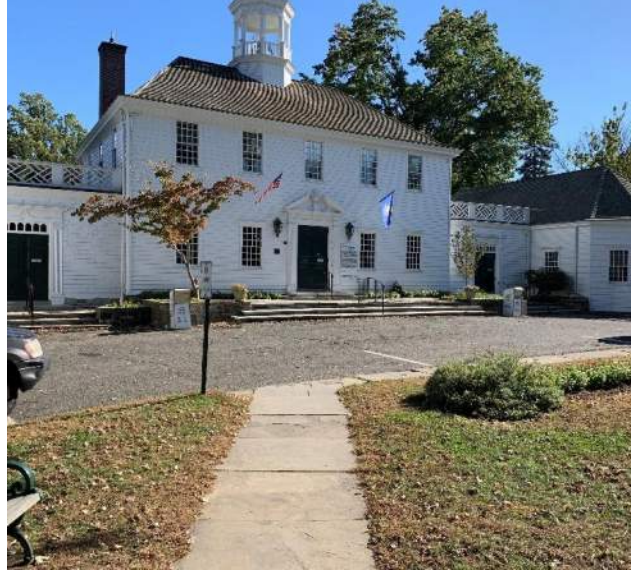
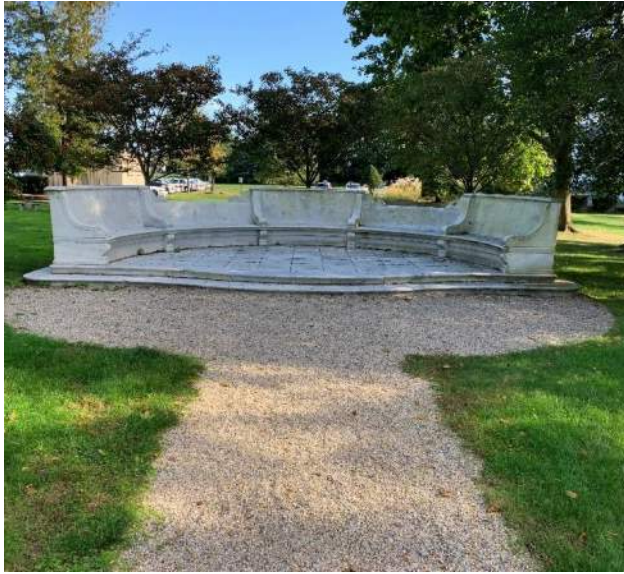
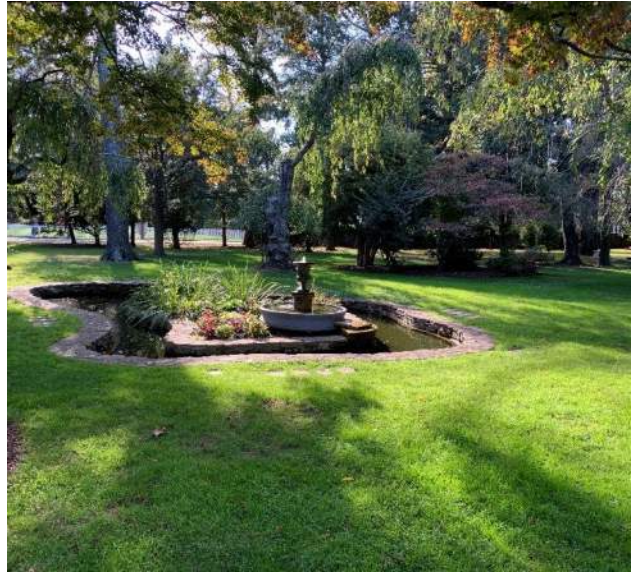
Overall use of Town Complex (accessing the municipal offices) is high. The use of the green spaces surrounding the buildings is medium. There's access to the complex from Old Gate Road and Beach Road. Complex has multiple buildings with adequate parking on site. Green spaces can be accessed throughout on-site sidewalks and parking lots. Gravel paths by Independence Hall may be challenging for ADA accessibility.

Description	Qty.	Cond.
Seating	Benches	6	4
	Picnic Tables	2	3
ADA seating	None		
Fencing	None		
Paths	Gravel		4
Lawn Area	Grass		4
Lighting	None		
Trash Bins	On site	8	3
Structures	Canopy area by Independence Hall	1	4
Other	Fountain Area	1	4
Other	Monumental Seating Area	1	1
Restrooms	Portable Restroom by Fairfield Com. Services	1	3

Notes:
There is a Bike Rack by Independence Hall entrance. There's also adequate parking by Independence Hall, Fairfield Museum, and Fairfield Community Services to access park area.

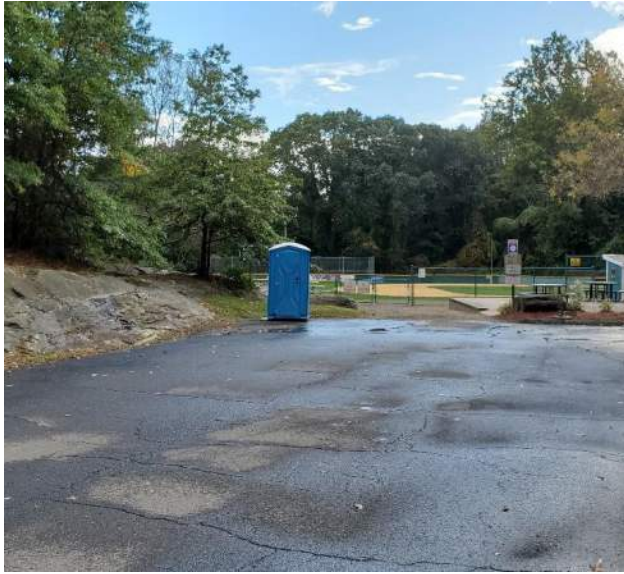
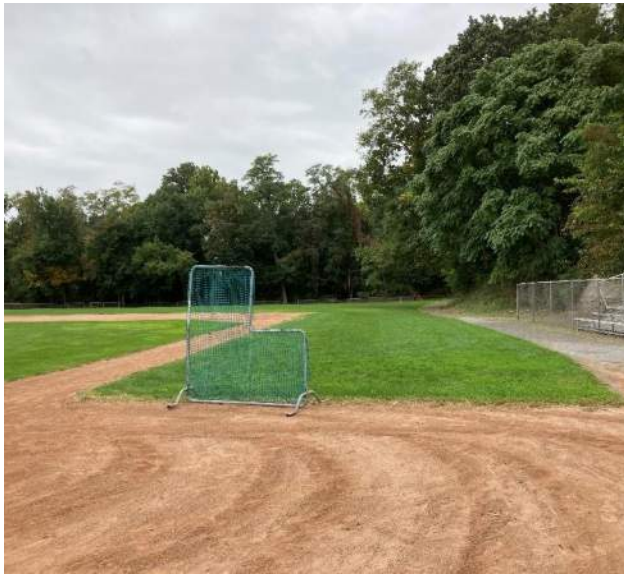
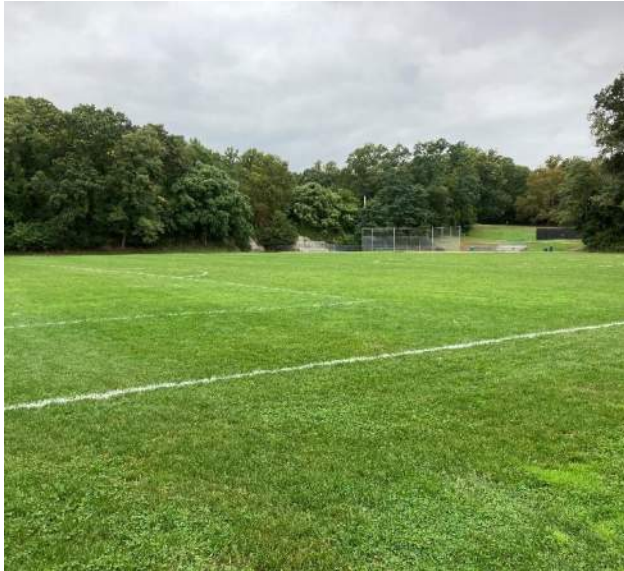
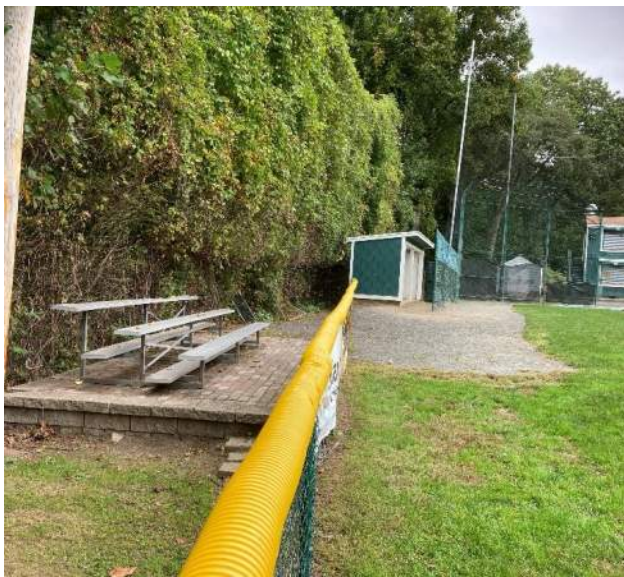
Tunxis Hill is a large park with a lot of facilities in average-to-poor condition, spread over a steep but beautiful hillside. Sport fields and courts appear to be in generally average or good condition and probably well used overall, but playground was only lightly used at time of visit and is in poor condition. Accessibility over the steep terrain would appear to be a main site challenge. There is a lower parking lot at Nordstrand Ave and an upper parking lot at Melville Ave, but the facilities in the mid-park level (pickleball, restrooms and playground) are not reachable along an accessibly sloped path from either of those parking lots. (Note: Playground is slated to be replaced in 2022)

HC parking only present at Nordstrand Ave parking lot. No striping in either parking lot so HC area is just a guess. Bituminous parking at both sites has many cracks.

Lower parking lot leads to gravel path
Upper parking lot leads to grass slope or steep (8%) cracked bit. sidewalk along Melville Ave
Internal park paths are steep, cracked or both

Creating accessible pathways at the right incline level will be challenging. Currently there is a rutted gravel path that leads from the lower parking lot to the lower baseball field. From there a cracked bituminous pathway which is 6% slope in parts leads up to the restrooms, pickleball courts and playground. Larger challenge will be a path from the upper parking area to the playground, as the access is currently over a field or along the Melville Ave sidewalk, which is cracked, bituminous at 8% slope. There is a cracked, flat bituminous path from that sidewalk to the playground, but the sidewalk itself is not accessible in its current condition and there is no parking/drop off area at Melville Ave.

Play equipment is peeling, rusting and generally at the end of its lifespan. Swings are also rusting and should probably be replaced.

Notes:
Court has several cracks throughout though still playable. One of the four courts has been closed due to the cracks. In need of new surfacing before too long.

The proposed replacement of the playground and the need to refurbish the pickleball courts opens opportunities for improvement at this park.

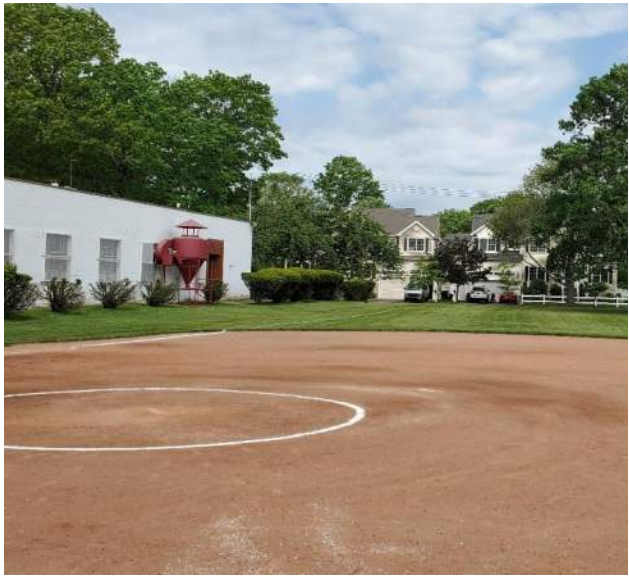
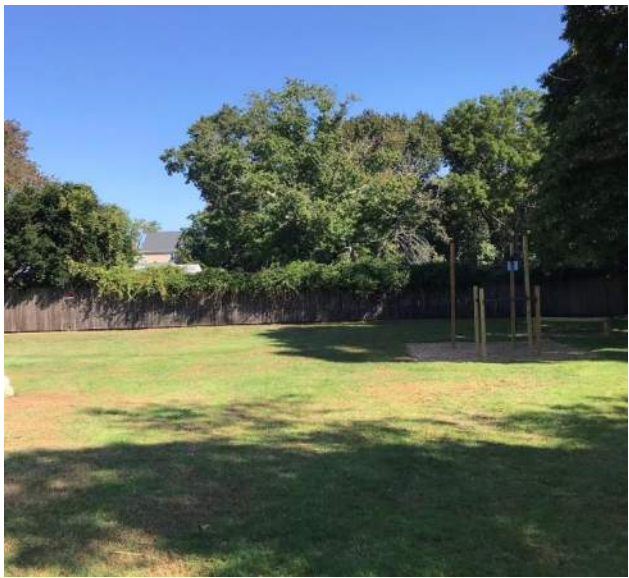
Notes:

Dugout benches have some rust.Paint chipping on one lock box.Outfield grass is in fair shape with some clover.

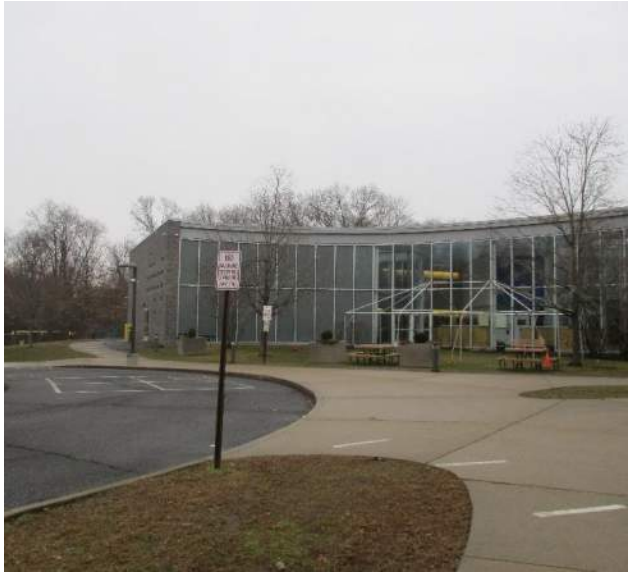
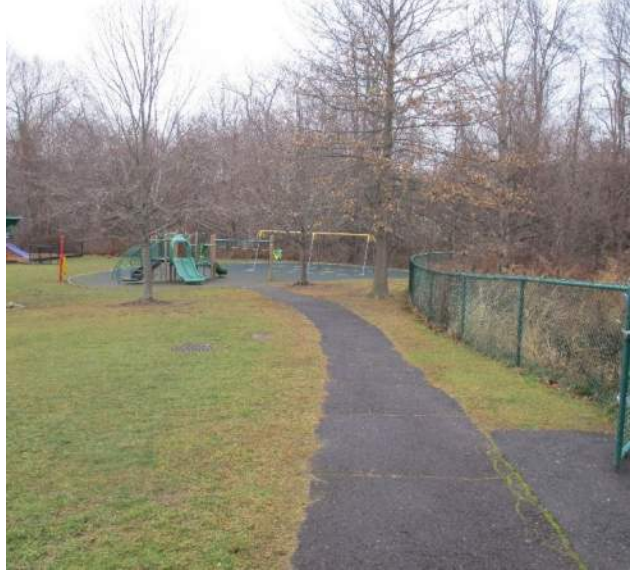
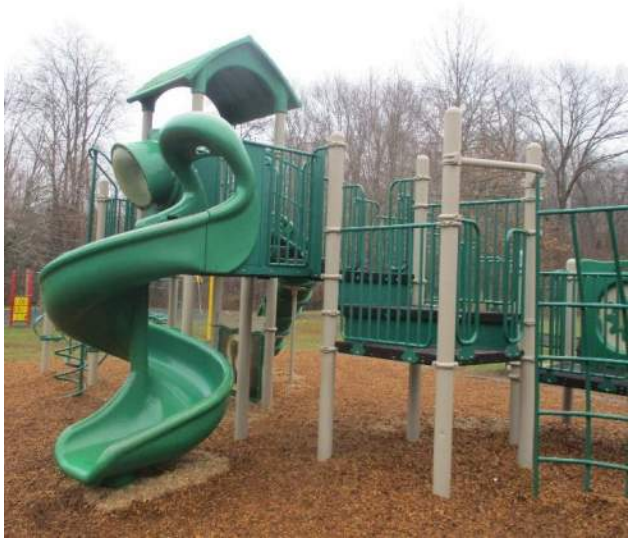
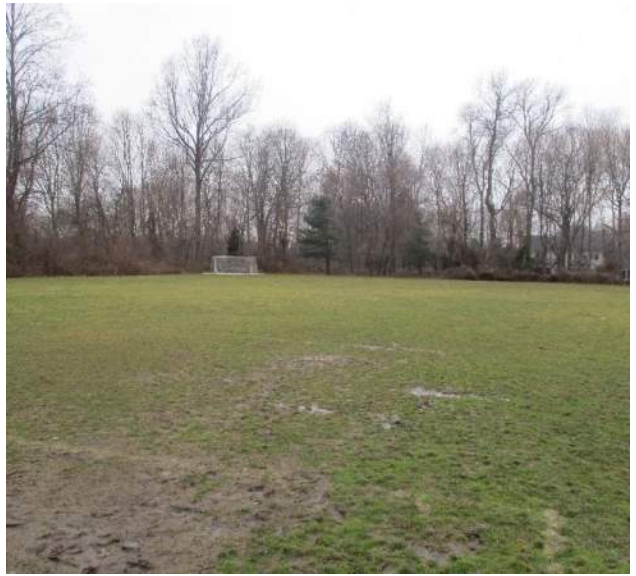
Playground equipment and rubberized surfacing (for one playground) is in poor condition

Some drainage issues and moderate wear to the soccer field observed

Notes:

Poor drainage on field

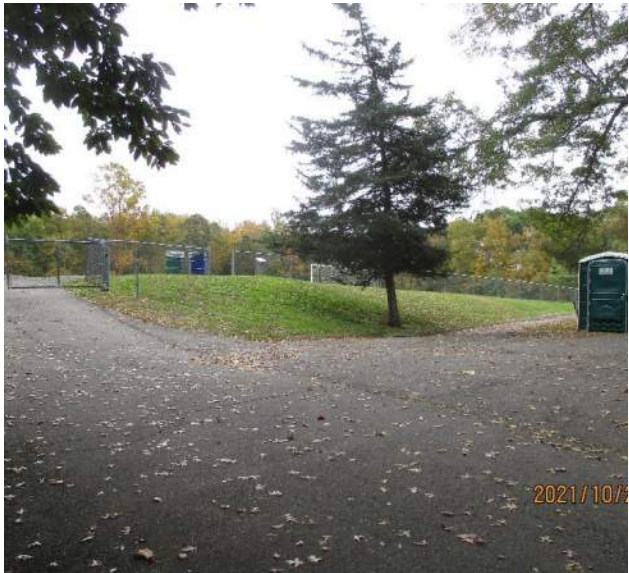
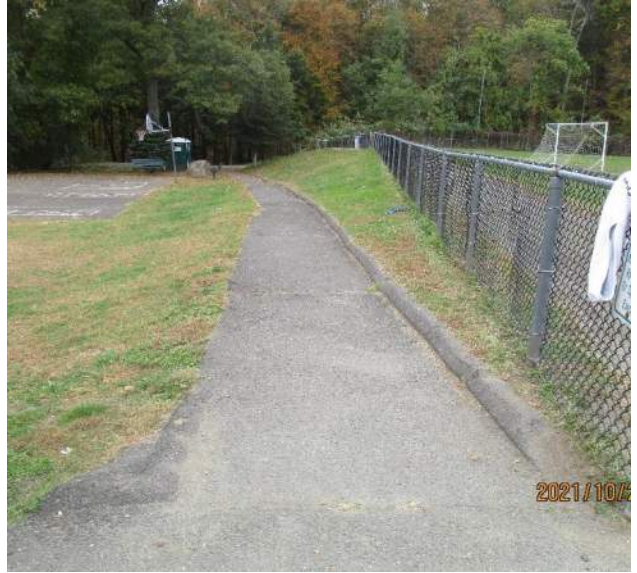
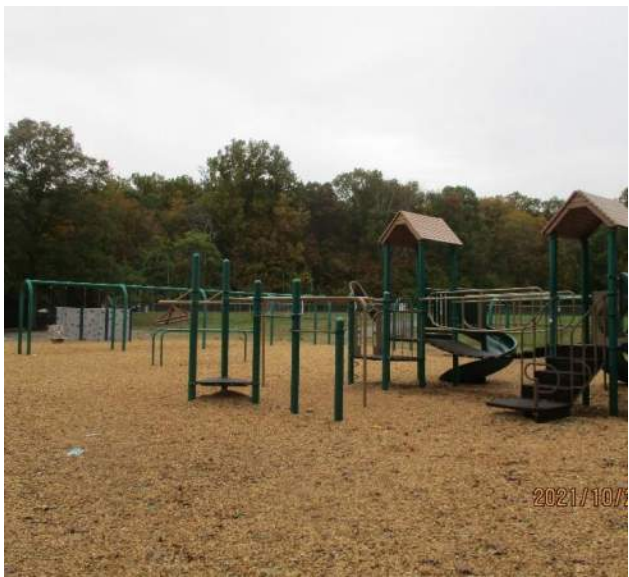
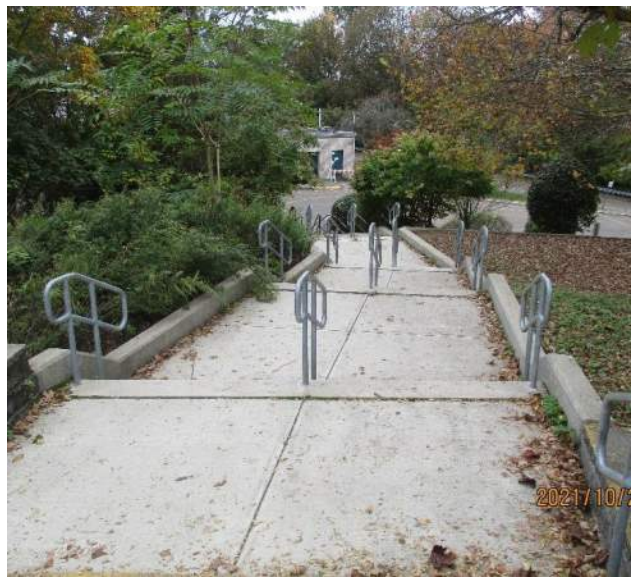
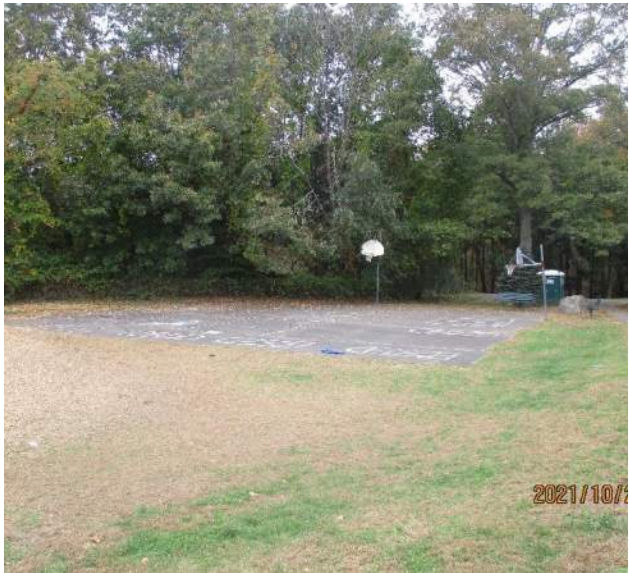
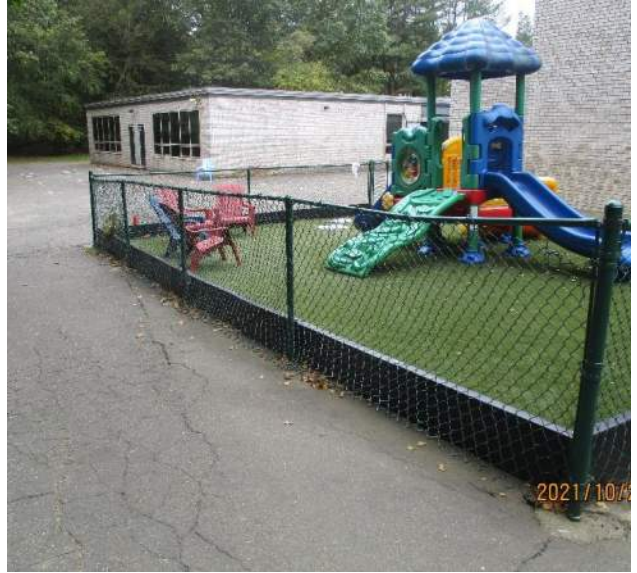
Turf damage observed in high use areas on field including goalie boxes – recommend overseeding for turf repair

Identified as "Kass Memorial"Perimeter chain link fencing overgrown in some areas – recommend trimming vegetationBasketball hoops in poor condition and replacement is recommendedTripping hazard exists in location of remnant basketball hoop base – removal recommended**SITE ELEMENT (EXAMPLE: FIELD, OR COURT)**Uses: Tennis courts (4 courts)

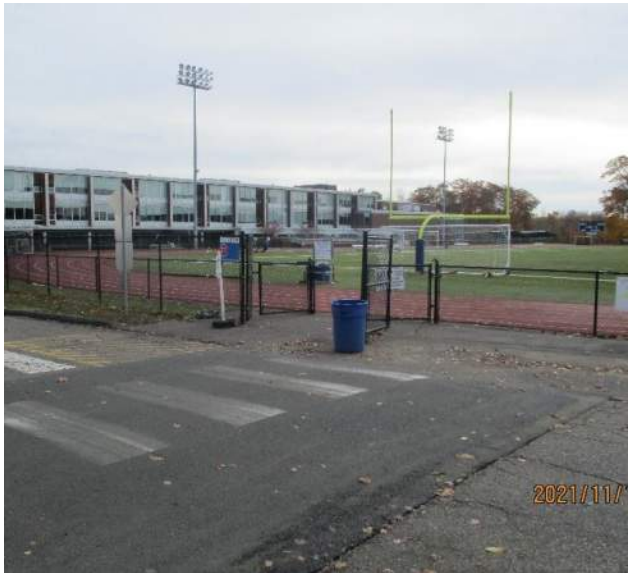
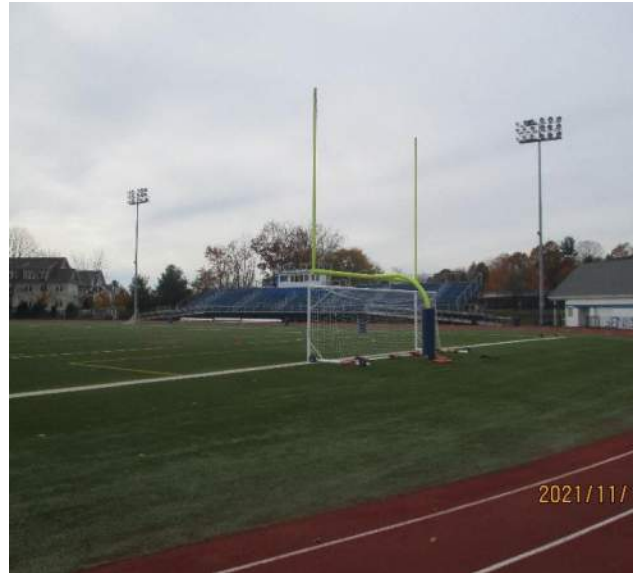
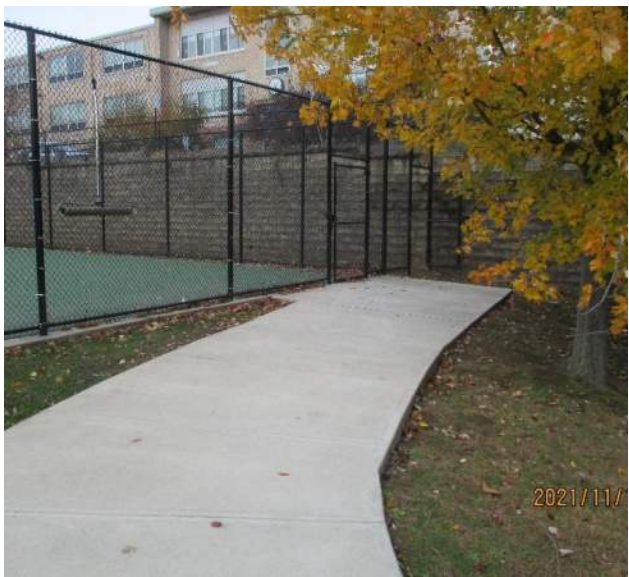
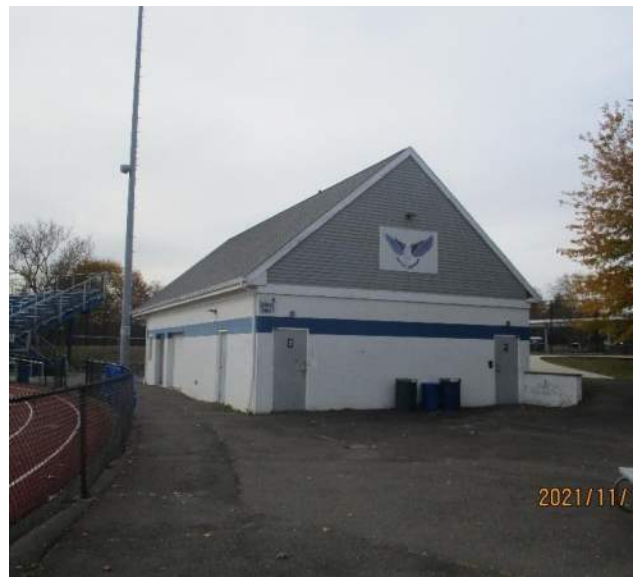
Notes:

Recently build and in great condition

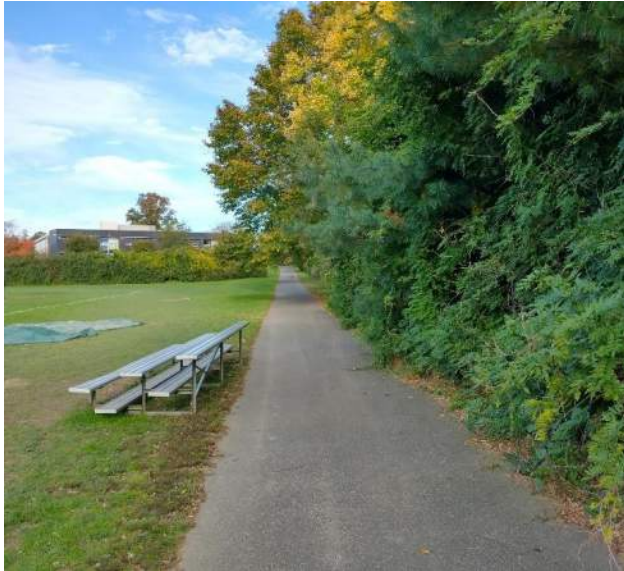
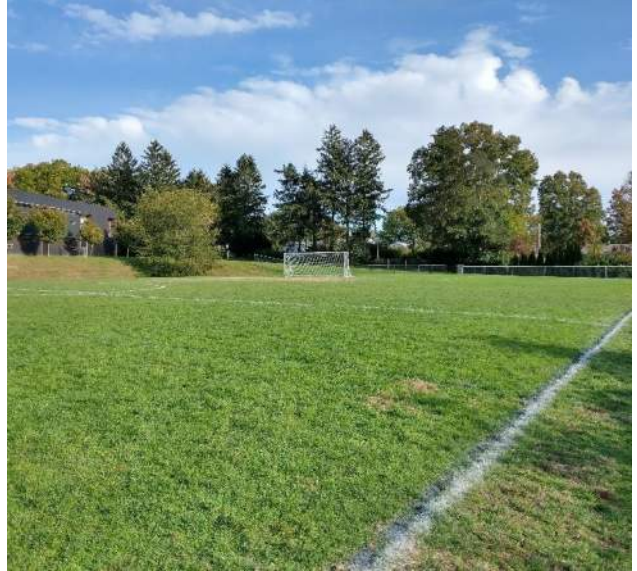
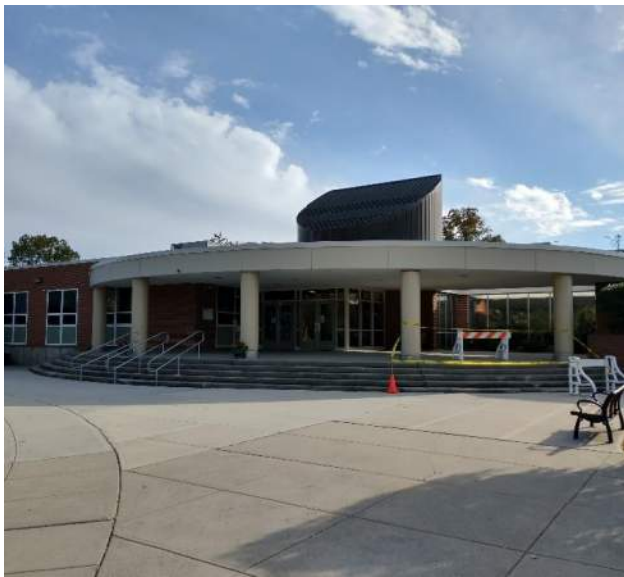
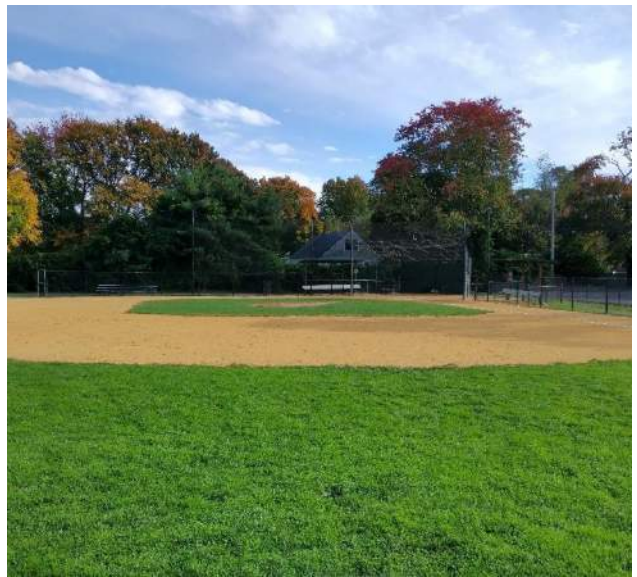
Moderate to heavy turf wear observed within goalie boxes – overseeding recommended for turf repair

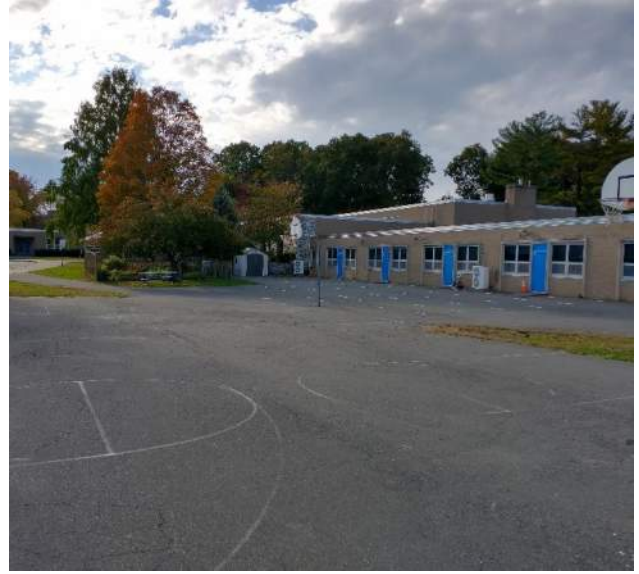
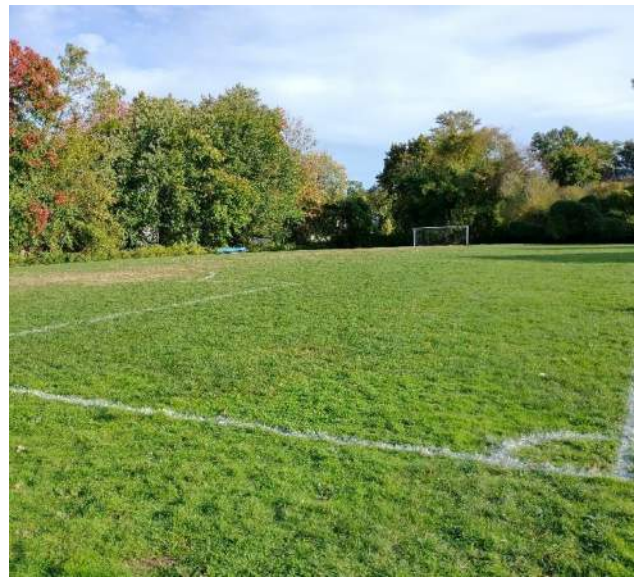
Basketball court pavement includes moderate to heavy cracking throughout1 hoop missing, multiple nets in poor condition

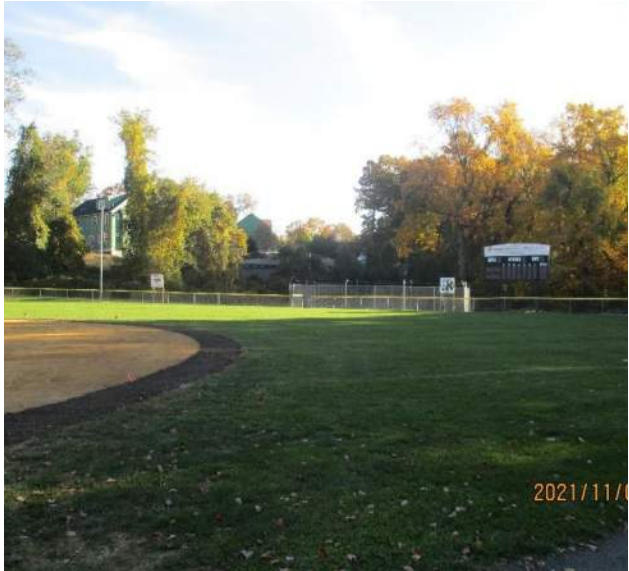
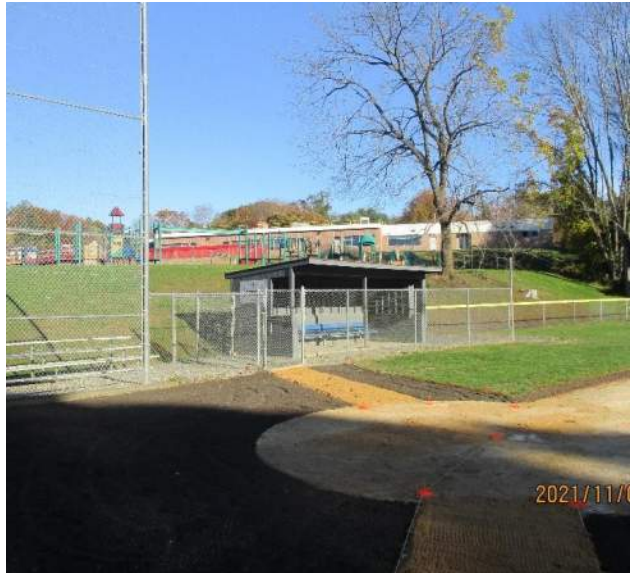
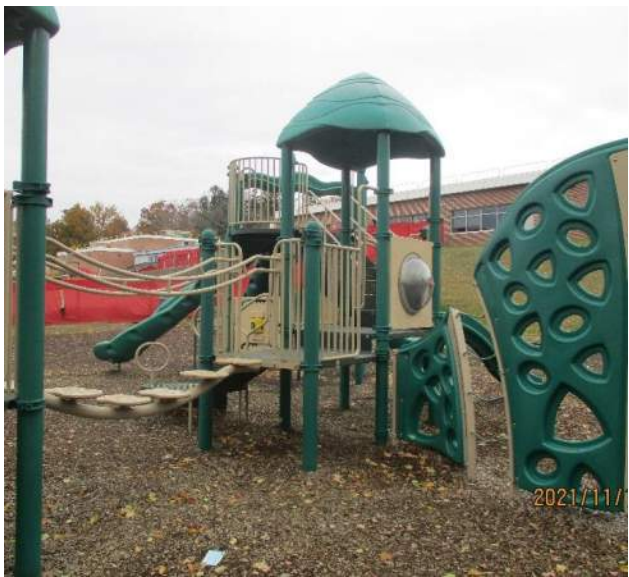
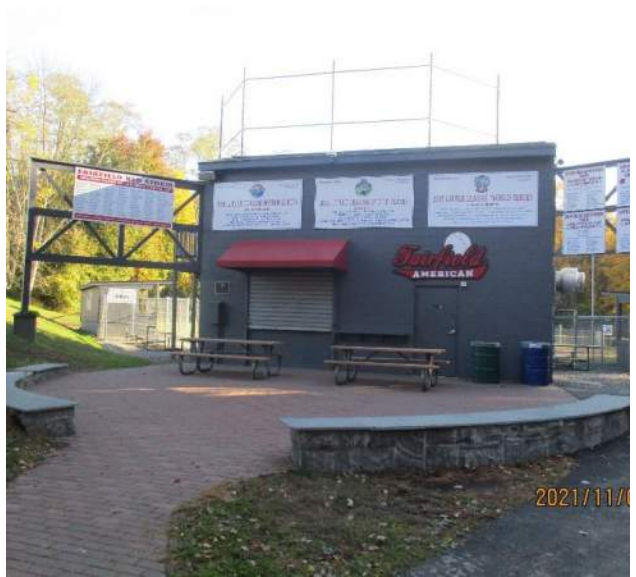
Field utilized by Fairfield American Little LeagueAccessible parking not available in close proximity to field

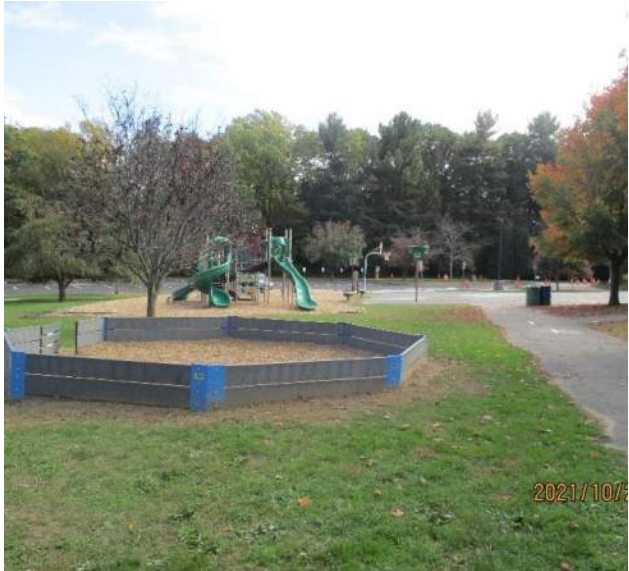
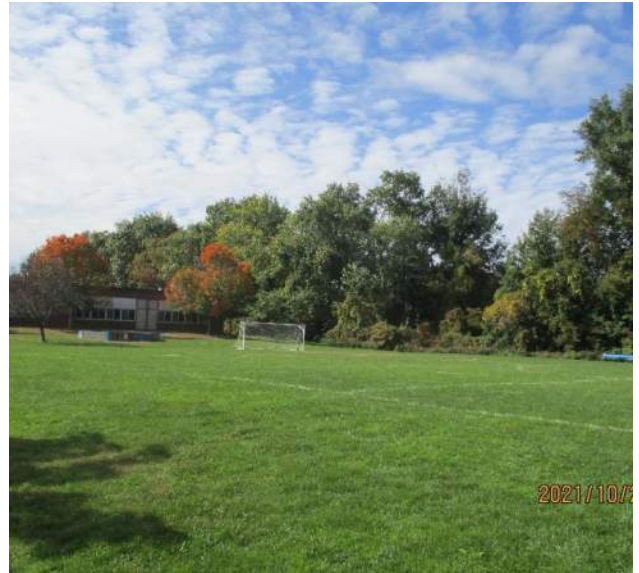
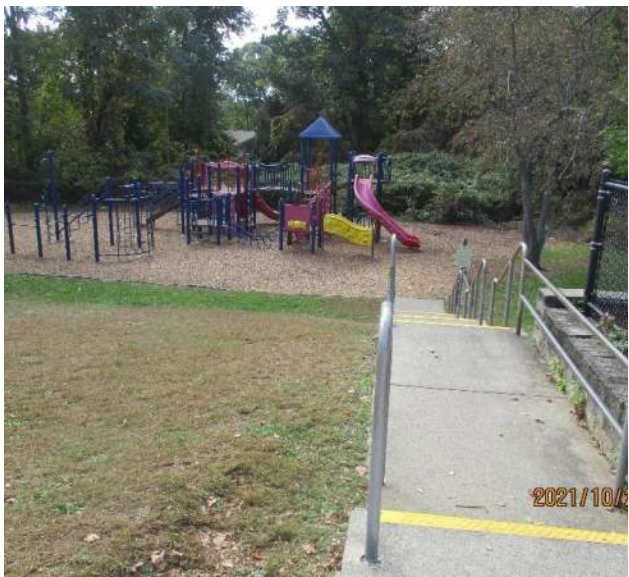
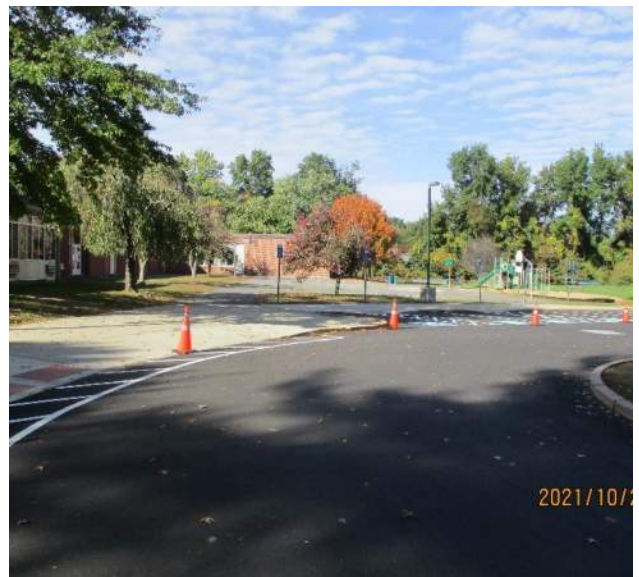
Good condition

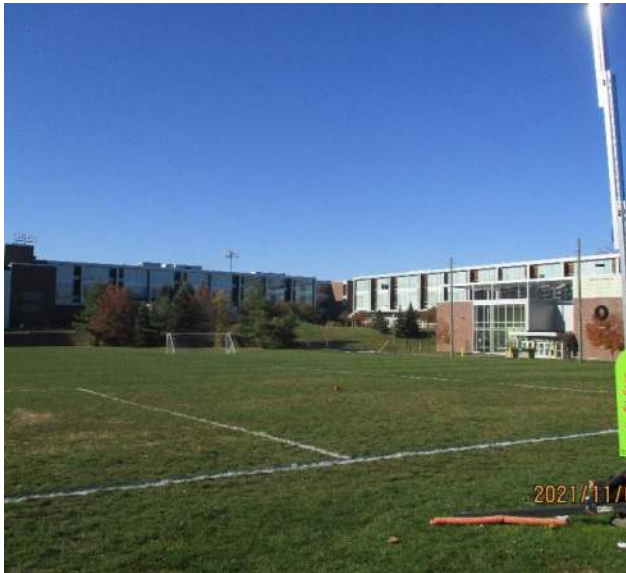
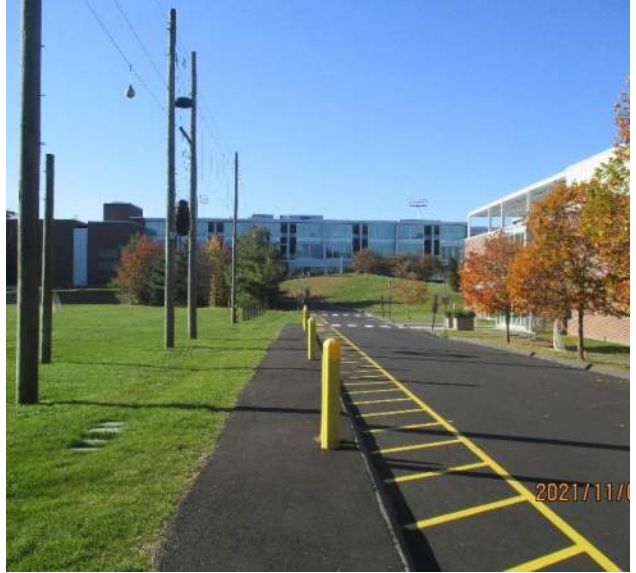
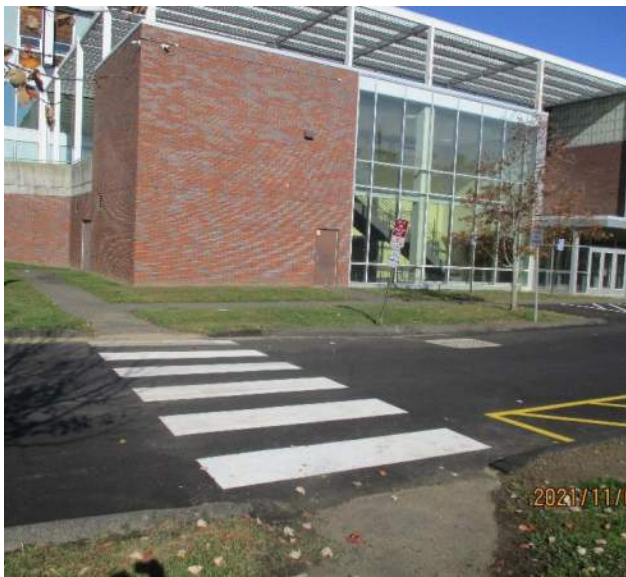
Turf wear at goalie boxes

Fencing – some locations need to be reattached to bars/posts

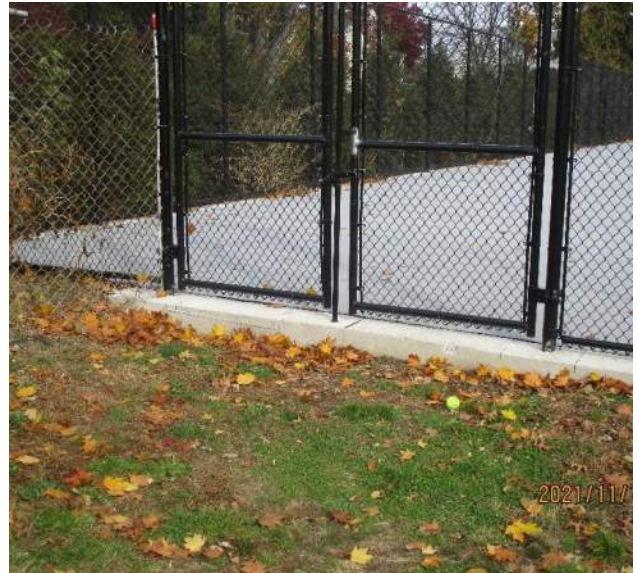
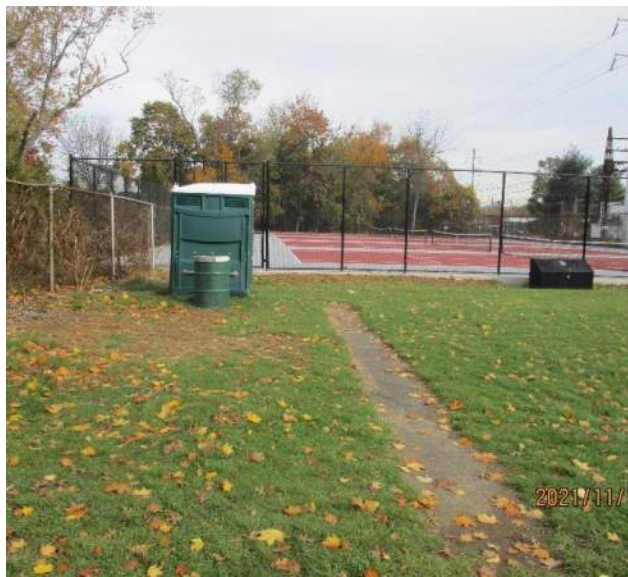
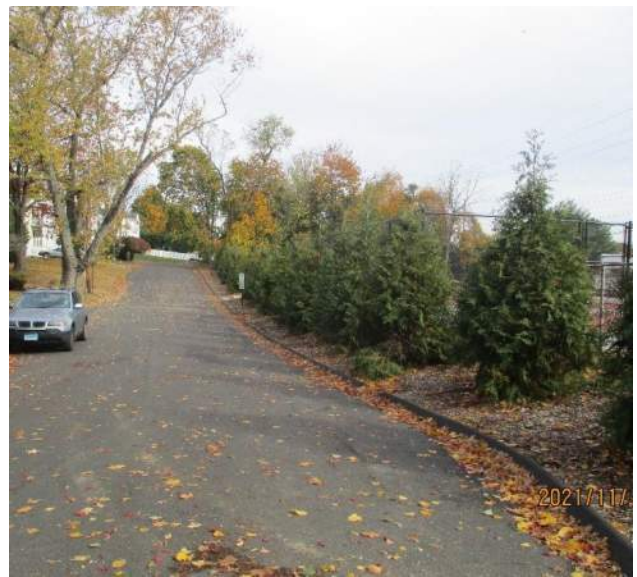
Surface recently resurfaced

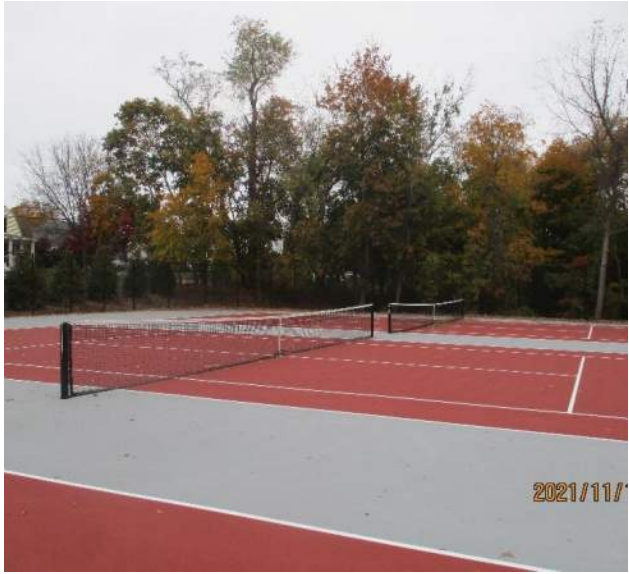
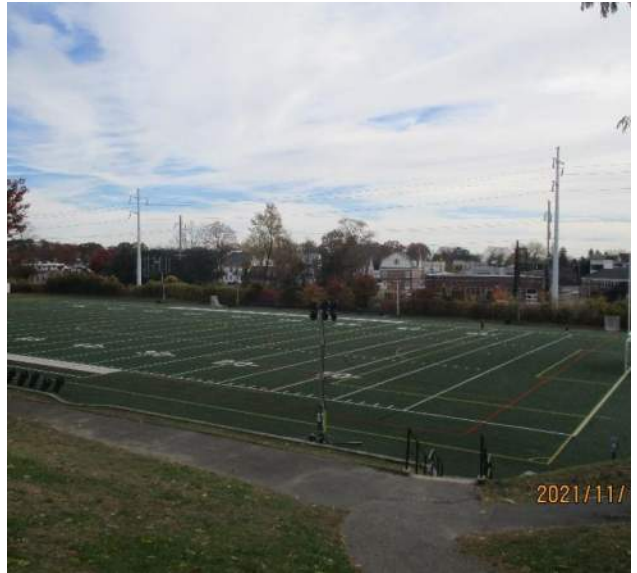
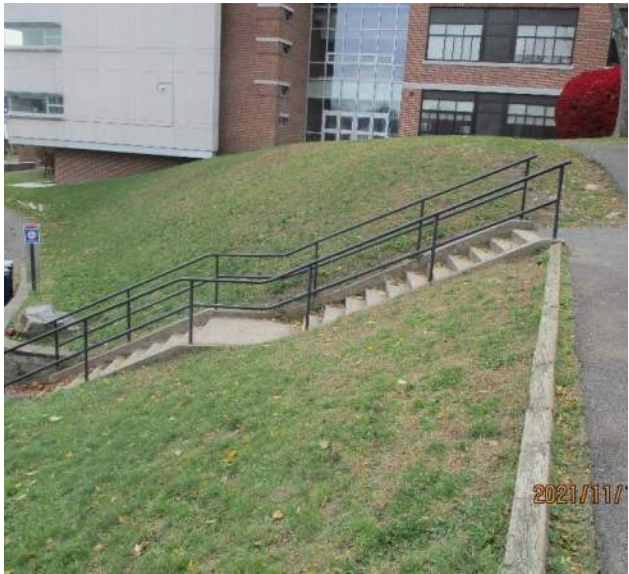
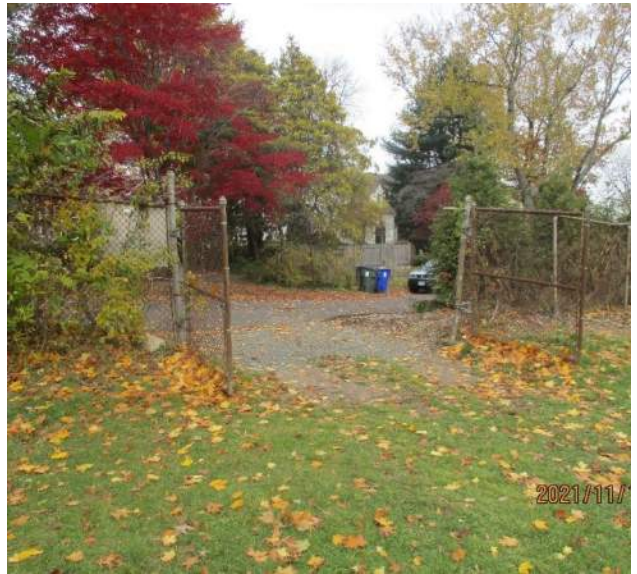
Tomlinson Middle School features a full turf field that was installed/replaced in 2017 and is in good condition. The turf field is accessed from the school and two parking areas. The lower parking area (south of the school) includes an accessible route to the field. The upper parking area (east of the school) includes stairs to traverse the large grade change. Improvements to access from parking areas to the field could be considered.

Moderate pavement cracking within HC parking spaces

Description	Qty.	Cond.
Seating	Spectator bleacher	2	3
	Player bench (16 feet long)	2	3
ADA seating	None		
ADA Companion Seating	None		
Fencing	Black vinyl coated, chain link fencing	perimeter	3
Infield	N/A		
Turf Field	Synthetic turf field	90,000sf	4
Lighting	Temporary portable lighting (South Star)	8	4
Lawn Area	N/A		
Field Orientation	SW-NE		
Other	Bituminous concrete path around field	perimeter	3
	Field netting along parking area	200 LF	4
	Football goalpost	2	4
