THE CITY OF GOLDEN

HISTORIC DISTRICT

RESIDENTIAL DESIGN GUIDELINES

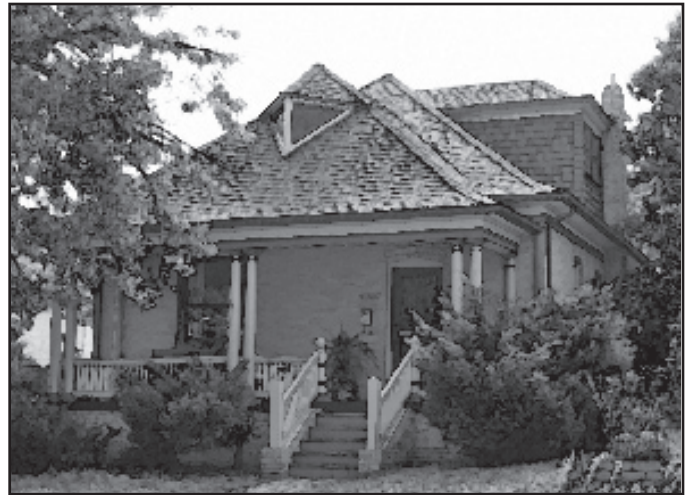
2.1.a Edwardian. Edwardian buildings are basically post-Victorian residences similar to the Queen Anne style in form and massing but lacking ornamentation. Sometimes called Princess Anne, these buildings feature multi-gabled roofs, asymmetrical massing, simple surfaces, and occasionally wrap-around porches, a short tower, and classical detailing.

Common elements:

1. multi-gabled roof
2. asymmetrical massing
3. simple surfaces
4. wrap-around porch
5. short tower
6. classical details

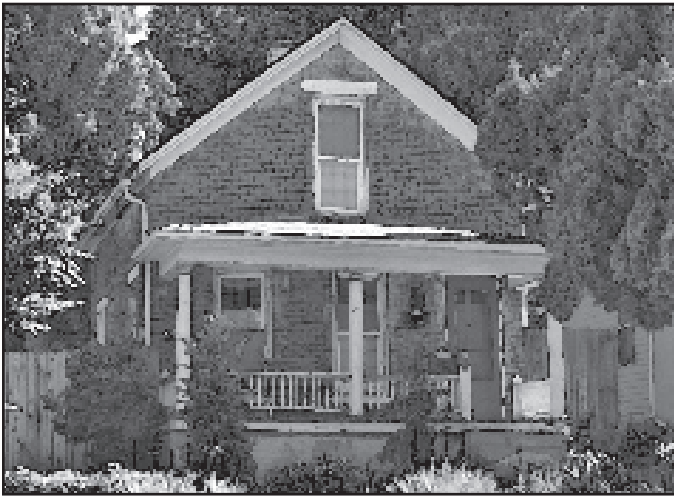
Common elements:

1. unadorned
2. gabled 'L' or simple gabled design
3. porches with spindle-work detailing
4. one exterior material
5. steeply pitched roof

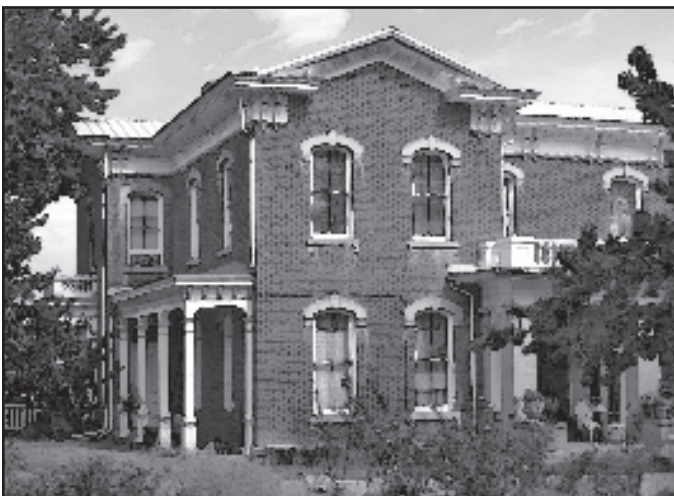
2.1.c Italianate. Like many Victorian-era styles, Italianate emphasized vertical proportions and richly decorative detailing. Designers and builders used the style on residential, commercial and industrial structures throughout Colorado from about 1870 up until the turn of the century. Italianate is characterized by a low-pitched hip roof, wide overhangs, bracketed cornice, a variety of fenestration (usually very tall, narrow, double-hung, one-over-one windows), molded window surrounds, and occasionally a cupola or balustrated balcony. Simple Italianate structures have a hip roof, bracketed eaves, and molded window surrounds. A more elaborate or high style example may feature

arcaded porches, quoins, tower, and ornate detailing.

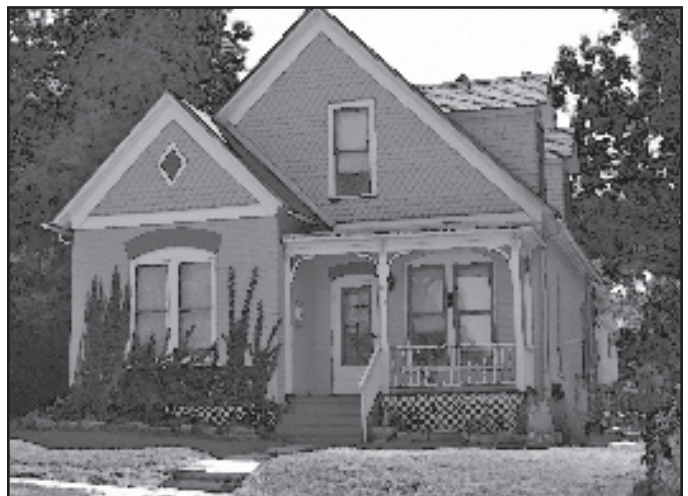
1. corner tower
2. dormers
3. scalloped and shaped shingles

4. iron roof cresting
5. sunburst detailing
6. turned spindles
7. porch
8. conical roof
9. multiple gables
10. bargeboard

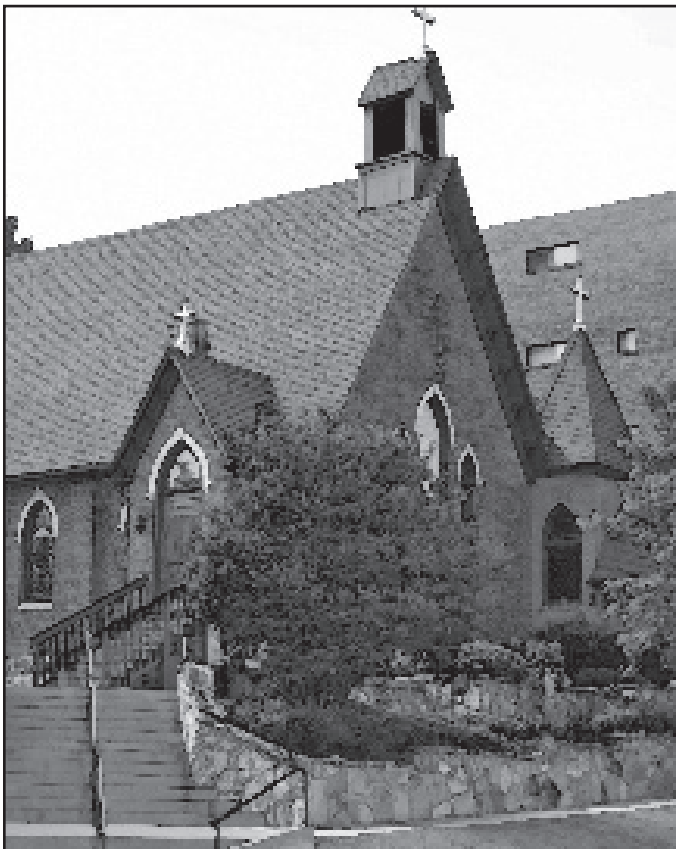
Common elements:

1. massive towers
2. flying buttress
3. stepped buttress
4. pointed arched window
5. steeply pitched roof
6. deeply recessed entrance

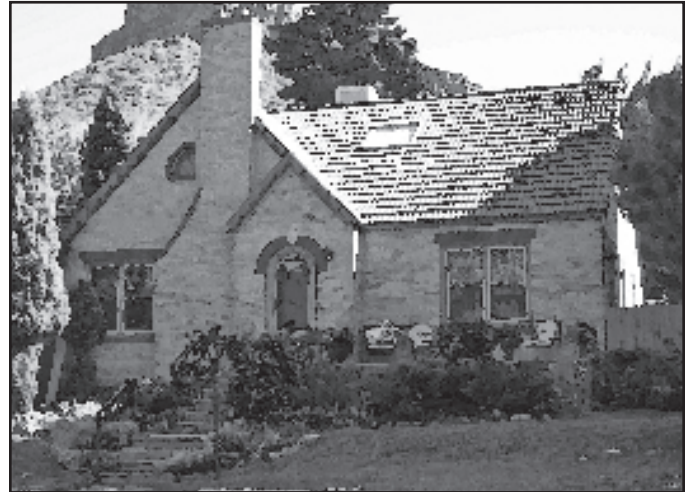
Common elements:

1. steeply pitched roof
2. steeply pitched gable entrance
3. decorative brickwork
4. arched entrance
5. stucco exterior
6. casement windows
7. large front picture window
8. multi-light windows

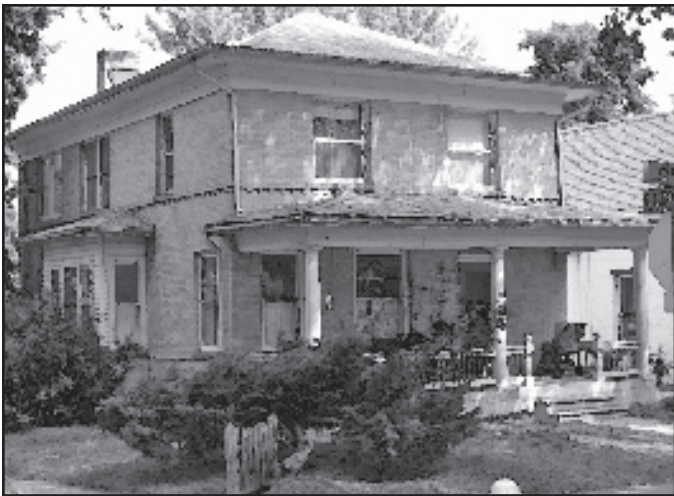
Common elements:

1. residential
2. square plan
3. front porch
4. two or more stories
5. unadorned exterior
6. hipped roof
7. shaped gable
8. side bays
9. Doric or Tuscan columns
10. brackets
11. square porch posts
12. dentils
13. classical frieze
14. modillions
15. roof overhang

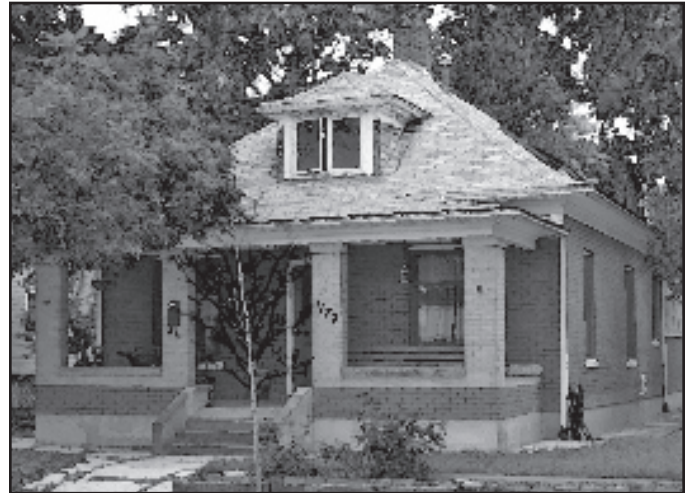
Common characteristics:

1. central dormer
2. hipped roof
3. thick porch posts
4. flared eaves
5. simplified Doric columns
6. belt course

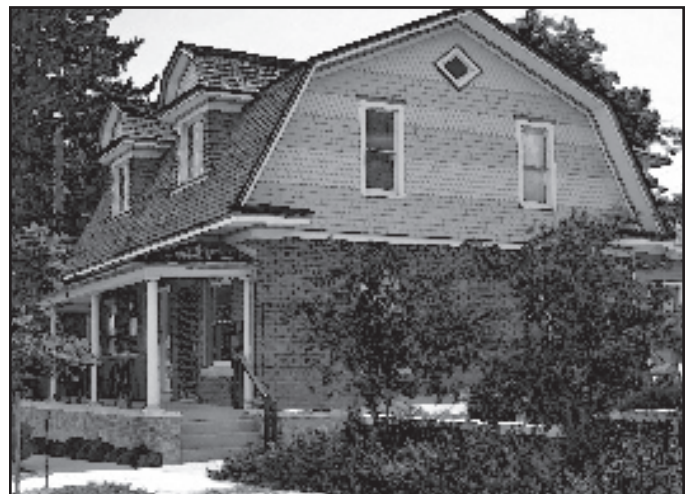
2.2.c Dutch Colonial. The gambrel roof is the distinguishing feature of the Dutch Colonial Revival. Primarily a residential style, it was popular in Colorado between 1900 and 1925. Other characteristic elements included wide overhangs, dormers, small oval windows in the gable ends, and a porch under the overhanging eaves of the gambrel roof, supported by columns. The building may be side-gabled, front-gabled, or form intersecting gables. A

steep, stepped gable, reminiscent of Flemish architecture, is also seen on occasion.

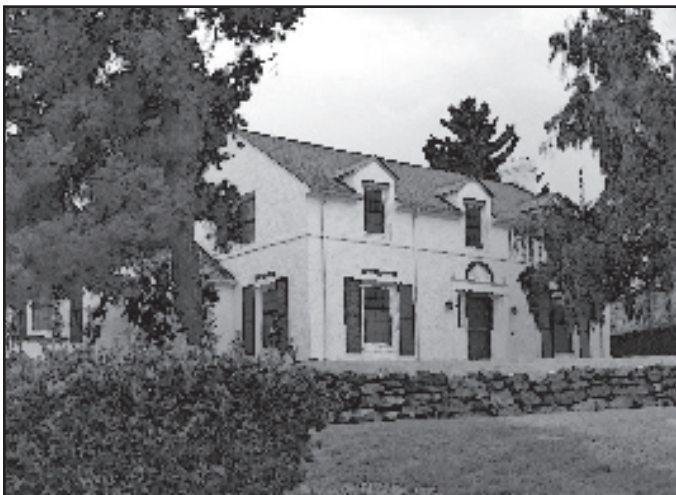
Common elements:

1. broken pediments
2. 8-over-8 sash windows
3. portico
4. fluted columns
5. Doric columns
6. Corinthian columns
7. pediments
8. fanlight
9. sidelight
10. shutters
11. dormer
12. eyebrow dormer

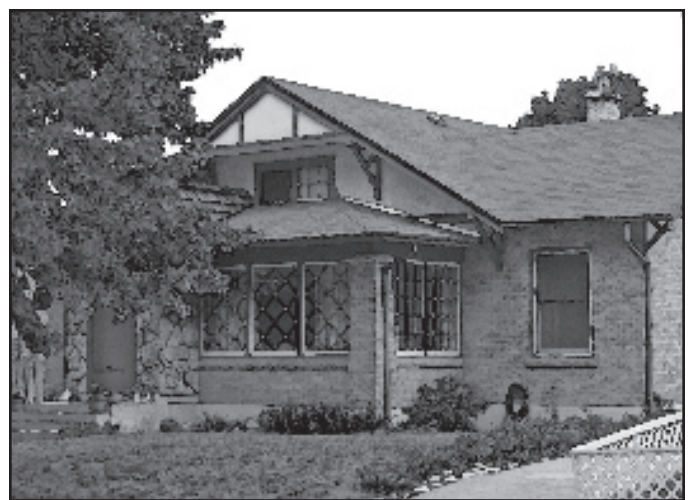
Common elements:

1. exposed rafter ends
2. clipped gable
3. false half-timbering

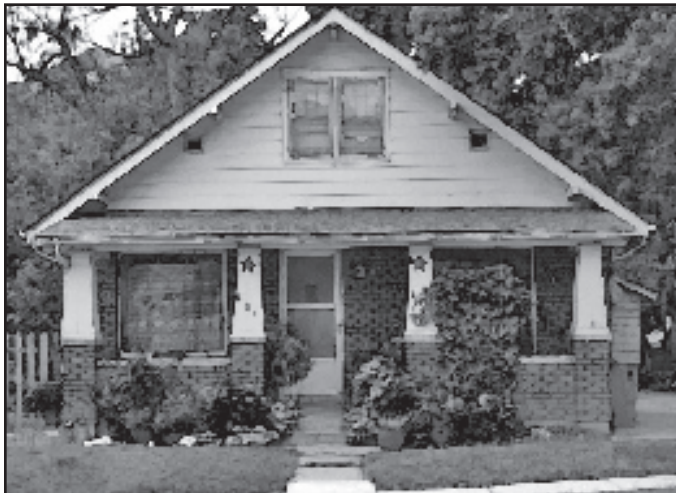
Common elements:

1. front gable roof
2. side gable
3. exposed rafter ends
4. large front porch with battered piers
5. pent-roofed bay
6. clipped gable
7. overhanging eaves

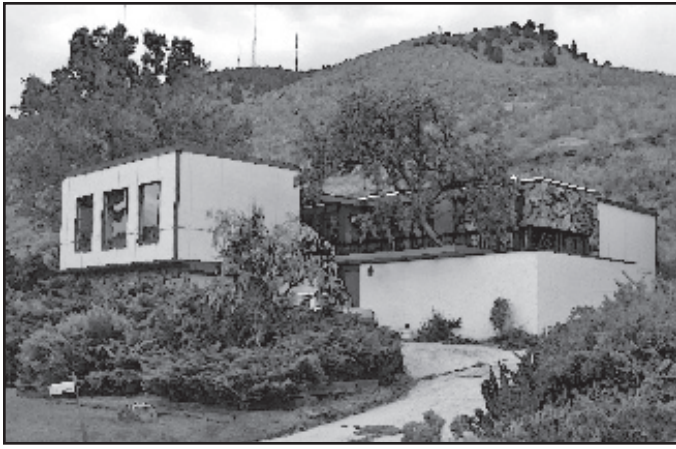
1. smooth, untextured surfaces
2. cantilevers
3. bands of windows
4. solid plane

5. casement windows

6. flat roof

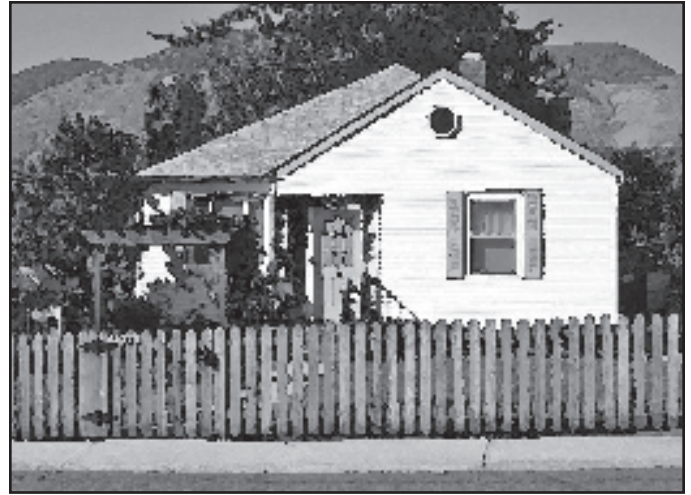
The Minimal Traditional was very loosely based on the Tudor Revival style of the 1920s and 1930s. It was a relatively small, one-story building often with a predominant front facing gable section or gabled covered entry, echoing Tudor features. Rather than the steeply pitched roof of its Tudor predecessor, the Minimal Traditional roof pitch was low or intermediate with closed eaves and rake. The simplified façade features few architectural details other than decorative shutters. Typical wall

materials include cement asbestos shingles in an assortment of colors, brick (usually striated), wood, or metal siding (a replacement material).

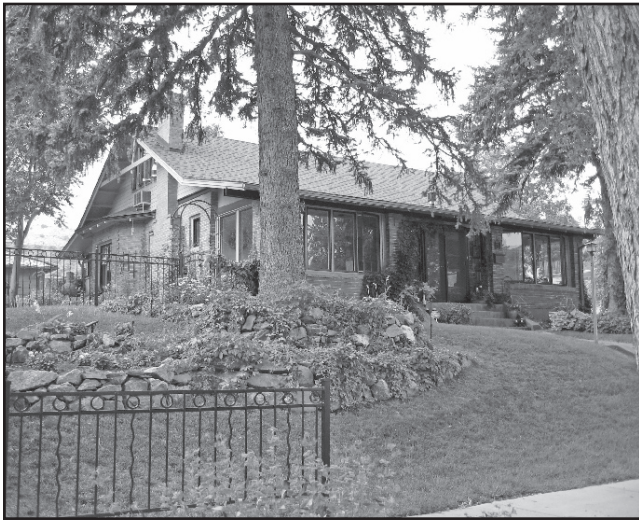
3.2.d Open Area & Landscape: The area between the street and the building is open, and most frequently lawn. Historic fences were low and open in character, and landscaping was limited. This preserved the open character of the streetscape.

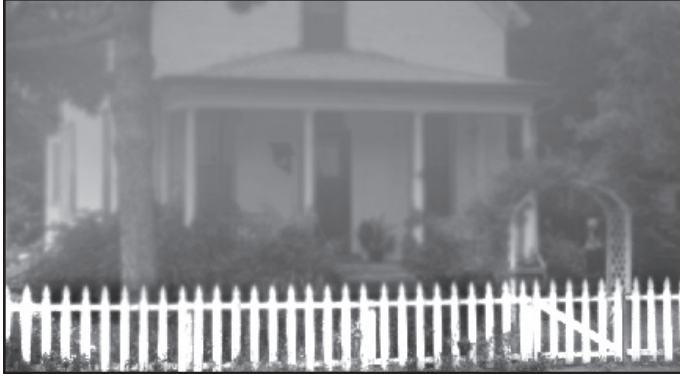
3.2.m Fences: Historically, the visibility of a house has been more important than creating privacy fence in the front yard. For this reason, front fences were open in character, frequently of wood or metal pickets and usually low. Solid wood fences were not used at the front of a house, and the present day addition of such a fence interrupts the visual character of the strong setback alignment.

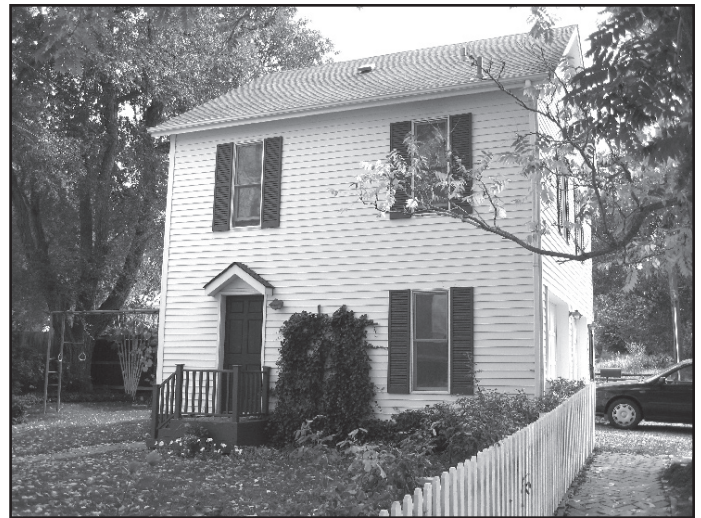
- Garages shall be at the side or rear of residential structures. Garages should not become a dominant feature in front of the house or in any location.
- Garage doors shall not be forward of the front façade of the residence.
