City of Hudson Historic Preservation Commission Application for Certificate of Appropriateness

326-328 Allen Street Hudson, New York 12534

Scope of Work: Exterior masonry and carpentry repair and roofing (see Addendum).

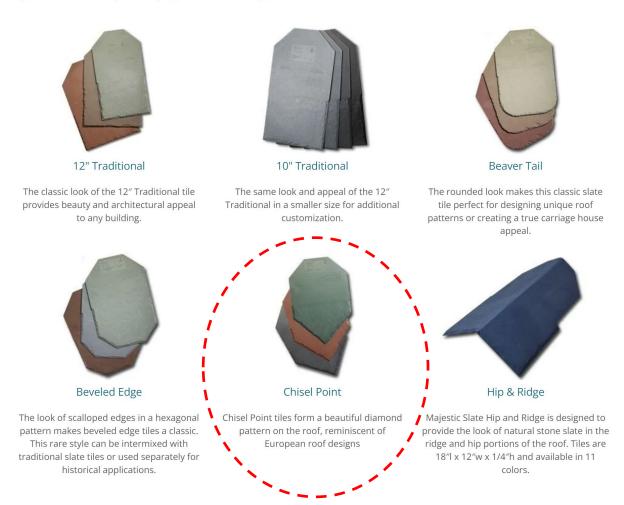
Many unique shapes and designs have been seen in slate roofing throughout history. EcoStar offers Majestic Slate in five tile shapes, along with Hip & Ridge, for endless opportunities to create unique and custom designs for any residential or commercial project. Whether your design calls for a traditional Georgian, modern bungalow, or contemporary ranch, our Majestic tile line has the perfect combination of options to enhance the personality of your architectural style.

a. **Mansard:** Replace with EcoStar[™] Majestic Slate, Chisel Point (diamond) shape, in color Midnight Gray, with matching hip caps at four corners. This is a leading brand of

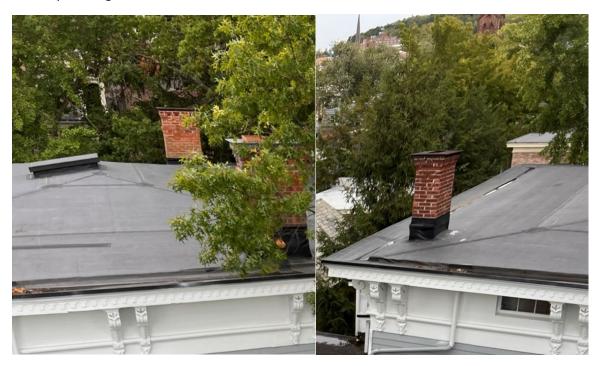
EPDM sample: detail of 330 Allen Street (neighboring property) showing EPDM roofing material and chimney flashing:

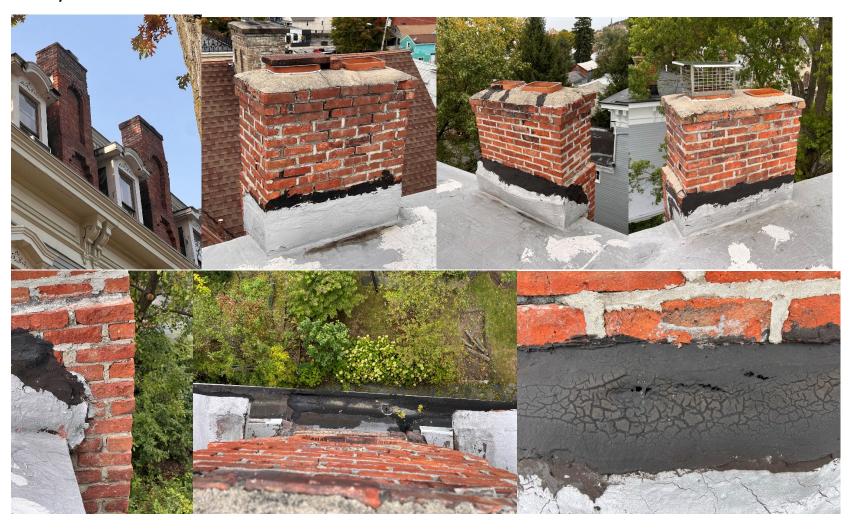
There are three chimneys, one on the west and two on the east wall of the building. Chimneys are internal and not visible below the Mansard roof line (third story). Chimneys show deteriorated / missing grout and some cracked bricks. Existing tar flashing has separated in spots, creating gaps potentially allowing water penetration. There is one metal chimney cap on southeast chimney. Water penetration has previously caused interior damage and must be remediated to prevent deterioration to the building structure.

Exposed brick will be repointed, concrete crowns rebuilt, and chimneys covered with stone slab caps supported by brick supports at each corner. EPDM flashing will be applied creating a water seal with the adjoining flat roof. If required subject to further investigation, one or more existing chimneys may be removed to the existing roofline and rebuilt like-for-as and to the above specifications.

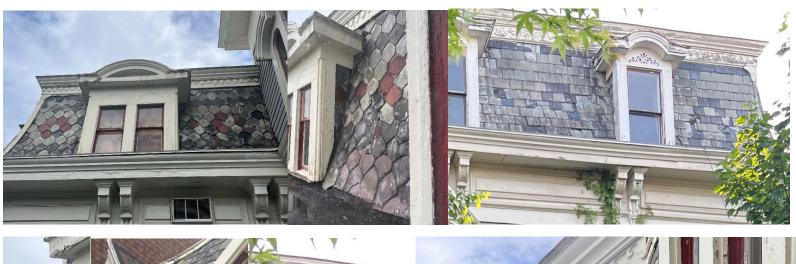
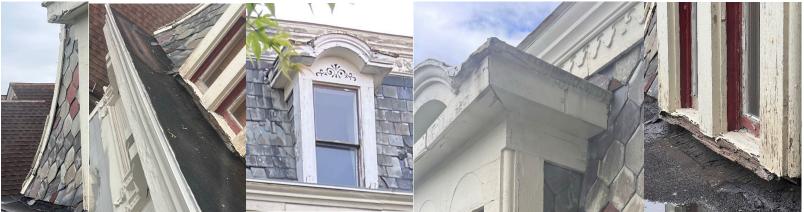
Mansard Roof, Dormer Windows, Trim

- a. Mansard: mismatched combination of hexagonal slate, rectangular slate and asphalt shingle. Slate is significantly deteriorated, cracked and delaminating throughout. Numerous slate tiles are broken or missing, exposing wood roofing substrate to the elements, or patched with bare sheet metal. A section on the northwest side has been replaced with asphalt shingle. Original floral color pattern is partially discernable but distorted due to patching with non-matching tiles and/or coated with tar in sections. Shapes: north side (rear) of building consists of rectangular slate tiles; south and east sides are primarily 6-sided (hexagonal) tiles (with some sheet metal patchwork); west side is combination of hexagonal slate and rectangular shingle.

- d. **Dormer Window Roofs:** Metal, generally intact. Some sections previously repaired (e.g. with spray foam) and misshapen.

- rubberized material manufactured to visually replicate slate.² Flash according to manufacturer's specifications.
- Top Flat Roof: Not visible from street. EPDM membrane applied to existing metal roof.
 Flash according to manufacturer's specifications. Install new metal Bilco access hatch
 (not visible from street).
- c. Yankee Gutter Lining: *Not visible from street*. EPDM membrane will replace existing asphalt roofing material gutter liner. Install new slip tube inserts into existing gutter downspout leaders. Flash according to manufacturer's specifications.
- d. **Dormer window roofs:** EPDM membrane applied to existing metal roof. New steel drip edges applied to create clean perimeter appearance and mask misshapen areas. Flash according to manufacturer's specifications.
- e. **Drip edges:** Steel (like-for-as existing).

- a. **Yankee Gutter Fascia and Soffits:** Repair and/or replace deteriorated wood elements like-for-as. Use epoxy filler as needed. Scrape, sand to original surface plane and repaint.
- b. **Dormer Windows:** Repair and/or replace deteriorated wood elements like-for-as. Use of epoxy filler as needed. Scrape, sand to original surface plane and repaint.
- c. Mansard Trim:
 - a. Corner Trim: Remove wood corner trim pieces and replace with EcoStar Majestic Slate hip caps to match Mansard roofing material (see above). ³
 - b. Top Edge Trim / Crown Molding: (Pending further investigation) if salvageable, scrape/sand and repaint existing top trim. If not salvageable, replace like-for-as.
- d. **Painting:** Scrape, sand and repaint wood elements.

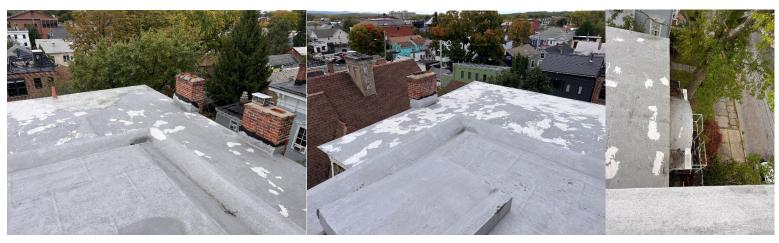
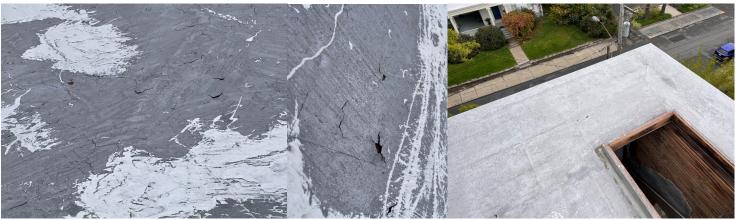
Flat Metal Top Roof

- b. Flat Top Roof: Not visible from street. Has slight pitch but not visible from street. Consists of welded metal, believed to be the original tin roof. Coated with silver coating. Silver coat is cracked and water potentially penetrating at weld seams. Steel drip edge along perimeter. Wooden roof access hatch in deteriorated condition.

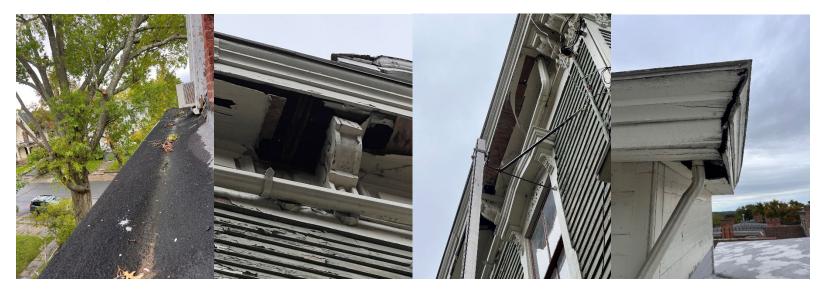
Yankee Gutters, Fascia and Soffits

- c. **Yankee Gutter Liners:** *Not visible from street.* Existing gutter lining consists of asphalt roofing material in aged / deteriorated condition. Perforated in sections leading to water penetration into and failure of soffits (see below). Steel drip edge along perimeter.

- a. Yankee Gutter Fascia and Soffits: Significant failure of soffits on south and west sides, with boards missing and/or rotted through, due to water penetration from failing sections of asphalt Yankee gutter liners (see above). Questionable areas / cracks on north and east sides for further investigation. Sections of fascia rotted and/or cracked.
- b. **Dormer Windows:** Significantly deteriorated wood elements throughout. Majority of window sills rotted out.
- c. **Mansard Trim:** Wood corner trim pieces significantly deteriorated. Top decorative trim appears largely intact (subject to further on-site investigation as elevation is approximately 45 feet above street level and inaccessible to homeowner).

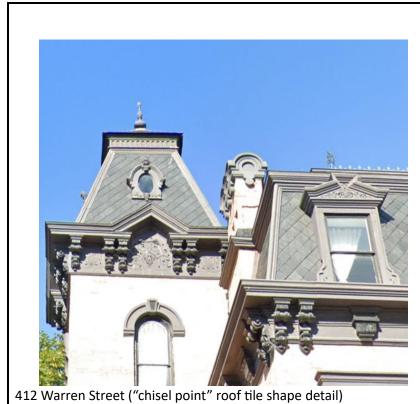
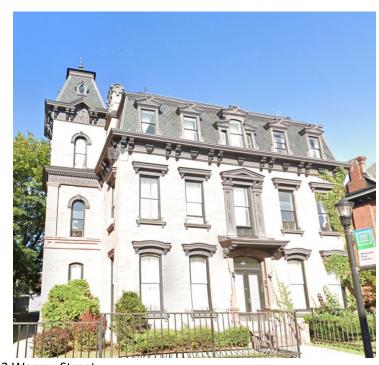
412 Warren Street is a nearby example of the "chisel point" (diamond) pattern on a Second Empire Mansard roof.
