***REVISED GEOTECHNICAL STUDY FOR THE
PREPARATION OF AN ENVIRONMENTAL IMPACT
REPORT FOR THE PROPOSED DEVELOPMENT
LOCATED AT 21845 MAGNOLIA STREET WITHIN THE
CITY OF HUNTINGTON BEACH, CALIFORNIA,***

Project No. 164011-01

**Dated: March 14, 2018
Revised November 15, 2018**

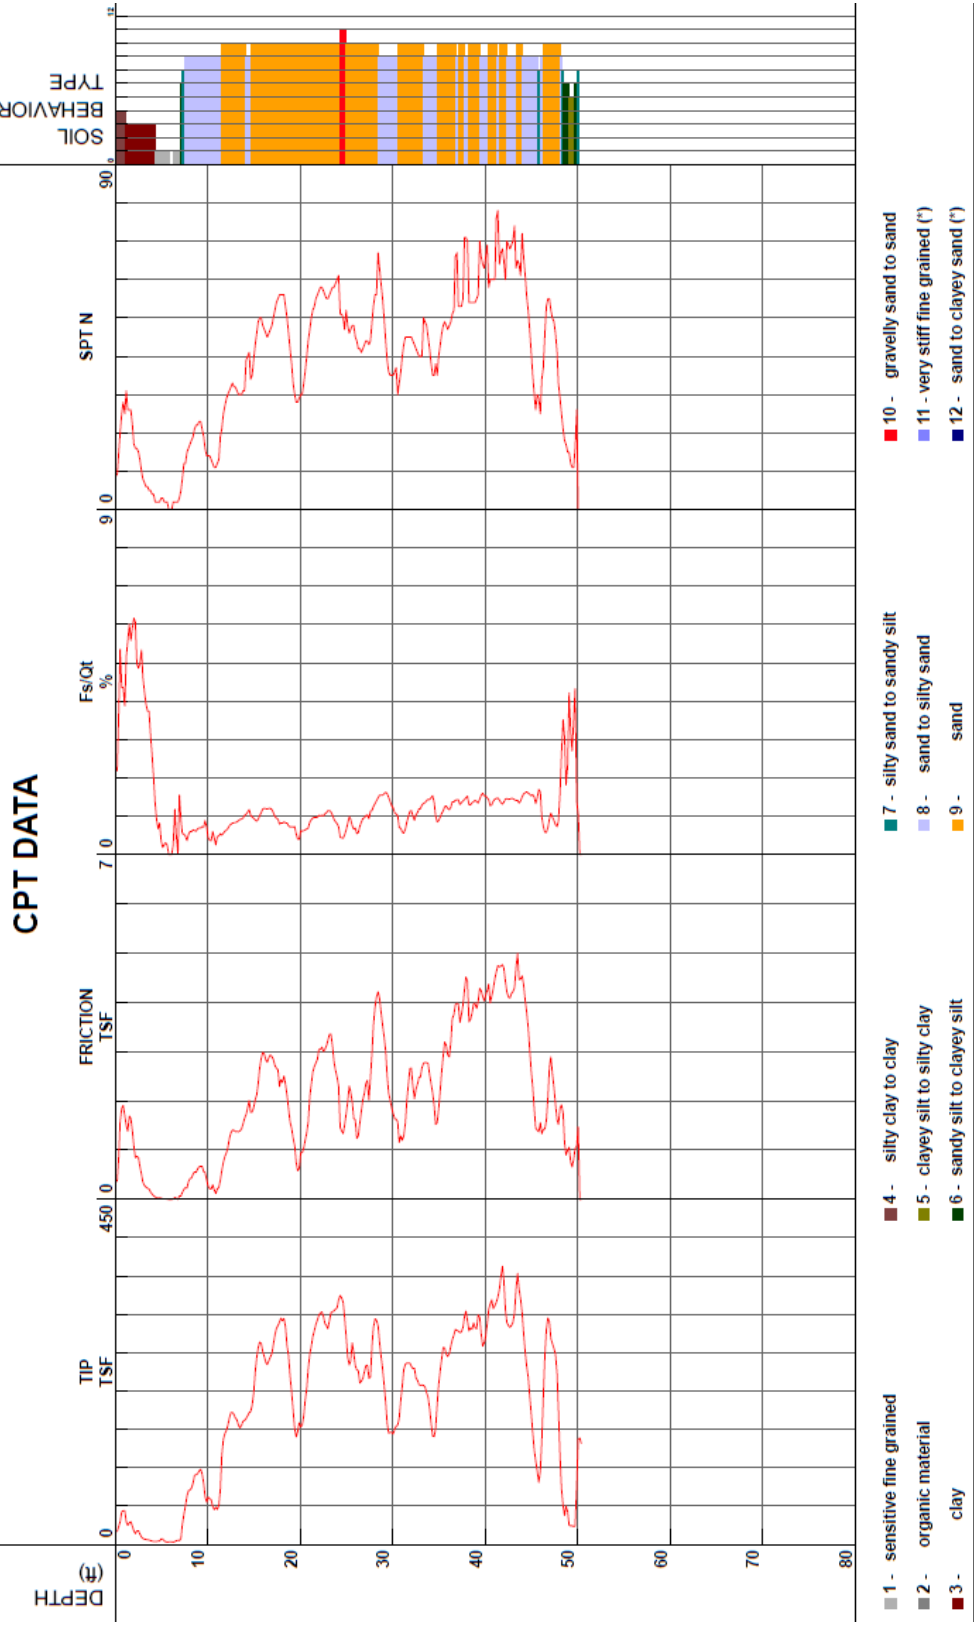
Project	Huntington Beach	Operator	DG-RC
Job Number	SHO-72233.4	Cone Number	DDGT350
Hole Number	CPT-12	Date and Time	1/14/2016 3:50:48 PM
EST GW Depth During Test	0.66 ft	Filename	SDF(018).cpt
		Maximum Depth	50.36 ft

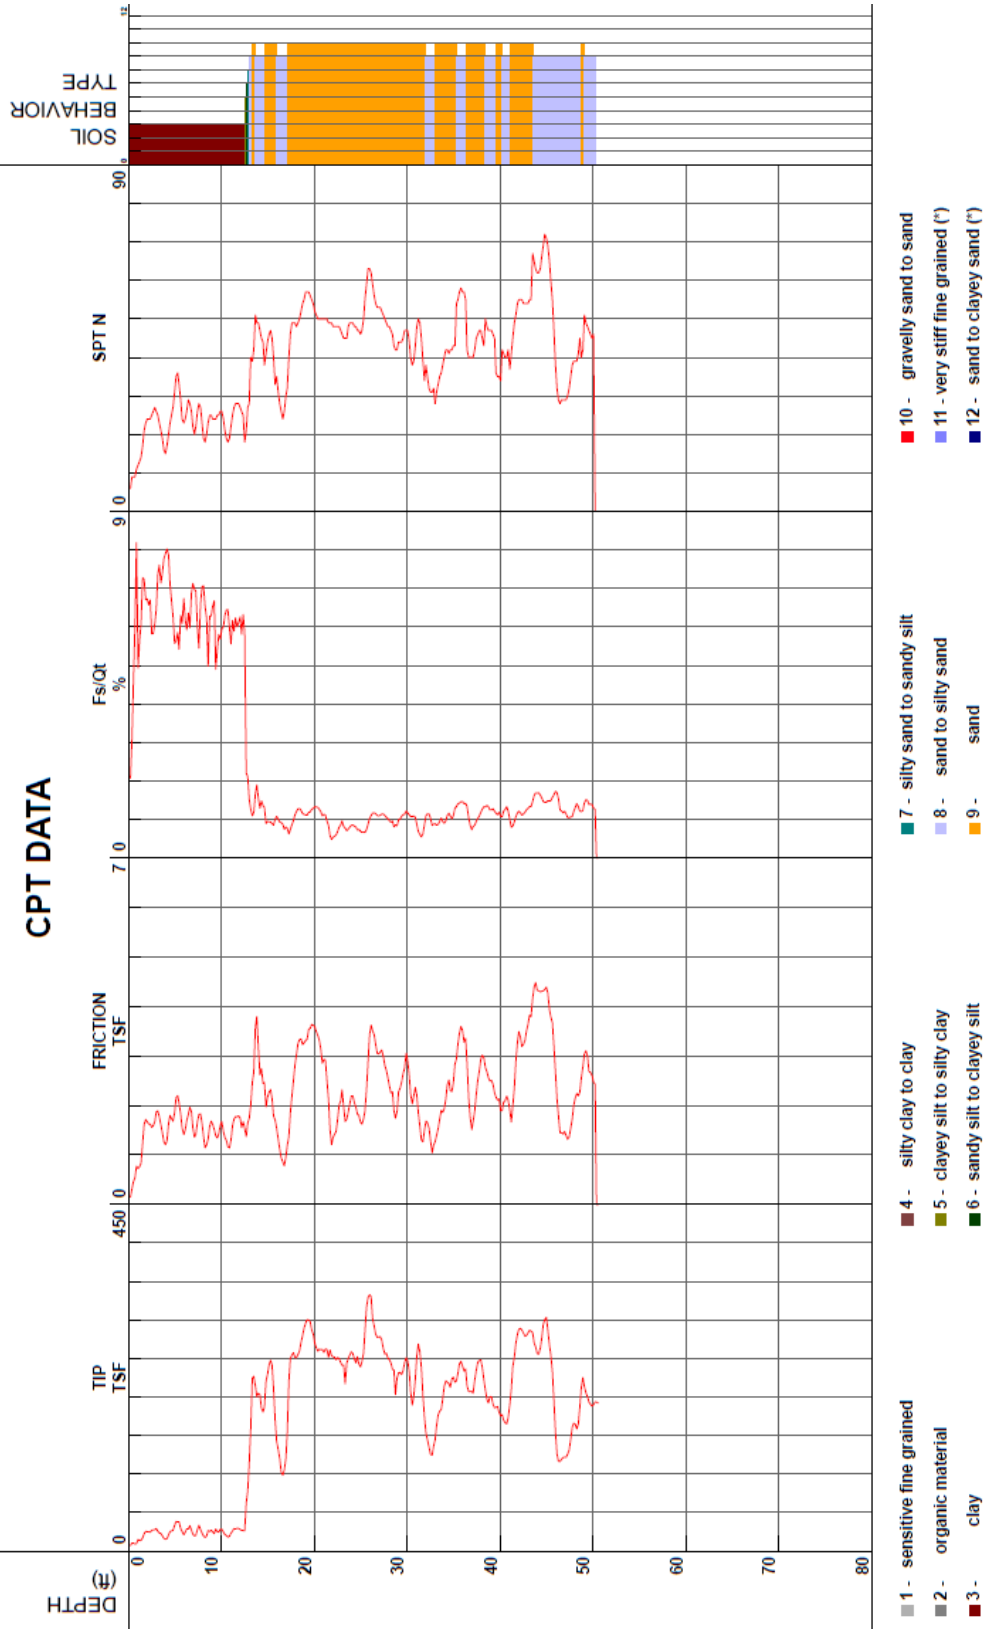
Project	Huntington Beach	Operator	DG-RC	Filename	SDF(017).cpt
Job Number	SHO-7233.4	Cone Number	DDGT350	GPS	
Hole Number	CPT-14	Date and Time	1/14/2016 2:49:09 PM	Maximum Depth	50.52 ft
EST GW Depth During Test	9.40 ft
