Watershed Based Plan Overview

Hanging Fork Watershed
Boyle, Lincoln, and Casey Counties
Kentucky

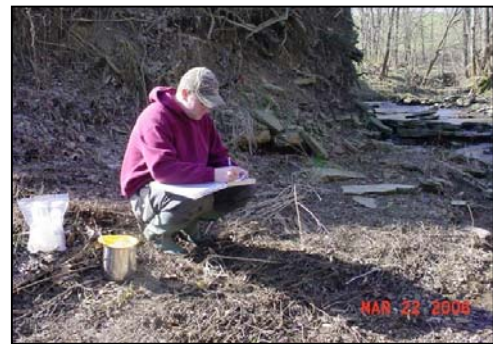
Of the sixty-one sites surveyed in Hanging Fork, the majority of the sites were determined to have poor habitat (Figure 1). Although the poor habitat designations were due to different factors at various sites, common trends were observed in the watershed.

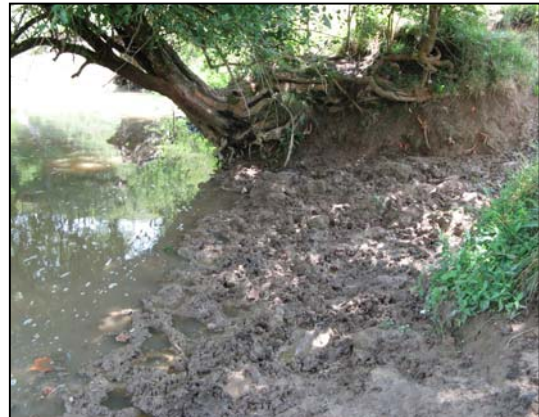
Impact of Cattle Grazing in Hanging Fork

In the agricultural areas of the watershed, the poorest habitats frequently occurred in streams that pass through grazing areas. Cattle allowed to graze along the creek trample the banks and impact habitat by creating erosion that impacts aquatic habitat with sediment. Grazing also reduces habitat as cattle consume much of the streamside vegetation. Forested streams were generally in better condition than streams in agricultural areas.
