PONTIAC HISTORIC DISTRICT COMMISSION

March 13, 2024, 6:00 pm

HDC 24-002
369 West Iroquois Road
By Paul Harang

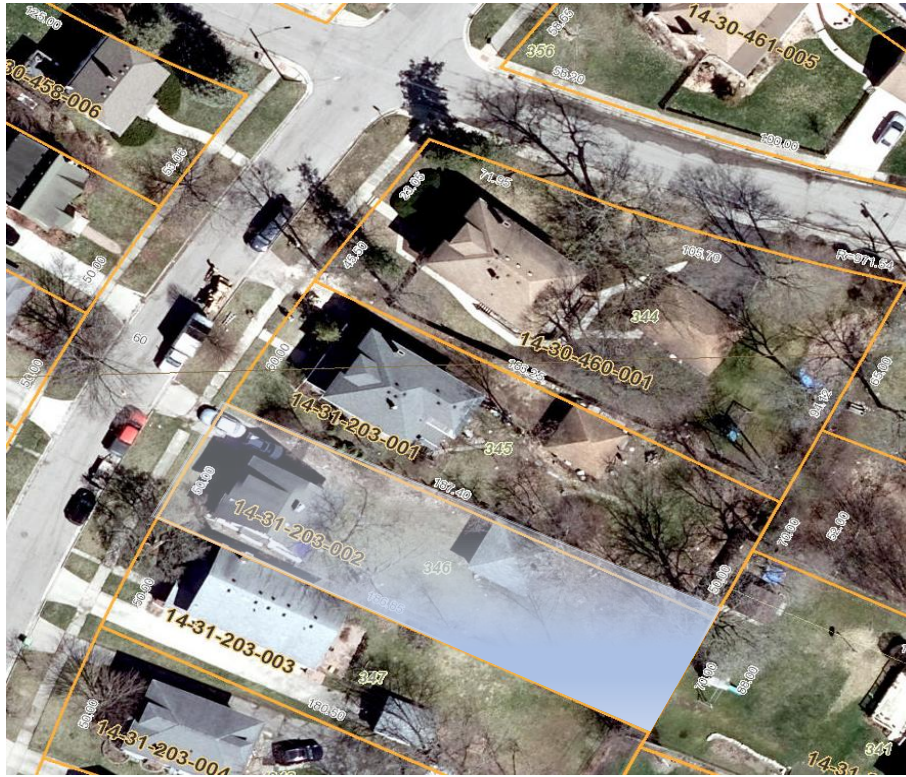
369 W. Iroquois Road was constructed in 1931. This American Bungalow - Craftsmen-style dwelling is characterized as, a 1-1/2 story frame structure with a gable roof, wide overhanging eaves with side brackets, and dormers on the front and rear roof lines. The dwelling facades are composed of vinyl siding and painted cedar shingles at each gable side wall. The garage is a hip roof structure having two (2) vehicle bays with

- The Seminole Hills Historic District was established in 1983.
- The subject property is located on the south side of West Iroquois Road nearer its intersection with Algonquin Road.
- The house and garage look in good condition with significant alterations to both structures.
- City records show in 2023 a hold was issued by Code Enforcement for work being done without a permit and Historic District Commission review for exterior alterations.

Staff recommends supporting the vinyl railings, vinyl windows on non-primary facades with grills, and the new garage doors if the commission can find these features to have deteriorated and require replacement with modern materials that are consistent with the district.

Staff does not recommend approval for the removal of original wood windows replaced by vinyl windows on the primary facade and the covering of wood garage siding and garage windows with vinyl siding.

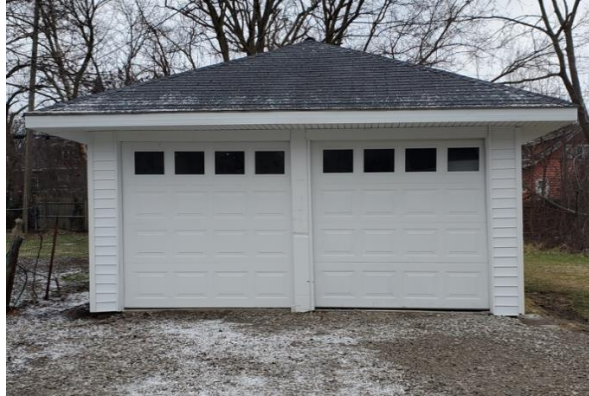
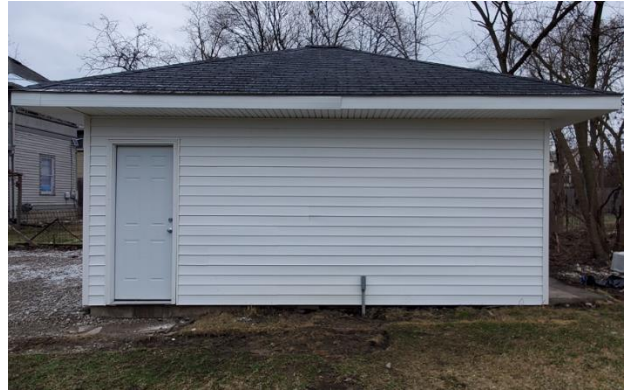
Figure 5 Photo of garage in 2024

The applicant indicated the wood siding on the garage was “very deteriorated” therefore, he covered the garage walls with vinyl siding to mimic the siding on the dwelling. However, this alteration is not consistent with either standard/ criteria.

Staff do not support the addition of vinyl windows on the Primary Façade or covering wood siding and wood windows in the garage. Staff also find it difficult to support the removal of the wood garage doors and removal of wood railings with vinyl railings on the stoop due to the fact staff were unable to inspect the condition of these features before their removal. However, metal garage doors are a common feature of the district, and the vinyl railings look consistent with the existing railing identified in the district therefore, the applicant will need to testify to the wood doors' condition at removal and indicate the condition of the wood rails needing to be replaced with vinyl railings.

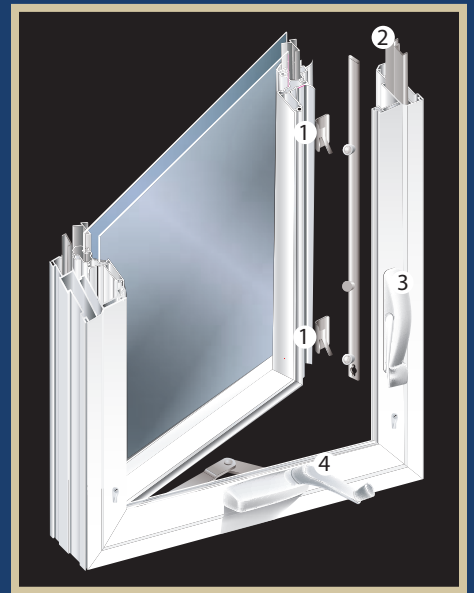
Casement Profile

- (1) Multi-point lock
- (2) Heavy-wall reinforced construction: Allows for slim-line look while insuring maximum strength and durability
- (3) Low profile curved lock: Lies flat, out of the way of window treatments
- (4) Low torque operator: Crank requires 33% less operating force; fold-down handle available

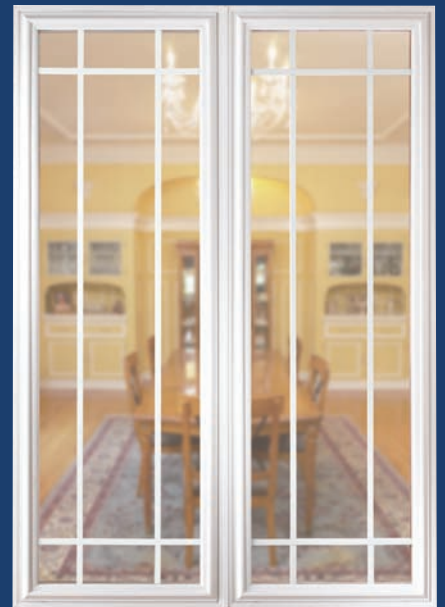
The Belmont has a unique profile sash and narrow frame to allow maximum exposed glass area.

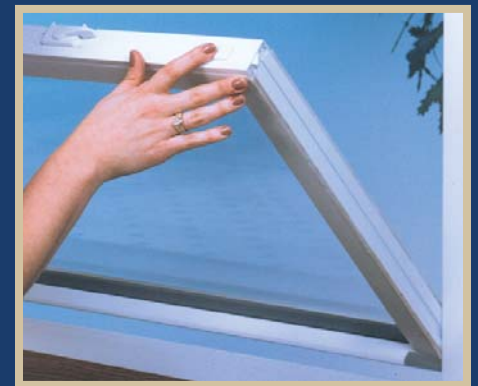
Easy Operation and Cleaning

Window cleaning is simplified with tilt-in upper and lower sashes.

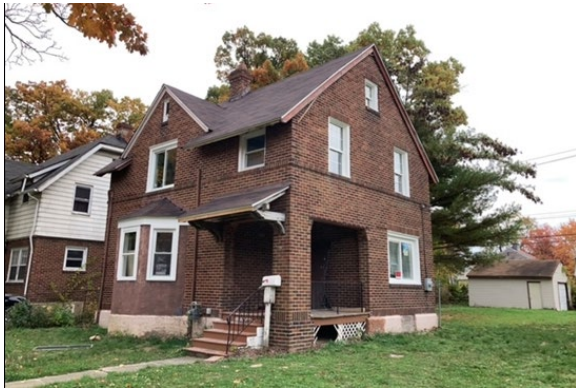
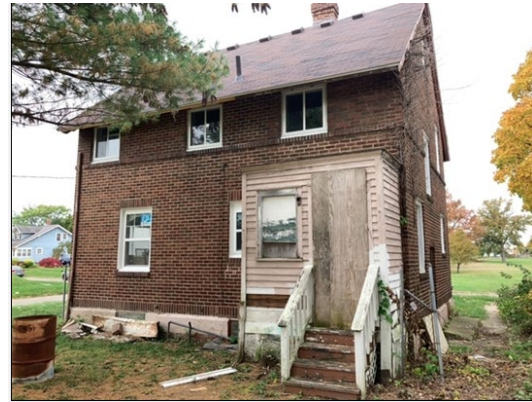
Figure – 2 Photo of House

The facades are composed of vinyl windows, boarded basement windows, and boarded openings on the rear bump out. The applicant has erected an opaque fence along the south property line without a permit but will be removing it to conform to the city fence regulations and input from the Commission.

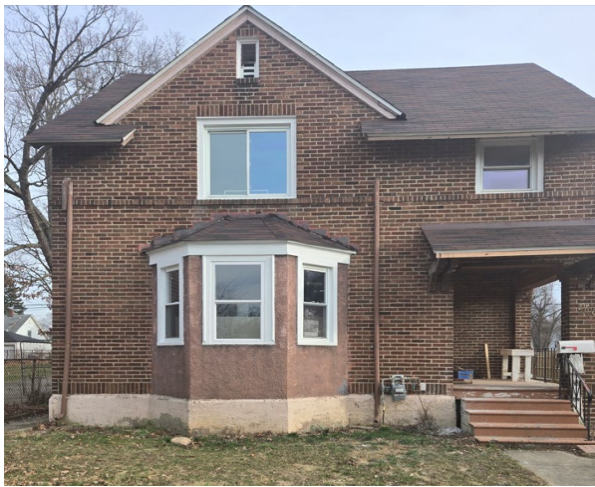
Figure 3: NORTH FAÇADE No changes to this façade, previous owners inserted vinyl windows in house without HDC approval.

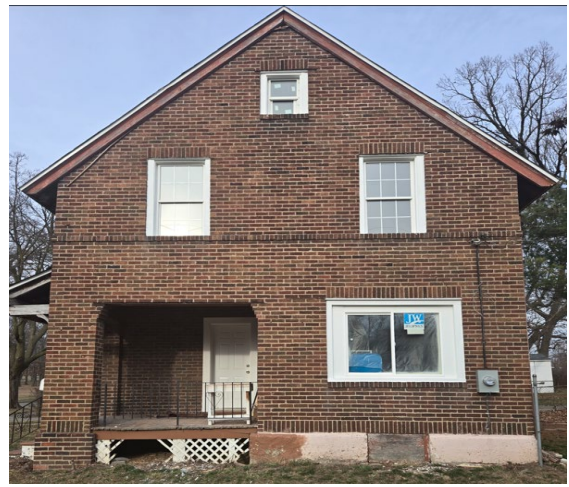
Figure 4: WEST FAÇADE Applicant installed second and third story vinyl windows and the metal door. The vinyl window on the first floor was installed by a previous owner.

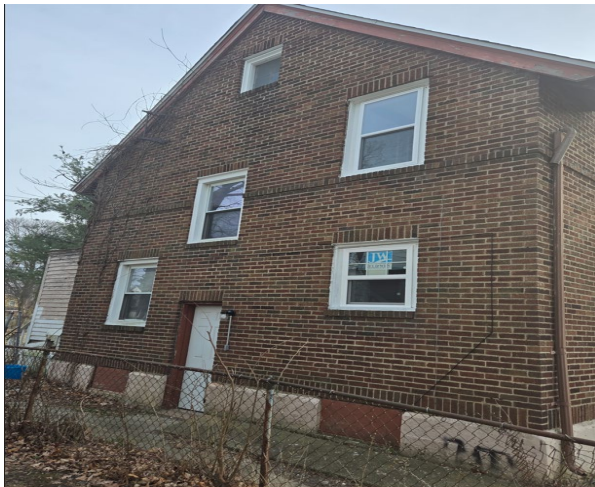
Figure 5: EAST FAÇADE Applicant installed the metal door and installed the vinyl window to the right of the door. The applicant is proposing a new 3rd story vinyl window. The remaining windows were installed by a previous owner without HDC approval.

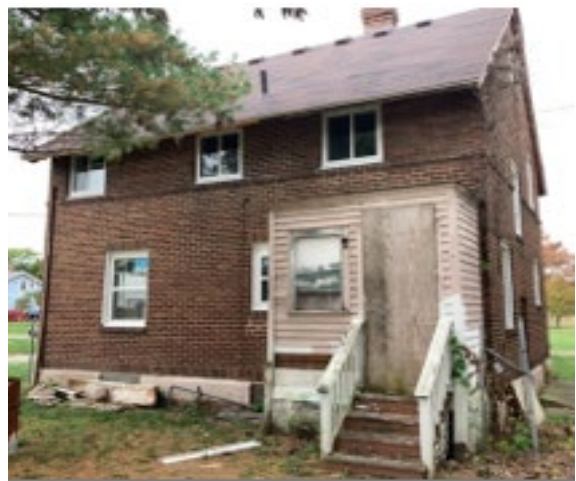
Figure 6: SOUTH FAÇADE The applicant installed the second-story middle vinyl window and both first floor vinyl windows. The remaining windows were installed by a past owner without HDC approval. The applicant is requesting to install a new vinyl window and metal door within the rear bump out.

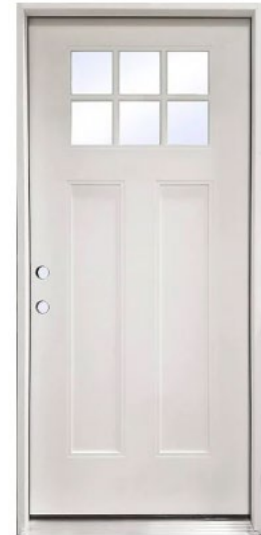
Figure – 7 example of door with lites.

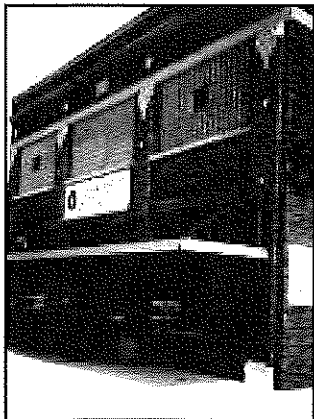
Application 1 (*Incompatible treatment, later corrected to meet the Standards*): This two-story, brick building was constructed between 1919-1920 to house the commercial operations of a local dairy. It was rehabilitated as legal offices. While the rehabilitation retained the character-defining glass block windows on the second floor of the primary street elevation the first floor storefront windows and entrance had to be replaced due to extensive deterioration.

Rehabilitated dairy building.

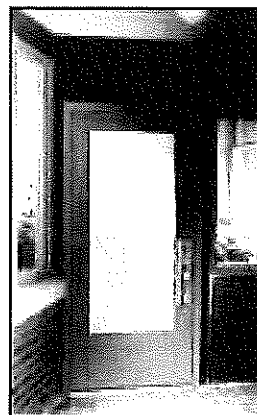
Appropriate replacement door.

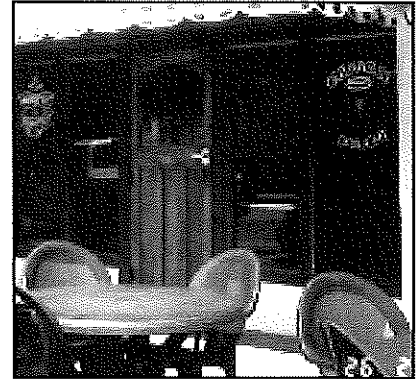
Rehabilitated storefront with incompatible stained glass door.

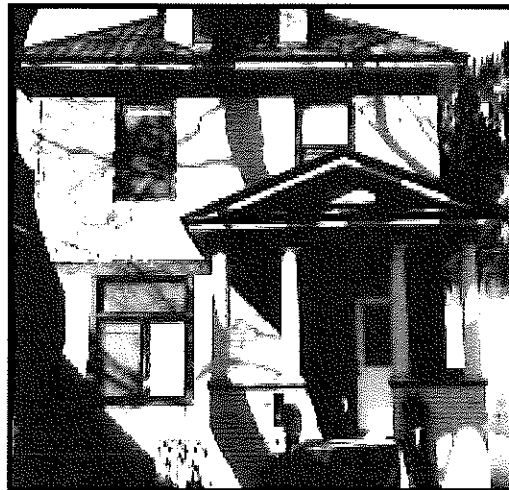
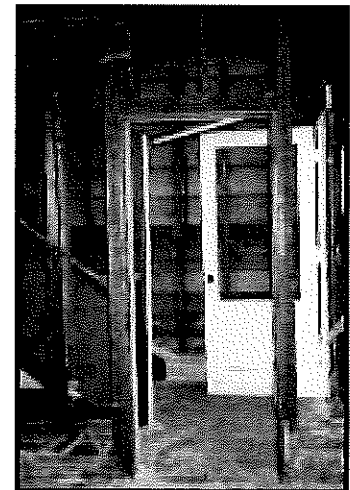
Application 3 (Incompatible treatment): In a third project, a two and one-half story Foursquare house with Colonial Revival-style details built in the first decade of the 20th century was rehabilitated for continued residential use. Although most of the interior finishes and features, including all lath and plaster, had been removed by a previous owner, the original front door still remained. In the course of the rehabilitation, however, this historic door was replaced with a new door featuring multi-paned glass with two vertical panels below, the same "stock" door, in fact, that was used in the dairy conversion project. This multi-paned door is no more compatible with the character of this early-20th century house, than it was with the 1920s dairy building. To meet the Standards, the owner would have had to have a new door fabricated based on photographs of the original to match the historic door which had been discarded in the rehabilitation. A compatible, contemporary door could also have been installed to meet the Standards.

Rehabilitated Foursquare house with inappropriate "stock" door (left) and no longer extant historic door (right) that was discarded in the rehabilitation.

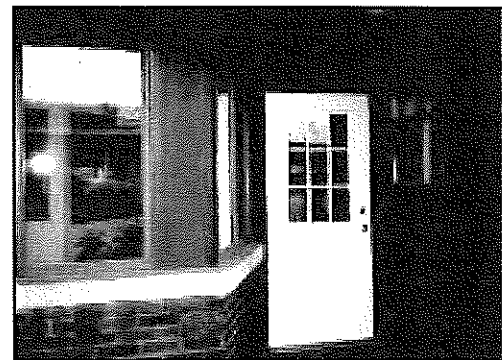
Incompatible "stock" door.

The storefront windows were replaced with simple, contemporary windows with dark-colored frames that were compatible with the historic building. But the "stock" white entrance door with its nine-pane glass and snap-in muntins above two vertical panels was not compatible with the historic building. In order to bring the project into compliance with the Standards, remedial work involved replacing the stock door with a simple glazed wood door that was compatible in both design and color with the historic building.

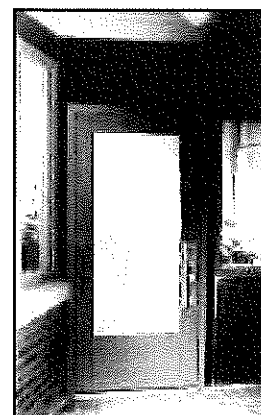
Appropriate replacement door.

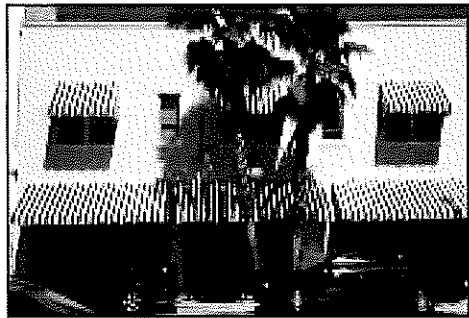
Rehabilitated 1920s commercial building.

were found to be inconsistent with both the plain character of the 1920s facade and with the replacement storefront. To meet the Standards, the owner replaced the doors with a simpler wood door with full length glass panel like the one shown in the accompanying sketch.

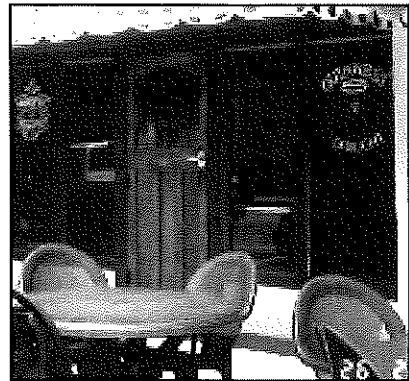
Rehabilitated storefront with incompatible stained glass door.

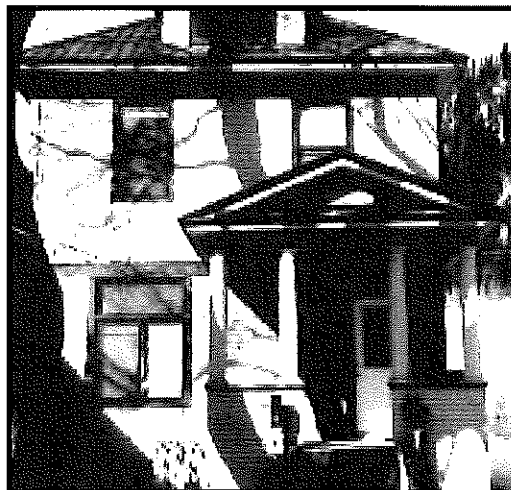
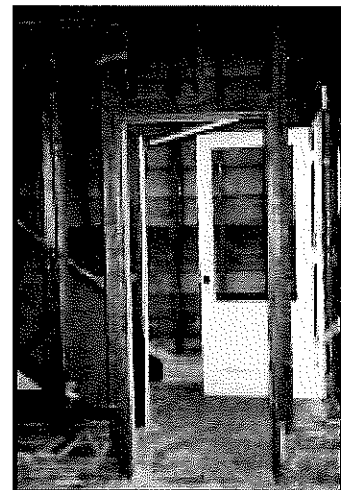
Application 3 (*Incompatible treatment*): In a third project, a two and one-half story Foursquare house with Colonial Revival-style details built in the first decade of the 20th century was rehabilitated for continued residential use. Although most of the interior finishes and features, including all lath and plaster, had been removed by a previous owner, the original front door still remained. In the course of the rehabilitation, however, this historic door was replaced with a new door featuring multi-paned glass with two vertical panels below, the same “stock” door, in fact, that was used in the dairy conversion project. This multi-paned door is no more compatible with the character of this early-20th century house, than it was with the 1920s dairy building. To meet the Standards, the owner would have had to have a new door fabricated based on photographs of the original to match the historic door which had been discarded in the rehabilitation. A compatible, contemporary door could also have been installed to meet the Standards.

In general, generic or “stock” doors with multi-paned glass, are not appropriate to use as exterior replacement doors in historic rehabilitation projects.

Rehabilitated Foursquare house with inappropriate “stock” door (left) and no longer extant historic door (right) that was discarded in the rehabilitation.
