# Soldotna Sports Center

## Facility Condition Assessment + Master Plan Concept

City of Soldotna | September 5, 2013

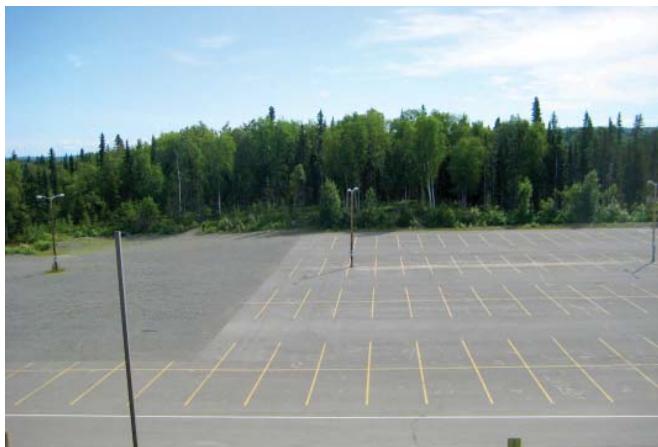
L-2 Unpaved Northeast Corner Of Site

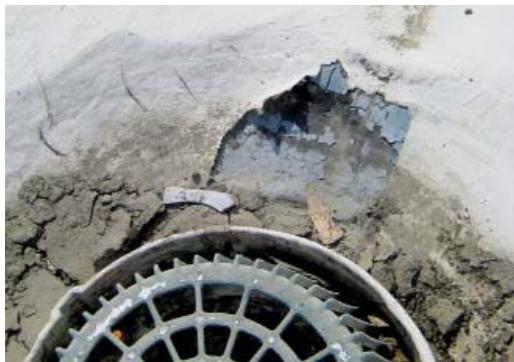
A-1 Roof Deterioration Around Drain

The roof drains are an old three piece construction type. The flanges are a point of leaks. There is significant deterioration of the drains as well as the roofing material at the roof penetrations.

1. Full roof replacement. Consider additional thermal insulation as part of re-roofing effort.
2. Repair/replacement of doors, frames and weather seals.
3. Conduct an evaluation of benefits to the community to advance accessibility modifications at this point in time. Relocation of walls and doors along with enlargement of restrooms would be required. Majority of walls are reinforced masonry.
4. Install thermal safety insulation be installed.

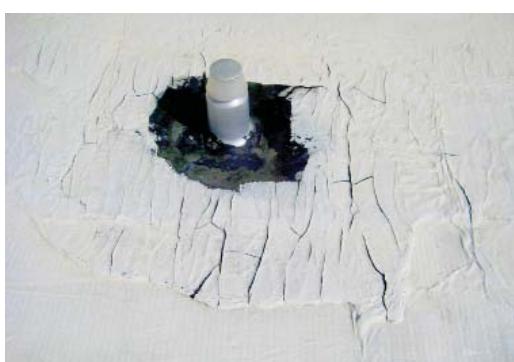
A-4 Roof Deterioration

The roof is 30 years old and has received topping systems to extend its life. The toppings overlay the original built-up roof assembly. There are major leaks, especially at locations of roof penetrations. The City of Soldotna has scheduled a roof replacement for the near future.

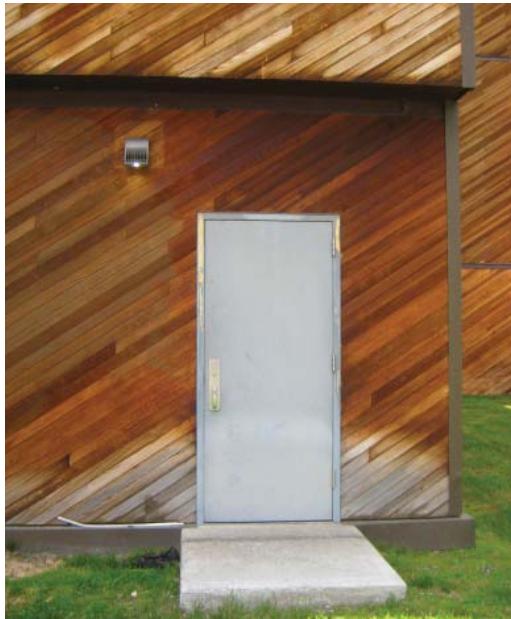
The roof areas are flat and have interior drains, with no downspouts and gutters or snow guards needed with the exception of the new team room addition which has a sloping metal roof that sheds water and snow towards an exit door. Most entrances do not have canopies but there is no rain or snow being directed to these areas since the roof that covers most of the facility is flat. The water being drained off of the team room has stained and bleached the exterior siding of the wall below.

A-5 Bleached Siding Adjacent Doorway

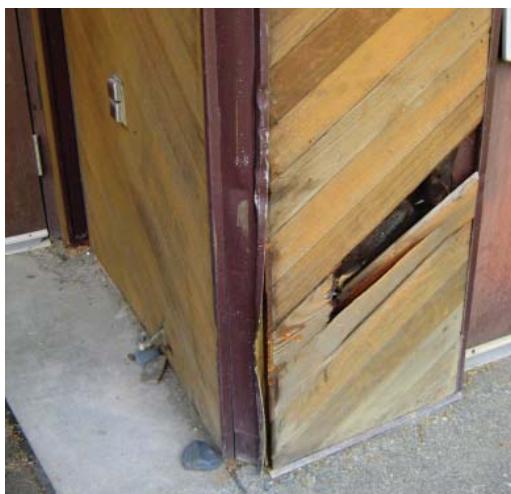
A-6 Damaged Exterior Corner

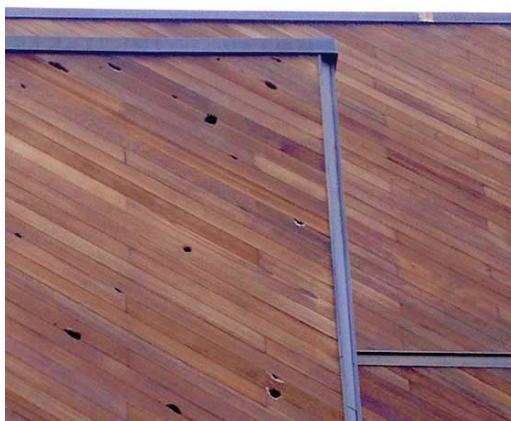
A-7 Bird Punctured Holes In Siding

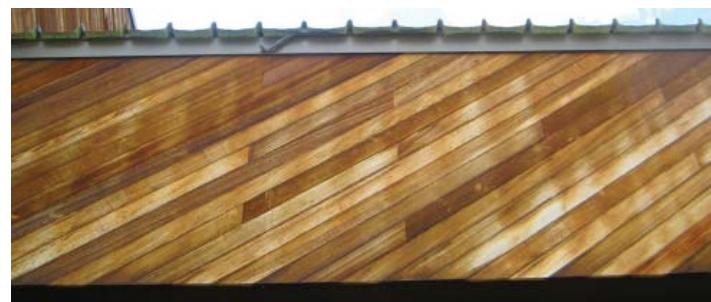
The wood siding on this facility is in good condition; however, there are a couple of issues that should be addressed. Water is being shed off of the new team room addition and damaging the exterior wood siding both at the upper soffit (white streaking marks) and the base of the wall near the door. Water is splashing off of the concrete apron and onto the wall (white bleached area to either side of the door). There is damage at an exterior corner by the central stair on the west elevation. Where the lawn areas meet the wood siding there is damage to the wood from a weed whacker. An exterior horizontal metal reveal member has paint that is flaking off. Woodpeckers have punctured holes into a section of the wood siding, primarily at the back side of the building.

A-8 White Streaking Marks At New Team Room Soffit

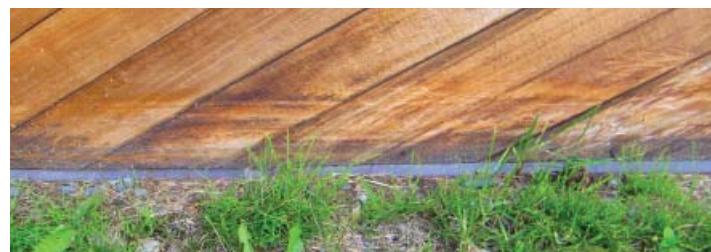
A-9 Weed Whacker Damage At Grade

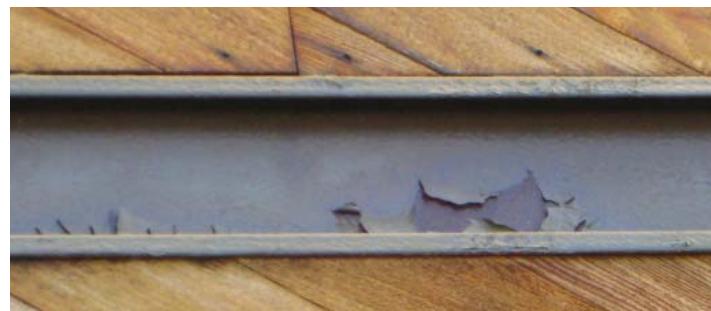
A-10 Paint Flaking

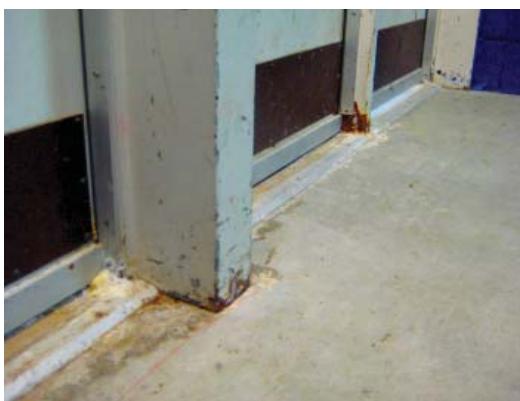
A-13 Arena Exit Doors

The exterior doors on the facility are thermal break hollow metal frames and hollow metal doors. All exterior doors have seen high levels of use. Many do not seal properly which contributes to heat loss. Light is visible between the door bottom and threshold in many locations. Also corrosion of the door and frame bottoms is occurring. Extensive signs of rust exist.

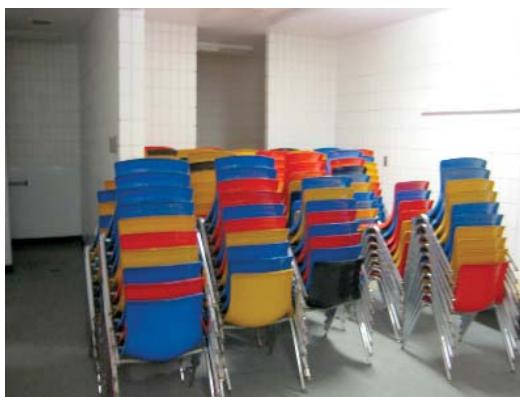
A-14 Locker Room Used For Storage

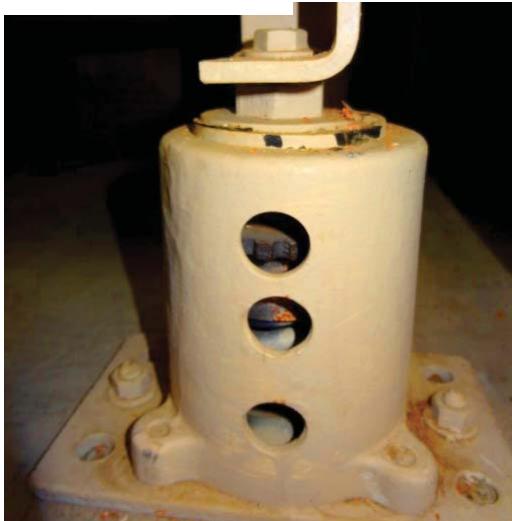
1. Vibration isolators for AHU-1 appear bottomed out and may contribute to system noise.
2. Grilles in locker/shower rooms appear to be steel and are corroding due to humid environment.

M-1 AHU-1 Bottomed out isolation

1. Provide housed isolators and thrust restraints sized properly for weight of fan.
2. Replace with aluminum grilles.
3. Provide supply air ventilation for both offices off of System AHU-2.

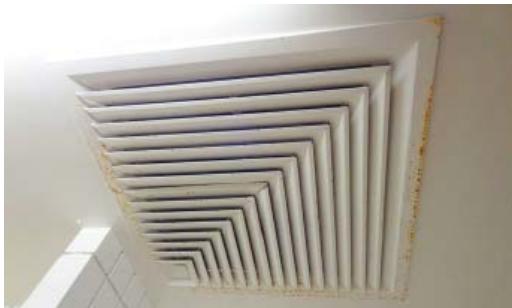
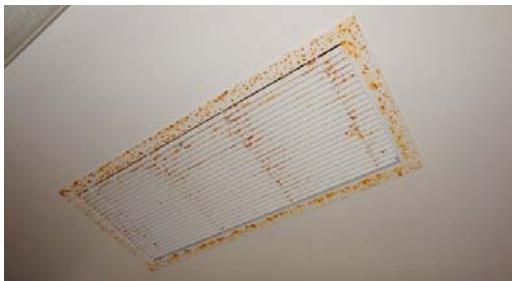
M-2.1 Grille Corrosion

M-2.2 Grille Corrosion

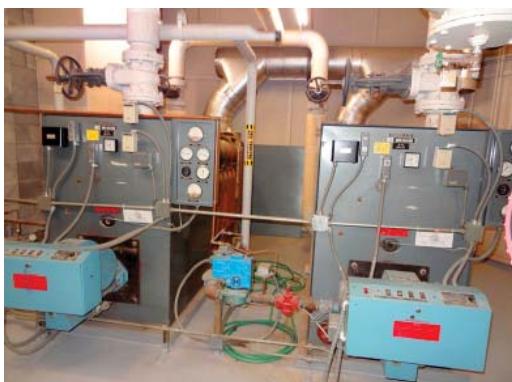
3. The existing exercise room was renovated into two offices leaving one without proper ventilation. One office has supply and the other has return.
4. Heating boiler B-1B section leak.

M-4 Failed Boiler

4. Provide new section for continued service of existing boiler, replace boiler with in kind model, or replace boiler plant to accommodate current and future loads.

Immediate consideration should be given to a new heating plant or replace the failed boiler section in time for winter operation. The single boiler is less than 50 percent of connected load considering the domestic water load is now also on the boiler system. The new heating plant could be located in the same space as existing and be sized to accommodate an addition or at least be piped to allow installation of another boiler in the future.

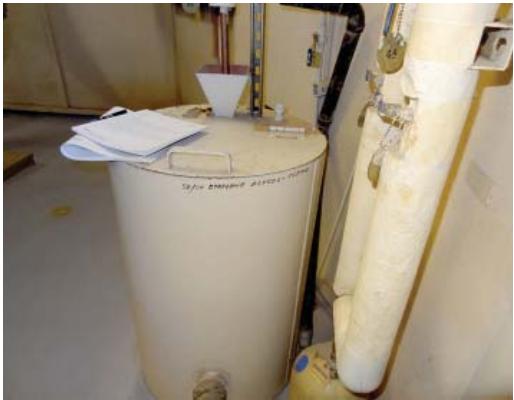
5. Existing glycol tank level controls are disconnected. There is a cold water supply for mixing with the glycol. Adding domestic water to system will diminish corrosion inhibitors of the glycol. Do not use water fill for mixing.

M-5.1 Glycol Tank

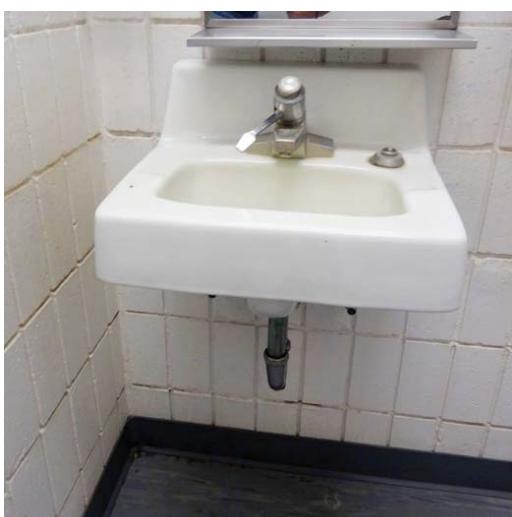
10. Hot water and waste piping from ADA accessible sinks are exposed.
11. Metered lavatory faucet in men's public restroom is broken.
12. Faucets for lavatories in restrooms 107 and 108 are not self shut off.

M-12 Faucet 107, 108

11. Repair or replace faucet.
12. Provide metered faucets.
13. Provide threaded cap on valve.

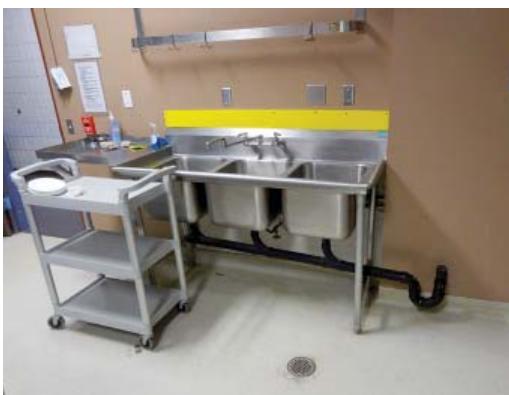
M-14 Three Compartment Sink, No Grease Interceptor

14. Provide grease inceptor.
15. Repipe drains with proper drainage fittings and direction flow.
16. Replace piping with 4 inch sprinkler supply.
17. Provide double check valve on sprinkler riser piping.
18. Provide second sprinkler zone and alarm valve per NFPA 13.

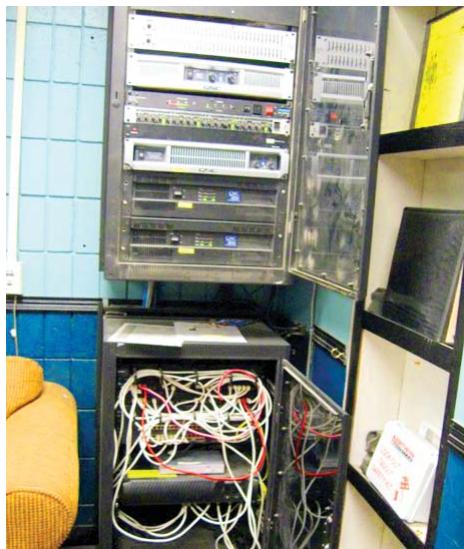
E-9 PA System Cabinets

There are two PA systems in the facility. One serves the ice rink arena the second system serves the conference room. Dedicated equipment working space was not being observed. Cabling was in disarray.
