prepared for Orange Hall Foundation, Inc. St. Marys, Georgia

prepared by Lord, Aeck & Sargent Architecture, Inc. April, 2006

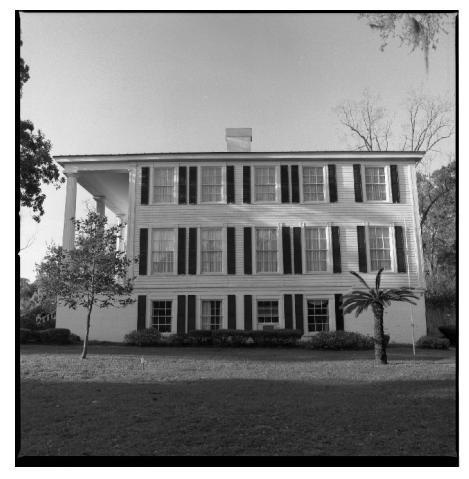
Figure II-5. North elevation of Orange Hall showing masonry foundation wall.

The foundation walls show no visible signs of structural failure, with only very minor cracking noted at the northeast corner. The critical issue at the foundation walls clearly involves moisture control and what appears to be a continuing problem with rising damp. Rising damp is a condition in which ground-based moisture is wicked upward by capillary action through permeable building materials, such as porous masonry. The moisture will continue to rise, sometimes evaporating, and if not able to evaporate, will rise until gravity overrides the capillary action. Visual indicators of this condition include the deposit of soluble salts that usually are either from dissolved calcium sulfate within the masonry, or stem from the water source. In cases where there is a large area of evaporation, the salt crystals will be deposited as a flour-like dusting on the surface of the masonry. In a

localized area of evaporation, the salt crystals will be deposited in small, flower-like formations termed efflorescence. The expanding salt crystals within porous masonry may result in spalling and decay at the surface. All of the foundation walls at Orange Hall are exhibiting these visual indicators of rising damp, either from past or current water infiltration. The most severe area of masonry decay is along the north wall. The painted finish, and in some cases the masonry faces, have "exfoliated" or spalled, with masonry dust and salt deposits remaining along the base of the walls.

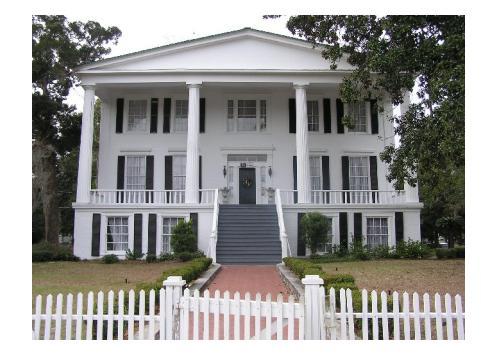
Figure II-9. Image showing step in wood trim at transition between masonry foundation and wood clapboard siding.

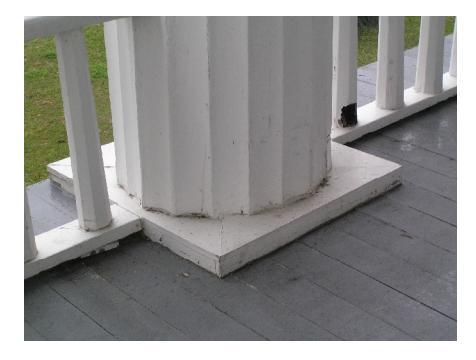
Figure II-11. Base of column showing added base element. Originally, no base was present, with the column shaft terminating directly into the porch floor.

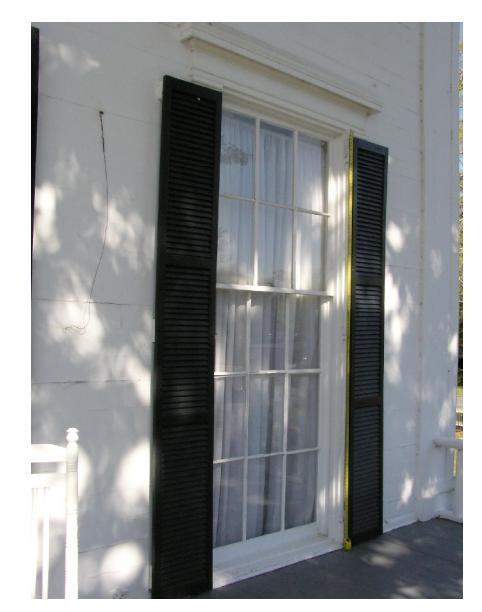
Overall, the condition of the historic windows at Orange Hall varies from fair to severely deteriorated. In many areas, years of paint build-up at the windows is masking significant deterioration of the wood components. During the site investigation, each of the lower basement level windows was inspected for rot, using a pointed tool to scrape away the paint and test the soundness of the wood. The condition of the wood was found to be soft and rotten in numerous locations. The deteriorated condition of the wood is

Figure II-13. Typical six-over-nine, window located at the First Floor, East Elevation.

most evident at the north elevation and northeast corner of the house. It is to be expected that when the paint coating is removed, additional and possibly severe deterioration will be evident. Evidence of water infiltration and condensation was observed at the interior of many of the windows. Several broken windowpanes were noted during the inspection. None of the windows are operational and the majority of the interior weight cords, necessary for the operation of the windows, are either missing or damaged. All of the windows have been painted shut. Gaps at the meeting rails, due to warping of the wood, are common, and in some cases have been stuffed with paper to reduce drafts. The historic muntin bars have a delicate, thin profile, are quite weak and are broken in several locations. The build-up of glazing putty and paint is distorting the true shape of the muntins. A wood consolidating product has been applied, using poor craftsmanship, to some of the damaged wood. At the west, or rear elevation, a historic window at the northwest corner has been removed and replaced with a door that provides access to the Old Kitchen (B10). At the first floor, a replacement window was also identified (W03). It is a close replica to the historic windows but does not have the pegged assembly detailing.

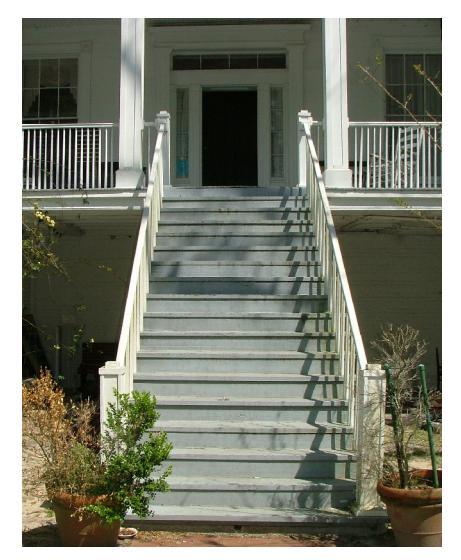
The condition of the rear porch is poor when consideration is given to the extensive reconstruction in evidence, and the condition of the underlying structural framing. Additional concerns include peeling paint, some wood deterioration and the condition of the porch railing, which was found to be loose in some locations.

Figure II-19. Detail view of rear stair and porch details.

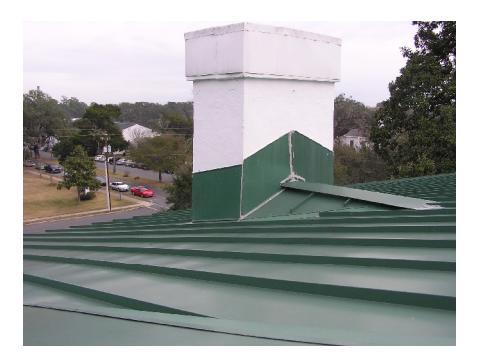
*Figure II-21. Detail of existing standing seam metal roof.*

The modern roof materials at Orange Hall are in very good condition. Screws used to attach the ridge cap are exposed to the elements and rusting. The absence of a gutter and downspout system is allowing rainwater to sheet down the north and south faces of the building. The water that is shed from the roof pools and collects along the foundation.

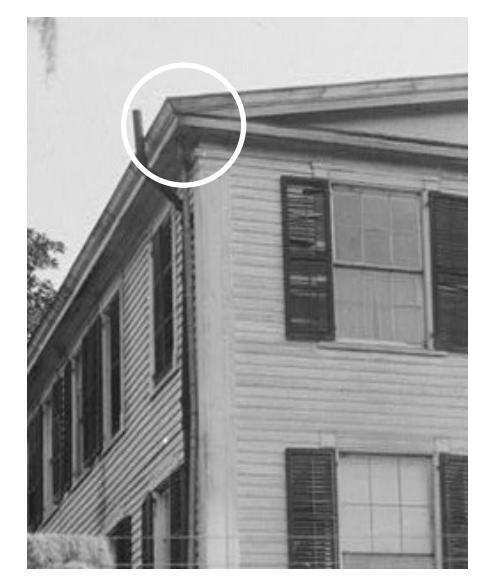
Orange Hall is presently lacking a gutter and downspout system. Round downspouts are visible in the 1933 HABS photographs at each corner of the house, but hanging gutters are not visible at the eaves, indicating that the gutters were built into the roof at that time. It is likely that Orange Hall originally had built-in or box gutters running east to west at the north and south eaves. Built-in gutters are typically constructed with wood and waterproofed with a sheet metal liner, often lead.<sup>16</sup> Built-in gutters "served well in styles like Greek Revival…where the aesthetic of the building façade – classic order, full scale cornices, roofline balustrades, or grandiose compositions with an exuberance of detail – became more important than its operation."<sup>17</sup> The roof framing, inspected in the attic, supports this assumption as it appears to have been modified at some point in the building's history. Newer roof framing is present at the end of each rafter along the north and south eaves.

Figure II-22. Detail of HABS photograph showing downspout connection to interior gutter system.

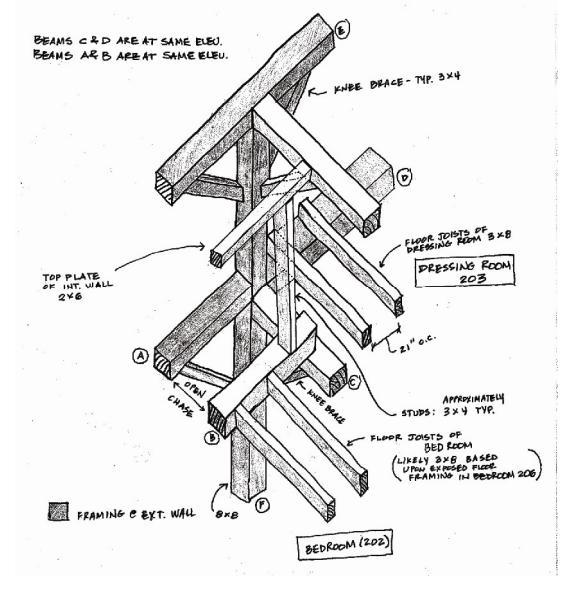
Figure II-26. Field sketch documenting the existing wall framing at Orange Hall.

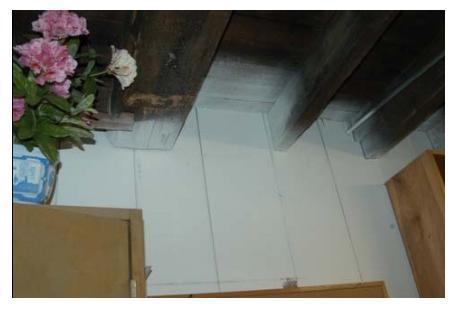
- S1. First floor structural members have been cut and are inadequately supported at added stair to basement. See Figure II-27. Adjacent to the basement stair in the Hall, numerous floor joists and columns have clearly been modified.

Figure II-27. First Floor Structural Members Severed at Stair.

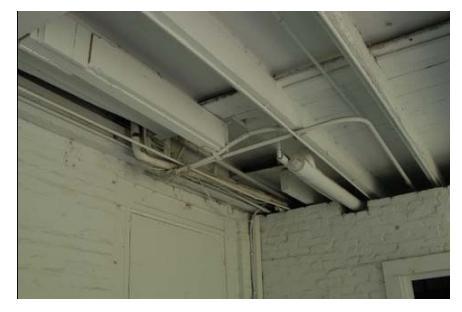
- S2. Structural joist has been completely removed for a portion of its length at first floor rear porch. See Figure II-28. One of the floor joists has a 4'-0" section cut away, and has been repaired by scabbing on a thin board. This repair is inadequate. At least six floor joists in the same location are bearing upon a beam, which is unsupported at one end.

Figure II-28. Structural Members that have been Cut at Rear Porch.

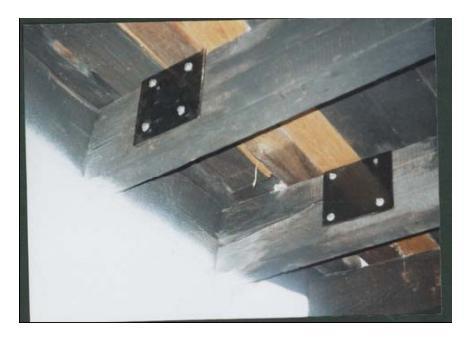
- S4. Sagging ceiling noted beneath front porch.
- S5. Splitting of first floor hallway 3x8 joists at notched ends noted. Added reinforcement plates have not adequately

addressed the problem. This condition appears to be related to the wall offset noted in item S12 below. See Figure II-30.

Figure II-30. Splitting of Ceiling Joists in Basement Level Hallway.

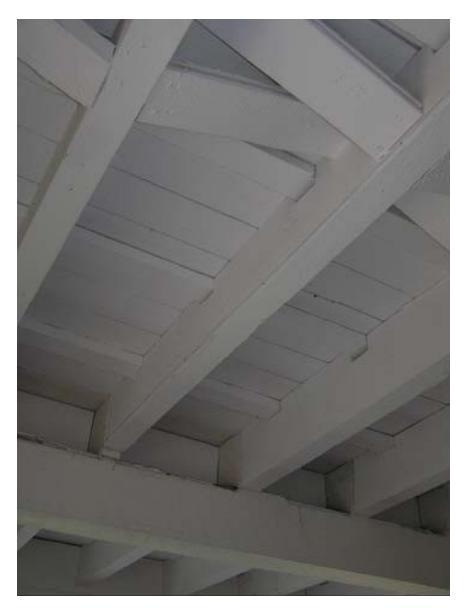
Figure II-31. Notching of Ceiling Joists to Accommodate Sleepers.

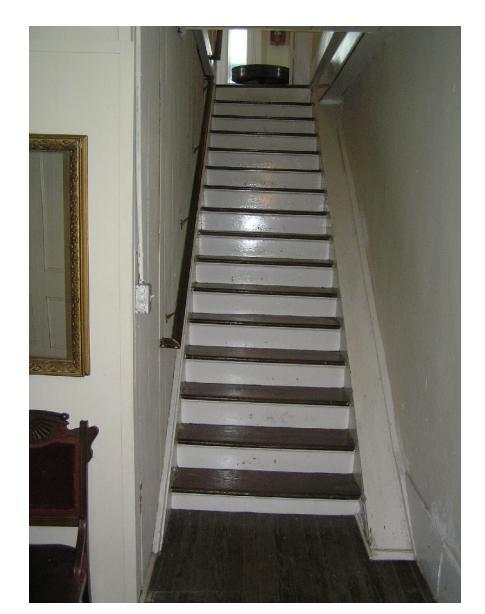
Stair B03 provides access from the basement level to the first floor above. Observed physical evidence suggests that this stair was modified from its original configuration or is an added feature. The basis of this theory rests in the abrupt severing of the structural members that support the first floor central hallway and subtle anomalies in the door trim elements.

The major structural elements that span across this space have been cut off and left without adequate support. Also, trim and finish materials are

Figure II-40. View of Stair B03.

awkwardly terminated at the stair, suggesting its current configuration was not an integral part of the initial design.

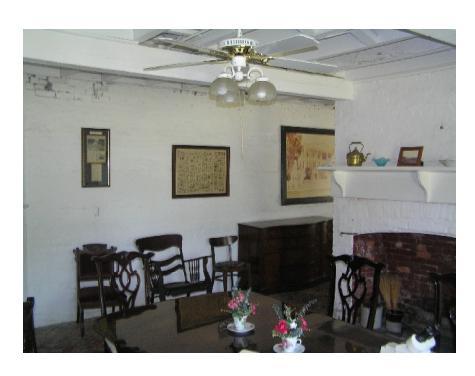
The Servant's Room is currently in relatively good condition. Evidence of rising damp along the north wall of the space is less severe than in the Old Kitchen but remains present. Also, the windows along the north wall of the Servant's Room are in severely deteriorated condition. There is no finished ceiling in this space. It appears the original ceiling joists, which would have spanned the entire space at one time, may have failed

Figure II-46. View of Servants' Room B09.

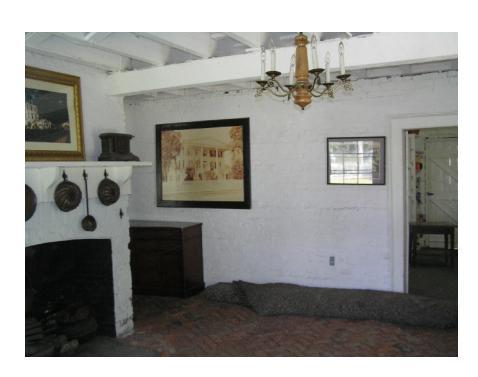
Figure II-47. View of Old Kitchen (B10).

The existing flooring in this space is loose laid brick set in a soft sandy soil and laid in a herringbone pattern. The floor is uneven, with several areas of settlement noted. Based on their wear, the rose colored bricks appear to be soft fired, exhibiting extensive pitting and rounded edges. A transition in brick type occurs between the Old Kitchen and the Servants' Room south of the fireplace. The results of the archaeological investigation lead to the conclusion that the existing brick floor is most likely original, given that all of the recovered artifacts date to no later than the early nineteenth century. No artifacts post dating construction of the house were found beneath the floor (See Archaeology).

The walls of the space are brick painted white. The north wall of the Old Kitchen is exhibiting severe deterioration due to rising damp. As discussed above, this condition is manifested on the interior of the masonry walls in the form of paint failure, paint bubbling and deterioration of the host masonry. The remaining walls in the space are in relatively good condition. The door (B10) in the west wall of the Old Kitchen was added by the City of St. Marys when the basement level was utilized by the Chamber of Commerce. This modern era opening would have originally held a window. Also, it appears the large stone threshold currently at this door may have been moved from its historic location below the door to the central hallway (B02b).

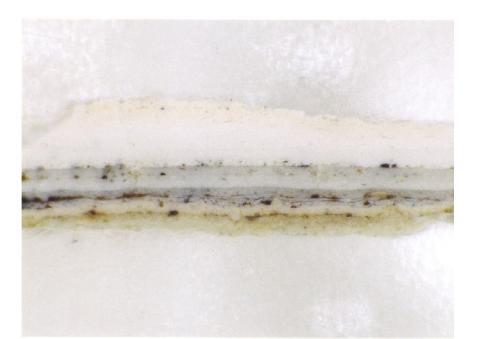
It was determined through examination of samples collected from the front and rear porches that all of the siding and trim of the house was originally painted white with lead-based oil paint. Samples were taken under the front and rear porches where it was anticipated that evidence would be in better condition due to protection from weathering. Although access to the main cornices could not be gained, it is believed that they would have been treated in the same manner as the door and window trim (See Samples Ext. 1-8 in Appendix F).

Figure II-80. A cross section photomicrograph illustrating the paint layer evidence taken from the flush board siding on the second floor under the rear porch (See Also Appendix F).

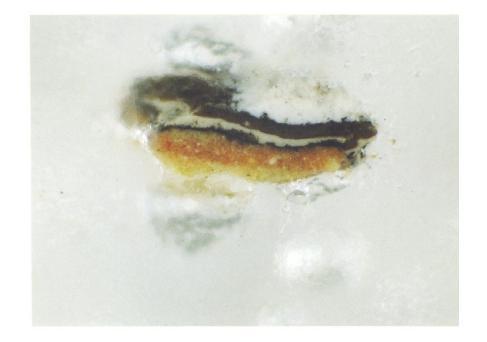
Paint evidence revealed that the interior doors were originally grained. The surviving evidence suggests that the first floor doors were grained differently than those on the second floor. Most of the doors have been stripped, but a few have not. Those doors that have not been stripped retain evidence that can be very carefully exposed to reveal the color and character of the original graining and therefore could serve as models for reproduction.

Figure II-81. A cross section photomicrograph showing evidence of graining taken from Door 104a (See Also Appendix F).

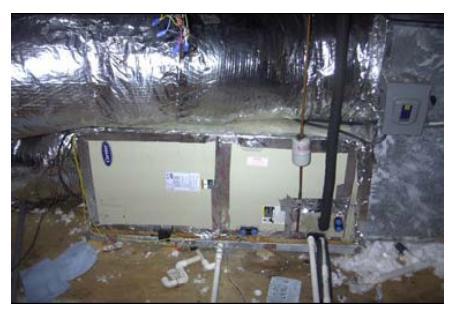
The existing Heating, Ventilating and Air Conditioning (HVAC) systems installed in Orange Hall consist of two DX split systems with the fan coil units located in the attic and the condensing units located outside on grade. These units serve the first and second floors. According to records, Sam Pickren Air Conditioning and Heating Company replaced the two fan coil units in the attic in May of 1999.<sup>30</sup> Also according to available documentation, both condensing units were replaced in May of 1994.<sup>31</sup> In 2004 one of these condensing units was replaced.

*Figure II-82. Four ton fan coil unit in attic.*

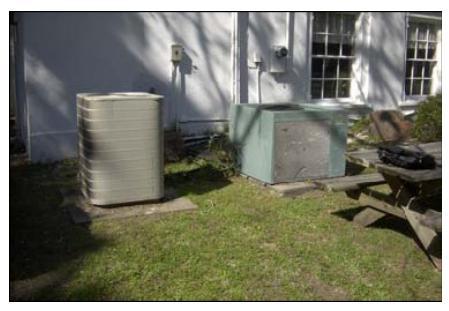
Figure II-83. Outdoor condensing units.

<sup>&</sup>lt;sup>31</sup> Sam Pickren Air Conditioning and Heating Company replaced the condensing units on 5/23/94. Turner Brothers Heating, Air & Refrigeration replaced one of these units in June of 2004. Records on file at Orange Hall.

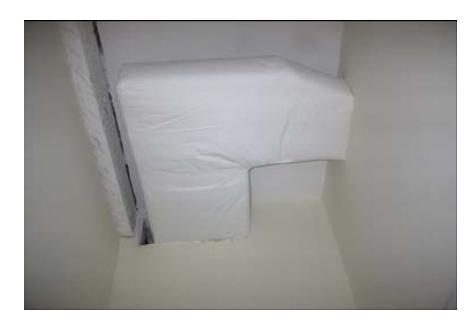
Supply grilles are located on the first floor, adjacent to the front and rear doors in the central entry hall. They are also located in the second floor hall in the front wall and alongside the door to the porch. The first floor restrooms have a supply duct routed exposed from the furred space in the second floor dressing room over both restrooms and the hall in between. Neither restroom has any visible supply grilles or exhaust. In the study report prepared by Commander John K. Mott in 1982 he noted the ductwork for the restroom supply had been installed, but individual drops with registers had not. He also noted that exhaust fans had not been installed to the restroom. This installation has not changed since his report.

Figure II-85. Exposed duct, first floor restroom.

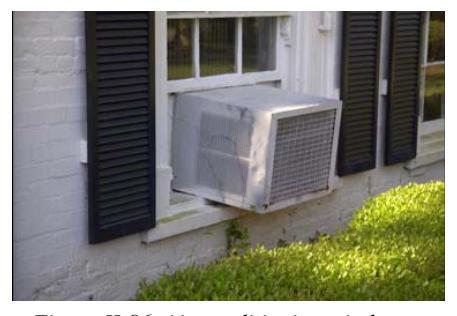
In the basement there is one air conditioning window unit, located in the northeast window of the Old Kitchen (B10). It is a Whirlpool cooling and heating unit. The HVAC system designed in 1980 called for basement cooling, however it was never installed. There are several ceiling fans located in the basement.

*Figure II-86. Air conditioning window unit in basement.*

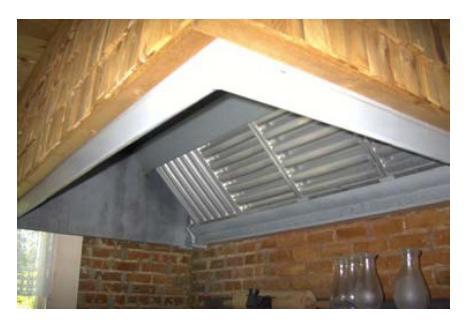
The commercial kitchen (B05) in the basement has a hood located over the electric range. It is galvanized, paintgrip steel, unpainted, about 7 feet wide by 4 feet deep. This hood was included in the original equipment quote prepared by E. H. Thompson Company in 1985. It was subsequently installed without an exhaust duct or exhaust fan. This is confirmed by correspondence from Mr. Scott Adams, Supervisor of Building Maintenance for St. Marys to then Mayor Hernandez, with a list of materials required to "bring it up to the recommended standards required by John Smith, Health Inspector." The omission of the exhaust duct and fan was one of the items noted. The fan's capacity is listed as a 2,890 CFM. Currently, the International Mechanical Code requires that a Type I hood be installed over food heat-processing appliances that produce grease vapors or smoke. It appears that the hood may meet this requirement, however the exhaust duct and exhaust fan are not in compliance with applicable codes. Also, the duct material, cleanouts, joints and fans must meet requirements for grease-laden air. Fan discharges are required to be at least 10 feet above grade. The exhaust hood currently has wood shingles installed on its outside surface. This is in violation of the requirement that the hood be 18" from combustible materials. In addition, the hood does not have a fire suppression system installed to extinguish any cooking fires. If the hood is to be used, the exhaust duct and exhaust fan must be replaced with the proper type, installed to meet code requirements, and a fire suppression system installed in the hood. These deficiencies described above provide ample reason to continue the policy of restricting use of this equipment.

Figure II-87. Exhaust hood located in commercial kitchen.

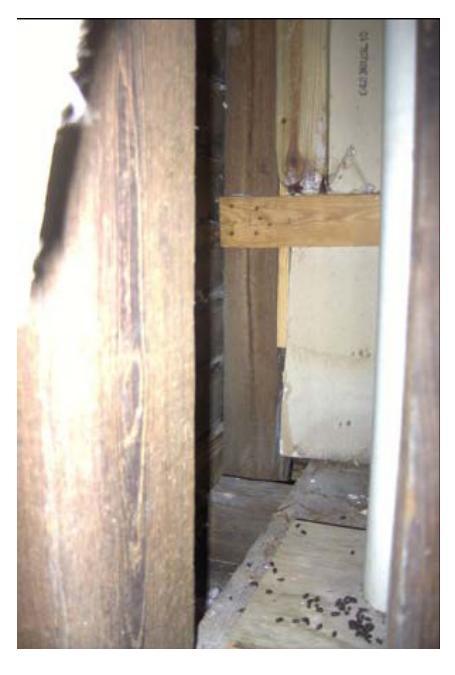
Removal of interior finishes at strategic locations allowed the wall cavity to be observed. Items of note within the wall included gaps in the lap siding where the top board overlaps the next lower board. These gaps, while they do not allow rain to enter, do allow insects, and most importantly, moisture to enter the wall cavity from outside. Because of these gaps, the air within the wall cavity has the same moisture level as the outside air. The top of the wall cavity is also open to the attic. In certain places, the wall cavity is also open to the basement where the exterior walls sit on the masonry basement walls.

The first calculation is for the existing condition of construction, with a non-continuous exterior paint film and gaps between the lap siding. Results show that during summer periods of high outside moisture levels, typical in the lower coastal area, and especially for the outside summer design conditions, the wall cavity has condensation when the existing air conditioning is operating to maintain 75 degrees. The temperature in the air cavity and at the surface of the drywall is below the dew point of the air in

Figure II-88. Wall cavity construction.

the cavity, causing condensation. An "X" indicates these conditions in the calculations. The calculations show this condition to exist based on existing equipment and also predicts condensation would occur if a new system was installed to control humidity within the building.

The second set of calculations assumes that the wall system is repaired to remove the gaps in the lap siding and by making the paint film continuous on the outside surface. Based on an ideal scenario, the calculations reveal that the wall cavity would not have condensation. In practice, however, it does not seem that this is possible with the lap siding currently installed. The gaps are between almost every set of boards, located between the supports, and the siding is bowed, making elimination of the gaps through refastening and paint application unlikely.

The wall cavity analysis reveals the existing wall assembly of Orange Hall is currently subject to condensation and it is predicted it will continue to be susceptible to this condition in the event humidity control is added. Although relatively intrusive, the correction for this would be to install a vapor barrier behind the existing lap siding. Installation would require the careful removal and reinstallation of the building siding. This vapor barrier would essentially prevent moisture laden air from entering the wall assembly. The barrier would be applied to existing wall members and would need to continue over the top of the wall at the attic level so as to close the top of the wall cavity.

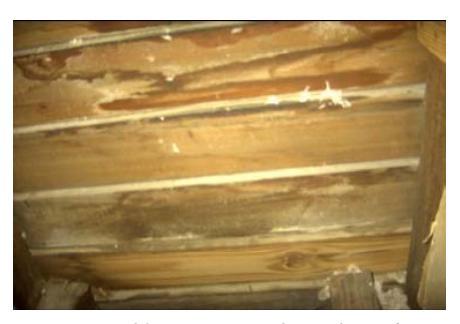
Figure II-89. Interior surface of wood clapboard siding.

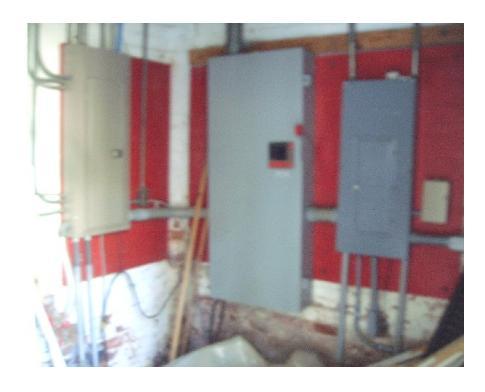
- It was observed during the site assessment that the Electrical Room (B12) was being used for storage of various items. A number of the items stored in this space were within the three-foot clearance zone required by the National Electrical Code.
- The circuit breakers in the general load panel were not identified either at the breaker or on a circuit directory. Identification is

Figure II-91. Main electrical panels.

required by the code. There were several holes in the HVAC panel with no breakers or filler plates, which allow access to live wiring. The HVAC panel also has a "high" leg on which a connection between this phase and a neutral could produce a voltage greater than 120 volts. This phase is correctly marked with orange tape. An experienced electrician should recognize these markings.

- A large waste pipe was observed running over the general load panel. This is a code violation and the pipe should be relocated.
- A large amount of the wiring has been run under the first floor, rear porch. This wiring is run in conduit and has been painted white to blend with the underside of the porch. The wiring was extended to ceiling lights and fans in the basement ceiling and up to the first and second floors in the wall cavities.

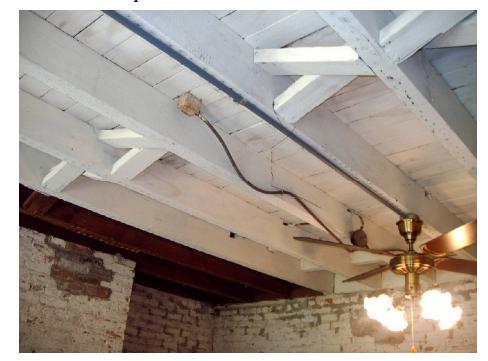
- A majority of the basement ceiling is of exposed construction. The commercial kitchen area and portions of the central hall have a plank ceiling. The wiring in the basement is concealed where there is a plank ceiling. In areas where the wiring is exposed it was generally installed in a neat and orderly fashion, however some areas of poor workmanship were observed.

*Figure II-93. Exposed wiring in basement.*

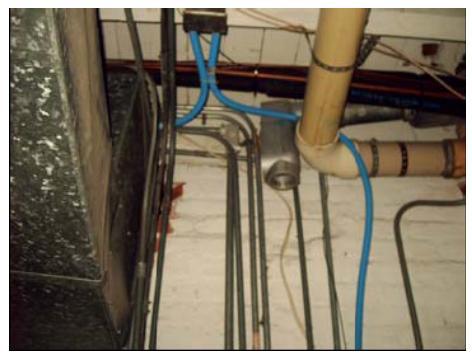
- On the first and second floor, most of the wiring is concealed above the drywall ceiling, channeled in the plaster ceiling or run in the wall cavities. This wiring needs to be checked for continuity, open circuits, reversed polarity and ground paths. Many of the outlets were tested during the system investigation and some were found to have no voltage reading.

Figure II-94. Image showing three types of wiring.

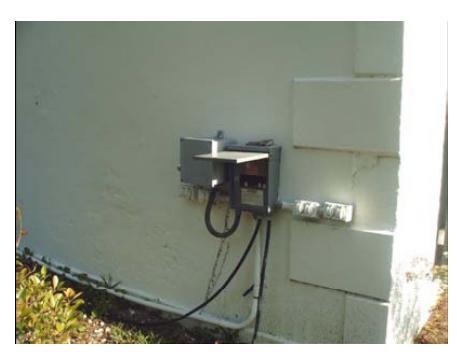
- As mentioned above, use of the commercial kitchen equipment has been restricted due to code violations. It was also learned that on several occasions outdoor outlets have been overloaded during special events.

Figure II-95. Exterior power outlets.

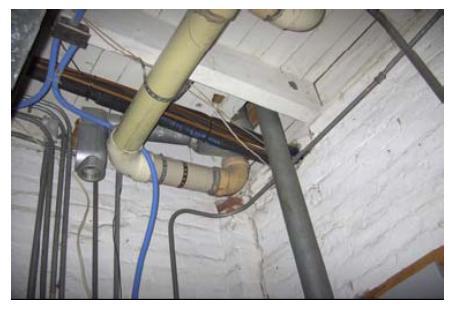
*Figure II-96. Vent line routing in Electrical Room.*

The kitchen waste lines have several problems. The Navy Reserve Construction Battalion roughed the waste lines in before the equipment was installed. When the equipment was installed, the vent line was not extended through the roof as required by code. The vent, located under the threecompartment sink, terminates below the flood rim of the sink and opens into

the room, potentially allowing sewer gases to escape into the room. There is no grease trap or interceptor installed in the waste line from the kitchen. The international Plumbing Code requires a grease trap or interceptor on all commercial kitchen lines containing grease-laden waste. There was a hub drain installed initially for an ice machine. This machine is not there and the drain is open. Without water entering this drain, the trap will dry out and gases and insects can enter the kitchen. If the drain is not going to be used, it should be capped.

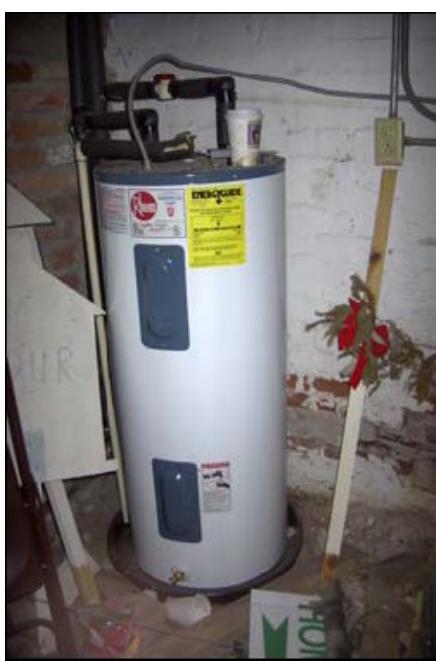
- An electric water heater in also located in the Electrical Room. The water heater has been located to allow the three-foot code clearance in front of the panels and no water pipes were observed passing over any panels.

*Figure II-97. Water heater in Electrical Room.*

The domestic water enters the building in the Electrical Room with a shut off valve and is routed to the first floor toilets, the kitchen and the basement restroom. The piping is mostly PVC with one galvanized line leading across the basement to the basement restroom. The PVC piping is not supported properly in the Electrical Room. The galvanized water line across the basement should be replaced with PVC like the other lines. The water heater is new and appears to be in good condition.

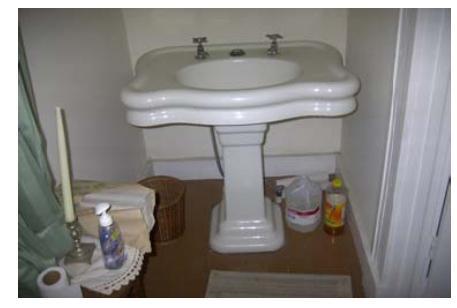
*Figure II-98. Lavatory in first floor restroom.*

The water closet located in the inside first floor toilet room has water running continually. Since this restroom is not used and the room is not vented, the running water causes high humidity in the room. The result of this high humidity is mold, as can bee seen on the water closet seat and cover. This condition must be repaired to prevent the mold from growing throughout the room and affecting the fabric of the house. If this toilet is not to be used, the water can be cut off to both fixtures. The faucet on the lavatory in this same room is leaking, causing rust streaks on the fixture. The faucet should be repaired or the water cut off to this lavatory.

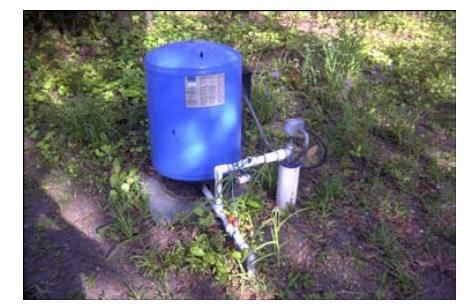
*Figure II-99. Irrigation pump and pressure tank.*

The irrigation water system was installed in the last couple of years and the pump appears to be in good condition. However, the piping on the pump has been damaged and the pressure gauge broken and now lying on the ground. It was also noted that several sprinkler heads were broken and are also lying on the ground. It was reported that the irrigation piping underground had been damaged when tents were installed on the grounds. The timer for the irrigation system is currently disconnected.

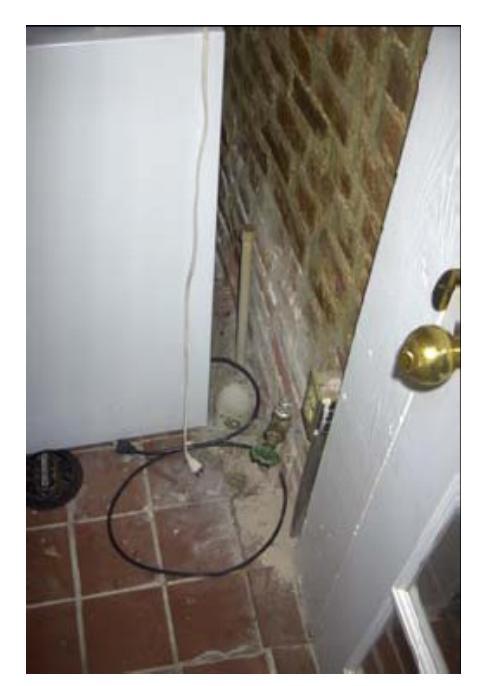
*Figure II-100. Hub drain and water connection for ice-maker.*

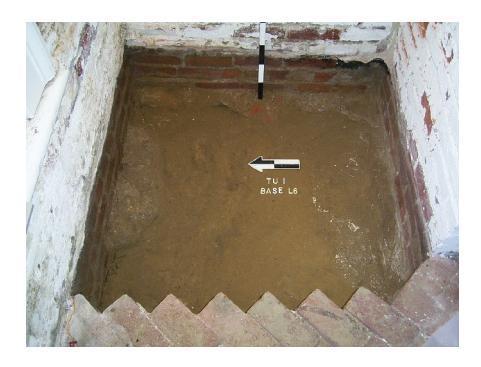
Figure II-111. Test Unit 1, Base of Level 6 Showing the top of the builder's trench.

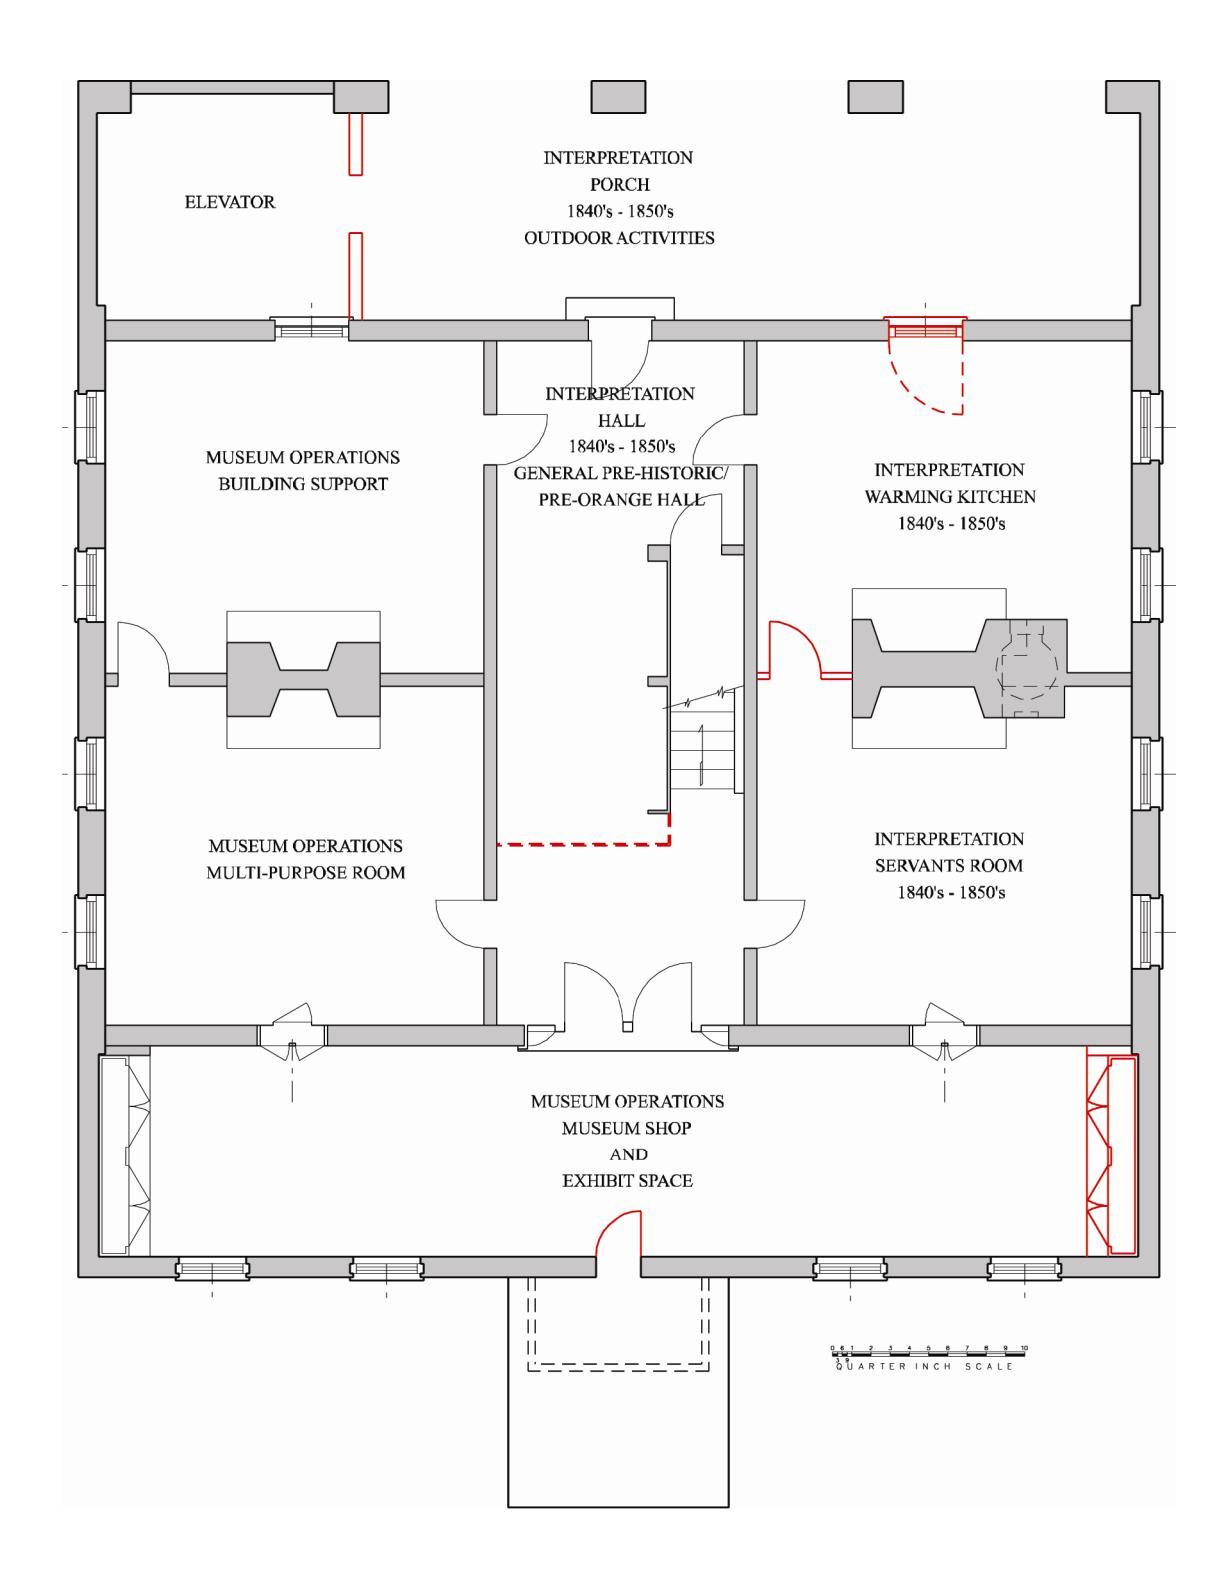
Figure III-4. Proposed Basement Level Treatment Plan. The items shown in red represent proposed alterations.

• Remove Door B10 and restore window to this location. Sash, jamb, interior and exterior trim elements should match other adjacent basement level windows.

- Reconstruct frame dividing wall and doorway between Old Kitchen and Servants' Room. This should be preceded by below floor investigation to determine if any evidence remains confirming the presence of a more substantial masonry dividing wall. If no evidence exists, construct wall in general accordance with that shown in HABS documentation (board and batten or vertical boards).

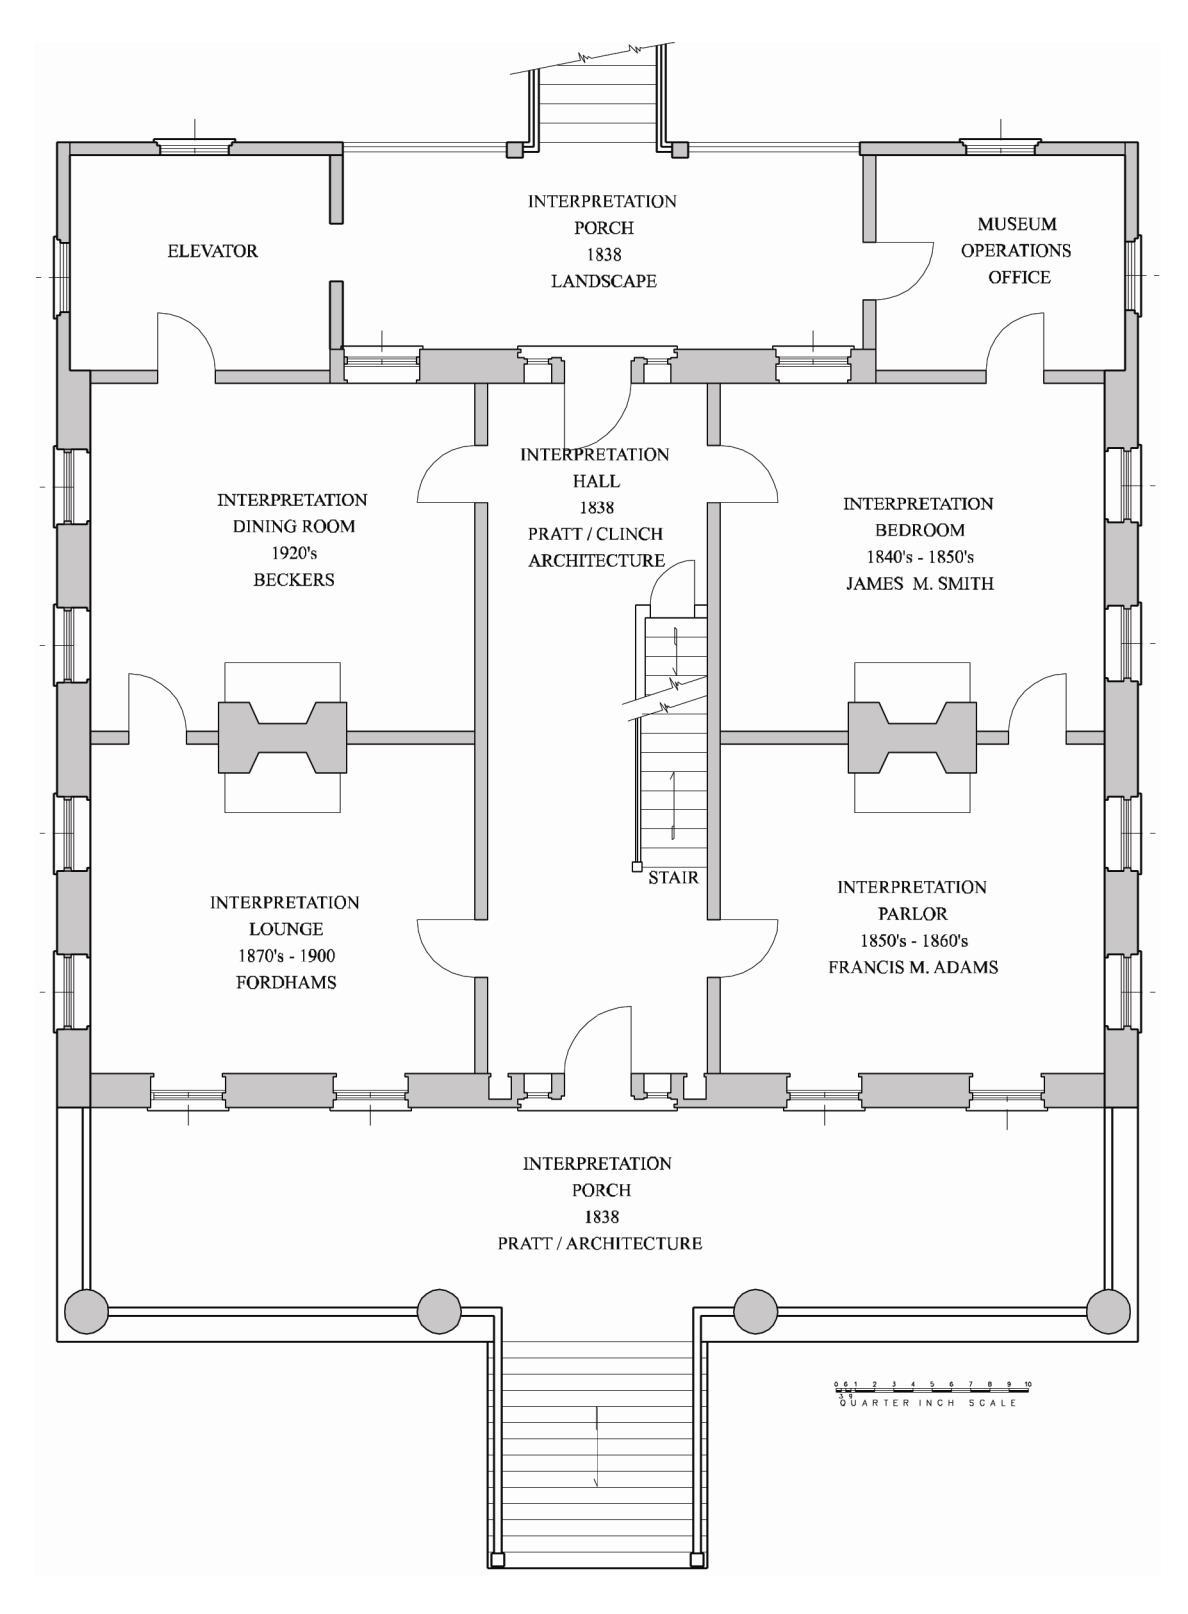
Figure III-5. Proposed First Floor Level Treatment Plan. With the exception of the alterations required for installation of the elevator no floor plan changes will be required at the first floor level.

- Existing plaster walls, cornices and ceiling medallions should be restored. Previous restoration/repair work conducted as part of the Title X program in the late 1970s and early 1980s has resulted in marred and damaged plaster features. Evidence should be gathered to determine original profiles and these features restored by persons skilled in the restoration of decorative plaster elements.

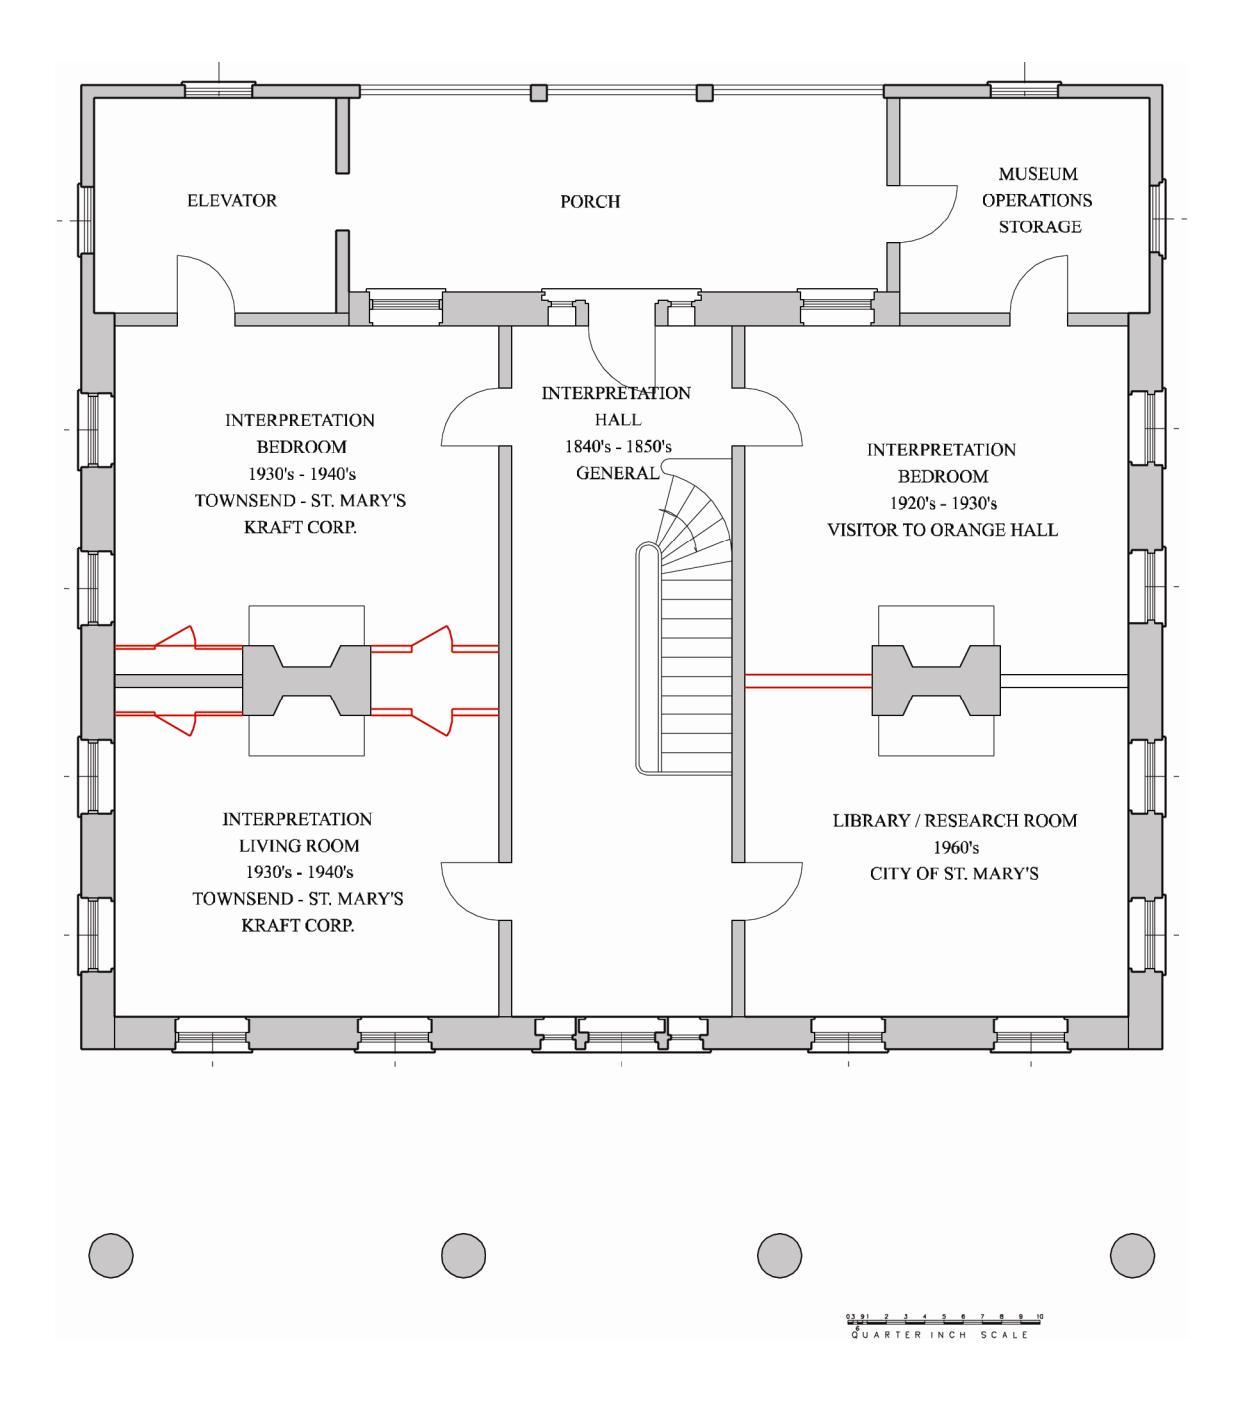
Figure III-6. Proposed Second Floor Treatment Plan. The items shown in red represent proposed alterations.

• Restore plaster wall and ceiling finish to second floor rooms. During the Title X Program of the late 1970s and early 1980s, the plaster wall and ceiling finish was removed

throughout the second floor. The existing finish consists of  $\frac{1}{2}$  drywall, which should be removed. Removal of these finishes provides an opportunity to learn more about the building, its structure and condition. Thorough documentation of the wall construction should take place upon removal of these finishes.

In addition, the ceiling has been dropped approximately 8" from its original elevation. It is recommended that the original wall and ceiling finishes be restored and the ceiling returned to its historic height.
