**Town of Fairfield**  
Town Planning and Zoning Commission  
725 Old Post Road  
Fairfield, Connecticut 06824

**To: Members of the RTM**  
**From: Jim Wendt, Planning Director**  
**Date: April 19, 2022**  
**Re: Opt-Out of State Mandated Zoning Regulation Language**

FAIRFIELD TOWN PLAN AND ZONING COMMISSION PROPOSED OPT-OUT OF  
STATE MANDATED REGULATION LANGUAGE REGARDING OFF-STREET PARKING.

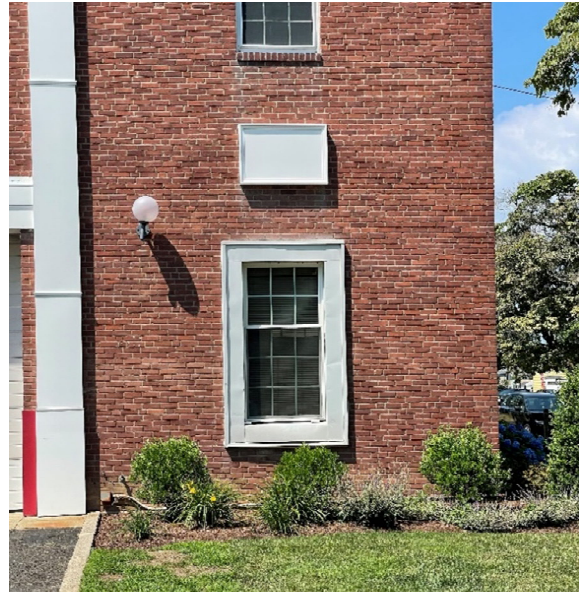
When evaluating the energy efficiency of a building, it is known that nearly 25–40% of all heat energy is lost through windows. The second-floor windows are original and should be replaced. The first floor's windows have been replaced when the previous renovation occurred. The windows located on the first floor were recently worked on, however, the window east of the garage bays (see left photo) is in poor condition. Due to a miscommunication in measurements, the surrounding window trim is too small for the perimeter. Its also is revealing blocking at the bottom of the window. In addition, they have taken some damage due to wear and tear, weather conditions, etc. In order to maintain the integrity of the wall this trim should be repaired or replaced.

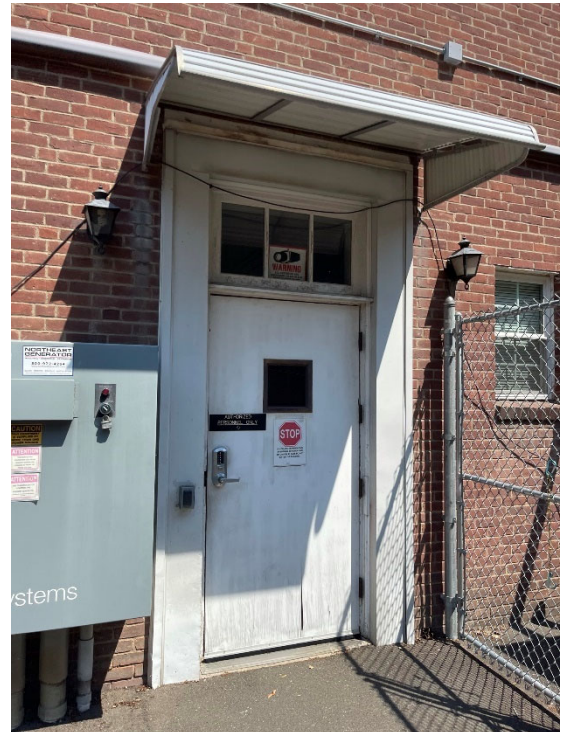
There are a variety of exterior doors. First and foremost, there are 6 large overhead doors (3 per side). These garage doors were recently replaced or refinished. Other standard doors are in fairly good condition. One of the exterior door's finish is beginning to fail. There is a large vertical tear and similar issues to the window trim are also noted around this door. This door should be replaced.

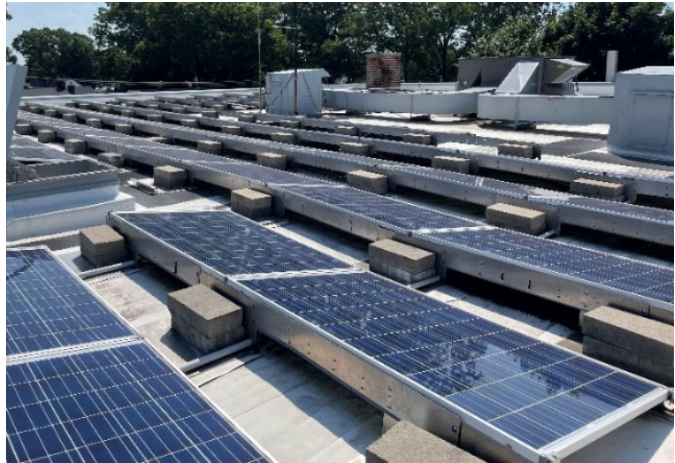
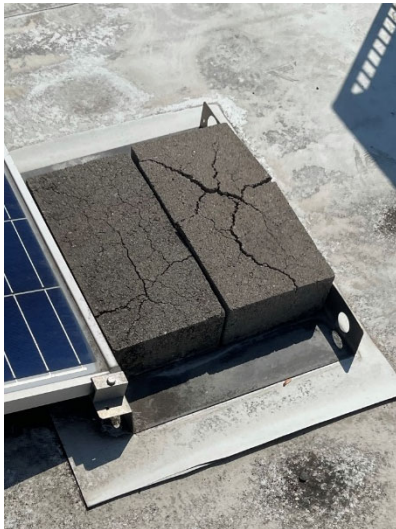
This single ply roof, Thermoplastic Polyolefin (TPO) was replaced in 2006. There is time until another replacement (5-15 years) depending on the warranty duration. It appears that the strainers on the roof have not been cleaned in a long time. This is creating some ponding on the roof, increasing risk for leaks in the building. The roof strainers should be clean at least twice a year, as a maintenance priority.

After the roof was replaced, solar panels were installed shortly after. The solar panels are mounted on sled-ballasted blocks, as you can see from the photograph above. There are multiple blocks that are cracked. If the blocks fall apart, the solar panels may become loose. These should be replaced as soon as possible. The hatch (as seen in the above photo) is unfortunately not to code. The International Building Code requires the building hatch to be "no less than 16 square feet in area with having a minimum dimension of 24 inches". In relation to the hatch, the roof ladder was not to code. OSHA states in section 1910.23 that individual rung ladder should be spaced out 7 inches, from the centerline of the rung to an object such as a wall or a hatch. This ladder gives about 1 inch of space from the hatch, giving no room to place a foot or hand on that specific part of the ladder. In addition to the condition of the ladder, the safety post installed to the right of the ladder is quite unstable so it would be recommended to install a new post or to re-fasten it to the ladder.

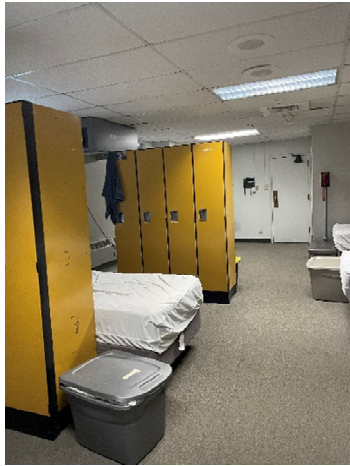
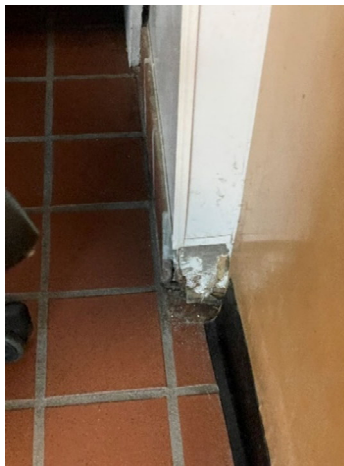
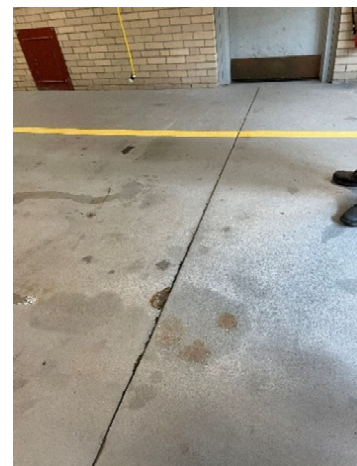
There are a variety of materials that are used in this building. The majority of the first floor is made of a plain concrete slab which is seen in the apparatus floor. Limited stains and cracks were noted. Vinyl Composition tile (VCT) is installed in all the livable areas such as the officers' rooms and locker rooms. Quarry tile is installed in the kitchen and is in fair condition. Some restrooms have older ceramic tile which is also in fair condition. There are some 9x9 vinyl asbestos tiling (VAT) tiles that will need to be tested for abatement. There is carpet in the dormitory and living area. This is nearing the end of its life expectancy and should be replaced soon.

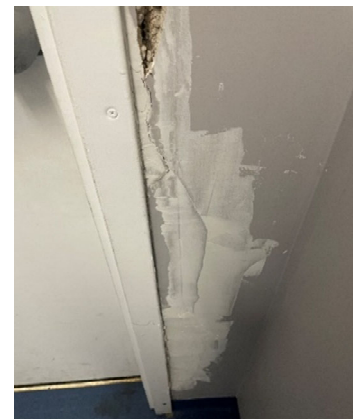
The interior walls consist of a variety of different materials from brick, concrete masonry units, tile, gypsum wall board, plaster, and fiberglass reinforced panels (FRP). All materials are in pretty good condition. With the renovation of the first floor, there is minimal work to be done to the walls. On the second floor there are multiple small items that need to be resolved. There are some areas that need repatching or repair work.

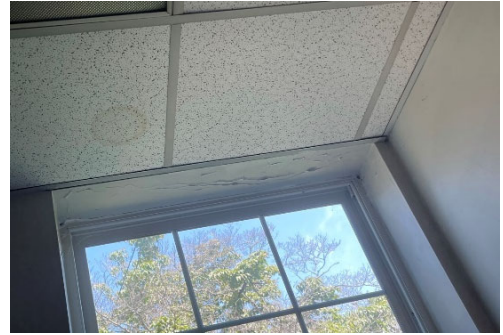
Ceilings throughout the building consists of hard ceilings made from plaster or gypsum wall board and dropped acoustical ceiling tile (ACT). Hard ceilings in the stairs could use some paint where lights have been changed. There are a portion of ACT that have been stained, broken, or are missing. If the tiles are damaged due to water, they should be replaced and inspected behind to determine if there is an underlying issue with leaks. Tiles that are missing expose wires and mechanical equipment and should be fixed. Some window heads at the ceiling level also have peeling paint and should be rectified within the window replacement project.

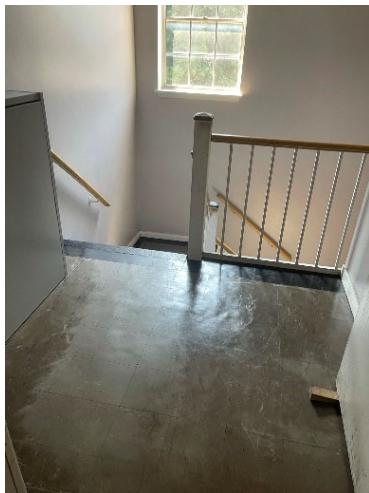
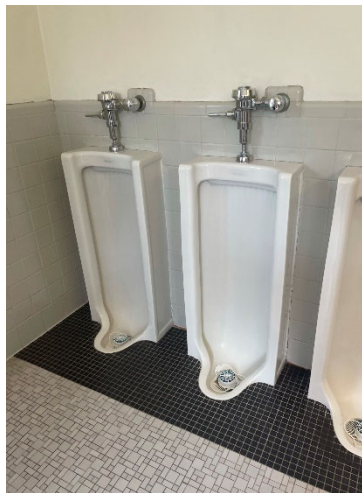
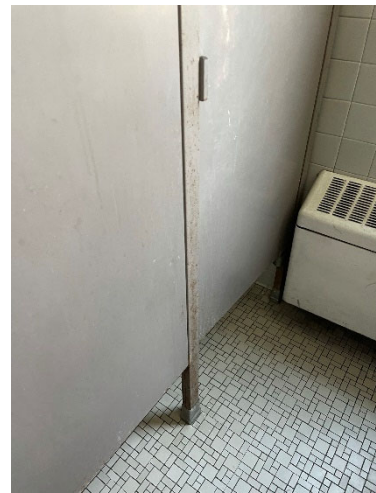
There are two stair towers in the fire house serving as means of egress, located on the eastern and western sides of the building. The first staircase located on the eastern side of the building was renovated and the abatement of the 9x9 tiles was taken care of. The floor was replaced with rubber flooring. The western staircase still occupies the 9x9 tiles which the fire department claims it will be abated in the near future. In both staircases the handrails do not meet code requirements and should be replaced or modified to accommodate the correct heights and extensions.

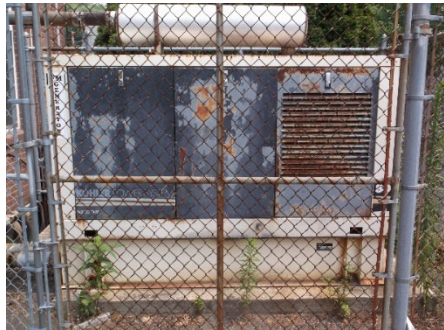
The existing electrical service is made up of a 400 amp 120/208V-3PH-4W Square D main breaker, with integrated C/T cabinet feeding an adjacent 400-amp automatic transfer switch (ATS) located in the Basement of the building. There is a second ATS on the south side of the building near the generator. The generator is an 80KW diesel 120/208V-3PH-4W with a single 300-amp output breaker located behind the building in the south-east corner installed in 1993. In addition to the normal utility service and the generator service, there is a feed coming from the Police Station microgrid. There is also a

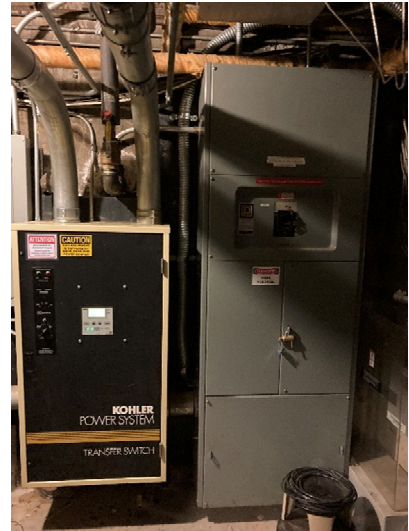
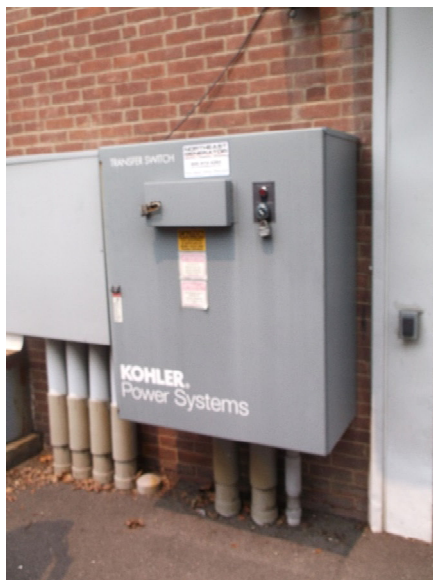
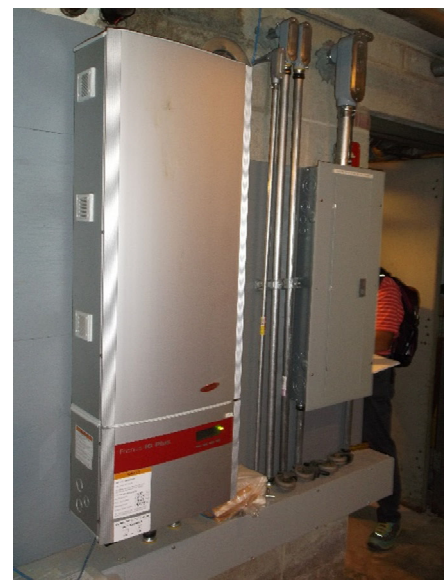
photovoltaic system on this building. This is made up of solar panels on the roof feeding two inverters in the basement just to the side when you come down the stairs. The ATS in the basement feeds two adjacent 200-amp main circuit breaker panels. These panels feed lighting and power throughout the building plus additional panels. There are a couple of original electrical panels nearing the end of their useful life along with a (6) circuit fused load center. The generator enclosure is showing signs of age (rusting throughout).

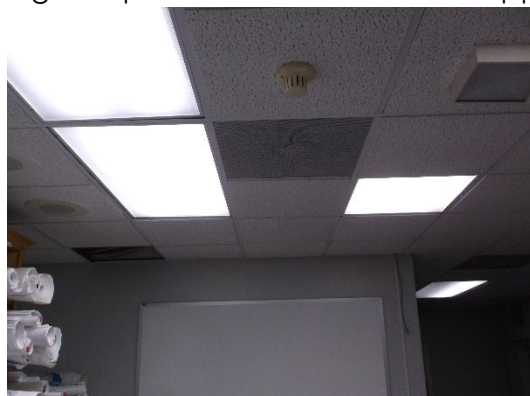
The existing interior lighting in the building is a mix of recessed fluorescent lensed 2x2 & 2x4 fixtures, recessed down lights, surface mounted wraparound fixtures, recessed 2x2 & 2x4 fixtures w/mini-cube lens, surface mounted industrial fixtures, wall mounted wall wash/vanity fixtures, recessed 2x4 parabolic fixtures, incandescent screw-in socket fixtures and surface mounted 2x4 high output fixtures. These fixtures appear to be in

fair/good

condition and working properly. It is our understanding that the majority of the fixtures have been upgraded with new LED bulbs. There are some fixtures that still have fluorescent or incandescent bulbs. These were areas that the town determined to be low use and would be replaced later as needed. Most of the areas have local toggle type & dimmer switches for control.

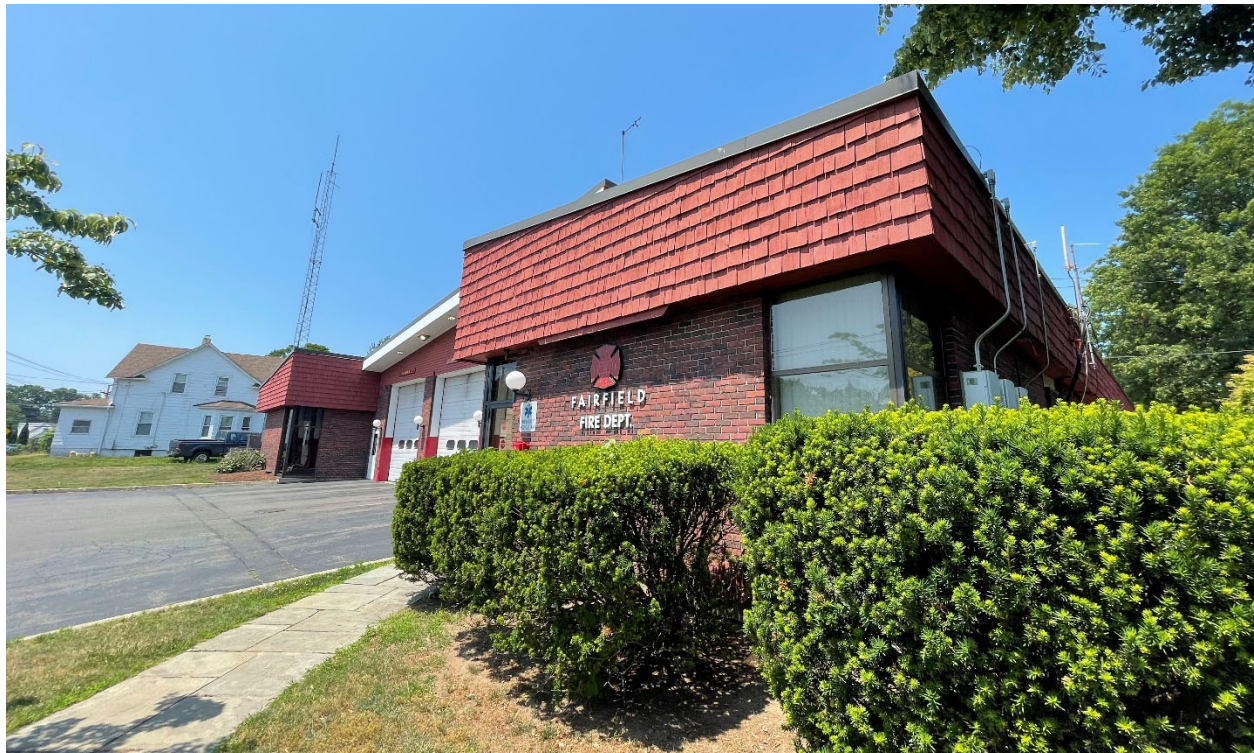
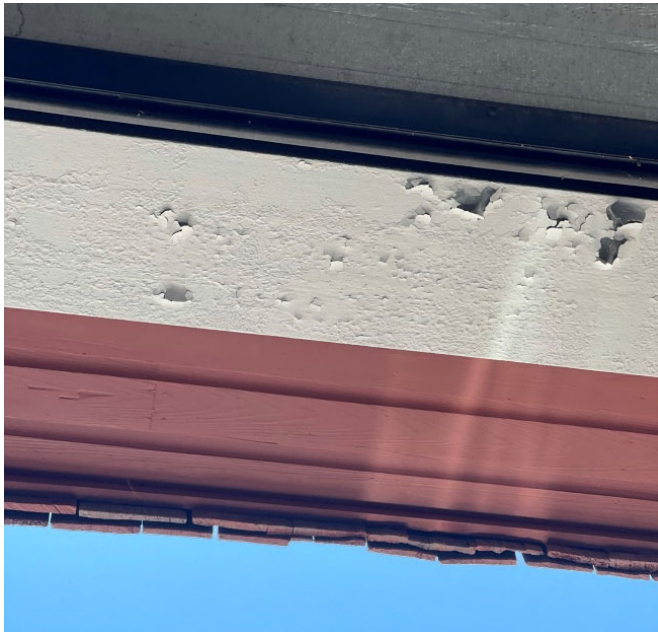
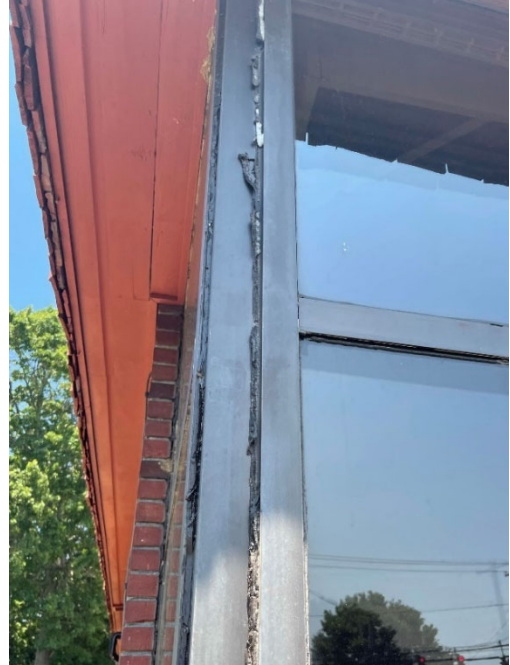
The exterior of the building is in good condition. The building is constructed with brick "veneer", rigid insulation, and painted concrete masonry unit interior. The energy efficiency of this construction is low, and typical in the 1970s ("pre-energy crisis"), and not one that is easily or readily corrected. Overall, the mortar is in reasonably good condition although the age of the building suggests that in the future a detail review should evaluate if repointing is required. The upper portion of these walls incorporate wood shingles. These are painted and appear in fair condition with some areas in need of repainting. Most notably, the soffit overhangs need to be scraped primed and painted. At the south elevation, there are existing grills with wire mesh laid on top. They are loose and curling and creating a tripping hazard. This should be replaced or secured to the grill. Overall, the exterior walls are in good condition.

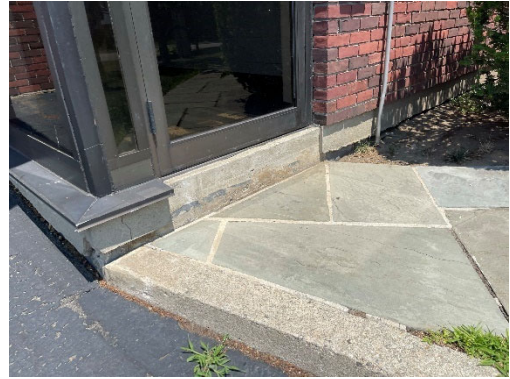
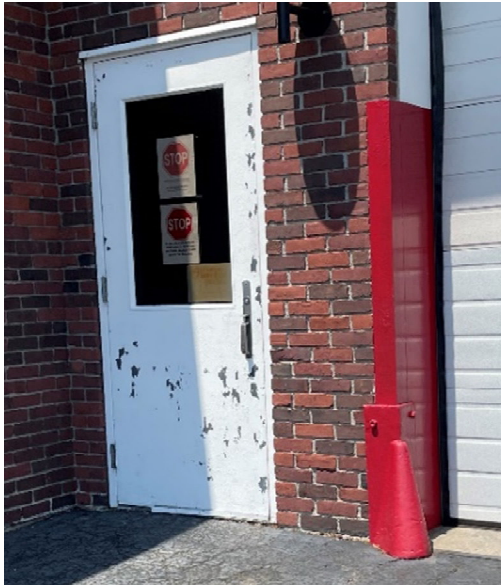
There are a variety of exterior doors. First and foremost, there are 6 large overhead doors (3 per side). These doors look a bit dated, and it appears some panels may have been replaced. The heads, jambs and sills are in good condition with some areas of chipped paint that should be maintained. Other standard doors are in fairly good condition. The front entrance is a glazed storefront system. The finish is beginning to fade but is in otherwise good condition. This door has a large step up to it. A ramp should be provided. The other metal exit doors have a significant amount of paint chipping. The weatherstripping is also beginning to fall off. The basement doors and frames are rusting. These doors should be repaired and repainted.

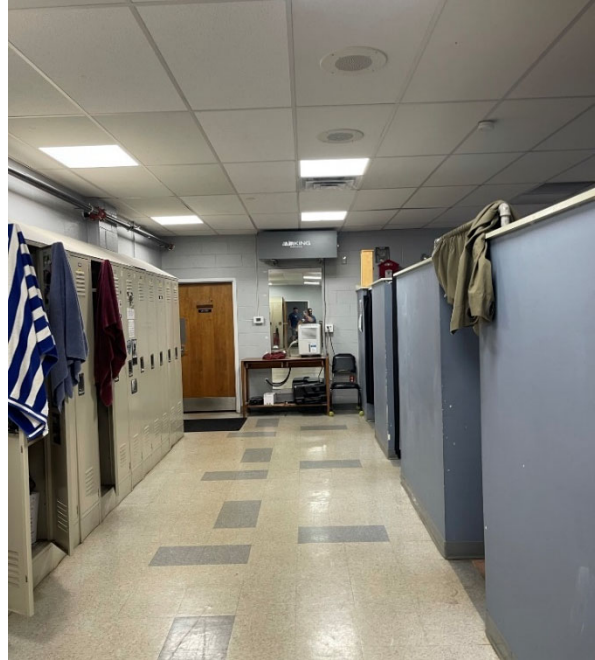
There are a variety of materials that make up the floors at this building. Starting with the apparatus bays, the concrete slab has seen many years of general wear and tear. There is staining and some minor cracks. The Emergency Operations Center, locker rooms, and much of the basement spaces contain vinyl composition tile (VCT). It appears dated or dirty and should be cleaned thoroughly or replaced. The dormitories and hallway contain carpet. Some areas are nearing the end of their useful life and should be replaced. The lounge area has been renovated with an epoxy floor that appears in good condition. Restrooms have ceramic tile which is original to the building but appears to be in good condition.

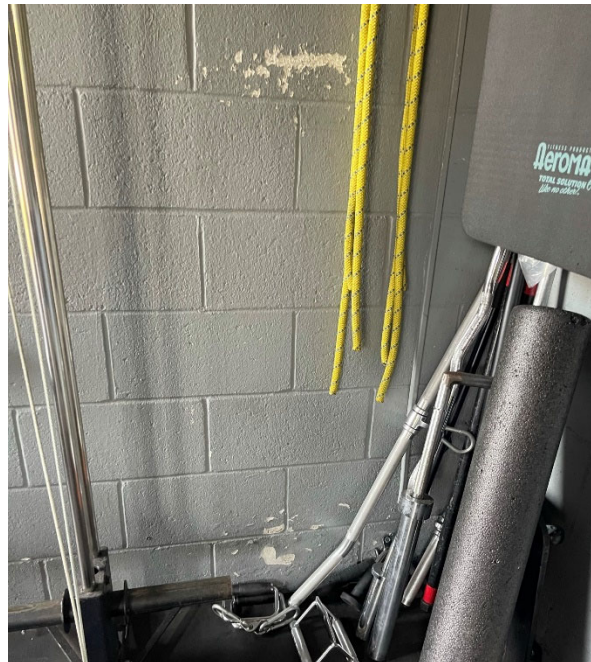
The walls are constructed from a variety of materials. Many walls are painted concrete masonry units (CMU). They are in good condition, however, some areas such as the apparatus bay, halls and bathrooms could use a new coat of paint. Areas are also peeling in the fitness room. The gypsum partitions in the dormitories require to re-finish and painting due to dings and dents that have damaged the walls over time.

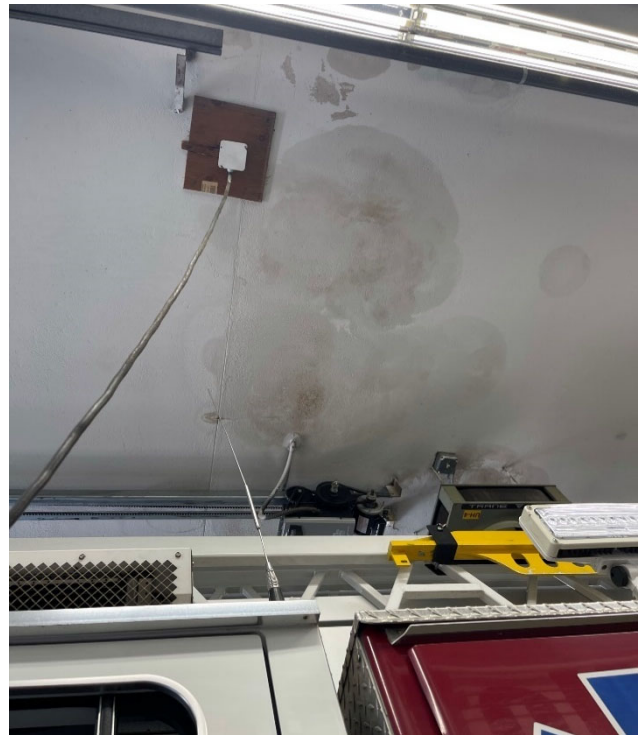
There are a variety of ceiling types within the building. Most are dropped acoustical ceiling tiles and others are a hard ceiling that is either plaster or gypsum. Due to age, ceilings in the building vary in conditions. The apparatus garage has seen some damage, as seen in the photograph to the right. It is evident that there is a leak above, either in the roof or equipment. This should be further investigated and repaired before further damage occurs. The ACT ceilings are a variety of ages or types, and some are also damaged. Many tiles should be replaced due to water stains, damage, or discoloration. These areas should be investigated to determine the source of any leaks and replaced once corrected.

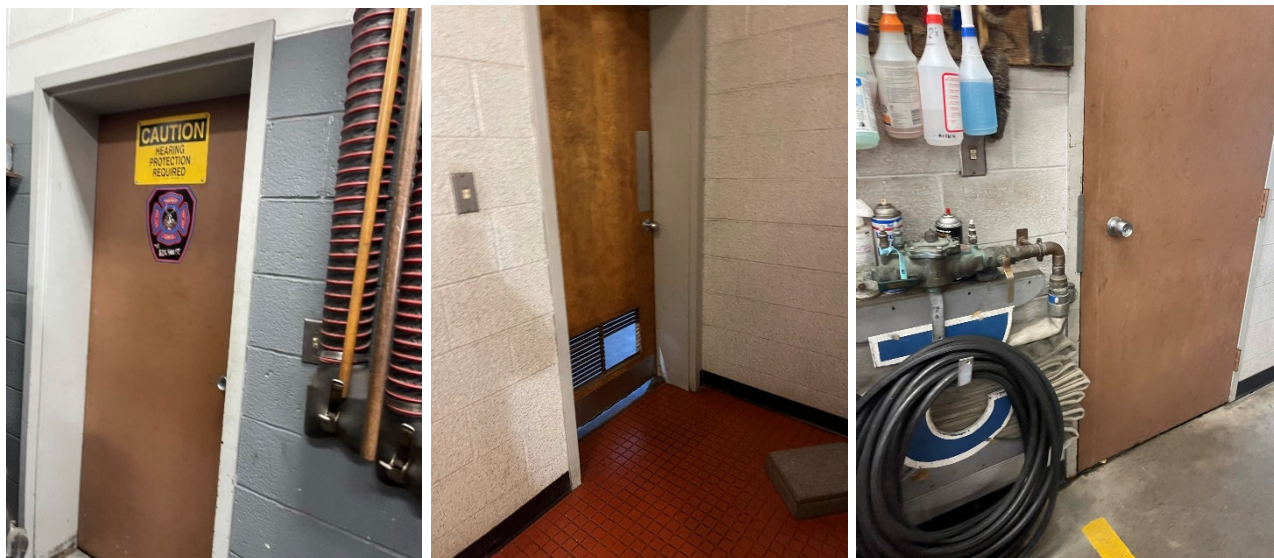
There are a variety of door types throughout this building, both wood and metal. Many are dated and in need of replacement while other areas that were renovated are in good condition. Older doors have knobs require twisting and do not meet American Disability Act requirements (ADA). The hardware should be changed. Some door jambs also exceed the allowable jamb depth and should be adjusted.

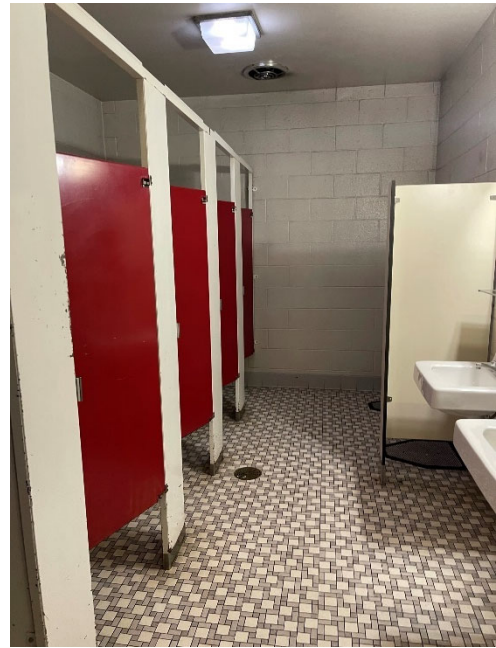
There are multiple restrooms throughout the station. Some are single unisex restrooms connected to private office or dormitory. There is a large one adjacent to the large dormitory and another smaller one off the lounge. None of the restrooms are ADA compliant nor are there any female restrooms. There are no ADA showers. Additionally, these spaces are dated and in need of renovations. The toilet partitions are showing their age. ADA compliancy and gender equality should be a part of the long-term capital planning of this station.

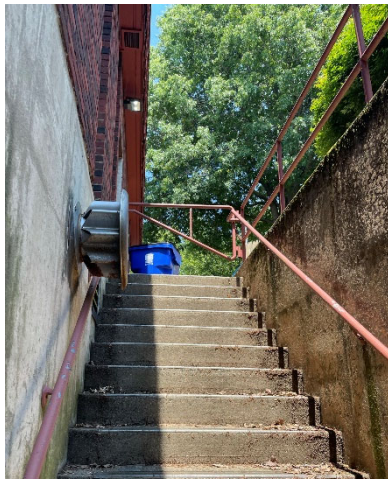
As noted within many of the sections, there are multiple code and accessibility issues within this building. Door hardware, ADA restrooms and showers and casework were previously noted. Other ADA issues are with certain spatial clearances within rooms and at doors. The required maneuvering clearances at doors is not always present in every location. These spaces should be adjusted to accommodate these accessibility clearances. Where they cannot be modified a power assisted door operator should be installed. Basement stairs do not have code complaint handrails with the appropriate extensions. Another issue noted was at the exterior. The egress out of the basement

consists of noncompliant handrails with extensions. The railing at grade does not have guardrails surrounding the egress stair which results in a safety hazard. There is no signage present in the building on the main levels, and the basement contains small room labels create based on a previous code. Recommendation for new signage to label all rooms and spaces with the associated dimensions, font, and height based on the 2009 ANSI 117.1 code. These items should be included in the long-term capital plan.

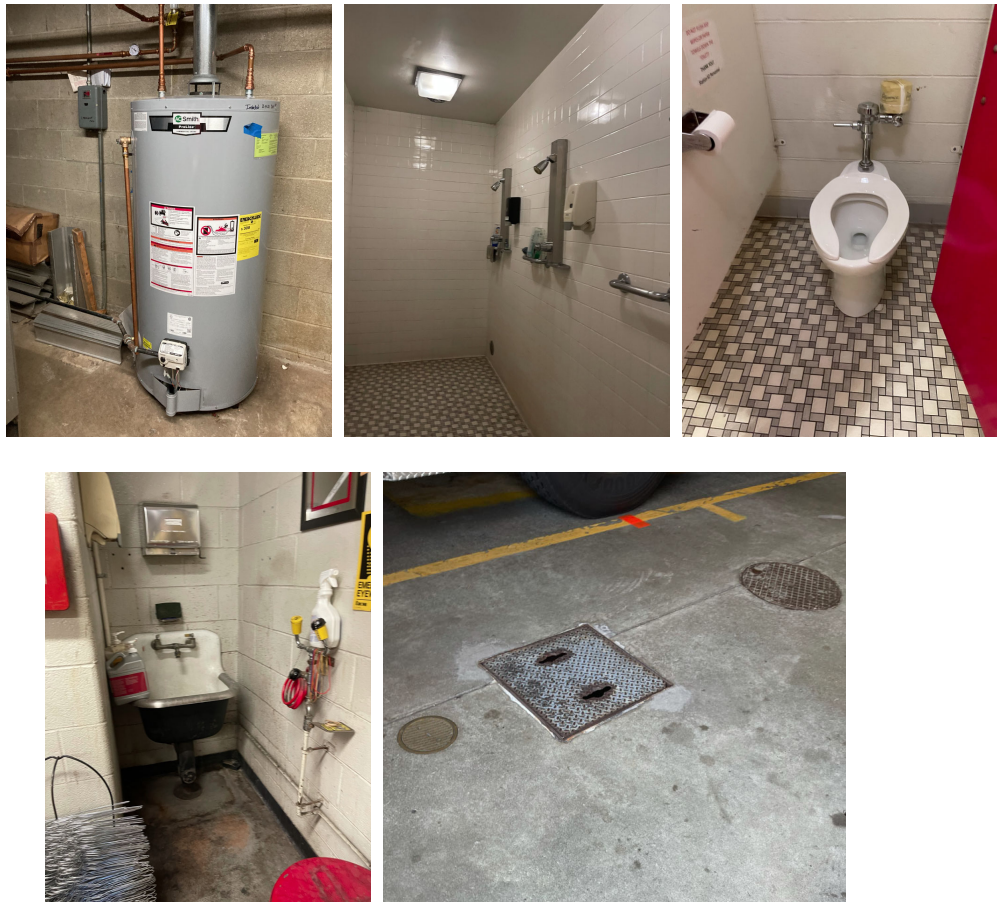
Additional fixtures in the building include a cast iron service sink in the Apparatus Bay. A fiberglass laundry sink with an indirect drain standpipe located behind the washer and dryer with an air admittance valve. An emergency eye wash as well. Tepid water was not provided. A commercial kitchen with a stainless-steel single compartment sink.

- Remove and replace plumbing fixtures with water saver fixtures.
- Test and inspect backflow preventers.
- Remove and replace exterior hose bibbs.
- Provide vacuum breakers on interior hose bibbs.
- Repair and provide insulation on all domestic water piping.
- Paint all exposed exterior gas piping.
- Provide scuppers on roof for secondary or emergency drainage.
- Remove and replace all gate valves with ball valves.
- Remove, replace and repair corroding domestic water piping.
- Provide tepid water and mixing valve to emergency eye wash.

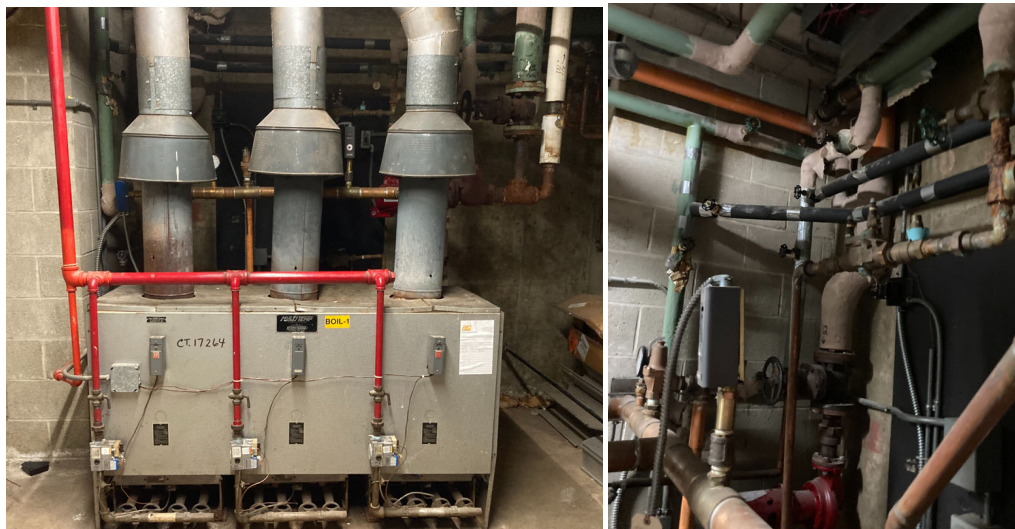
The existing boiler, located in the basement, is a Multi Temp Hydrotherm 3 module boiler. Products of combustion are vented through a sidewall mounted Field Controls vent cap. Combustion air is from a Field Controls combustion air system. We were not able to determine the age of the boiler, however the boiler is not original to the building based on the newer copper piping supply manifold connected to the existing steel pipes. The boiler flue piping is showing signs of wear. One (1) inline pump serves the building.

The piping distribution system and associated components are showing signs of wear. We were unable to determine the age of the piping, but it is likely original to the building. Piping systems, with proper maintenance, can operate for 50 years, however, older piping system should be inspected utilizing ultrasonic testing to determine rates of corrosion within piping.

The insulation covering the hot water piping appears to be original to the building. Piping insulation has a useful life expectancy of approximately 20 years. Sections of existing steel hot water piping and all new copper piping are not insulated.

- Replace existing boiler and associated near boiler specialties. The new boiler will be high efficiency condensing boiler, with flue and combustion air pipes connected directly to the outdoors.

- Replace in-line pump.
- Perform ultrasonic testing for the rest of the piping system to determine the rates of corrosion within the pipes. Replace pipes as needed.

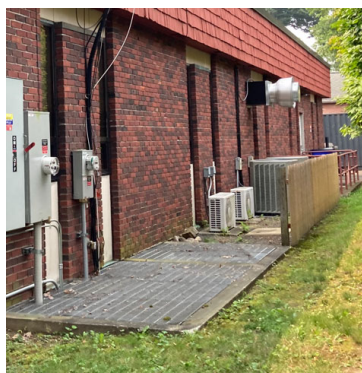
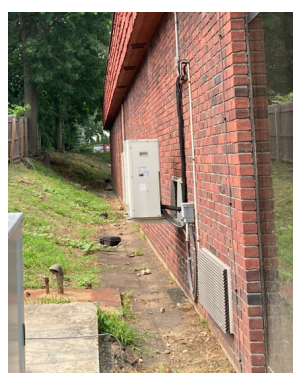
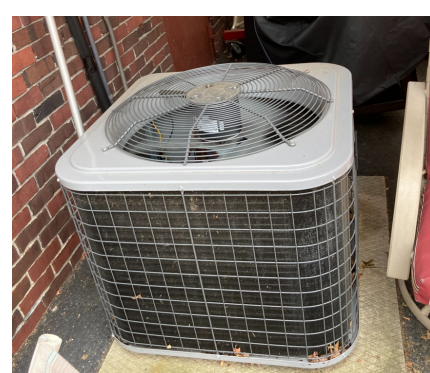
Thru the wall mounted air conditioner was provided in the Weight Room. This unit appears to be original to the building and is beyond its useful service life of 10 years. A 2-ton Daikin ductless split heat pump unit was added in the weight room. The Daikin ductless split system, manufactured in 2016, is within its useful life expectancy.

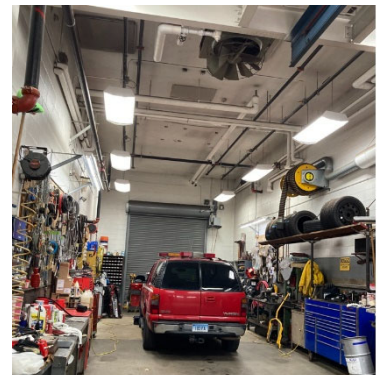
The International Mechanical Code Section 404.2 requires that a minimum of 0.05 cfm per square foot of continuous ventilation be provided and 0.75 cfm per square foot of ventilation air during all occupied hours. In addition to this exhaust fan, a means to provide make-up air, either by a separate supply fan or a louvered opening with motorized damper, would be installed to maintain the air balance for the space. Please note that this ventilation requirement needs to be met regardless of whether a tail pipe exhaust system has been installed.

- Replace dryer indoor vent kit.
- Provide exhaust fan and outdoor air to the apparatus bay. Provide with CO/NO2 detection system.
- Replace unit heaters in apparatus bay.

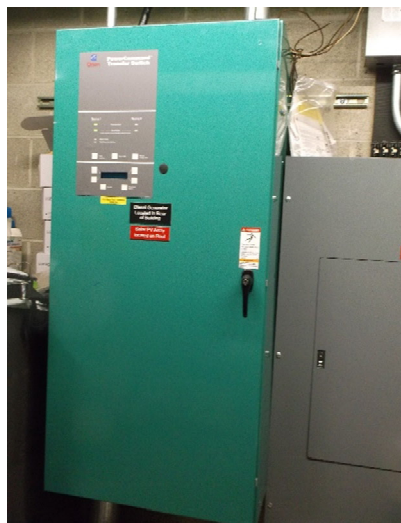
Figure 2-30: ATS Switch

The existing electrical service is made up of a new 400 amp 120/208V-3PH-4W G.E. combination main breaker/service switch and CT cabinet. The service switch feeds the main distribution panel (MDP) through the adjacent automatic

transfer switch located in the Basement (south-east corner). The MDP feeds panels in the basement and first floor. The service switch, MDP, ATS and half of the panels are newer, the remaining panels appear to be original to the building (1969). There is an 60KW diesel emergency generator 120/208V-3PH-4W located behind the building in the north-east corner. The generator has a single output breaker (225

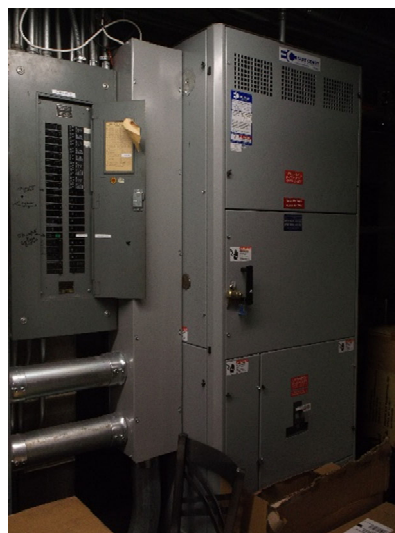
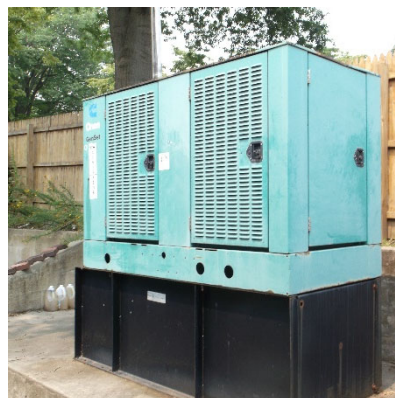
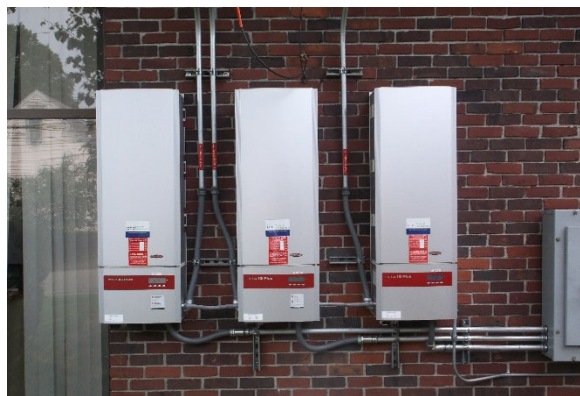
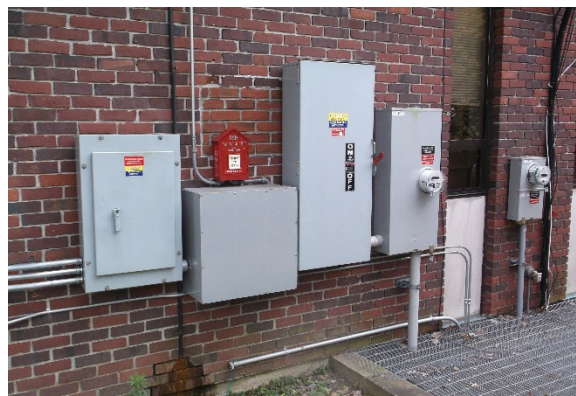
amps) that feeds the emergency side of the automatic transfer switch. The generator was installed in August of 2000 and appears to be in good condition with a little rust starting on the enclosure, we are not aware of any issues with this equipment. In addition to the normal electrical and generator distribution, there is also a photovoltaic system. This is made up of solar panels on the of the roof that feed (3) wall mounted inverters for approximately 180-amp distribution. The disconnect switch, utility meters and inverters are on the exterior wall east side of the building (southern corner).

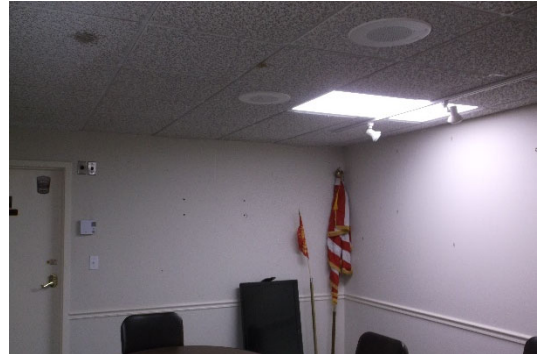
LED flood lights and wall mounted adjustable “reading” lights at each bunk. These fixtures appear to be in fair/good condition and working properly. It is our understanding that the majority of the fixtures have been upgraded with new LED bulbs. There are some fixtures that still have fluorescent or incandescent bulbs. These were areas that the town determined to be low use and would be replaced later as needed. Some of the areas have local toggle type & dimmer switches for control while others have low voltage switches. The existing exterior lighting for the building is

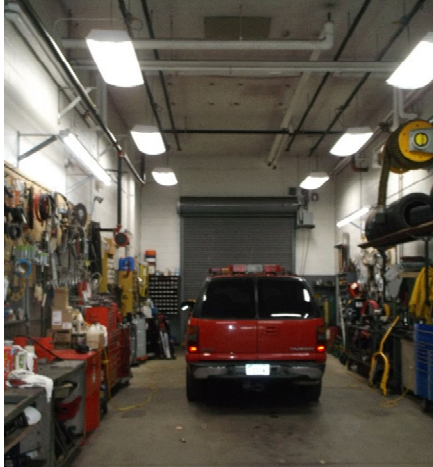
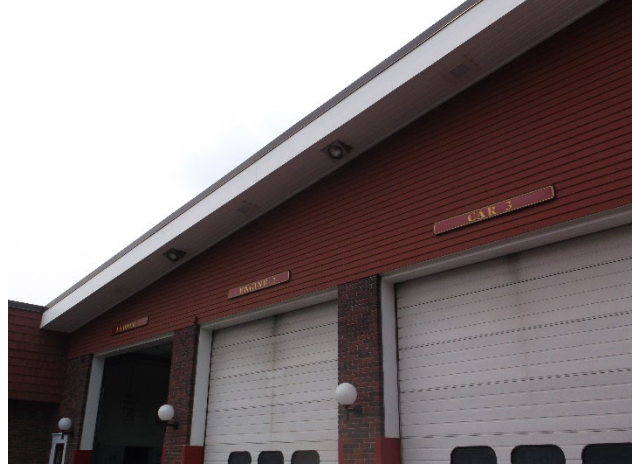
made up of wall mounted incandescent globe type fixtures on the front of the building with some semi-recessed spotlights in the overhang between the garage doors. There are small wall mounted LED flood lights on the east side and back of the building along with one wall mounted HID flood light in the back. We were not able to determine the operation of the exterior fixtures at the time of our inspection.

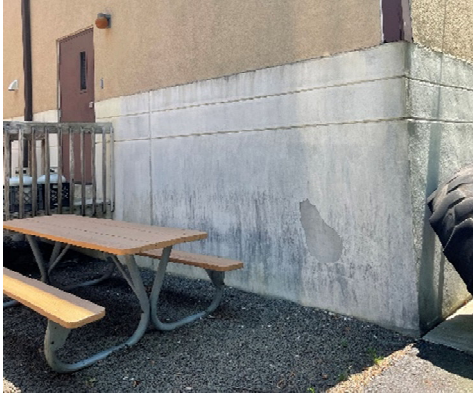
Considering the age of this building the exterior walls are in great condition. The concrete foundation looks dated with the rear portion consisting of staining and a little deterioration. The exterior brick walls of the fire station are generally in good condition, with a limited areas of settling and spalling. The building is constructed with brick "veneer" with no air space evident, predictable for its age. The energy efficiency of this construction is very low, and typical in the 1920s ("pre-energy crisis"), and not one that is easily or readily corrected. It is evident that repointing in some areas have been previously performed. There are still some limited areas which will eventually require

repointing or repairing, most notably on the lower portions of the wall near grade or near downspouts and windows. Generally, the mortar is in reasonably good condition and should continue to be monitored. The stucco and the wood shingles in the gable ends appear to be in good condition. Overall, the building's envelope is in good condition, considering its age.

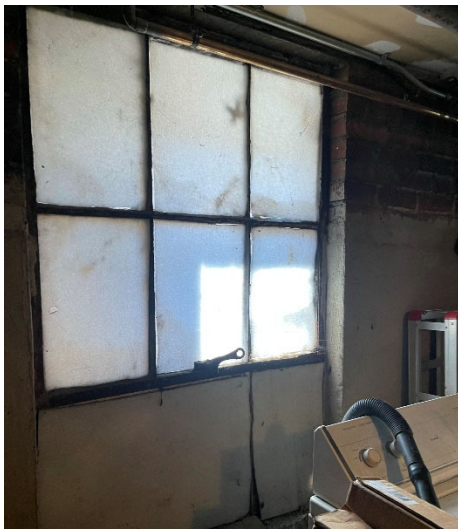
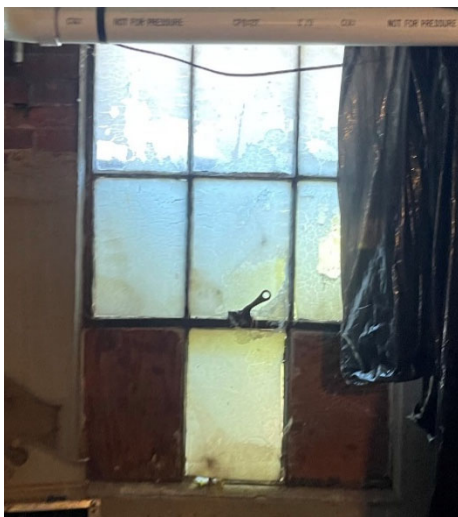
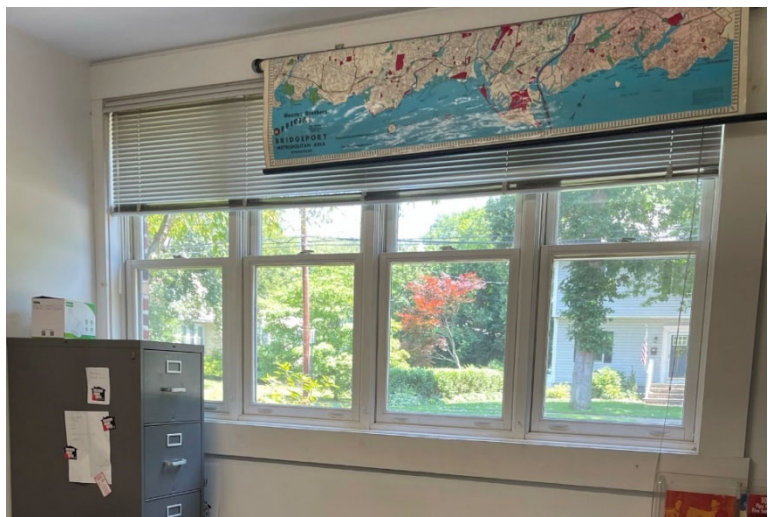
The windows at this fire station have replaced the original windows. They vary between type and size. Large windows in the apparatus bay are wood with limited operability. Most of the remaining windows throughout the station are vinyl replacement double hung systems. It was reported that the windows in this building are difficult to operate and its very problematic. This is a common occurrence with many vinyl replacements. It may be because the track is dirty and needs lubrication. It is recommended to clean and lubricate the window tracks. Additionally, there are basement windows that are original steel assemblies with single pane of glass. It is recommended to replace any old or nonfunctioning windows.

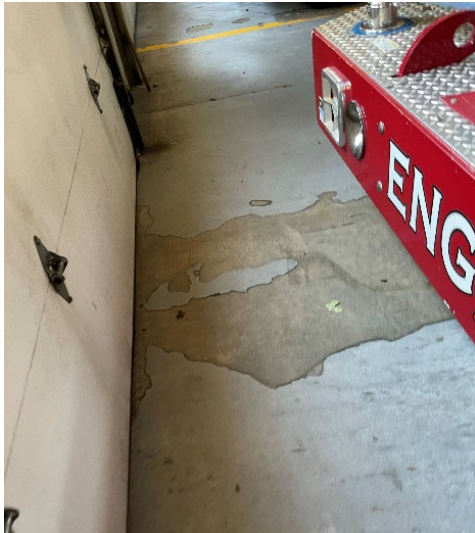
There are a variety of materials that are used in this building. The apparatus bay is a concrete slab which has held up well. The slab was painted including striping, but much of it has begun to wear away. This should be repainted with an epoxy type of product to withstand the wear and tear of the trucks and associated activities. There is carpet present in the lounge area connected to the kitchen, which is worn due to circulation. It is recommended to replace the carpet. In other spaces of the building such as the dormitory the carpet is in better condition. Vinyl Composition Tile (VCT) is located in the remaining spaces of the building which are all in good condition.

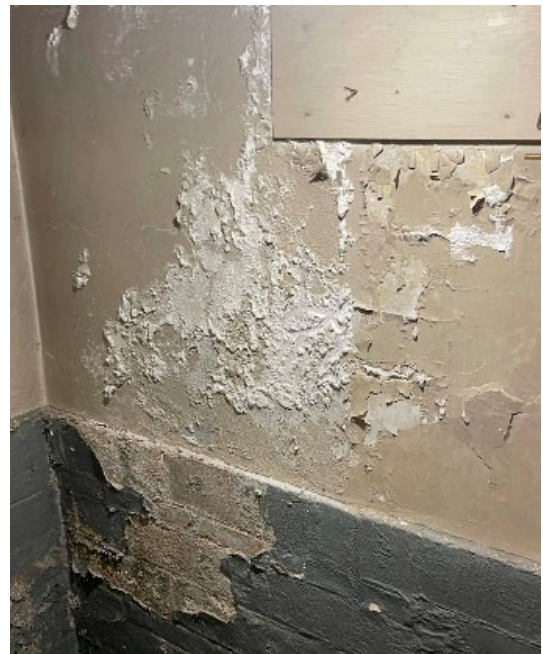
The interior walls consist of a few different materials from brick, concrete, and gypsum wall board. On the main floor and second floor all materials are all in good condition and well maintained. The baseboard, on the other hand, should be refinished due to multiple cracks and chips in towards the floor area due to the natural wear and tear from circulation. The basement has some issues. There is likely a moisture problem such as hydrostatic pressure or some type of water infiltration as seen from the photograph of the basement wall (right). The paint is peeling and is in poor shape. There is not usable space in the basement so appearance may not be a priority. It should be further evaluated to determine if there is a problem.

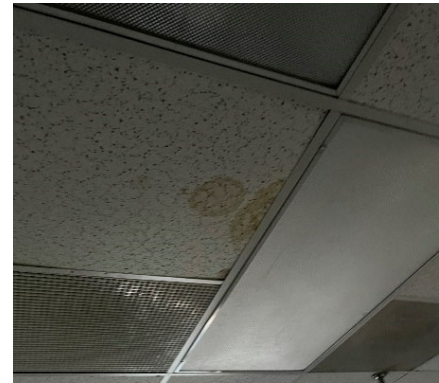
There are two types of ceilings present at this station. Every room except the apparatus bays, bathrooms, and basement, has acoustical ceiling tile (ACT). The ceilings appear to be in good condition, aside from a few limited tiles that are stained or discolored. Those tiles should be replaced. The remainder of the building is built with gypsum wall board with a painted finish that is in good condition.

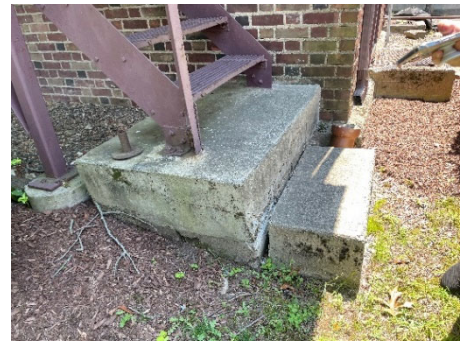
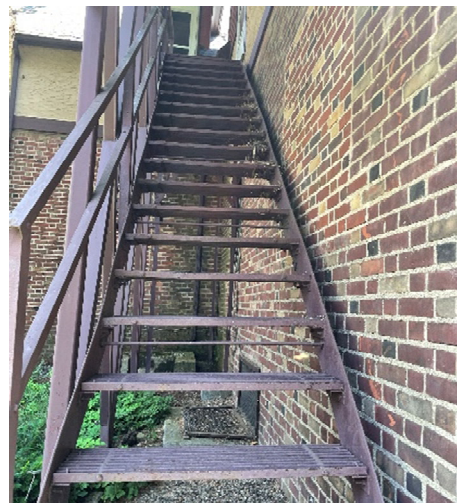
There are currently three sets of stairs in this building. The first staircase is in the center of the building at the front entrance. The stairs are in good condition and have recently been worked on. The second staircase which leads to the basement. This is a wood constructed stair and with the moisture issue at the basement this stair should be investigated for structural integrity. The handrails do not meet code requirements. The third stair is an exterior staircase, used as the second means of egress for the dormitories upstairs, pictured in the photographs at the right. This metal exterior staircase is located towards the back of the building terminating at two large concrete steps. The condition of this staircase is poor. The bottom concrete stairs that support the bottom of the metal stair is in disrepair. This should be replaced as it is settling.

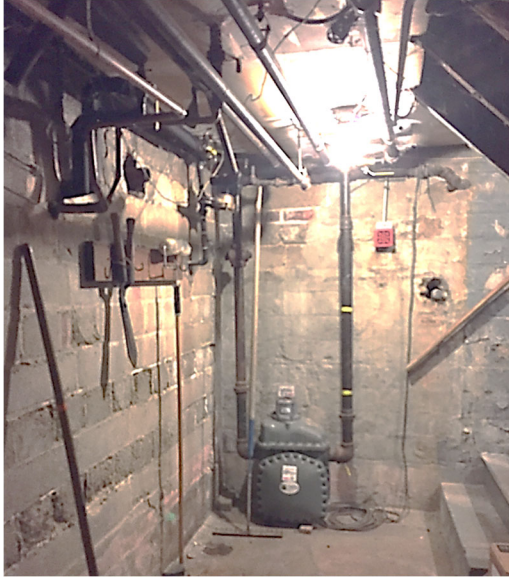
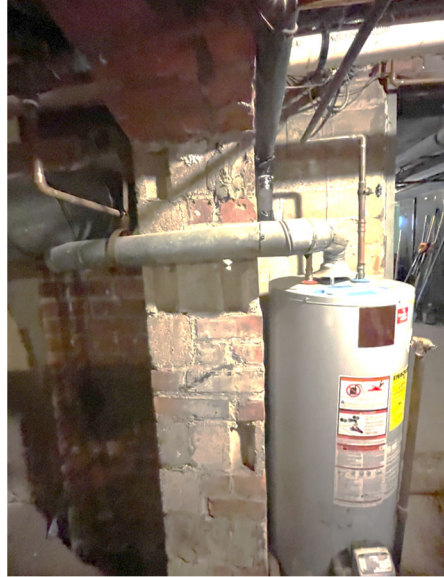
Domestic hot water serving the building is from a 40-gallon State Industries natural gas fired storage water heater with an input capacity of 40,000 BTUH. The heater is in the basement adjacent to the boiler. The heater was manufactured in 2014 and has a useful life expectancy of 10 to 15 years. Products of combustion are vented into the existing chimney through a sheet metal flue. There is no hot water recirculating pump, thermal expansion tank and ASSE1017 mixing valve installed. We recommend adding those components for compliance.

- Remove and replace plumbing fixtures with water saver fixtures.
- Provide a thermal expansion tank, a ASSE1017 thermostatic mixing valve on the water heater and a recirculating system as there is a long wait for hot water and exceeds code requirements.
- Test and inspect backflow preventers.
- Provide missing insulation around water heater on water piping.

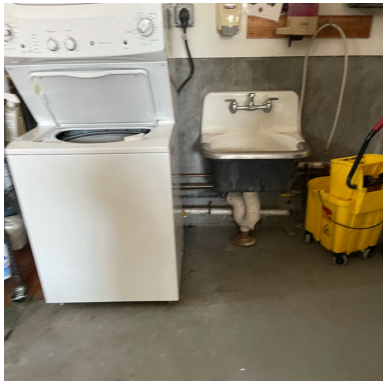
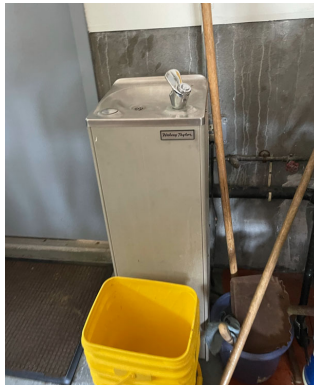
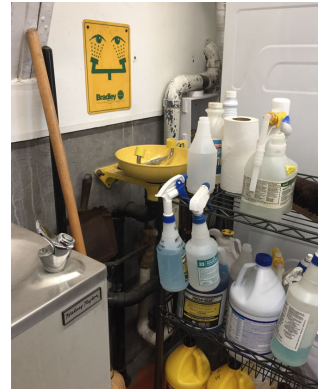
Additional fixtures, located in the Apparatus Bay, include a cast iron service sink and a water cooler. A laundry indirect drain standpipe is located adjacent to the service sink. The emergency eye wash is in the apparatus bay, fed with cold water only. Current OSHA/ANSI standards require a supply temperature range of 60-100 deg F to emergency

fixtures. Adding hot water supply and a thermostatic mixing valve to the current installation will provide a safe, inviting code-compliant water temperature at this fixture.
