**Town of Fairfield**  
Town Planning and Zoning Commission  
725 Old Post Road  
Fairfield, Connecticut 06824

**To: Members of the RTM**  
**From: Jim Wendt, Planning Director**  
**Date: April 19, 2022**  
**Re: Opt-Out of State Mandated Zoning Regulation Language**

FAIRFIELD TOWN PLAN AND ZONING COMMISSION PROPOSED OPT-OUT OF  
STATE MANDATED REGULATION LANGUAGE REGARDING OFF-STREET PARKING.

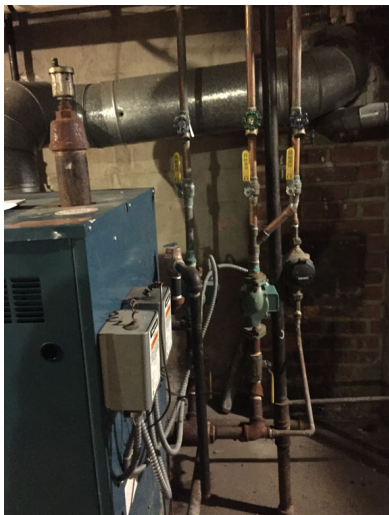
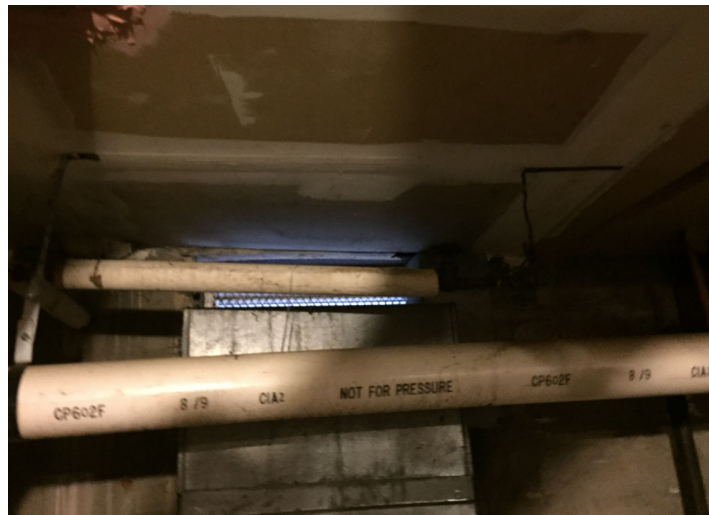
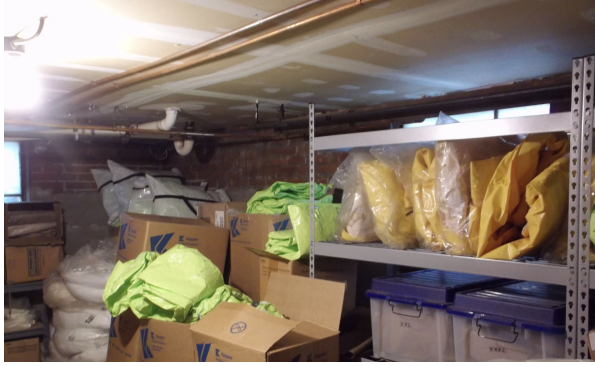
Based on the observed abandoned steam condensate system in the boiler room, the original building appears to have been served by a steam boiler. The hot water piping distribution system appears to be installed the same year as the boiler. Hot water supply and return piping system has a useful life expectancy of 50 years.

Hot water supply and return piping in the basement are uninsulated.

- Replace in-line pumps.
- Provide piping insulation with thickness complying with the Energy Code.
- Engage the service of a Chemical Service Provider to maintain proper water treatment to the building water loop

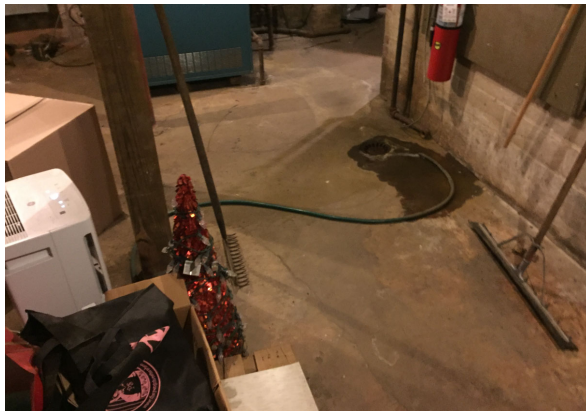
Basement is used as a storage space. There is no mechanical ventilation provided to the basement.

A portable dehumidifier is provided in the basement. Condensate drain is routed to the nearest floor drain.

- Provide unit heater in the basement.
- Provide basement with dehumidifier with outside air duct connections for ventilation. Provide condensate drain piping terminating to an indirect drain in the basement.

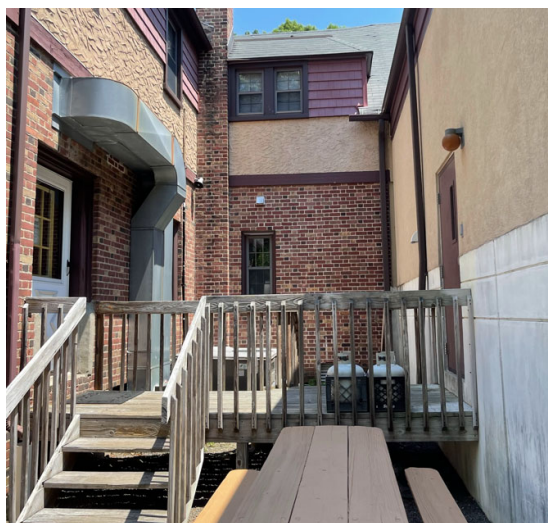
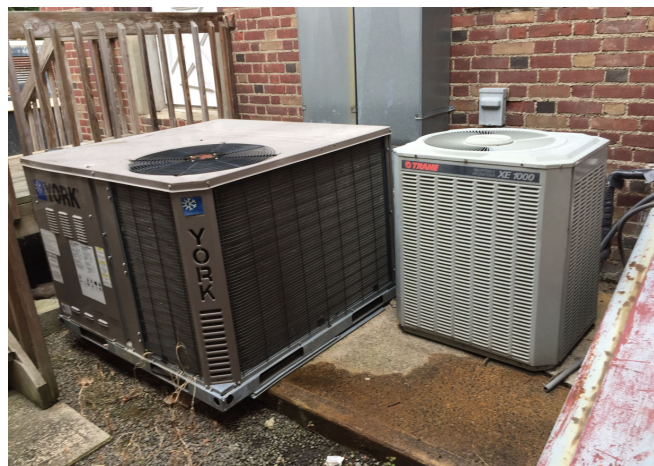
A packaged unit and a split system, consisting of an air handling unit and a remote air-cooled condensing unit, serve the first and second floor occupied spaces. The packaged unit is manufactured in 2006 and the split system in 1994, both units have outlived their useful service life expectancy of 15 years. Both systems are using the obsolete refrigerant R22.

The packaged unit and the air-cooled condensing unit are mounted on a concrete pad in the courtyard. There is inadequate service and airflow clearance between the two units.

- Extend housekeeping pad to properly support the units and to provide manufacturer required service and airflow clearances.
- Replace split system. Provide outdoor air ductwork connection to the air handling unit for ventilation. Replace associated thermostat.

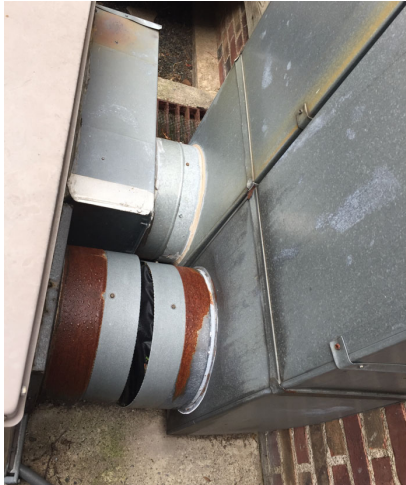
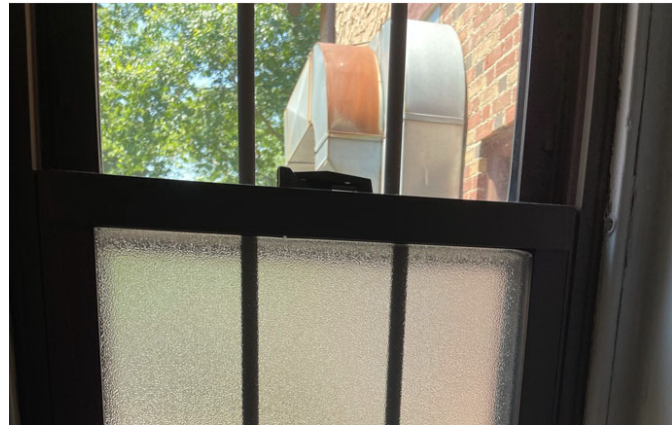
The 3-ton outdoor packaged unit serves the first-floor dormitory, lounge, kitchen, and office spaces. This unit does not have outdoor air intake connections. The exterior supply and return ductwork are provided with liner. Given the age of the unit, it is most likely that the existing liner thickness do not meet the code required R value. Exterior supply and return ductwork have surface corrosion. The 3.5 ton split system serves the second-floor space.

- Replace packaged outdoor unit with new unit capable of delivering ventilation air to the space. Replace associated thermostat.
- Replace the exterior ductwork. New exterior ductwork should be provided with insulation and protective jacket.

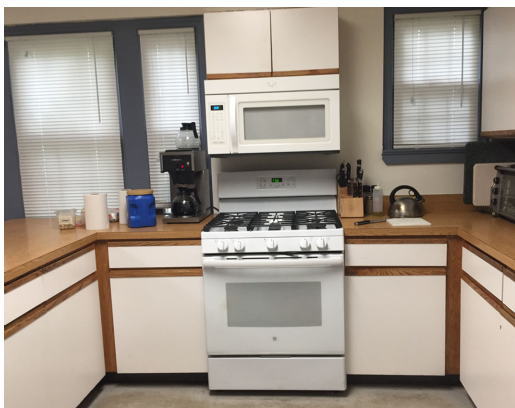
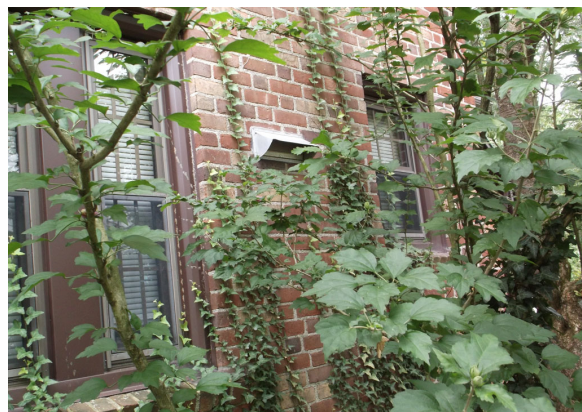
The existing cooking appliance is residential gas stove. Over the range microwave vent hood is provided and air is exhausted through wall cap. There is no make-up air to the kitchen as required by code. A range hood with approved fire suppression system is required. Per International Mechanical Code Section 507.1.2, domestic cooking appliances utilized for commercial purposes require Type I hood, domestic cooking appliance utilized for domestic purposes within a commercial setting shall comply with IMC section 505. The Authority Having Jurisdiction shall determine code compliance for a particular application. A residential hood with UL300A suppression system may be considered for this type of application. However, the use of this type of use shall be approved by the AHJ.

- Replace toilet room exhaust fans.
- Provide gas fired cooking appliance with hood with fire suppression system.
- Provide tempered make-up air to the space equivalent to 80% of air being exhausted.

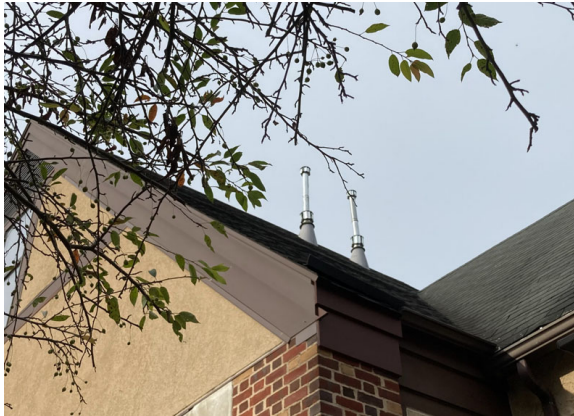
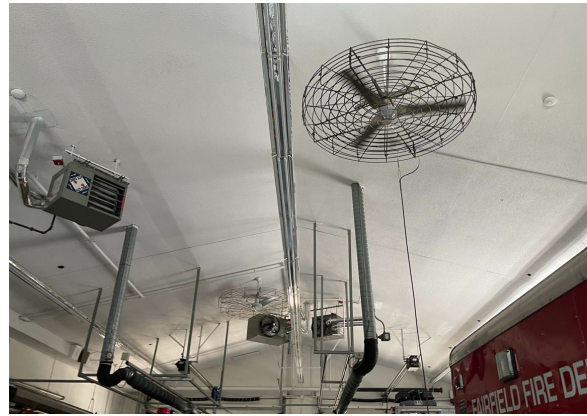
The Apparatus Bay is currently heated by three (3) gas fired unit heaters. We are unable to determine the age of the unit, however, the unit heaters appear to be in good condition. New concentric vent adapter in the attic and new vertical concentric vent terminations were recently installed to replace the corroded flue terminations. Ceiling fans are provided to help circulate the air in the space.

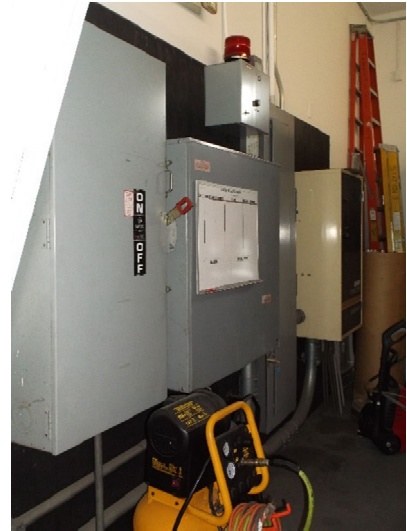
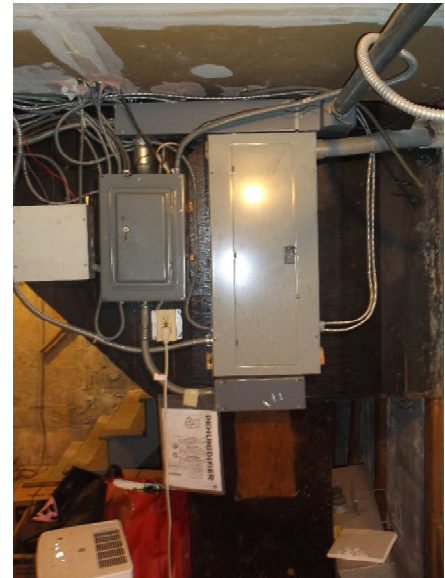
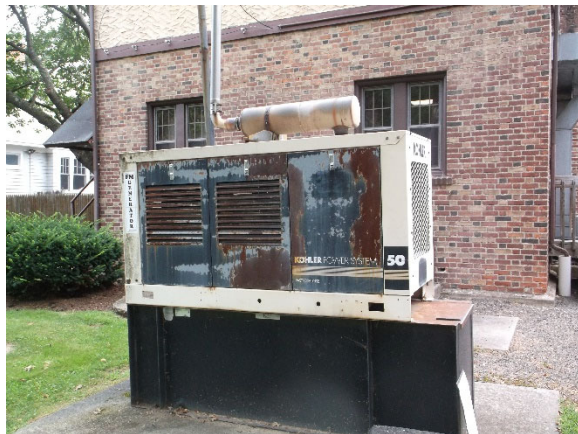
automatic transfer switch (ATS) located on the other side of the MDP. The MDP feeds panels in the basement and first floor. The service switch, MDP, ATS and most of the panels appear to be from the 1996 renovation. There is a 50KW diesel emergency generator 120/208V-1PH-3W located behind the building on the west side. The generator has a single output breaker (225 amps) that feeds the emergency side of the automatic transfer switch (ATS) in the

Apparatus Bay. The generator was installed during the 1996 renovation and the enclosure has a large amount of rust on it, we are not aware of any issues with this equipment.

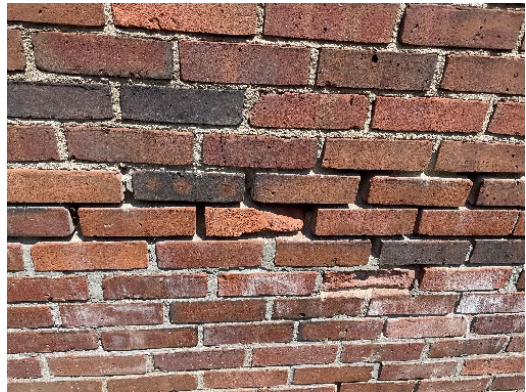
Having been constructed over 100 years ago, the buildings envelope is in fair condition. The exterior brick walls of the fire station are generally in poor condition, aside from the front, with a limited areas of settling and spalling. The building is constructed with brick "veneer" with no air space evident, predictable for its age. The energy efficiency of this construction is very low, and typical in the 1910s ("pre-energy crisis"), and not one that is easily or readily corrected. It is evident that repointing in some areas have been previously performed. There are still many various areas throughout the remaining of the building which require repointing or repairing. There are a few areas of damage to the stucco coats, exposing the wire mesh. This should be repaired.

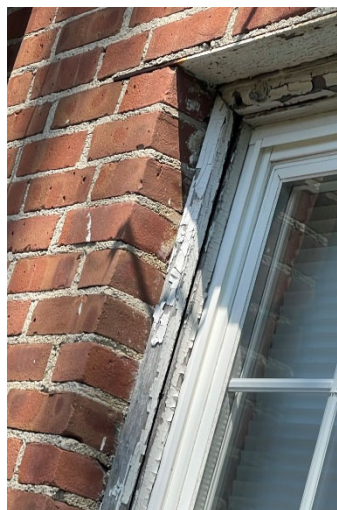
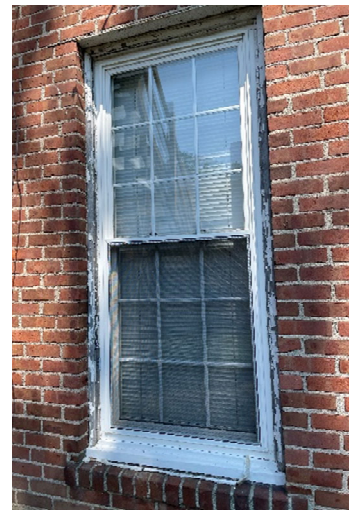
When evaluating the energy efficiency of a building, it is known that nearly 25–40% of all heat energy is lost through windows. The majority of the windows are original single-glazed with wood frame windows. It appears storm systems have been added for some improvement. Regardless, these windows are in poor condition. The paint is peeling on both the window itself and the trim. In some cases, wood has deteriorated on the mullions, and the glass is barely hanging in. Trim is split and cracked in some areas. Additionally given their age they may contain lead paint. It is highly recommended that these windows be replaced. Additionally, window lintels are rusting and should be scraped primed and painted.

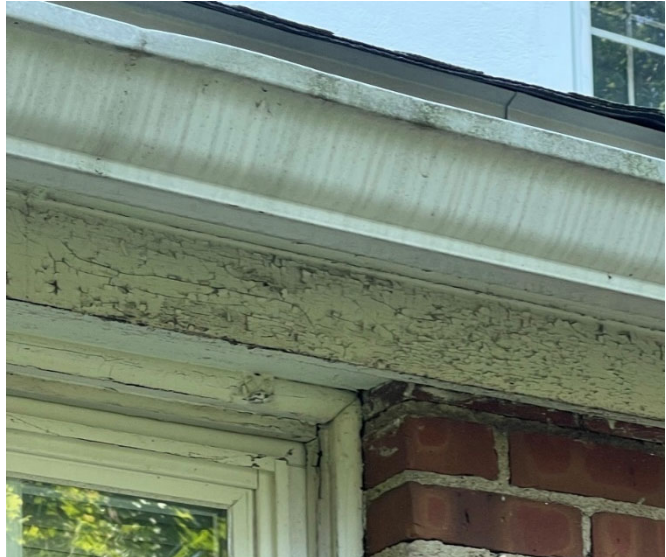
The building, simplistic in plan has a simple hip roof constructed over the second floor. There is also a small shed roof over the first floor at the rear of the building. The roofs consist of asphalt shingles. Fascias and soffits and trim are wood and like the windows. Main of the visible portions are they are in poor condition. The paint is peeling, and the wood appears to be in disrepair. These should be replaced when the roof is next replaced. Due to the sloping nature of the roof the roof was not able to have a full inspection. It was replaced 2013 and will likely be due for replacement 2033-2043 depending on warranty.

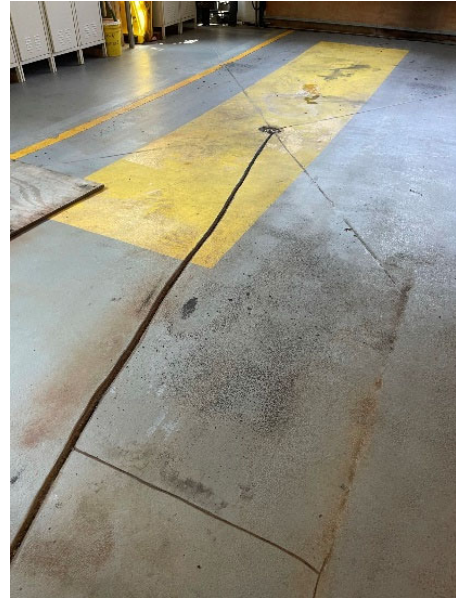
There are a variety of materials that make up the floors at this building. There are multiple spaces which would need a replacement or refinishing. Beginning with the apparatus bay floor, there is a very large crack in the concrete slab which extends from the inner point of the slab to the center where the drain is located. This is intentional to eliminate what can be assumed was a "bird bath" situation due to the slab not being correctly

pitched to the drain. Paint is also being to wear with some adjacent areas of slab beginning to chip and deteriorate. This should be monitored and repaired. At the main entrance there is a painted concrete slab that is peeling and should be repaired. Other areas have VCT or tile which is in fair condition. The carpet in the dormitories on the second-floor volunteer spaces is in disrepair. The carpet has reached the end of the line. The remainder of the second floor is made of wood. It has minimal damage and will require new layer of finish. Many of the floors are set at different levels requiring one to transverse on stairs while moving through the building. Ramps should be included however the layout and small rooms makes this quite a challenge.

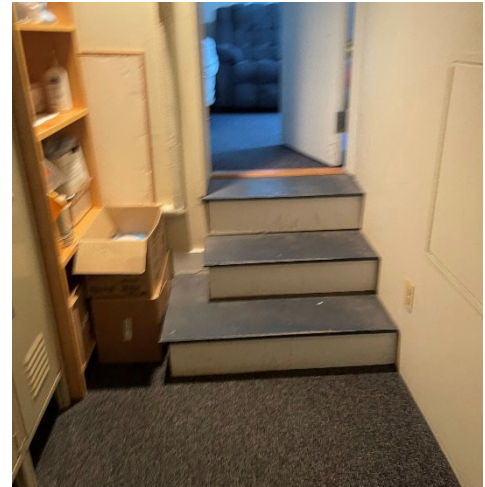
There is one internal stair serving this building and one exterior egress stair. As mentioned, there are also small multiple stairs and steps throughout the first floor. They are in overall in good condition, however, none of them are to build to today's code. The interior stairs located on the western side of the building are not code compliant and require an intermediate landing as the rise is greater than 12 feet. Nor are the handrails compliant. The stair is likely grandfathered in, but the handrails should be changed. Stairs on the lower level also require handrails and should have ramps included.

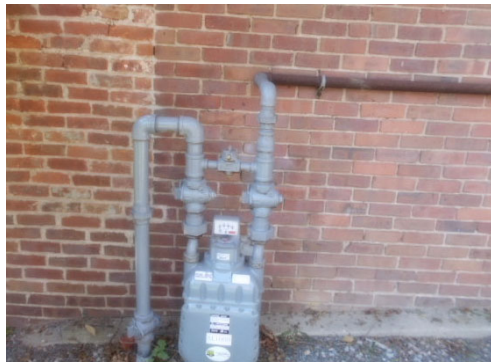
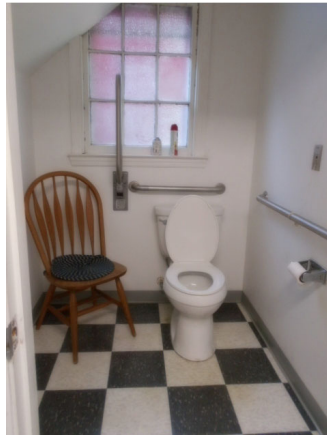
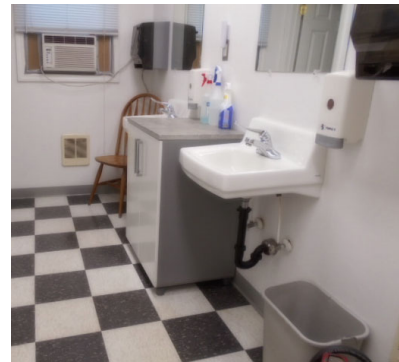
The gas service is routed underground to the back of the building under the rear exterior stairs, where the service pressure regulator, and gas meter are located. Gas is distributed to the gas fired boiler and the two(2) kitchen gas range in the building, using black steel pipe. Exterior gas piping is exhibiting surface corrosion. Painting gas piping is recommended.

- Remove and replace plumbing fixtures with water saver fixtures.
- Remove and replace water heater, provide an expansion tank, a thermostatic mixing valve on the water heater and a recirculating system through the pipe tunnel as there is a long wait for hot water and exceeds code requirements.
- Test and inspect backflow preventers.
- Provide missing insulation around water heater on water piping.
- Paint exterior gas piping.

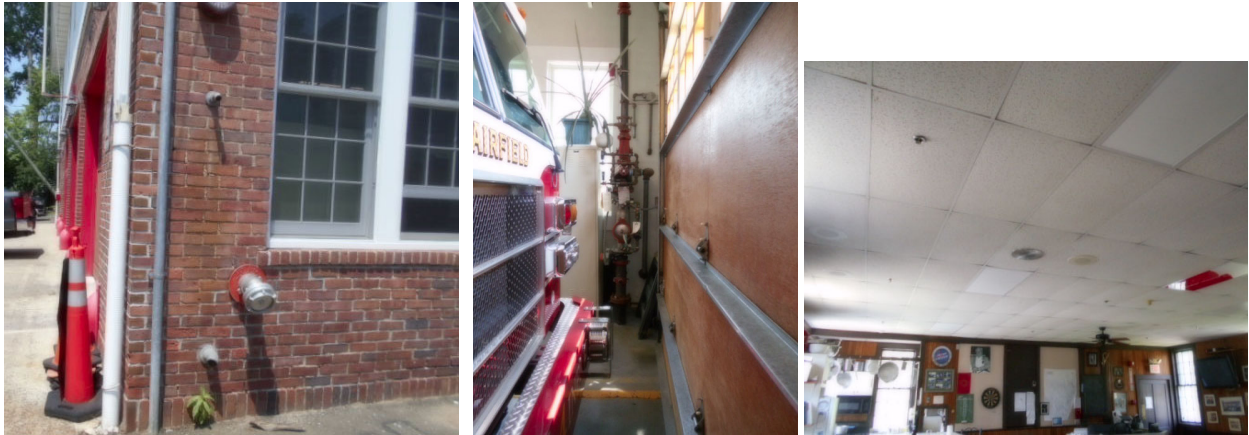
There is an existing fire protection sprinkler system in the building. A vertical, double check valve backflow preventer is provided at the riser in the corner of the apparatus garage, near the garage doors. There is a concern, if the doors are left open for an extended period in winter conditions, the system could freeze

- Continue to maintain, test, and inspect sprinklers and devices as required by code.

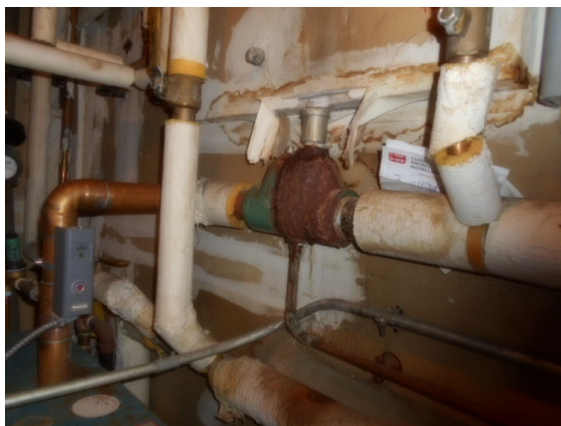
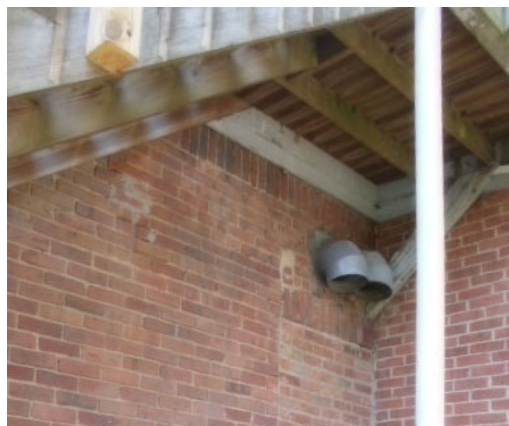
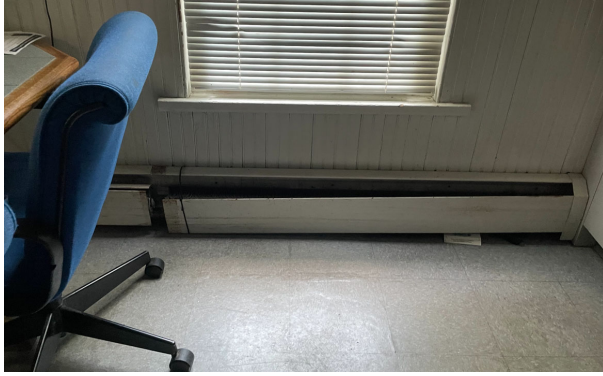
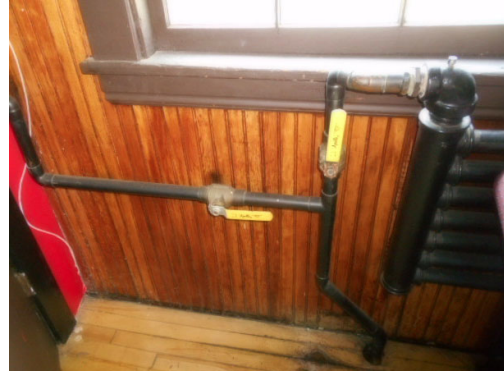
A cast iron gas fired Burnham boiler model IN8 is in the mechanical room adjacent to the officer's room and the Apparatus Bay. The boiler has an input capacity of 245,000 BTUH. Inline pumps are provided to circulate hot water to four (4) heating zones. According to ASHRAE, cast iron boiler useful life expectancy is 30 years and inline circulating pumps have a useful life expectancy of 10 years. We were unable to determine the date of manufacture and installation of the boiler and the inline pumps. The pumps and the boiler maybe either at the end or beyond their useful service life. Products of combustion are vented into the chimney through a sheet metal flue. Combustion air, one terminating high and one terminating low in the boiler room, ducted from the exterior wall, appear to be sized per International Mechanical Code. Bird screens are not observed at the combustion air outside terminations.

The air separator is exhibiting significant surface corrosion and sections of hot water piping in the boiler room are missing insulation.

The insulation covering the hot water piping throughout appears to be original to the building. Piping insulation has a useful life expectancy of 20 years. In addition to having outlived its useful life, it appears to be non-conforming to current code requirements for thickness.

Perimeter radiation, fed from the boiler system, provides heat in most of the occupied spaces. Second floor heating is though perimeter radiators made from multiple rows of steel pipes. Perimeter radiators appear to be original to the building and are beyond their useful life expectancy.

- Replace existing boiler and associated near boiler specialties. The new boiler will be high efficiency condensing boiler, with flue and combustion air pipes connected directly to the outdoors.

- Engage the service of a Chemical Service Provider to maintain proper water treatment to the building water loop
- Replace in-line pumps.
- Perform ultrasonic testing for the rest of the piping system to determine the rates of corrosion within the pipes. Replace pipes as needed.

- Provide piping insulation with thickness complying with the Energy Code.
- Replace toilet room exhaust fans.
- Replace Officer's Room air conditioner with a ductless split system that can provide the code required ventilation and air conditioning.

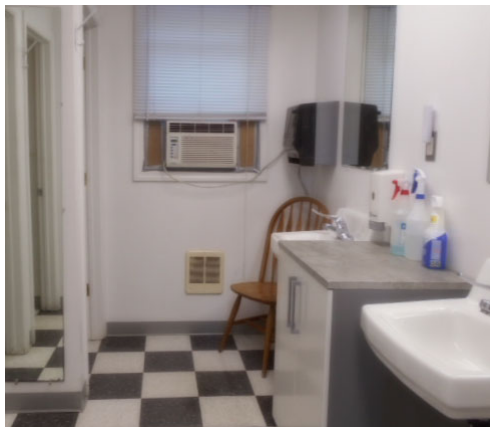
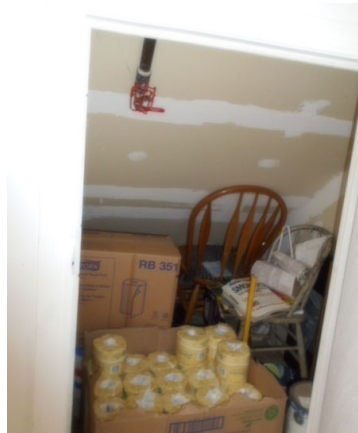
Bathroom heating is a wall mounted electric heater. No improvement is recommended at this time. If renovation is scheduled in the future, we recommend replacing the electric heater.

Entry/Stairs area heating is from a wall mounted electric unit heater. No improvement recommended at this time.

A sprinkler pipe and sprinkler head are installed in the storage below the stairs. The storage room does not have heating equipment. The sprinkler pipe within this storage space maybe subjected to freezing temperature.

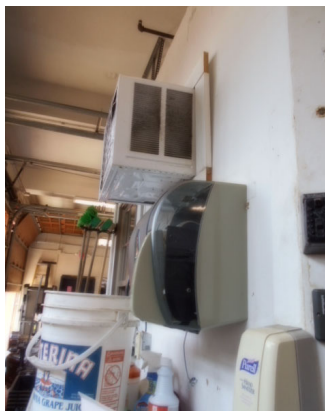
The first floor Officer's Room is housed in one (1) Bay and is lacking ventilation. Adding tempered ventilation air ins recommended. Cooling is provided by a wall mounted air conditioning unit. Expelled heat from air conditioning unit is discharged into the apparatus bay. The condensate drain is collected in a bucket. There is no active heating element provided in the room. Heating is currently from the radiated warm air from the boiler room.

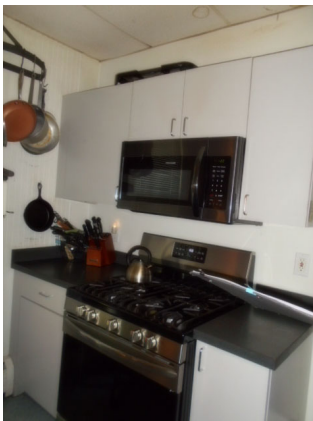
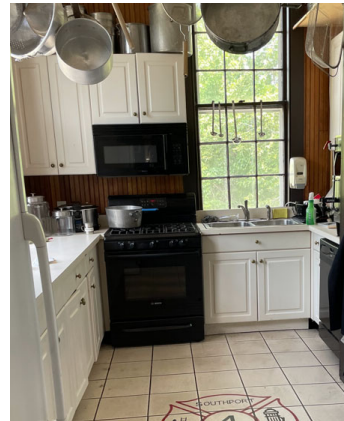
Over the range recirculating microwave vent hoods are provided at each cooking range. A fan pulls air through the filter and recirculated back to the space. The existing cooking appliances are residential stove. Per International Mechanical Code Section 507.1.2, domestic cooking appliances utilized for commercial purposes require Type I hood, domestic cooking appliance utilized for domestic purposes within a commercial setting shall comply with IMC section 505. The Authority Having Jurisdiction shall determine code compliance for a particular application. A residential hood with UL300A suppression system may be considered for this type of application. However, the use of this type of use shall be approved by the AHJ.

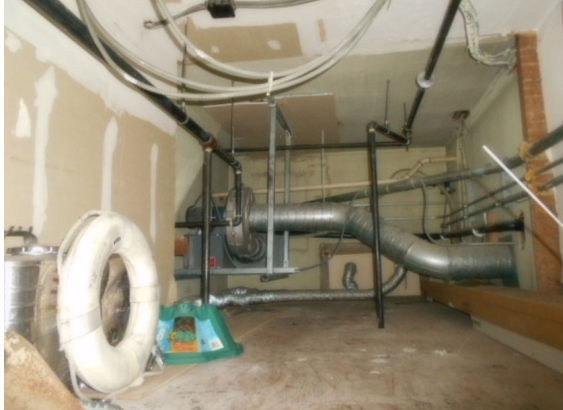
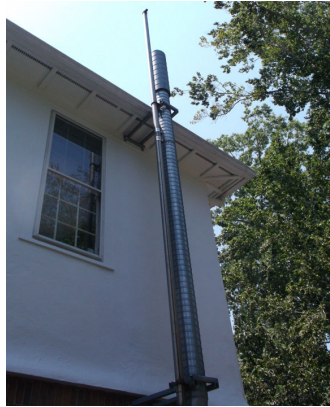
The Apparatus Bay is currently heated by hot water unit heaters. The unit heaters appear to be original to the building and have outlived their useful life expectancy of 20 years. Apparatus Bay ventilation air comes from open overhead doors.

A tail pipe exhaust system currently removes products of combustion from active vehicles. A fan, mounted in the mechanical mezzanine above the toilet room, exhausts the air through a vent stack which runs up the exterior of the building to above the roof line. We were not able to determine the model, capacity and age of existing system at the time of visit. We are not aware of any issues with this system however, it was mentioned that a plan is in place to replace/improve all of town of Fairfield fire house tailpipe exhaust systems.

The International Mechanical Code section 404.2 requires that requires that a minimum of 0.05 cfm per square foot of continuous ventilation be provided and 0.75 cfm per square foot of ventilation air is exhausted when any vehicle is running within the space. In modern installations a CO/NO2 detection system is installed which triggers the operation of exhaust fan. In addition to this exhaust fan, a means to provide make-up air,

either by a separate supply fan or a louvered opening with motorized damper, would be installed to maintain the air balance for the space. Please note that this ventilation requirement needs to be met regardless of whether a tail pipe exhaust system has been installed.

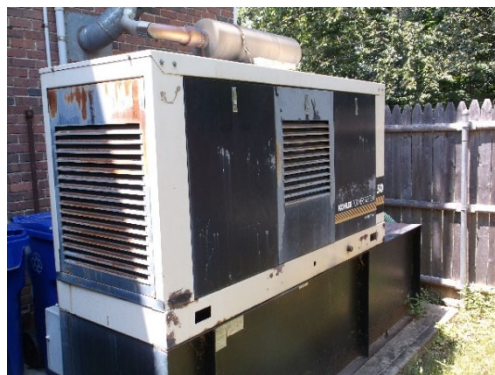
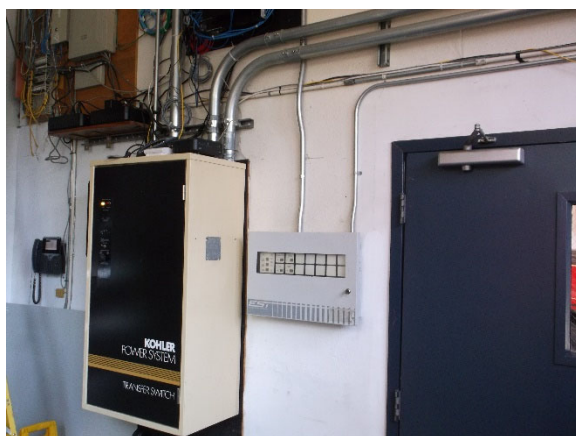
output breaker (225 amps) that feeds panels 'LP1' & 'LP2' via an automatic transfer switch. The generator was installed on 11/6/95, with the enclosure showing signs of age (rusting throughout).

- Replace existing wall switches with new occupancy sensors and dimmer switches.
- Replace the existing fire alarm system, at the end of its useful life.
- Add additional emergency lights to meet current code required light levels.
- Install emergency lighting at the exterior of all egress doors to meet current code requirements.
- Repair/Replace existing rusted generator enclosure.

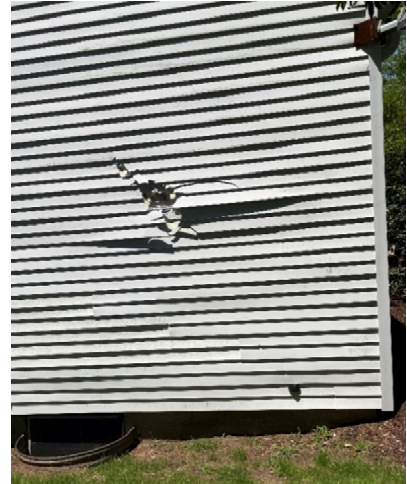
Much of the exterior of the building is in good condition. The building is constructed with brick “veneer”, rigid insulation, and a glazed concrete masonry unit interior. The energy efficiency of this construction is low, and typical in the 1970s (“pre-energy crisis”), and not one that is easily or readily corrected. Overall, the mortar is in reasonably good condition although the age of the building suggests that in the future a detail review should evaluate if repointing is required. The side buildings are covered with vinyl siding. Some of it is in disrepair. A portion of the eastern façade should be repaired. The north side needs to be cleaned.

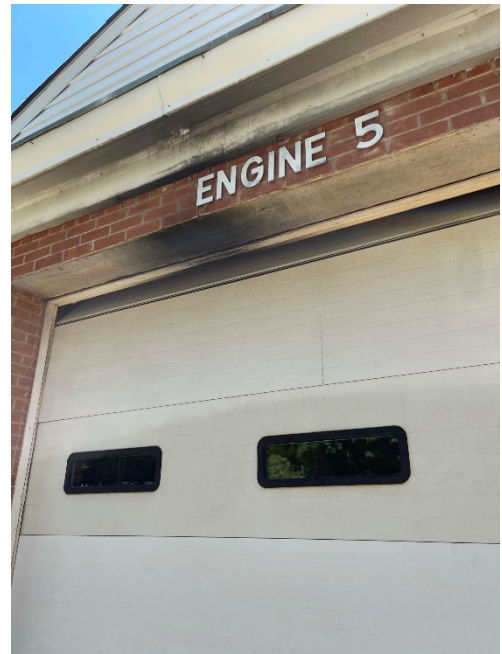
There are a variety of exterior doors. First and foremost, there are 2 large overhead doors. These doors look to be in fine working order. The concrete below was recently redone. The corner guards are rusting and peeling and should be refinished. The door heads are rusting slightly but some areas are stained with black soot. This should be cleaned. Other exterior doors are wood and in fair condition. The front door to the watch room is peeling. The door also has knobs that require twisting. It is also up two steps. A ramp should be provided. The remaining doors appear in better condition and are only accessible from a set of stairs. Minimally the main door used for public should be made accessible.

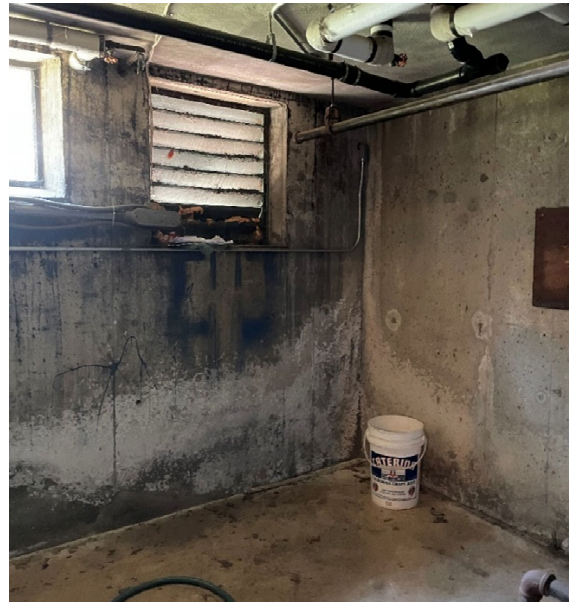
There are a few different materials in this building. The glazed block in the apparatus bay is in good condition given its age. Mortar joint have held up well but overall, the surfaces could use a good cleaning. The walls in the restroom have ceramic wall tile and are in good condition. Walls throughout the rest of the station are gypsum wallboard. The renovated areas are in very good condition while other areas are in fair condition with some areas in need of paint. Some areas of the basement walls have signs of efflorescence and possible mold indicating a moisture issue. This area of the wall should be inspected to determine the underlying cause.

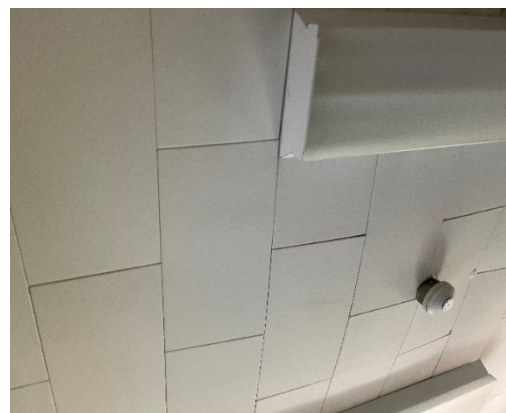
There are a few types of ceilings in this building. The apparatus bay ceiling is painted plaster. The remaining ceilings are primarily acoustical ceiling tile (ACT). There are two types that are evident and correlate with the construction timeframe. The newly renovated spaces consist of 2x2 ACT hung on an exposed grid. This is typical for today. While the original spaces remain to have a 1x2 concealed spline ACT. Given its age it could contain asbestos. Regardless these ceilings are not easy to work with and it should be replaced in the future.

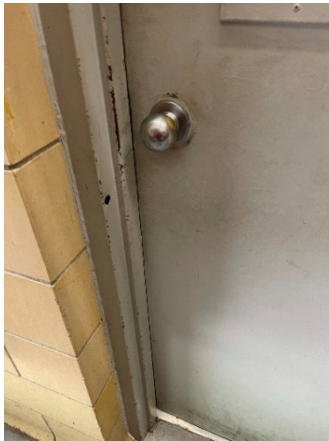
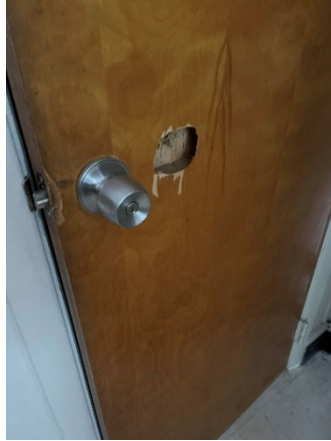
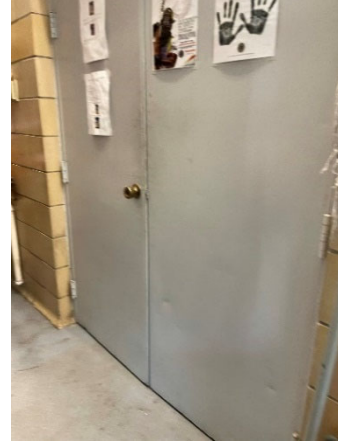
There are both hollow metal doors and frames along with wood doors and frames throughout the station. The doors are in fair to poor condition. Hollow metal doors and frames need to be painted. Several wood doors are in disrepair. Some are hollow and damaged. They should be replaced. Most door hardware are knobs that require twisting. They need to be replaced with lever or pull handles.

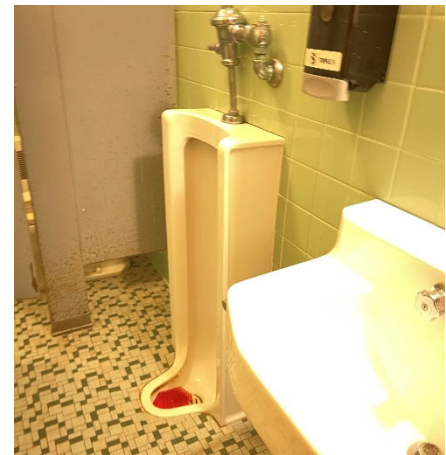
There are multiple restrooms throughout the station. None of the restrooms are ADA compliant nor are there any female restrooms. There are no ADA showers. Additionally, the urinals are floor mounted which are no longer code compliant. These spaces are dated and in need of renovations. The toilet partitions are also showing their age and beginning to rust. ADA compliancy and gender equality should be a part of the long-term capital planning of this station.

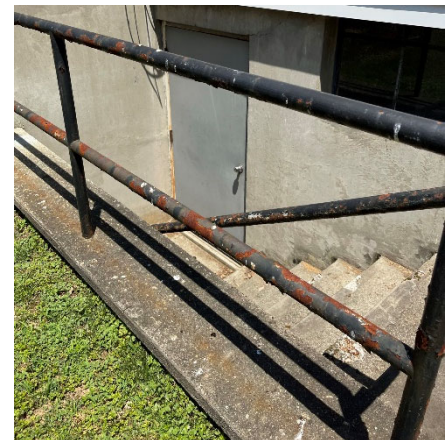
The only interior stairs are to the basement and as previously mentioned VAT floor tile is apparent. The handrail is also not code compliant with the proper extensions. The exterior stairs from the basement handrail and guard rails are also not compliant. They are also rusted. These should be replaced.

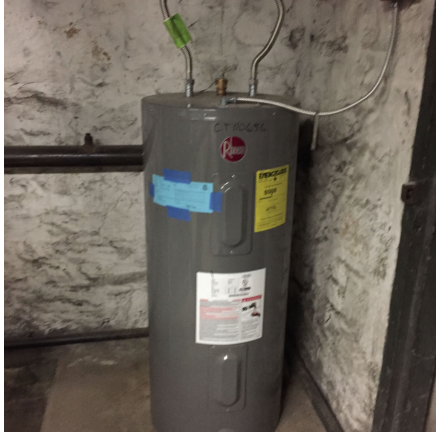
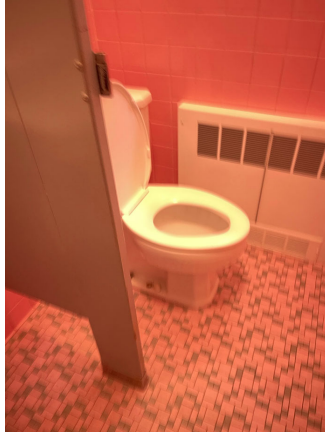
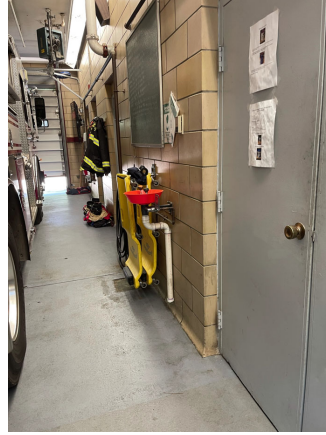
Additional fixtures in the building include a fiberglass service sink in the Apparatus Bay. A laundry indirect drain standpipe with air admittance valve is located behind the washer and dryer. The emergency eye wash is in the apparatus bay, fed with cold water only. Current OSHA/ANSI standards require a supply temperature range of 60-100 deg F to emergency fixtures. Adding hot water supply and a thermostatic mixing valve to the current installation will provide a safe, inviting code-compliant water temperature at this fixture.

- Remove and replace plumbing fixtures with water saver fixtures.
- Provide an expansion tank, a thermostatic mixing valve on the water heater and a recirculating system through the pipe tunnel as there is a long wait for hot water and exceeds code requirements.
- Test and inspect backflow preventers.
- Provide a vacuum breaker on the laundry tub sink.
- Convert the sanitary system from septic to a public sewer system if possible.
- Provide tepid water to eye wash.
- Provide floor drains in basement boiler rooms where needed.

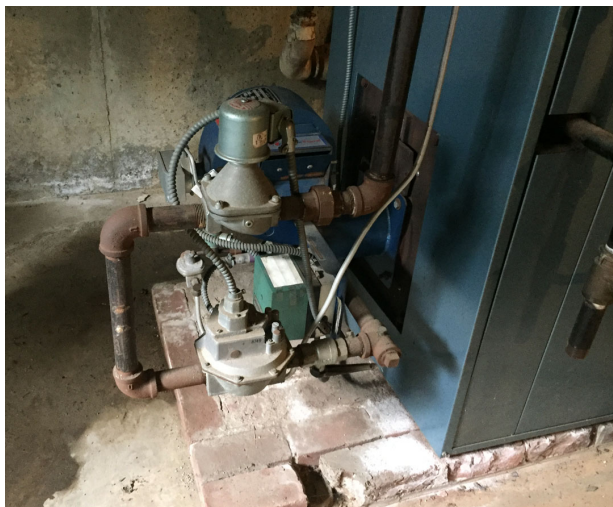
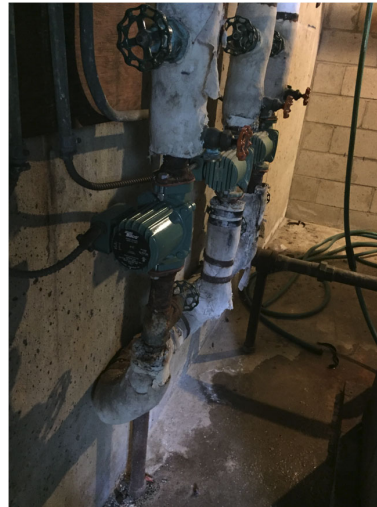
The hot water piping distribution system appears to be original to the building. The hot water piping is in the basement and is routed in the tunnel to the crawlspace below the dayroom and kitchen area. Hot water supply and return piping has a useful life expectancy of 50 years. The boiler supply manifold is showing signs of heavy wear.

The insulation covering the hot water piping appears to be original to the building. Hot water piping through the tunnel appears to be missing insulation. Piping insulation has a useful life expectancy of approximately 20 years. In addition to having outlived its useful life it is likely that it is non-conforming to current code requirements for thickness.

- Provide piping insulation with thickness complying with the Energy Code.
- Provide unit heater in the basement.
- Provide basement with dehumidifier with outside air duct connections for ventilation. Provide condensate drain piping terminating to an indirect drain in the basement.

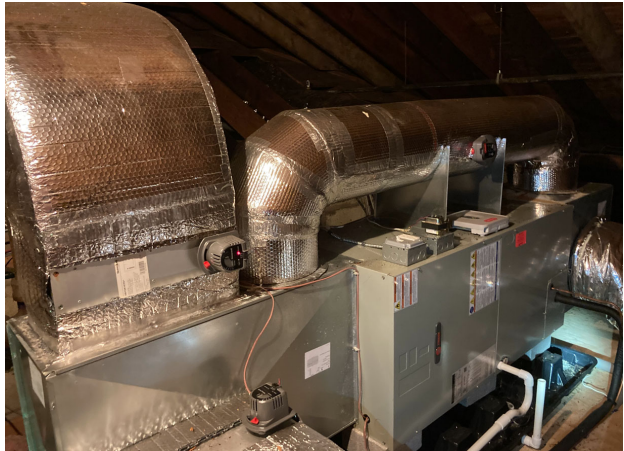
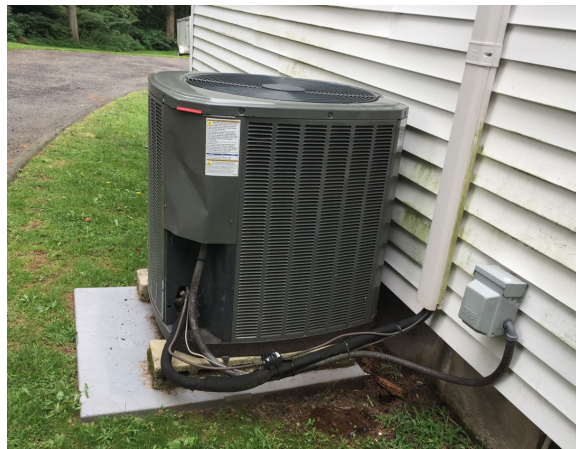
The air-cooled condensing unit, located on the south side of the building, is mounted on a concrete masonry unit block on top of the pre-fabricated pad. The unit has a dent and was pushed close to the exterior wall. This was caused by the fallen tree from the

storm. We recommend moving the unit away from the exterior wall to maintain the manufacturer's airflow clearance requirements.

- Move air-cooled condensing unit away from the exterior wall.
- Replace refrigeration piping insulation. Provide all exterior refrigeration piping insulation with aluminum jacket.

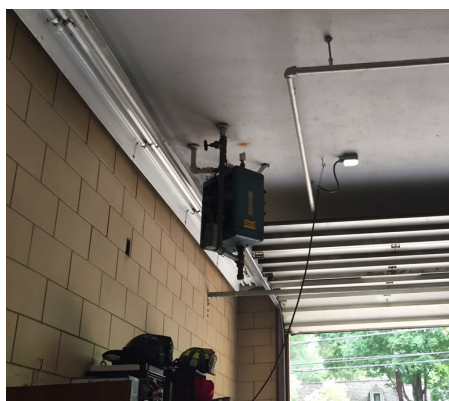
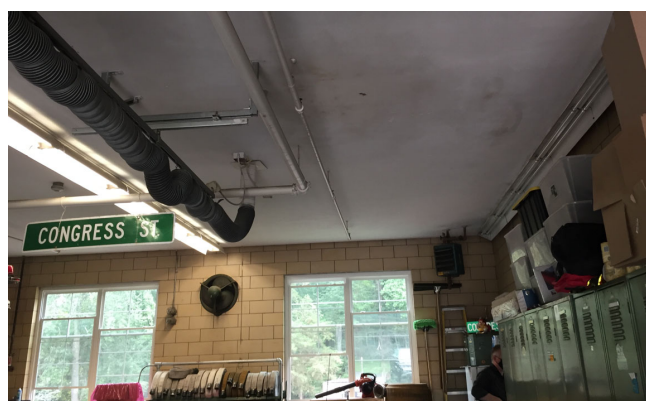
The Apparatus Bay is heated by two (2) hot water unit heaters. The unit heaters appear to be original to the building and have exceeded their useful life expectancy of 20 years.

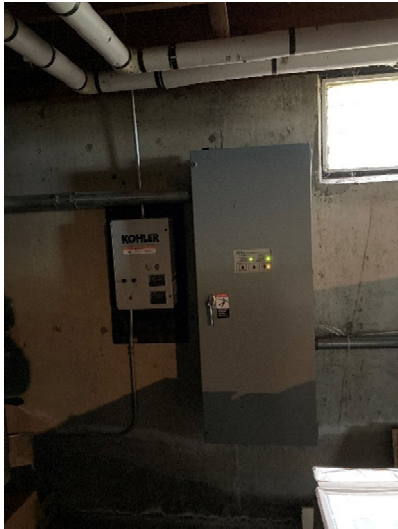
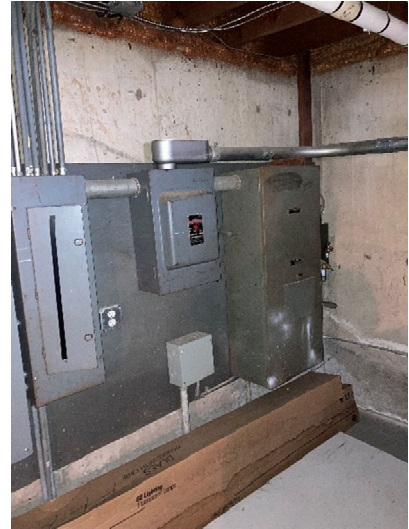
The existing electrical service is made up of a 200 amp 120/208V-1PH-3W Trumbull Electric service rated fused disconnect switch with integral CT cabinet. The service switch feeds what appears to be a manual transfer switch, which also has a feed from the generator. The manual

switch in turn feeds the MDP via an old electrical panel (used as a splice box). The MDP feeds a load center in the basement in addition to all of the branch circuits for the building. All of this equipment is in the

- Replace the existing electrical panels and service switch with new. Eliminate the manual transfer switch and wire new normal service through the existing ATS. Provide a new 2-section MDP panel to eliminate all of the "split" type breakers.
- Replace existing wall switches with new occupancy sensors and dimmer switches.

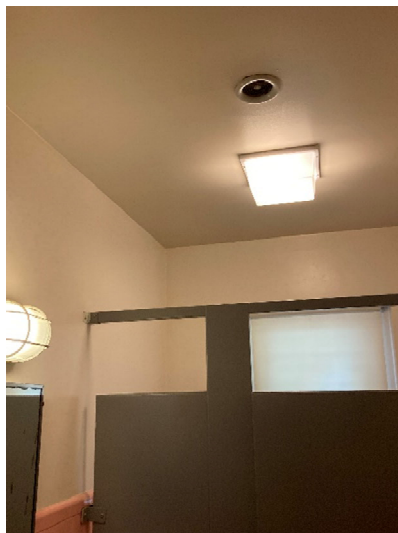
The existing interior lighting in the building is a mix of recessed fluorescent lensed 2x4 fixtures, screw-in incandescent sockets, surface mounted incandescent/fluorescent round, square & oval fixtures, surface mounted industrial fixtures, surface mounted fluorescent wraparound fixtures

and wall mounted reading lights (bunks). These fixtures appear to

be in fair/good condition and working properly. It is our understanding that the majority of the fixtures have been upgraded with new LED bulbs. There are some fixtures that still have fluorescent or incandescent bulbs. These were areas that the town determined to be low use and would be replaced later as needed. Most of the areas have local toggle type & dimmer switches for control of the light fixtures, with a

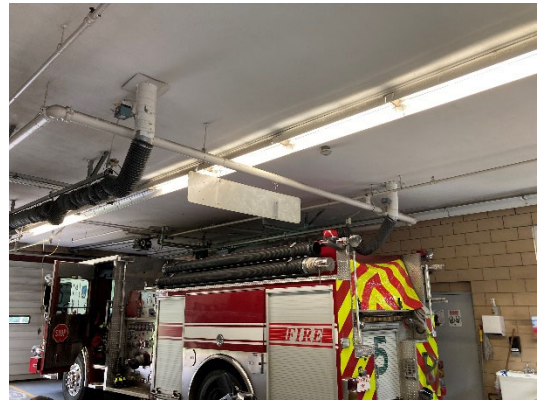
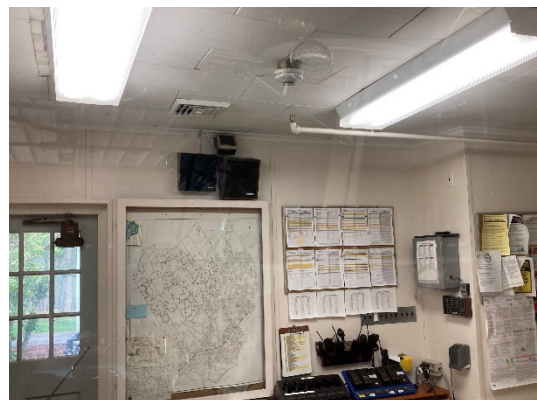
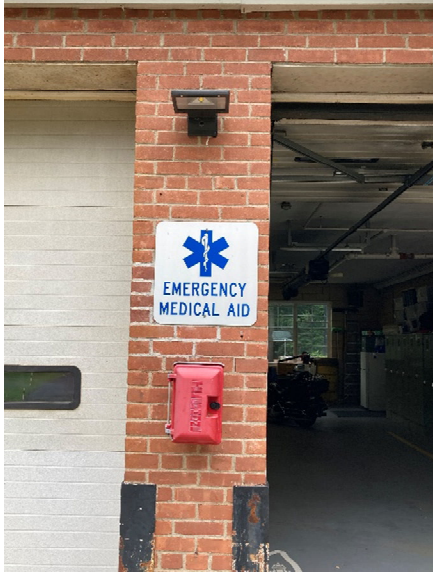
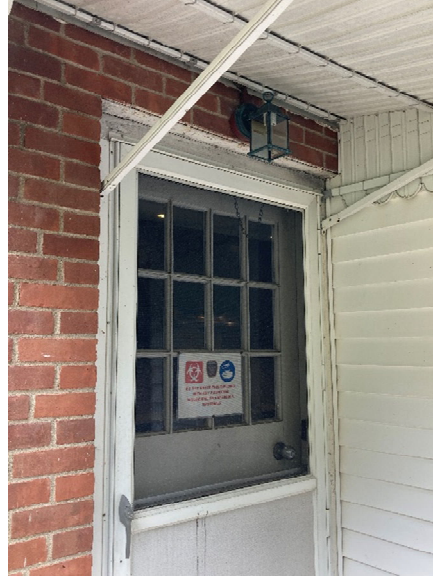
couple of spaces with rotary timer switches and wall occupancy sensor switches for control. The existing exterior lighting for the building is made up of wall mounted incandescent "lantern" type fixtures on the front and back of the building with a twin headed incandescent spotlights at the south-west corner of the building. There is a wall mounted LED full cut-off light between the front overhead doors and some adjustable LED flood lights on the back of the building. We were not able to determine the operation of the exterior fixtures at the time of our inspection.

- Add a fire alarm manual pull station at all egress doors that currently do not have one.
- Install missing smoke detector in hallway outside of Office & Bunk room.
- Install emergency lighting at the exterior of all egress doors to meet current code requirements.
- Replace existing exterior weatherproof receptacle covers with “in-use” covers.
