**Town of Fairfield**  
Town Planning and Zoning Commission  
725 Old Post Road  
Fairfield, Connecticut 06824

**To: Members of the RTM**  
**From: Jim Wendt, Planning Director**  
**Date: April 19, 2022**  
**Re: Opt-Out of State Mandated Zoning Regulation Language**

FAIRFIELD TOWN PLAN AND ZONING COMMISSION PROPOSED OPT-OUT OF  
STATE MANDATED REGULATION LANGUAGE REGARDING OFF-STREET PARKING.

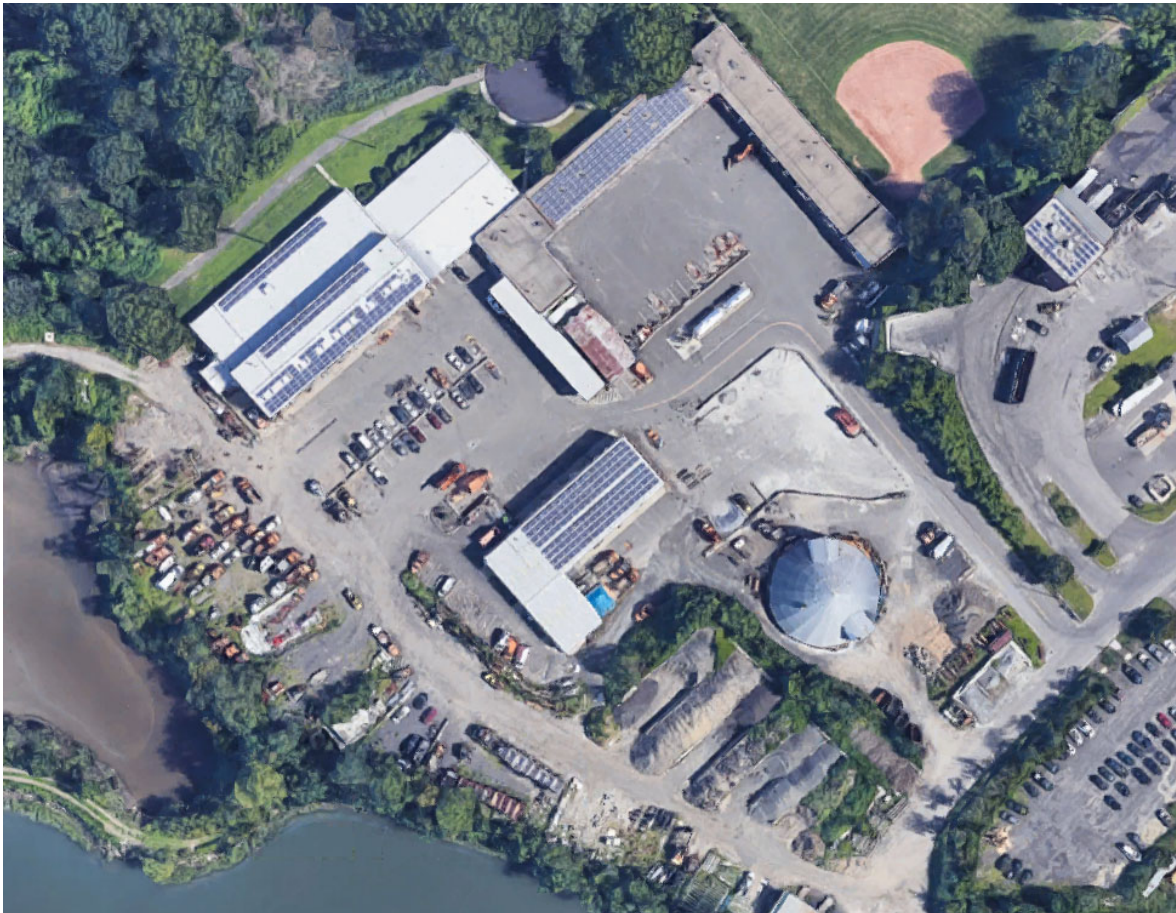
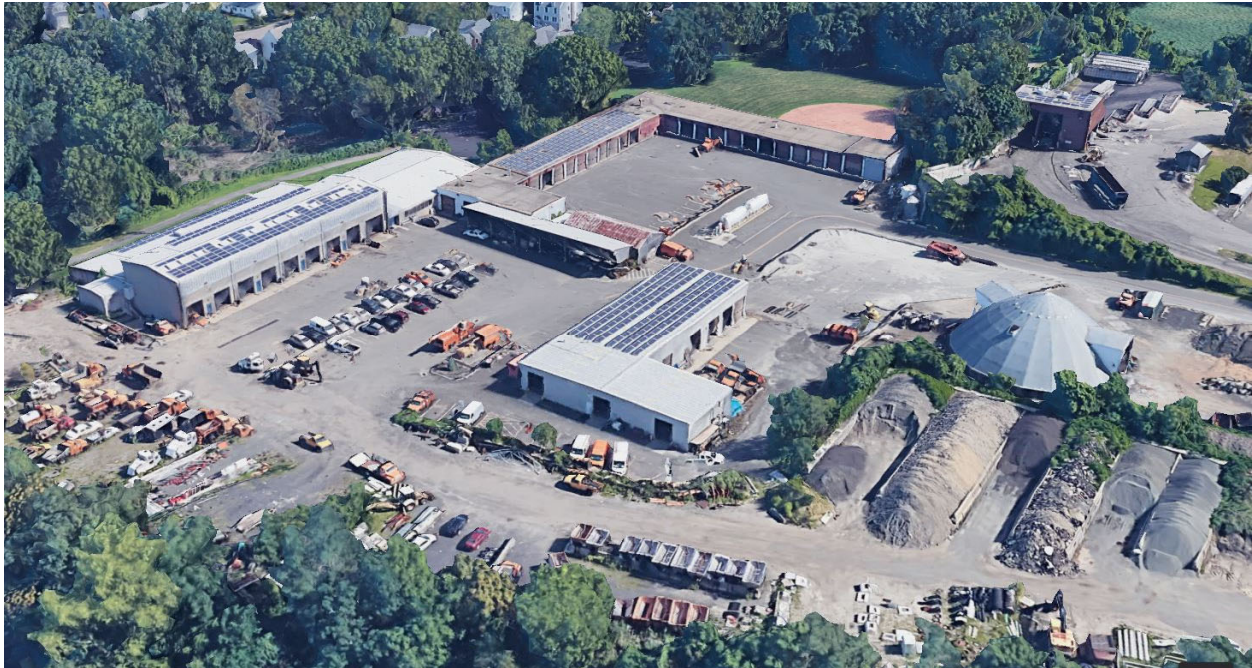
The series of buildings overall are in fair condition. Considering the variety of ages of these buildings, the issues vary through each as well. The mechanics bays at the far left in the photo is newer and so is the Carpenters shop/parks L-shaped garage in the center both with solar panels. The Admin section abuts the mechanics bays and is connected to the oldest portion, the U-shaped Old Garage/truck bays, and the Masons Garage.

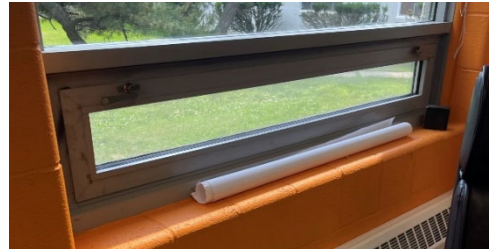
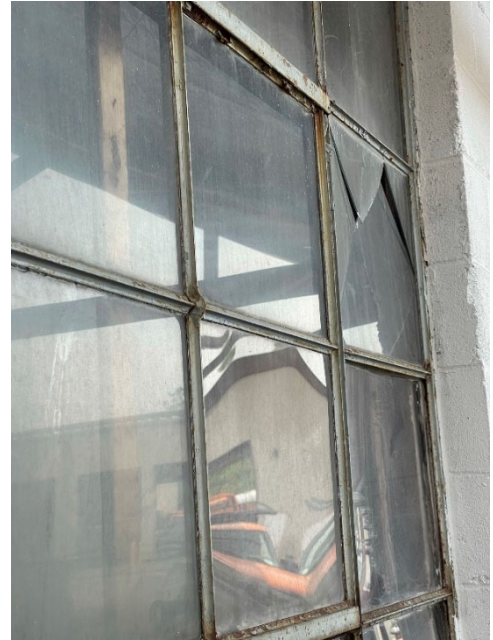
There are limited windows throughout the buildings. Most are within the Admin building and the Old Garage/truck bays. Admin has aluminum window systems. They are double glazed with an air space with small operable portions for ventilation. They appear to be in good condition throughout this building. The Old Garage/truck bays contain original single pane steel windows. These are in very poor condition. Many have rusted away or have broken glass, and all are covered with clear plastic at the interior. Although this is a garage with less concern for energy efficiency, these windows are so far gone that they should be replaced. In lieu of standard windows a less costly option may be to use a fiberglass sandwich-panel assembly such as a Kalwall system.

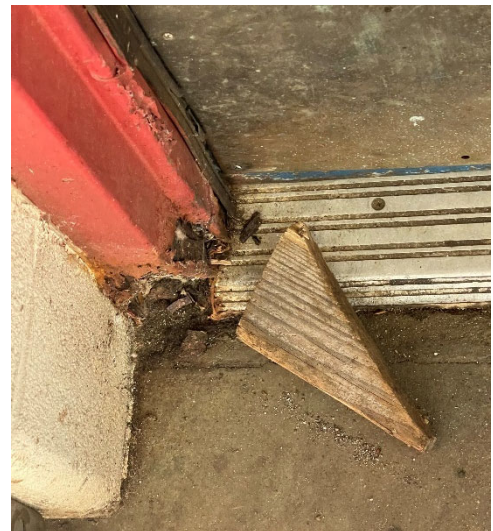
There are a variety of exterior doors. There are many overhead doors throughout the facility. While many doors were open and unable to be seen during the time of the assessment, these doors appear in good condition. The heads, jambs and sills are in good condition with some areas chipped or dented as previously noted. The garage doors at the Old Garage are obviously older and many are fading in color and portions of the panels have been replaced. Many of the jambs are also peeling and some of the metal sill angles have begun to wear away. These doors should continue to be monitored and replaced as needed. The remaining standard doors throughout the buildings are primarily metal with limited wood doors in the original Old Garage. The hollow metal frames and doors in some areas such as the Admin Building and Mechanical Building are rusting and should be replaced. It is suggested to replace these exterior doors with aluminum doors and frames to avoid future corrosion.

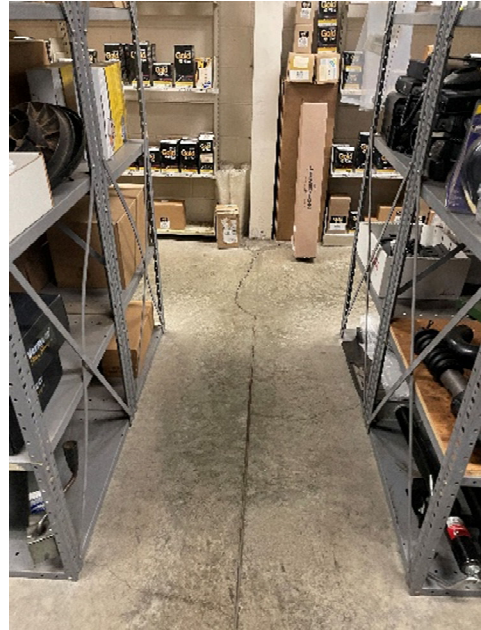
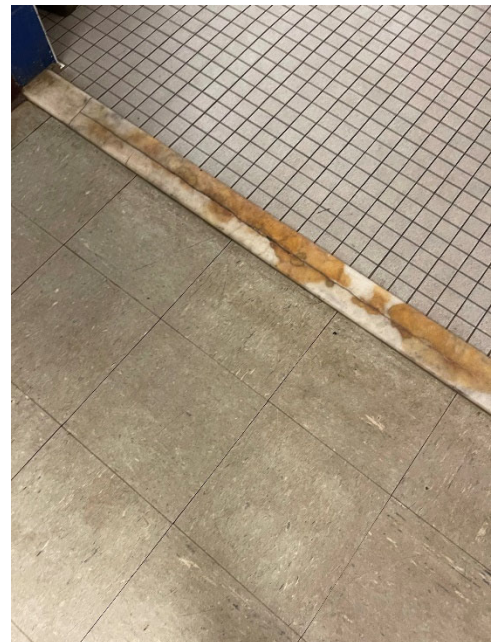
There are a variety of interior wall types and partitions through this complex of buildings. Primarily most walls throughout all the buildings consist of painted concrete masonry units (CMU). This is evident in the Mechanics Garage and Admin Building, the Old

Garage and much of the Carpenters Building. Overall, the CMU is in good condition with some stepped cracking in limited areas. These should be repaired as some already have. In addition to CMU the Carpenter's building has exposed insulation paneled walls. A small portion in the Old Garage and in the Mason's Garage has wood paneling. They all appear in fine condition. Other materials in the Admin building consists of ceramic wall tile at the restrooms and locker room. There are also some gypsum wallboard partitions in the office suite. These all appear in good condition. In the wash bay of the Mechanics Garage the column bases are rusting. These should be scraped, primed and epoxy coated to protect the integrity of the structure.

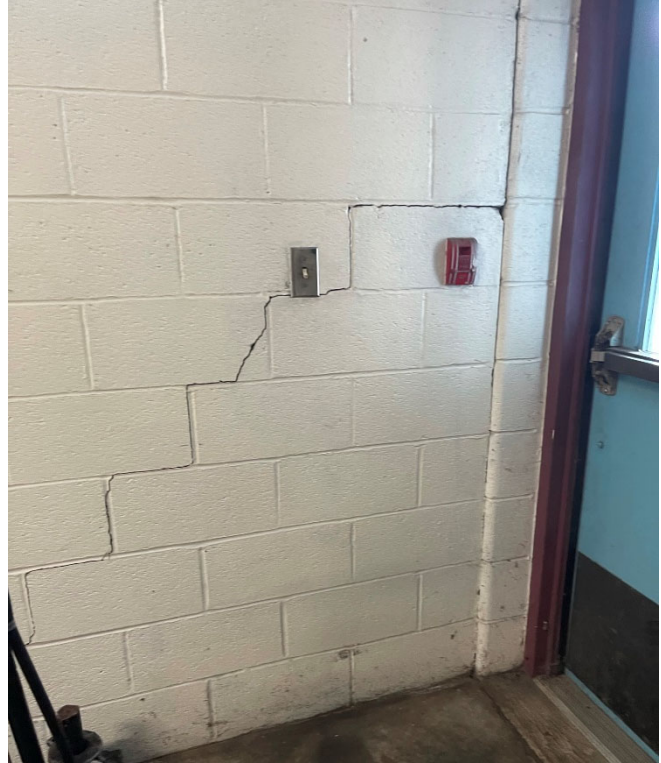
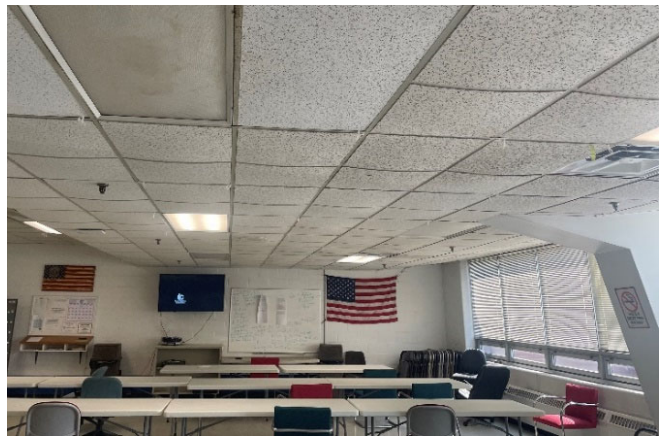
There are few finished ceilings throughout the overall complex. The Mechanics and Carpenters Garage both consist of exposed insulation panels under the roof deck. Most of the Old Garage and the Masons Garage has an exposed deck. They appear in good condition. There is a portion in the Old Garage with a plaster ceiling which is in fine condition. The Admin building had a variety of ceiling types such as Acoustical Ceiling Tiles

(ACT), exposed insulation and plaster. Some of the ACT is 2x2 and others are 2x4. They are not in the best condition. They are older and are beginning to sag. Signs of stains, dirt, and contact with moisture are present. They should be replaced in the future as many areas are nearing the end of their useful life.

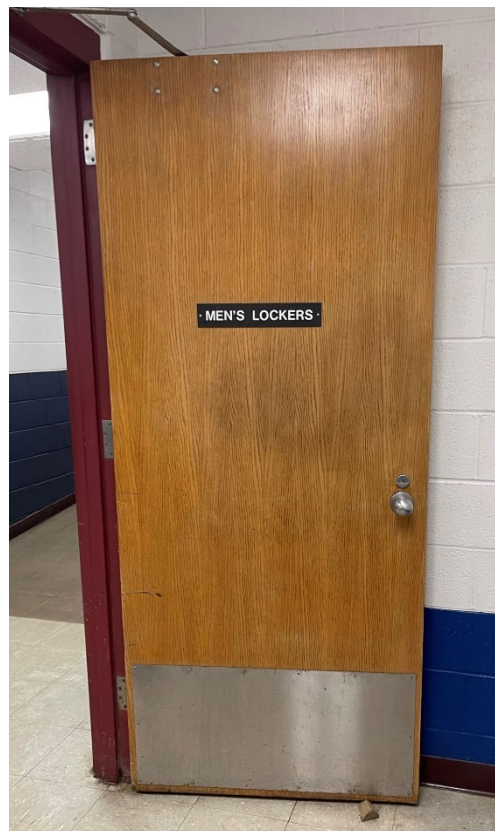
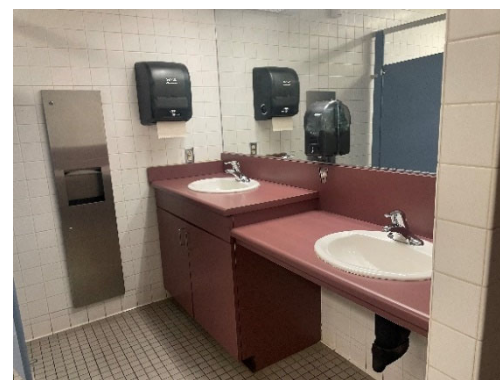
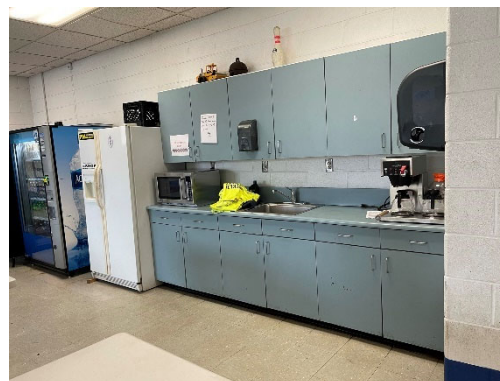
There is limited casework throughout the facility. In the training room of the Admin Building a plastic laminate bank of casework accommodates a breakroom area. The sink is not ADA complaint nor is there a knee space incorporated.

As noted within many of the sections, there are multiple code and accessibility issues within this building. Door hardware, ADA restrooms and showers and casework were previously noted. Other ADA issues are with ramps and stairs. The ramps in the Admin Building do not have any handrails. The stairs in the training room does not have compliant handrails with extensions. Additionally, much of the signage throughout the complex is not compliant and should be updated. Many ADA accessibility issues were noted at this facility. This is a common occurrence given the age of the building. These items should be included in the long-term capital plan.

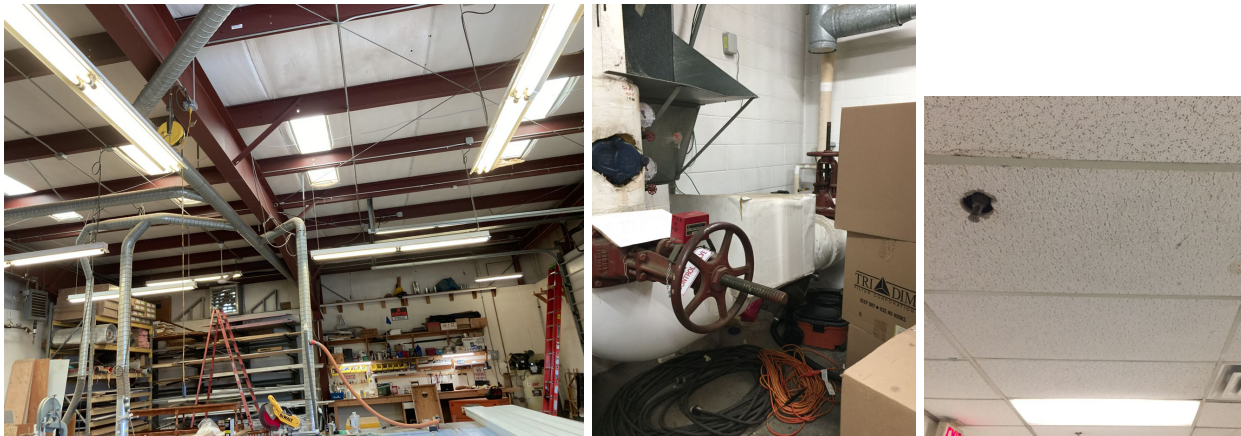
Some sprinkler heads missing escutcheons.

- Provide a dry pipe system with sprinklers in the garage.
- Continue to maintain, test, and inspect sprinklers and devices as required by code.
- Provide sprinkler pipe escutcheons where missing.

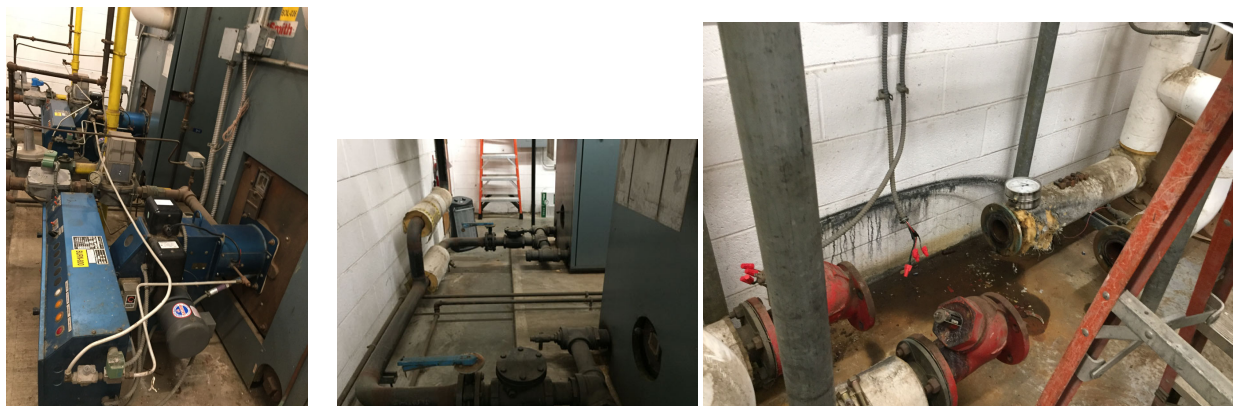
Two (2) boilers located in the mechanical room serve the admin and the mechanics bays. Both Boilers are H.B. Smith Series 28A-6 and were manufactured in 1989. Cast iron boilers have a useful expected lifespan of approximately 30 years. At 32 years old they have outlived their serviceable life. Products of combustion are vented through sheet metal flue to the roof. Combustion air to boiler room appears to be adequate. Two(2) pumps serve the building. Inline pumps have a useful life expectancy of 10 years. Both pumps are being repaired at the time of visit.

The hot water piping distribution system appears to be the same age as the building. Piping system, with proper maintenance and proper water treatment, can operate for 50 years, however, piping system should be inspected utilizing ultrasonic testing to determine rates of corrosion within the piping.

The insulation covering the hot water piping is original to the building. Hot water pipe sections are missing insulation. Piping insulation has a useful life expectancy of approximately 20 years. In addition to having outlived its useful life it is likely that it is non-conforming to current code requirements for thickness.

A hot water unit heater provides heating for the mechanical room. The unit appears to be good condition. Finned tube radiation provided in perimeter offices and training room appear to be in good condition. Cabinet unit heater provided in vestibule is in poor condition.

- Admin
  - Replace existing boiler and associated near boiler specialties. The new boiler will be high efficiency condensing boiler, with flue and combustion air pipes connected directly to the outdoors.

- Replace in-line pumps.
  - Provide chemical bypass feeder in the boiler room.
  - Engage the service of a Chemical Service Provider to maintain proper water treatment to the building water loop and cooling tower loop.

- Provide piping insulation with thickness complying with the Energy Code.
  - Replace cabinet unit heater in the admin vestibule.
  - Repair/replace worn out fittings.

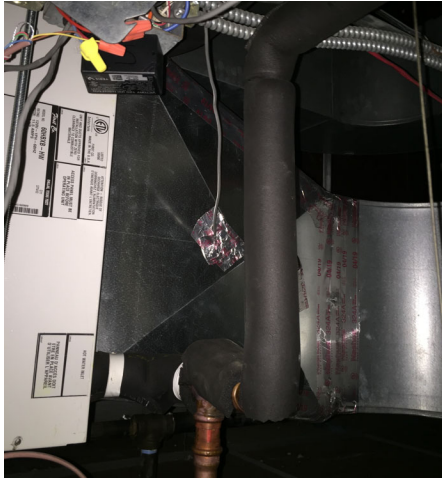
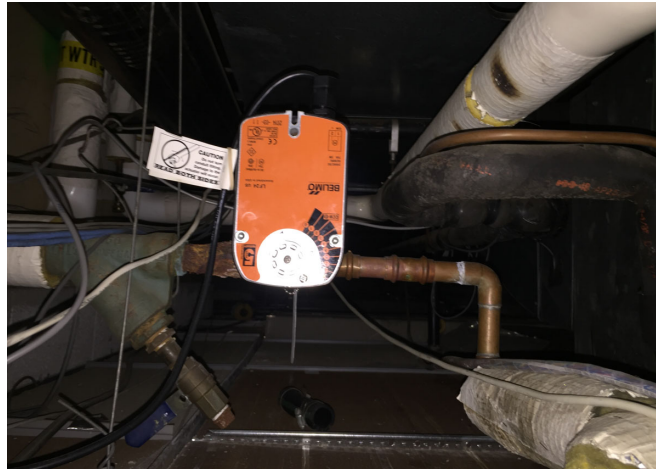
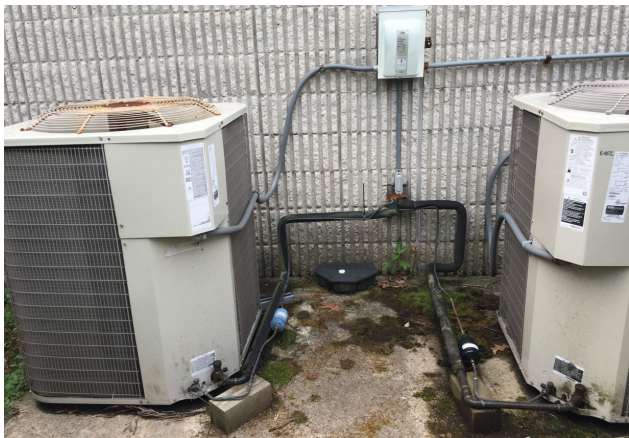
There are two(2) ducted split systems providing heating and cooling to the admin. One system serving the training room has a capacity of 5 tons. The indoor unit appear to be recently replaced and is matched with a standard efficiency air cooled condensing for this system manufactured in 2014. Based on the capacity, this unit should be equipped with economizer. Economizer allows the system to provide free cooling to the space

when the outdoor air temperature is cooler than the indoor air temperature. The second system serving the office area has a capacity of 4 tons. The indoor unit is a Carrier manufactured in 1989 matched with an air cooled condensing manufactured in 2012. Both condensing units are using the refrigerant R22. Refrigeration piping insulation is starting to deteriorate. The systems appear to be provided with local controls.

- Provide ductwork insulation.
  - Replace exhaust fans serving toilet rooms and locker room. Clean and seal existing ductwork. Rebalance system.
  - Provide economizer dampers (outside air and return air damper) and economizer control at air handling unit.

- Replace indoor unit serving the admin office. Clean and seal existing ductwork.
  - Replace existing temperature controls.
    - Consider adding DDC system to allow remote adjustment of setpoints and monitoring of space conditions and alarms.

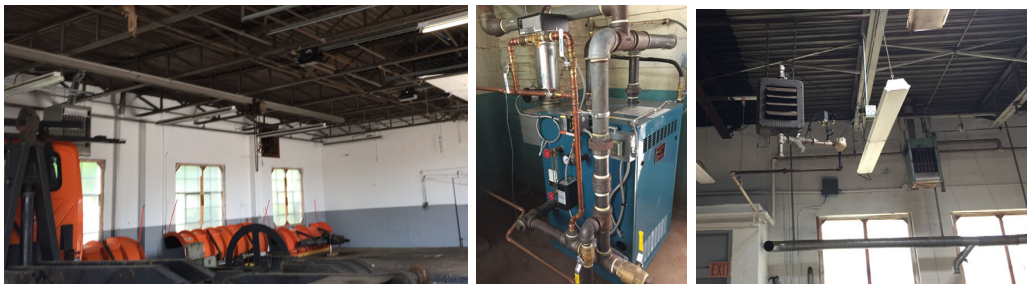
The corner area of the Old Garage /Truck Bays is heated using a Burnham model IN61 steam boiler. This boiler was recently installed and serves all the existing steam unit heaters and radiators in the adjacent space. The steam condensate receiver appears to be original to the building. Products of combustion are vented into the chimney through a sheet metal flue.

The Northeast wing of the Truck Bay appears to have a tailpipe exhaust system. This system appears to be old and likely near beyond its useful service life.

- Replace ductless split system.
- Mason's Garage/Old Garage / Truck Bays
  - Add exhaust fans and outside air intake in the and provide carbon monoxide and nitrogen dioxide detectors and control system to energize exhaust fans and provide alarm on detection of vehicle exhaust.

- Replace steam condensate receiver.
- Carpenter's Shop and Parks Garage
  - Repair/ Provide pipe insulation in the Carpenter's Shop.
  - Engage the service of a Chemical Service Provider to maintain proper water treatment to the building water loop.

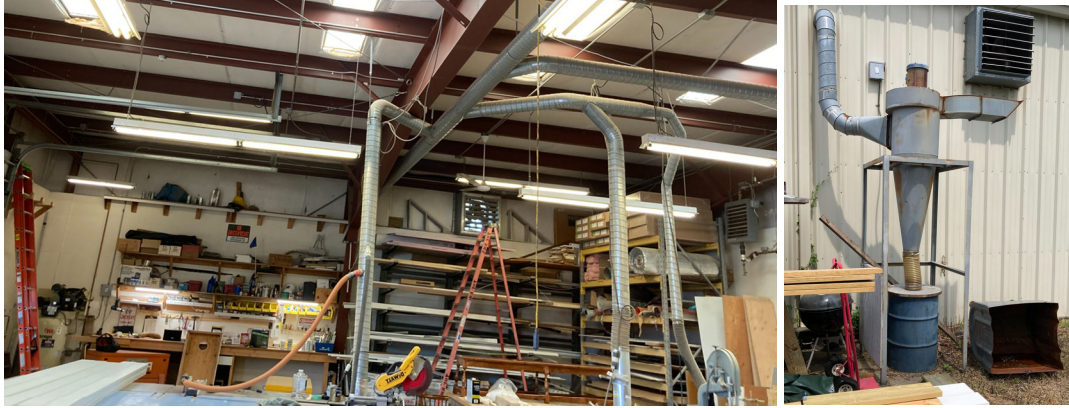
A dust collection system is provided in the Carpenter's shop. The system consists of a utility exhaust fan, duct collector and metal ductwork with duct drops and duct collars at the equipment. The system appears to be serviceable but is showing signs of surface corrosion.

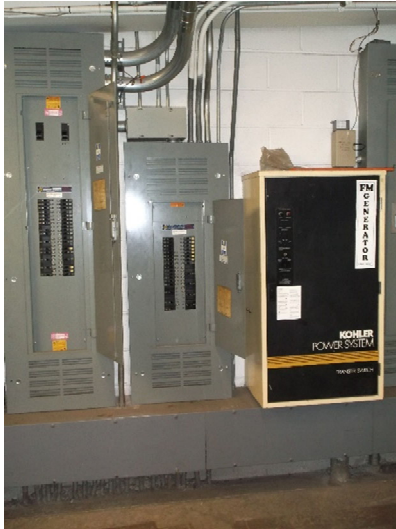
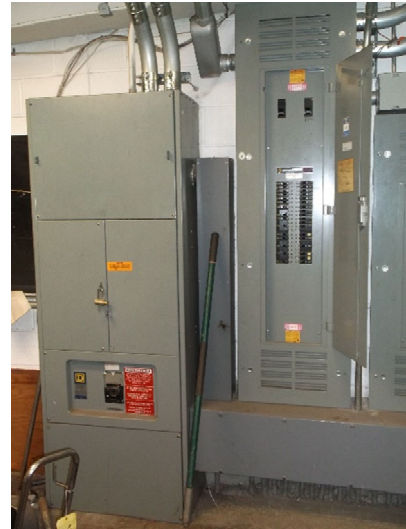
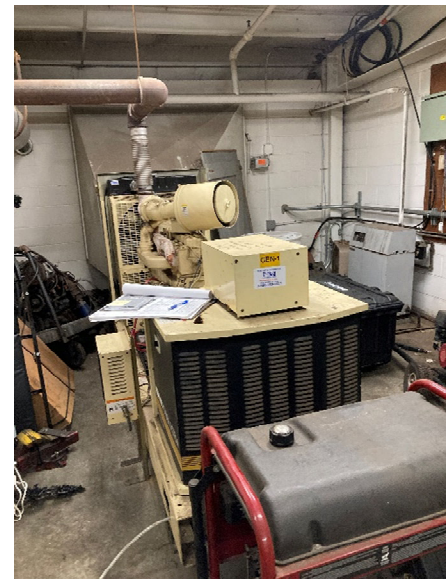
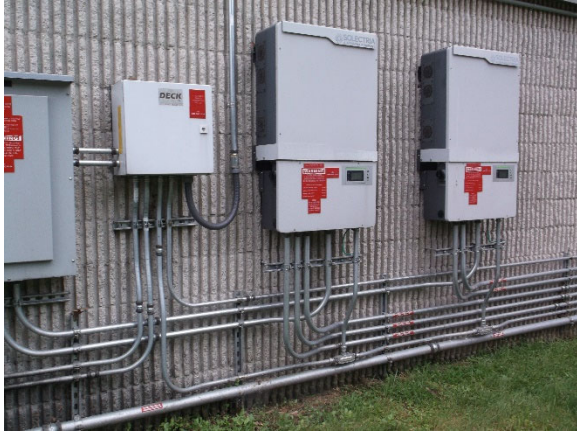
The existing electrical service for the Mechanics Garage/Admin. Building and Carpentry Shop/ Parks Department building is made up of an 800 amp 120/208V-3PH-4W Square D main breaker, with integrated C/T cabinet feeding an adjacent 400-amp normal distribution (2-section panel 'PP-1') and a 400-amp generator distribution (3-section panel 'EP-1') via automatic transfer switch (ATS) located in the mechanical room of the Mechanics building. Panels 'PP-1' & 'EP-1' feed panels 'PP-2' & 'EP-2' in the Admin. building each from a 225A-3P breaker in their respective panels. Panel 'PP-1' also feeds a panel in the Carpentry Shop from a 150A-3P breaker. These panels feed all the branch circuits within their respective buildings. The generator is an 125KW diesel 120/208V-3PH-4W with a single 400-amp output breaker located in the same room as the main switch. There is also a photovoltaic system on the Mechanics building and the Parks Dep. building. These are made up of solar panels on the roofs of the buildings feeding two inverters on the exterior of each building. The inverters on the Parks building then run underground and connect into the main distribution on the back of the Mechanics building.

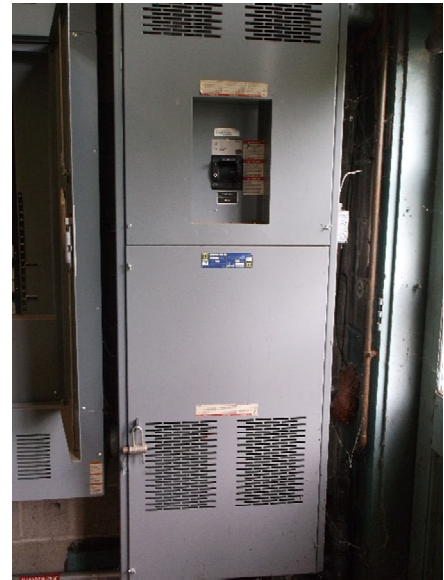
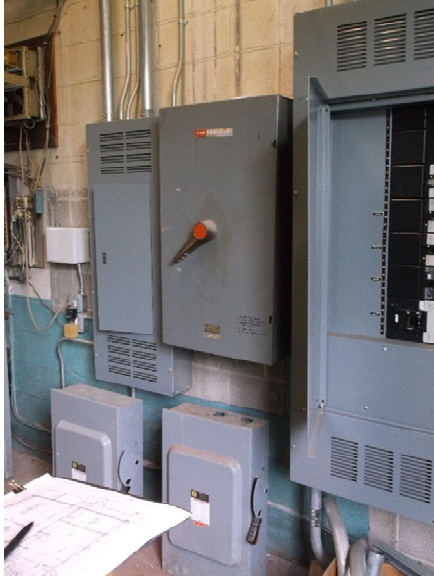
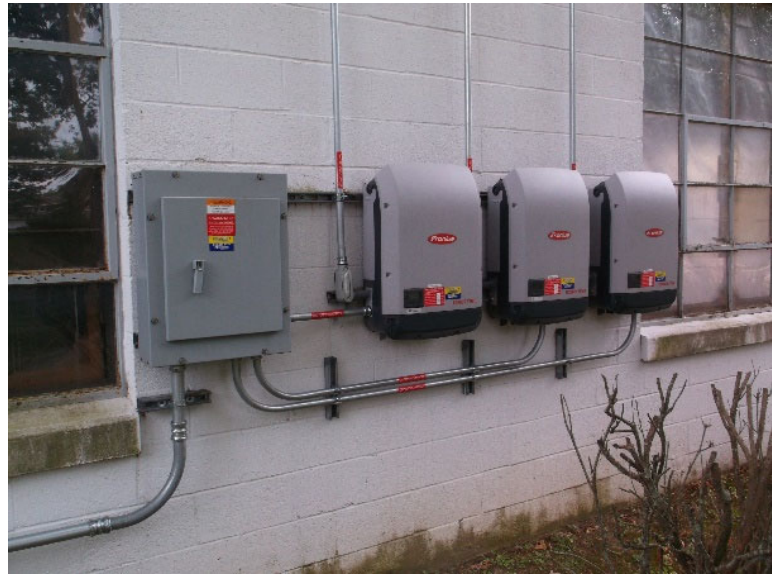
The existing electrical service for the Old Garage/Vehicle Storage Building and Mason's Garage is made up of a 400 amp 120/208V-3PH-4W Square D main breaker, with integrated C/T cabinet feeding an adjacent 400-amp distribution panel (MDP). The MDP feeds an adjacent old manual transfer switch which then feeds an adjacent local panel. The MDP also feeds a series of single and three phase load centers throughout the building. One of these load centers (south-west corner) feed an 8-circuit load center in the Mason's Garage from an overhead feeder between the buildings. There is also a photovoltaic system on the west roof of the Old Garage/Vehicle Storage building. This is made up of solar panels on the roof of the building feeding three inverters and control panel on the exterior of building.

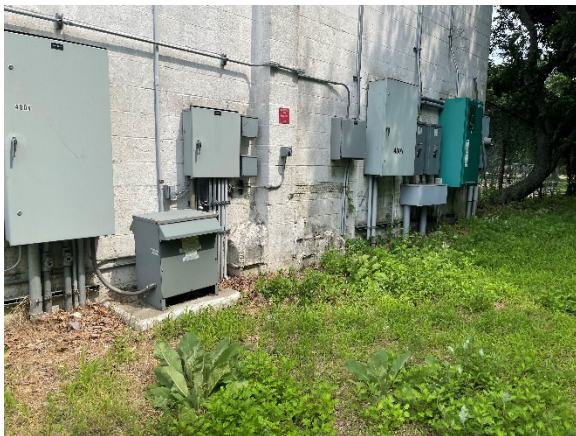
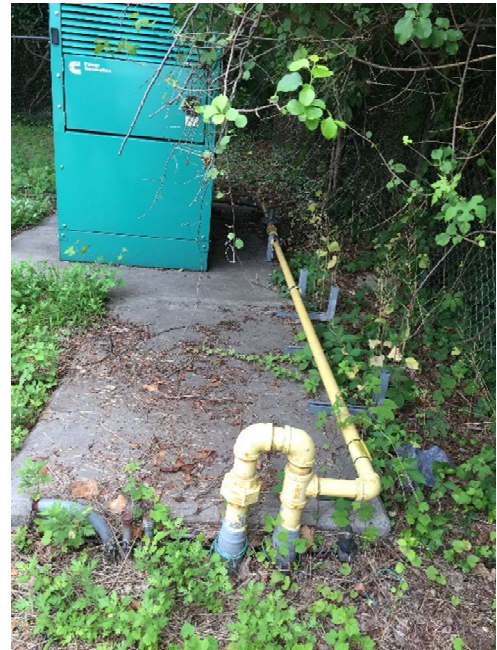
There is a third existing electrical service on the exterior of the Old Garage (east corner) that is made up of a 400 amp 277/480V-3PH-4W Square D main breaker and in-line meter, that feeds an adjacent 400-amp automatic transfer switch (ATS) which in turn feeds an adjacent distribution panel. The distribution panel feeds another 480V panel, step down transformer and 120V panel further down the wall. There is a 125KW natural gas generator that also feeds the ATS from two enclosed breakers (one active, one spare). This service is for the propane fuel dispensing/pumping system (no longer in use).

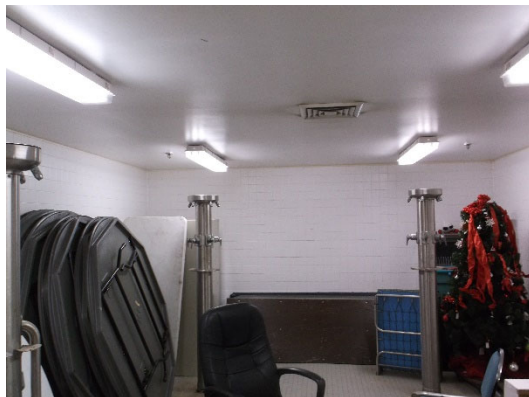
The existing interior lighting throughout all of the buildings is a mix of recessed fluorescent lensed 2x4 fixtures, surface & pendant mounted wraparound fixtures, surface & pendant mounted industrial fixtures, surface mounted fluorescent strip fixtures, surface/wall & pendant mounted fluorescent gasketed fixtures and high output lensed industrial fluorescent fixtures. Most of these

fixtures appear to

be in fair/good condition and working properly. It is our understanding that the majority of the fixtures have been upgraded with new LED bulbs. There are some fixtures that still have fluorescent or incandescent bulbs. These were areas that the town determined to be low use and would be replaced later as needed. Most of the areas have local toggle type & dimmer switches for control

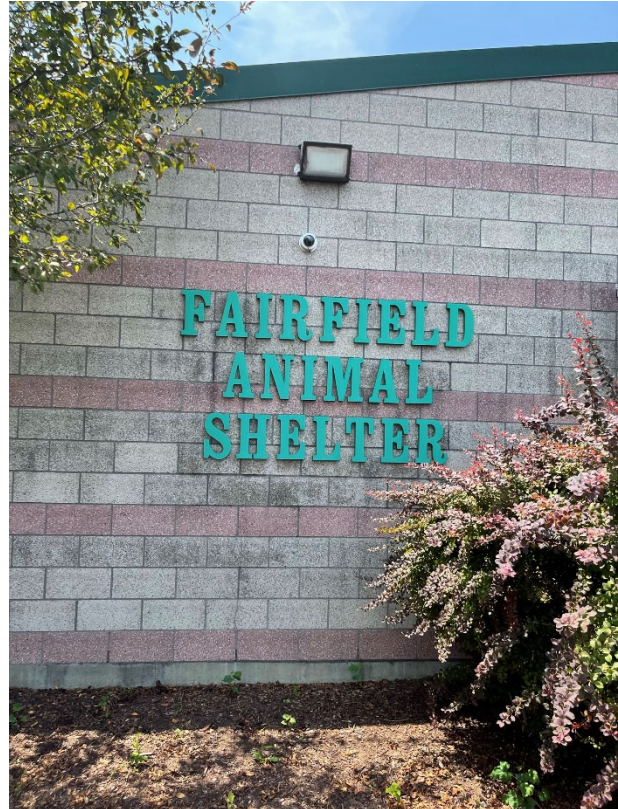
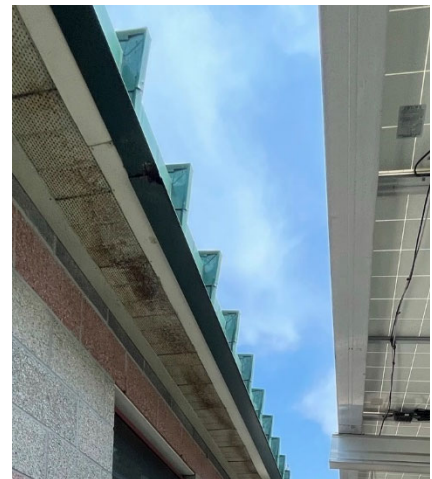
The roof was not reviewed in proximity due to the sloping nature and the photovoltaics on the system. The roof is a metal standing seam roof. Given the age and type of roof it likely has a life expectancy of 20 - 30 years. Therefore, replacement may want to be considered in the capital plan at about 10 years. The roof eve vents at the soffit have gotten dirty and should be cleaned. Also, vegetation should be controlled as not to continuing growing onto the building.

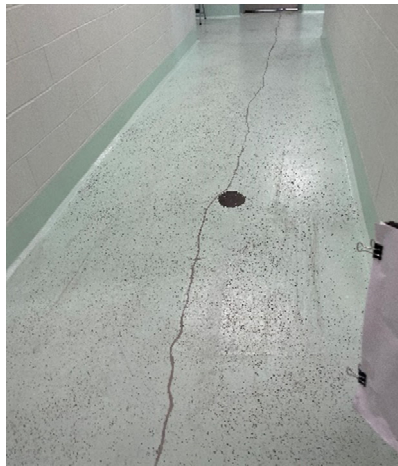
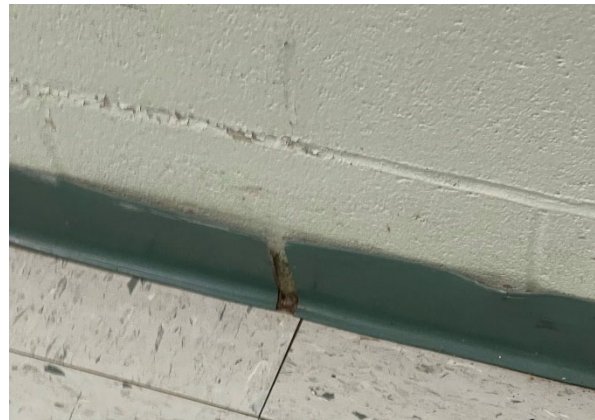
There are a variety of floor types at this building. Vinyl composition tile (VCT) with a rubber base is the predominate throughout many of the spaces with epoxy flooring in the kennels and ceramic tile at restrooms. The rubber base in many locations consist

of gaps and seams that appear to be failing. One

area in the hallway against the mechanical room shows evidence of a leak. To improve this situation, the location of the water in the mechanical room should be reviewed. Once rectified, the efflorescence of the wall would need to be scraped off followed by repainting the brick wall. The Rubber base would also need to be removed and the mastic should be scraped off and reapplied to place on the rubber base again. The damaged vinyl composite tiles

should also be removed along with the mastic that is damaged by water and reapplied with new VCT and mastic.

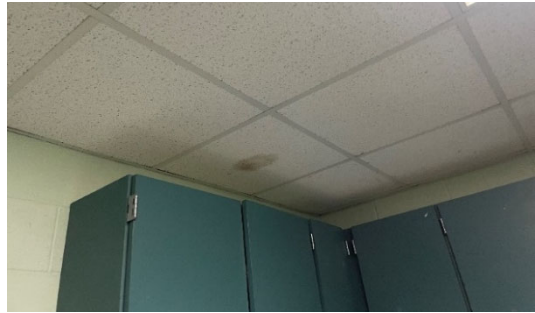
Ceilings throughout are dropped acoustical Ceiling Tiles (ACT). Most of the ceilings are in good condition. There are a few tiles that should be replaced due to water damage.

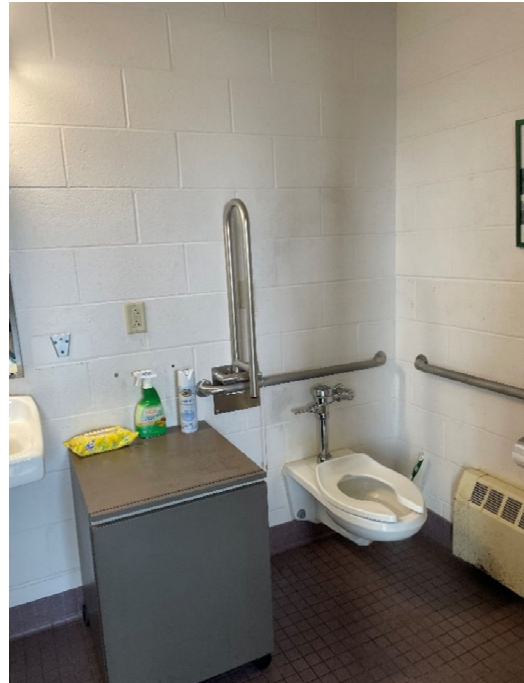
There are two restrooms within this facility, one off the public lobby for guests and one in the work area for employees. Both are unisex, and both are required to be accessible. They have the adequate space. They are missing the vertical grab bar and one of the sinks is missing pipe sleeves.

A09	Vertical grab bars are missing	(B)1108.0 (ANSI A117.1) 603-606			2			Install grab bars	\$ 1,000	
A10	Restroom sink pipe sleeves are missing	(B)1108.0 (ANSI A117.1) 603-606			2			Install pipe sleeves	\$ 500	
A11	Insufficient knee space provided at sink and/or workstation in kitchen.	4.32 (ADA)			2			Provide accessible sinks and workstations per ADA Section 4.32. 27" high x 30" wide x 19" deep.	\$ 5,000	
A12	Some signage needs updating				2			Install code complaint signage	\$ 1,250	
INTERIOR SUBTOTAL										\$ 12,250
PLUMBING/FIRE PROTECTION										
P01	Backflow preventers need to be tested and inspected yearly	IPC			2			Test and inspect backflow preventers	\$ 250	
P02	Provide missing insulation	IPC	4					Provide missing pipe insulation	\$ 1,200	
P03	Remove and replace water heater	Maint.		3				Remove and replace water heater, valves and accessories	\$ 5,000	
P04	Exterior gas piping corroding	General		3				Paint all exterior gas piping	\$ 1,500

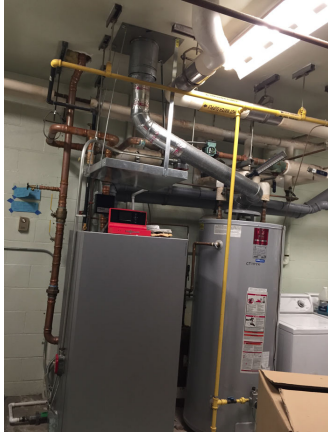
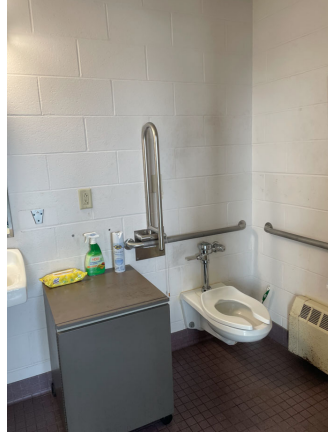
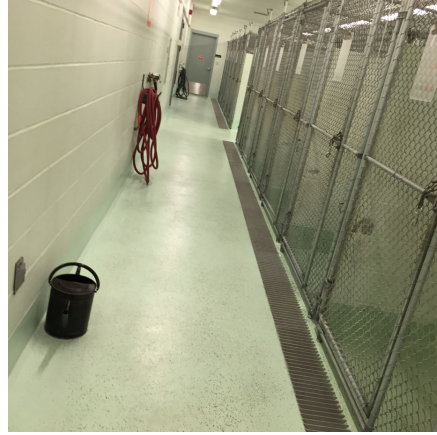
Existing plumbing fixtures in the building include vitreous china, wall-mounted commercial water closet with flush valves, wall mounted commercial lavatory with manual faucet, and counter mounted stainless steel kitchenette sink, not meeting ADA requirements. There is an emergency eye wash in the Janitor's Room is blocked with storage and has cold water only, not tepid water as required.

- Provide missing insulation around water heater on water piping.
- Remove and replace water heater, recirculation pump, expansion tank and valves, provide with ASSE1017 thermostatic mixing valve.
- Paint all exterior gas piping.
- Remove and replace kitchenette sink to make it ADA compliant.
- Pipe hangers are corroding and will affect water piping life expectancy, repair, or remove and replace.
- Piping throughout boiler room is foam sealed not fire stopped. Provide UL rated compliant firestopping.
- Insulation is missing on piping, provide new insulation where missing.
- Some of the water piping is corroding in boiler room. Repair or remove and replace.
- Maintenance needs to be done round exterior gas meter to clear weeds growing.
- Tested and inspect backflow preventer feeding boiler water makeup and sprinklers. Location is too high as well.

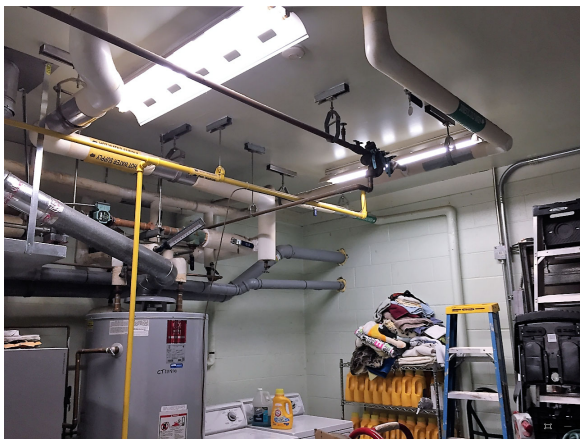
The facility has a limited area system only in the boiler room that ties into the domestic water supply with a backflow preventer and shutoff valve at the ceiling. This type of system is limited to only six sprinklers in any fire area maximum. The piping is copper tubing with soldered joints. There is no flow switch or alarm, so if the system discharges, no one may know. There is not a tamper switch on the valve, if the system is turned off, the sprinklers will not discharge water.

The town may consider fully sprinklering the building with a new service, alarms, and devices.

- Provide a fully sprinklered building throughout with a new service, alarms, and devices.

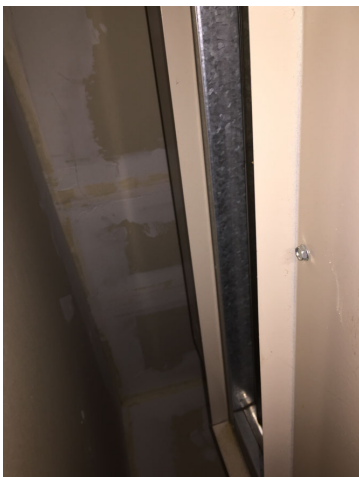
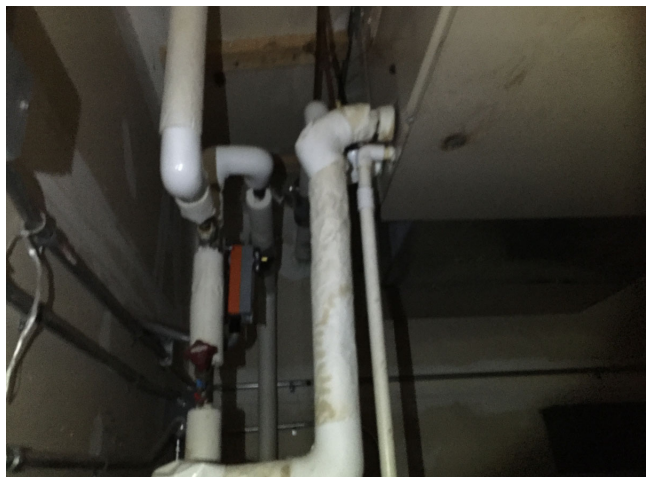
A single zone 5-ton split system provides, heating ventilation and air conditioning to the office and adjacent spaces. This system is original to the building and is operating on the obsolete R22 refrigerant. The system consists of an air handling unit, hot water coil, refrigeration coil and a remote air-cooled condensing unit. The air handling unit is in the attic mechanical space and the duct distribution is routed above the ceiling to diffusers and grilles. Existing drawings did not have provisions for economizer, based on the capacity, this unit should be equipped with economizer to provide free cooling to the space when the outdoor air temperature is cooler than the indoor air temperature. It was also observed that the air handling unit return duct plenum is open to the attic mechanical space, this opening should be capped. Duct in the mechanical space is not insulated.

- In accordance with the International Energy Conservation code, units providing 100% ventilation air requires energy recovery ventilator. Provide energy recovery ventilator.
- Replace the exterior ductwork. New exterior ductwork should be provided with insulation and protective jacket.
- Replace split system. Provide the new system with economizer. Replace refrigeration piping. Provide new refrigeration piping with insulation. Provide all exterior refrigeration piping insulation with aluminum jacket.

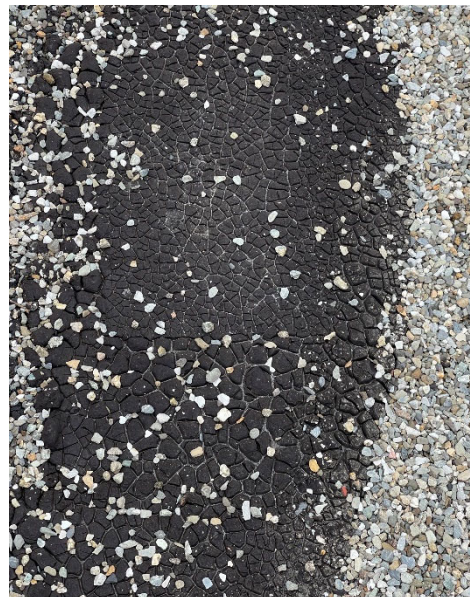
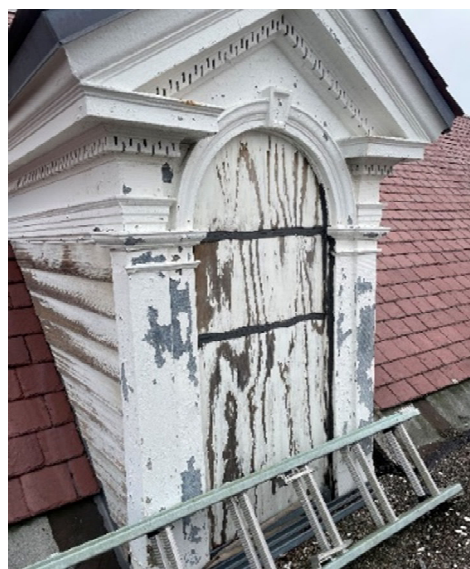
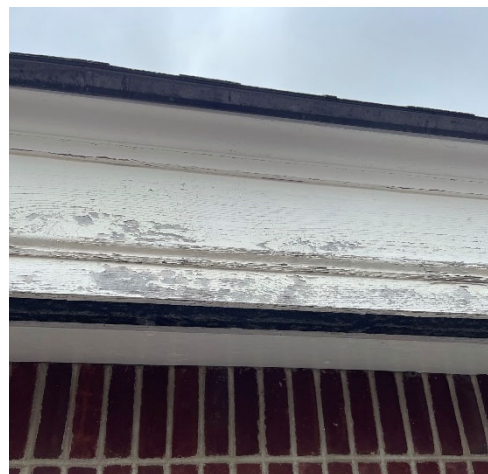
There are a variety of roofs throughout the facility. The low slope "flat" roof is a ballasted modified bituminous roof assembly. The roof is in fair condition but there are many areas where the ballasted areas have run thin leaving the bitumen exposed to the elements. These areas are wearing and water penetration which is evident in the alligatoring and bubbling. Most of the roof is covered with solar panels. A small area of sloped roofs is clad in metal panels. The remaining sloped roofs are slate tile roofs in gray and terra cotta. Some of these tiles have fallen out and been removed. These should be replaced. Some of the roof drains are clogged or have vegetation growing in them. They should be cleaned. Some areas of the wood fascia have peeling paint. On the original portion the library, there are dormers which have been infilled with wood and painted. These items should be scraped of the old paint, primed, and repainted as the fascia will be done.

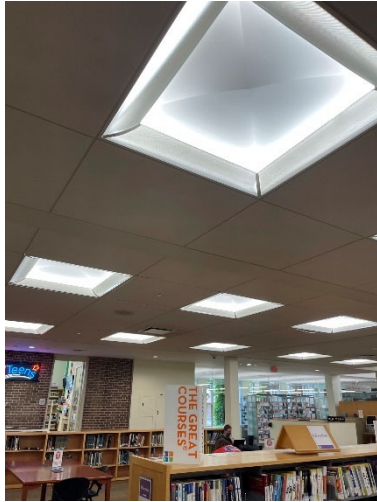
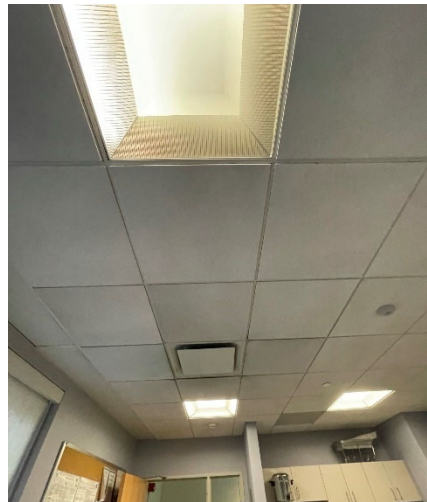
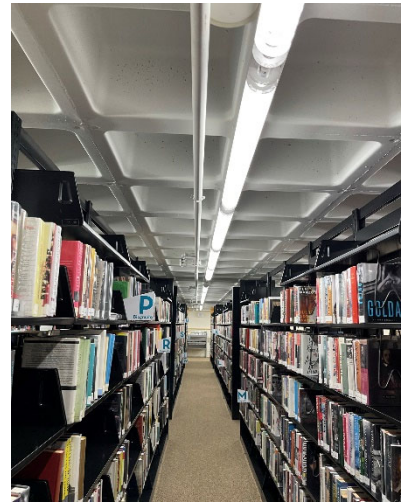
There are a variety of ceiling types. Most spaces have dropped Acoustical Ceiling Tile (ACT) while some of the original spaces have plaster ceilings. The Main floor consists of 2 x 2 ACT, and 4x4 ACT. Some areas have a dropped egg crate system. Another area has an exposed waffle slab. A few plaster areas including the Memorial Room on the second floor have some areas that need to be repaired. Overall, the ceiling is in great condition.

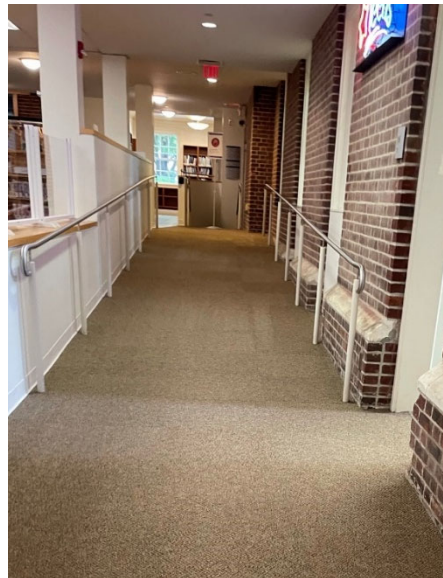
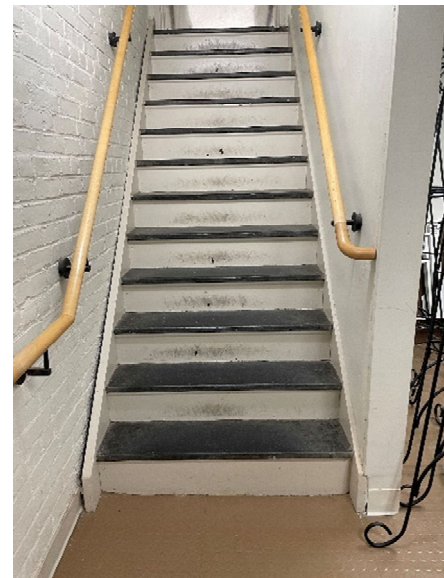
There are many stairs within the facility. Most of them are in good condition, with few minor items to adjust. The stairs between the basement of the Main Library and the ground level, unfortunately, do not meet the building code and ADA compliance. Firstly, the rise and run of a stair should not exceed 7

inches by 11 inches where in this case, it is 8.5 inches by 9 inches. The stairs are too tall and do not have enough foot room to properly place your foot on the step. In addition,

a stairway should have a landing at the top and bottom of the stair. This stair does not have a top landing. These issues can only be rectified if they are rebuilt. There are existing ramps in the library, however, there are a few ramps which do not meet the code or compliance. The ramp located outside of the teens room, as seen in the photograph to the right, does not have handrail extension of no less than 12 inches beyond the bottom and top landings of the ramp. These should be extended to comply.

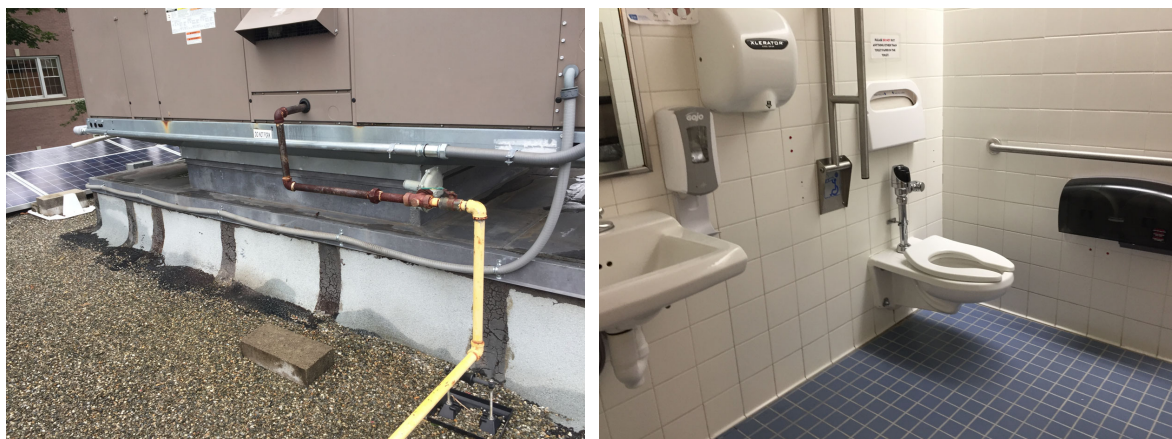
Cups were put into the plumbing vent stack rendering it inoperable and will affect the drainage system.

- Provide missing insulation and mixing valve at water heater.
- Repaint gas piping on roof and provide drip legs per code.
- Remove and replace kitchenette sink for accessibility.

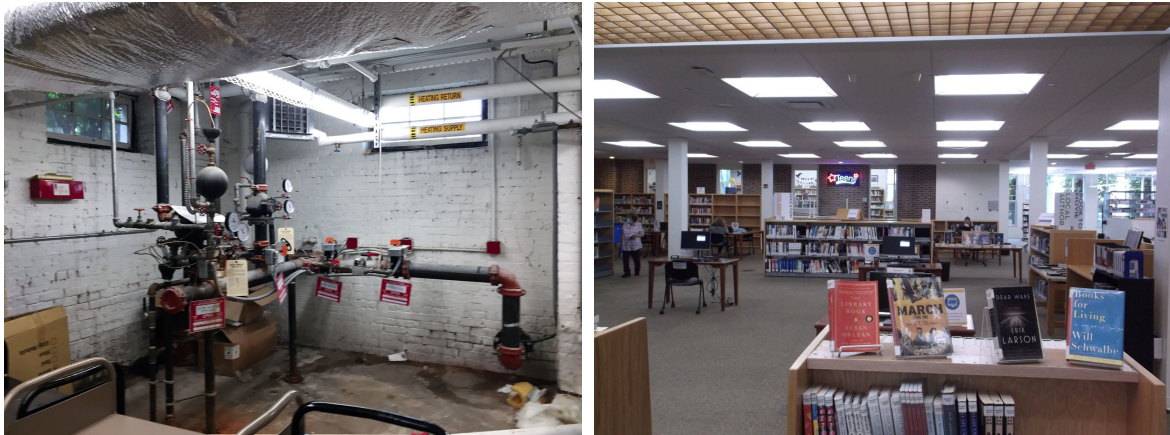
The main sprinkler service is in the basement, it looks to be in conformance and regularly tested and maintained.

- Continue to maintain, test, and inspect sprinklers and devices as required by code.
