**Town of Fairfield**  
Town Planning and Zoning Commission  
725 Old Post Road  
Fairfield, Connecticut 06824

**To: Members of the RTM**  
**From: Jim Wendt, Planning Director**  
**Date: April 19, 2022**  
**Re: Opt-Out of State Mandated Zoning Regulation Language**

FAIRFIELD TOWN PLAN AND ZONING COMMISSION PROPOSED OPT-OUT OF  
STATE MANDATED REGULATION LANGUAGE REGARDING OFF-STREET PARKING.

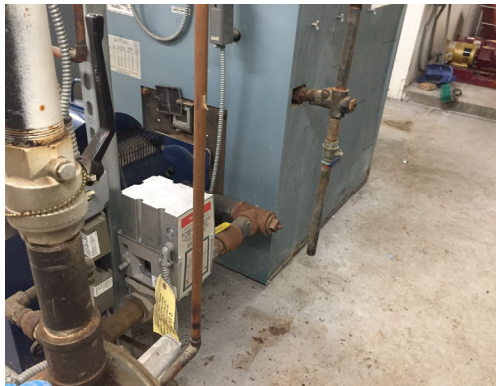
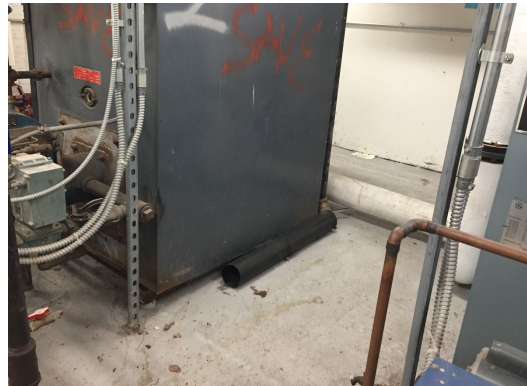
The building is heated using two (2) boilers mounted on the mechanical room floor, no housekeeping is provided. The newer boiler is Smith model 19A-W-07, cast iron gas fired with a Power Flame burner. This boiler, installed in 2005, has an IBR rating of 783 MBH. The older boiler was installed in 1985 and was provided with new powerflame burner in 2005. Gas fired, cast iron boilers have a useful expected lifespan of approximately 30 years, the newer boiler is at middle of its useful service life, while the older boiler is beyond its serviceable life. Near boiler piping is showing signs of corrosion.

- Provide boiler housekeeping pad.
- Replace the older boiler.
- Provide chemical bypass feeder in the boiler room.
- Provide cooling tower water filtration system.
- Engage the service of a Chemical Service Provider to maintain proper water treatment to the building water loop and cooling tower loop.
- Replace worn parts and rusted flange connections. Provide new gaskets and repair leaks.
- Consider replacing exterior ductwork insulation and jacket. Clean and seal ductwork
- Consider replacing the rooftop unit serving the office with a variable volume unit with hot reheat to help control humidity in the spaces. Consider rebalancing the system.
- Paint rusted cooling tower platform.
- Replace water source heat pump units and cooling tower in kind or consider using a conventional air to air split system.

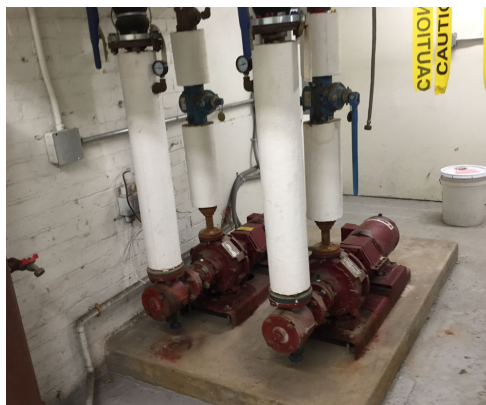
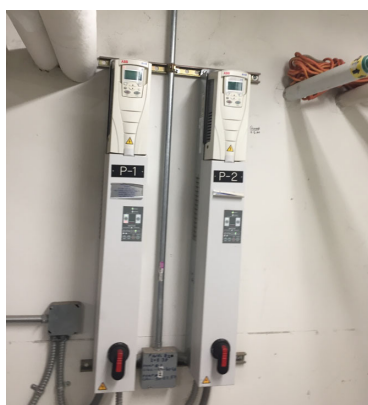
Two(2) pumps in lead/standby operation, circulate hot water to all heating terminal units in the building. All terminal units , i.e., cabinet unit heaters, unit heaters, ceiling radiant panels, are in good condition. Base mounted pumps have an expected life span of 20 years. There are signs of rust, but the pumps in general, appear to be maintained.

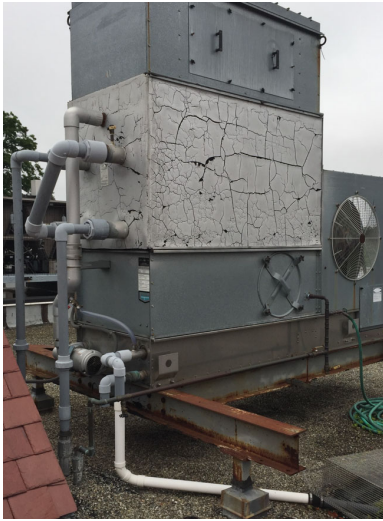
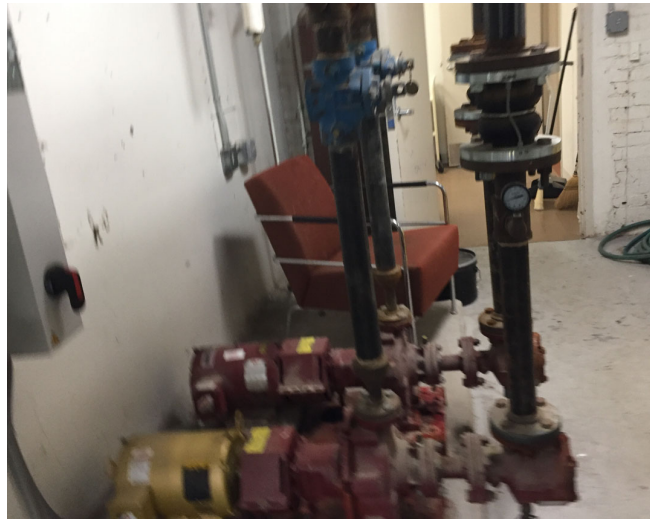
The cooling tower, manufactured by Evapco in 2001, is located on a steel platform of roof. The steel platform is rusted and in need of painting. The cooling tower pumping system is in the basement. Cooling towers have a useful life expectancy of 20 years. Two(2) pumps in lead/standby operation, circulate water to water source heat pumps

and cooling tower. Pumps, suction diffusers, reducers and flange connections are showing signs of wear. Condenser water piping has no insulation.

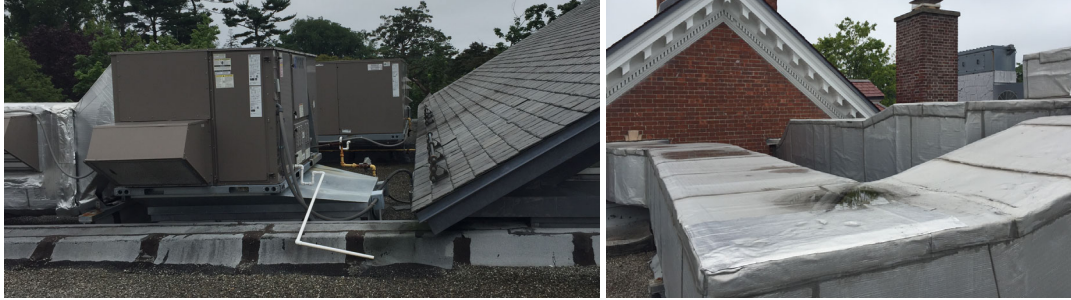
For roof top units configured for horizontal discharge, ductwork distribution system is routed exposed above roof. The exterior ductwork appears to have insulation and weatherproof cladding. Joints should be inspected to ensure proper weather sealing. Considering the age of the associated equipment, the R value of existing insulation may not conform with the current energy code requirements.

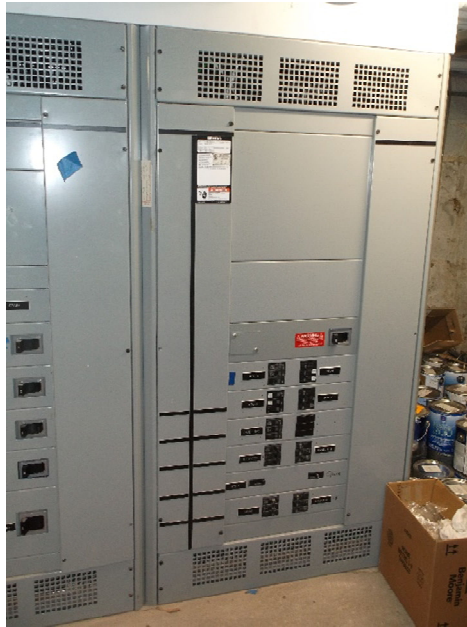
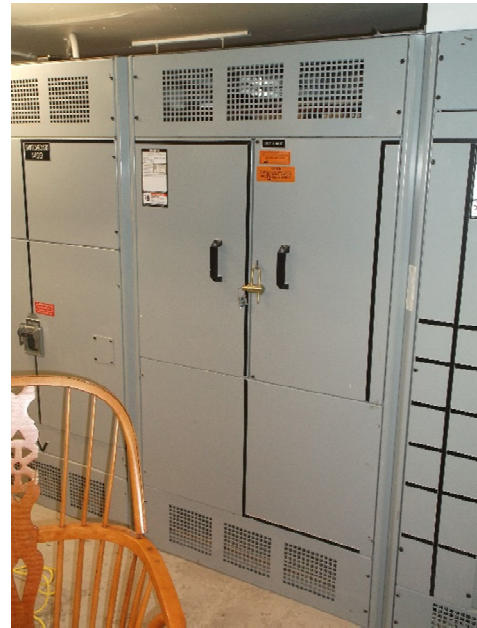
The existing electrical service is made up of a 1600 amp 120/208V-3PH-4W switchboard, with a 1600-amp main breaker, an integrated C/T cabinet and two adjoining distribution sections. The switchboard was installed in the building in 2004 and is in good condition. The switch board is fed underground from

the utility company pad mounted transformer (North-East corner) through the exterior wall and into the back of the main switch. The two distribution sections feed

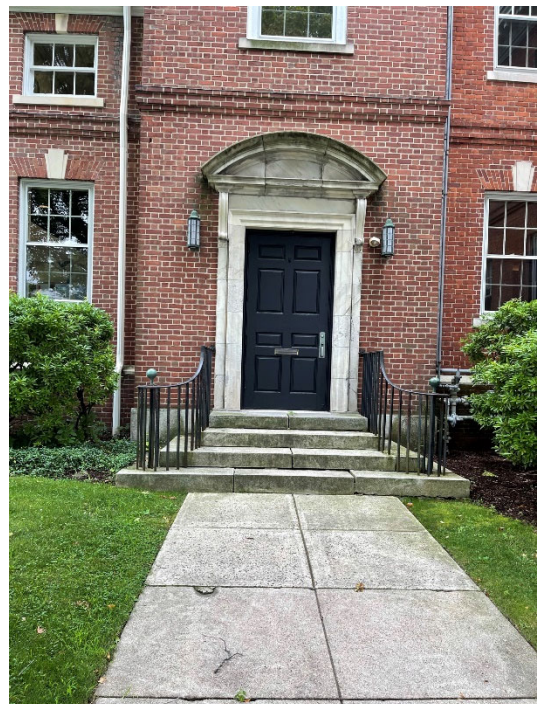
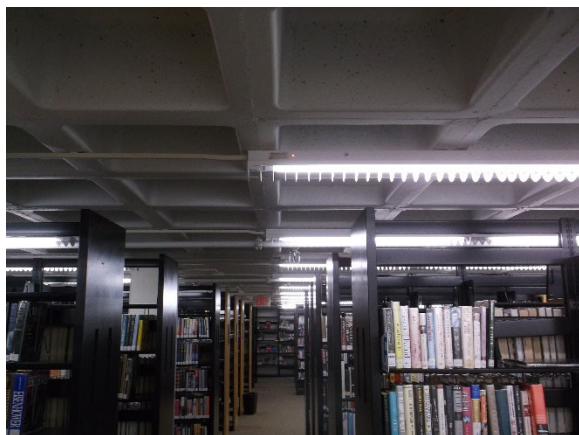
conjunction with local toggle type & dimmer switches for added control. The existing exterior lighting for the building is made up of fluorescent/incandescent wall mounted lantern type fixtures at the doors of the original portion of the building. The rest of the building has small wall mounted LED wall pack fixtures at the back entrance doors, wall mounted LED full cutoff fixtures along the back sidewalk area and indirect wall mount fixtures and short pole light at the south side entrance. There are exterior rated "jelly jar" type fixtures on each of the mechanical units on the roof. At least one of these has a

cracked lens and needs a new bulb. We were not able to determine the operation of the exterior fixtures at the time of our inspection.

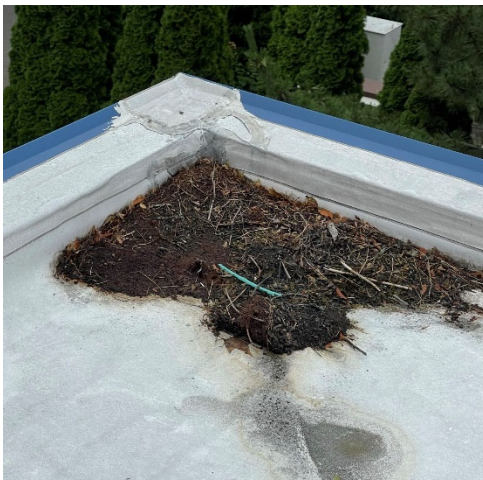
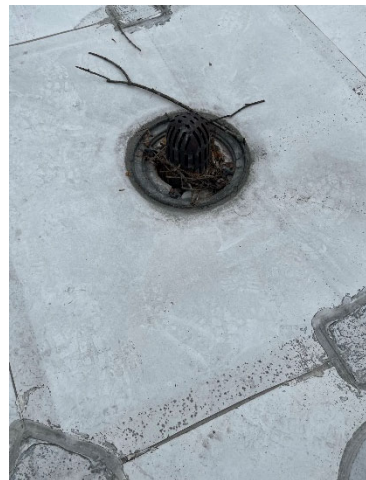
The existing roof on the Woods Library is a Thermal Polyolefin (TPO) roof. Much of the roof is covered with photovoltaic panels. There is no evidence of damage to the membrane and seams appear to be holding up well. The roof was observed following large amounts of rain and there is some debris collecting on the roof. There should be scheduled maintenance cleanup at least twice a year. The drains would benefit from larger cages around them to filter out the debris.

- Water heater needs a thermostatic mixing valves for scald prevention.
- Provide a thermal expansion tank, a ASSE1017 thermostatic mixing valve on the water heater and a recirculating system as there is a long wait for hot water and exceeds code requirements.
- Test and inspect backflow preventers.
- Provide missing insulation around water heater on water piping.
- Remove and replace water heater.
- Paint exterior gas piping.
- Remove and replace kitchenette sink to make it ADA compliant.
- Remove and replace roof drain strainers with larger ones.

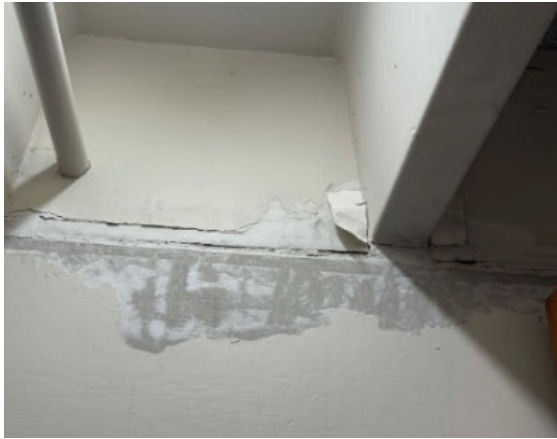
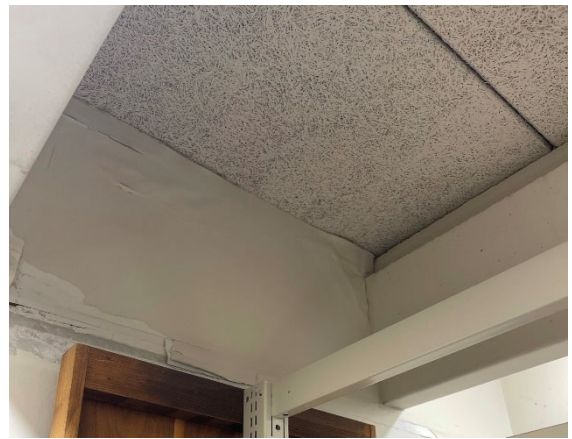
The walls in the Woods Library are mostly gypsum wall board or plaster. There are some walls that bring the stone from the outside inside. Most walls are in good condition, however, there are a few spaces that should seek attention. The wall on the mezzanine level directly under the roof, as seen in the photograph on the right, shows the peeling of paint and drywall providing evidence of water damage within the exterior wall.

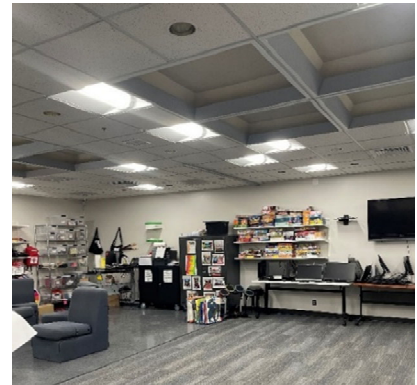
There are a variety of ceiling types in this library. Most of the ceilings are mostly composed of 2x2 acoustical ceiling tiles (ACT). They are all in good condition with a few stained or damaged tiles that should be replaced. Additionally, there are some areas with exposed cementitious and concrete decking.

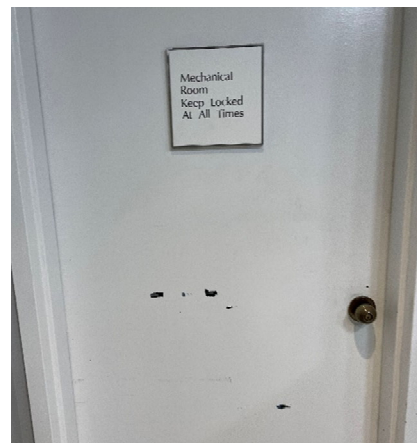
Most of the interior doors are wood set within hollow metal frames. There are some hollow metal doors and frames. Overall, they are in good condition. Most doors have compliant hardware, but the basement level has many knobs that require twisting. The hardware should be replaced to follow the current code requirements.

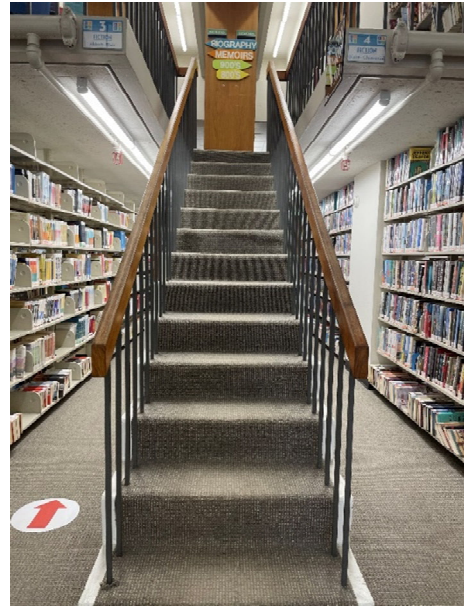
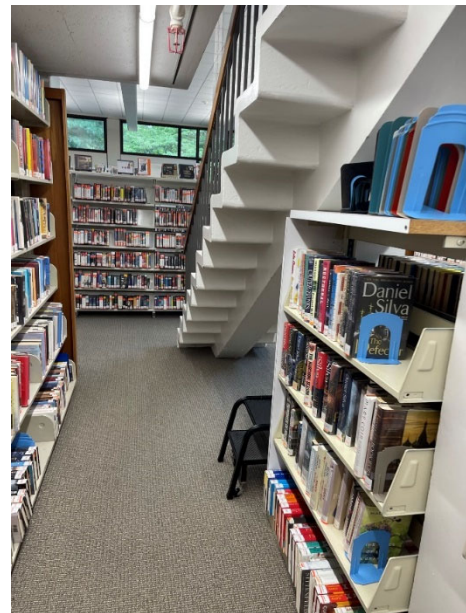
There are three sets of stairs within this building. There are multiple issues with the stairs which lead up to the mezzanine floor, as seen in the photograph to the right. The handrails are not to code and the width of the stair is too small. The International Building Code states the width of the stair shall be no less than 44 inches.

In addition, both the mezzanine and the basement stairs do not meet the International Building Code in relation to the standard "rise over run" of the steps. The requirement of the stairs is a 7-inch maximum rise by 11-inch minimum run.

Additionally, the underside of the stairs should be blocked to comply the minimum vertical clearance of 80" as seen in the diagram from the 2010 ADA Standards for Accessible Design. Protection should be added under these stairs.

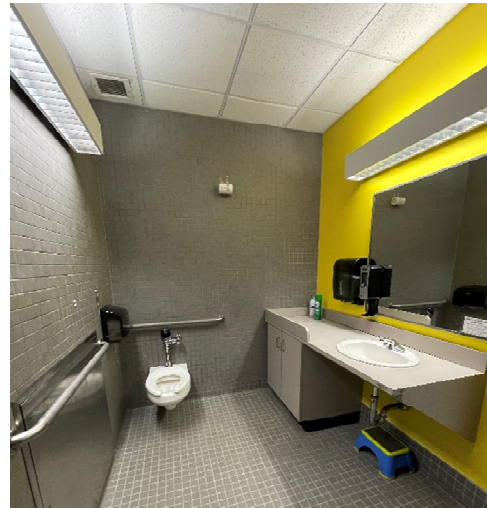
There are multiple restrooms throughout the library. There are 3 single restrooms on the basement level. None are ADA compliant. The fixtures would need to be changed modified and the arrangement made so that both the sink, toilet and door had the proper clearances. The same scenario applies to the restrooms on the main level. Although the children's room complies and is only missing a vertical grab bar and sink pipe sleeves. These should be added to comply.

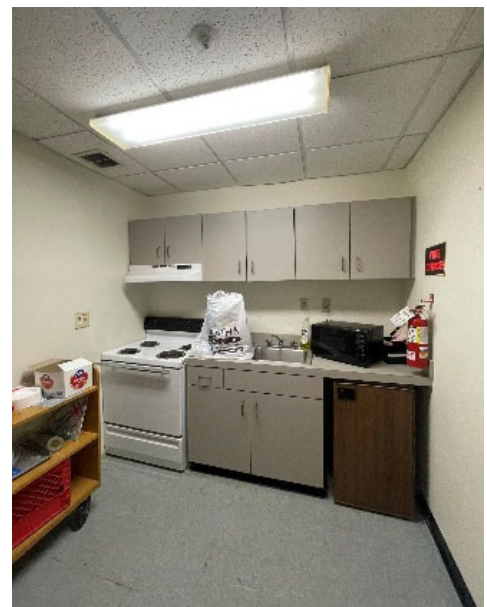
There is limited casework throughout the facility. There is a breakroom on the main level and a small kitchenette in the basement. The plastic laminate casework is in good condition. However, it does not provide a knees space or an accessible sink.

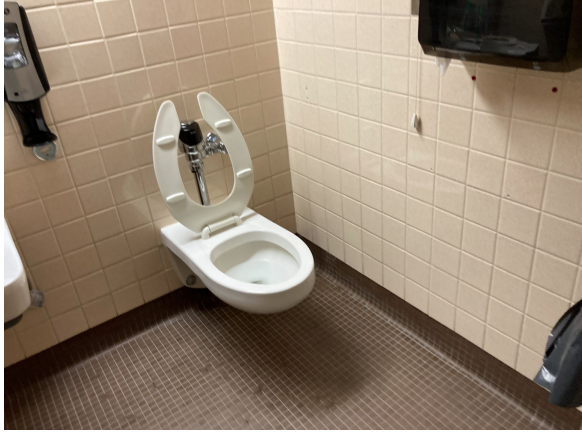
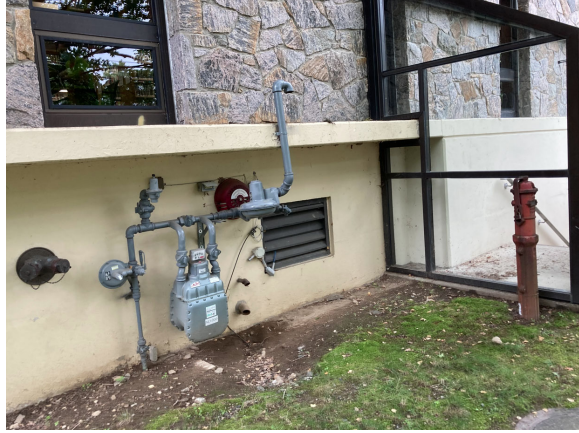
Existing plumbing fixtures in the building include vitreous china, wall-mounted commercial water closet with sensor flush valve, wall mounted commercial lavatory with sensor faucet, and counter mounted stainless steel kitchenette sink, not meeting ADA requirements. The electric water cooler was replaced recently with a new wall mounted unit with a sensor bottle filler and meets ADA requirements. Refer to Architectural Narrative for further information.

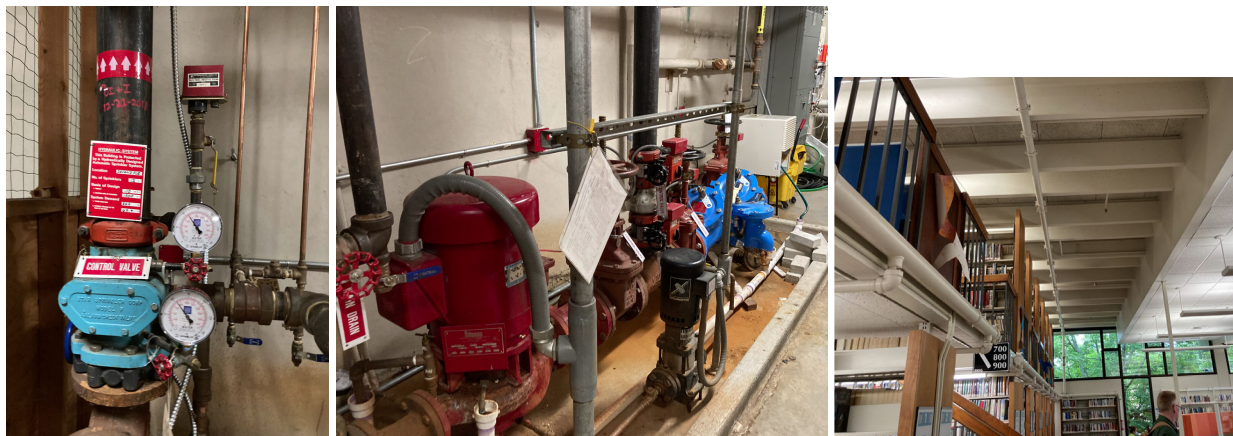
A 30 hp, 500 gpm, 142 psi electric fire pump is in the basement to add pressure to the sprinkler system. The system is complete with a jockey pump to main pressure for any small leaks, controllers for each pump. The fire pump test header is located indoors near the fire pump which requires hoses to be brought outside for drainage during a full flow test. The fire pump is required to be separated and in its own 1 hour rated room.

- Continue to maintain, test, and inspect sprinklers, fire pump and devices as required by code.
- Provide a separate rated room for the fire pump in accordance with NFPA 20.

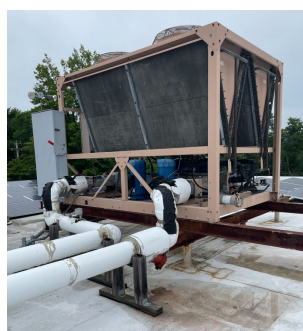
The York model YCAL044 air cooled scroll chiller is located on an elevated steel platform on the roof. The chiller has a cooling capacity of 47 tons. The chiller's lifespan is anywhere between 15 to 20 years. Based on the chiller's serial number, the unit is manufactured in 2002, and is at the end of its useful service life.

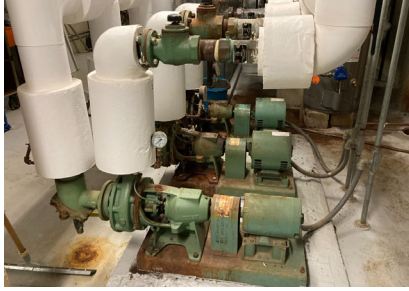
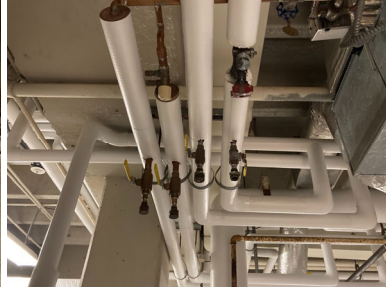
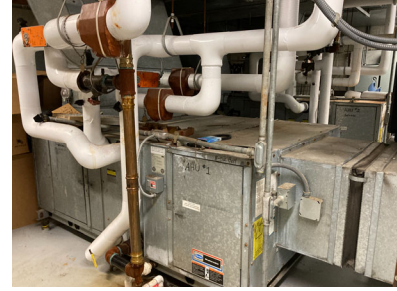
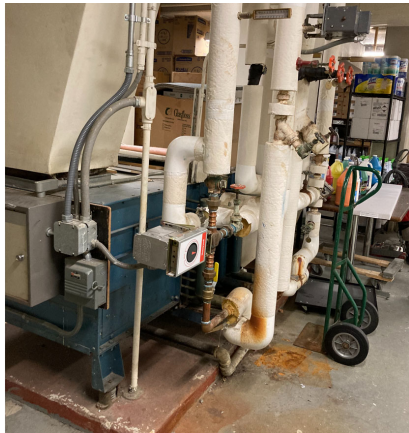
Three(3) pumps serve the building. One pump serves the hot water loop, one pump serves the chilled water loop and the third pump is for backup. Base mounted pumps have an expected life span of 20 years. Pump bases are rusted. Flanged connections and fittings are rusted.

Piping insulation in the mechanical room appears newer. No identification label is provided. Sections of copper piping are not insulated.

- Replace the boiler and all near boiler piping specialties.
- Provide chemical bypass feeder in the boiler room.
- Engage the service of a Chemical Service Provider to maintain proper water treatment to the building water loop.
- Repair pumps and replace worn components.
- Replace worn parts and rusted flange connections. Provide new gaskets and repair leaks.
- Provide mechanical room and adjacent space with dehumidifier with outside air duct connections for ventilation. Provide condensate drain piping terminating to an indirect drain in the basement.
- Review air handling unit controls. Provide economizer, if not currently provided.
  - For economizer, add exhaust fan, damper and controls.
- Replace all proprietary Unity Controls with FX controller, compatible with Town's DDC Controls.
- Remove all obsolete sensors in spaces.

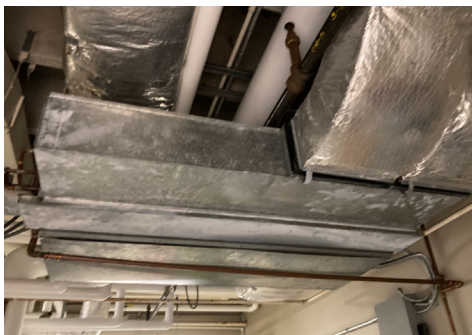
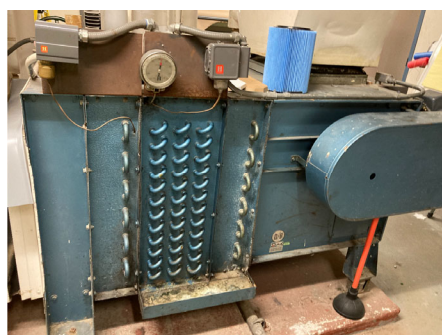
There are three(3) air handling units located in the mechanical room AHU-1 is a Carrier 39LC110 and AHU-2 is a Carrier 39LC108. Both units, base mounted, were manufactured in 1989. Indoor air handling units have a useful expected lifespan of approximately 20 years. At 32 years old these units have well surpassed their expected service life. One air handling unit is suspended from the structure. We were not able to get the information of the unit. AHU-3 is a Dunham Bush HAH-32, is located in the storage room. We were not able to determine the age of the unit. There are no visible physical damage to the unit. There is outside air ductwork connection to the units, however, we were not able to determine if units are provided with economizer function.

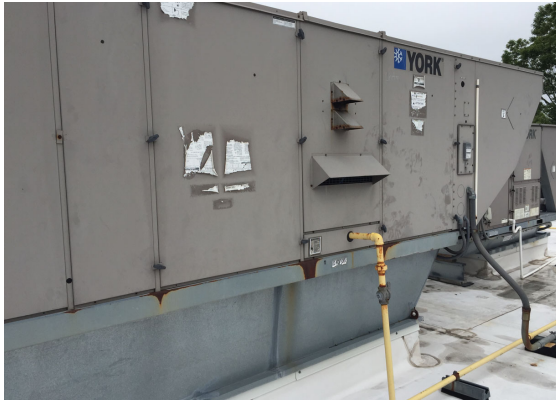
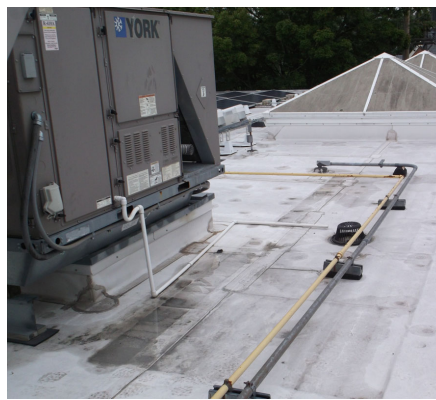
One (1) 15 ton gas fired roof top unit and one(1) 6 ton gas fired unit are located on the roof 1990 addition. The larger unit was manufactured in 2007 and the smaller unit in 2010. With a useful life expectancy of 15 years, these units have approximately 3- 5 useful years remaining subject to proper maintenance.

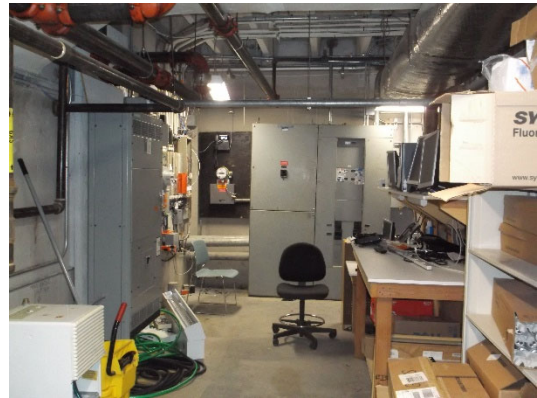
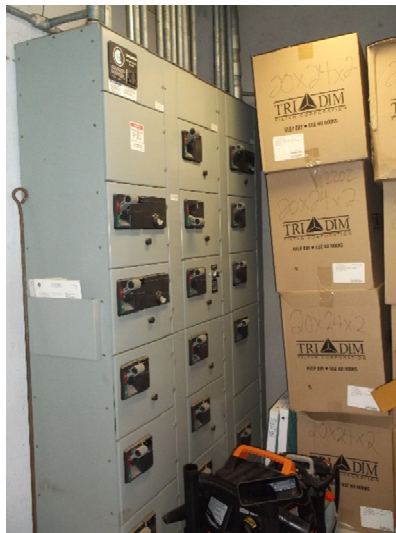
The existing electrical service is made up of an 800 amp 120/208V-3PH-4W Westinghouse switchboard, with an 800-amp main breaker, an integrated C/T cabinet and adjoining distribution section. The switchboard is the original from when the building was built in 1967 and is in fair condition. The switch board is fed underground from the utility company pole mounted transformer power-bank on pole #7990 through the exterior wall

- Replace existing electrical distribution equipment and associated wiring, except for panel 'PB-EM' and fire pump service switch.

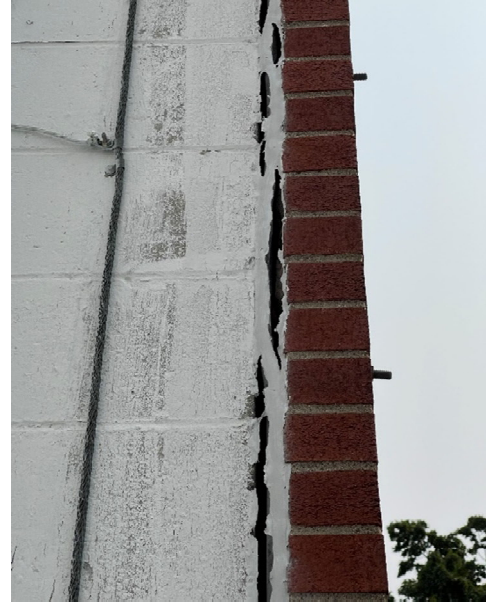
This single-story facade is in good condition. The brick walls are generally in good condition, with a limited areas of settling and spalling. The building is constructed with brick "veneer" with no air space evident. The energy efficiency of this construction is very low, and typical in the 1960s ("pre-energy crisis"), and not one that is easily or readily corrected. There are a few areas which will eventually need repointing or repairing but generally, it has held up well. There is one area that should be addressed. As seen in the photo, the intersection of the brick and CMU joint is failing and should be caulked. The CMU at the rear and some of the siding needs painting. Additionally, some of the woodwork including column bases, should be repaired, and painted.

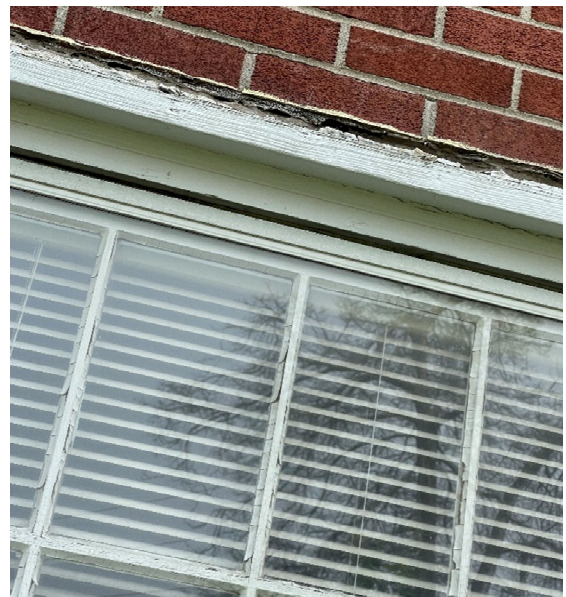
The windows in the recreation center are in poor condition. These double-hung single glazed windows are likely original. When evaluating the energy efficiency of a building, it is known that nearly 25–40% of all heat energy is lost through windows. These windows are contributing to the energy loss of this building. While they appear in good condition on the interior on the exterior they appear in disrepair. The wood is wearing, the caulk is failing. These windows should be replaced with double or triple glazed efficient systems.

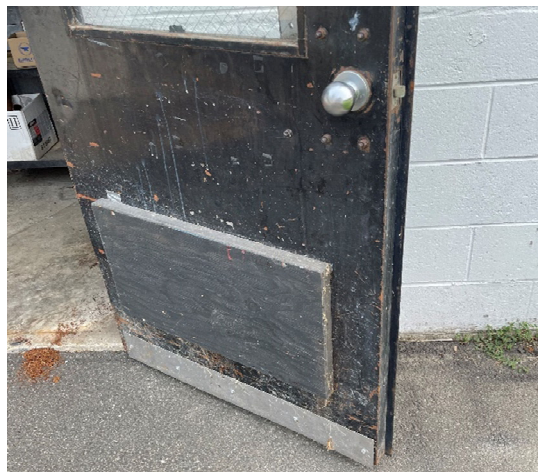
The doors throughout are a variety of materials and ages. The main entrance metal door looks to be newer and is in good condition. The rear door is older with single pane glass but in good condition. Both the locker exit and mechanical exit door frames are beginning to rust. These should be scraped, primed, and painted. The mechanical room door is too far gone with rust and should be replaced. In addition, the door hardware is not ADA compliant as it requires twisting. Some of the wood trim around the doors needs replacement.

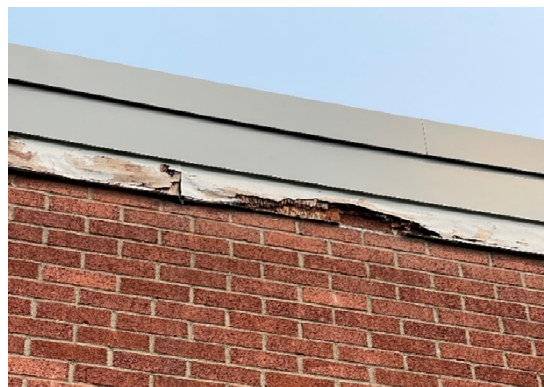
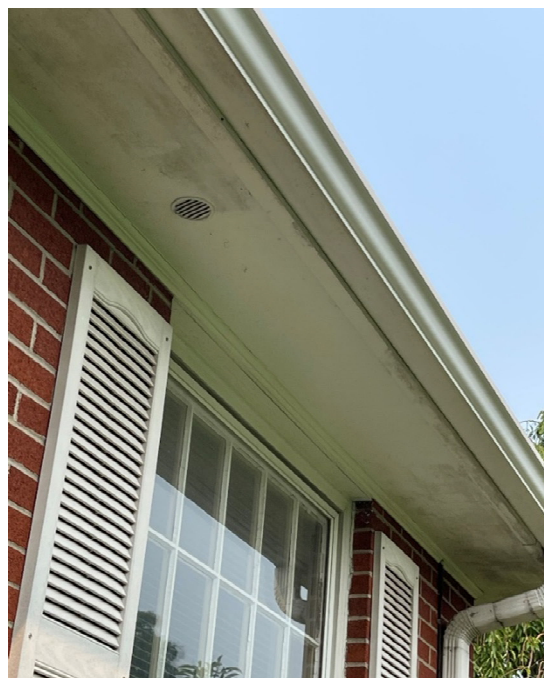
There are multiple roofs on this building. The original front is consist of a series of hips and gables roofed with asphalt shingles. The reaming portion of the roof is a series of two low slope roofs with a single ply rubber membrane. The black roof is likely EPDM and white roof TPO. The roof is drained with a series of scuppers and collection boxes that a transferred via gutters and down spouts. There are a series of skylights that bring natural overhead light into the fitness center. There is an original wood fascia left partially exposed under the metal gravel stop. The wood is nearing the end of its useful life with areas of rot and decay. The guardrail at the mechanical equipment at the rear is not code compliant and should be replaced. The asphalt shingles appear to be wearing and nearing the end of its useful life. The wood soffits need painting. The soffit vents also appear minimal and likely need to be increased. Additionally, the gutter is mangled and dented. which are damaged making the purpose of the system to struggle in draining water from the roofs.

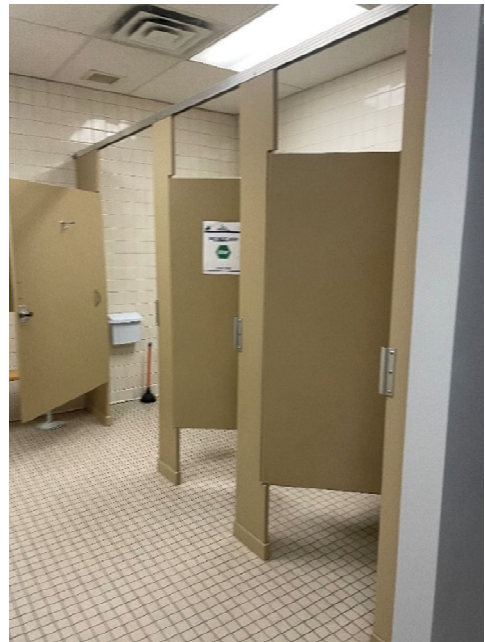
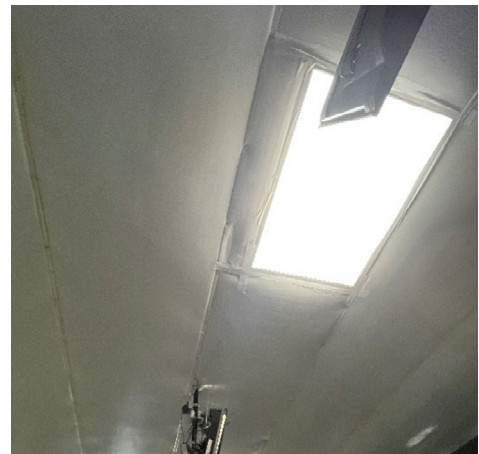
There are male and female locker room restroom combinations in the center. The rooms are in good condition. They have recently been renovated to incorporate ADA showers. The handicap toilet stalls are missing the vertical grab bars. These should be added.

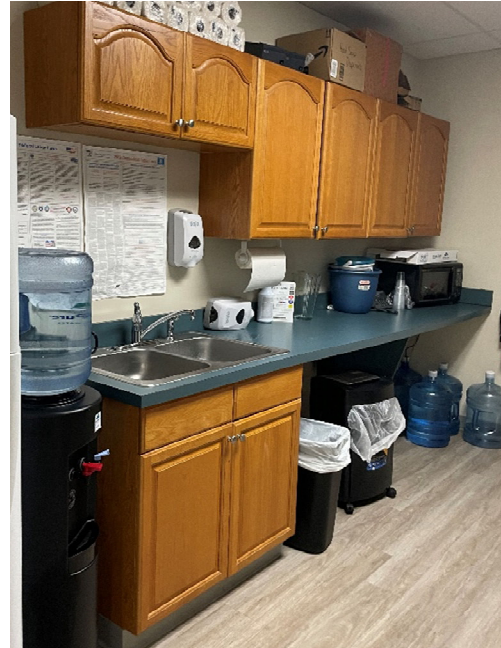
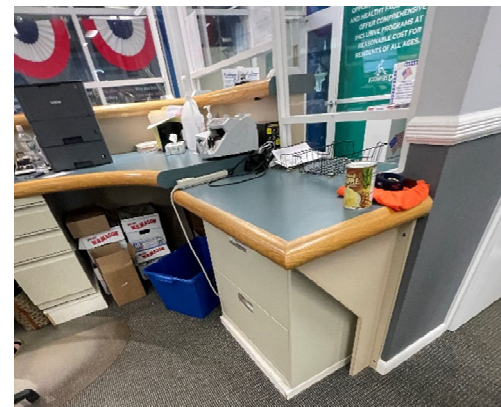
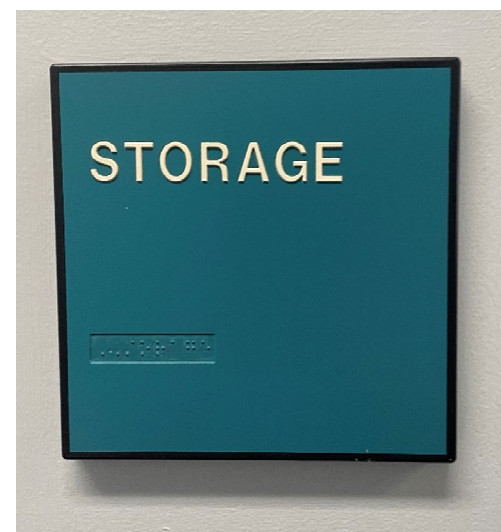
Most of the casework throughout the facility is a combination of wood and plastic laminate. It is all in fair condition. However, none have accessible knee spaces with countertops at 2'-10" high. In the All-Purpose Room the counter exceeds the 2'10" and does not have a knee space or accessible sink. The kitchenette sink is not compliant. A portion of the reception counter does have an area for visitors at 2'-10". These items should be adjusted and incorporated.

As noted within the previous sections, there are some code and accessibility issues within this building. In addition to casework and vertical grab bars, the signage should be addressed. The signage is dated and installed at the wrong height. These items should be included in the long-term capital plan.

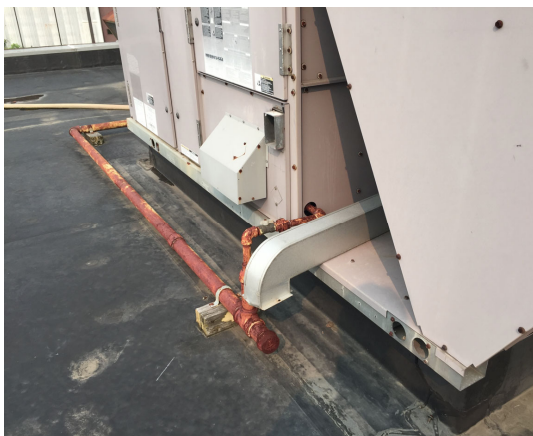
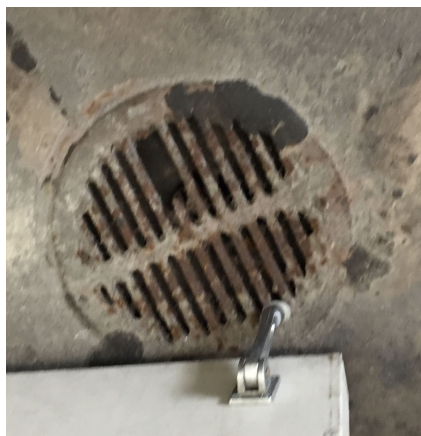
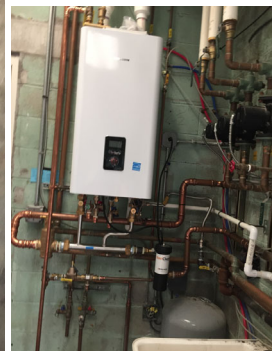
The water heater is missing drip leg on the gas piping.

Insulation is missing at the water heaters.

Exterior hose bibbs are missing vacuum breakers.

Gas piping to rooftop units are missing drip legs.

Plumbing fixtures are in good shape, need to be re-caulked.

Floor drain strainers are rusted and broken.

- Repair/Replace existing exterior hose bibbs are missing vacuum breakers.
- Repair/Replace/Add missing pipe insulation.
- Paint exterior gas piping.
- Repair/Replace existing floor drain strainers

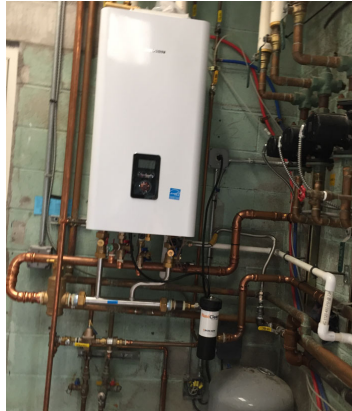
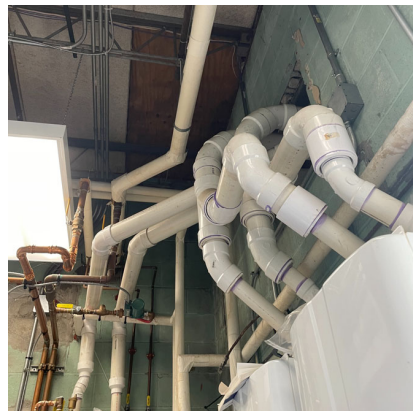
The boiler is a Navien model NFC 200 Condensing Fire Tube Combi-boiler. The boiler is manufactured in 2012. Products of combustion and combustion air are vented into the exterior wall through PVC pipes.

There are three (3) independent zones serving the building. The (3) zones are fed from individual inline pumps off the boiler supply manifold. The manifold is not insulated.

- Replace PVC flue piping with polypropylene piping.
- Provide new piping insulation.
- Provide guard rails for units within 10 ft of the edge of the roof.
- Reinstall flue pipe extension on one unit.
- Replace roof top units. Provide new unit with single zone variable volume configuration with demand control ventilation. Consider providing unit with hot gas reheat for space humidity control. Provide DDC controller.
- Clean all existing ductwork.
- Engage the service of a Chemical Service Provider to maintain proper water treatment to the building water loop.

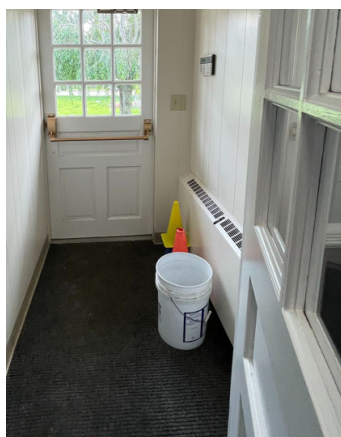
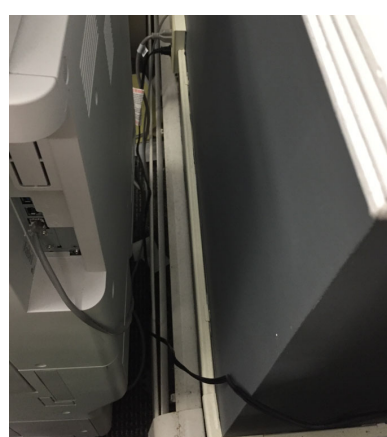
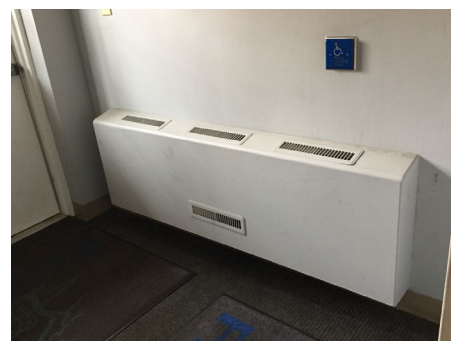
The age of the piping distribution system throughout the building is unknown, piping system, with proper maintenance and proper water treatment, can operate for 50 years, however, piping system should be inspected utilizing ultrasonic testing to determine rates of corrosion within the piping.

A combination of commercial and residential style finned tube radiation is provided along the perimeter walls. They are old and condition varies from fair to poor.

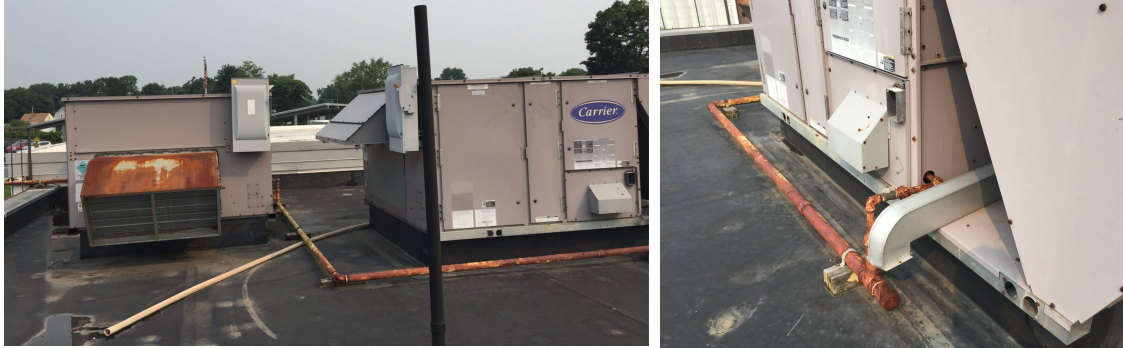
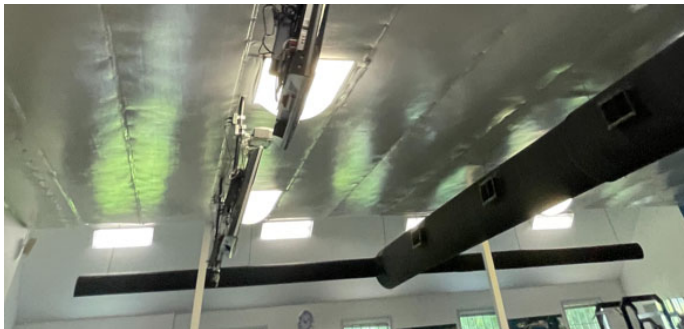
Two (2) Carrier roof top units, manufactured in 2001, provide cooling, heating, and ventilation to the spaces. Units are mounted close to each other on the flat roof. Both

units have flue vent extension to keep flue gas away from the outdoor air intake. Flue extension on one unit is not in place. Each unit has a cooling capacity of 15 tons and heating input capacity of 533,000 BTUH. Packaged units have useful life expectancy of 15 years and these units are operating beyond their expected life span. Units are showing of surface corrosion. Both units are mounted on roof curbs and are configured for downflow connections. Unit serving the office provides air to the spaces using a network of distribution ductwork located above ceiling terminating to ceiling mounted supply diffusers and sidewall registers . Unit serving the fitness provide air to the space through exposed ductwork with duct mounted registers.

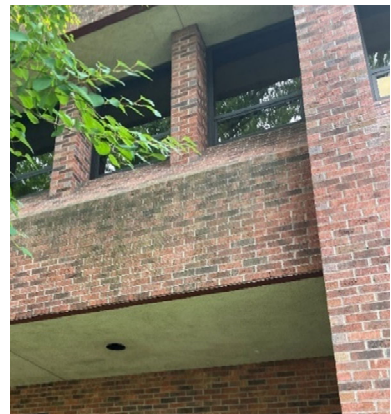
The exterior of the building is in good condition. The building is constructed with brick "veneer", rigid insulation, air space and painted concrete masonry unit or brick interior. Overall, the mortar is in reasonably good condition although the age of the building suggests that in the future a detail review should evaluate if repointing is required. Additionally, some vegetation and mildew have been growing at the base of the building in some areas. These should be cleaned and sealed to ensure the longevity of this construction.

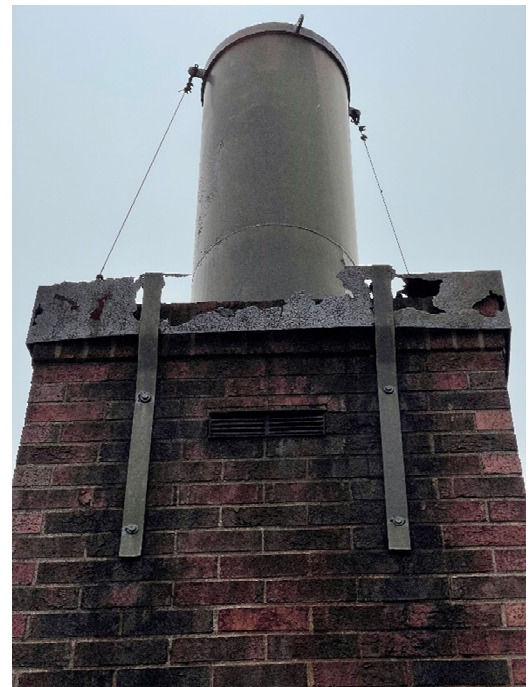
The roof is a low slope roof with a parapet. It is covered with a single ply rubber roof membrane, likely EPDM. The roof is accessible through a penthouse accessed by a ships ladder. The penthouse door is rusting and should be included with the other doors although it may need full replacement. The roof itself appears in good condition. There are no known leaks or damage to the roof. There are sticks and debris which should be cleaned. The mechanical units supports are rusting and should be scraped primed and painted. The chimney requires a good cleaning and replacement of the end cap as it has deteriorated.

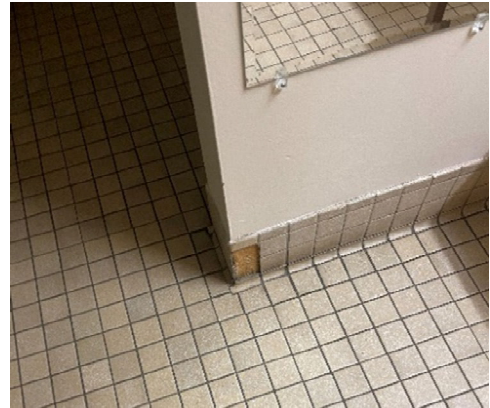
There are multiple floor types throughout the station. Most of the building is carpeting which is in fair condition. It appears to be dated as many areas are wearing such as high traffic areas and portions of offices. Some of the VCT is older style and in fair condition. Restrooms have the same ceramic tile throughout most of the spaces. It too is dated but holding up well with a few areas of damaged tile. The flooring although not a high priority, should be considered for future improvements while the damaged areas should be repaired sooner.

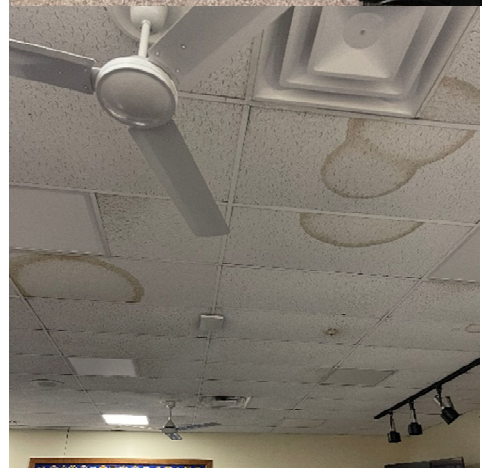
The ceilings throughout are acoustical ceiling tiles (ACT). Additionally, there is a fair amount of gypsum ceilings. Many areas were noted with stained ACTs and damaged areas of gypsum due to water damage or general wear and tear most notably around ceiling registers. Some ceiling registers were rusting. Some of the ACT are 2x4 which tend to sag. The ceilings should be considered for future improvements.

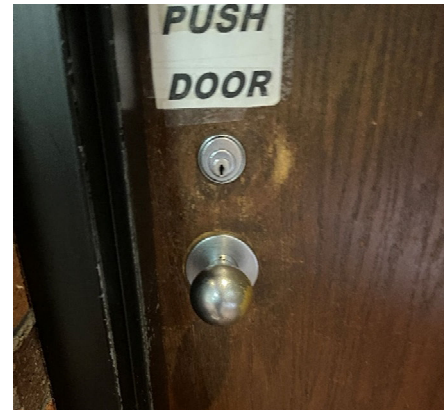
The doors throughout the Police Station are wood set within hollow metal frames with some hollow metal doors. Generally, they are in good condition. Some wood doors would benefit from refinishing and frames from repainting but most importantly the majority of the door hardware is not to code. The doors currently have doorknobs that require twisting. These doors are not ADA compliant and should be changed out with lever handles.

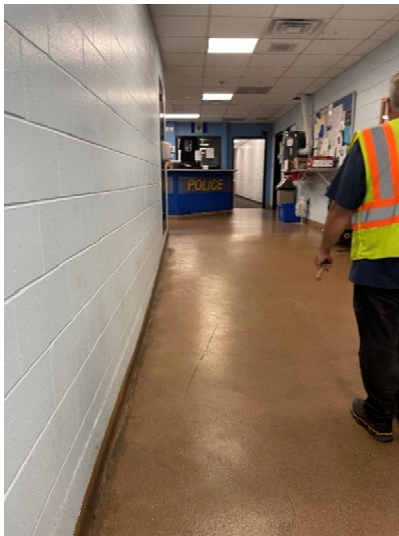
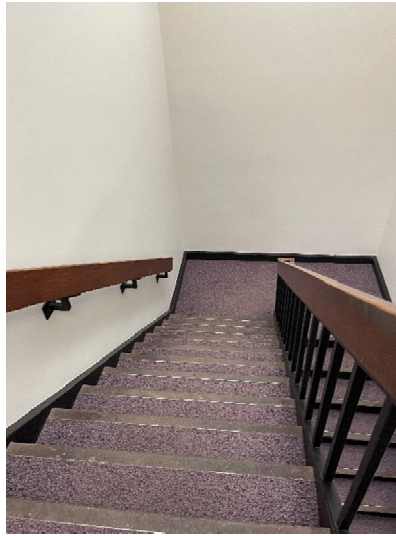
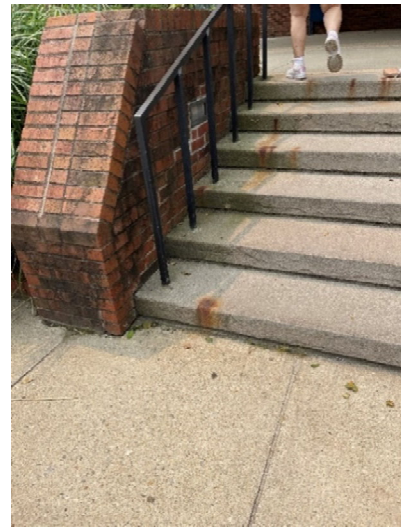
The stairs on the interior of the Police station are in good condition. However, the handrails profile and height are not compliant. The exterior stairs also do not have compliant handrails. In addition, there is rust stains and mildew on the brick walls and concrete steps. These areas should be cleaned. Additionally, there is a ramp in the hallway connecting the lobby and the adjacent garage. There are no handrails included with is required for any rise greater than 6". One should be installed at both sides of the hallway.

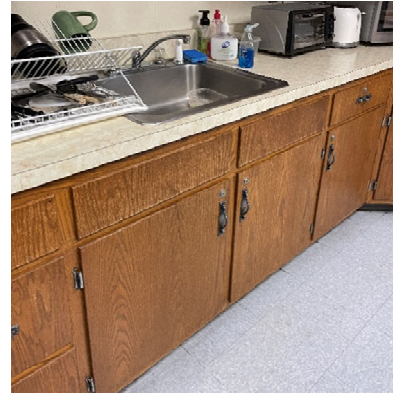
There is a variety of casework throughout the facility. Some of the plastic laminate is likely original and some seem to be new replacements. Most is not ADA compliant as there needs to be an accessible knee space incorporated. Where sinks are provided within casework, they too are not accessible. These should be modified at each program location.

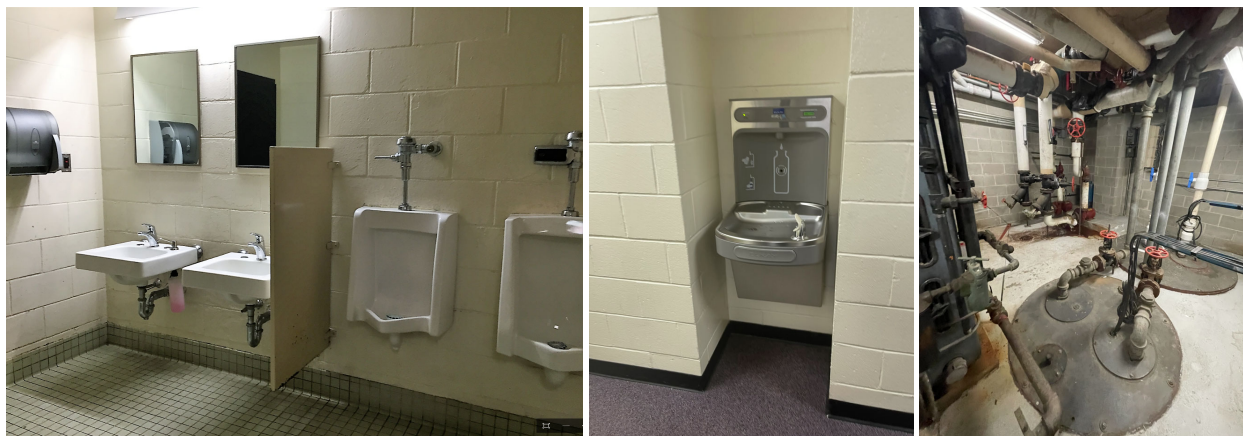
Plumbing fixtures are in good condition and well maintained. Most of the plumbing fixtures are not ADA compliant and need updating. There are stainless steel security fixtures for prisoners.

Insulation is missing on the domestic water piping.

Handicap lavatories are missing insulation for scald protection.

- Repair/Replace/Add missing pipe insulation.
- Paint exterior gas piping.
- Replace plumbing fixtures to comply with ADA requirements.

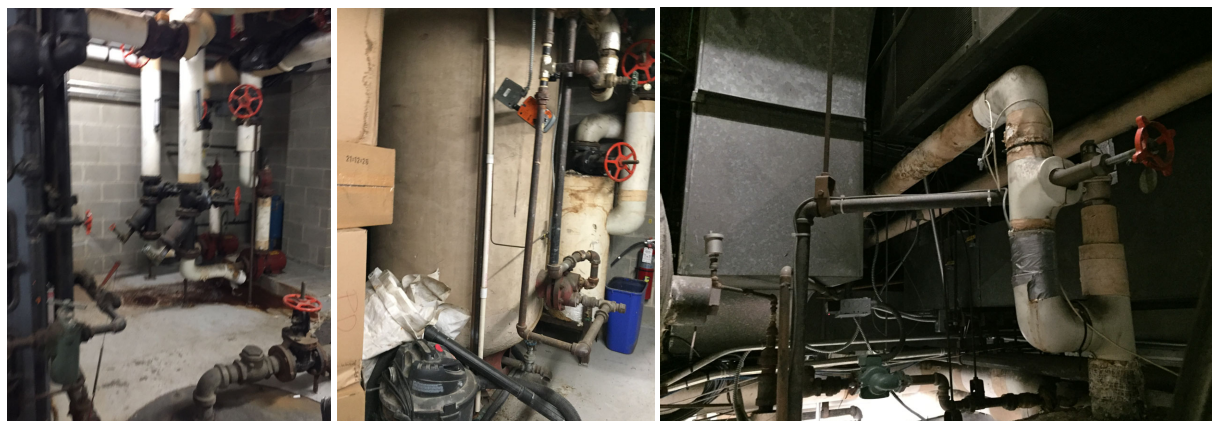
The boiler supply manifold is showing signs of heavy wear. The hot water piping distribution system is original to the building and is showing signs of heavy wear. Piping system, with proper maintenance and proper water treatment, can operate for 50 years, however, piping system should be inspected utilizing ultrasonic testing to determine rates of corrosion within the piping.

The insulation covering the hot water piping is original to the building. Hot water pipe sections are missing insulation. Piping insulation has a useful life expectancy of approximately 20 years. In addition to having outlived its useful life it is likely that it is non-conforming to current code requirements for thickness.

- Replace existing boiler and associated near boiler specialties. The new boiler will be high efficiency condensing boiler, with flue and combustion air pipes connected directly to the outdoors.
- Replace base mounted pumps. Provide Variable Frequency Drives.
- Perform ultrasonic testing for the rest of the piping system to determine the rates of corrosion within the pipes. Replace pipes as needed.
- Repair piping insulation within the boiler room.
- Provide piping insulation at all uninsulated piping.
- Provide chemical bypass feeder in the boiler room.
- Engage the service of a Chemical Service Provider to maintain proper water treatment to the building water loop, cogenerator heating medium loop and cooling tower loop.
- Replace unit heater in the boiler room.
