**Town of Fairfield**  
Town Planning and Zoning Commission  
725 Old Post Road  
Fairfield, Connecticut 06824

**To: Members of the RTM**  
**From: Jim Wendt, Planning Director**  
**Date: April 19, 2022**  
**Re: Opt-Out of State Mandated Zoning Regulation Language**

FAIRFIELD TOWN PLAN AND ZONING COMMISSION PROPOSED OPT-OUT OF  
STATE MANDATED REGULATION LANGUAGE REGARDING OFF-STREET PARKING.

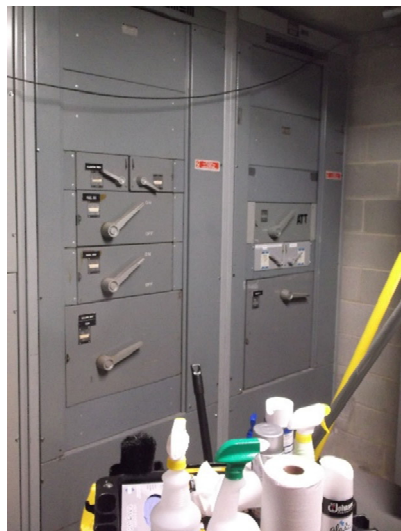
The existing electrical service is made up of a 1600 amp 120/208V-3PH-4W Westinghouse switchboard, with a 1600-amp main switch, an integrated C/T cabinet and (2) adjoining distribution sections with a third section free standing in the south-east corner. The switchboard is the original from when the building was built in 1974 and is in fair condition. The main switch and adjacent CT cabinet

have recently been replaced. The switch board is fed from an underground utility vault located below the Salley Port entrance. From there it runs in the unexcavated space to the north of the basement and into the back of the main switch. The distribution sections feed multiple panels, mechanical equipment, Chiller (CH-1), cell tower and the elevator. The electrical panels are all original except for a couple of panels. The original panels and switchboard are in fair condition but nearing the

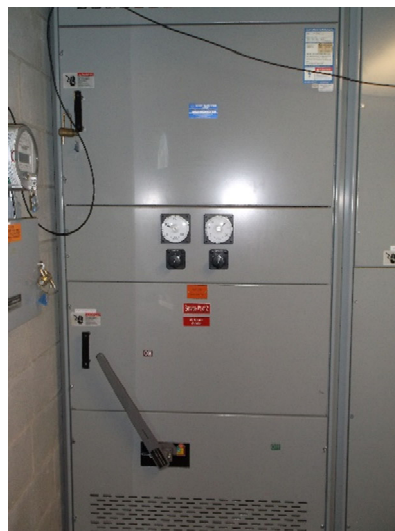
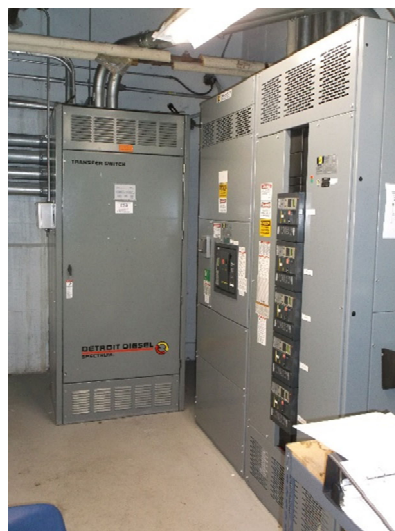
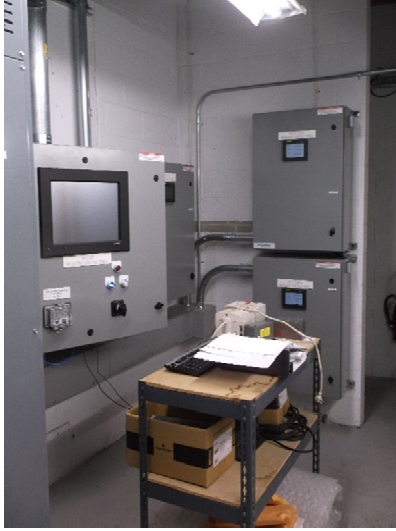
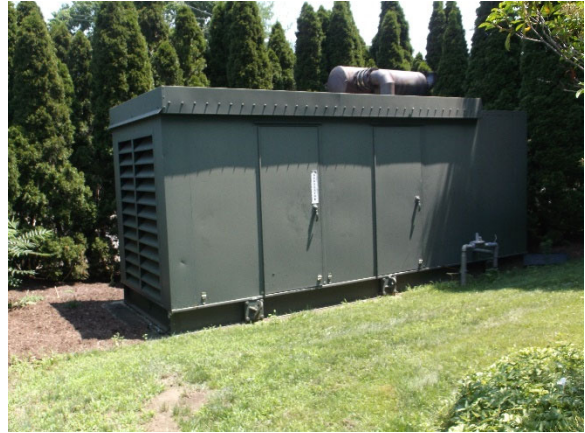
end of their useful life. There is a 1600 amp 120/208V-3PH-4W natural gas emergency generator located out front in the north-east corner. The generator has a single output breaker (1600 amps) that feeds a Square D emergency distribution system. The emergency distribution is made up of a 1600-amp Detroit Diesel automatic transfer switch. Which intern feeds the Square D emergency switchboard. The switch board is made up of a 1600-amp main breaker section and a distribution section that feeds the ATS-P for the police station, ATS-OH for operation hope, ATS-F1 for fire house #1 and ATS-C1, C2, C3 for the cell tower. In addition to the normal and generator distribution systems there is a microgrid system. That system connects the normal electrical distribution, generator distribution and co-gen plant on the roof.

- Replace existing normal electrical distribution equipment and associated wiring, except for a couple of newer panels (penthouse, UPS #1-3, RP1A, etc.). Generator and Microgrid equipment are newer and do not need to be replaced.

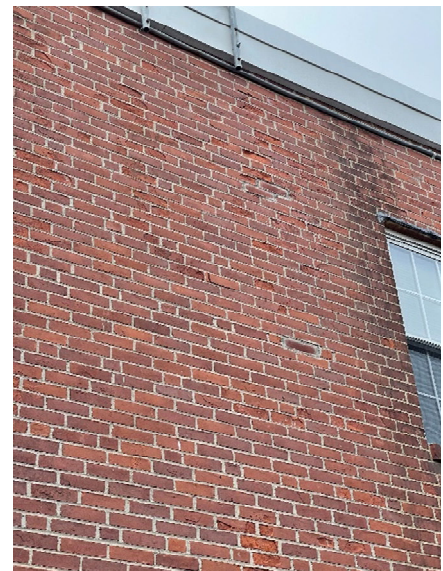
This two-story facade has many areas of disrepair. The building is constructed with brick “veneer” with no air space evident. The energy efficiency of this construction is very low, and typical in the 1950s (“pre-energy crisis”), and not one that is easily or readily corrected. The exterior brick walls have a considerable amount of settling and spalling. The north and west elevations have a large amount of spalling bricks throughout that should be replaced. In addition the building should be cleaned and remove the unwanted vegetation on the side of the building.

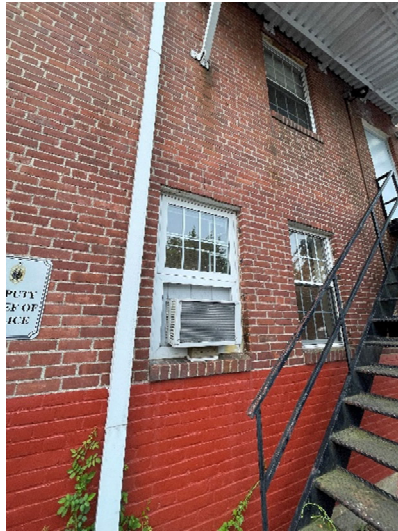
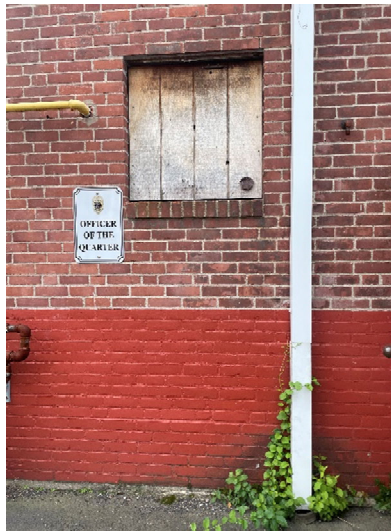
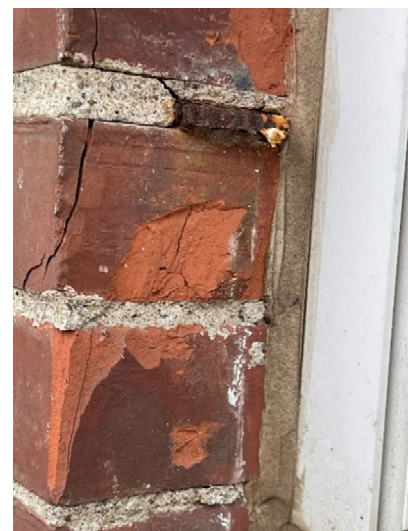
The windows at Operation Hope are operable double hung vinyl windows systems. These double-glazed systems are replacement windows. They appear to be in good condition. Many of the metal lintels at the window heads are beginning to rust. These should be scraped, primed and painted. Some of the brick sills are also spalling.

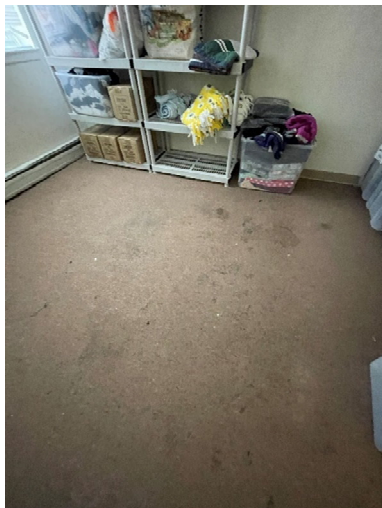
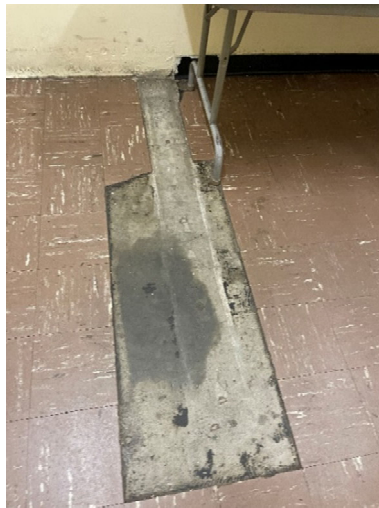
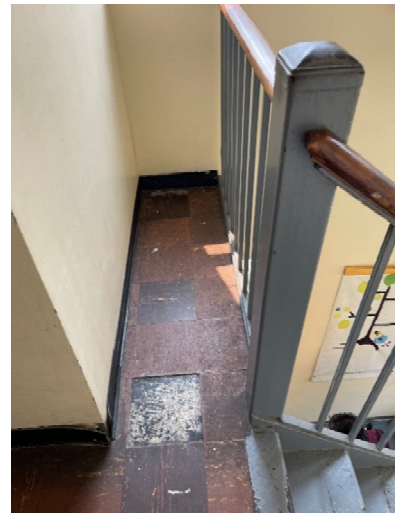
The flooring materials in Operation Hope vary based on the spaces viewed and they are in fair to disrepair condition. There is carpet located in the lobby, office areas, shelter rooms. The carpet is damaged and worn down. The vinyl composition tile (VCT) is located in the majority of the second floor and in the hallways on the ground floors. Many are damaged or missing leaving mastic visible. In addition to the condition of the VCT, the rubber base is mangled and should be replaced. The elevator lobbies and some stairwells consist of 9x9 tiles which likely contain asbestos and should be replaced.

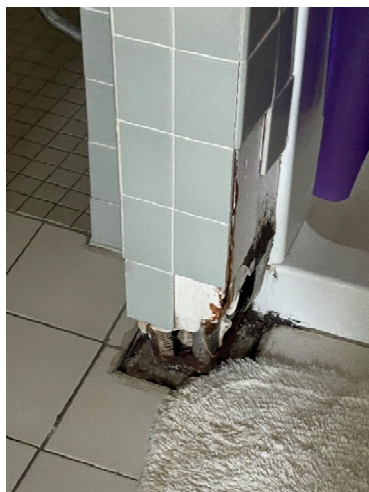
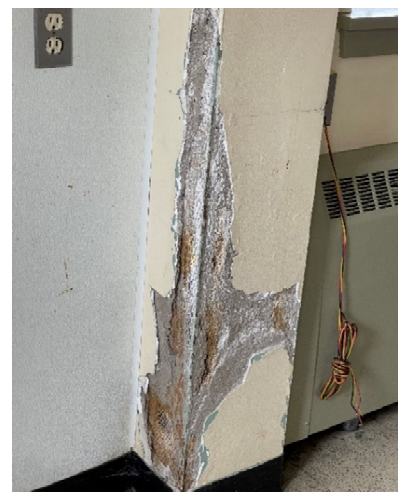
The interior walls in Operation Hope are made of plaster and gypsum wall board. There is a significant amount of the materials which are damage and in need of repair or replacement. The restrooms have ceramic tile which also has many damaged areas.

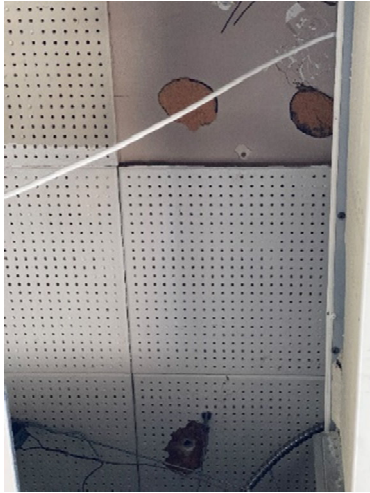
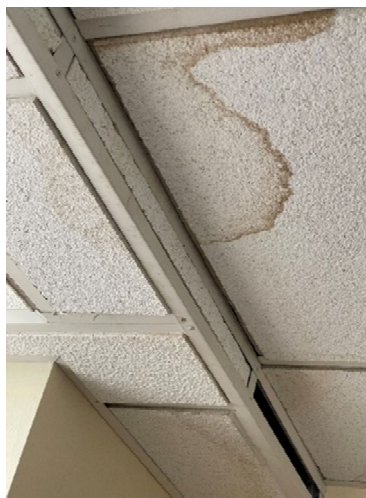
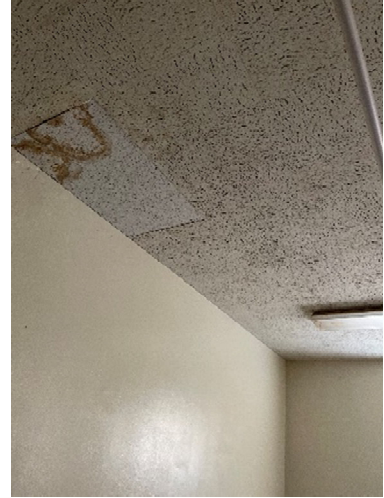
There are a variety of ceiling types throughout the facility. There is a combination of ACT dropped ceiling but also a variety of spline ceilings. ceilings in the building are in disrepair. There are many stained or missing tiles in the main office which should be replaced. The captain's office contains much staining which should result in the replacement of all tiles.

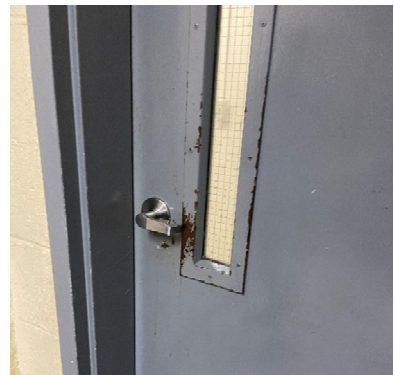
There are a variety of door types at the facility. Most are hollow metal set in hollow metal frames. There are also some wood doors. Some of the doors are worn and would benefit from a fresh coat of paint. Some door hardware is not accessible. Knob handles require grasping and twisting and are not in compliance. Additionally, there are some lever handles that are small when they should be 3.8" to 4". These should be replaced.

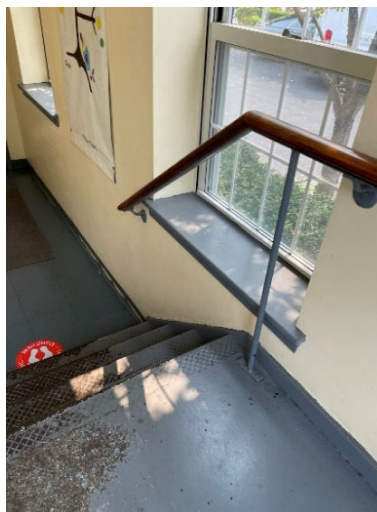
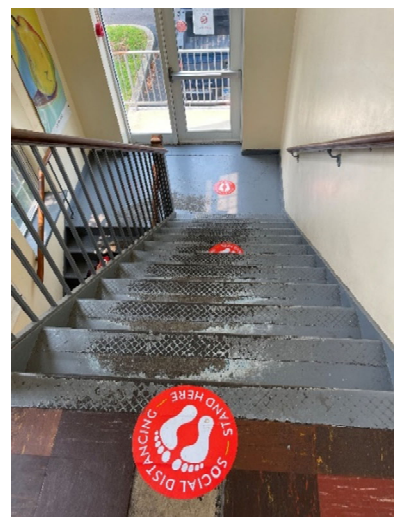
The existing stairs are in fair condition. The painted stairs are worn and the 9x9 tile was previously mentioned. Additionally, the stair handrails do not have the extensions and the guardrails do not have the required height. These items should be modified to conform.

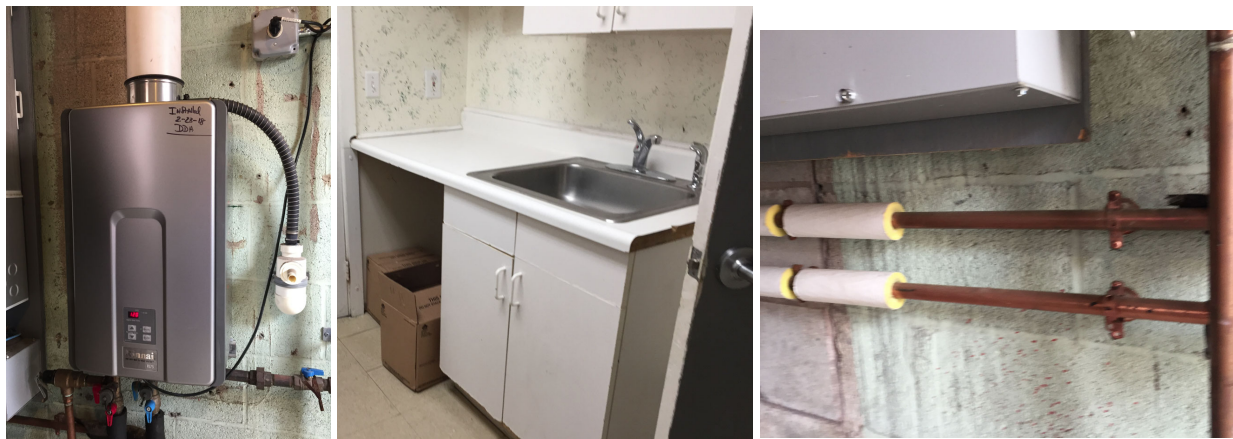
Natural gas is the heating source and the gas service is routed from the gas main in Nichols Street. The gas meter is located on the building's exterior. Gas piping on and near the roof is rusted and needs to be repainted.

The water heater was installed 3 years ago and is an instantaneous wall mounted type. It is missing drip leg on the gas piping.

Plumbing fixtures are older and need upgrades. Fixtures are not ADA compliant. There is also an 80-gallon electric water heater missing a thermostatic mixing valve and insulation.

Exterior hose bibbs are broken and need replacement.

- Repair/Replace existing exterior hose bibbs are missing vacuum breakers.
- Repair/Replace/Add missing pipe insulation.
- Paint exterior gas piping.
- Repair/Replace existing plumbing fixtures for ADA compliance.
- Replace exterior hose bibbs.

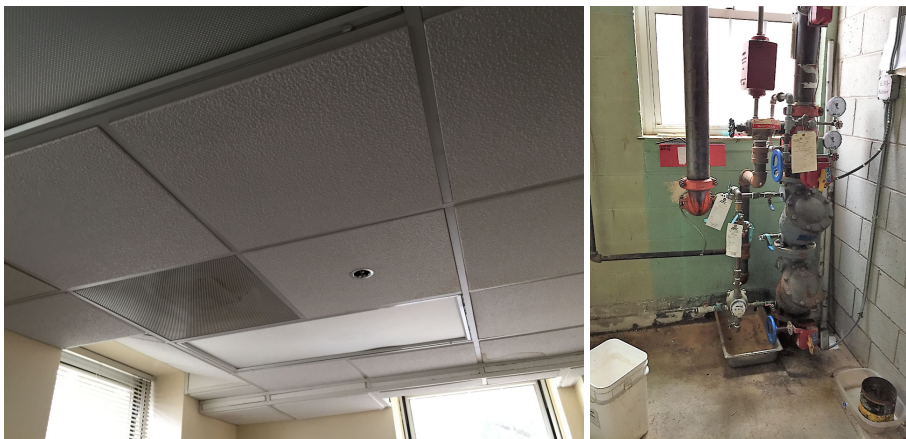
The four-inch main sprinkler service is in the lower level. It consists of a vertical reduced pressure principal backflow preventer, alarm check valve with a metered bypass. It was installed in 1987. The pressure is good, tested at 90 psi static. The systems were last tested 6/7/17 & 10/18/12 and are out of date. There isn't a floor drain in the space and if backflow occurs, it could dump a large amount of water into the space and cause damage.

- Provide a floor drain for the backflow preventer for drainage.
- Yearly test and maintain sprinkler system components as required by NFPA 13.

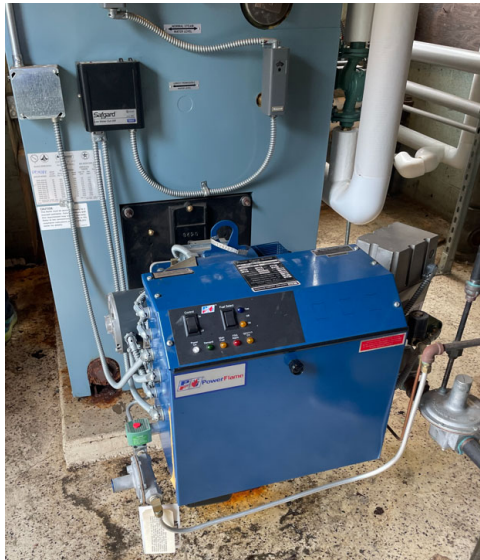
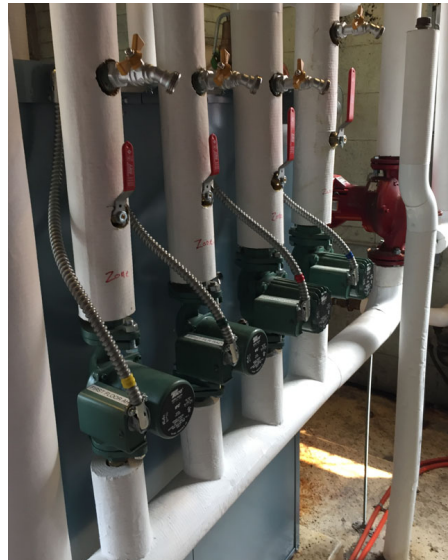
There are four (4) independent zones serving the building. The four (4) zones are fed from individual inline pumps off of the boiler manifold. Inline pumps are installed the same year as the boiler. Each zone is controlled by a local thermostat.

Age of the hot water piping distribution system beyond the boiler room is unknown, piping system should be inspected utilizing ultrasonic testing to determine rates of corrosion within the piping. Section of hot water piping have no insulation.

- Perform ultrasonic testing for the rest of the piping system to determine the rates of corrosion within the pipes. Replace pipes as needed.
- Provide piping insulation.

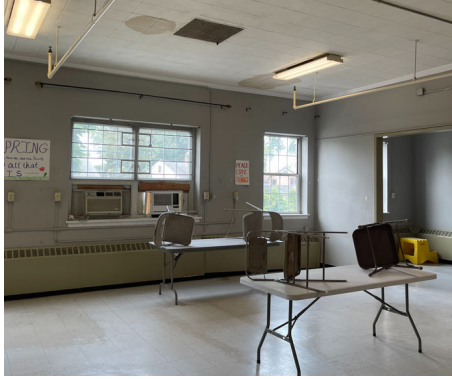
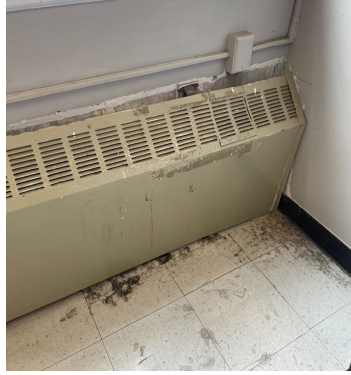
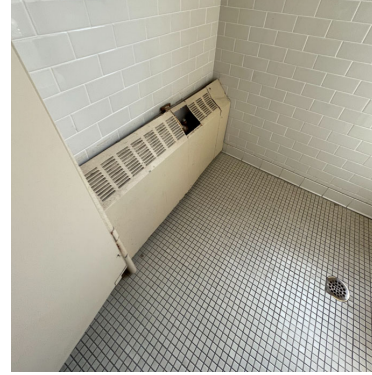
Common areas and service areas are served by window mounted air conditioning units. The window air conditioning units are of varying conditions; unit life for this type of equipment is 5 – 7 years.

Finned tube radiation is utilized at vestibules, common area and common area toilet rooms. Finned tube radiation is generally in poor condition.

- Replace finned tube radiation in toilet /shower rooms.
- Replace finned tube radiation in common area.
- Replace finned tube radiation in dwelling units. Consider adding manual thermostatic control valve at each dwelling unit.

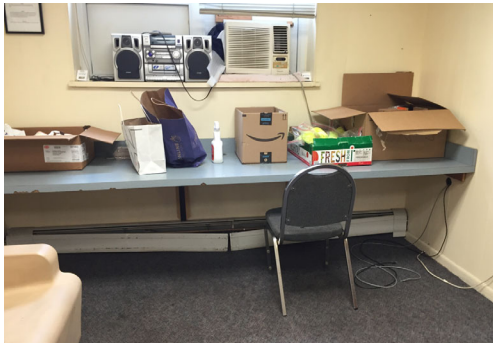
Heating in all dwelling units is done by perimeter finned tube radiation. Perimeter finned tube radiation are in poor condition. Several dwelling units are equipped with window mounted air-conditioning units which plug into adjacent wall receptacles. The window air conditioning units are of varying conditions; unit life for this type of equipment is 5 – 7 years. Ventilation in the dwelling units is through operable windows and exhaust grilles.

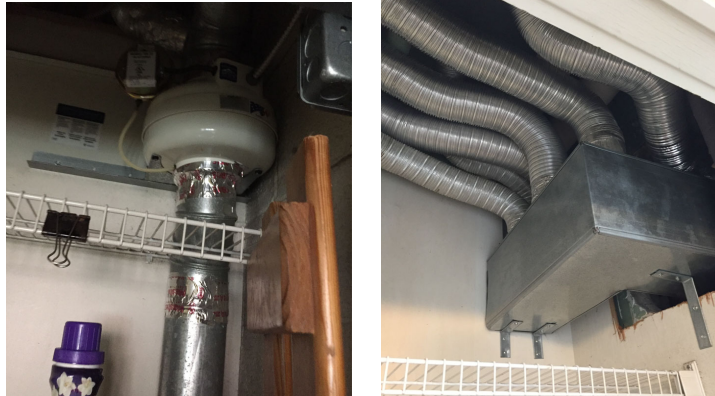
Dryer exhaust, provided with inline fans, appears to be routed to a common exhaust duct through exterior wall. Make-up air comes from adjacent space volumes. Exhaust ductwork joints are held together by metallized duct tape and should be upgraded.

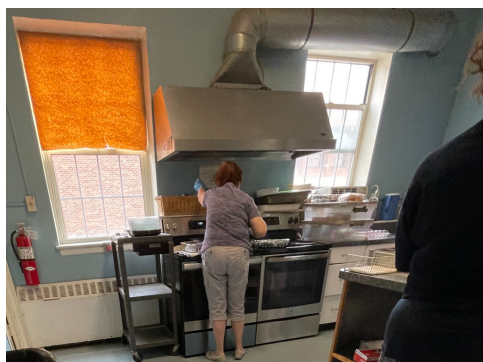
The existing cooking appliances are provided with a vent hood ducted to a wall cap. There is also no makeup air for the kitchen. Per International Mechanical Code Section 507.1.2, domestic cooking appliances utilized for commercial purposes require Type I hood with fire suppression system. The cooking appliances are gas open-burner ranges, and are defined as heavy duty appliance per IMC section 202. IMC section 507.5.2 requirement for heavy duty cooking appliance using a wall mounted canopy type of hood is 400 CFM/linear foot. IMC section 508 requires make-up to be supplied during operation of commercial kitchen exhaust.

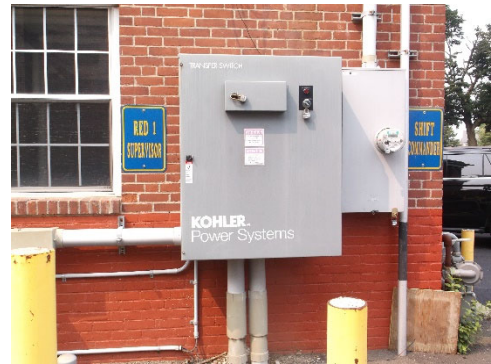
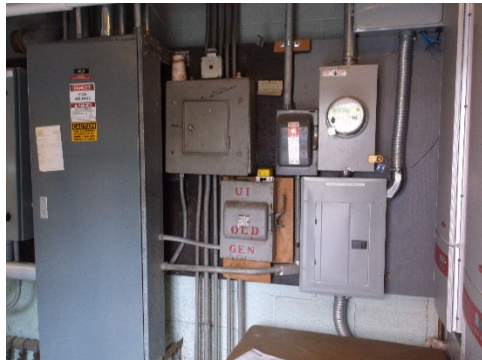
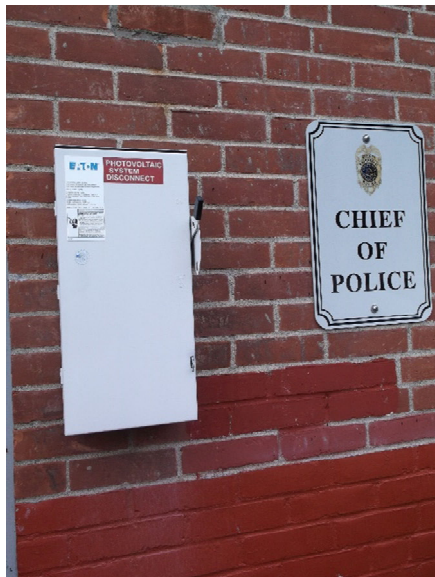
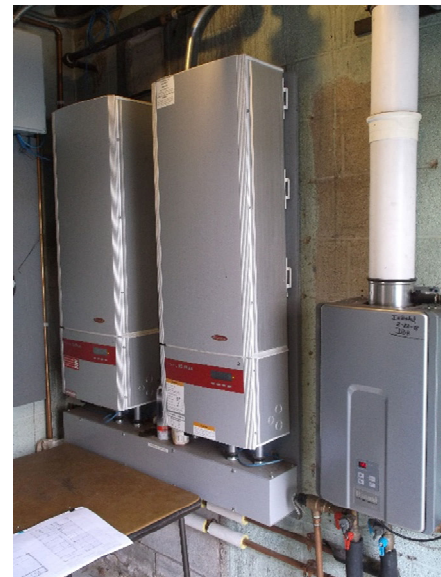
The existing electrical service is made up of a 400 amp 120/208V-3PH-4W service switch inside the (Kohler) transfer switch mounted on the exterior of the building (north-east corner) outside the Boiler room. The in-line meter and main switch are fed

of the parking lot by the fuel pump. The main switch/ATS feeds the main distribution panel (MDP) in the Boiler room. The MDP feeds other electrical panels, mechanical equipment, and the elevator. The generator side of the transfer switch is fed from a breaker in the generator distribution panel in the basement of the Police Station next door. In addition to the normal/generator electrical distribution, there is also

a photovoltaic system. This is made up of solar panels on the roof feeding two inverters in the Boiler room. This building is also connected to the microgrid system of the Police station.

- Replace existing electrical distribution equipment and associated wiring, except for new panel install on second floor during the last renovation.
- Replace existing ungrounded receptacles with new ground receptacles and matching cover plates.
- Replace all existing receptacles and phone & network outlets with new except for those installed under the last addition/renovation.
- Replace all old rusty bathroom "call for aid" devices with new.
- Replace existing toggle type switches with new occupancy sensors and dimmer switches.
- Install emergency lighting at the exterior of all egress doors to meet current code requirements.
- Replace all paper exit signs with new illuminated exit signs.

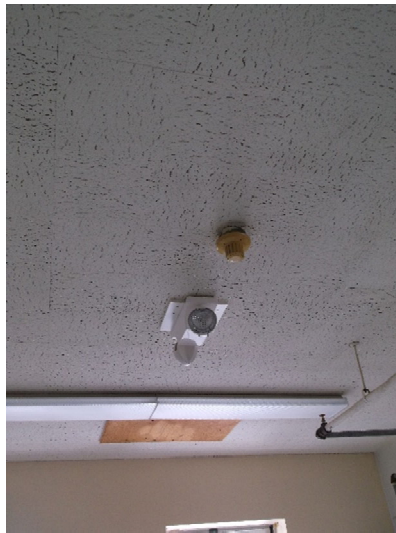
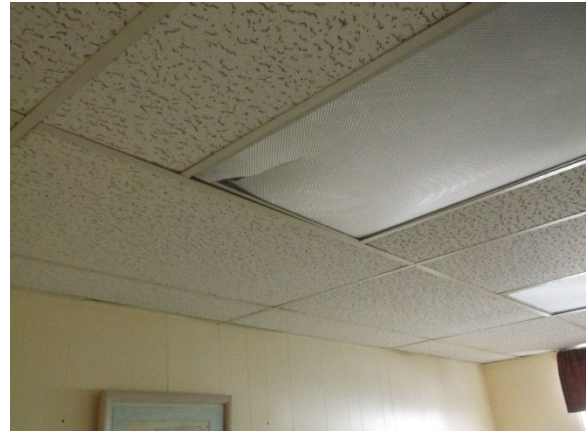
The existing interior lighting in the building is a mix of recessed lensed fluorescent 2x2, 2x4 & 1x4 fixtures, recessed down lights, surface mounted wraparound fixtures and 4-foot industrial fluorescent fixtures. These fixtures are in fair condition, with some of the lens cracked and/or broken.

have been upgraded with new LED bulbs. There are some fixtures that still have fluorescent or incandescent bulbs. These were areas that the town determined to be low use and would be replaced later as needed. Most of the areas appear to be controlled by local toggle type switches with a couple of lights controlled by a rotary time switch. There are a couple of lights not working at this time, they may just need new bulbs. The existing exterior lighting for the building

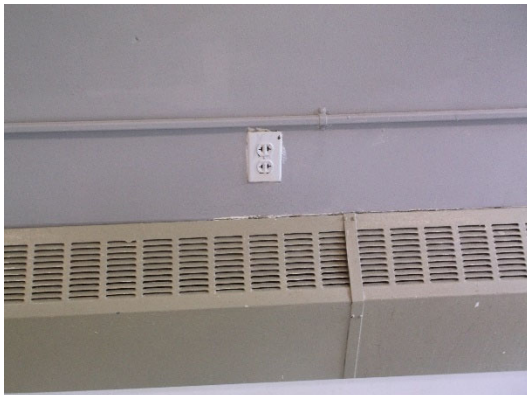
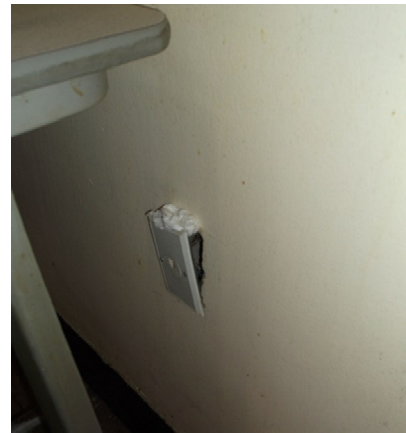
Existing wiring devices (receptacles & light switches) in the building are a mix of recessed and surface mounted. There are a few ungrounded receptacles (2-prong not 3) in the building, in addition to a large number of receptacles that have had the face of the device painted over. The devices overall appear to be in fair/poor condition.

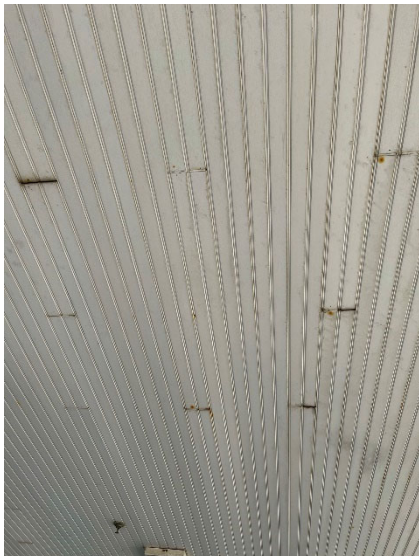
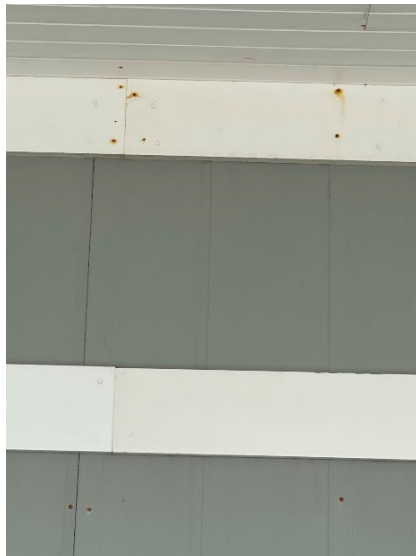
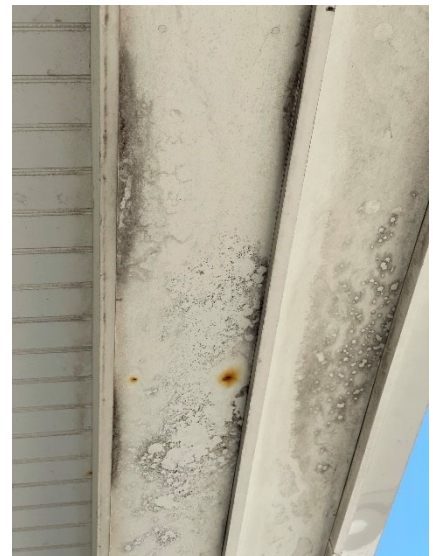
The Pavilion's building envelope is sheathed in vertical Hardie panels and detailed with a PVC trim. Overall, it is in good condition. Many of the nails have begun to rust. Additionally, the underside of the roof overhangs also has rusting nails and missing spacers. All exterior PVC surfaces should be power washed followed by priming the rusted nail head with a rust inhibitor primer, and then a fresh coat of paint. The material has more life left to it, if properly protected.

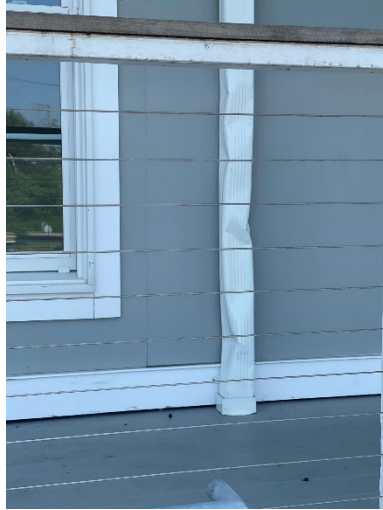
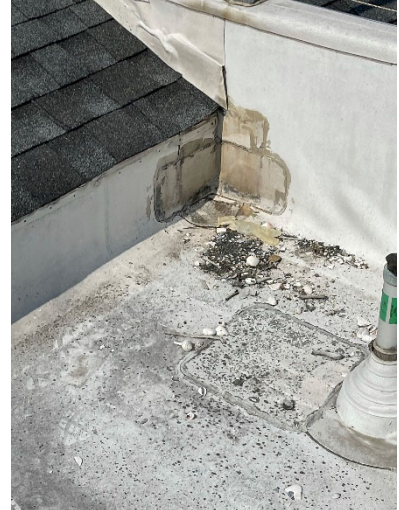
The roof is a combination of a Thermoplastic Polyolefin (TPO), Ethylene Propylene Diene Monomer (EPDM) membrane and asphalt shingles. The roof is in good condition, aside from the general cleaning of debris which should be done at least twice a year on any building. There are also some damaged downspouts that should be repaired.

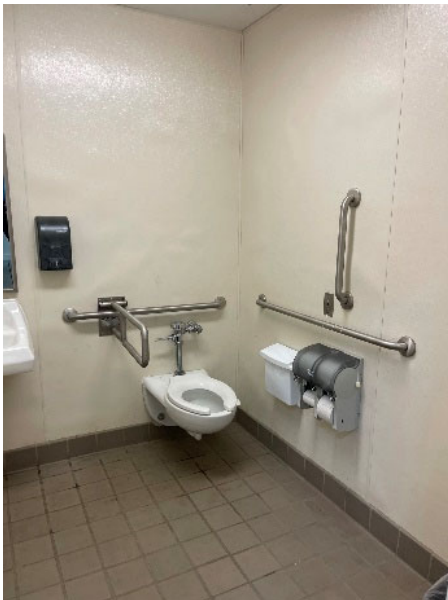
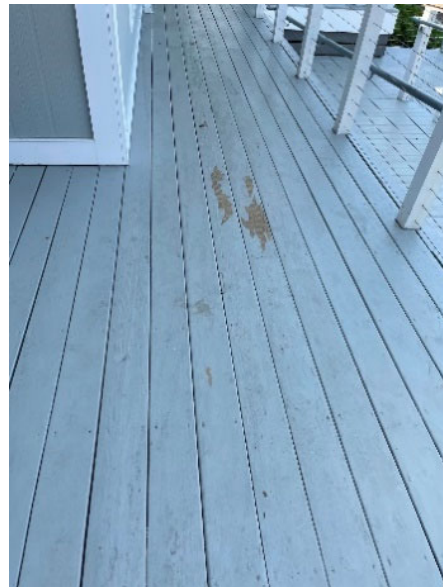
The floors of the Penfield Pavilion are in good condition. The wood floors in the locker room and outdoor areas have been worn down with the constant sand and water from pedestrian circulation resulting in peeling paint. These should be monitored and maintain to add longevity to the materials. The remainder of the consists of ceramic and quarry tiles and concrete flooring.

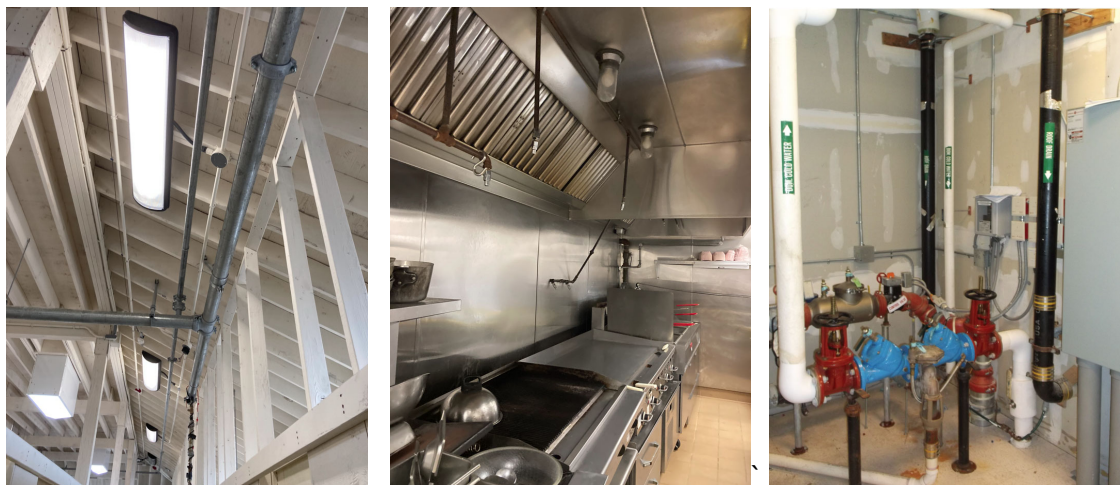
There is an exposed drum drip assembly for the dry pipe sprinkler system. The system is heat traced and must have experienced a freeze-up. The system may not be piped correctly or needs to be drained.

- Replace all corroding exterior sprinklers with non-corrosive ones.
- Repipe the drum drip assembly for the dry pipe sprinkler system. To prevent a freeze up.
- Continue to maintain, test, and inspect sprinklers and devices as required by code.

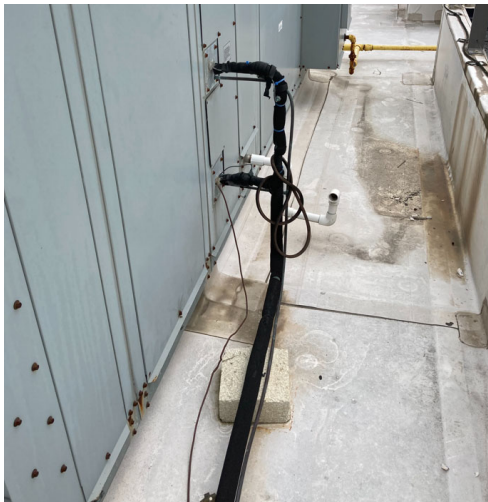
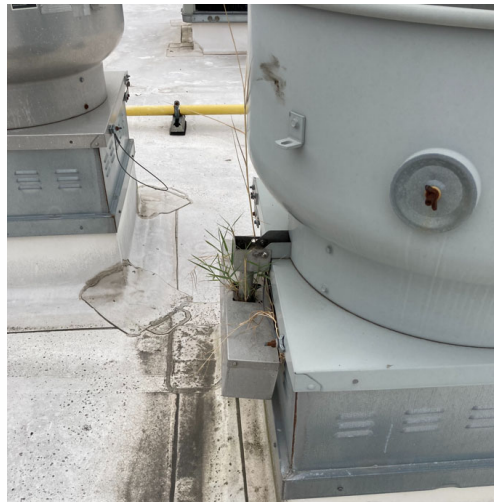
The warming kitchen and the concession kitchen are provided with the code compliant type I hood with Ansul system complete with UL exhaust fan, and make-up air unit. The make-up units and the associated air cooled conditions are manufactured in 2011. Refrigerating piping insulation is starting to deteriorate. The exhaust fans are provided with grease trap. These grease traps require periodic maintenance.

- Replace refrigeration piping insulation. Provide insulation with aluminum jacket.
- Clean grease trap and replace the disposal grease absorber. Consider periodic inspection and grease trap.
- Provide exhaust fan and ventilation air in lifeguard area.

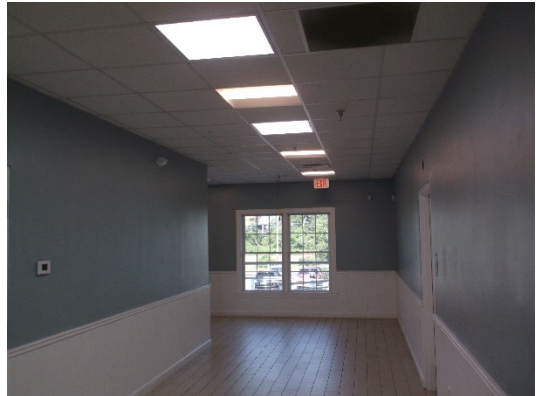
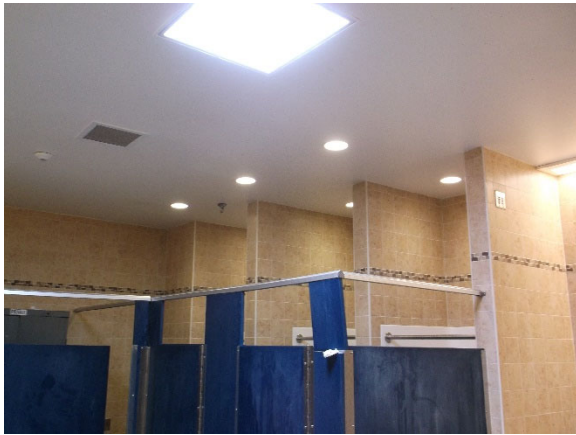
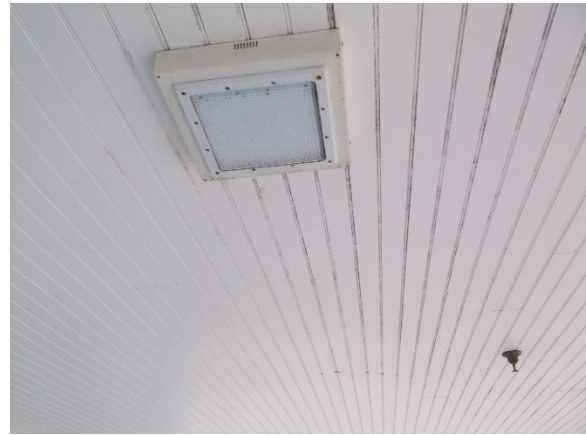
properly. It is our understanding that the majority of the fixtures have been upgraded with new LED bulbs. There are some fixtures that still have fluorescent or incandescent bulbs. These were areas that the town determined to be low use and would be replaced later as needed. Most of the areas have occupancy sensors to turn the lights on and off in conjunction with local toggle type & dimmer switches for added control. The existing exterior lighting for the building is made up of fluorescent/incandescent surface mounted "jelly jar" type fixtures with round reflectors, surface mounted square LED light fixtures and some wall mounted fluorescent elliptical shaped fixtures. Most of these fixtures are in fair/poor condition (rusting exterior

finish). We were not able to determine the operation of the exterior fixtures at the time of our inspection.

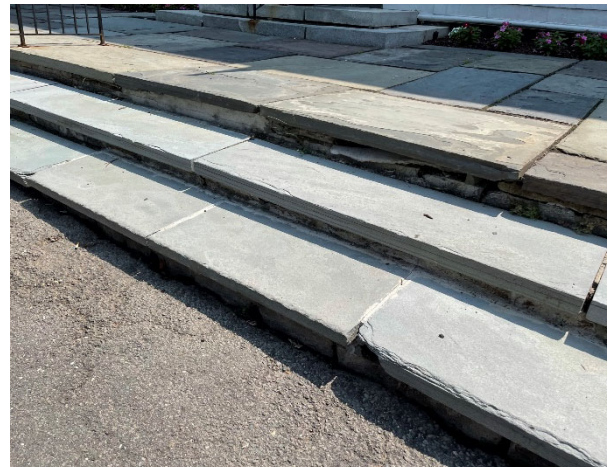
The exterior facades of the Old Town Hall are in good condition. The siding is composed of wood shingles and is painted white. There are multiple layers of paint but overall, it is holding up well. There are also some areas of painted masonry construction which is also holding up well. These areas do have some vegetation growing against the façade which should be removed to maintain the integrity of the masonry and mortar joints. The stone foundations appear to be in good condition. Given its age, the mortar should be inspected on a regular basis and repointed as necessary. The front porch slate is beginning to wear. Some areas are chipping away at the corners and the mortar joints are failing in places.

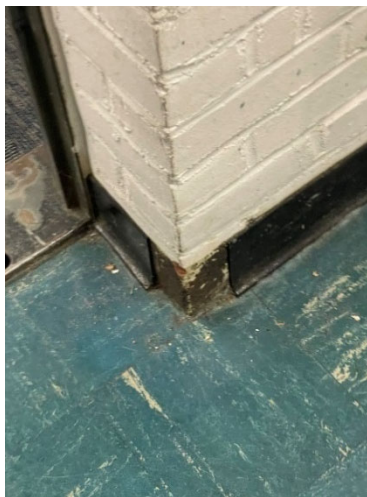
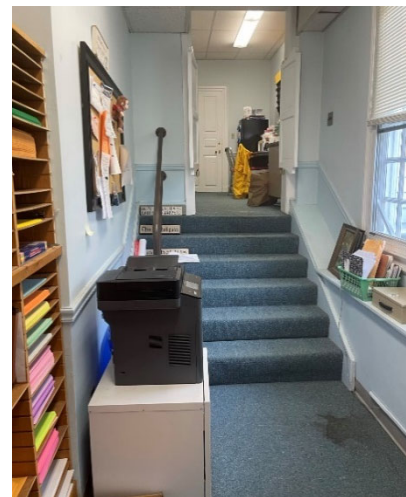
There are a variety of floor types at the Old Town hall. there are a variety of carpeting types. Some are in good condition while others have stains, are worn and dated which should be replaced. There is a large amount of vinyl asbestos tile (VAT) that should be abated. There is additionally wood and stone flooring which are all in fair to good condition.

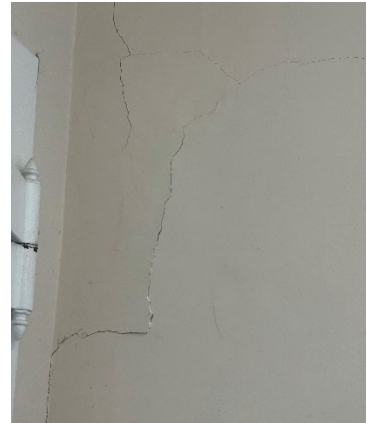
There are a variety of wall types most notably plaster along with some gypsum wallboard, ceramic tile. Overall, the walls are in fair condition with areas of damaged plaster and peeling paint in a few areas. Specifically portions of paint that peeled off the walls in the Tax Collectors office which should be scraped, patched, primed, and painted.

Figure 14-4: Wall Condition

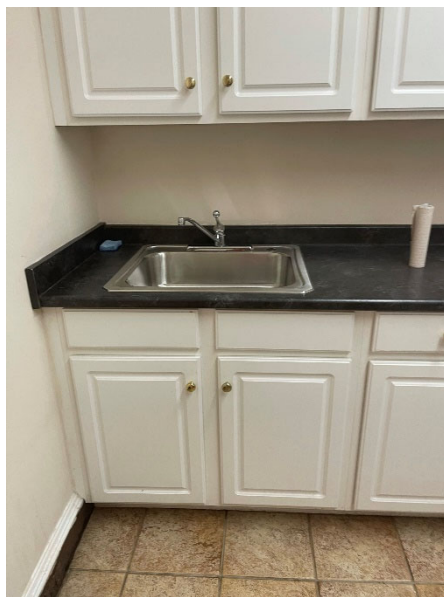
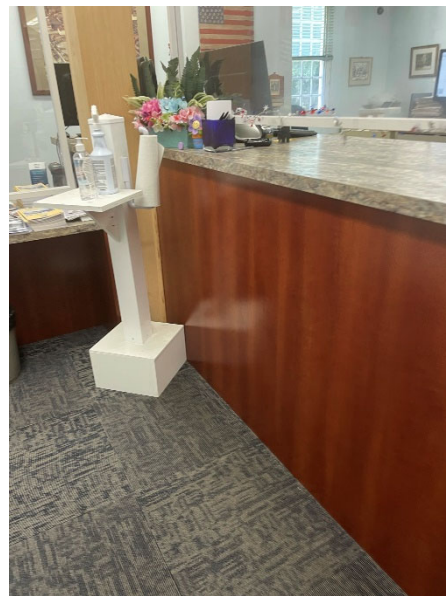
There is a variety of casework and counters throughout the facility. most are wood and in fair condition. However, some areas are not ADA compliant as there is no nice space or 2'-10" counter for visitors at offices. Casework with sinks do not have a compliant sink or knee space included. These should all be updated to comply.

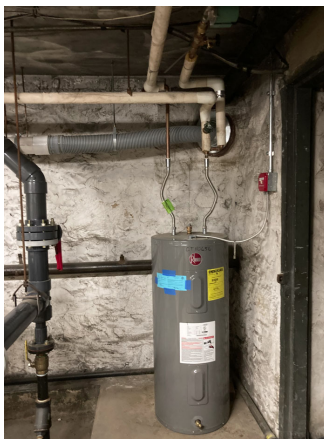
The water heater is electric, newer in good condition, but missing a tempering valve for scald prevention.

*Electric Water Heater in Basement*

- Repair/Replace/Add missing pipe insulation.
- Provide tempering valve at water heater.
- Paint exterior gas piping.
- Repair/Replace existing plumbing fixtures for ADA compliance.

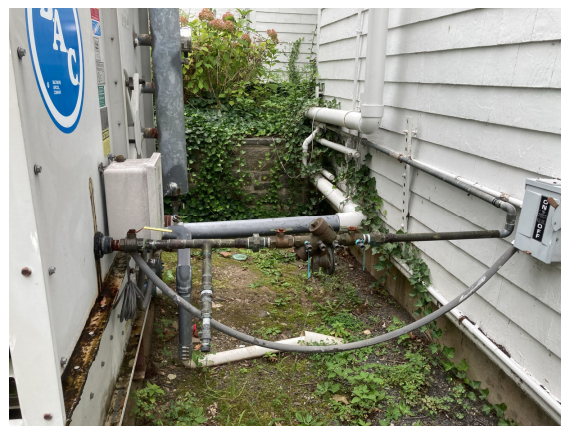
*Exterior Cold-Water Piping to the Cooling Tower*

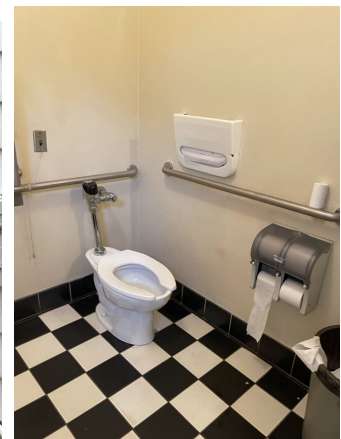
Plumbing fixtures are minimal and in good condition. Handicap accessible lavatory needs pipe insulation on exposed piping, required clearance and mounting heights.

*ADA Water Closet*

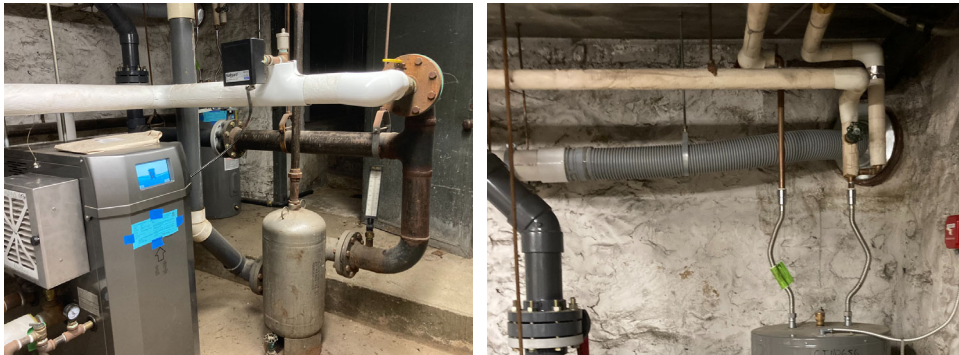
The low pressure /water tube boiler, manufactured by NTI model Lx300, is located in the basement. Based on the serial number, the boiler is manufactured in 2013. Flue piping, a combination of PVC and flex pipe routed into the existing chimney. The flex pipe, which appears to be the chimney liner, is not installed in accordance with the manufacturer's requirements. The boiler is equipped with air filter kit to draw combustion air from the space, sufficient outside air should be provided to the basement. Supply and return piping material are a made of steel and PVC.

- Replace boiler vent piping connection with a short piece of approved manufacturer vent kit adapter.
- Replace PVC and flex pipe with polypropylene rigid pipe connecting to the rigid pipe connector in the approved polypropylene chimney liner kit.

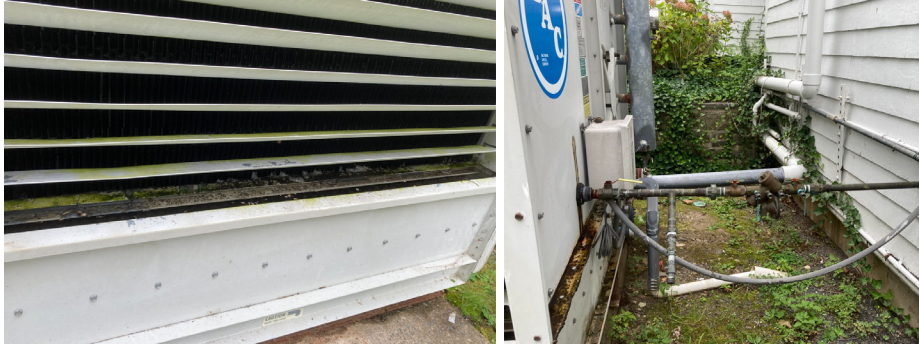
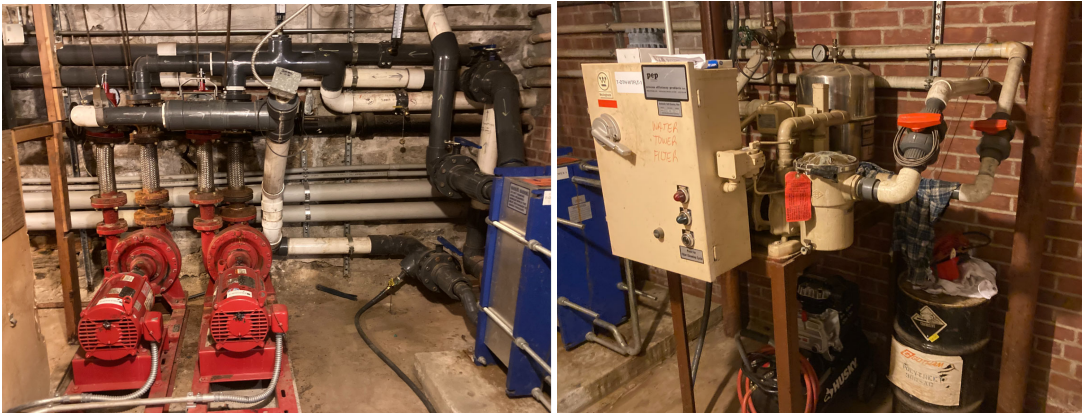
The cooling tower, manufactured by Baltimore Air Coil, is located on grade. The cooling tower pumping system and the associated PEP filtration system is in the basement. Cooling towers have a useful life expectancy of 20 years. Based on the serial number, this cooling tower is likely manufactured in 2002 and is at the end of its useful service life. Two(2) pumps circulate water through heat exchanger to cooling tower. Both reducers and flange connections are rusted. Piping material used is a mix of schedule 40 and schedule 80 PVC.

- Engage the service of a Chemical Service Provider to maintain proper water treatment to the to the building water loops.
- Replace worn parts and rusted flange connections. Provide new gaskets and repair leaks.

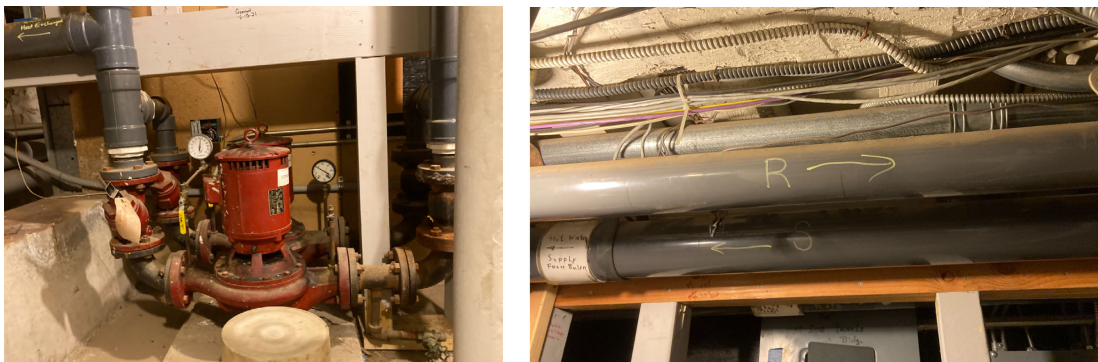
The piping distribution system in the building is a 2- pipe system. Two(2) pumps, lead/standby operation, circulate water throughout the building to multiple water source heat pumps. Both pumps have minor wear. Flanged connections are rusted. Piping material used is a mix of schedule 40 and schedule 80 PVC.

- Replace all PVC pipes used for the 2-pipe building loop ( supply and return) with either steel or copper. Provide insulation.
- Provide outside air ductwork with motorized damper to the basement.

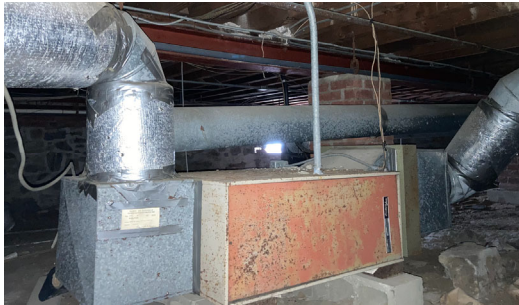
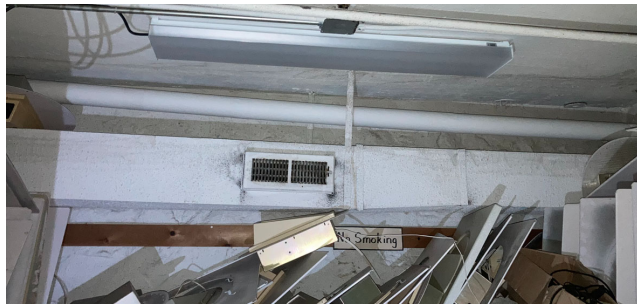
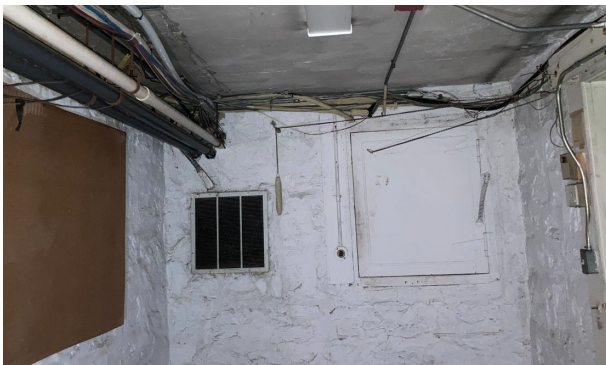
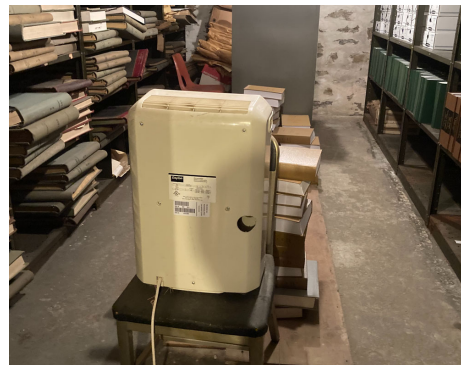
An air handling unit located in the crawlspace, circulates air in the basement. This unit had outlived its useful service life. Duct distribution system and associated diffusers and grille are in need of cleaning.

- Replace air handling unit in the crawlspace. Provide outdoor air connection to the unit. Clean and seal all existing ductwork, registers, and grilles. Re-insulate as required.

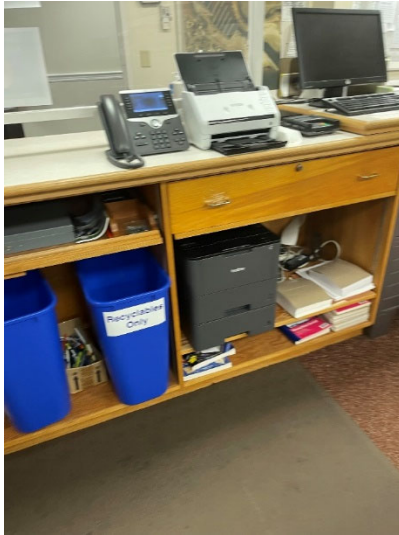
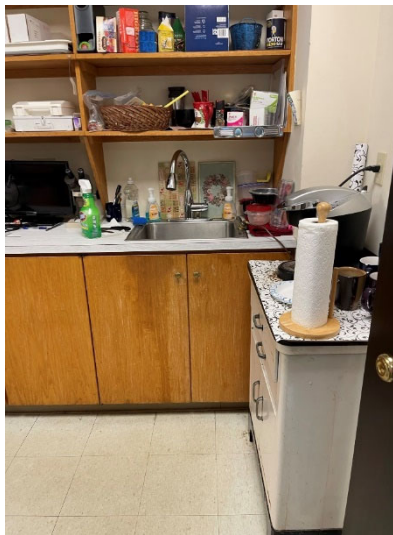
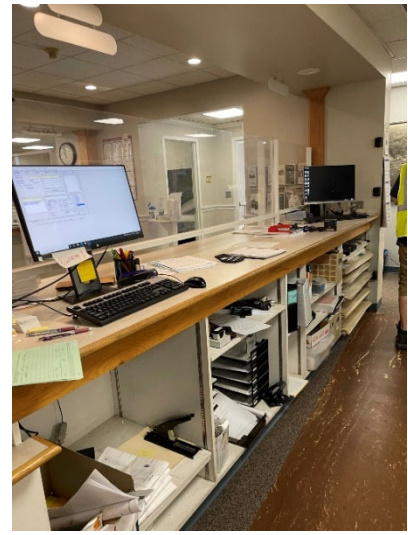
There is a variety of casework and counters throughout the facility. Most are wood and lack a knee space. Casework with sinks do not have a compliant sink or knee space included. These should all be updated to comply.

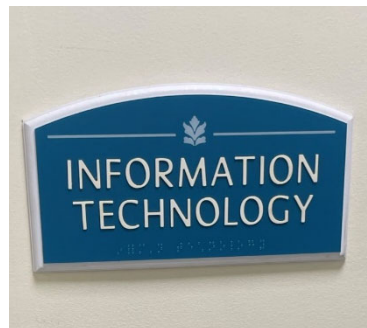
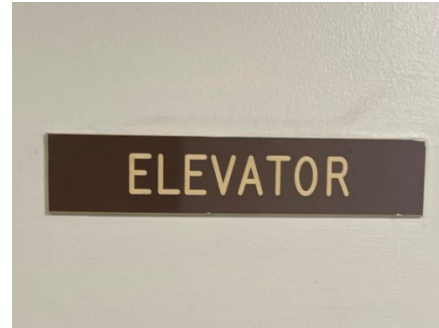
As noted within many of the sections, there are multiple code and accessibility issues within this building. Door hardware, stairs, ADA restrooms and casework were previously noted. A few doors do not have the required accessibility clearances. Where they cannot be modified a power assisted door operator should be installed. Signage is a very important item which should be incorporated into this building. Although each room has a room name and label, the dimensions, height, and lack of braille are not code compliant. These items should be included in the long-term capital plan.
