**Town of Fairfield**  
Town Planning and Zoning Commission  
725 Old Post Road  
Fairfield, Connecticut 06824

**To: Members of the RTM**  
**From: Jim Wendt, Planning Director**  
**Date: April 19, 2022**  
**Re: Opt-Out of State Mandated Zoning Regulation Language**

FAIRFIELD TOWN PLAN AND ZONING COMMISSION PROPOSED OPT-OUT OF  
STATE MANDATED REGULATION LANGUAGE REGARDING OFF-STREET PARKING.

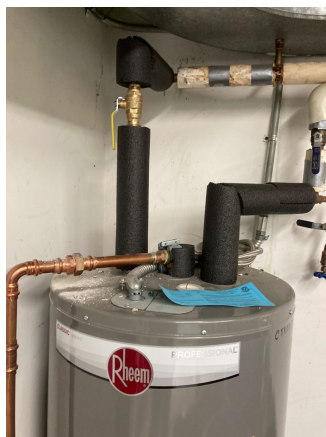
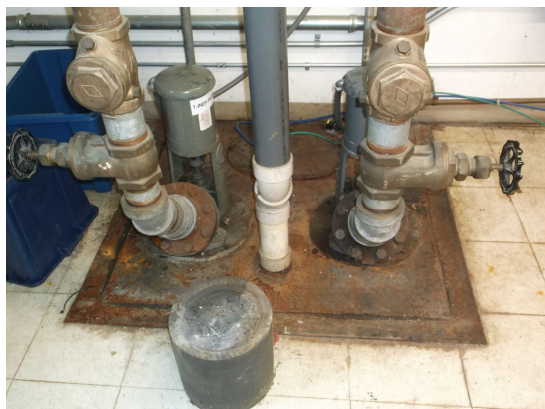
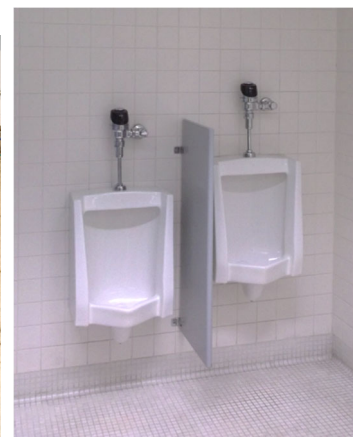
The gas service is routed from the gas main in Old Post Road to an exterior gas meter which serves the boilers. Exposed gas piping on the roof is severely corroding and should be painted or replaced at a minimum.

A roof drain strainer is missing. This can cause clogs as nothing is preventing debris entering the storm piping.

Sump pumps/Sewage ejectors were found in the basement. Further inspection and testing need to occur.

- Test and inspect backflow preventers as required by Aquarian Water Company.
- Provide a thermostatic mixing valve on the water heater.
- Repair/Replace/Add missing pipe insulation.
- Paint exterior gas piping.
- Replace roof drain strainer – note this is an immediate repair needed as it can cause damage to the building and appears to be ponding and clogging now.
- Test, inspect and repair sump pumps/sewage ejectors.

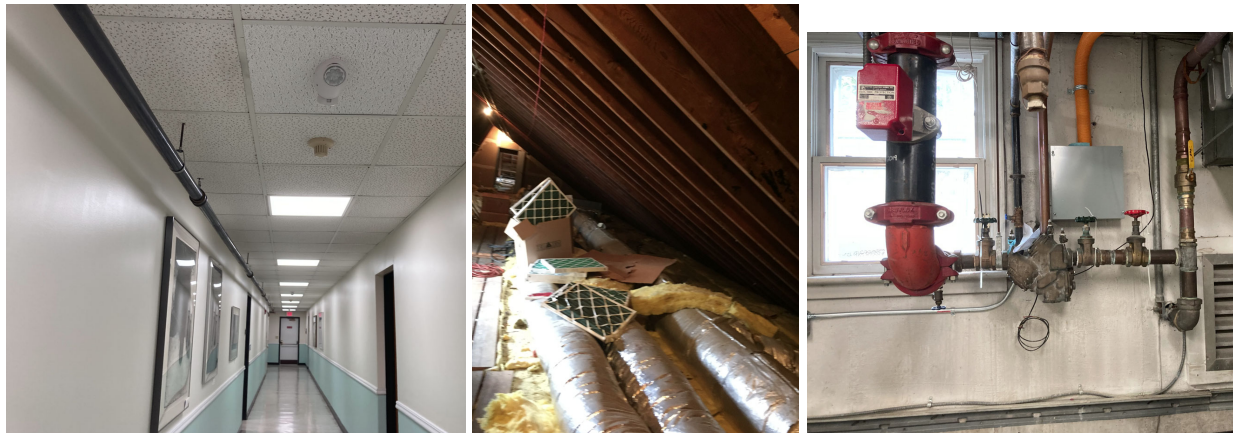
Distribution piping is black steel with mechanical and threaded fittings. Areas are provided with upright sprinkler heads.

A server/computer room exists with a raised floor, a gaseous suppression system sometimes protects these rooms so water does not damage sensitive electronic equipment.

- The attic did not appear to be sprinklered. Provide a dry pipe sprinkler system in the attic.
- Provide a new sprinkler service from the street, minimum four-inch with backflow preventer and fire department connection. Hydraulically calculate all existing piping for correct sizes and upgrade as necessary. Provide sprinklers in any areas where they may be lacking.
- Continue to maintain, test, and inspect sprinklers and devices as required by code.

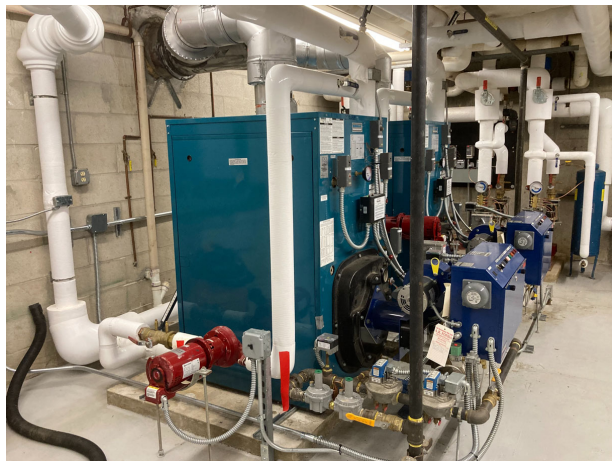
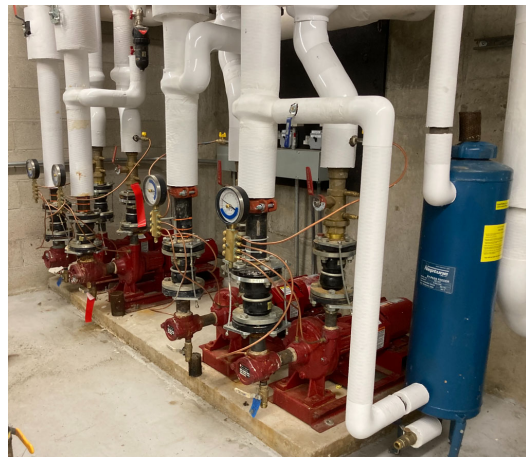
The building is heated using two (2) boilers located in the basement. Boilers are Burnham model V906, 6-section cast iron gas fired with Power Flame burner. Each boiler has an IBR rating of 690 MBH. The new boiler plant was installed in 2020. The boiler plant is equipped with filtration system and chemical by-pass feeder. Products of combustion are vented into the existing chimney through a sheet metal flue. Combustion air to boiler room appears to be adequate. Each boiler is provided with a blend pump to protect the cast iron section from low return water temperature. There are four (4) base mounted pumps serving the building. Two (2) pumps on a lead/lag configuration serves the East Wing and the other two (2) pumps on a lead/lag configuration serves the West Wing. Pumps are provided with variable frequency drives.

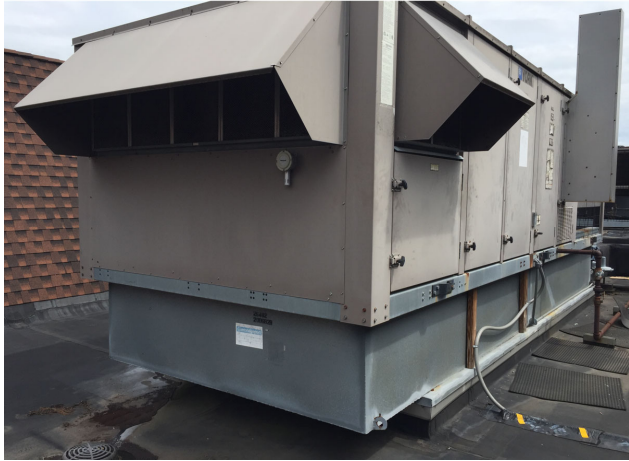
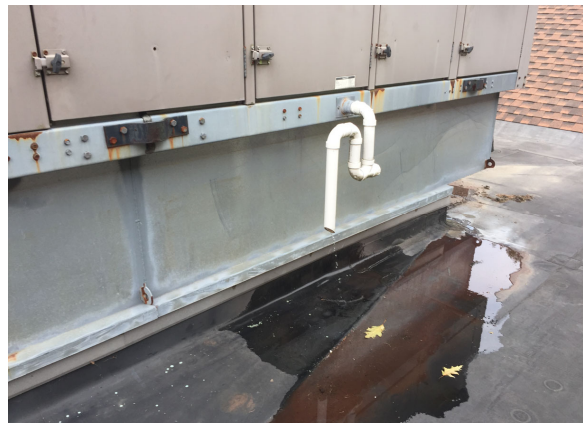
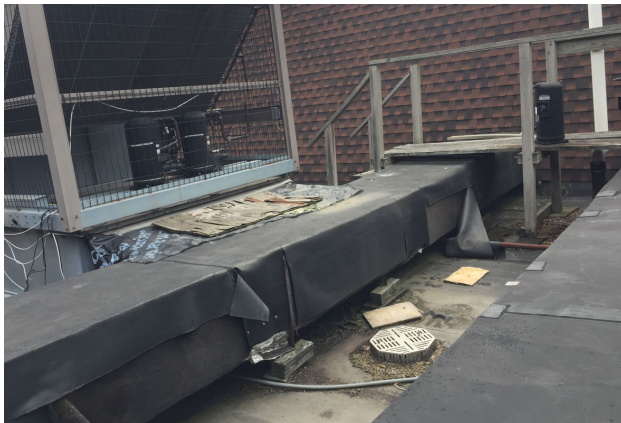
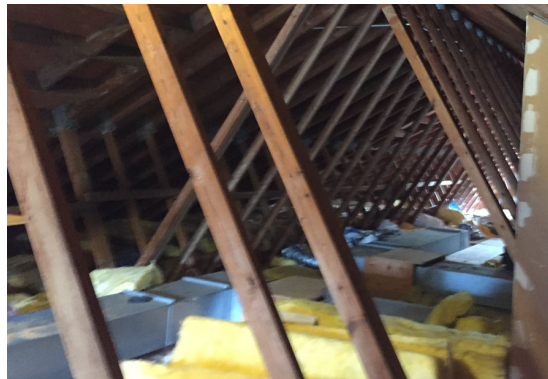
There are two (2) roof top units providing cooling, heating, and ventilation to the spaces. Both units are manufactured by York. One unit serving the second floor is manufactured in 2008, has a cooling capacity of 25 tons and heating input capacity of 533,000 BTUH. The other unit serving the first floor is manufactured in 2006, has a cooling capacity of 25 tons and heating input capacity of 466,000 BTUH. Packaged units have useful life expectancy of 15 years. These units are at the end of their expected life span. Units are showing of surface corrosion. Condensate drain piping is trapped and spilling close to the curb. The drain should be piped to the nearest roof drain to eliminate ponding. It is also observed that the relief air bird screens are damaged. Ductwork distribution system are routed exposed on the roof through the attic space. Both units provide air to the

space using a network of distribution ductwork located above ceiling terminating to ceiling mounted supply diffusers. Diffusers are provided with either motorized dampers or VAV box for zone control. The exterior ductwork and insulation /cover are in poor condition. Some of the ductwork routed through the attic are missing insulation. The R value of existing insulation does not conform with the energy code requirements for ductwork located in the attic.

- Replace the relief air bird screen for both units.
- Extend condensate drain piping to nearest roof drain.
- Replace roof top units. Provide new unit with multizone variable volume configuration with the same capacity as the existing with Multizone VAV unit. Provide unit with hot gas reheat coil to help with humidity control in the space.
- Clean and seal exterior ductwork. Replace insulation and provide jacket.
- Clean and seal interior ductwork. Replace/add insulation to achieve the Energy Code required R value of 12 for ductwork located in the attic (outside of the building envelop).
- Replace the 4-ton split system serving the IT offices.
- Replace all proprietary Unity Controls with FX controller. Replace all wireless controllers and sensors with wired controllers and sensors. Remove all obsolete sensors in spaces.
- Remove existing fuel oil tank.

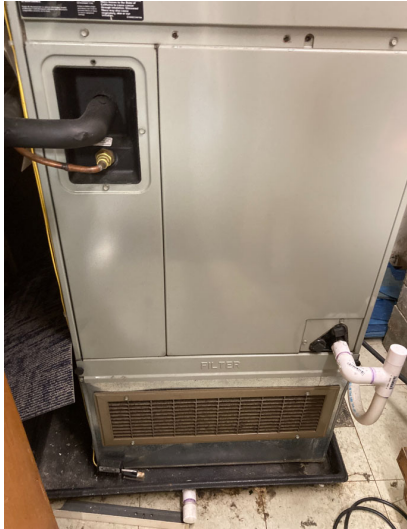
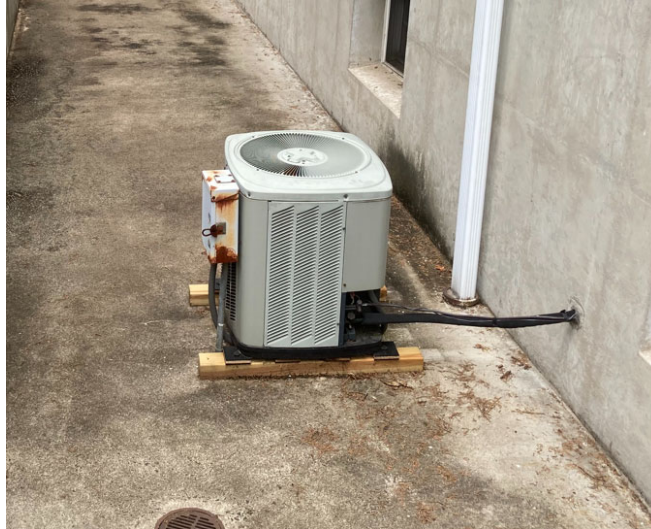
The IT offices in the basement is served by a 4-ton Trane split system. The Trane unit, located in the closet, operating on the obsolete R-22 refrigerant. The split system, manufactured in 2004, has been in operation for more than 16 years. The system has outlived its service life expectancy. The duct distribution system is routed above ceiling to supply diffusers. The outside air ductwork is routed behind the unit and the return grille is place just below the filter. The unit appears to be returning air from the closet.

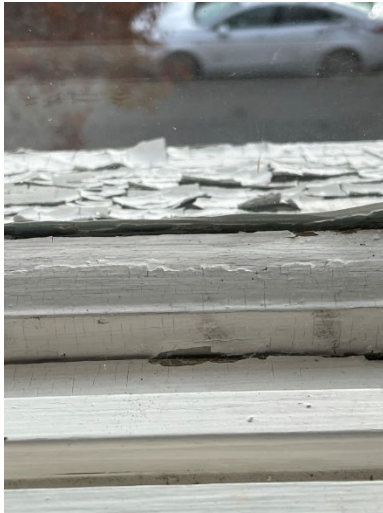
When evaluating the energy efficiency of a building, it is known that nearly 25–40% of all heat energy is lost through windows. The windows here are old wood double hung window units with a single layer of glazing. They appear to be original to the building. A few have been replaced to match. With only a single pane of glazing in these windows. Although these windows give the historic appeal to this building, they should be

considered for replacement with a more energy efficient system that can mimic the original style. Otherwise, continued maintenance and repairs to these windows are essential to maintain their lifespan. Minimally, the windows are in dire need of painting. They should be scraped, primed, and painted. Additionally other buildings on this site have storm windows have been integrated at the interior for some added improvement, creating 2 layers of glass. That could be an option here if not interested in pursuing a full replacement.

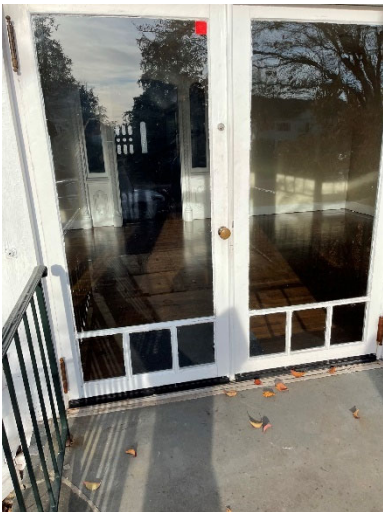
There are a variety of wood exterior doors. They appear to be in good to fair condition. The rear door is largely glass and should be laminated per code.

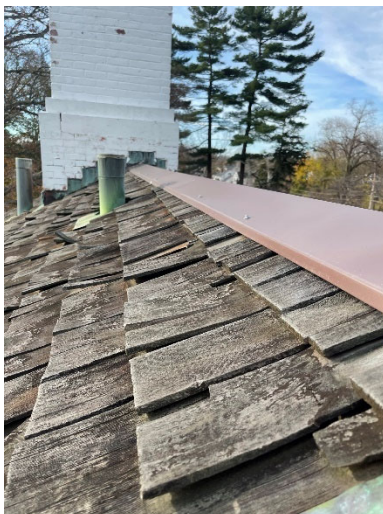
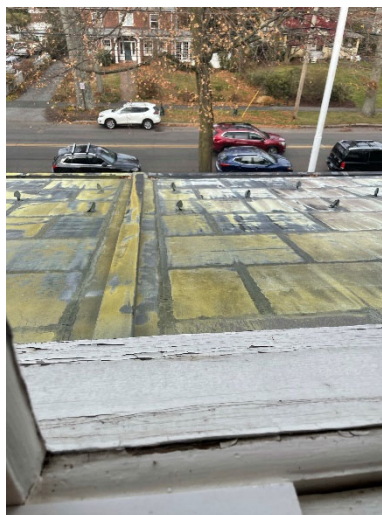
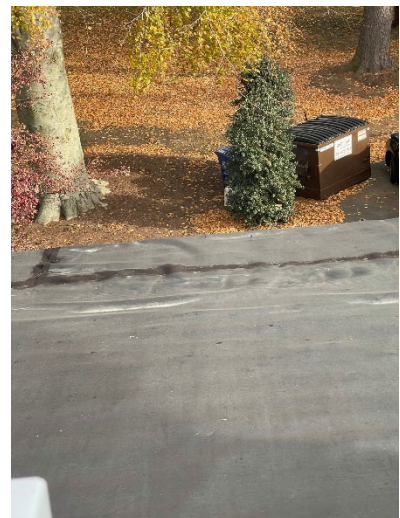
There are a variety of roof types at Bur mansion. The main gable is cedar shingles. This roof is nearing the end of its useful life. Other shed roofs are metal systems which are also exceeding their useful life. One area has a temporary membrane roof laid over it. This was done temporarily 3-4 years ago. The roofs at this building should be replaced.

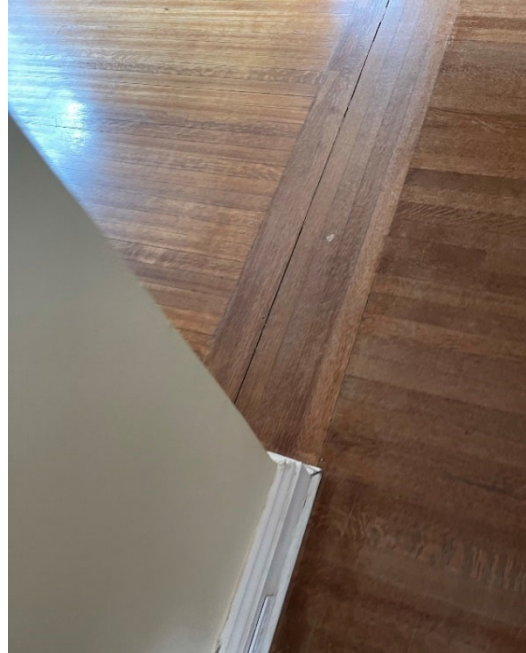
There are a variety of flooring materials that are used in this building such as wood, parkay. Ceramic tile and quarry tile. The tile is all in good condition. However, the wood floors are nearing the end of their useful life and don't appear to have much life left in them. The first floor appears in worse condition than the second.

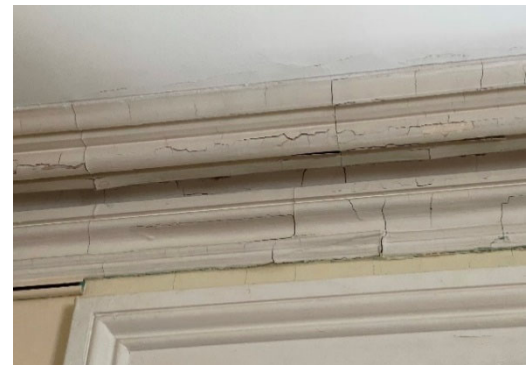
There are a mostly plaster. The front hall has a mural. The rooms seem to be well painted with limited areas in need. Some peeling paint was noted in the offices upstairs.

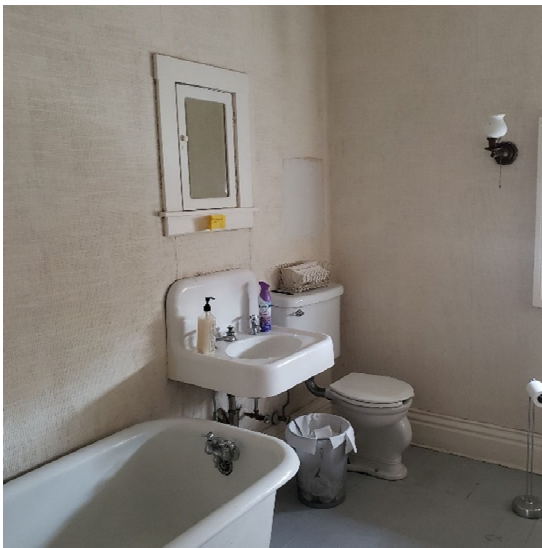
There are multiple restrooms throughout the facility. On the main level a men's and women's room was added in 2016. These rooms meet ADA. An existing old restroom exists under the stair. This is dated, awkward, not highly used and should be removed. On the second floor there is one restroom which is not ADA. This should be modified. On the third floor there are 2 restrooms which are too not ADA. One should be made compliant. The two could be combined into one. If each floor offers a restroom, one should be made accessible.

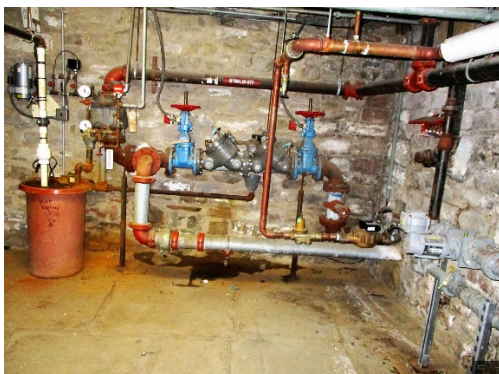
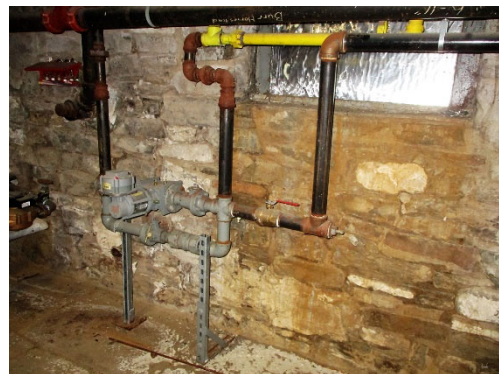
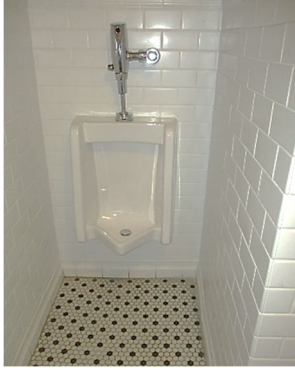
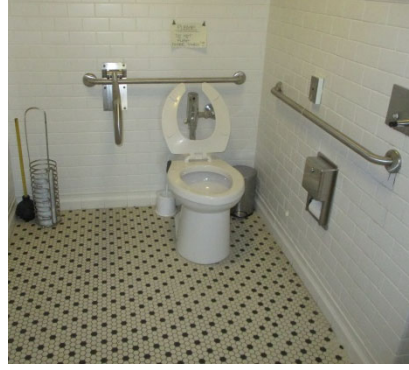
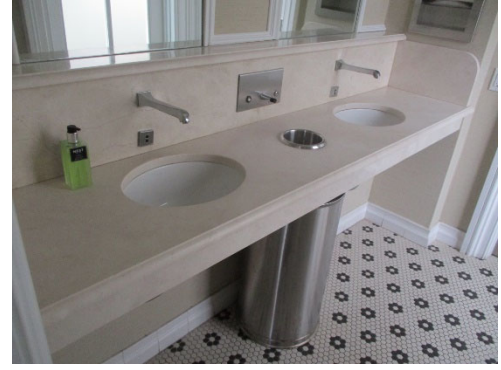
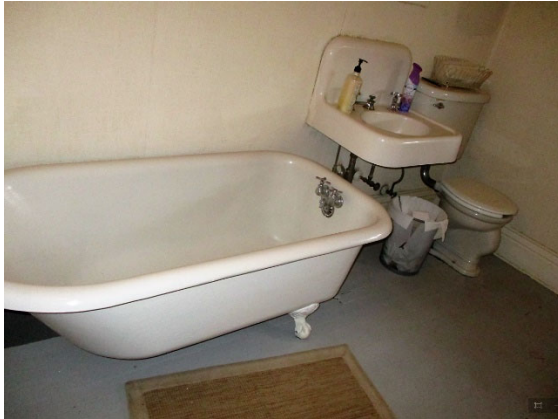
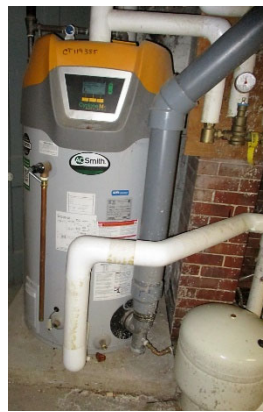
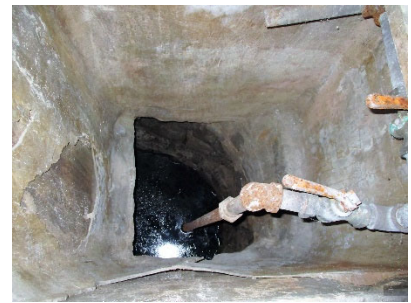
Cold water piping is missing insulation which may condensate, drip and cause moisture issues.

Plumbing fixtures on the first floor were upgraded to ADA compliant type with electronic commercial flush valves in 2016 and are in good condition. The plumbing fixtures on the upper levels are older tank type water closets and pedestal style sinks and a bathtub to match the architecture. One of the toilets had an issue with it running and may need replacement. It was mentioned that the piping was replaced in the walls.

- Repair/Replace older plumbing fixtures on upper levels.
- Replace sanitary piping in basement and on site.
- Cap off and fill existing well in basement per health department regulations.
- Insulate cold water piping.

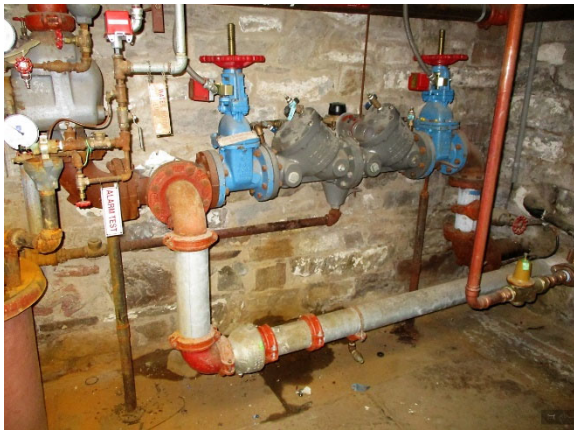
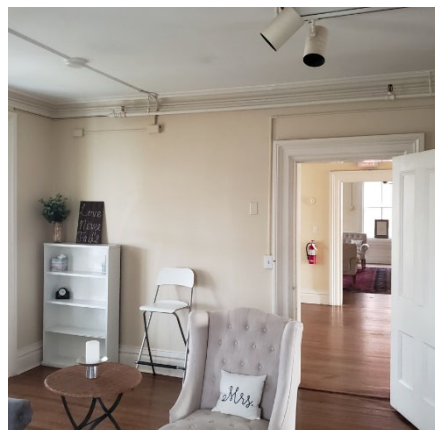
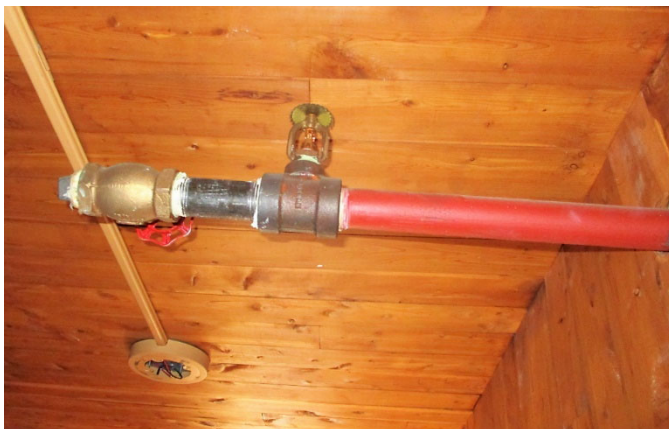
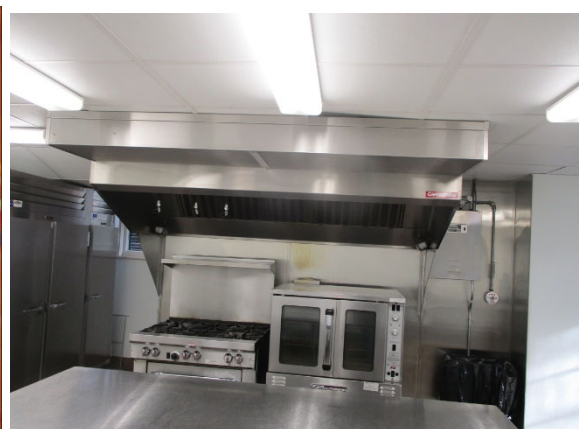
The sprinklers are not older than 50 years old, so they're not required to be replaced.

The kitchen hood is protected with an Ansul type system wet chemical suppression system.

- Some of the sprinkler pipe is rusting/corroding, recommend painting piping.
- Continue to test and maintain sprinkler and hood suppression system.

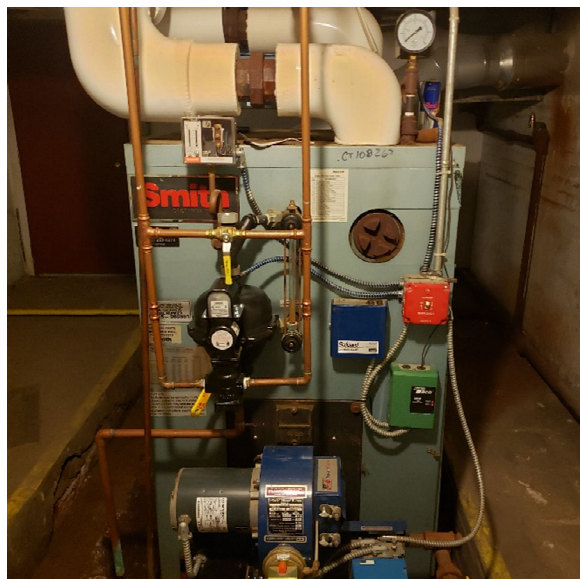
The existing steam boiler, located in the basement, is a cast iron gas-fired HB Smith boiler Series 19A with a Power Flame burner. The boiler has an IBR rating of 431,000 BTUH. Based on the serial numbers, the boiler was manufactured in 2006, and has been in operation for over 15 years. Cast iron boilers have a useful life expectancy of 30 years. Products of combustion are vented into the existing chimney through a sheet metal flue. Combustion air appears to be inadequate, and the system has no redundancy.

*Existing boiler*

- A baseline to be established with the Department of Interiors regarding the parameters of renovating a historical building such as the Burr Mansion.
- Replace existing boiler and associated boiler specialties. Provide redundancy in the heating system with multiple new hot water boilers. The new boilers will be high

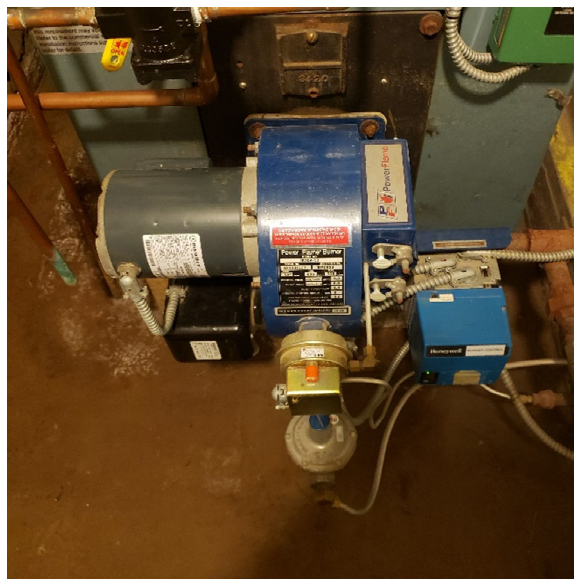
*Existing boiler burner*

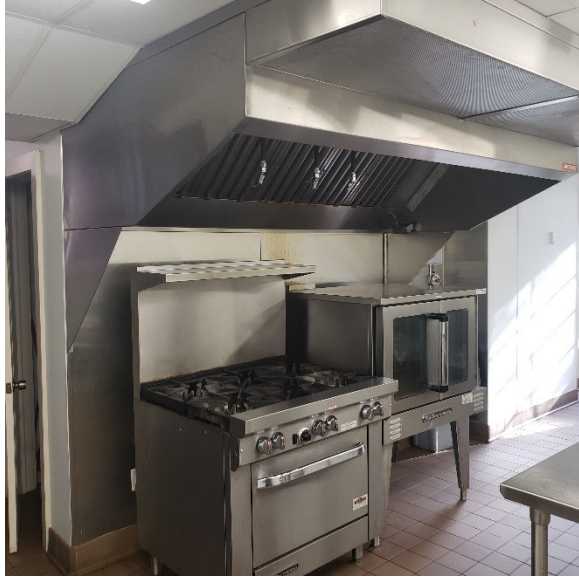
The existing gas stove associated commercial kitchen exhaust hood with an Ansul fire protection system, exhaust fan, gas-fired makeup air unit and wall mounted ductless split system serving the kitchen were installed several years ago. The kitchen exhaust fan is mounted to the side wall of the building and the gas-fired makeup air unit is in the basement. All HVAC equipment associated with the kitchen appear to be in working order, excellent condition and installed per code requirements.

*Existing kitchen stove & commercial hood*

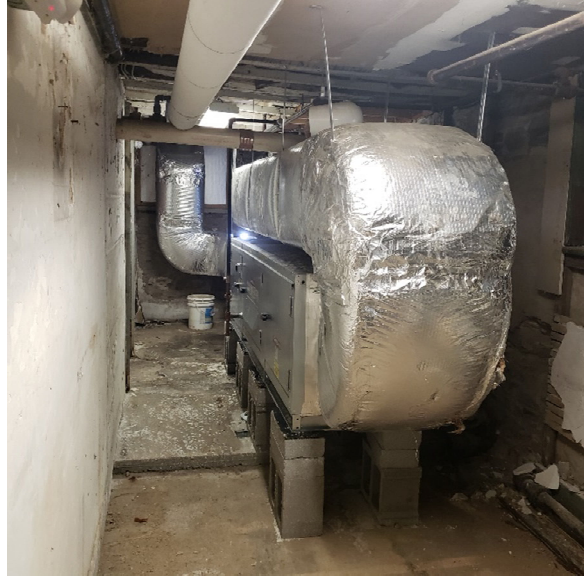
*Existing kitchen makeup air unit*

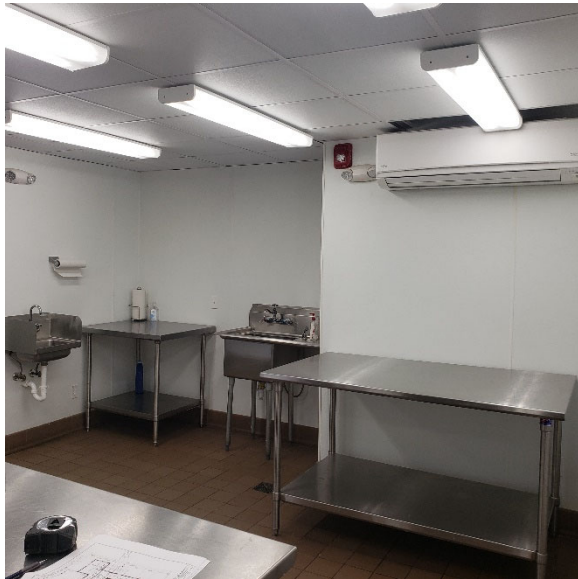
*Existing kitchen wall mounted indoor heating/cooling unit*

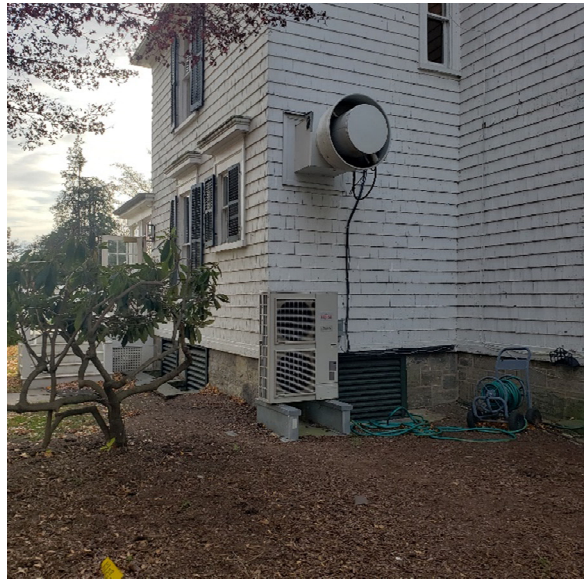
*Existing kitchen exhaust fan & outdoor heat pump.*

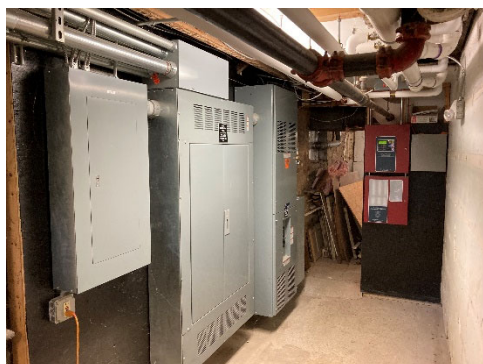
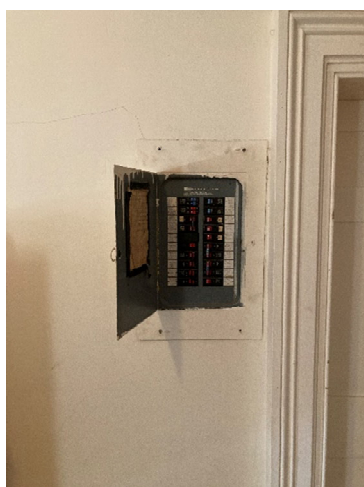
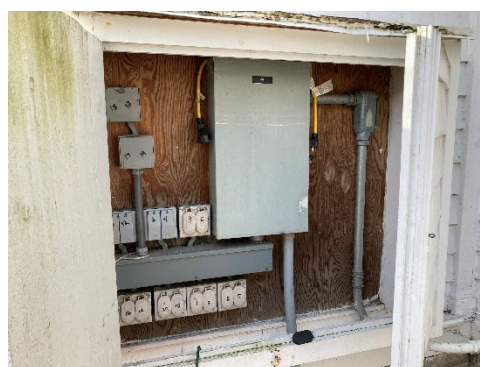
The existing electrical service is made up of a 120/208V-3PH-4W Square D main breaker, and integrated C/T cabinet and adjacent distribution panel and local panel (EPB1). This equipment was installed in 2016 and is in good condition. The main breaker is fed underground from the utility company pad mounted transformer at the west corner of the property. The main distribution panel (MDP) feeds five or more local panels. The 2016 renovation also

added a panel in the kitchen (KP-1) that was called for to be fed from the MDP but is not listed in the panel schedule. Along with the main distribution equipment and adjacent panel (EPB1) the other panel in the basement (EPB2) and the new kitchen panel are in good condition. There also is a

panel on the exterior of the building (south-east side near doors to the Hall), that serves the tent area for outdoor events. The panel is within a wooden enclosure, the panel and adjacent receptacles are in fair-good condition. The two recessed panels, one on the second and one on the third floor are nearing the end of their useful life and should be replaced.

- Replace existing wall switches with new occupancy sensors and/or dimmer switches throughout the three main floors.
- Replace the two existing recessed electrical panels on the second and third floor with new panels.

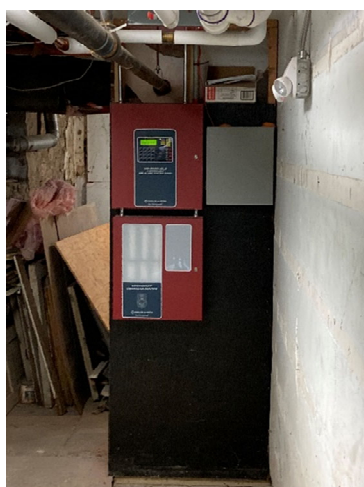
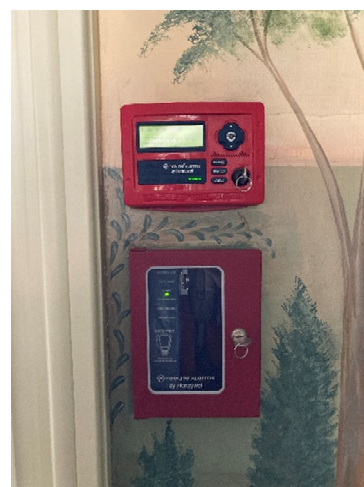
The fire alarm system (Fire Lite #MS-9200UDLS by Honeywell) is located in the basement across from the main electrical equipment. There is a remote annunciator panel adjacent to the front door along with a semi-recessed cabinet with a microphone for paging. Also, there are manual pull stations and audio/visual devices throughout the building in addition to smoke

and heat detectors throughout the building. In the Kitchen, there is a hood suppression system that we assume is connected to the fire alarm system.

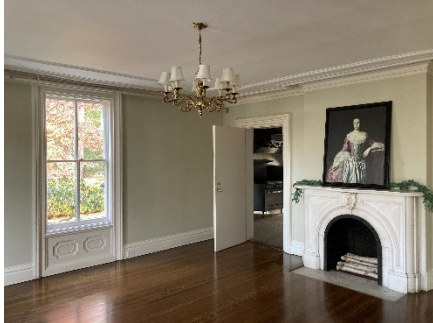
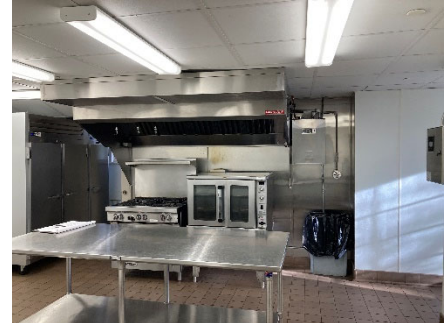
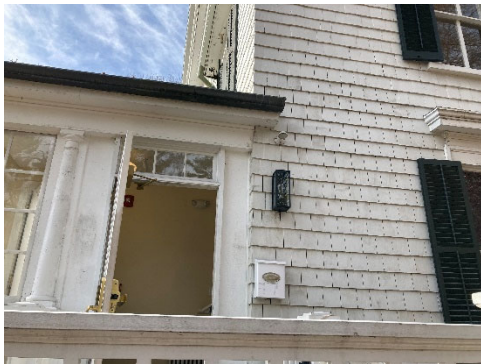
The existing interior lighting in the building is a mix of pendant mounted incandescent chandeliers, incandescent wall sconces, incandescent track lights, surface mounted fluorescent/LED fixtures, and some pull chain light fixtures. Except for the lights installed under the 2016 renovation, the rest of the lights are old and

should like to be replaced. The existing exterior lighting is made up wall mounted sconce type fixtures at the doors and a single LED flood light on the back of the building at the second floor aimed at the open tent area.

Emergency lighting for the interior of the building is made up of self-contained emergency twin head fixtures and exit signs with remote emergency lamps. Exits signs throughout the building are thermoplastic signs wall and/or ceiling mounted with red

lettering and emergency batteries. The exit signs and emergency lights all appear to be in good condition. The appears to be only one single head emergency light on the exterior of the building at the new stair behind the Kitchen. The two main entries (front & back) do not appear to have emergency egress light fixtures. Also, the handicap accessible ramp at the back of the building does not have either normal or emergency lighting.

- Replace existing surface mounted track lighting with new LED fixture more in style with the building.
- Replace existing pendant and surface mounted incandescent and fluorescent light fixtures throughout the building with new energy efficient fixtures that match the style of the building.

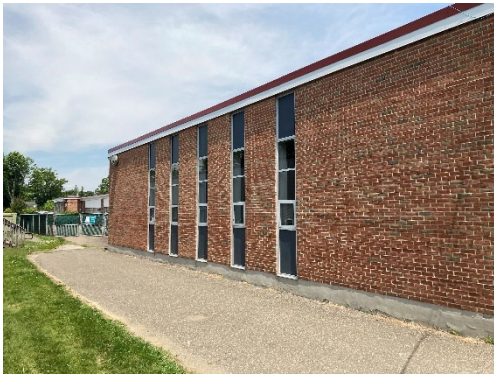
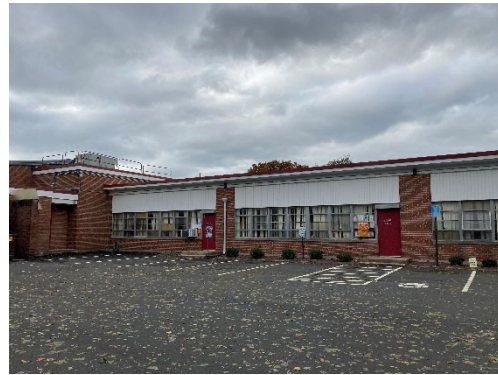
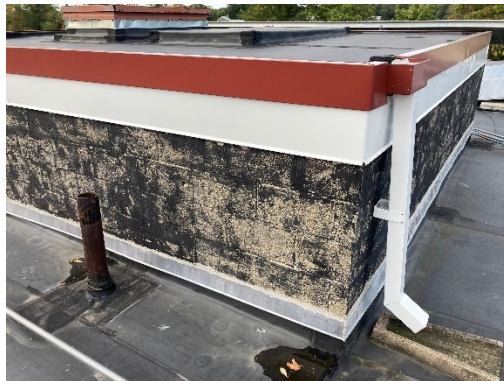
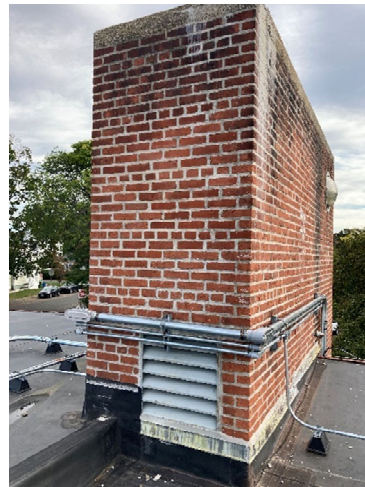
The exterior of the building is in good condition. The original building is constructed with brick “veneer”, airspace, and concrete masonry unit (CMU) backup wall. The gymnasium addition consists of a brick “veneer” airspace, and a painted concrete masonry unit (CMU) interior. Overall, the mortar is in fair condition, with some areas in need of repointing and minor brick repair. Areas where the foundation wall is exposed are showing signs of wear and the parge coating is chipping off. At the existing storefront systems, the top third has been covered with a vertical vinyl siding, it appears to be in fair condition with limited signs of wear. The chimney brick is coated in soot and the chimney cap is showing signs of significant wear and deterioration. A previously used mechanical mezzanine built out of CMU appears to have had roofing/asphalt parge coat that has deteriorated.

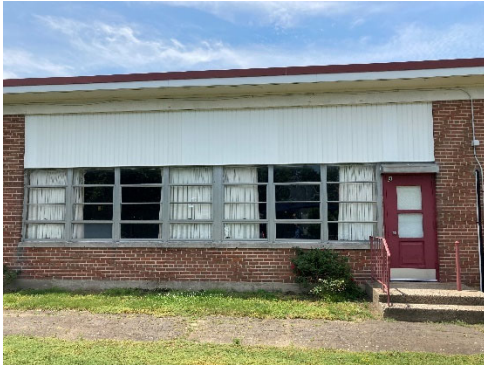
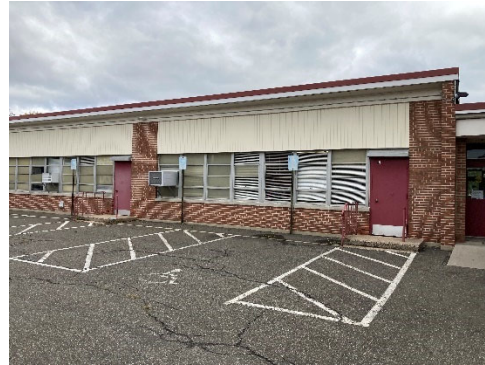
The storefront window systems are original to the building, they are single pane glass. They are in poor condition and showing significant signs of wear – the caulking is deteriorating (see attached HazMat report for information regarding potential PCBs), and the majority of window panes have yellowed. All of the storefront window systems are past their

lifespan and should be replaced with a more energy efficient double glazed insulated aluminum window system. The concrete sills are showing signs of wear, but are not failing. The windows at the raised roof of the cafeteria are also original to the building and in need of replacement. The entrance storefront system is in good condition and appears to have been replaced when prior additions/renovations were completed on the building.

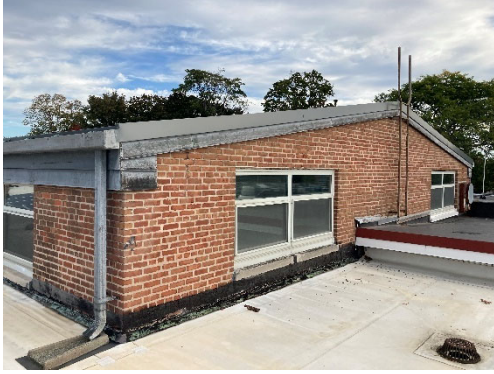
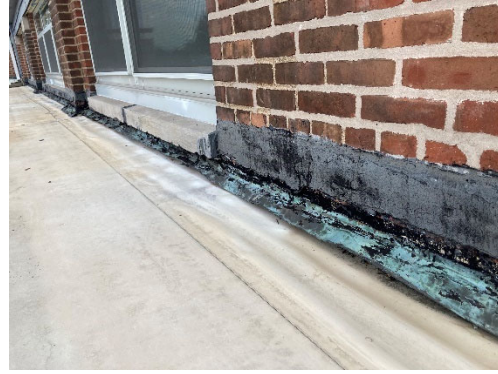
The existing roofs are EPDM. They have all been replaced recently and are in good condition. The metal coping around the perimeter is in good condition, it appears to have been replaced when the roofs were replaced. At the base of the brick wall along the perimeter of the raised roof area over the cafeteria, the transition flashing is in need of replacement, it is showing significant signs of deterioration and is failing in certain locations – this should be tested as it appears to be an asbestos containing material. Similarly, the coping and flashing along the raised roof edge is showing significant signs of wear and could be replaced. Upon observation of the gutters along the raised roof area, they are showing signs of wear and contained standing water due to lack of pitch towards the leaders, they should be replaced and properly pitched to drain. The majority of the roof has PV panels. Adjacent to the main building, the portables at the rear have a roof that is poor condition and leaking – this roof should be replaced fully to prevent further interior damage.

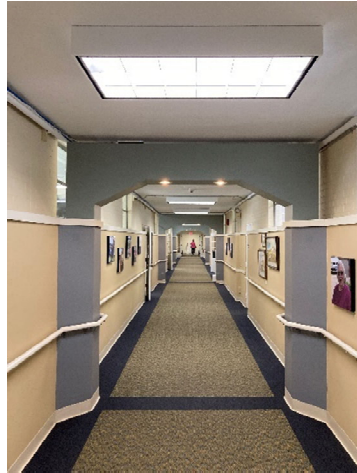
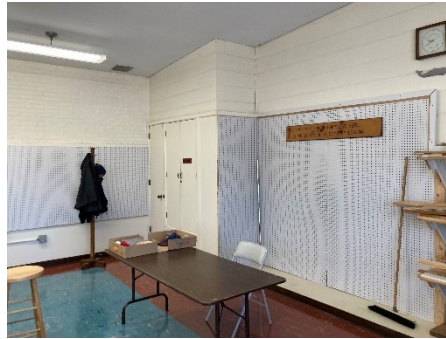
There are a variety of floor types at this building. The lobby consists of stone that is in good condition and is showing minimal signs of wear. A majority of the flooring is carpeted with rubber base, this includes the corridor, multiple activity rooms, and offices. The carpet in these areas is in good condition, it appears to have been replaced within 10 years as there is minimal wear and tear. The rooms that do not contain carpet are vinyl composition tile (VCT) with rubber base. The flooring appears to have been replaced when prior additions/renovations had been completed and is in fair condition but showing signs of wear and tear, missing or damaged pieces of rubber base, and patchwork where tiles had been replaced. The gymnasium and cafeteria flooring are both wood and appear to be in good condition and not showing signs of significant wear and tear. The toilet room and kitchen flooring is denoted in the "Restrooms" and "Kitchen" sections of this report.

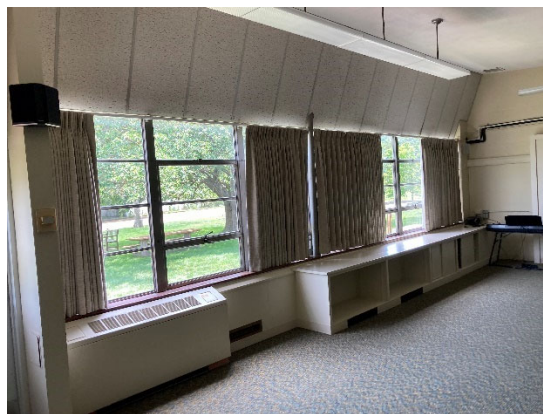
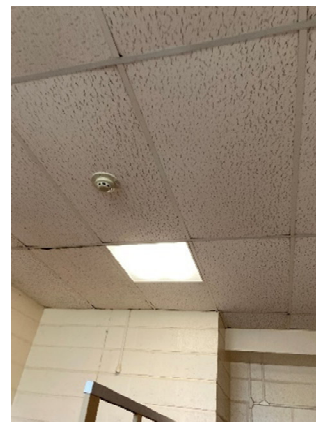
The majority of ceilings throughout are plaster lathe with limited access areas. These are in good condition. There is multiple locations where dropped acoustical ceiling tiles (ACT) are used, this includes being installed vertically at the top of the storefront window systems in every room. The tiles are showing signs of wear, broken and discolored – these should be replaced as necessary.

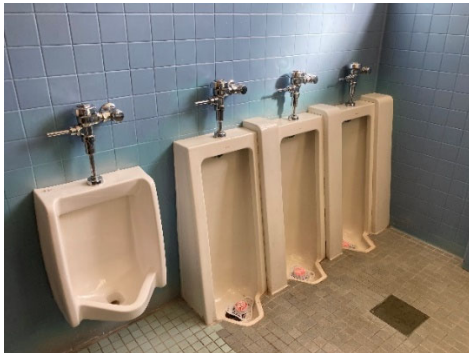
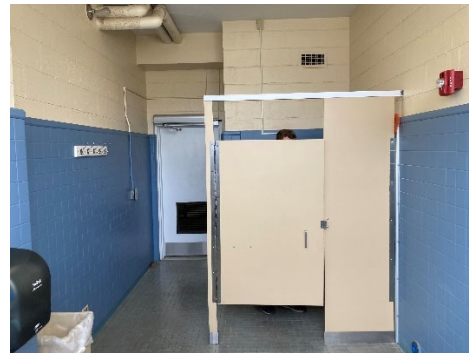
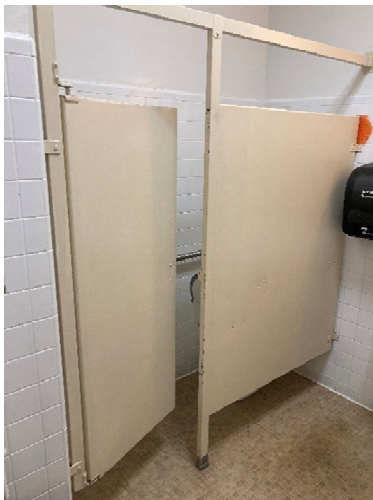
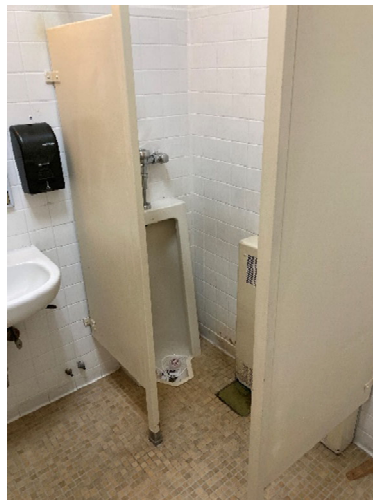
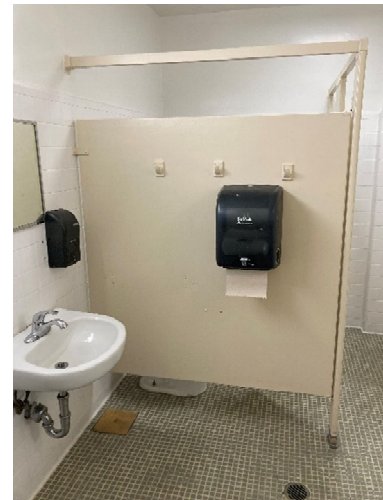
There are two sets of gang toilet rooms and two single user toilets existing. One set of gang toilet rooms is located off the main lobby, the other set is off the main corridor. The set of single user toilet rooms are located adjacent to the gymnasium and an additional single user toilet is in the offices and adjacent to the kitchen. All toilet rooms are in need of renovation as they do not meet ADA compliance and the fixtures and finishes appear to be original to the building. In order to make the two gang toilet rooms off the lobby ADA compliant, they will need to be modified to be single user toilet rooms – and potentially combined into one single user toilet room. The entry doors do not meet ADA compliance and will need to be modified. All fixtures, lavatories, mirrors, lighting, and finishes (floor tile, wall tile, and ceiling) are in need of replacement. Similarly the gang toilet rooms located down the corridor are in need of updating, including but not limited to fixtures, lavatories, mirrors, partitions, lighting and finishes (floor tile, wall tile, and ceiling). The two single user toilet rooms adjacent to the gymnasium currently do not meet ADA compliance and should be updated to meet these requirements. New fixtures, lavatories, and finishes (floor tile, wall tile, and ceiling) to be replaced. The single use toilet rooms off the offices and kitchen currently do not meet ADA compliance and the fixtures/finishes are in need of replacement. A further ADA study will need to be conducted to analyze compliance of entry in/out of each toilet room.

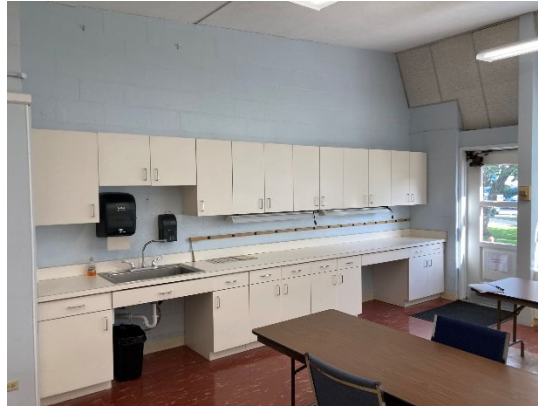
The casework is located in the craft room. It consists of plastic laminate base and upper cabinets casework with laminate countertops. The base cabinets are in fair condition with edges beginning to wear. The sink is stainless steel. All cabinet hardware appears to be in good, functioning condition.

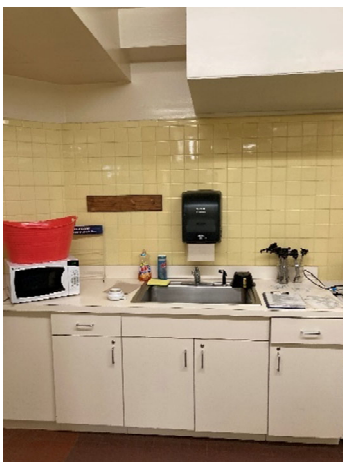
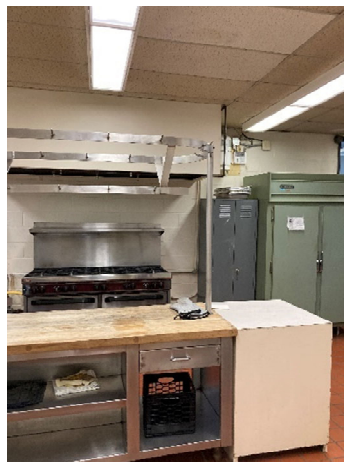
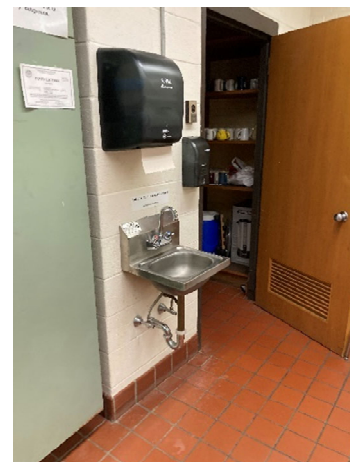
The kitchen currently functions as a warming kitchen for the facility. The existing finishes are showing significant signs of wear and are in need of replacement. The finishes should be updated to reflect the most up to date health codes – washable ceiling tiles, FRP wall coverings, and either new quarry tile or epoxy flooring. Existing plastic laminate base and upper cabinets are in fair condition and showing minor signs of wear, including the countertops. The existing equipment appears to be in fair condition. Refer to the MEPFP sections of this report for more information regarding systems.

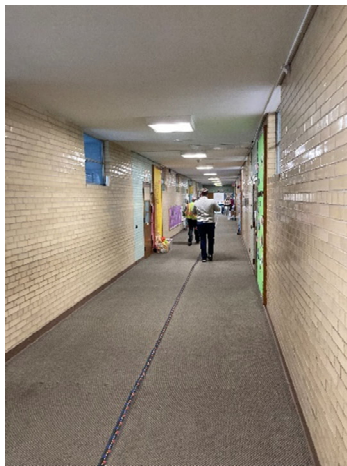
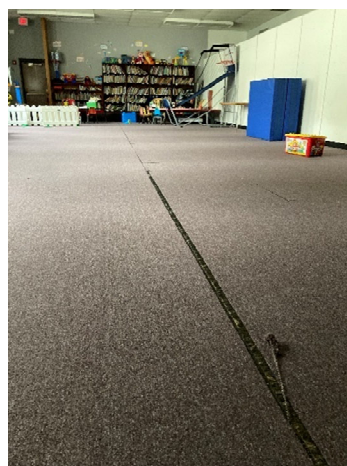
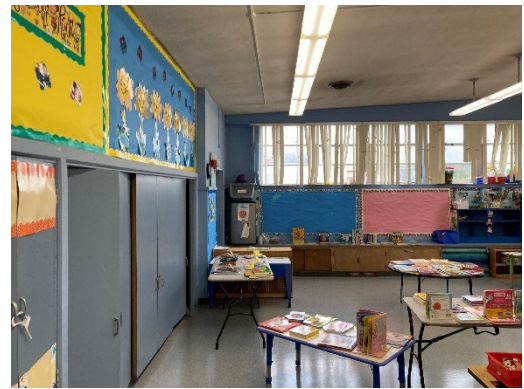
The main corridor of the Daycare is carpeted with rubber base. The carpet in these areas is in fair condition, it is showing significant signs of wear and tear, fraying, and discoloring – this should be replaced. The rooms that do not contain carpet are vinyl composition tile (VCT) with rubber base. The flooring appears to have been replaced and is in fair condition but showing signs of wear and tear, missing or damaged pieces of rubber base, and patchwork where tiles had been replaced.

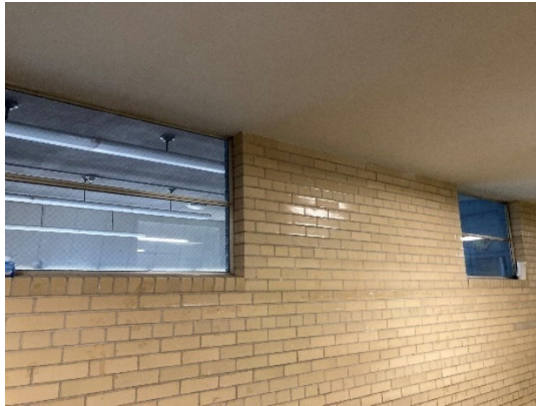
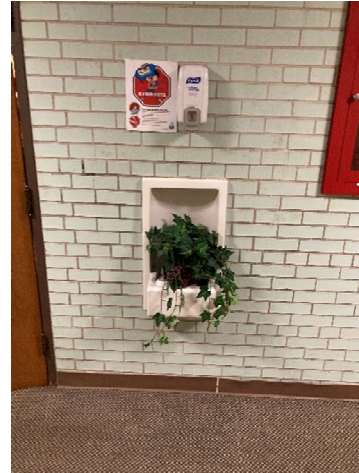
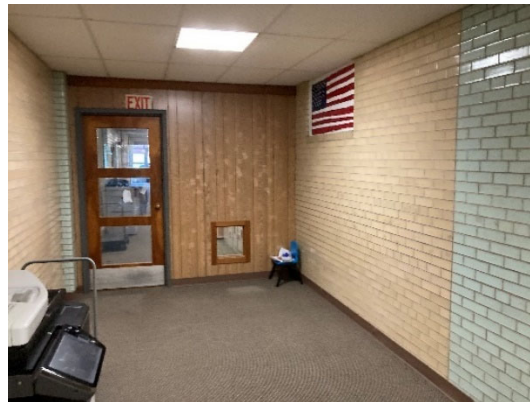
The walls throughout are painted concrete masonry units and brick. They are in good condition, aside from having an outdated aesthetic. If desired, repainting the corridor walls would improve the general aesthetic of the corridor.

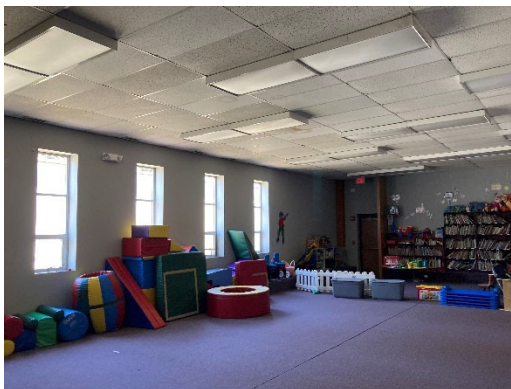
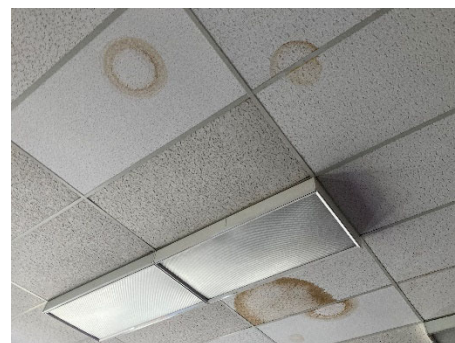
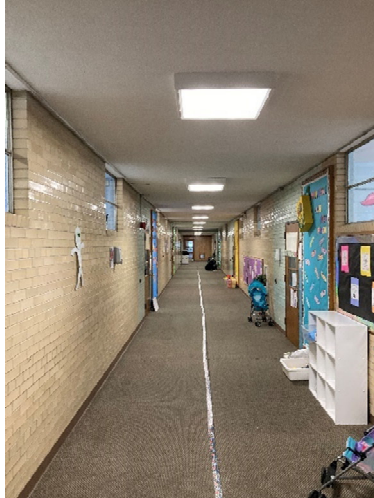
The majority of ceilings throughout are plaster lathe with limited access areas. These are in good condition. There is multiple locations where dropped acoustical ceiling tiles (ACT) are used, this includes being installed vertically at the top of the storefront window systems in every room. The tiles are showing signs of wear, broken and discolored – these should be replaced as necessary.

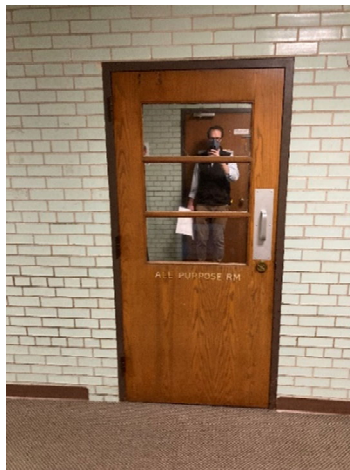
The interior doors in this building are primarily wood in hollow metal frames. They are in good condition but could use new paint. There are some miscellaneous hollow metal doors in hollow metal frames.
