**Town of Fairfield**  
Town Planning and Zoning Commission  
725 Old Post Road  
Fairfield, Connecticut 06824

**To: Members of the RTM**  
**From: Jim Wendt, Planning Director**  
**Date: April 19, 2022**  
**Re: Opt-Out of State Mandated Zoning Regulation Language**

FAIRFIELD TOWN PLAN AND ZONING COMMISSION PROPOSED OPT-OUT OF  
STATE MANDATED REGULATION LANGUAGE REGARDING OFF-STREET PARKING.

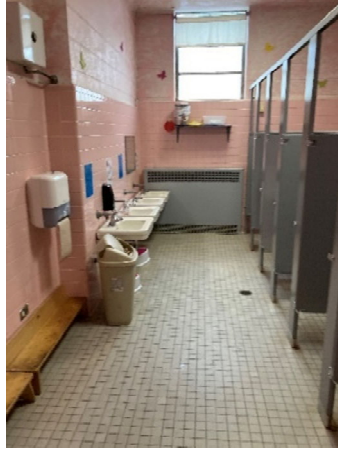
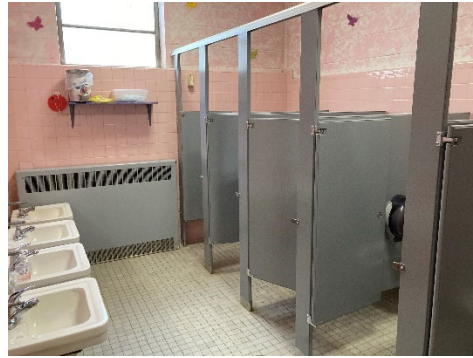
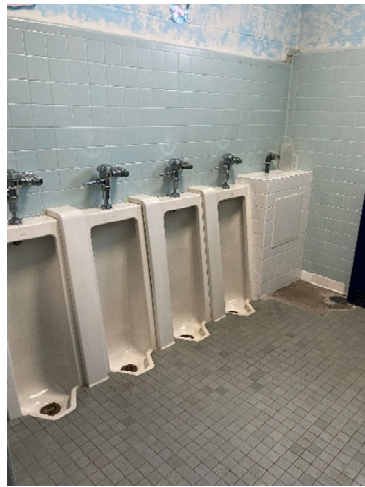
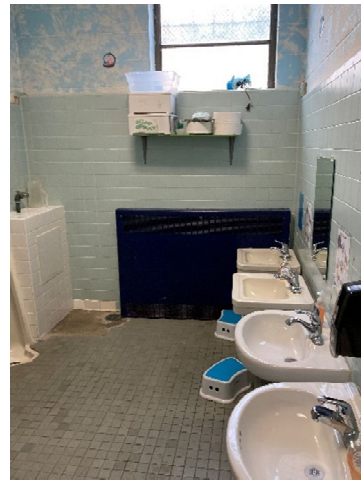
There are four total toilet rooms in the Daycare. Two gang toilet rooms and two single user toilet rooms located off two classrooms. The gang toilet rooms are located off the main corridor – these toilet rooms currently do not meet ADA compliance. The existing finishes consist of tile and painted CMU walls, and plaster ceiling. The finishes and fixtures appear to be original to the building and are in fair condition – the floor could use replacement as it is showing greater signs of wear than the walls. The existing toilet partitions are in good shape, but an ADA stall is not provided.

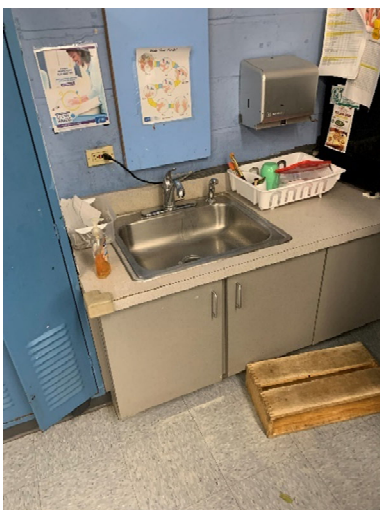
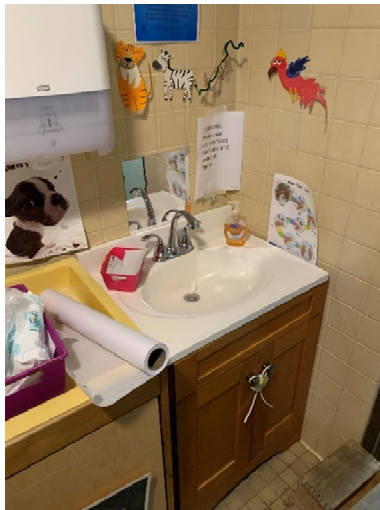
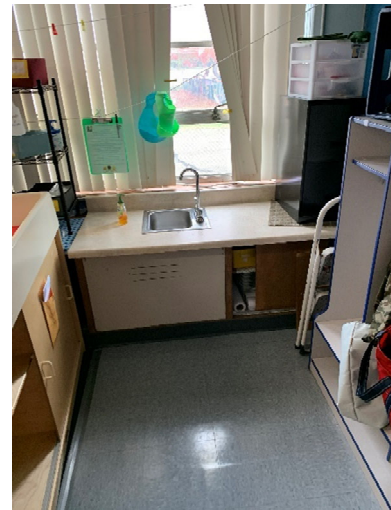
There is casework located throughout multiple classrooms. The existing sinks at casework are ADA compliant per a side approach, some sinks may need to be relocated to meet ADA reach requirements. The base cabinets are in poor condition and should be replaced.

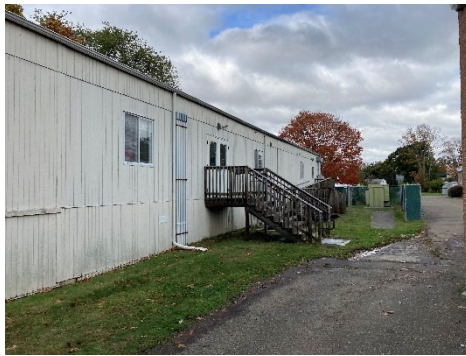
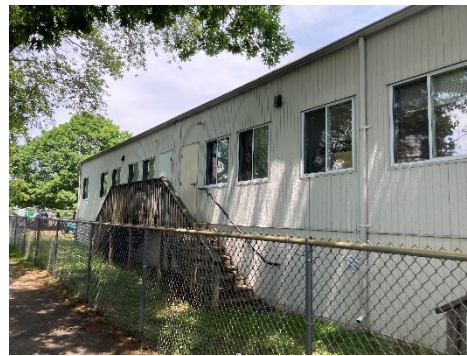
The Health Center is adjacent to the Senior Center/Daycare building. These portables were previously used at a school in town and were relocated to this site to be used as the Health Center. The exterior of the portables are in poor shape and showing significant signs of wear.

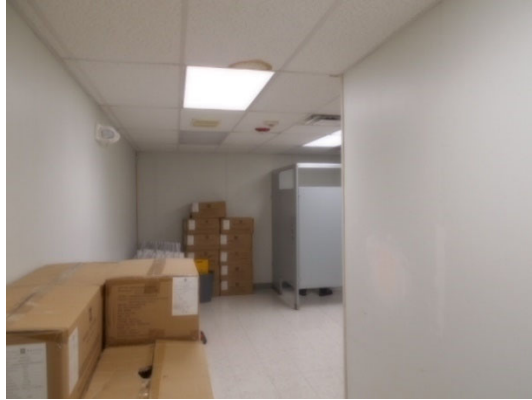
The majority of ceilings throughout are acoustical ceiling tiles (ACT). There are multiple areas where the roof has leaked and the tiles are compromised – these should be replaced as necessary.

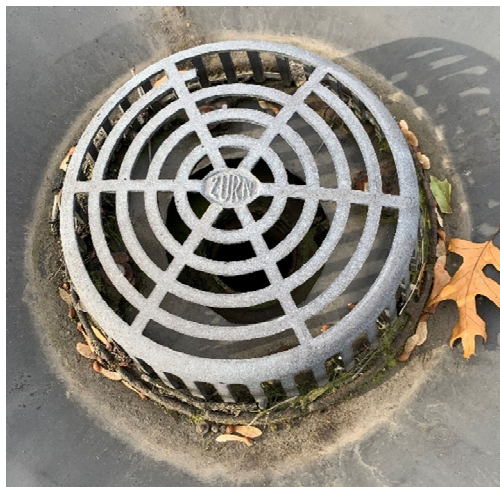
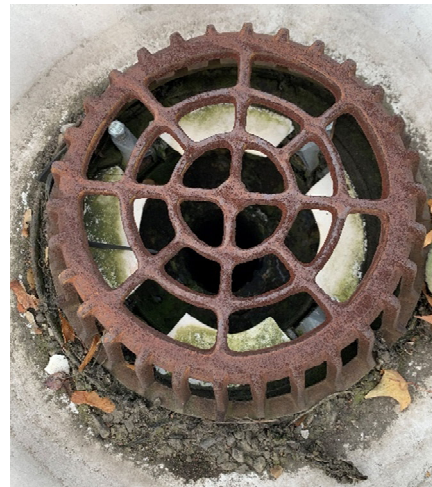
There are various styles of roof drains located on the roof of the main building, which consists of the Senior Center and Daycare. Some of those drains do not have grates which cover the entire roof penetration. Overall, the grates showed varying signs of wear and tear due to age and location on the roof. It is important to note that there is no secondary drainage system.

*Comparison of varying degrees of wear and tear on roof drain grates*

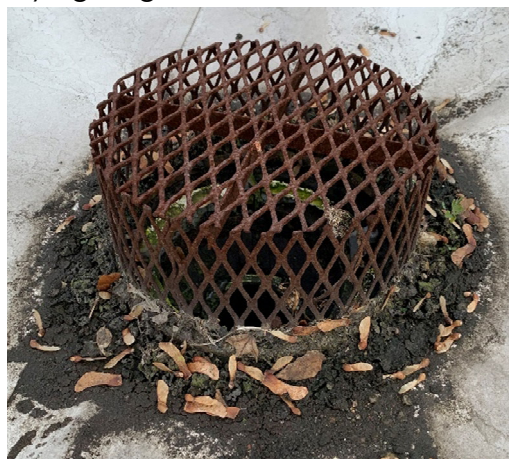
*Example of outdated roof drain grate*

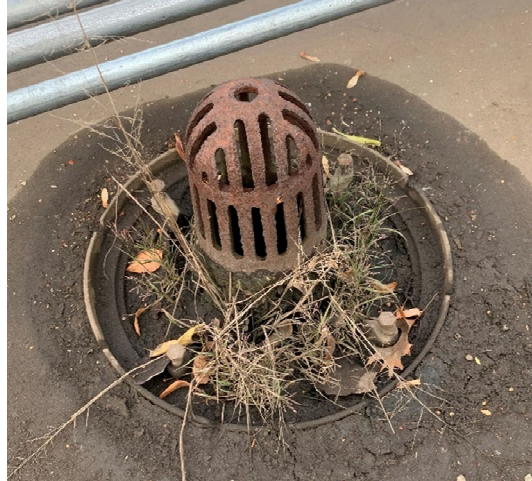
*Example of outdated and ineffective roof drain grate*

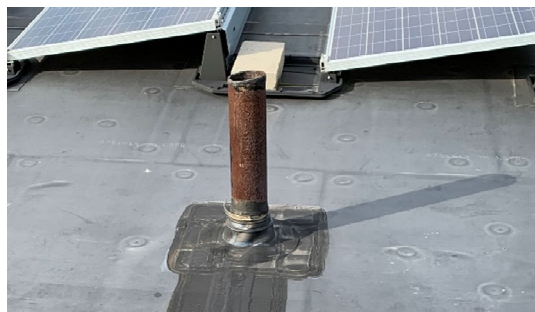
Also on the roof are penetrations for vent piping to release waste gases into atmosphere. Like the roof drains, these pipes have varying degrees of wear and tear. Most show signs of rust.

*Vent to Roof showing signs of rust*

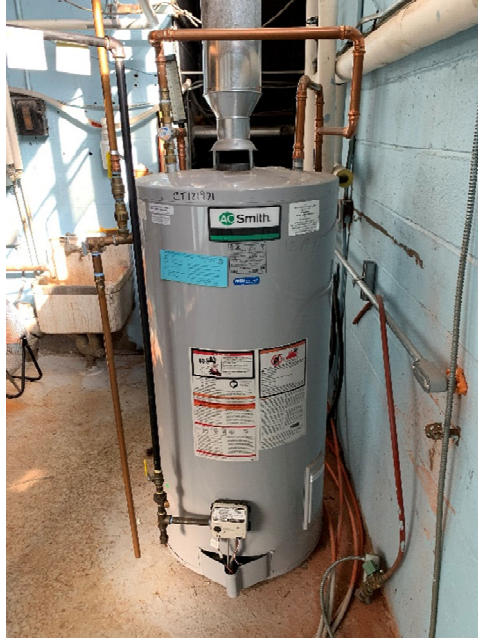
Domestic hot water serving the building is from a vertical storage type, 74-gallon A.O. Smith natural gas fired storage water heater with an input capacity of 75,100 BTUH. The heater is in the boiler room. The heater is over 4 years old and appears to be in good condition. Products of combustion are vented into the existing chimney through a sheet metal flue. There is a hot water recirculating pump to maintain temperature. An ASSE1017 mixing valve was not observed as installed. Piping was missing insulation. We recommend adding those components for compliance.

*Existing A.O. Smith Water Heater*

- Provide missing insulation for water piping around water heater(s) as well as other missing sections.
- Remove and replace all plumbing fixtures which are not ADA compliant and/or not in accordance with the occupancy requirements in the Architectural assessment.
- Remove and replace old piping where needed.
- Remove and replace old roof drains. Complete routine maintenance to make sure the grates are not blocked by debris or weeds.
- Replace existing grease interceptors or add new grease interceptor to meet meet proposed increase in Kitchen usage.
- Add required gas piping to serve new HVAC equipment

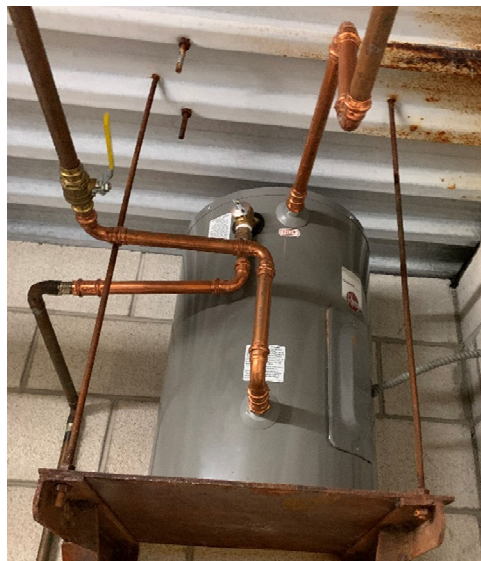
There is a second water heater which serves the portion of the senior center that was added during the 1977 renovation. That unit is a Rheem electric water heater with a storage capacity of 10 gallons. It was manufactured in 2016 and appears to be in good condition. We recommend adding insulation to the missing sections of connected piping.

*Existing Rheem Electric Water Heater*

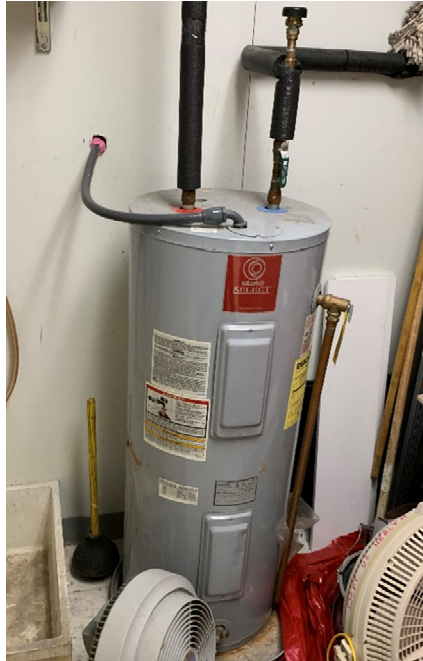
The annex building has its own hot water generation. There is a 10-gallon State Industries electric water heater which generates hot water for the Men's and Women's bathrooms. This unit is reaching the end of its useful life expectancy. Each individual lavatory and sink in the building's offices has its own point of use instantaneous electric water heater.

*Existing State Industries Electric Water Heater*

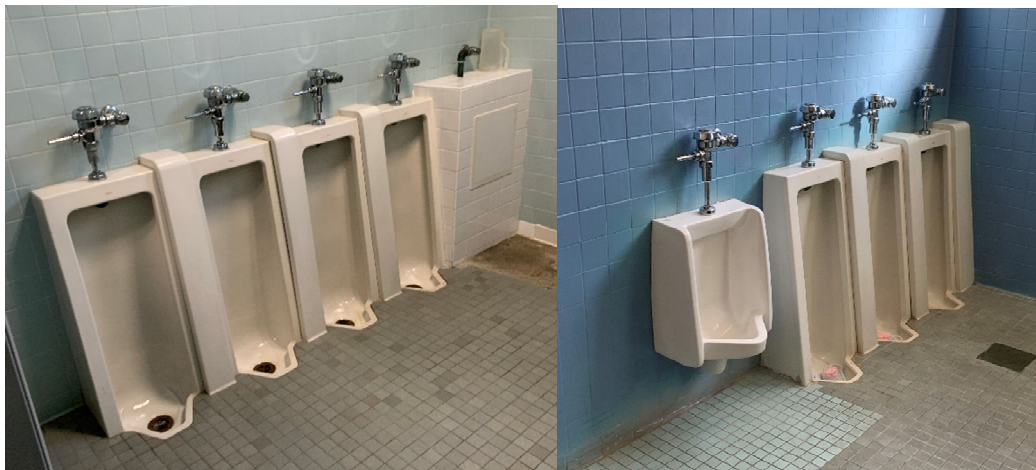
Existing bathroom plumbing fixtures are vitreous china and include wall hung lavatories, water closets, and urinals as well as floor mounted water closets and urinals. Many of these fixtures are outdated and not ADA compliant. The floor mounted urinals need to be replaced with wall-hung fixtures.

*Examples of Existing Urinal Fixtures*

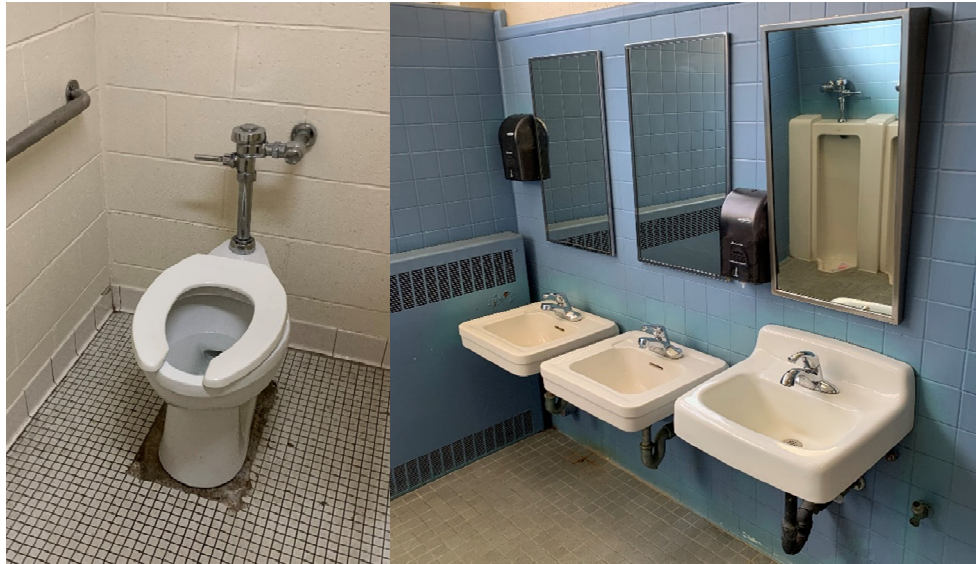
*Examples of Bathroom Plumbing Fixtures*

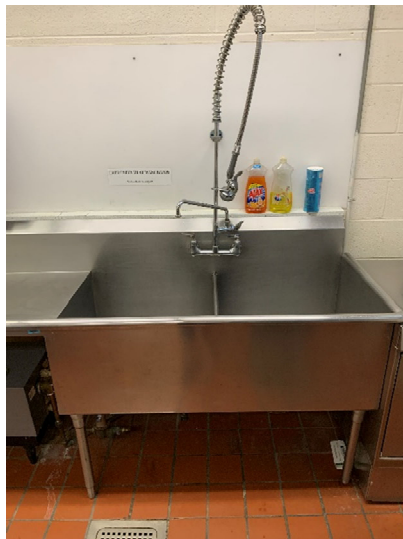
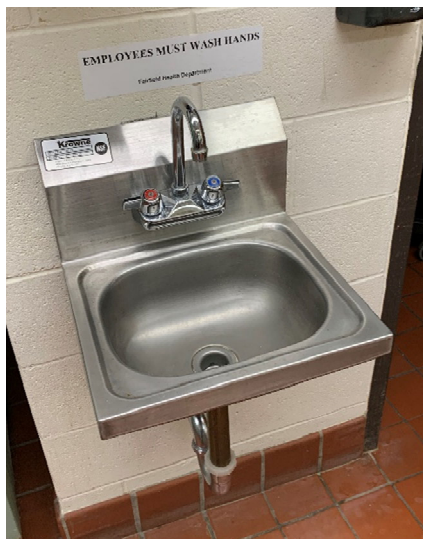
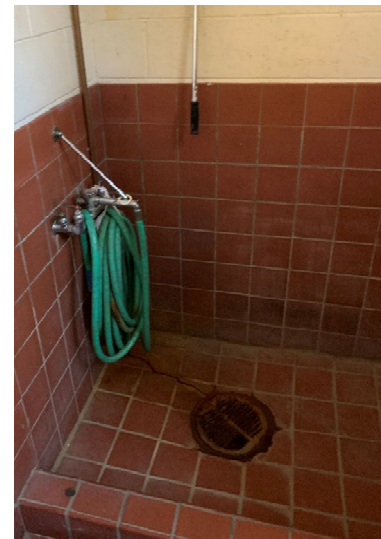
The kitchen contains stainless steel plumbing fixtures which include a drop-in sink, double compartment dishwashing sink, and a wall hung handwashing lavatory. There are two existing grease interceptors and one of them is offline. They will not be able to handle the increased capacity of the proposed kitchen renovation. There is as a mop sink as well in the custodial area and a bathroom with a floor mounted water closet and wall hung lavatory.

*Existing Kitchen Plumbing Fixtures*

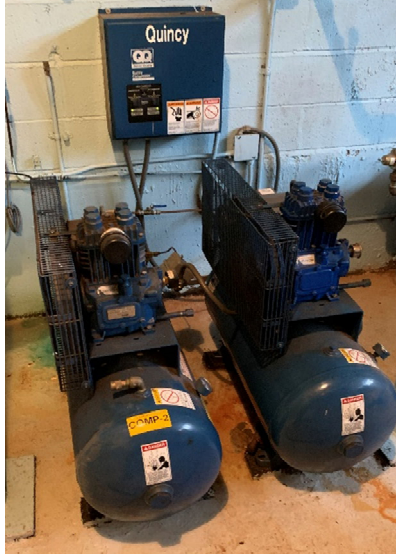
There are two Quincy air compressors in the Boiler Room which supply pressurized air to serve the pneumatic controls. They are approaching the end of their useful life expectancy.

*Existing Quincy Air Compressors*

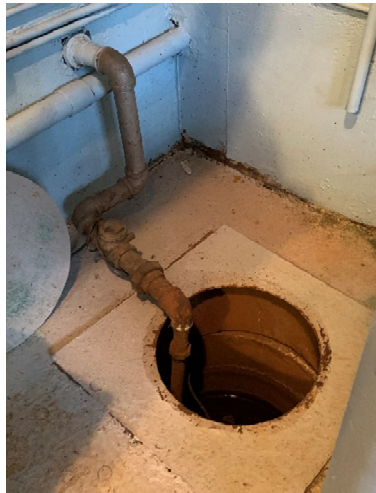
There is an existing sump pit in the facility piped from an unknown origin and it is unclear whether it is still in use or needed to remain in service. At the time of the survey, it is unclear as to its service and or operations.

*Existing Sump Pit in Boiler Room*

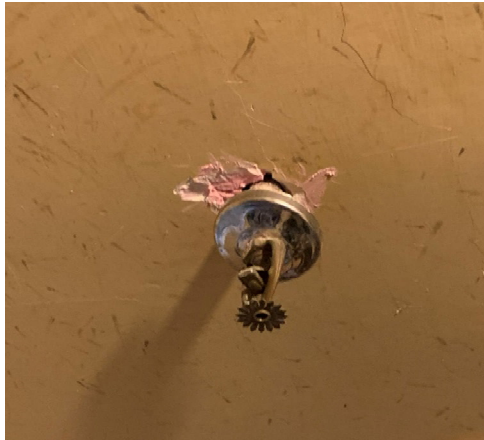
The facility has a limited area sprinkler system serving the custodial rooms. The service ties into the domestic water supply with a backflow preventer and shutoff valve at the ceiling. There is one pendent sprinkler in the ceiling of each of these rooms. The piping is copper tubing with soldered joints. There is no flow switch or alarm, so if the system discharges, no one may know. There is not a tamper switch on the valve, if the system is turned off, the sprinklers will not discharge water.

*Typical Pendent Sprinkler Head*

The town may consider to fully sprinkler the building with a new service, alarms, and devices in accordance with NFPA 13.

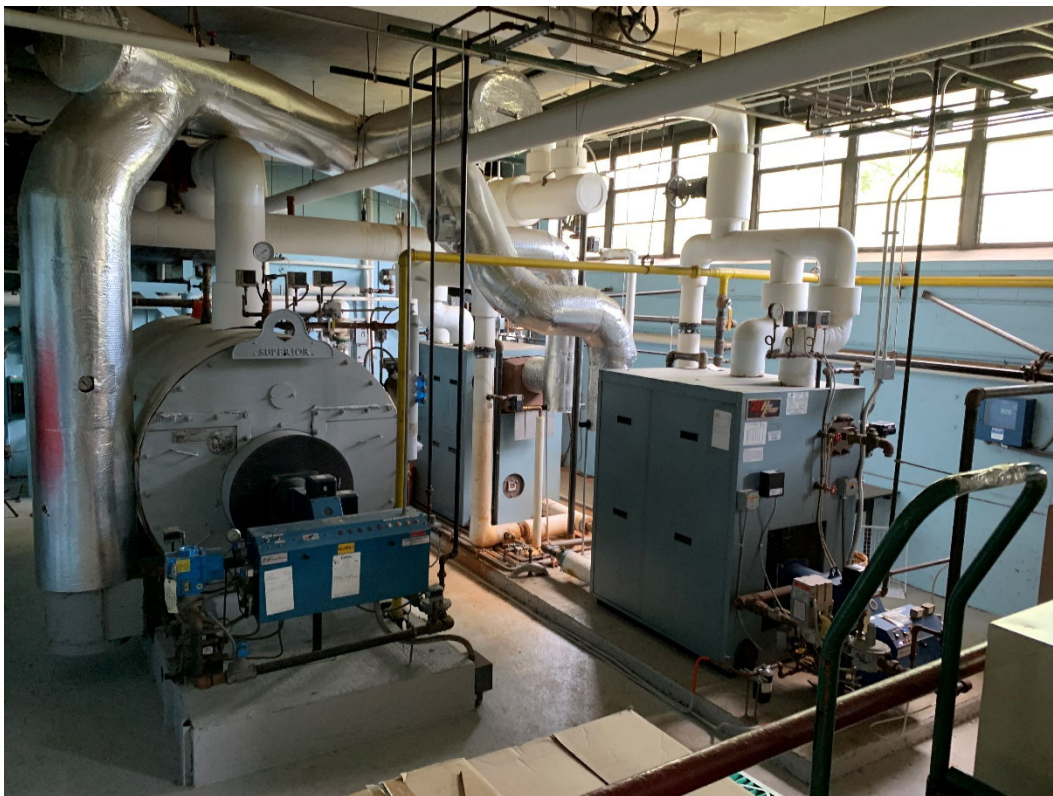
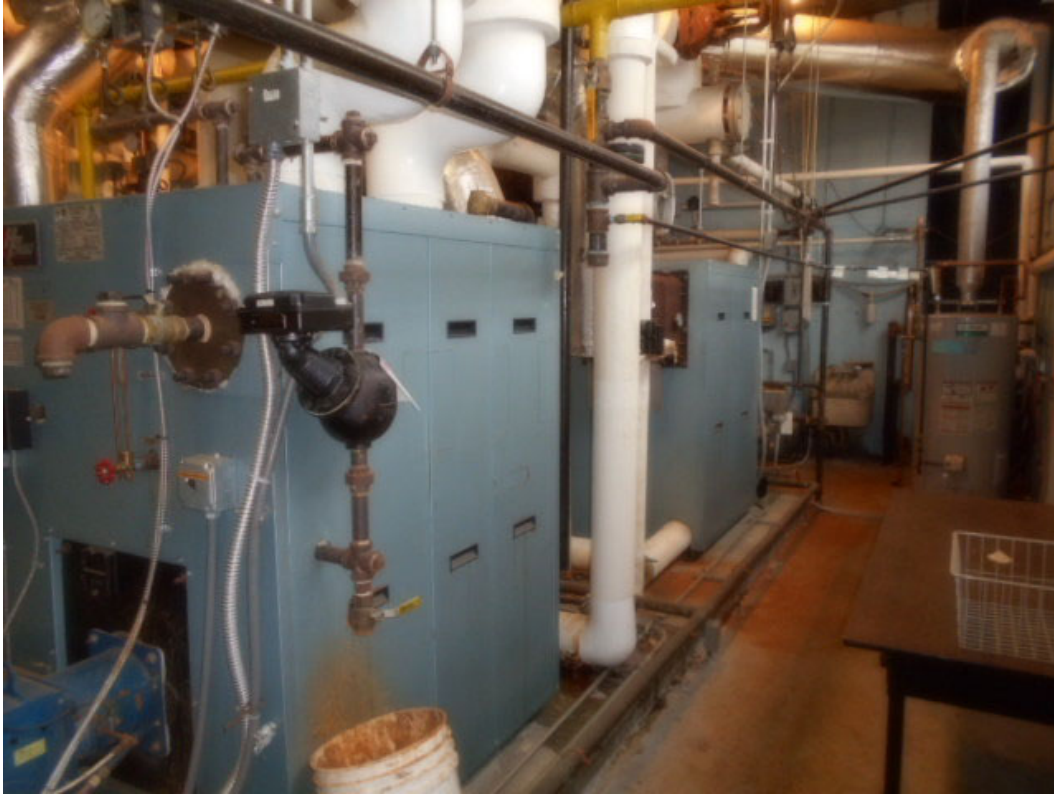
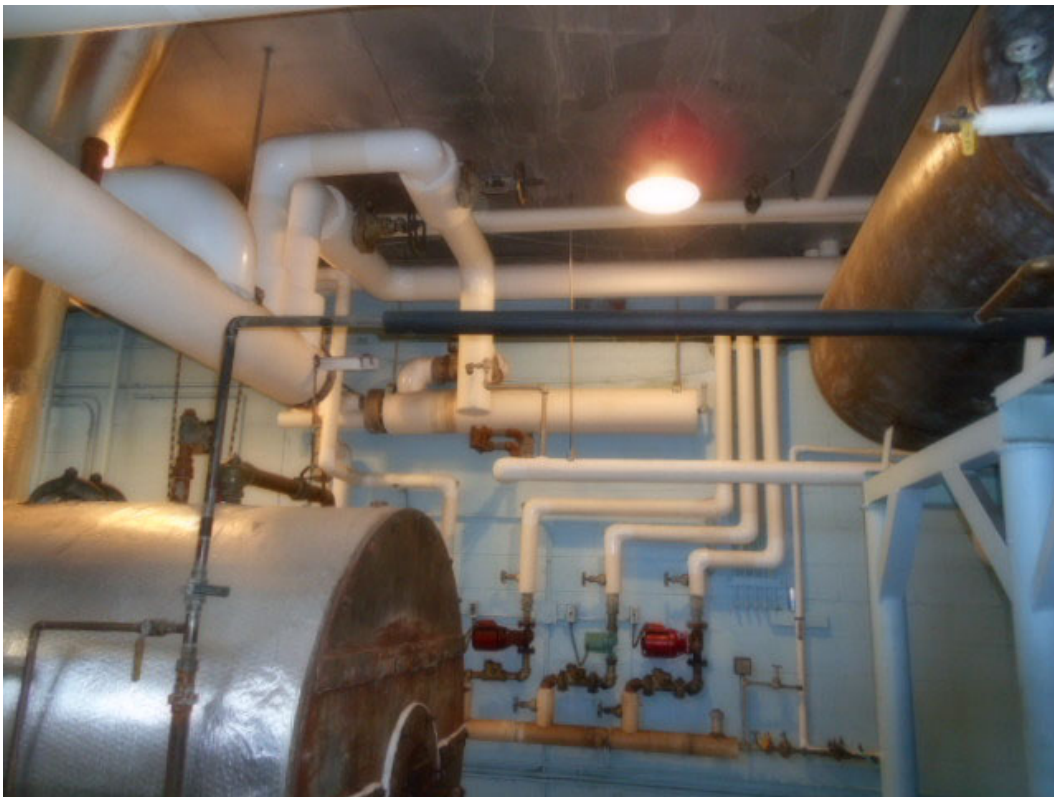
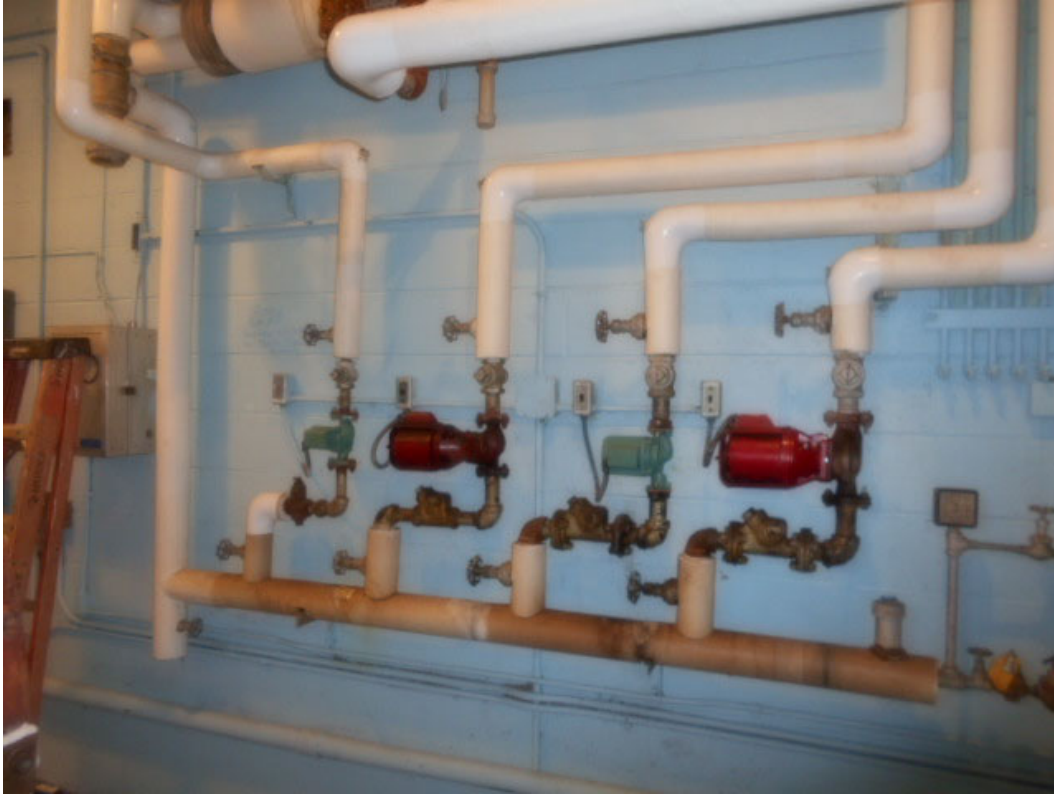
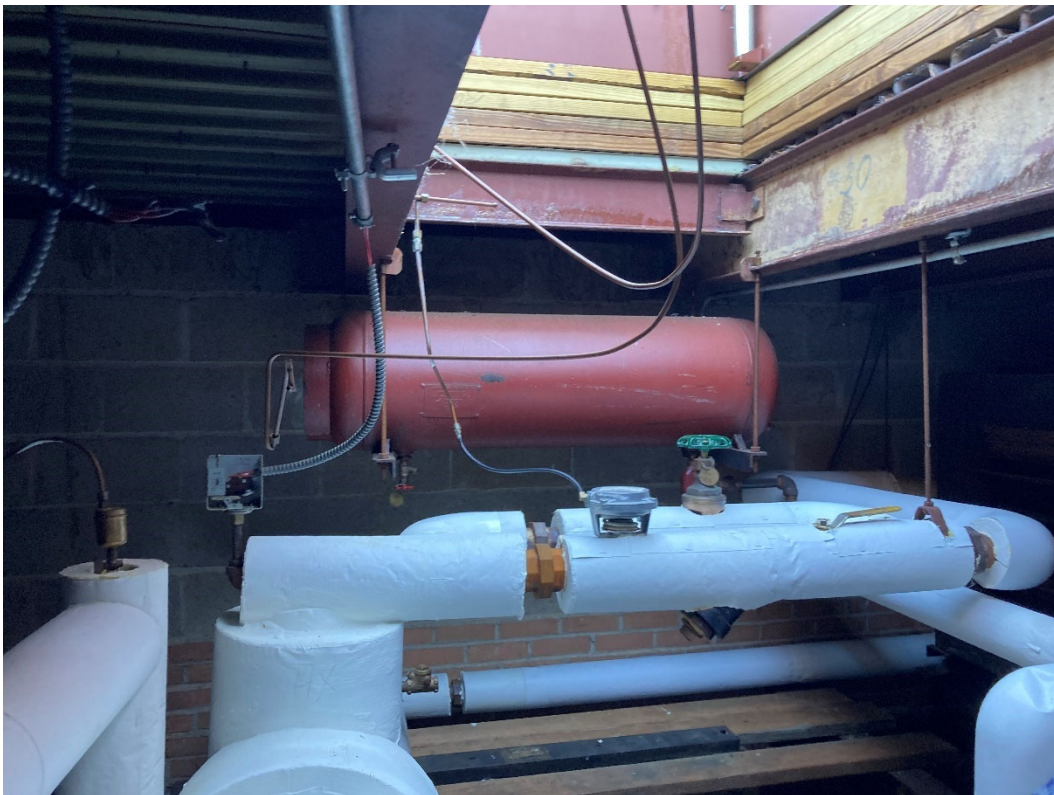
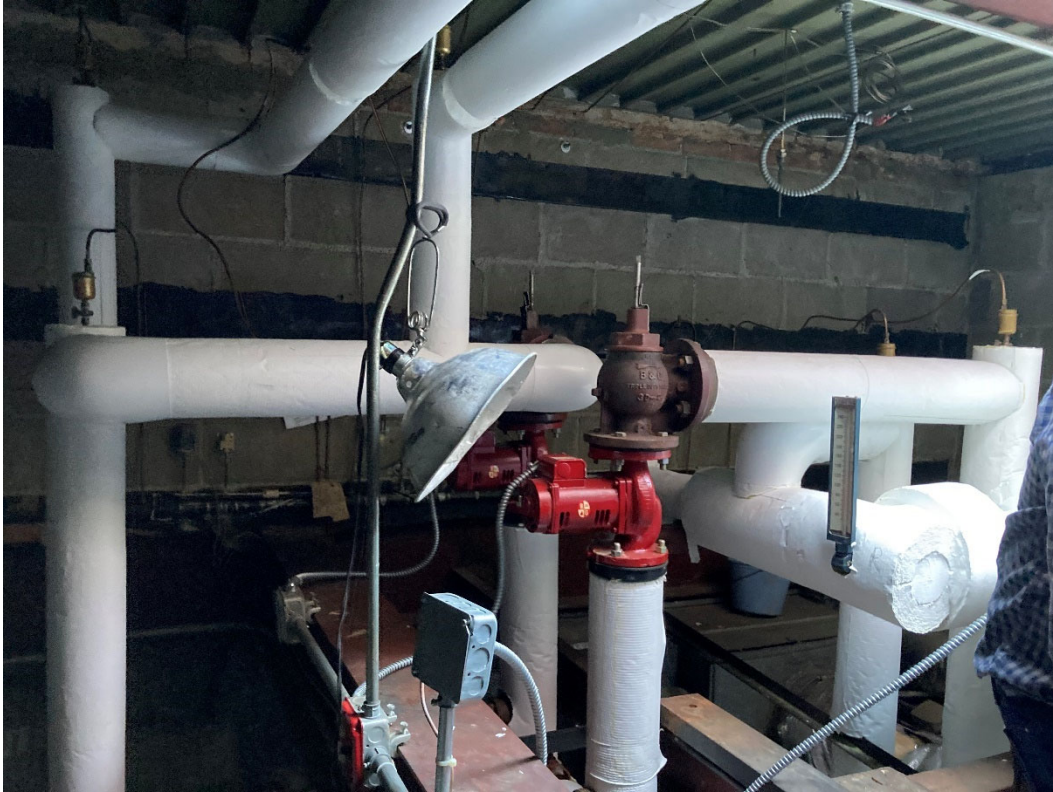
A central boiler plant located in the mechanical room on the ground level provides heating for the entire building. Two of the three existing steam boilers are HB Smith Cast Iron sectional boilers with dual fuel (oil and gas) Powerflame burners. The existing nameplate indicates the boilers are a 28HE-6 series Smith boiler with a NET IBR Rating of 1,773,000 Btu/Hr. The two boilers generate heat for the facility and distribute steam to existing equipment in the original construction portion of the building. Steam is fed to equipment such as perimeter convection units, unit heaters, cabinet unit heaters, baseboard radiation and rooftop unit steam coils. The HB Smith Boilers were replaced in 2005 and appear to be in good condition. With proper maintenance of the equipment, the life expectancy of the boilers are 30 years and the burners are approximately 20 years. Therefore these boilers are just at over half their service life expectancy and the burners will need to be replaced within the next 5 years. The current capacity of these boilers are only sized for full load of the building with no redundancy. The third existing steam boiler is a Superior horizontal tank type with dual fuel (oil and gas) Powerflame burners. The boiler is in poor condition and beyond its service life expectancy. The existing nameplate indicates the boiler is a model G4 RC 70A Superior boiler which has been decommissioned. Associated gas, electrical and water are all disconnected. Multiple steam-hot water converter stations located in the mechanical room and above corridor ceilings provide hot water to equipment throughout the entire building. Hot water is distributed to equipment such as fan coil units, unit ventilators, cabinet unit heaters, unit heaters and fin tube radiators. The steam-hot water convertor located in the mechanical

room is in poor condition and beyond its service life expectancy. The convertors located above the ceilings throughout the building and their associated pumps, expansion tanks, etc. were replaced in 2014 and appear to be in good condition. The steam-hot water convertors are well within their service life expectancy of 24 years however the associated pumps are nearing their 10 year life expectancy.

Flue gases are routed through metal breeching connected to a masonry chimney which terminates above the roof. Combustion air is supplied by an intake louver located above the exterior double doors of the boiler room and is in poor condition and not installed to current code requirements.

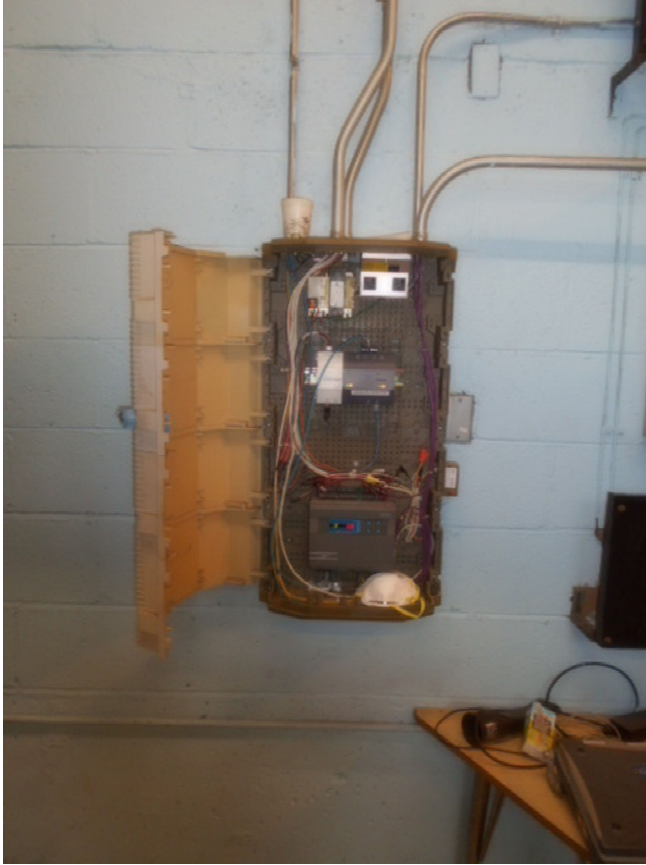
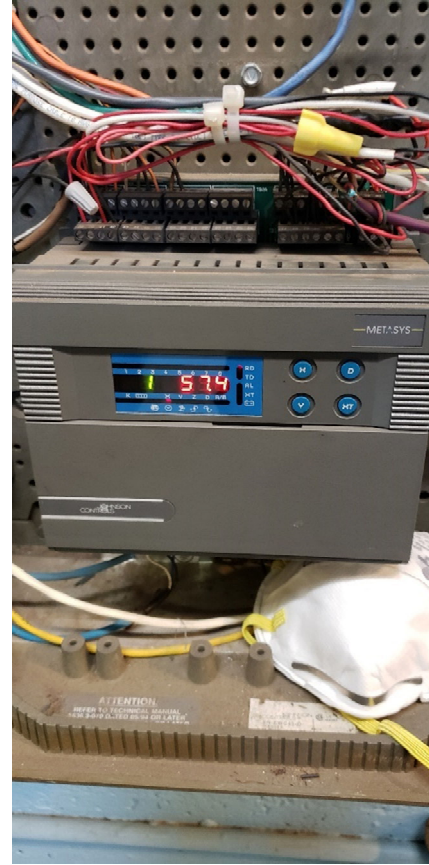
Existing Temperature Control systems throughout the facility are mostly stand alone, operated by electro pneumatic control and cannot be monitored or controlled through a central building management control system or internet. This type of control system is considered obsolete technology and replacement parts are not readily available. Only the rooftop units are tied into a Johnson Metasys building management system. The systems should be considered to be beyond the end of their use life but appear to be functioning properly and may be kept in service during the construction process.

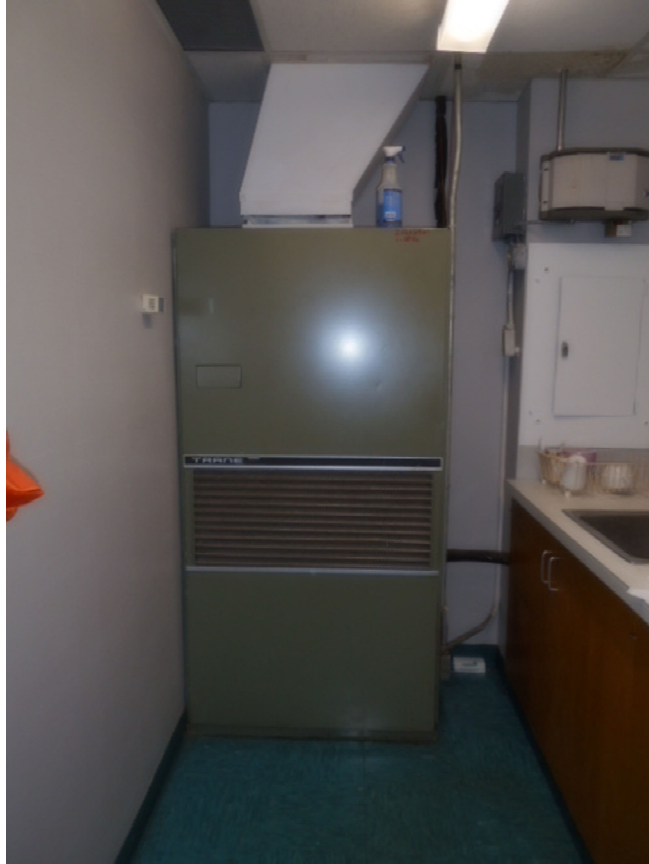
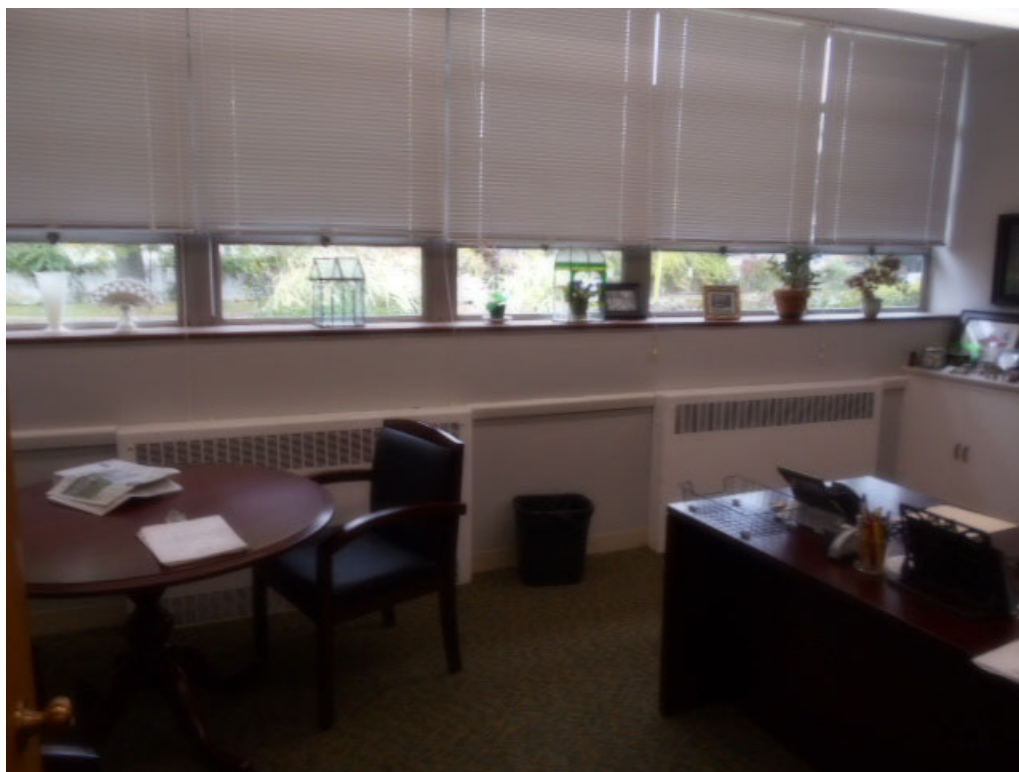
Front reception area and offices are served by floor mounted air conditioning units with a roof mounted condensing unit and duct distribution for cooling, operable windows for ventilation and hot water radiation provides heating to the spaces. All of the equipment in this area is in poor condition, beyond their service life expectancy and should be replaced.

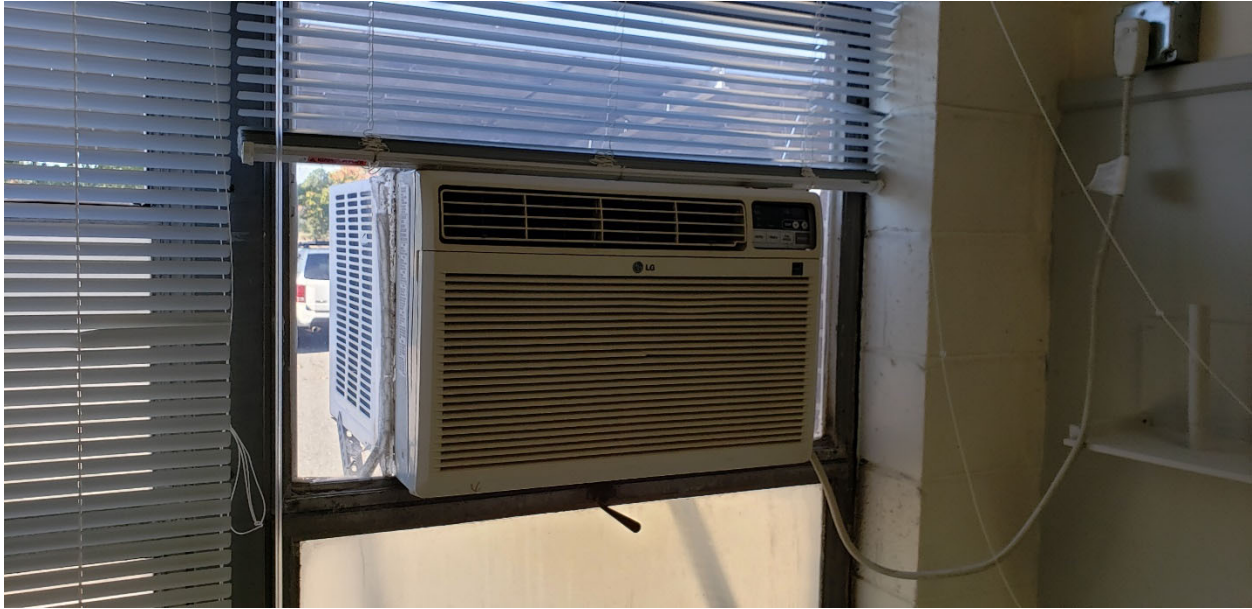
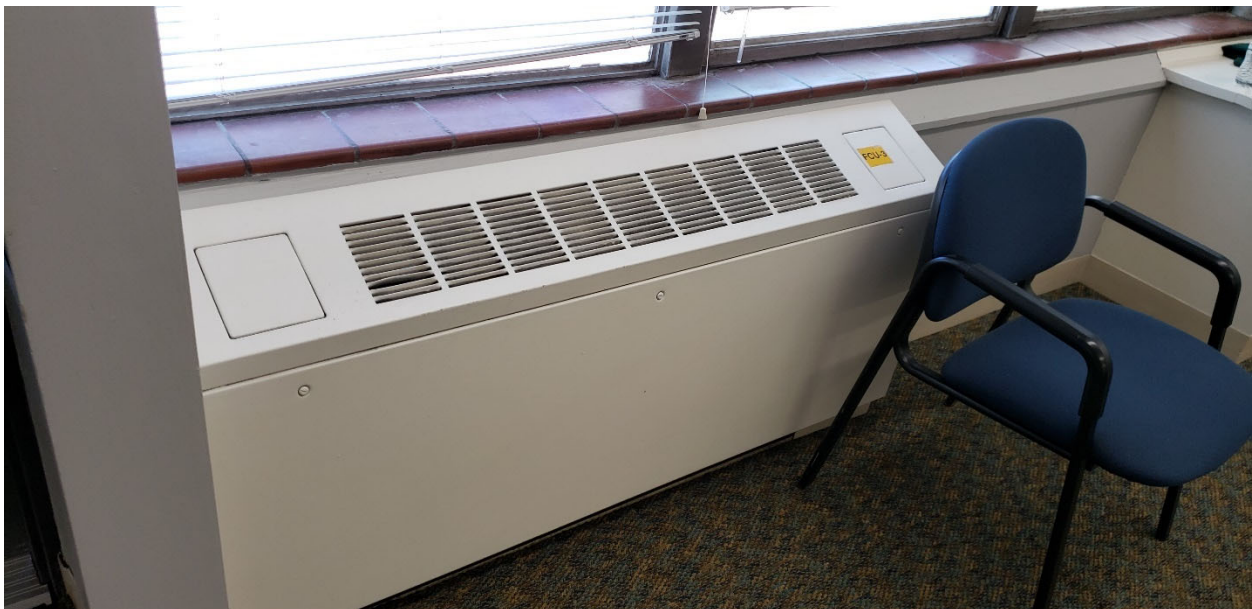
Senior Activity Rooms, are served by window mounted air conditioning units for cooling, operable windows for ventilation and floor mounted hot water fan coil units by the windows for heating. The existing supply diffusers and return grilles mounted to the ceiling are associated with an existing heating & ventilation system which is inactive and abandoned in place. The window units appear to be in fair condition but have exceeded their life expectancy of 10 years. The floor mounted fan coil units are in poor condition, beyond their service life expectancy of 20 years and should be replaced.

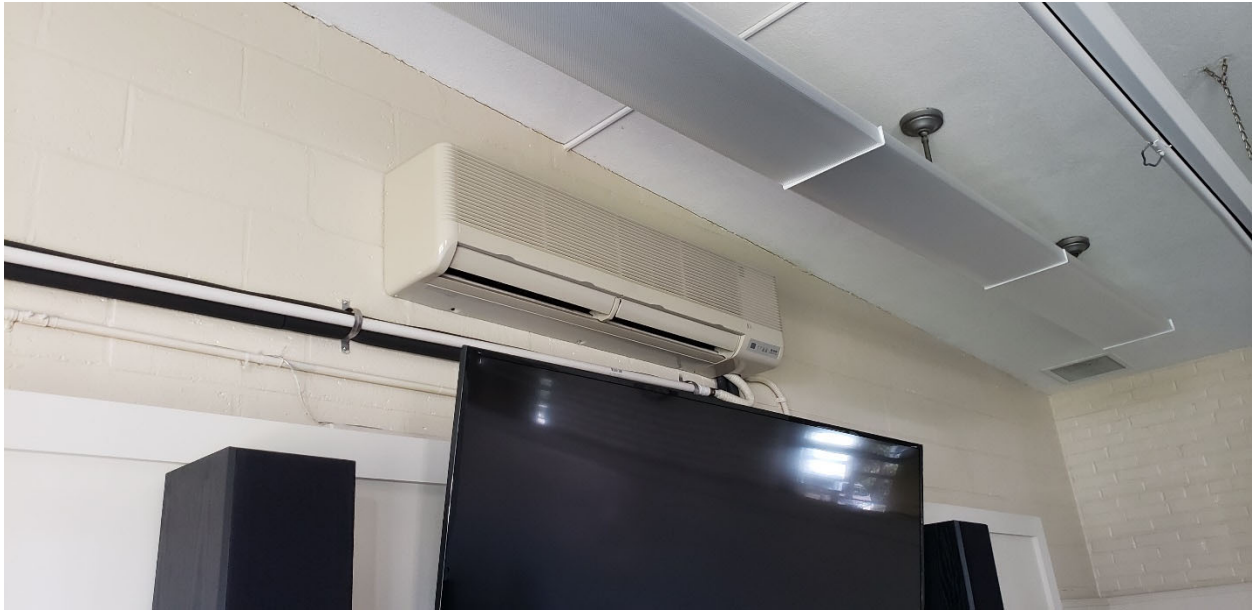
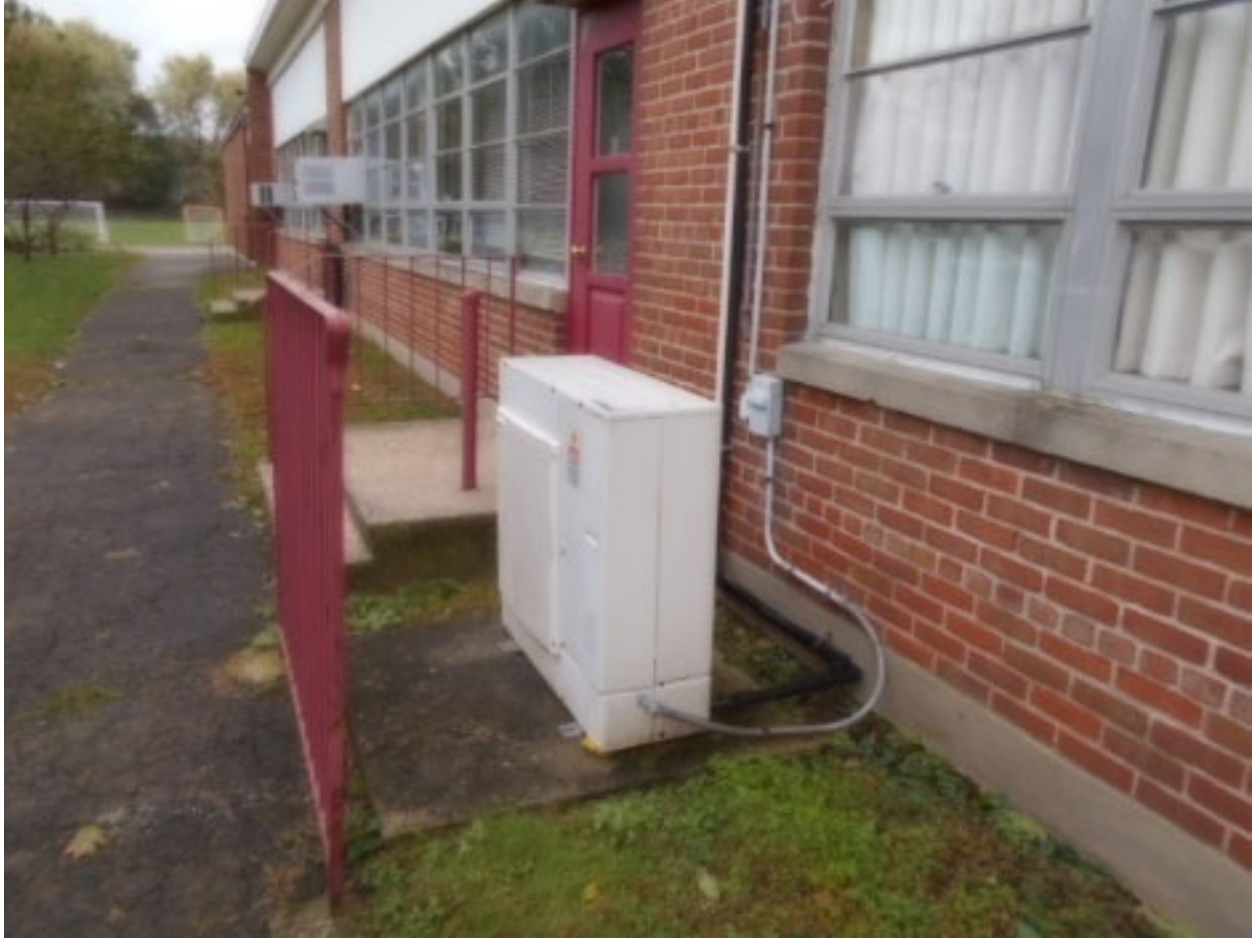
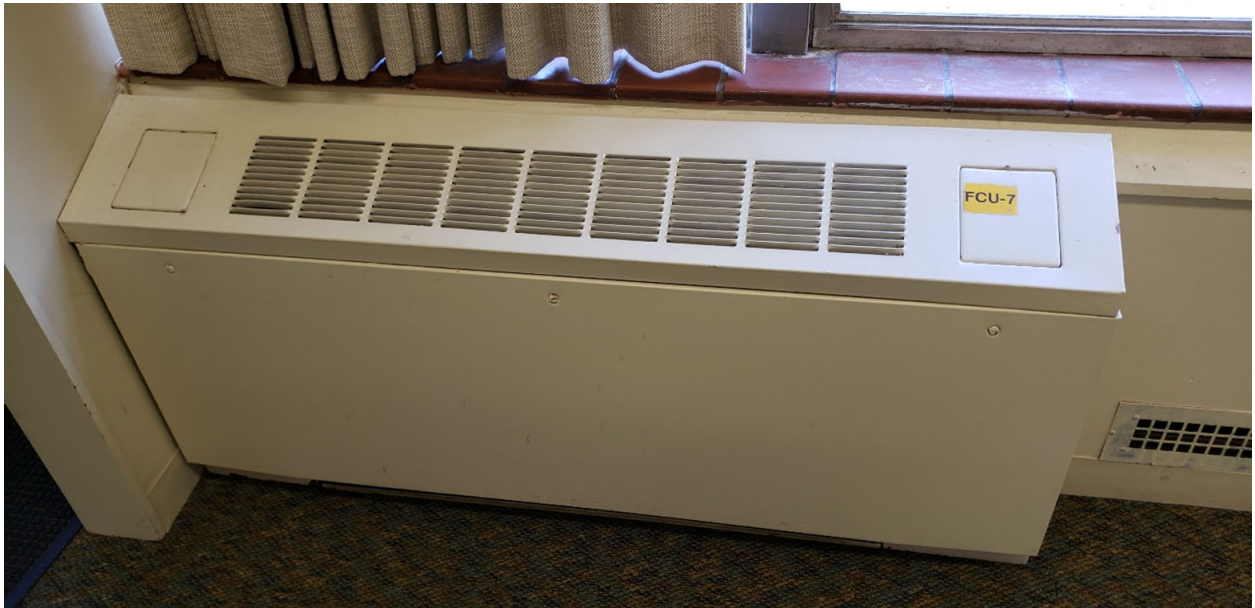
Media Meeting Rooms, are served by wall mounted indoor air conditioning units with outdoor condensing units for cooling, operable windows for ventilation and floor mounted hot water fan coil units for heating. The existing supply diffusers and return grilles mounted to the ceiling are associated with an existing heating & ventilation system which is inactive and abandoned in place. The window units appear to be in fair condition but have exceeded their life expectancy of 10 years. The floor mounted fan coil units are in poor condition, beyond their service life expectancy of 20 years and should be replaced.

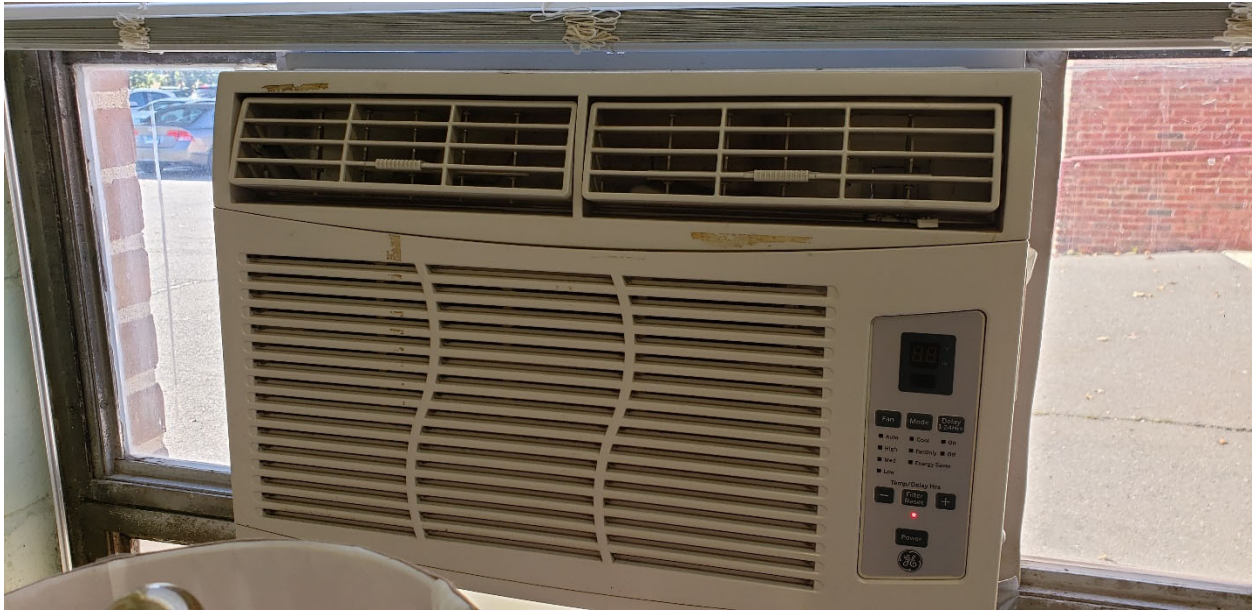
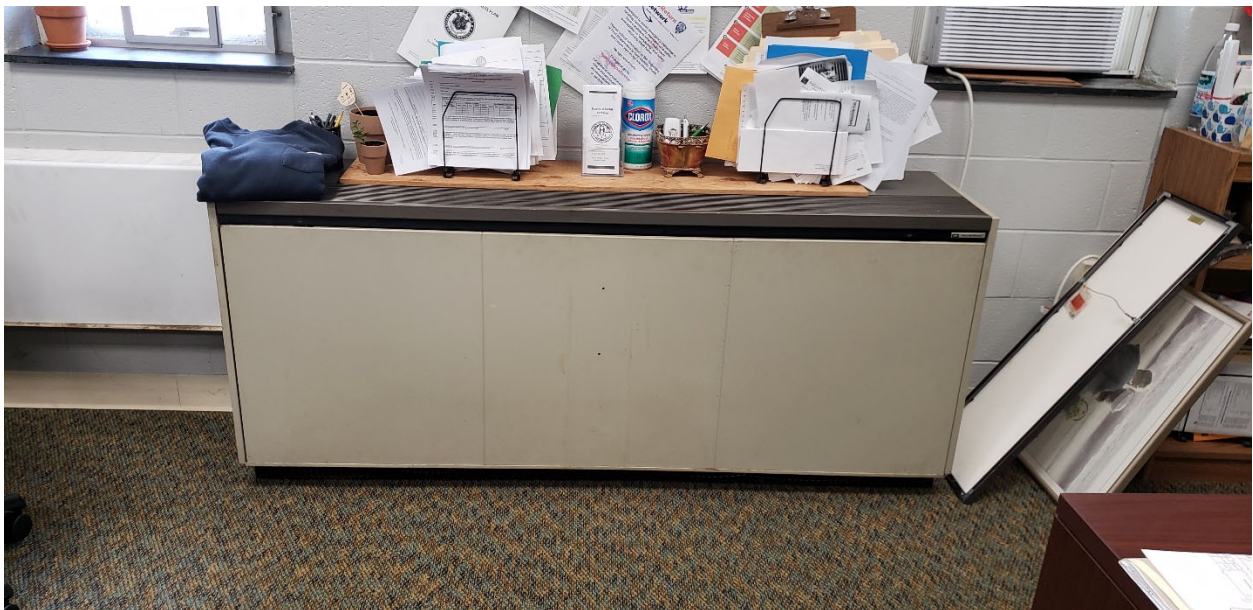
Southwest Offices, are served by window mounted air conditioning units for cooling and hot water unit ventilators along the perimeter which provide heating and ventilation only to the space it is located in. The window units appear to be in fair condition but have exceeded their life expectancy of 10 years. The floor mounted unit ventilators are in poor condition, exceeded their service life expectancy of 20 years and should be replaced. Unit ventilators are considered obsolete technology for classroom use at present.
