**Town of Fairfield**  
Town Planning and Zoning Commission  
725 Old Post Road  
Fairfield, Connecticut 06824

**To: Members of the RTM**  
**From: Jim Wendt, Planning Director**  
**Date: April 19, 2022**  
**Re: Opt-Out of State Mandated Zoning Regulation Language**

FAIRFIELD TOWN PLAN AND ZONING COMMISSION PROPOSED OPT-OUT OF  
STATE MANDATED REGULATION LANGUAGE REGARDING OFF-STREET PARKING.

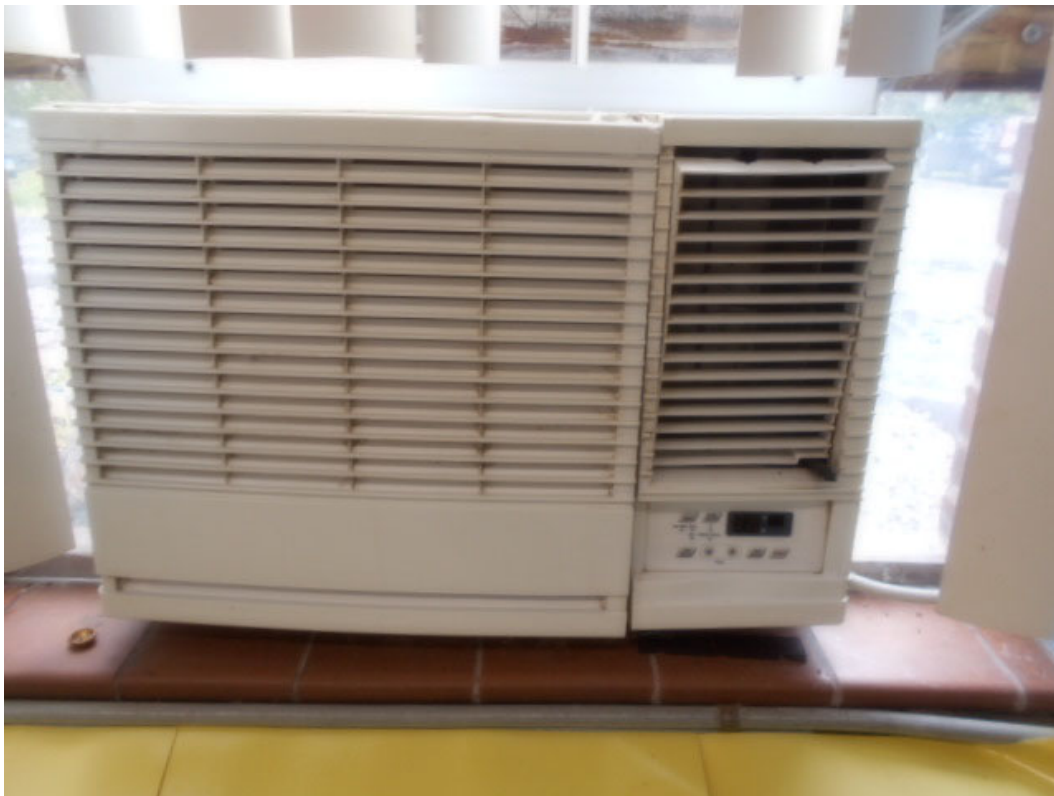
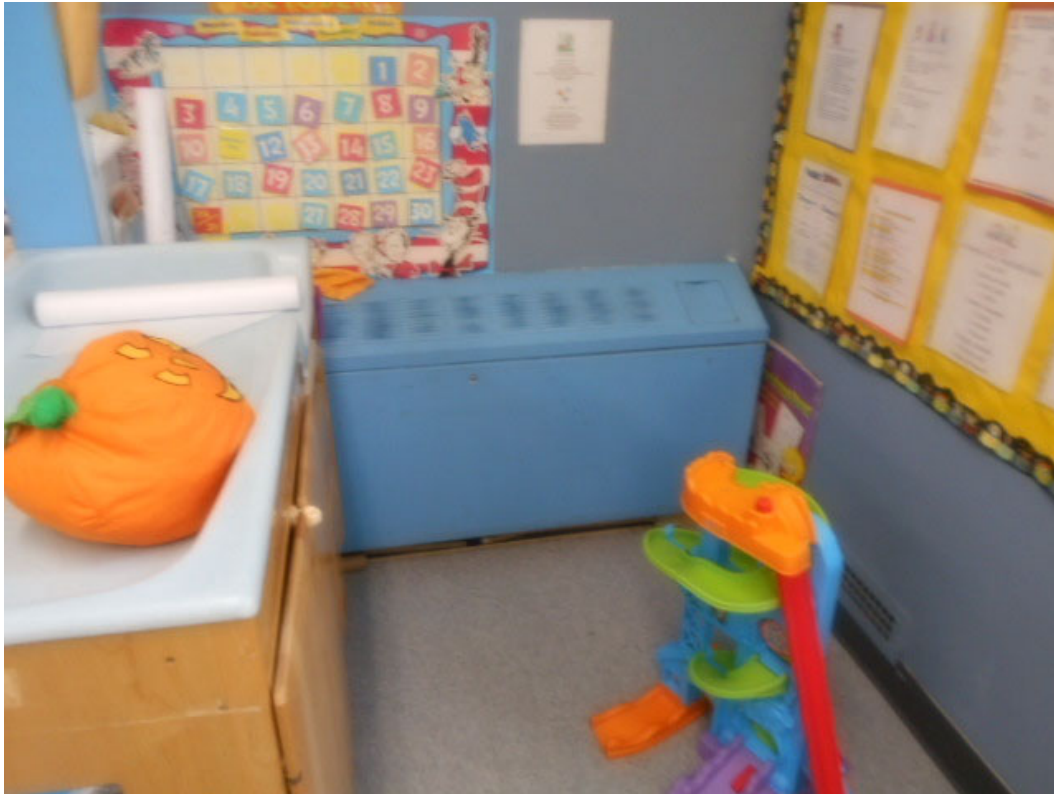
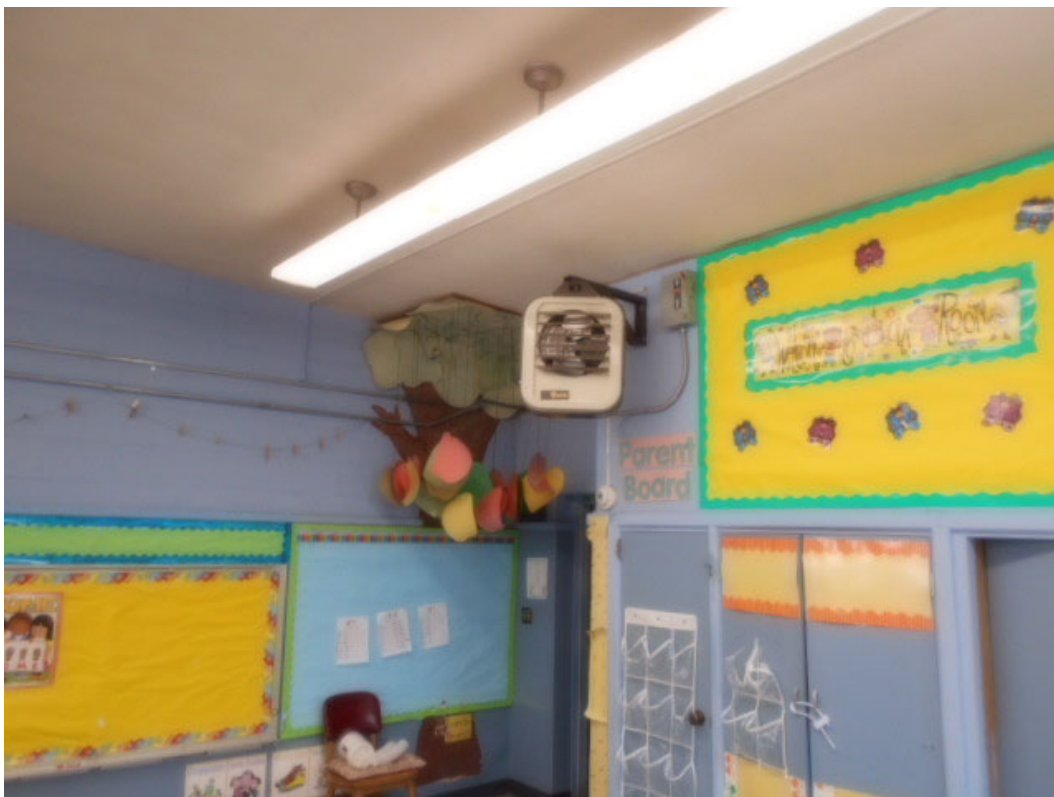
Daycare Rooms, are served by window mounted air conditioning units for cooling, operable windows for ventilation and floor mounted fan coil units by the windows for heating. Several classrooms contain additional heating via electric unit heaters. The existing supply diffusers and return grilles mounted to the ceiling are associated with an existing heating & ventilation system which is inactive and abandoned in place. The window units appear to be in fair condition but have exceeded their life expectancy of 10 years. The floor mounted fan coil units are in poor condition, beyond their service life expectancy of 20 years and should be replaced. Electric unit heaters appear to be in good condition.

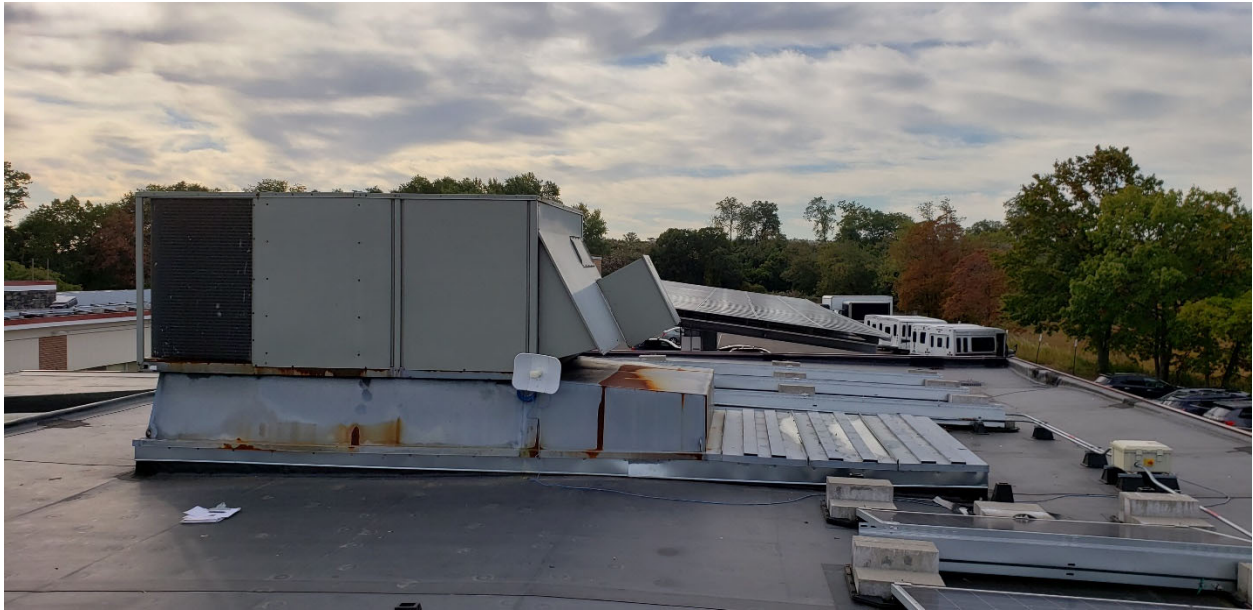
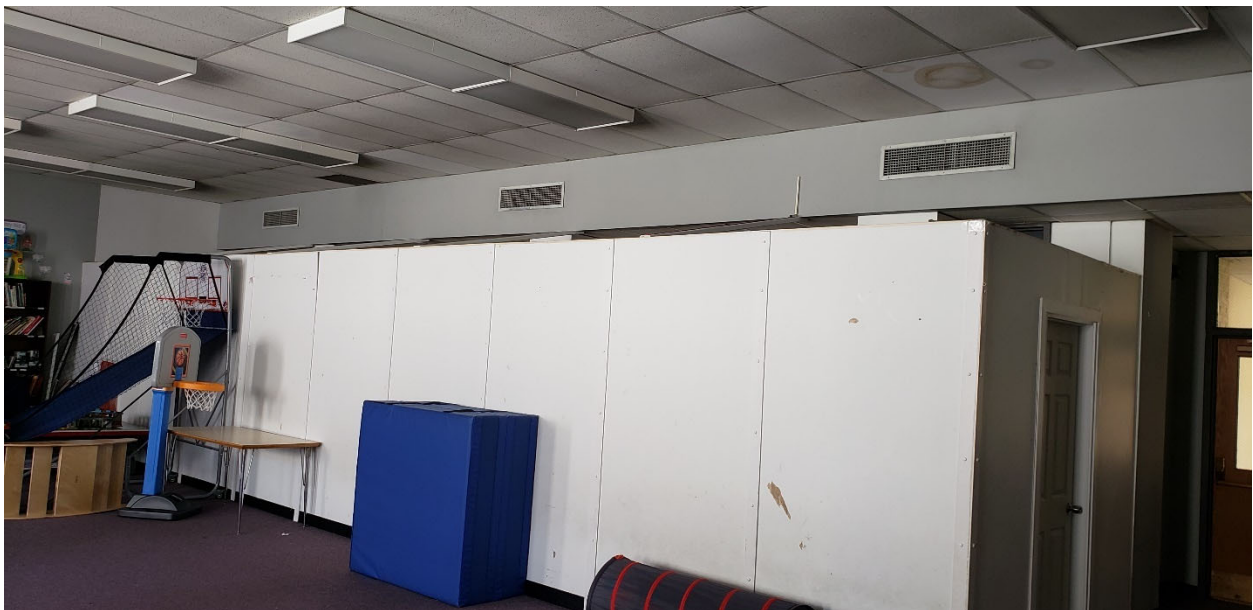
The large daycare room and back offices are served by an existing dedicated packaged rooftop unit (RTU-1) with integral Direct Expansion (DX) refrigerant cooling coils, electric heating section and ductwork distribution to provide heating, cooling and ventilation to the space. The rooftop unit is in poor condition, has exceeded its service life expectancy of 15 years and should be replaced.

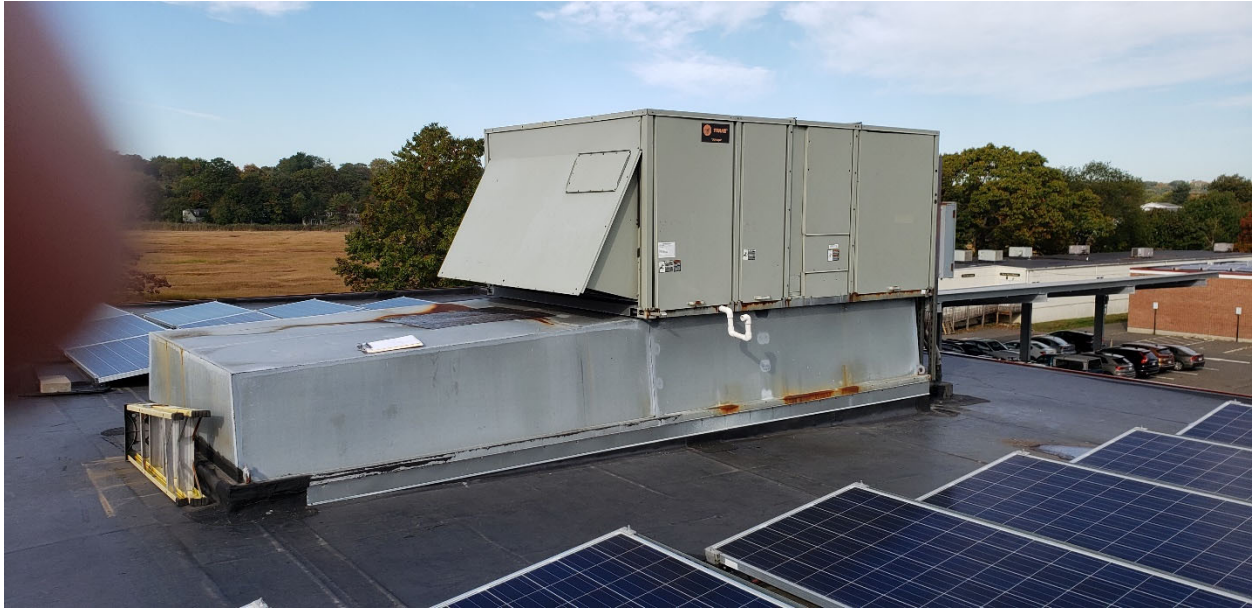
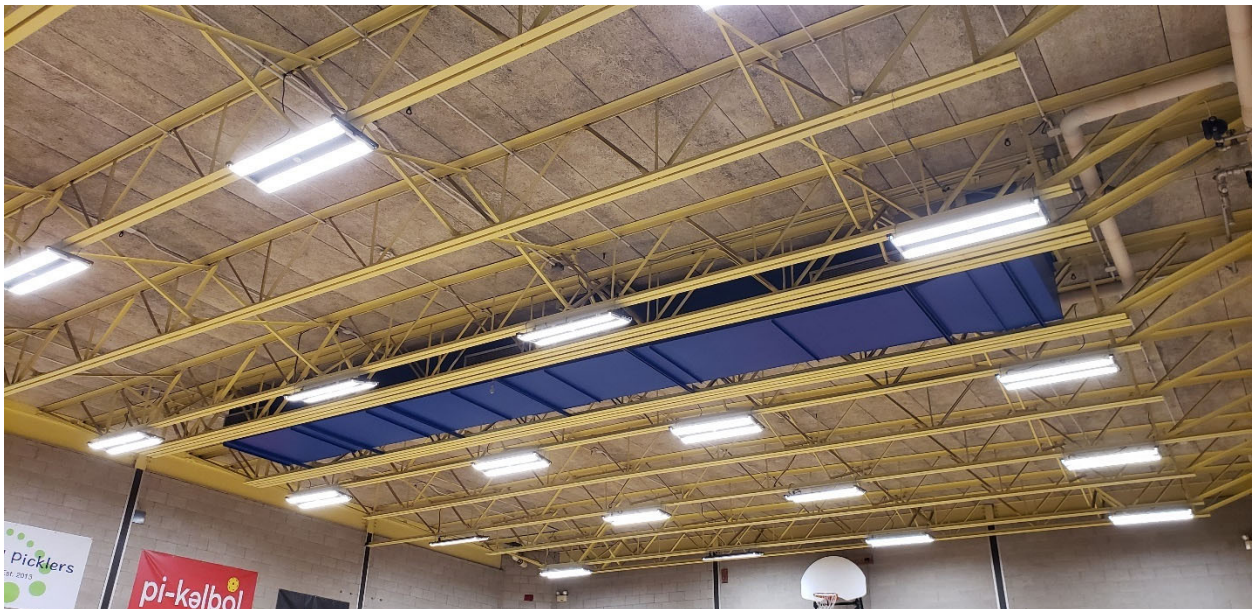
The Gymnasium is served by an existing dedicated packaged rooftop unit (RTU-2) with integral Direct Expansion (DX) refrigerant cooling coils, steam heating section and ductwork distribution to provide heating, cooling and ventilation to the space. The rooftop unit is in poor condition, has exceeded its service life expectancy of 15 years and should be replaced.

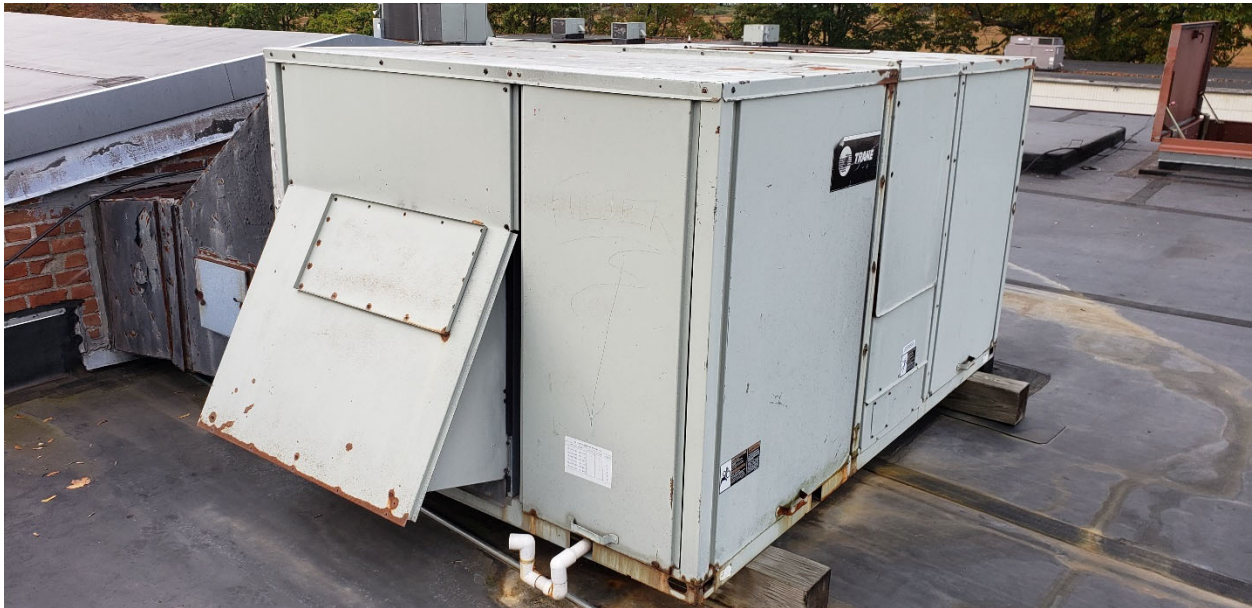
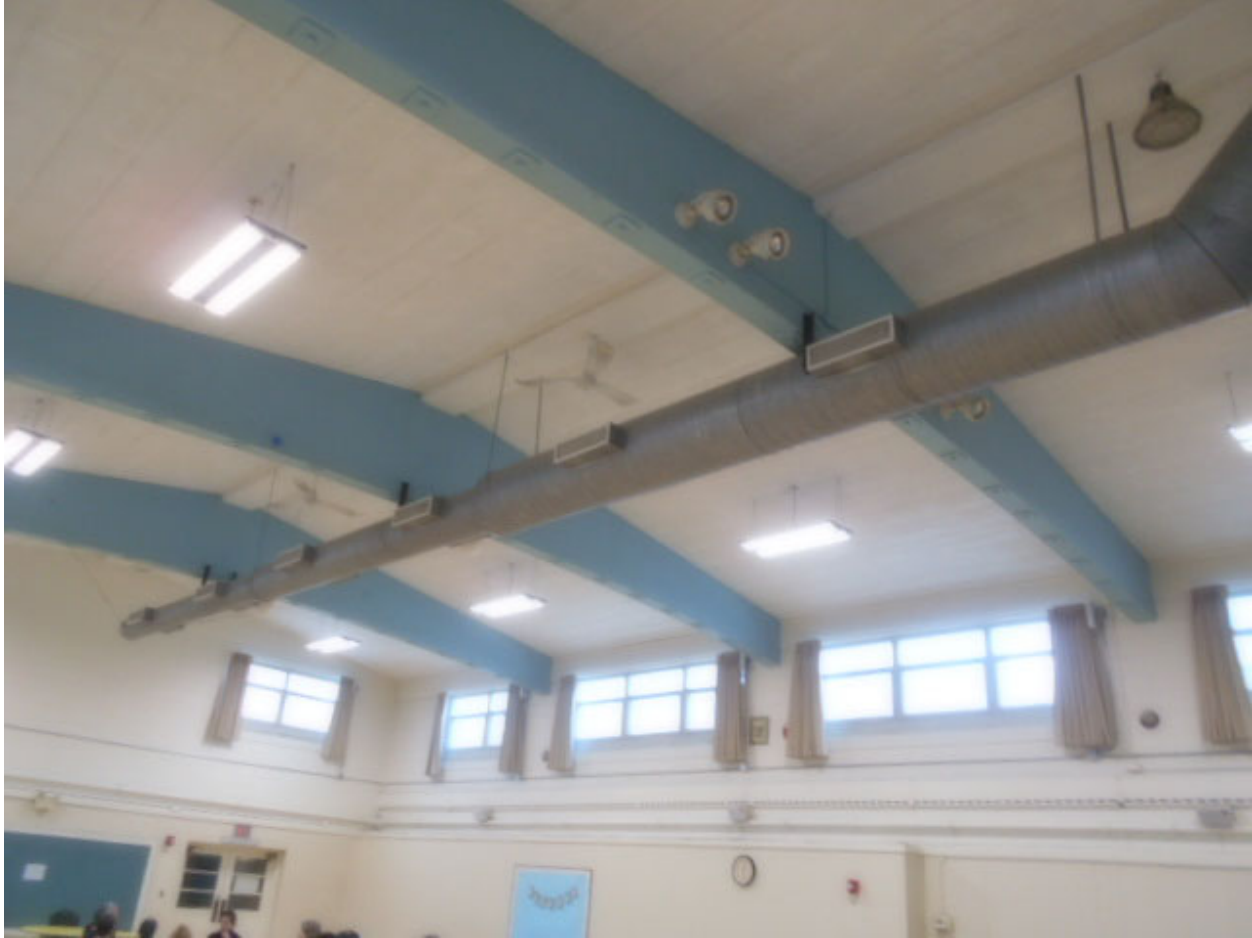
The All Purpose/Lunch Room & Stage are served by multiple HVAC systems. An existing dedicated packaged rooftop unit (RTU-3) with integral Direct Expansion (DX) refrigerant cooling coils and ductwork distribution to provide cooling to the space. The space is heated via wall mounted radiation located just below the windows. Ventilation was once provided by a heating & ventilation (H&V) unit located above the stage storage room. The H&V unit is inactive and abandoned in place. Therefore this area has no provisions for ventilation. The ductwork associated with this unit may contain asbestos. All three of these systems are in poor condition, have exceeded their service life expectancy and should be replaced.

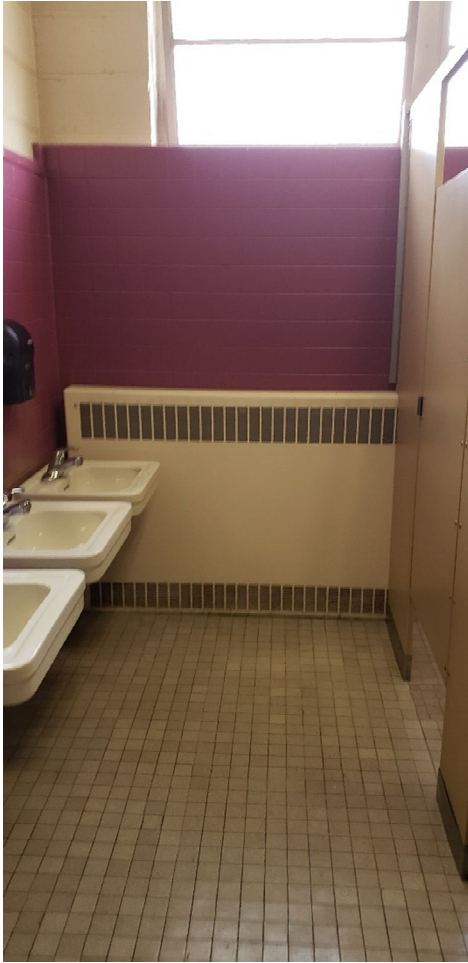
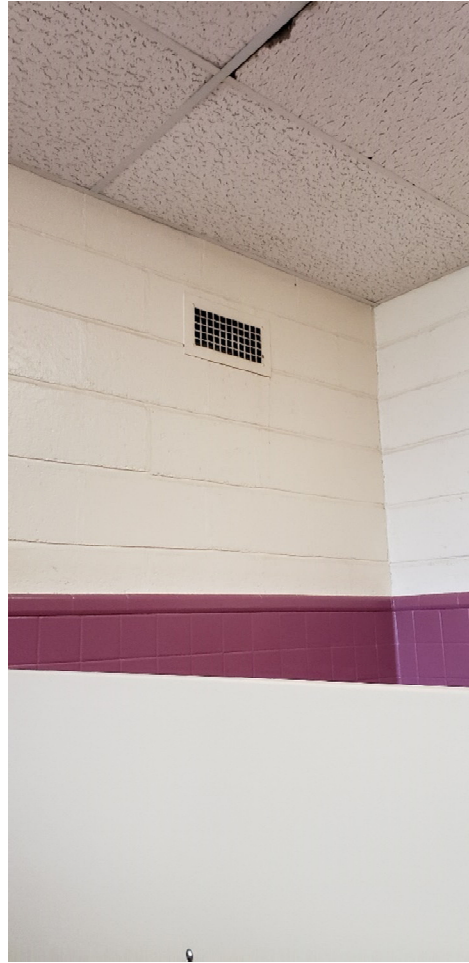
Toilet rooms and janitor closets are ventilated by independent exhaust fans. Make-up air to the spaces are provided by operable windows, transfer air louvers within doors and/or undercuts of doors. Toilet rooms with exterior walls contain either steam or hot water radiation along the perimeters. The roof mounted exhaust fans serving the toilet groups along with the perimeter radiation are in poor condition, beyond their service life expectancy of 20 years and should be replaced.

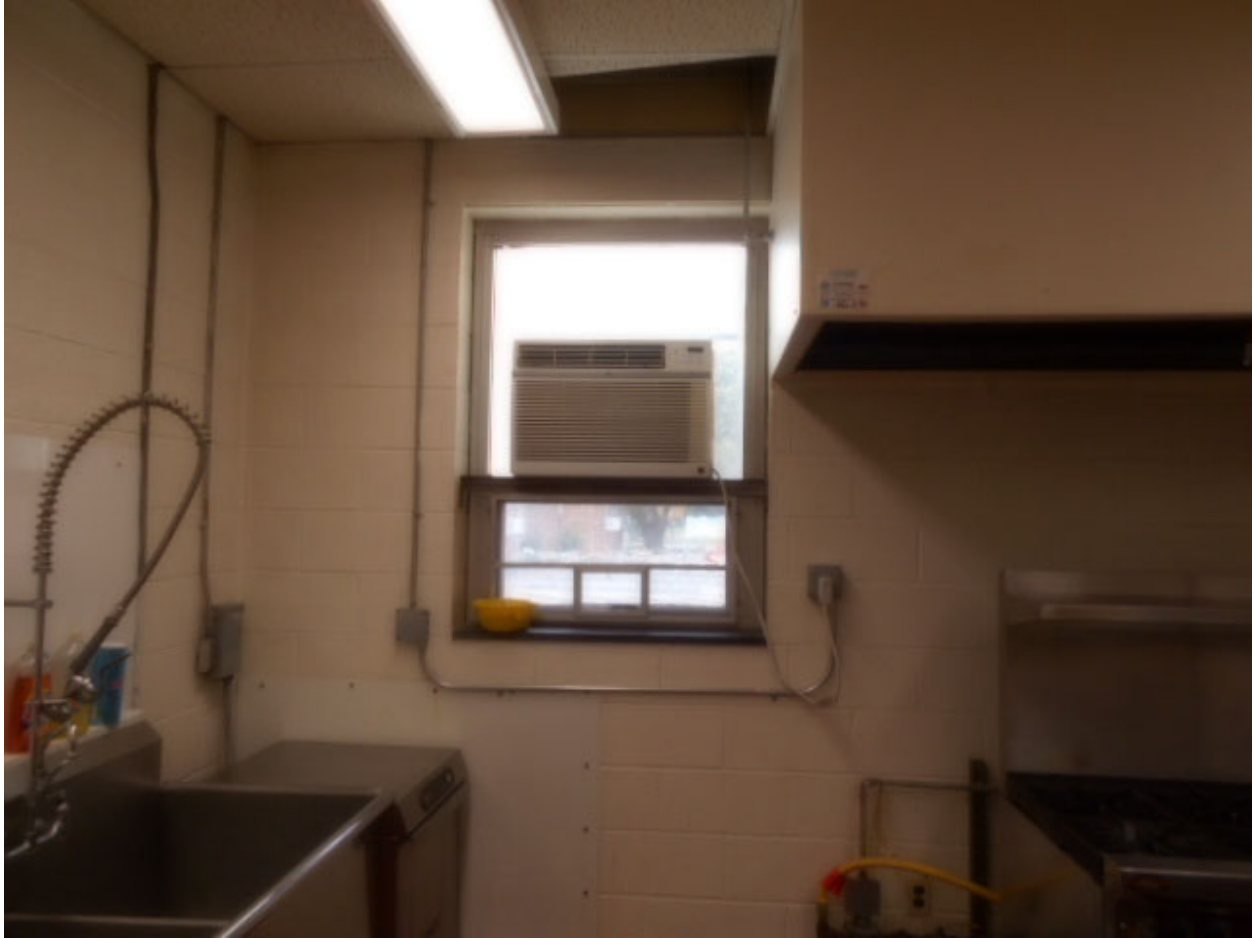
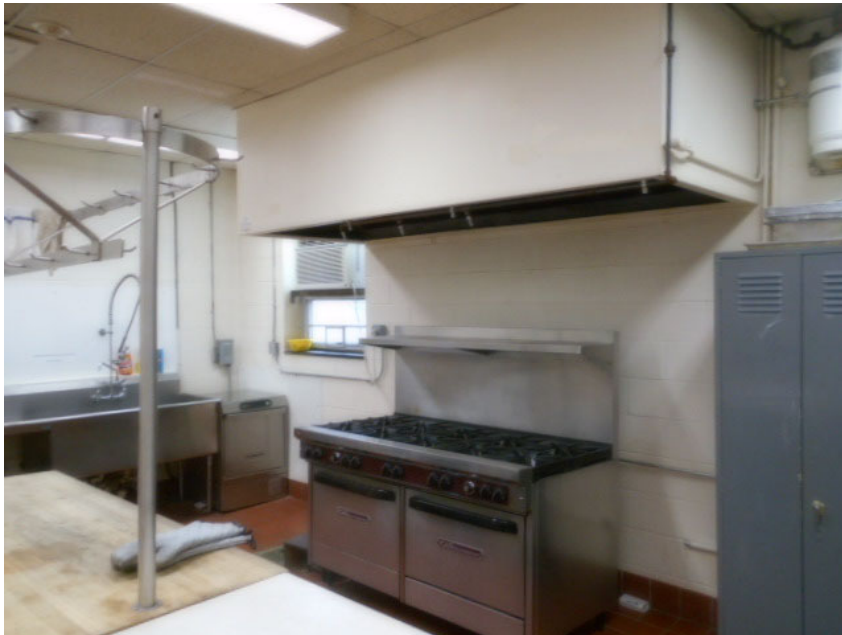
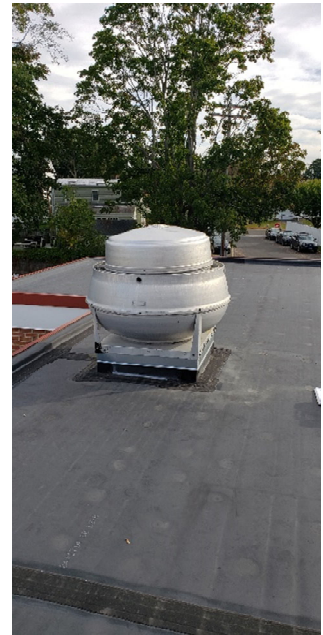
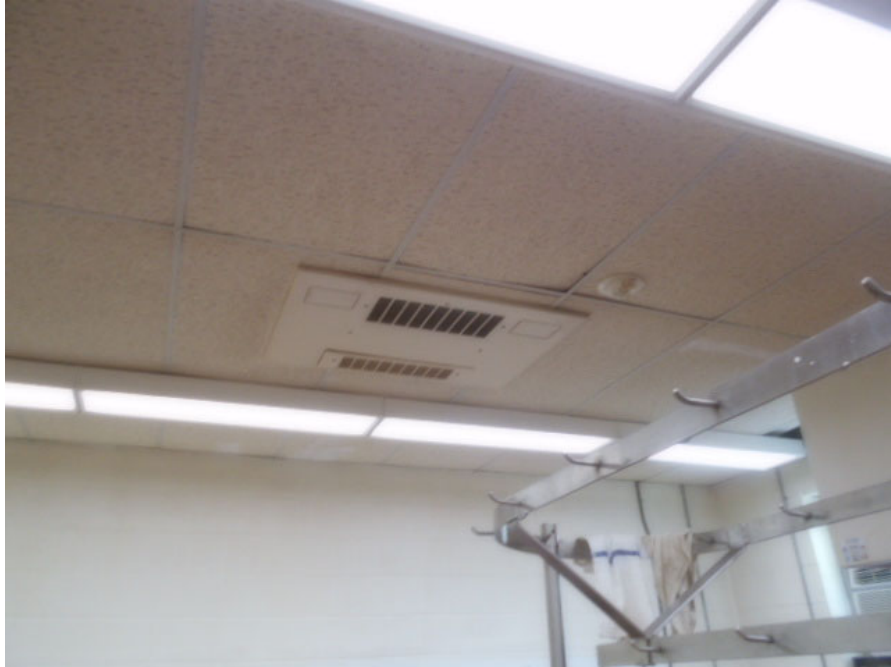
The Kitchen is served by window mounted air conditioning units for cooling, operable windows for ventilation and a ceiling mounted cabinet unit heater for heating. The window unit appears to be in fair condition but has exceeded its life expectancy of 10 years. The cabinet unit heater is beyond the service life expectancy of 20 years and should be replaced.

The existing roof mounted exhaust fan serving the kitchen hood appears to be in fair condition but is beyond its service life expectancy. The kitchen hood is a Type 1 grease exhaust hood equipped with a clean agent fire extinguishing system interlocked with the roof fan and gas solenoid shut-off valve. The hood contains integral light fixtures and grease baffles all in which are in poor condition and in need of replacing.

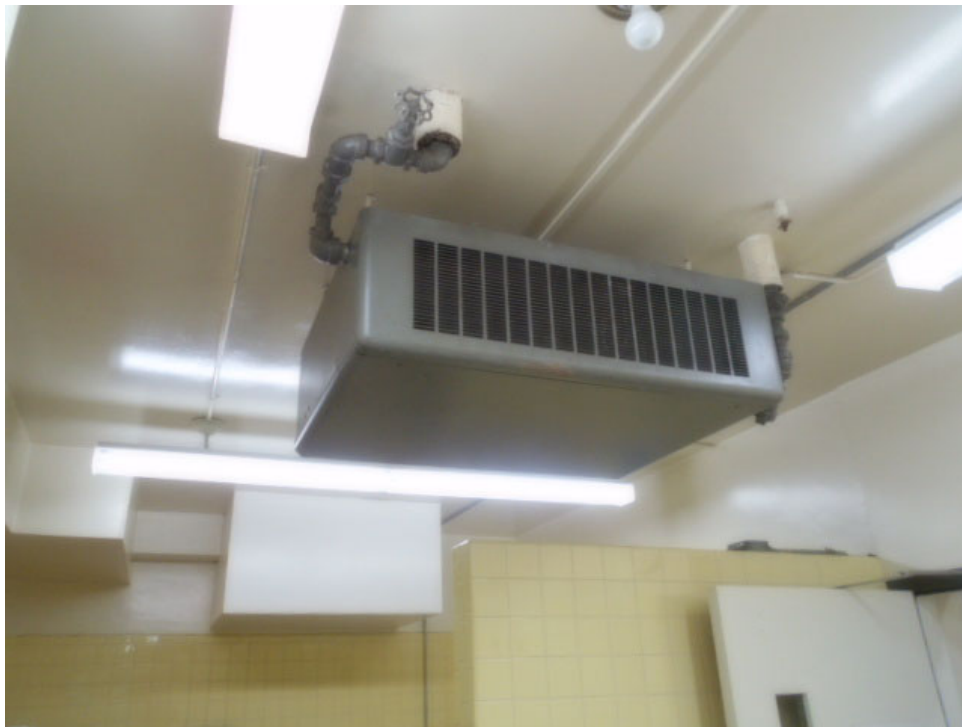
The Servery is served by a ceiling hung cabinet unit heater providing heating only. The cabinet unit heater is in poor condition, beyond the service life expectancy of 20 years and should be replaced.

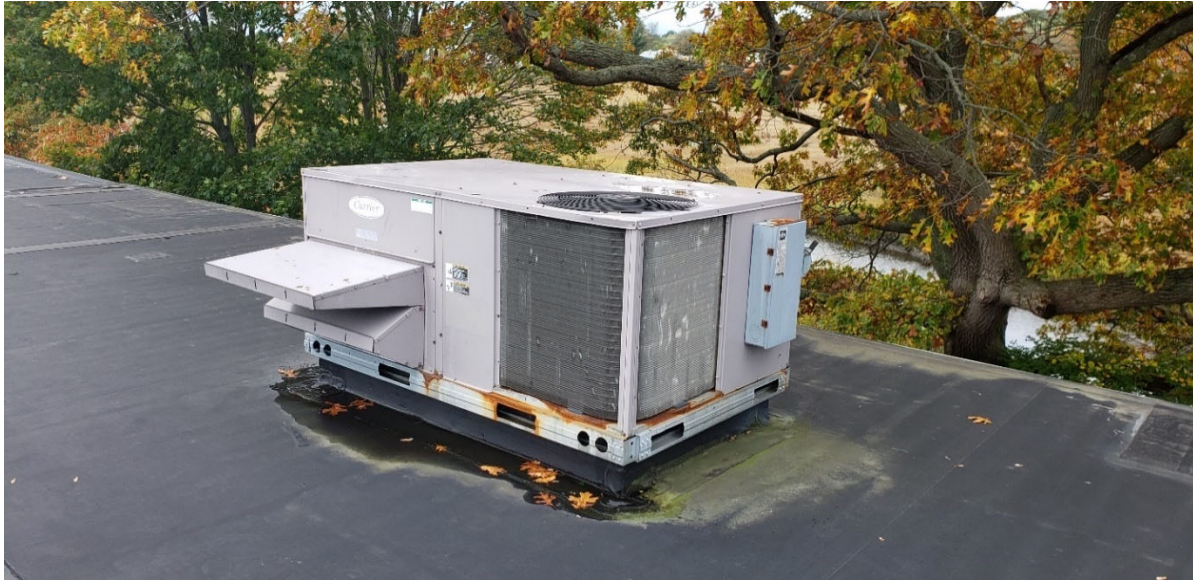
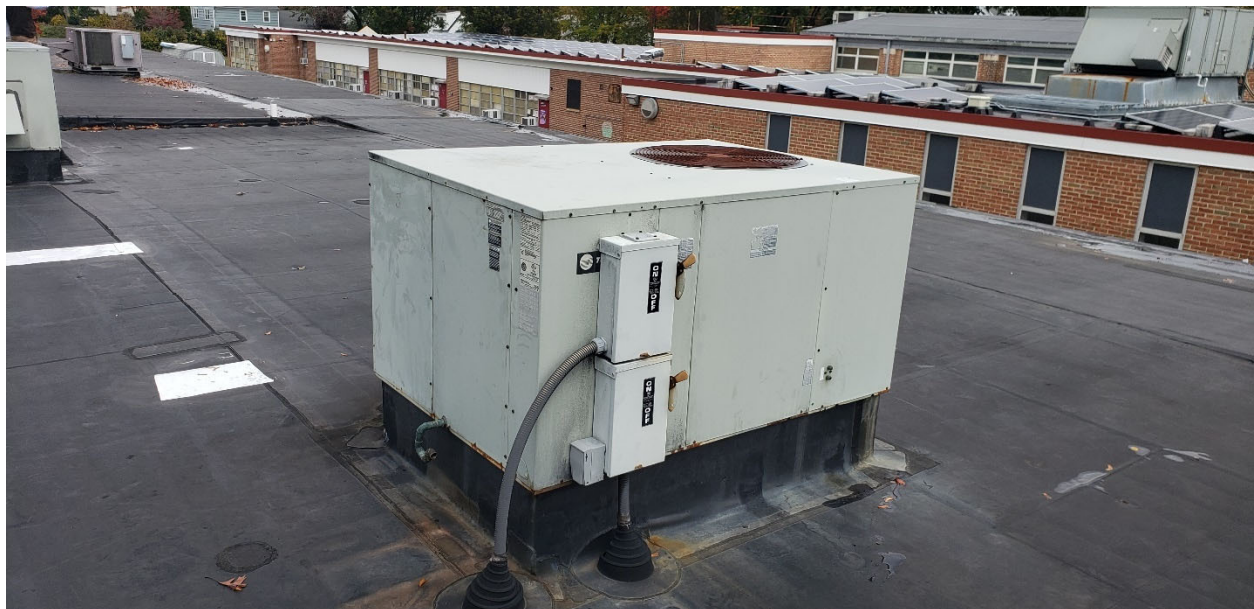
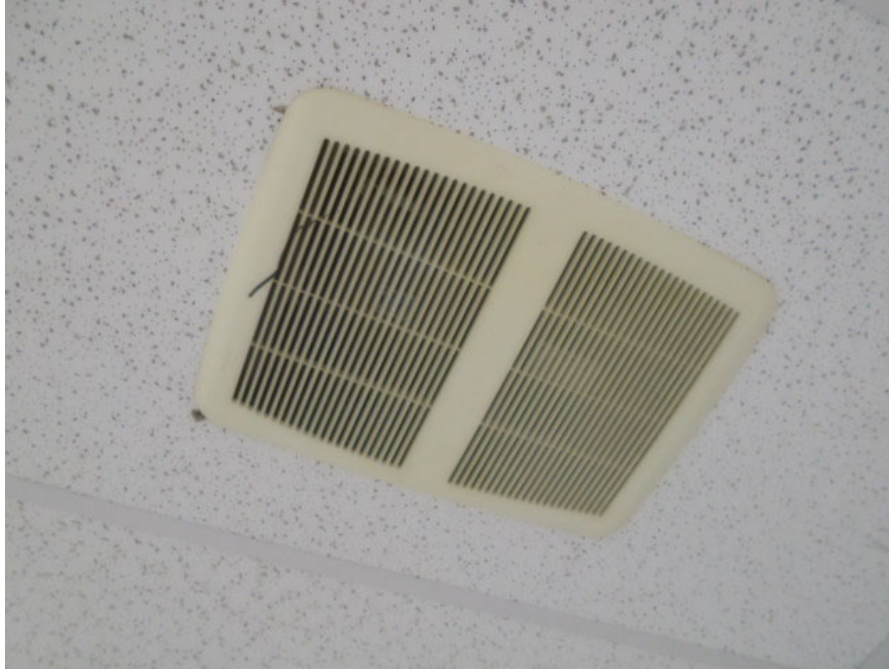
### **Portable Building**

The portable building is served by (6) packaged rooftop units with integral Direct Expansion (DX) refrigerant cooling coils, electric heating section and ductwork distribution to provide heating, cooling and ventilation to the space. The rooftop units are in poor condition, have exceeded their service life expectancy of 15 years and should be replaced. The building also contains toilet rooms which are conditioned by a rooftop unit (RTU-6). Each toilet room contains independent ceiling mounted exhaust fans which appear to be in fair condition but beyond their serviceable life of 15 years.

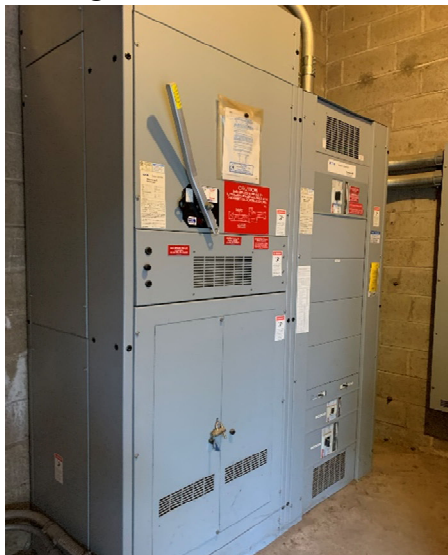
**Switchgear and Main Distribution**

The Bigelow Building electrical service consists of a switchgear rated for 1,600A, 120/208V -3 Phase, 4 wire with distribution section. The switchgear is fed from a utility pad-mounted transformer located at the east side of the building. The pad-mounted transformer feeds the switchgear via underground secondary service. The distribution section feeds multiple subpanels and equipment located throughout the facility. The switchgear and distribution panel located in the former utility vault, were manufactured by Cuttler Hammer, appear to be installed recently and are in good condition. Panels throughout the facility are a combination of original and newer, with ratings from 100A to 200A, three-phase and manufactured by Square D and Federal Electric. There is one electrical panel labeled as "PP2" located in a closet with limited space. The closet is currently used as a storage room blocking accessibility to the panel. The NEC code requires access for all electrical panels to have a minimum of 3' clearance in front. Removing or relocating items from the closet to another location is recommended to meet accessibility code requirements.

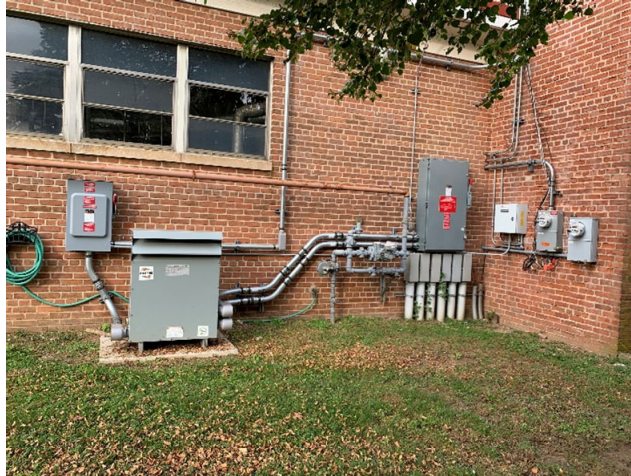
#### **Bigelow Photovoltaic Distribution System**

In addition to the Bigelow electrical service, the building is equipped with a photovoltaic system rated at 480V. Solar panels are installed throughout 90% of the roof and are interconnected with utility-interactive inverters that feed a 480V, 200A disconnect. The 200A disconnect feeds a 150KVA, 480/277V-208V step-down transformer

that feeds a 208V, 600A disconnect. Inverters are located on the roof and disconnects, and a stepdown transformer are located on the exterior wall at the east side of the building. The system appears to be installed recently and is in good condition.

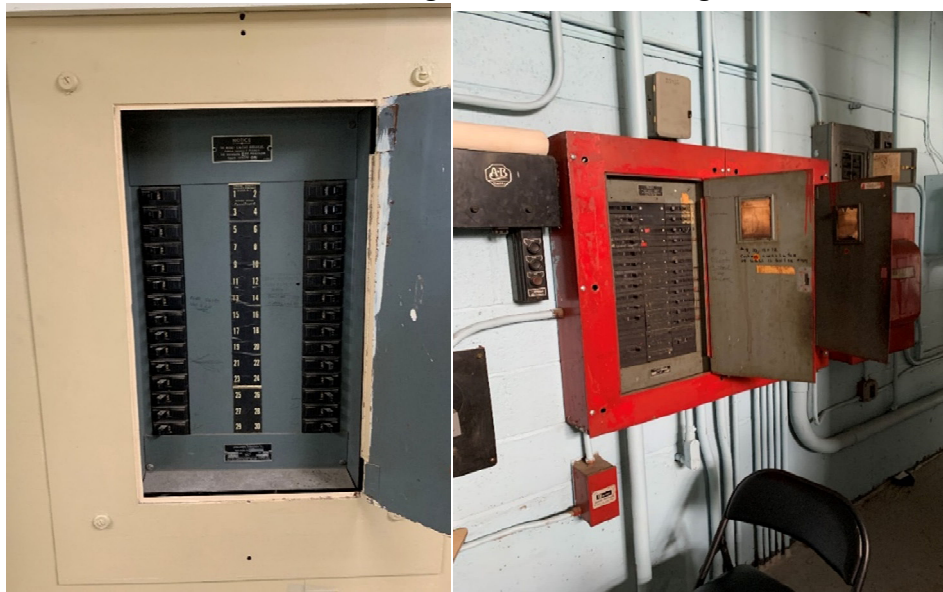
#### **Bigelow Obsolete Original Panels**

The condition of all panels throughout the Bigelow Building varies from obsolete, fair, and good. Original panels appear to be over 40 years old and given the age of the equipment, replacement parts may be difficult to obtain in future renovations. The typical life expectancy of electrical panels is approximately 40 years. Assuming original panels are presumed to be over 40 years old, replacement of original panels should be considered in the near future. Also, multiple panels were without designation name tags and directory. The NEC code requires that all panels shall be marked and provided with a circuit designation directory.

Bigelow Senior Center/Child's Garden - 100 Mona Terrace Facility Condition Cost Estimate									
TAG NO.	ASSESSMENT	SYSTEM/ CODE REF.	RANKING				CORRECTIVE ACTION	ITIMIZED ESTIMATED COST	REMARKS
ELECTRICAL SYSTEMS									
E1	Old electrical panels (at or beyond useful life)	Maint.	3				Replace old electrical panels with new, newer panels can remain	\$ 27,450	Bigelow Bldg.
E2	Fire Alarm Manual pull station for doors used as egress	NFPA 72		2			Add pull stations to each egress door use as egress	\$ 2,500	Bigelow Bldg.
E3	ADA exit signs	NFPA 72		2			Provide ADA exit signs for corresponding door use as egress	\$ 3,000	Bigelow Bldg.
E4	No Exterior emergency egress lighting and additional for interior	NEC			1		Add an emergency light fixture w/battery and test switch for each egress door	\$ 4,500	Bigelow Bldg.
E5	Power Receptacles (GFI, Tamperproof, original)	General	4				Replace original, provide GFI and Tamperproof power receptacles	\$ 8,400	Bigelow Bldg.

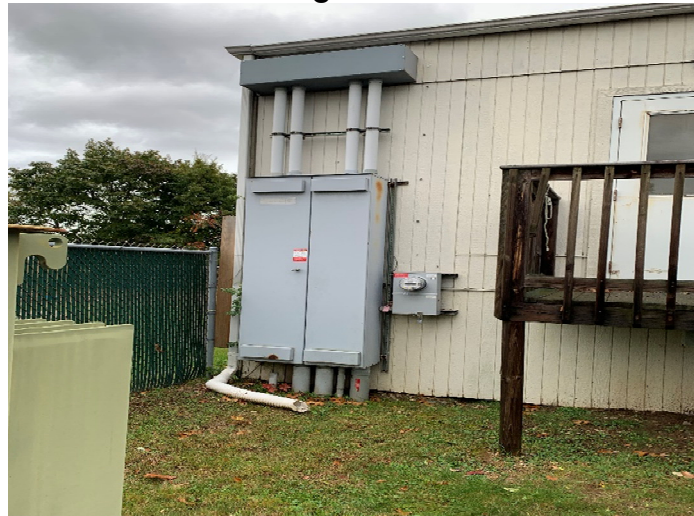
**Public Health Nursing Main Distribution Panel**

The Public Health Nursing Building electrical service consists of a main distribution panel rated for 800A, 120/208V -3 Phase, 4 wire with integrated current transformer compartment. The main distribution panel is located outside and mounted to the exterior east side wall of the building. The main distribution panel is fed from the utility pad-mounted transformer via underground secondary service. The distribution panel feeds multiple subpanels located throughout the facility. The Cuttler Hammer distribution panel appears to be original to the building and is in fair condition. However, the enclosure is starting to show signs of deterioration with some areas getting rusty. Panels throughout the facility are newer, in good condition, and manufactured by General Electric.

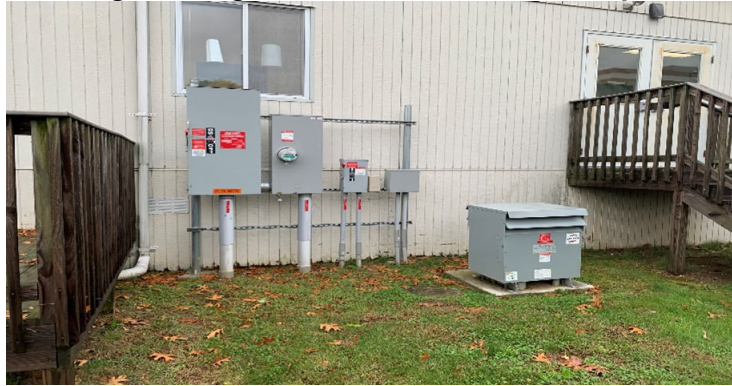
### **Nursing Building Photovoltaic Distribution System**

In addition to the electrical service for Public Health Nursing Building, the building is equipped with a photovoltaic system rated at 480V. Solar panels are installed in the parking lot and are interconnected with utility-interactive inverters that feed a 480V, 100A disconnect switch. The 100A disconnect feeds a 112.5KVA, 480/277V-208V step-down transformer that feeds a 208V, 400A service disconnect. Inverters are located in the parking lot and disconnects, and a stepdown transformer is located on the exterior wall at the east side of the building. The system appears to be installed recently and is in good condition.

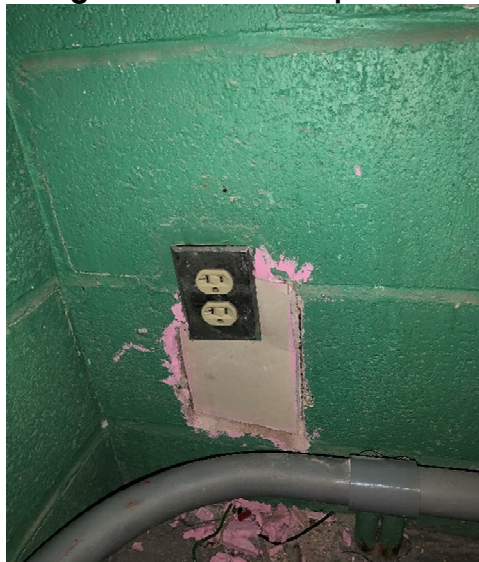
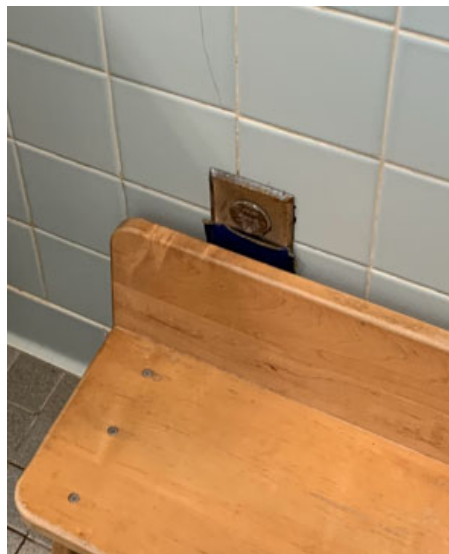
Power receptacles throughout the Bigelow facility consist of a combination of recessed and surface-mounted duplex receptacles with metal and nylon cover plates. It was observed that multiple receptacles were replaced, and additional were recently added to suit window air conditioning units and other equipment. Multiple power receptacles, without GFI (ground circuit interrupter) protection were observed in toilet and utility rooms. GFI power receptacles are required to be installed in potentially wet and utility areas such as toilets and utility rooms. Receptacle tamper-proof should be considered in daycare areas, offices, and corridors. The condition of the power receptacles throughout the facility varies from obsolete, fair, and good. The typical life expectancy of power receptacles is approximately 30 years. Based on observation, original power receptacles are presumed to be over the typical life expectancy and therefore, replacement of units should be considered in the near future. Power receptacles throughout The Public Health Nursing Building consist of recessed duplex receptacles with nylon cover plates. Power receptacles are newer and in good condition.

### **Bigelow Power Receptacle not GFI in Utility and Toilet Rooms**

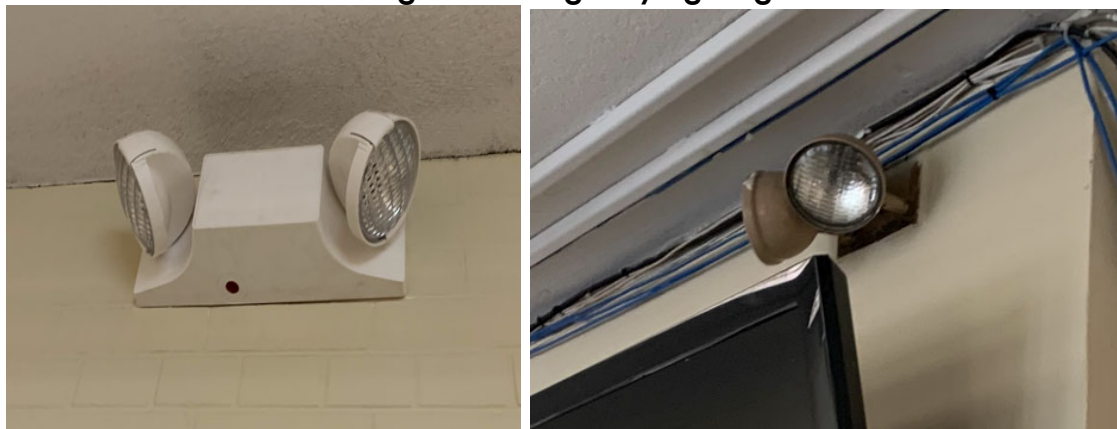
### **Bigelow Emergency Lighting**

The Bigelow emergency lighting system is based on self-contained twin head battery units throughout the paths of egress. The self-contained units appear to be in fair

condition however, multiple units appear to be obsolete and nearing the end of their useful life. Replacement of those units with LED units should be considered in the near future. Emergency lighting in the Gym appears to be mounted higher than recommended by the manufacturer. There is lacking emergency lighting in corridors and in classrooms with doors used as egress. No emergency lighting was observed at exterior of egress doors. The Public Health Nursing Building emergency lighting system is based on self-contained twin head battery units throughout the interior paths of egress and a single remote head at the exterior of each egress door and along the accessible ramps. The self-contained units and remote heads appear to be in fair condition and provided in sufficient numbers.

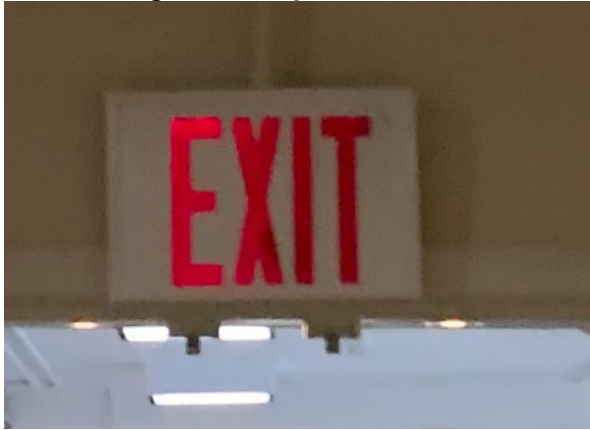
The Bigelow exit signs throughout are LED with a combination of thermoplastic and metal housing. The units appear to be in fair condition and installed in the required locations however, there were multiple units not fully illuminated and classrooms with egress doors without exit signs. There were no ADA / accessible exit signs at egress doors as required by code. Adding accessible signs should be considered to meet code updates. The Public Health Nursing Building's exit signs are LED with thermoplastic housing. The exit signs are in good condition and provided in sufficient numbers within common areas. Adding accessible signs should be considered to meet code updates.

**Exit Sign not Fully Illuminated**

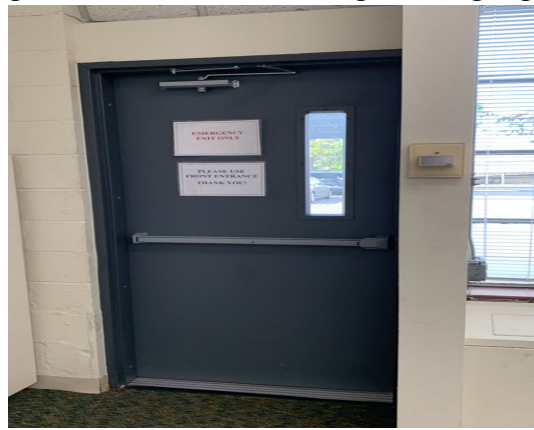
**Egress Door without Exit Sign & Emg. Lgt.**

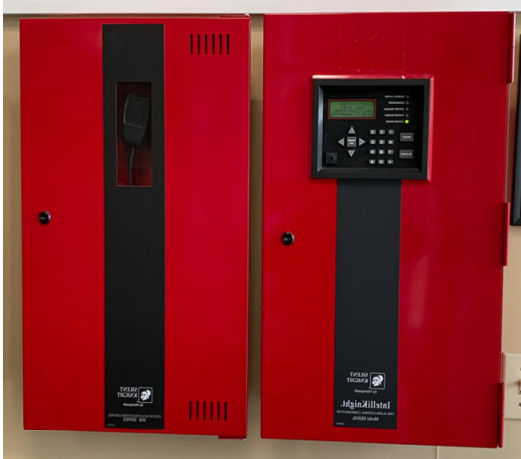
**Bigelow Fire Alarm Panel**

The Bigelow addressable fire alarm system is manufactured by Silent Knight. The system includes a fire alarm control panel, voice evacuation, ADA speaker/strobes, smoke detectors, heat detectors and pull stations. Peripheral units were installed in the required locations however, there were classrooms with egress doors without a pull station. The fire alarm system is relatively new, modern, and peripheral units are ADA compliant. The Public Health Nursing Building addressable fire alarm system is manufactured by Fire-Lite. The system includes a fire alarm control panel, remote annunciator panel, ADA speaker/strobes, smoke detectors, and pull stations. Peripheral units were installed in the required locations. The fire alarm system is relatively new, modern, and peripheral units are ADA compliant.
