H. SMITH RICHARDSON GOLF COURSE CLUBHOUSE
FEASIBILITY STUDY

Re: Report of Findings

H. Smith Richardson Golf Course
Clubhouse Renovation/ Expansion/ Replacement Feasibility Study
Fairfield, CT

Re: **Building Evaluation of the
Mechanical, Electrical, Plumbing and Life Safety Systems
Smith Richardson Golf Course Clubhouse
2425 Morehouse Highway
Fairfield, CT**

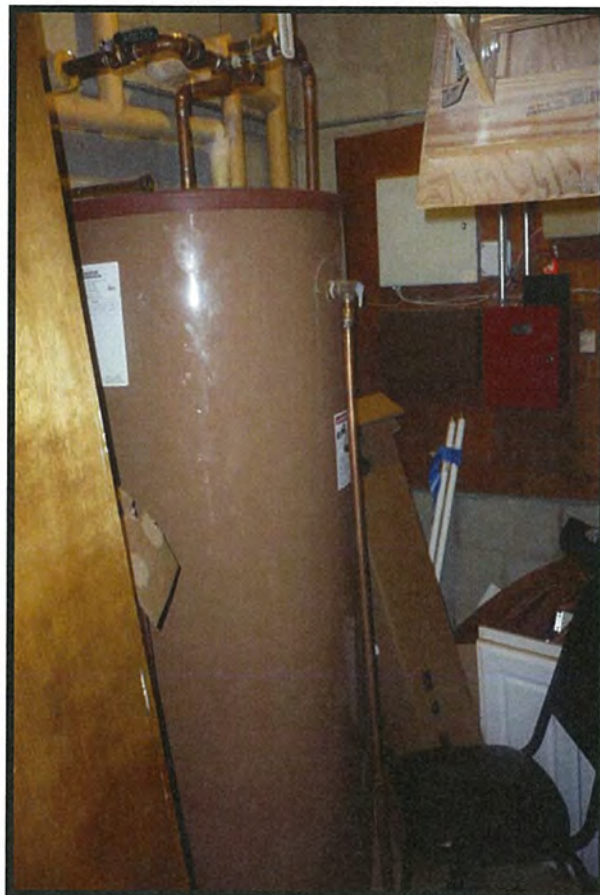
Photo #10: Domestic Hot Water Heater

There is a 1-1/2" domestic water main that enters the building in the corner of the main electrical room which supports the domestic water needs of the facility. Hot water is produced by one Hubbell, 120 gallon hot water heater model SE120-7.5-7.5 SLR (Photo #10). There are two heating 7.5 kW heating elements in the unit and the heater appears to have been replaced within the past 3-5 years. The men's and women's room bathrooms and locker rooms are located within the main building and are supported by these systems.

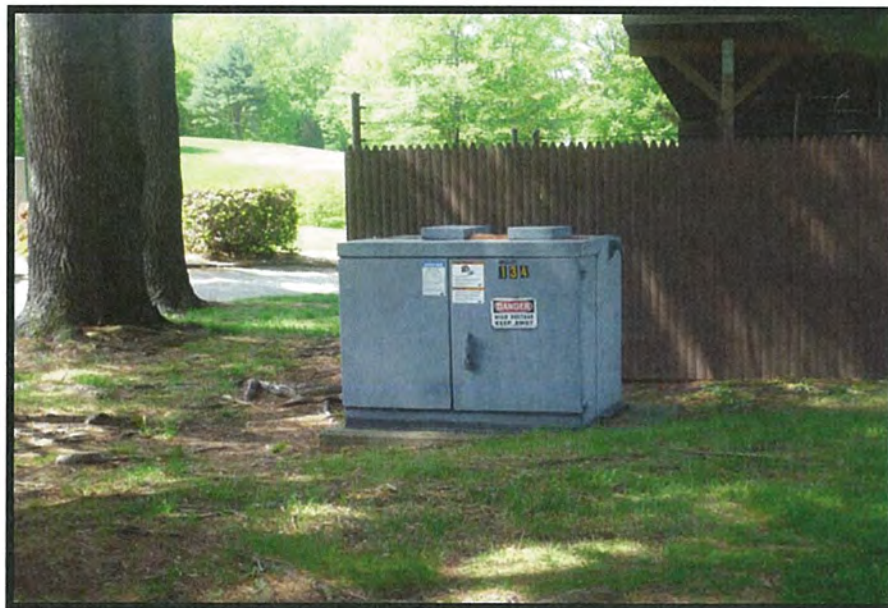
Photo #12: Utility Company Transformer

The primary high voltage electrical service enters the facility from overhead utility poles that are routed up the main entry driveway. A pad mounted utility transformer is located adjacent to the pump station which feeds an underground service to the main electrical room in the building (Photo #12). This information is based on our review of the original design drawings and will be verified with the local utility company provider, United Illuminating. Within the main electrical room there is a main switch and metering compartment that are rated at 600 amp, 120/208 volt, 3 phase, 4 wire (Photo #13). The main switch feeds distribution panel PP-1 which is also rated at 600 amps. The major panels and associated loads are as follows:

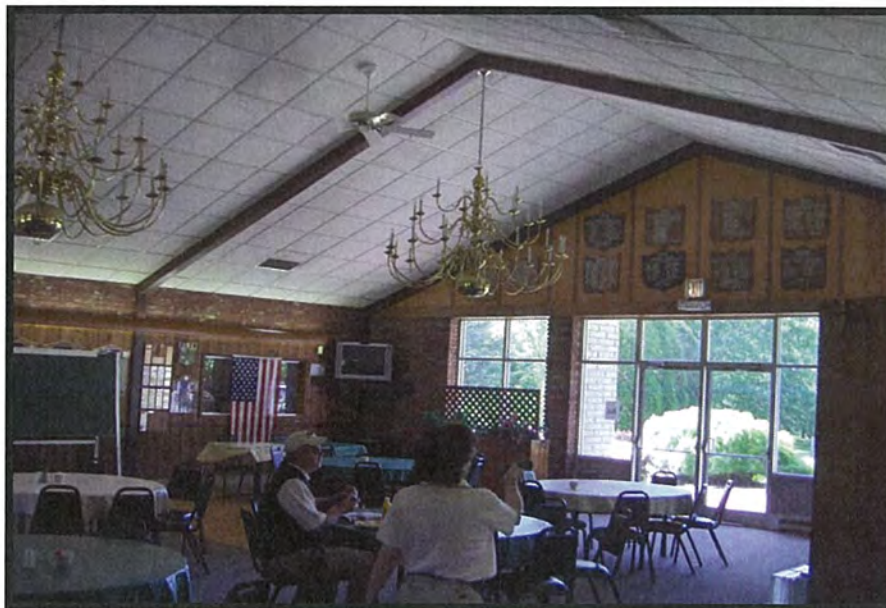
Photo #14: Dining Area Emergency Lighting

Emergency lighting throughout the building is provided by the use of battery pack twin head fixtures in selected areas. It appeared that most of the areas had coverage but the lounge/dining area required additional fixtures to meet current code (Photo #14). The exit signs throughout the facility appear to utilize integral battery back-up in the event of a power loss. All emergency lighting and exit signs will most likely also be upgraded with new energy efficient fixtures during any renovation of the facility.
