# Petoskey Slope Failure Study

Petoskey, Michigan

September 16, 2020 | 13269.601.R1.Rev0

## 13269.601.R1.Rev0

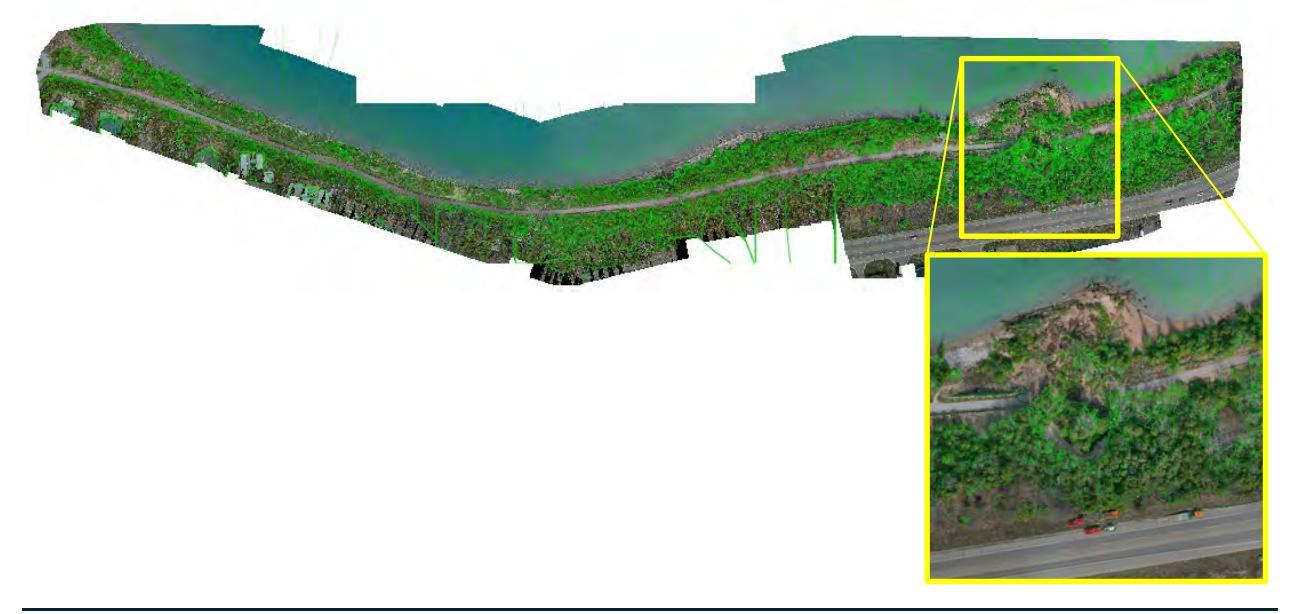
Figure 2.3: Site Topography (Baird, 4/22/2020)

An overview map with topographic contours (extracted from the UAV digital terrain model) is show in Figure 2.3. A series of profiles (comparing the various bluff topography data sets) is show in Figure 2.4 and Figure 2.6. The comparison of topographic data (i.e. 2012 – 2020) portrays the extent of the recent coastal bluff collapse, as well as minor sloughing failures.

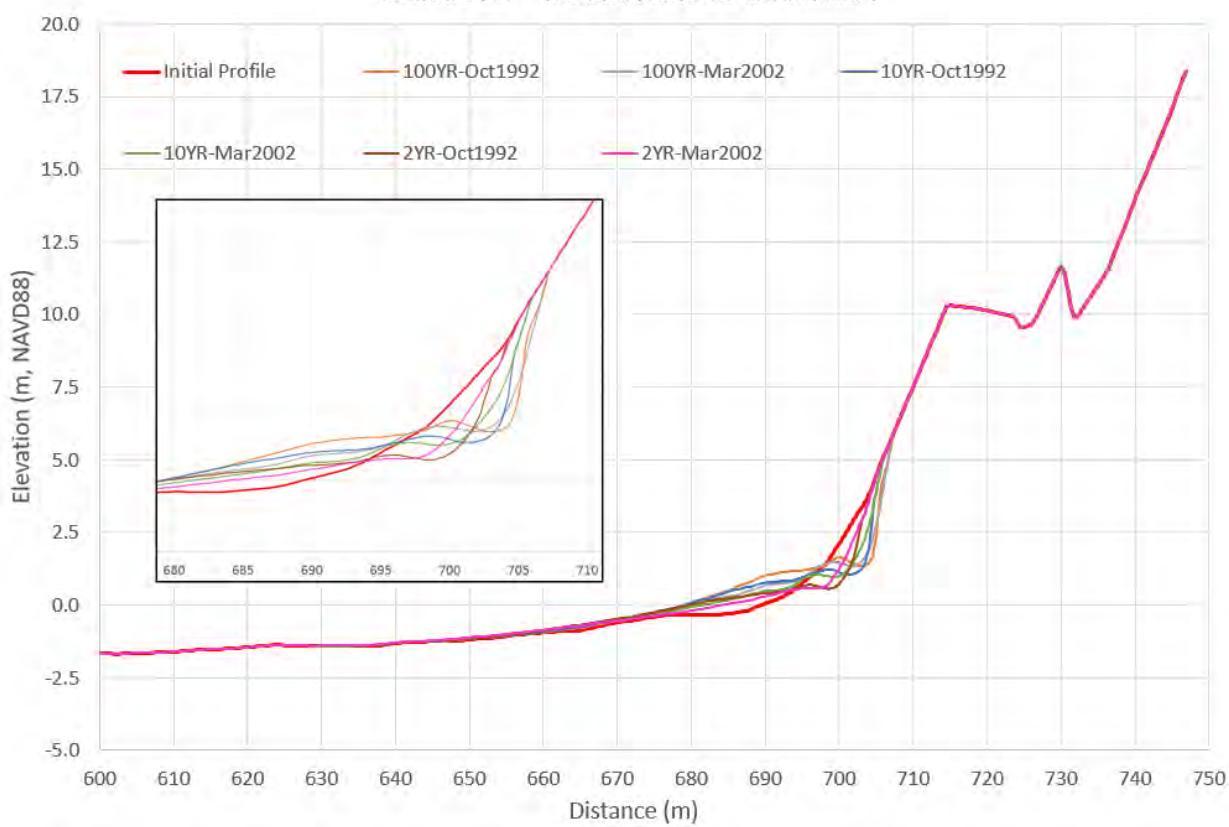
Figure 4.3: Predicted Toe Erosion for Nine different Scenarios (a close up of the toe area is shown in the inset figure)

Predicted toe erosion for all cases are summarized in Figure 4.3. COSMOS predicted up to 6 m (~20 ft) of toe erosion (or recession) under the 100-year lake level in combination with the October 1992 storm, which is the least likely modeled event based on return period. COSMOS also predicted up to 4 m (~13 ft) of toe erosion under the 2-year lake level in combination with the March 2020 storm. It should be noted that COSMOS assumes the lakebed material is non-erodible substrate (i.e. cobble and stone) and the material at the toe of the bluff is sand material with no cohesion. These results will be considered in slope stability analysis discussed in the next section.

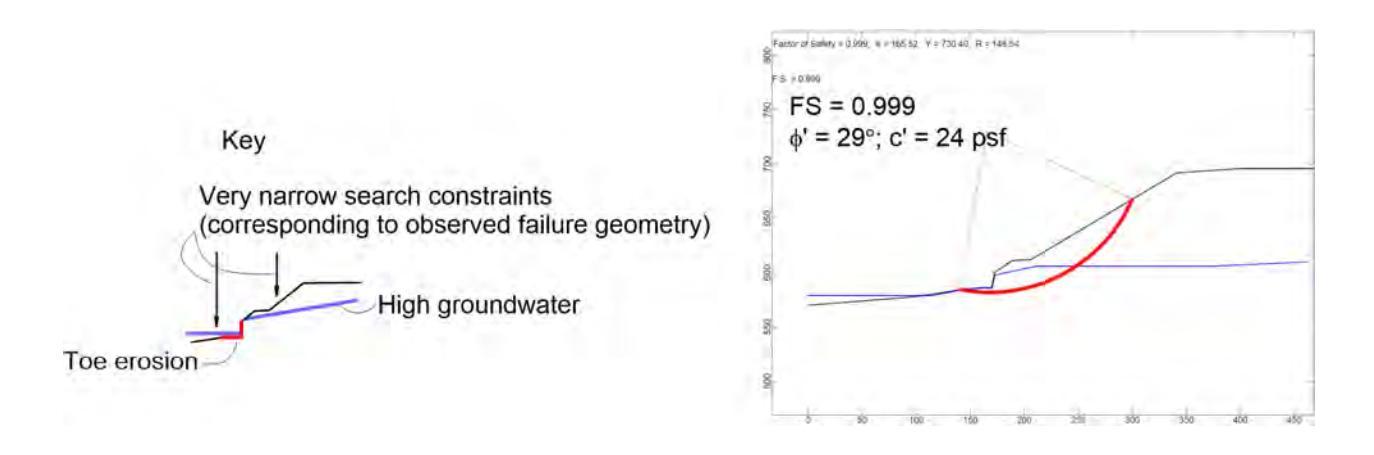
Using the April 2020 deep-seated failure surface as a guide (observed/measured failure geometry, current lake levels, etc.), OHM calibrated the soil strength parameters for use in the deep-seated slope stability analyses. It should be noted that this overall analysis also required judgements in terms of actual soil properties and parameters, and groundwater levels within the slope to define that surface which was believed to be present at the time of the failure.

erosion is consistent with the erosion modeling described earlier in this report. We note that this particular parameter (toe erosion) was not directly observed by anyone leading up to the failure, and it represents an assumed condition-yet one that is probable at the time of the failure. We then assumed groundwater conditions based on MDOT's recent monitoring well readings in this area of the bluff. This parameter, too, is assumed on some level as the groundwater elevations recorded in July by MDOT may not be entirely representative of the groundwater conditions at the time of the failure in April 2020. A moist unit weight,  $\gamma$ , of 108 pcf; a saturated unit weight,  $\gamma$ sat, of 120 pcf; a friction angle,  $\phi$ ', of 29 degrees; and a cohesion intercept, c', of 24 psf were used in subsequent analyses of potential deep seated failures for three representative profiles along the section of interest in this study. The profile locations are shown in Figure 4.7.

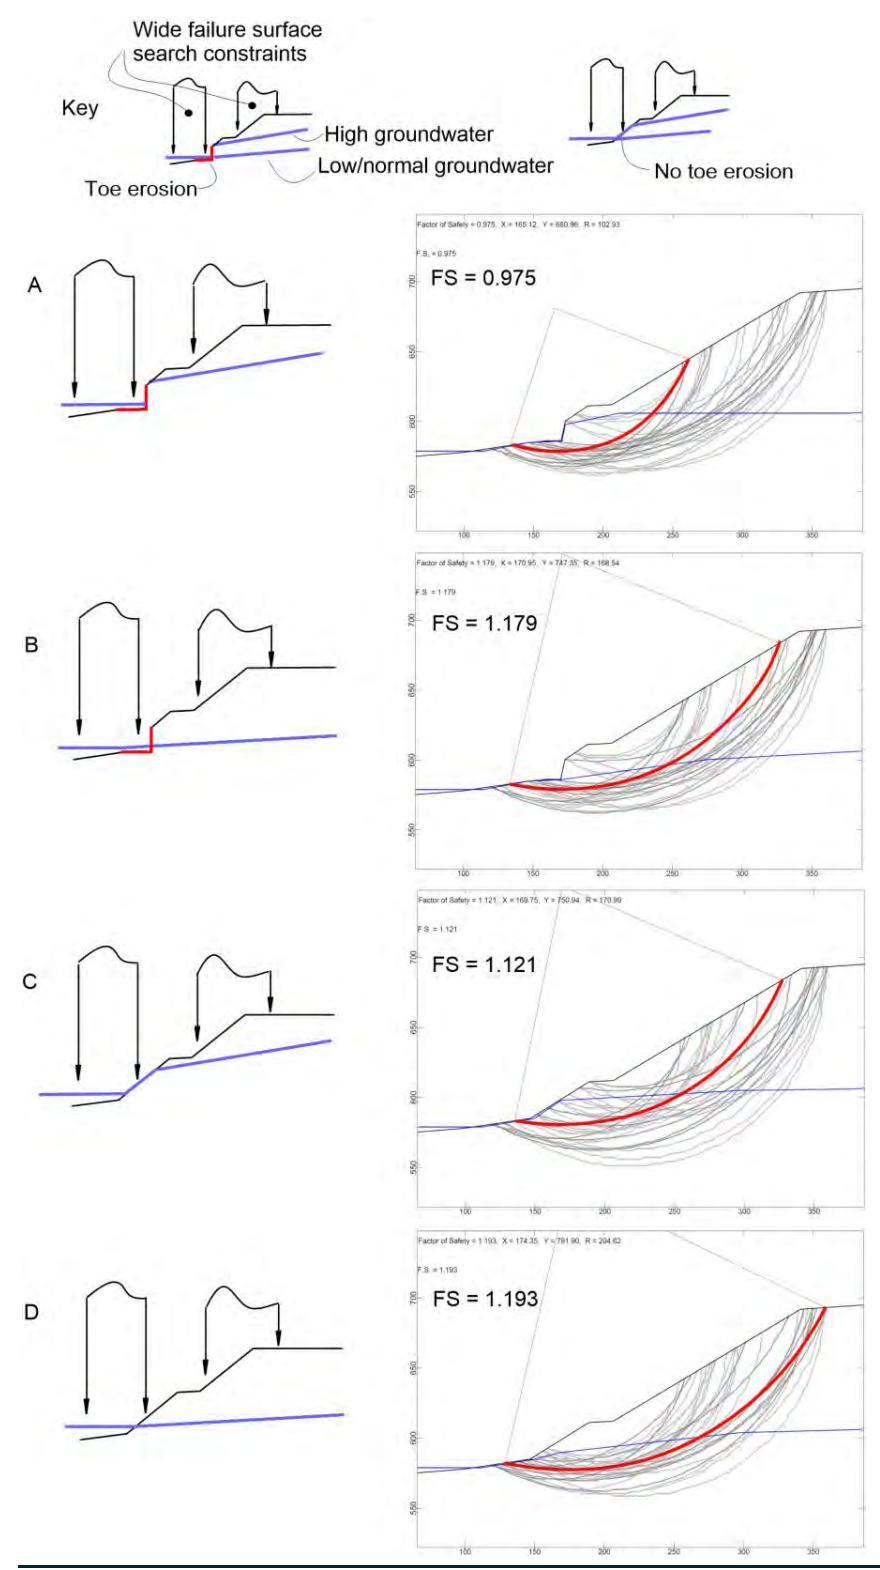
Figure 4.8: Profile 1 Slope Stability Analysis

Figure 4.8 (A) includes the Profile 1 slope geometry with an elevated groundwater level consistent with a wet season (i.e. during the spring or sometime shorter after, depending on lag time related to groundwater appearance, etc.). Toe erosion is included in this trial as well. In essence, this particular trial is intended to model the slope under rather extreme conditions to observe the FOS under these conditions. The FOS was 0.975; below unity, or the failure conditions (FOS=1).

Figure 4.8 (B) had similar conditions to that of Figure 4.8 (A), except that the ground water elevation was lowered. The FOS with this reduction in ground water elevation was 1.179; approximately 20% improvement in FOS from the analysis in Figure 4.8 (A).

Figure 4.8 (C) included the higher groundwater table, but without the 20 feet of toe erosion. From this trial, we see the FOS decreases to 1.121, yet still an approximate 15% improvement over the conditions in Figure 4.8 (A).

Figure 4.8 (D) did not include toe erosion, and the groundwater table was lowered. These conditions represent the most favorable in terms of slope stability. The FOS in this case was 1.193; about 22% greater than the condition in Figure 4.8 (A) where there was toe erosion combined with a high groundwater table.

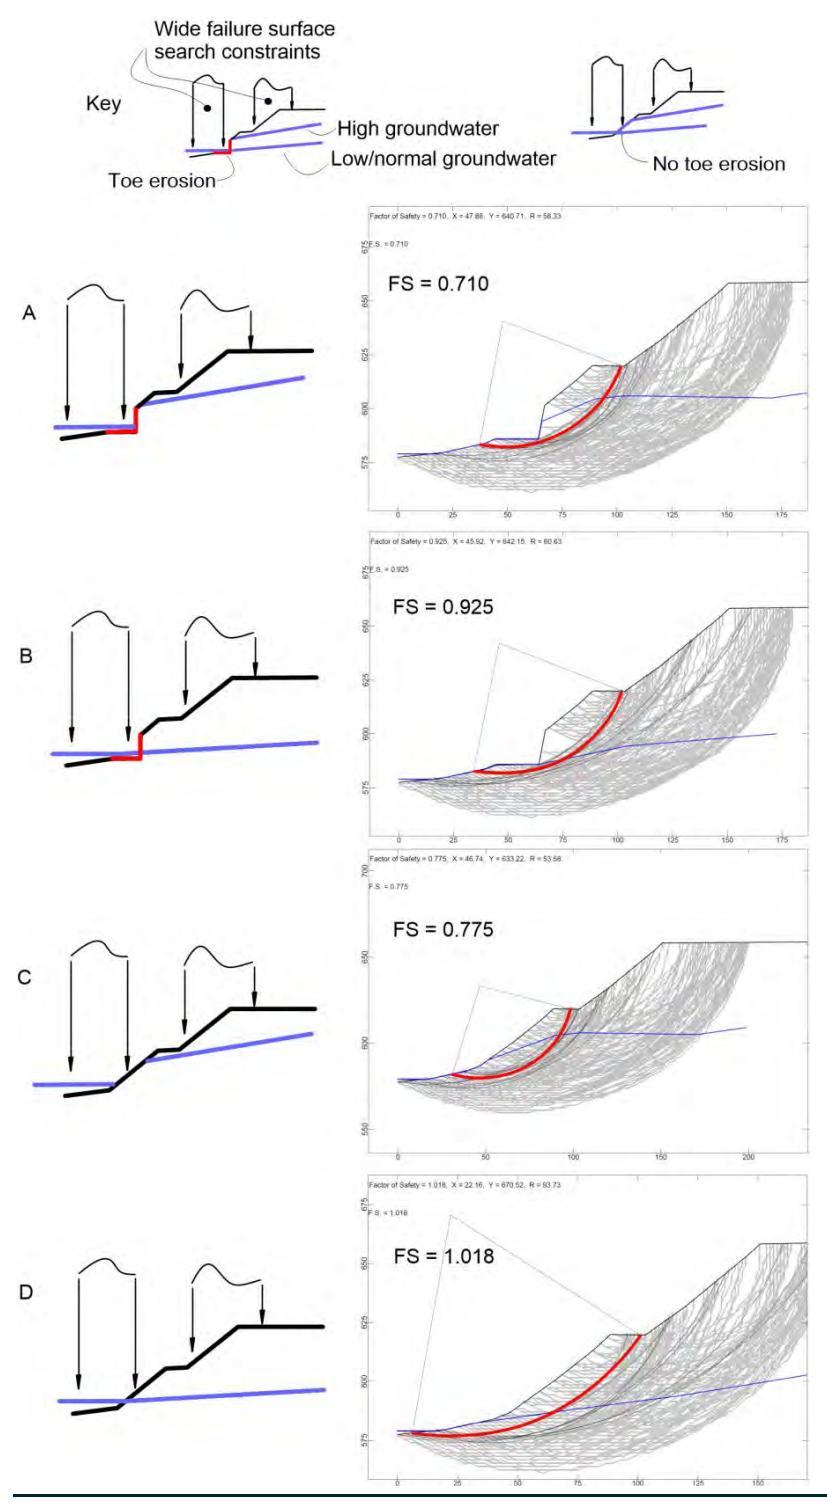
Figure 4.9: Profile 2 Slope Stability Analysis

We performed a similar suite of slope stability analyses on a different profile (Profile 2) as shown in Figure 4.9 (A through D).

Using the same soil parameters, groundwater condition, and toe erosion assumptions, this location also appeared to be relatively unstable. We note that even though many of the following factors of safety results indicate failure, this may or may not exactly match the observed condition of the slope. There is a possibility that the parameters, toe erosion, and/or groundwater conditions are different at that site. The main idea of this exercise is to take the same parameters and conditions and apply them to a slightly different slope profile geometry to observe the results.

In this case, the effects of the toe erosion individually, holding the groundwater constant (i.e. comparing Figure 4.9 (A with C) and Figure 4.9 (B with C)) yields a difference of about 10%. The effects of examining groundwater individually (i.e. comparing Figure 4.9 (A with B) and Figure 4.9 (C with D)) suggests a variation of around 30%. Once again, both of these contributing factors are important when considering the stability of a slope.

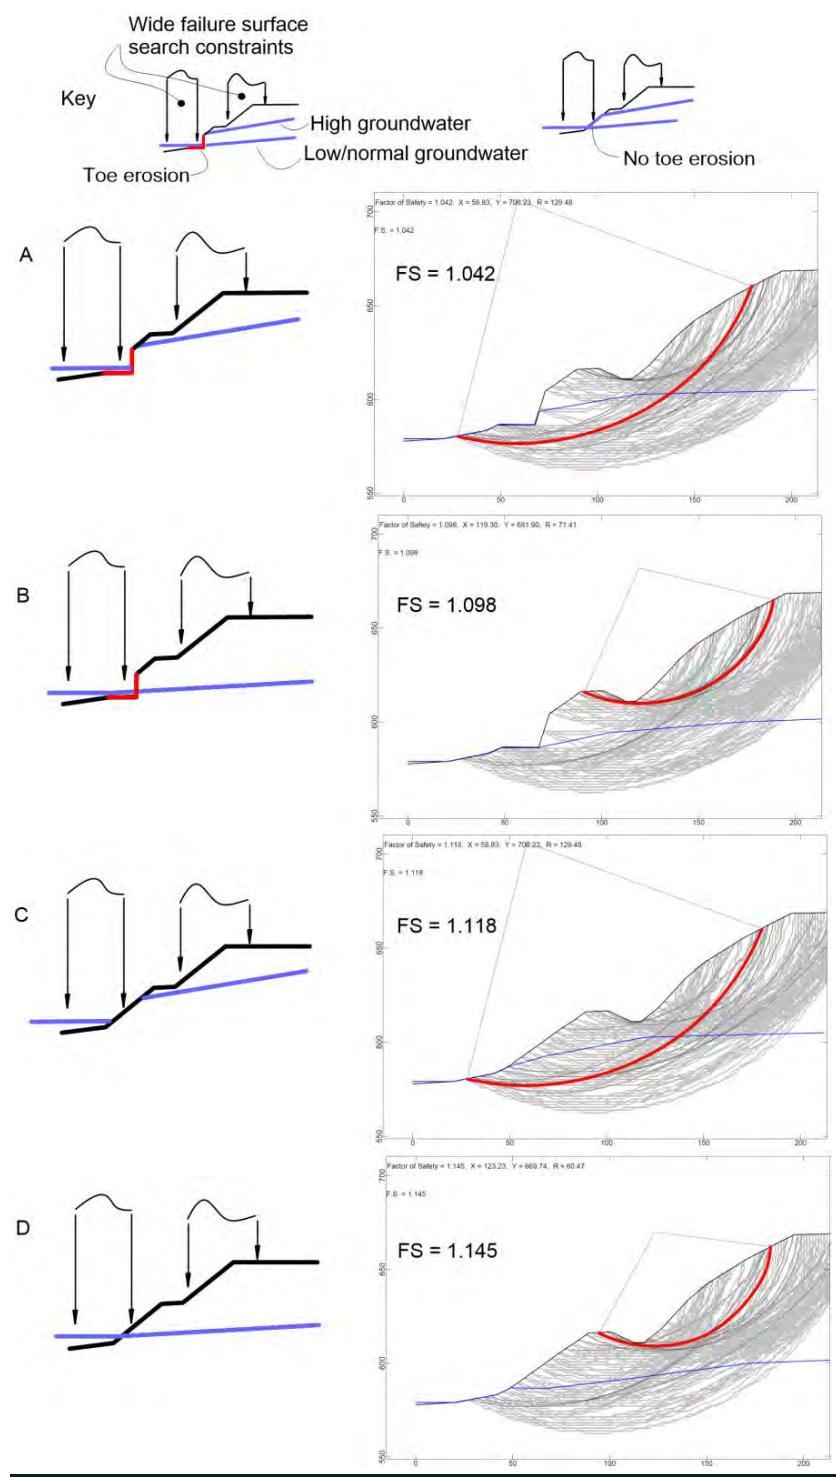
Figure 4.10: Profile 3 Slope Stability Analysis

Finally, we examined Profile 3 in a similar way (see Figure 4.10 A through D).

This profile was rather unique in that it featured a rather prominent swale on the roadside of the existing trail. It is important to note that the critical failure surface (shown in red) was found to be on the upper part of the slope, likely due to the geometry and steepness of the ground in that area (see Figure 4.10 (B) and (D)). Figure 4.10 (A) and (C), on the other hand, exhibited a deeper-seated failure surface, extending from near the crest of the bluff to the beach area. This is a reminder that localized deep-seated failures should be considered along with the failures extending throughout the bluff face.

A comparison between Figure 4.10 (A) and Figure 4.10 (C), along with Figure 4.10 (B) and Figure 4.10 (D), to examine the effect of toe erosion only, suggested a difference between 4 and 7%. A comparison between Figure 4.10 (A) and Figure 4.10 (B), and Figure 4.10 (C) with Figure 4.10 (D), showed a difference between 2 and 5%. Interestingly, for this particular slope geometry, the toe erosion played a greater role than the groundwater elevation, although both features led to measurable differences in the stability of the slope.

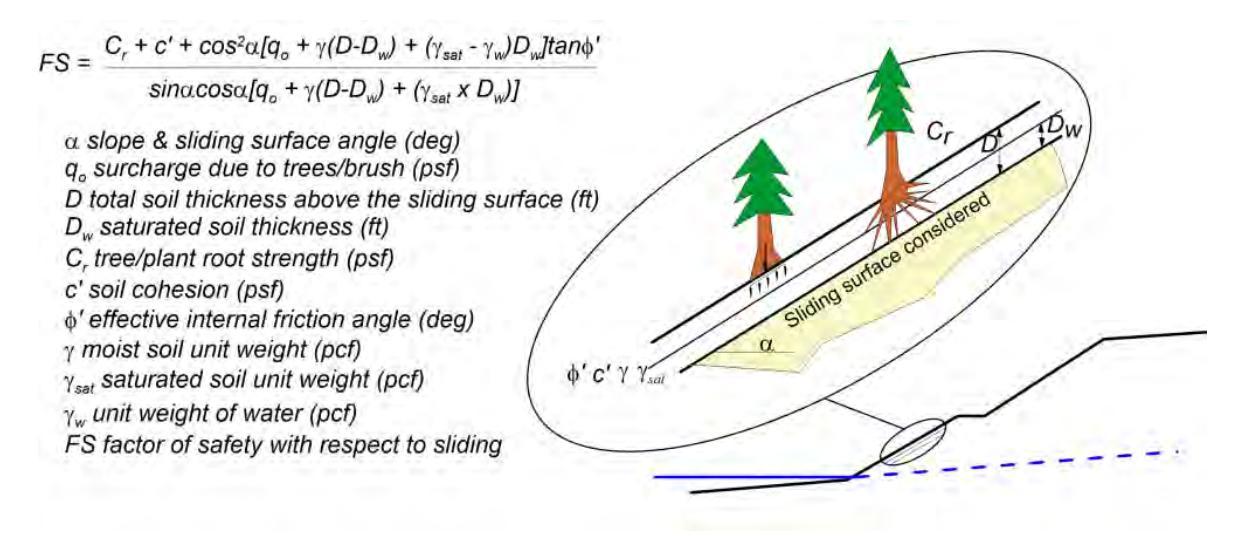
#### Figure 4.12: US Forest Service Infinite Slope Equation and Schematic

some amount of toe erosion (perhaps near the beach due to wave action), that slice of soil would lose some of its ability to maintain equilibrium. The question that then comes in is whether the friction of the soil along the potential shearing plane has enough strength to stay in place. The plant/tree root "cohesion" contribution also becomes important, among other parameters. Figure 4.12 shows a depiction of the US Forest Service approach for reference.

In reviewing existing literature on the subject, a reasonable  $C_r$  has been found to be on the order of 100 psf added to the contribution due to friction. We considered this strength contribution, along with a reduced root cohesion parameter of 50 psf to investigate the general effects on the FOS with respect to sliding.
