CONDITION SURVEY REPORT & REPAIR RECOMMENDATIONS

PHOENIX PLAZA & PARKING GARAGE Pontiac, MI

Submitted by: DESMAN Associates May 2012

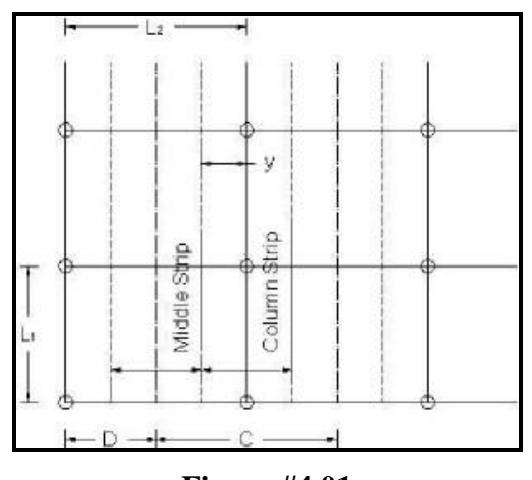
evaluation. The top surface of the Plaza was not observed due to the overburden. A majority of the top surface deterioration occurred around columns and at column strips and a majority of the bottom surface (soffit) deterioration occurred near the midspan of the middle strip – see **Figure #4.01** for the location of a column strip and middle strip in a two-way flat slab system. The location of the deterioration is primarily due

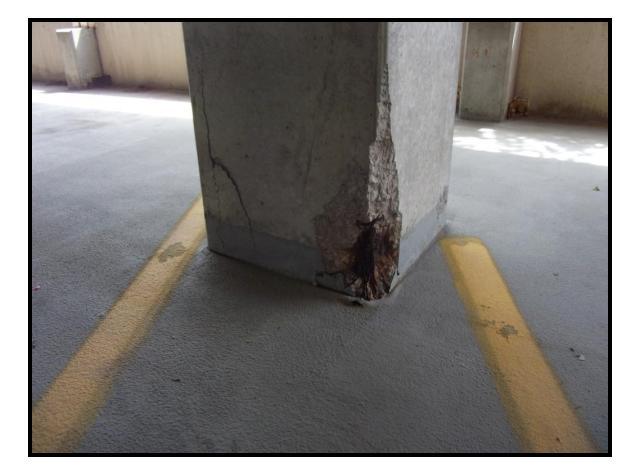
spalling were observed on both the columns and walls. The deterioration is believed to be due to corrosion of the mild reinforcing steel as a result of exposure to chloride-laden moisture. The column deterioration was primarily located at the base, or near the drive surface – see **Photo #4.05**. The concrete at this location is in a "splash zone" and, therefore, is exposed to higher chloride concentrations.
