OSWEGO CANAL CORRIDOR BOA

APPENDIX L: FORMER CYCLOTHERM SITE STRUCTURAL ASSESSMENT

**Former Cyclotherm Site
Retaining Structures/Wall
Condition Inspection and Structural Assessment**

**Prepared for:
Bergmann Associates
March 23, 2017**

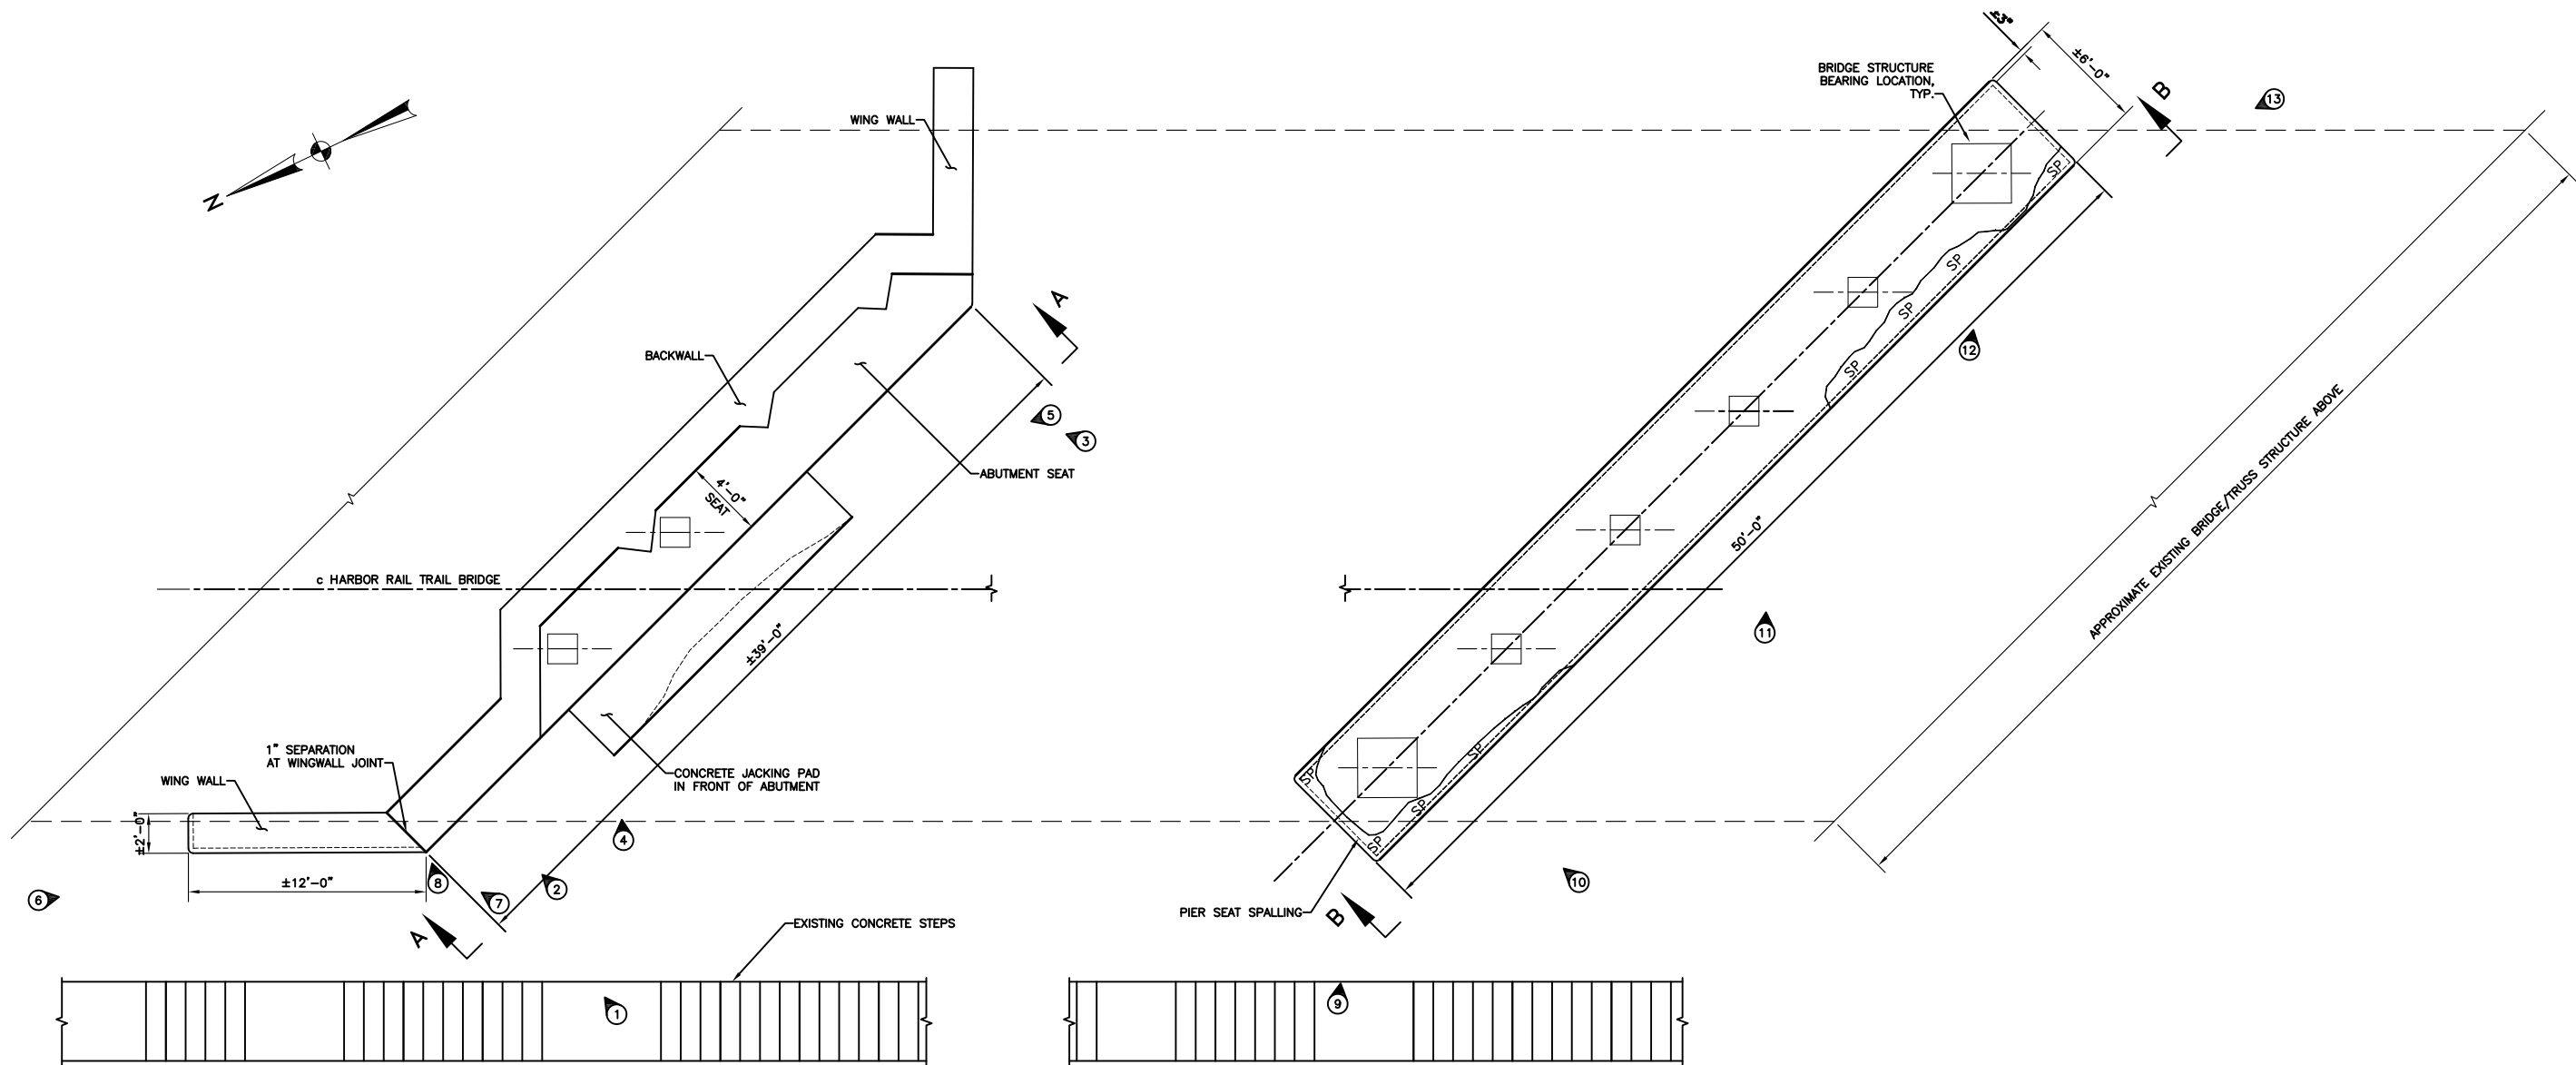
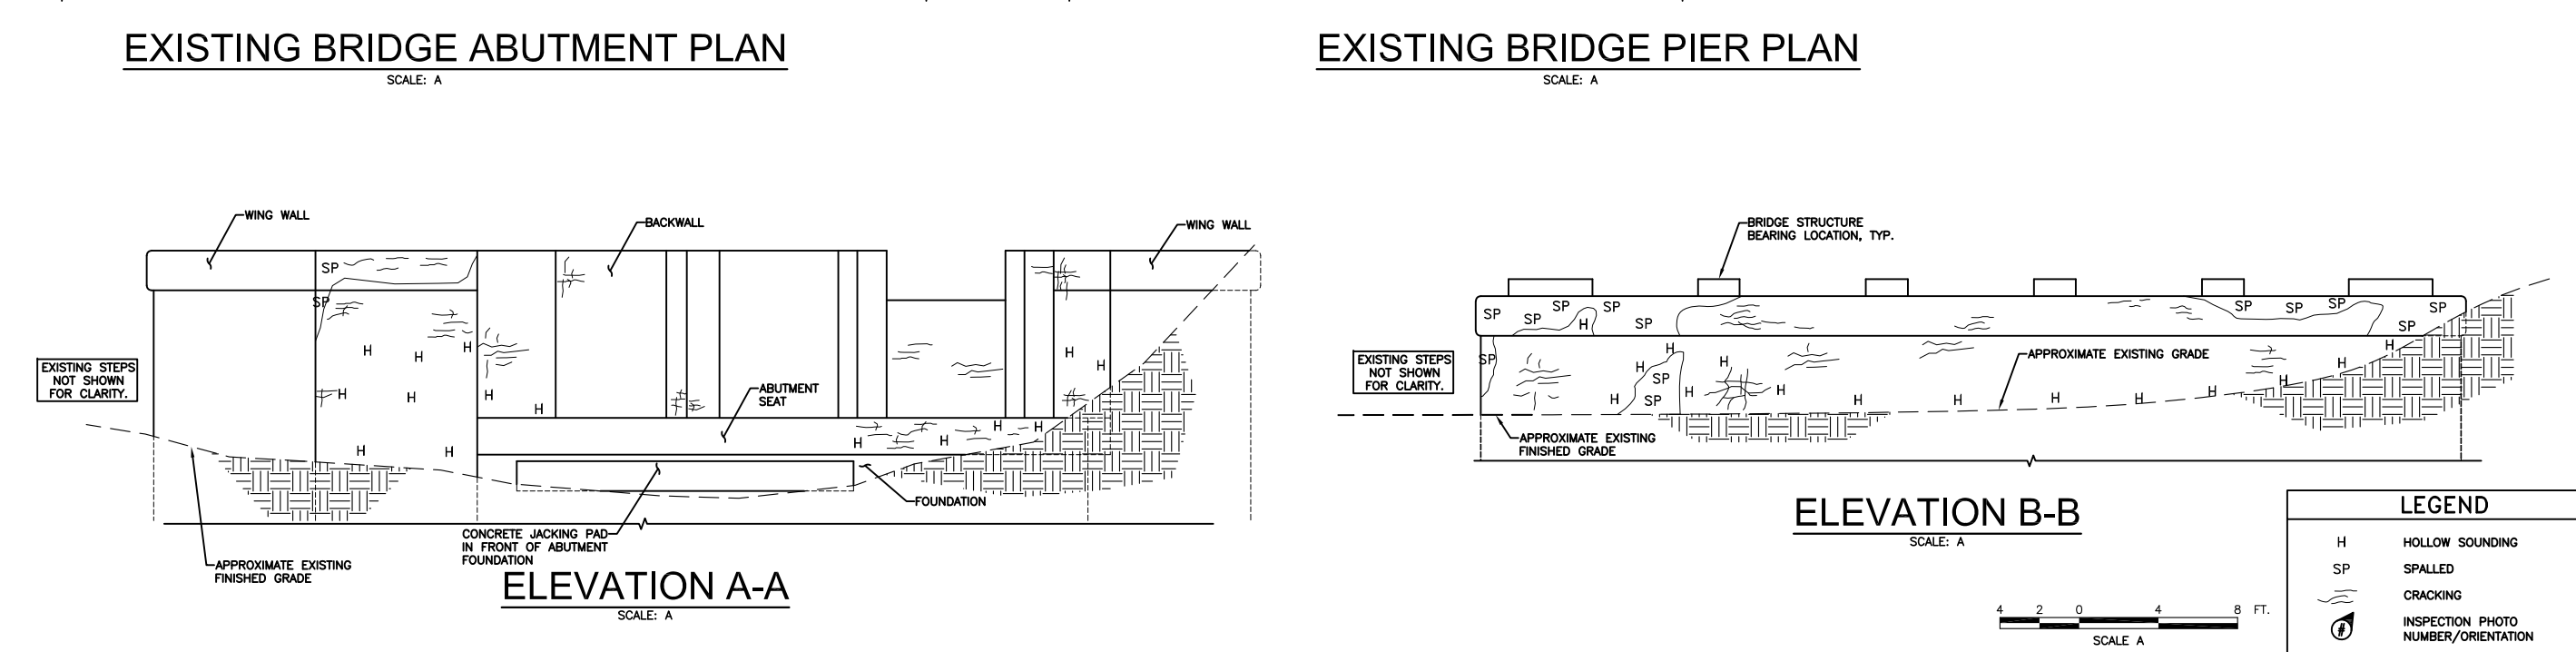
PROJECT NO: 40-16-175
DATE: MARCH 2017
DRAWING NO: SK-1
SCALE: AS NOTED

The abutment appears to be a conventional concrete gravity structure. The footings are entirely below grade and the foundation type is unknown. The abutment measures 39' wide and the north wing wall is 12' long. The south wing wall extends below grade and its length is unknown.

The concrete is in fair structural condition, especially considering its age. There is widespread minor cracking, surface spalling, and hollow-sounding areas affecting approximately 50% of

At the north side of the abutment, the wing wall construction joint is separated up to 1" at the top of the wall. This appears to be indicative of minor settlement of the wing wall foundation, which may have occurred due to normal settlement shortly after construction. The wall appears stable.

The concrete pier is 50' long x 6' wide. The pier is located at the bottom of the steep embankment slope. The west face is exposed up to 6' vertically, but the east face is almost completely buried with embankment material spilling onto the top of the pier. The footings are entirely below grade and the foundation type is unknown.

The concrete is in fair to poor condition. There is widespread cracking, spalling, and hollow-sounding areas affecting approximately 70% of the exposed surfaces. The top corner of the seat is spalled 2" to 6" deep along the north end and most of the west side. The concrete remains solid beneath the superstructure bearings, and there is no structural cracking or distress.

3. It is recommended that the concrete surfaces be cleaned and concrete spalls be properly repaired. Following the concrete repair the application of a penetrating concrete sealer to reduce absorption is recommended as a preventative maintenance measure.
