OSWEGO CANAL CORRIDOR BOA

APPENDIX N: WESTSIDE COAL PIER STRUCTURAL ASSESSMENT

**Westside Coal Pier
Condition Inspection and Structural Assessment**

**Prepared for:
Bergmann Associates
March 23, 2017
(Revised May 26, 2017)**

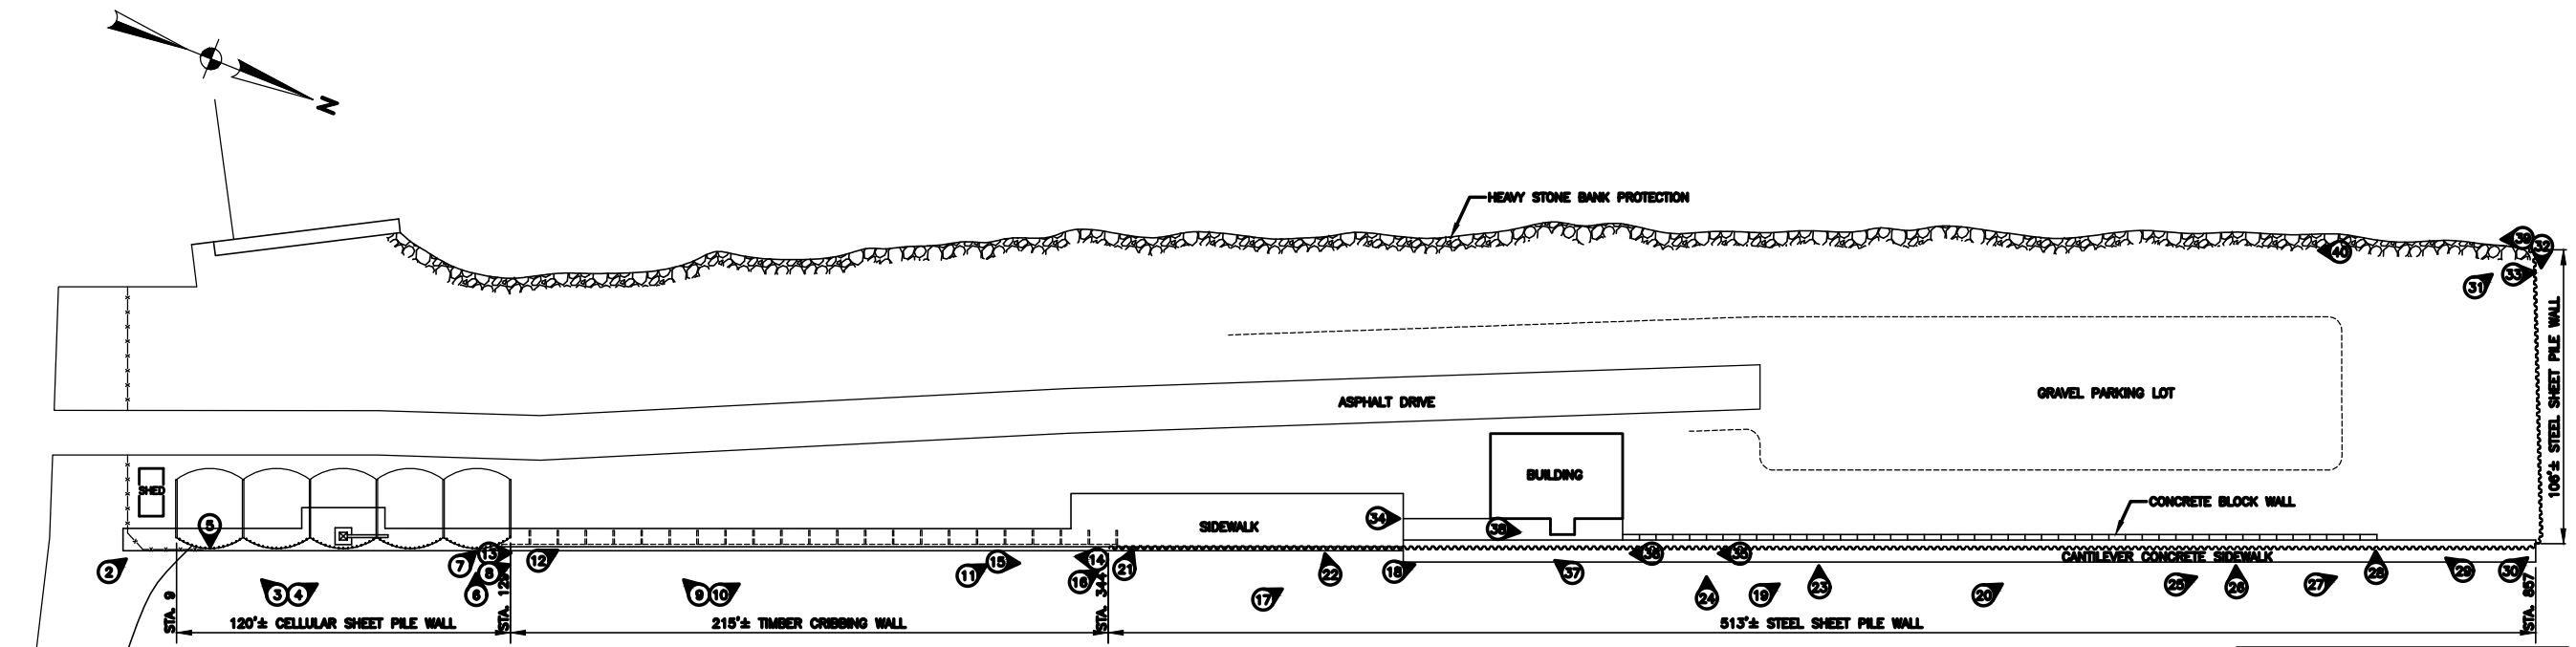
A steel sheet pile wall extends from STA 344 to 857, and the sheeting continues approximately 110' across the north end of the pier (Photos 16 through 20). The wall height is approximately 21' to 25' above the harbor bottom, the water depth is approximately 14' to 17', and the pile embedment depth is unknown. This portion of the wall consists of 16" wide x 5" deep x 3/8" thick U-shaped sheet piles (PDA27 or similar), and most likely dates from the 1930s (Photo 33). The top of the sheets are anchored to a horizontal waler and tie-backs behind the sheeting. The piles are severely corroded with large rust holes near the water level. Overall pile section loss varies and is estimated in the range of 60% to 90% (Photos 21 and 23). Probing through several holes with a survey rod, timber could be felt about 1' to 2' behind the sheeting. The sheeting appears to have been placed immediately in front of an older timber wall. The timber wall remnants appear to be limiting the loss of backfill through the holes in the steel sheeting, but settlement of sidewalk slabs behind the wall suggests that active erosion is occurring as wave action constantly flushes water in and out of the holes (Photo 38).

Based on observations above the water level, the current safety and stability of portions of the pier wall is questionable. The old timber wall from STA 129 to 344 has large areas of severe misalignment and settlement which suggest that failures may have already occurred below water.

The steel sheet pile retaining walls are approximately 70 to 80 years old. From STA 344 to 857 and continuing along the north end, the sheeting is severely corroded with large holes near the water level. The tied-back wall configuration relies on the flexural strength of the sheet piles, which have been compromised by section loss in the high stress region near the water level. The weight of the concrete walkway and the wood deck at the yacht club building also induce axial stress on the sheet piles. Considering the severity of section loss without serious deformation of the sheet pile wall, it is suspected that remnants of the original timber cribbing behind the wall may be resisting a substantial portion of the lateral earth pressure on the wall.

1. Prior to any future construction or redevelopment on the coal pier replacement of the existing retaining wall systems is strongly recommended. This can be accomplished by increasing the width and length of the pier as shown in the sketch SK-2, included at the

6. The tied-back sheet pile wall appears to be at the end of its service life and should be programmed for replacement.

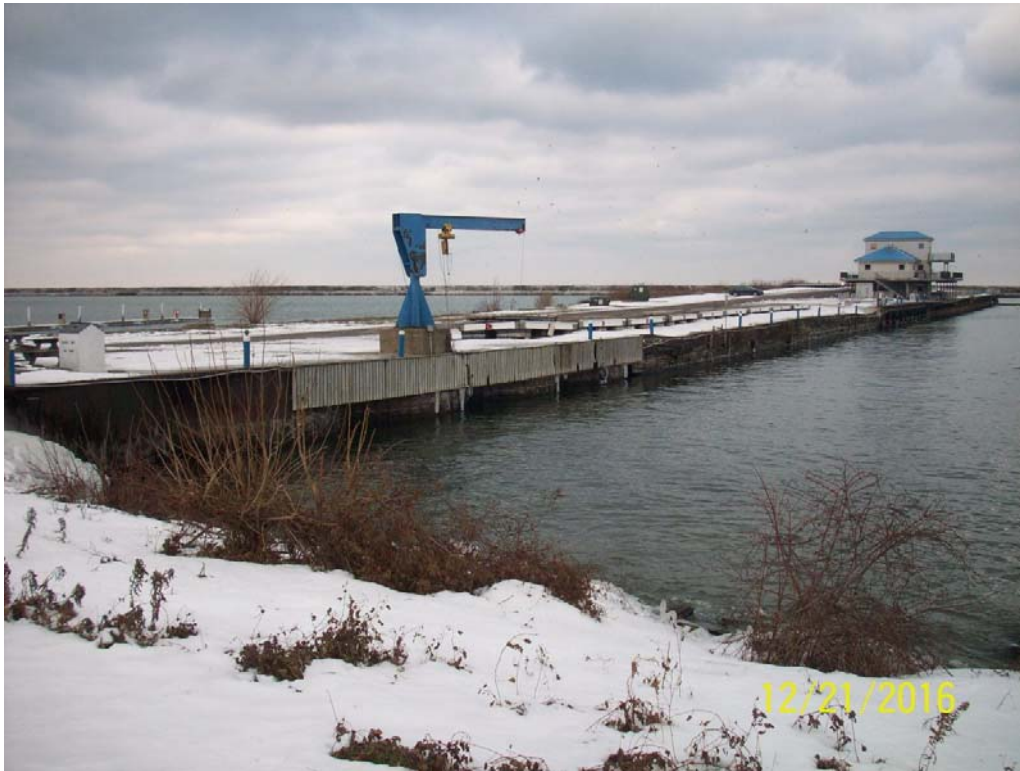
Photo 1 – East side of pier, looking northwest from shore
