# REMEDIAL ACTION REPORT PCB-Contaminated Fill Pile

### Town Reclamation Yard 183 Richard White Way Fairfield, Connecticut

Logical Environmental Solutions, LLC 354 South River Road Tolland, Connecticut

December 5, 2017

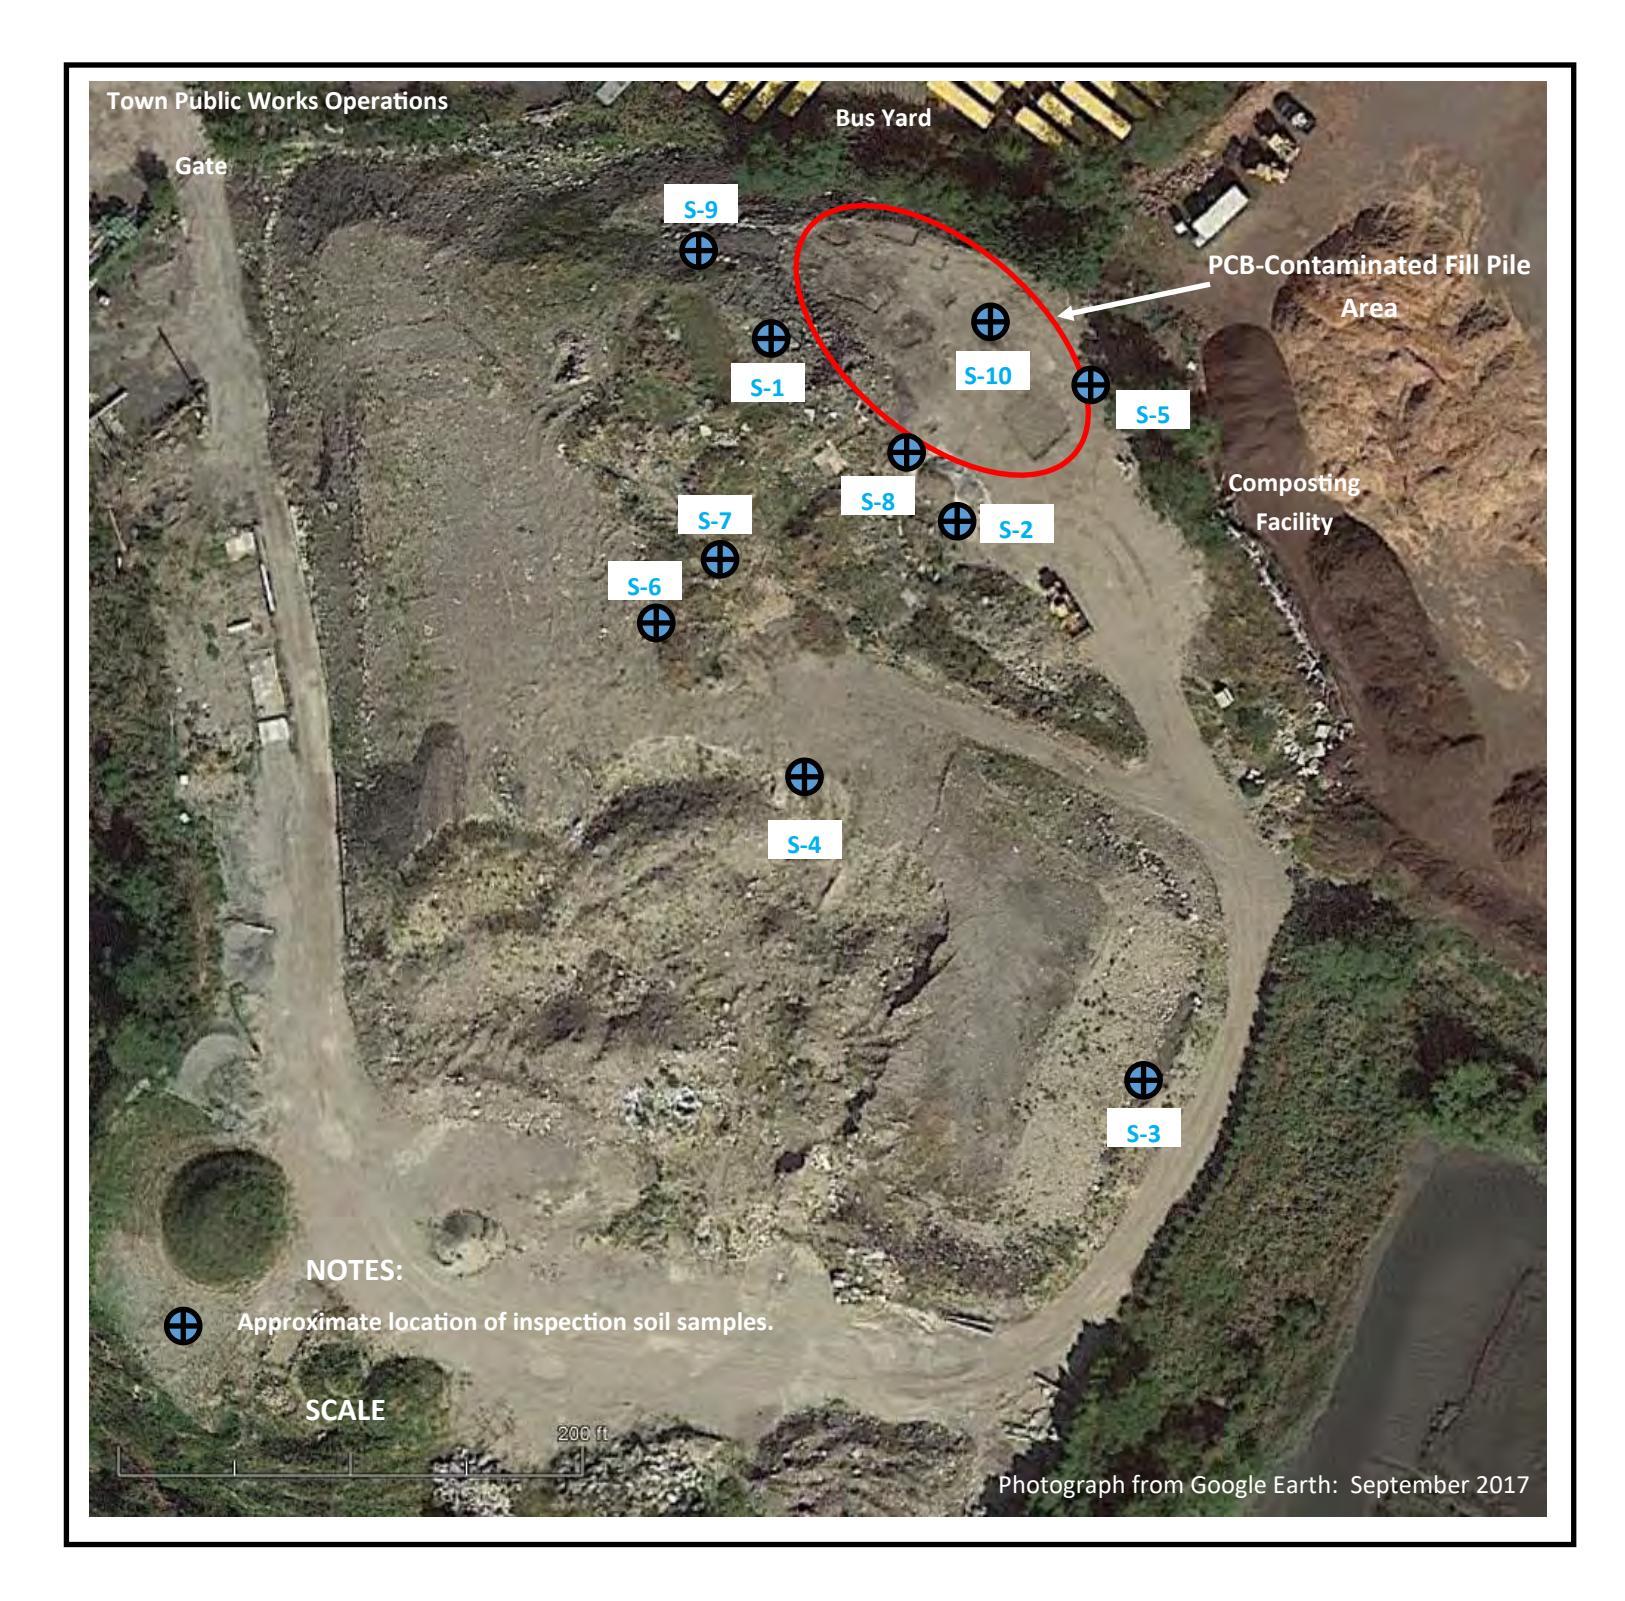
### **INSEPCTION SAMPLE LOCATIONS (Approximate)**

September 29 to November 29, 2016 Town of Fairfield - Reclamation Yard 183 Richard White Way Fairfield, Connecticut

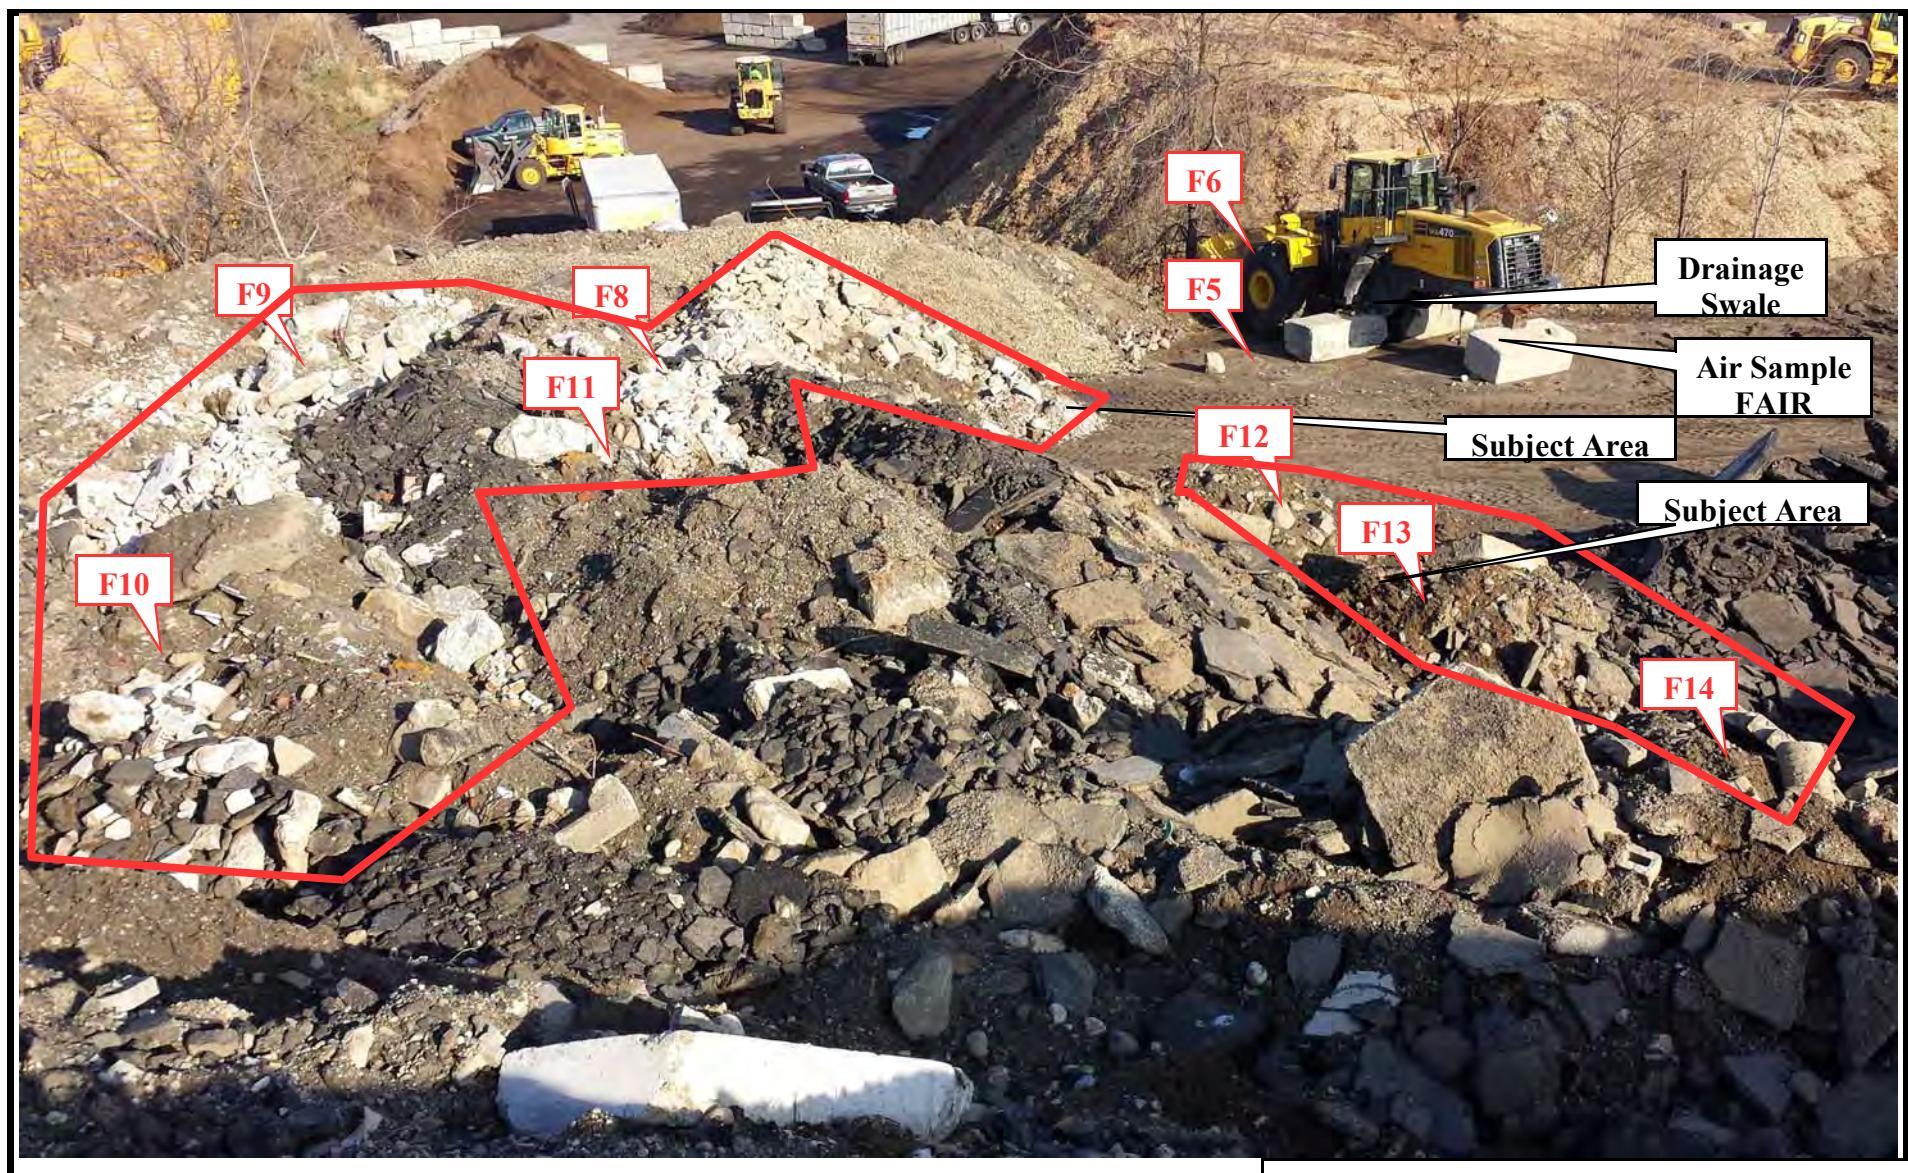
*Osprey Environmental Engineering, LLC 146 East Main Street, Clinton, Connecticut* **Soil Sampling Locations – Sheet 1**

Fairfield Aggregate Recycling Yard183 Richard White Way, Fairfield, CTDate: December 2016Scale: NTS

In summary, the results of Osprey's investigation indicated that PCBs were detected in three samples collected from the eastern portion of the pile at concentrations that included 0.38 mg/kg, 0.69 mg/kg, and 13.4 mg/kg. Leachable lead was detected at slightly elevated concentrations ranging from 0.023 mg/L to 2.2 mg/L, but were not detected at a concentration exceeding the RCRA hazardous waste concentration of 5.0 mg/L. Total lead (450 mg/kg) and arsenic (11 mg/kg) were detected in one soil and one sediment sample at slightly elevated concentrations. The soil and sediment samples also contained elevated concentrations of PAHs and petroleum hydrocarbons which were attributed to the presence of asphalt. Appendix A contains Tables 6 to 9 that summarize the results of the sample analyses, as well as a figure depicting Osprey's sample locations (F-1 to F-14).

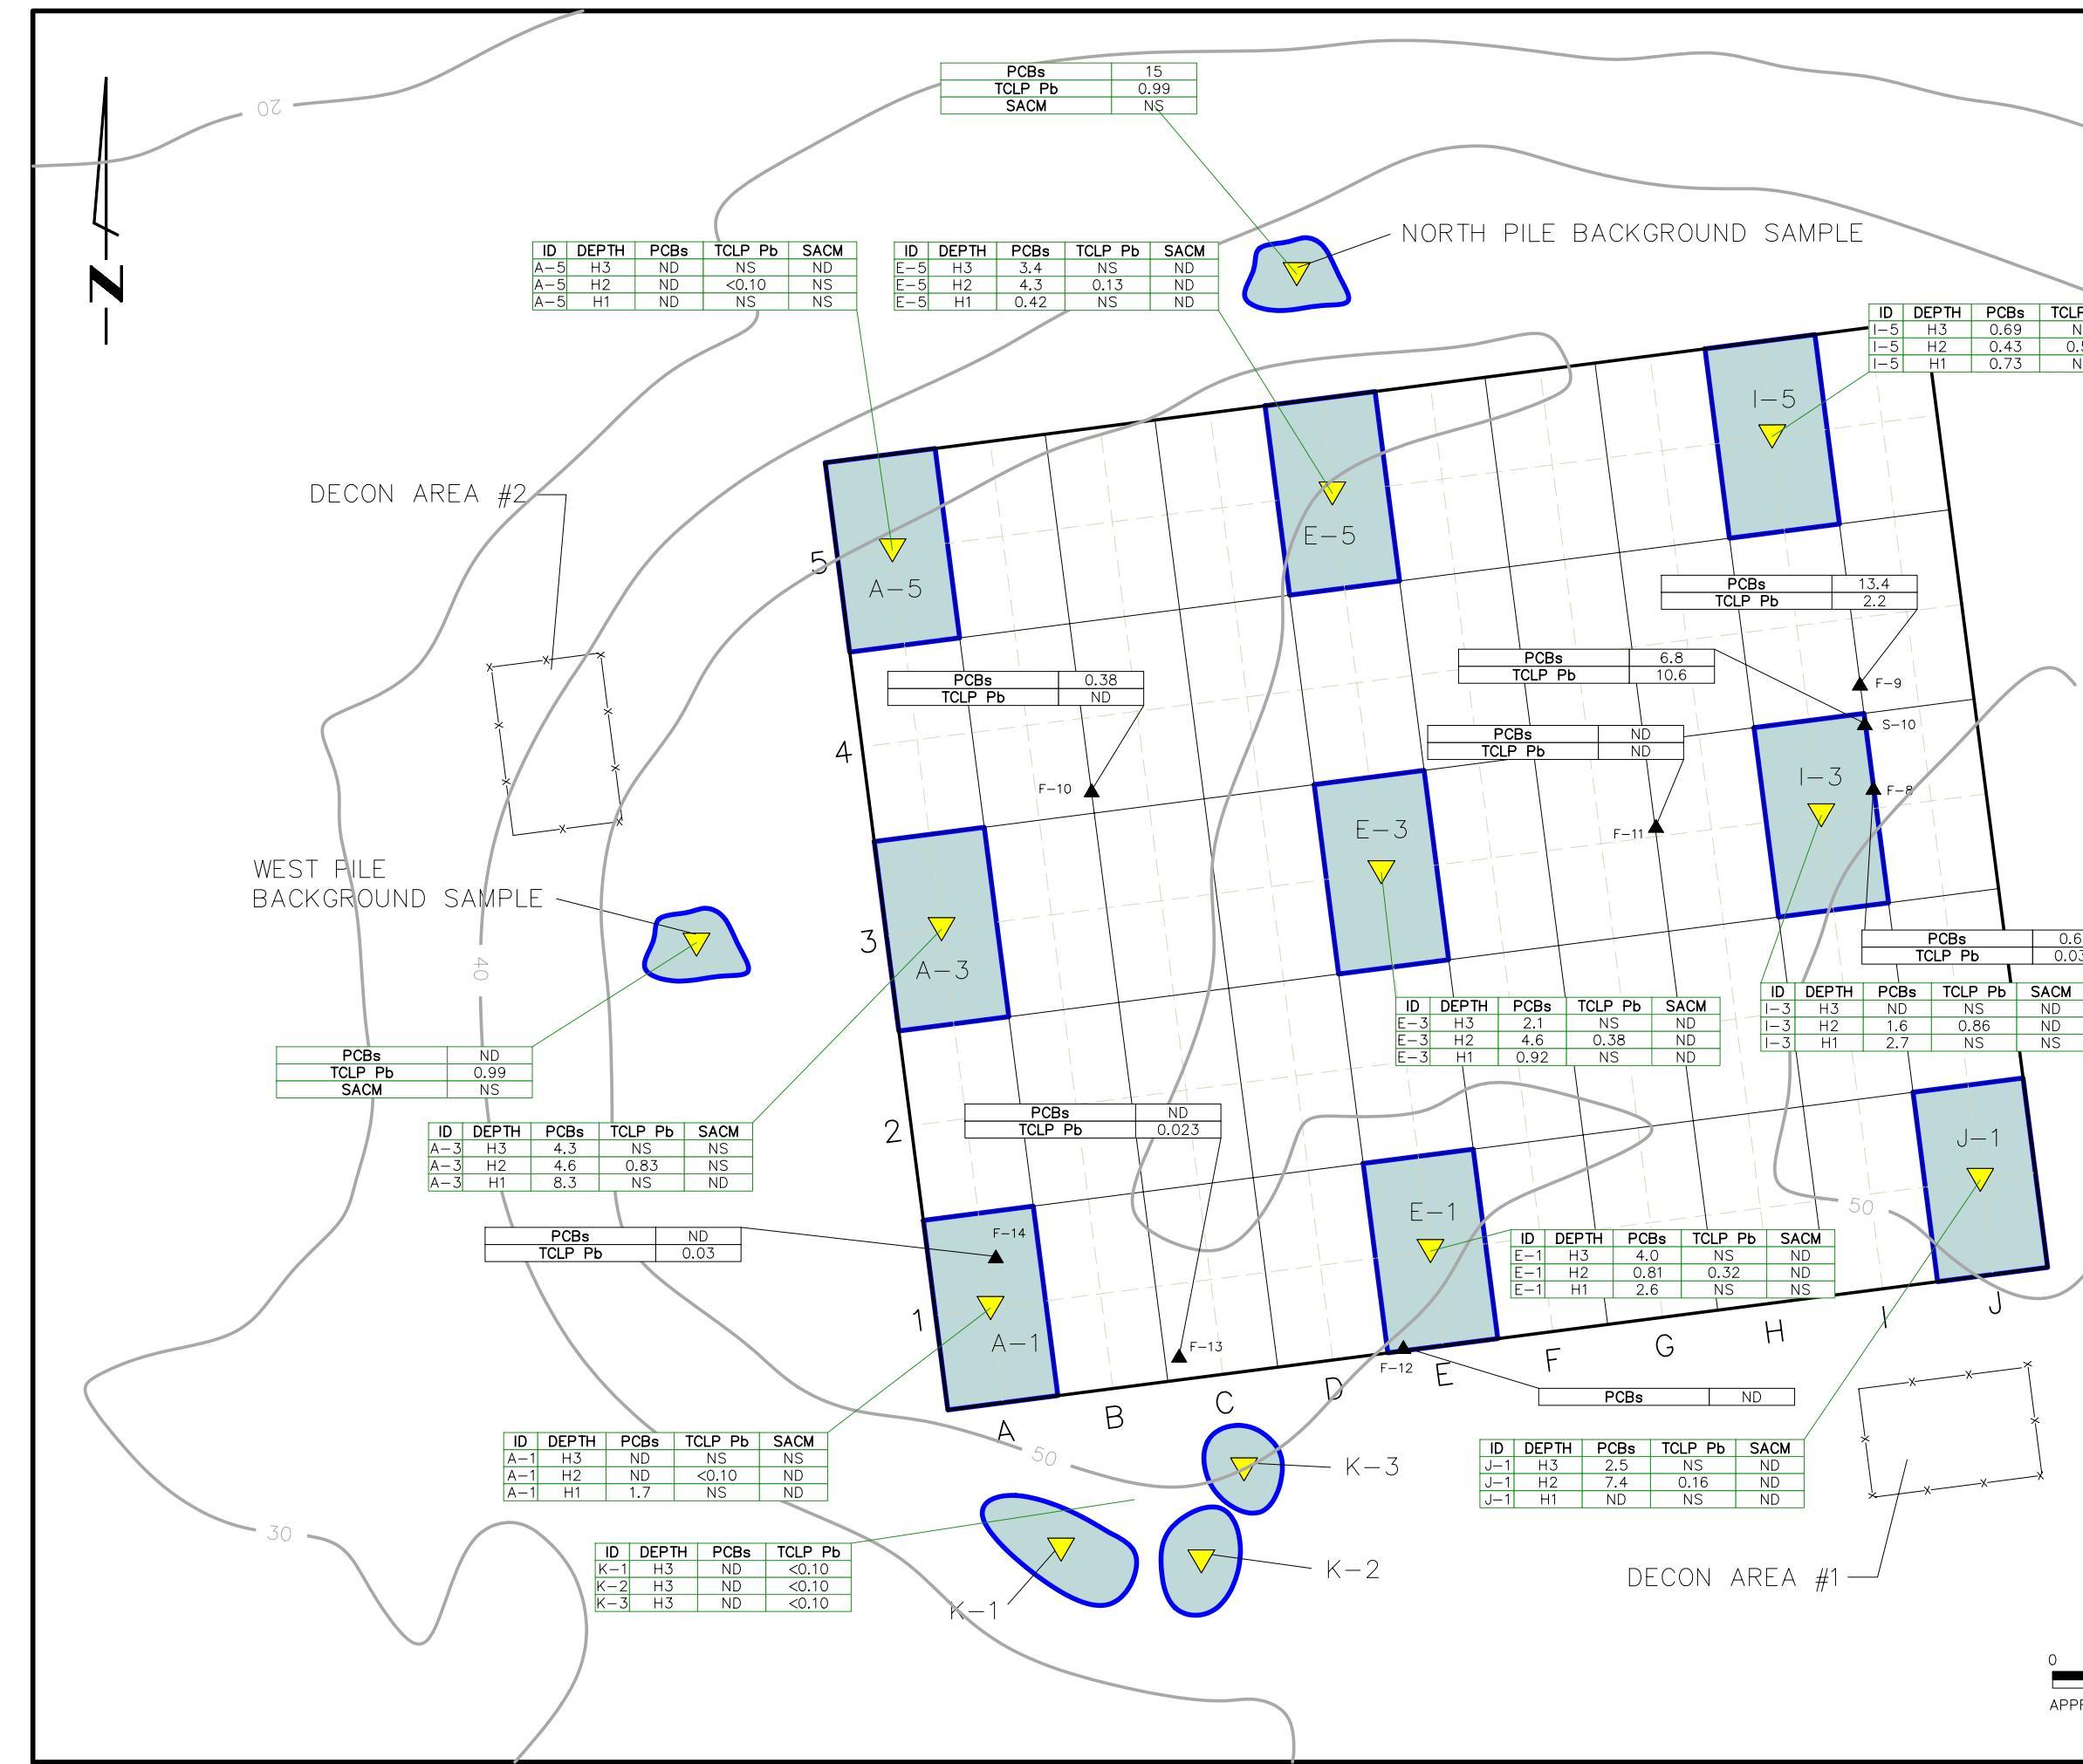
LP Pb SACM	30				
NS ND 0.59 ND NS NS					
	MULTI-LEVEL SAMPLING LEGEND				
	SAMPLE POINT DEPTHS SAMPLED				
	A1, A3 A5 0-3, 3-7 AND 7-10 E3, E5 I3, I5				
	E1, J1 0-4', 4-7' AND 7-10'				
	K1, K2, K3 SINGLE LEVEL SAMPLING				
	H3 TOP LAYER OF SOIL HORIZON				
	H2 MIDDLE LAYER OF SOIL HORIZON H1 BOTTOM LAYER OF SOIL HORIZON				
	° <sub>x</sub>				
	LEGEND				
	30 TOPOGRAPHICAL CONTOUR (FEE	ET)			
.69 037	TEST EXCAVATION				
	SOIL SAMPLE LOCATION				
	SOIL SAMPLE LOCATION COLLECTED BY OTHERS LOCATIONS ARE ESTIMATES ON	LY			
	ND NOT DETECTED ABOVE LAB DETECTION LIMITS				
	NS NOT SAMPLED				
	SACM SUSPECTED ASBESTOS CONTAINING MATERIALS				
	UNITS PCBS IN MG/KG TCLP Pb IN MG/L				
	Genvironmenta	а I, шо			
PROX. SCALE (FEET)	10 ICALE (FEET) Figure 1: Preliminary Materials Sampling Plan Construction Materials Processing Facility Richard White Way Fairfield, Connecticut				
	JOD ING. 361.2/08.02.1/ D/B: ILD DATE: 02/	1/

in Accordance with 761.61. The investigation involved the advancement of ten (10) test pits in the eastern portion of the Reclamation Yard to take multi-level samples from the pile for analyses of PCBs using the Soxhlet extraction method EPA 3540C/8082A, leachable (TCLP) lead, and asbestos. Two additional shallow samples were collected from areas anticipated to be beyond the extent of the PCB-contaminated fill for analyses of the same parameters. The investigation was completed by Complete Environmental Services under the direction of LES, GO Environmental, and the Town of Fairfield in February 2017. In summary, the investigation indicated that asbestos-containing materials and RCRA hazardous lead concentrations were not detected in the thirty-two samples collected during this investigation phase. Concentrations of PCBs were detected greater than 1 mg/kg in seventeen (17) of the thirty-two samples collected from the pile, with the highest PCB concentration being 15 mg/kg. A plan depicting the sample locations, and table 10 that summarizes the results of the sample analyses are included in Appendix A.

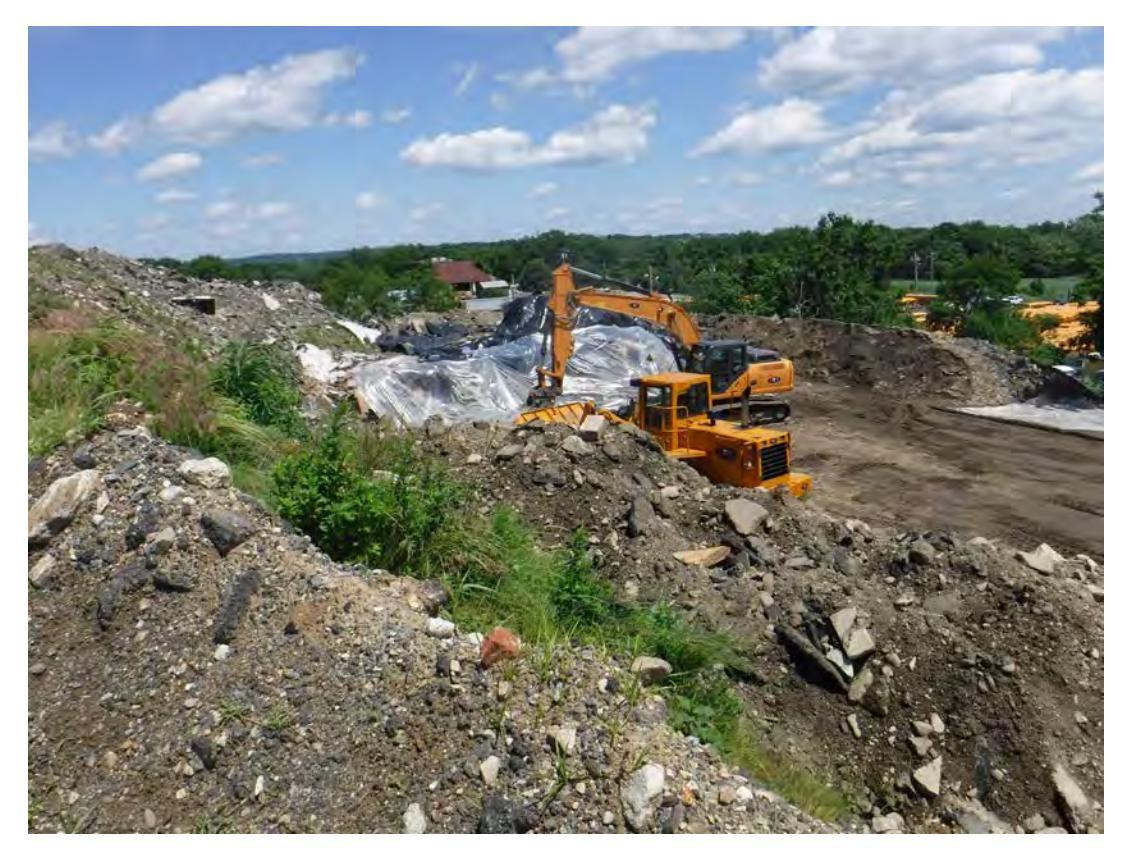
Photograph 1 - June 16, 2017: PCB-contaminated fill pile area covered by polyethylene sheeting.

In response to the November 29, 2016 Reclamation Yard sample results, the Town of Fairfield covered the eastern portion of the pile with polyethylene sheeting to prevent potential stormwater and wind impacts. The Town also directed their stormwater consultant, Osprey Environmental Engineering, LLC, (Osprey) to collect additional samples from the pile area, the stormwater sedimentation basins including the inlet and outlet, and the stormwater channel at Pine Creek. The purpose of the additional soil and sediment samples was to determine if additional areas of PCB-contaminated soil were present in surficial material in the eastern portion of the pile that may be subject to stormwater runoff, and to determine if contaminants were potentially migrating offsite and impacting the adjacent properties and sensitive salt marsh/surface water body receptors. Osprey also collected an air sample to determine if airborne dust from the pile contained elevated concentrations of lead that could adversely impact adjacent property occupants.

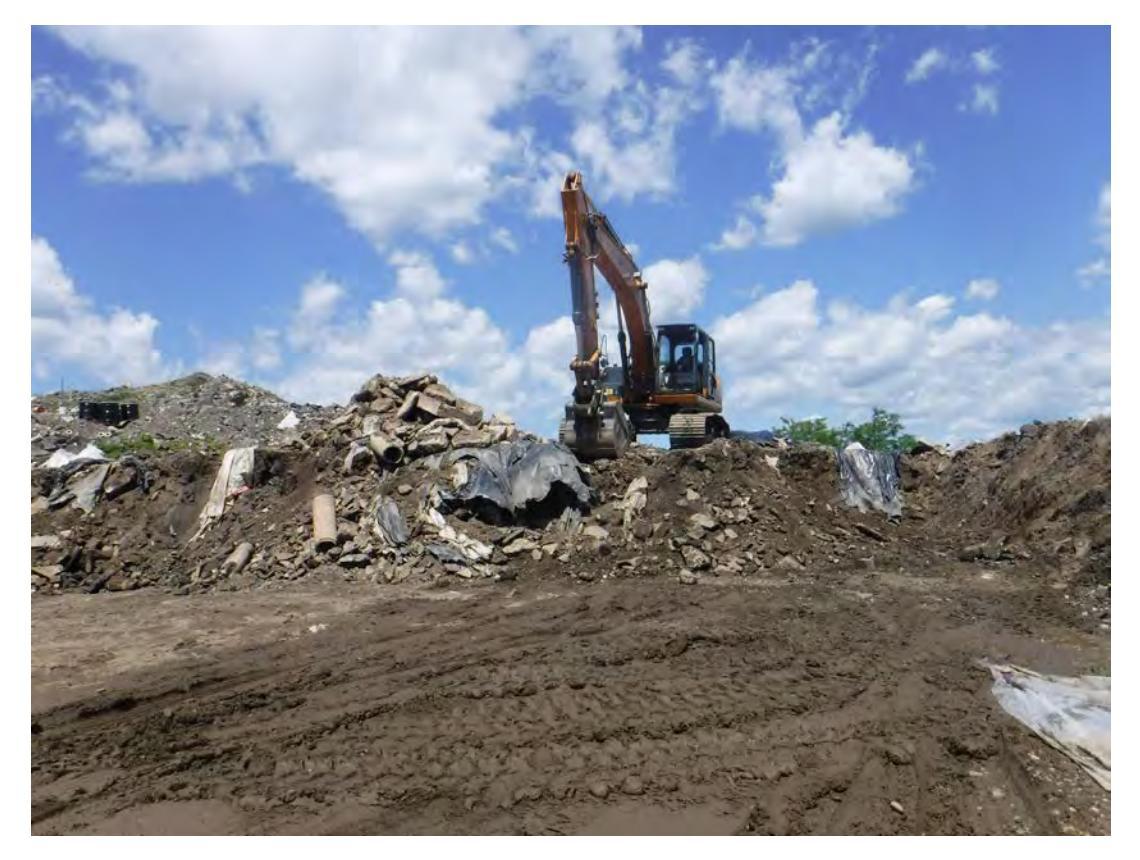
Photograph 2 - June 20, 2017: Segregating the bulky debris from the soil. Debris was placed on polyethylene sheeting (lower right) prior to sampling by LES.

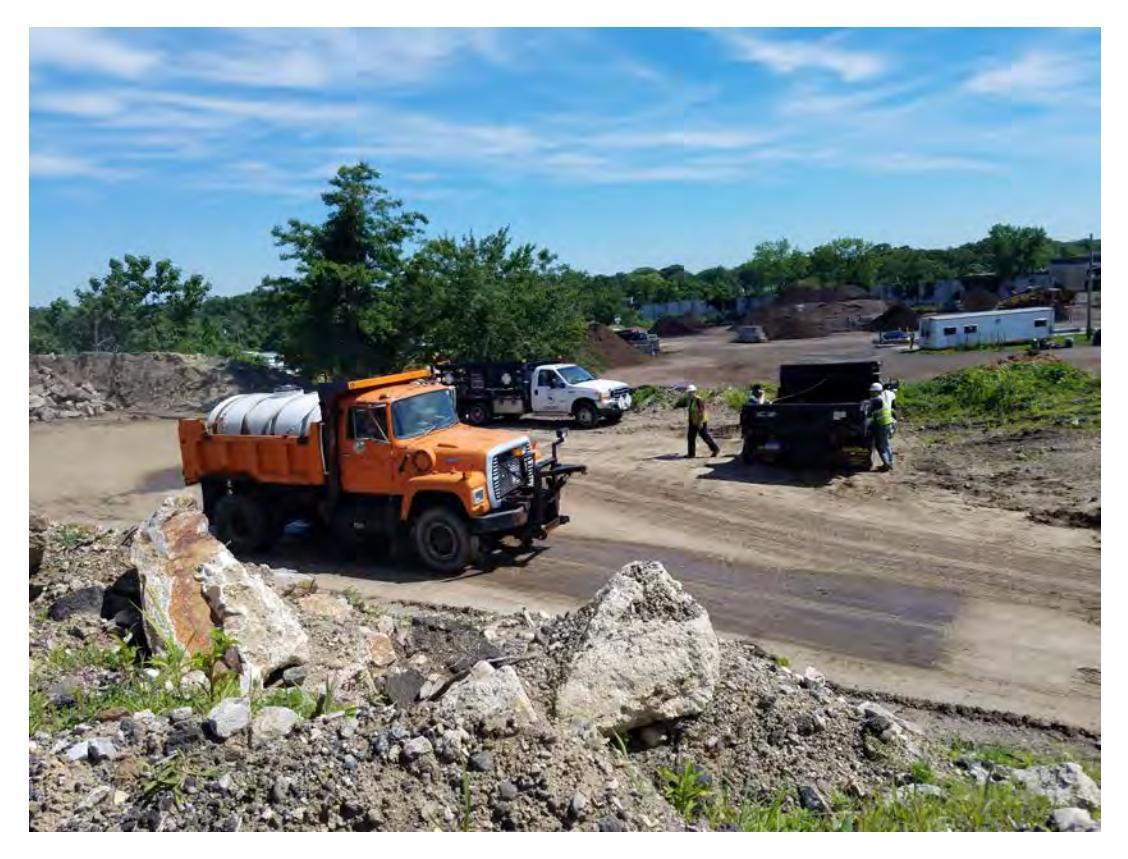
Photograph 3 - June 22, 2017: Dust control measures undertaken by Town using water truck.

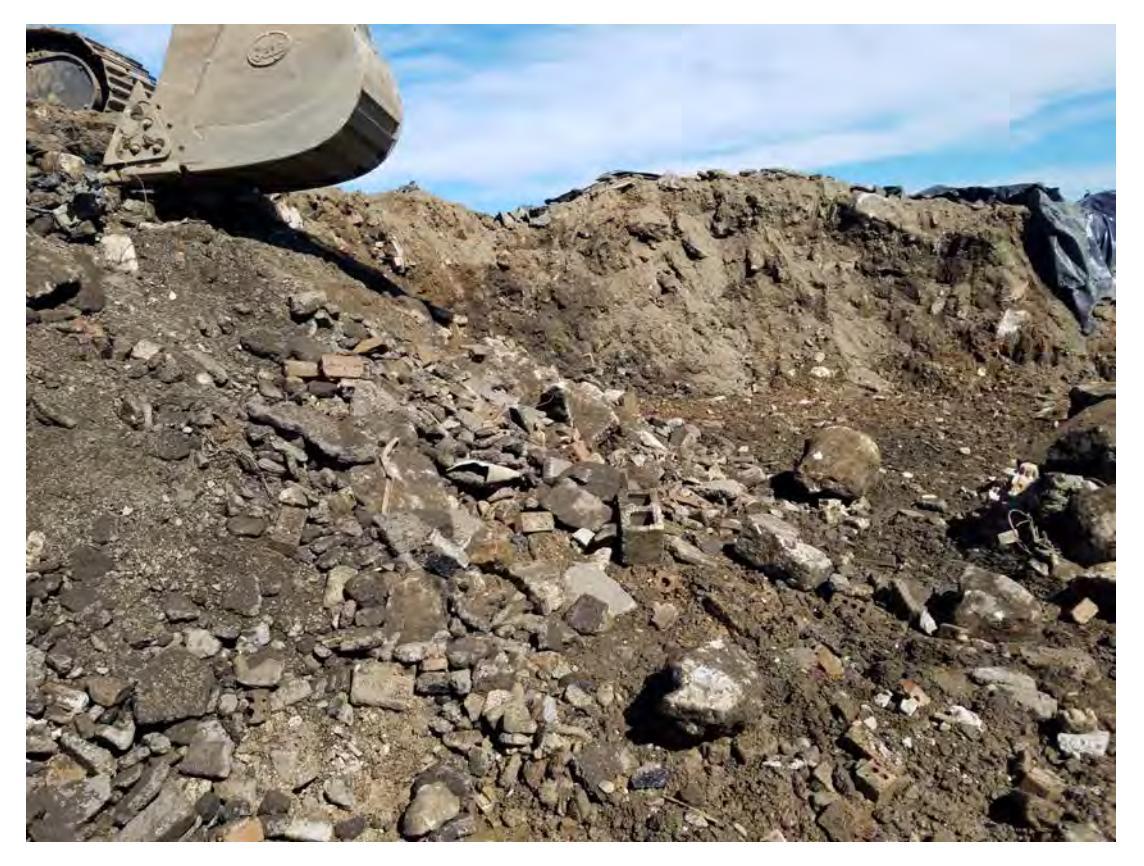
Photograph 4 - June 22, 2017: Type of fill material present in PCB-contaminated area.

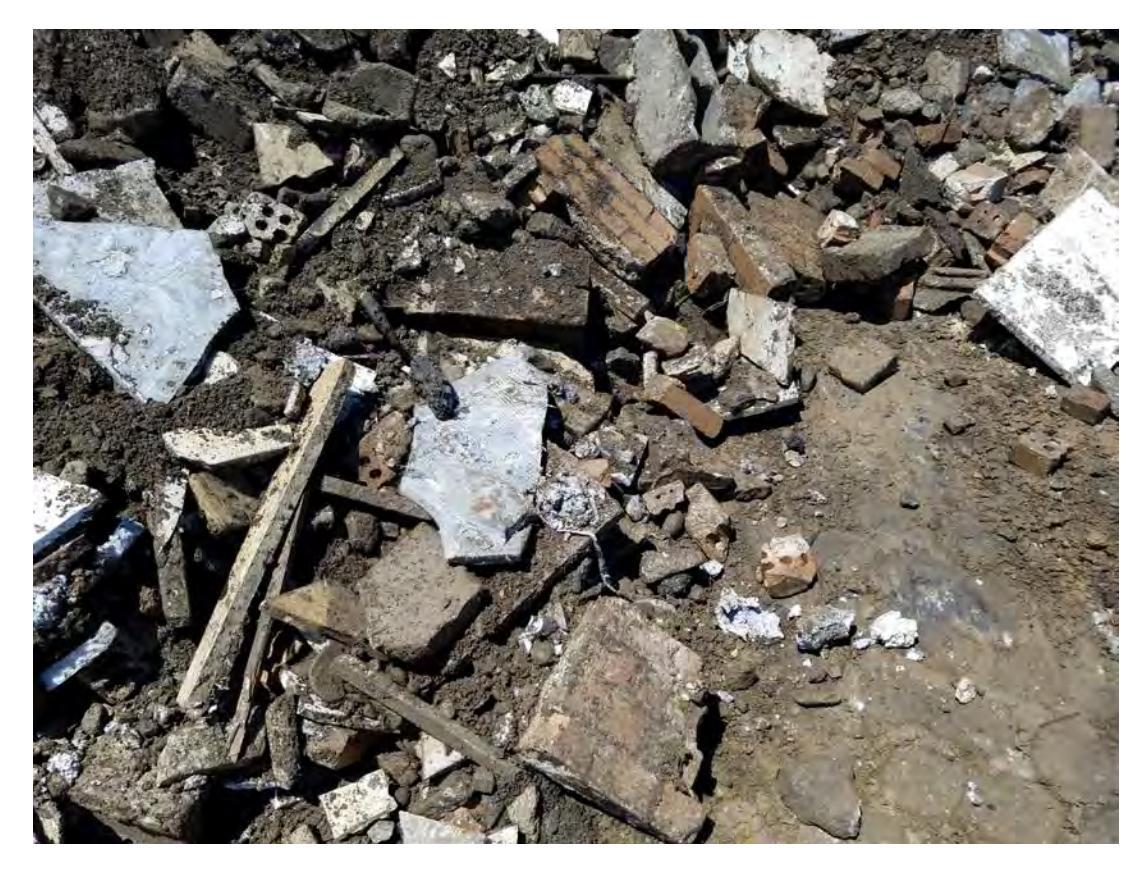
Photograph 5 - June 23, 2017: Fill material present in PCB-contaminated area.

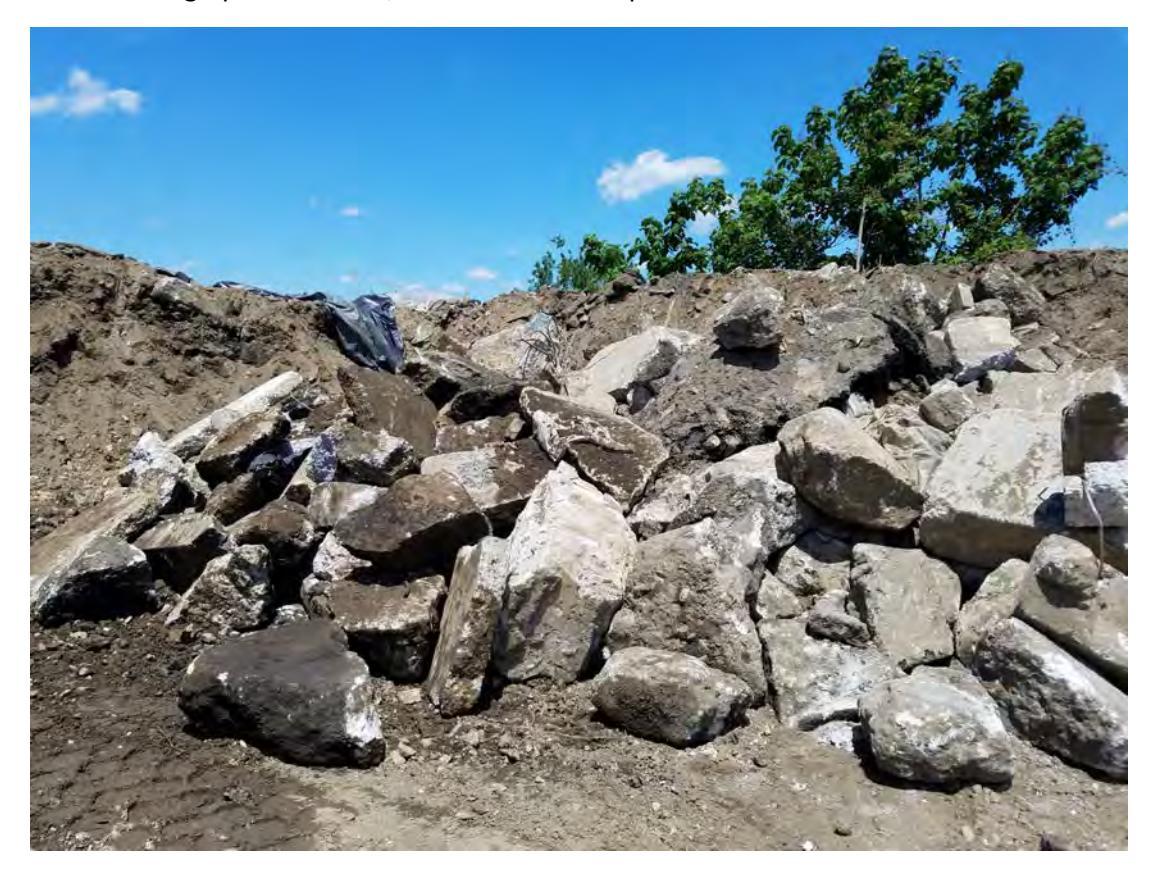
Photograph 6 - June 22, 2017: Additional bulky debris segregated from pile area.

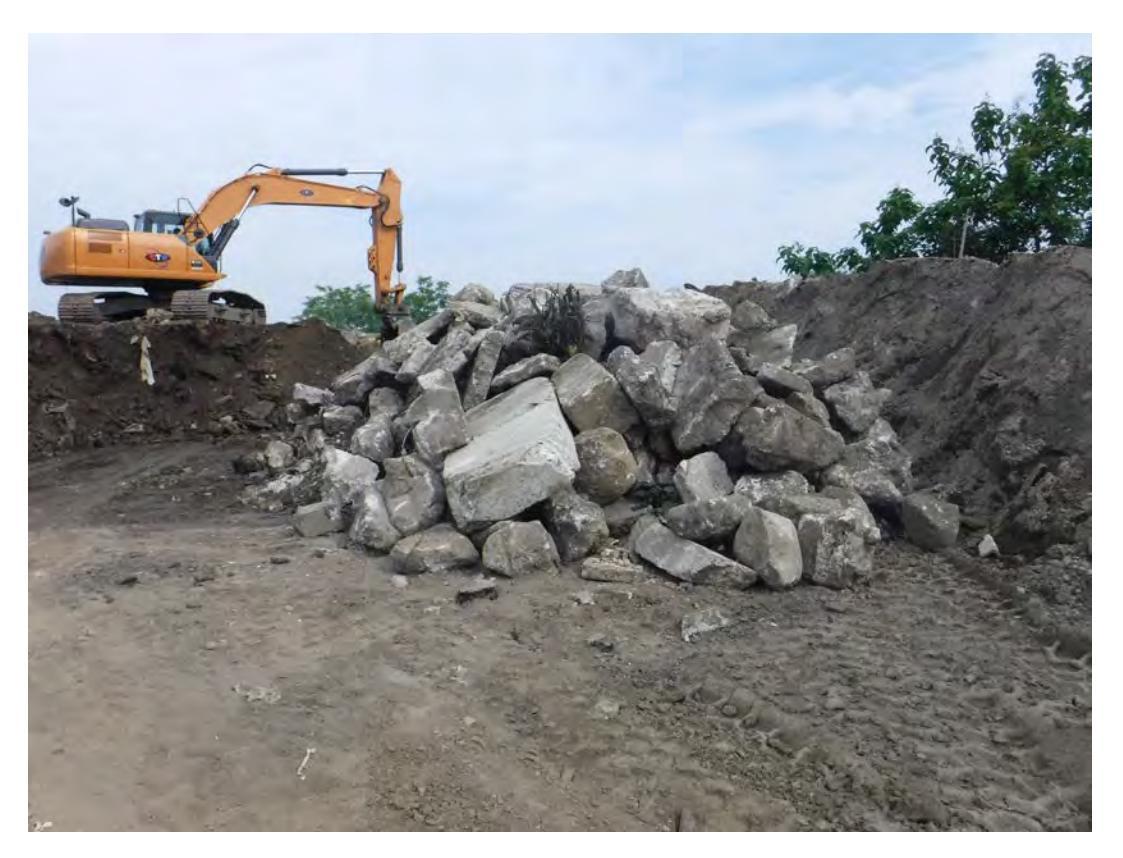
Photograph 7 - June 23, 2017: Final pile of bulky debris to be placed on polyethylene prior to sampling.

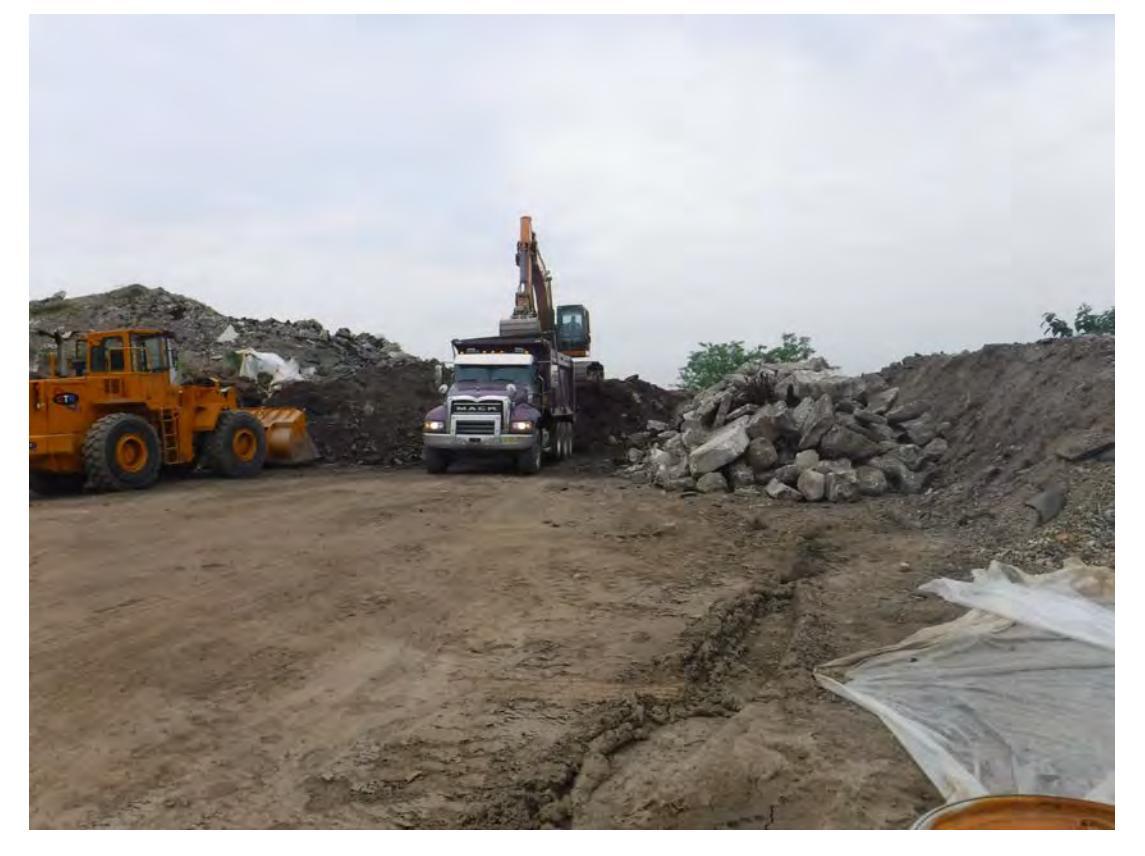
Photograph 8 - June 23, 2017: Triaxle truck being loaded for transport of soil to Hazelton Creek disposal facility.

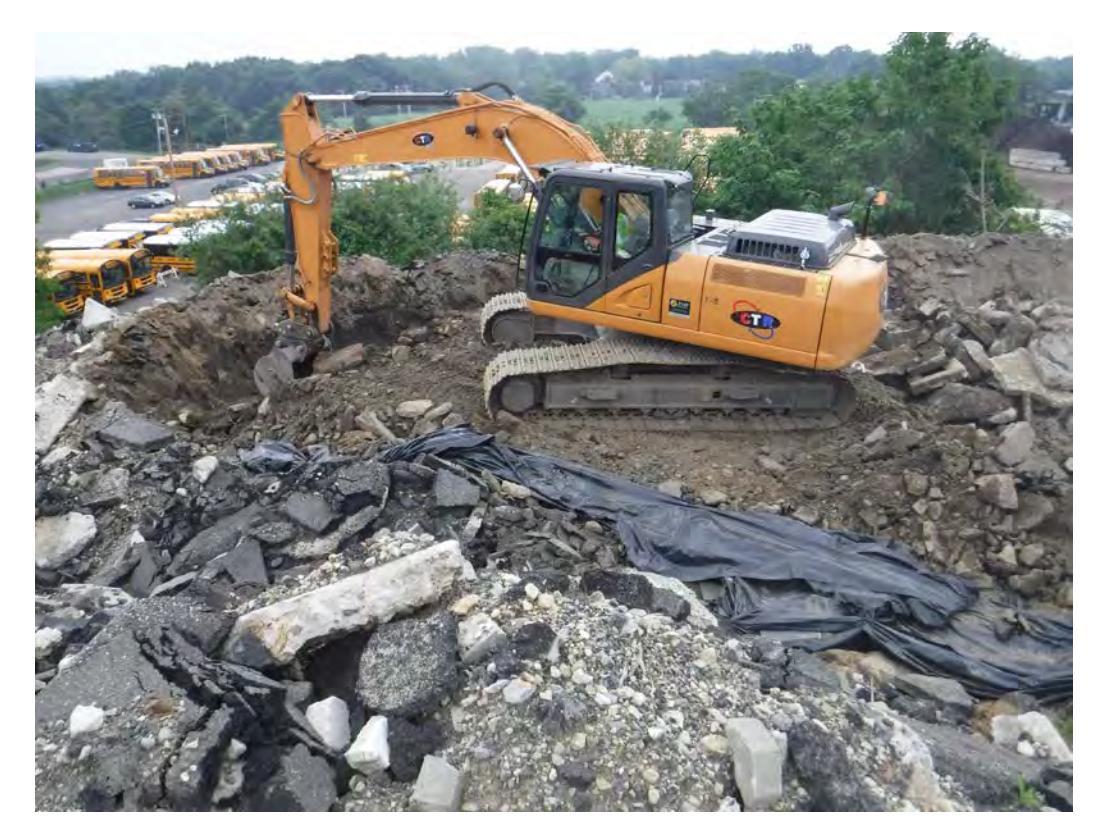
Photograph 9 - June 23, 2017: Excavating soil from the north sidewall (to left) and bottom of the PCBcontaminated area.

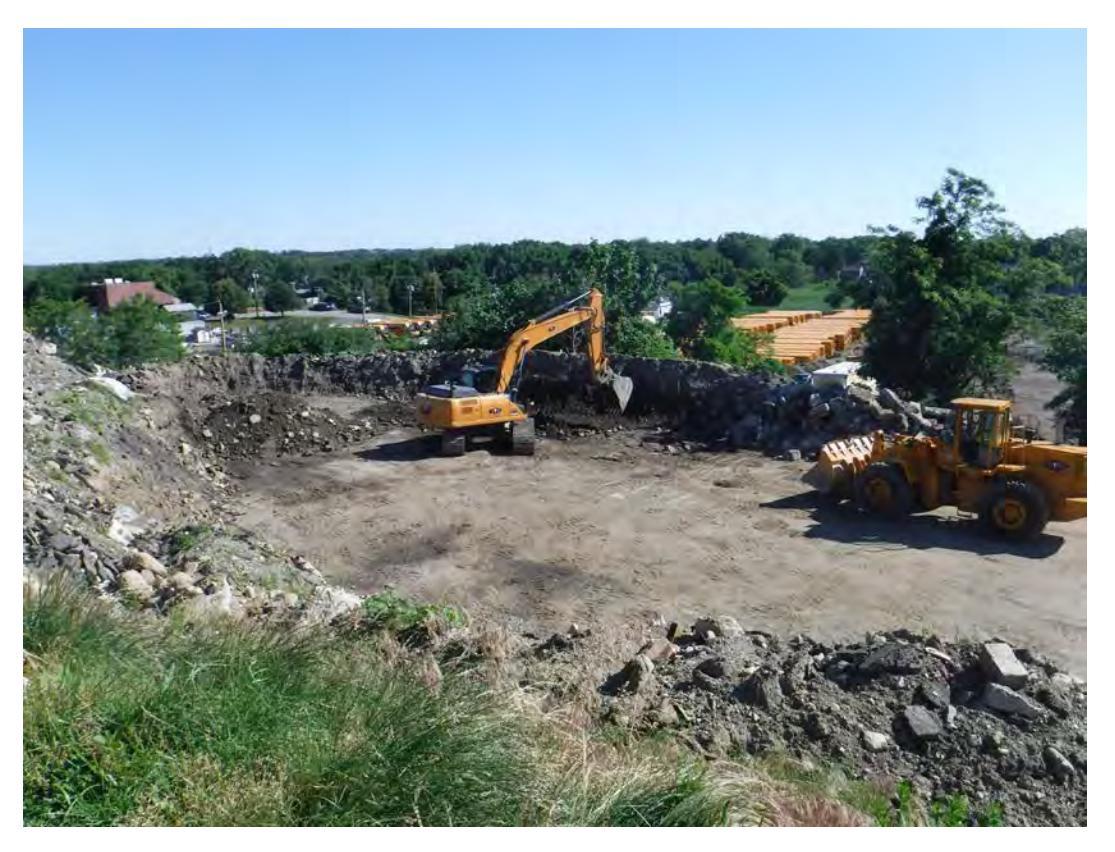
Photograph 10 – June 26, 2017: Excavating soil from the eastern sidewall and bottom of the PCBcontaminated area.

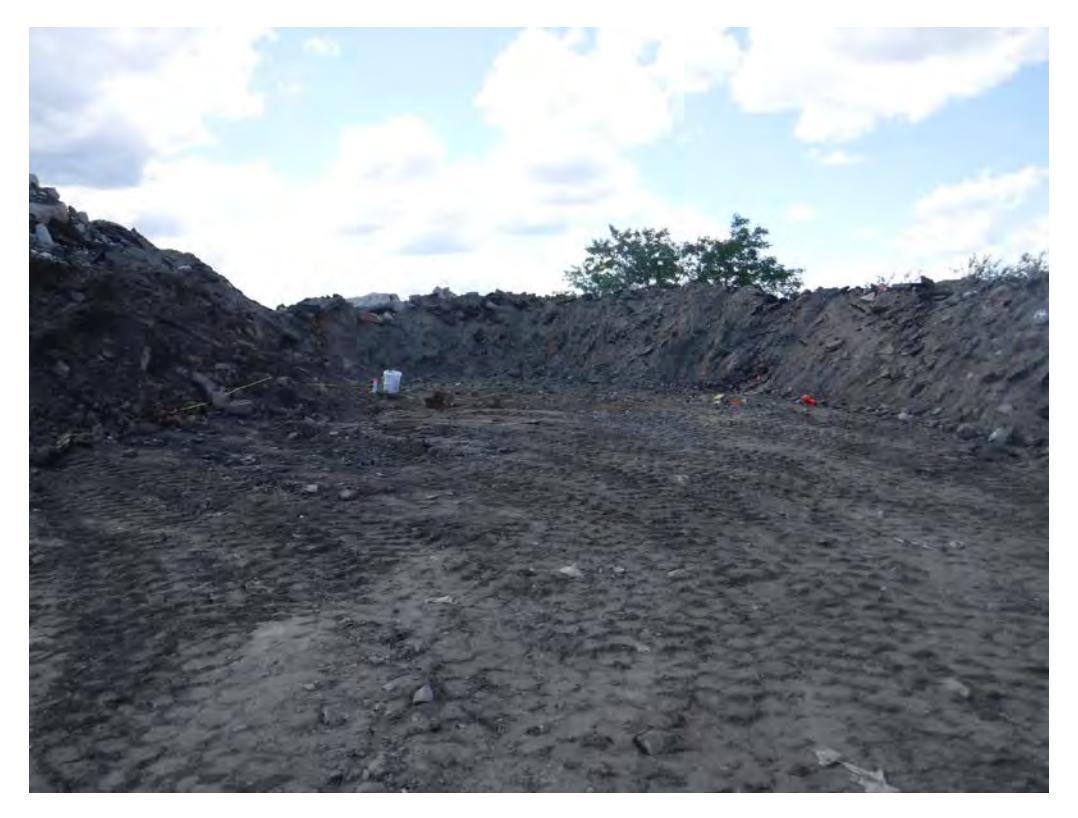
Photograph 11 - June 26, 2017: Initial 1.5-meter sampling grid being set up for western (left), northern (center), and eastern (right) sidewalls and bottom.

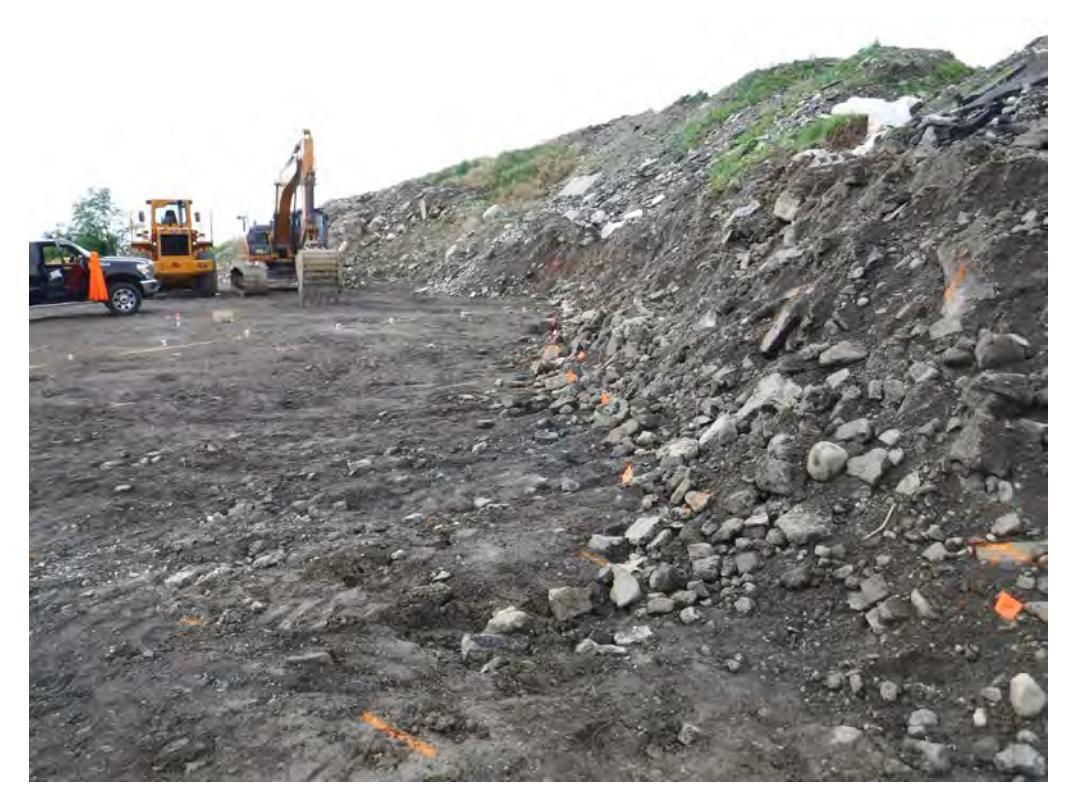
Photograph 12 - June 27, 2017: Sampling grid set up for western sidewall and bottom.

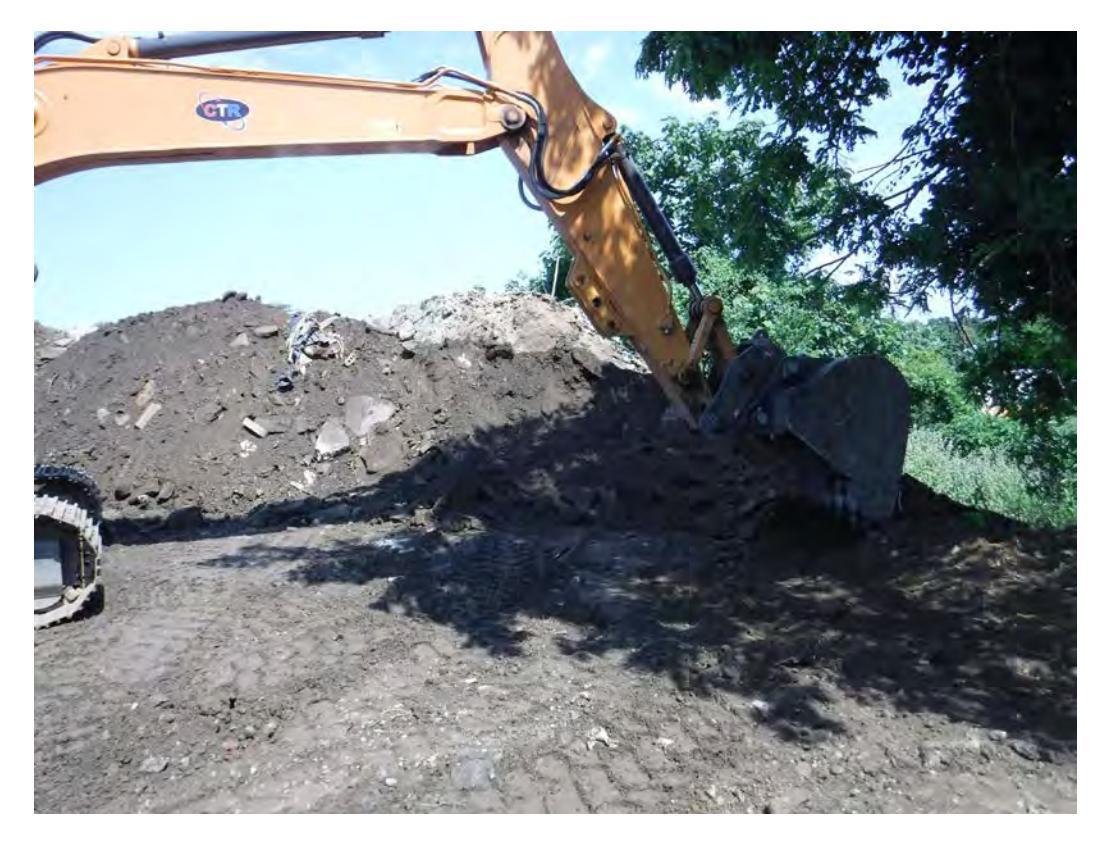
Photograph 13 – July 18, 2017: Start of the excavation of the entire eastern sidewall of the pile area for subsequent offsite disposal.
