# REMEDIAL ACTION REPORT PCB-Contaminated Fill Pile

### Town Reclamation Yard 183 Richard White Way Fairfield, Connecticut

Logical Environmental Solutions, LLC 354 South River Road Tolland, Connecticut

December 5, 2017

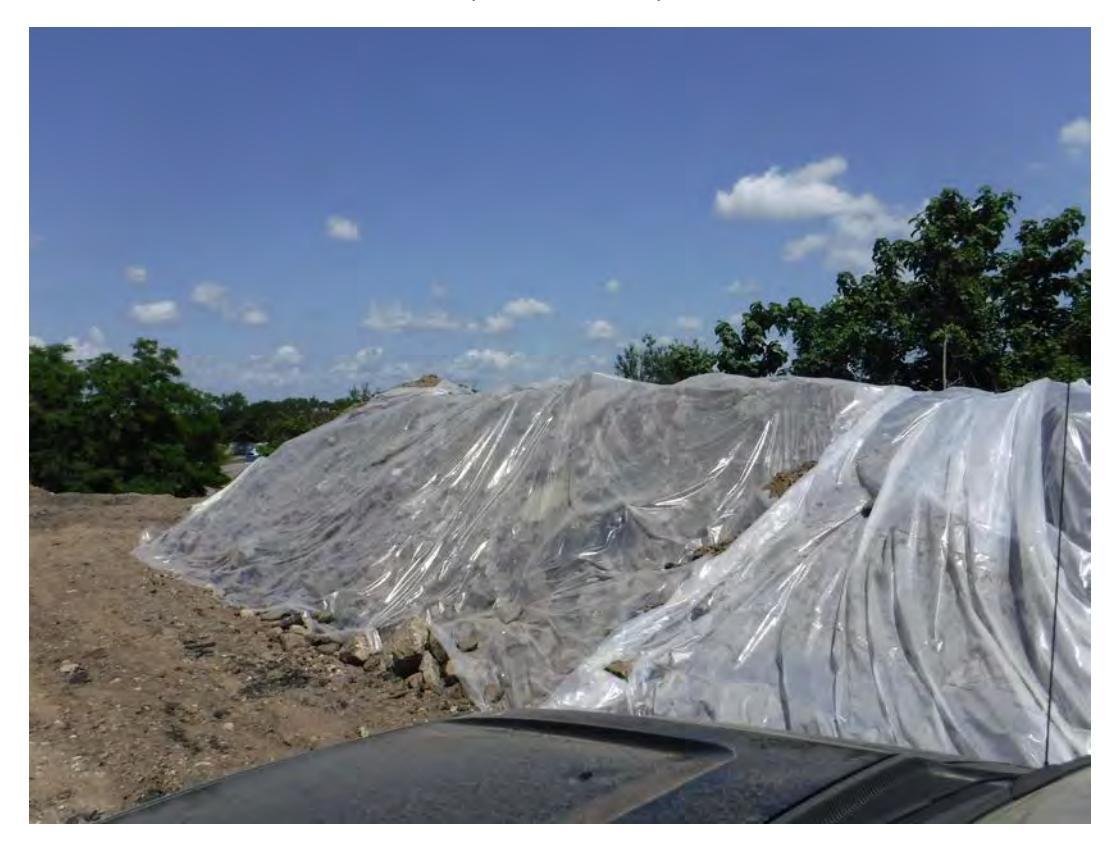
Photograph 14 – July 18, 2017: Soil from the eastern sidewall covered by poly and ready to be loaded for offsite disposal.

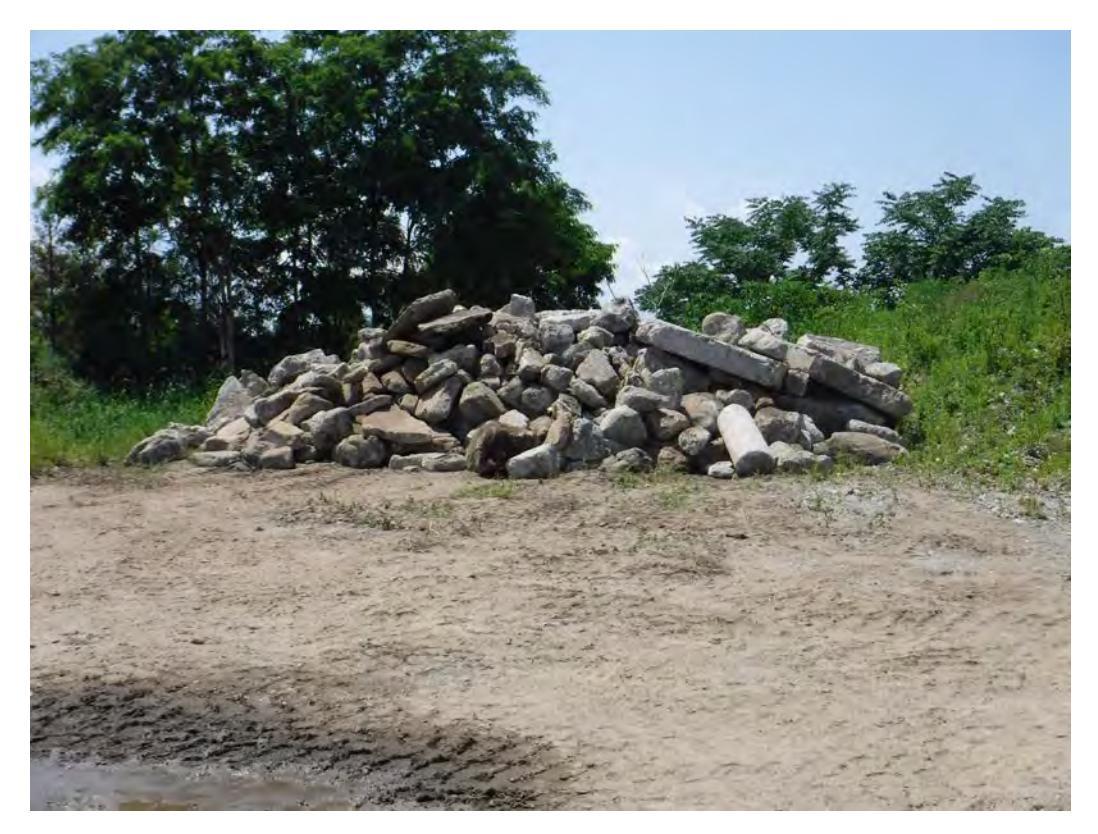
Photograph 15 – July 18, 2017: Pile of the bulky debris that tested ND for PCBs and was moved to the southwest region of the Reclamation Yard.

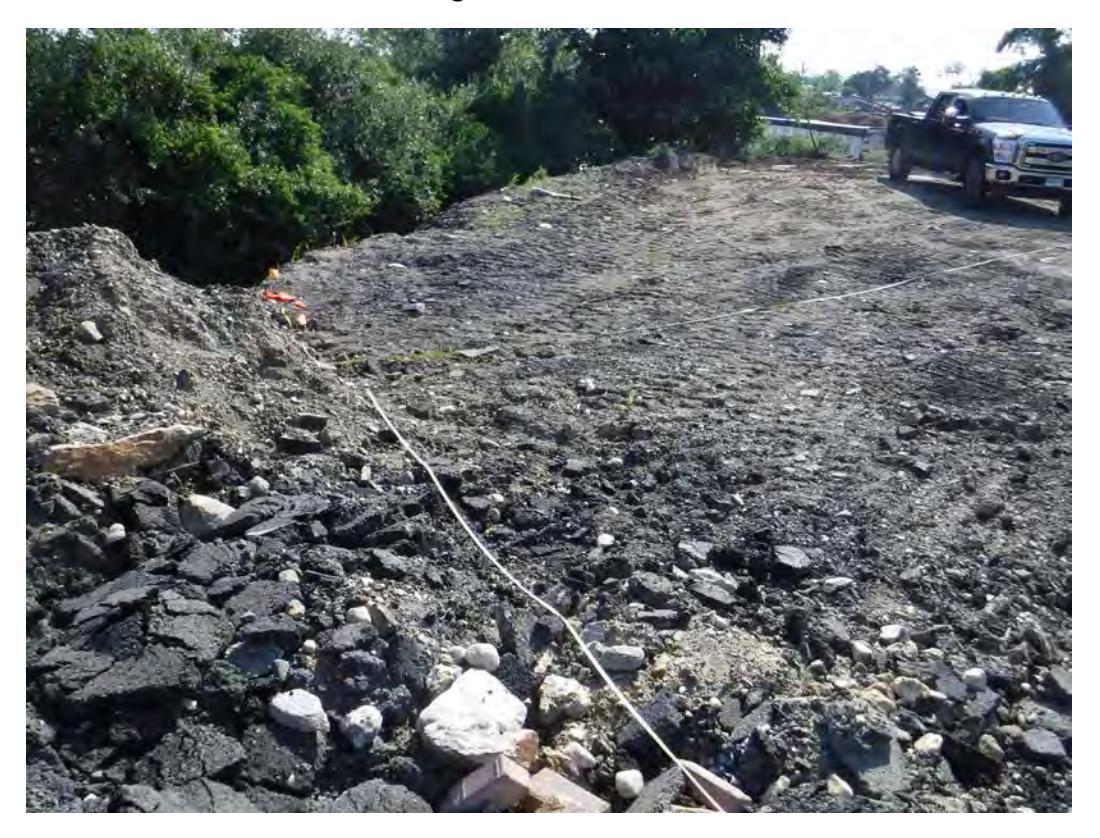
Photograph 16 – August 16, 2017: Laying out the grid for the additional confirmation soil sampling of the pile bottom.

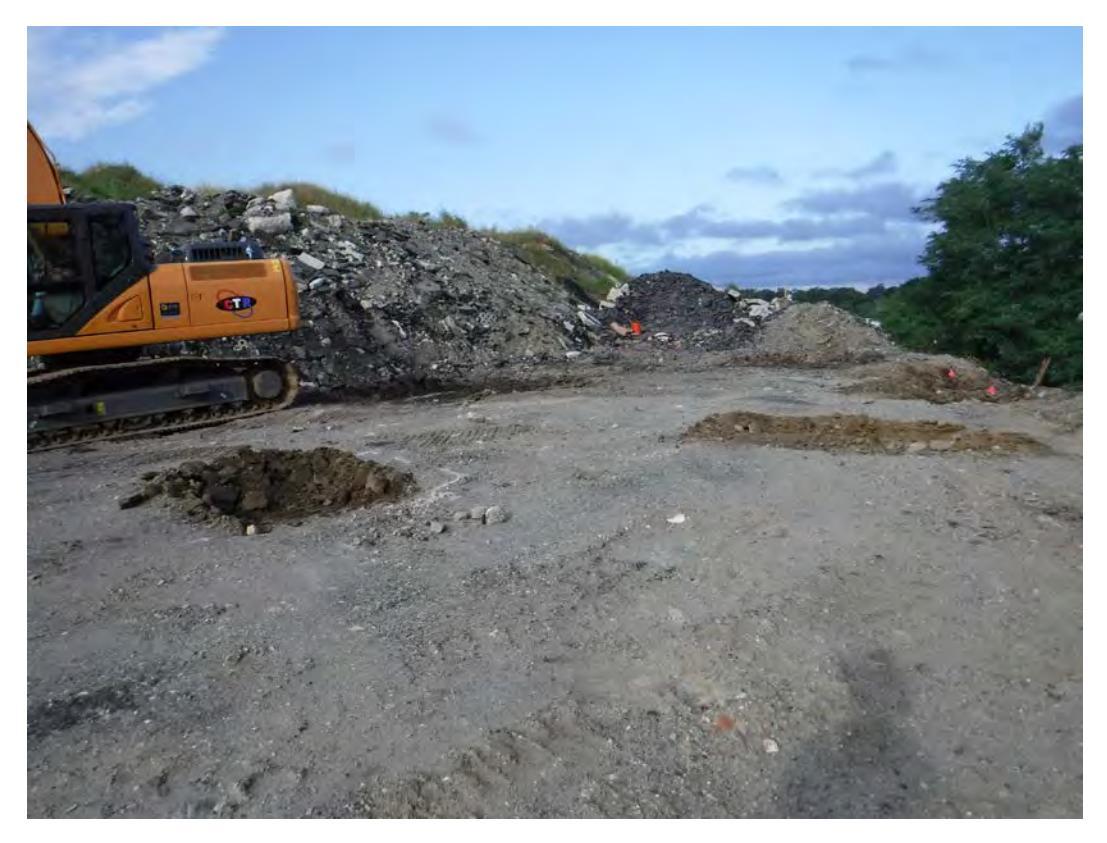
Photograph 17 – September 19, 2017: "Hot-spot" remediation of bottom sample areas that contained PCBs greater than 1 mg/kg.

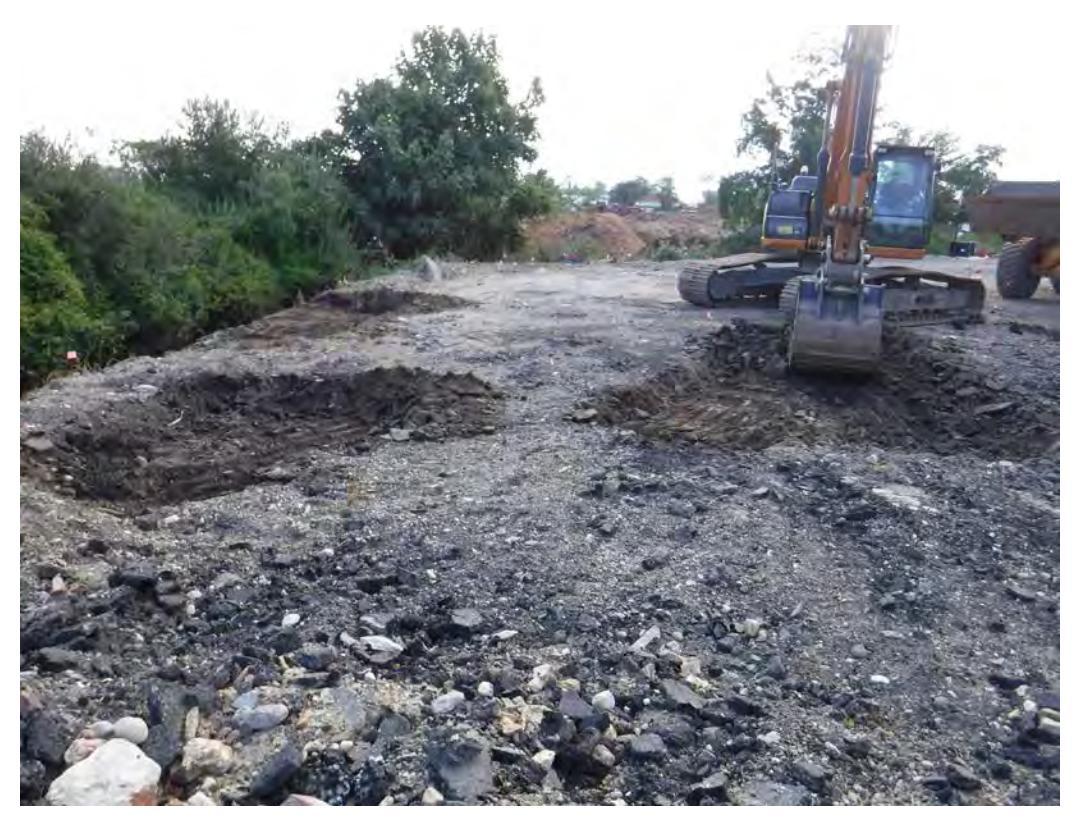
Photograph 18 – September 19, 2017: "Hot-spot" remediation of bottom sample areas that contained PCBs greater than 1 mg/kg.

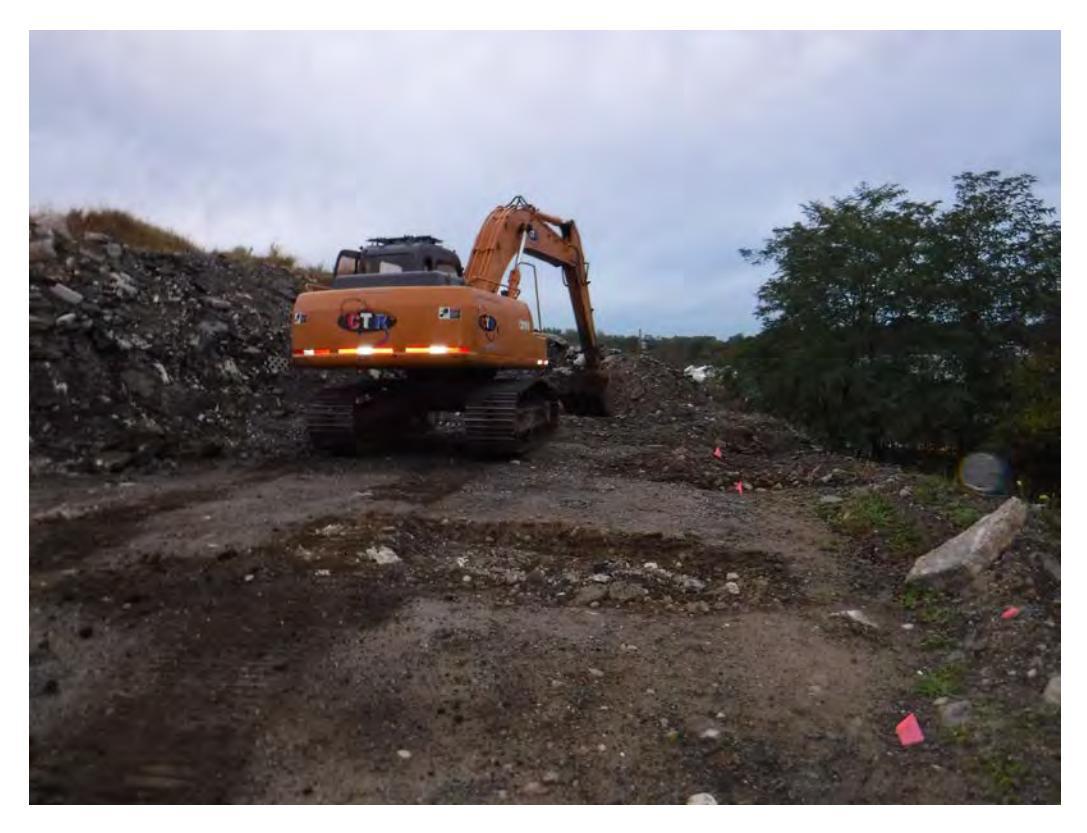
Photograph 19 – October 11, 2017: Final "hot-spot" remediation of bottom sample areas that contained PCBs greater than 1 mg/kg.

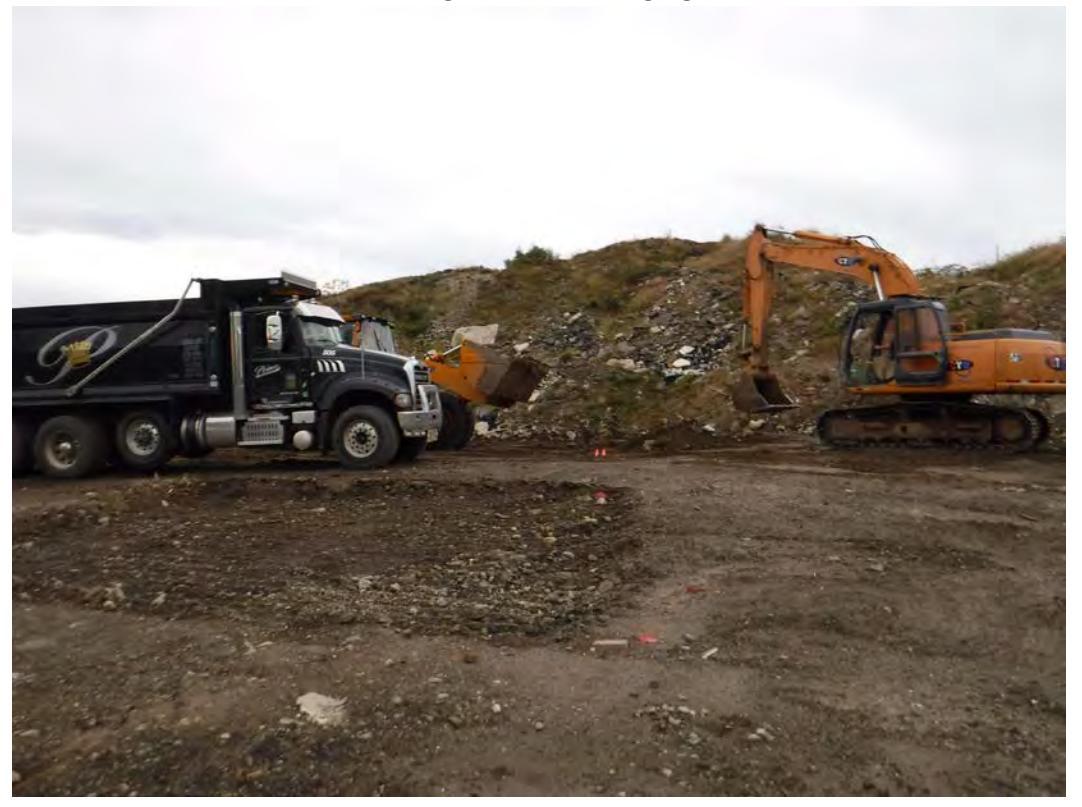
Photograph 20 – October 11, 2017: Final truck being loaded with PCB contaminated soil for offsite disposal.
