SUMMARY OF RECLAMATION YARD INSPECTION

Week No.: 5

Inspection Date: October 28, 2016

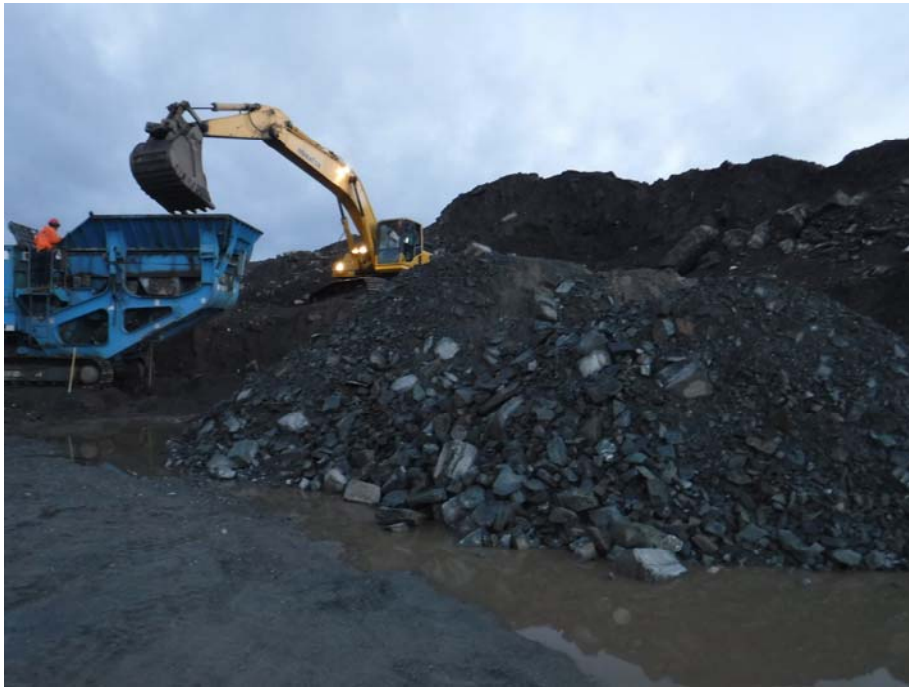
Screening new material along southern edge of main pile. Photograph taken from southern side of main pile facing northwest.

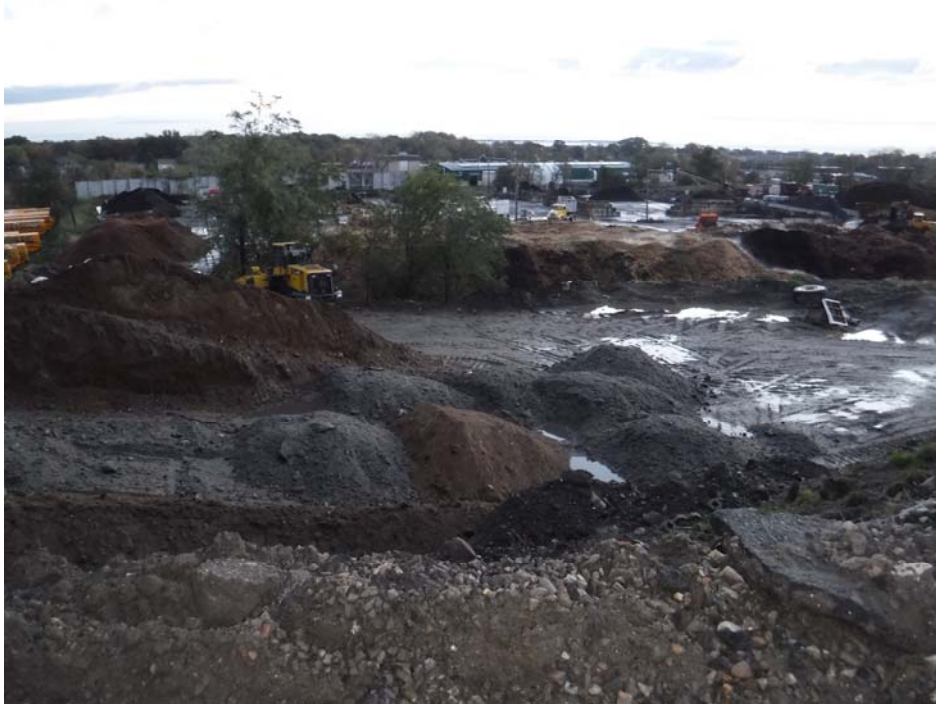
Eastern side of main pile, looking down from top of the pile, facing east. Soil has been re-worked/moved to assist in filling in/drying out large puddles due to rain. The brown soil consists of material represented by the S-5 sample collected October 14, 2016 and the gray soil consists of material represented by the S-1 sample collected September 29, 2016.
