# Fairfield Beach Neighborhood Meeting

## Public Works Yard Remediation

APRIL 13, 2017

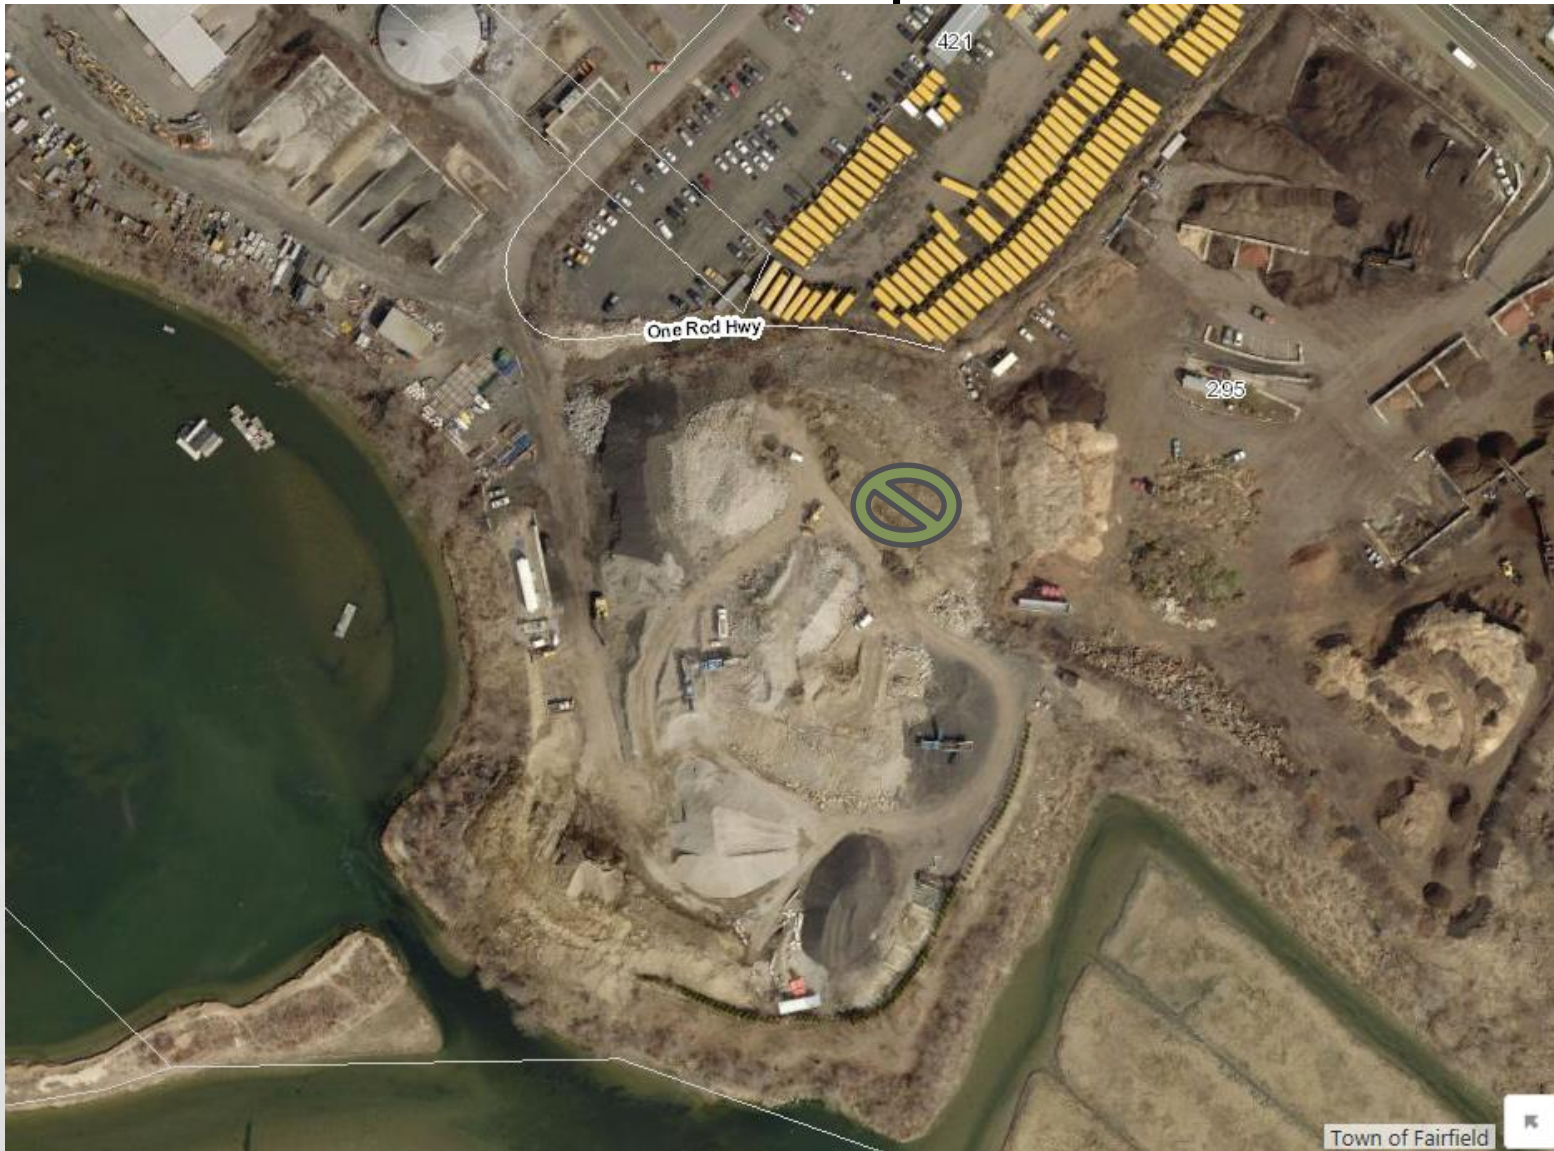
# Site Map

- As part of the Remedial Investigation, eleven test pits were completed and 32 soils samples were collected.
- Select samples were analyzed for PCBs, lead, and asbestos by independent State Certified Laboratory.
- Highest PCB concentration was 16 ppm. No Asbestos Containing Materials. No Hazardous Levels of Lead detected in this round of sampling.
- Laboratory data was compiled and reviewed to determine the degree and extent of the contaminated material.

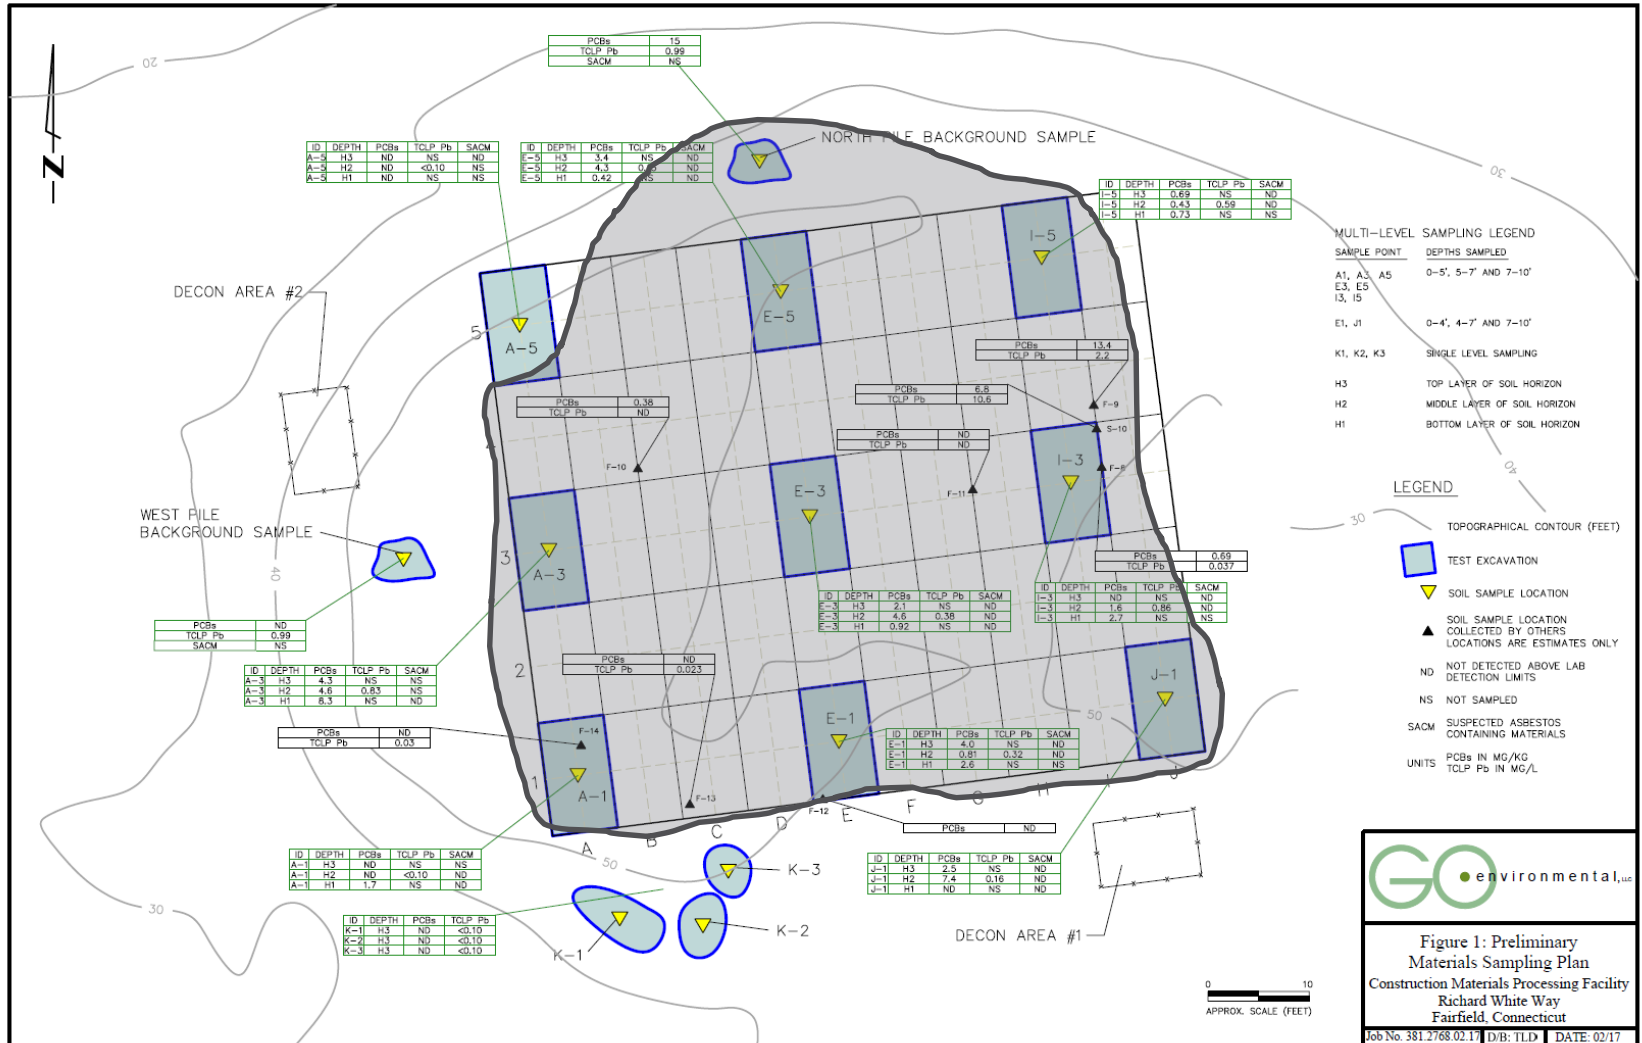
## What does this mean?

- Did not exceed thresholds of Toxic Substances Control Act (TSCA) which is 50 ppm for PCBs. Can be disposed of as Non-TSCA Regulated PCB waste material.
- LEP from Logical Environmental developed a Remedial Action Plan (RAP) dictated by the results of the Remedial Investigation as represented in Request for Proposals - Bid #2017-73
- To date, CTDEEP has not issued any formal enforcement order for the removal of the waste. The CTDEEP PCB Division was consulted on the remedial investigation design and continues to be consulted on the progress of the remediation.
- Town's LEP acting as an agent of CTDEEP to oversee and certify remediation.

- Excavate impacted soils into lined, covered roll-offs containers
- Transport to certified disposal facility
- Collect Post Excavation Soil Samples for verification
- If not verified clean, additional material will need to be removed
- Prepare Remedial Action Report (RAR) of the final post remediation findings and submit to the CTDEEP PCB Division.
- LEP verifies cleanup completed to CTDEEP and EPA regulations
